A Thesis in Historic Preservation Presented to the Faculties of the University of Pennsylvania in Partial Fulfillment of the Requirements for the Degree of Master of Science in Historic Preservation 2007.

**THE INTERPLAY OF TECHNOLOGY AND DURABILITY:
THE EVOLUTION OF 20TH-CENTURY HIGH-RISES AND IMPLICATIONS
FOR PRESERVATION PHILOSOPHY**

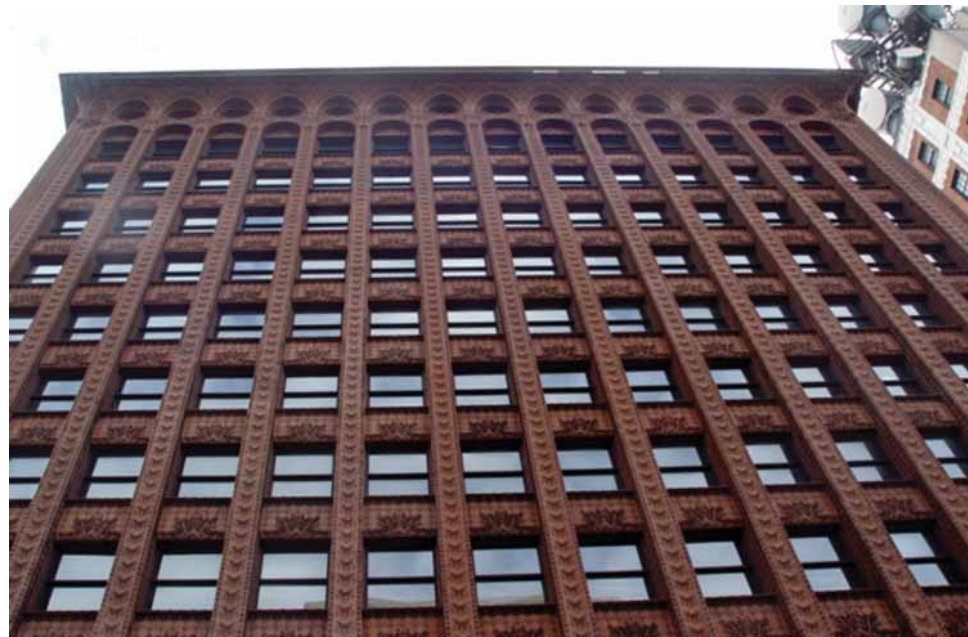
Figure 4.3 - Detail of the Guaranty Building facade, photo by B. Dandona 6 Nov. 2006.

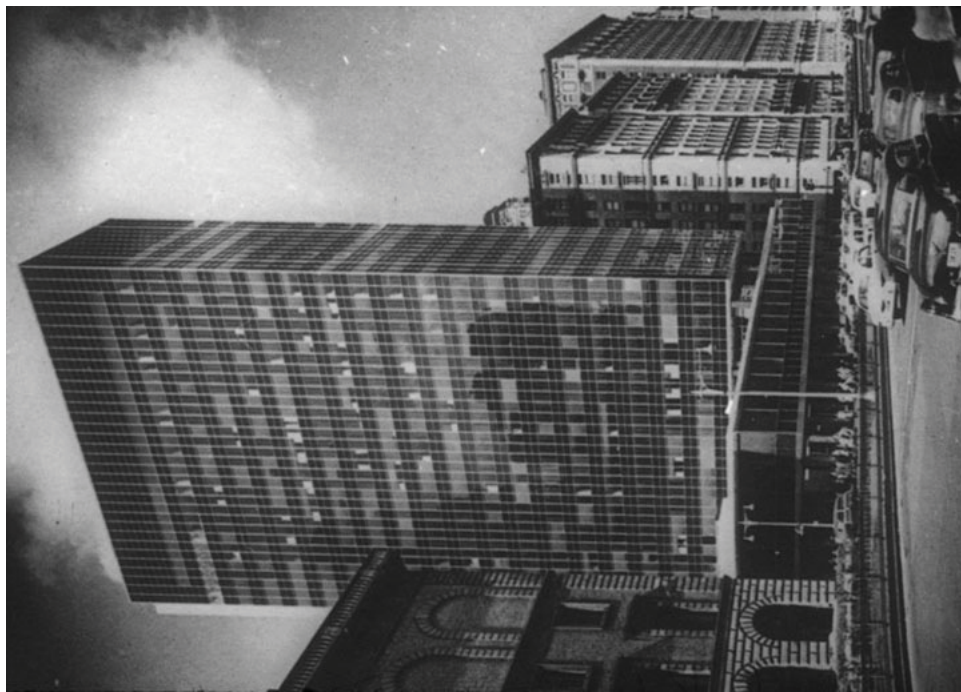
Figure 6.1 - Lever House, photo by E. Buckley 19 Dec. 2006.

In 2002, Lever House underwent a major restoration in which the entire curtain wall was removed and re-skinned with a new system that was visually “in-kind” to the original, but with many technical improvements (see *Figures 6.1 & 6.2* and *Drawing 6.1*). Even if the same 1950s curtain wall system were available, it was not desirable to reproduce the same system because of the inadequacies and failures of the original (these issues will be discussed in further detail in Chapter 10). Though the original curtain wall has already been replaced, this service life analysis strives to assess the lifespan of the *original* curtain wall compared to other high-rise vertical enclosures.

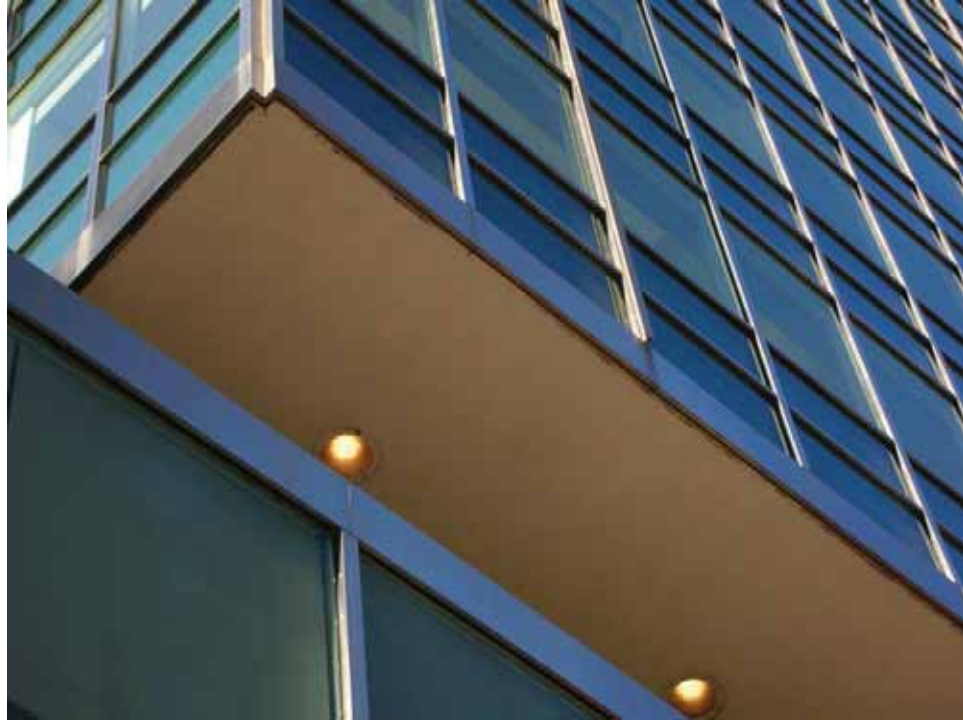
Figure 6.3 - Lever House curtain wall after replacement, photo by E. Buckley 19 Dec. 2006.

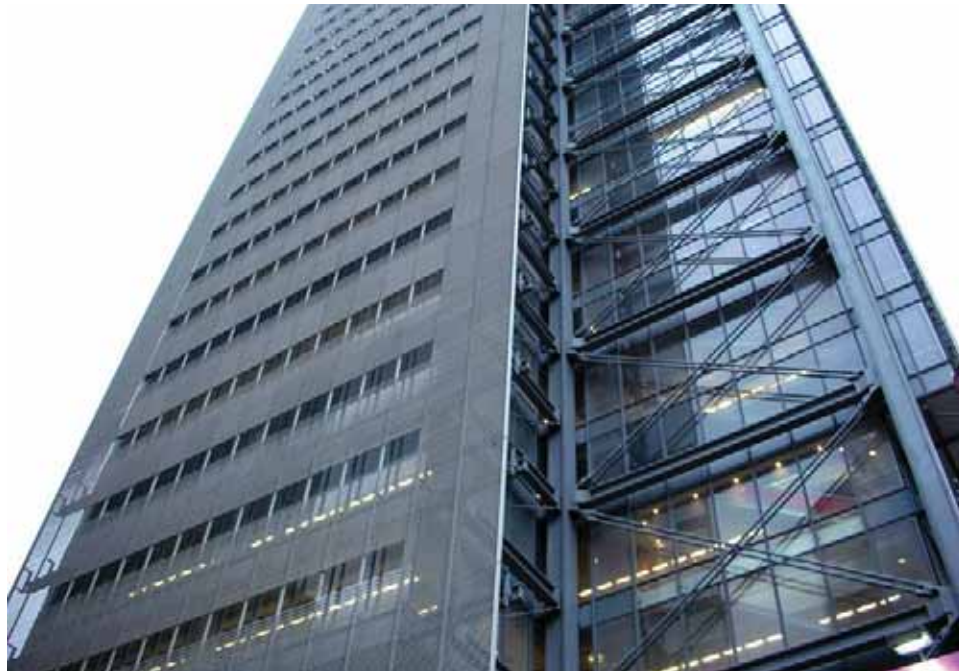
Figure 8.1 - New York Times Tower rendering. Source: <http://images.businessweek.com/ss/06/01/greenscrapers/image/7_mainnytimesb.jpg>.

Designed by premier contemporary architect Renzo Piano in collaboration with New York architecture firm FxFowle, construction on the New York Times Tower broke ground in 2005 (see *Figure 8.1*). This new high-rise is the biggest and most ambitious project unveiled in Manhattan since the devastation of the World Trade Center Towers on September 11, 2001.¹⁵⁶ Construction is still in progress and the new high-rise is slated for completion sometime this year (2007). The New York Times (NYT) Tower joins a collection of recently constructed high-rises that emphasize their sustainable features, and have consequently been termed “green towers.” In 2006, the tower was included in a New York City exhibit sponsored by the Skyscraper Museum, which showcased green towers that “propose radically new ways of being environmentally friendly.”¹⁵⁷

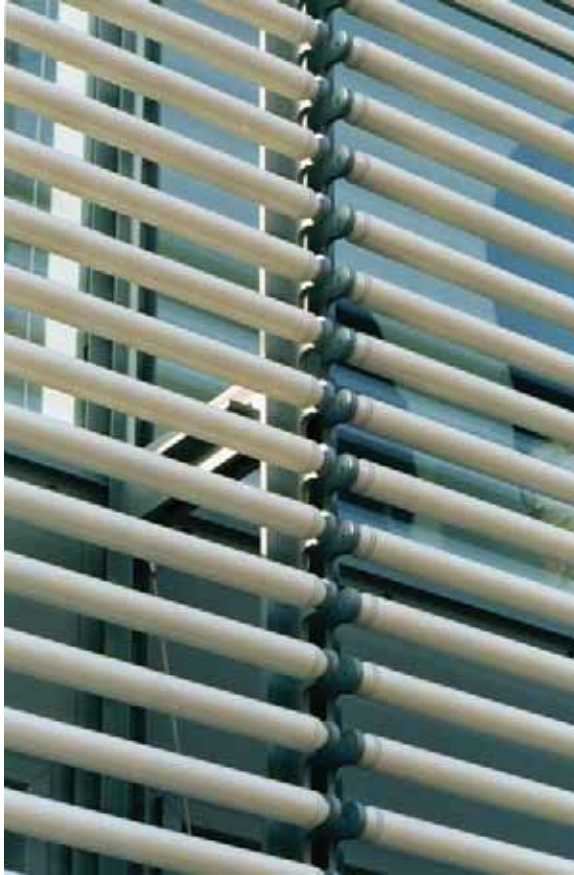
Figure 8.3 - Mock-up of ceramic tube skin on New York Times Tower.
Source: Fx Fowle Architects.

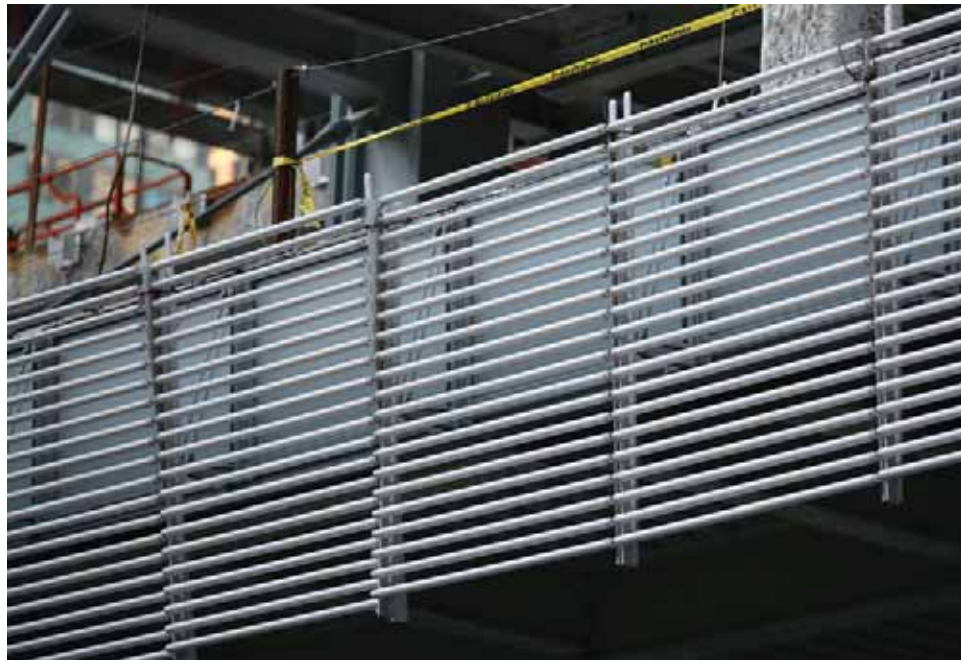
Figure 8.4 - New York Times Tower - network of ceramic tubes under construction, photo by E. Buckley 19 Dec. 2006.

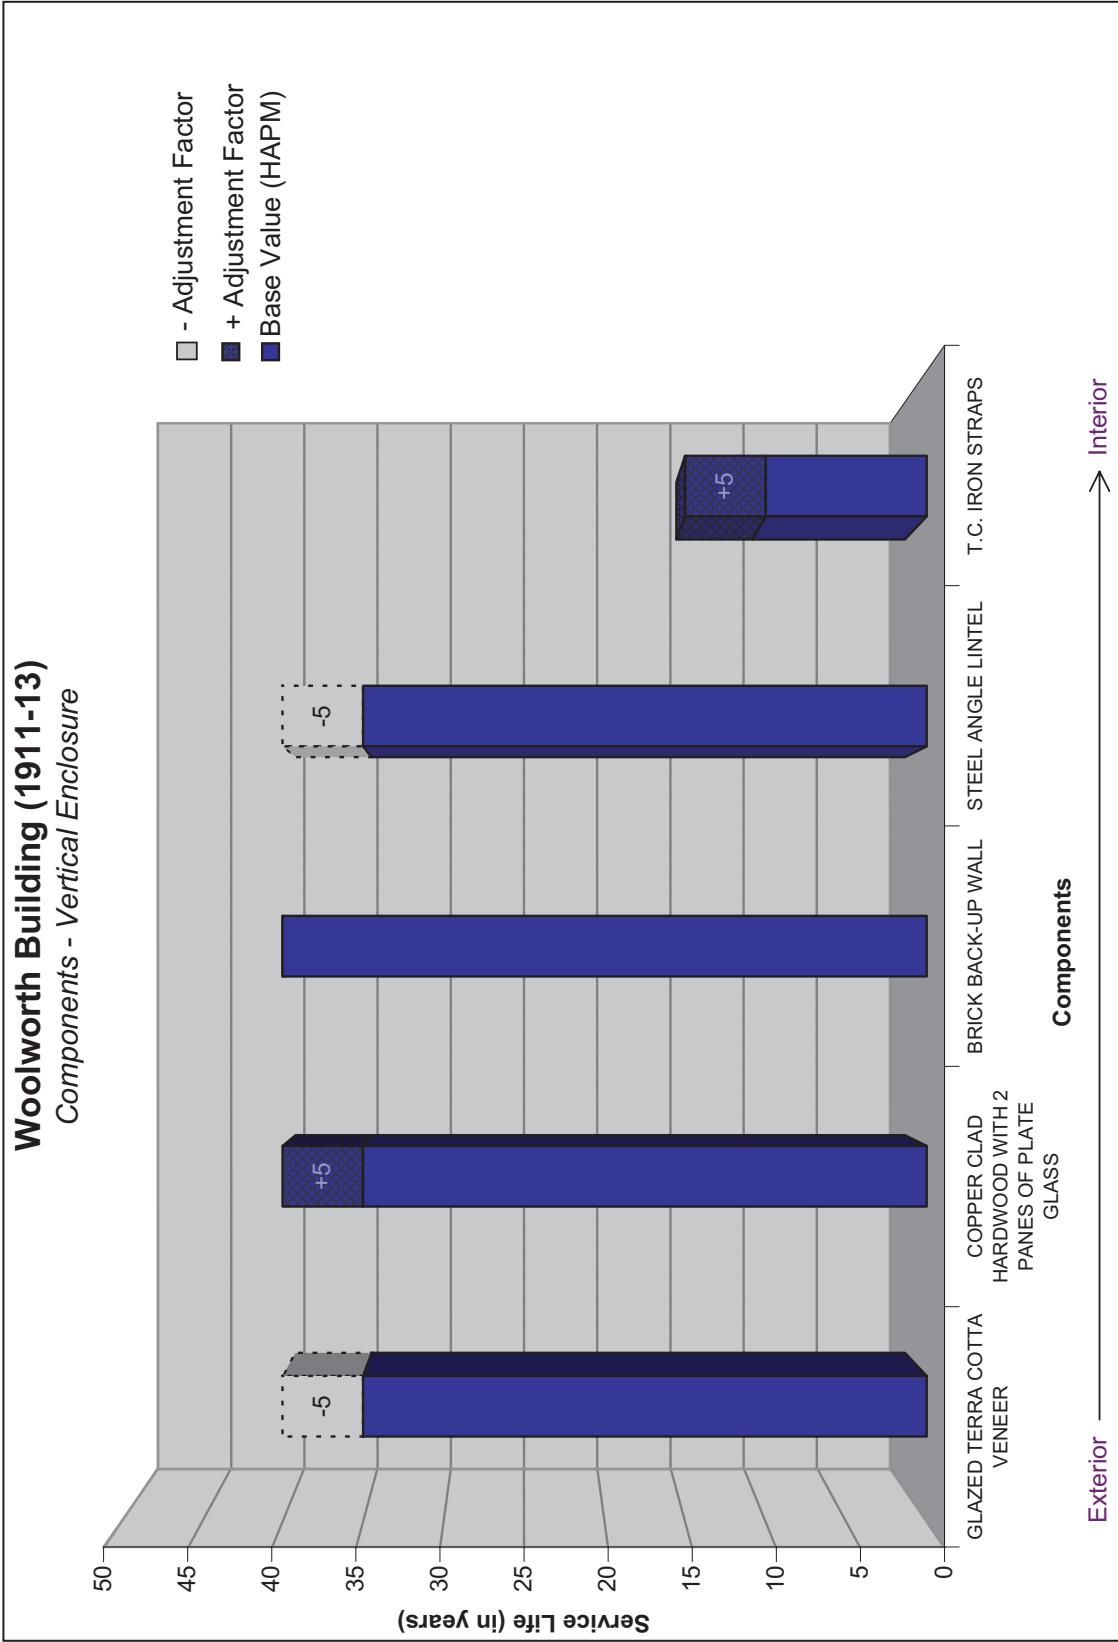
Graph 4.2 - Service Life Analysis - Woolworth Building.
