# Characterization, Analysis and Interpretation of the Surface Finishes of Kiva E, Long House, Mesa Verde National Park

A Thesis in Historic Preservation Presented to the Faculties of the University of Pennsylvania in Partial Fulfillment of the Requirements for the Degree of Master of Science in Historic Preservation 2007.

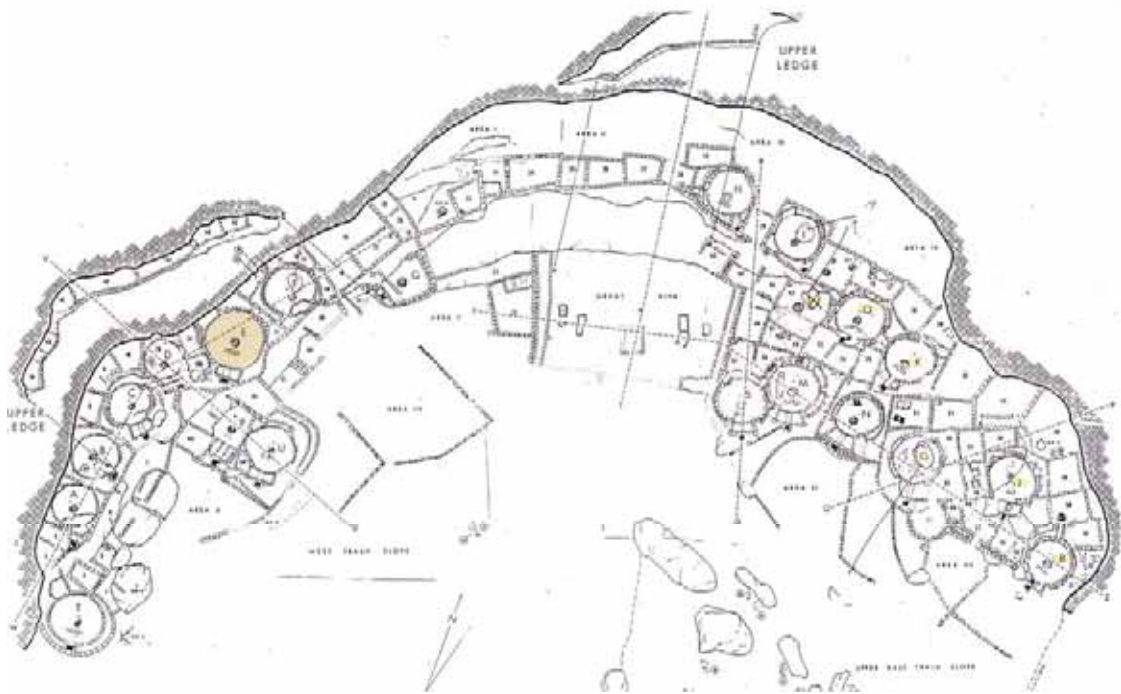
**Figure 2.2.** Plan of Long House (Cattanach 1980).

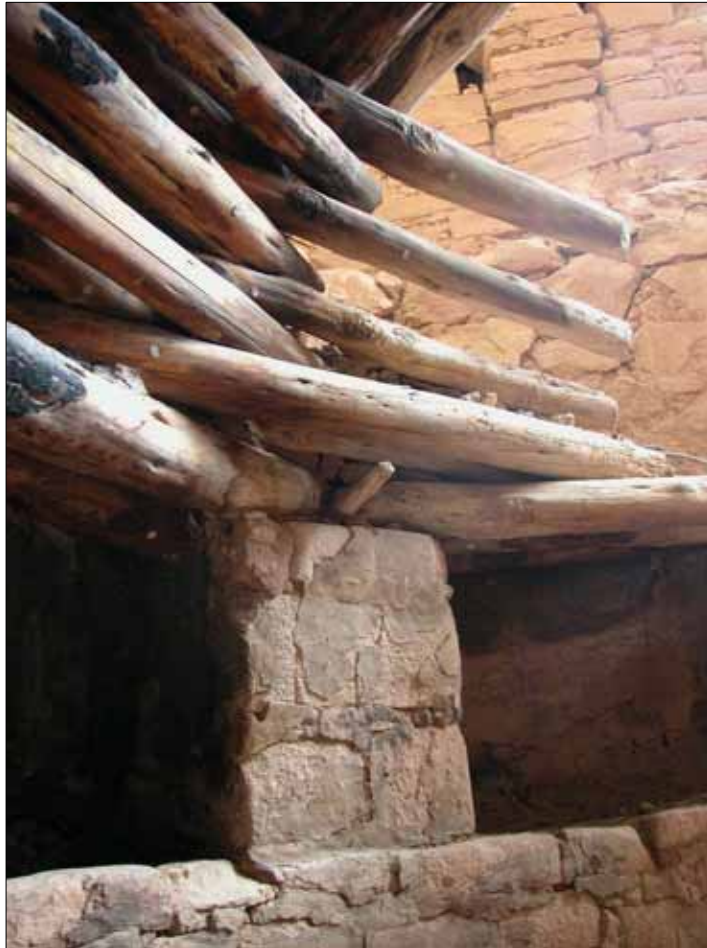
**Figure 3.2.** Kiva roof cribbing with vigas supported by the pilaster and resembling basketry in Cliff Palace (CASPAR 2003).

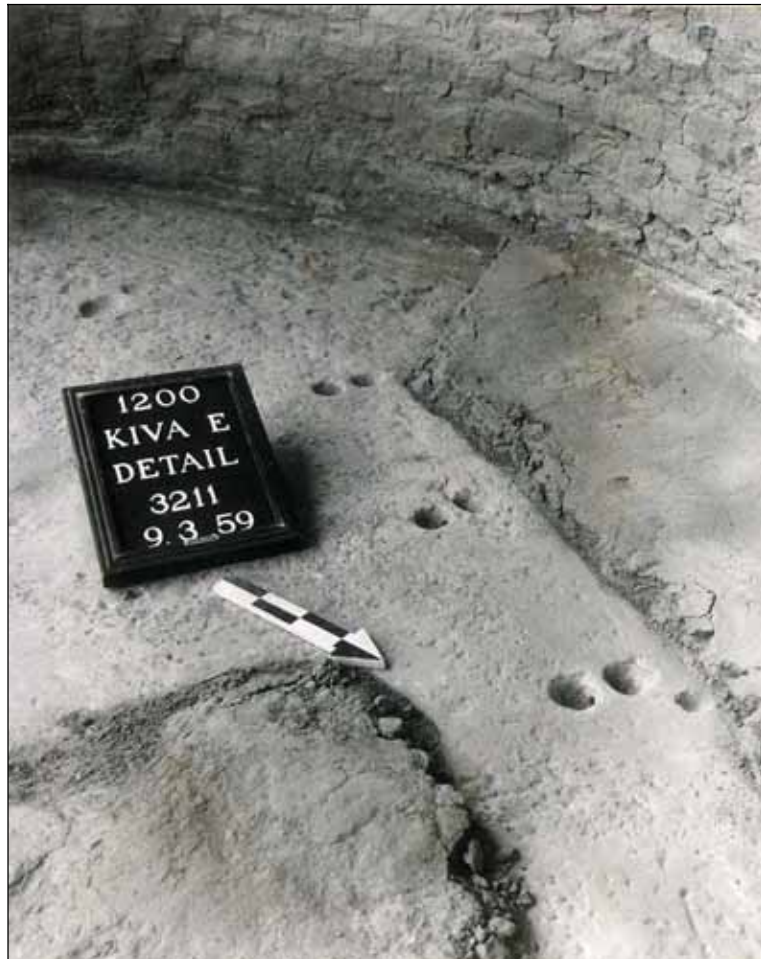
covers a majority of the floor. The 1959-1961 Wetherill Project excavation/interpretation has exposed part of the original bedrock floor. Three sets of loom holes have been pecked into the bedrock floor along the northwestern wall of the banquette. George Cattnach's excavation report records a fourth incomplete set directly to the southwest of the other three. In keeping with both Hopi and Zuni practices, it has been suggested that these loom holes served for an upright loom.

**Figure 4.3.** Detail of loom holes in the bedrock floor of Kiva E (Nichols 1959).

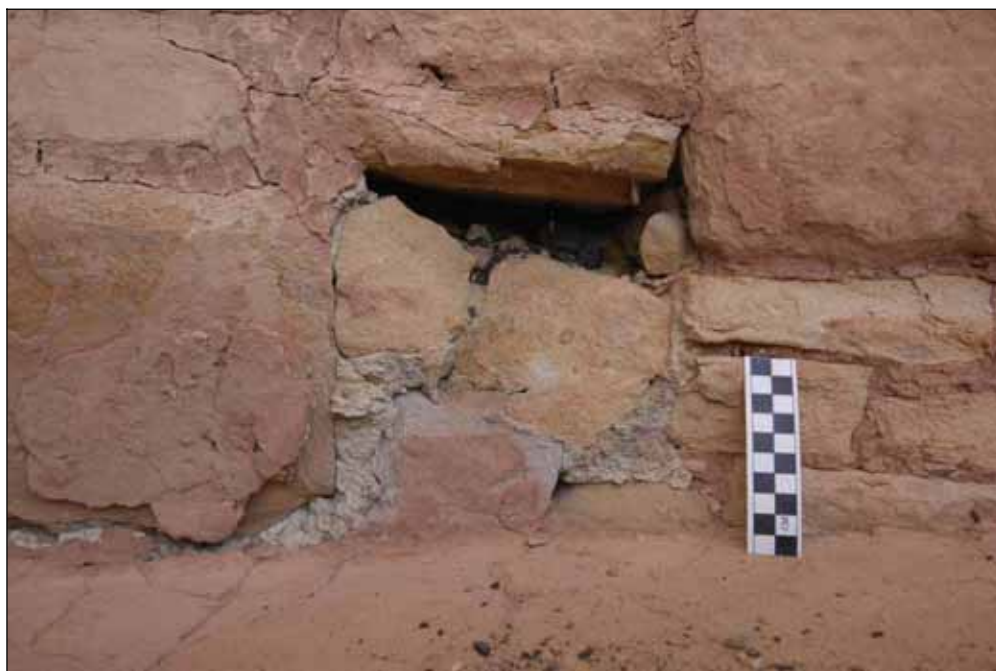
The original masonry was laid in a finely textured, reddish-brown colored earthen mortar which appears, in some places, to have been spread beyond the mortar joints, serving as the base coat for plaster or smooth extruded mortar/plaster. Along the base of the northwestern banquette wall between Pilasters 3 and 4, a grey shaley mortar has been used presumably as an early repair of the lower courses above the bedrock and as an infill to an original niche (now concealed) before or at the time of the later plaster floor. Excavation of the niche in August of 2006 revealed sand and bits of coal within the wall, confirming the report in Cattnach's field notes from 1959. As the mortar and stone masonry are friable and discrete nodules of salt are present, this area appears to have been subject to degradation

from recurrent moisture penetration, seemingly from the time of construction and resulting in prehistoric repair.

**Figure 4.4.** Excavated niche of the lower portion of the northern banquette wall (Jensen 2006).

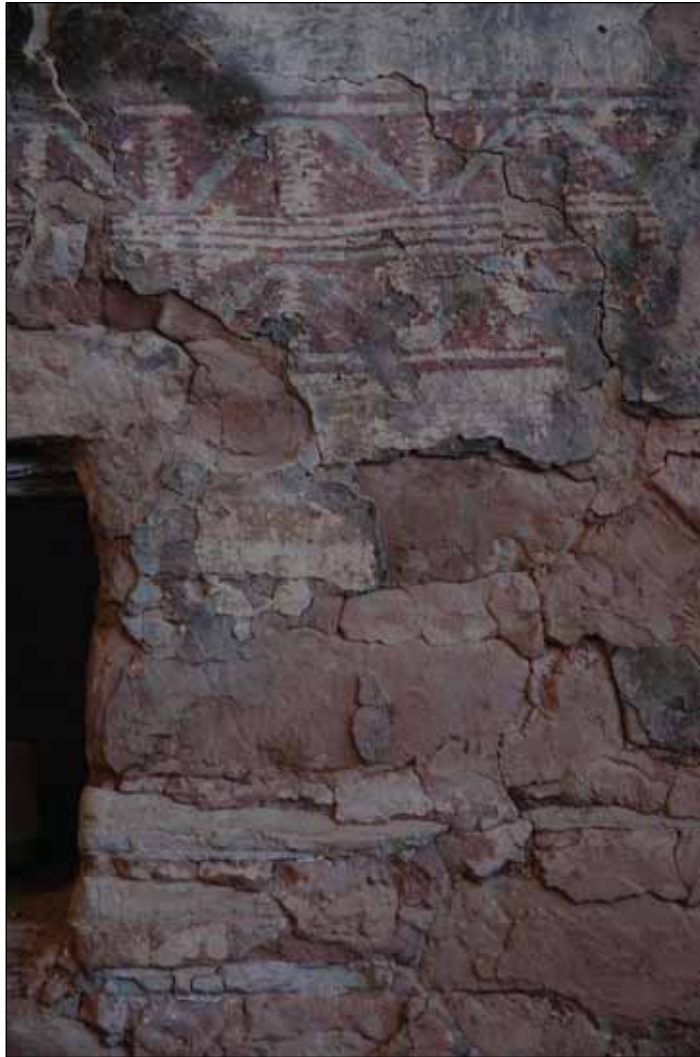
Perhaps one of the most elaborate and complex surviving wall designs found park wide, the remnants of the embellishment located below Inter pilaster space 4 along the east wall of the kiva provide insight to the intricacy, care and craft given to the design and adornment of these ceremonial chambers. Intact to the right of Niche 4, a geometric banded design with opposing triangular shapes with irregular borders and separated by three lines of uniform width is painted in red on a white ground with greenish blue accent lines. The blue paint appears to have been applied rather thickly by comparison with evident brush marks, seemingly from brushes made from yucca fibers. Small remnants of what is believed to be the continuation of the band design with the same red markings on a white ground is located farther east of the bulk of the design just below where the upper wall of the banquette has collapsed.

**Figure 4.5.** Detail of banded embellishment below Pilaster 4 with remnants of blue pigment around Niche 4 (Ferron 2006).

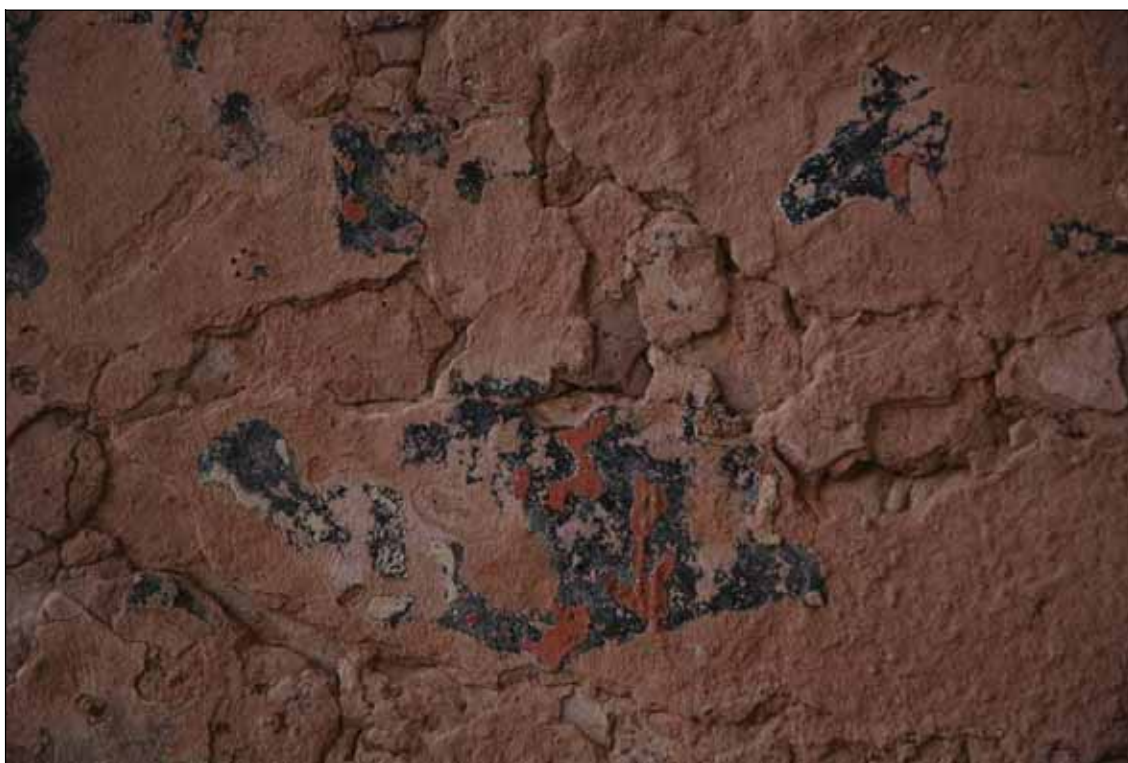
within the kiva where this bright red pigment is currently present. On the upper left quadrant of the pilaster face a partial design element survives with a red (although less intense in hue) line painted diagonally across the cream colored ground. Remnants of cream colored paint on the face of Pilaster 1 are assumed the same scheme as the red embellishments. In the center of the pilaster face are small fragments of yellow ochre, as part of a scheme that appears earlier than that of the vibrant red embellishments. Also part of an earlier scheme, is the evidence of bright white paint heavily sooted and covered by a subsequent campaign.

**Figure 4.6.** Detail of fragmentary bright red paint on the mid-face of Pilaster 1 (Ferron 2006).

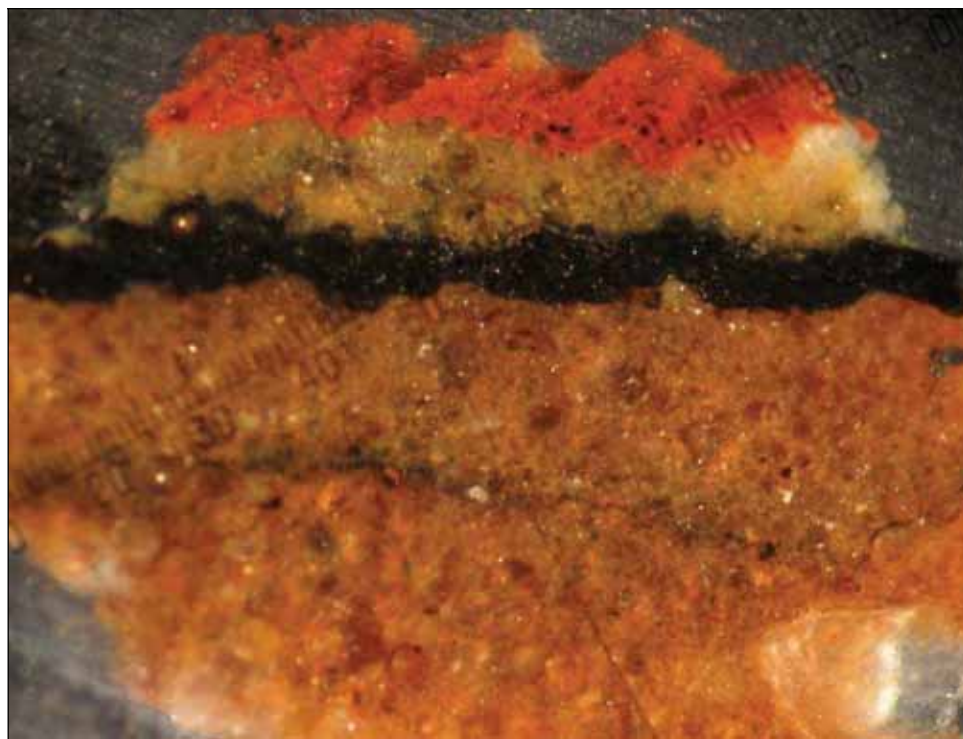
**Figure 6.1.** Photomicrograph of sample M07 exhibiting a fragment of bright red wash from the mid-face of Pilaster 1. Viewed in reflected light at 50x magnification.

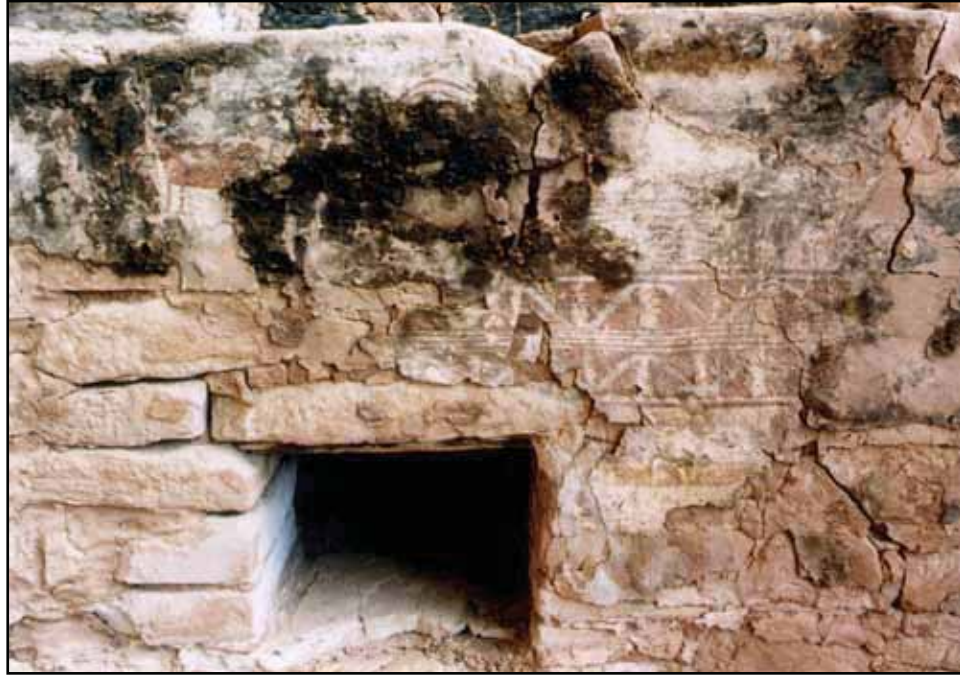
**Figure A.20.** Condition of the embellishment along the east wall of the banquet (Begay 05/24/1988).

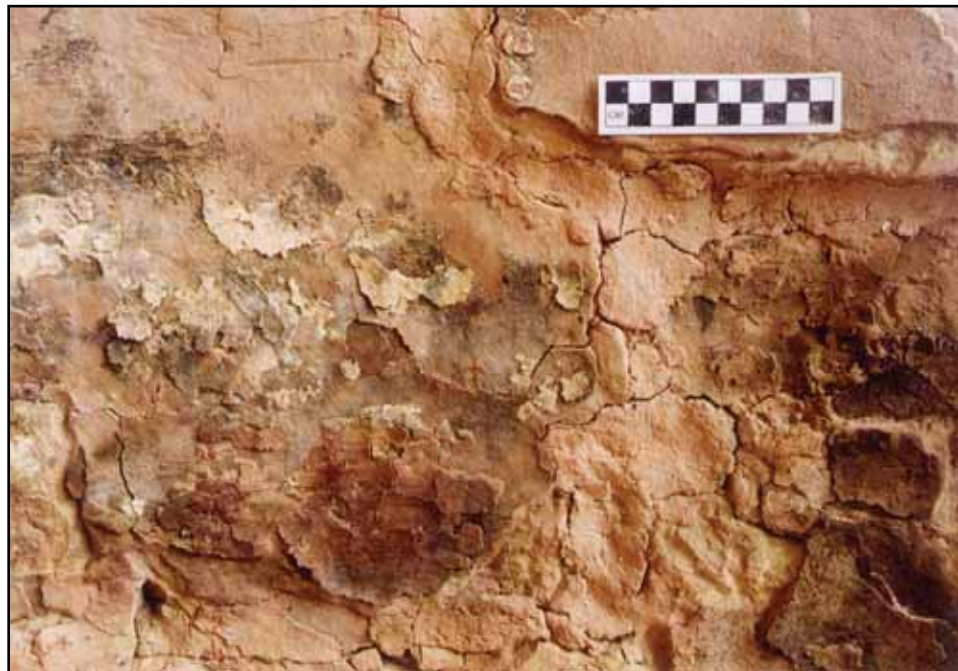
**Figure A.21.** Detail of a fragment of the red dado over white ground with suggestions of blue-green linear designs, these plaster elements are no longer present (Fiero 7/14/1999).

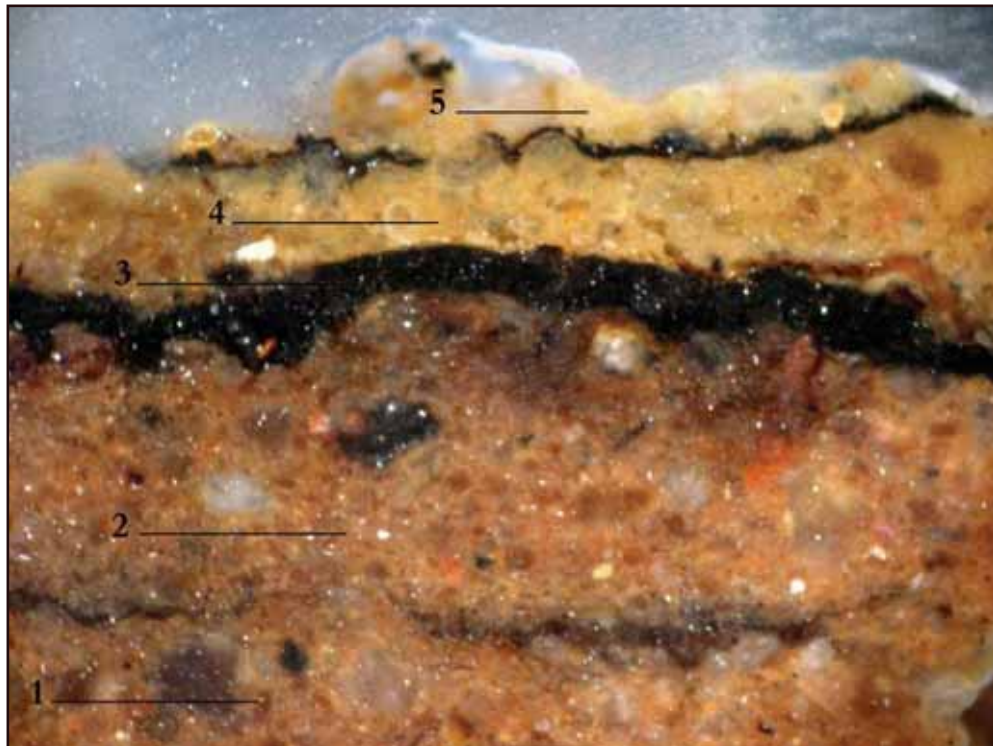
Support: Stone and Mortar				
Layer	Color	Thickness		Scheme
1	pink-tan	++ /	plaster substrate	Scheme 1
2	pink-tan	++	plaster	Scheme 1
3	black	-	soot	Scheme 2/3
4	creamy-white	+ /	wash	Scheme 4
5	creamy-white	-	wash	Scheme 5

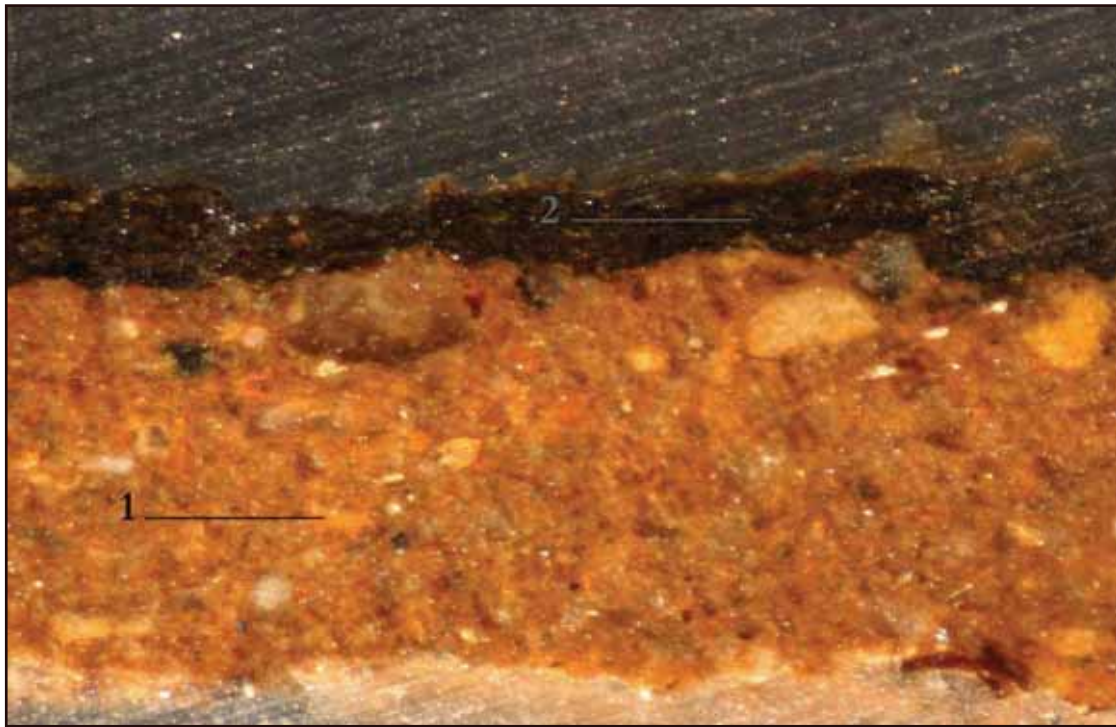
Support: Stone and Mortar				
Layer	Color	Thickness		Scheme
1	pink-tan	++	plaster substrate	Scheme 1
2	black	- ^	soot	Scheme 2-3

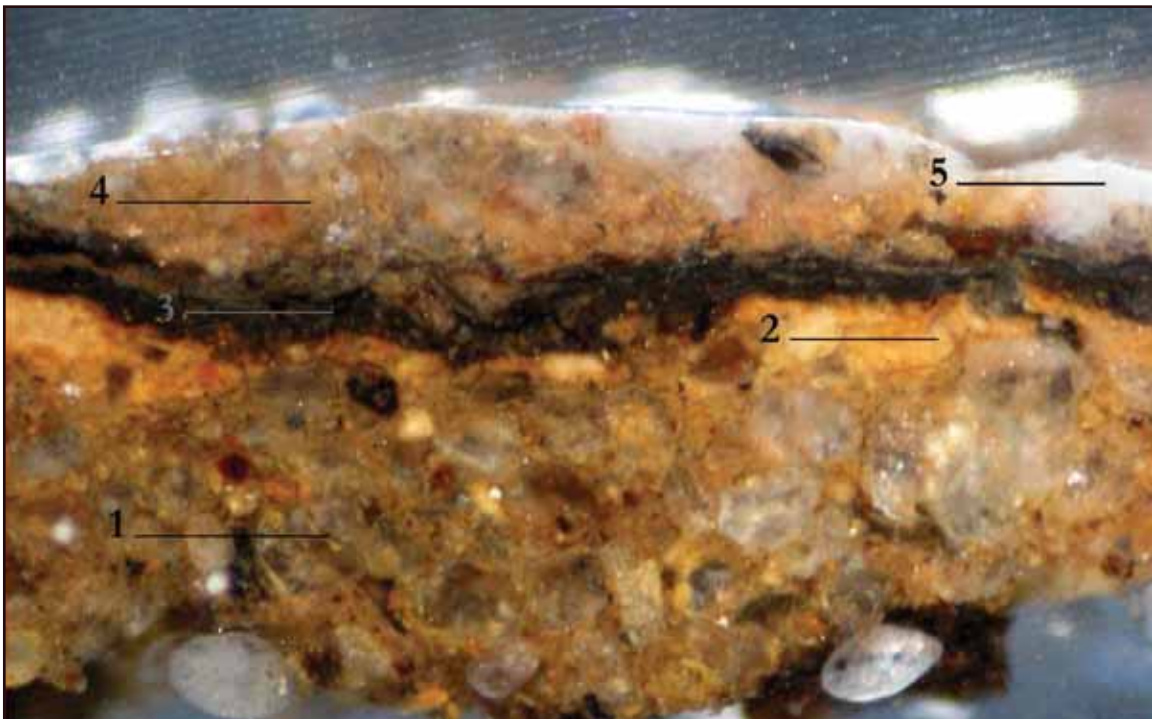
Support: Stone and Mortar				
Layer	Color	Thickness	Material	Scheme
Note: Partial layer of soot occurs before layer 1, presumably from sample M08 (a)				
1	light brown	++	plaster	Scheme 4
2	cream-white	-- ^	wash	Scheme 5
3	black	- ^	soot	Scheme 5
4	pink-tan, lt brown	++ ^	plaster	Scheme 6
5	bright white	--- ^	incomplete	indeterminate; inclusions in layer 4?

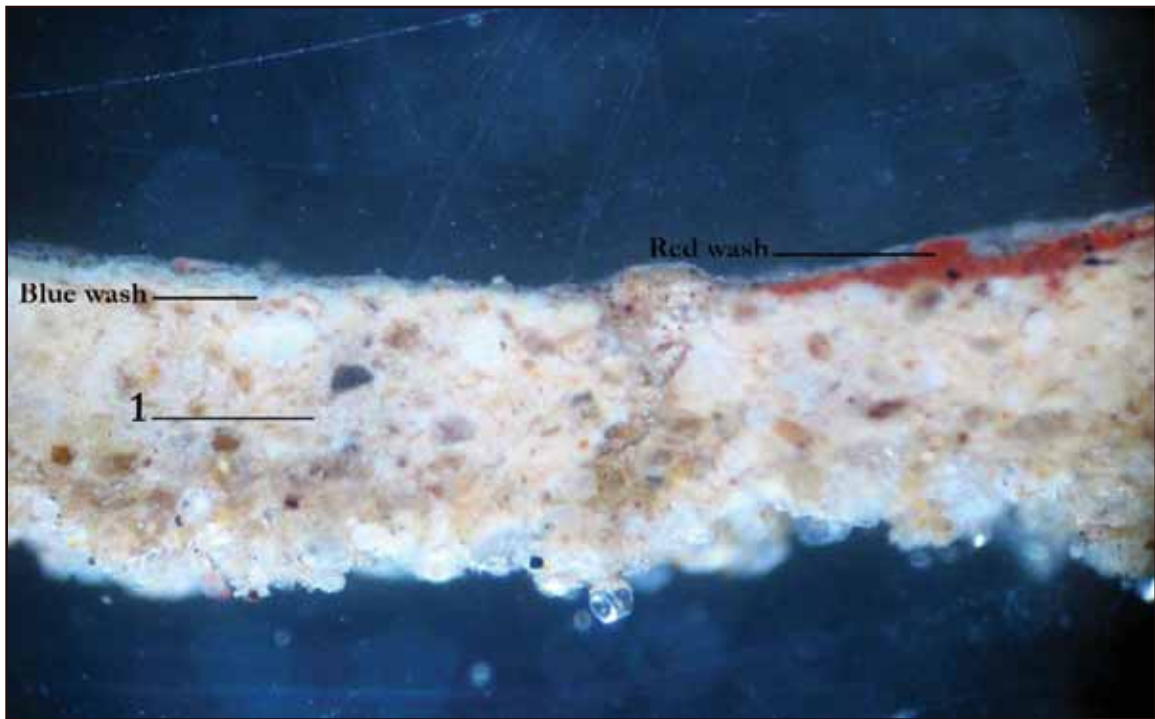
Support: Stone and Mortar			
Layer	Color	Thickness	Scheme
1	white	+ / ^	plaster
2	blue/red	- /	wash
