# The Ohio State Pavilion at Philadelphia's 1876 Centennial Exhibition: Identification, Survey and Evaluation of 20 Types of Ohio Stone

Presented to the Faculties of the University of Pennsylvania in Partial Fulfillment of the Requirements of the Degree of Master of Science in Historic Preservation 2006.

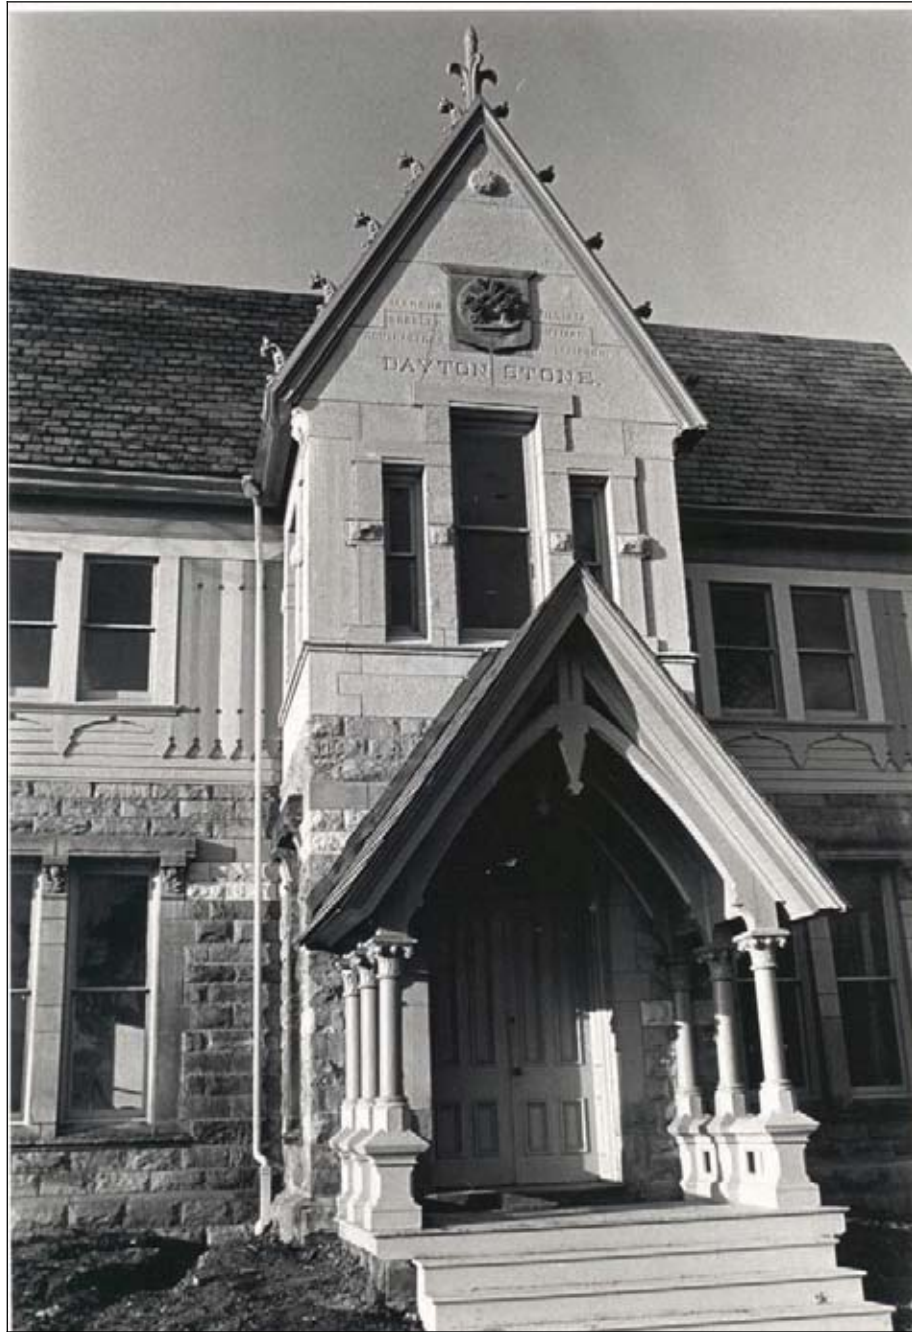
**Figure 1.4:** *South elevation of Ohio House after Bicentennial restoration efforts 1976, note absence of pyrite staining in “DAYTON STONE” limestone in projection gable (Fairmount Park Commission.).*

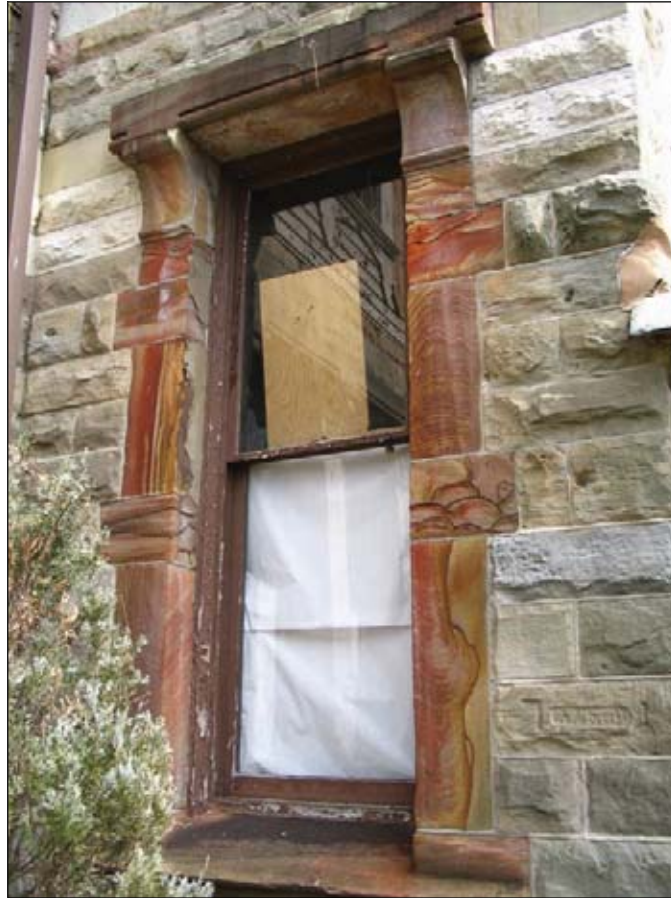
**Figure 3.1:** *Liesegang rings in sandstone in window surrounds in front bay.*

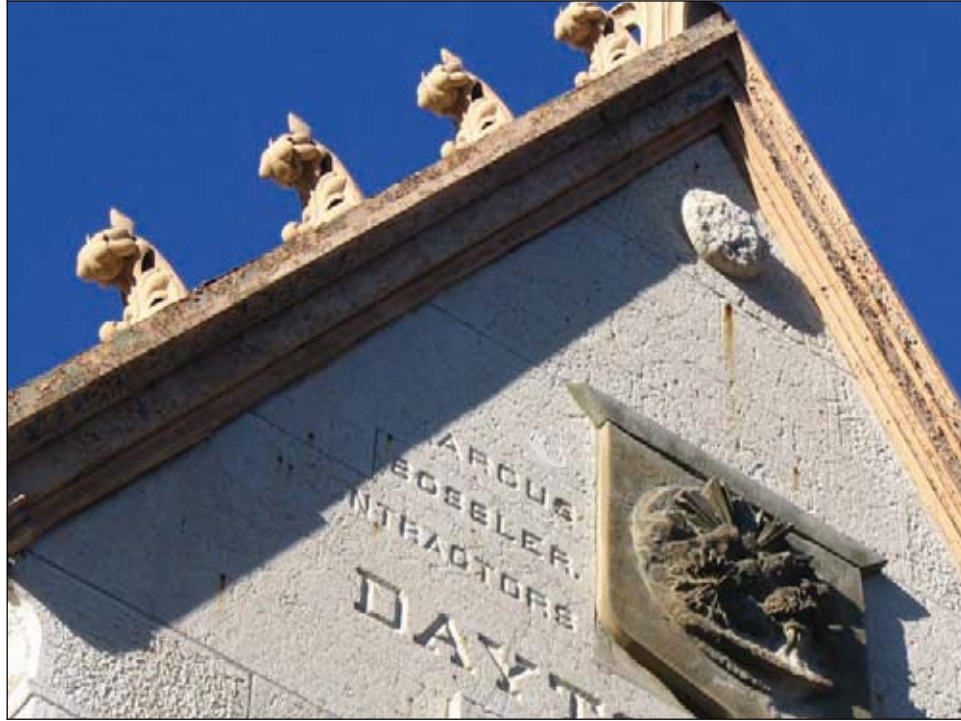
*Figure 3.2: Detail of pyrite inclusions and pitting in Dayton limestone.*

the rock formation weathered out and filled with a less stable material. (See figure 3.2) When originally quarried the variation in composition may have been undetected, but after years of exposure in an urban environment the less stable material has drastically deteriorated. This underscores the effects of secondary minerals and impurities on limestone performance.

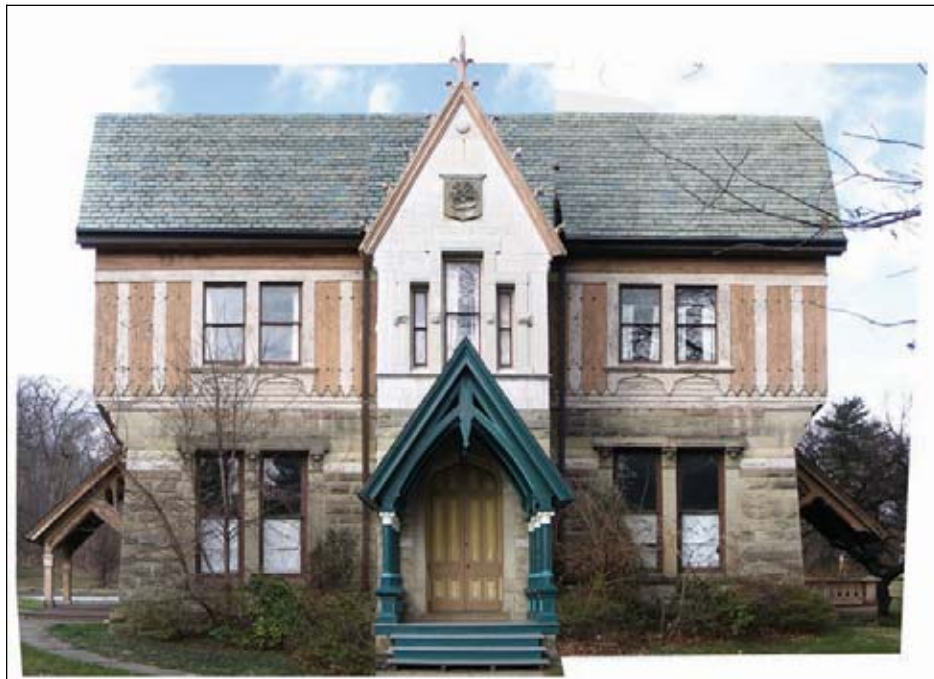
*Figure 4.1: Photographic montage of south elevation.*

montages were created for the three masonry elevations and rubbersheeted to the CAD drawing. (See Figure 4.1) After the drawings were complete a grid overlay was applied to each elevation, dividing the façade into manageable areas which allow for sufficient detail but also fit on legal size paper to facilitate recording in the field. Grid sections were plotted in pdf format and then printed on 11” x 14” paper.

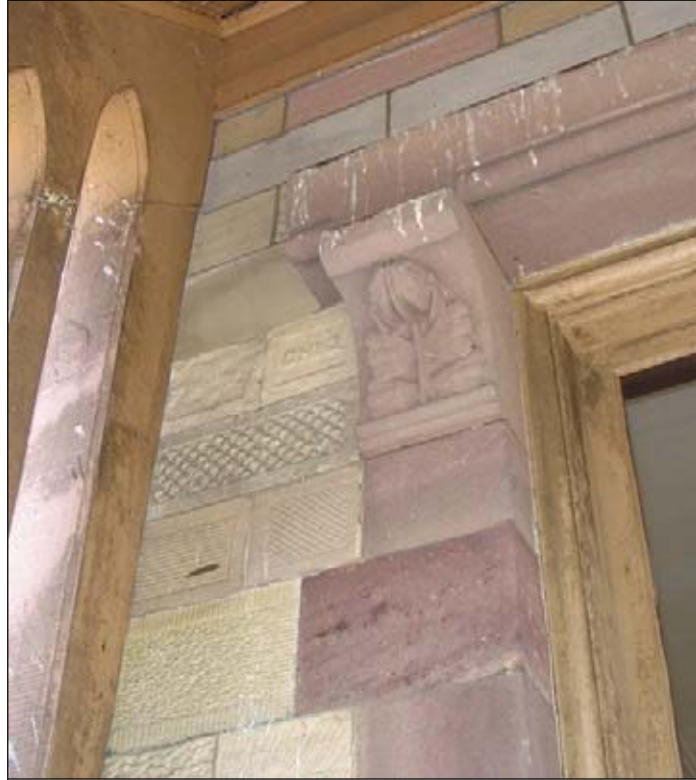
**Figure 4.3:** *Detail various surface finishes, under porch on west elevation.*

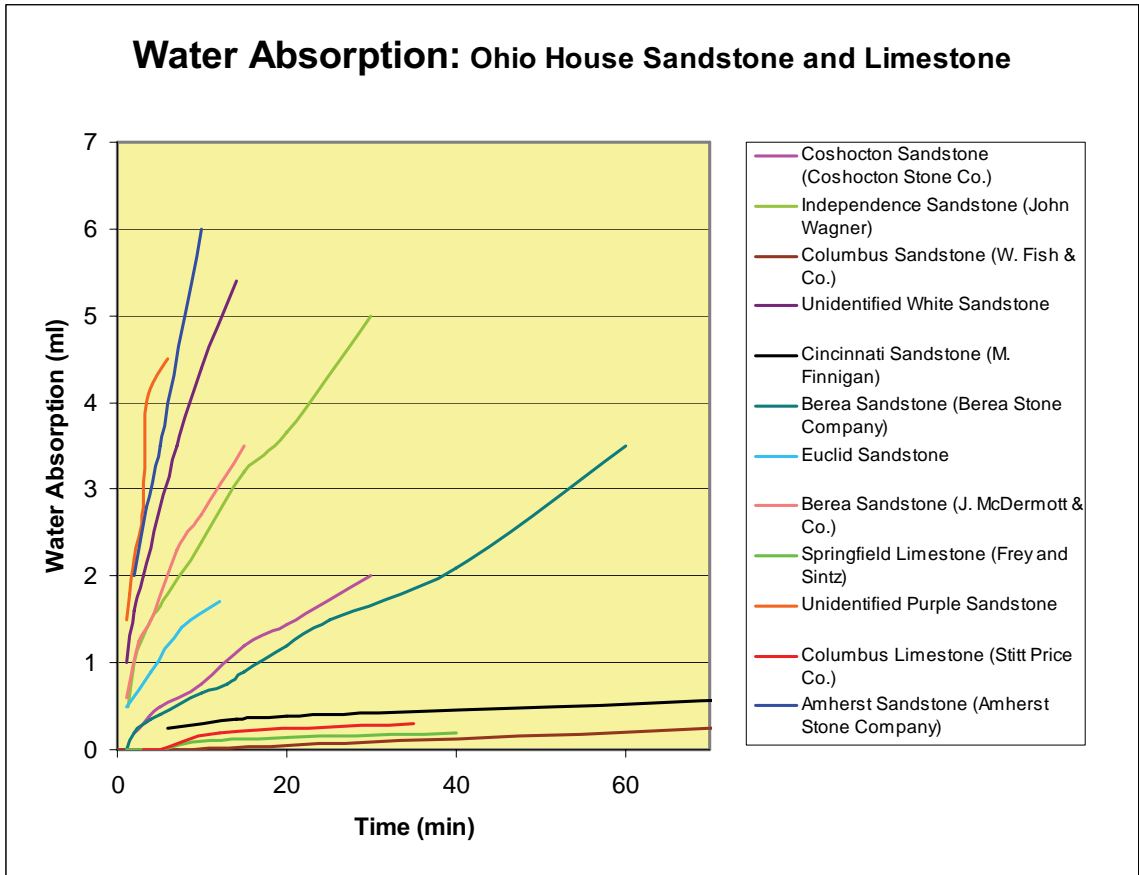
**Figure 4.4:** Water absorptions of Ohio House stone types, where water absorption ( $cm^3$ ) is a function of time (min.), graph includes 12 of the 20 types of stone (\* indicates limestone).

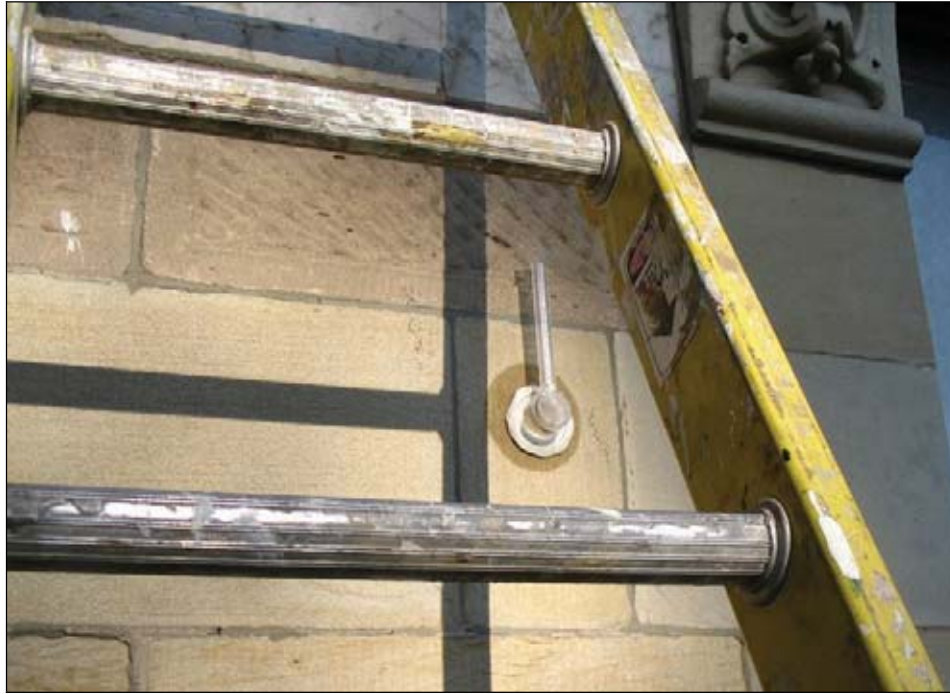
**Figure 4.5:** Rilem Water Absorption Test on Berea Sandstone (*J. McDermott & Co.*)

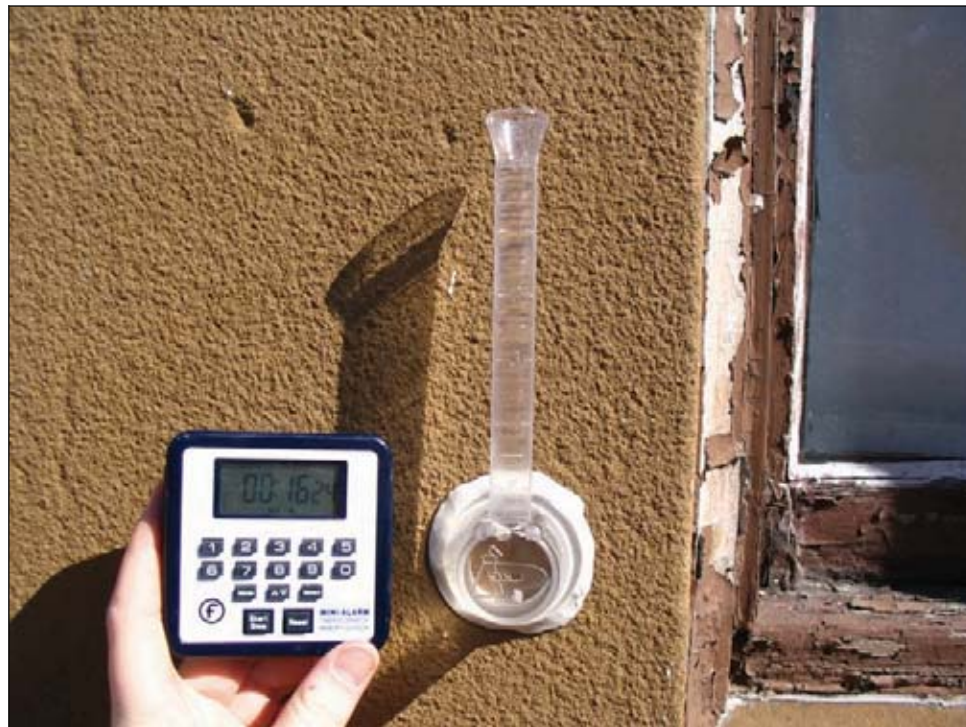
**Figure 4.6:** Rilem Water Absorption Test on Columbus Sandstone (*W. Fish & Co.*), note zero water absorption after 16 minutes.

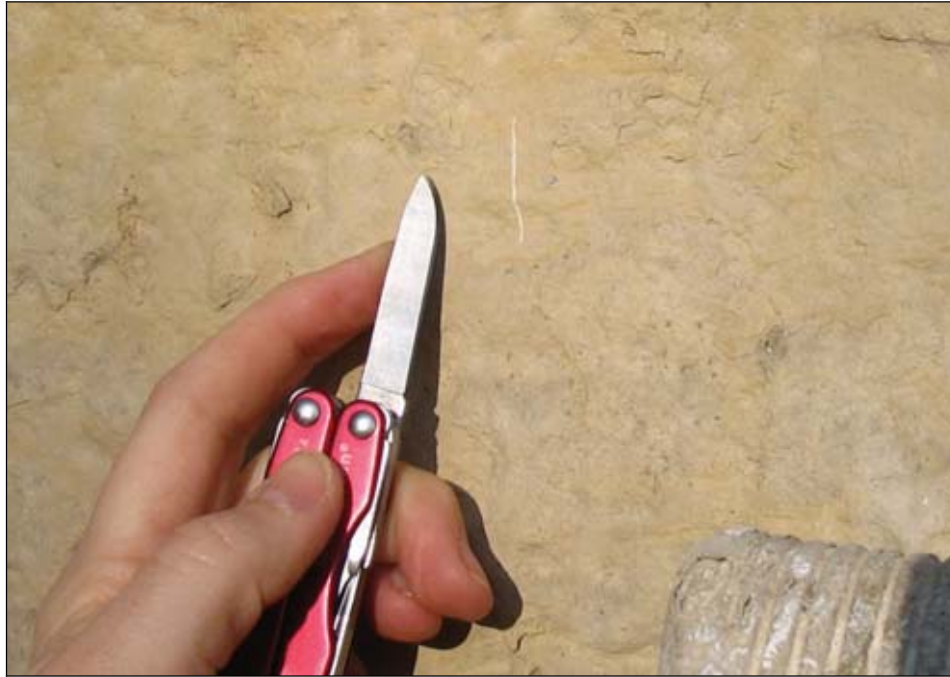
**Figure 4.7:** Mohs hardness test indicating Springfield limestone is softer than 5.5.

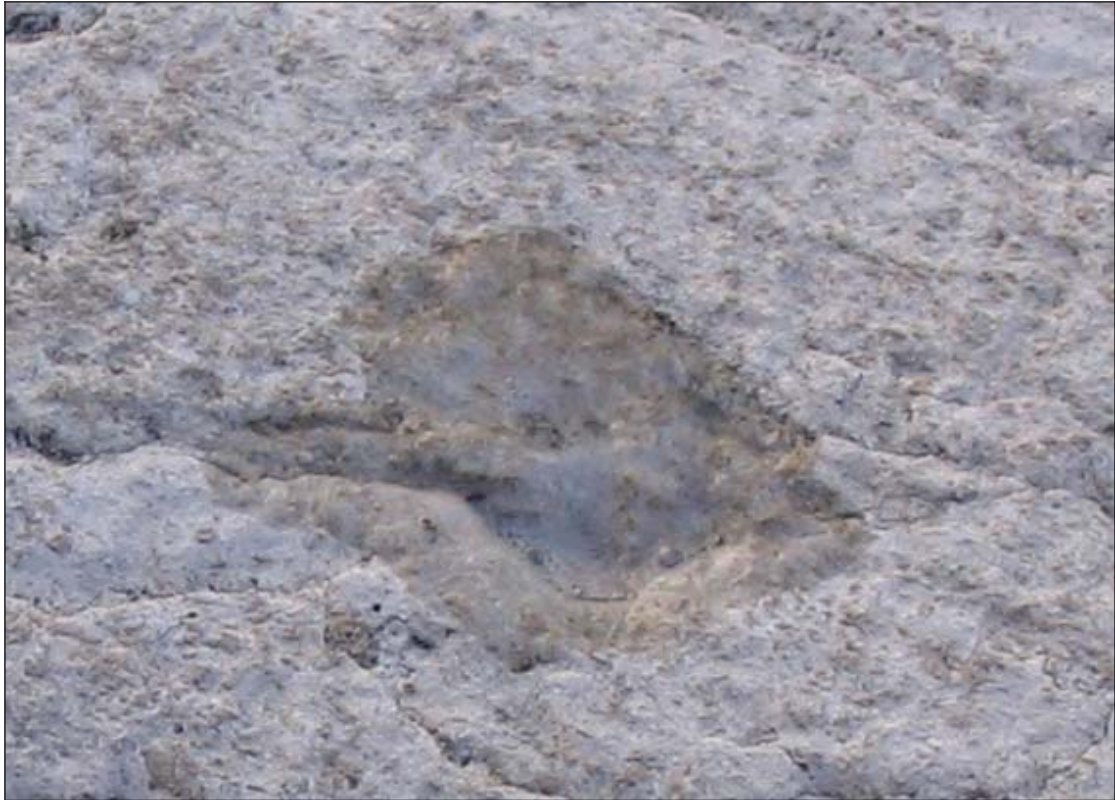
**Figure 4.8:** *Detail of hydrochloric acid effervescing on Dayton limestone indicating the presence of calcium carbonate.*

**Carbonate ID:** To determine which of the stones in the Ohio House contain a significant amount of calcium carbonate, hydrochloric acid was dropped on each stone type and monitored for effervescence. When exposed to acid, insoluble carbonates ( $\text{XCO}_3$ ) will dissolve and produce  $\text{CO}_2$  gas. This test was used to identify the stones composed of calcite (calcium carbonate,  $\text{CaCO}_3$ ) and/or dolomite (calcium and magnesium carbonate,  $\text{CaCO}_3 \cdot \text{MgCO}_3$ ).<sup>85</sup> The test was performed as a means to verify the results of the literature review regarding composition.

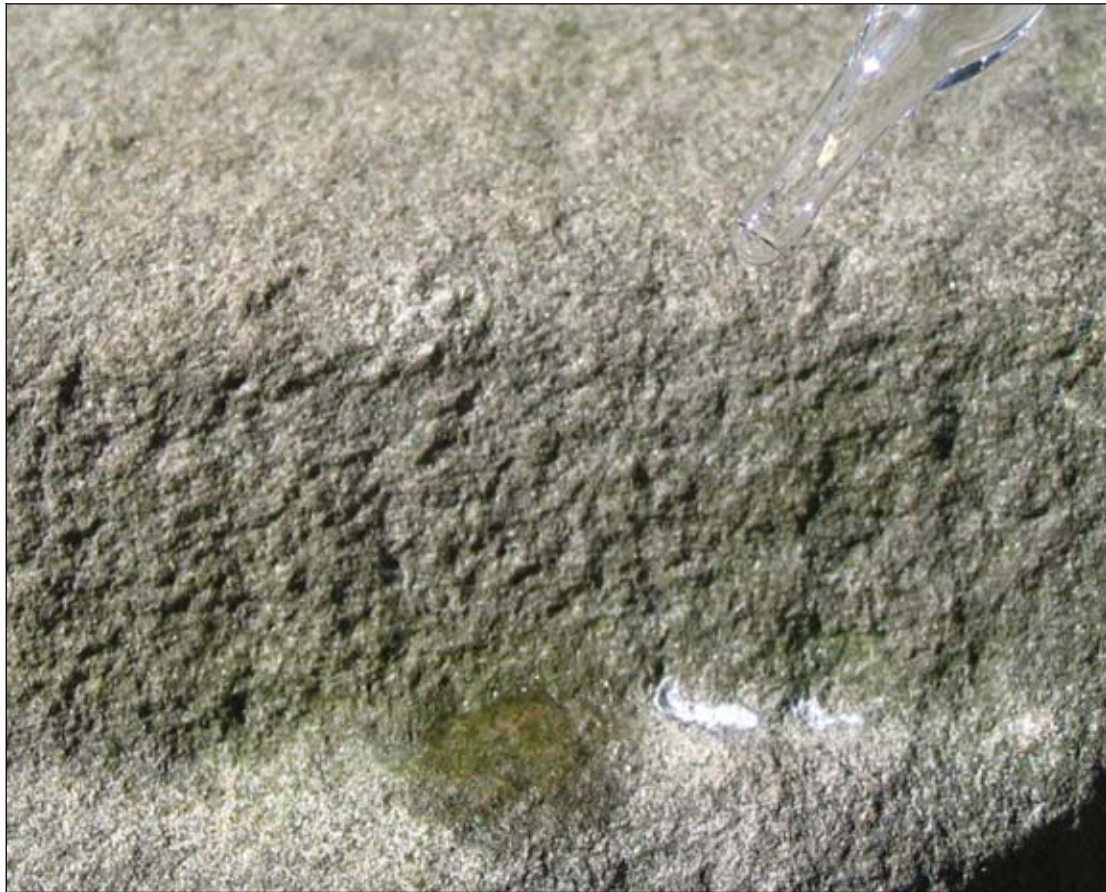
**Figure 4.9:** *Detail of hydrochloric acid not effervescing on Berea sandstone.*

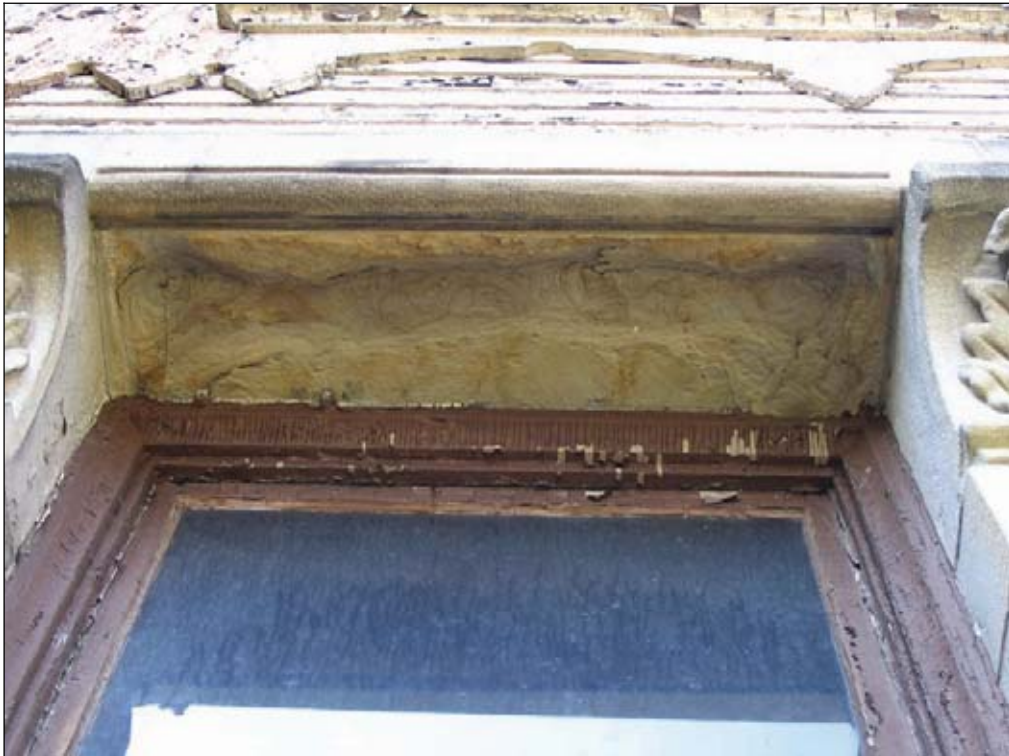
There is a very strong correlation between active decay and open joints; there are very few open joints recorded without adjacent active decay. Location and design also account for the severe deterioration on the underside of the window lintels and surrounding trim. The window lintels on the projecting front bay (Unidentified Liesgang Ring Sandstone) of the south façade and the window lintels on the right side of the south façade display areas of loss from 2 inches to as great as 5 inches deep. (See Figure 5.2)

*Figure 5.2: Detail of underside of window lintel on south façade, stone displays over 2 inches of loss.*

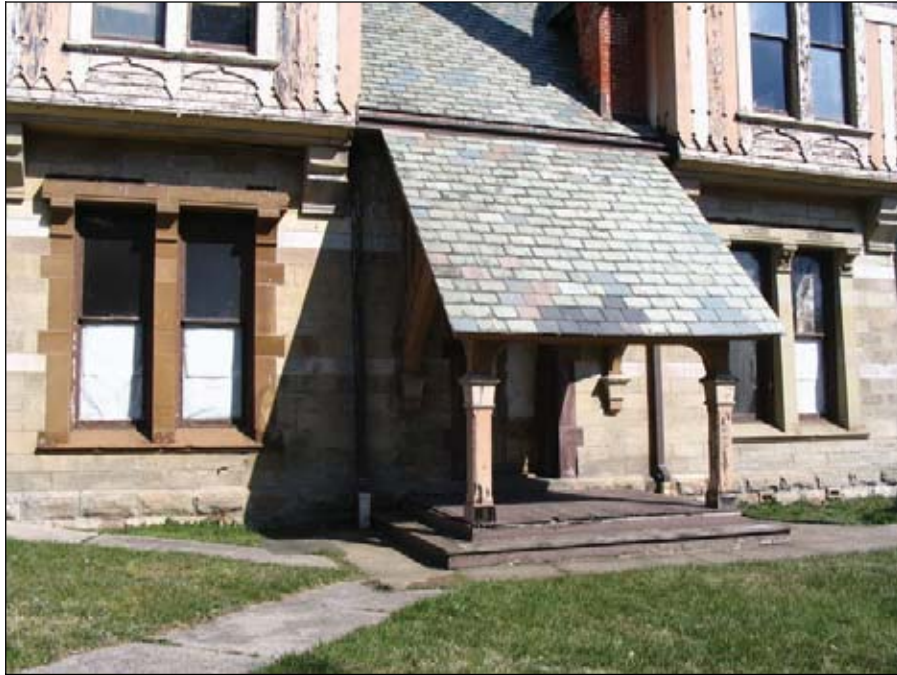
**Figure 5.3:** *Photo illustrating path of strong sun exposure on west façade and areas of shade from the porch, note the exposure of lower right stone in the Coshocton sandstone (Coshocton & Co).*

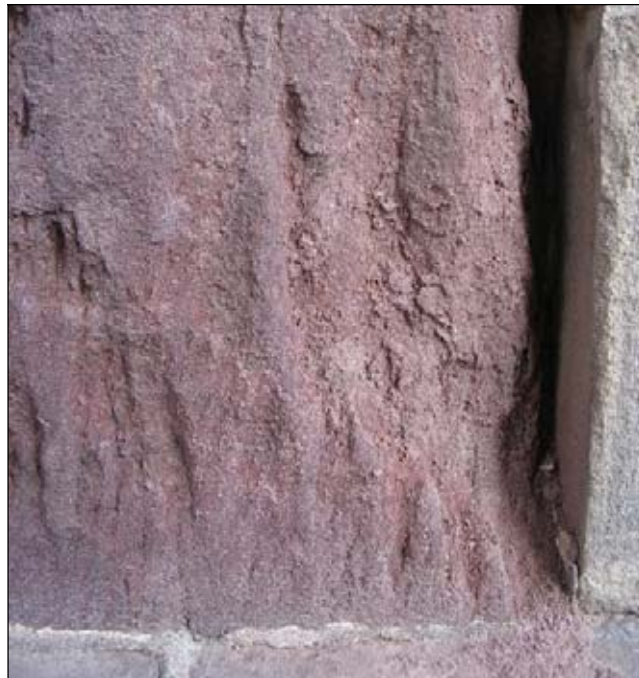
**Figure 5.4:** *Detail of deteriorated of lower right stone in the Coshocton sandstone (Coshocton & Co) window surround.*

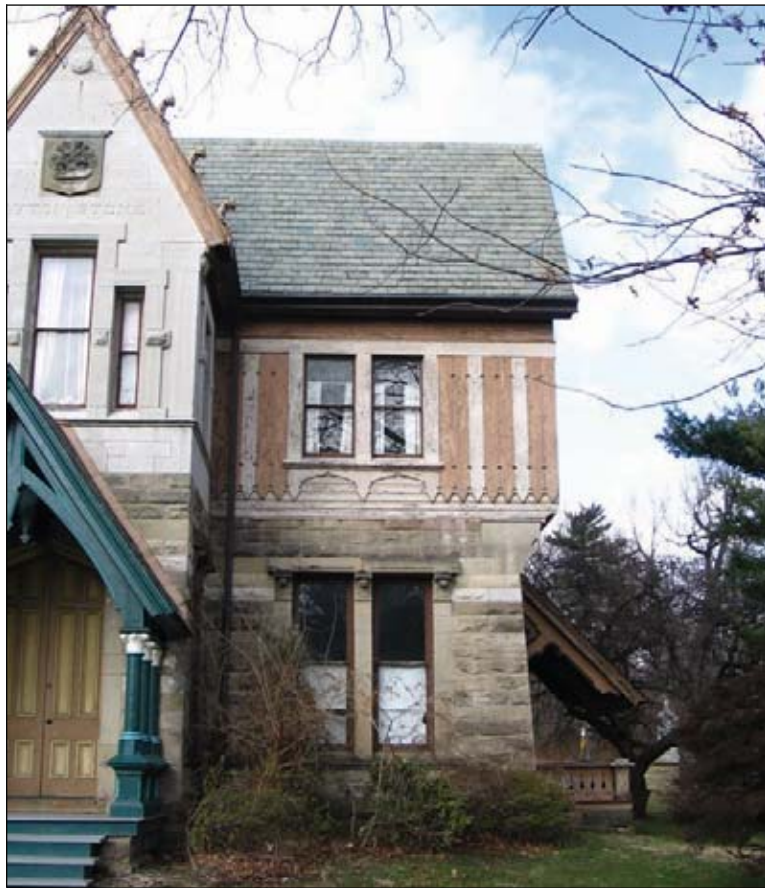
central area of severe decay flanked by areas of sound stone. (See Figures 5.5 and 5.6) In mapping sun paths on this side of the building, it became clear that the sound stone is protected by the strong summer sun by leaves on surrounding shrubbery and the decay is directly exposed. In the future, more sophisticated environmental monitoring techniques on all of these factors could be preformed to produce a more specific diagnosis.

**Figure 5.5:** *Photo illustrating proximity of shrubbery to deteriorated area of lower right side of south façade.*

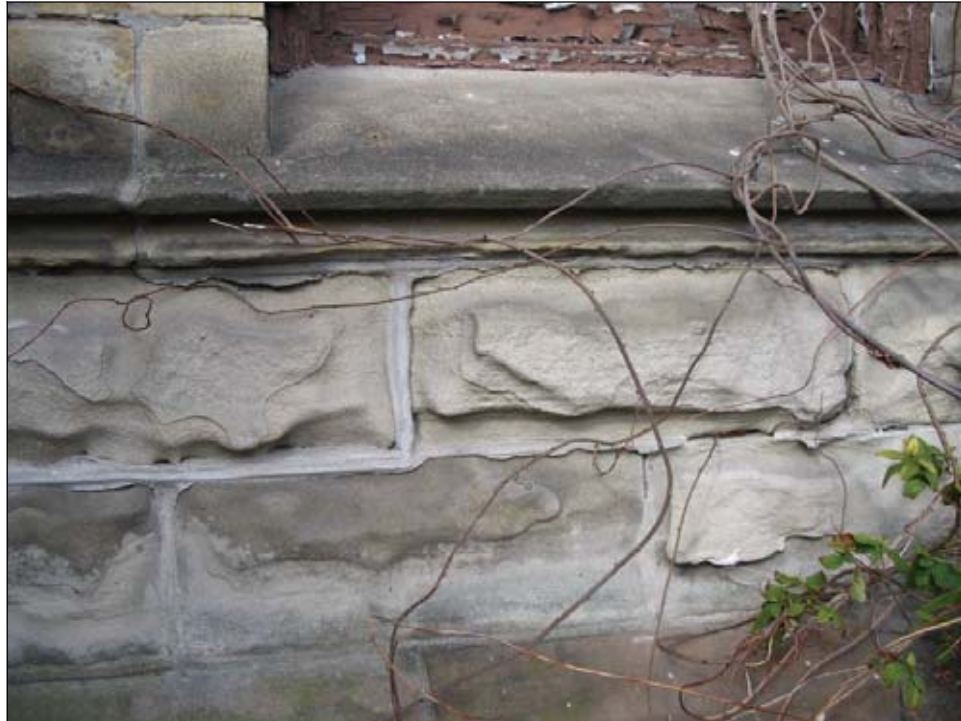
**Figure 5.6:** *Detail of deteriorated area of lower right side of south façade due to stronger summer sun exposure.*

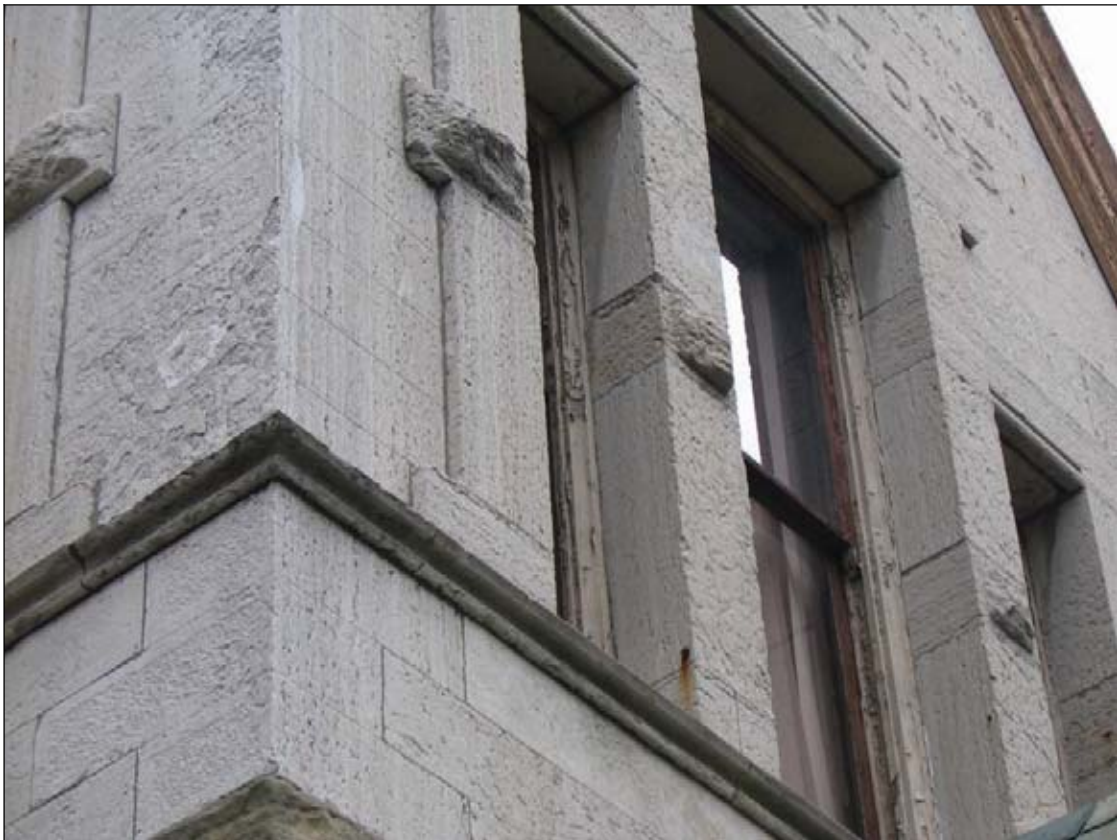
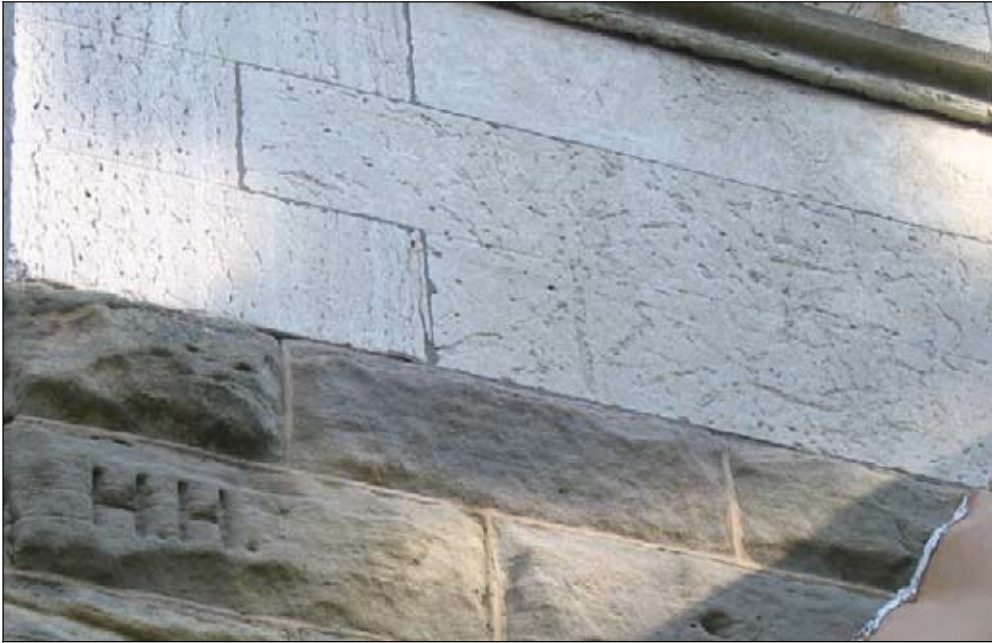
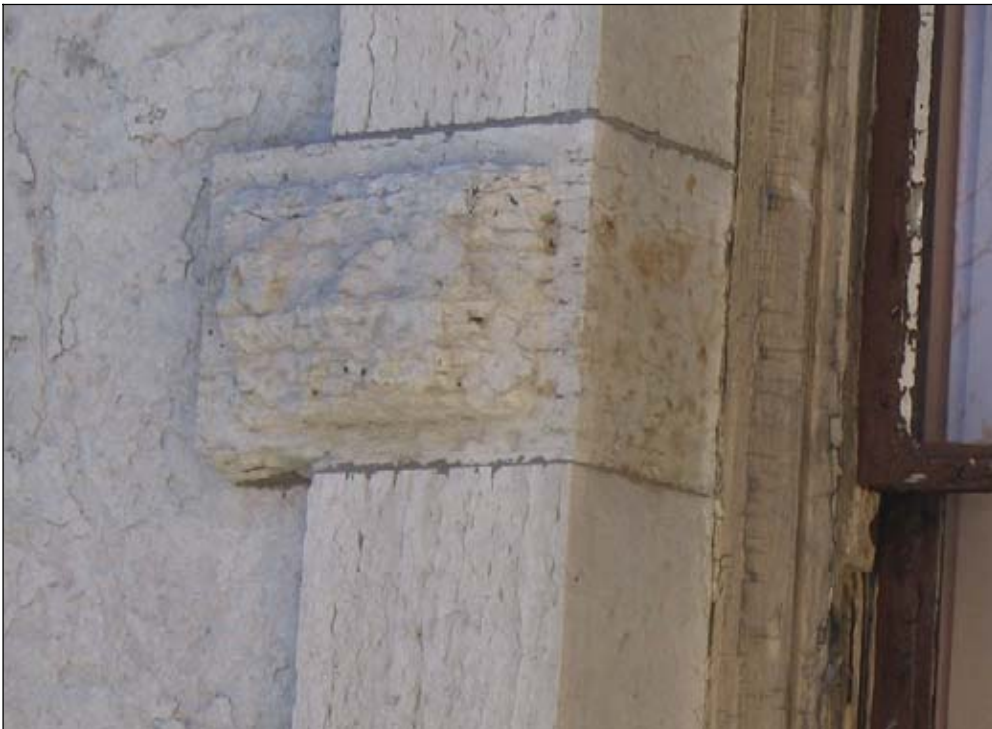
**2. Pitting:** Pitting of the stone surface due to the weathering out or erosion of the matrix of aggregate creating small concave cavities. (Based on Fitzner definition 1b.g)

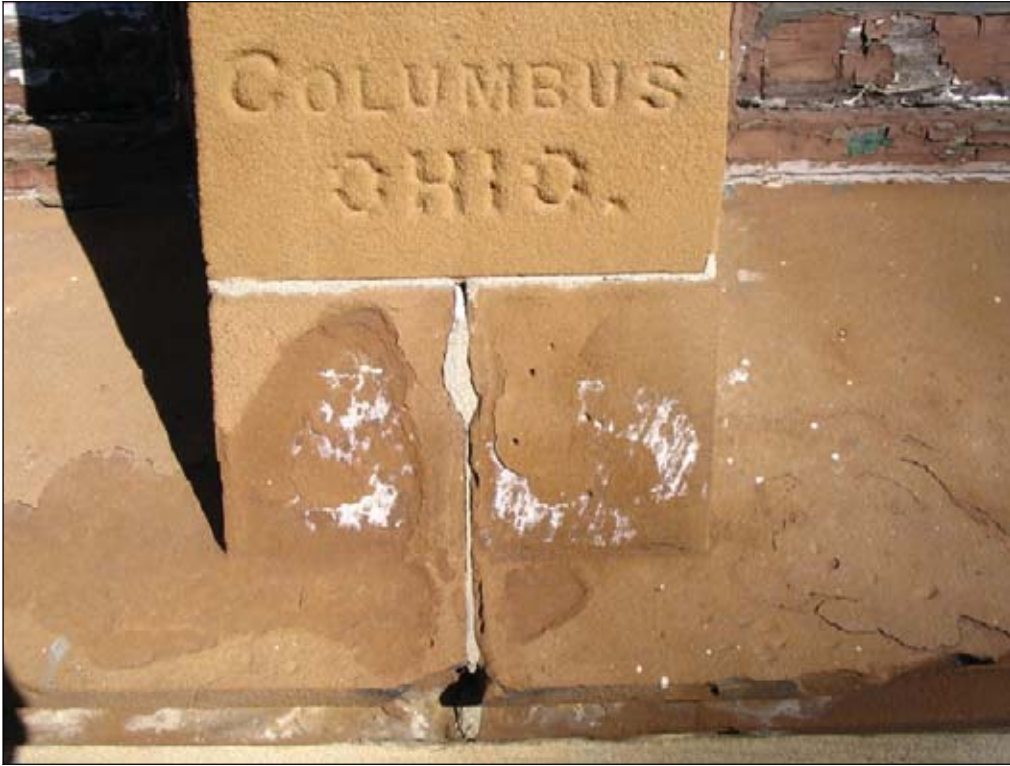
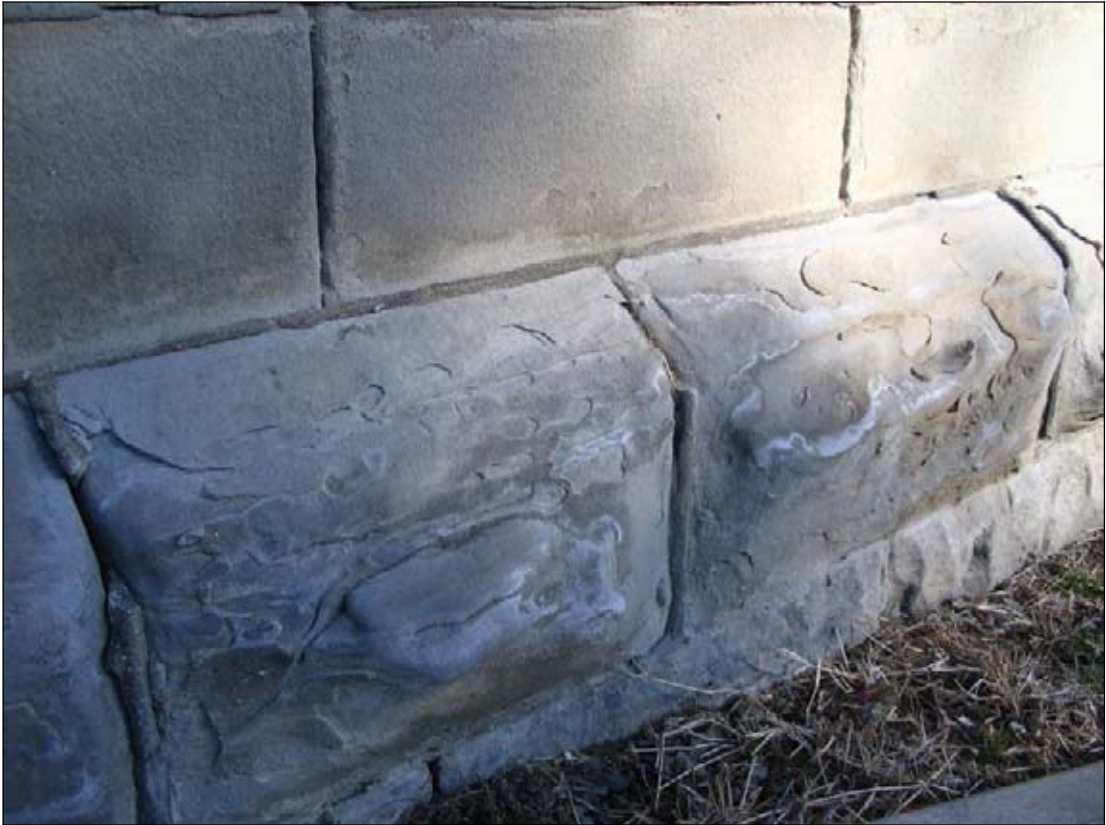
**5. Efflorescence:** Loose salt deposits on or under the surface of the stone. (Based on Fitzner definition 2c.)

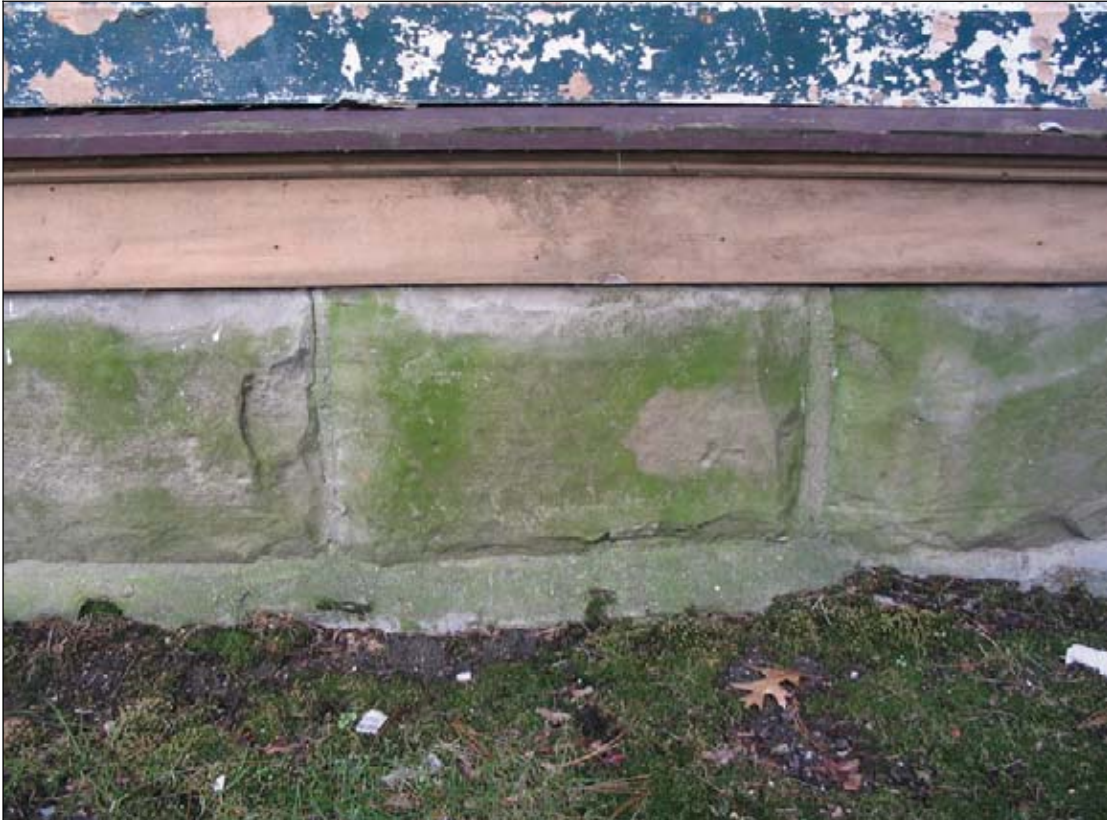
**6. Biological Growth:** The growth or presence of biological life on the surface of the stone by microbiological colonization of algae, fungus, or lichens. (Based on the Fitzner definition 2e.)

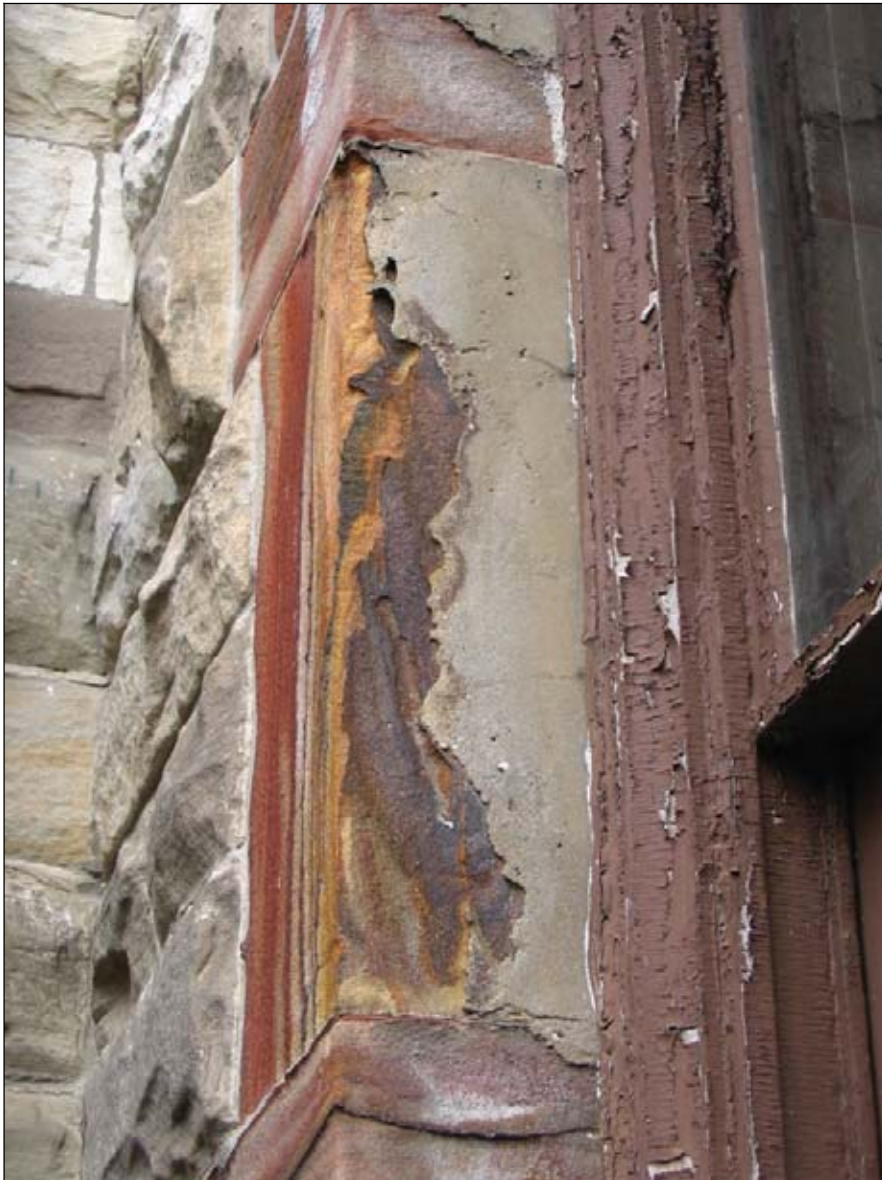
**7. Composite Repair:** A Portland cement mortar based system used as a surface repair for losses greater  $\frac{3}{4}$  inch in width. They are primarily found on the window trim in the Ohio House. (Based on ACL definition.)

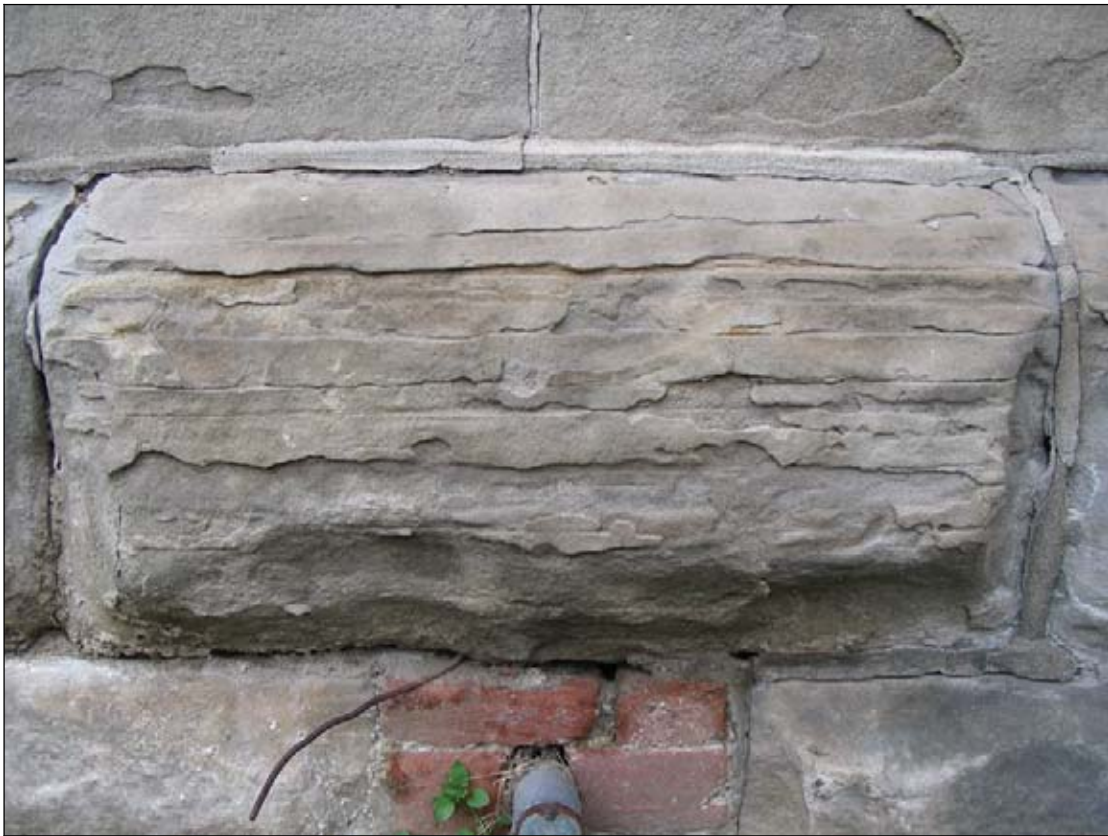
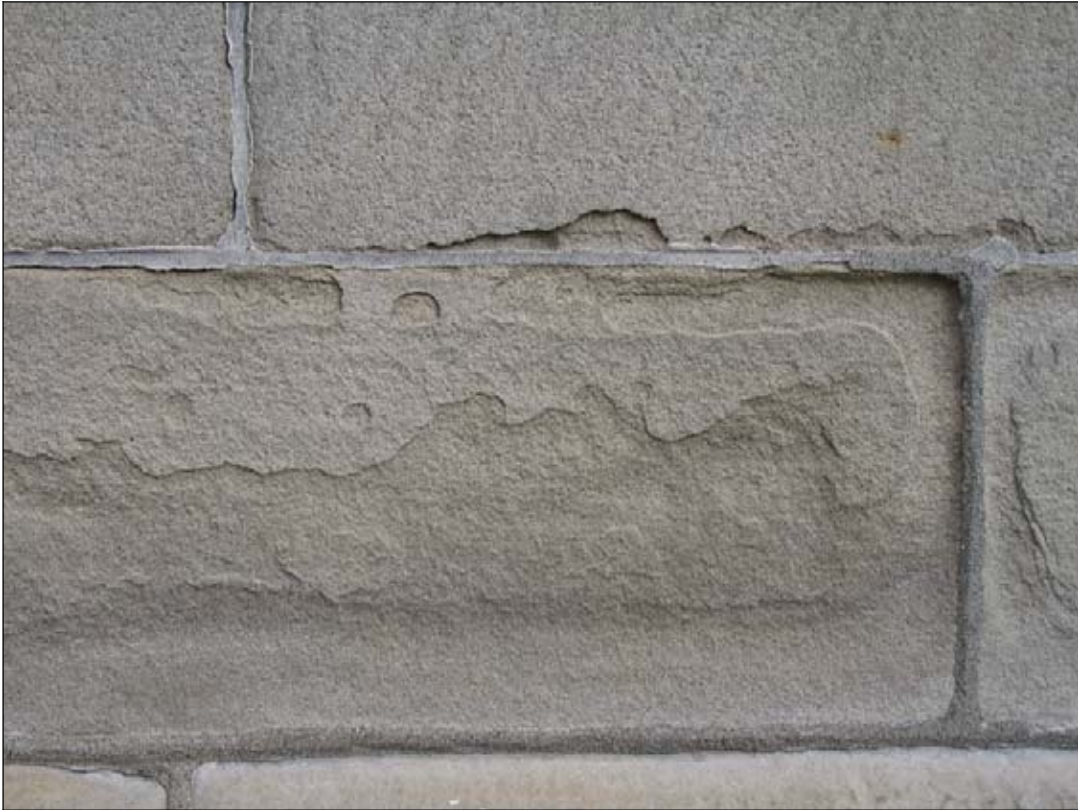
**9. Contour Scaling/Detachment:** This condition combines the often interrelated contour scaling and detachment. Contour scaling is observed as the detachment of larger, platy stone elements parallel to the stone surface, either following the stone structure or independent of stone structure. Detachment is defined as exfoliation which occurs where the leaves of a foliate stone are weathered into layers which detach from the sound stone substrate and delamination which occurs in laminar stones when layers separate from one another and/or the sound stone substrate. (Based on the Fitzner definitions 3e and 3f.)

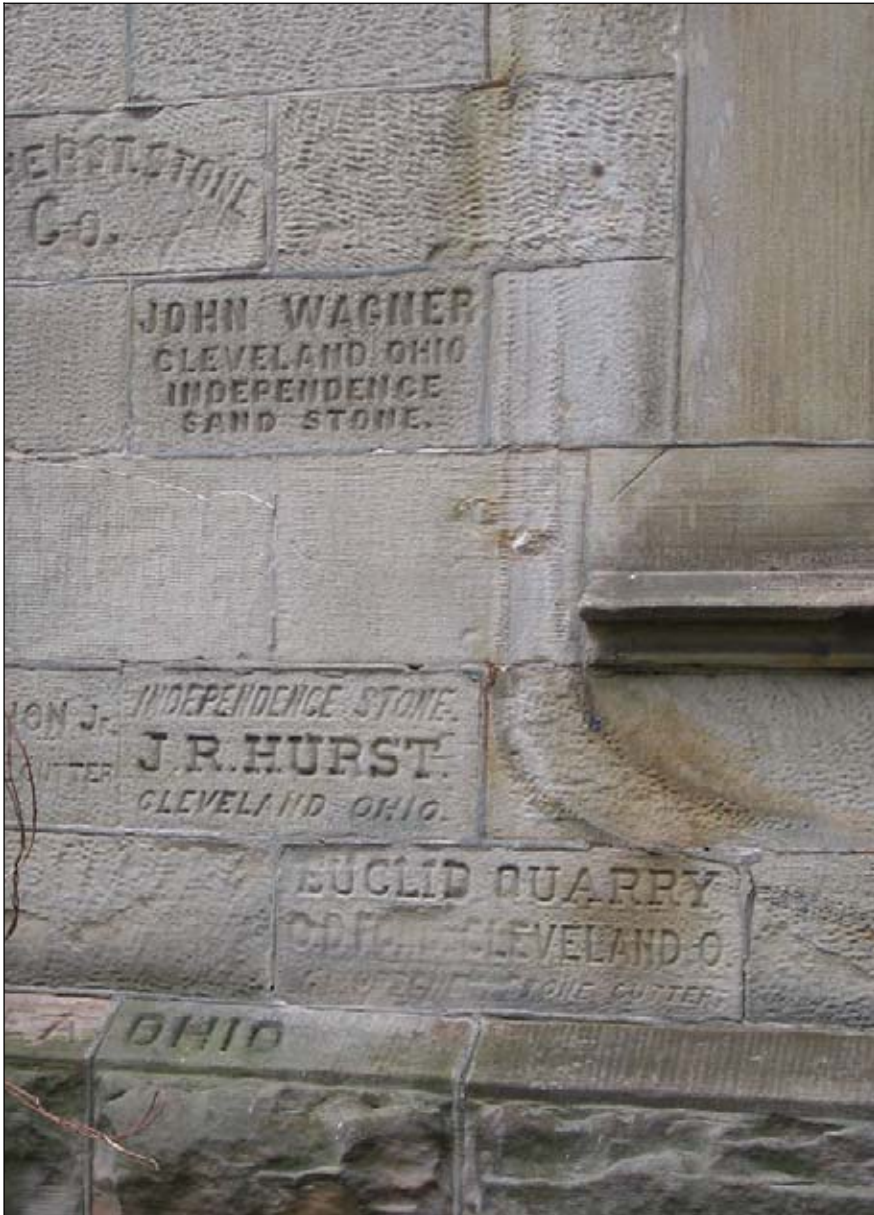
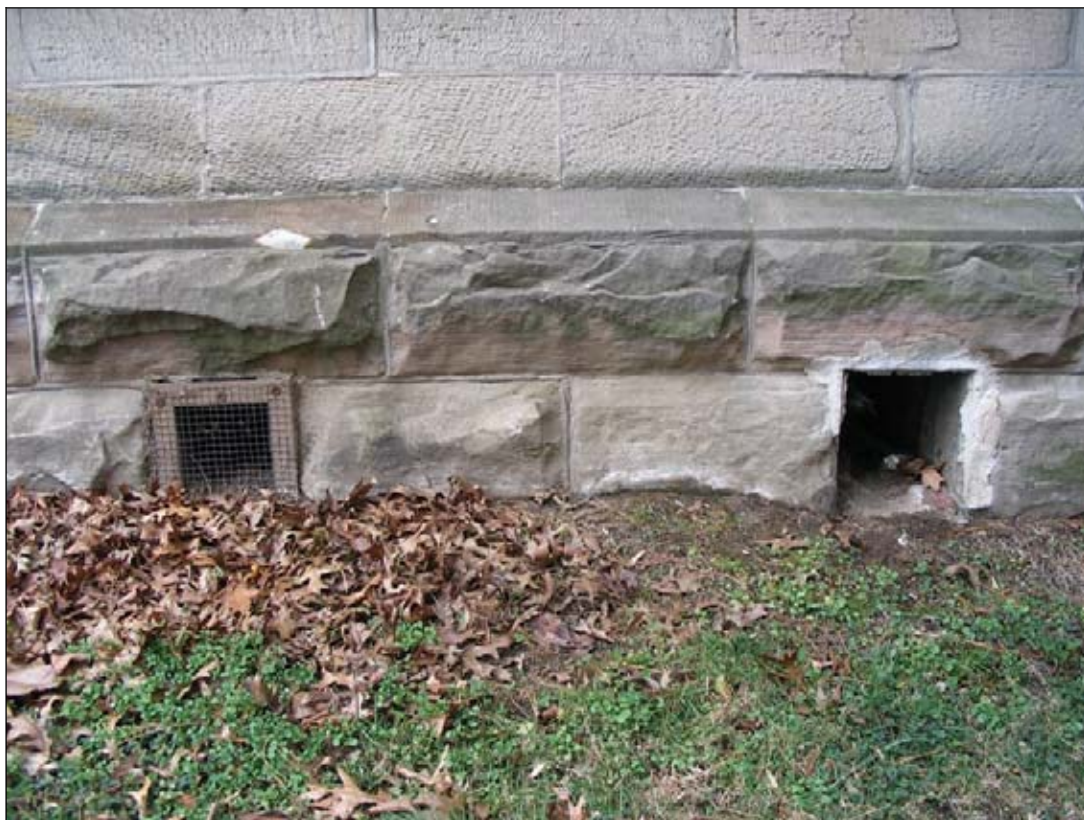
**10. Condition Unique:** Examples of unique conditions include missing screens on basement windows, evidence of a feature from a historic photo, or an unusual inclusion.
