# An Approach to Conservation and Presentation of the Terrazzo Map Pavement of the New York State Pavilion in Queens, New York

Ann Thorkelson  
*University of Pennsylvania*

A Thesis in Historic Preservation Presented to the Faculties of the University of Pennsylvania in Partial Fulfillment of the Requirements for the Degree of Master of Science in Historic Preservation 2007.

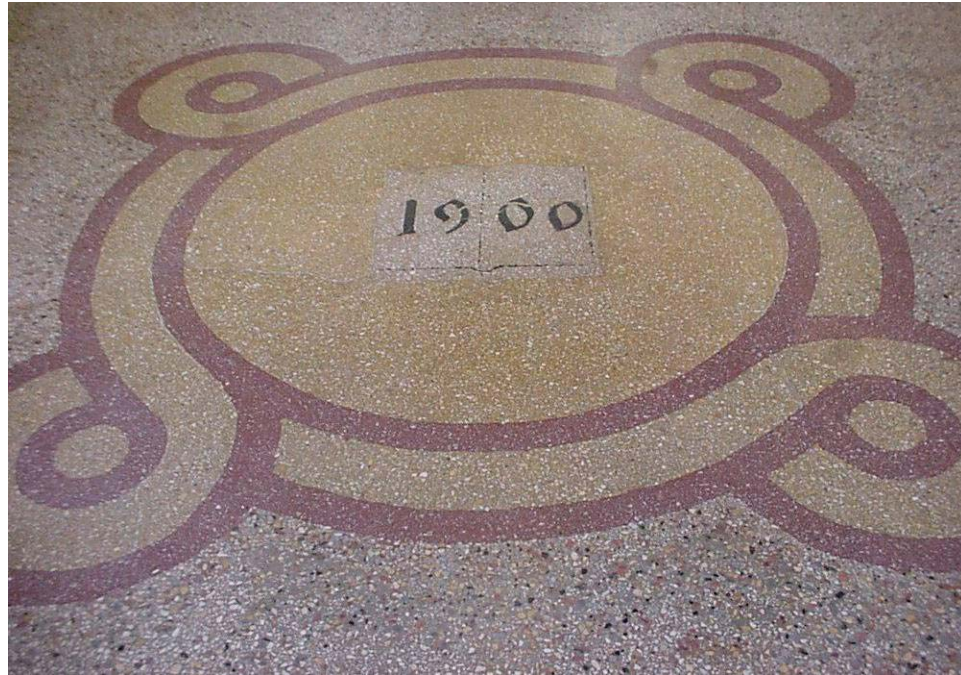
Figure 5: Before restoration of the terrazzo in St. Joseph's Library, St. Joseph Missouri.  
Source: [http://www.ntma.com/07\\_2005\\_honor\\_awards\\_desc.php?job\\_name=stjoseph1](http://www.ntma.com/07_2005_honor_awards_desc.php?job_name=stjoseph1)

A featured project on the NTMA website is the restoration of a terrazzo floor in St. Joseph's Public Library in St. Joseph's, Missouri. The floor dates from 1900 and was discovered during the removal of carpet as part of the overall renovation of the building.<sup>22</sup> The floor was cracked and de-bonded from the surface and the terrazzo contractor who was called in recognized the value and aesthetic quality of floor and advised repair and restoration.<sup>23</sup> The restoration approach involved stabilizing the floor by injecting epoxy to re-adhere detached sections to the substrate, re-grouting the cracks and epoxy injection points with a tinted grout, and grinding and polishing the floor. (Figure 5 and 6). The goal of the project was to stabilize and visually minimize the

damage while bringing out the colors and pattern of the original design. While the repairs are still slightly discernable, the intention was to emphasize the original floor, not the repair, and restore this original feature of the building. The techniques used for repair follow the procedure outlined on the NTMA website and discussed above. The goal was to match the original color and texture using a tinted matrix and marble chips that matched the size and color of the original floor. This approach to terrazzo restoration is a standard approach taken by companies that make repairs to damaged terrazzo and recommendations for repair as specified by the National Terrazzo and Mosaic Association.

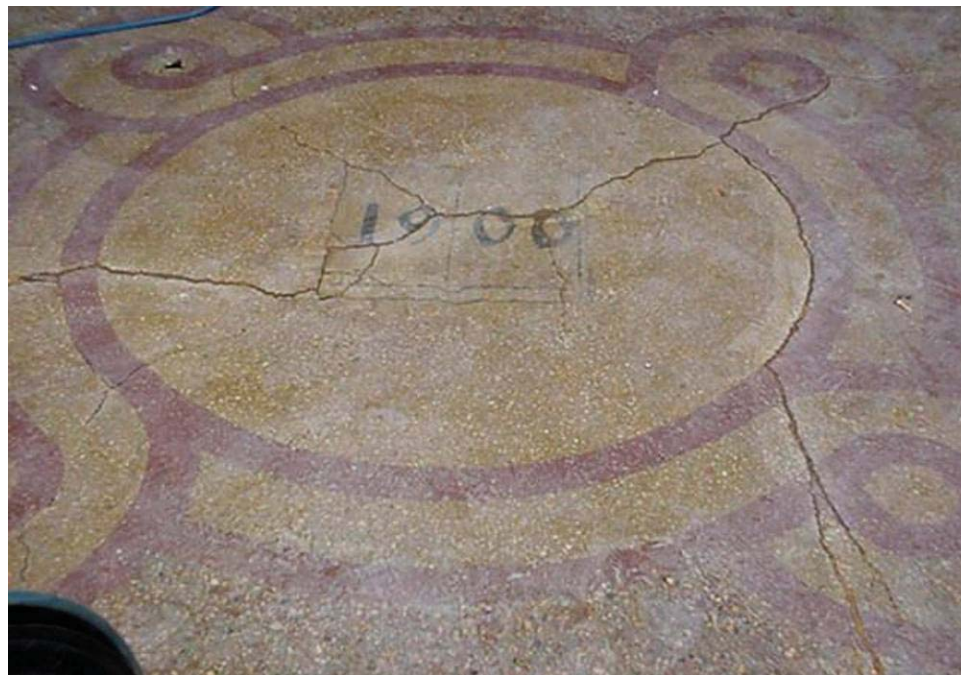
Figure 6: After restoration of the terrazzo in St. Joseph's Library, St. Joseph Missouri.  
Source: [http://www.ntma.com/07\\_2005\\_honor\\_awards\\_desc.php?job\\_name=stjoseph1](http://www.ntma.com/07_2005_honor_awards_desc.php?job_name=stjoseph1)

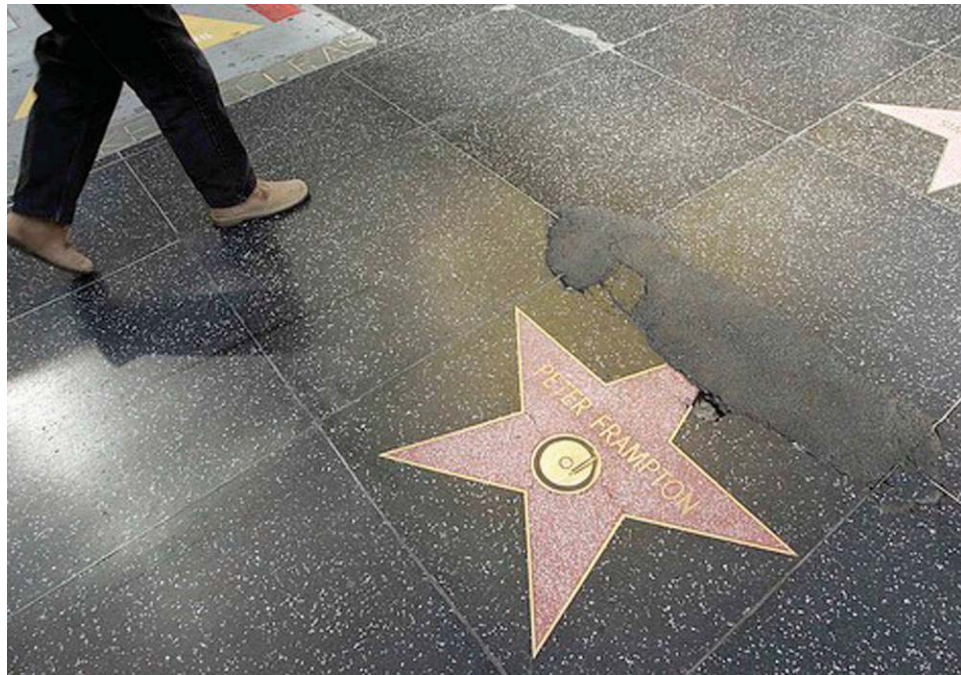
Beginning in 1994 with the construction of an underground metro line, the Hollywood Walk of Fame began to display cracking and “buckling”.<sup>26</sup> (Figure 7). Past and continuing damage from the metro, and potential thermo-expansion problems are the two opposing speculations as to the cause of the problem, but neither has been proven yet. While discovering the source of the problem is key to preventing future damage, the intermediate solution has been to replace the 121 damaged black terrazzo squares and an additional 16 that have stars in them, in time for the 2007 Oscars.<sup>27</sup>

Figure 7: A damaged and patched terrazzo star from the Hollywood Walk of Fame.  
Source: Loss Angeles Times, February 9, 2007. <http://www.latimes.com/news/local/la-me-stars9feb09,1,3826359.story?page=2&cset=true&ctrack=1&coll=la-headlines-california>

The decision to replace the stars, rather than repair them or wait until a long term plan can be established speaks to the power of the floor and to the value of the terrazzo material. There is little question of the value of the floor to Hollywood, but the original material at this point in time was secondary to what the floor represented and symbolism trumped authenticity.

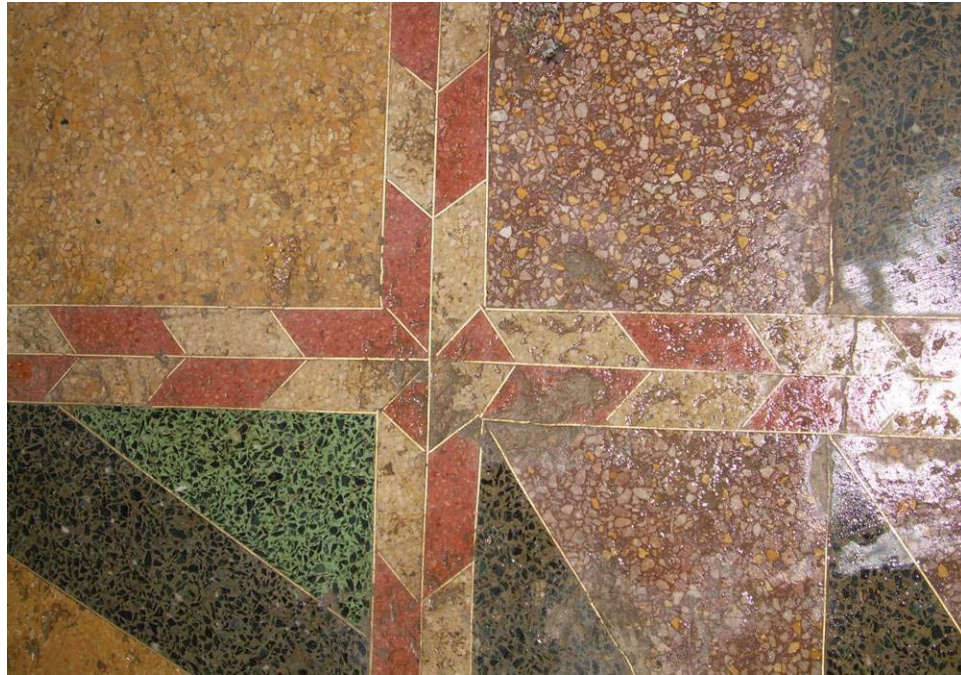
The interior terrazzo floor had been covered by carpet prior to restoration and the damage consisted of various size holes, some of which were drilled into the floor to accommodate pipes, cracks that penetrated the terrazzo topping, pitting, and fine cracks. (Figure 8).

Figure 8: The terrazzo floor in the lobby of the East Columbia Building before conservation. Source: Andrea Morse, Sculpture Conservation Studios.

Terrazzo manufactures were consulted about the construction method used, and the most appropriate materials and techniques for making repairs. Epoxy was used for touch ups for small cracks on the interior terrazzo but not the exterior pavement due to the yellowing of the epoxy outdoors. The steps for conservation taken to the interior pavement included grinding the floor to remove previous coatings, the deepening of

cracks and holes prior to filling them with a mortar, the addition of marble chips, grinding the floor level with the existing terrazzo, coating the floor with a tinted mortar to fill in fine cracks, polishing, application of an acrylic sealer, and finally a hard wax coating. Holes and cracks were deepened to ensure good adhesion of the mortar mix but were not widened which would have resulted in further loss of the original material. The mortar used to make fills consisted of pigment, cement, sand, water, acrylic emulsion, followed by marble chips matching the original terrazzo mix in color and size. The process used for making fills involved an initial layer of mortar followed by marble chips pressed down into the mortar. This process was repeated three times till the void was filled and left to dry for 12-24 hours prior to grinding the surface level with the floor.

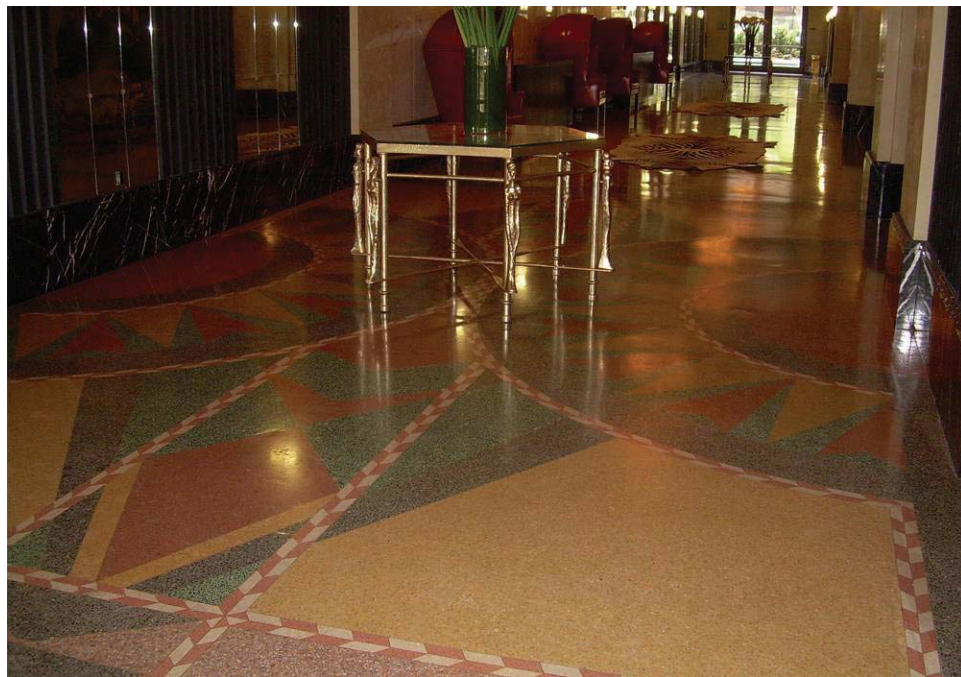
Figure 9: The terrazzo floor in the lobby of the East Columbia Building, after conservation. Source: Andrea Morse, Sculpture Conservation Studios.

The imagery of the interior terrazzo is a repetitive pattern of sunbursts and surrounding borders, while the exterior terrazzo depicts a repetitive Chevron symbol. To compensate for loss of the pattern imagery, the entire floor was photographed and the photos montaged together, prior to any intervention, to observe the repetition of the pattern and how it transitioned throughout the entire floor. A conscious effort was made to respect the original construction method by using compatible materials and repair techniques that followed the steps used in constructing the terrazzo originally. The goal of the repairs was to match as closely as possible the original floor and minimize the visual impact of the repairs. (Figure 9). In addition to consulting terrazzo companies that were familiar with this construction method, manuals such as the terrazzo specifications

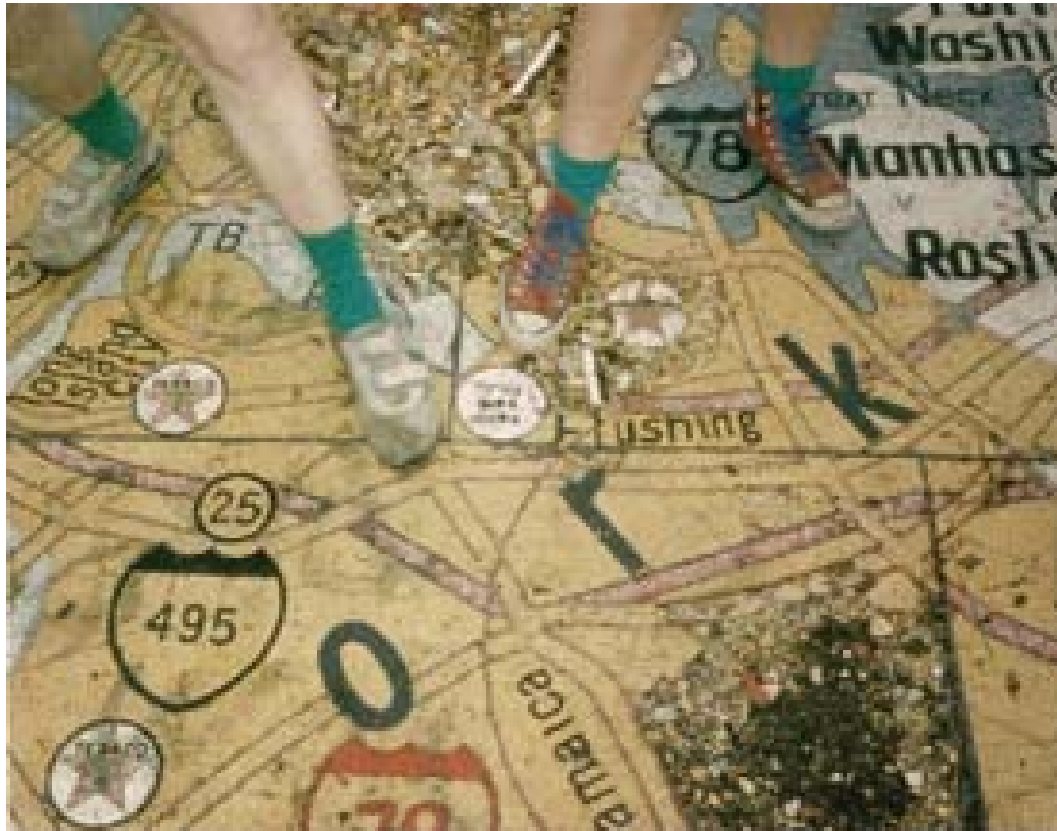
Figure 13: Visitors standing by the in the Queens section of the terrazzo pavement in the late 1980's.  
Source: Andy Looney, <http://www.wunderland.com/WTS/Andy/nywf.htm>

Pavilion.<sup>63</sup> (Figure 13). Souvenir theft of pieces of the pavement was known to occur.<sup>64</sup> The New York City section of Long Island has suffered tremendous loss and has been partially filled in with patches of concrete. As the location of the Pavilion, it seems likely that this portion of the map may have been a popular target for people seeking souvenirs of plastic letters from their hometown. Currently, the Pavilion is closed to the public but is used by the Queens Theater to store props for their shows.

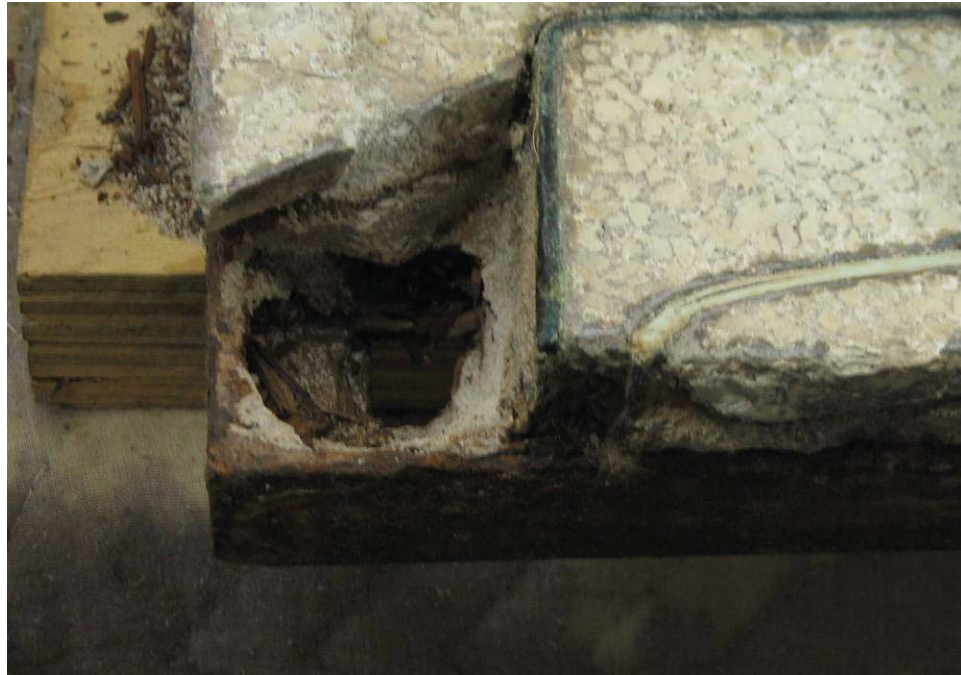
Figure 14: Detail of a damaged terrazzo tile showing the metal frame, terrazzo, underbed and a hold where the plywood support has rotted. Source: Photo by author.

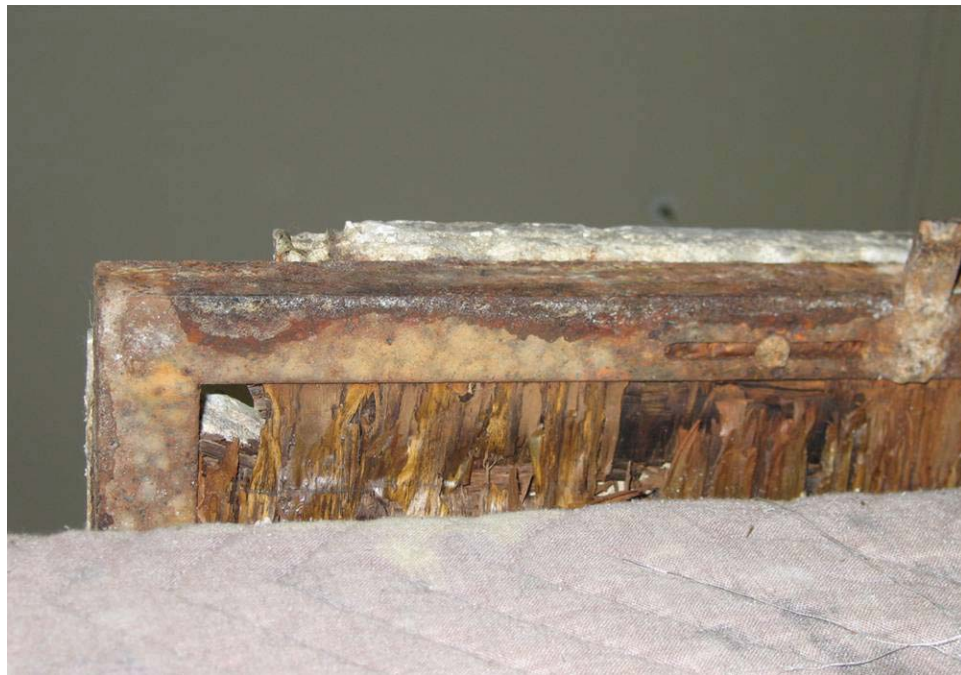
Figure 15: View of a terrazzo tile from below with rotting plywood. Source: Photo by author.

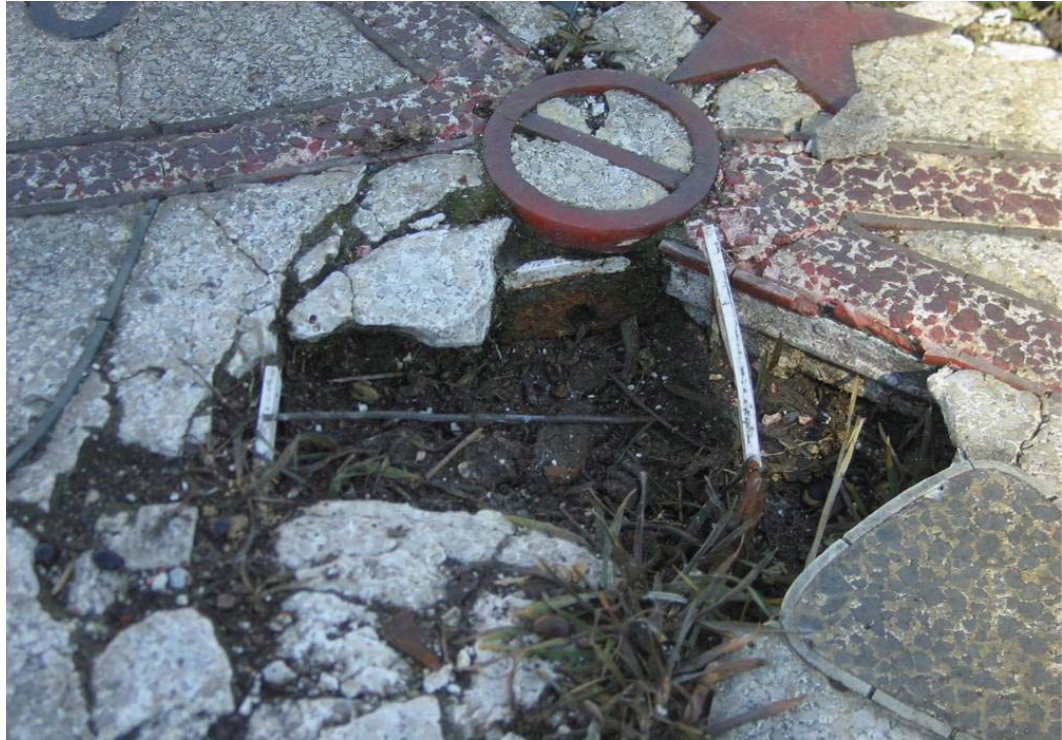
Figure 16: Detail of the insets and support system in a damage tile on site. Source: photo by author

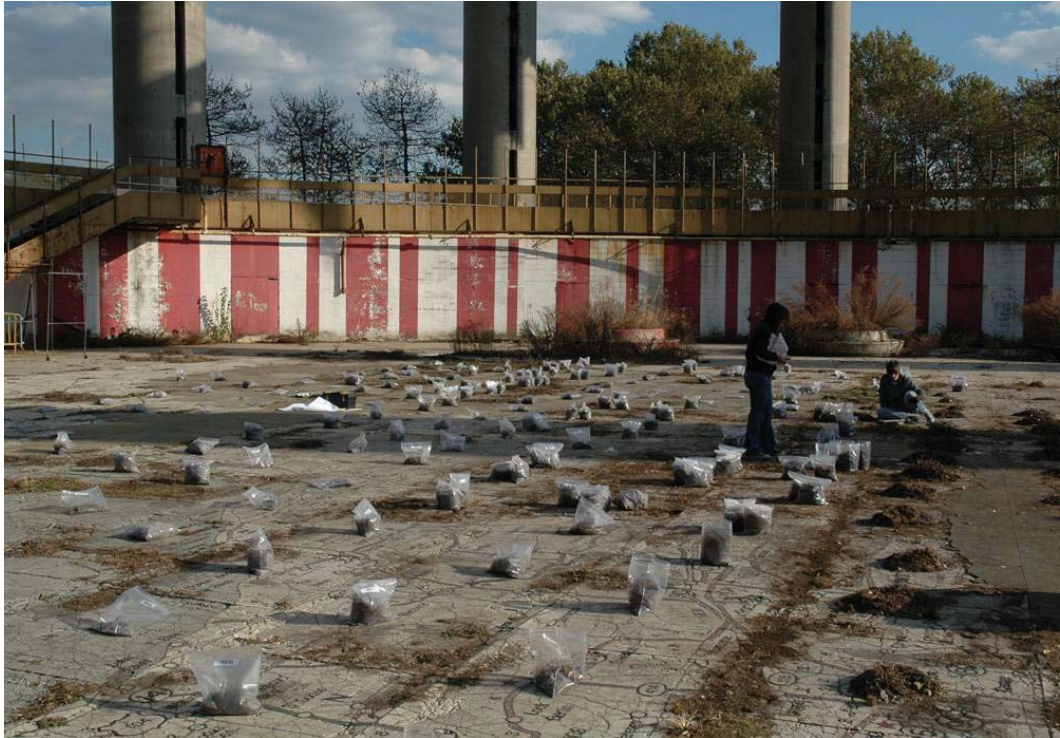
Figure 17: Students collecting debris, loose terrazzo, and plastic in November 2006.  
Source: photo by author

Two site visits were made in October and November, 2006 and were dedicated to clearing the pavement of vegetation and sweeping each tile to collect and bag loose material. (Figure 17). Each tile was given an alpha numeral for identification and each bag that contained material from a tile was labeled as well. The numerical values assigned to each tile, ranging from 0-10, worst condition to best condition, were based on an overall assessment of the tile condition, not on multiple factors averaged into one number. However, the single number attributed to each tile did consider the degree of cracking, deformation, and presence or lack of original material. As the major factor determining the integrity of the terrazzo pavement, loss of material is directly related to the overall values addressed. A high value reflects a low percentage or area of loss, and a higher integrity and quantity of original fabric. (Appendix C, Map 1).

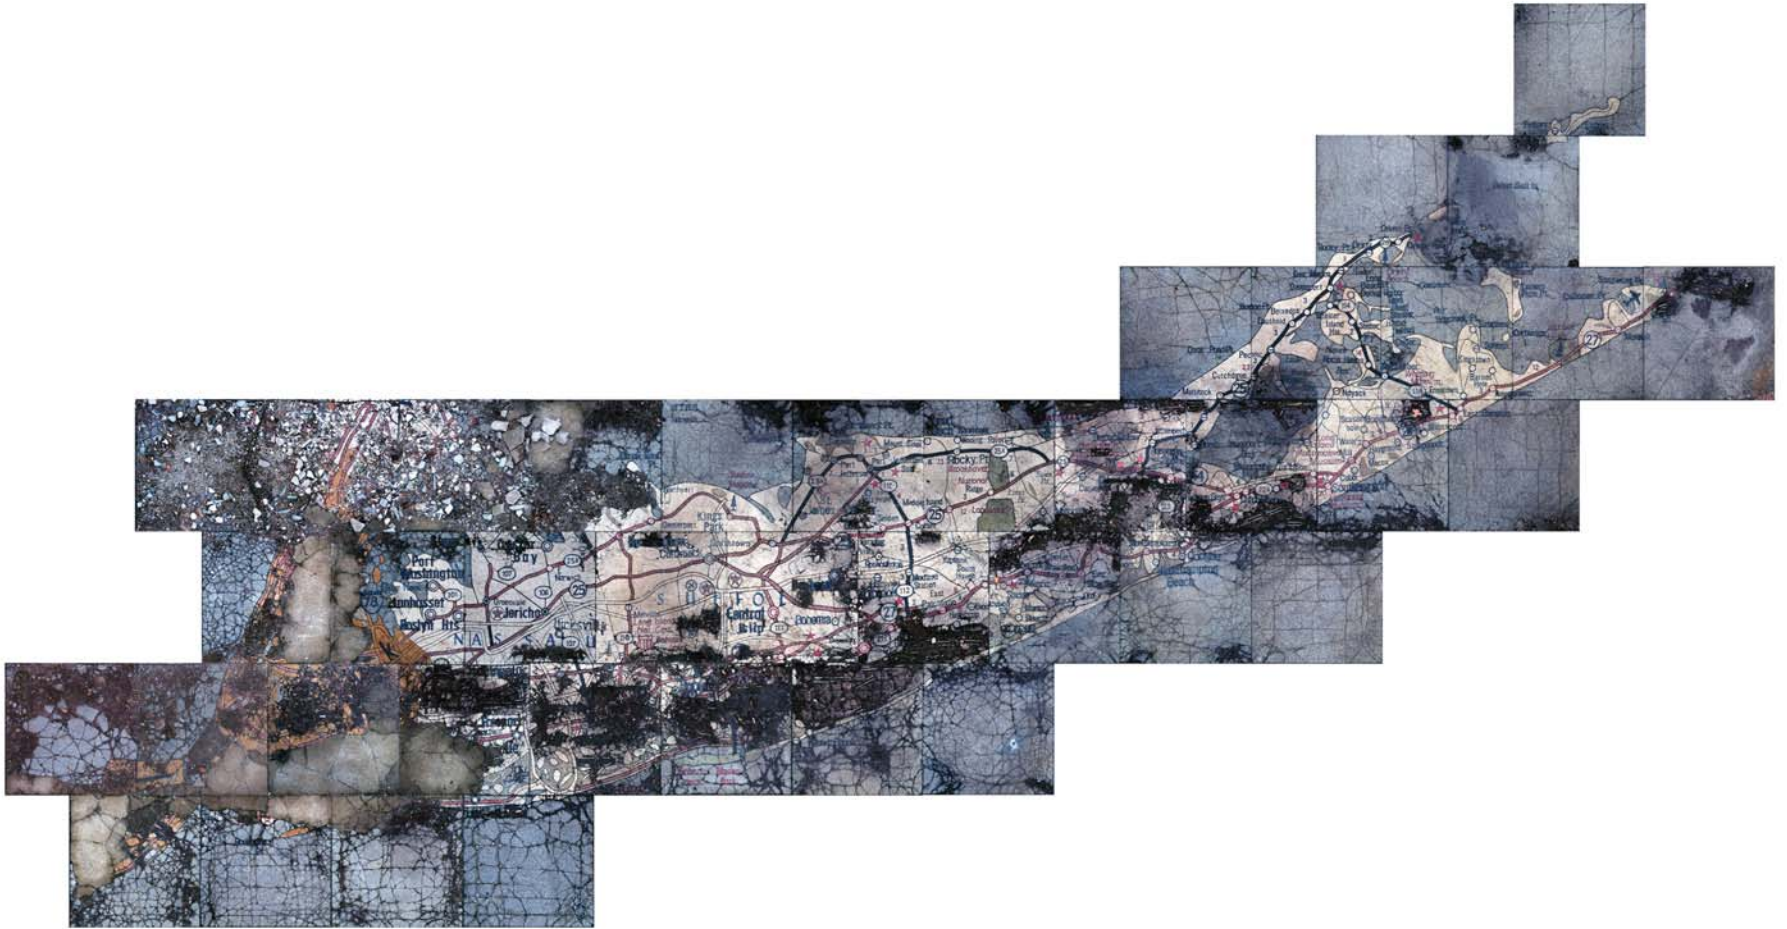
The 40 Terrazzo tiles that comprise the Long Island section of the terrazzo pavement. Photos by John Hinchman, November 2006.

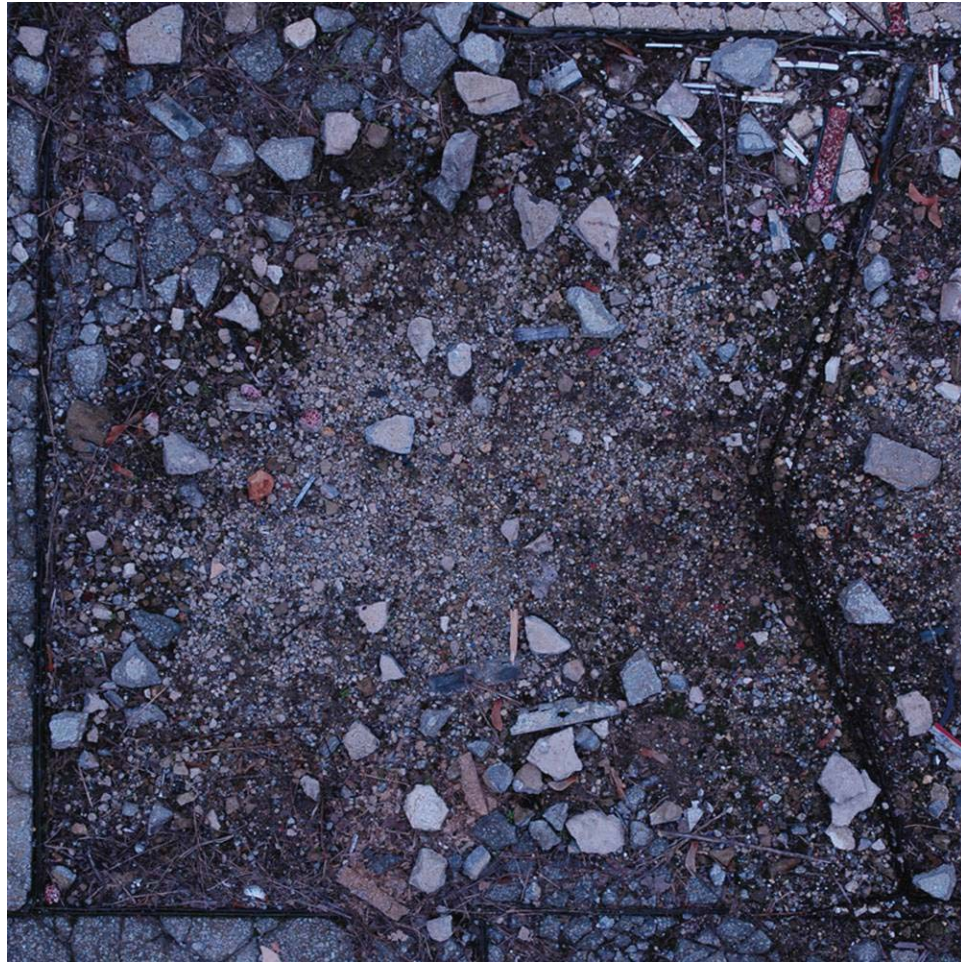
Loss: The absence of terrazzo or plastic insets revealing the substrate below.

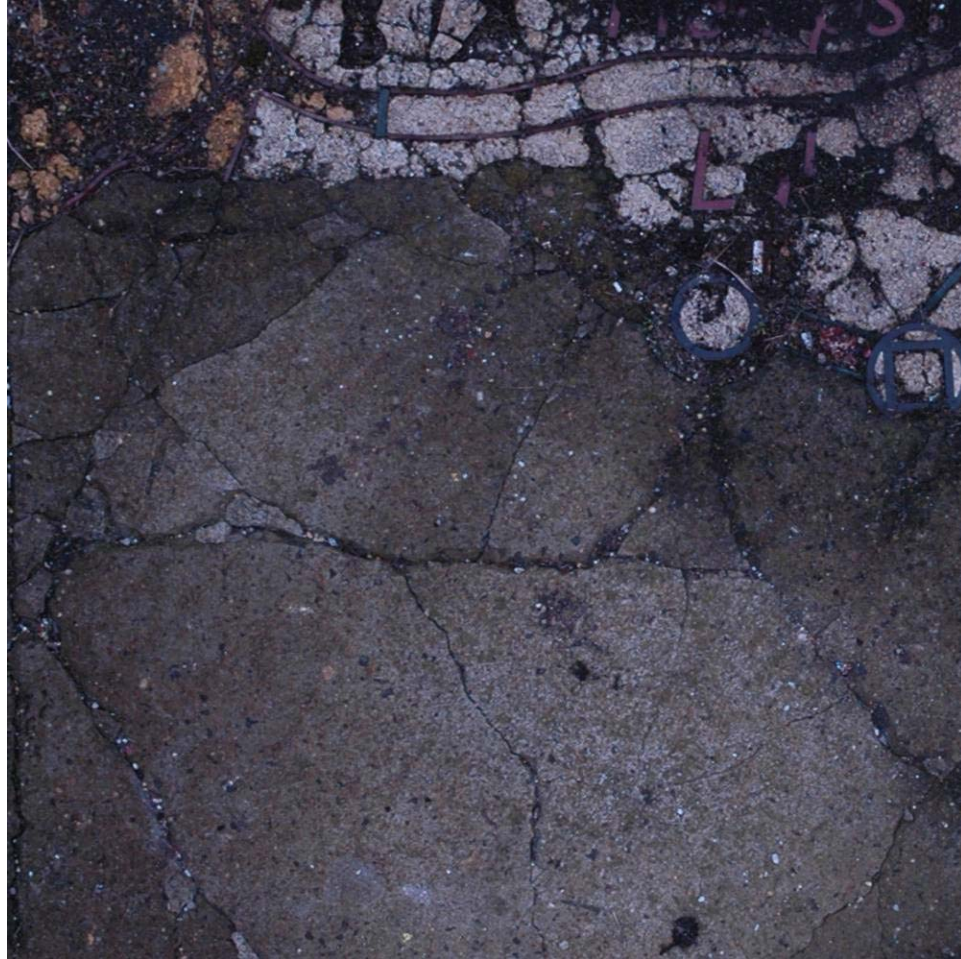
Fill: The presence of cement that filled a previous area of loss.

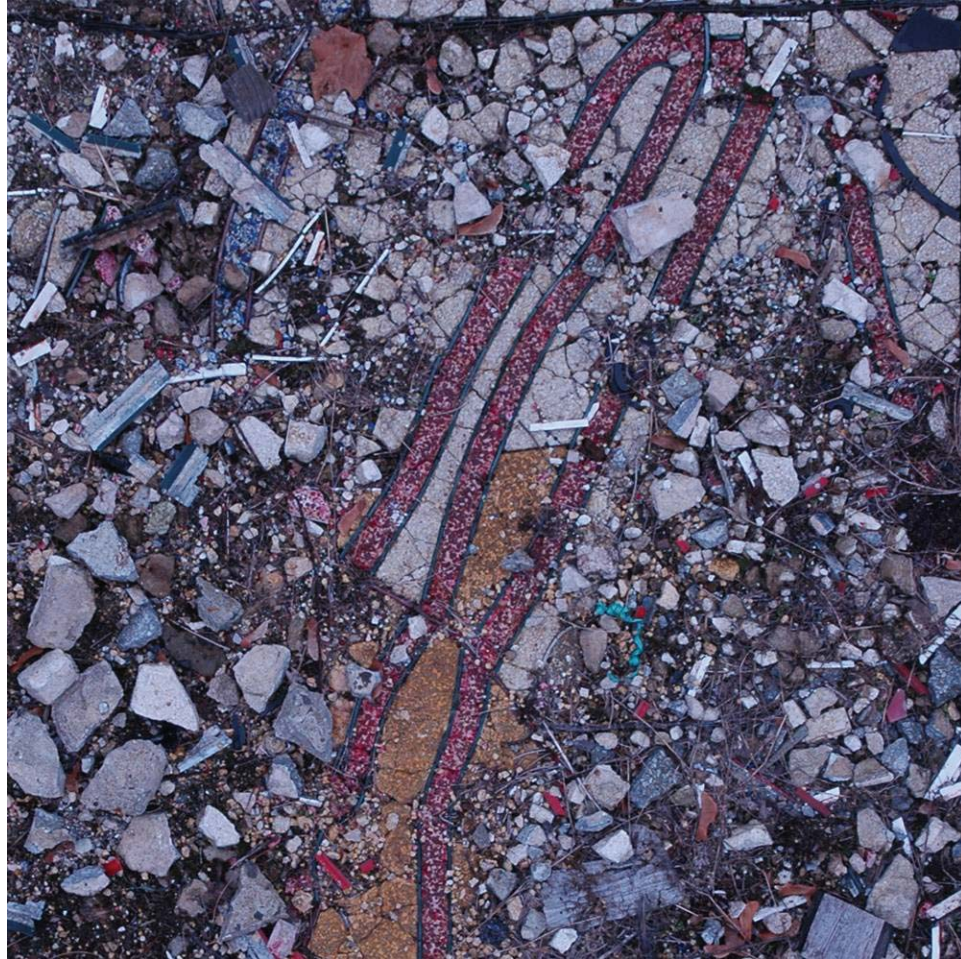
Incipient Spall: Terrazzo that has begun to detach from the panel but still remains connected. Often seen in association with loss, cracking, debris, and vegetation.

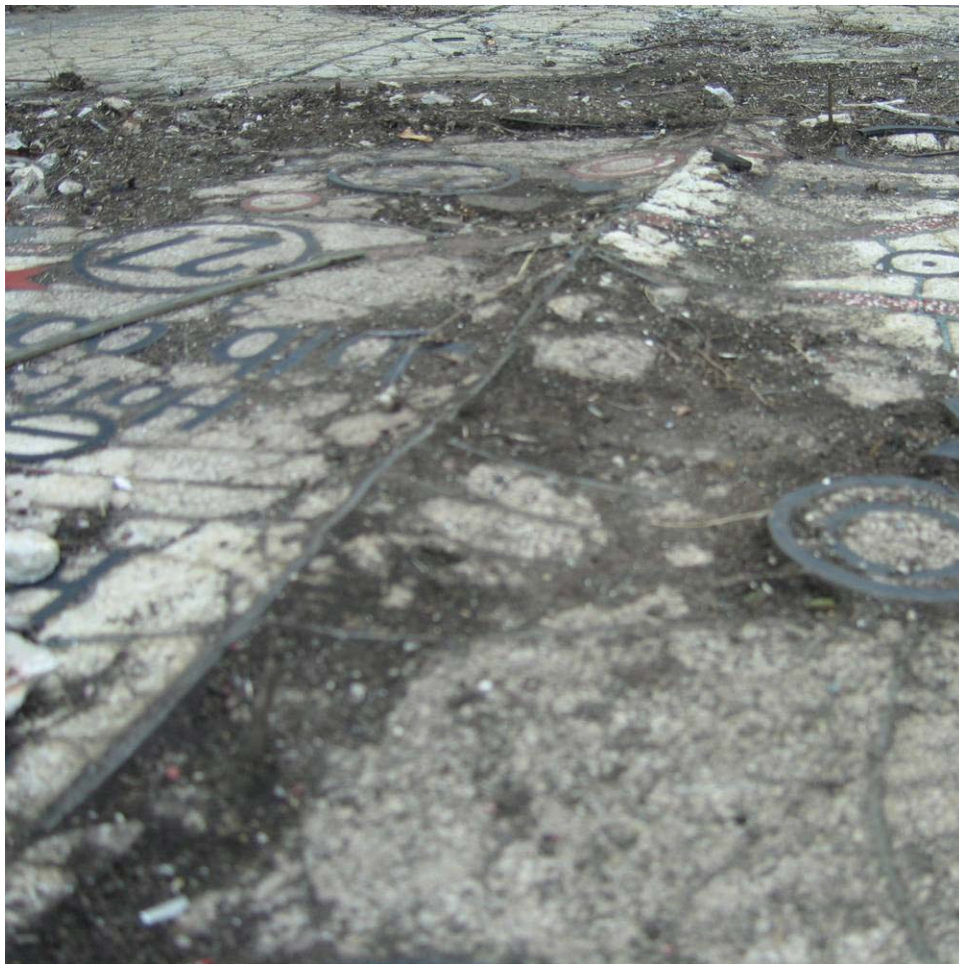
Deformation: Deformation is characterized by the concave warping of the panel, whereby the center is lower than the perimeter edge.

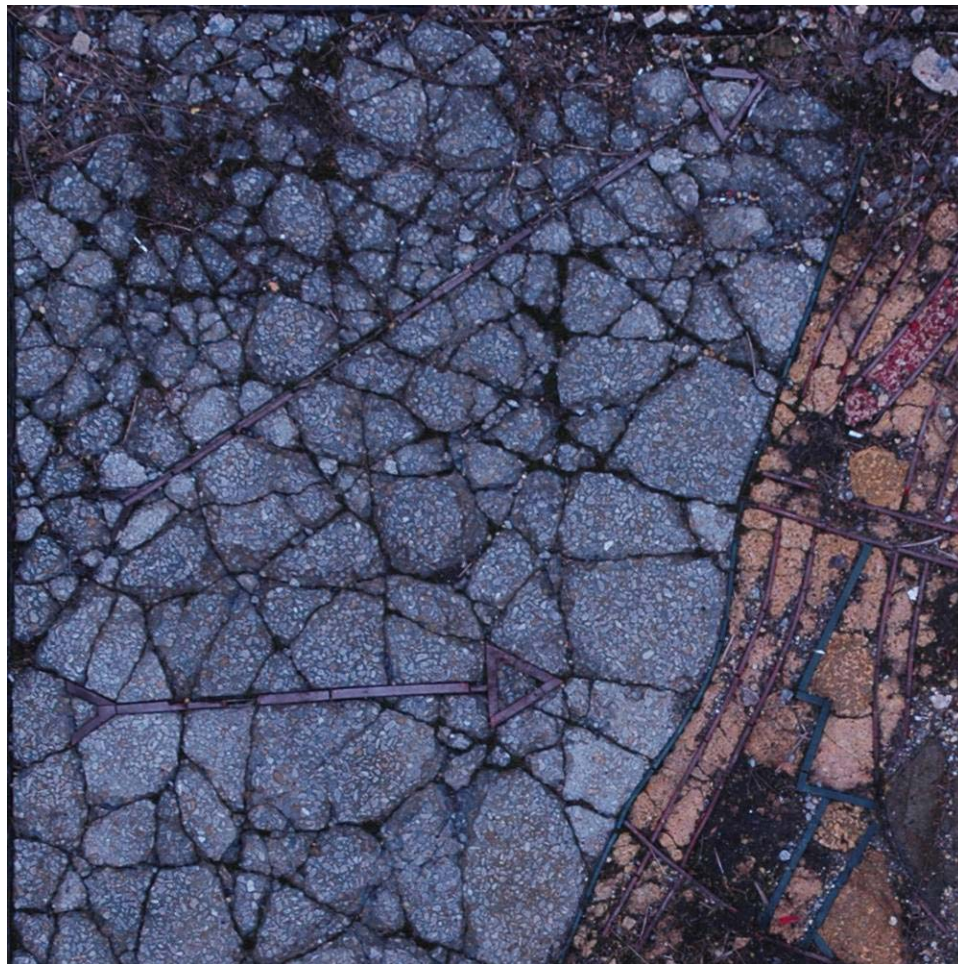
Network Cracking: A patterned arrangement of cracks that have been divided into three levels of severity.

Severe Network Cracking: Cracks that have penetrated the terrazzo topping, forming “islands” of terrazzo. Deformation is often seen in conjunction with this condition.

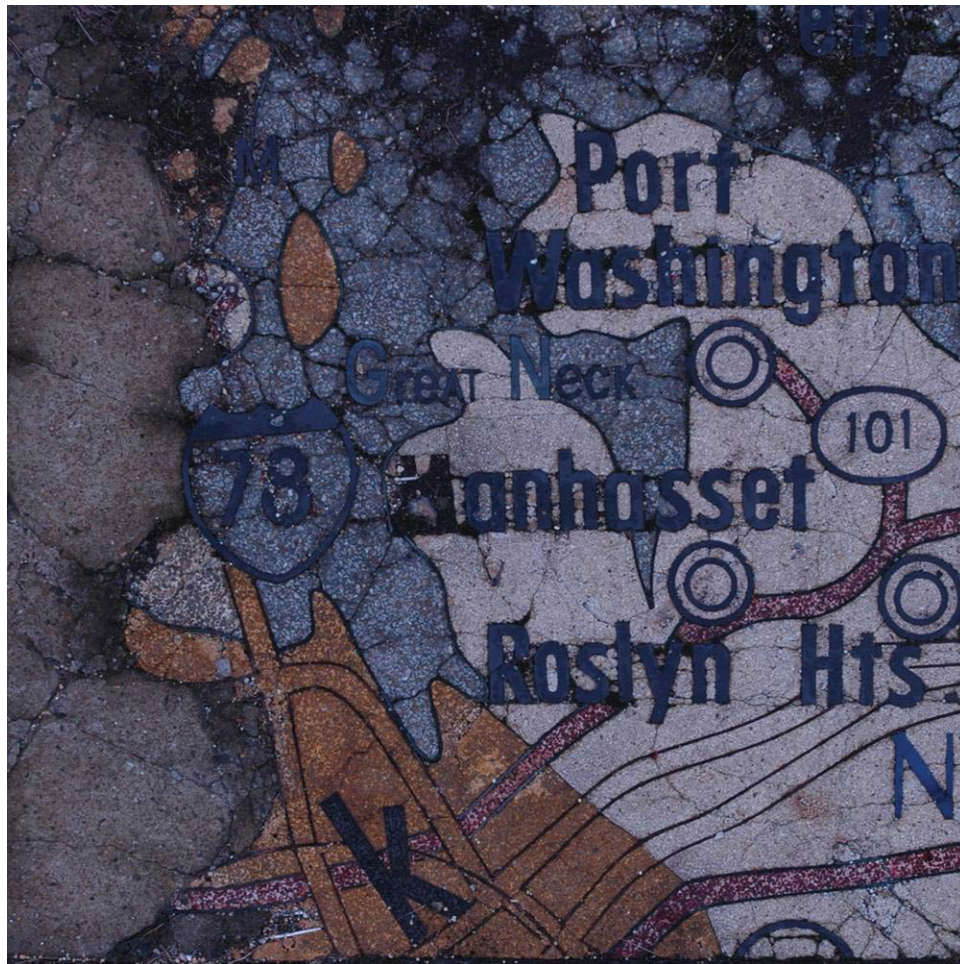
Moderate Network Cracking: A network of cracks that penetrate the terrazzo but where the integrity of the terrazzo and overall imagery are still in tact. Cracks are deeper than the minor network cracking but do not create “islands” of terrazzo like severe cracking.

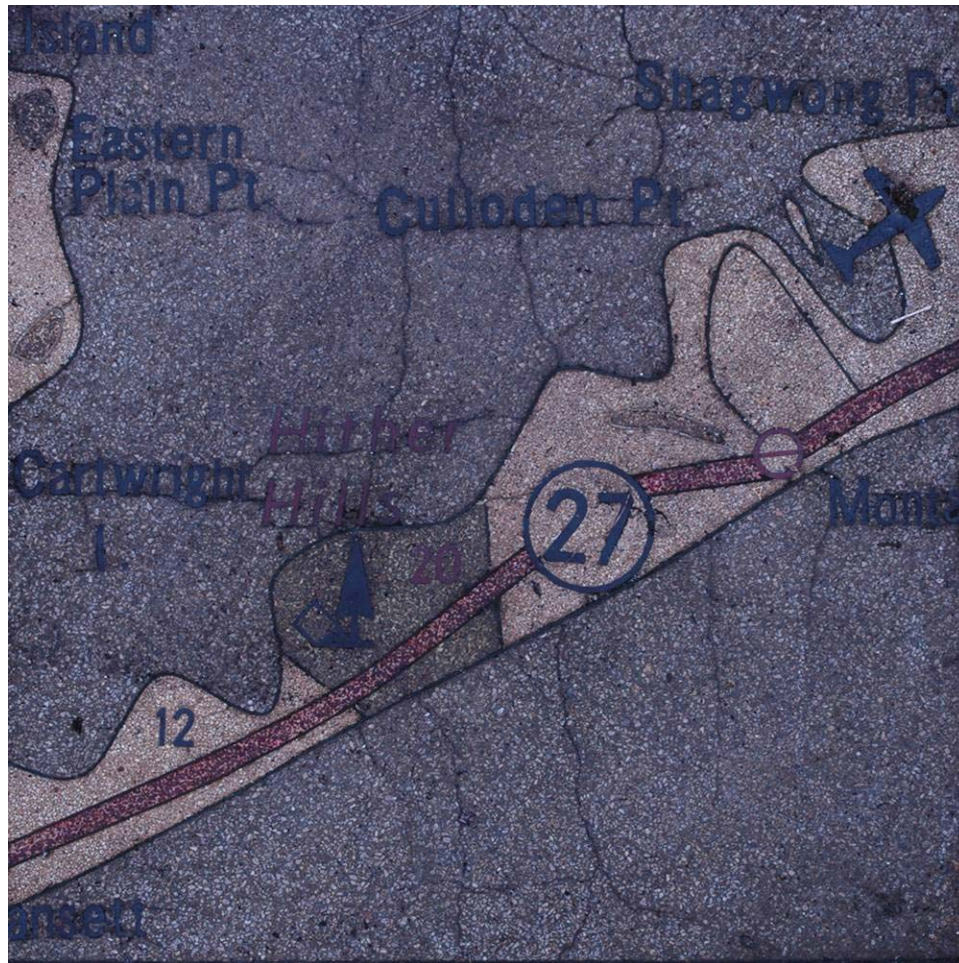
Minor Network Cracking: Cracks that remain close to the surface of the terrazzo and do not contribute to deformation of the panel.

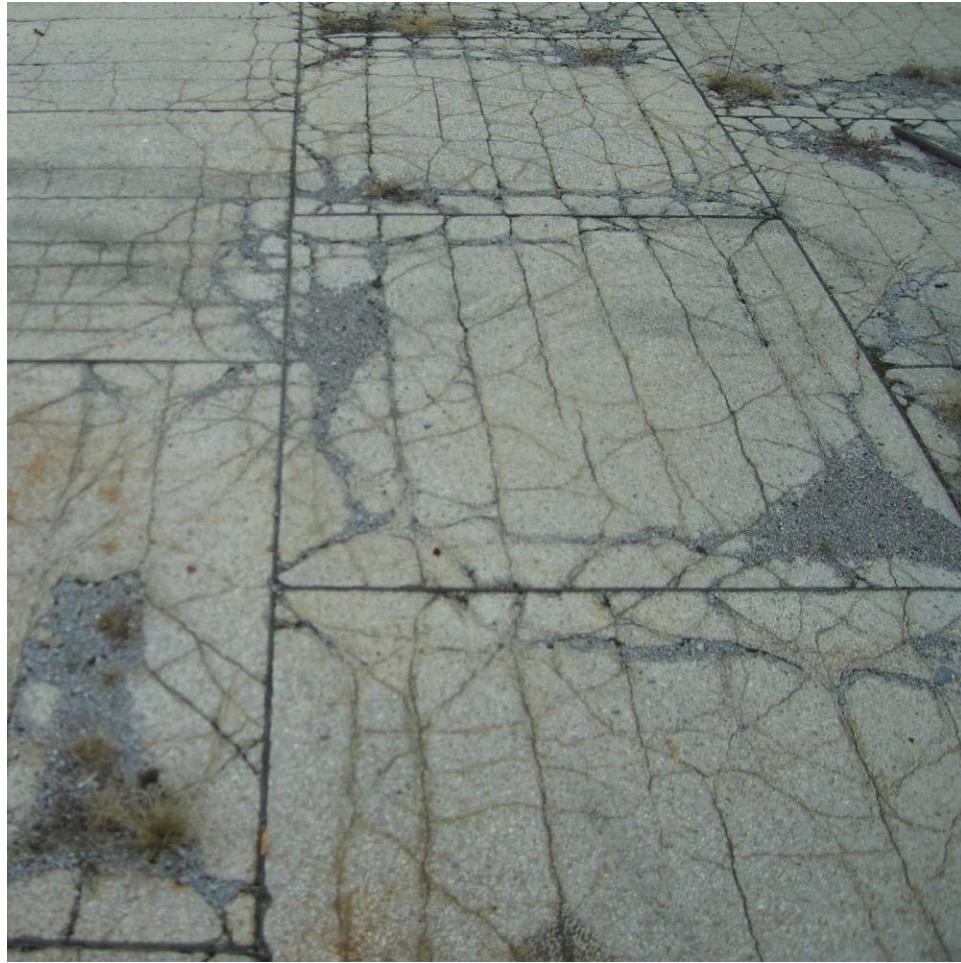
*Parallel Cracking*: Cracks that appear parallel to each other and the edges of the tile.

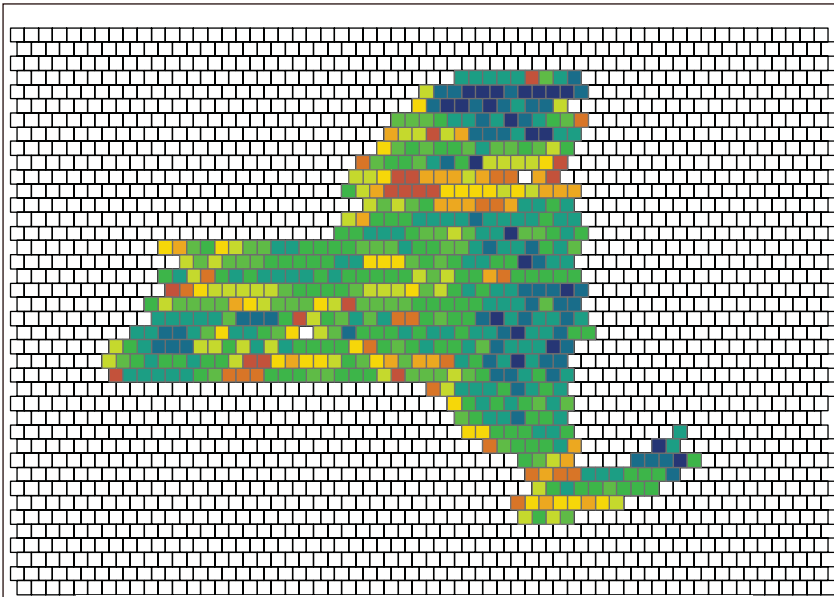
Map 1: Overall Conditions of the 567 tiles of New York State.

All 567 tiles within New York State were given a value on a scale of 1-10. No tiles were given a value of 10, but all the other numbers are represented. The values represent the overall condition of each tile based on the integrity of the existing material and the severity of loss and damage. A value of "0" indicates tiles that have been replaced with cement.

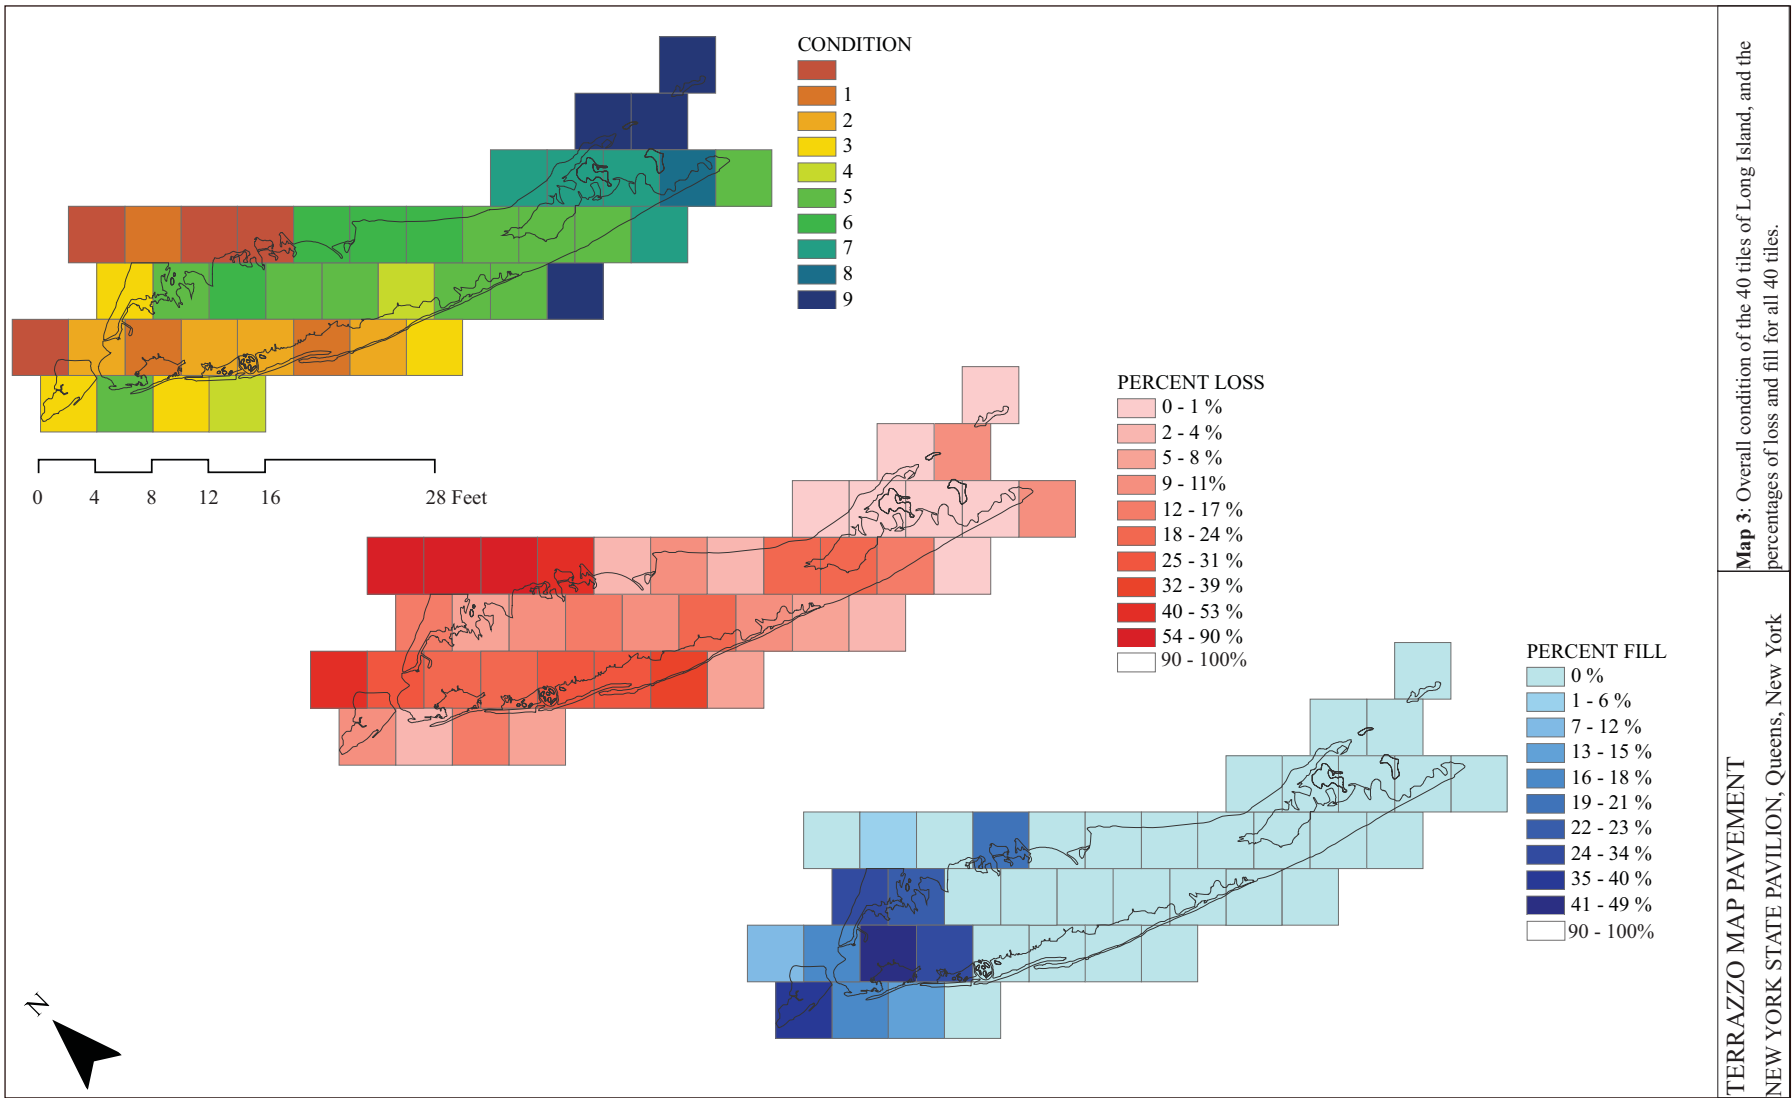
**Map 3:** Overall condition of the 40 tiles of Long Island, and the percentages of loss and fill for all 40 tiles.
