THE EARLY PHRYGIAN GATE AT GORDION, TURKEY: AN INVESTIGATION OF DRY STONE MASONRY IN SEISMIC REGIONS AND RECOMMENDATIONS FOR STABILIZATION

A THESIS in Historic Preservation Presented to the Faculties of the University of Pennsylvania in Partial Fulfillment of the Requirements of the Degree of MASTER OF SCIENCE IN HISTORIC PRESERVATION 2009

The gate's current conditions include extensive cracking, spalls, split faces, missing chinking stones, open joints and in- and out-of-plane displacements, which partially result from the complex history of the site. Constructed around 900 BC, the Early Phrygian Gate only briefly served as the main entryway to the citadel. Inhabitants from later periods continuously restructured the citadel mound, always utilizing the earlier structures as foundations for new construction. The changing load patterns resulting from different building campaigns caused a series of visible structural conditions—most notably cracking and displacement. Though cracking previously occurred from additional loads of the later city walls, displacement continues to be an active condition. Presently, several agents potentially threaten the gate's stability and include weath

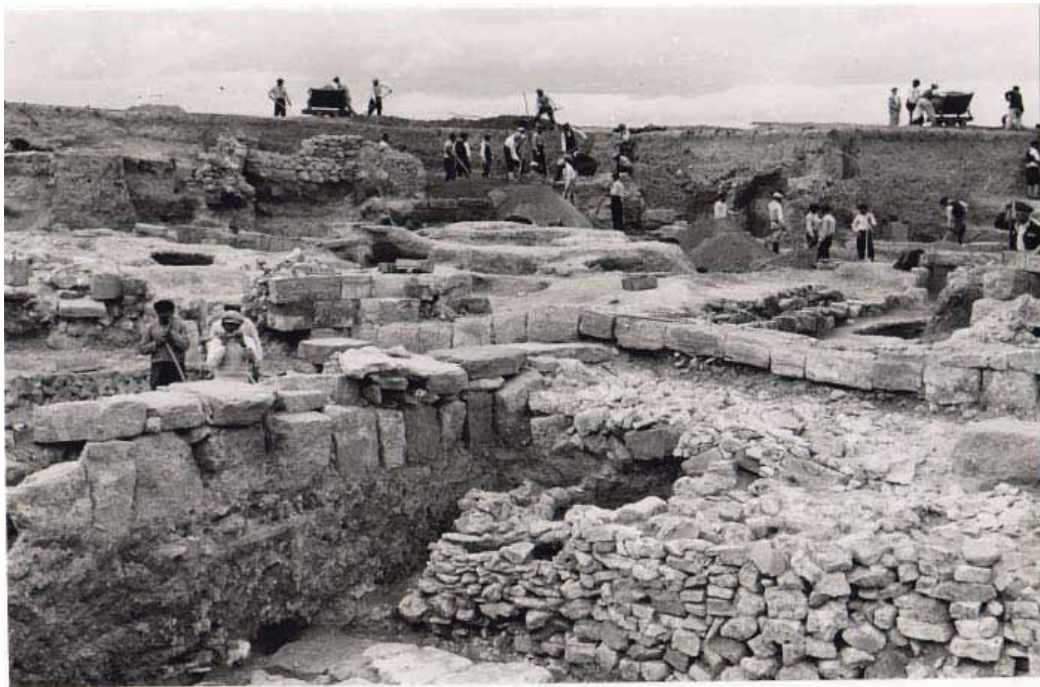
Figure 4. Excavations to clear the Middle Phrygian building stones. *From the Gordion Archives, ca. 1955.*

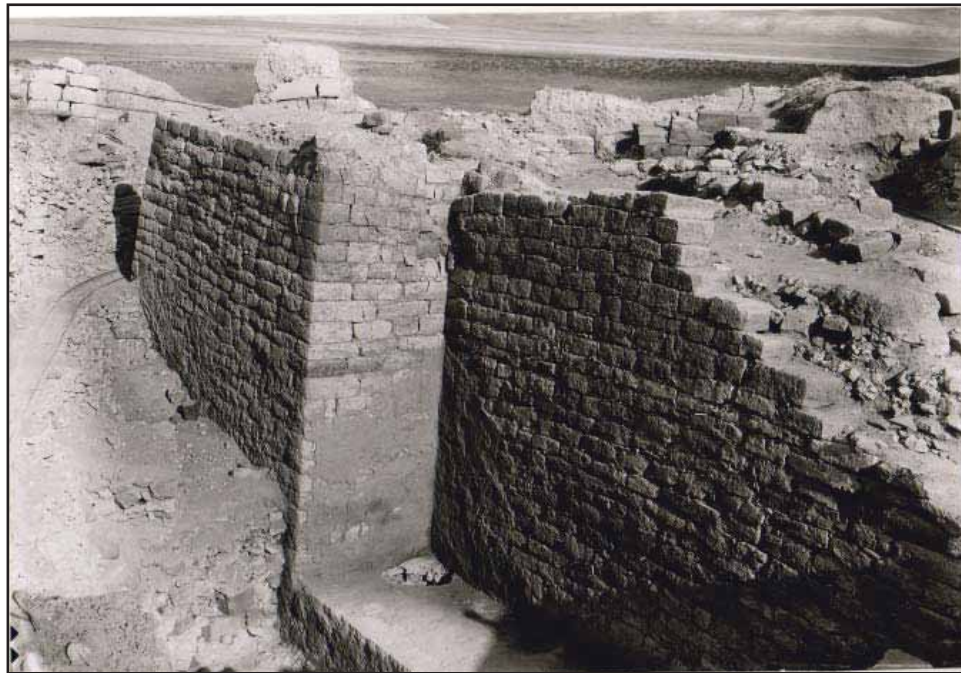
Figure 5. Only the South Court's entryway facade was excavated; clay construction fill remains in the interior court. *From the Gordion Archives, ca. 1955.*

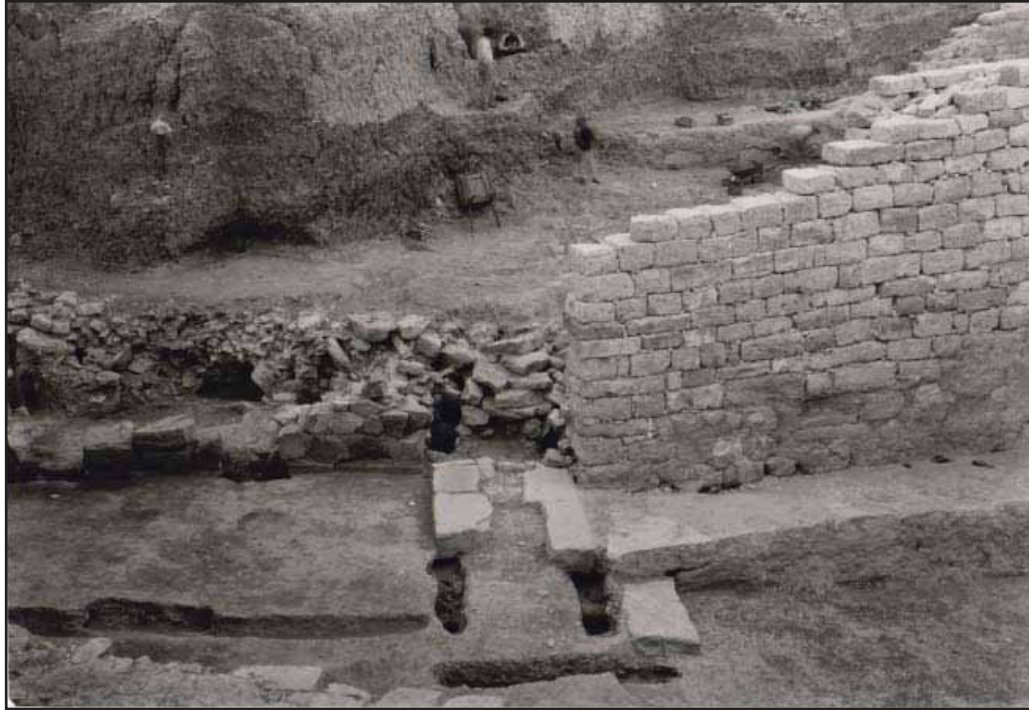
Other wooden components include the timber used as foundation beds for the massive stone masonry walls. The form of the disintegrated timber remains molded in areas where the rough logs were bedded in clay.⁹ These logs carried the weight of the outer face of the northern wall of the entrance ramp (and presumably of the southern wall).¹⁰ Though the disintegration of the wooden structural supports produced some instability (noted by Young in his 1955 excavation report), the walls of the formal entryway appeared generally stable at the time of excavation due to the design and construction methods.¹¹

Figure 6. Impression from timber foundation beam at North Court. *From the Gordion Archives, ca. 1955.*

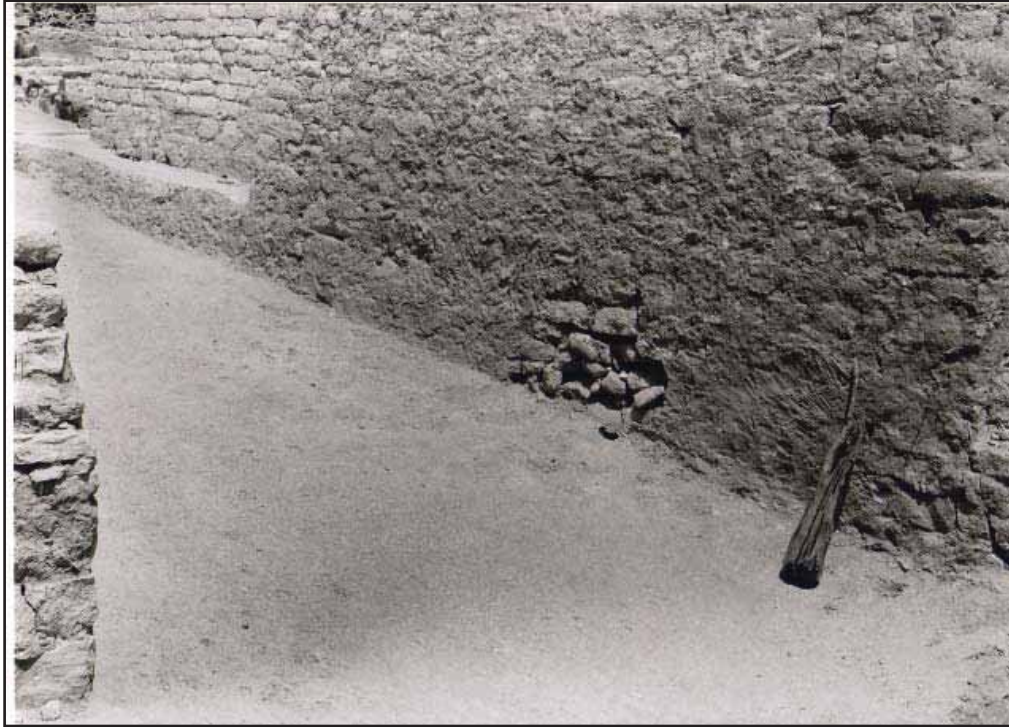
has since been lost due to its exposure to environmental conditions and, as of 2006, only remnants of the earthen finish remain on the southeast exterior elevation, areas of an interior North Court wall, and as broken plaster keys in many of the head joints.¹⁶

Figure 8. Extant earthen plaster on the southeast elevation of the North Court. *From the Gordion Archives, ca. 1955.*

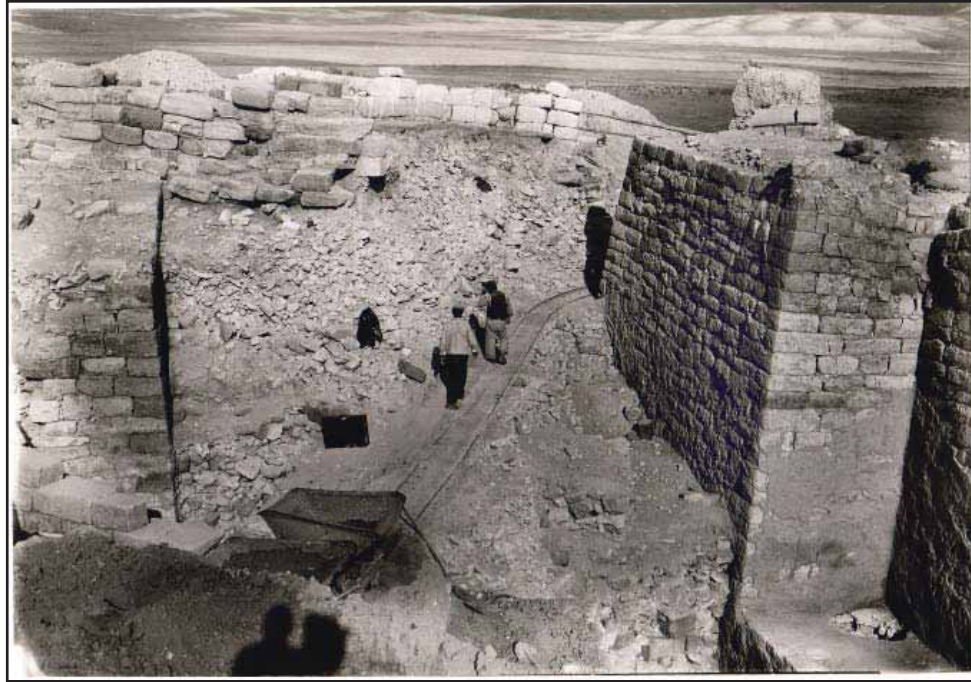
Figure 9. Excavations of the Early Phrygian entryway. *From the Gordion Archives, ca. 1955.*

By clearing away the Middle Phrygian-period fill and exposing this section of Early Phrygian wall, the archaeologists discovered the three-wythe veneer and rubble wall system employed by the Phrygian builders. Additionally, observations were made on the differences in stability between the upper Middle Phrygian and lower Early Phrygian walls. Young noted that the later buildings showed evidence of displacement; walls tended to move relative to slopes in the foundation.²⁸ This sliding observed in the Middle Phrygian walls was not apparent in the Early Phrygian walls. Young reported on the stability of the Early

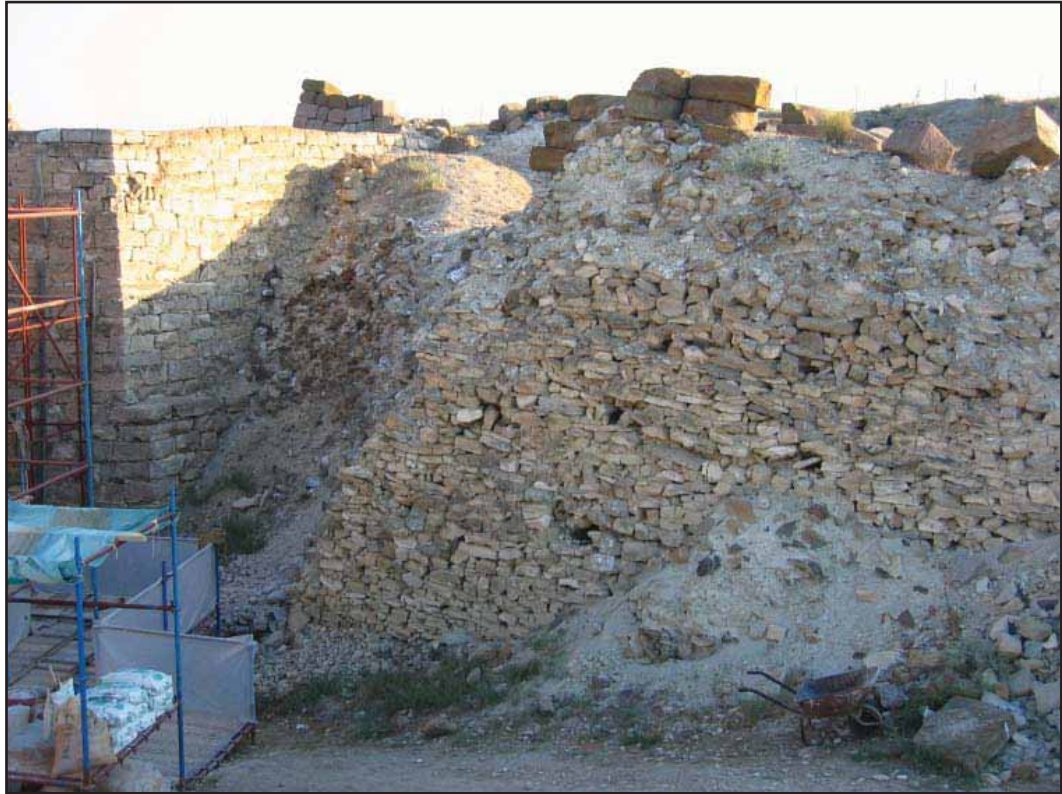
Figure 10. Rubble fill laid during the Middle Phrygian period. *By Wong, 2006.*

from the rubble fill above and behind the gate walls.³¹

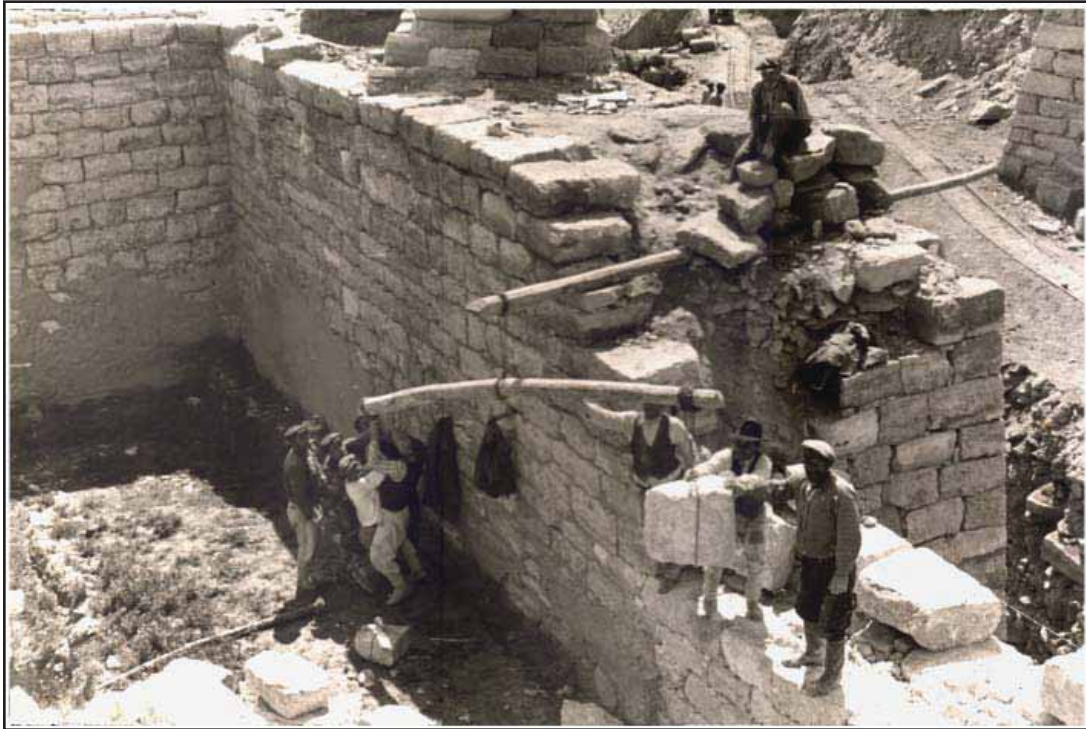
Figure 11. Reconstruction of the southwest elevation of the North Court. *From the Gordion Archives, ca. 1955.*

During the 1955 campaign, workers dismantled the Middle Phrygian damn wall and, due to the challenge of disposing of so much stone, used the blocks to reconstruct the inner southwest wall of the North Court.³⁵ After this season, the gate had been mostly cleared to the level of the Middle Phrygian town and some instability was evident. Over the course of the next three excavation seasons, workers incorporated rubble debris as buttressing for areas in need of additional structural support.³⁶

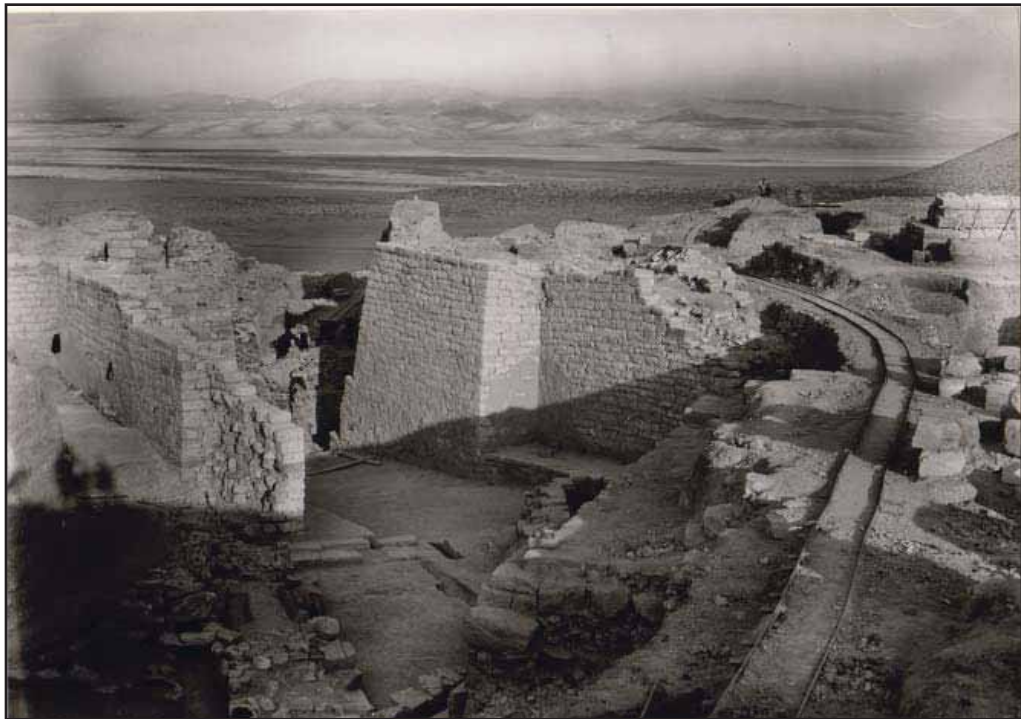
Figure 12. The Polychrome House foundations were uncovered at the interior of the main entryway. *From the Gordion Archives, ca. 1955.*

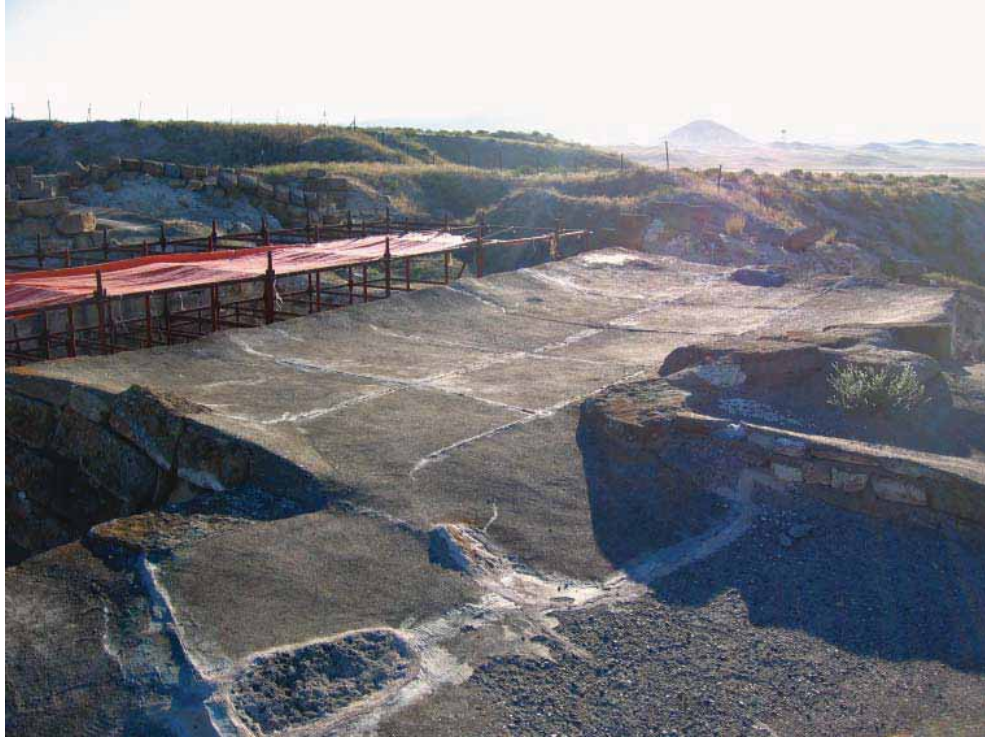
Noticeable deterioration resulting from water ingress instigated the first major conservation effort of the Early Phrygian Gate. A concrete cap was installed on much of the North Court (though a large portion of the southern wall was never capped).³⁷ The concrete cracked soon after installation and failed to prevent water penetration to the rubble core. However, the cap remained in place for about thirty years before being replaced.

Figure 13. Cap on the South Court. *By Wong, 2006.*

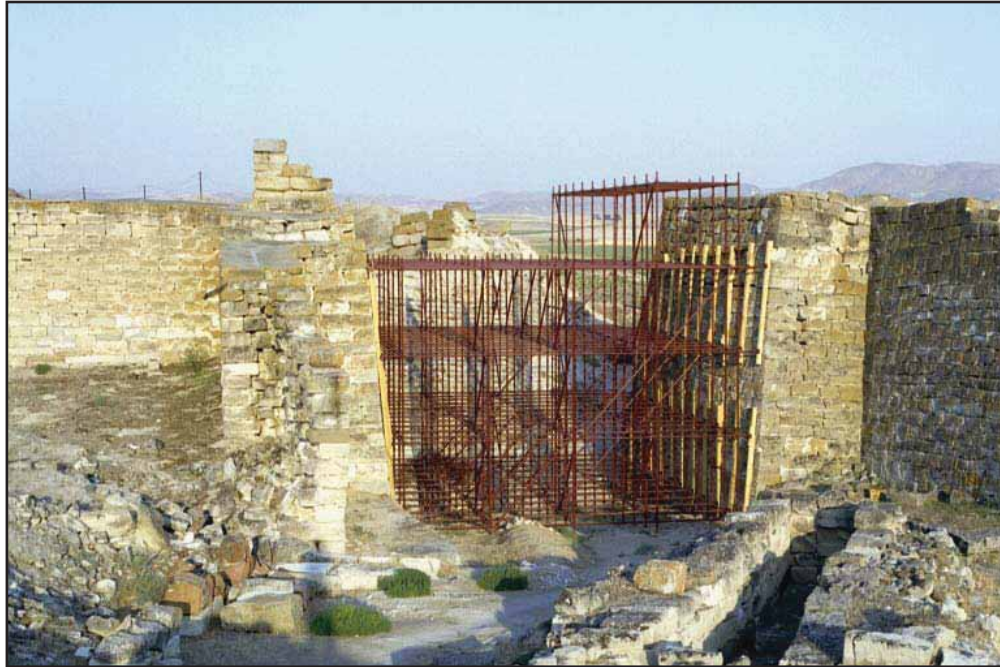
Figure 14. The scaffolding erected after the Izmit earthquake. *By Goodman, 2001.*

The gravity grouting effort began in 2002—after the scaffolding was positioned along the central gateway—and continued through the 2006 season. The grouting team first tested the method on a trial wall south of the gate complex. After successfully grouting the trial wall, the team resumed the injection grouting process on the unstable South Court walls. The grout selected was specified for the unique characteristics of the gate. Goodman recorded the formulation in his 2003 site report:

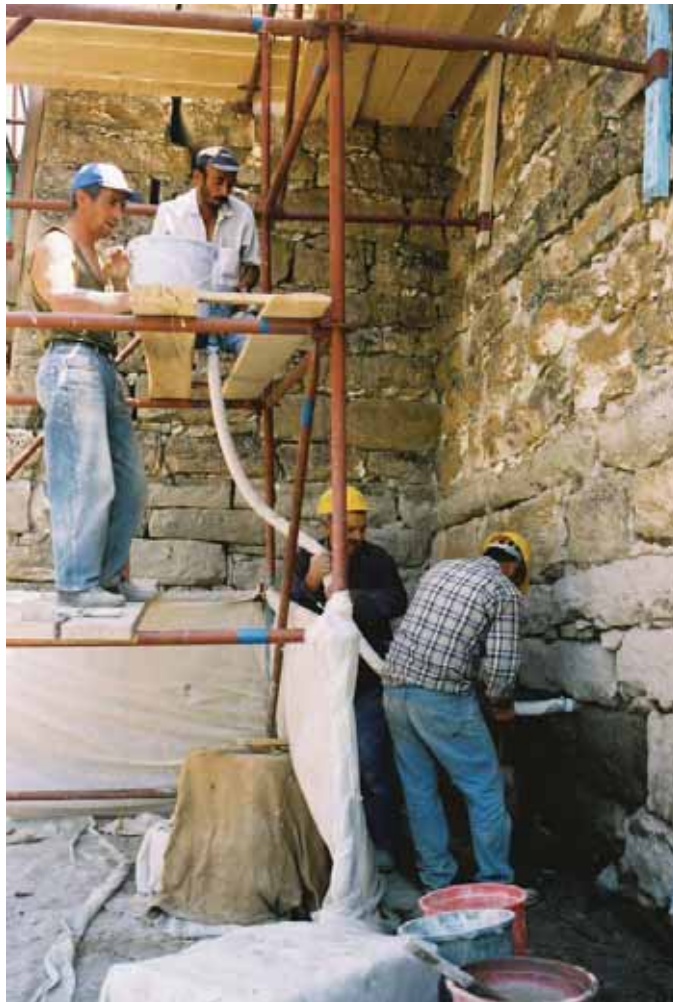
Under these conditions, the ideal grout binder is Hydrated Hydraulic Lime (HHL). A specialized hydraulic lime, *Cheax Blanche* from Lafarge Co., has a long track record of use in architectural conservation and was imported from France for this purpose....The grout formula, mixed as a wet slurry, combines HHL and local sand (Belikopru Olnm) with low fired pozzolanic brick dust added to enhance hydraulic set.⁴⁷

Figure 15. Gravity grouting process applied to the South Court. *By Goodman, 2001.*

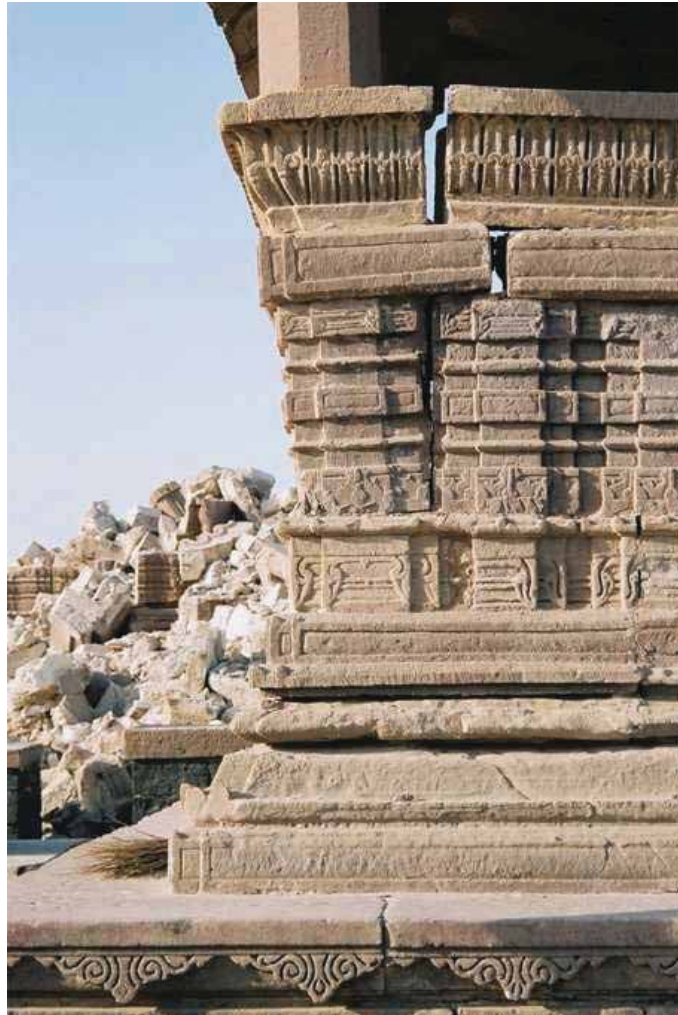
to damage. Common damage observed in many masonry structures includes vertical and stepped cracks and open joints. Vertical fractures generally occur around large openings – particularly windows, doors and arches.⁹⁴ Diagonal stepped cracks form in dry stone and mortared masonry systems and result from inelastic sliding (displacement caused by shear stress).⁹⁵ This cracking pattern corresponds with horizontal loads, which cause the linear deformation.

Figure 17. Vertical crack produced by seismic action. *From* www.conservationtech.com

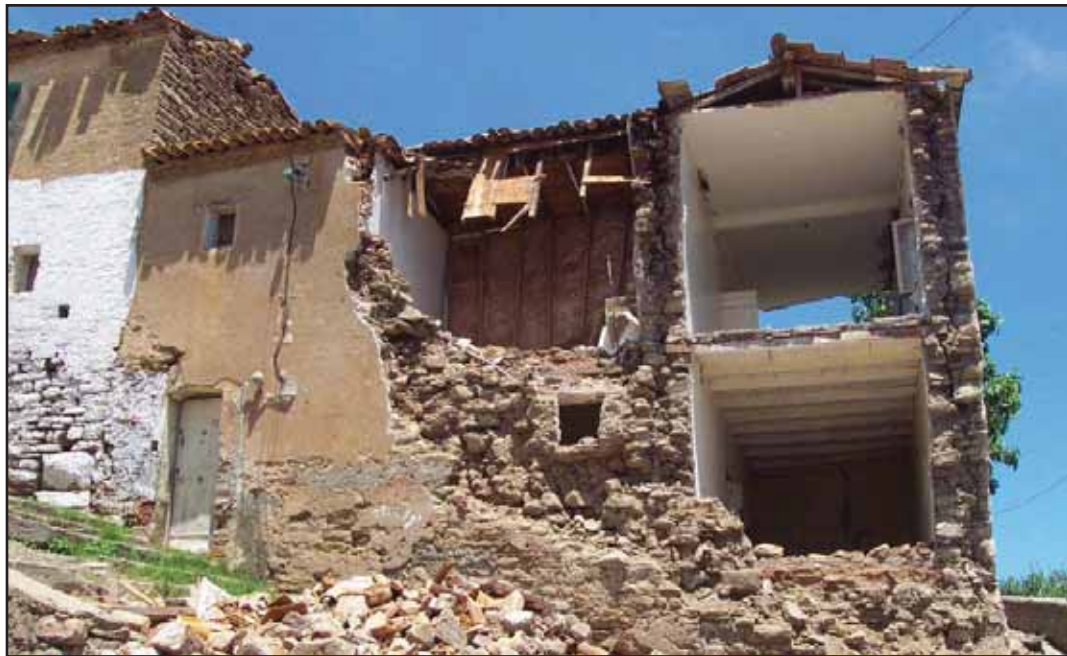
Though shear stress generally emerges as diagonal stepped cracks, shear failure can also occur from differential stiffness within walls, which results from varying rigidity of connections and the strength of lintels.⁹⁶ These differences in rigidity or connection strength produce diagonal cracks – though not necessarily stepped cracks. Other structural failures are specific to certain construction methods. Lateral loads applied to multiple leaf masonry systems emphasize any structural deficiencies. As previously mentioned, when not properly tied, the wall can separate or collapse with horizontal – and even vertical – forces. These out-of-plane bending failures typically occur in brittle systems under horizontal forces. However, all buildings are subject to partial or full collapse due to inadequate connections or anchoring. Wall deformation or separation generally occurs in corners of poorly connected load-bearing structures.

Figure 18. Failed corner of a multiple leaf system. *From www.world-housing.net.*

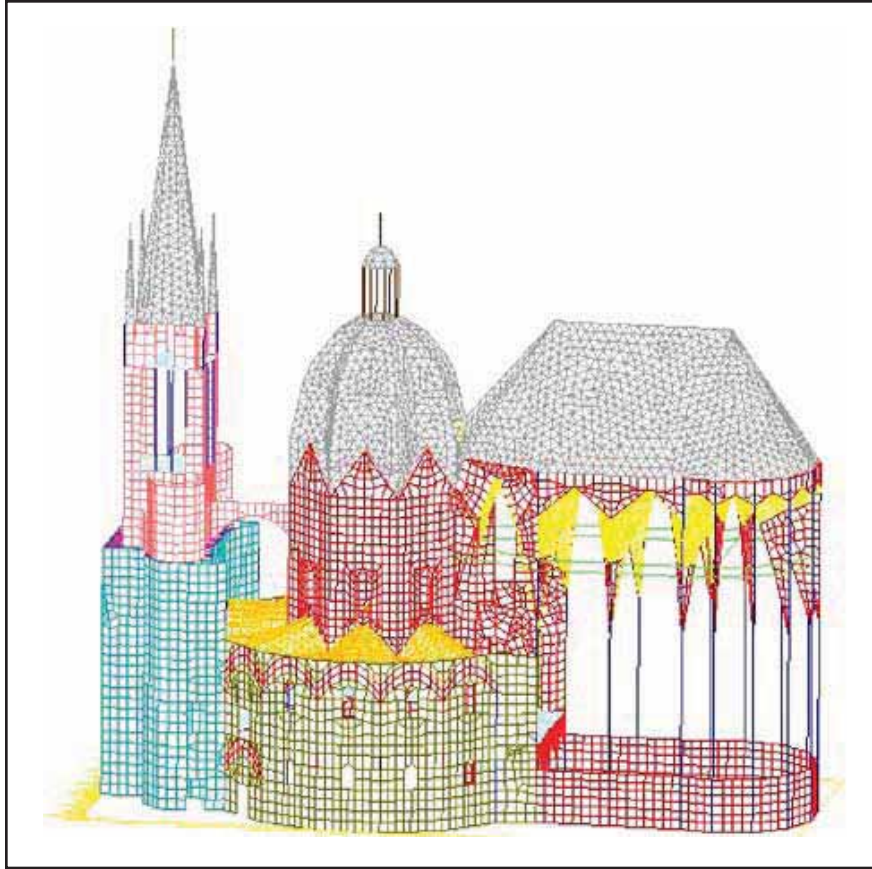
Figure 26. The complete mesh of the Aachen Cathedral, Germany. From *Mistler et al.*, 2006.

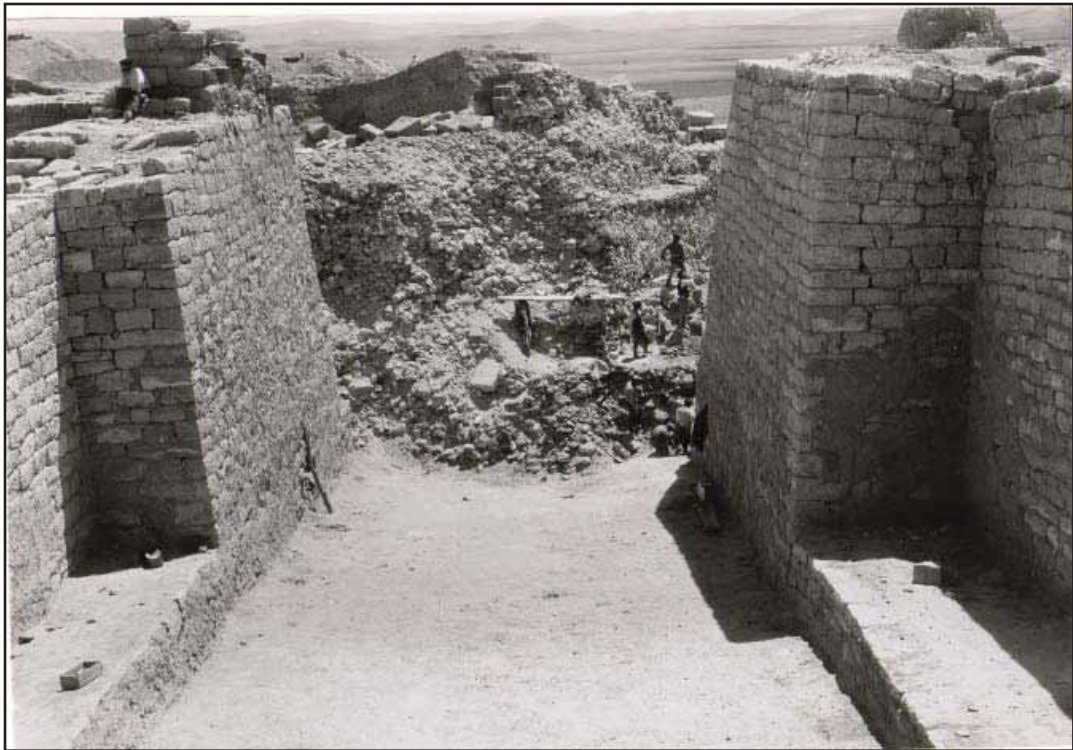
Figure 30. Excavation of the gate entryway. *From the Gordion Archives, ca. 1955.*

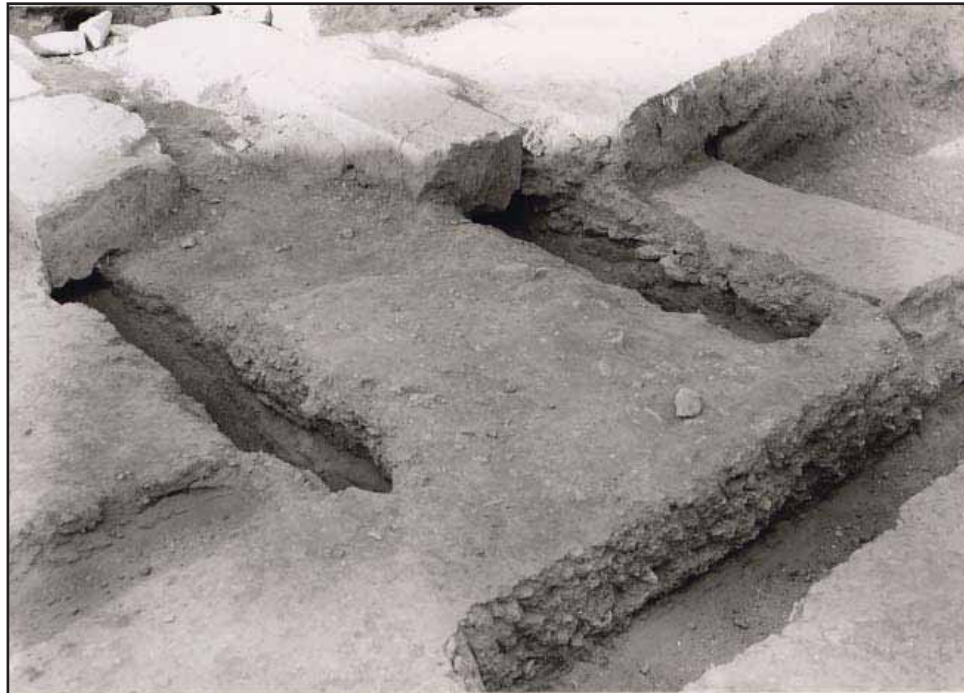
Figure 31. Depiction of molded clay which formerly surrounded structural timbers.
From the Gordion Arhives, ca. 1955.

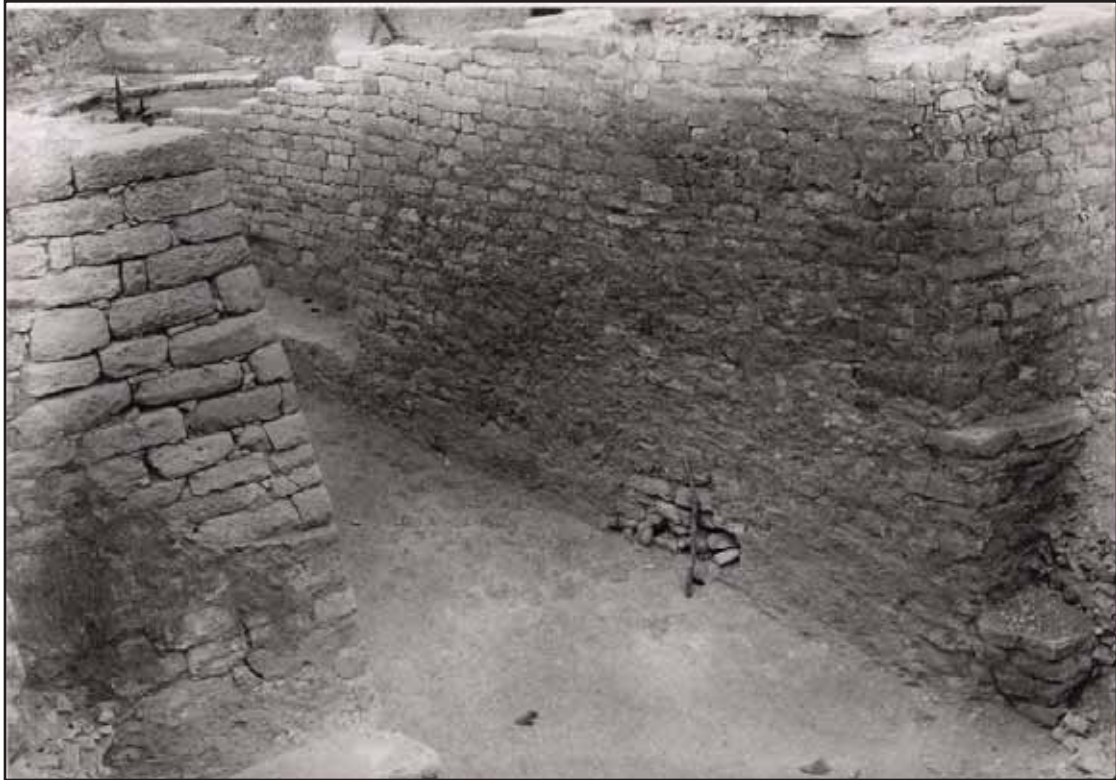
Figure 32. Southeast elevation of the North Court showing vertical cracks. *From the Gordion Archives, ca. 1955.*

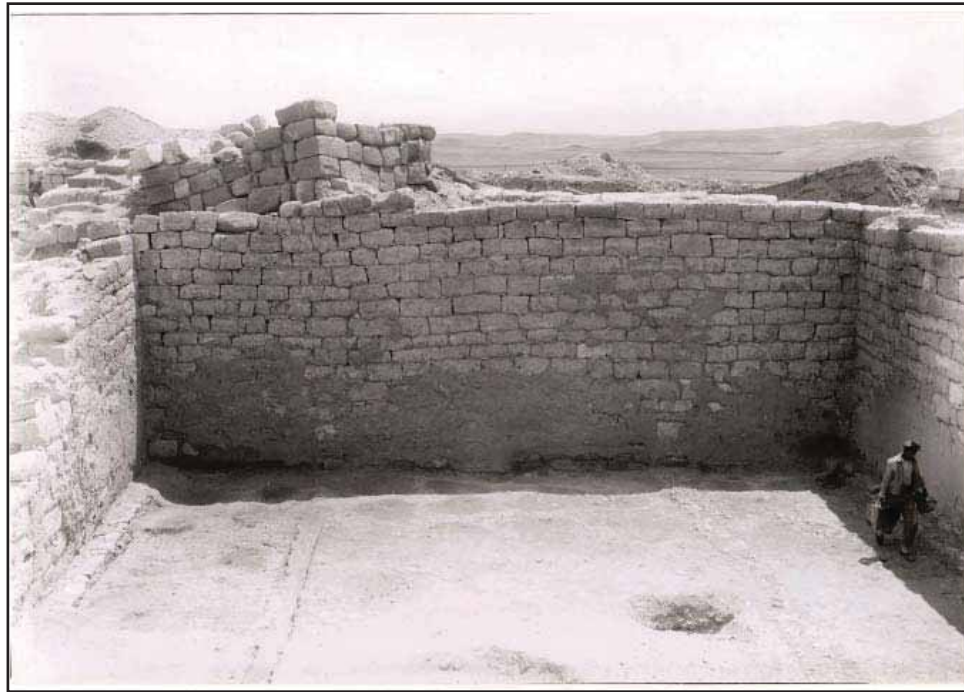
Middle Phrygian structure and lateral pressure from soil backfill, since the exterior fill abutting the northeastern walls was not cleared during excavations. A significant length of the Middle Phrygian structure spans both walls and has resulted in compression cracking—particularly evident in the east interior elevation. Joints in this location have also sheared and likely exerted some force toward the inner corner. Though bulging generally occurs at the base of a wall, the bulge in the east elevation is visible at the top, directly below the remaining Middle Phrygian courses. These types of bulges result from compressive forces and appear as a backward tilting action.

Figure 34. East interior wall of the North Court with shear cracks from the remaining Middle Phrygian wall. *From the Gordion Archives, ca. 1955.*

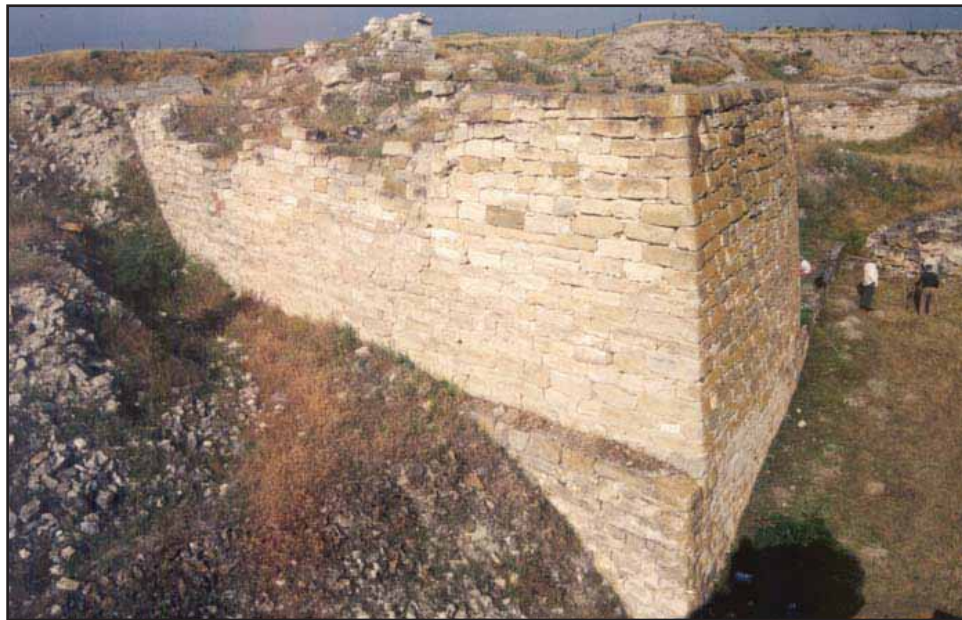
The large bulge in the northeastern elevation was first identified in the 1970s and has incrementally enlarged in recent decades.¹⁶⁸ Following the 1999 Izmit earthquake, measurements taken using plumb lines indicated 3-4 centimeters of movement in the central portion of the bulge.¹⁶⁹ The ground motion during the seismic event likely mobilized the core material and caused further settlement. Prior to the event, incremental movements were recorded but considered nonthreatening.¹⁷⁰

Figure 36. Displacements of the rubble core have increased the size of the bulge in the South Court wall. *By Goodman, 2000.*

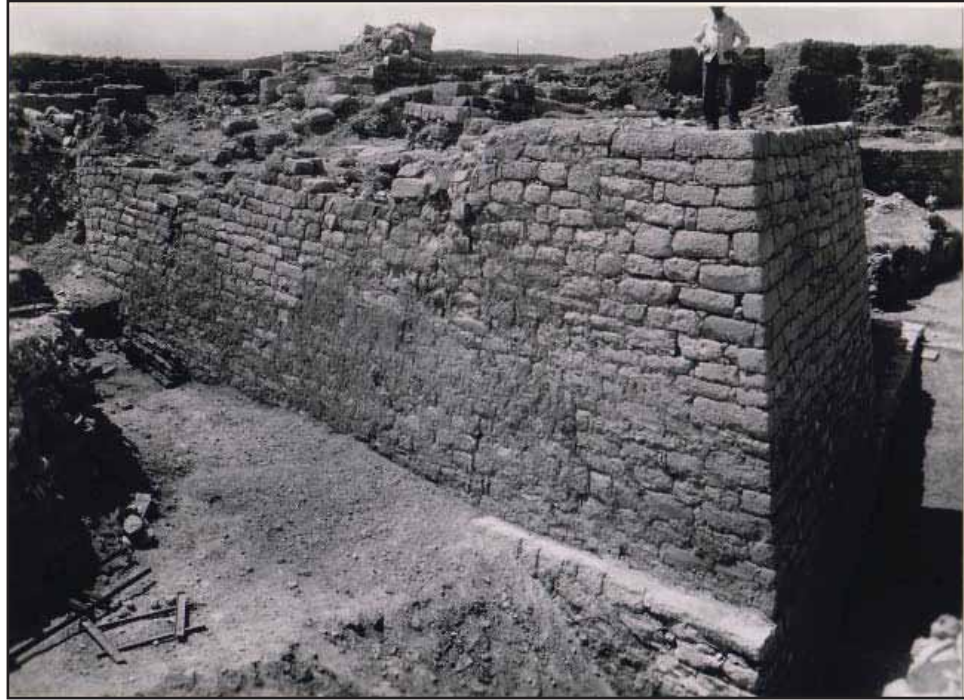
Figure 37. The east elevation of the South Court shows missing stones and depressions in several areas. *From the Gordion Archives, ca. 1955.*

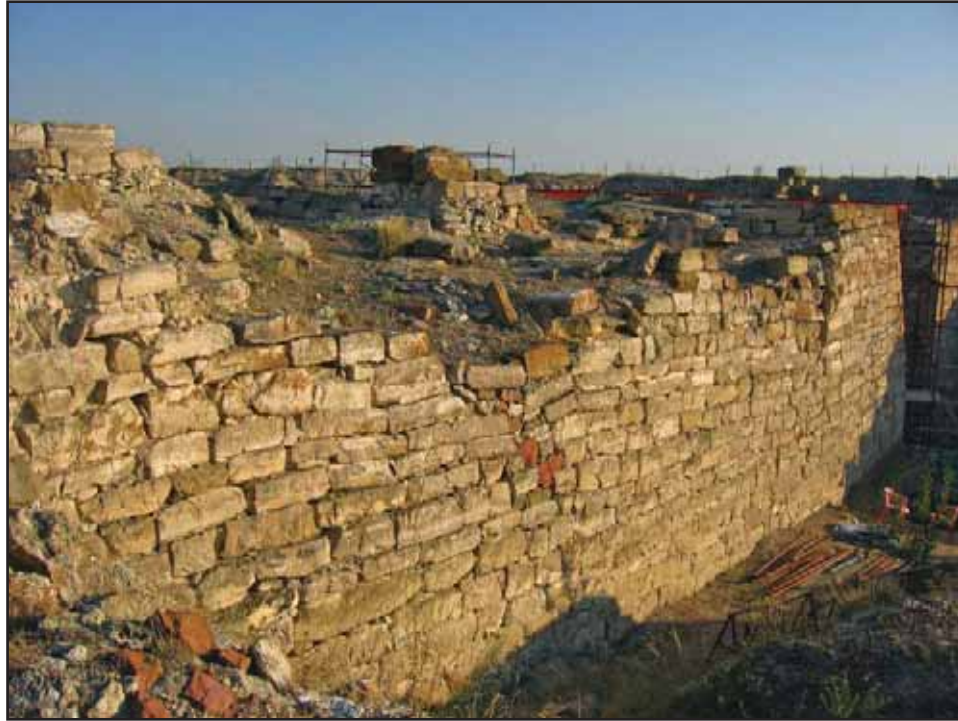
Figure 39. The general instability is evident in the South Court, which is only partially excavated. *By Wong, 2006.*

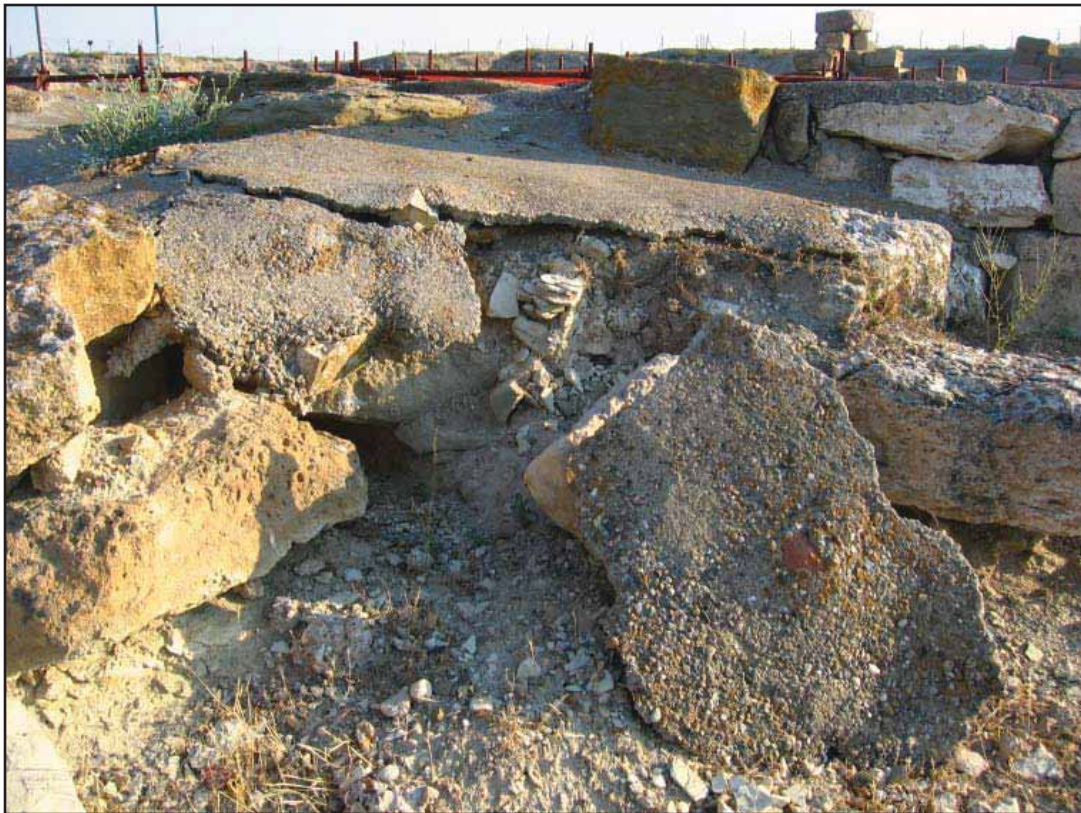
Figure 40. The concrete cap has failed in areas and allowed water to penetrate the core.
By Wong, 2006.

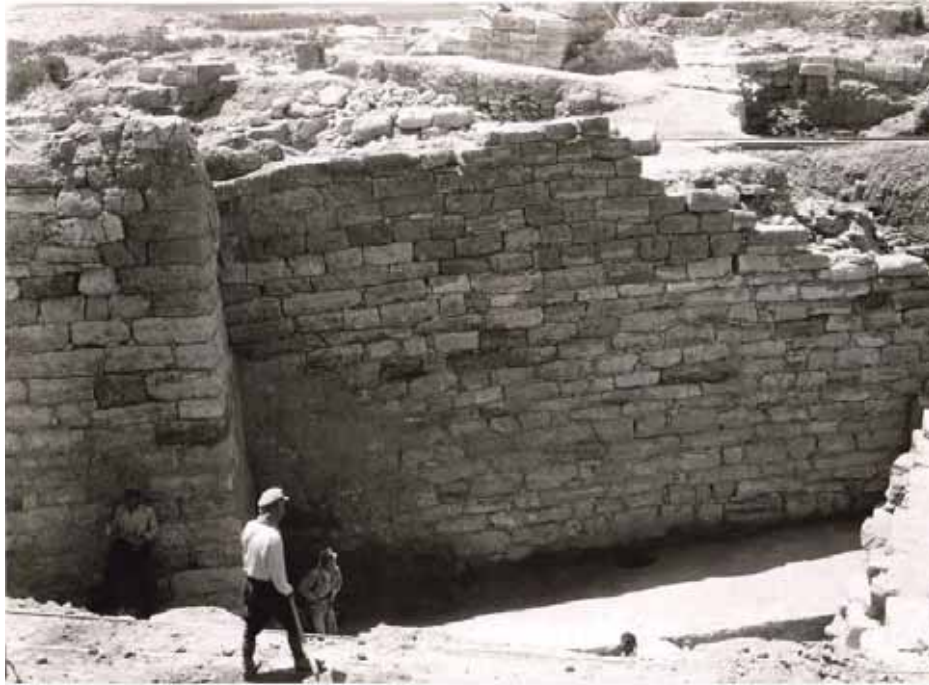
SOUTH COURT NORTHWEST ELEVATION

Gordion Archives, ca. 1955

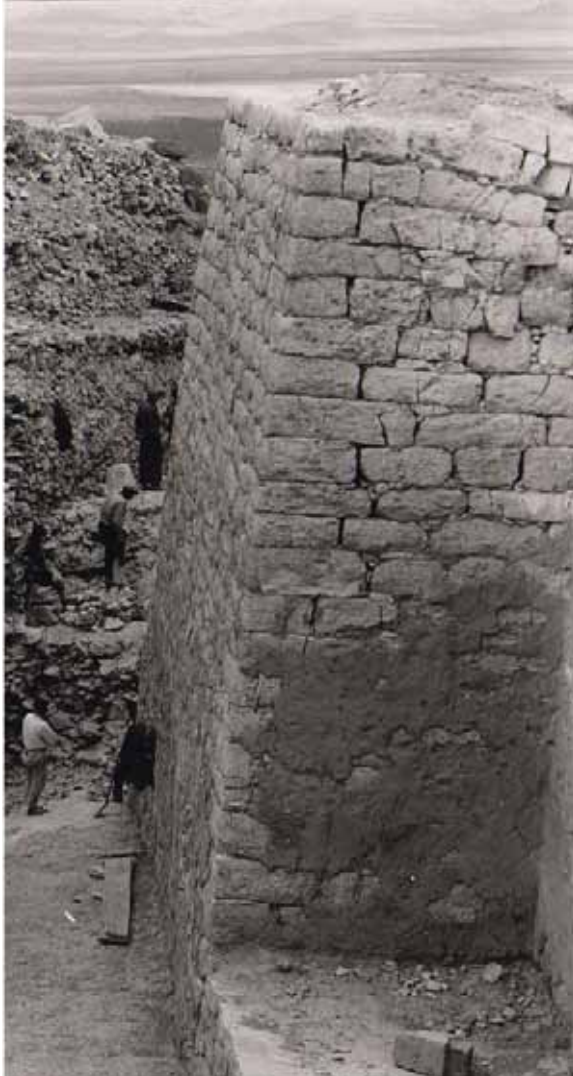
SOUTH COURT WEST RETURN

Gordion Archives, ca. 1955
