# Rediscovering an American Master: An Examination and Analysis of the Decorative Plaster Ceiling of Robert Winthrop Chanler's Whitney Studio, New York

Lauren Vollono Drapala  
*University of Pennsylvania*, lvollono@design.upenn.edu

A THESIS

Historic Preservation

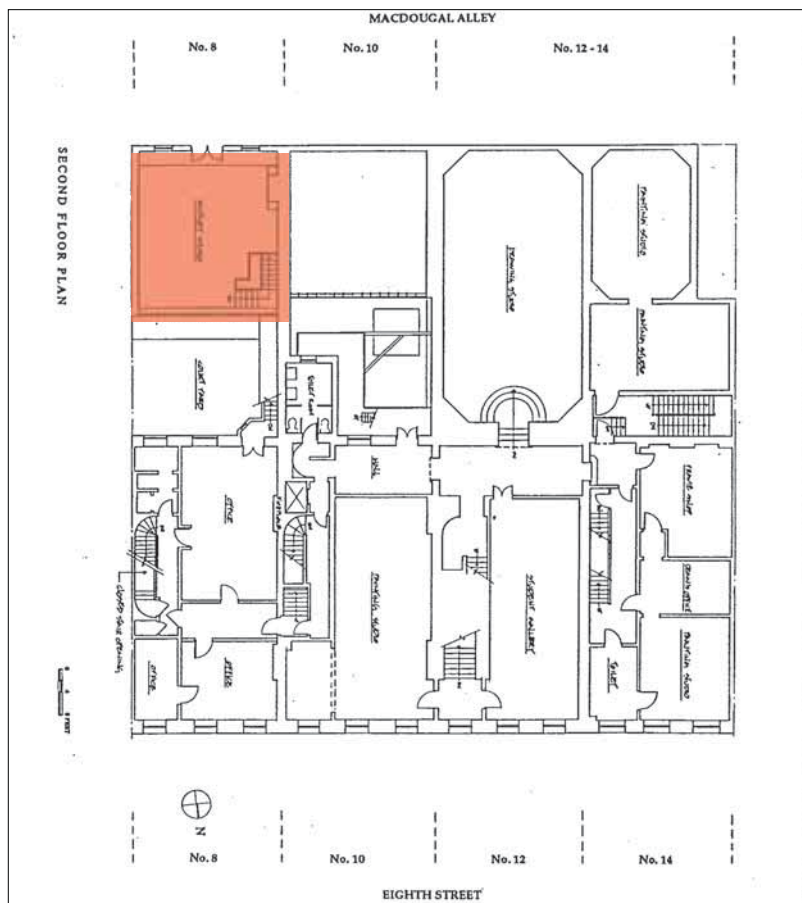
**Figure 1.2. Second floor plan of the New York Studio School with Whitney Studio highlighted (HSR, 1993).**

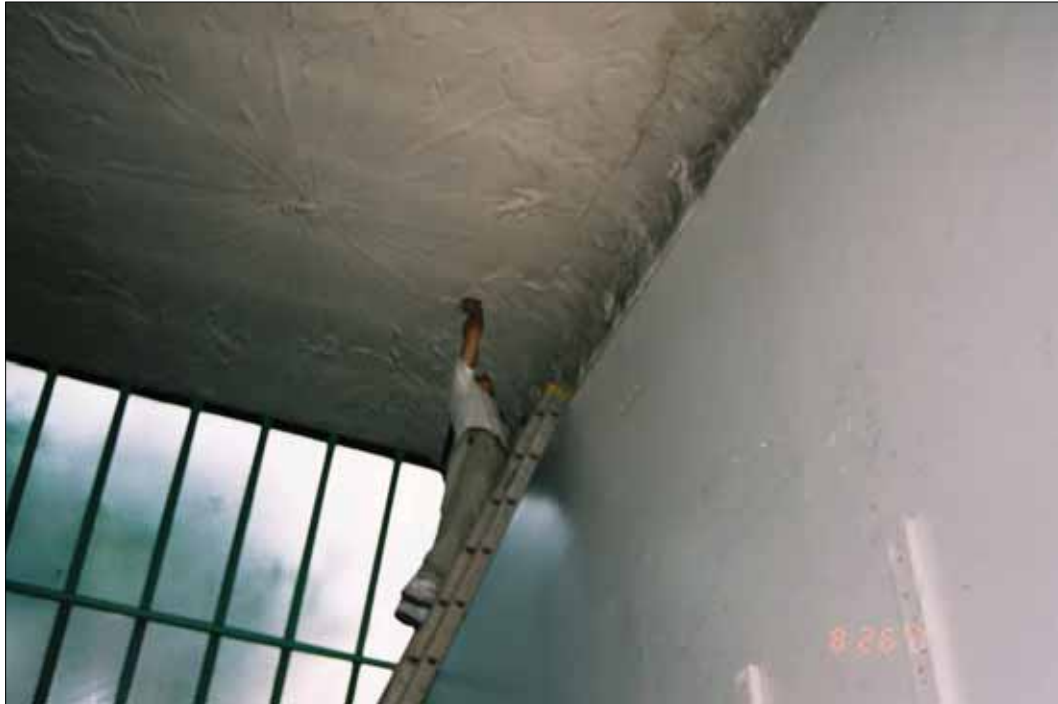
**Figure 2.12. Brice Bowman (SuperStructures) measuring cracks in plaster, 2001 (Archives of the New York Studio School).**

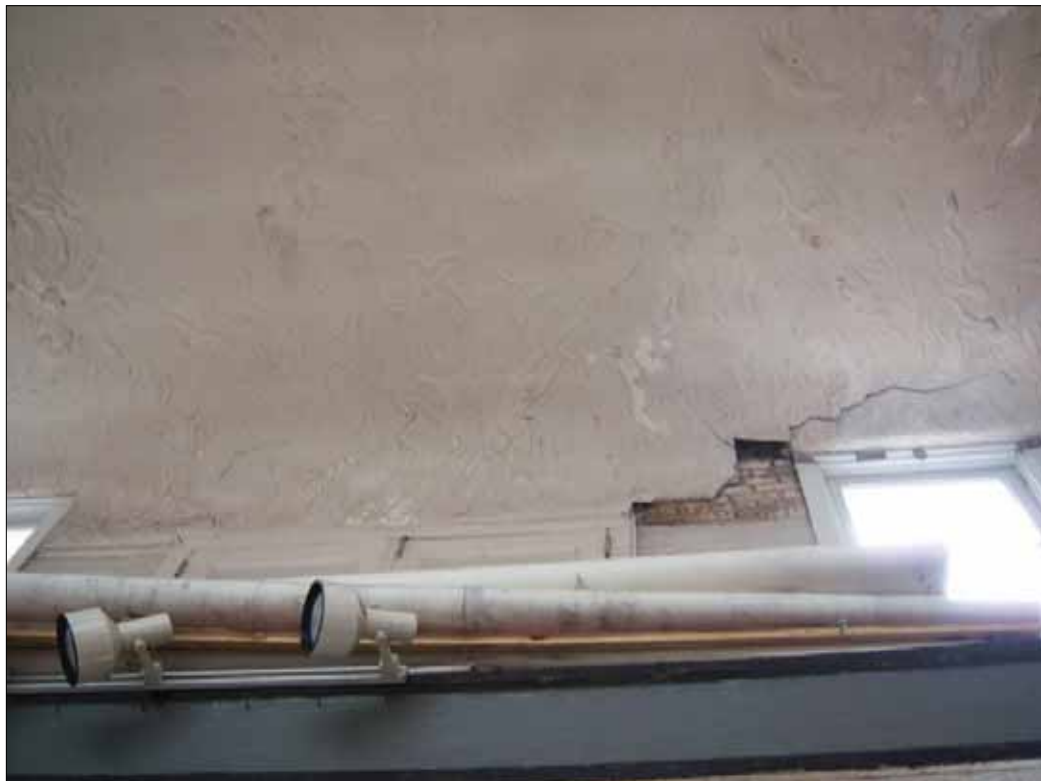
**Figure 2.13. Following the cornice failure (L. Vollono, 2009).**

In March, 2008, a two foot-square corner of the curved cornice on the south wall collapsed. The school shutdown its longtime public tours of Whitney's workspace and has since taken measures to care for the ceiling in order to prevent any further damage.<sup>32</sup> Kaitsen Woo Architects were consulted the following summer on the structural integrity of the ceiling. Wesley Haynes, a preservation specialist with the firm, told *New York Times* writer Eve

Kahn, "The entire armature holding up the ceiling is rusted...We didn't see anything that suggested catastrophic failure, but it's just a matter of time."<sup>33</sup> World Monuments Fund and Integrated Conservation Resources immediately began collaborating to stabilize the structure, and the University of Pennsylvania's Architectural Conservation Laboratory became involved to further develop conservation strategies for the studio and plaster ceiling.

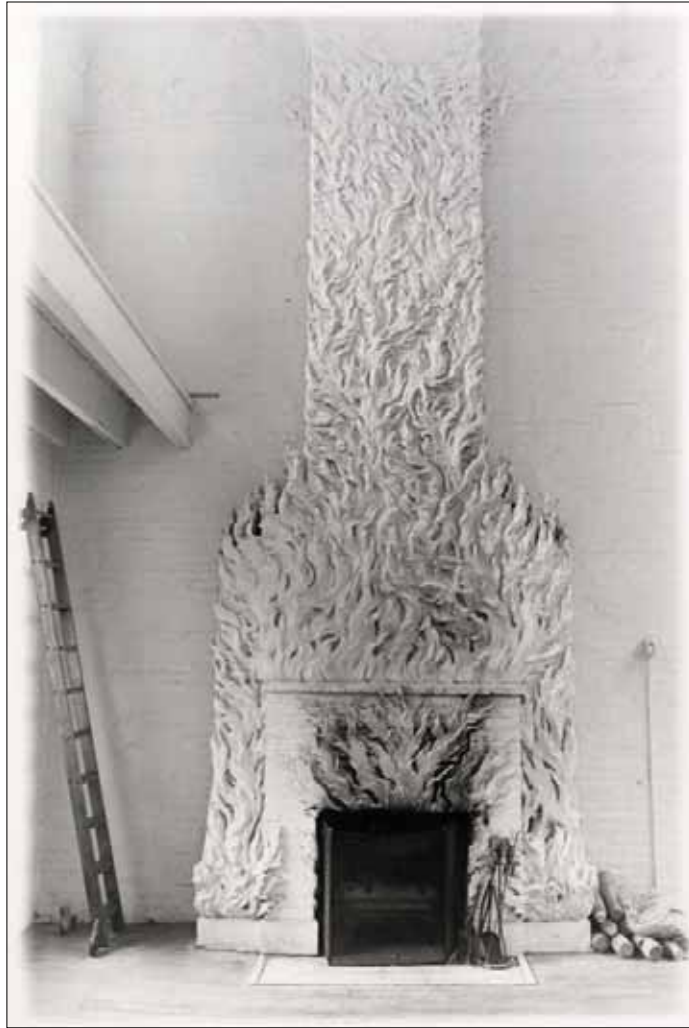
**Figure 3.1. Fireplace in Whitney Studio by R. W. Chanler, undated (Archives of the New York Studio School).**

background of celestial orbs, planets, stars, flames and clouds. The two major anchoring points on the ceiling are the fireplace in the south-west corner and the radiating sun on the north-east corner. Both are symbols of concentrated energy, emitting rays and flames across the entire length of the ceiling. While the ceiling and fireplace were originally polychrome, interventions following Gertrude's death in 1945 resulted in the over-painting of white.<sup>2</sup>

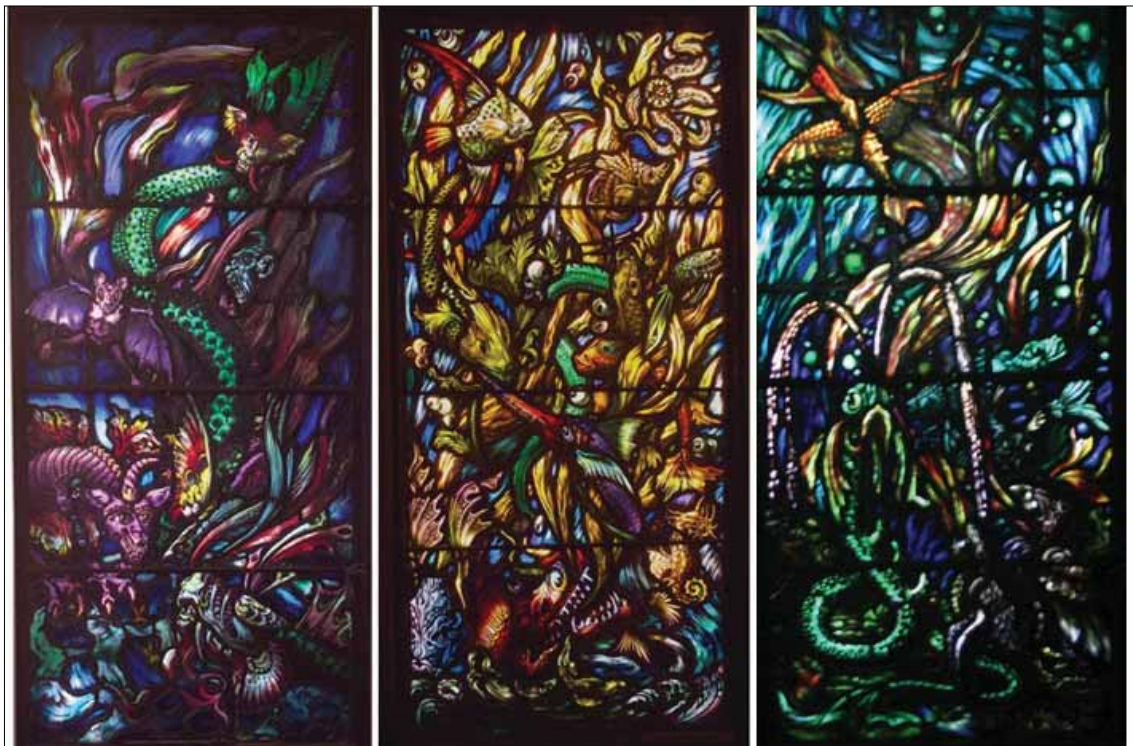
**Figure 3.2. Example of three of the original seven stained glass windows within the studio by R.W. Chanler (Retro Modern Lighting, 2006).**

Light was originally filtered through a south-facing diagonal skylight and seven Chanler-designed stained glass windows, all of which still exist. They take on a Boschian scheme of fantastic images of impossible creatures, each an amalgam of different animals and colors. The windows are composed of leaded stained glass that has been hand painted with enamels and enhanced by a glass layering technique called plating.<sup>3</sup> Each window's subject deals with a different realm of existence, relating to creatures that inhabit the sea, the ground and underneath it, the sky and the cosmos.

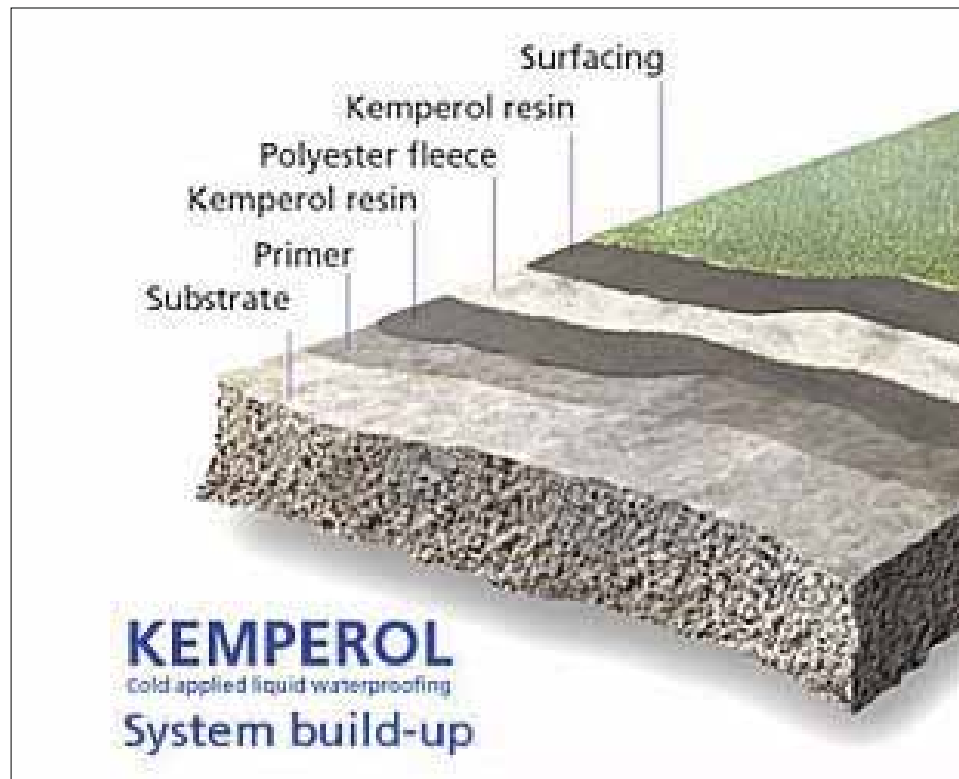
Figure 5.2 Model of Kemper Roofing system (Kemper, [http://www.kempersystem.co.uk/waterproofing\\_intro.asp](http://www.kempersystem.co.uk/waterproofing_intro.asp), 2010)

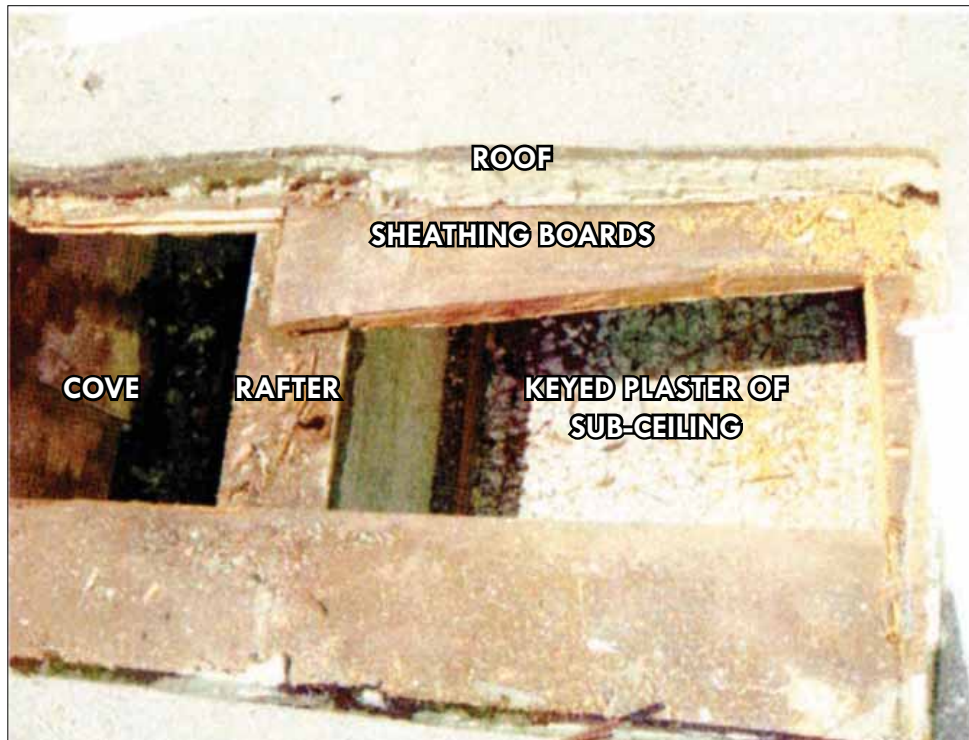
**Figure 5.3. Roof probe towards the west wall, with cove to the far left, roof rafter and keyed plaster of sub-ceiling in the center (Kaitsen-Woo, 2008).**

Below the external roof are the original 2" x 9" roughsawn roof rafters, which span the building from east to west and are set into pockets in the brick side walls. Nailed into the roof rafters from below are full-dimension 2" x 4" wood panel frames with expandable metal lath that carry the flat plaster sub-ceiling.<sup>2</sup> (Fig. 5.3) Presumably the plaster sub-ceil-

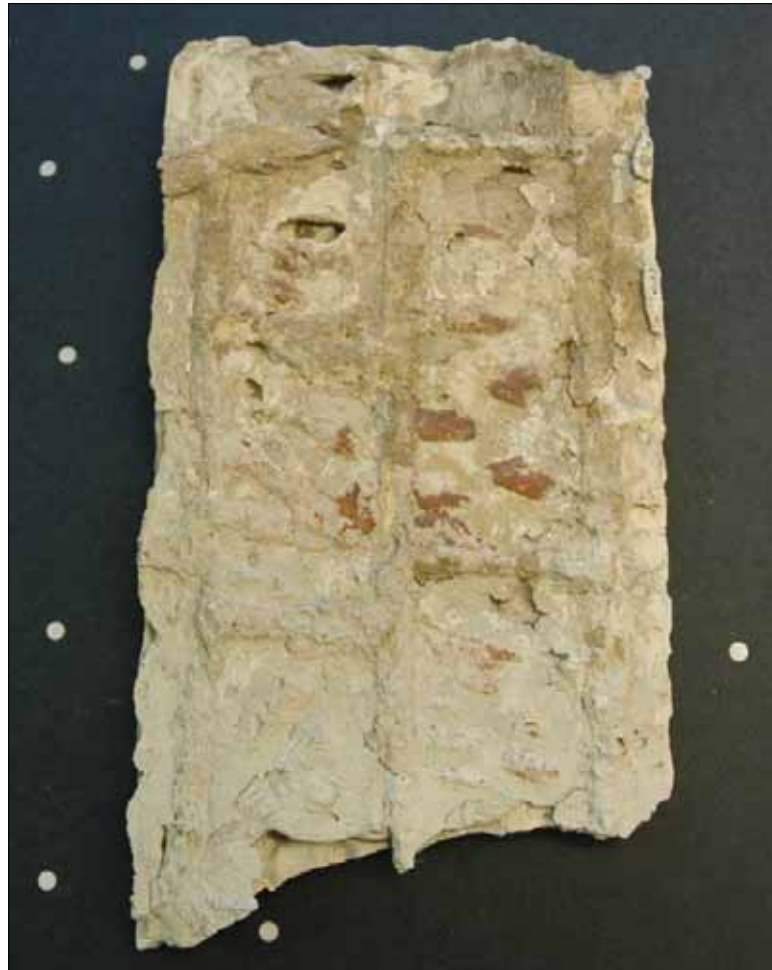
**Figure 5.4. Backing of cornice segment that had fallen in May, 2008. Evidence of keying to the masonry is visible in the brick pattern imprint ( L. Vollono, 2009).**

ing was installed as a support for the ornamental plaster relief ceiling. Further investigation of the roofing system will need to be conducted to determine the distance between the roof rafters, as well as the dimensions of the panel frames that support the substrate ceiling.<sup>3</sup> The ornamental ceiling was installed (and probably created) in long rectangular panels, running north to south, and surrounded by a separate cove cornice around the perimeter of the interior. The cornice is attached with wooden bridges to the adjacent rafters above and applied directly to the brick walls at the bottom, keyed into the mortar joints. (Fig. 5.4) Both

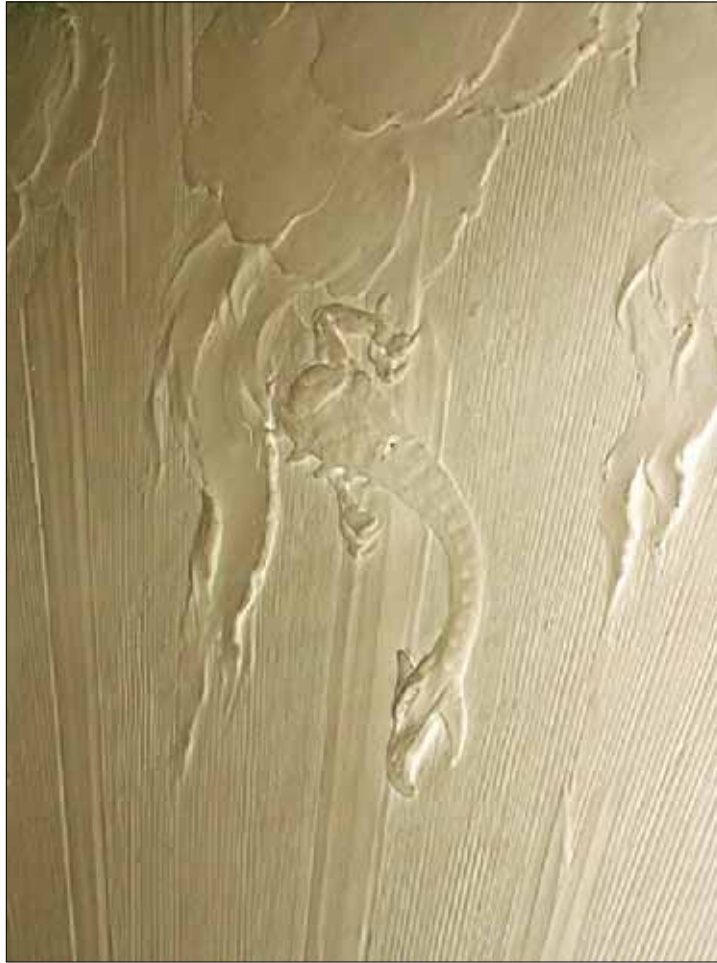
**Figure 5.5. Griffin (relief appliqué) with exposed nail used to fix piece. The over tooled background surface (in situ applied rays and ridges) continues under the pre-cast figure, with hand-applied relief-work (flames and clouds) used to conceal the edges of the appliqué (L. Vollono, 2009).**

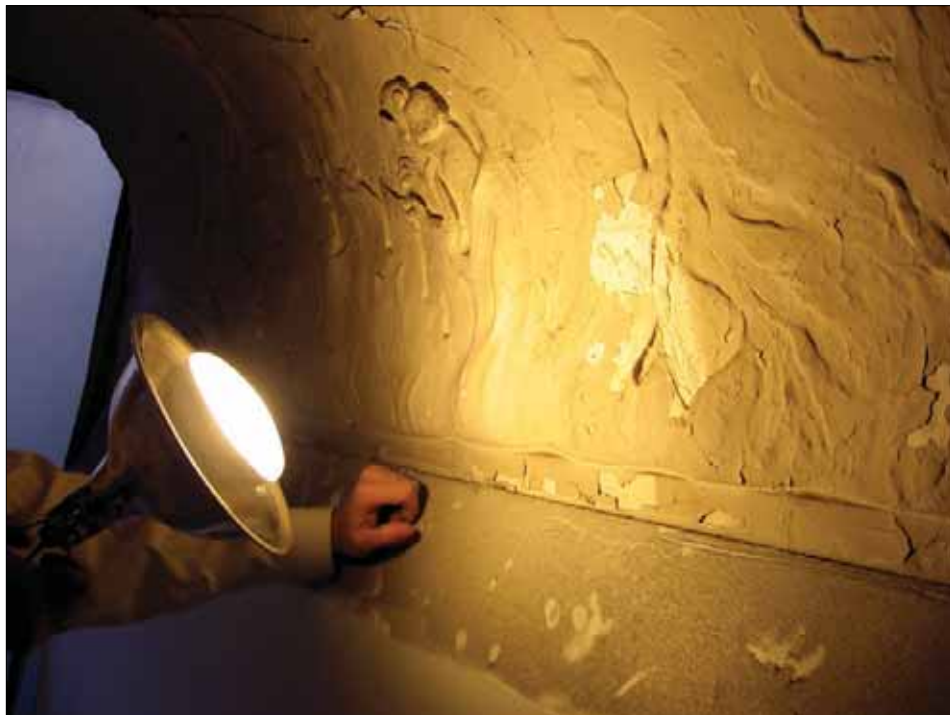
**Figure 5.6. Curved cornice on East wall, with removed appliqué portion (GWAS2010.P2), November 2009. Old World chameleon figure is further evidence of applied pre-cast element, surrounded by a series of applied flames to visually and physically fix the element in place (L. Vollono, 2009).**

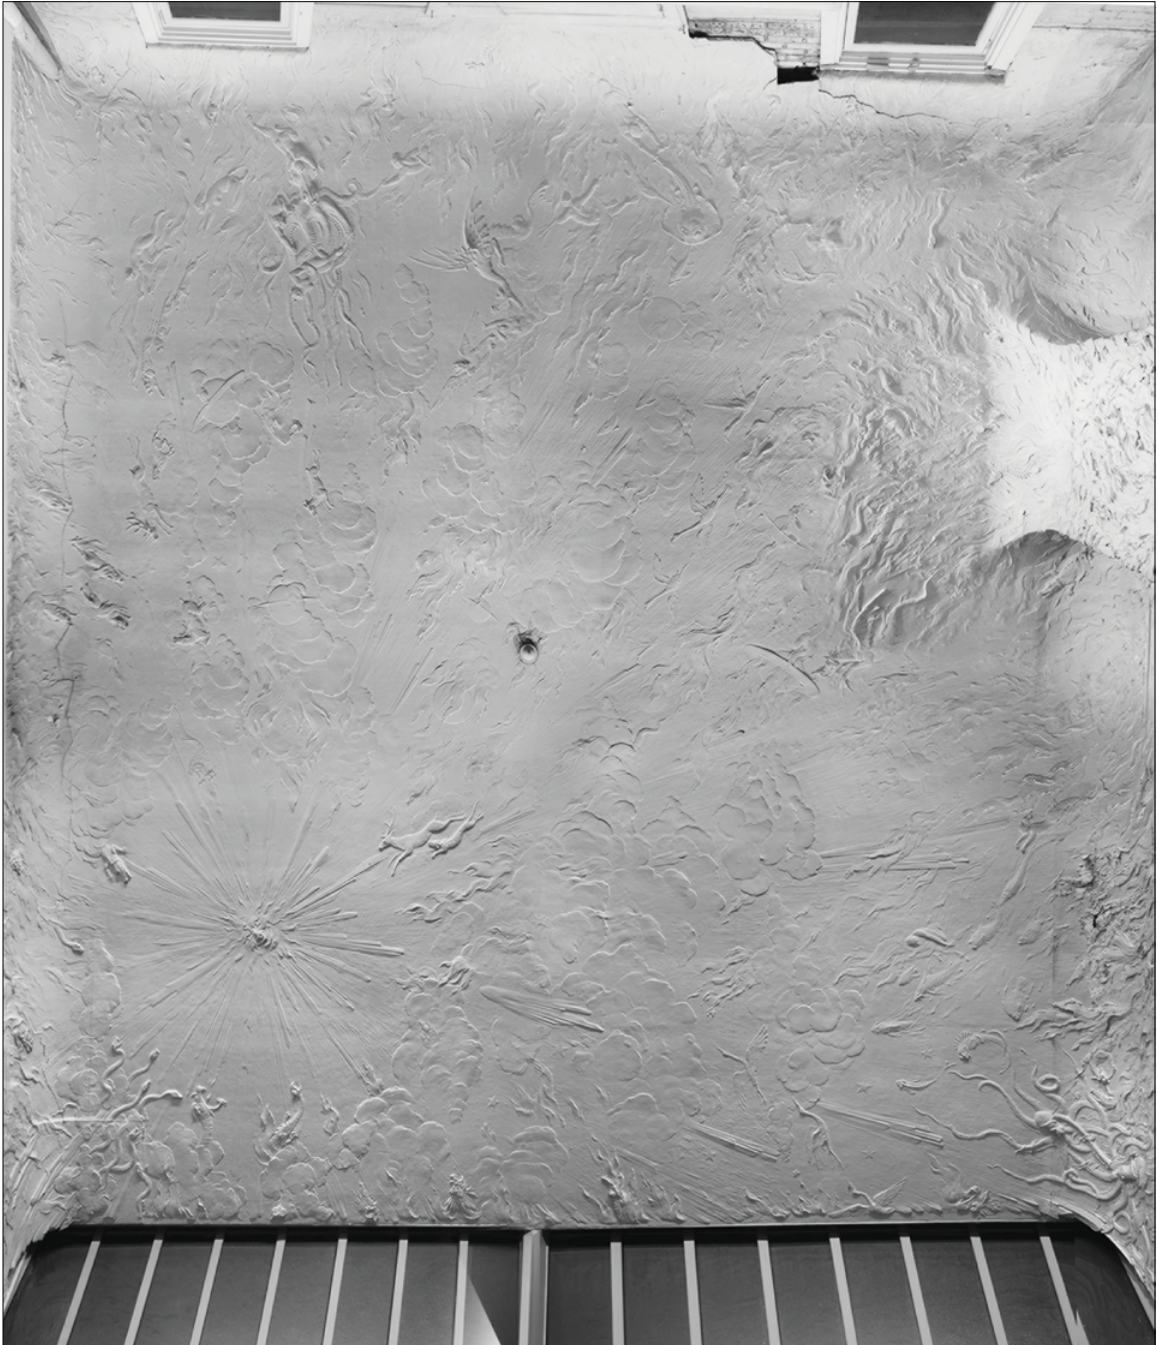
For ease of use in the field, the photomontaged image of the ceiling was divided into smaller, manageable sections, which were then printed in black and white on 11' by 17" paper and placed into individual mylar sheets. Each sheet was then numbered sequentially

**Figure 6.2. Photomontage of Whitney Studio ceiling (J. Elliott & J. Hinchman, ACL, 2009).**

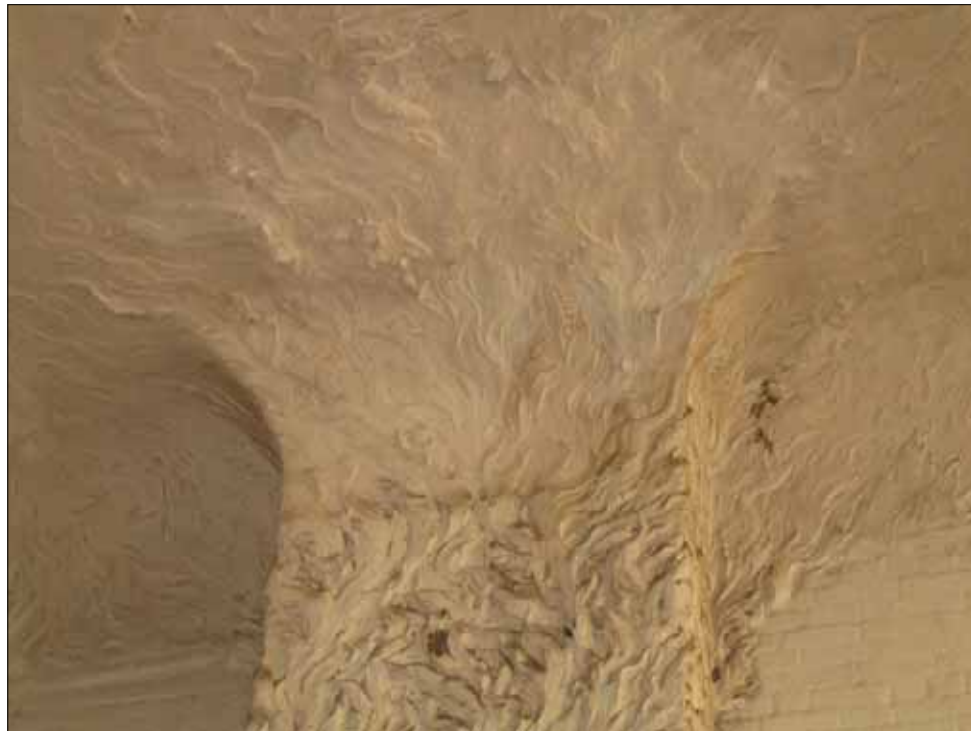
Pitting and staining were observed in areas related to the infiltration of water. **Pitting** was defined as the formation of small and large shallow cavities on the surface of the

Figure 6.3. Detail of Pitting on Fireplace, 2006 (Archives of the New York Studio School).

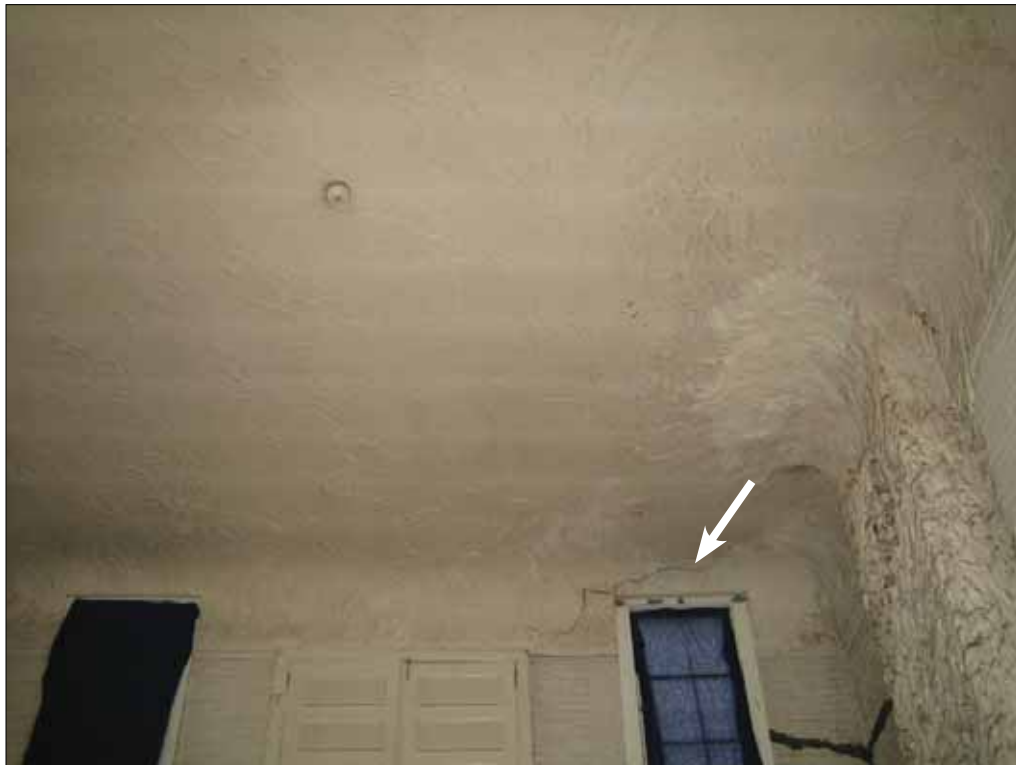
**Figure 6.4. Ceiling cornice prior to cornice loss, November, 2006 (Archives of the New York Studio School).**

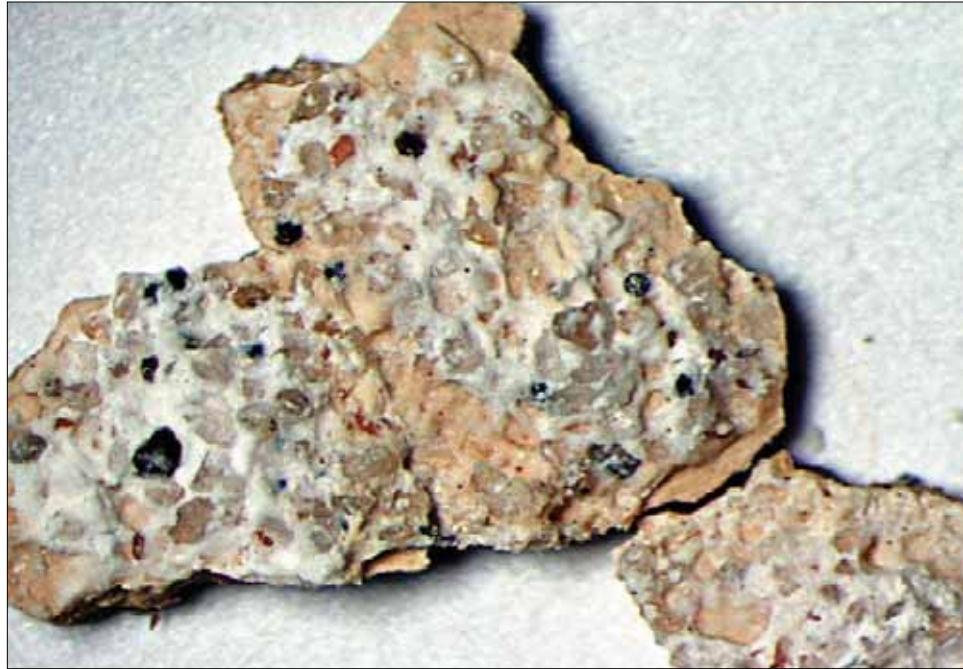
**Figure 7.3. Macro photos of small detached sections of the paint that show the sandy finish plaster selectively attached to the back side of the gesso (J. Zucker, 2007).**

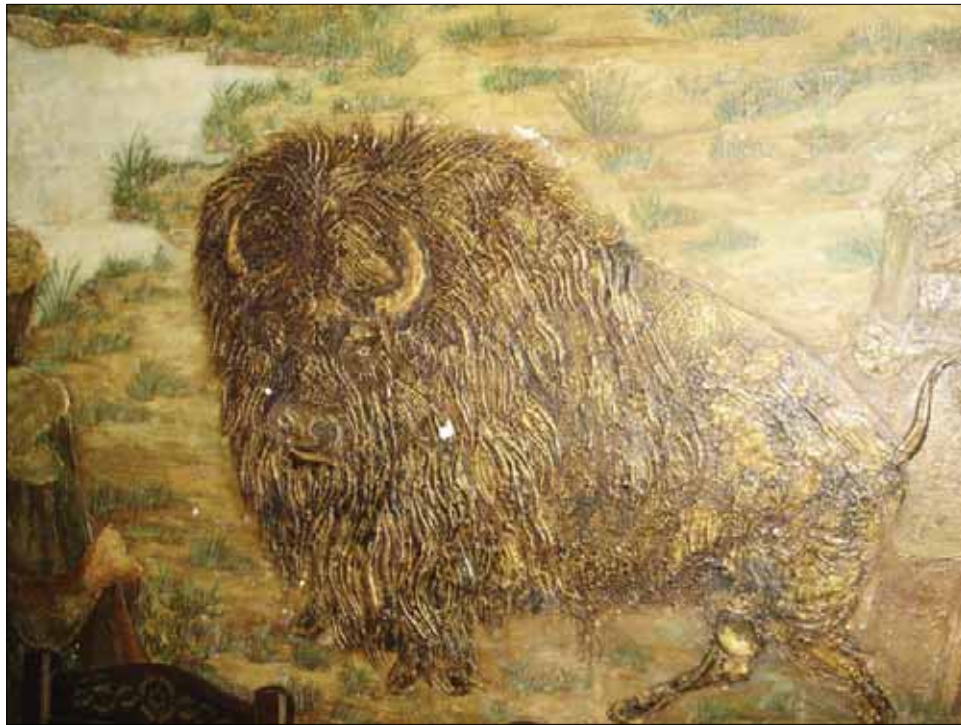
**Figure 7.4. Evidence of flaking on a detail of a buffalo. This figure also illustrates Chanler's technique of glazing over a gilded, gessoed surface. Buffalo Room, Coe Hall (L.Vollono, 2010).**

Given the early evidence of this problem, conservators have hypothesized that the problem is inherent in the substrate as a product of its installation, and any conservation will be a maintenance plan that involves continually re-attachment of the surface to its plaster sub-

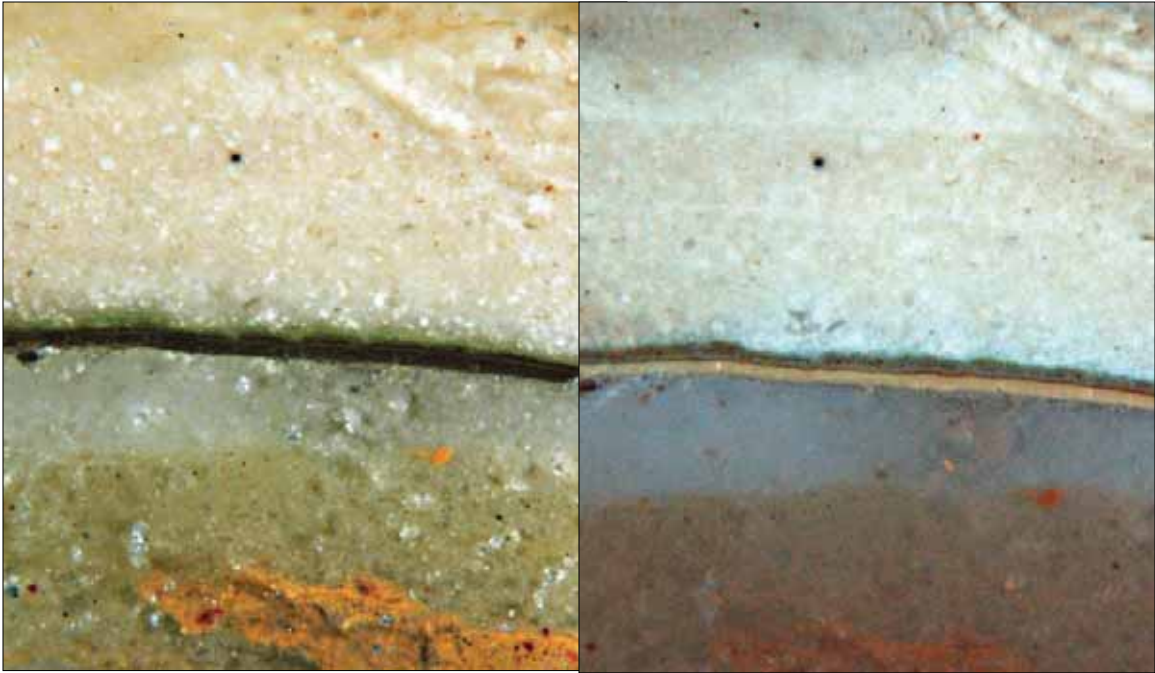
**Figure 7.5. Cross sections from an area of the mural that was plastered over. The layers in the middle are the “paint layers”. This area should not have been effected by the restoration attempts of the 1970’s and 80’s. Left: Normal, Right: UV Fluorescence (J. Zucker, 2006).**

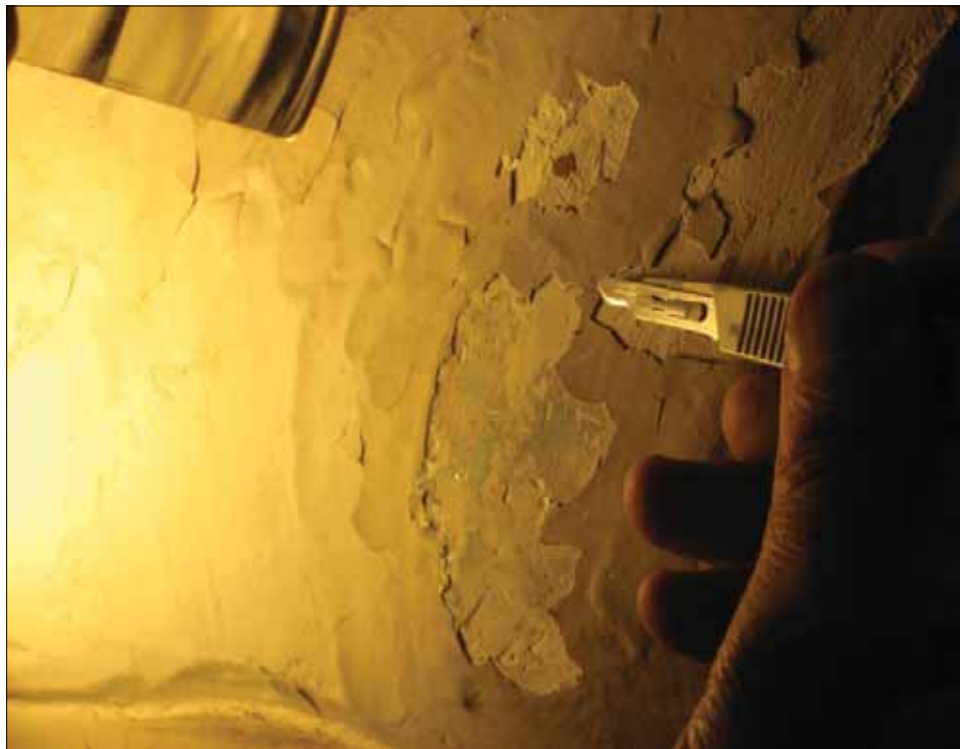
In order to remove the samples, a disposable scalpel was used to puncture the surface and the blade was rotated to remove the finish stratigraphy along with a portion of the plaster substrate. Each sample was then placed into a coin-sized manila envelope that

**Figure 8.1. On-site paint exposure with a scalpel, conducted by Frank Matero (L. Vollono, 2009).**

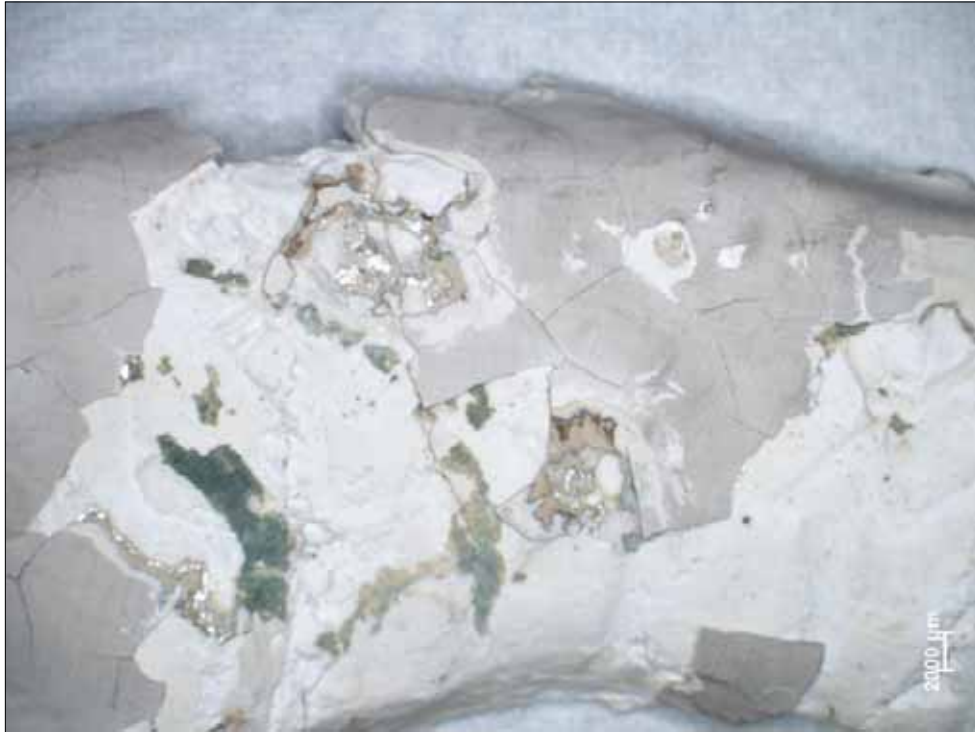
**Figure 8.2. Paint exposure on snake applique, revealing layers of green and metallic leafing, 7.1x mag, reflected light (L.Vollono, 2010).**

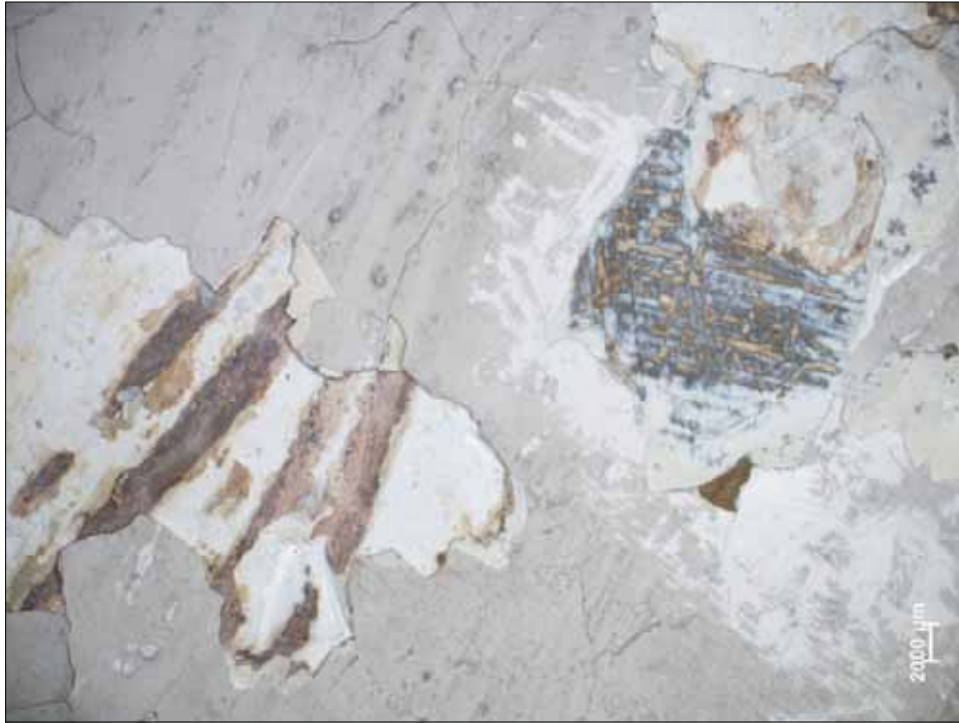
**Figure 8.3. Paint exposure on fallen cornice panel, revealing mauve color in creasing, 7.1x mag, reflected light (L.Vollono, 2010).**

The fallen cornice piece fragment contained traces of a deep mauve (Munsell: 10RP 4/2) in the creases of its relief sections. (Fig. 8.3) This color appears throughout the sample, but appears to be inconsistent throughout the panel. This may be evidence of earlier problems of cohesion between the paint and plaster substrate, resulting in the flaking and loss of

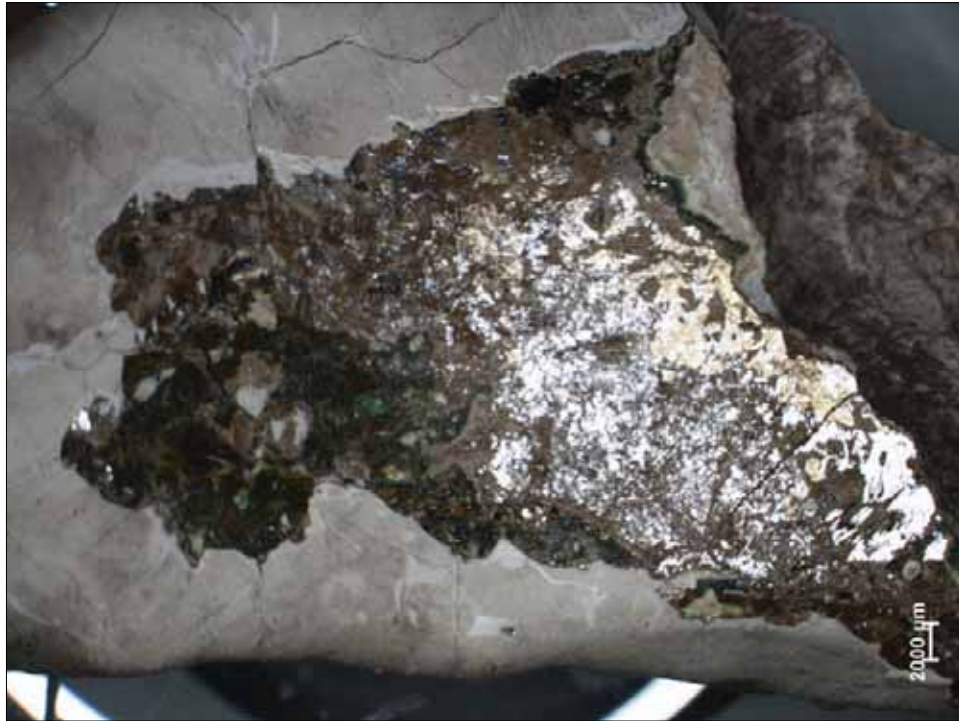
**Figure 8.4. Paint exposure on fireplace flame, revealing layers of green, metallic leafing and bronzing powder, 7.1x mag, reflected light (L.Vollono, 2010).**

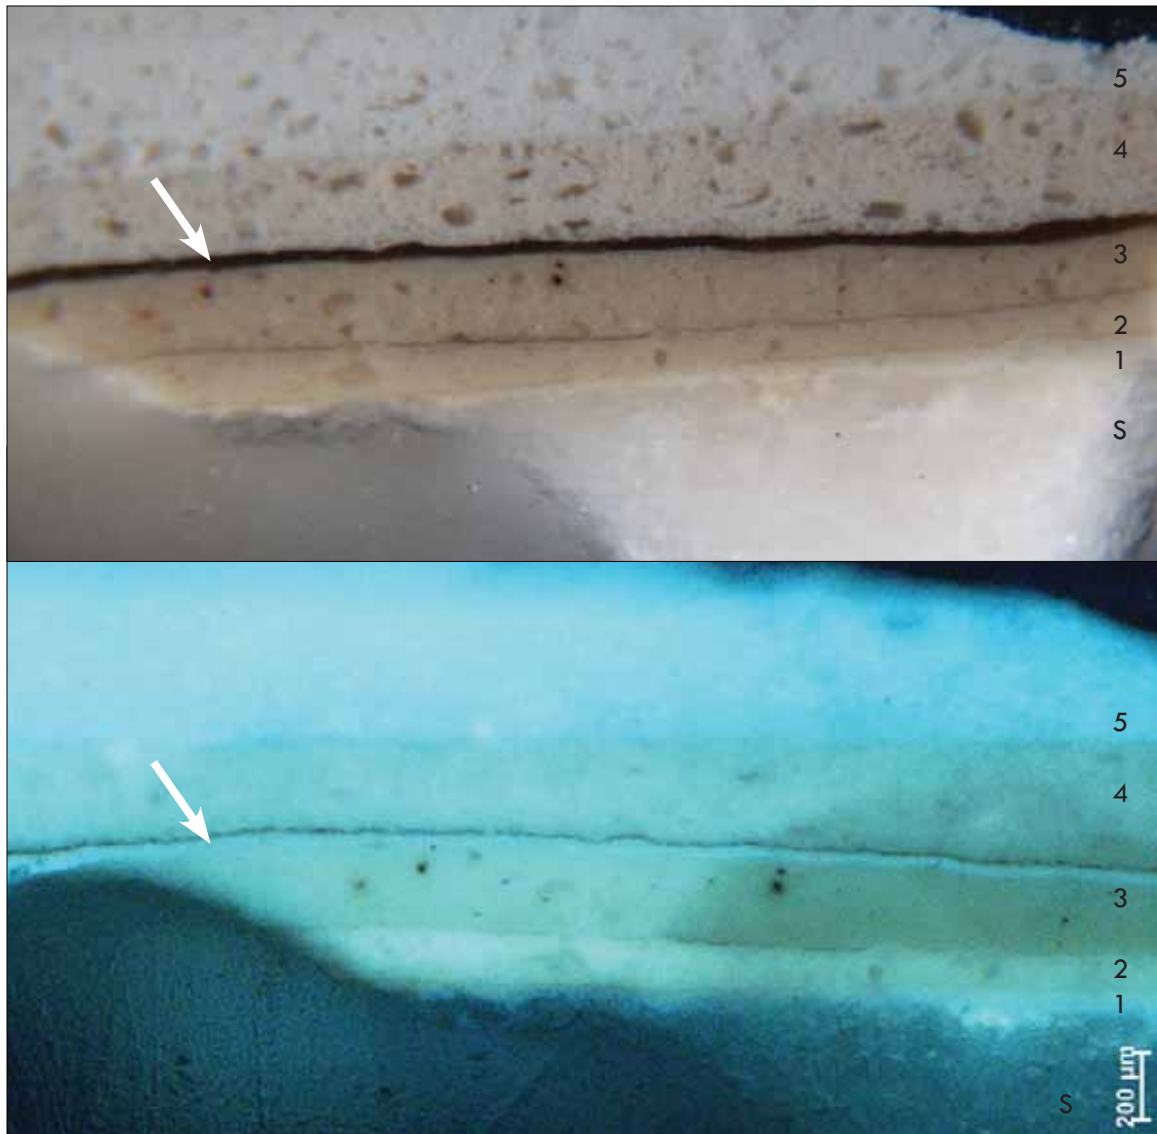
**Figure 8.6. Cross section (GWAS01.2010.1) revealing glazes between schemes 1-3 under UV light, 200x mag, Top: reflected, Bottom: BV filter, fluorescence (L.Vollono, 2010).**

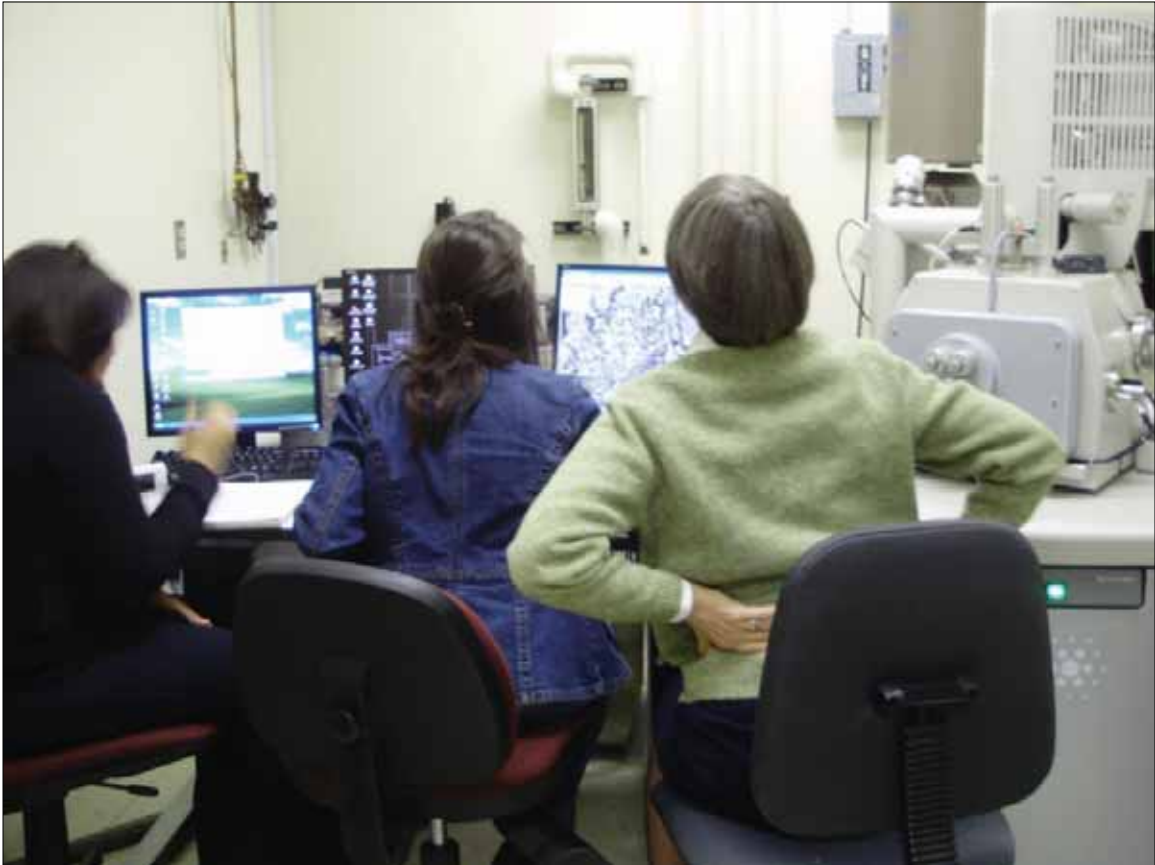
**Figure 8.7. Team of analysts, comprised of Tiffani Simple, Lolita Rotkina and Dr. Elena Charola, using SEM-EDS to analyze samples (L.Vollono, 2010).**

Analysis was performed at the University of Pennsylvania's Regional Nanotechnology Facility at the Laboratory for Research on the Structure of Matter, Edison Building. An FEI Quanta 600F scanning electron microscope coupled with electron dispersive spectroscopy was operated by Lolita Rotkina. (Fig. 8.7)

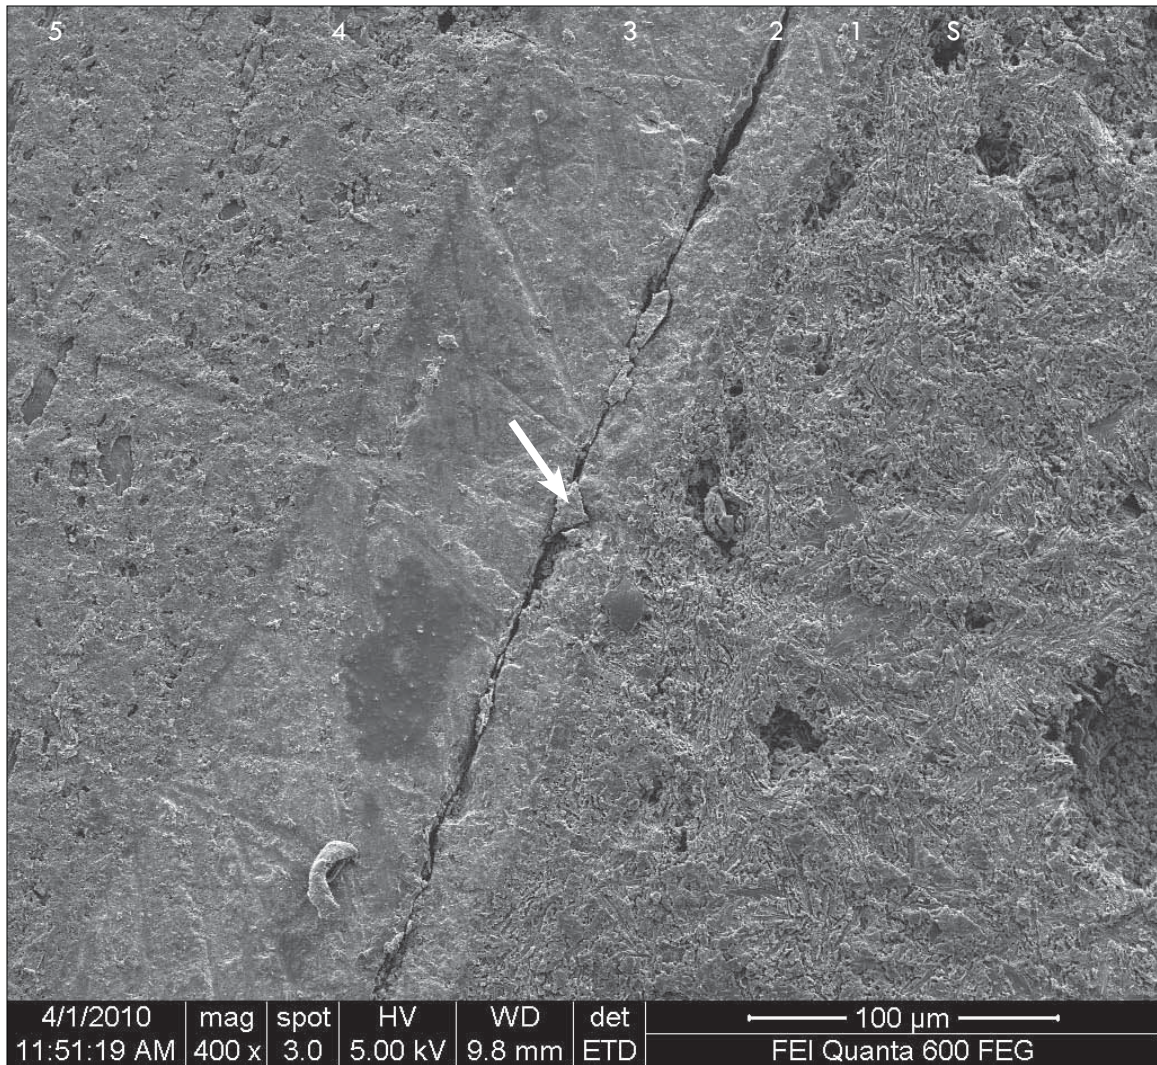
**Figure 8.8. SEM-EDS Sample from dragon's snout (GWAS01.2010.09), with flaking metallic leafing highlighted, 400x mag (L.Vollono & L. Rotkina, 2010).**

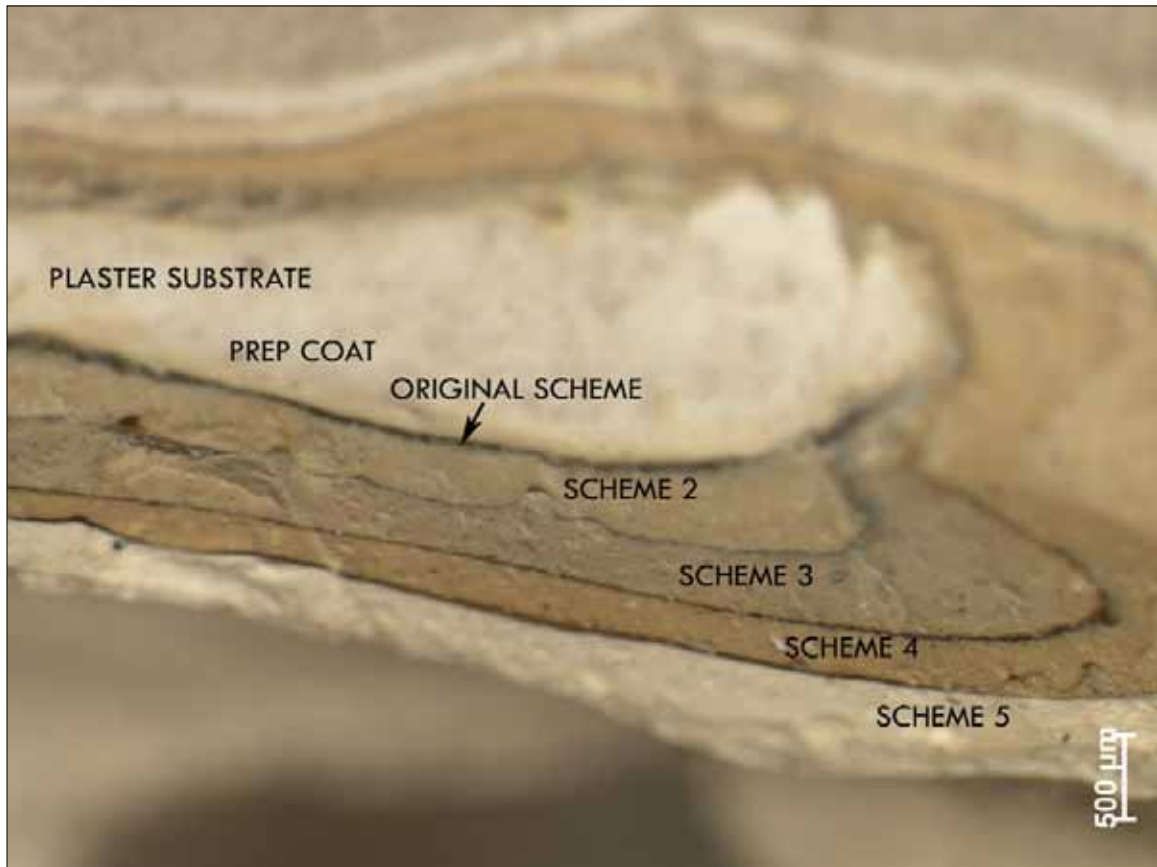
**Figure 9.1. Stereoscopic view of snake applique, with exposed schemes, 5x mag, reflected light (L.Vollono, 2010).**

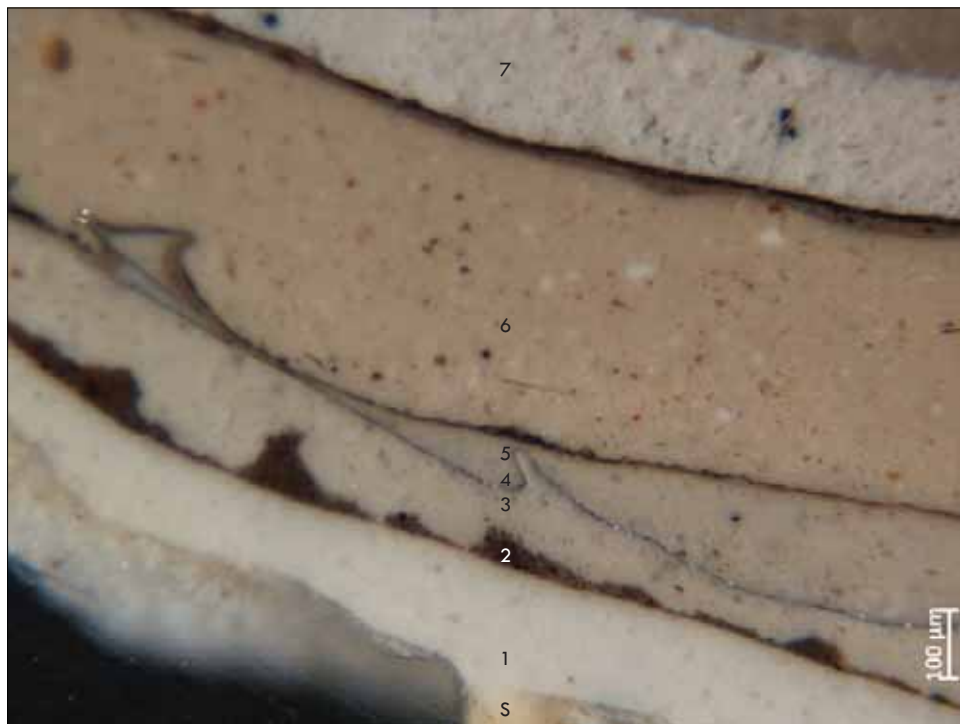
**Figure 9.2. Cross section GWAS03.2010.28, displaying both original paint and metallic foil layers, 100x mag, reflected light (L.Vollono, 2010).**
