# Rediscovering an American Master: An Examination and Analysis of the Decorative Plaster Ceiling of Robert Winthrop Chanler's Whitney Studio, New York

Lauren Vollono Drapala  
*University of Pennsylvania*, lvollono@design.upenn.edu

A THESIS

Historic Preservation

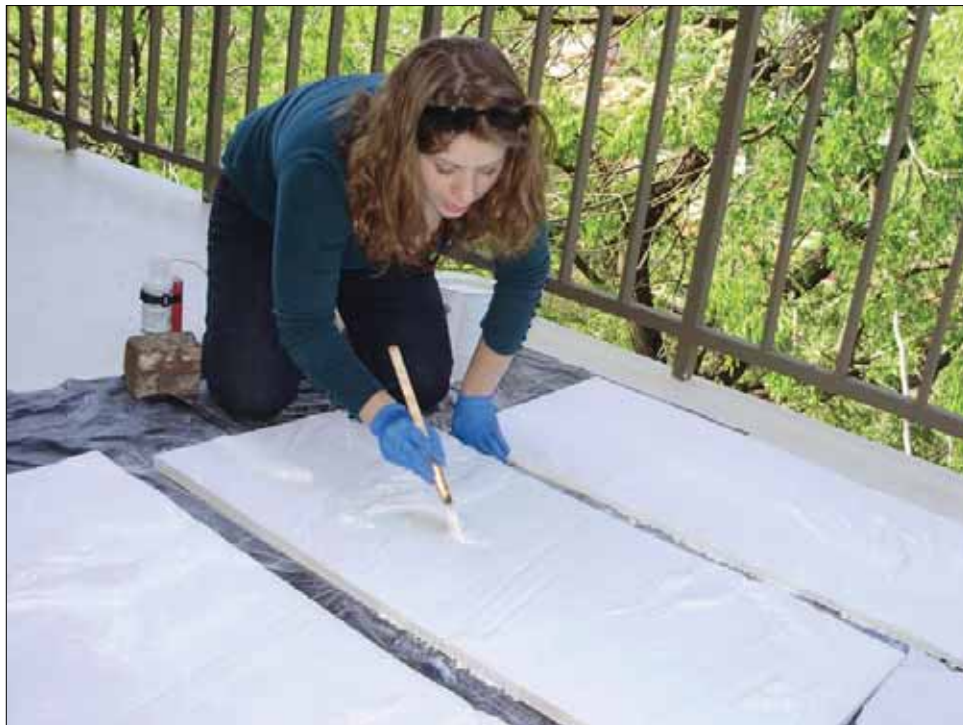
**Figure 9.4.** Author applying B-I-N Shellac Base to each plaster mold (Y. Hernandez, 2010).

B-I-N™ Shellac-Base Primer Sealer, before being applied with two coats of Behr Antique White Flat Acrylic latex paint matched to the original base coat. (Fig. 9.4)

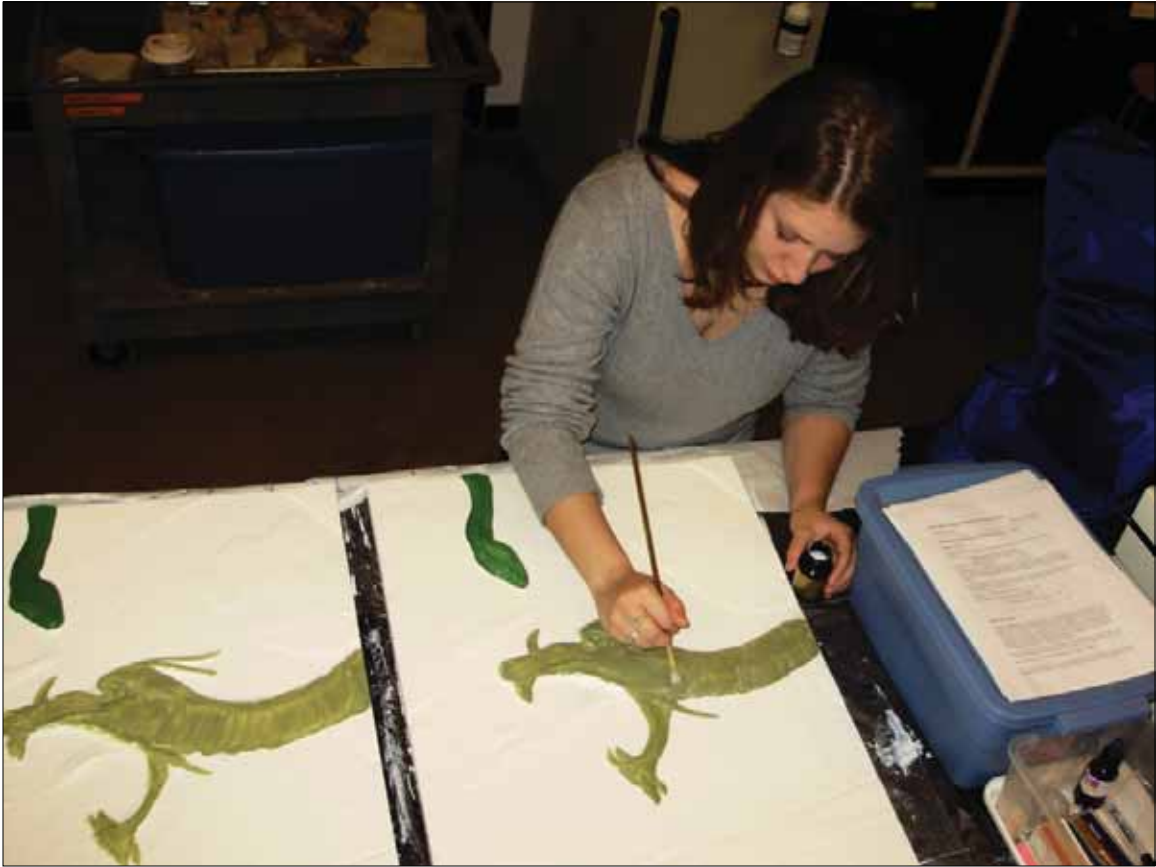
Figure 9.5. Author applying oil size for aluminum gilding (S. Rogers, 2010).

Paints were mixed to match the Munsell Color references, and applied to the dragon and snake figures prior to gilding. Once dried, Old World™ oil size was applied to the snake, dragon and griffin and left to set for an hour. (Fig. 9.5) After the aluminum leafing was applied and left to dry for 72 hours, the surface of each figure was abraded using

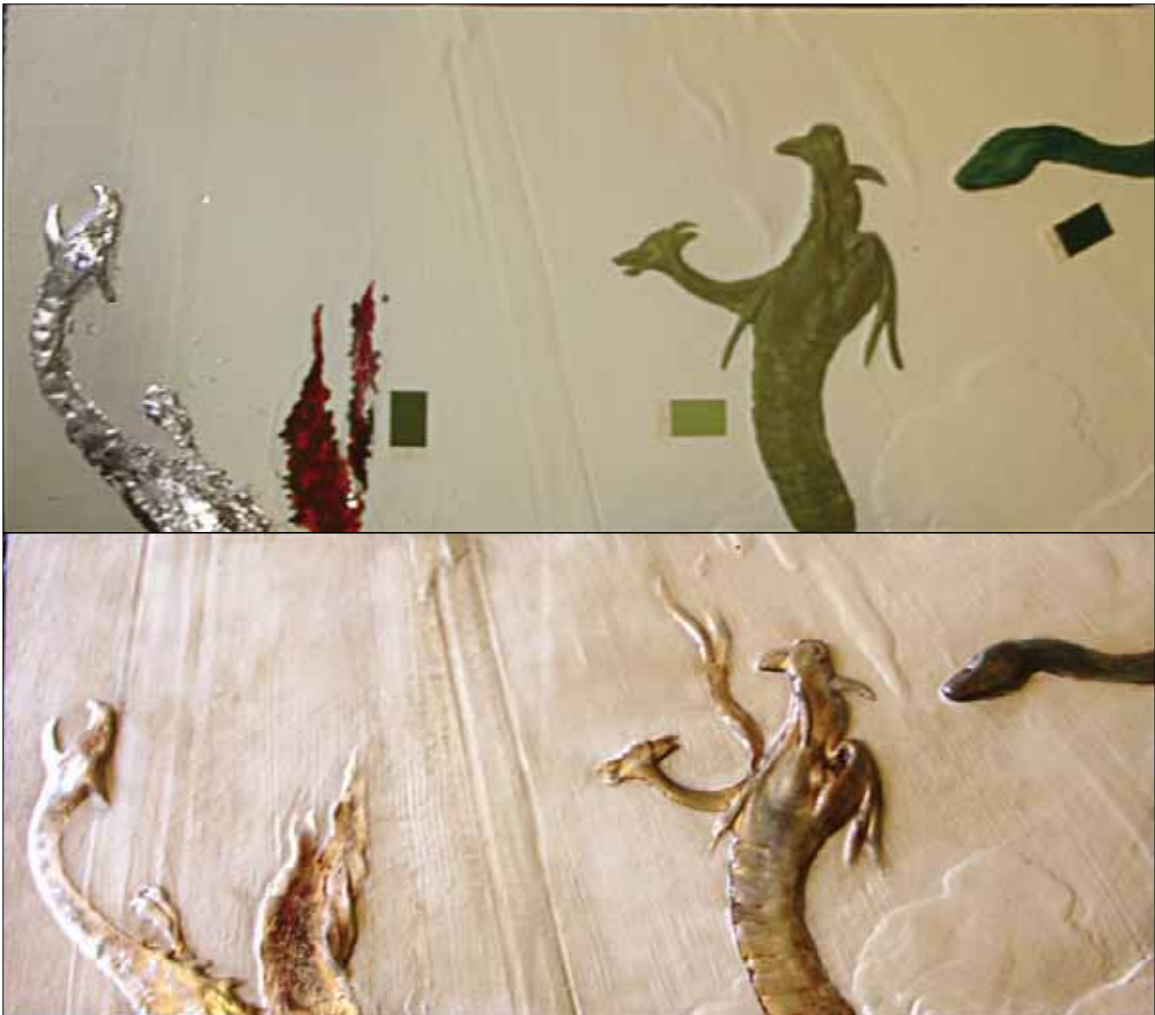
**Figure 9.6. Top: figures with corresponding Munsell color matches. Below: Finished interpretative scheme of the original Whitney Studio ceiling. (L. Vollono, 2010).**

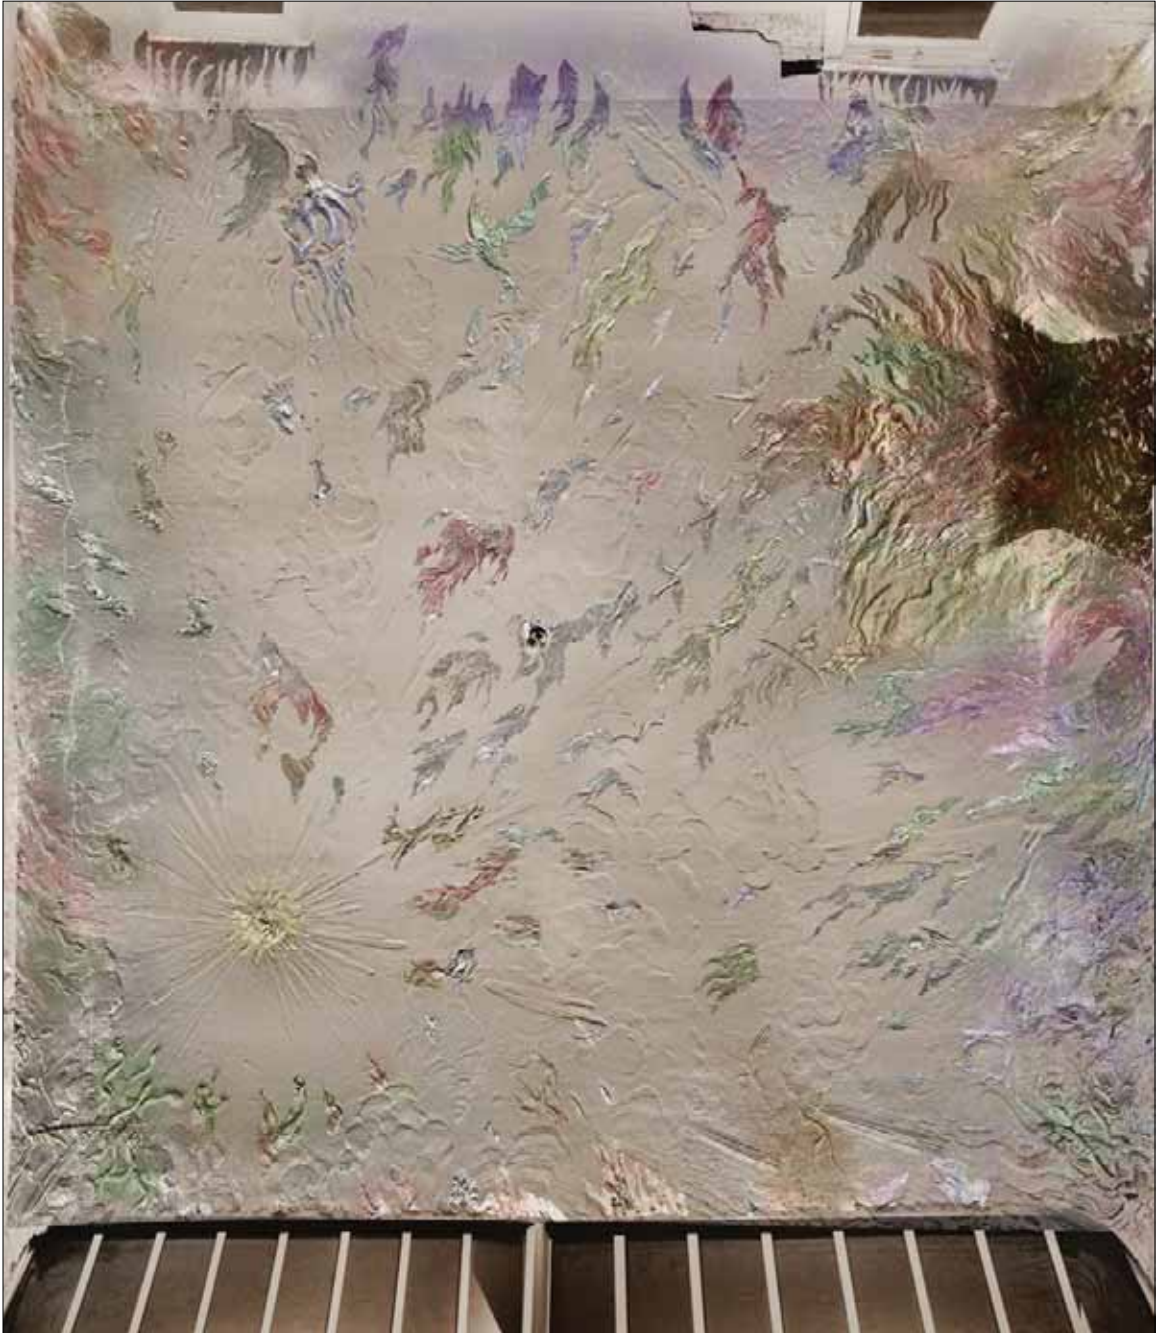
Figure 9.7. Reconstruction of original decorative scheme on Whitney Studio ceiling (L. Vollono, 2010).

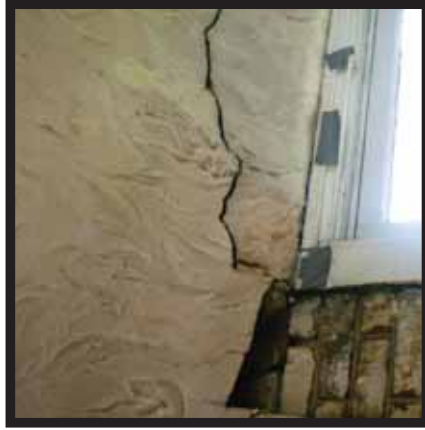
(a) abnormally large crack along cornice failure

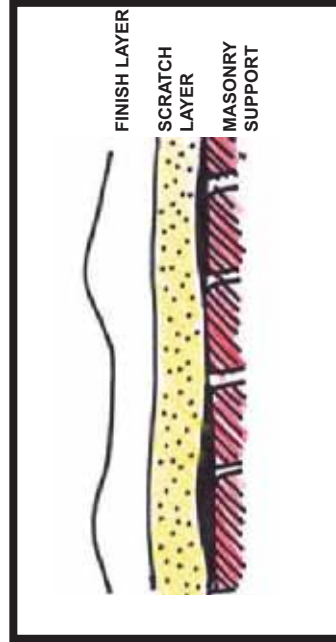
(b) Detachment of scratch layer from structural substrate

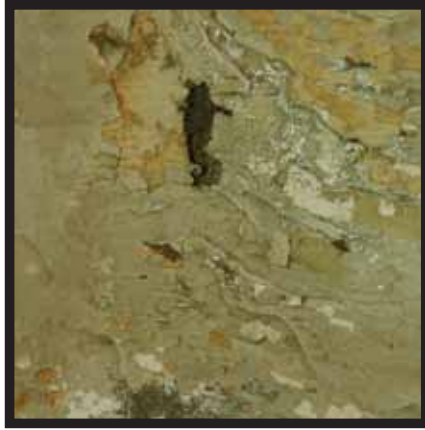
(a) plaster staining with wire mesh exposed

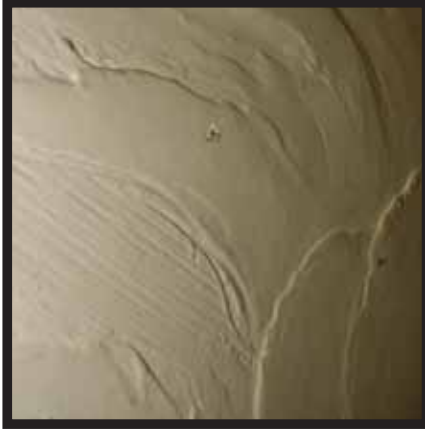
(b) staining surrounding nail hole

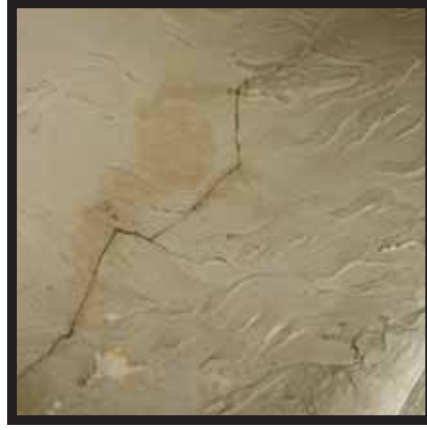
(c) staining due to prior treatment

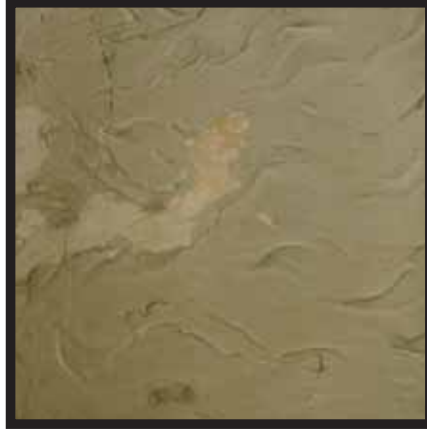
(d) stained plaster behind peeled paint

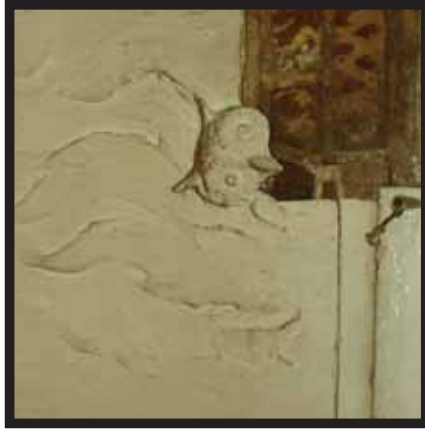
(a) cornice failure

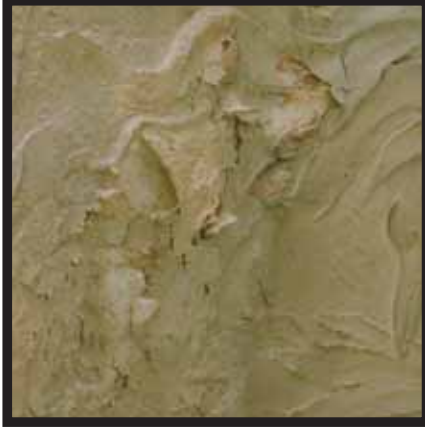
(b) vulnerable plaster due to paint loss

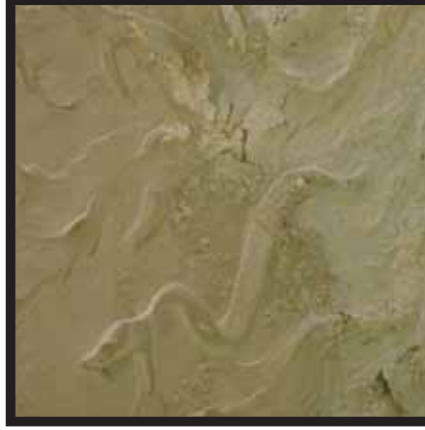
(c) loss due to extensive pitting

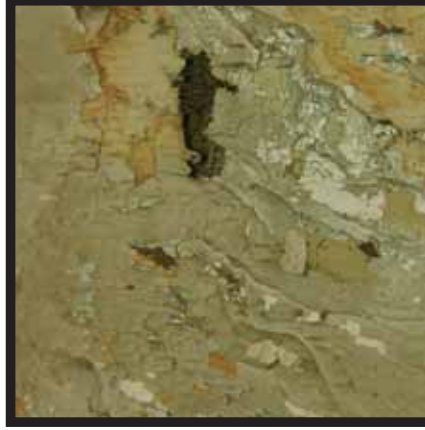
(d) erosion of metal fasteners

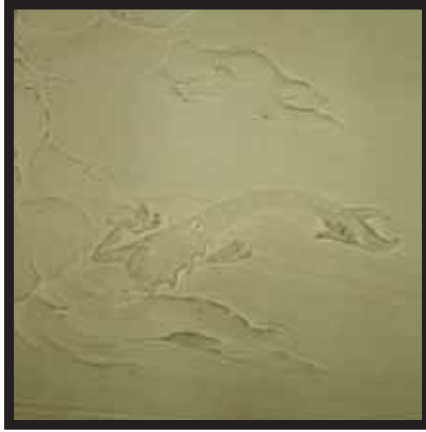
(a) soiling along high relief

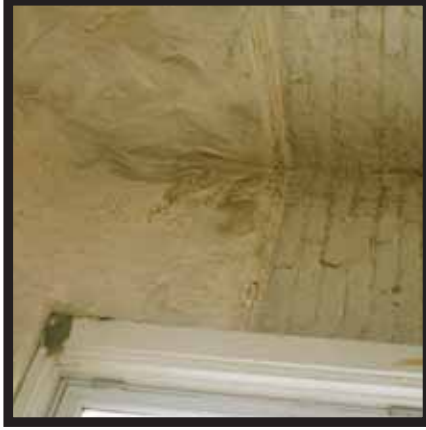
(b) soiling trapped in the corner next to the fireplace

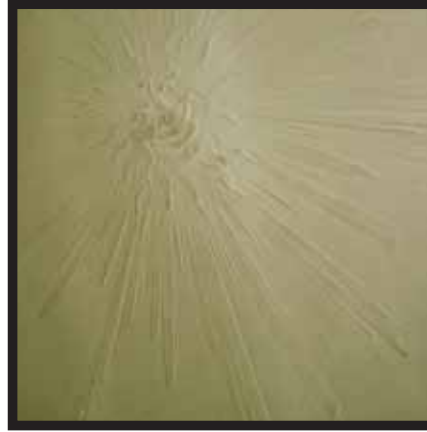
(c) soiling on long stretches of relief.

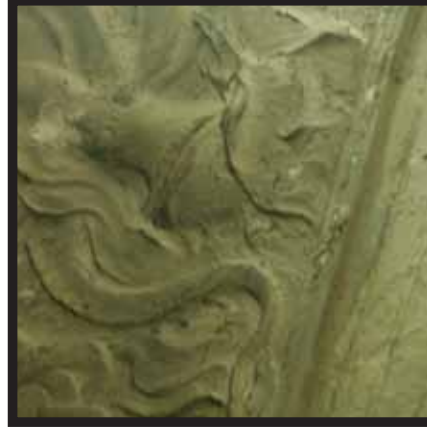
(d) soiling along very three-dimensional portion

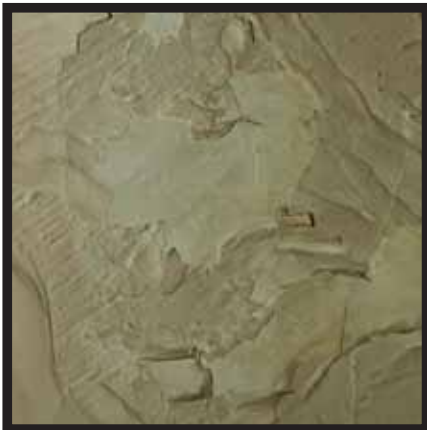
(a) peeling reveals bronze toning

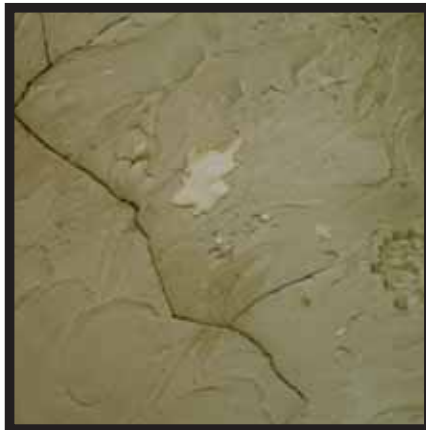
(b) extensive paint flaking

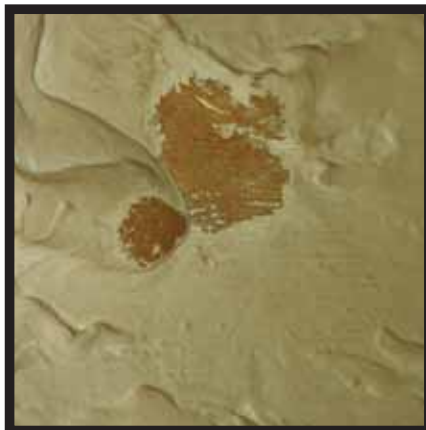
(c) evidence of former paint reveals

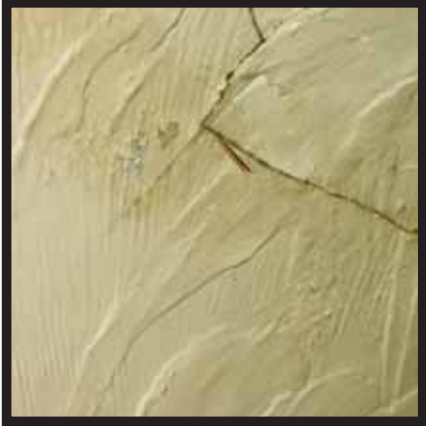
<b>DEFINITION</b>	Previous placement of markers, called "teillales," to test crack movement.	
<b>SITE IDENTIFICATION</b>	Markers were found along the east wall of the ceiling cornice.	
<b>GRAPHIC</b>

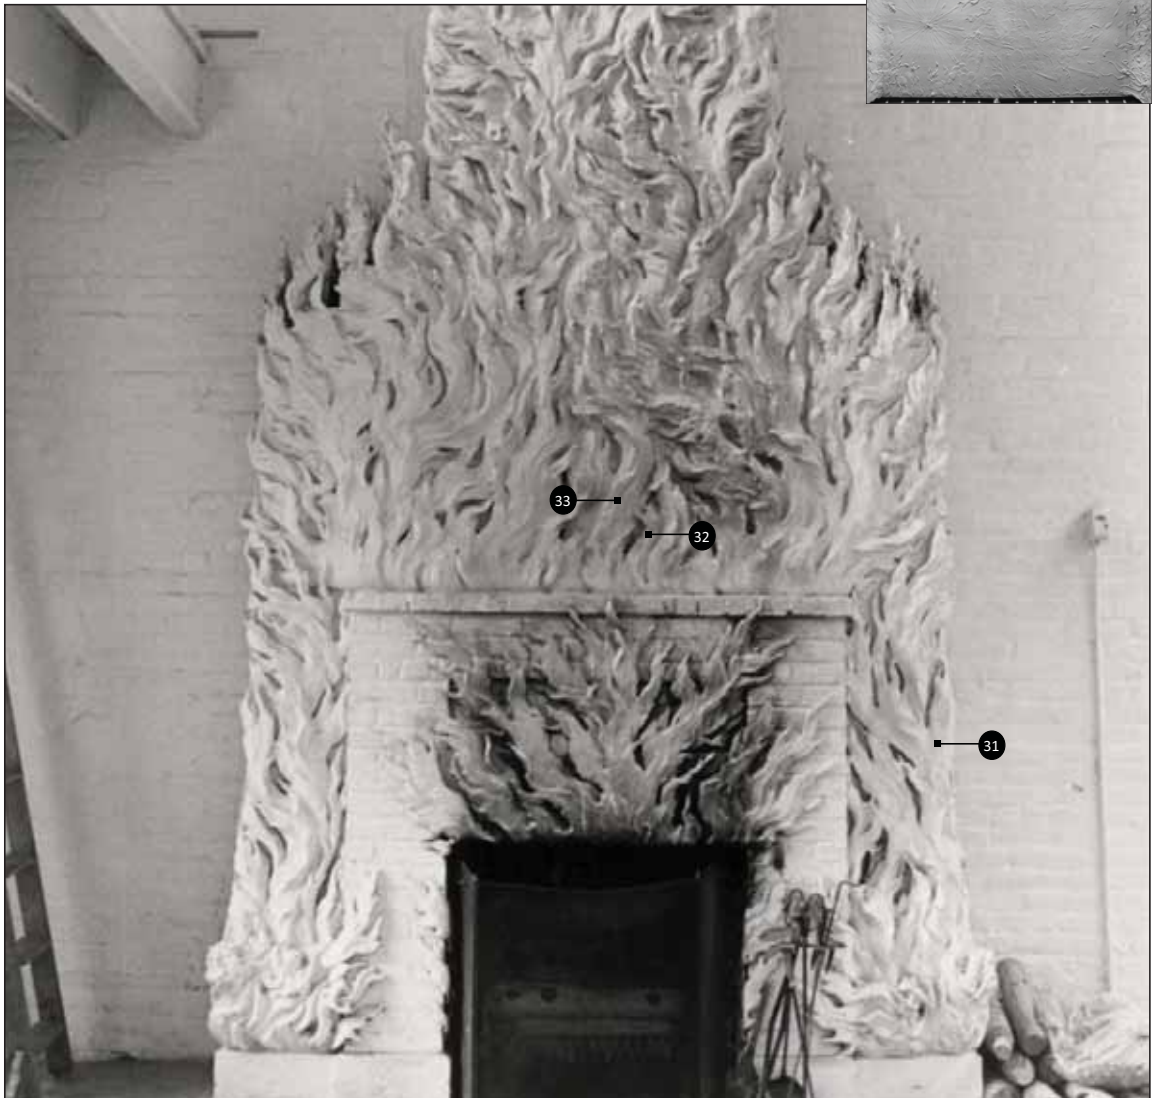
Sample (GWAS 01.2010- #)	Description	Analytical Testing
31	Side of fireplace, towards bar off flame	Cross section
32	Snake above fireplace - plaster substrate	Cross section
33	Flame above fireplace - plaster substrate	Cross section

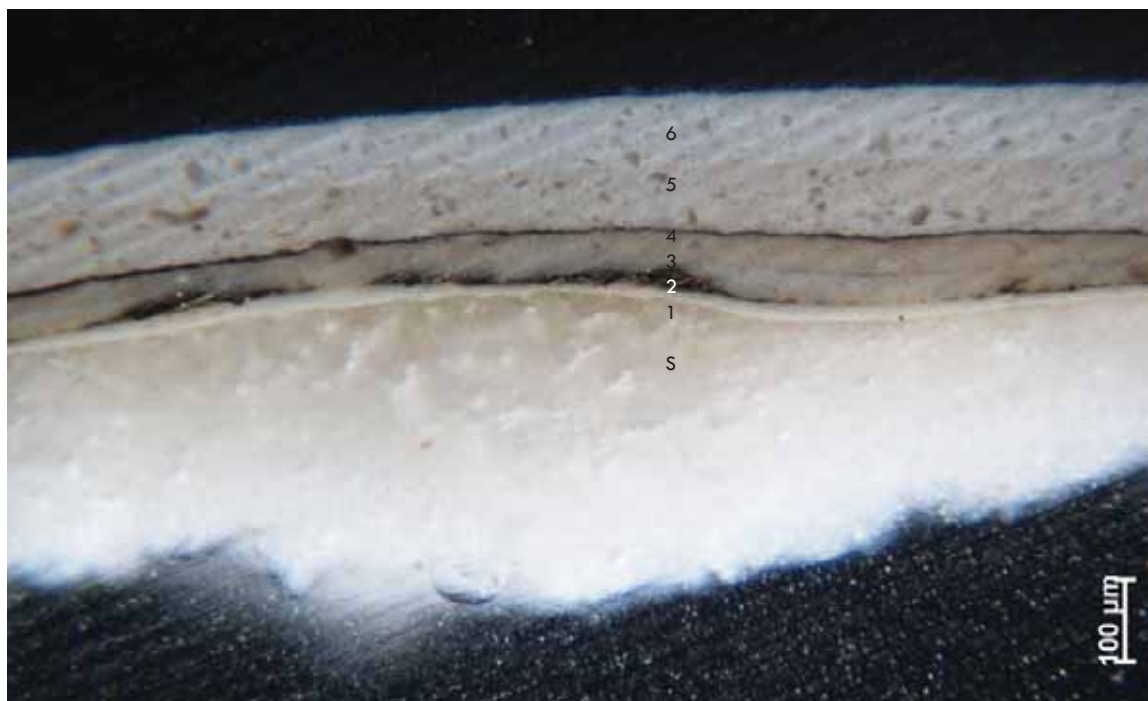
SAMPLE #: GWAS01.2010.02	DATE SAMPLED: November 16, 2009
ROOM: G.V. Whitney Studio	DATE ANALYZED: December, 2009
DESCRIPTION: Sun face, bottom right lip	MAGNIFICATION: 100x
MICROSCOPE: Olympus CX 31	CAMERA: Nikon DS-F11
LIGHT SOURCE: Reflected Quartz Halogen	SOFTWARE: NIS Elements BR

LAYER	COLOR	DESCRIPTION
6	White	Top layer, Latex paint
5	Off-white	Latex paint
4	Darkened Varnish / Tan	Lead-based paint
3	Dirt layer / Off-white	Lead-based paint
2	Gold	Bronzed metal application
1	White	Lead-based preparatory paint
S	Plaster	Substrate

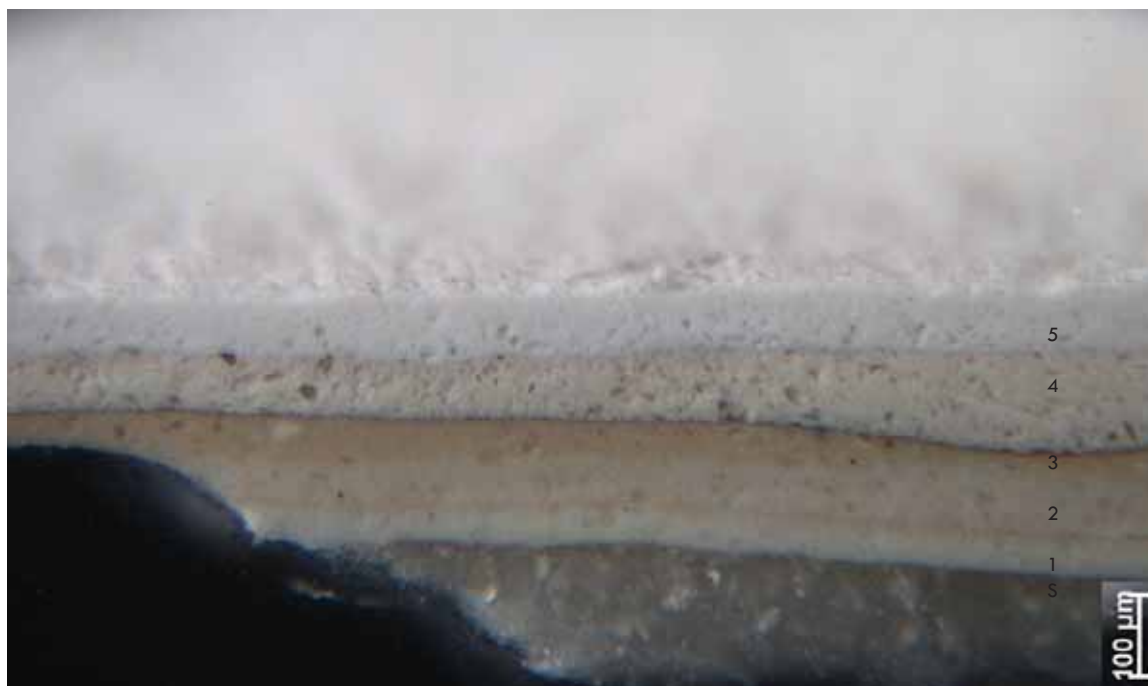
SAMPLE #: GWAS01.2010.04	DATE SAMPLED: November 16, 2009
ROOM: G.V. Whitney Studio	DATE ANALYZED: December, 2009
DESCRIPTION: Sun face, rt. pupil of the eye	MAGNIFICATION: 100x
MICROSCOPE: Olympus CX 31	CAMERA: Nikon DS-F11
LIGHT SOURCE: Reflected Quartz Halogen	SOFTWARE: NIS Elements BR

LAYER	COLOR	DESCRIPTION
5	White	Top layer, Latex paint
4	Off-white	Latex paint
3	Darkened Varnish / Tan	Lead-based paint
2	Dirt layer / Off-white	Lead-based paint
1	White	Lead-based preparatory paint
S	Plaster	Substrate

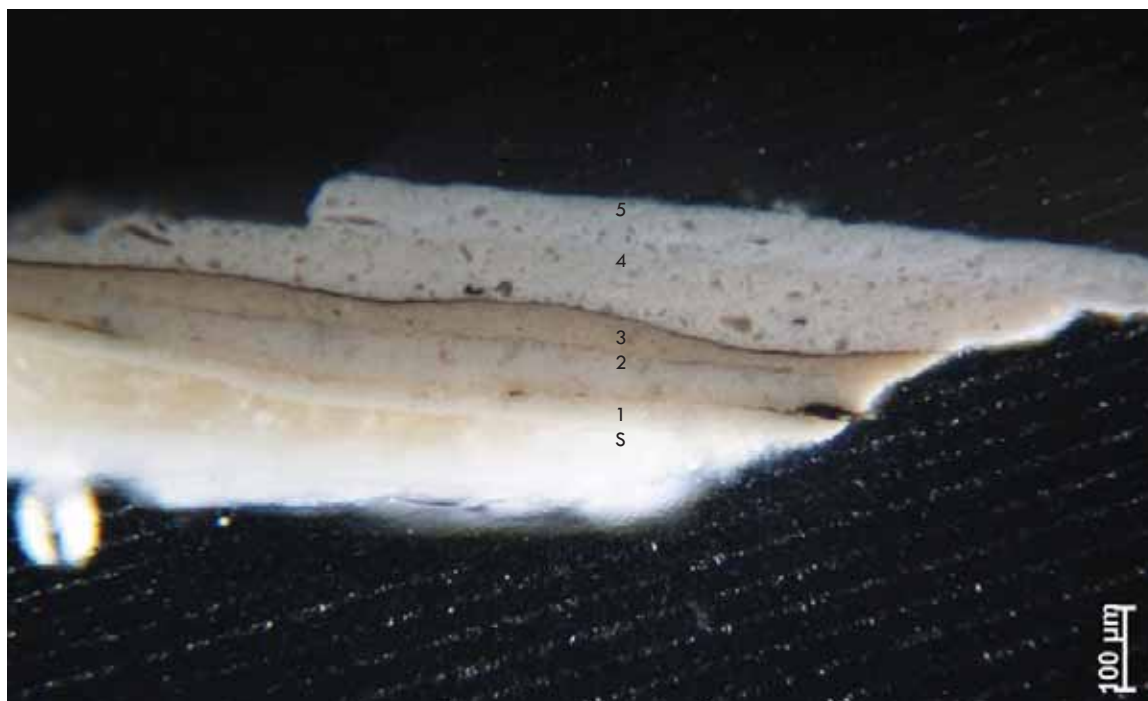
SAMPLE #: GWAS01.2010.05	DATE SAMPLED: November 16, 2009
ROOM: G.V. Whitney Studio	DATE ANALYZED: December, 2009
DESCRIPTION: Eyebrow edge, rt. side sun	MAGNIFICATION: 100x
MICROSCOPE: Olympus CX 31	CAMERA: Nikon DS-F11
LIGHT SOURCE: Reflected Quartz Halogen	SOFTWARE: NIS Elements BR

LAYER	COLOR	DESCRIPTION
5	White	Top layer, Latex paint
4	Off-white	Latex paint
3	Darkened Varnish / Tan	Lead-based paint
2	Dirt layer / Off-white	Lead-based paint
1	White	Lead-based preparatory paint
S	Plaster	Substrate

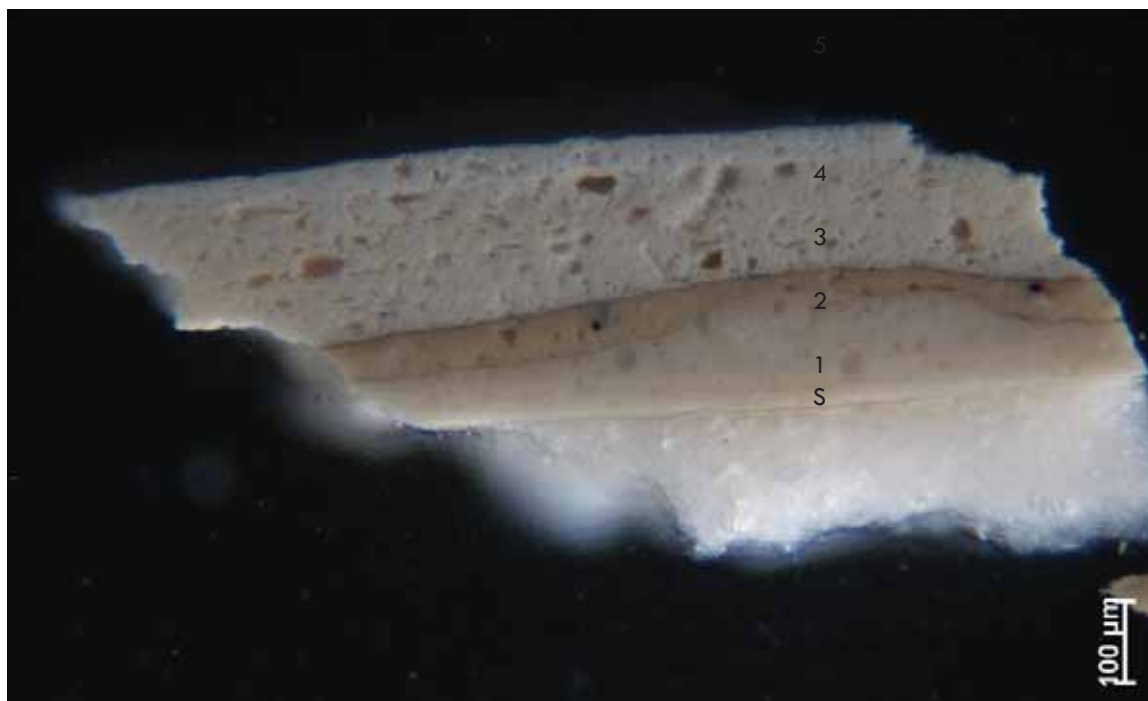
SAMPLE #: GWAS01.2010.06	DATE SAMPLED: November 16, 2009
ROOM: G.V. Whitney Studio	DATE ANALYZED: December, 2009
DESCRIPTION: Ray background, above sun	MAGNIFICATION: 100x
MICROSCOPE: Olympus CX 31	CAMERA: Nikon DS-F11
LIGHT SOURCE: Reflected Quartz Halogen	SOFTWARE: NIS Elements BR

LAYER	COLOR	DESCRIPTION
5	White	Top layer, Latex paint
4	Off-white	Latex paint
3	Darkened Varnish / Tan	Lead-based paint
2	Dirt layer / Off-white	Lead-based paint
1	White	Lead-based preparatory paint
S	Plaster	Substrate

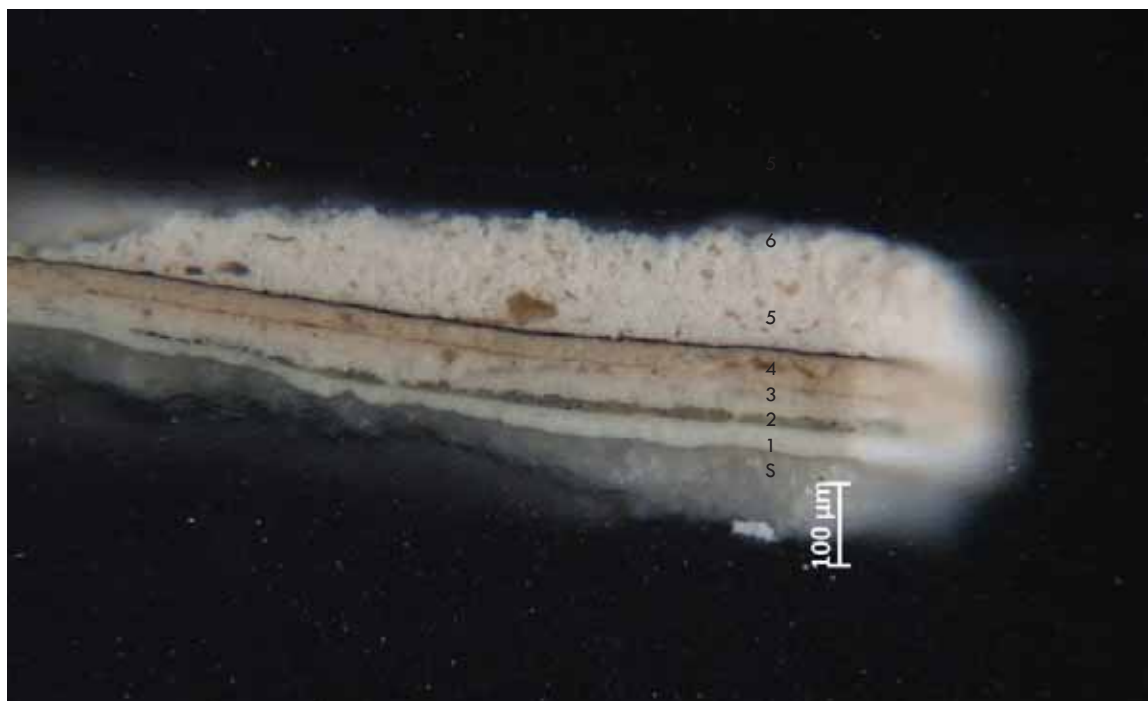
SAMPLE #: GWAS03.2010.08	DATE SAMPLED: November 16, 2009
ROOM: G.V. Whitney Studio	DATE ANALYZED: March, 2010
DESCRIPTION: Tongue of dragon	MAGNIFICATION: 100x
MICROSCOPE: Olympus CX 31	CAMERA: Nikon DS-F11
LIGHT SOURCE: Reflected Quartz Halogen	SOFTWARE: NIS Elements BR

LAYER	COLOR	DESCRIPTION
6	White	Top layer, Latex paint
5	Off-white	Latex paint
4	Darkened Varnish / Tan	Lead-based paint
3	Dirt layer / Off-white	Lead-based paint
2	Dark green (10Y 7/4)	Glaze application
1	White	Lead-based preparatory paint
S	Plaster	Substrate

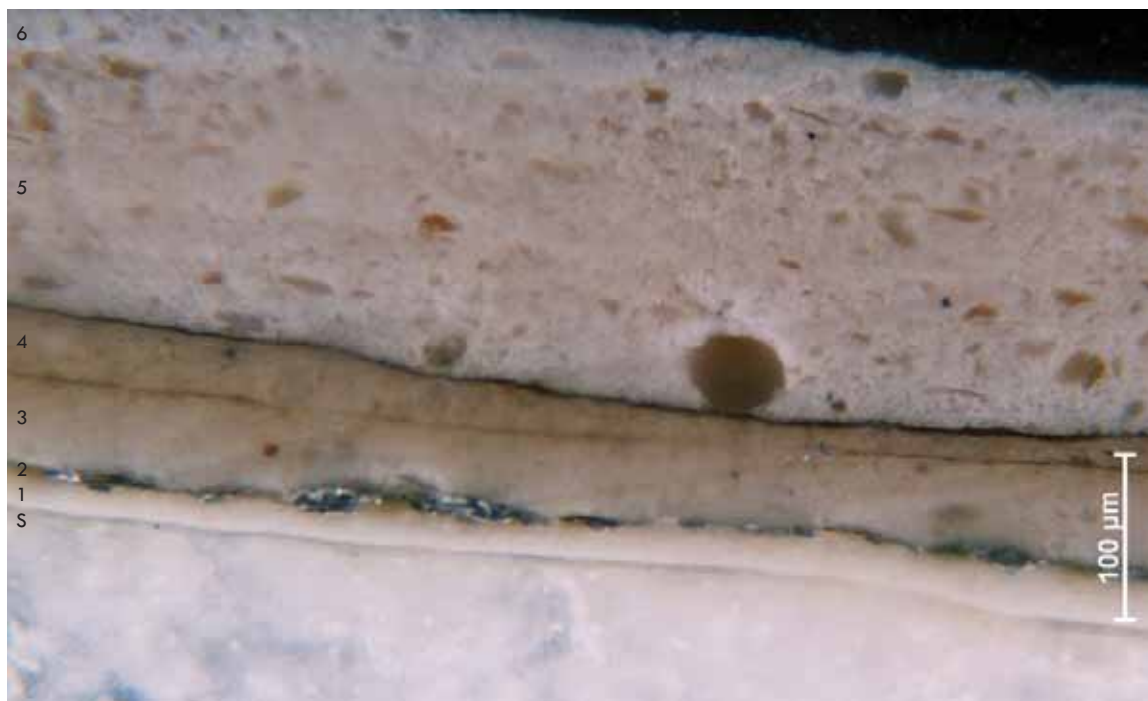
SAMPLE #: GWAS01.2010.09	DATE SAMPLED: November 16, 2009
ROOM: G.V. Whitney Studio	DATE ANALYZED: December, 2009
DESCRIPTION: Snout of dragon	MAGNIFICATION: 100x
MICROSCOPE: Olympus CX 31	CAMERA: Nikon DS-F11
LIGHT SOURCE: Reflected Quartz Halogen	SOFTWARE: NIS Elements BR

LAYER	COLOR	DESCRIPTION
6	White	Top layer, Latex paint
5	Off-white	Latex paint
4	Darkened Varnish / Tan	Lead-based paint
3	Dirt layer / Off-white	Lead-based paint
2	Silver	Metal foil application
1	White	Lead-based preparatory paint
S	Plaster	Substrate

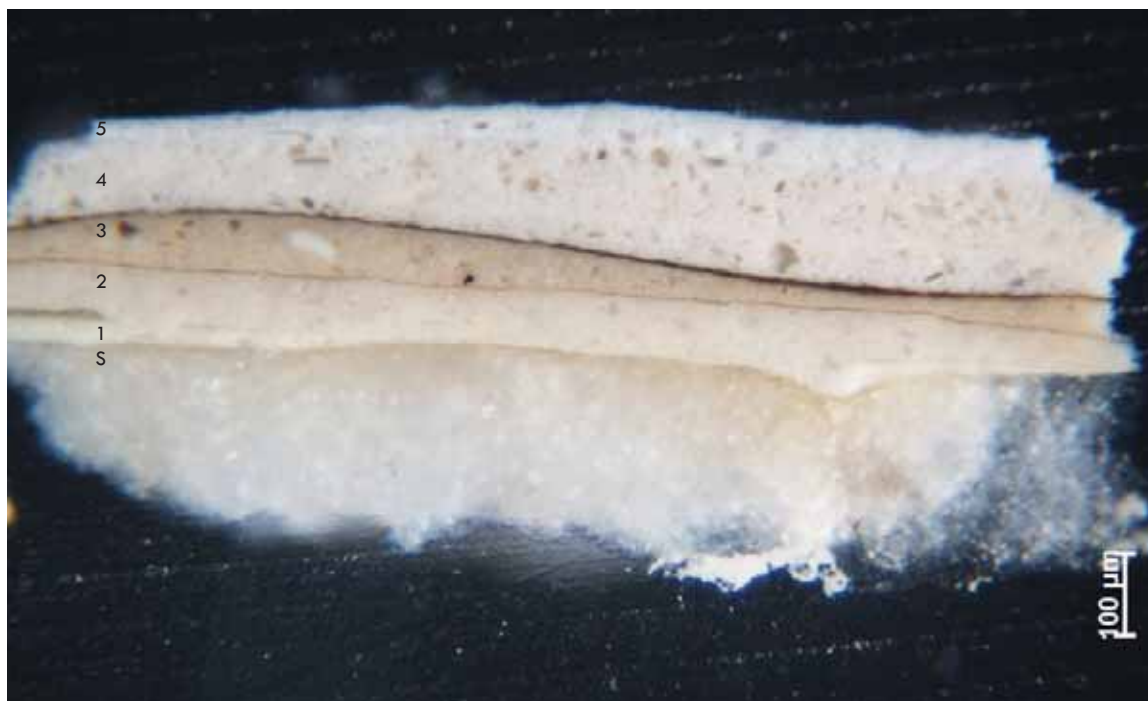
SAMPLE #: GWAS01.2010.10	DATE SAMPLED: November 16, 2009
ROOM: G.V. Whitney Studio	DATE ANALYZED: December, 2009
DESCRIPTION: Neck of Dragon	MAGNIFICATION: 100x
MICROSCOPE: Olympus CX 31	CAMERA: Nikon DS-F11
LIGHT SOURCE: Reflected Quartz Halogen	SOFTWARE: NIS Elements BR

LAYER	COLOR	DESCRIPTION
5	White	Top layer, Latex paint
4	Off-white	Latex paint
3	Darkened Varnish / Tan	Lead-based paint
2	Dirt layer / Off-white	Lead-based paint
1	White	Lead-based preparatory paint
S	Plaster	Substrate

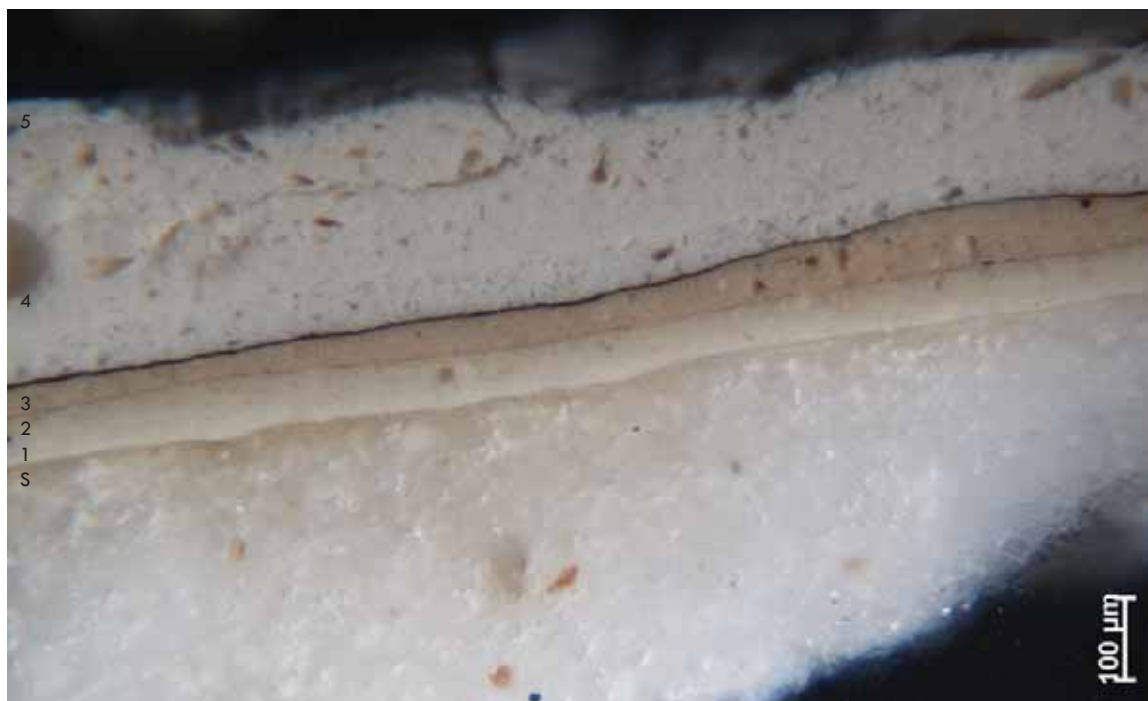
SAMPLE #: GWAS01.2010.11	DATE SAMPLED: November 16, 2009
ROOM: G.V. Whitney Studio	DATE ANALYZED: December, 2009
DESCRIPTION: Cloud beyond Dragon	MAGNIFICATION: 100x
MICROSCOPE: Olympus CX 31	CAMERA: Nikon DS-F11
LIGHT SOURCE: Reflected Quartz Halogen	SOFTWARE: NIS Elements BR

LAYER	COLOR	DESCRIPTION
5	White	Top layer, Latex paint
4	Off-white	Latex paint
3	Darkened Varnish / Tan	Lead-based paint
2	Dirt layer / Off-white	Lead-based paint
1	White	Lead-based preparatory paint
S	Plaster	Substrate

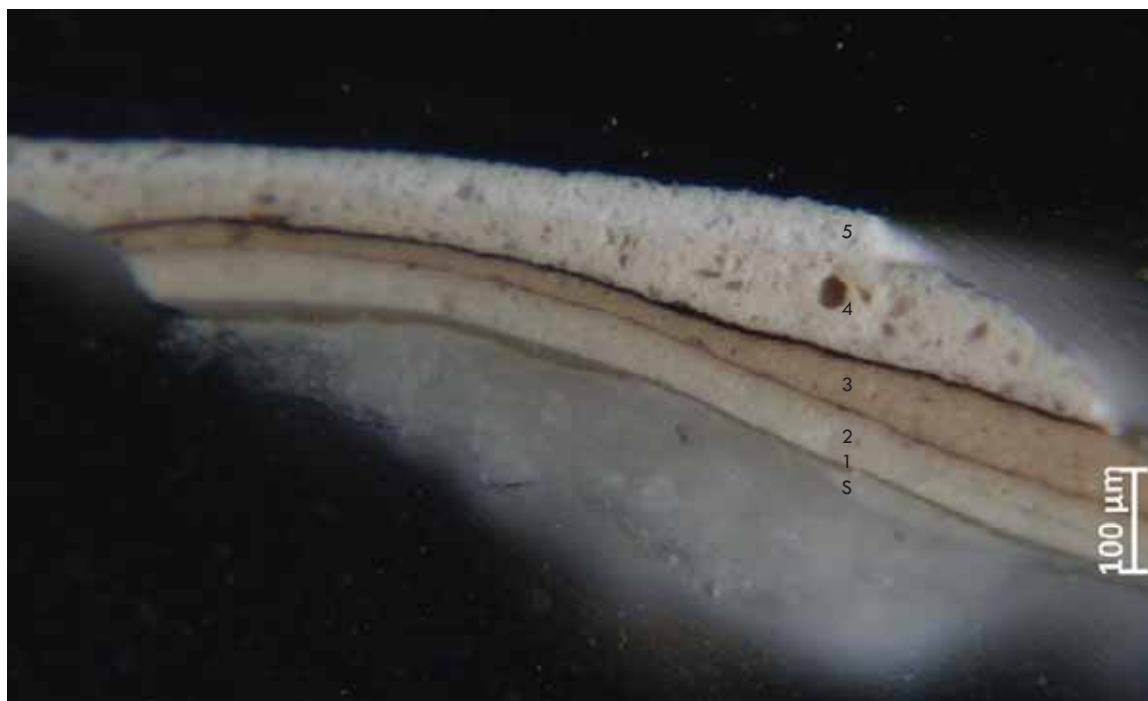
SAMPLE #: GWAS03.2010.12	DATE SAMPLED: November 16, 2009
ROOM: G.V. Whitney Studio	DATE ANALYZED: March, 2010
DESCRIPTION: Combed ridge, dragon	MAGNIFICATION: 100x
MICROSCOPE: Olympus CX 31	CAMERA: Nikon DS-F11
LIGHT SOURCE: Reflected Quartz Halogen	SOFTWARE: NIS Elements BR

LAYER	COLOR	DESCRIPTION
5	White	Top layer, Latex paint
4	Off-white	Latex paint
3	Darkened Varnish / Tan	Lead-based paint
2	Dirt layer / Off-white	Lead-based paint
1	White	Lead-based preparatory paint
S	Plaster	Substrate

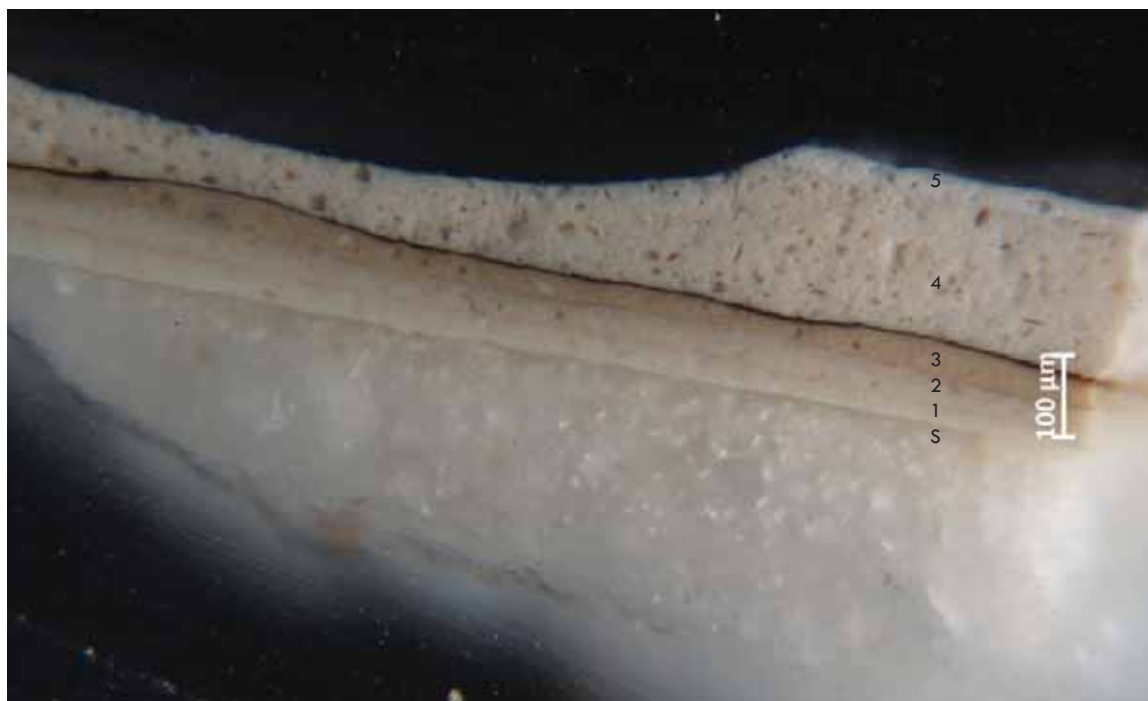
SAMPLE #: GWAS03.2010.13	DATE SAMPLED: November 16, 2009
ROOM: G.V. Whitney Studio	DATE ANALYZED: March, 2010
DESCRIPTION: Ray background	MAGNIFICATION: 100x
MICROSCOPE: Olympus CX 31	CAMERA: Nikon DS-F11
LIGHT SOURCE: Reflected Quartz Halogen	SOFTWARE: NIS Elements BR

LAYER	COLOR	DESCRIPTION
5	White	Top layer, Latex paint
4	Off-white	Latex paint
3	Darkened Varnish / Tan	Lead-based paint
2	Dirt layer / Off-white	Lead-based paint
1	White	Lead-based preparatory paint
S	Plaster	Substrate

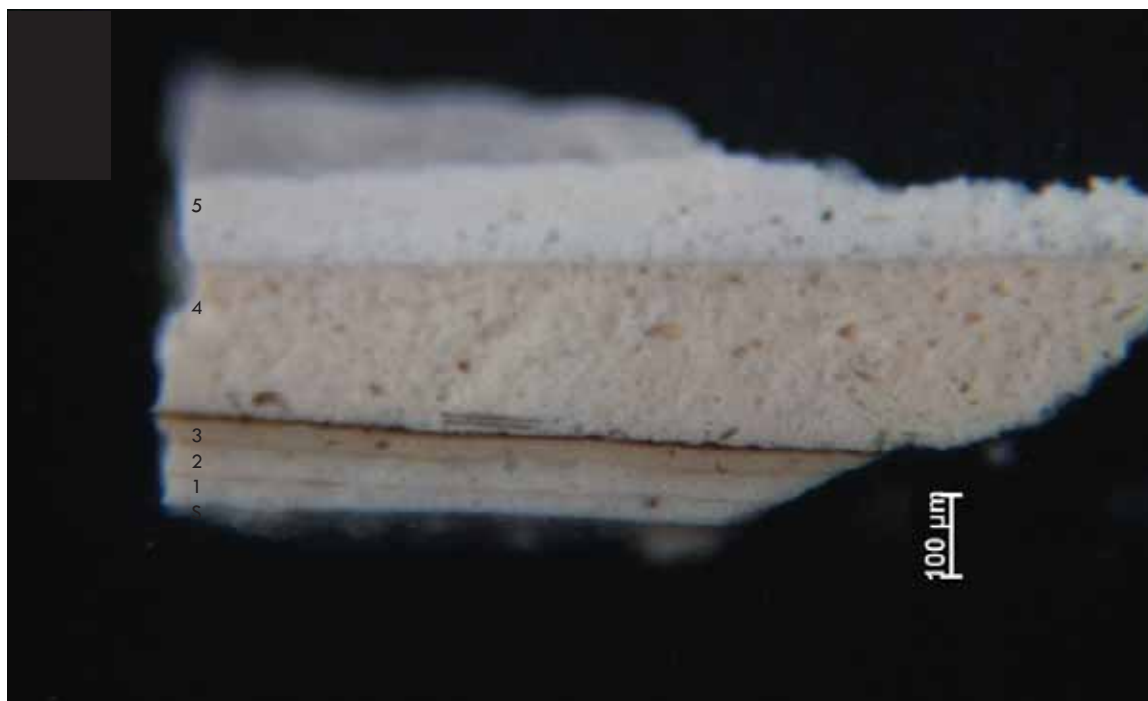
SAMPLE #: GWAS01.2010.13	DATE SAMPLED: November 16, 2009
ROOM: G.V. Whitney Studio	DATE ANALYZED: December, 2009
DESCRIPTION: Ray background	MAGNIFICATION: 100x
MICROSCOPE: Olympus CX 31	CAMERA: Nikon DS-F11
LIGHT SOURCE: Reflected Quartz Halogen	SOFTWARE: NIS Elements BR

LAYER	COLOR	DESCRIPTION
5	White	Top layer, Latex paint
4	Off-white	Latex paint
3	Darkened Varnish / Tan	Lead-based paint
2	Dirt layer / Off-white	Lead-based paint
1	White	Lead-based preparatory paint
S	Plaster	Substrate

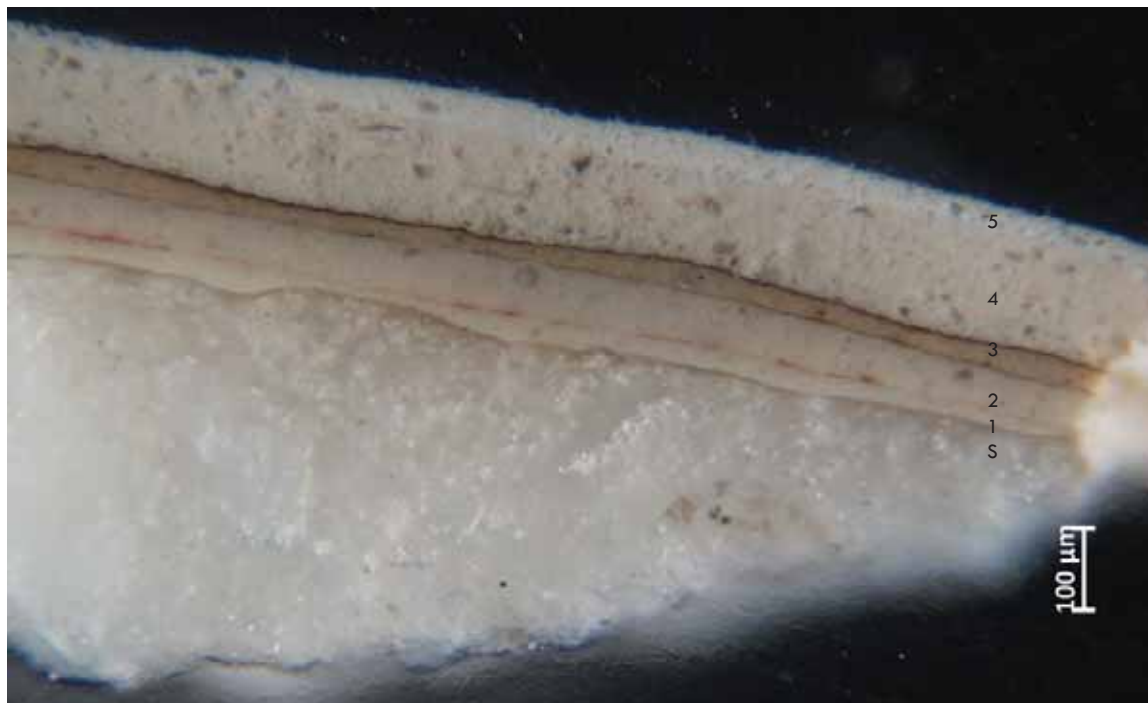
SAMPLE #: GWAS03.2010.17	DATE SAMPLED: November 16, 2009
ROOM: G.V. Whitney Studio	DATE ANALYZED: March, 2010
DESCRIPTION: Cloud	MAGNIFICATION: 100x
MICROSCOPE: Olympus CX 31	CAMERA: Nikon DS-F11
LIGHT SOURCE: Reflected Quartz Halogen	SOFTWARE: NIS Elements BR

LAYER	COLOR	DESCRIPTION
5	White	Top layer, Latex paint
4	Off-white	Latex paint
3	Darkened Varnish / Tan	Lead-based paint
2	Dirt layer / Off-white	Lead-based paint
1	Orange Varnish / White	Lead-based preparatory paint
S	Plaster	Substrate

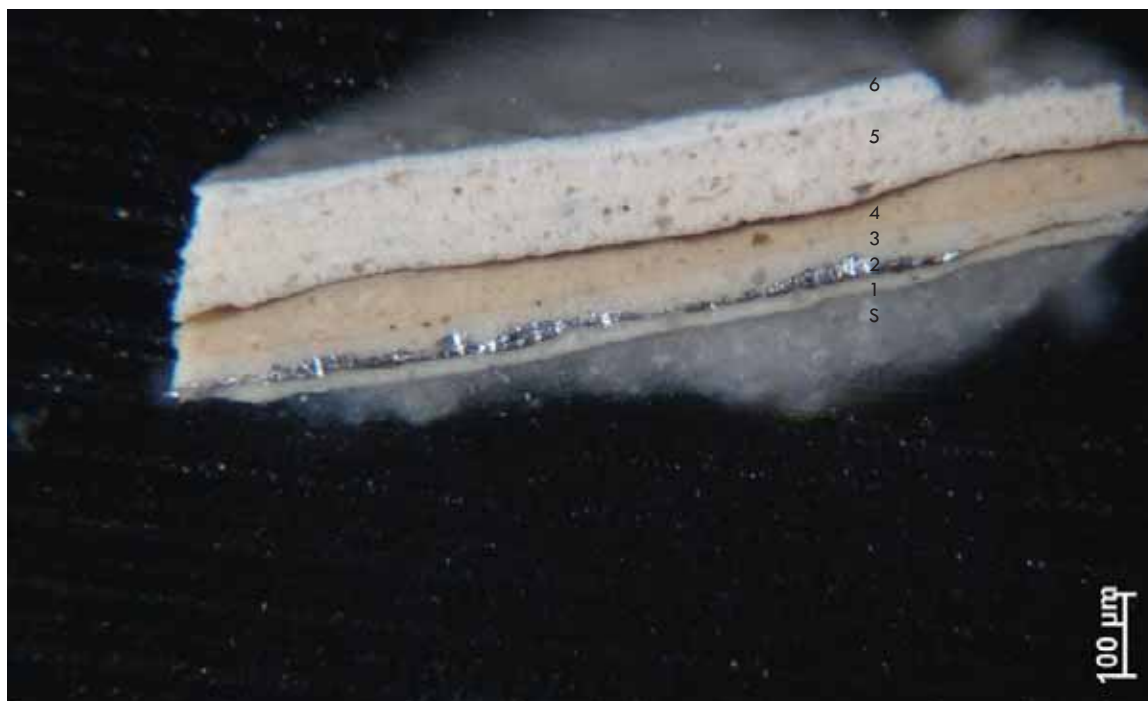
SAMPLE #: GWAS01.2010.18	DATE SAMPLED: November 16, 2009
ROOM: G.V. Whitney Studio	DATE ANALYZED: December, 2009
DESCRIPTION: Deer snout	MAGNIFICATION: 100x
MICROSCOPE: Olympus CX 31	CAMERA: Nikon DS-F11
LIGHT SOURCE: Reflected Quartz Halogen	SOFTWARE: NIS Elements BR

LAYER	COLOR	DESCRIPTION
6	White	Top layer, Latex paint
5	Off-white	Latex paint
4	Darkened Varnish / Tan	Lead-based paint
3	Dirt layer / Off-white	Lead-based paint
2	Silver	Metal foil application
1	White	Lead-based preparatory paint
S	Plaster	Substrate

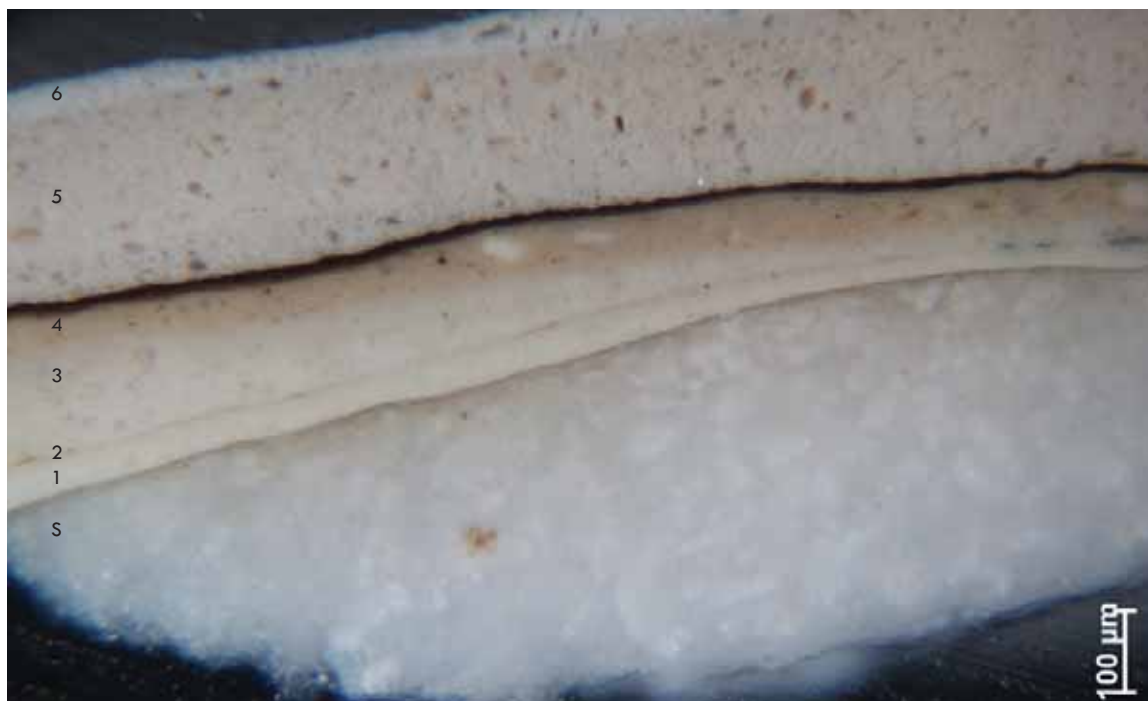
SAMPLE #: GWAS01.2010.19	DATE SAMPLED: November 16, 2009
ROOM: G.V. Whitney Studio	DATE ANALYZED: December, 2009
DESCRIPTION: Deer antler	MAGNIFICATION: 100x
MICROSCOPE: Olympus CX 31	CAMERA: Nikon DS-F11
LIGHT SOURCE: Reflected Quartz Halogen	SOFTWARE: NIS Elements BR

LAYER	COLOR	DESCRIPTION
6	White	Top layer, Latex paint
5	Off-white	Latex paint
4	Darkened Varnish / Tan	Lead-based paint
3	Dirt layer / Off-white	Lead-based paint
2	Silver	Flaky metal foil application
1	White	Lead-based preparatory paint
S	Plaster	Substrate
