# Rediscovering an American Master: An Examination and Analysis of the Decorative Plaster Ceiling of Robert Winthrop Chanler's Whitney Studio, New York

Lauren Vollono Drapala  
*University of Pennsylvania*, lvollono@design.upenn.edu

A THESIS

Historic Preservation

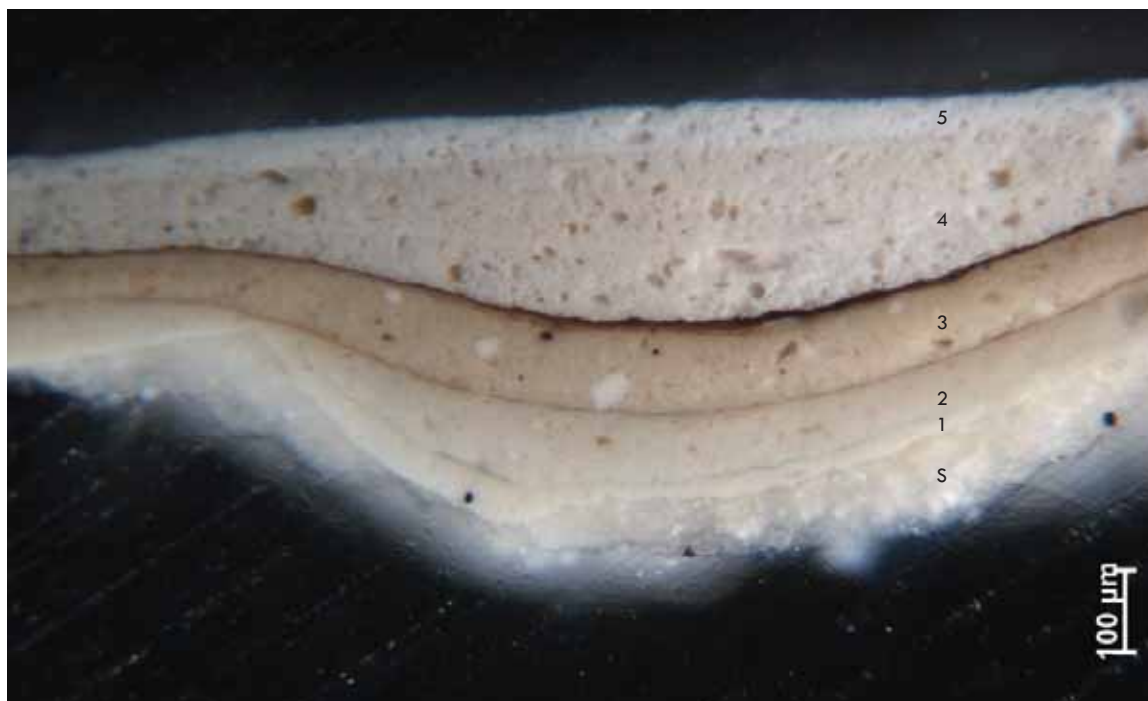
SAMPLE #: GWAS01.2010.20	DATE SAMPLED: November 16, 2009
ROOM: G.V. Whitney Studio	DATE ANALYZED: December, 2009
DESCRIPTION: Combed ridge	MAGNIFICATION: 100x
MICROSCOPE: Olympus CX 31	CAMERA: Nikon DS-F11
LIGHT SOURCE: Reflected Quartz Halogen	SOFTWARE: NIS Elements BR

LAYER	COLOR	DESCRIPTION
5	White	Top layer, Latex paint
4	Off-white	Latex paint
3	Darkened Varnish / Tan	Lead-based paint
2	Dirt layer / Off-white	Lead-based paint
1	White	Lead-based preparatory paint
S	Plaster	Substrate

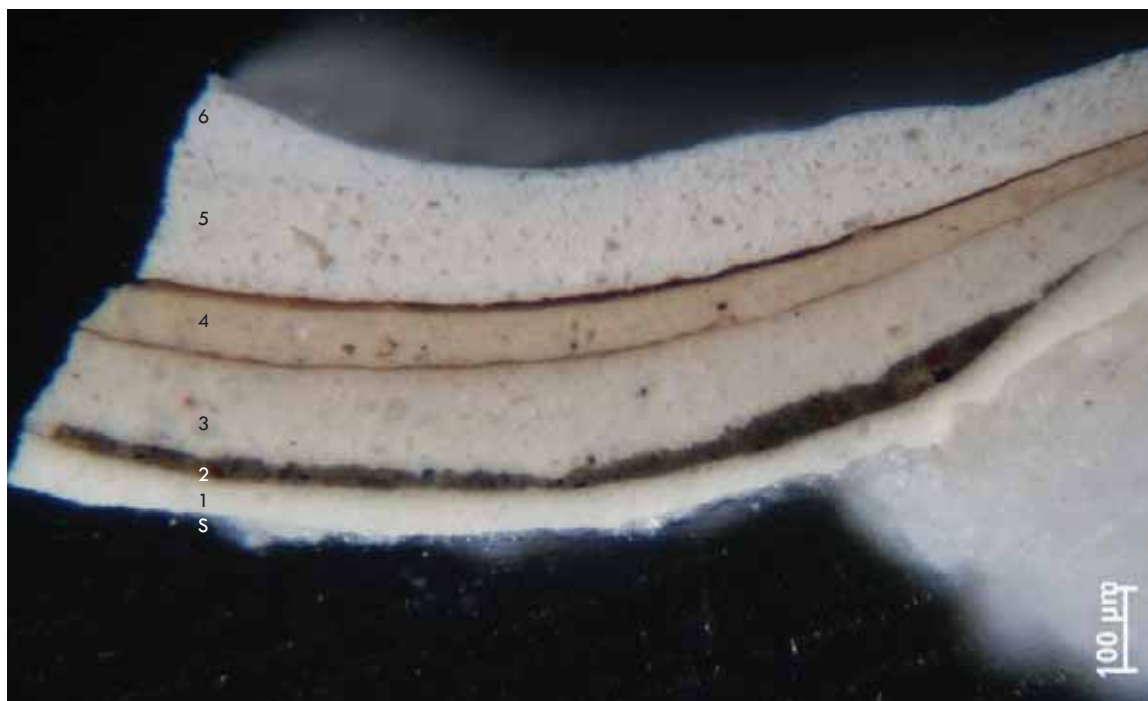
SAMPLE #: GWAS01.2010.21	DATE SAMPLED: November 16, 2009
ROOM: G.V. Whitney Studio	DATE ANALYZED: December, 2009
DESCRIPTION: Edge of mouth on alligator	MAGNIFICATION: 100x
MICROSCOPE: Olympus CX 31	CAMERA: Nikon DS-F11
LIGHT SOURCE: Reflected Quartz Halogen	SOFTWARE: NIS Elements BR

LAYER	COLOR	DESCRIPTION
6	White (N 9.5N/)	Top layer, Latex paint
5	Off-white	Latex paint
4	Darkened Varnish / Tan (10YR 8/2)	Lead-based paint
3	Dirt layer / Off-white	Lead-based paint
2	Dark green (7.5GY 4/4)	Paint
1	White (N9.25/)	Lead-based preparatory paint
S	Plaster	Substrate

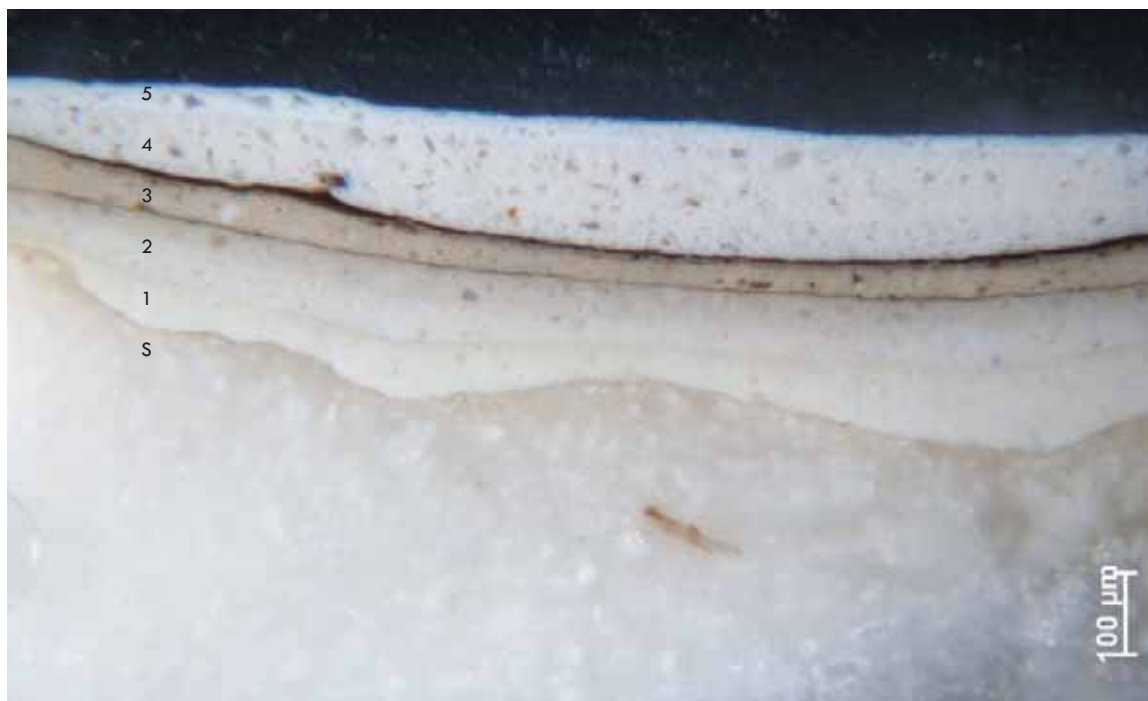
SAMPLE #: GWAS01.2010.22	DATE SAMPLED: November 16, 2009
ROOM: G.V. Whitney Studio	DATE ANALYZED: December, 2009
DESCRIPTION: Combed ridge, alligator	MAGNIFICATION: 100x
MICROSCOPE: Olympus CX 31	CAMERA: Nikon DS-F11
LIGHT SOURCE: Reflected Quartz Halogen	SOFTWARE: NIS Elements BR

LAYER	COLOR	DESCRIPTION
5	White	Top layer, Latex paint
4	Off-white	Latex paint
3	Darkened Varnish / Tan	Lead-based paint
2	Dirt layer / Off-white	Lead-based paint
1	White	Lead-based preparatory paint
S	Plaster	Substrate

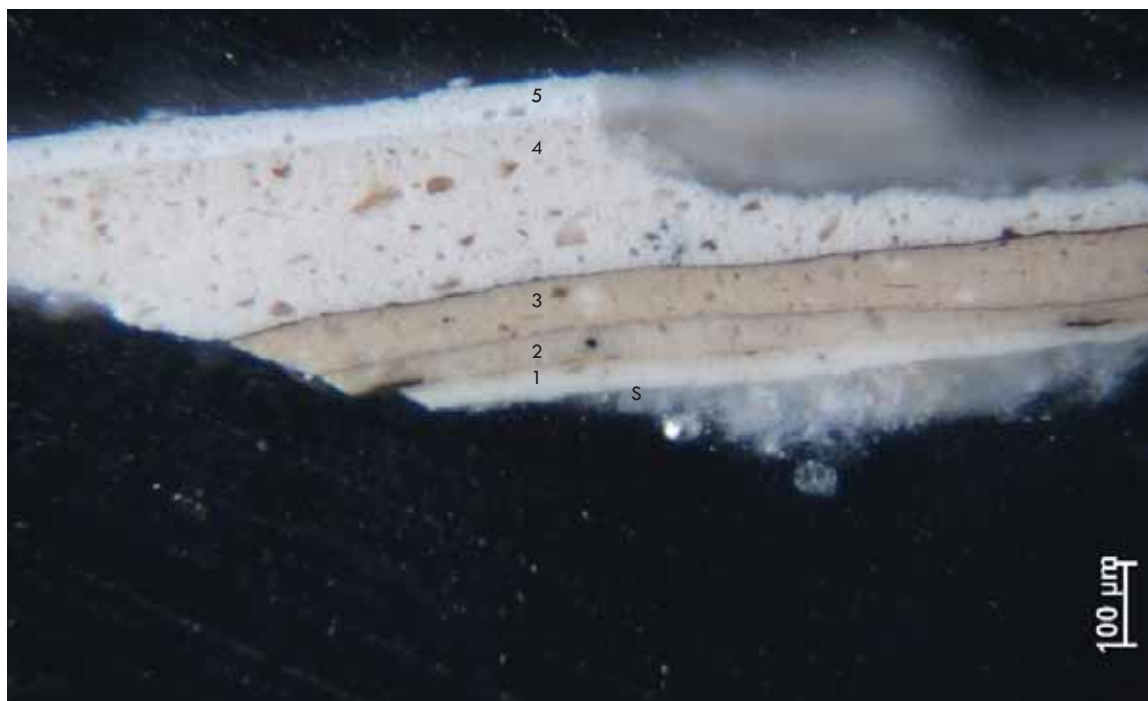
SAMPLE #: GWAS01.2010.23	DATE SAMPLED: November 16, 2009
ROOM: G.V. Whitney Studio	DATE ANALYZED: December, 2009
DESCRIPTION: Ray in front of alligator	MAGNIFICATION: 100x
MICROSCOPE: Olympus CX 31	CAMERA: Nikon DS-F11
LIGHT SOURCE: Reflected Quartz Halogen	SOFTWARE: NIS Elements BR

LAYER	COLOR	DESCRIPTION
5	White	Top layer, Latex paint
4	Off-white	Latex paint
3	Darkened Varnish / Tan	Lead-based paint
2	Dirt layer / Off-white	Lead-based paint
1	White	Lead-based preparatory paint
S	Plaster	Substrate

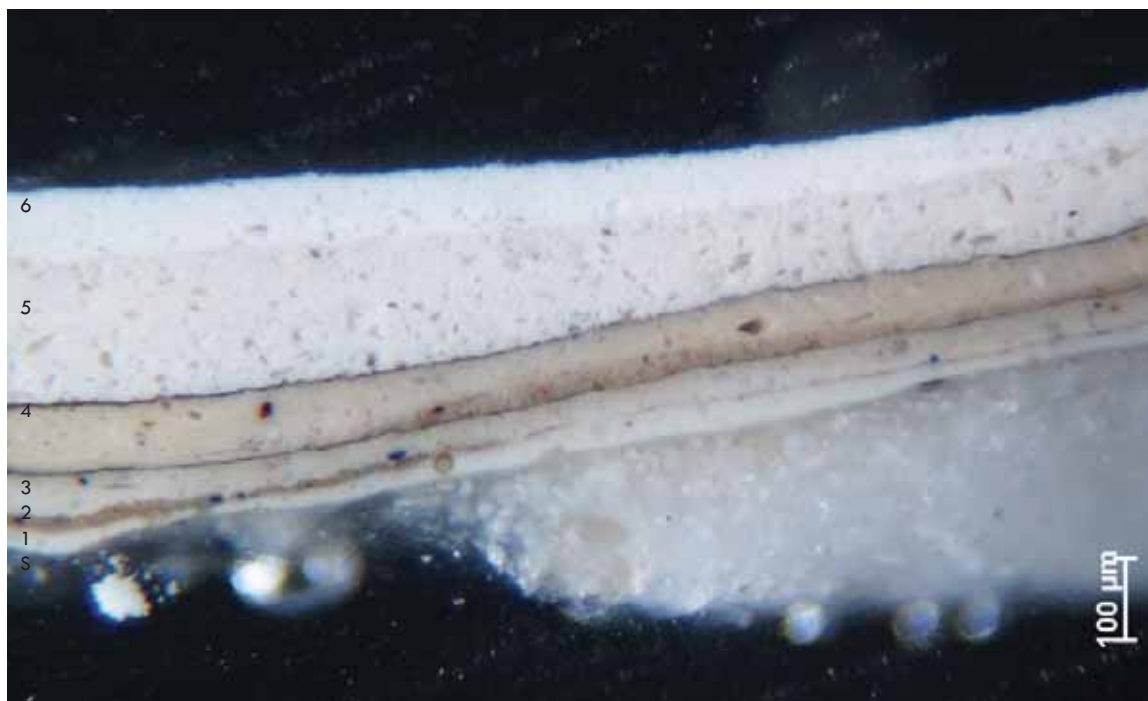
SAMPLE #: GWAS01.2010.024	DATE SAMPLED: November 16, 2009
ROOM: G.V. Whitney Studio	DATE ANALYZED: December, 2009
DESCRIPTION: Hair of head figure, cornice	MAGNIFICATION: 100x
MICROSCOPE: Olympus CX 31	CAMERA: Nikon DS-F11
LIGHT SOURCE: Reflected Quartz Halogen	SOFTWARE: NIS Elements BR

LAYER	COLOR	DESCRIPTION
6	White	Top layer, Latex paint
5	Off-white	Latex paint
4	Darkened Varnish / Tan	Lead-based paint
3	Dirt layer / Off-white	Lead-based paint
2	Tan	Glaze application
1	White	Lead-based preparatory paint
S	Plaster	Substrate

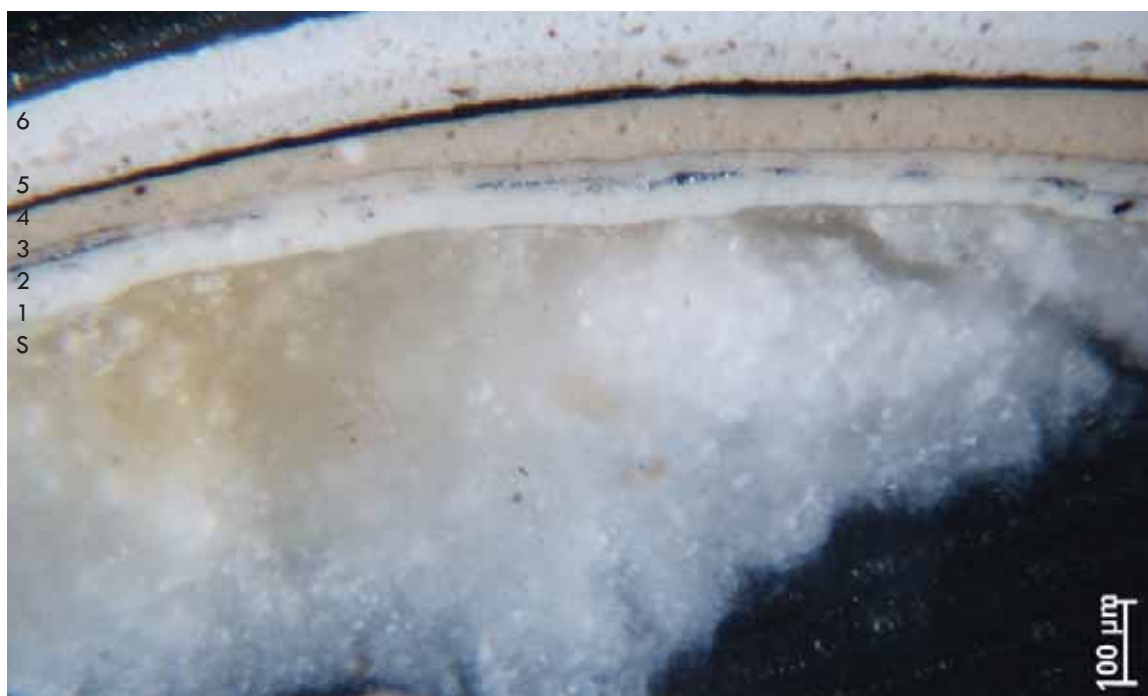
SAMPLE #: GWAS01.2010.25	DATE SAMPLED: November 16, 2009
ROOM: G.V. Whitney Studio	DATE ANALYZED: December, 2009
DESCRIPTION: Body of alligator	MAGNIFICATION: 100x
MICROSCOPE: Olympus CX 31	CAMERA: Nikon DS-F11
LIGHT SOURCE: Reflected Quartz Halogen	SOFTWARE: NIS Elements BR

LAYER	COLOR	DESCRIPTION
6	White	Top layer, Latex paint
5	Off-white	Latex paint
4	Darkened Varnish / Tan	Lead-based paint
3	Dirt layer / Off-white	Lead-based paint
2	Silver	Metal foil application
1	White	Lead-based preparatory paint
S	Plaster	Substrate

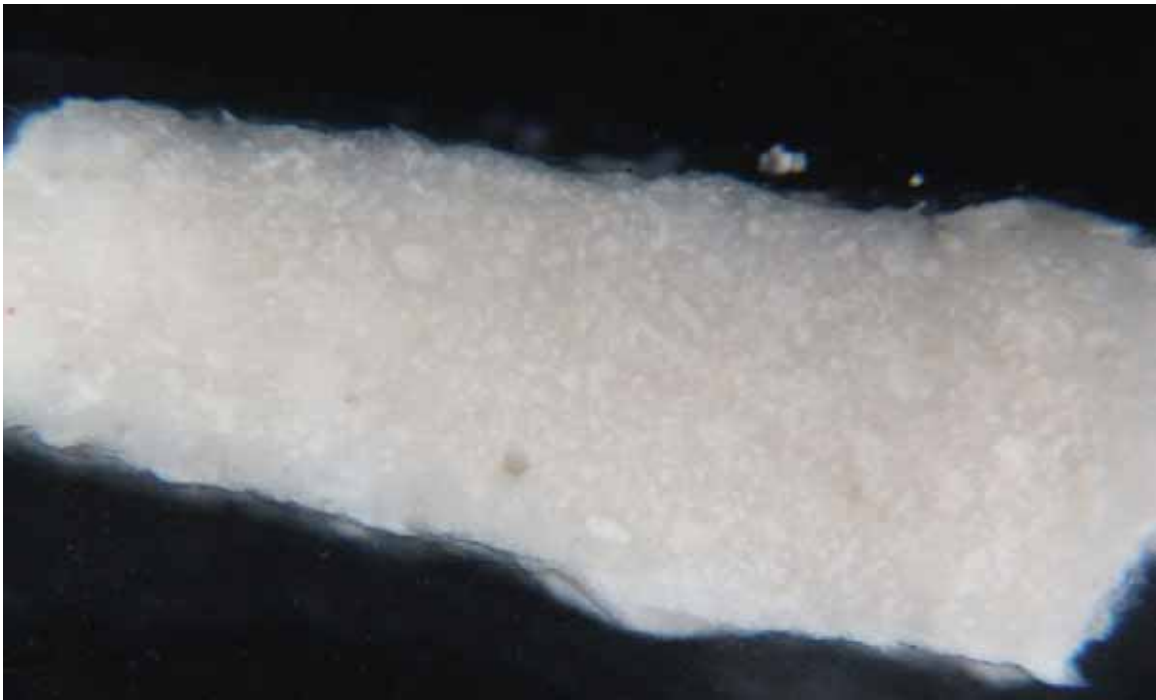
SAMPLE #: GWAS03.2010.26	DATE SAMPLED: November 16, 2009
ROOM: G.V. Whitney Studio	DATE ANALYZED: March, 2010
DESCRIPTION: Plaster from snake	MAGNIFICATION: 100x
MICROSCOPE: Olympus CX 31	CAMERA: Nikon DS-F11
LIGHT SOURCE: Reflected Quartz Halogen	SOFTWARE: NIS Elements BR

LAYER	COLOR	DESCRIPTION
S	Plaster	Substrate

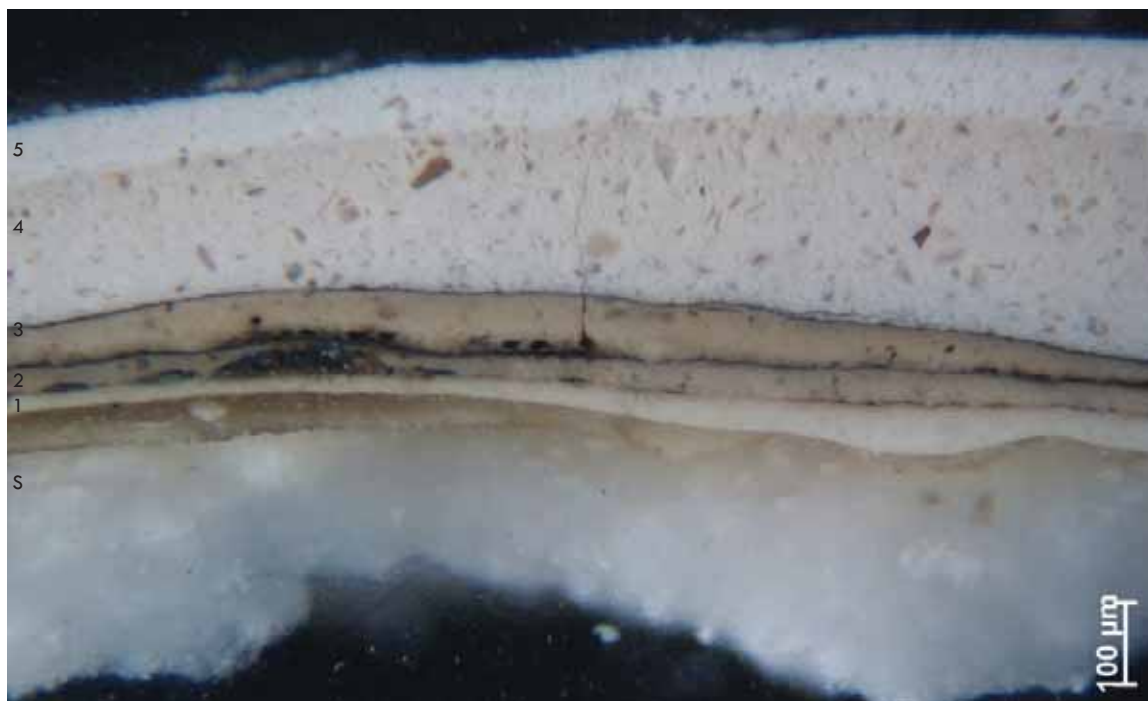
SAMPLE #: GWAS01.2010.27	DATE SAMPLED: November 16, 2009
ROOM: G.V. Whitney Studio	DATE ANALYZED: December, 2009
DESCRIPTION: Lip of head figure on cornice	MAGNIFICATION: 100x
MICROSCOPE: Olympus CX 31	CAMERA: Nikon DS-F11
LIGHT SOURCE: Reflected Quartz Halogen	SOFTWARE: NIS Elements BR

LAYER	COLOR	DESCRIPTION
5	White	Top layer, Latex paint
4	Off-white	Latex paint
3	Darkened Varnish / Tan	Lead-based paint
2	Dirt layer / Off-white	Lead-based paint
1	White	Lead-based preparatory paint
S	Plaster	Substrate

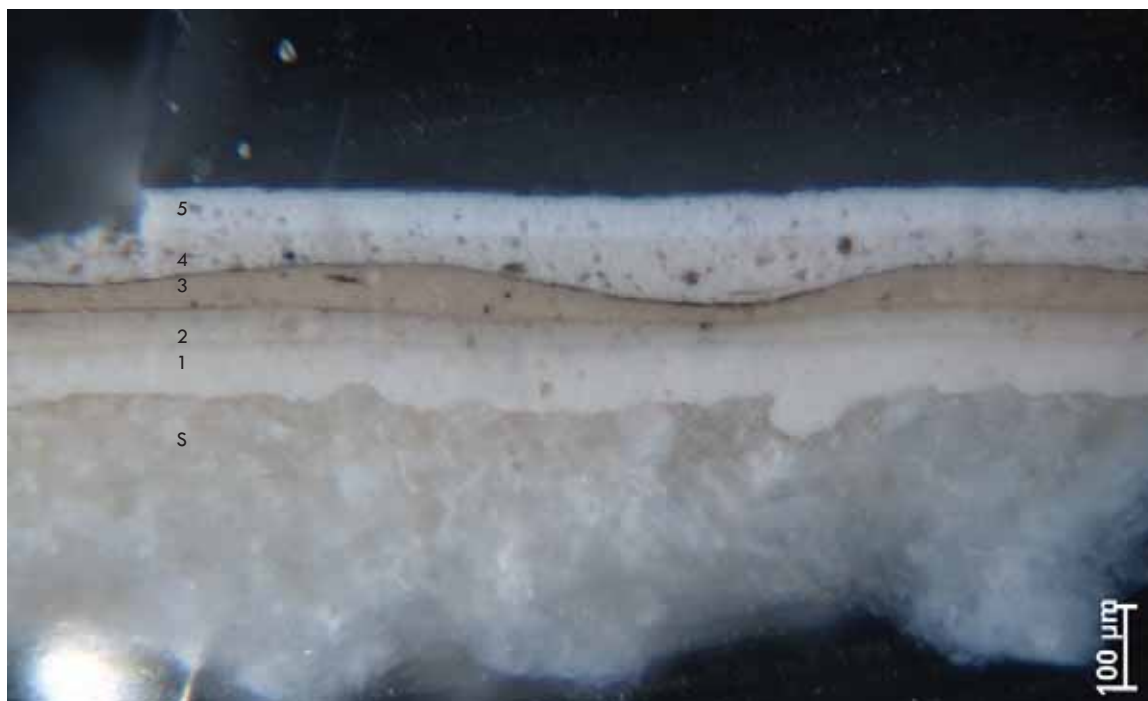
SAMPLE #: GWAS01.2010.29	DATE SAMPLED: November 16, 2009
ROOM: G.V. Whitney Studio	DATE ANALYZED: December, 2009
DESCRIPTION: Cloud behind alligator	MAGNIFICATION: 100x
MICROSCOPE: Olympus CX 31	CAMERA: Nikon DS-F11
LIGHT SOURCE: Reflected Quartz Halogen	SOFTWARE: NIS Elements BR

LAYER	COLOR	DESCRIPTION
5	White	Top layer, Latex paint
4	Off-white	Latex paint
3	Darkened Varnish / Tan	Lead-based paint
2	Dirt layer / Off-white	Lead-based paint
1	White	Lead-based preparatory paint
S	Plaster	Substrate

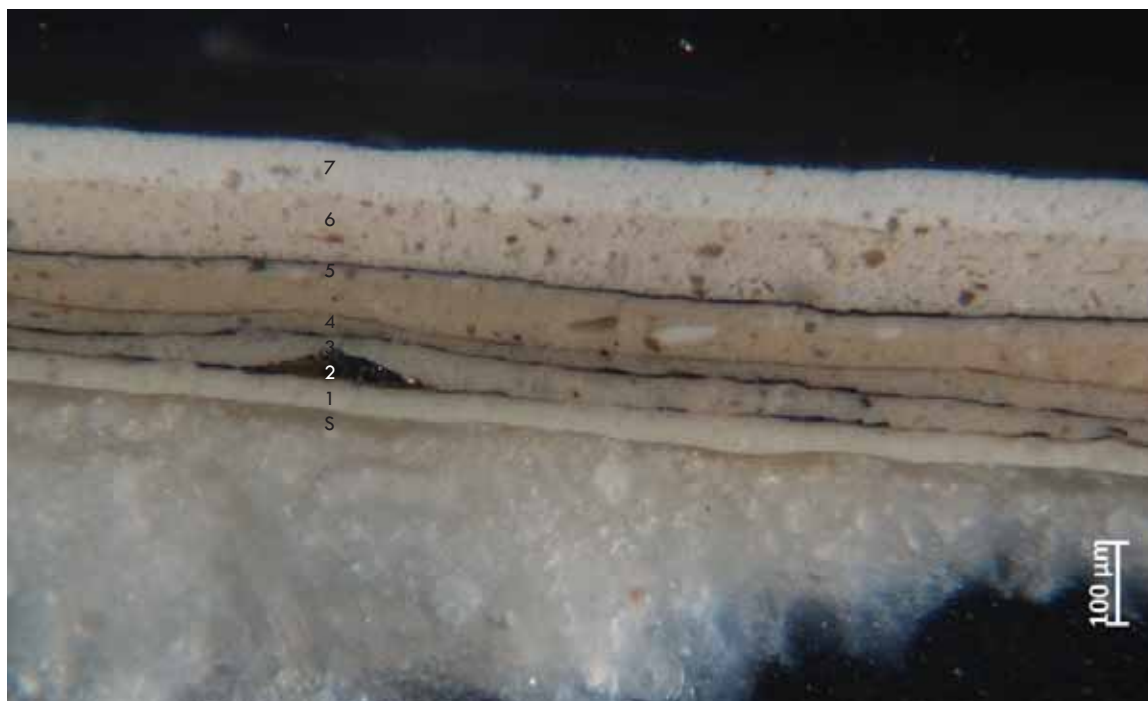
SAMPLE #: GWAS03.2010.30	DATE SAMPLED: November 16, 2009
ROOM: G.V. Whitney Studio	DATE ANALYZED: March, 2010
DESCRIPTION: Body of snake	MAGNIFICATION: 100x
MICROSCOPE: Olympus CX 31	CAMERA: Nikon DS-F11
LIGHT SOURCE: Reflected Quartz Halogen	SOFTWARE: NIS Elements BR

LAYER	COLOR	DESCRIPTION
7	White	Top layer, Latex paint
6	Off-white	Latex paint
5	Darkened Varnish / Tan	Lead-based paint
4	Dirt layer / Tan	Lead-based paint
3	Dirt layer / Off-white	Lead-based paint
2	Silver	Metal foil application
1	White	Lead-based preparatory paint
S	Plaster	Substrate

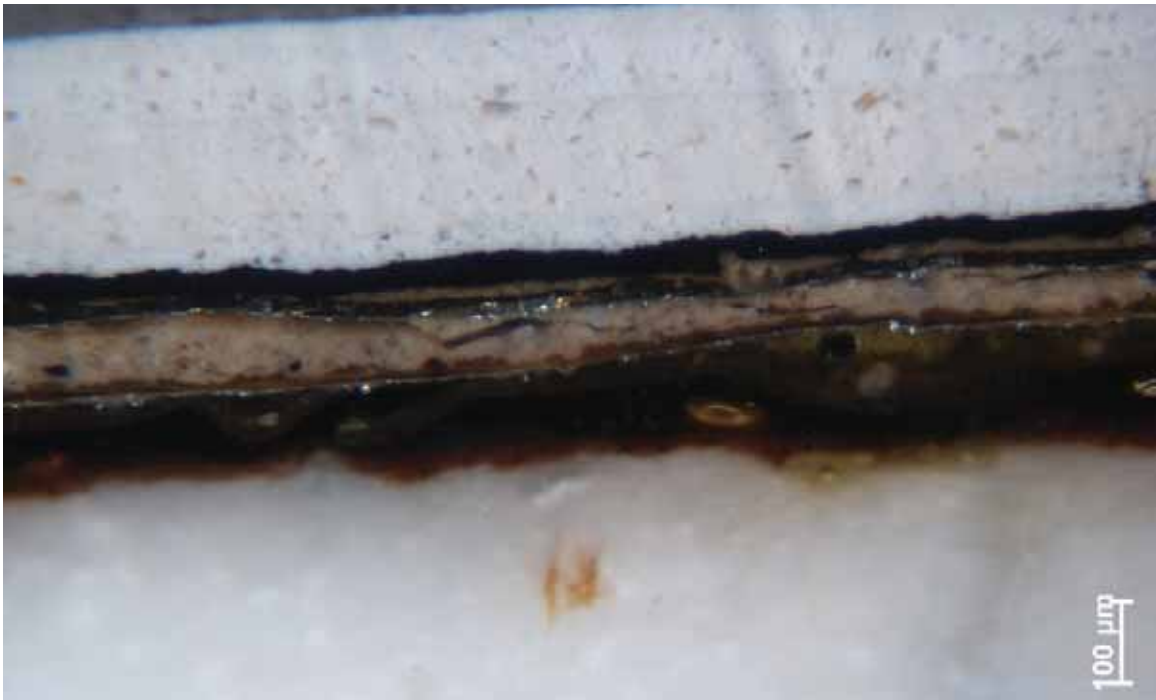
SAMPLE #: GWAS01.2010.32	DATE SAMPLED: November 16, 2009
ROOM: G.V. Whitney Studio	DATE ANALYZED: December, 2009
DESCRIPTION: Snake above fireplace	MAGNIFICATION: 100x
MICROSCOPE: Olympus CX 31	CAMERA: Nikon DS-F11
LIGHT SOURCE: Reflected Quartz Halogen	SOFTWARE: NIS Elements BR

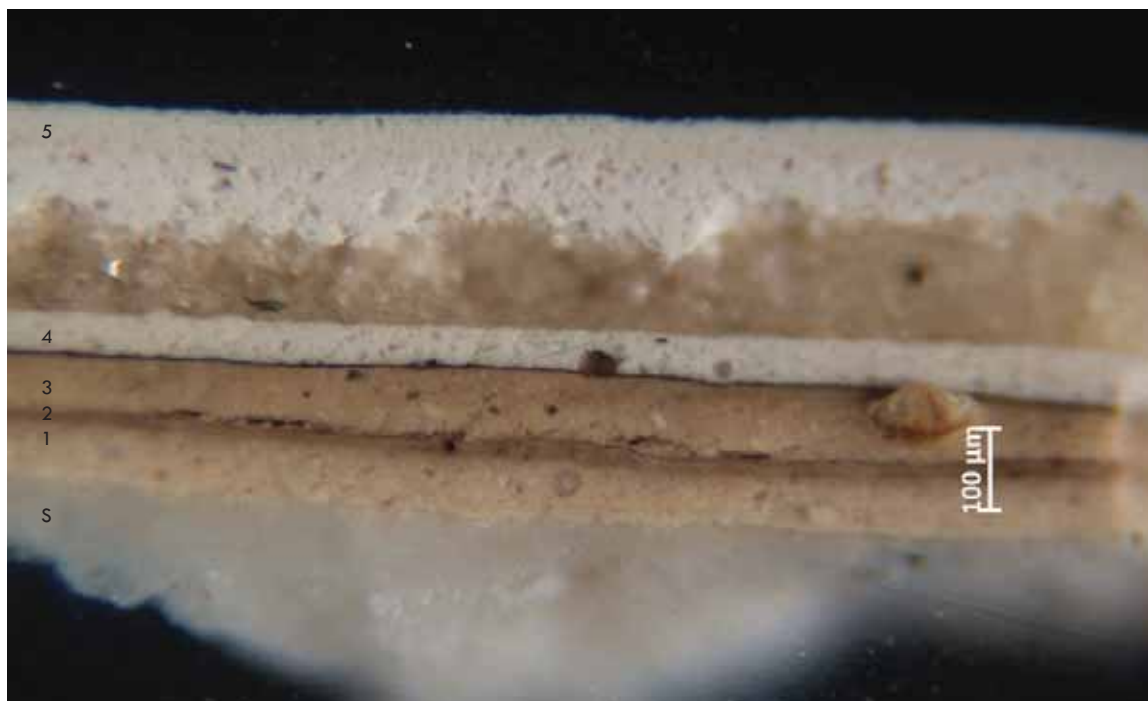
SAMPLE #: GWAS03.2010.34	DATE SAMPLED: November 16, 2009
ROOM: G.V. Whitney Studio	DATE ANALYZED: March, 2010
DESCRIPTION: Cornice Piece	MAGNIFICATION: 100x
MICROSCOPE: Olympus CX 31	CAMERA: Nikon DS-F11
LIGHT SOURCE: Reflected Quartz Halogen	SOFTWARE: NIS Elements BR

LAYER	COLOR	DESCRIPTION
5	White	Top layer, Latex paint
4	Off-white	Latex paint
3	Darkened Varnish / Tan	Lead-based paint
2	Brown	Thin glaze
1	Off-white	Lead-based preparatory paint
S	Plaster	Substrate

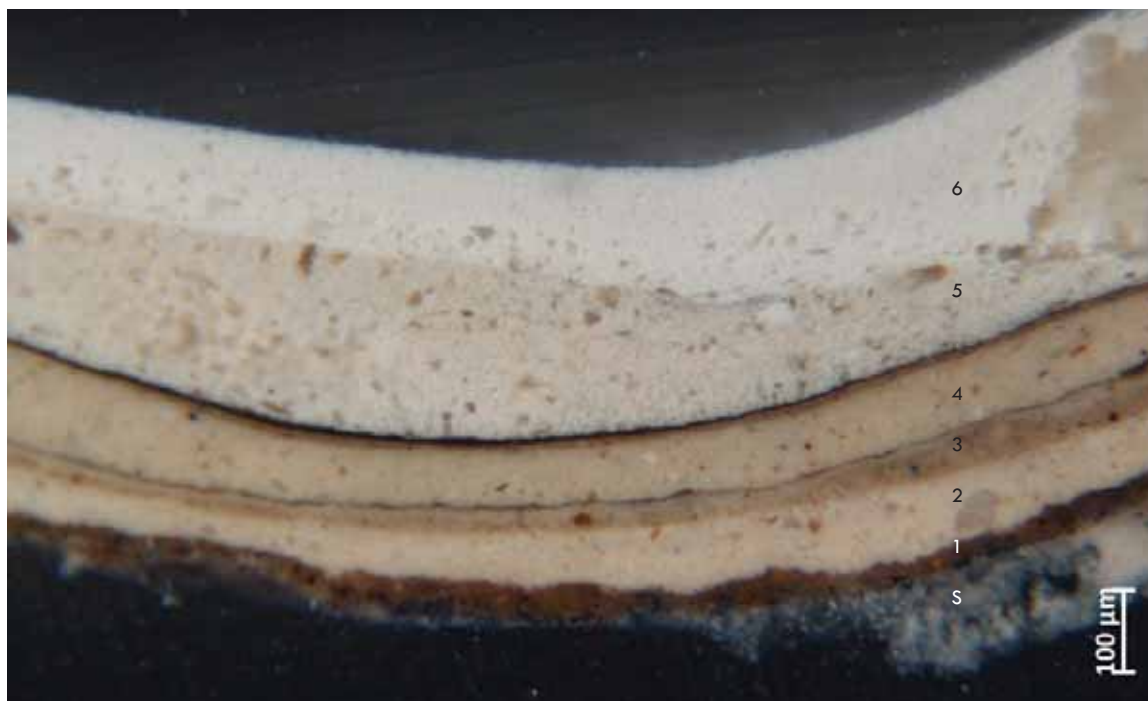
SAMPLE #: GWAS03.2010.36	DATE SAMPLED: November 16, 2009
ROOM: G.V. Whitney Studio	DATE ANALYZED: March, 2010
DESCRIPTION: Cornice Piece- Crease	MAGNIFICATION: 100x
MICROSCOPE: Olympus CX 31	CAMERA: Nikon DS-F11
LIGHT SOURCE: Reflected Quartz Halogen	SOFTWARE: NIS Elements BR

LAYER	COLOR	DESCRIPTION
5	White	Top layer, Latex paint
4	Off-white	Latex paint
3	Darkened Varnish / Tan	Lead-based paint
2	Brown	Thin glaze
1	Mauve (10RP 4/2)	Glaze
S	Plaster	Substrate
