# Corrosion Prevention in Historic Concrete – Monitoring the Richards Medical Laboratories

A THESIS  
In  
Historic Preservation

MASTER OF SCIENCE IN HISTORIC PRESERVATION  
2011

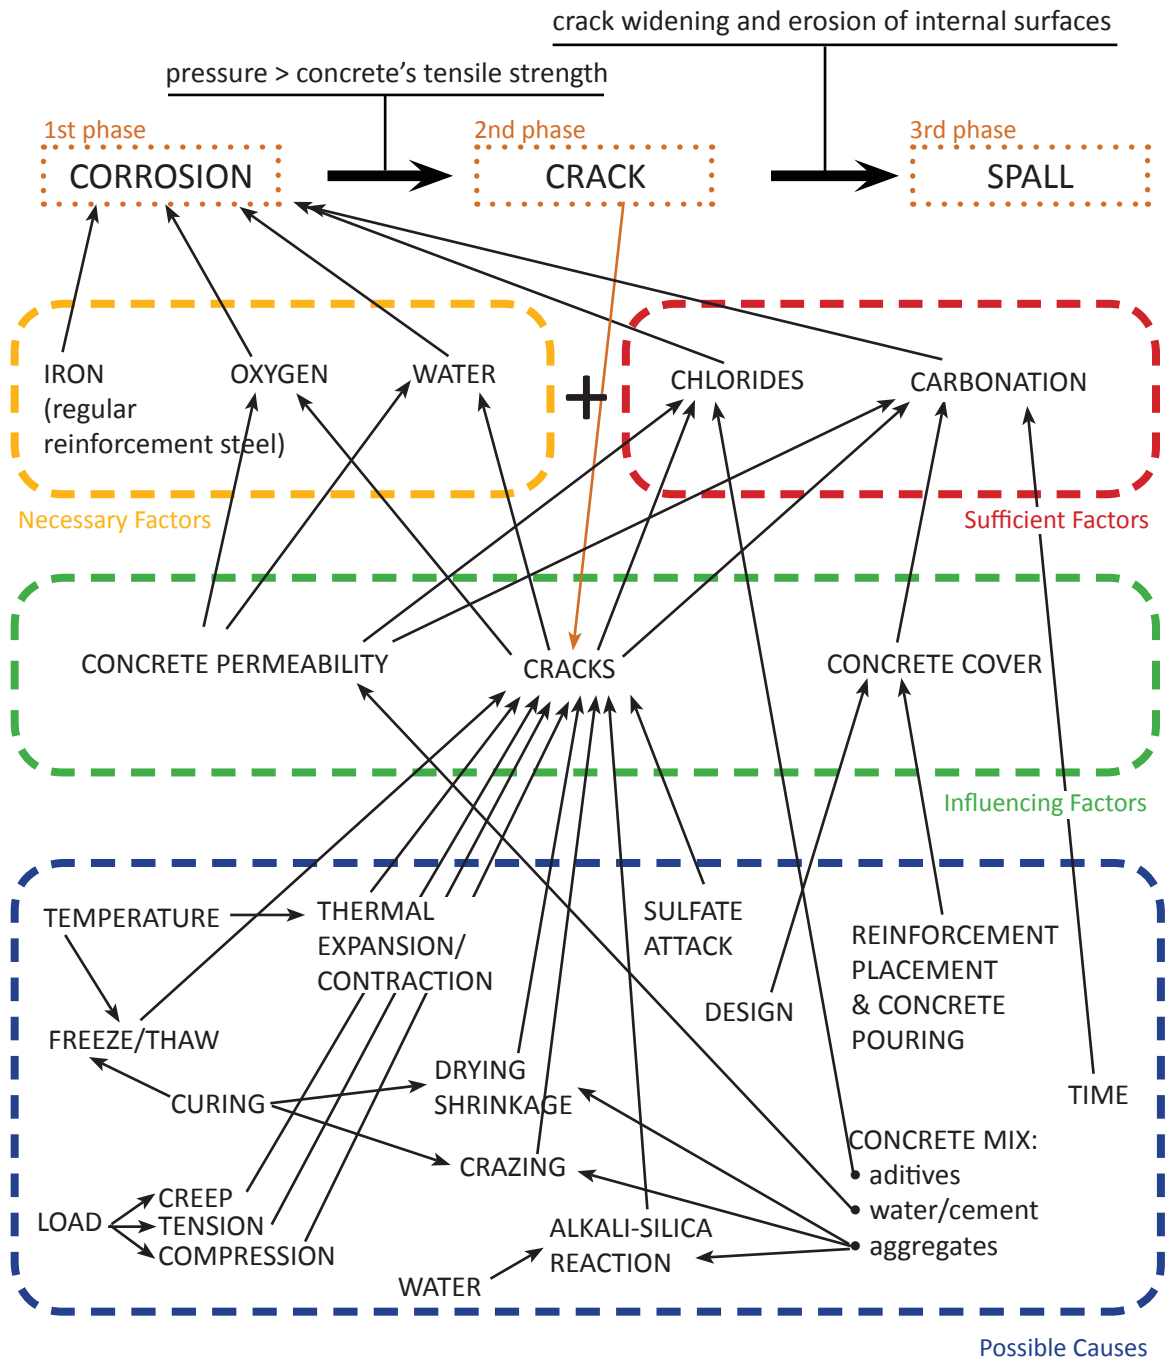
Illustration 3.1- Diagram of the three phases of the corrosion mechanism in reinforced concrete and a holistic view of factors that can affect corrosion.

In addition to understanding its initiation process, it is also important to understand how the corrosion process progresses. This process is marked by key thresholds that divide the process into distinct phases (ill. 3.1). When considering intervention, the chosen approach should be tailored to the specific corrosion phase, since each phase presents different types of damage. This will dictate the scale of the intervention as well as the extent to which an intervention would be invasive to the existing material, an important consideration with historic buildings. Based on this comprehensive understanding of the damage process, it is possible to

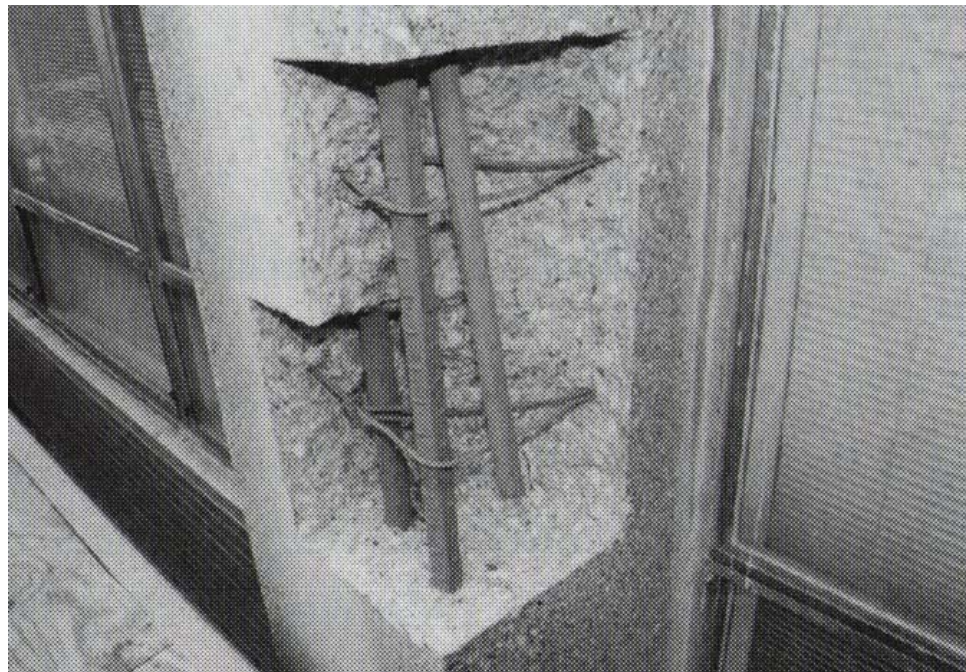
Figure 3.4- Preparation of damaged area to be repaired by patching. (Macdonald, 2003)

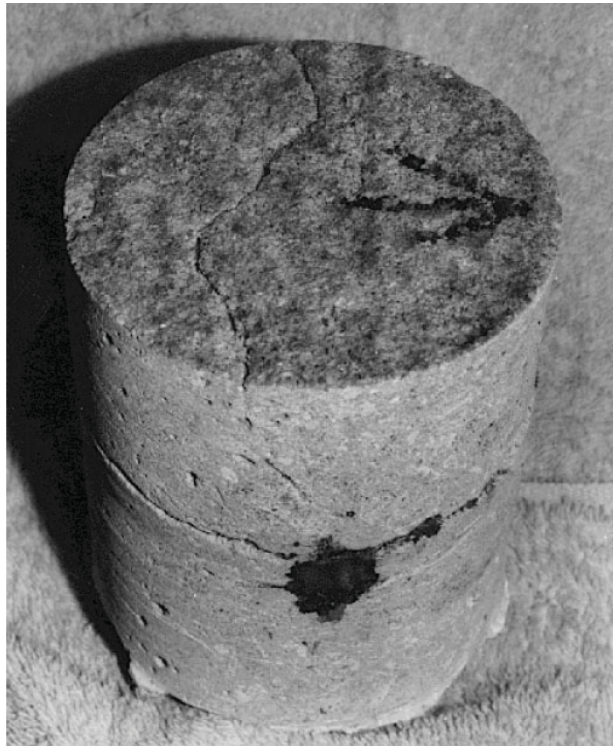
Figure 4.2- Example of a core sample showing corroded reinforcement and cracks. (Walker, Lane and Stutzman, 2006)

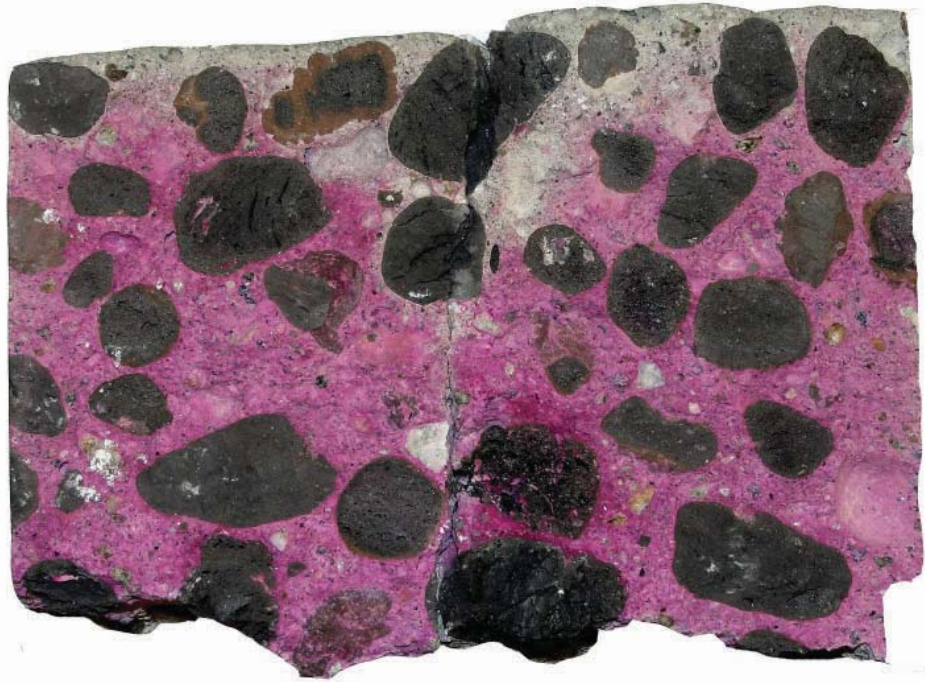
Figure 4.9- Phenolphthalein tints areas with  $\text{pH} > 9$ .

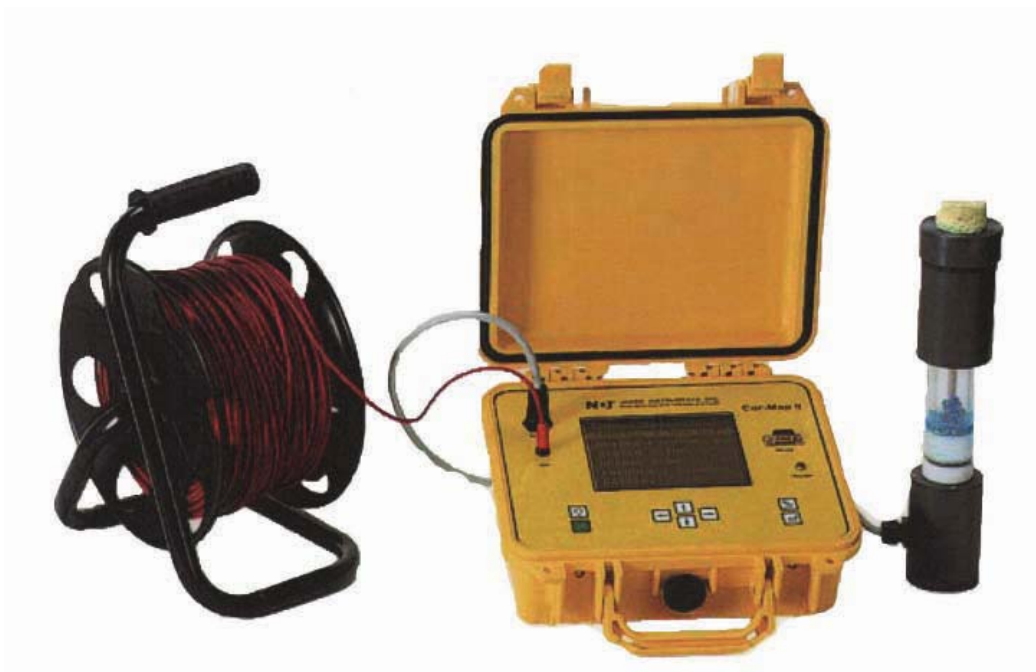
Figure 4.13- Example of equipment that uses a half-cell to measure corrosion potential. (<http://www.ndtjames.com/Cormap-II-8482-s/100.htm>)

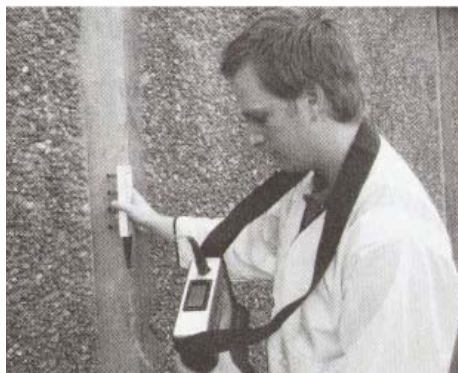
Figure 4.14- Equipment and procedure used to measure concrete resistivity. (Broomfield, 2007)

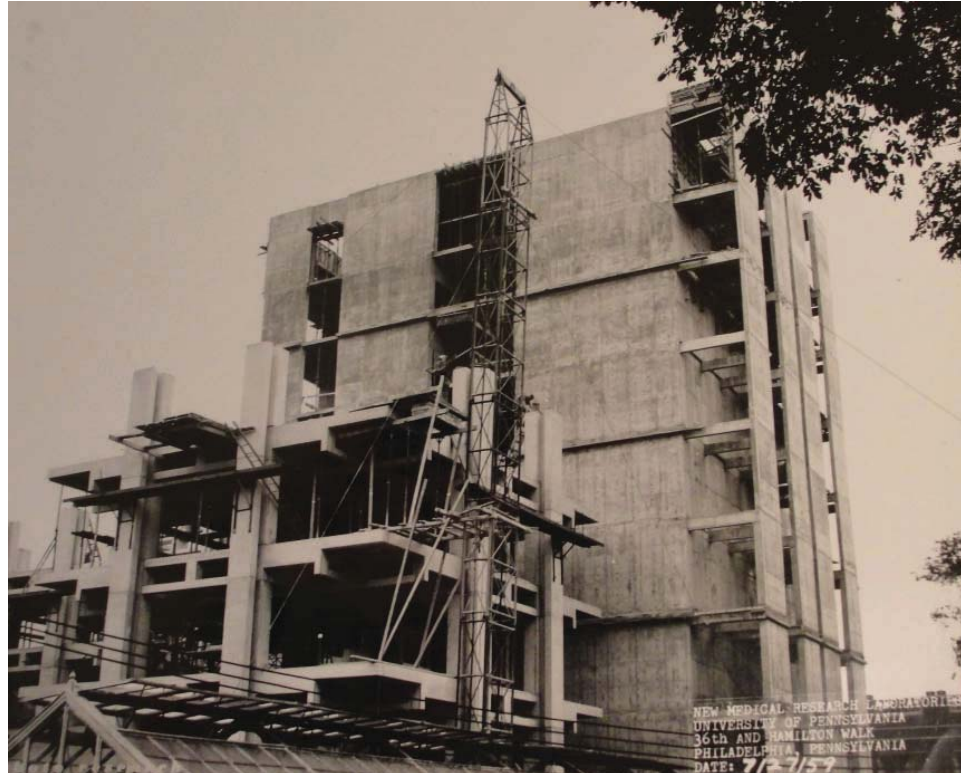
Figure 5.11- Construction photograph showing tower X's cast-in-place structure. (The Architectural Archive, University of Pennsylvania, 030.IV.A.490.12.42)

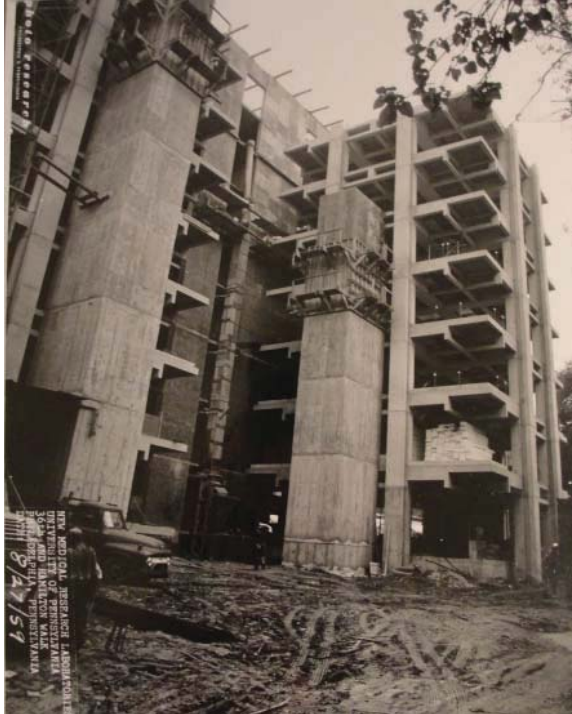
Figure 5.13- Construction photograph showing the cast-in-place structure of a subsidiary tower and the precast structure of a laboratory tower. (The Architectural Archive, University of Pennsylvania, 030.IV.A.490.12.45)

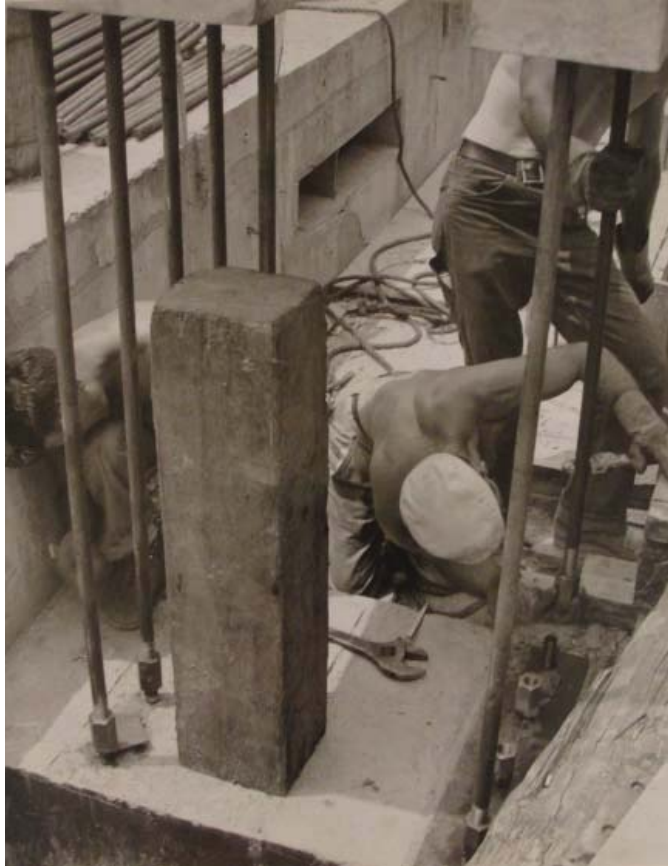
Figure 5.15- Column tendons being connected during erection of the pre-cast structure. (The Architectural Archive, University of Pennsylvania, 030. IV.A.490.11.1)

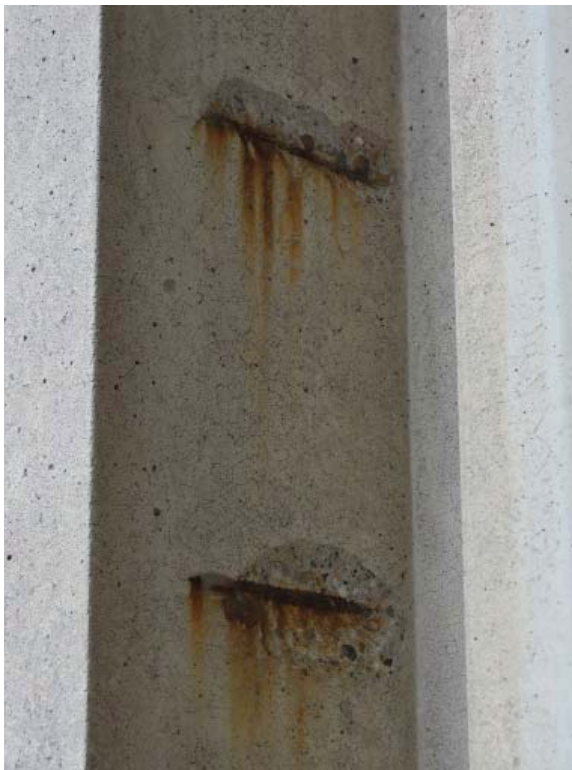
Figure 5.23- Corrosion stain associated with spall.

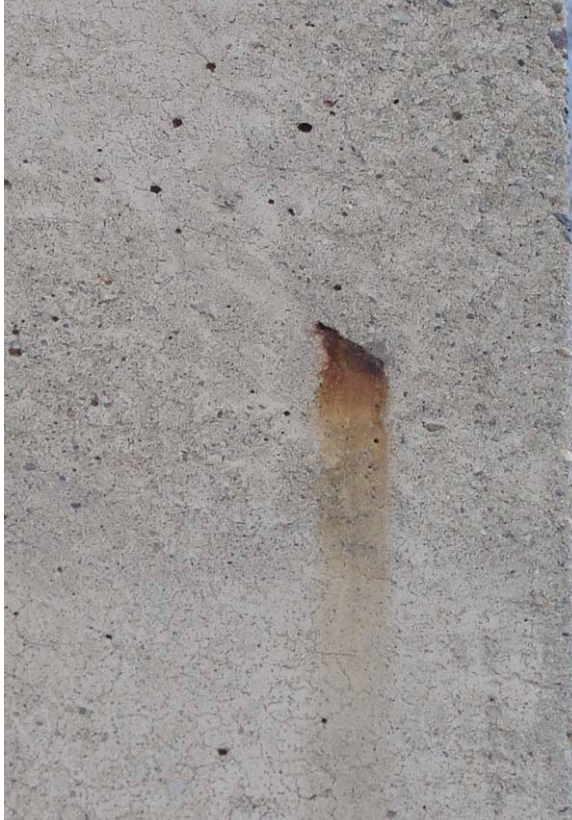
Figure 5.24- Corrosion stain associated with exposed reinforcement.

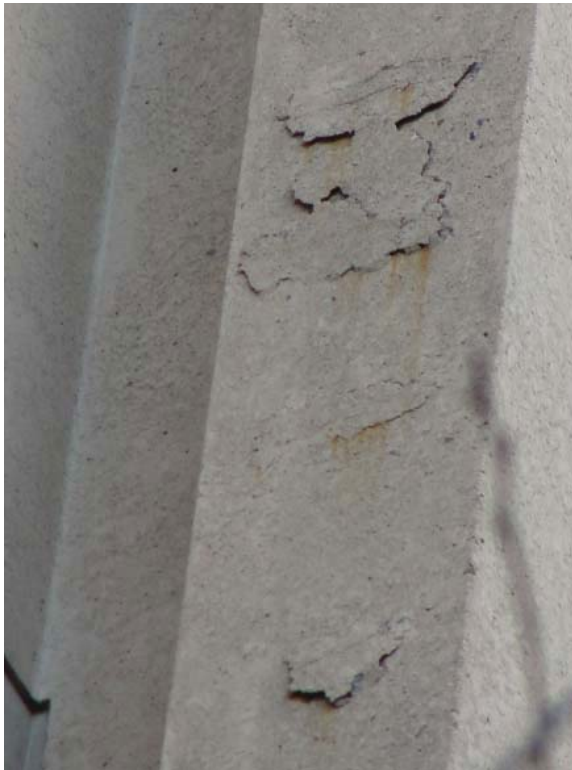
Figure 5.25- Cracks that can develop into spalls.

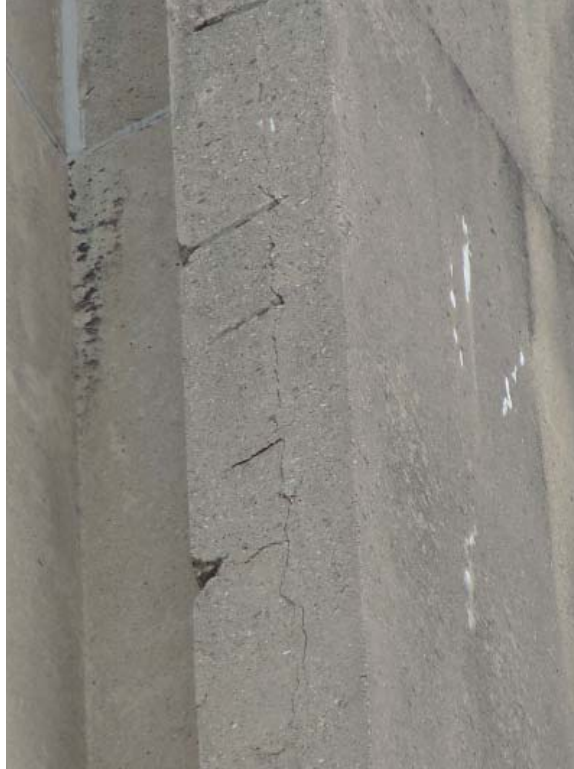
Figure 5.26- Longitudinal crack.

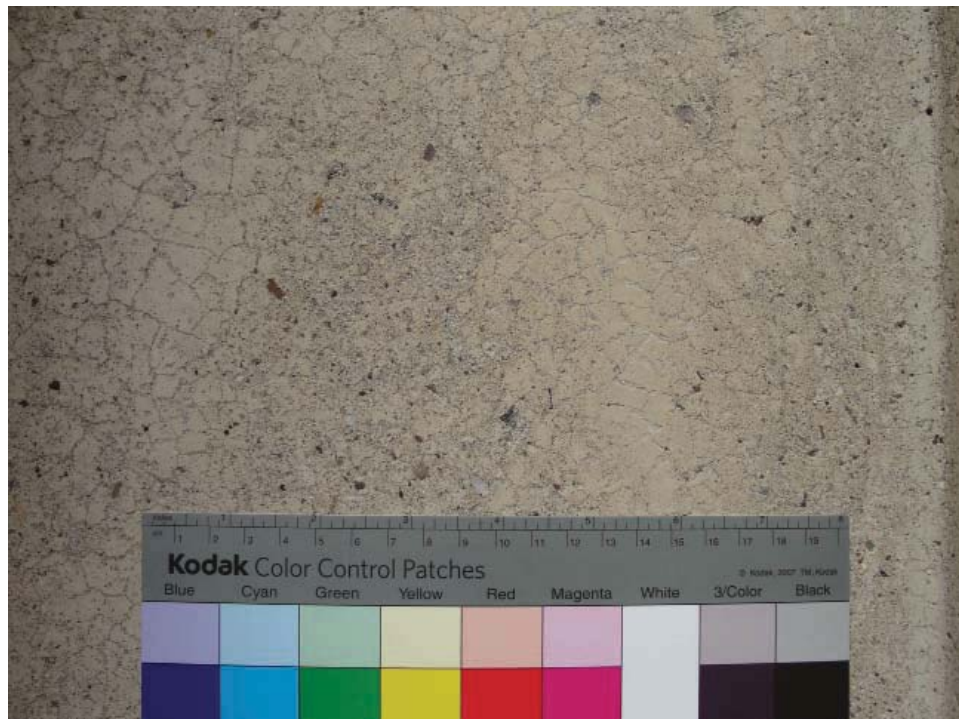
Figure 5.27- Crazing.

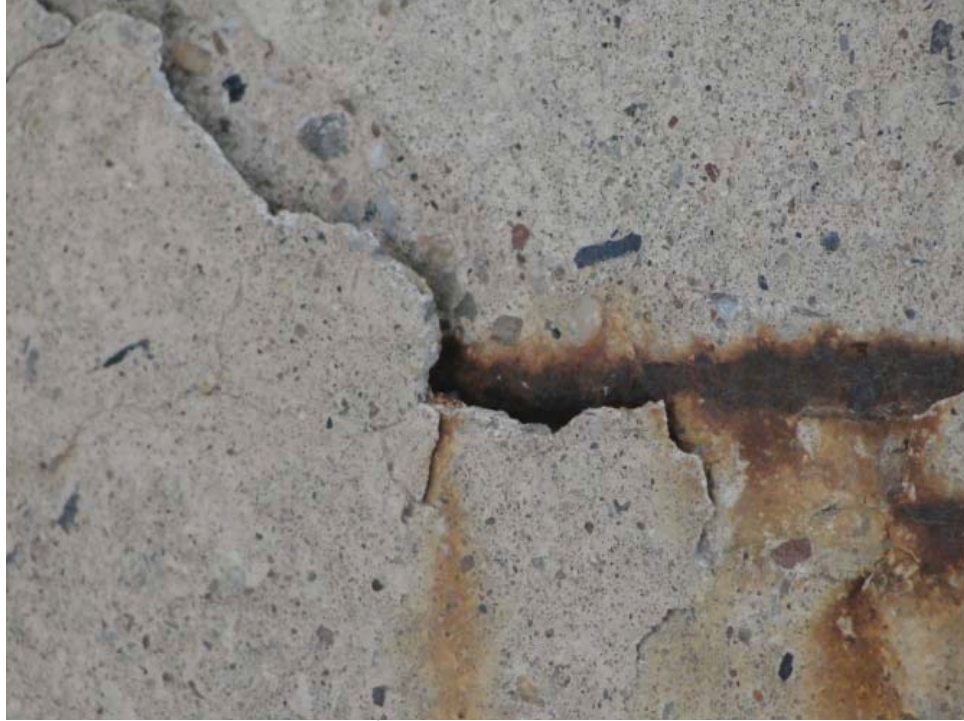
Figure 5.28- Spall on a column flange.

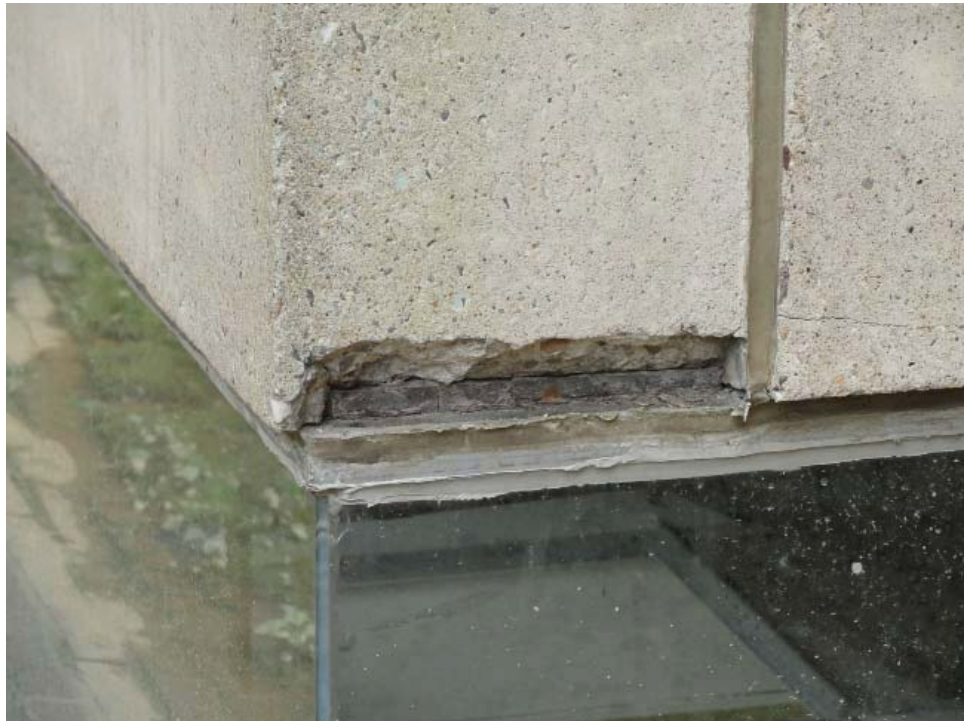
Figure 5.29- Spall on a window corner.

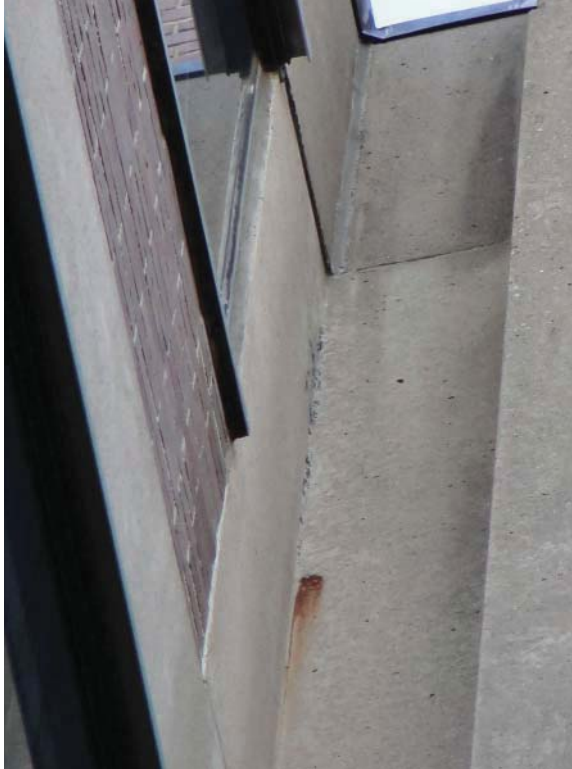
Figure 5.30- Exposed reinforcement, originally lacking concrete cover.

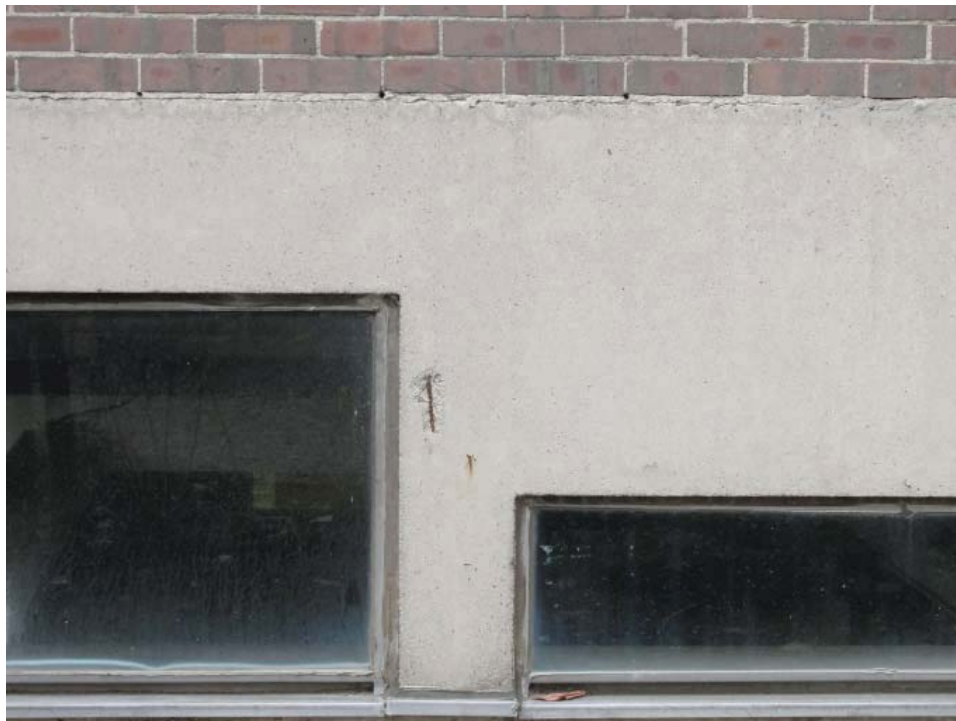
Figure 5.31- Exposed reinforcement on edge beam.

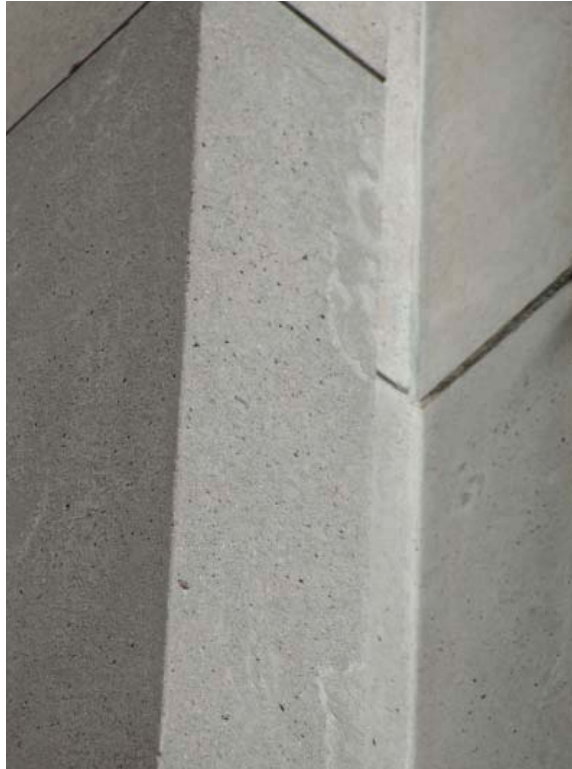
Figure 5.32- Repair on the edge of column flange.

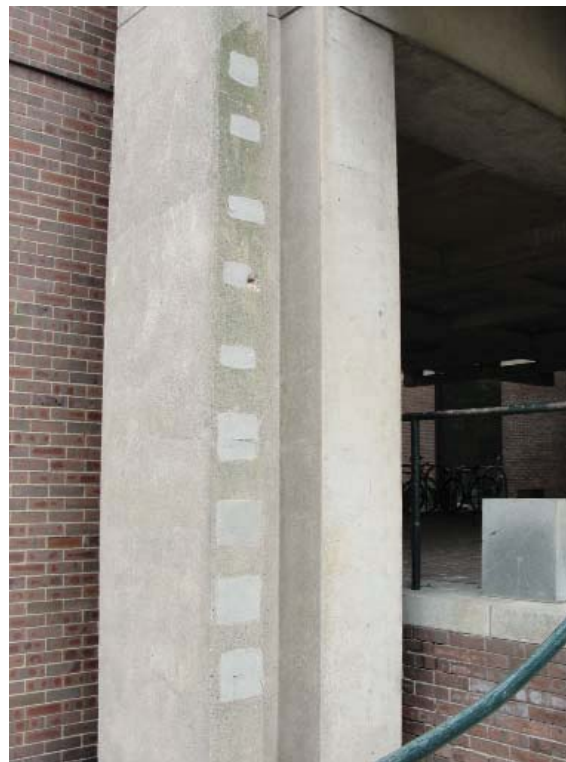
Figure 5.33- Patches on the ground floor level section of the northwest column on the north façade of tower.
