CLEANING METHODS FOR THE REMOVAL  
OF LIMEWASH FROM PAINTED PLASTER  
SURFACES: UTILIZING ION EXCHANGE  
RESINS ON THE INTERIOR  
ARCHITECTURAL FINISHES OF THE  
CAPILLA DE NUESTRA SEÑORA DEL  
ROSARIO IN IGLESIA SAN JOSÉ, IN SAN  
JUAN, PUERTO RICO

A THESIS In Historic Preservation Presented to the Faculties of the University of Pennsylvania in Partial Fulfillment of the Requirements of the Degree of MASTER OF SCIENCE IN HISTORIC PRESERVATION 2009

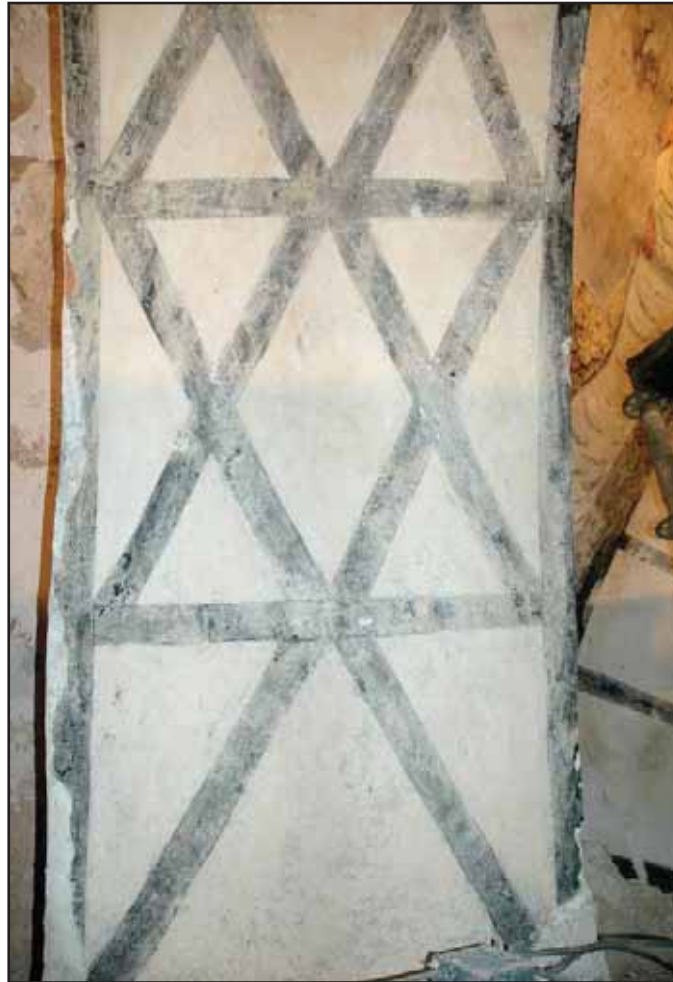
**Figure 2.5: Black banding and intersecting cross pattern on intrados of arch (Source: Johnston and Silva, 14).**

The black banding, ranging between 2-3 inches, adorns the upper portions of the chapel. It either articulates the junctions of the architectural elements, or creates ashlar block and crossing X designs (see fig. 2.5). The painters incised lines in the wet enlucido to

mark the placement and width of the black bands, before infilling these lines with carbon black paint.<sup>16</sup>

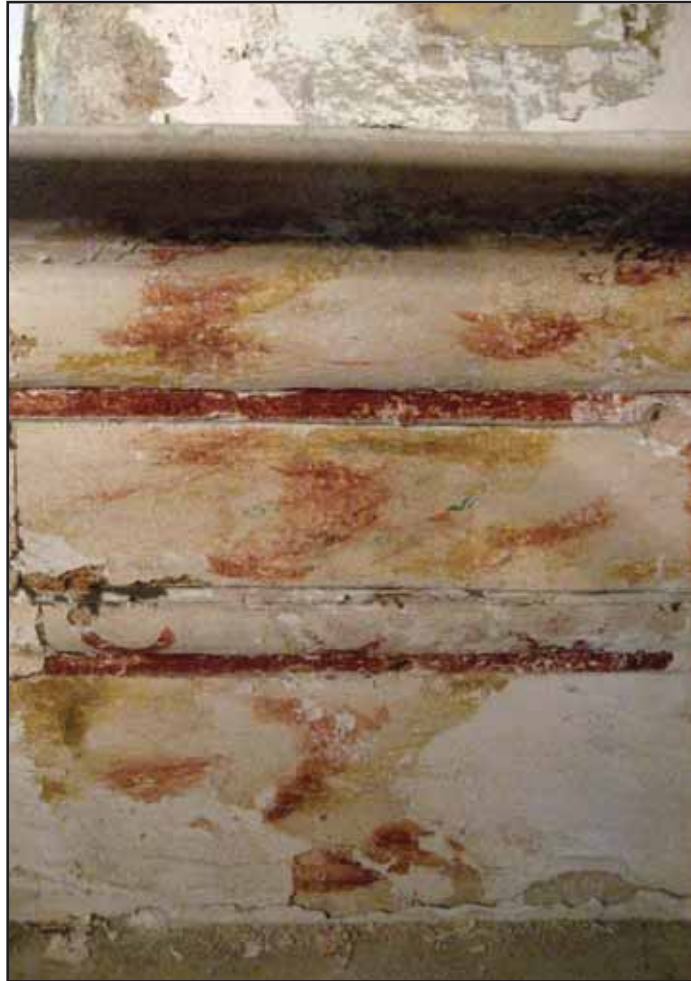
**Figure 2.6: Faux marbling on sanctuary cornice  
(Source: Johnston and Silva, 17).**

The faux marbling scheme appears on the original chapel cornice (see fig. 2.6). The painters used red ochre, yellow ochre, and green pigments in a freehand technique. Two fillets were painted in solid dark red and the cyma reversa received the same pigment in a pattern of semicircles.<sup>17</sup>

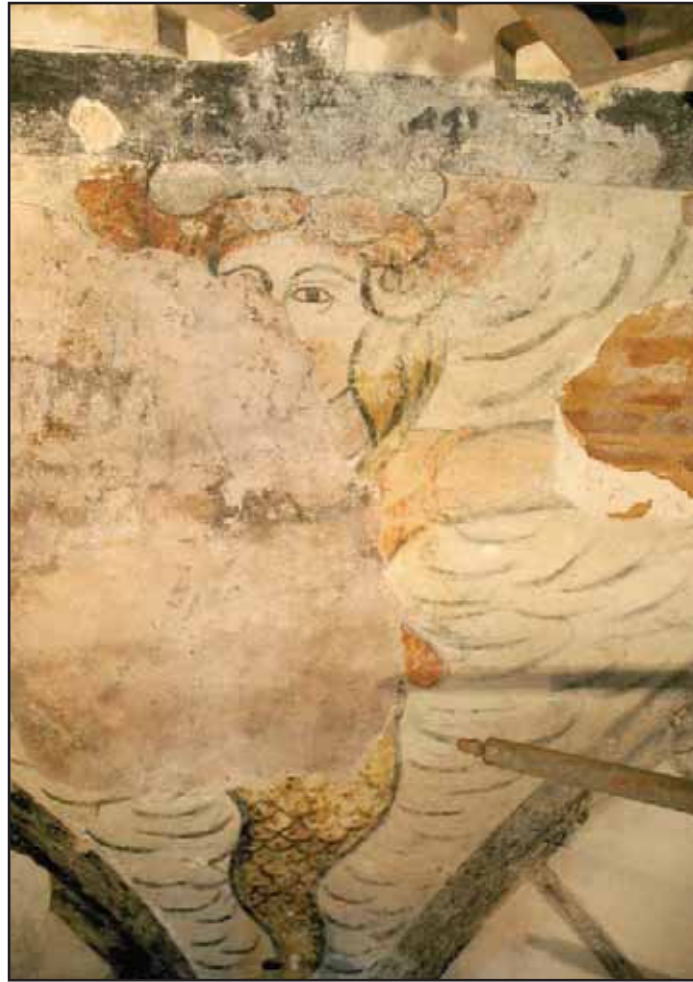
**Figure 2.7: Southwest pendentive, one of *las sirenas***  
(Source: Johnston and Silva, 20).

gle figure of a mer-creature, or *la sirena* (see fig. 2.7). These figures consist of carbon black, red ochre, yellow ochre, and green pigments. Carbon black banding outlines the pendentives, while wave-like black marks and greenish-blue wash surround the figures like water.<sup>18</sup>

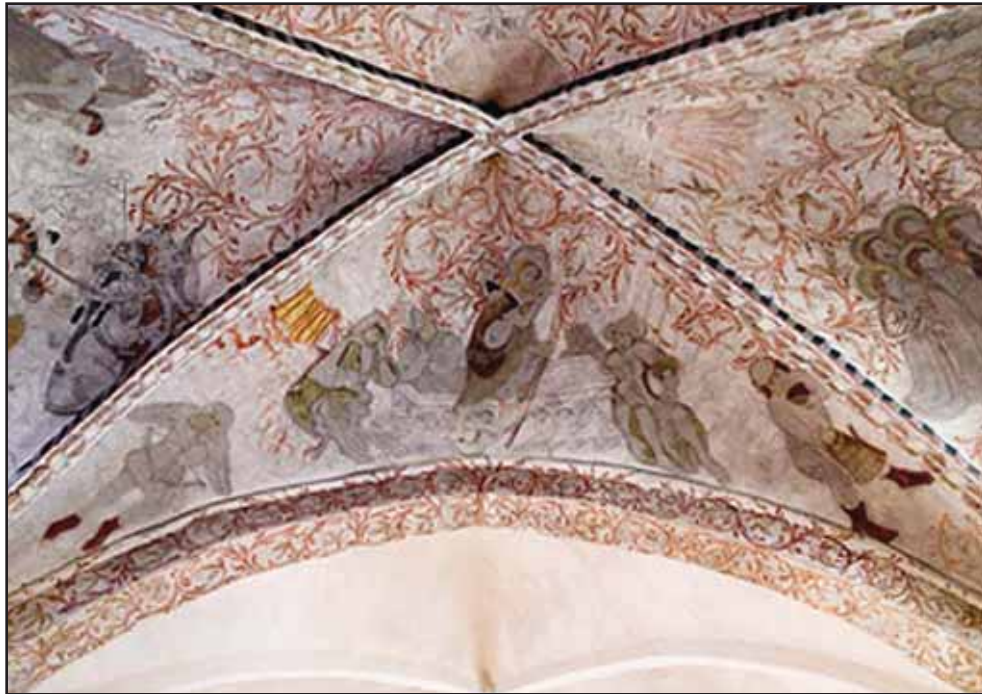
**Figure 3.1: Figures on the wall paintings in Undløse Church (ca. 1425) treated with the Carlsberg Preparation in 1920 (Source: Brajer).**

Rothe's work represents an early foray into preventative conservation treatment. However, the treatment does have its drawbacks. It is not easily reversible and dust attracts to treated areas (see fig. 3.1).<sup>11</sup> Furthermore, when conservators selectively treated moisture and salt-damaged areas years later, they discovered that untreated portions of the paintings experienced ruptures and flaking. This resulted from migration of moisture and salt solutions from the treated areas, where they could not penetrate the "Preparation" barrier, to the comparatively porous untreated areas, where they crystallized.<sup>12</sup>

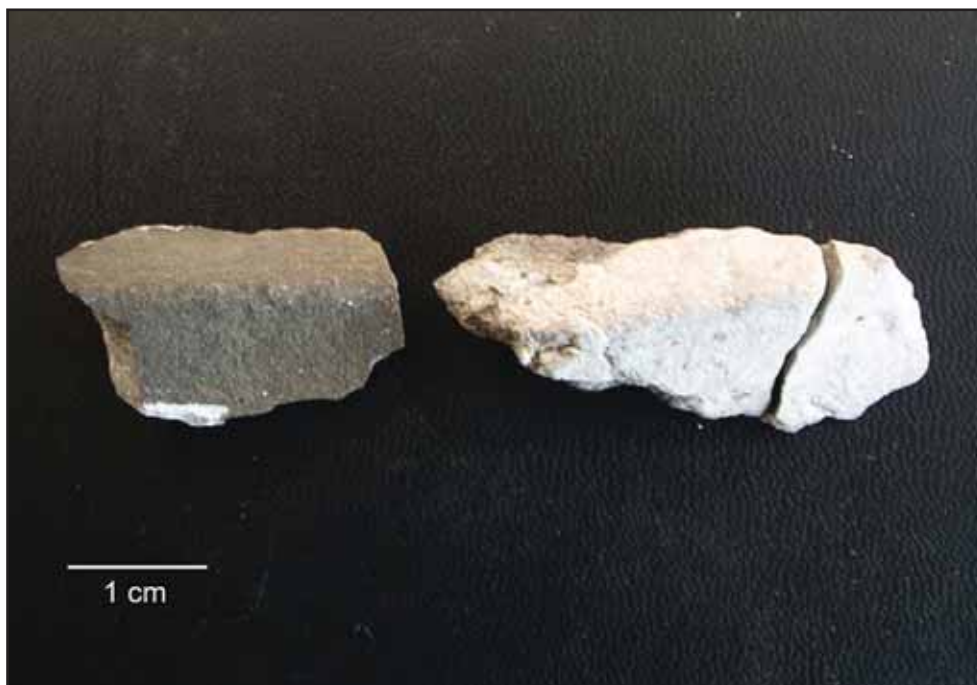
**Figure 4.3: Limestone sample with black encrustation compared to sample cleaned with ion exchange resin (Source: Martínez-Arkarazo, 515).**

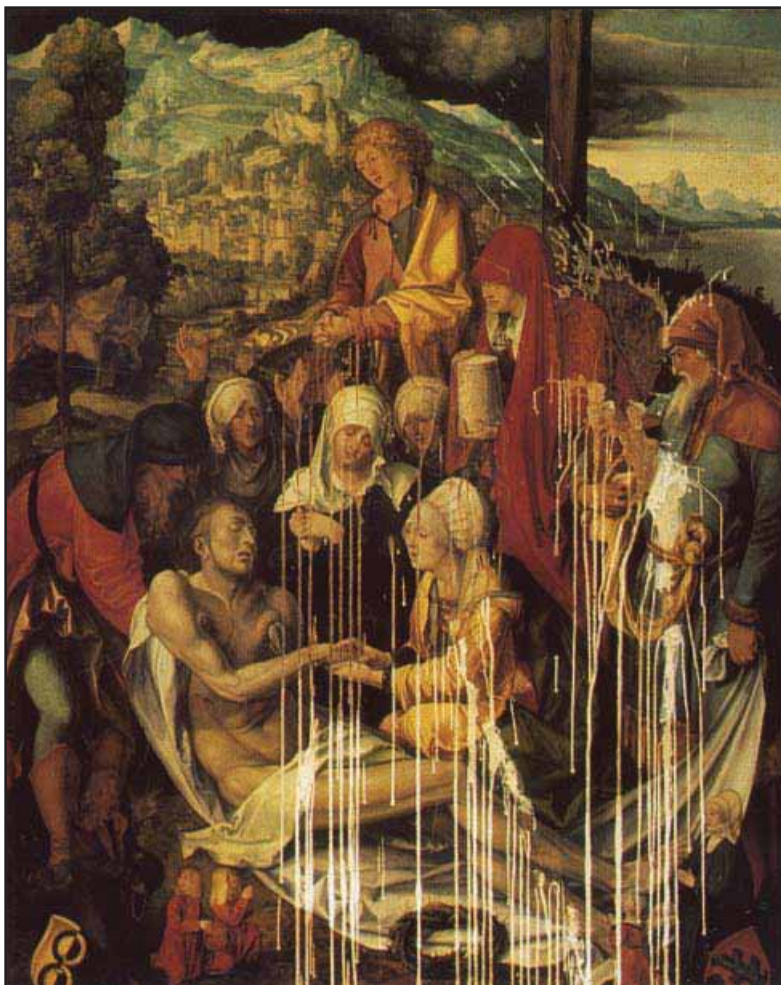
**Figure 4.4: 'Lamentation of Christ' after attack and during treatment with ion exchange resin (Source: Heimberg, color plate).**

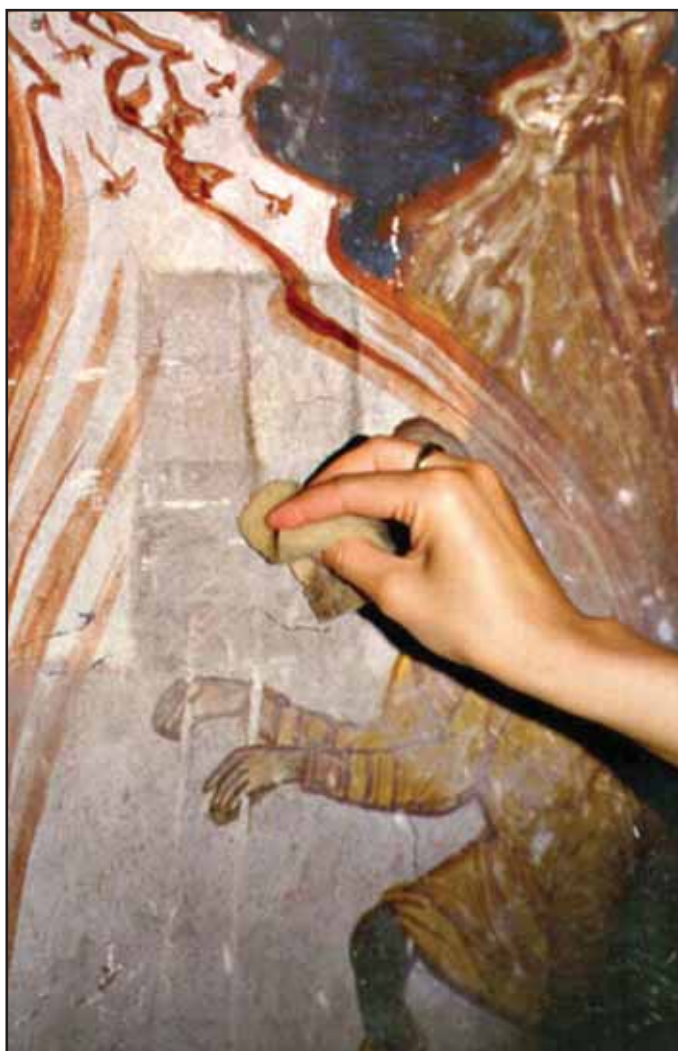
**Figure 4.6: Cleaning mural with ion exchange resin through Japanese paper (Source: Metaneira).**

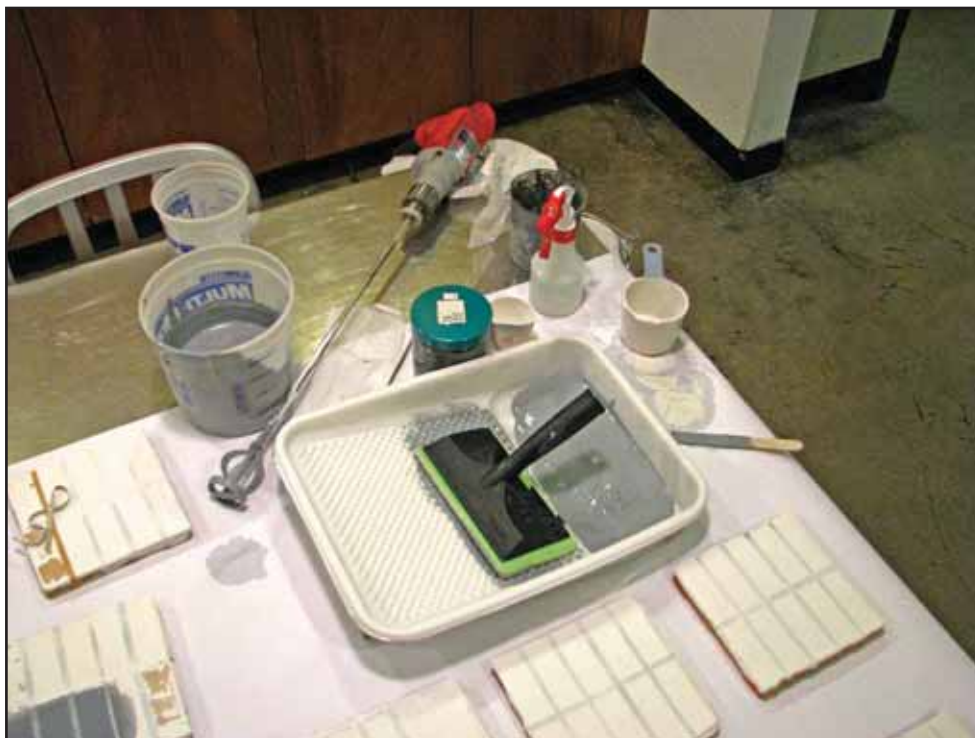
**Figure 5.5: Materials used in sample preparation, including Polyken tape, terracotta tiles, limewash, drill, lamp black, and pad painter (Source: C. Smith, 2009).**

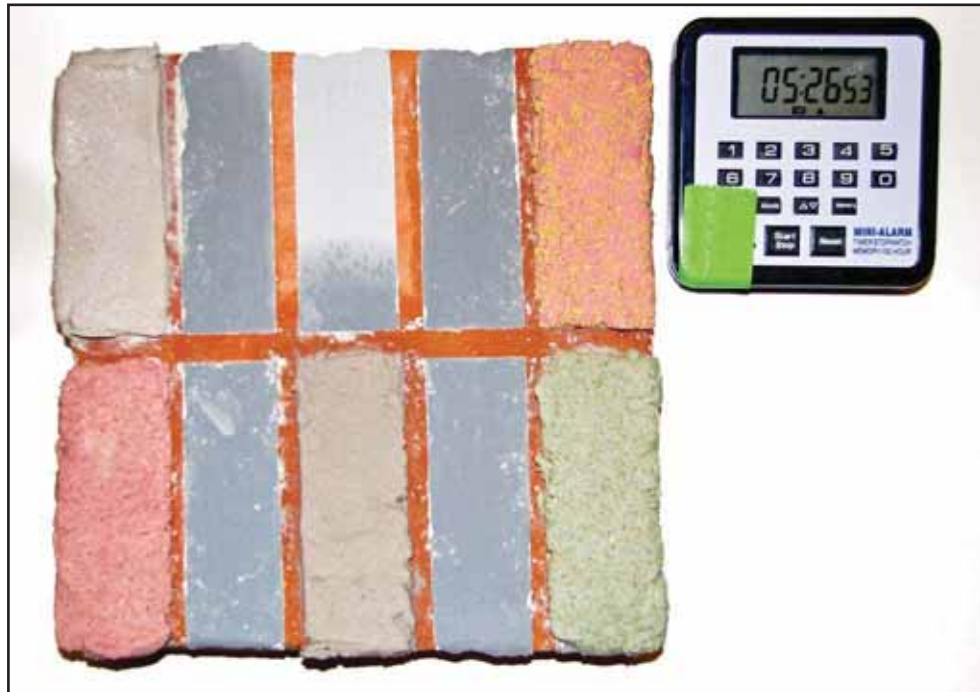
Figure 5.7: Tile covered with fresh resin formulations. Counterclockwise from bottom: C-211 H, control, C-211 Na, CNP 80, TP 207 (Source: C. Smith, 2009).

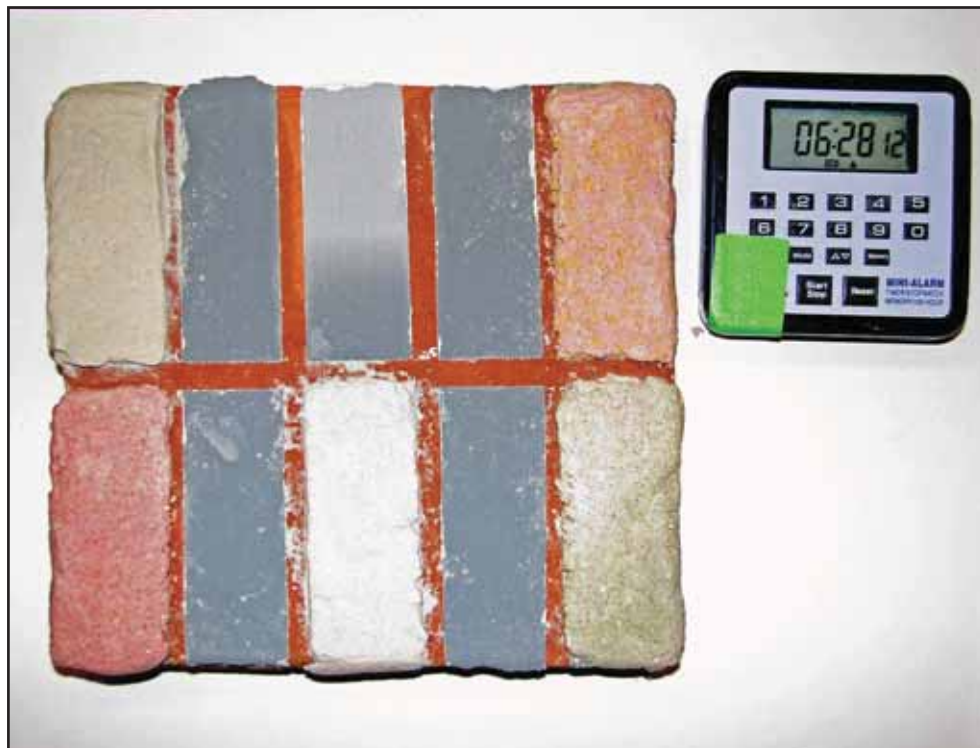
Figure 5.8: Used resins exposed after one hour (Source: C. Smith, 2009).
