A Technical Study of the Mural Paintings of the Interior Dome of the Capilla de la Virgen del Rosario, Iglesia San José, San Juan, Puerto Rico

Presented to the Faculties of the University of Pennsylvania in Partial Fulfillment of the Requirements for the Degree of Master of Science in Historic Preservation 2006.

**A TECHNICAL STUDY OF THE MURAL PAINTINGS ON THE INTERIOR
DOME OF THE CAPILLA DE LA VIRGEN DEL ROSARIO,
IGLESIA SAN JOSÉ, SAN JUAN, PUERTO RICO**

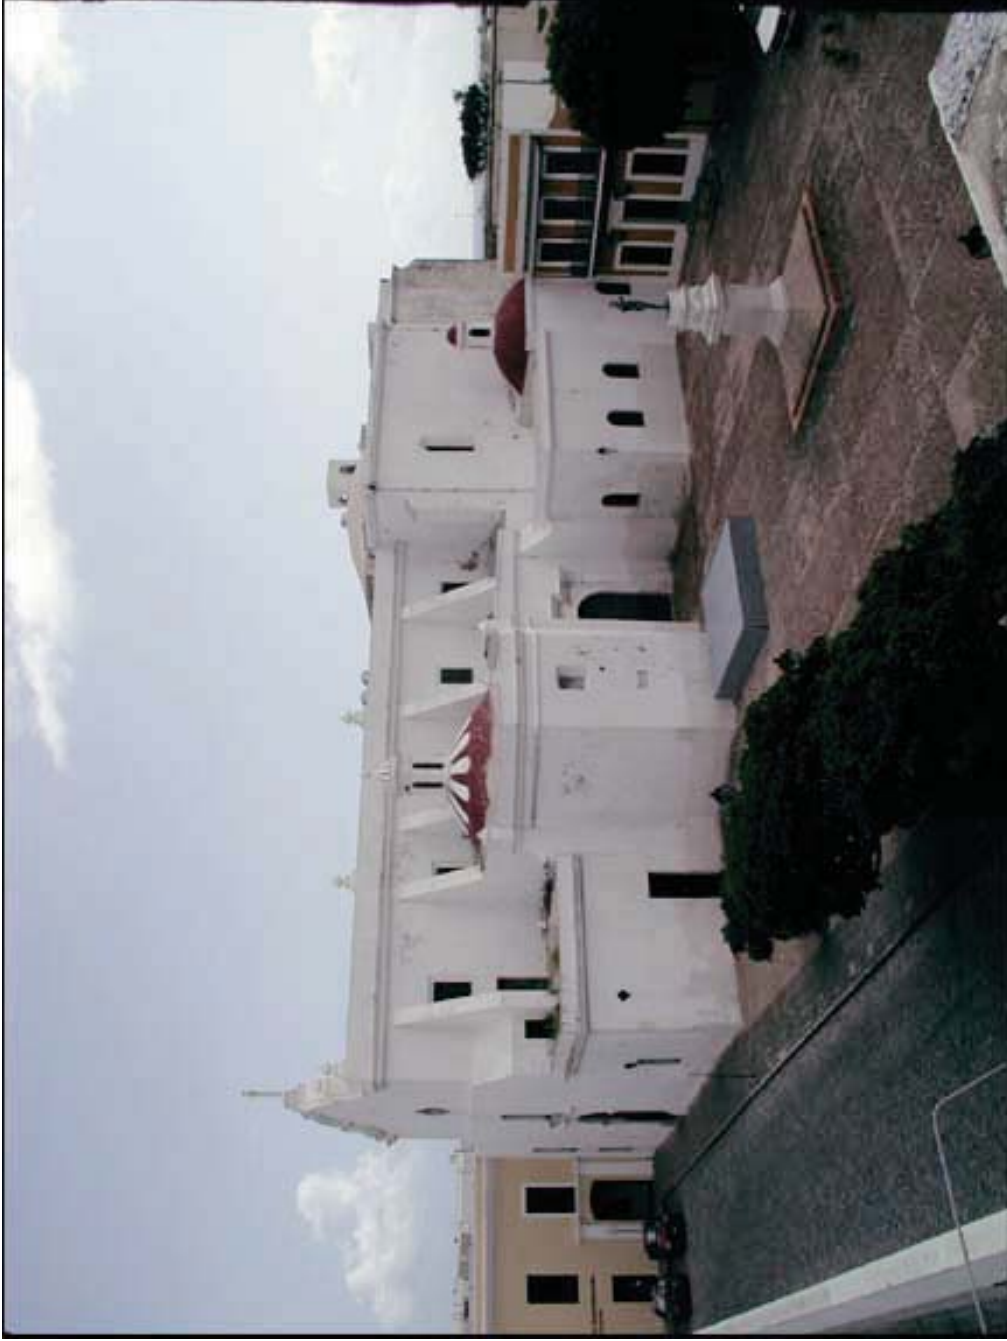
Figure 1: South elevation of *Iglesia San José*. The Rosario Chapel features a red dome with white petals. (Source: Pantel y del Cueto & Associates, 2002)

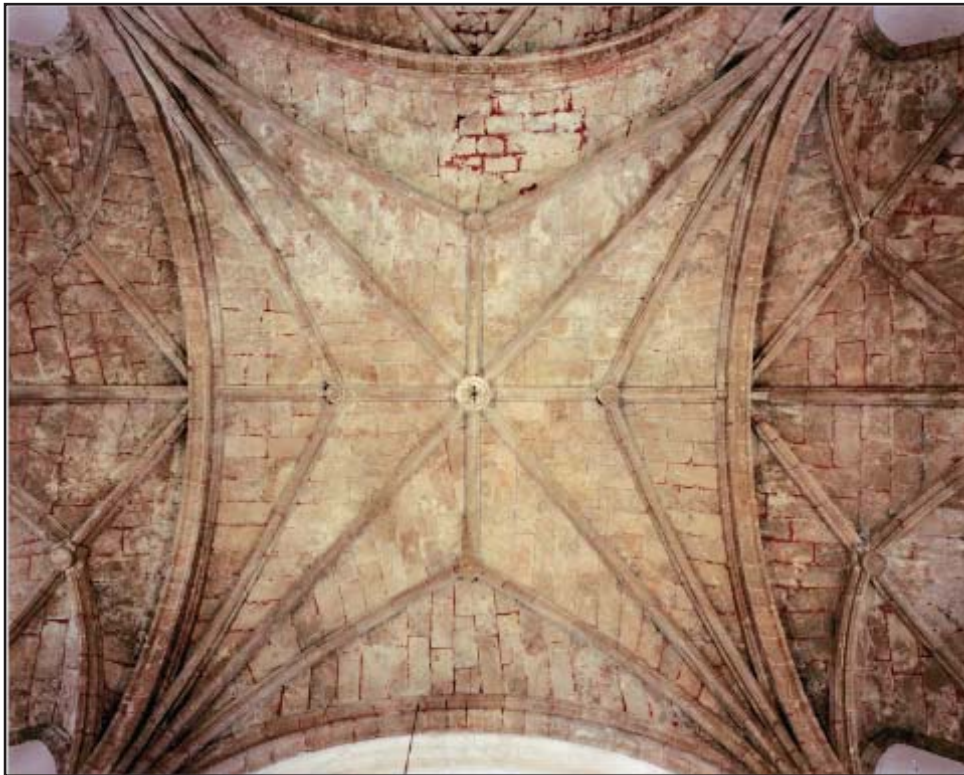
Figure 3: Stelliform groin vaulted ceiling of the Sanctuary. (Source: Pantel y del Cueto & Associates, 2002)

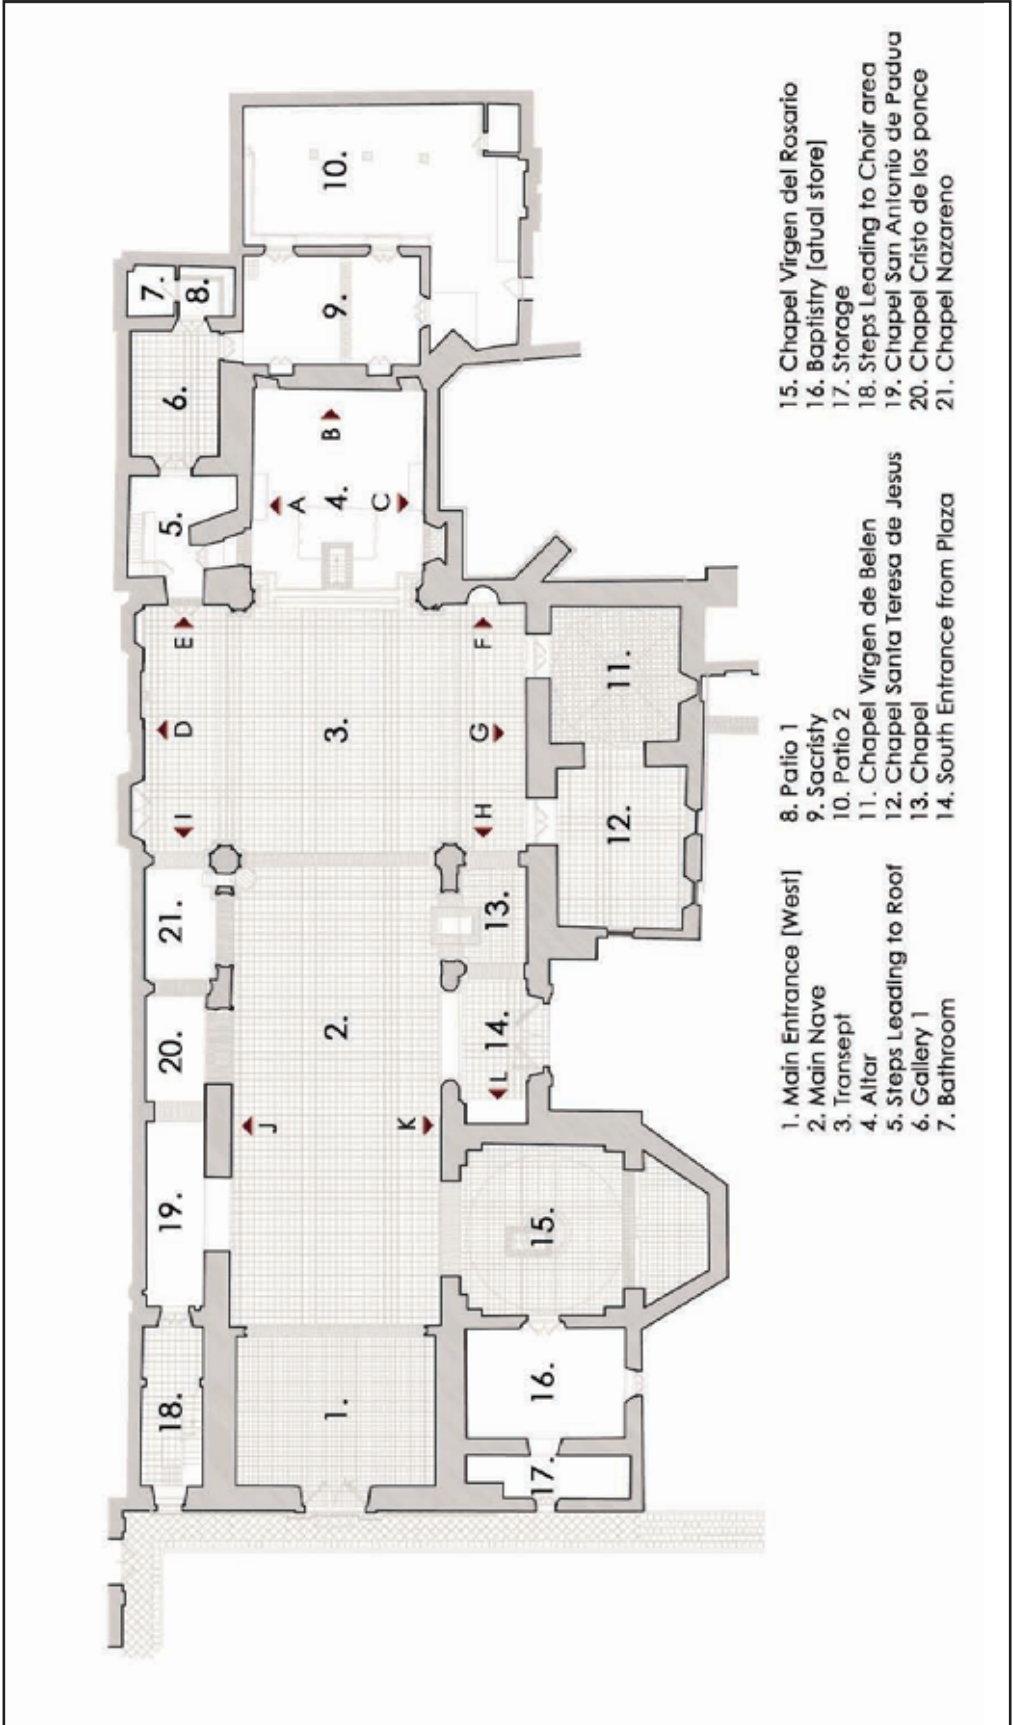
Figure 4: Plan of *Iglesia San José*. (Source: Pantel y del Cueto & Associates)

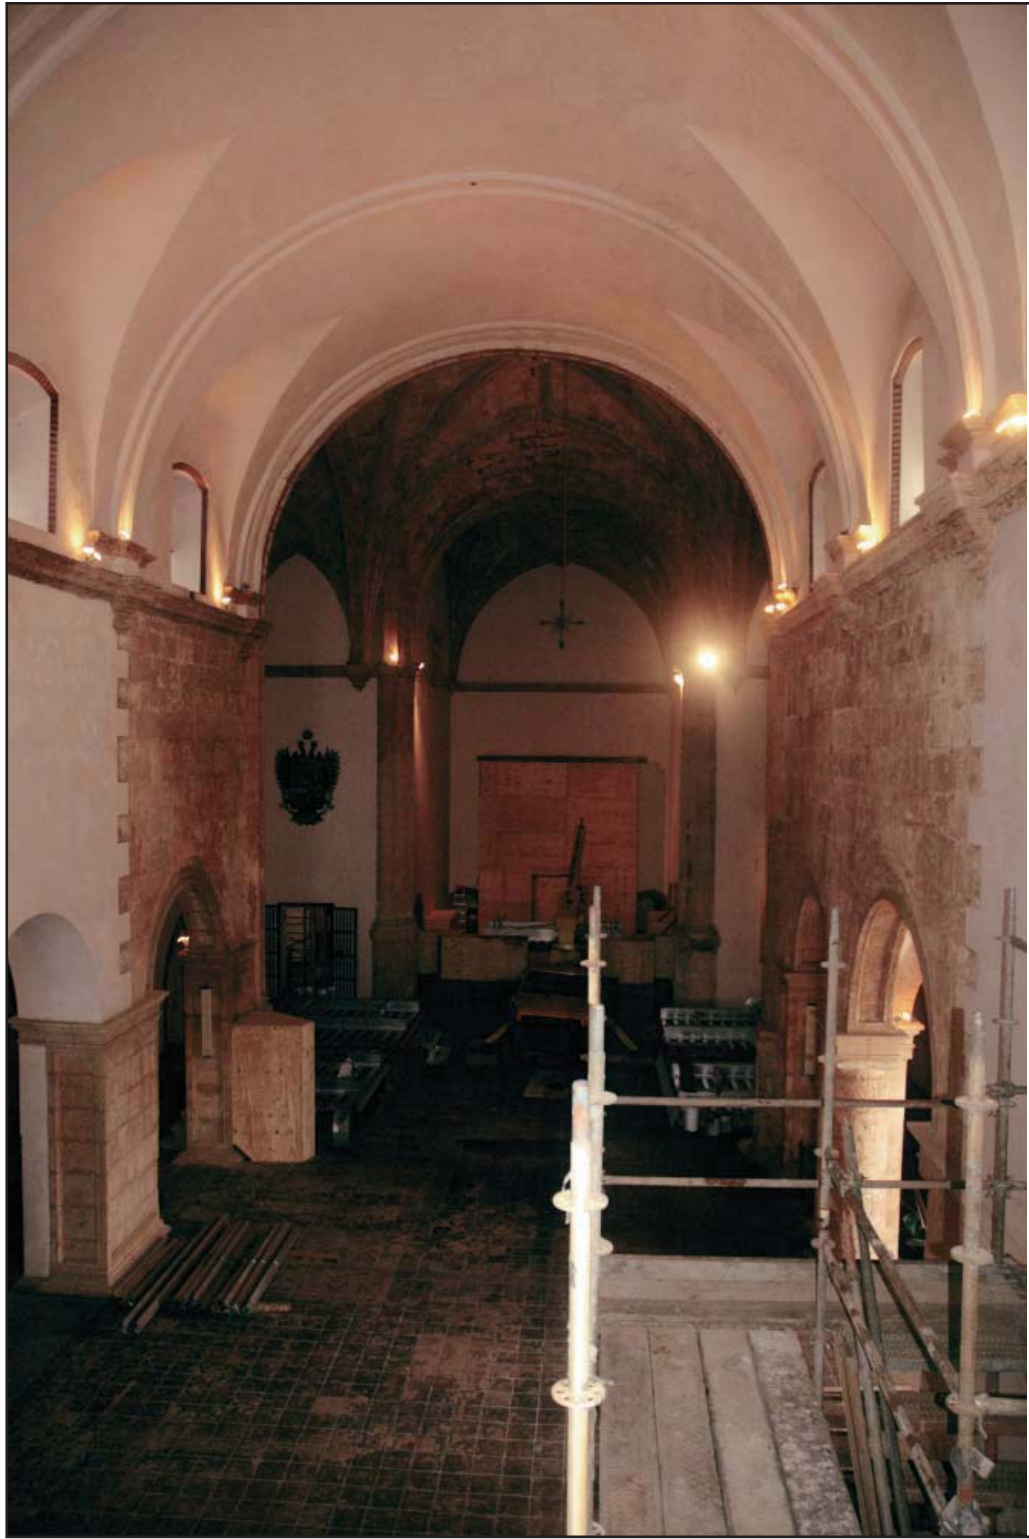
Figure 5: View of nave barrel vault from the choir loft. Rosario Chapel to the rear right. (Source: C. Silva, 2006)

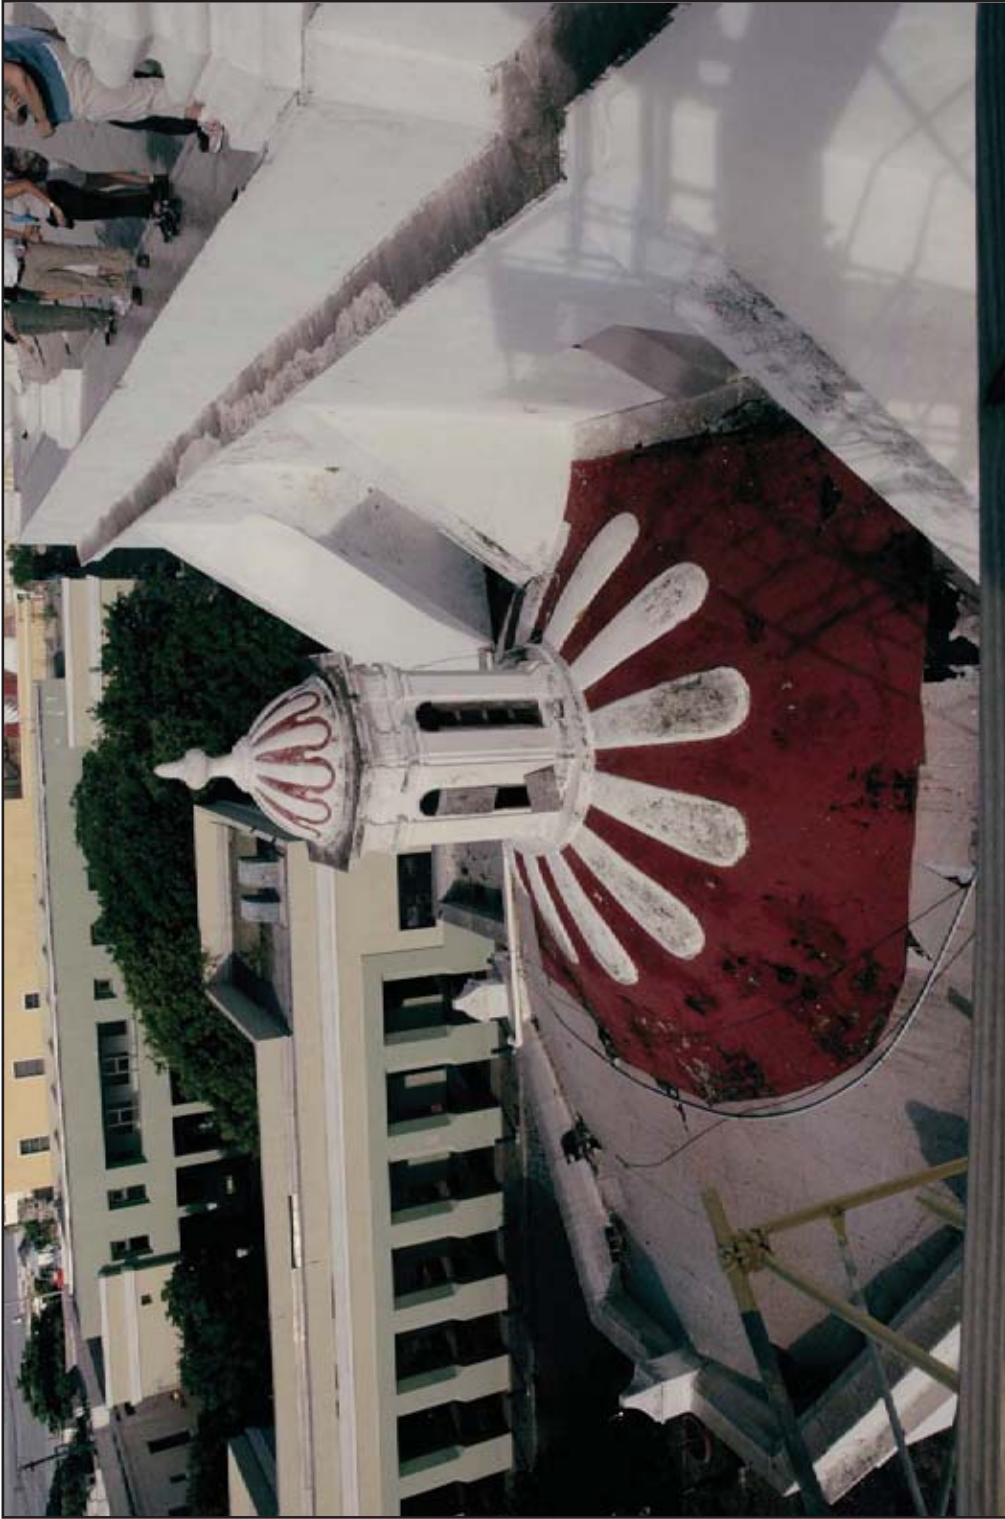
Figure 6: Rosario Chapel roof with buttress supports. (Source: C. Silva, 2006)

In 1776, four years and two hurricanes later, 4,000 pesos were sent by the King of Spain for repairs.¹⁷ It is at this time that buttresses are thought to have been added to help support the newly constructed brick barrel vault of the main nave.¹⁸ Some of these buttress supports rest on the lower roofs of the side chapels including the dome of the Rosario Chapel and clearly post date the construction of the chapel (Figure 6).

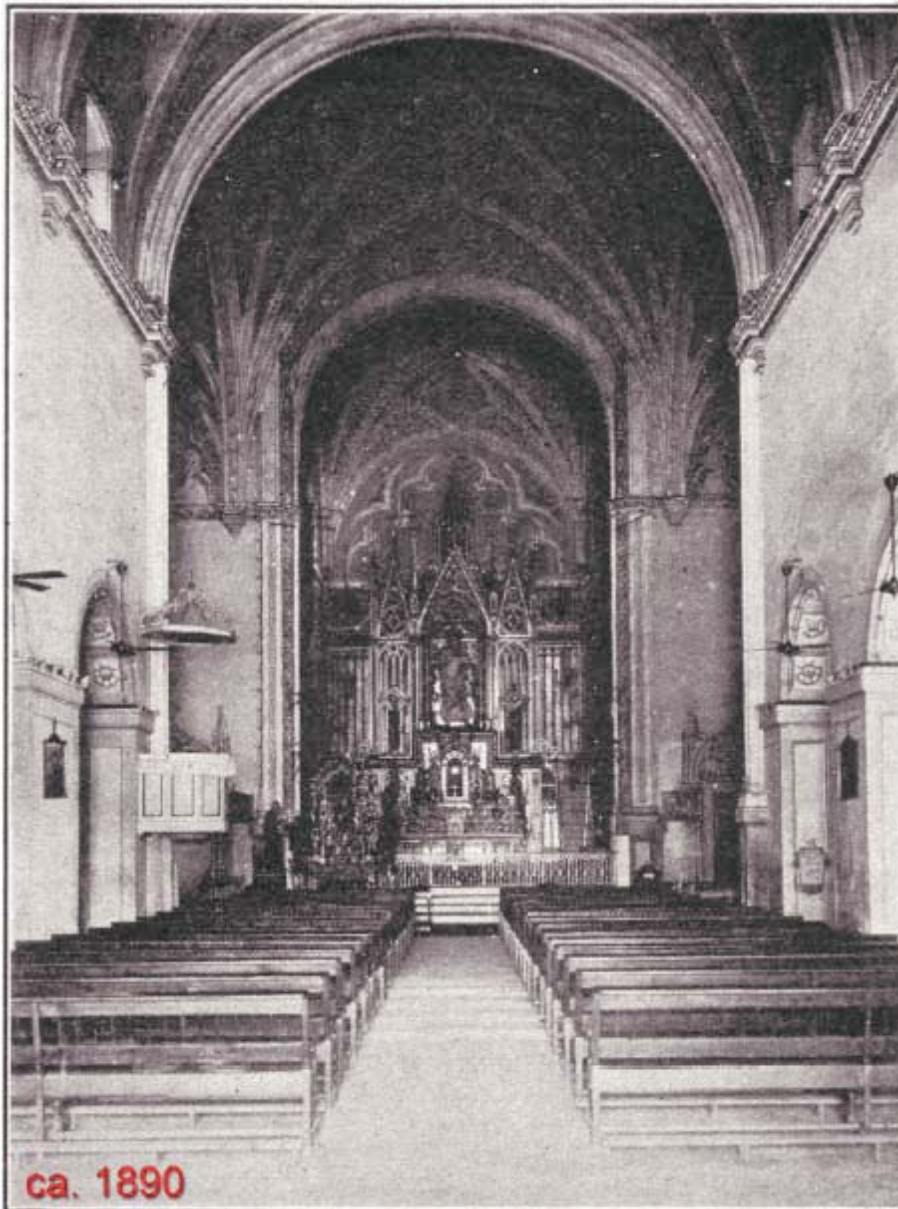
Figure 7: Circa 1890 photograph taken from the Nave looking towards the Transept and Sanctuary.
(Source: Antonio Daubón, private collection)

A 1910 photograph (Figure 8), of the transept looking east toward the sanctuary, reveals the stelliform vaulted ceilings clearly are decorated with star ornaments, which have been described as “gold leafed, gypsum plaster elements”.²⁷ An earlier 1890’s image (Figure 7), shows the *trompe l’oeil* painted coffers with rosettes that once decorated the intradoses of the arches of the nave. The church has been described in interviews as having had all its plaster surfaces painted with both geometric as well as floral motifs.²⁸ By 1935, all the previously mentioned decorative elements were completely over painted in white faux ashlar blocks (Figure 9).²⁹

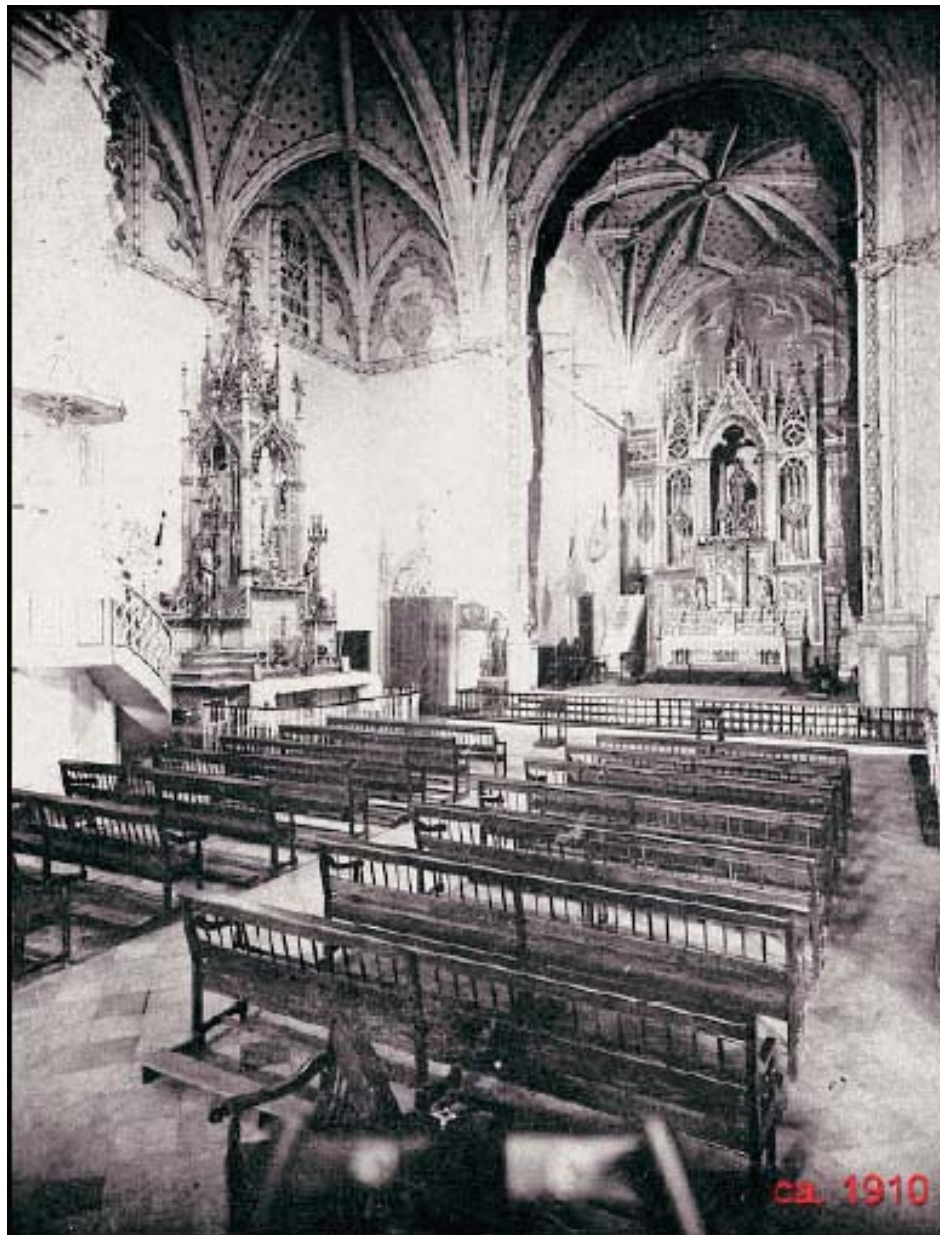
Figure 8: Circa 1910 photograph taken from the transept looking towards the sanctuary. (Source: Antonio Daubón, private collection)

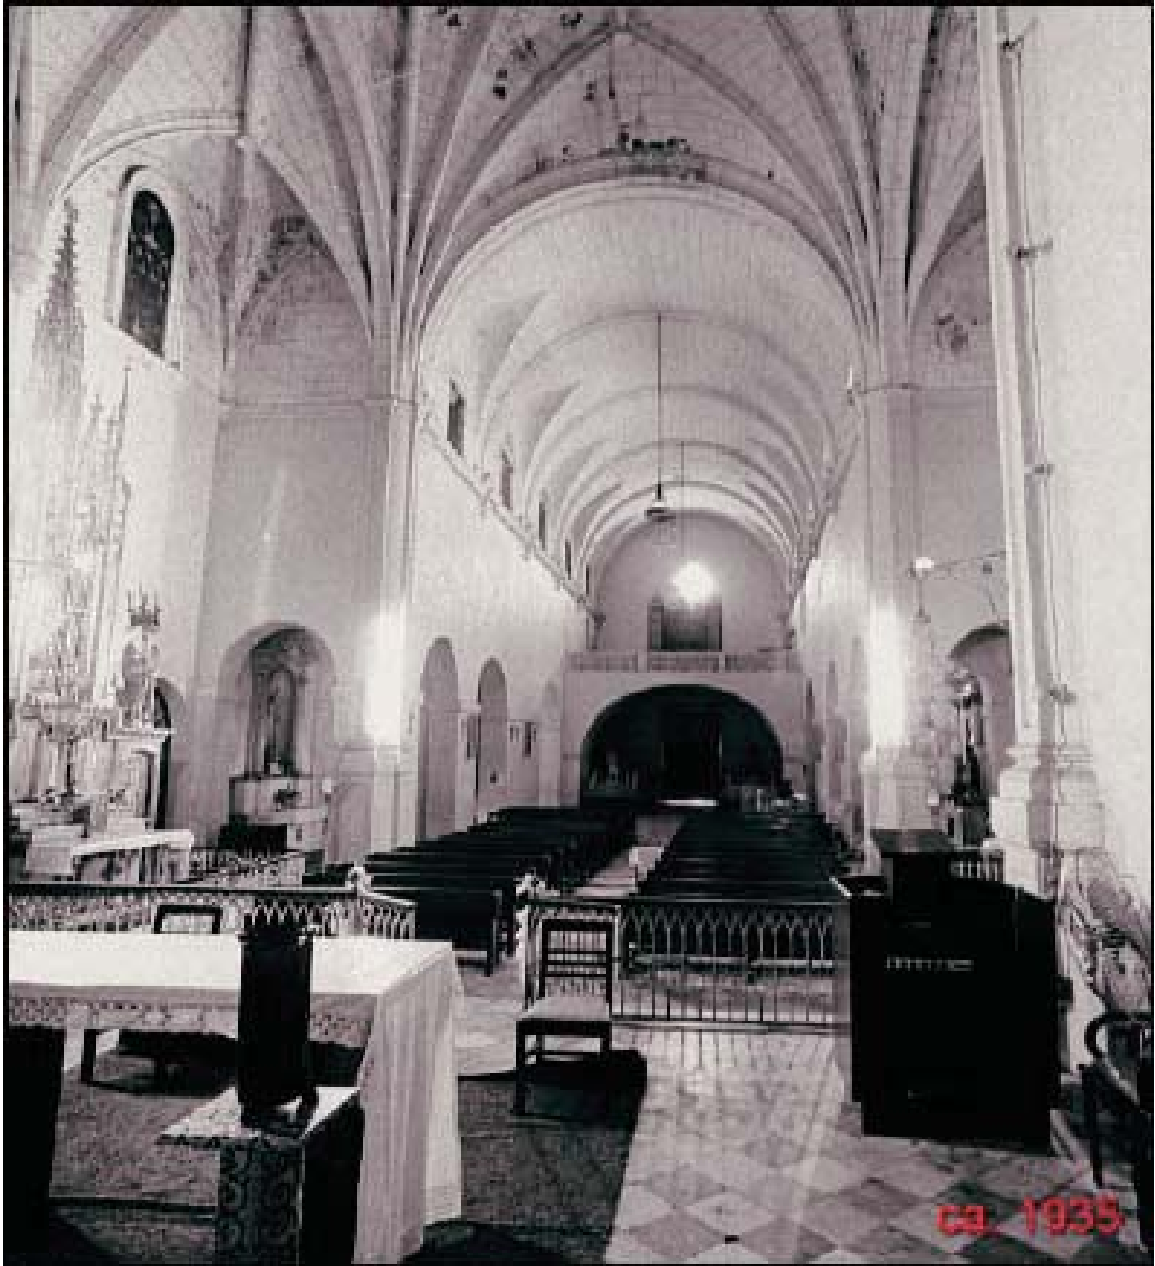
Figure 9: Circa 1935 photograph taken from the sanctuary looking toward the nave.
(Source: HABS, PR, 7-SAJU,1-20)

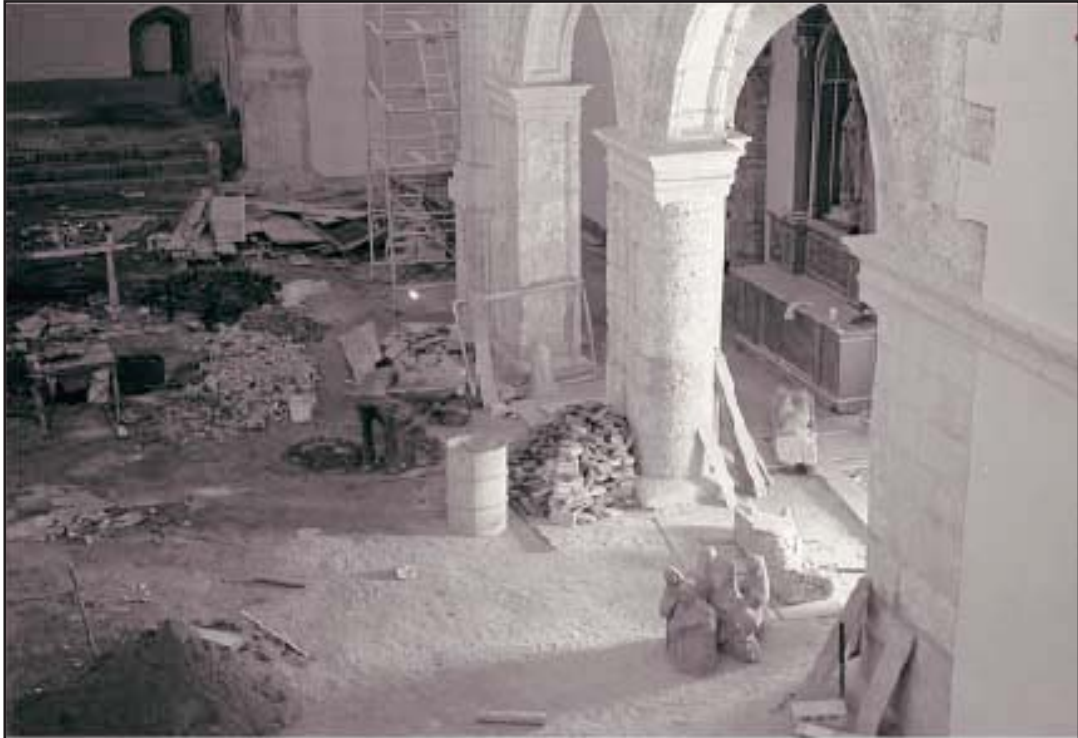
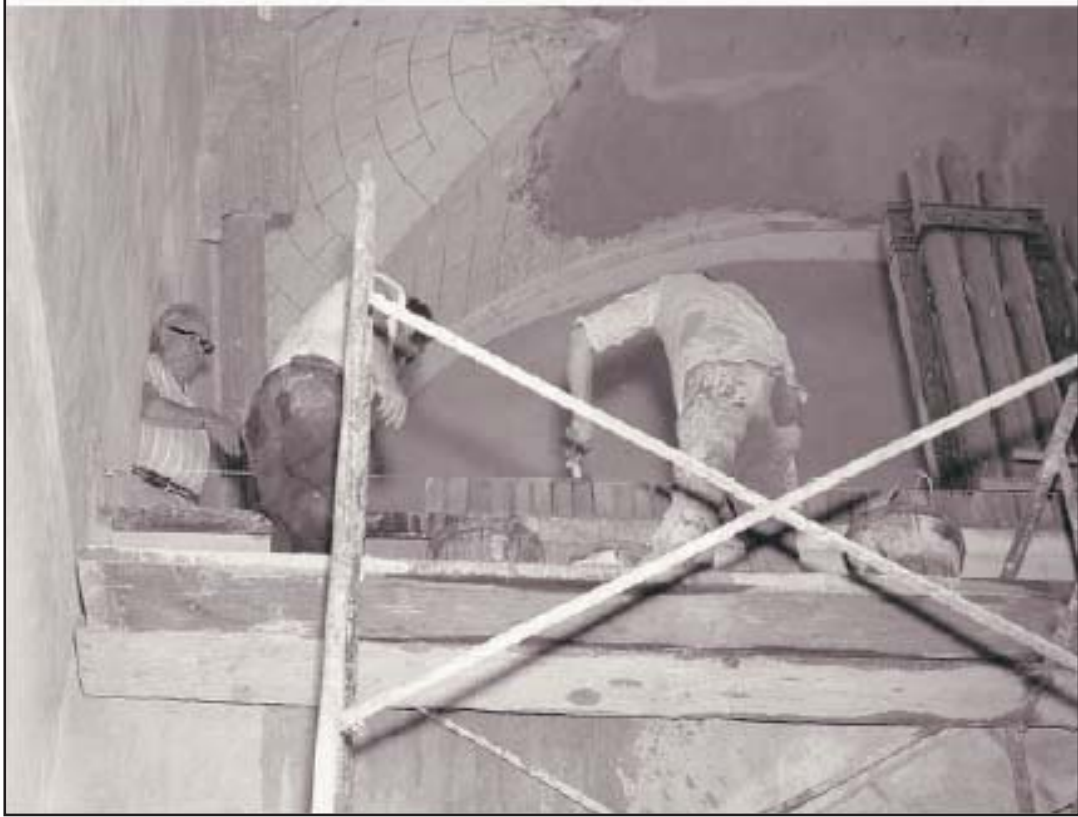
Figure 10: Circa 1980 interior excavation and restoration.
(Source: Pantel y del Cueto & Associates)

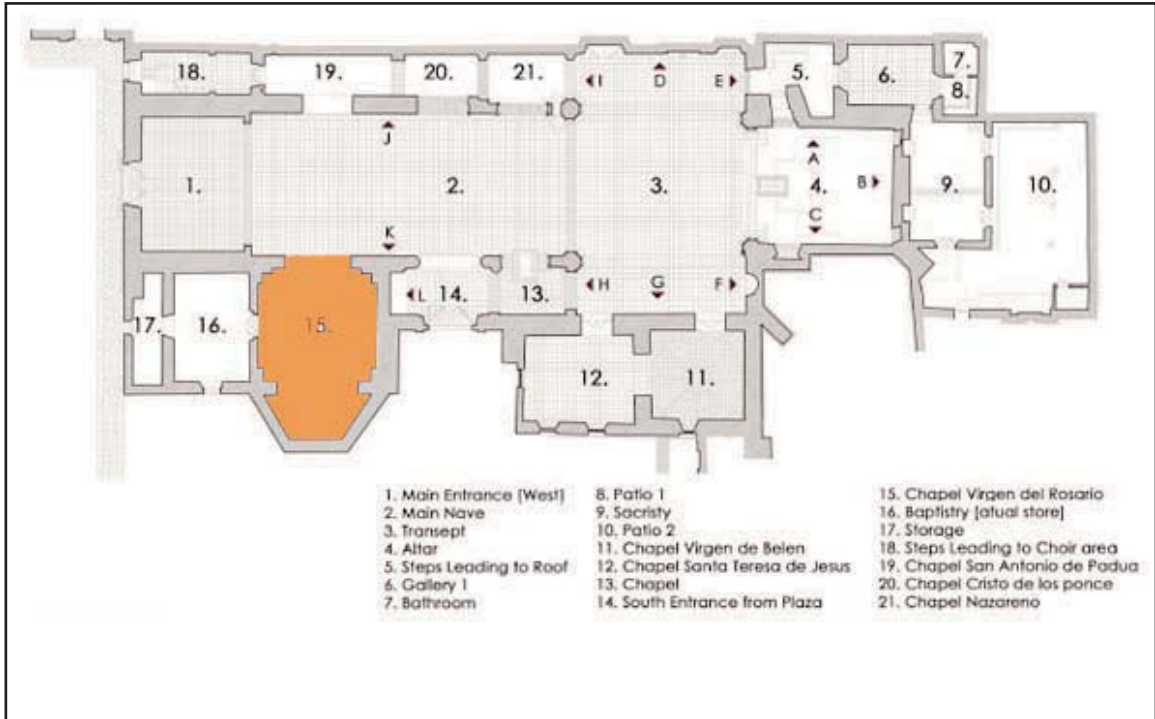
Figure 11: Plan of Iglesia San José, Rosario Chapel annotated in orange. (Source: Pantel y del Cueto & Associates)

The Capilla de la Virgen del Rosario is essentially a 26' square plan with a 26'x10' sanctuary projecting on the south end (Figure 11). The space is surmounted by a brick dome and lantern supported by four Roman arches (Figures 12-14). The base of the hexagonal lantern is approximately 34' above the ground and stands 13' above the surface of the roof (Figures 6 and 13). The juncture of the four arches form pendentives in each corner. These features and the dome have been repeatedly painted over the course of time with a series of distinct mural and decorative paintings (Figures 15-23). The southern end of the chapel contains the sanctuary, where the altar is placed, which extends approximately 10'6" outside the square of the main space, and is enclosed by a fan vault which is also decoratively painted.

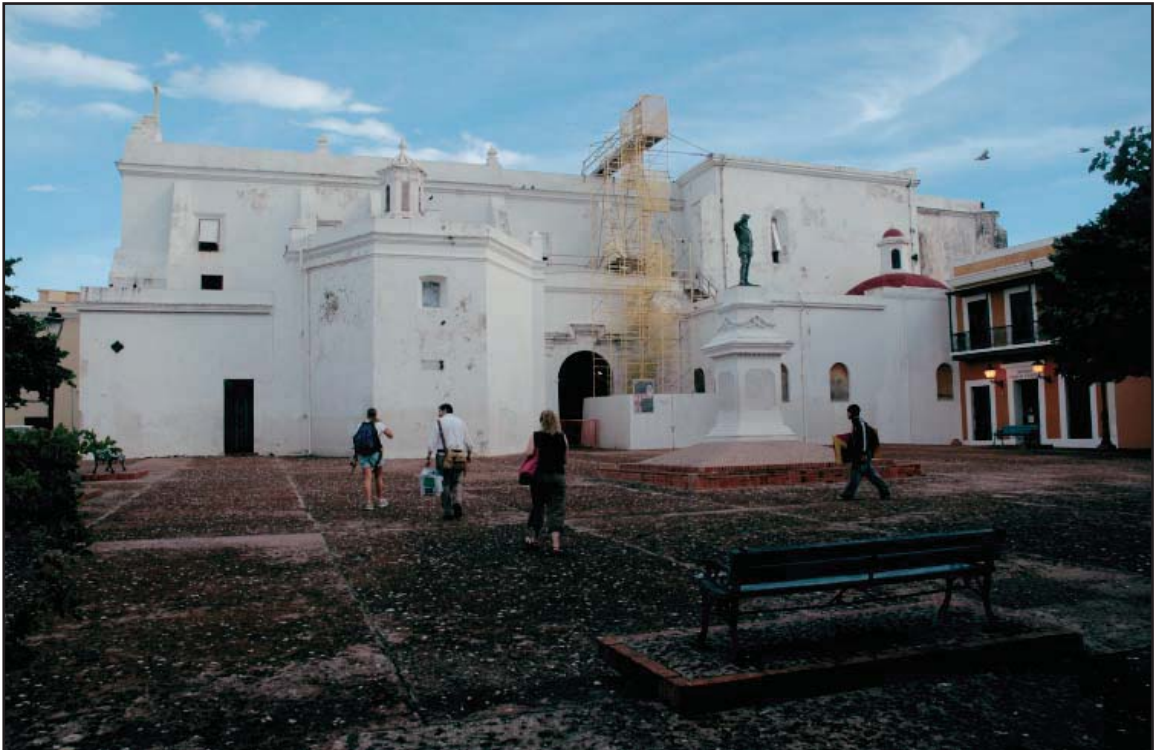
Figure 12: South elevation of Iglesia San José, Rosario Chapel located west (left) of the scaffolding. (Source: C. Silva, 2005)

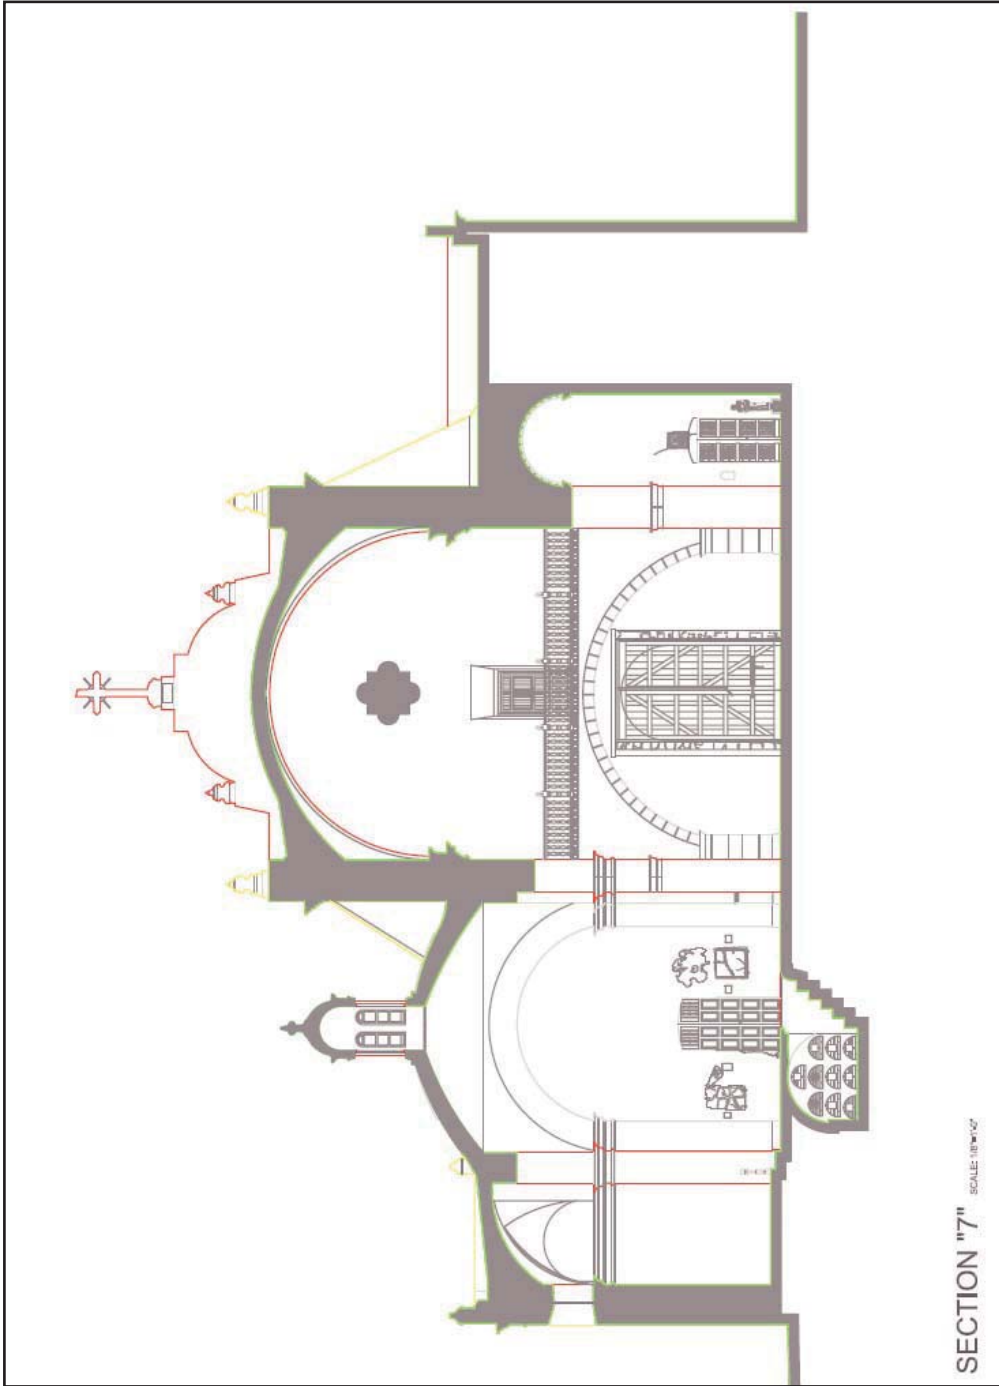
Figure 13: Section of Iglesia San José, Rosario Chapel located on the left.
 (Source: Pantel y del Cueto & Associates)

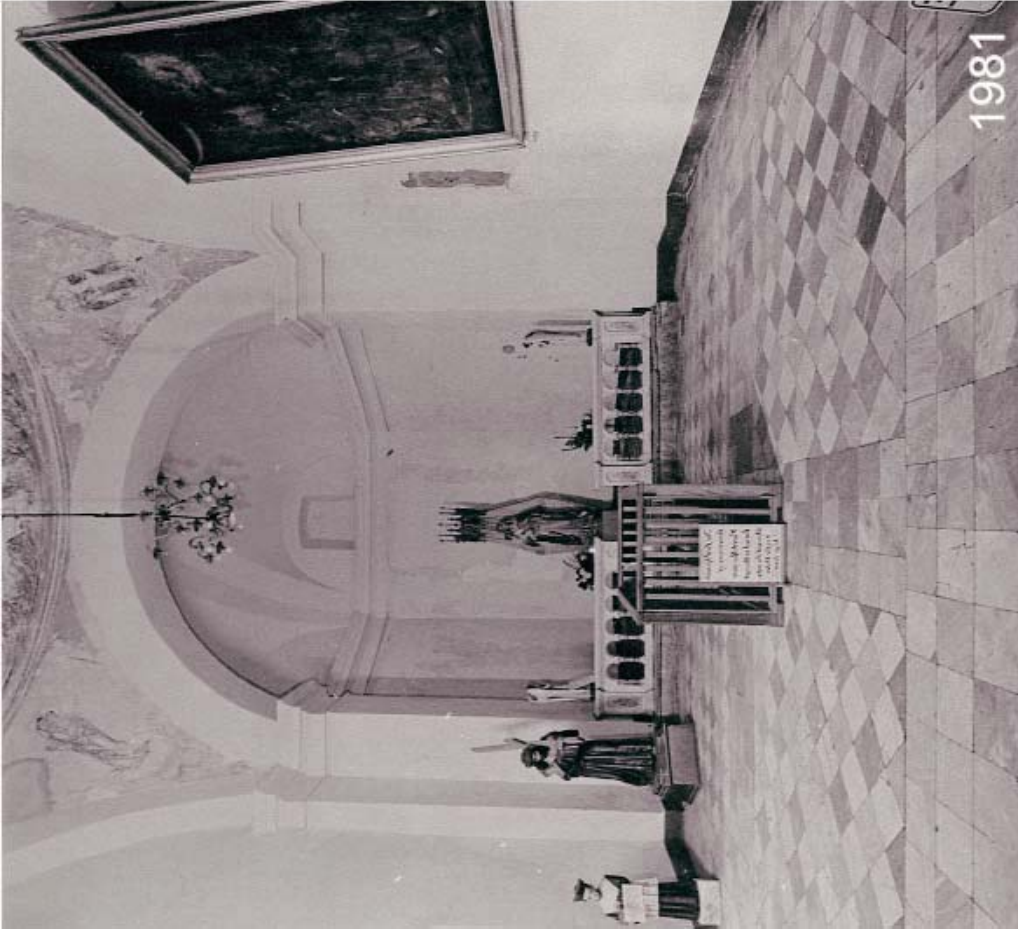
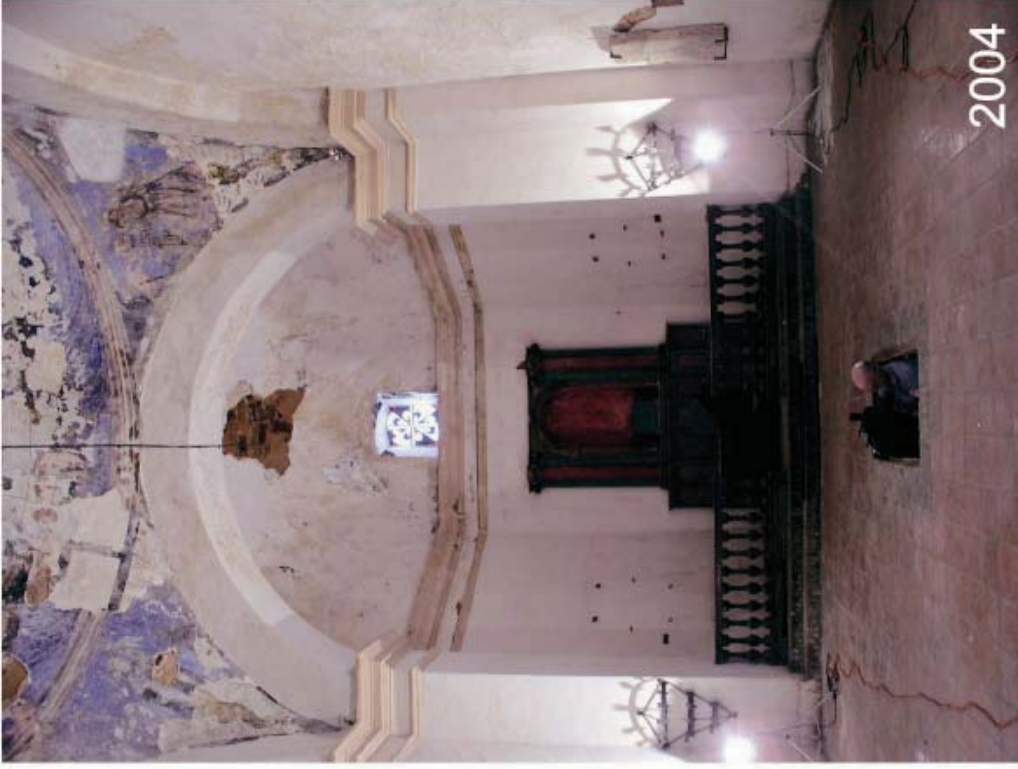
Figure 14: Interior of the Rosario Chapel, (left 1981, right 2004). (Source: Pantel y del Cueto & Associates)

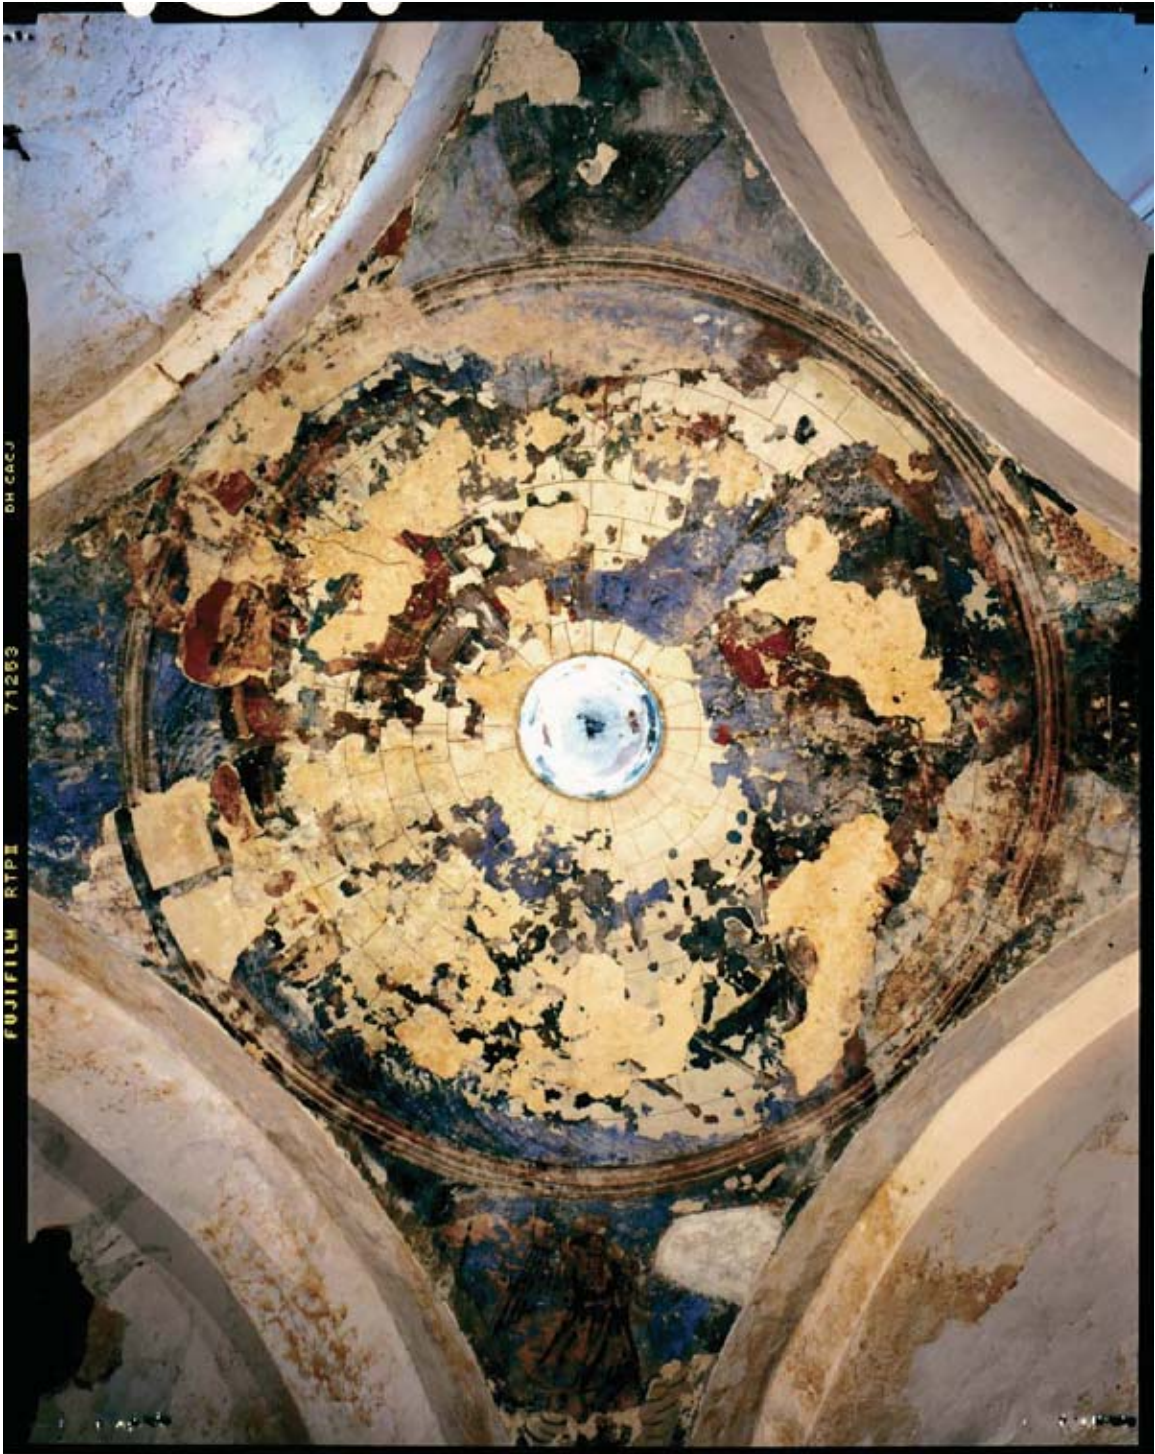
Figure 15: Rosario Chapel interior dome. (Source: Joseph Elliott, 2004)

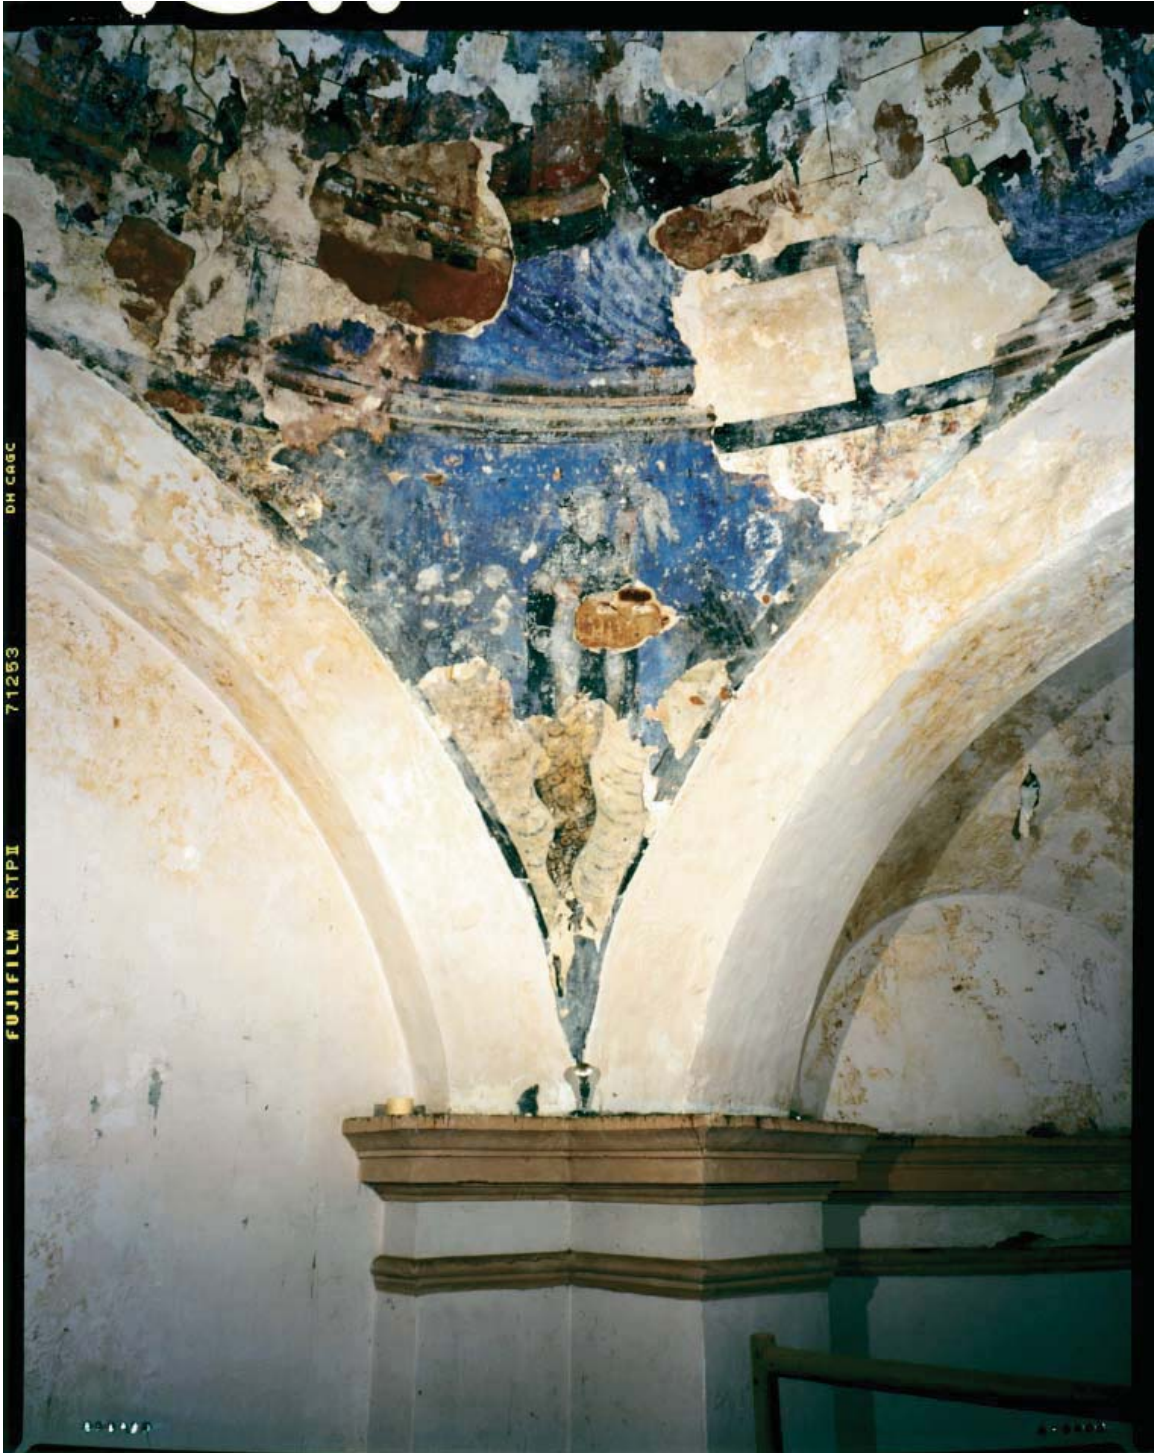
Figure 16: Pendentive 1, southeast corner of Rosario Chapel.
(Source: Joseph Elliott, 2004)

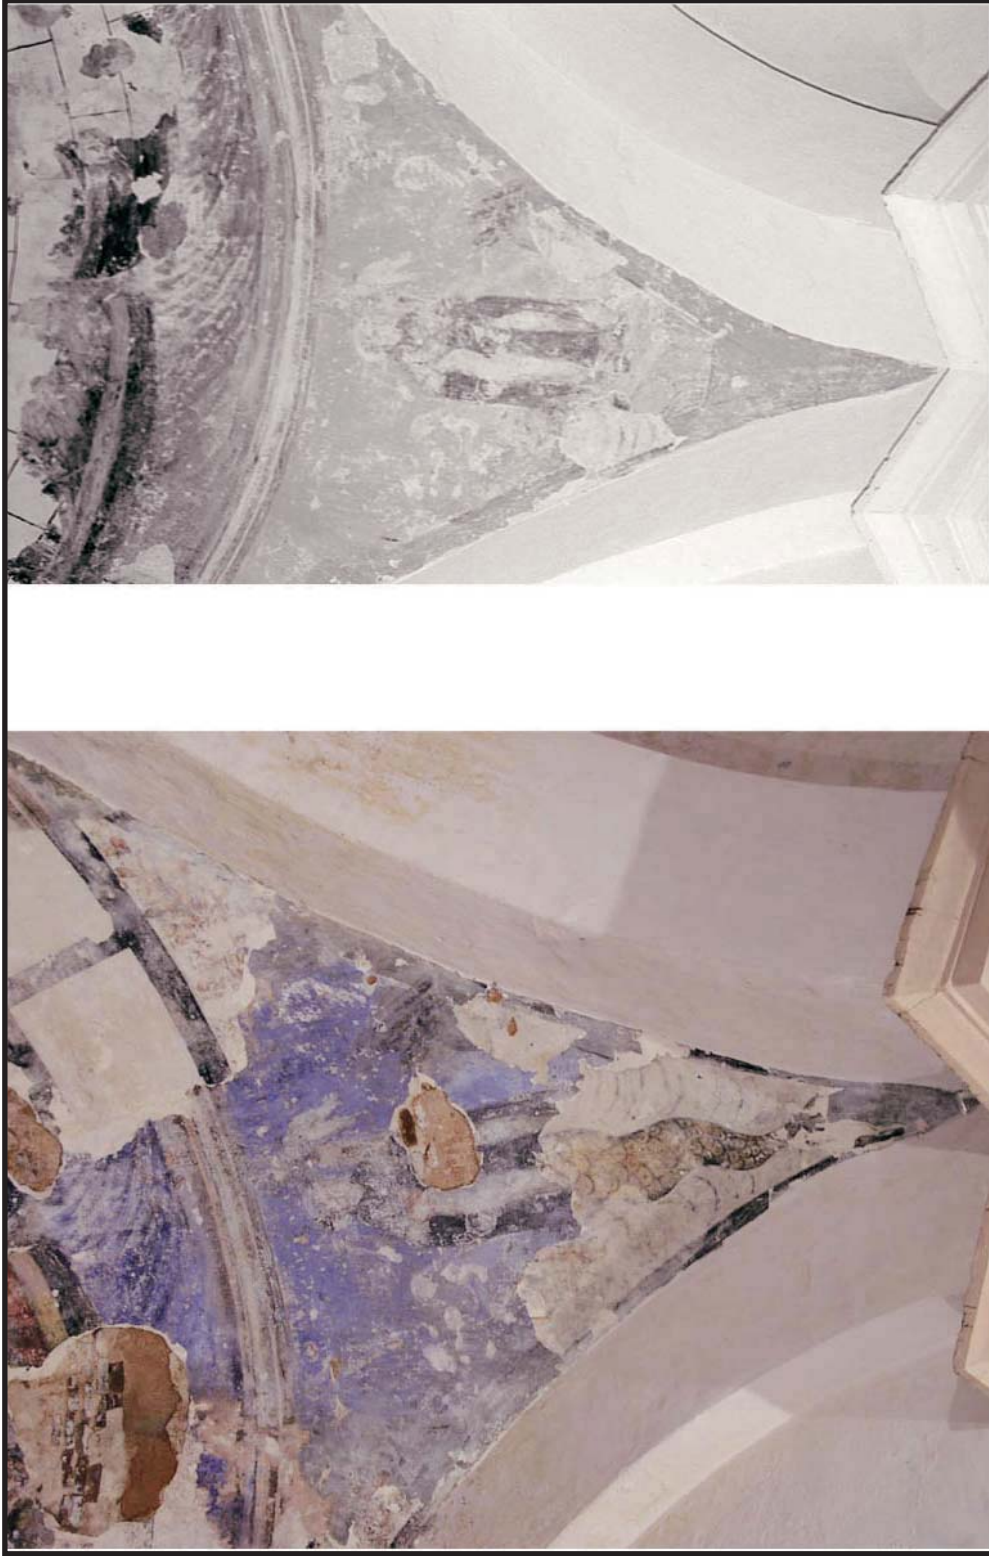
Figure 17: Photographic comparison of Pendentive 1, on the left is a 2004 image and on the right, an image taken in 1981. Note the deterioration in terms of areas of loss and image legibility over a twenty year time span. (Source: Pantel y del Cueto & Associates)
