A Technical Study of the Mural Paintings of the Interior Dome of the Capilla de la Virgen del Rosario, Iglesia San José, San Juan, Puerto Rico

Presented to the Faculties of the University of Pennsylvania in Partial Fulfillment of the Requirements for the Degree of Master of Science in Historic Preservation 2006.

**A TECHNICAL STUDY OF THE MURAL PAINTINGS ON THE INTERIOR
DOME OF THE CAPILLA DE LA VIRGEN DEL ROSARIO,
IGLESIA SAN JOSÉ, SAN JUAN, PUERTO RICO**

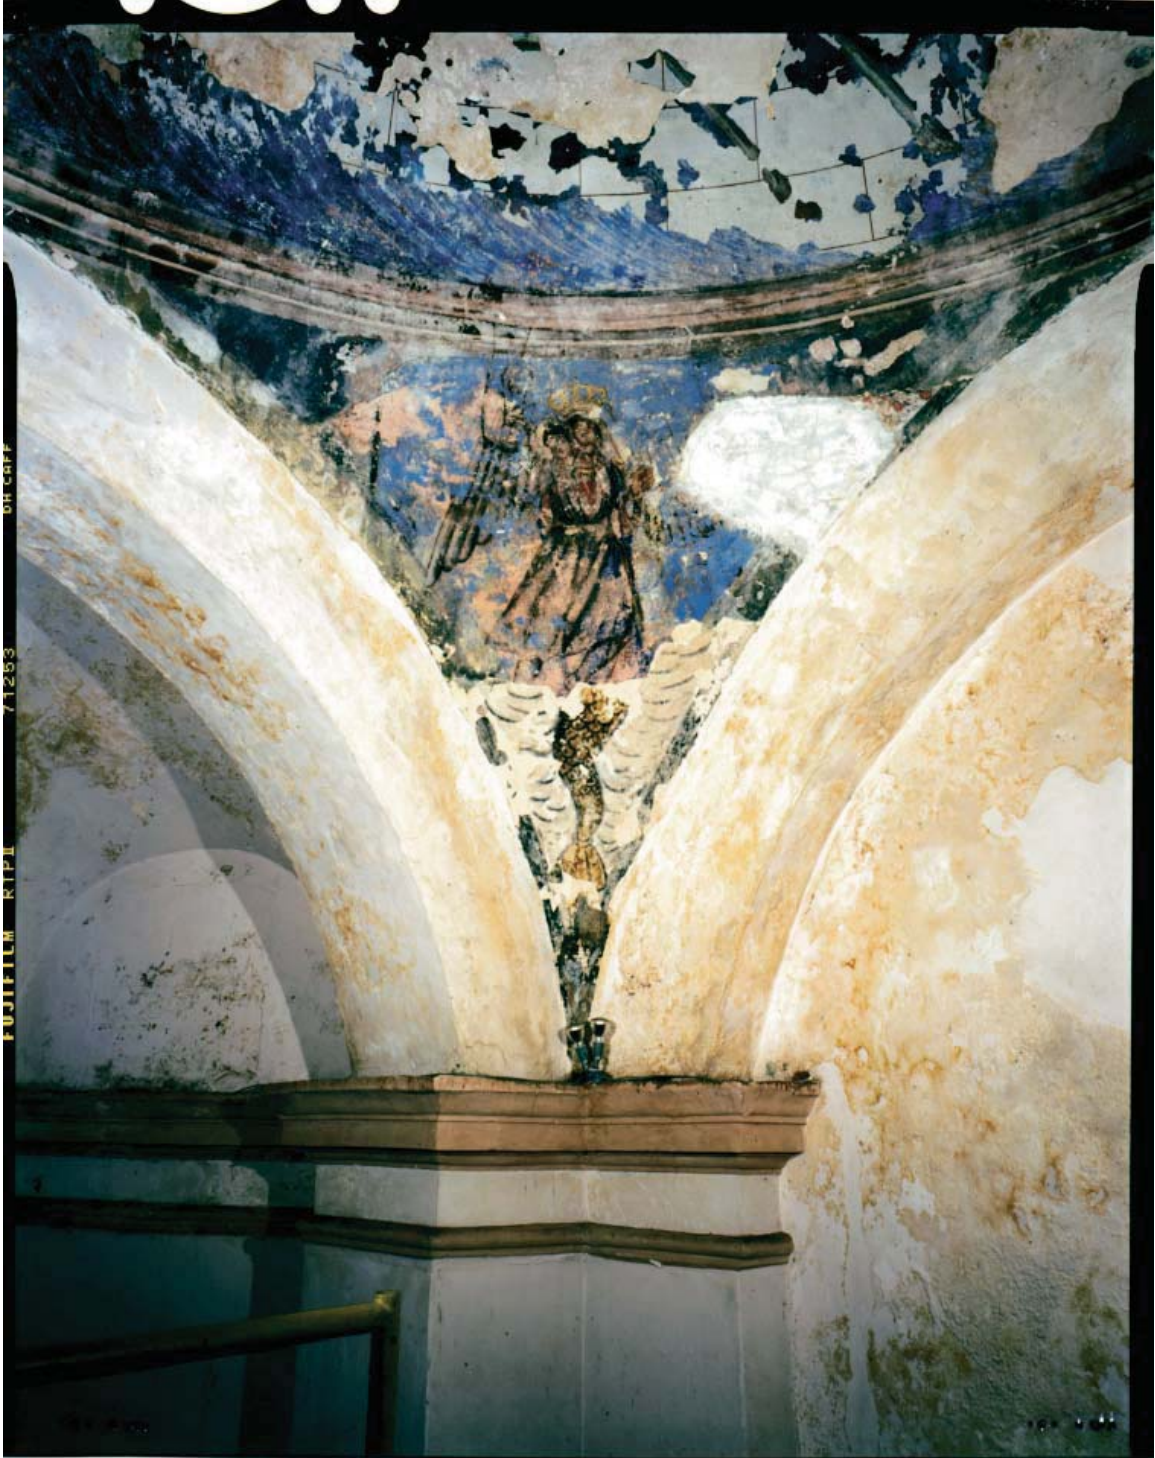
Figure 18: Pendentive 2, southwest corner of Rosario Chapel.
(Source: Joseph Elliott, 2004)

There is a large area of loss down to the original mural Campaign A at the valley point of Pendentive 2 (Figure 18). A 1 ½' x 2' area, along the upper right edge of the pendentive has been patched with repair mortar and remains unpainted. In addition there is a large area of loss measuring 2 ½' x 2 ½', which now exposes the brick dome construction. Due to excessive powdering and binder loss, the earlier Campaign C imagery often shows through making both campaigns nearly illegible. What can currently be seen is a faint image of the Virgin Mary, distinguishable with the aid of a 1982 photograph (Figure 19). The Virgin is depicted wearing a large gold crown and veil, a yellow and red under robe draped by a brilliant blue cloak. She holds the child Jesus in her right proper arm, while the left is extended with her hand closed as if she were holding something no longer visible (Figures 56-58). There is also a dark charcoal gray area in the upper left corner which is similar to the border color on Pendentive 4. The bottom edge of the dome, (framing the top of the pendentives), is defined by the faux cornice from Campaign C, which was not over-painted.

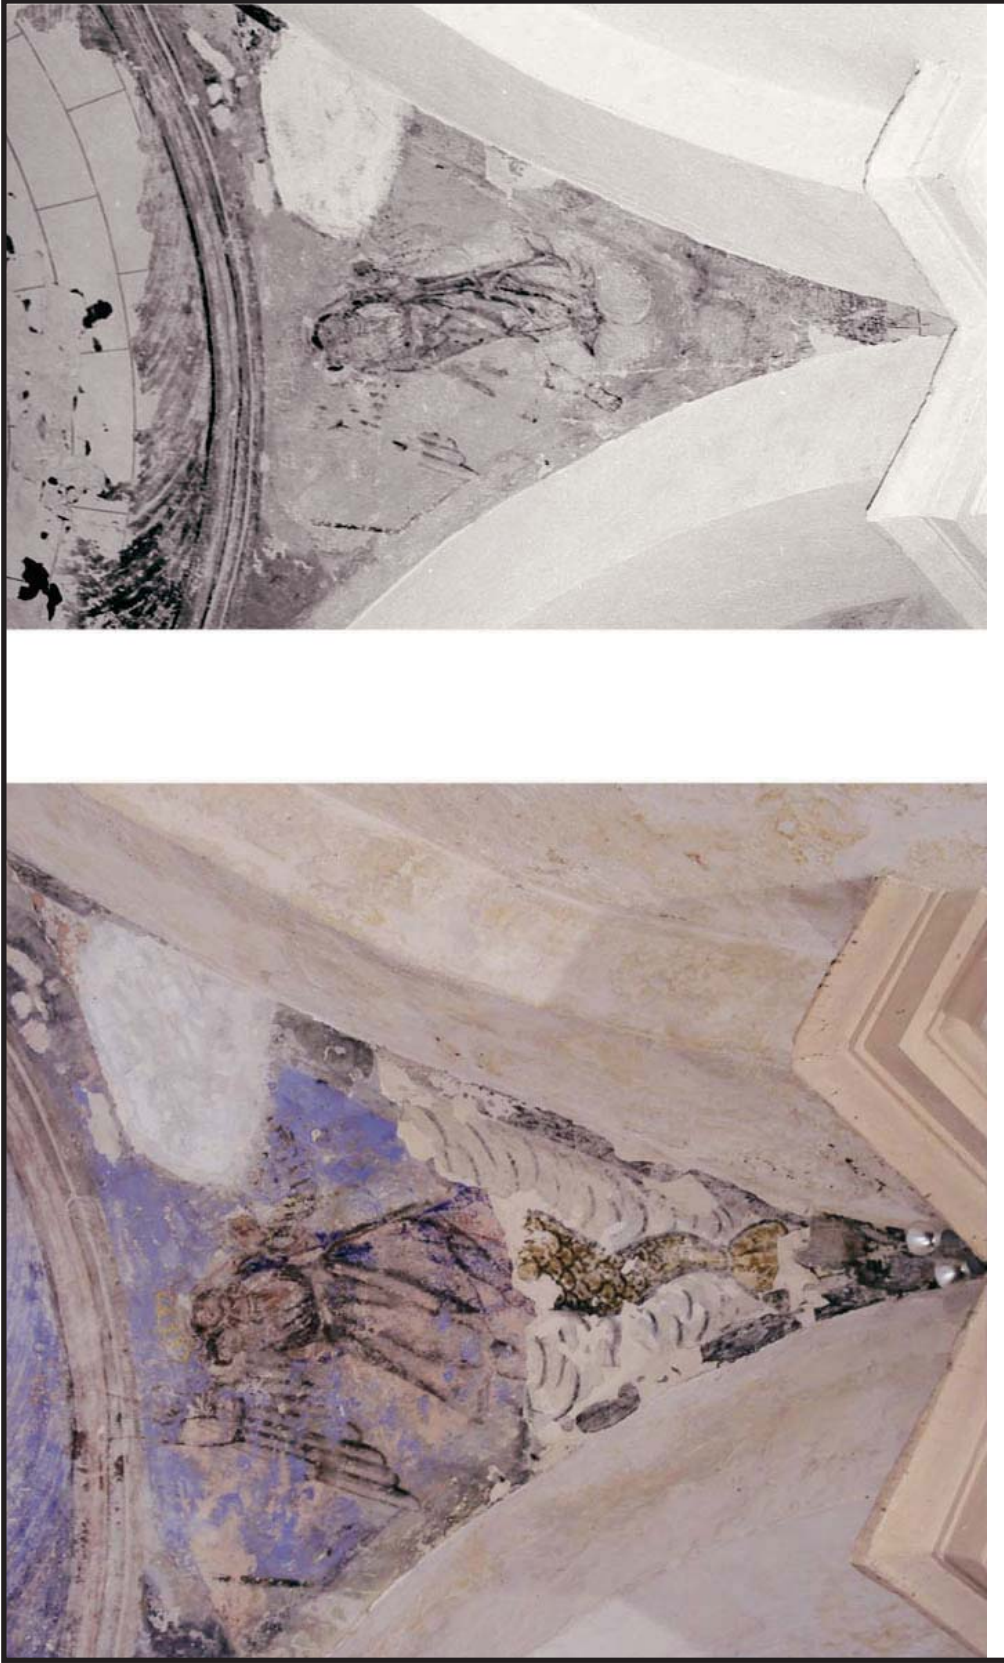
Figure 19: Photographic comparison of Pendentive 2, on the left is a 2004 image and on the right, an image taken in 1981. Note the deterioration in terms of areas of loss and image legibility over a twenty year time span. (Source: Pantel y del Cueto & Associates)

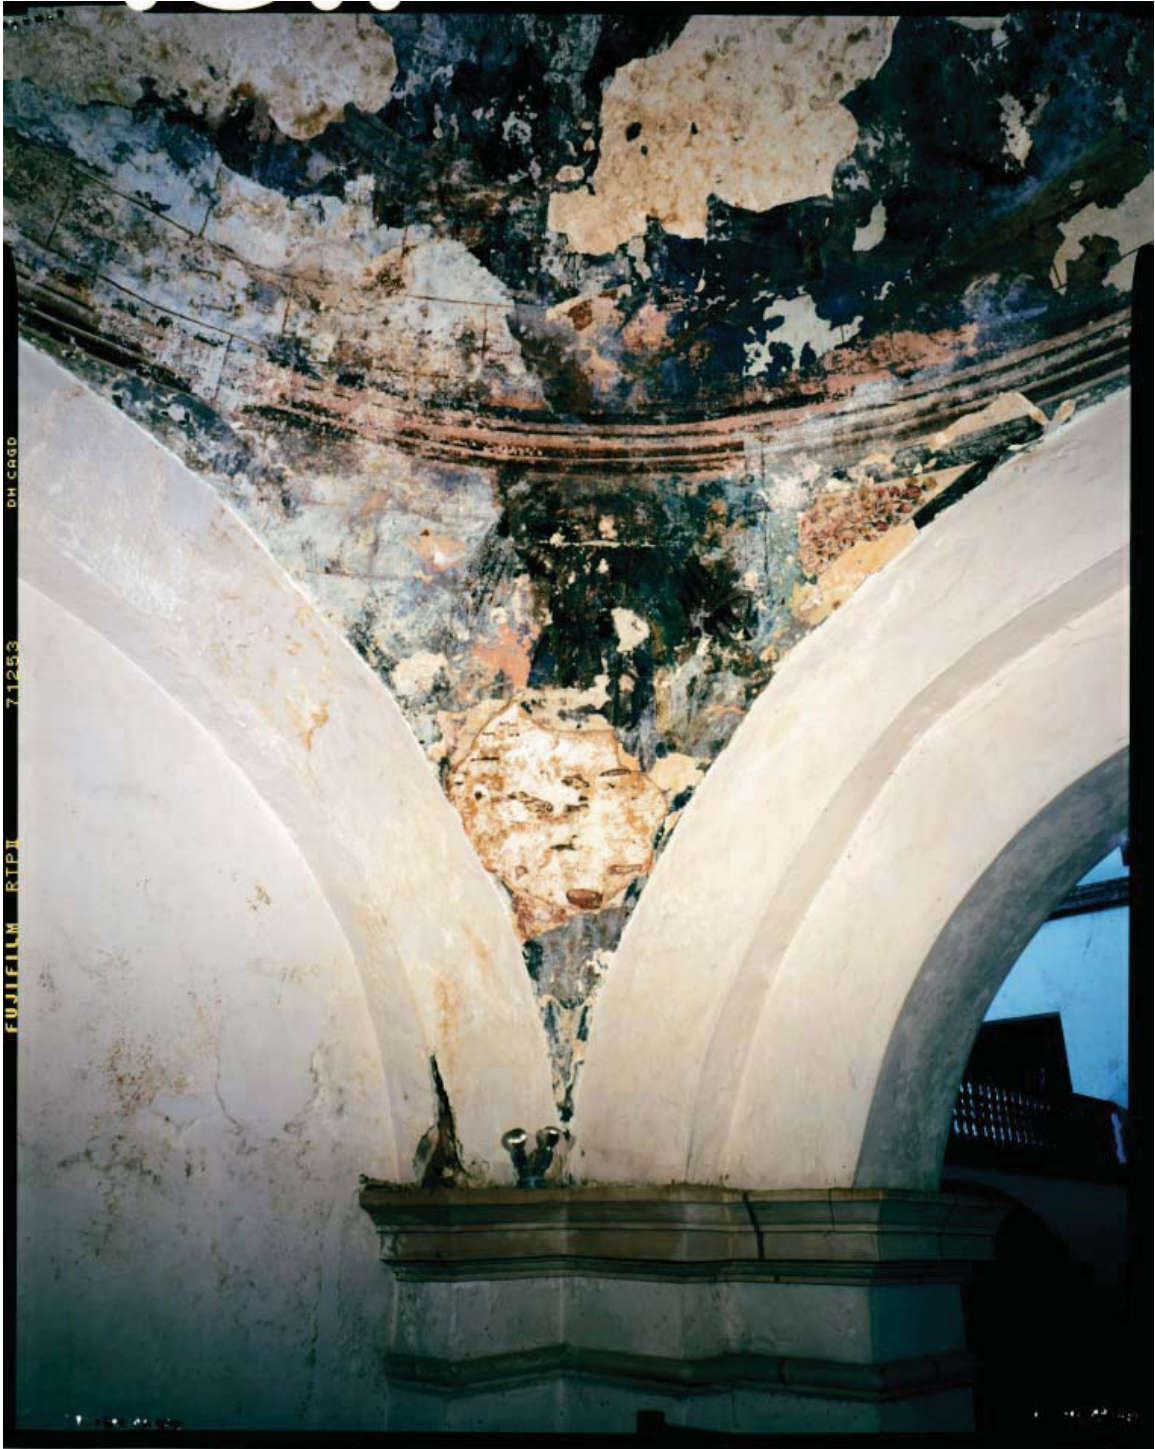
Figure 20: Pendentive 3, northwest corner of Rosario Chapel.
(Source: Joseph Elliott, 2004)

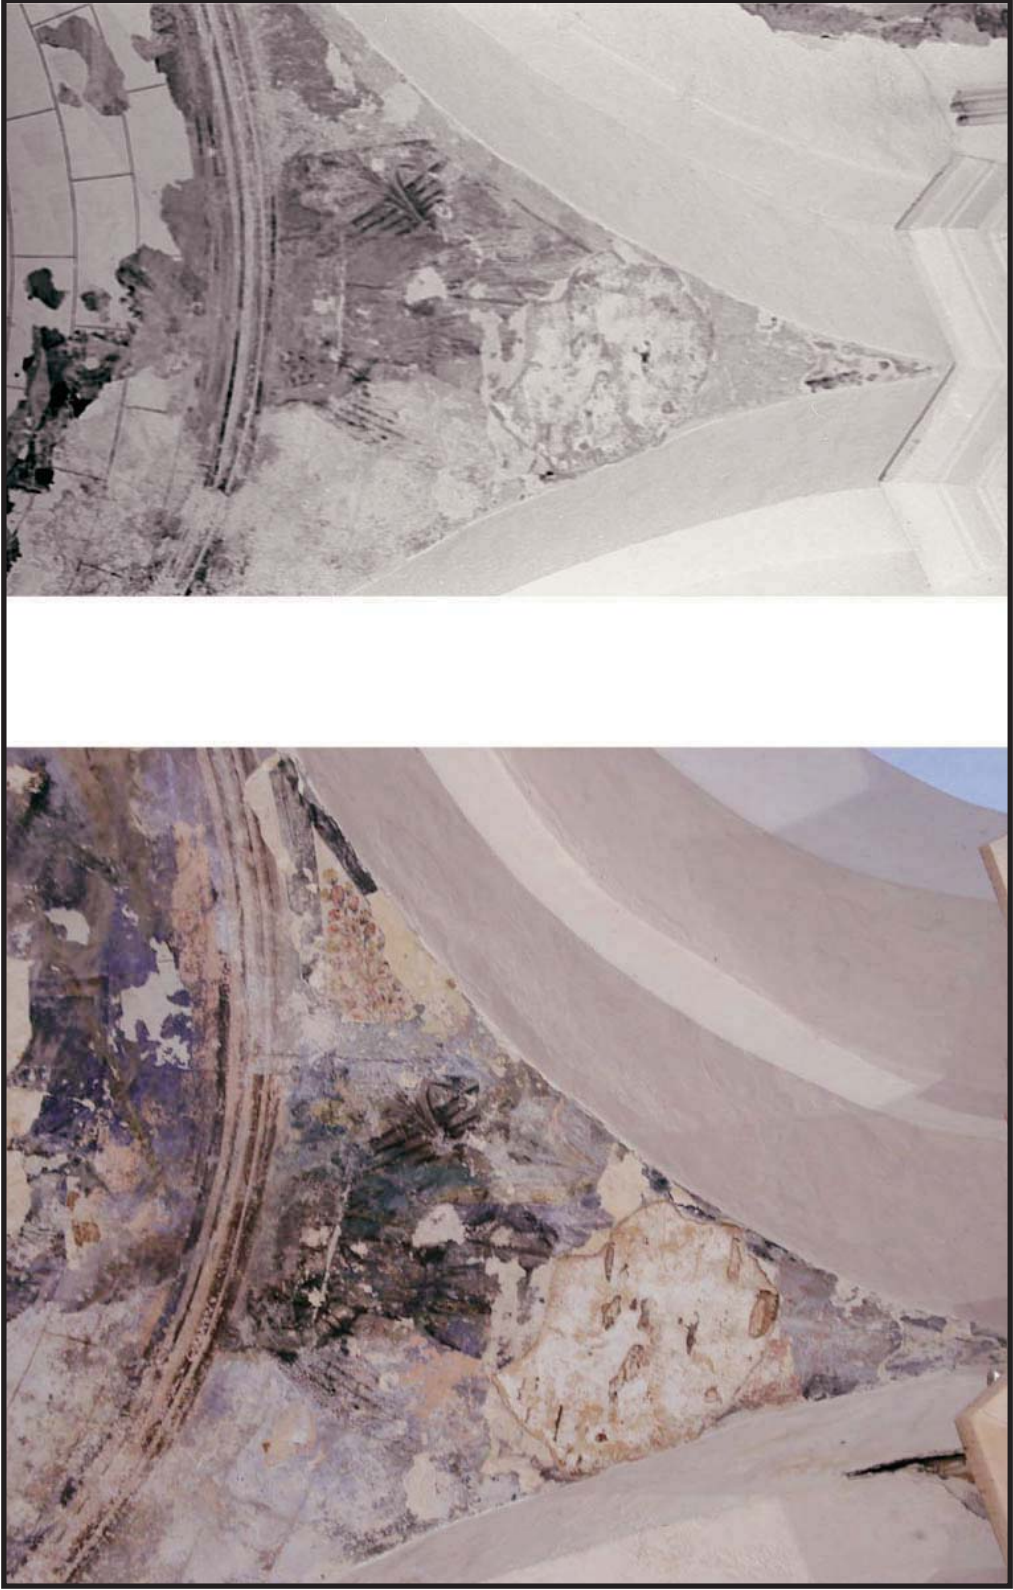
Figure 21: Photographic comparison of Pendentive 3, on the left is a 2004 image and on the right, an image taken in 1981. Note the deterioration in terms of loss and image legibility over a twenty year time span. (Source: Pantel y del Cueto & Associates)

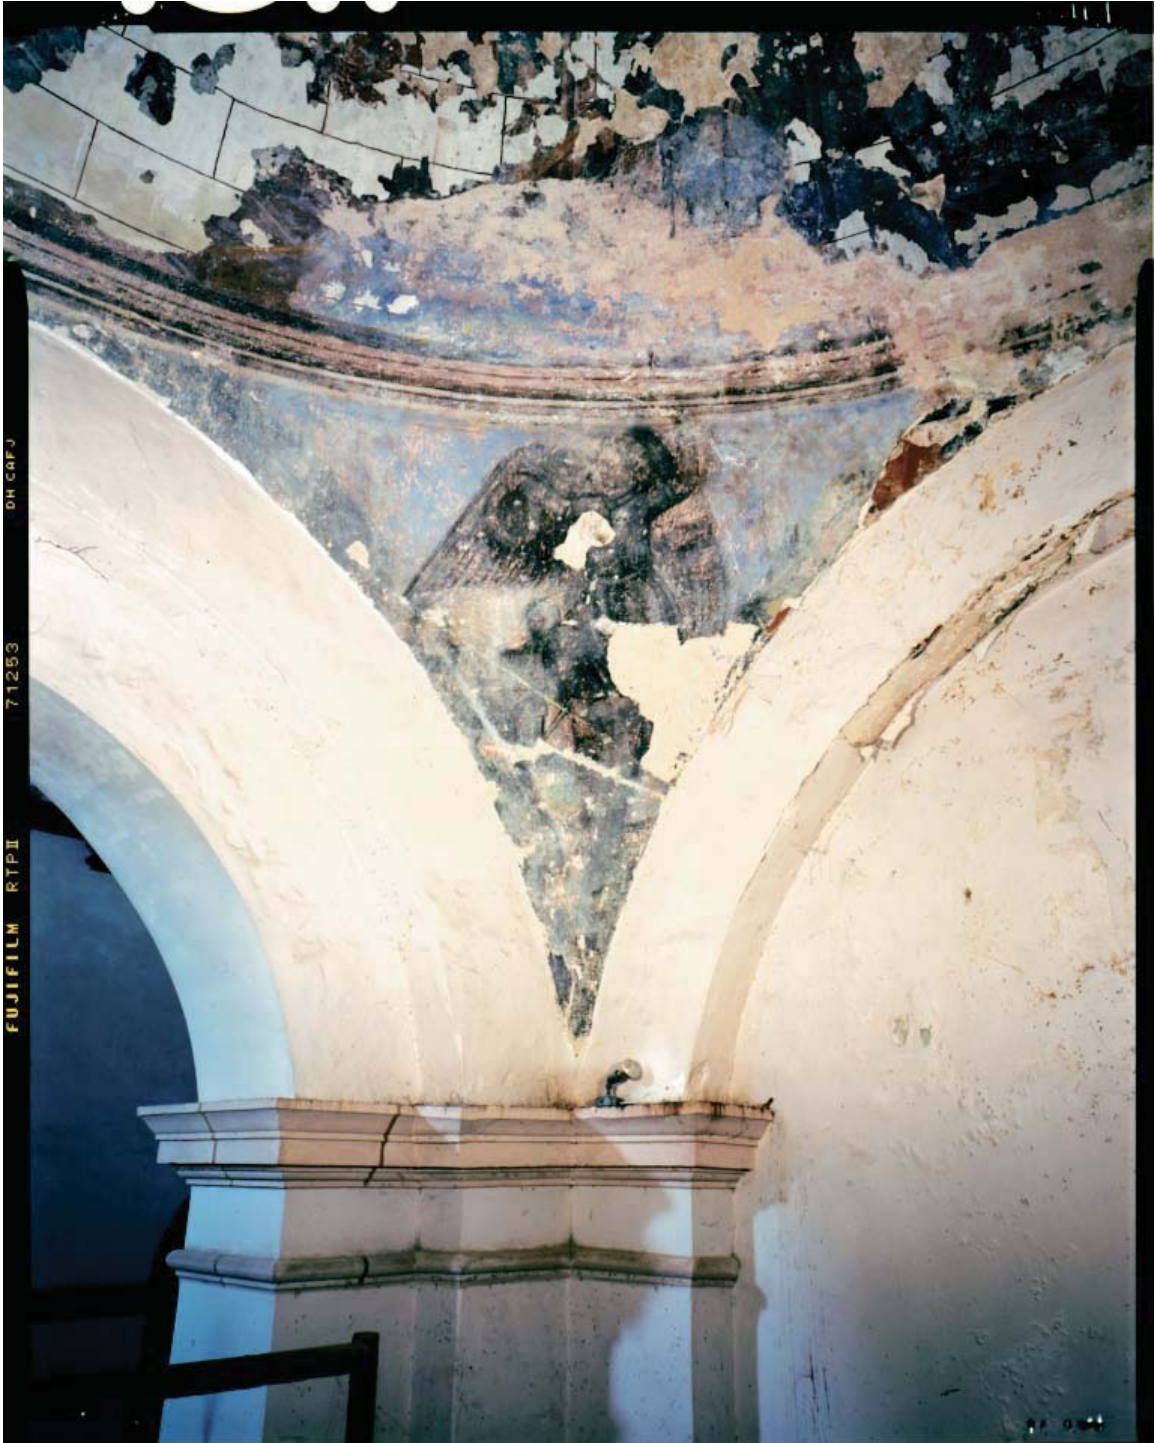
Figure 22: Pendentive 4, northeast corner of Rosario Chapel.
(Source: Joseph Elliott, 2004)

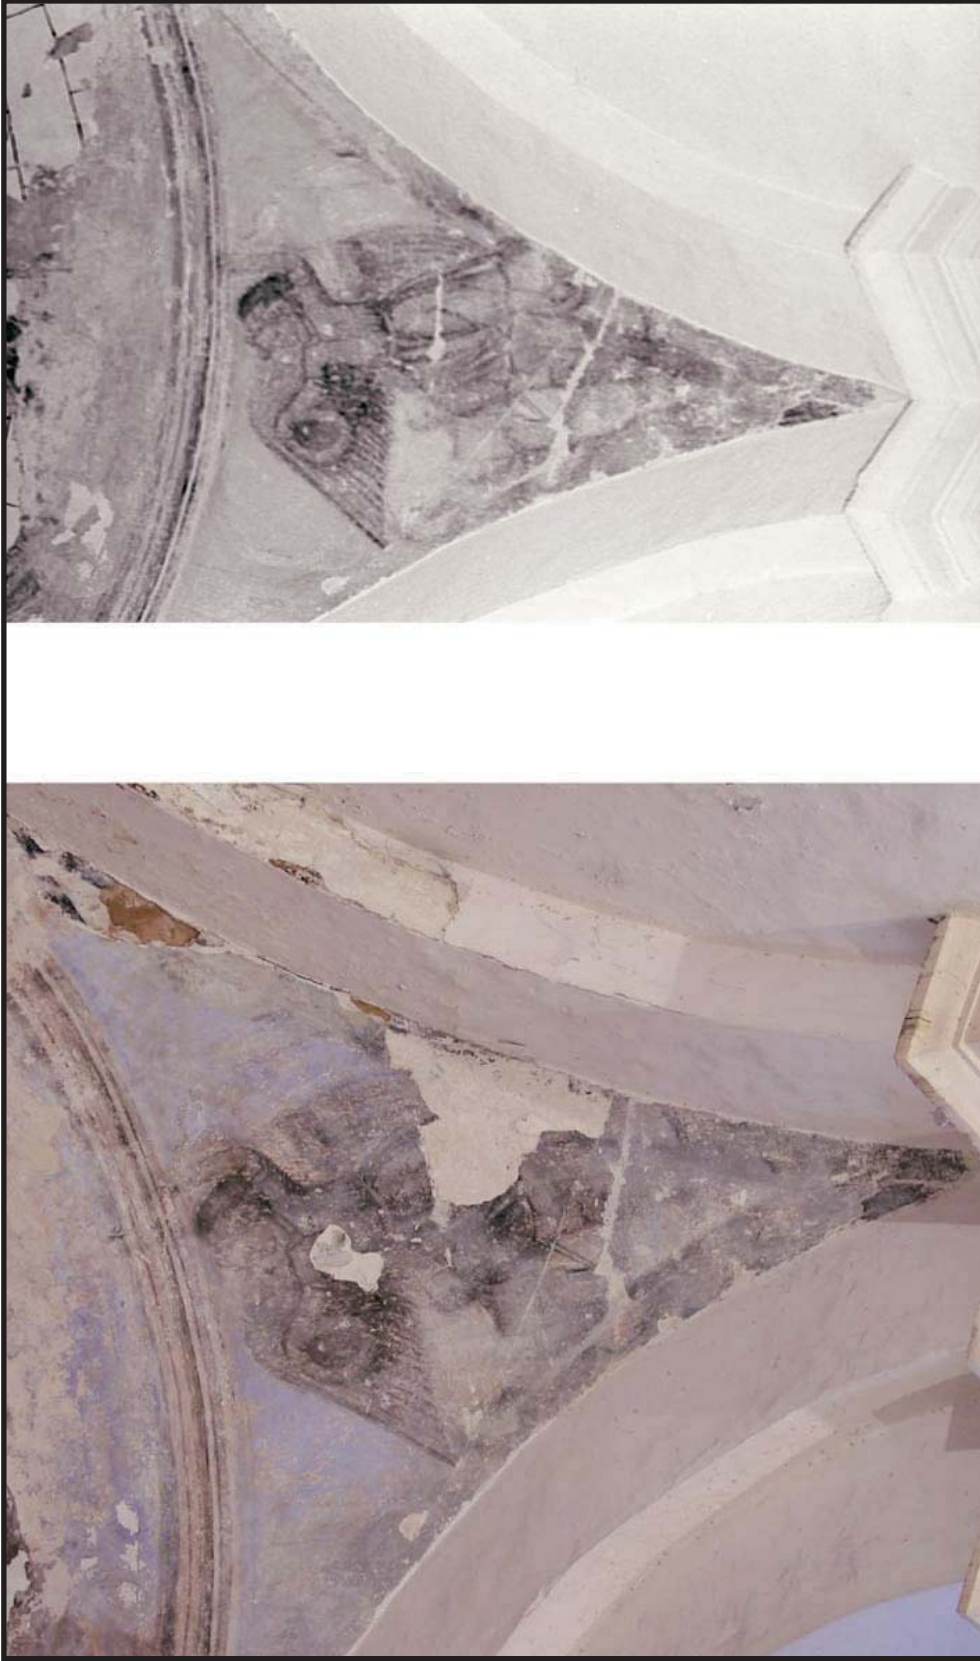
Figure 23: Photographic comparison of Pendentive 4, on the left is a 2004 image and on the right, an image taken in 1981. Note the deterioration in terms of areas of loss and image legibility over a twenty year time span. (Source: Pantel y del Cueto & Associates)

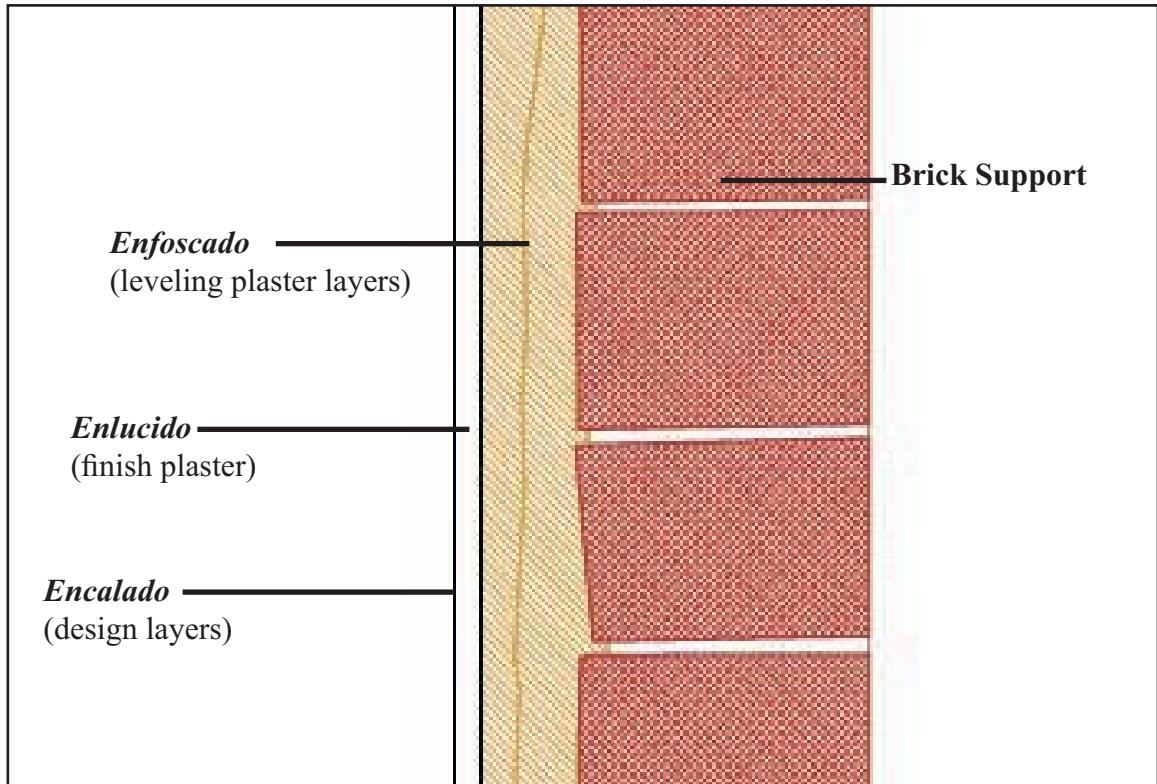
Figure 24: Schematic of masonry support, plaster substrate and design layer sequence composing the Rosario Chapel dome and pendentives.

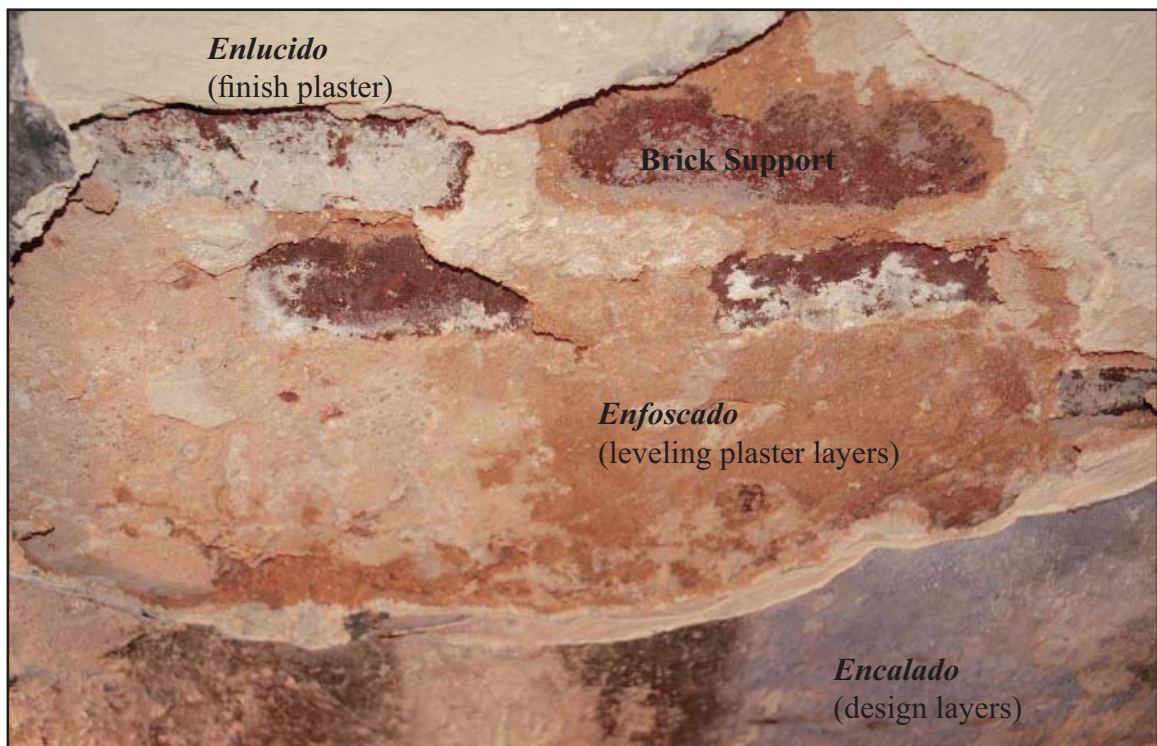
Figure 25: Detail from area of loss on Pendentive 1. (Source: C. Silva, 2006)

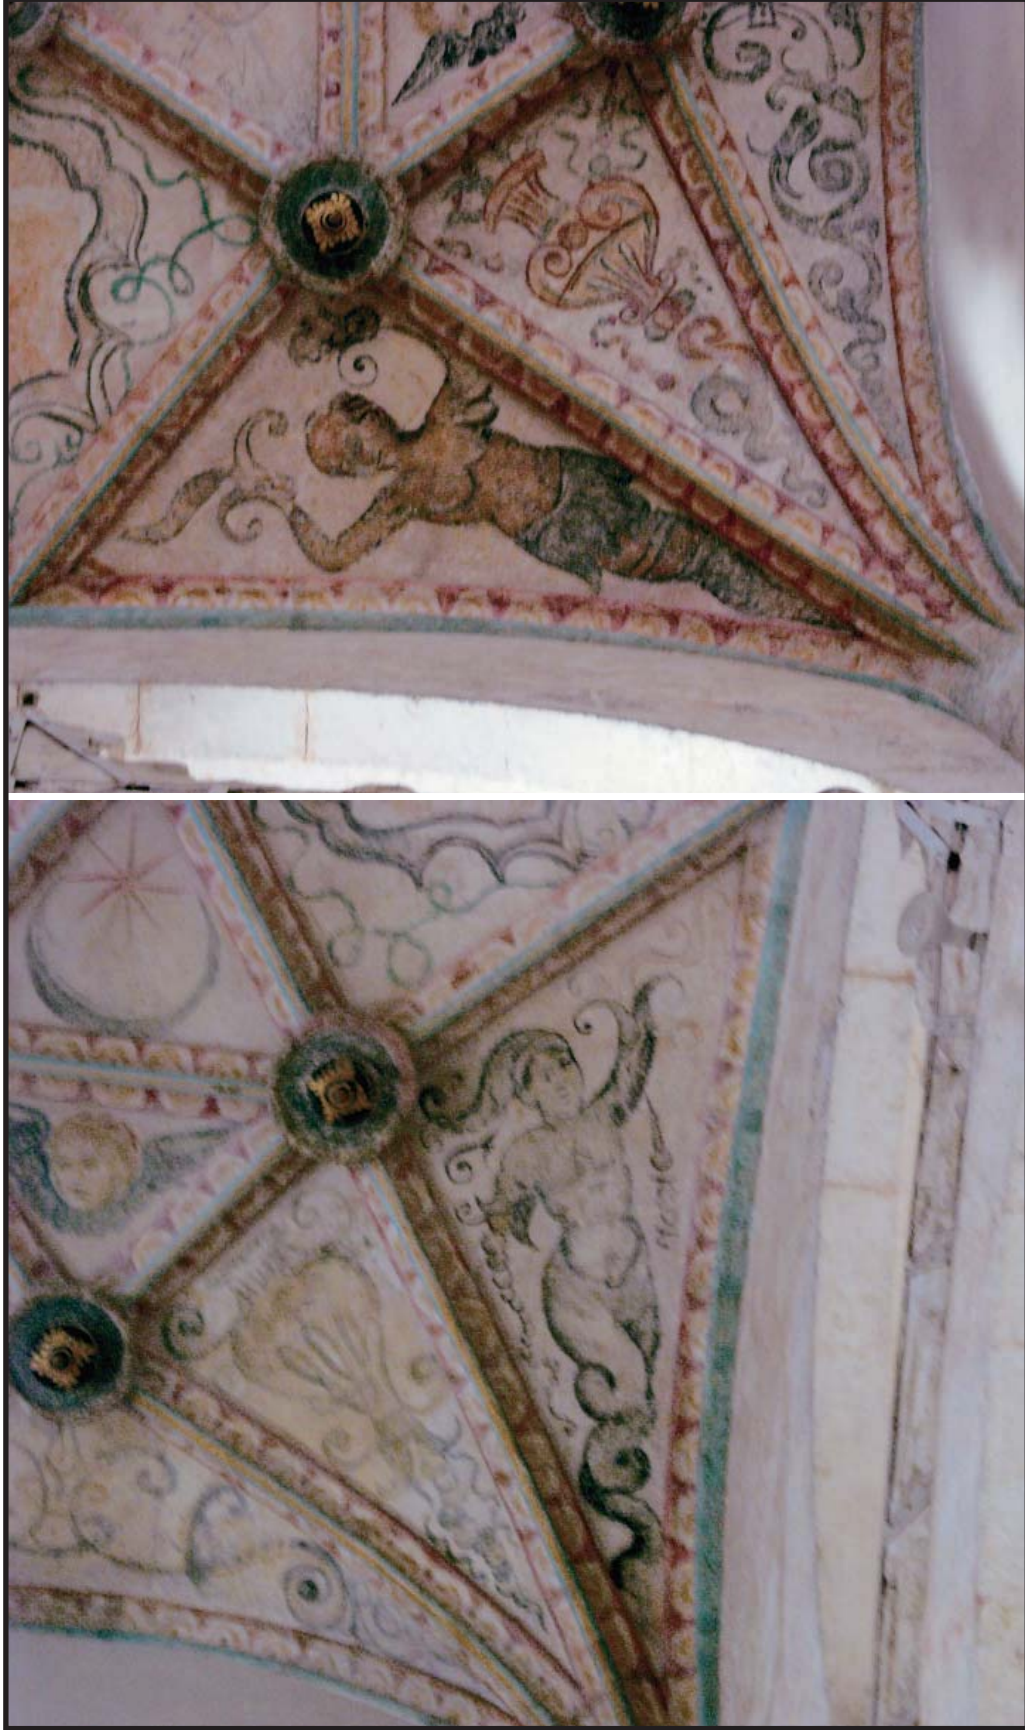
Figure 26: Mer-creatures from the Cathedral of Santa Maria la Menor, located in Santo Domingo. Paintings are thought to date from the 16th century. (Source: Pantel y del Cueto & Associates, 2005)

Clearly the most striking feature of this campaign is the monumental mer creatures (*la serena*). This unique iconography is difficult to place in an art historical context. In myth, mermaids or sirens were said to have the power to enchant sailors with their songs. They were traditionally seen as symbols of seductive temptations that must be overcome to achieve salvation.³² In the present case, the mer creatures are used in a highly untraditional manner; they adorn the Chapel of the Virgin of the Rosary, holding bouquets of roses thought to represent the rosary. This likely had local resonance for the maritime, island culture of Puerto Rico, though it does not appear to conform to dominant traditions of European Christian iconography. Mer creature (*la serena*) imagery is found in the ceiling vault paintings of the Cathedral *Santa Maria la Menor* (Figure 26), a

Mer creature imagery is found elsewhere in the Caribbean; in the ceiling vault paintings of the Cathedral *Santa Maria la Menor*, and in the relief escutcheon of the Ponce family in the Sanctuary of Iglesia San José. However, the Rosario Chapel is unique in that mer creatures are represented in monumental scale, and are the dominant iconographic features in the chapel. The mer layer is the most visually legible in the chapel, and has the greatest surface area remaining on the pendentives and potentially the dome. I believe that conservation efforts would be most successful if the dome and pendentives were restored to the first campaign (A). This would allow the chapel to be read as a single scheme rather than the fractured and visually confusing space that exists

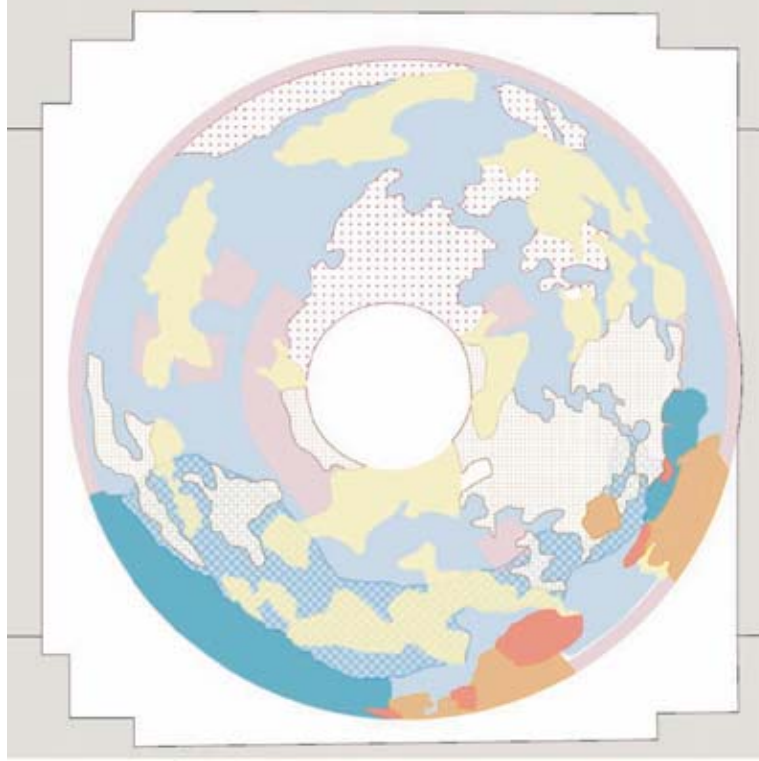
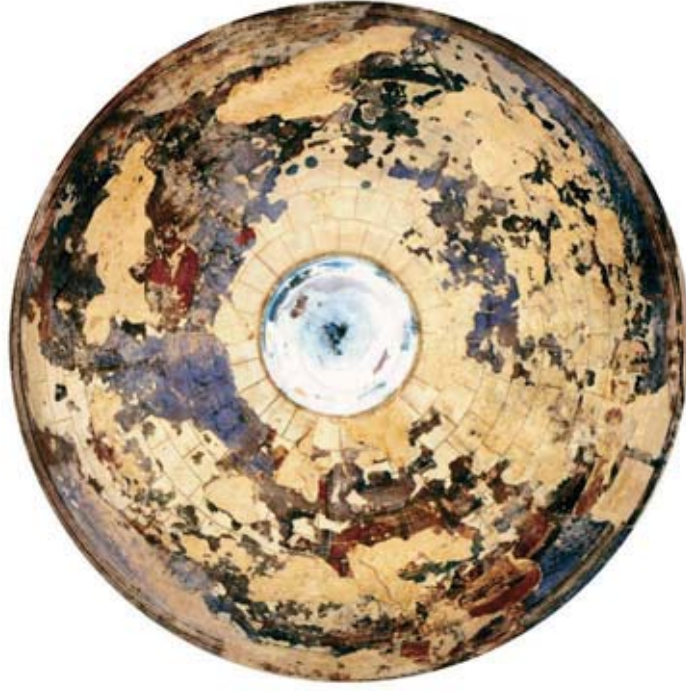
A1, Map 1: Painting Campaign Map, Rosario Chapel Dome

IGLESIA SAN JOSÉ, SAN JUAN PUERTO RICO
ROSARIO CHAPEL DOME
 Extant Mural Campaigns

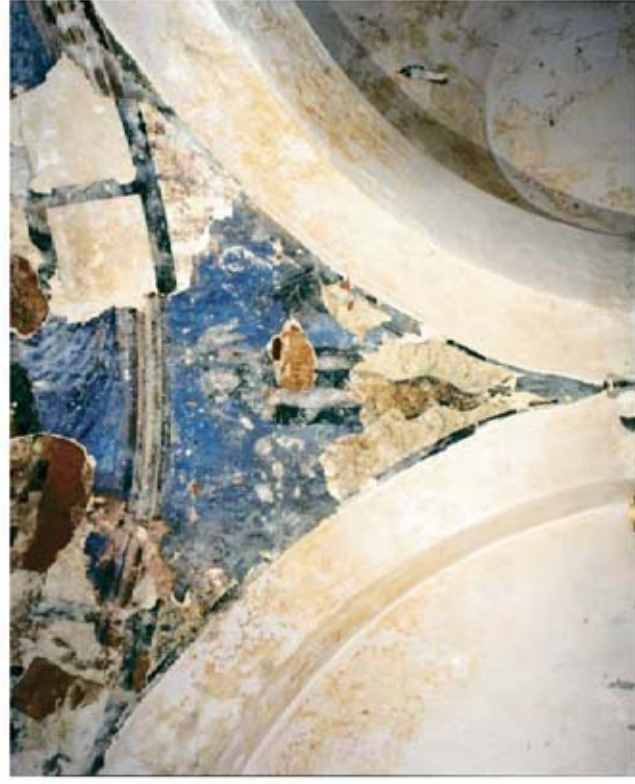
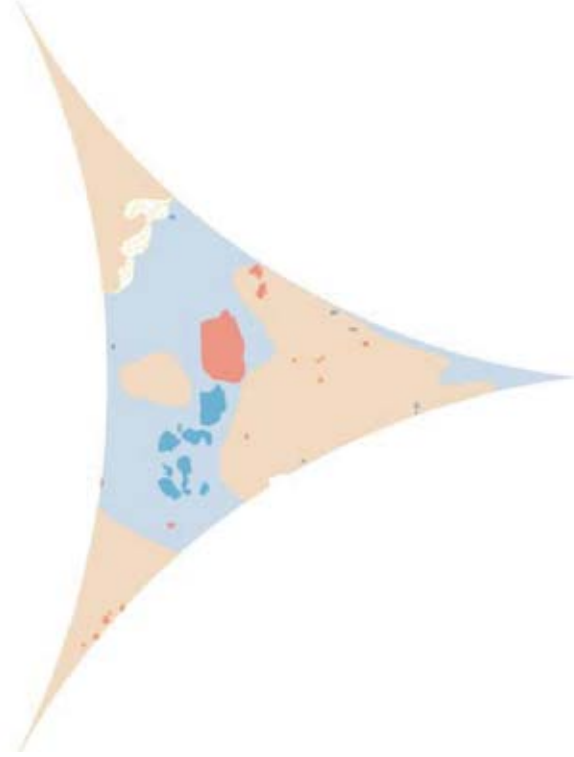
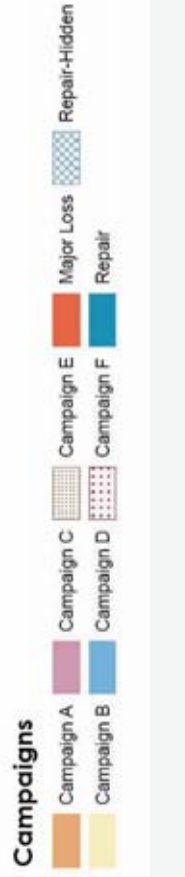
A2, Map 2: Painting Campaign Map, Rosario Chapel, Pendentive 1

IGLESIA SAN JOSÉ, SAN JUAN PUERTO RICO
ROSARIO CHAPEL PENDENTIVES
 Pendentive 1: Extant Mural Campaigns

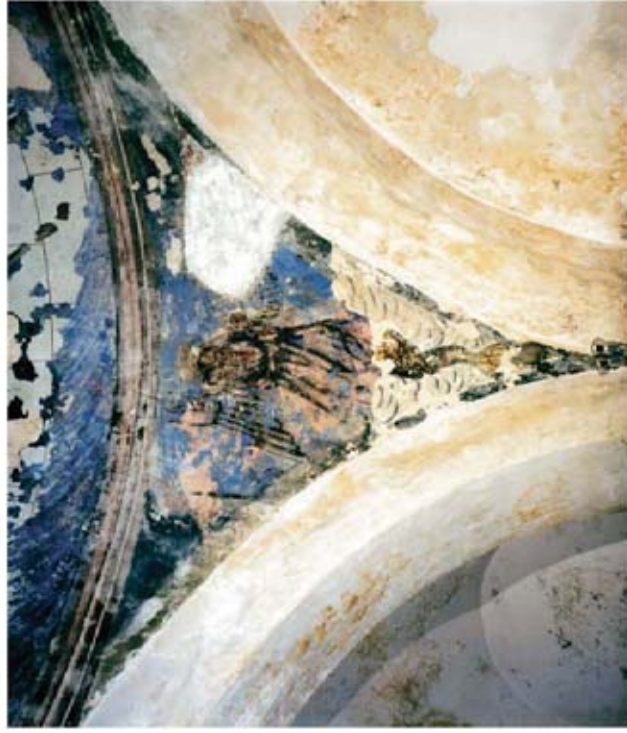
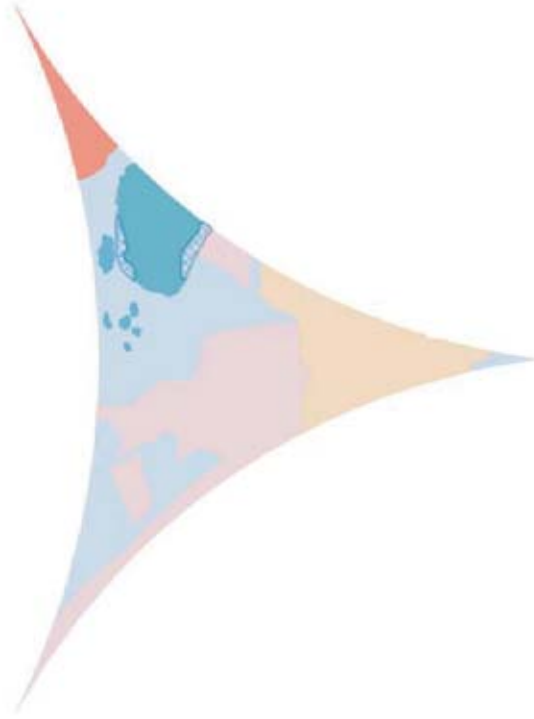
A3, Map 3: Painting Campaign Map, Rosario Chapel, Pendentive 2

IGLESIA SAN JOSÉ, SAN JUAN PUERTO RICO
ROSARIO CHAPEL PENDENTIVES
 Pendentive 2: Extant Mural Campaigns

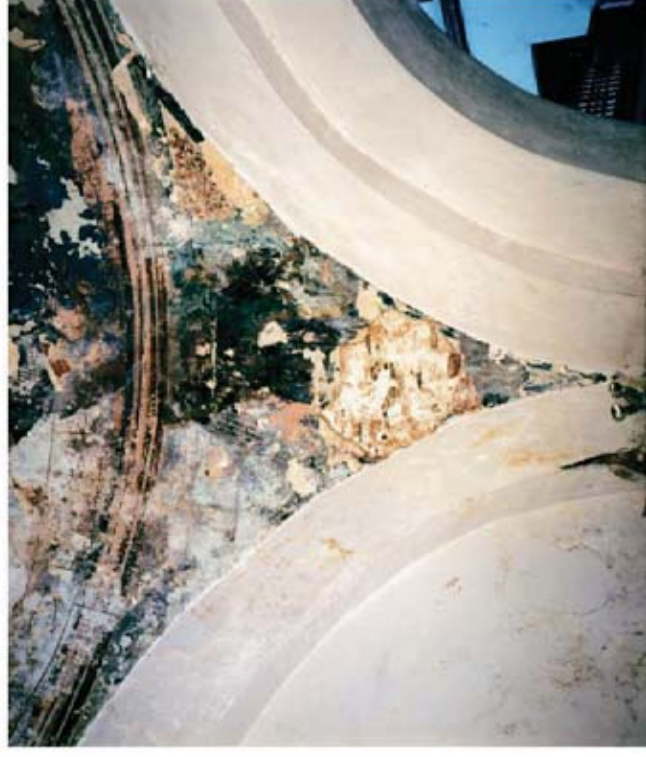
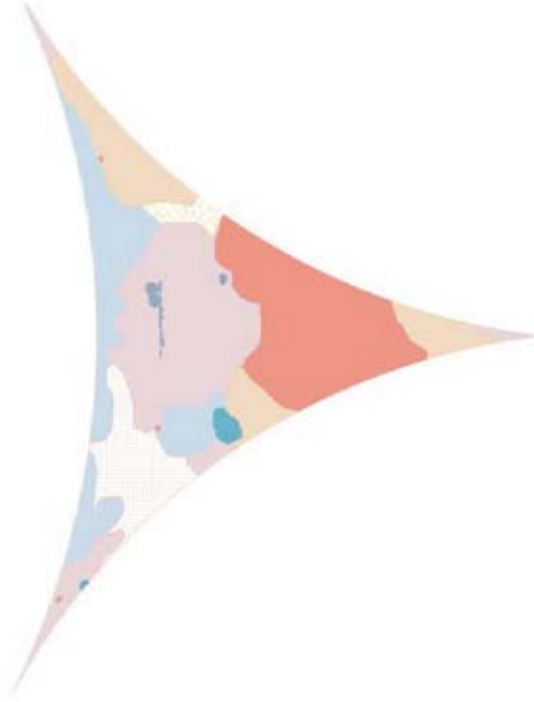
A4, Map 4: Painting Campaign Map, Rosario Chapel, Pendentive 3

IGLESIA SAN JOSÉ, SAN JUAN PUERTO RICO
ROSARIO CHAPEL PENDENTIVES
 Pendentive 3: Extant Mural Campaigns

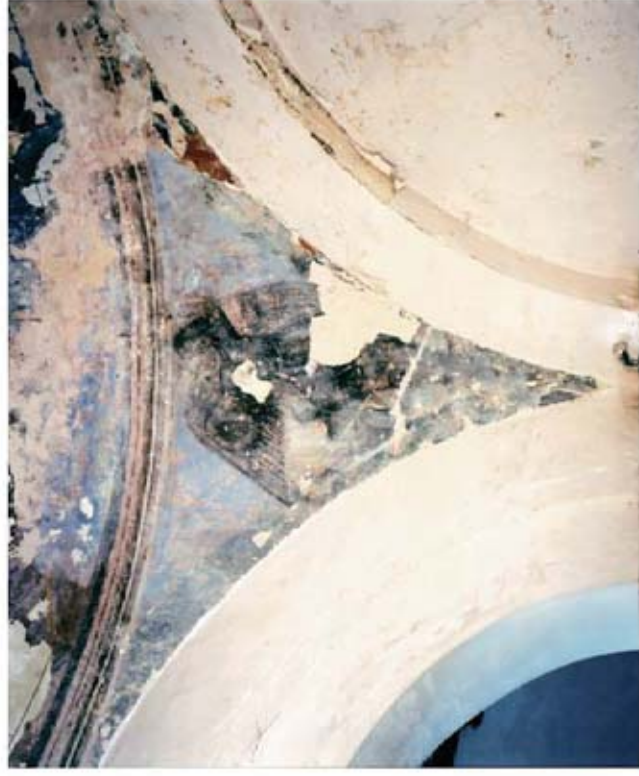
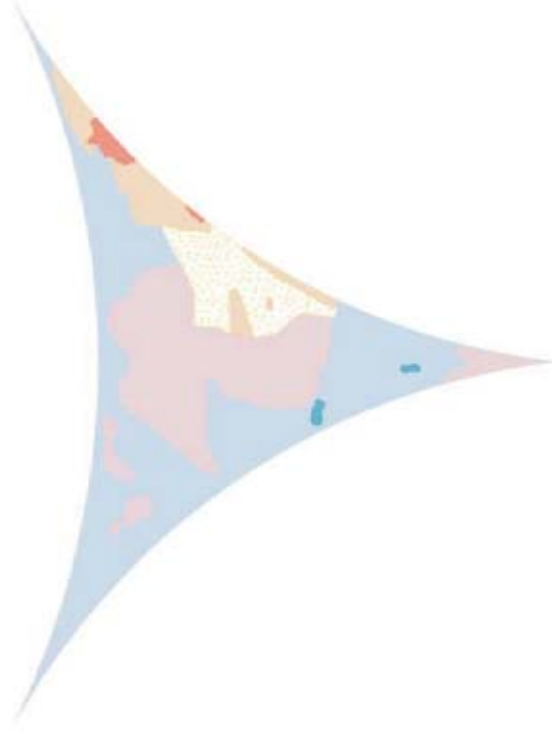
A5, Map 5: Painting Campaign Map, Rosario Chapel, Pendentive 4

IGLESIA SAN JOSÉ, SAN JUAN PUERTO RICO
ROSARIO CHAPEL PENDENTIVES
 Pendentive 4: Extant Mural Campaigns

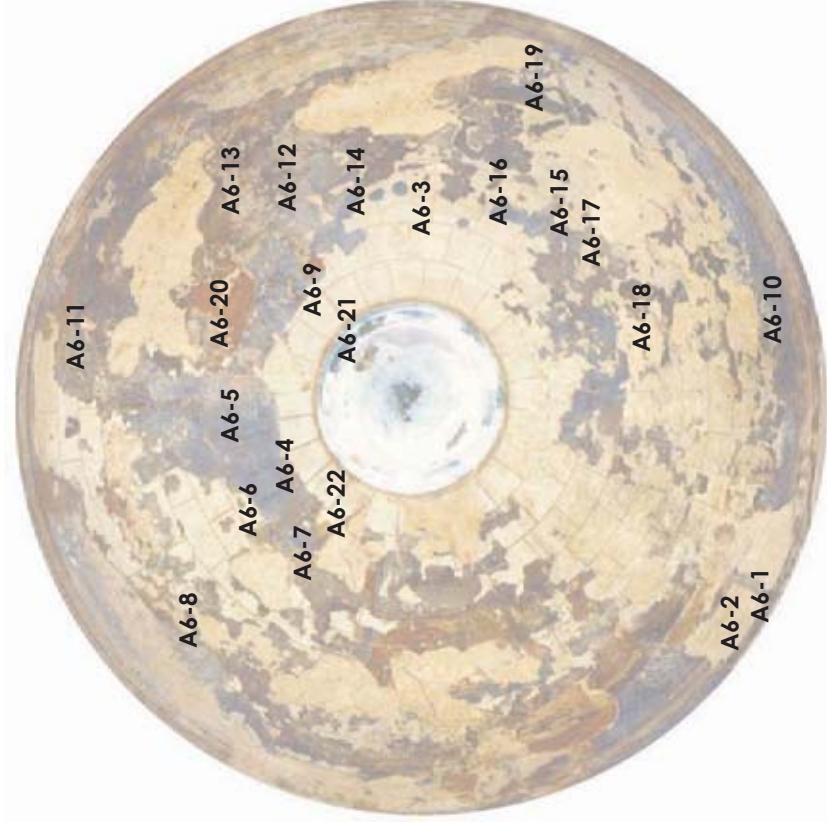
A6, Map 6: Map of Dome with Detail Locations

IGLESIA SAN JOSÉ, SAN JUAN PUERTO RICO
ROSARIO CHAPEL DOME
Location of Photographic Details

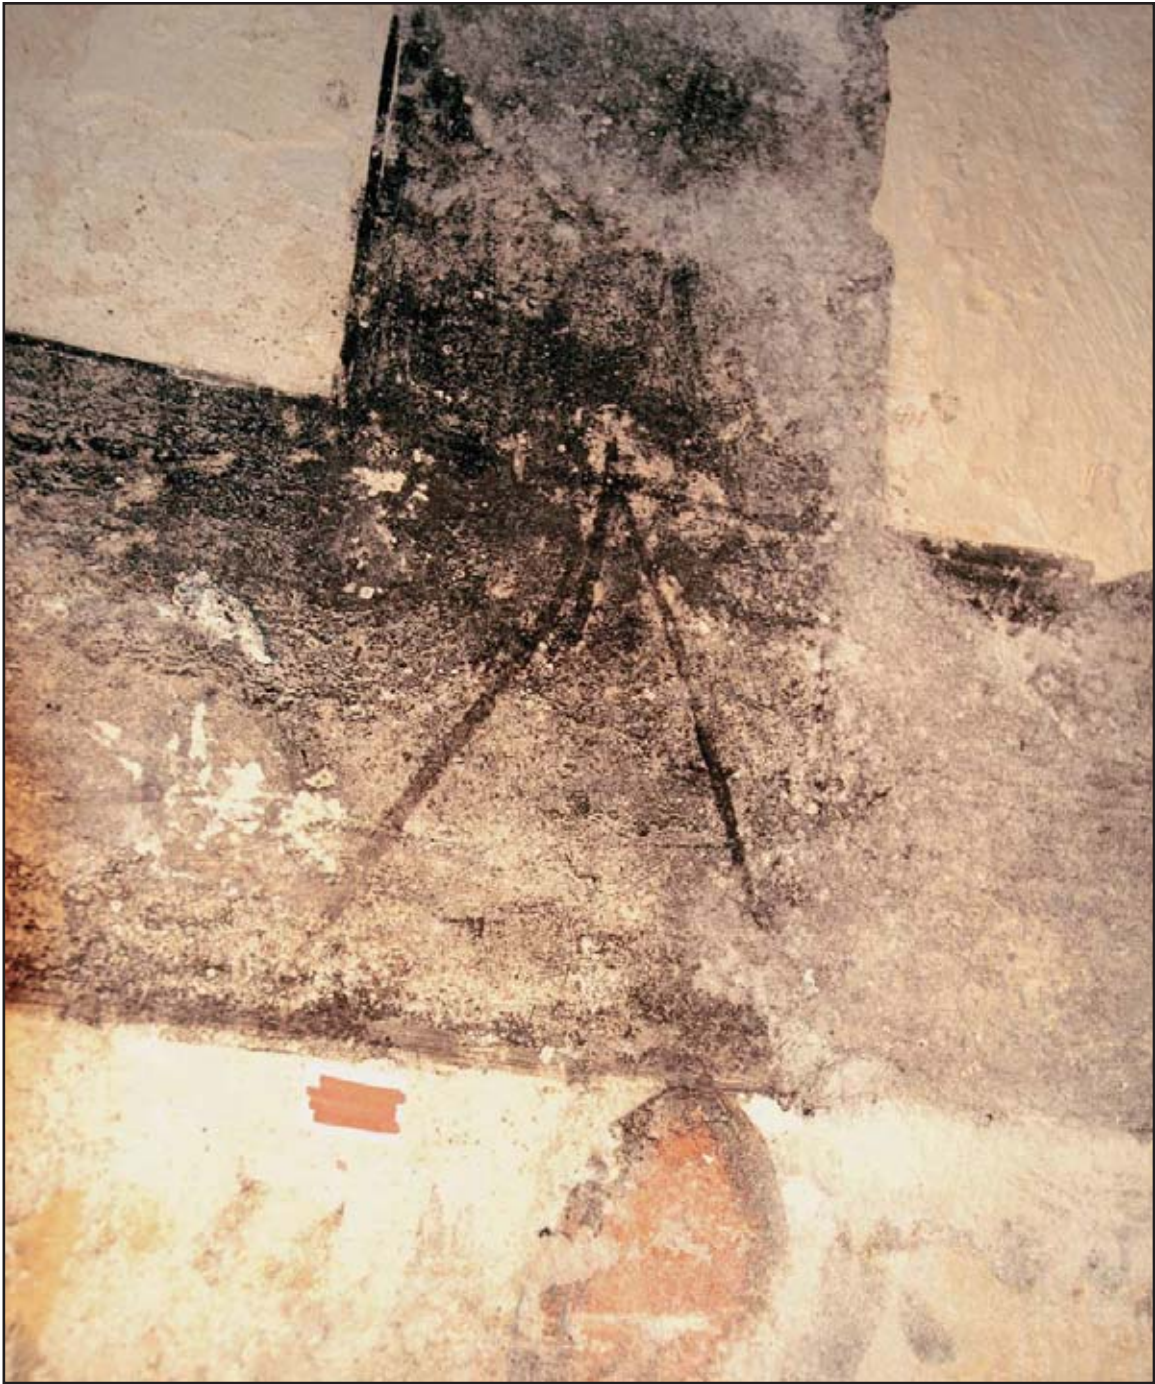
Figure 29: Detail (A6-1) Incised lines used to layout painting, Campaign A
(Source: C. Silva, 2005)

Incised lines and other marks, made while the plaster was still wet, were evident along the base of the dome and along the edge of some of the pendentive's black framing elements. These incised lines demarcate the width of the thick black band along the base of the dome as well as mark the center points of the vertical joint lines, creating the faux ashlar blocks which appear to move up into the dome. They were probably incised to help guide the layout and over designs (Figure 29). Large brush marks, approximately two inches in width are visible within the black bands which were loosely applied within the boundaries of the incised lines and junctions between architectural elements. The black bands accentuate the architectural forms that delineate the Rosario Chapel.

Incised lines and other marks, made while the plaster was still wet, are evident along the banding elements throughout the dome. These incised lines demarcate the width of the thick black banding and mark the center points of the vertical joint lines creating the faux ashlar blocks. Large brush marks, approximately two inches in width are visible within the black bands which were loosely applied within the boundaries of the incised lines and junctions between architectural elements.
