A Technical Study of the Mural Paintings of the Interior Dome of the Capilla de la Virgen del Rosario, Iglesia San José, San Juan, Puerto Rico

Presented to the Faculties of the University of Pennsylvania in Partial Fulfillment of the Requirements for the Degree of Master of Science in Historic Preservation 2006.

**A TECHNICAL STUDY OF THE MURAL PAINTINGS ON THE INTERIOR
DOME OF THE CAPILLA DE LA VIRGEN DEL ROSARIO,
IGLESIA SAN JOSÉ, SAN JUAN, PUERTO RICO**

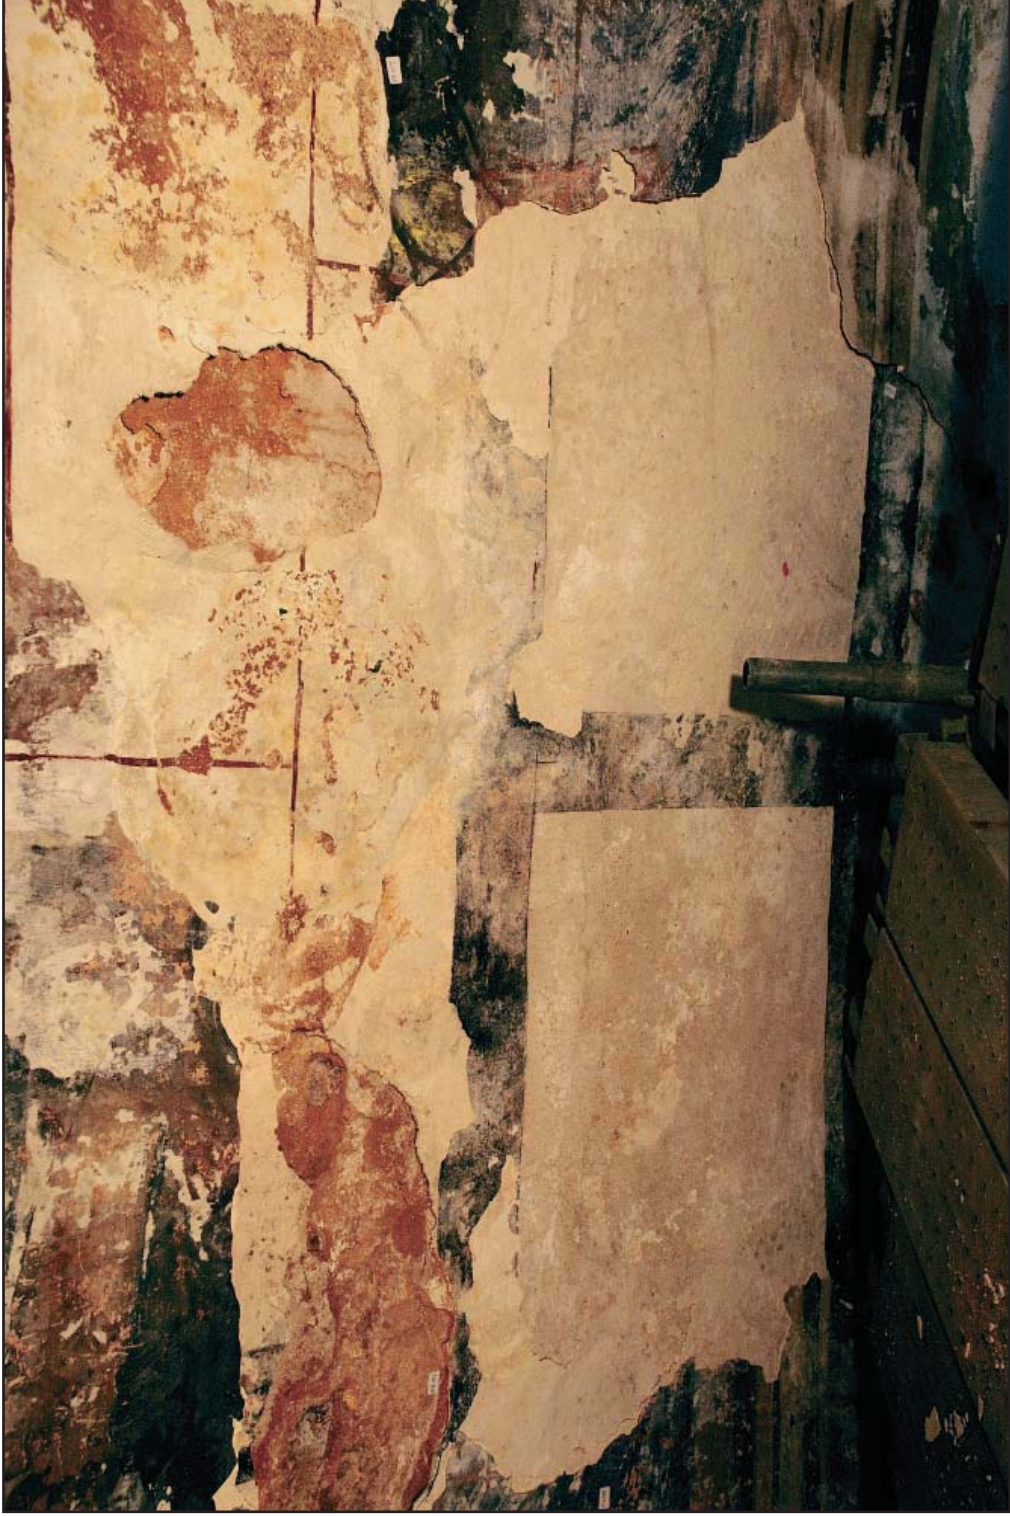
Figure 30: Detail (A6-2) Ashlar motif evident in the dome, Campaign A (Source: C. Silva, 2006)

A faux ashlar motif decorates the dome, giving the illusion of a stone block dome. This is a simple abstract scheme using thick black lines to create the joints between the blocks and the white of the unpainted *enlucido* to form the blocks themselves (Figure 30). Three horizontal bands are presently exposed, the bottom edge of the dome is defined by a 6" thick black band, and the second band is 5" thick and located 24" above the first. A third band is only partially exposed but lies 22" above the second band, (the thickness is unknown). Vertical lines between the first and second bands are 4 ½" thick and are placed approximately 48" apart. The second tier of vertical lines, between the second and third bands, are 4 ¼" thick and are offset by 24" from the center of the vertical lines from the first tier.

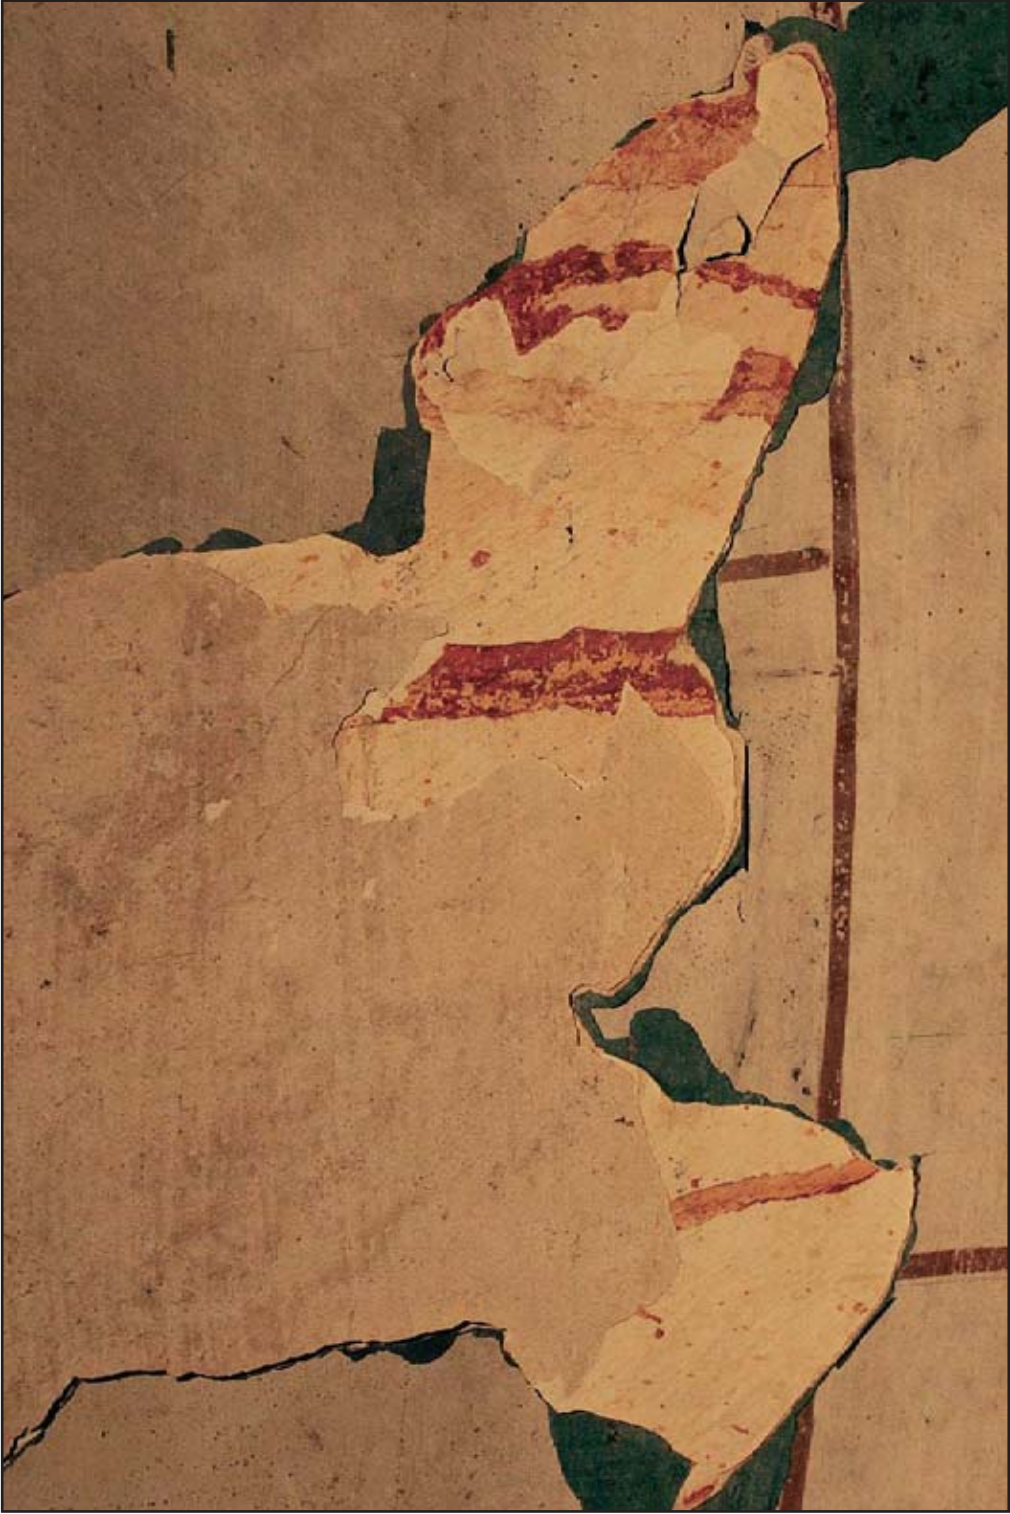
Figure 31: Detail (A6-3). Red marbalizing, Campaign B under later limewashes. (Source: C. Silva, 2006)

Campaign B is the same for the dome, pendentives and arches. A very abstract faux marbleizing technique is executed in red on a white ground, representing veined marble (Figure 31). No other decorative motifs were observed in association with this campaign; however their existence cannot be discounted at this time.

This design layer appears to have been executed in water soluble paint applied to a white lime wash ground. There is no evidence of incised lines, pouncing or under drawing. The red faux marble veins have been applied using loose, freehand strokes with a soft, long haired brush, approximately ½” in diameter pencil brush. There were no lines defining faux ashlar blocks found during site examination.

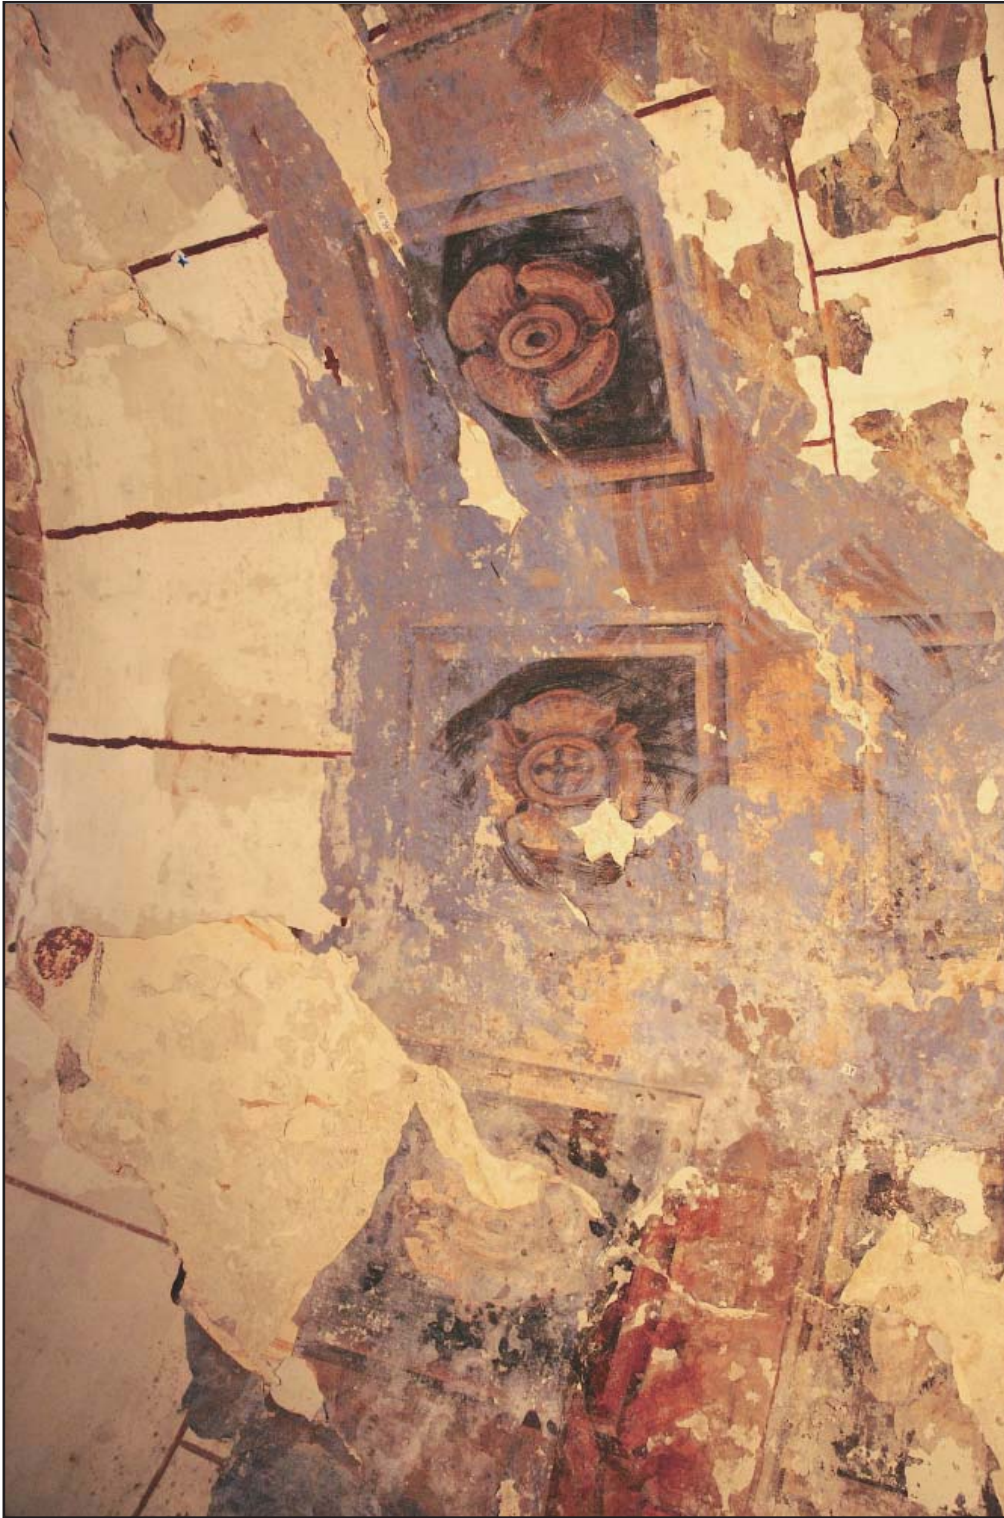
Figure 32: Detail (A6-4). Faux coffers, Campaign C. (Source: C. Silva, 2006)

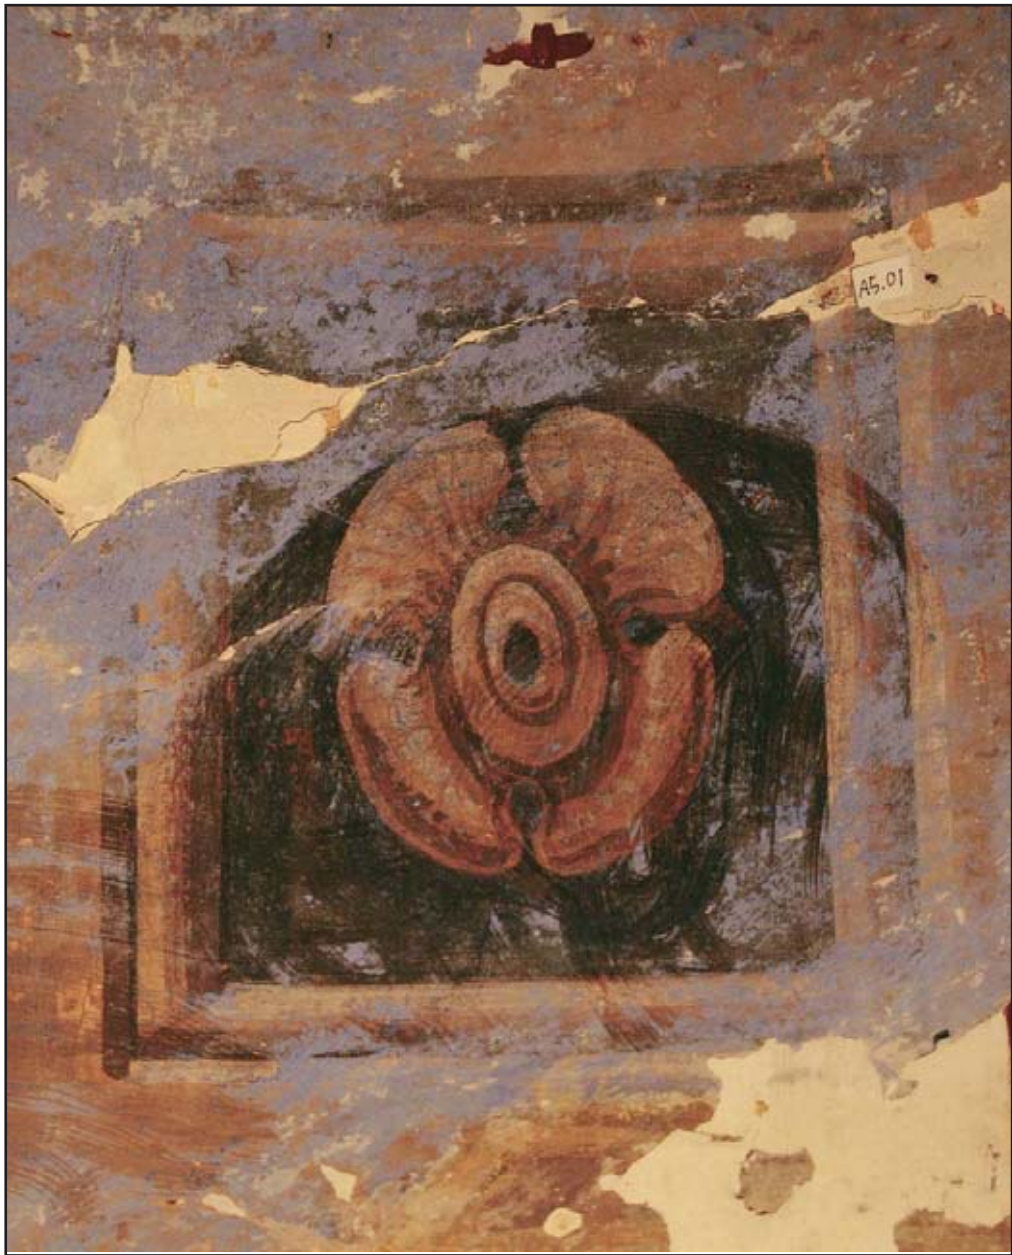
Figure 33: Detail (A6-5) Faux coffer, Campaign C (Source: C. Silva, 2006)

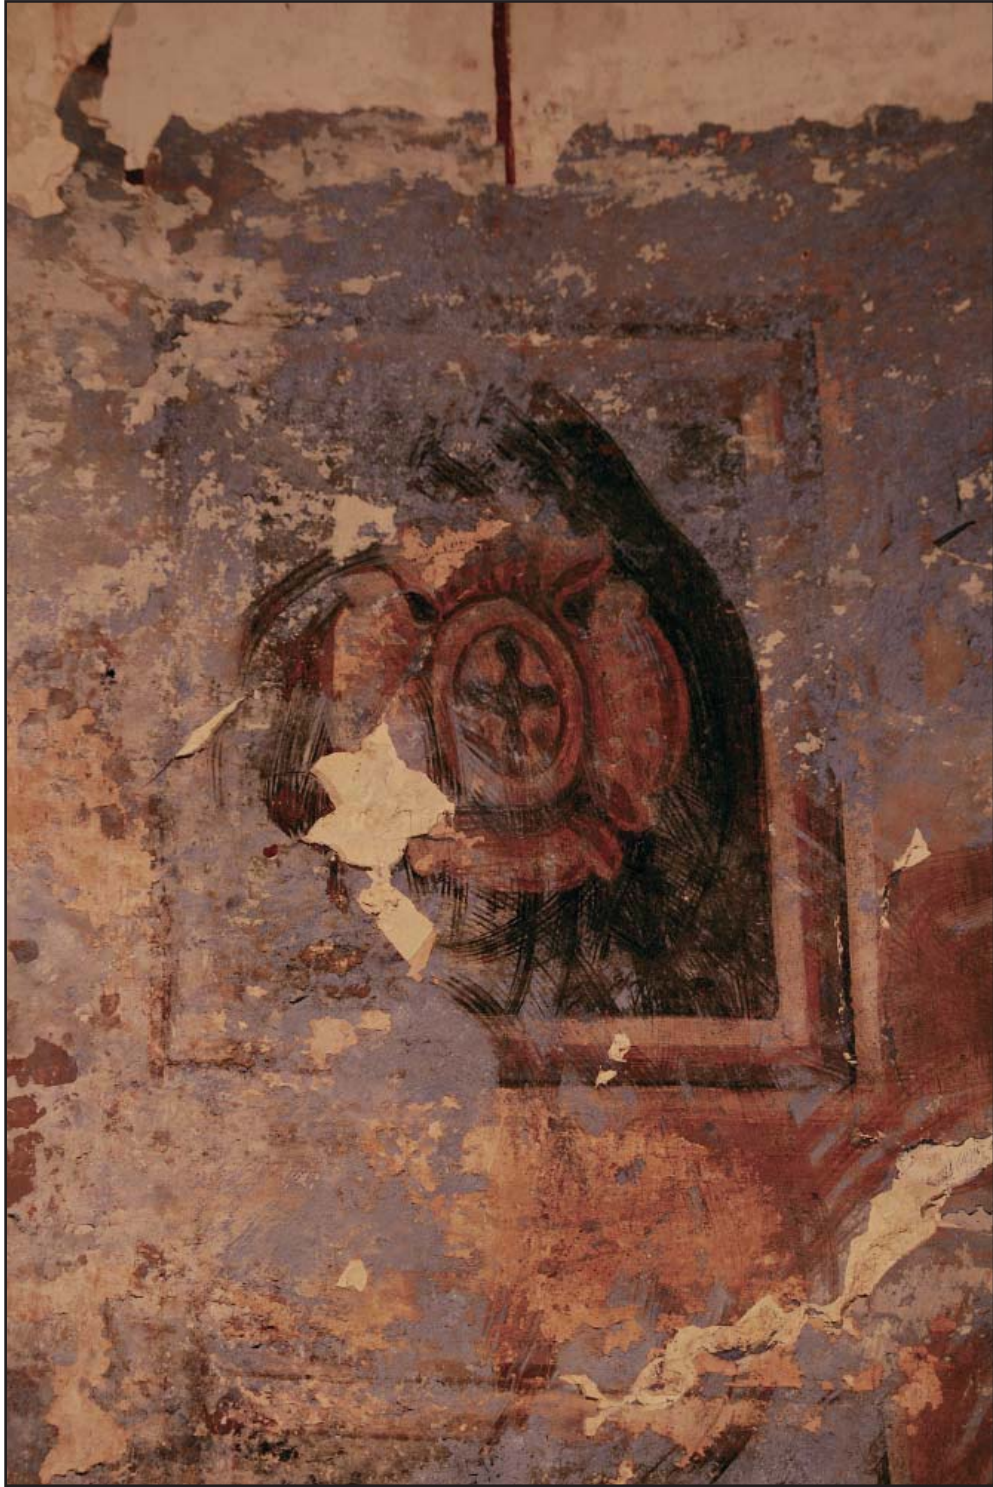
Figure 34: Detail (A6-6) Faux coffer, Campaign C (Source: C. Silva, 2006)

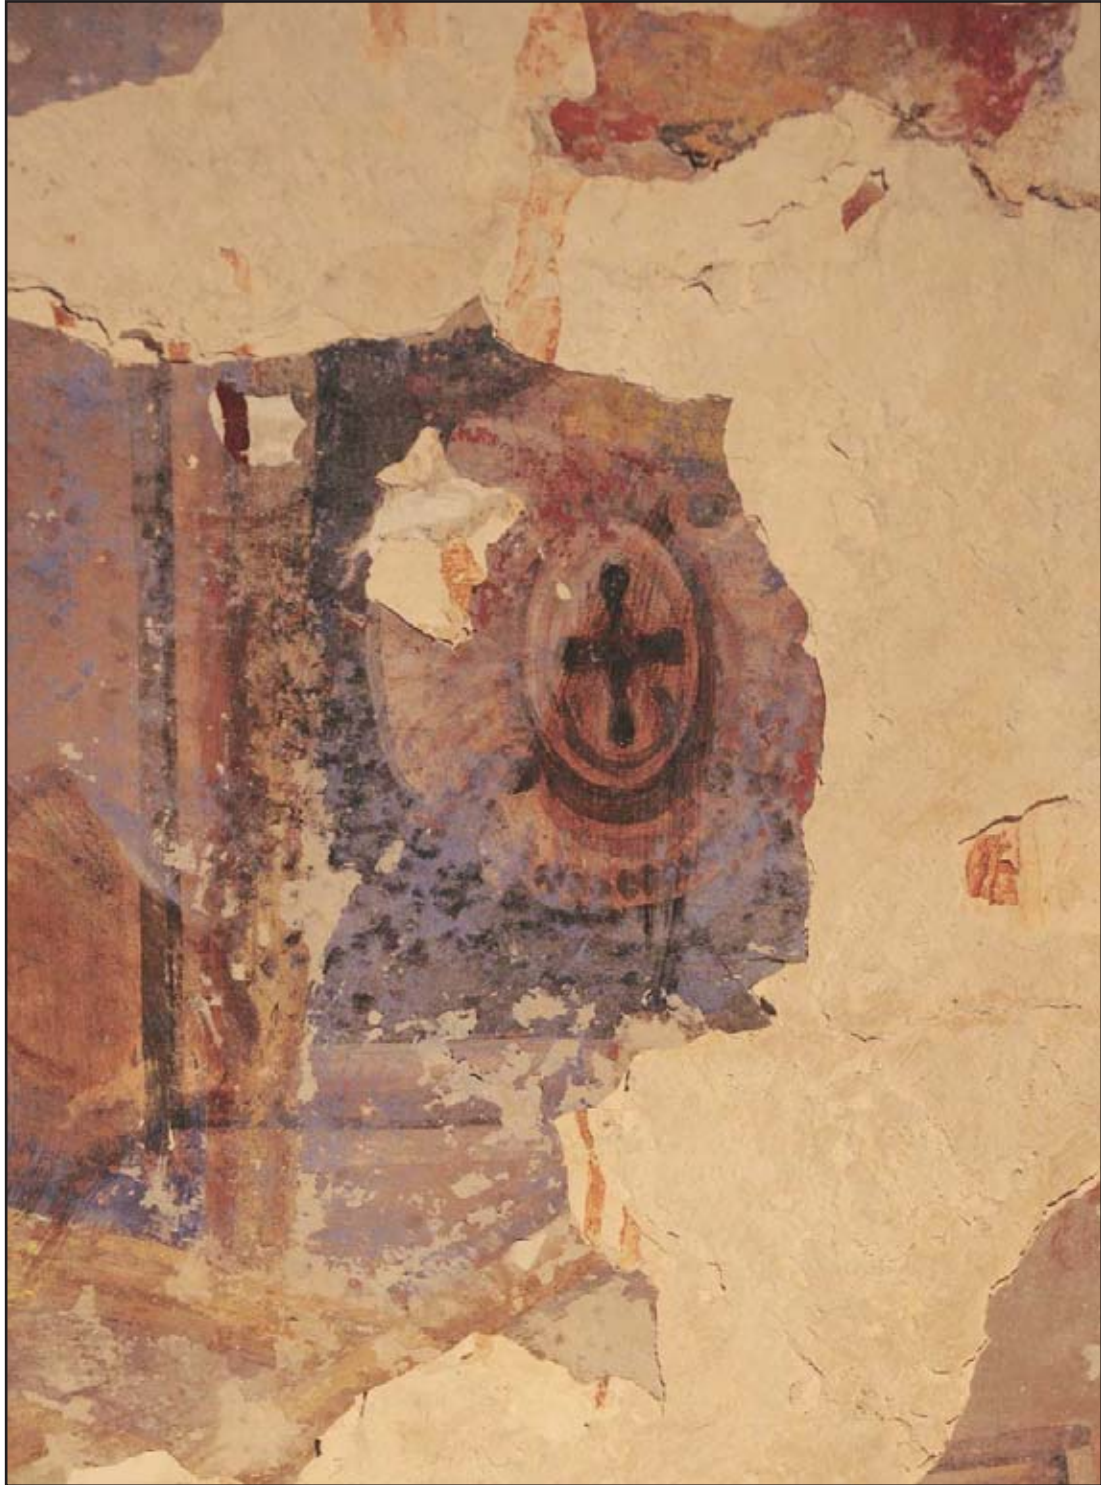
Figure 35: Detail (A6-7) Faux coffer, Campaign C (Source: C. Silva, 2006)

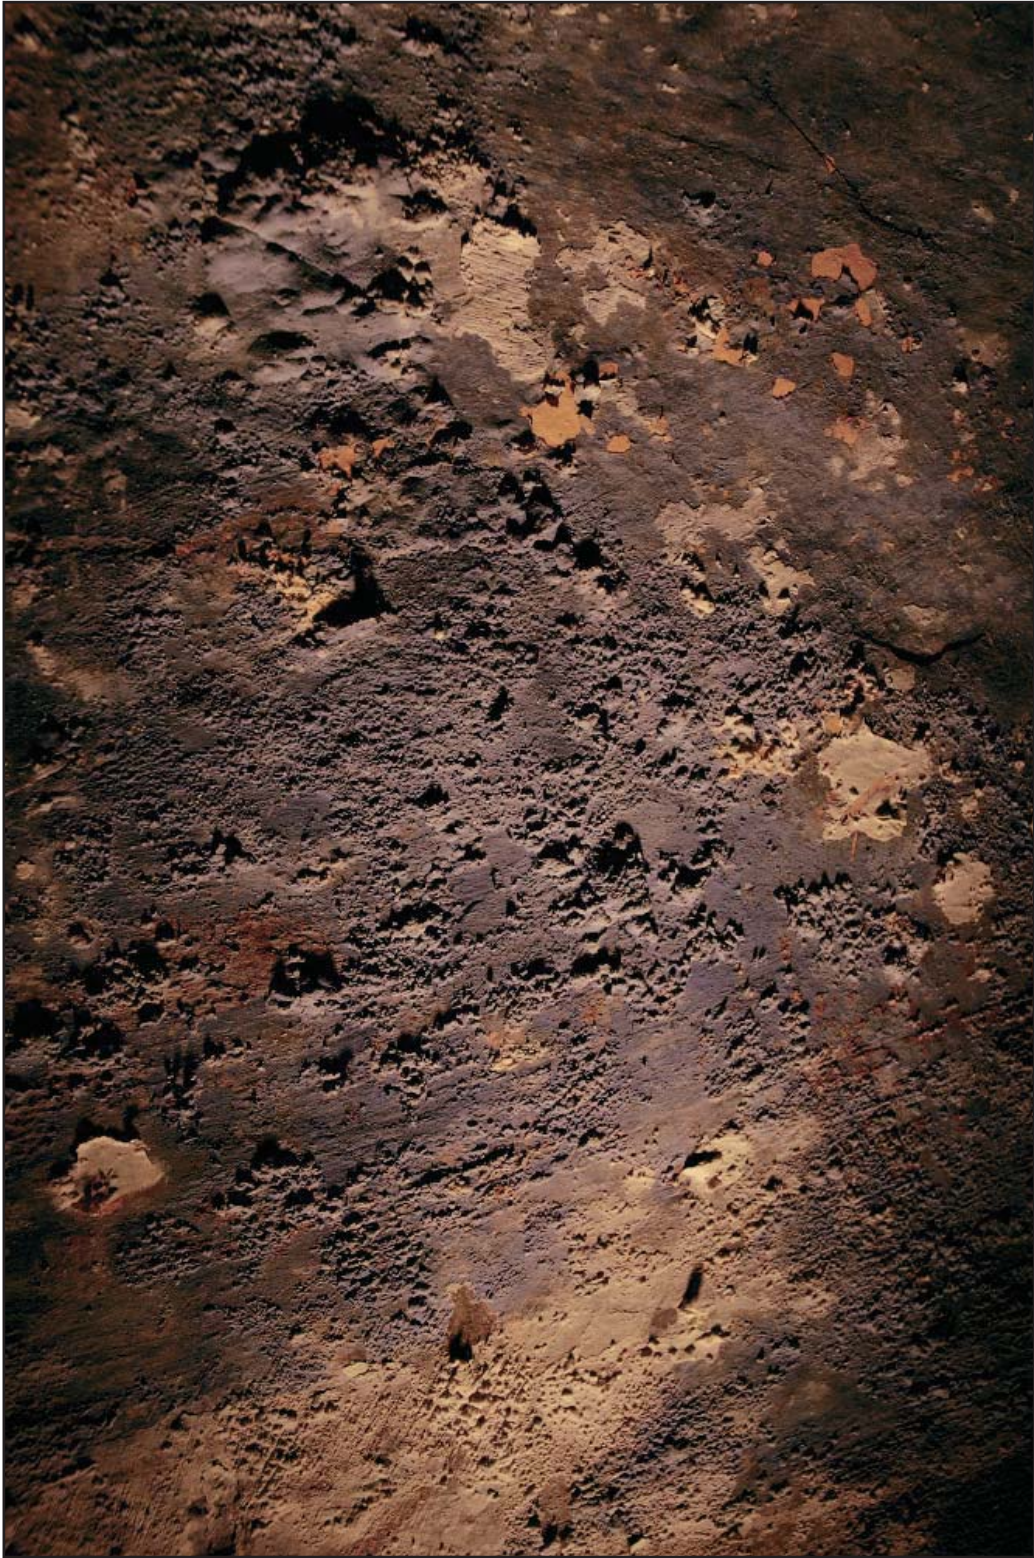
Figure 36: Detail (A6-8) Image of surface conditions: blistering, flaking, and salts. (Source: C. Silva, 2006)

Campaign D is one of the most fragile and incomplete of all the painting campaigns. What remains in most areas are friable fragments depicting partial figures. The surfaces are greatly disrupted by salts, blistering, and flaking, as seen in figure 36. This layer appears to have used an organic binder as a medium which has failed over time.

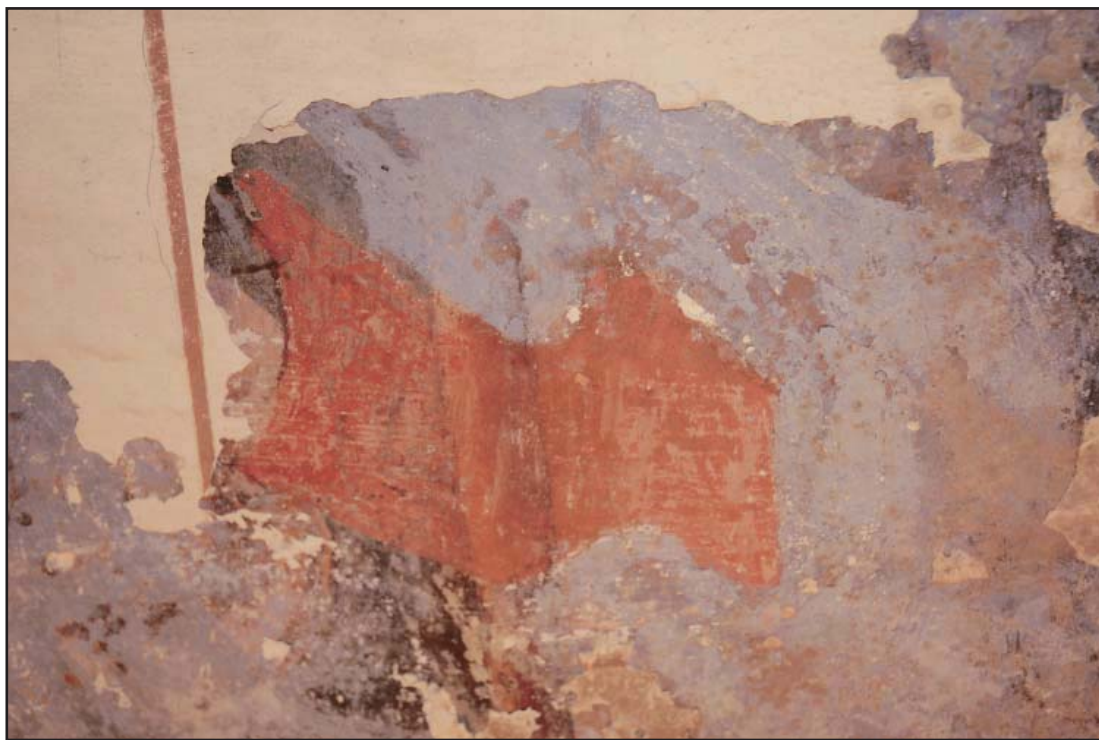
Figure 37: Detail (A6-9) Image of red flag, Campaign D (Source: C. Silva, 2006)

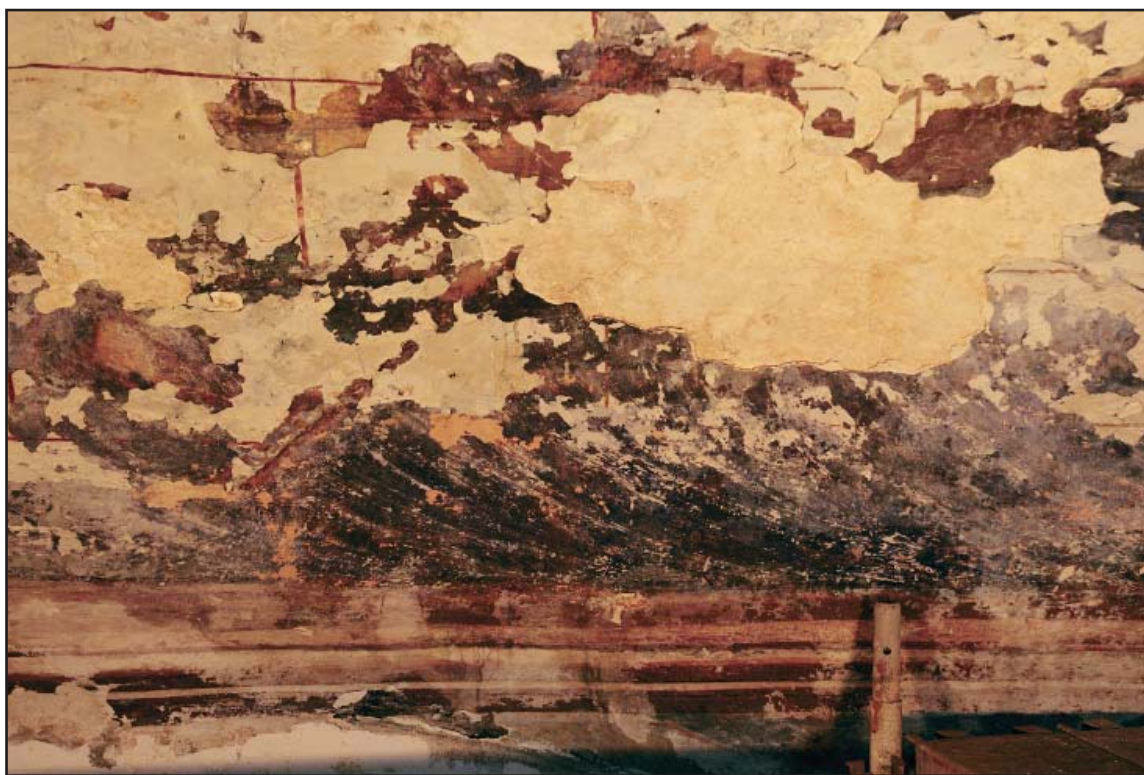
Figure 38: Detail (A6-10) Water motif at the base of the dome, Campaign D (Source: C. Silva, 2006)

This is the most complex composition in the Rosario Chapel, incorporating a figural narrative thought to depict the 1571 Battle of Lepanto. As mentioned earlier, this is an extremely fragmented campaign making legibility difficult. Much of this layer has been lost, over-painted, or has deteriorated to such an extent that earlier layers are now visually dominant. Six small galley ships can be distinguished, each equipped with multiple oars, and a single mast and sail (Map 1). The ships in the foreground measure approximately ten feet long. The bodies of the ships are painted in two to three thick horizontal bands of color (Figure 47). Above the sails fly flags in either red or blue (Figure 37). A wave motif, created by slashing strokes of blues and white (Figure 38), frames the bottom edge of the dome, providing a visual base.

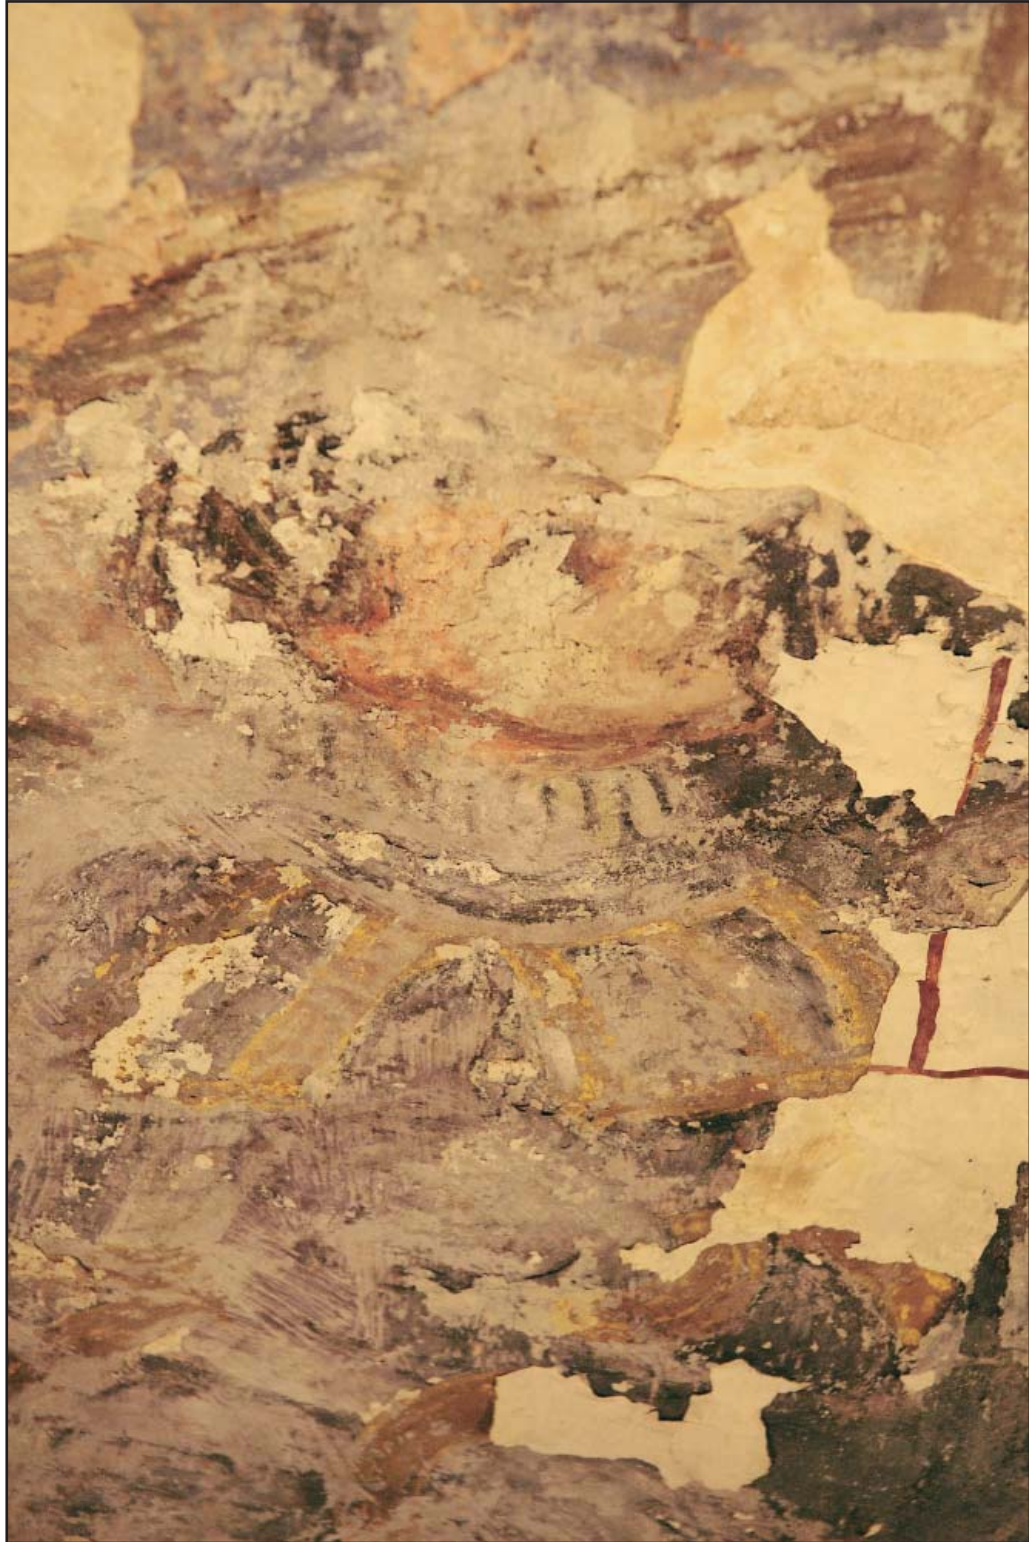
Figure 39: Detail (A6-11). Head of mariner 1, Campaign D
(Source: C. Silva, 2006)

white ruffled collar, and a dark grey uniform trimmed in gold (Figure 39). Moving counterclockwise, mariners 2 and 3 appear to be in the same galley boat and both are leaning in the same southerly direction (Figure 40). Mariner 2 appears to be wearing a grey suit of armor with a flat brimmed helmet; he is armed with a large spear and sports a curly mustache (Figure 41). The third mariner leans over the bow of the ship wearing a black uniform jacket trimmed in gold; he has longer wavy hair and a moustache (Figure 42). One of the most distinct characters is mariner 4, he stands tall on the aft of the boat and appears to be controlling the rudder (Figure 44). He wears what looks like a dark gray suit of armor his neck is completely covered and a tall helmet protects his head. He is armed with a large, sword with a gold handle sheathed in a brown leather belt. The fifth mariner has only his head exposed with what looks like short-cropped hair, a beard and mustache (Figure 45). Mariner 6 is similarly obscured with only a tall helmet and part of his face exposed (Figure 46). Mariners 4, 5 and 6 all appear to be aboard the same boat (Figure 43). There are a number of vault forms which resemble small enclosures characteristic of ships from this period. They sit higher up on the dome perhaps to place them in the background (Figure 48). The eastern half of the dome is difficult to understand visually, although the palette makes a definite shift moving from blue to ochre and green, (possibly depicting the shores of Lepanto).

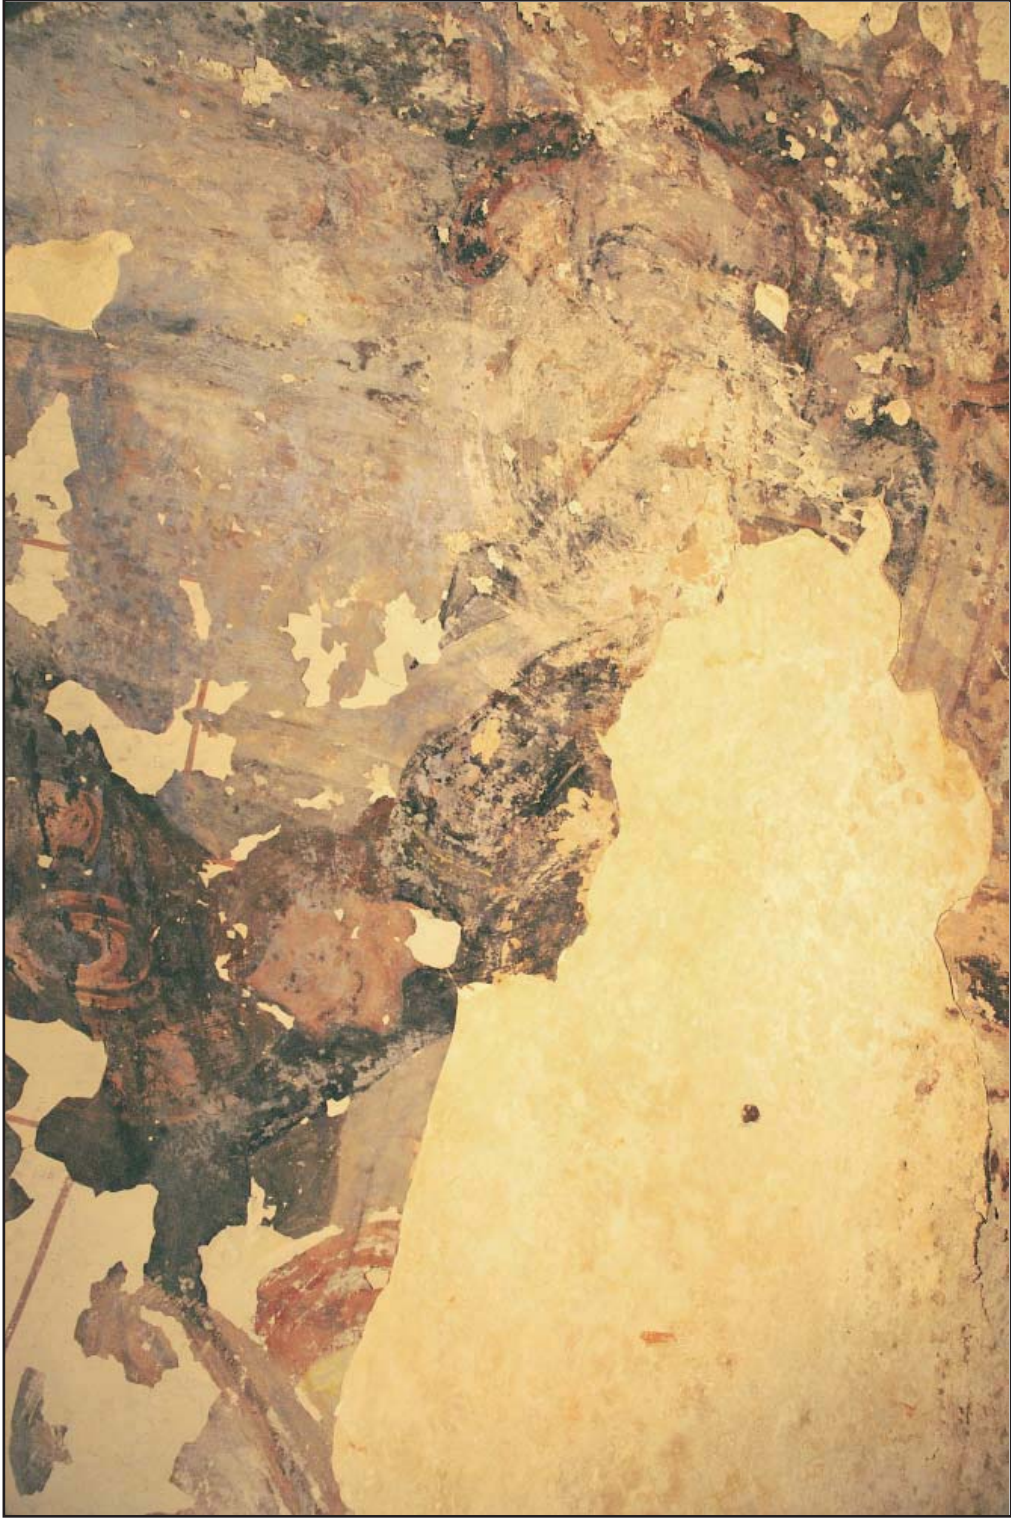
Figure 40: Detail (A6-12) Image of mariners 2 and 3, Campaign D (Source: C. Silva, 2006)

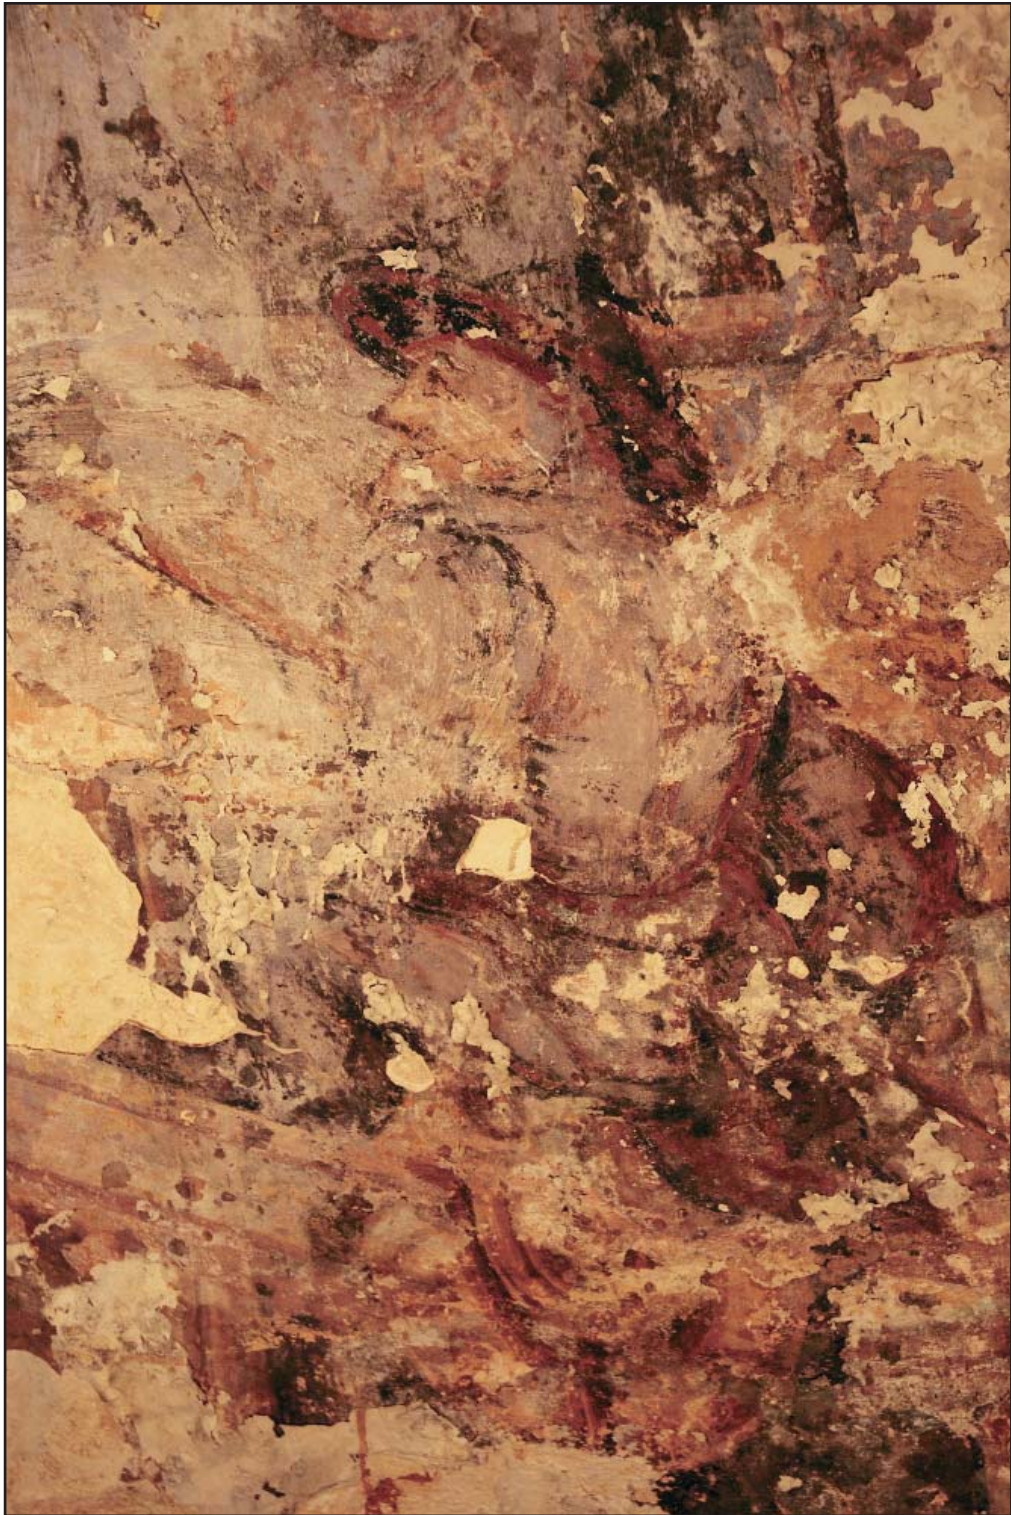
Figure 41: Detail (A6-13) Image of mariner 2, Campaign D
(Source: C. Silva, 2006)

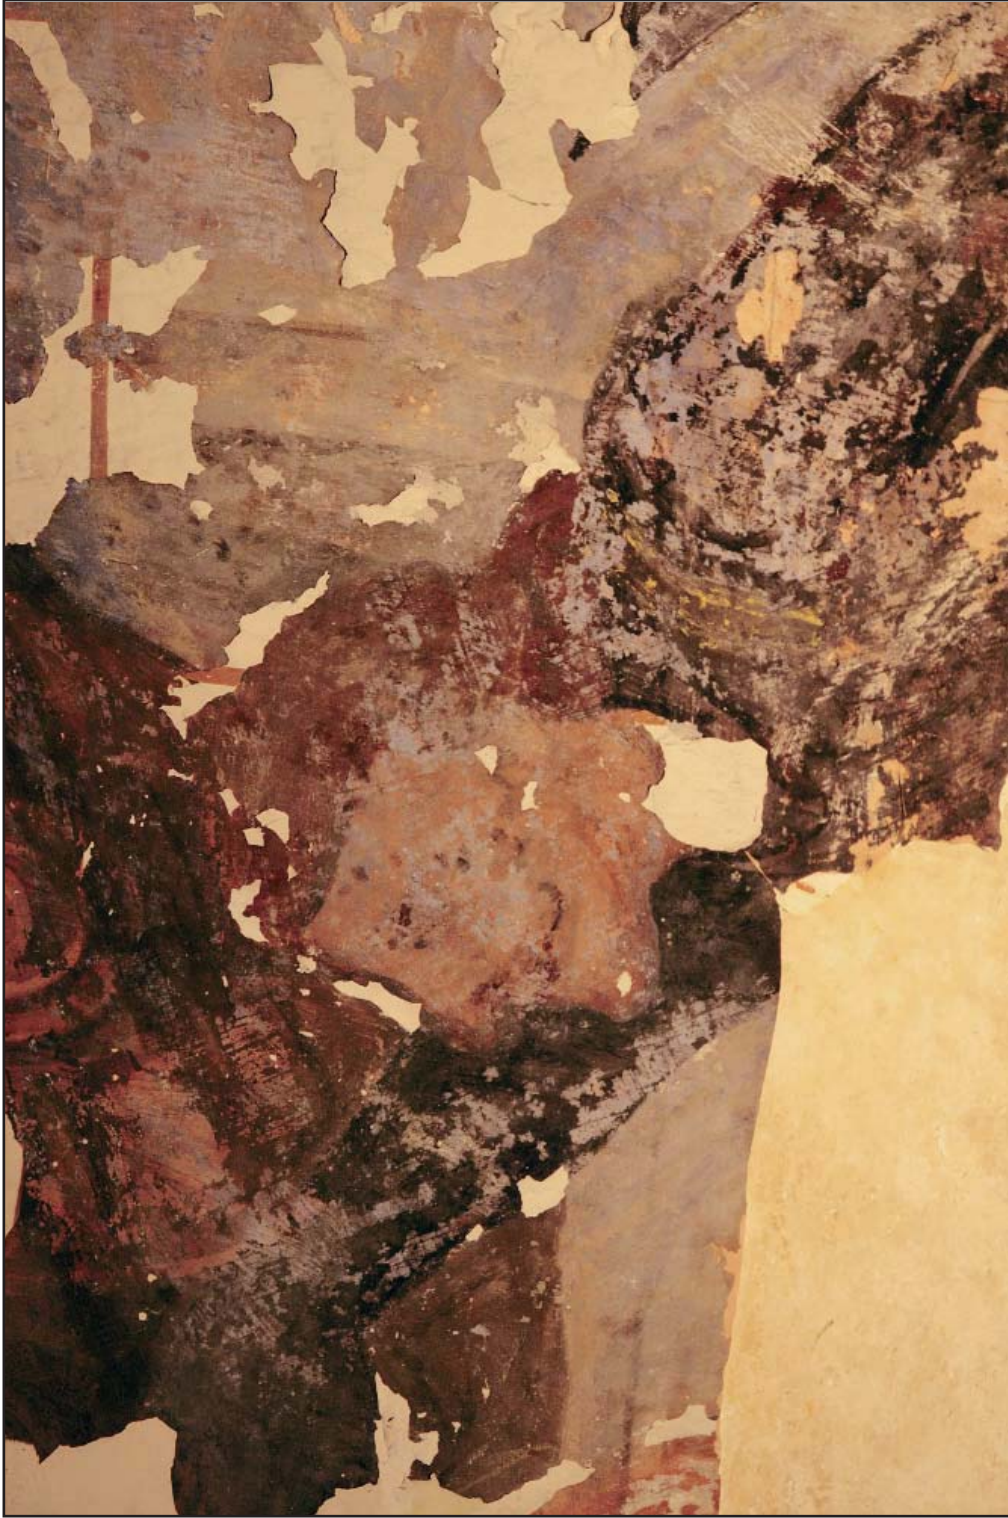
Figure 42: Detail (A6-14) Image of mariner 3, Campaign D (Source: C. Silva, 2006)

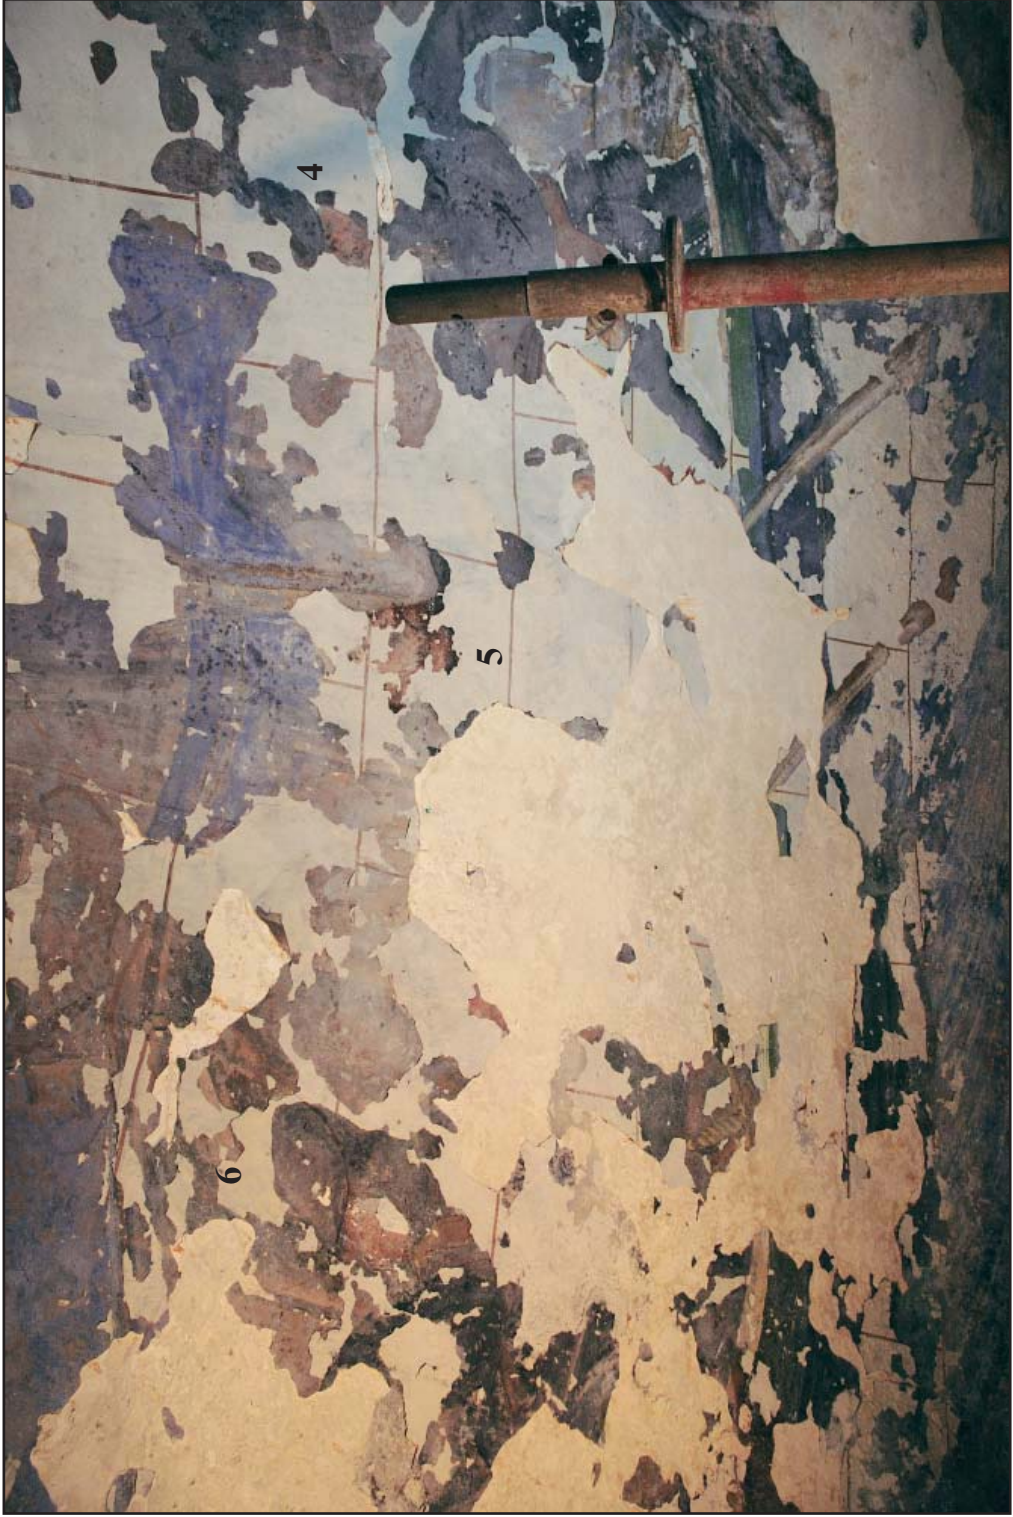
Figure 43: Detail (A6-15) Overview of mariners 4,5 and 6, Campaign D (Source: C. Silva, 2006)

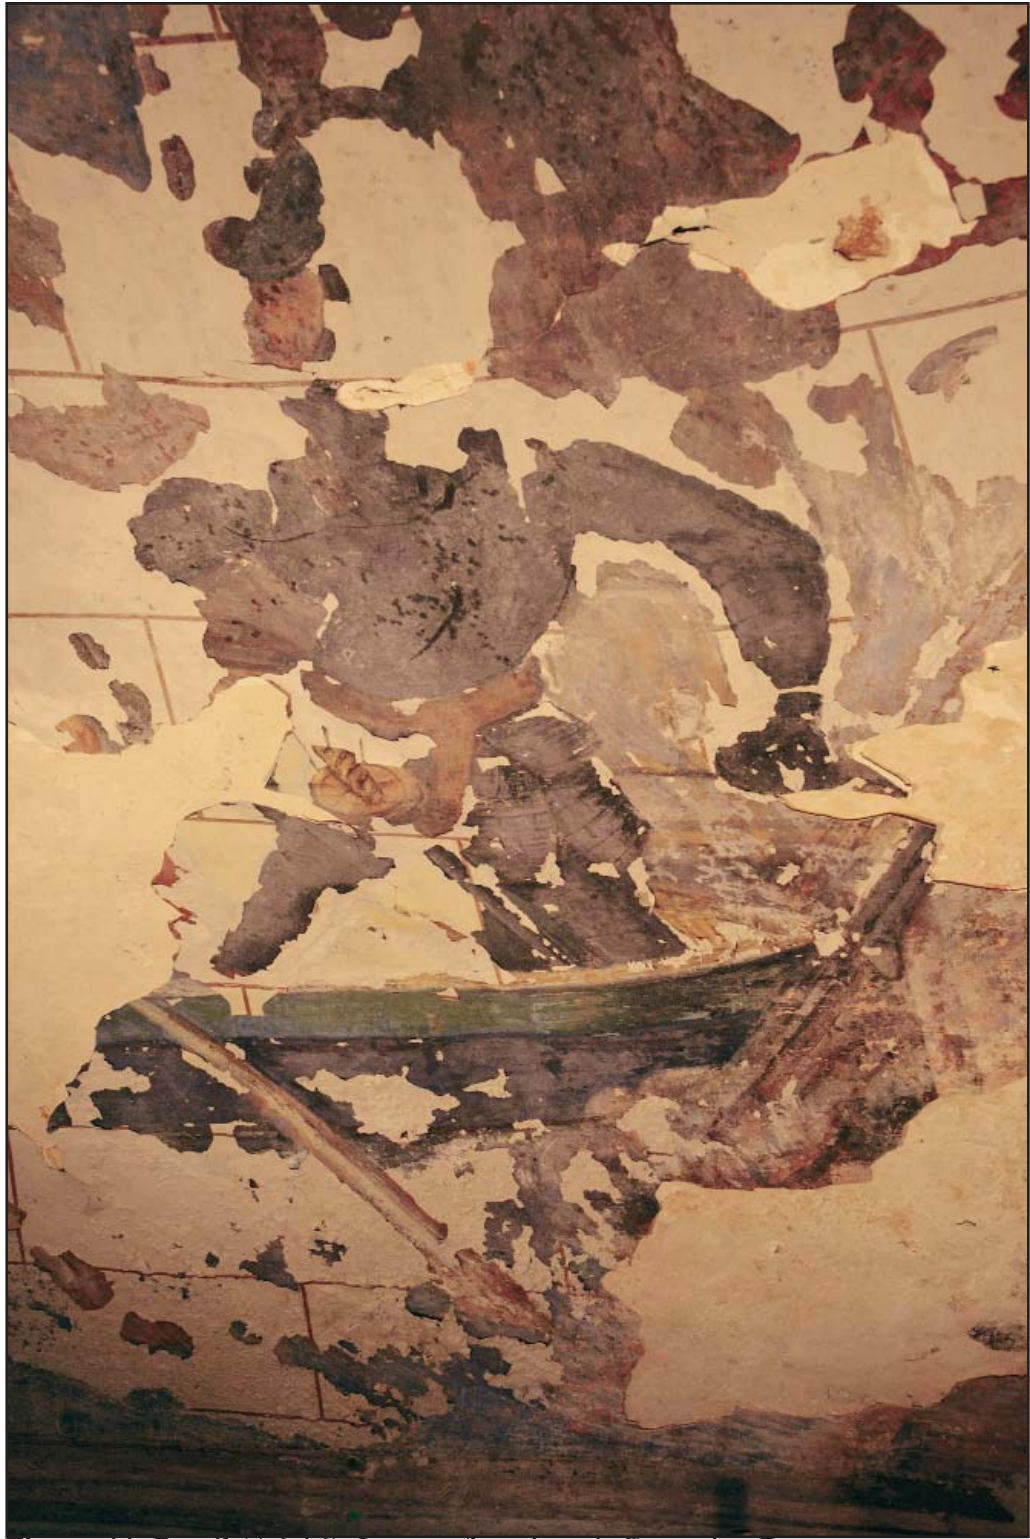
Figure 44: Detail (A6-16) Image of mariner 4, Campaign D
(Source: C. Silva, 2006)
