A Technical Study of the Mural Paintings of the Interior Dome of the Capilla de la Virgen del Rosario, Iglesia San José, San Juan, Puerto Rico

Presented to the Faculties of the University of Pennsylvania in Partial Fulfillment of the Requirements for the Degree of Master of Science in Historic Preservation 2006.

**A TECHNICAL STUDY OF THE MURAL PAINTINGS ON THE INTERIOR
DOME OF THE CAPILLA DE LA VIRGEN DEL ROSARIO,
IGLESIA SAN JOSÉ, SAN JUAN, PUERTO RICO**

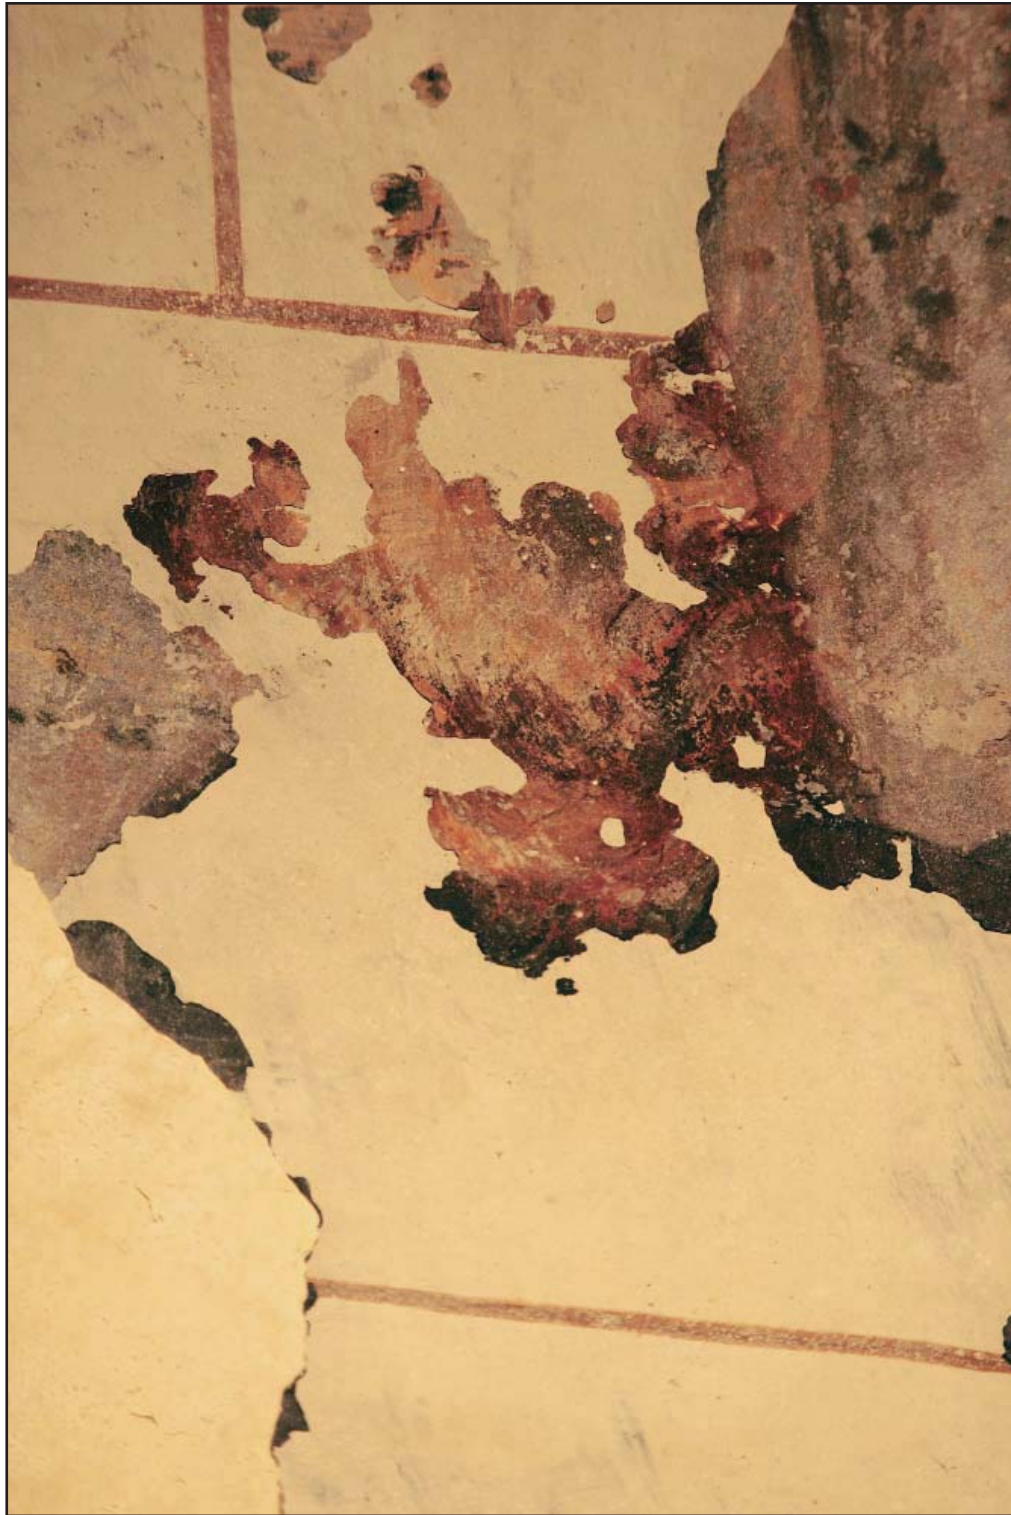
Figure 45: Detail (A6-17) Image of mariner 5, Campaign D
(Source: C. Silva, 2006)

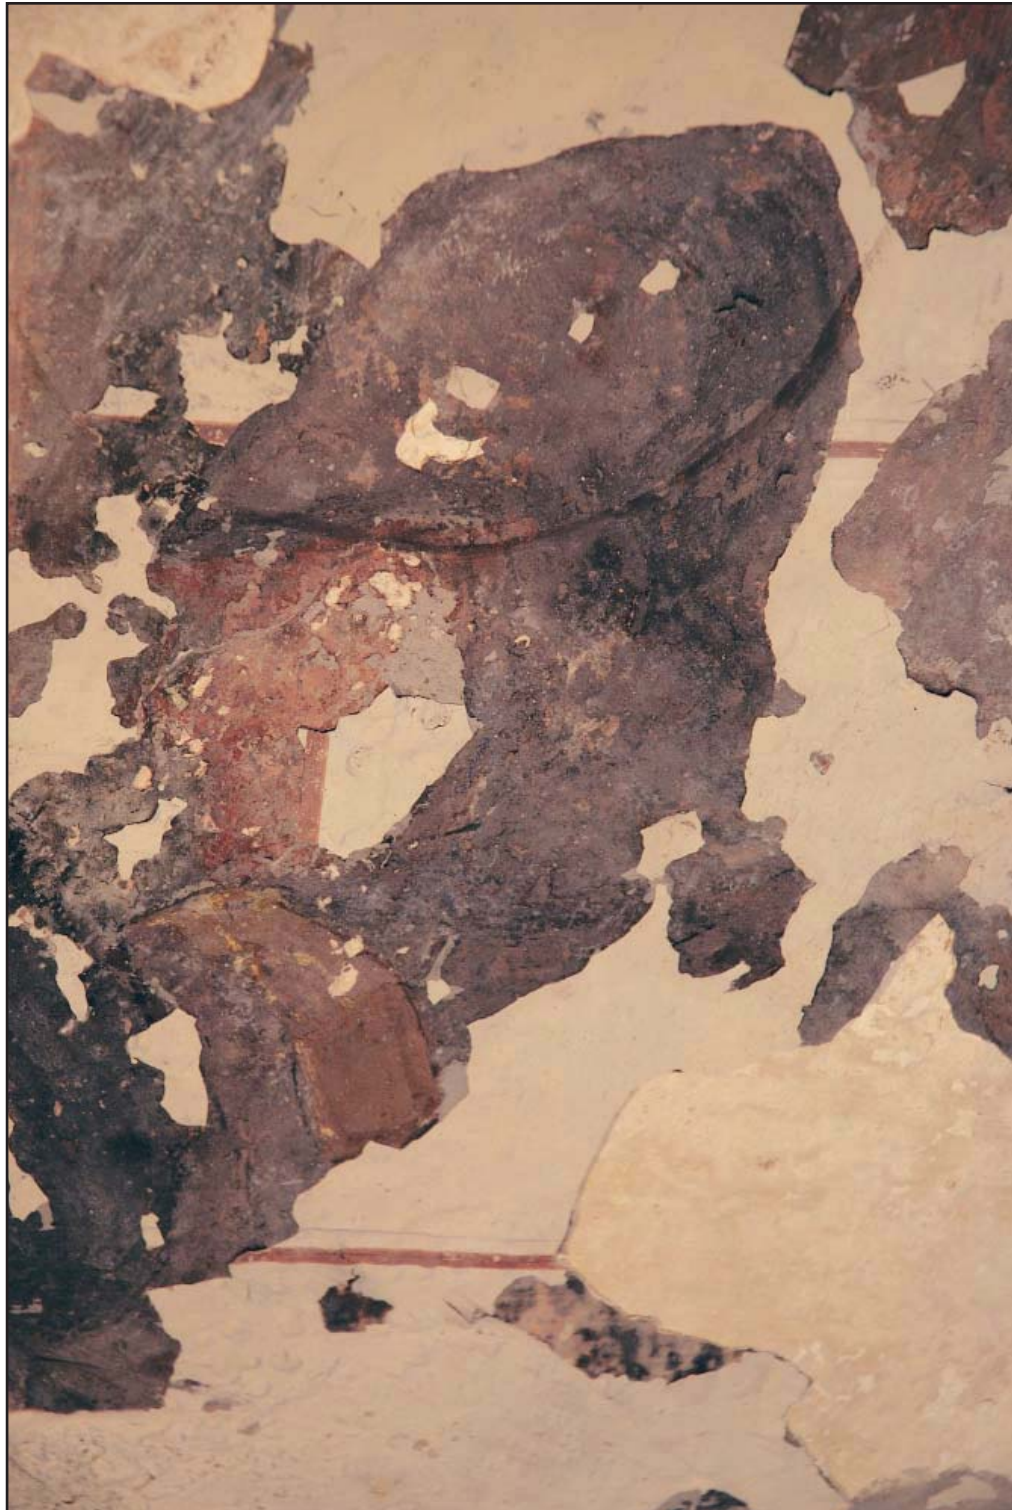
Figure 46: Detail (A6-18) Image of mariner 6, Campaign D
(Source: C. Silva, 2006)

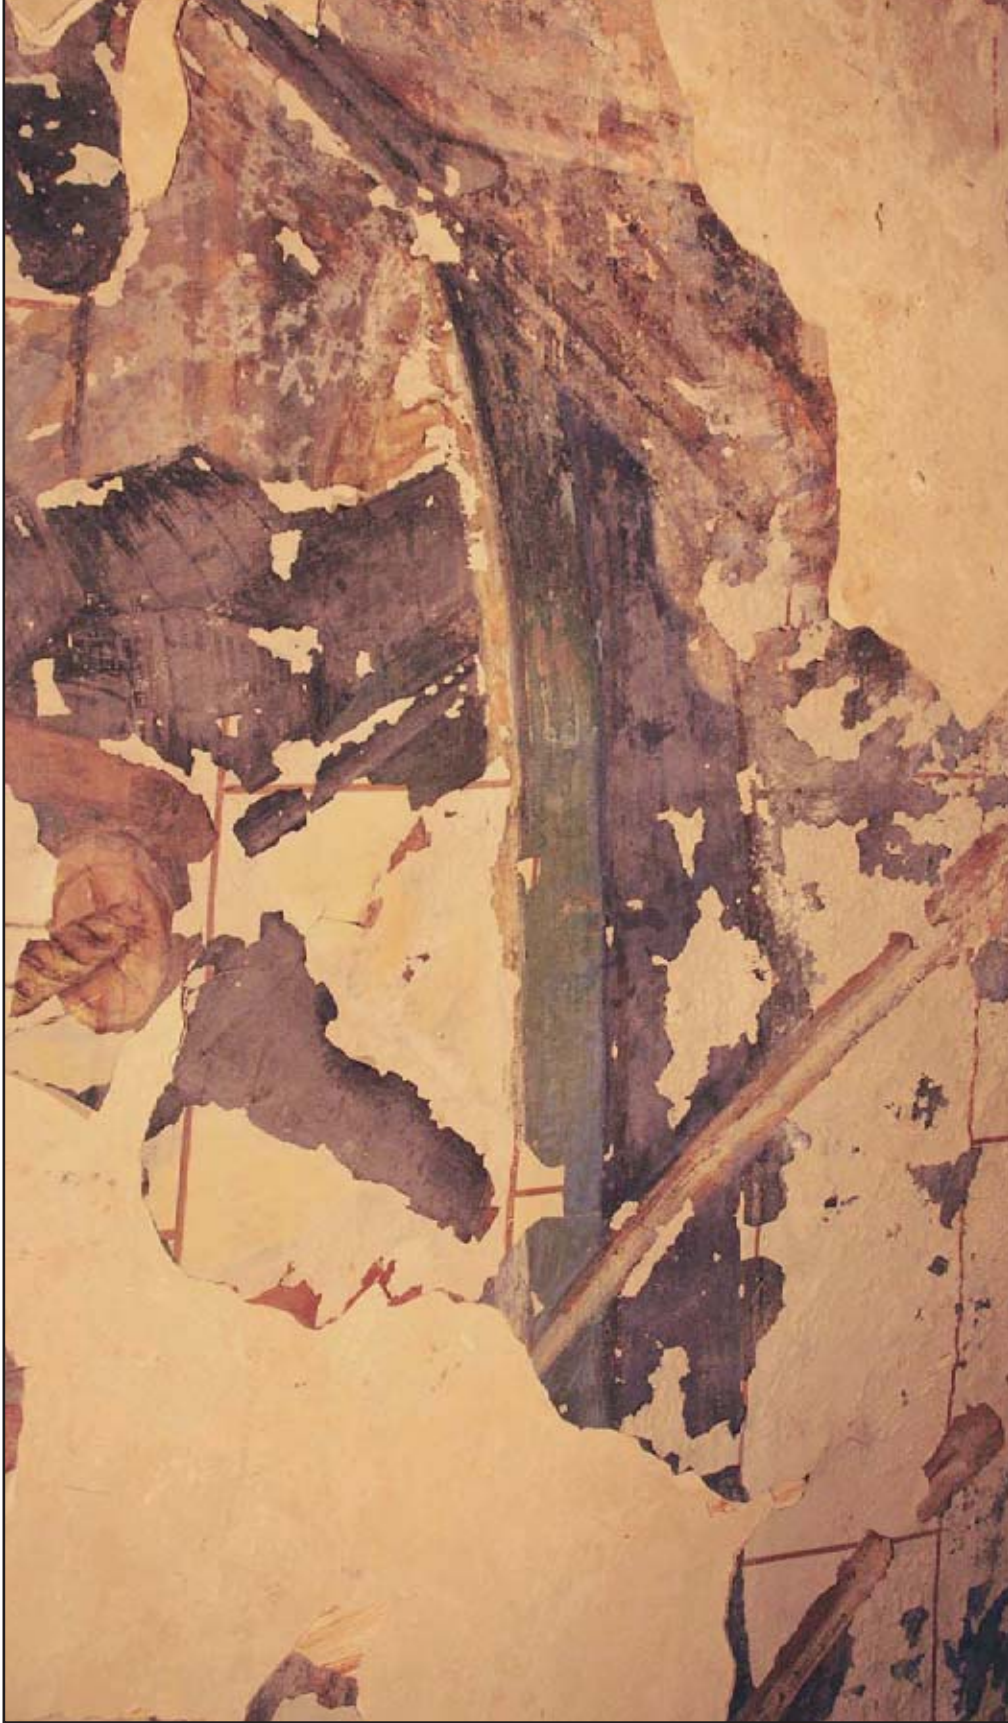
Figure 47: Detail (A6-19) Partially exposed boat with oars, Campaign D (Source: C. Silva, 2006)

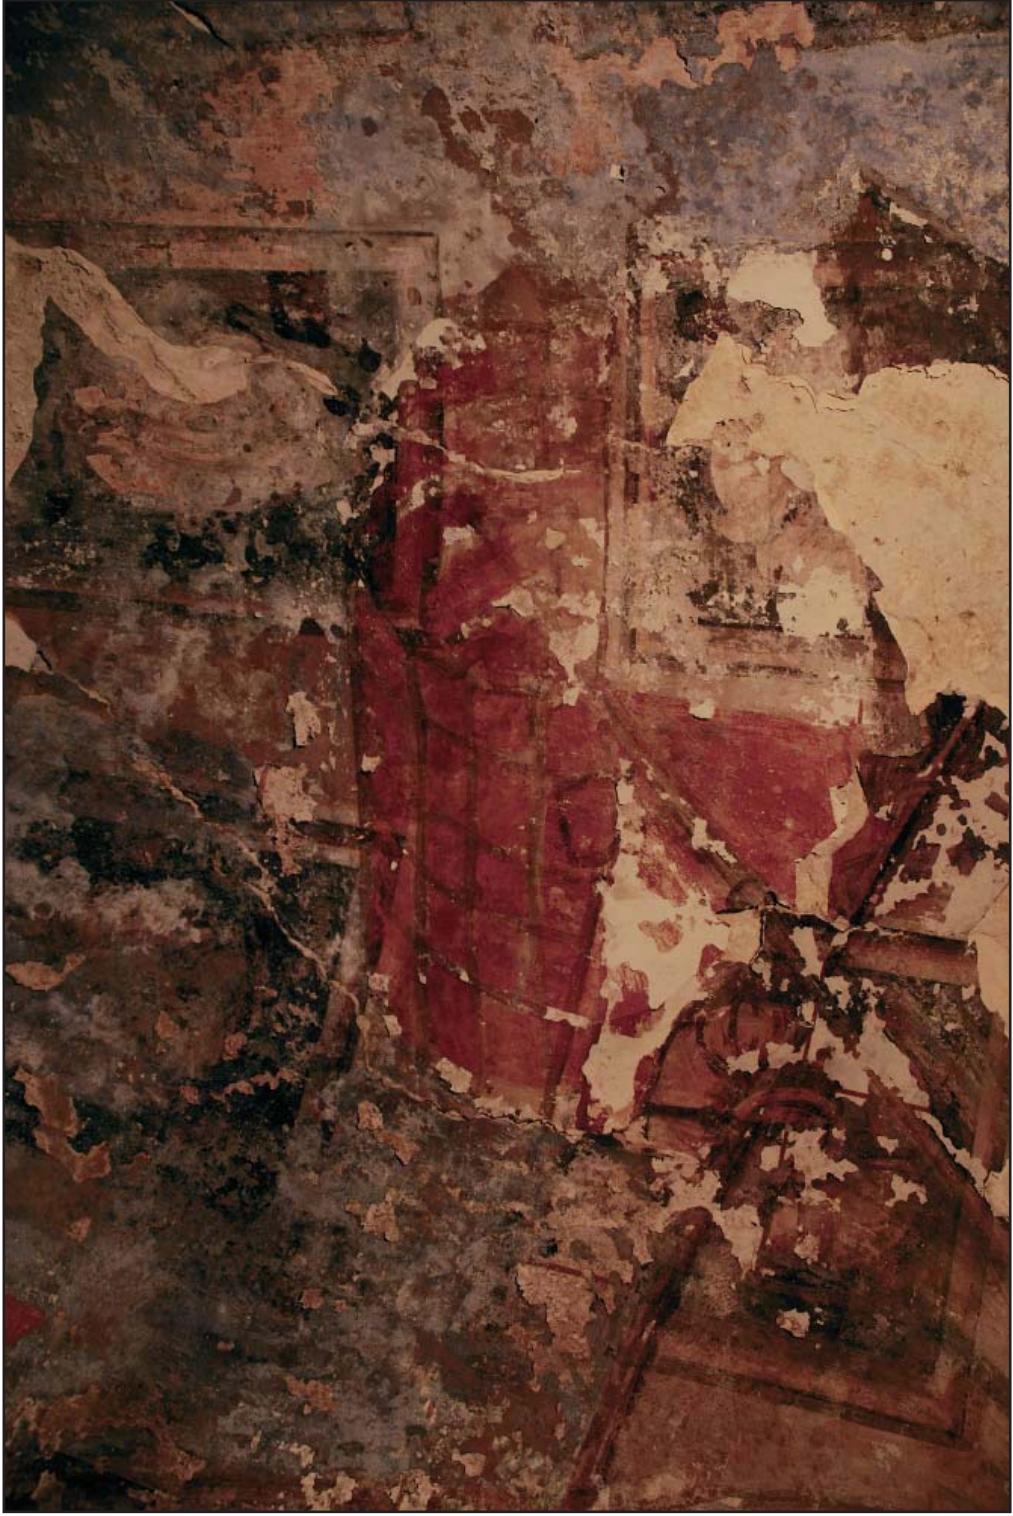
Figure 48: Detail (A6-20) Red, vault shaped ship enclosure, Campaign D (Source: C. Silva, 2006) Compare with similar enclosure in Figure 28.

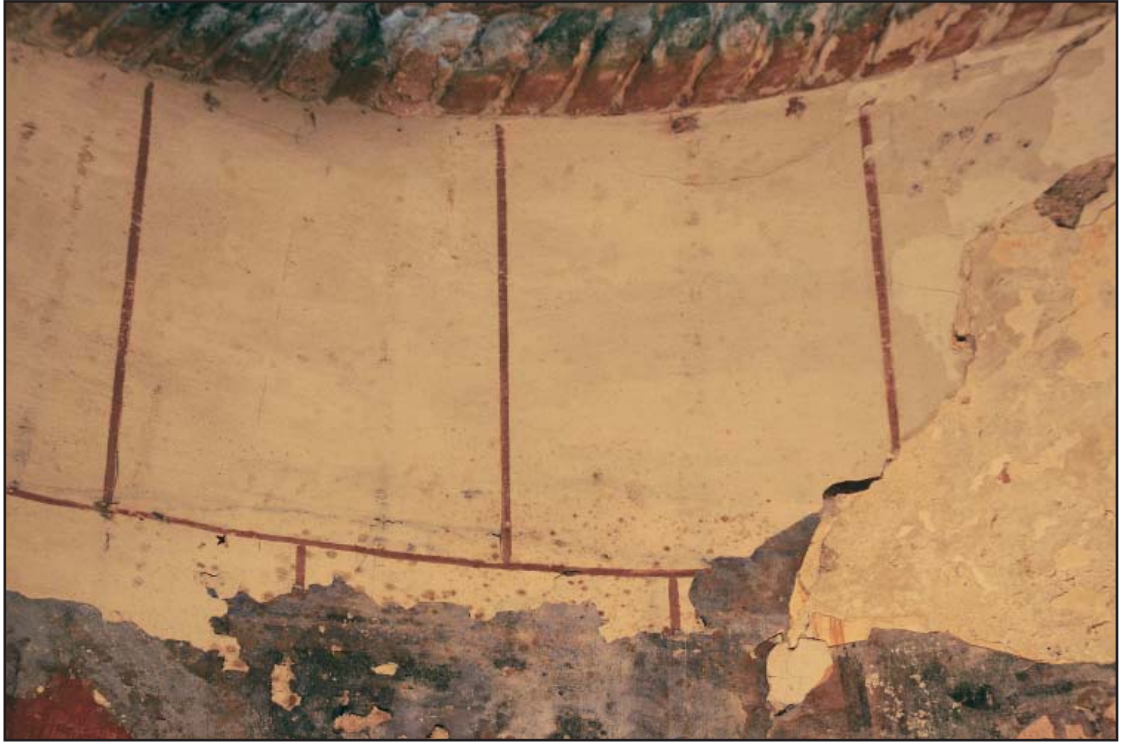
Figure 49: Detail (A6-21) Measured ashlar, ca 1890 Campaign E
(Source: C. Silva, 2006)

A faux ashlar motif decorates the dome, giving the illusion of masonry construction. This is a simple scheme using ¼” wide lines to create the joints between blocks. The ground is a white lime wash with thin red penciling used for the joint lines (Figure 49). Campaign E is the same for the dome, pendentives and arches. Much of this layer has been lost. Each block located near the oculus measures 7 ¼” across the top, 12” in height and 10 ¼” along the base. The blocks at the bottom of the dome measure 48” wide and 12” high. This campaign can be dated to at least ca. 1890-1920 based on historic photographs (Figures 7-9).

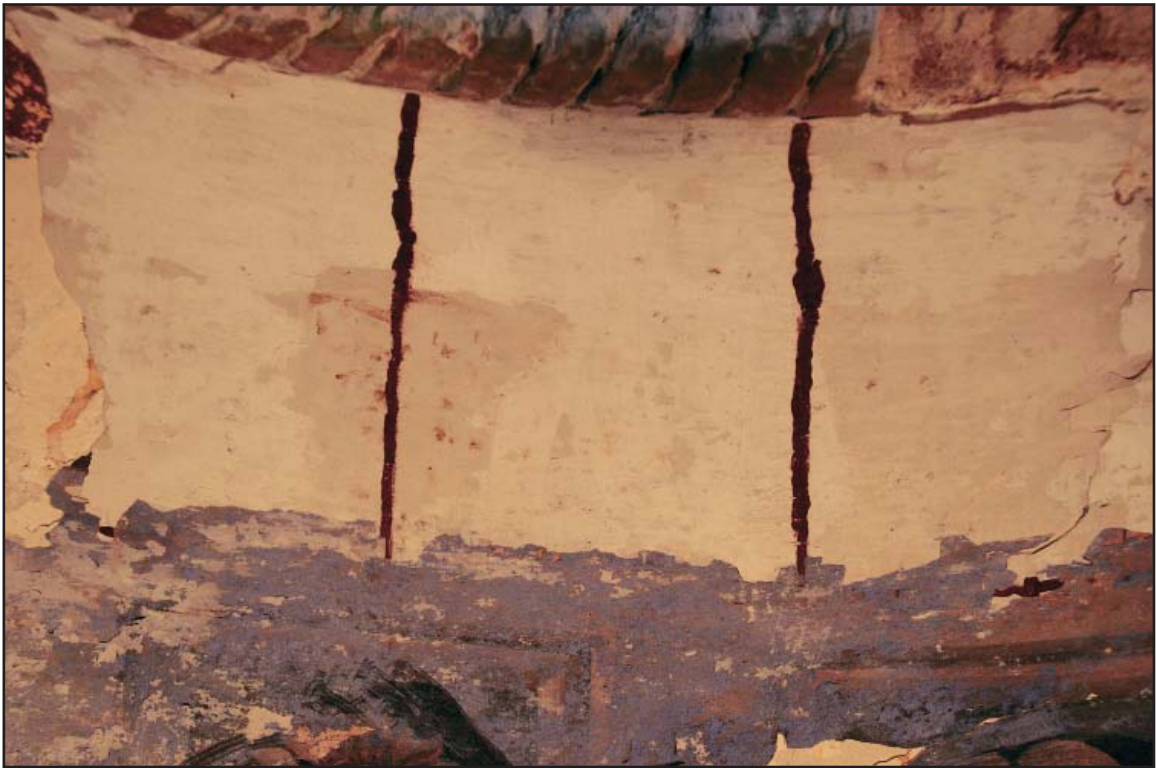
Figure 50: Detail (A6-22) Free-hand ashlar, Campaign F (Source: C. Silva, 2006)

A faux ashlar motif decorates the dome, suggesting masonry construction. This is a simple scheme using thin lines to create the joints between blocks. The ground is a white lime wash with thin red pencilling used for the joint lines (Figure 50). Campaign F is the same for the dome, pendentives and arches and appears to have been an attempt to repair losses to Campaign E. Much of this layer has also been lost as well. The layout of the individual blocks follows the dimensions of the previous ashlar campaign.

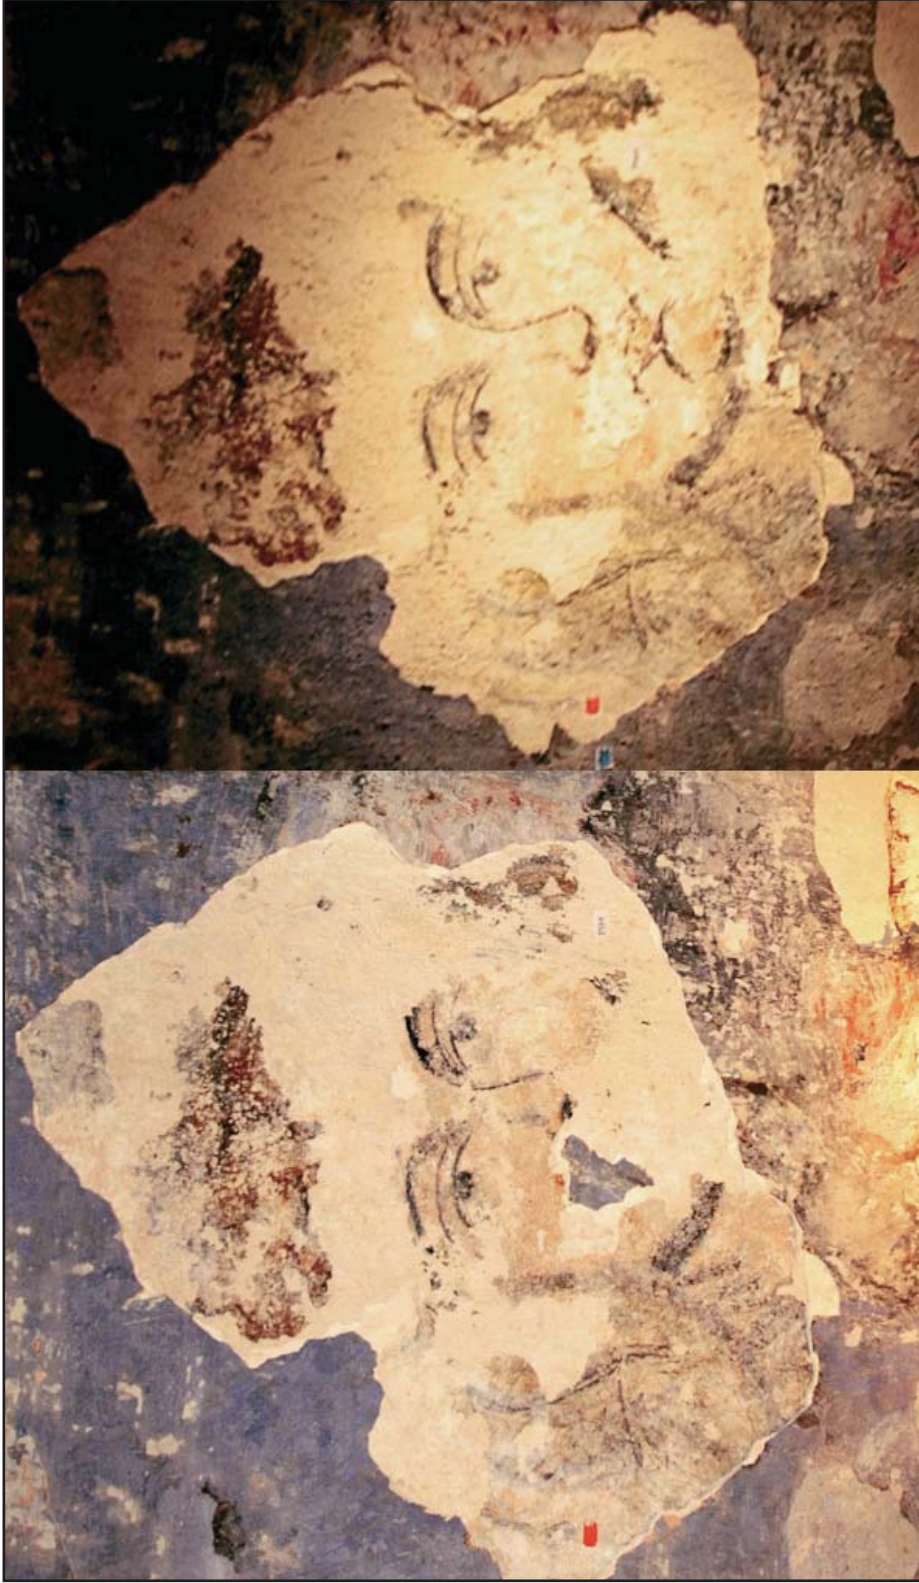
Figure 51: Detail (A7-1) Mer creature's head as it was exposed, Campaign A (Source: C. Silva, 2005)

51). Without more of the image being exposed, it is difficult to determine if these figures are intended to be male, female, or androgynous. Each of these mer (*la serena*) figures is surrounded by a stylized water motif of black wave like marks and a faint green-blue wash (Figure 52).

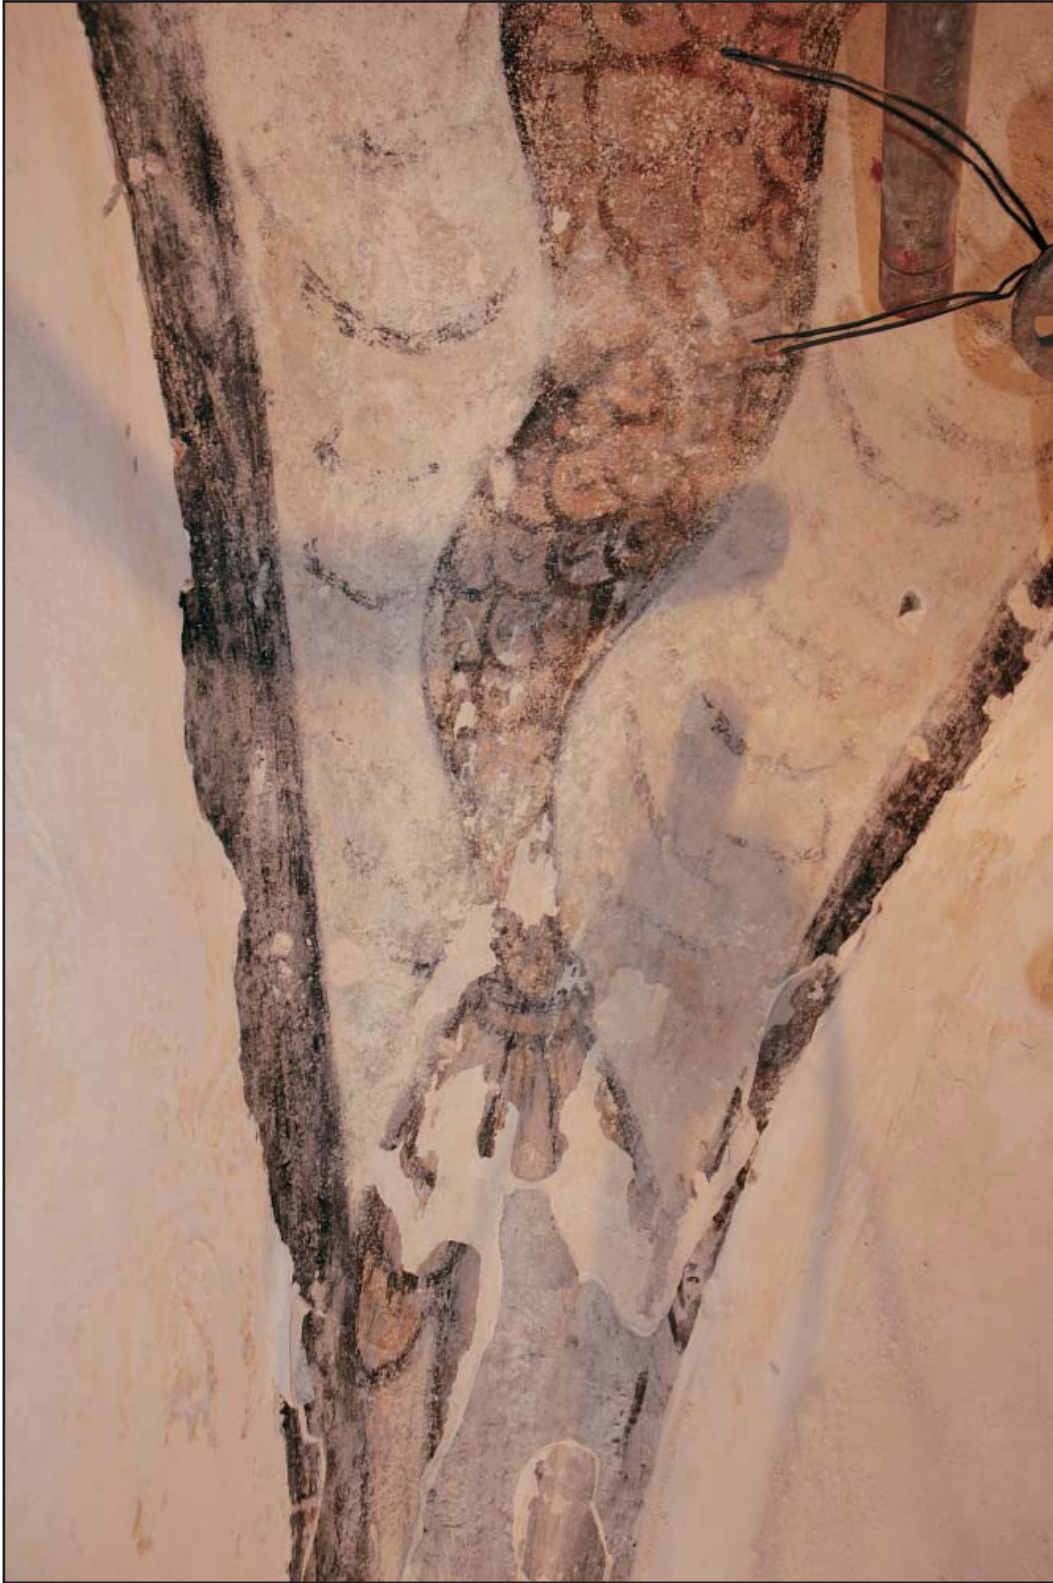
Figure 52: Detail (A7-2) Mer-figures tail, surrounded by water motif and black banding, Campaign A (Source: C. Silva, 2006)

A water motif surrounds the figure. Waves are represented by a series of black concave brush strokes applied over a faint green blue wash (Figure 52).

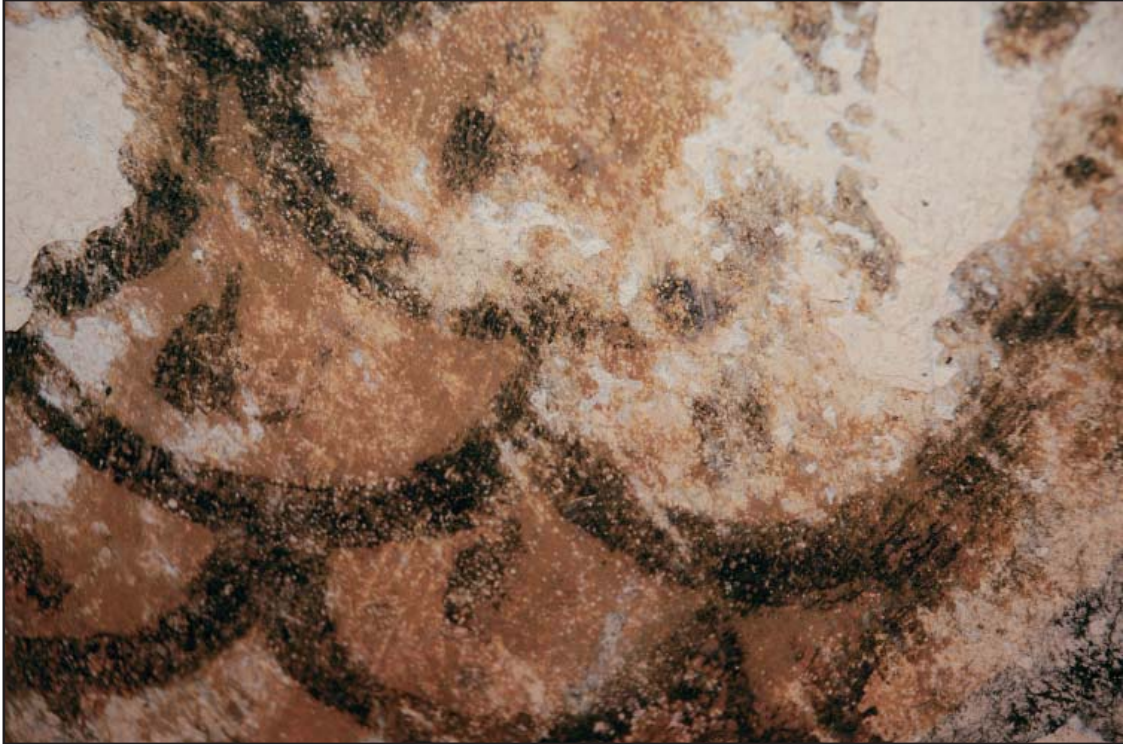
Figure 53: Detail (A7-3) Image of scales on Mer figure's tail, Campaign A
(Source: C. Silva, 2006)

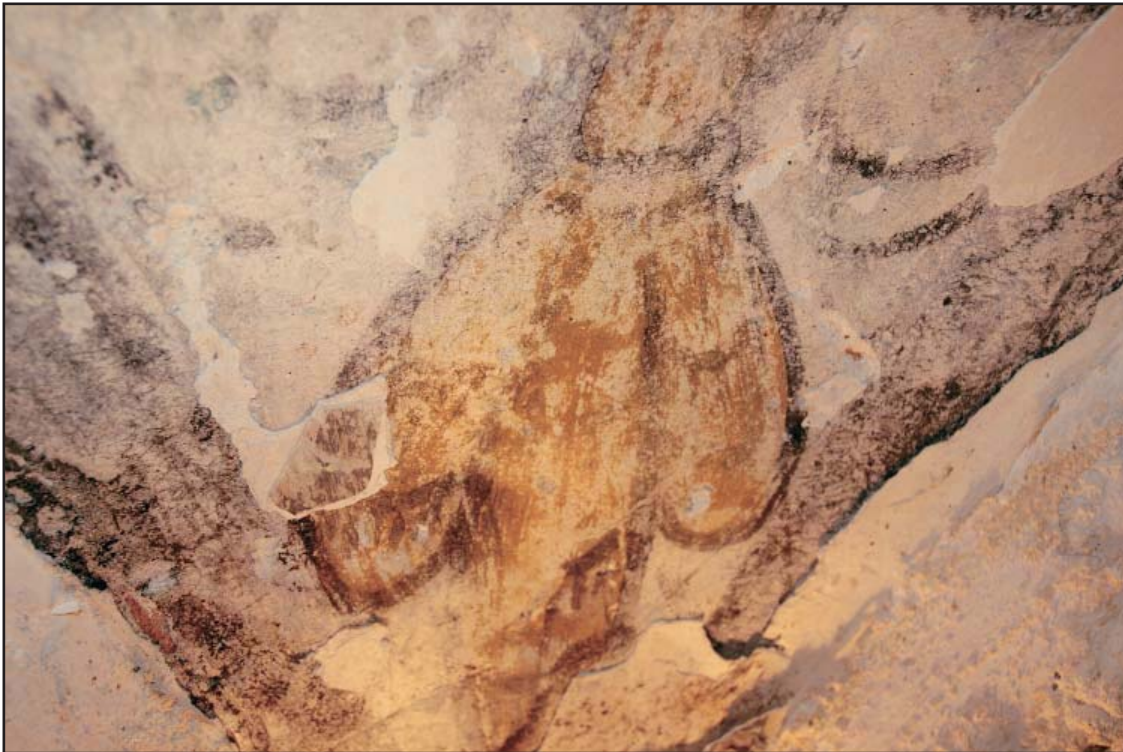
Figure 54: Detail (A7-4) Detail of the bottom of Mer creature's tail,
Campaign A (Source: C. Silva, 2006)

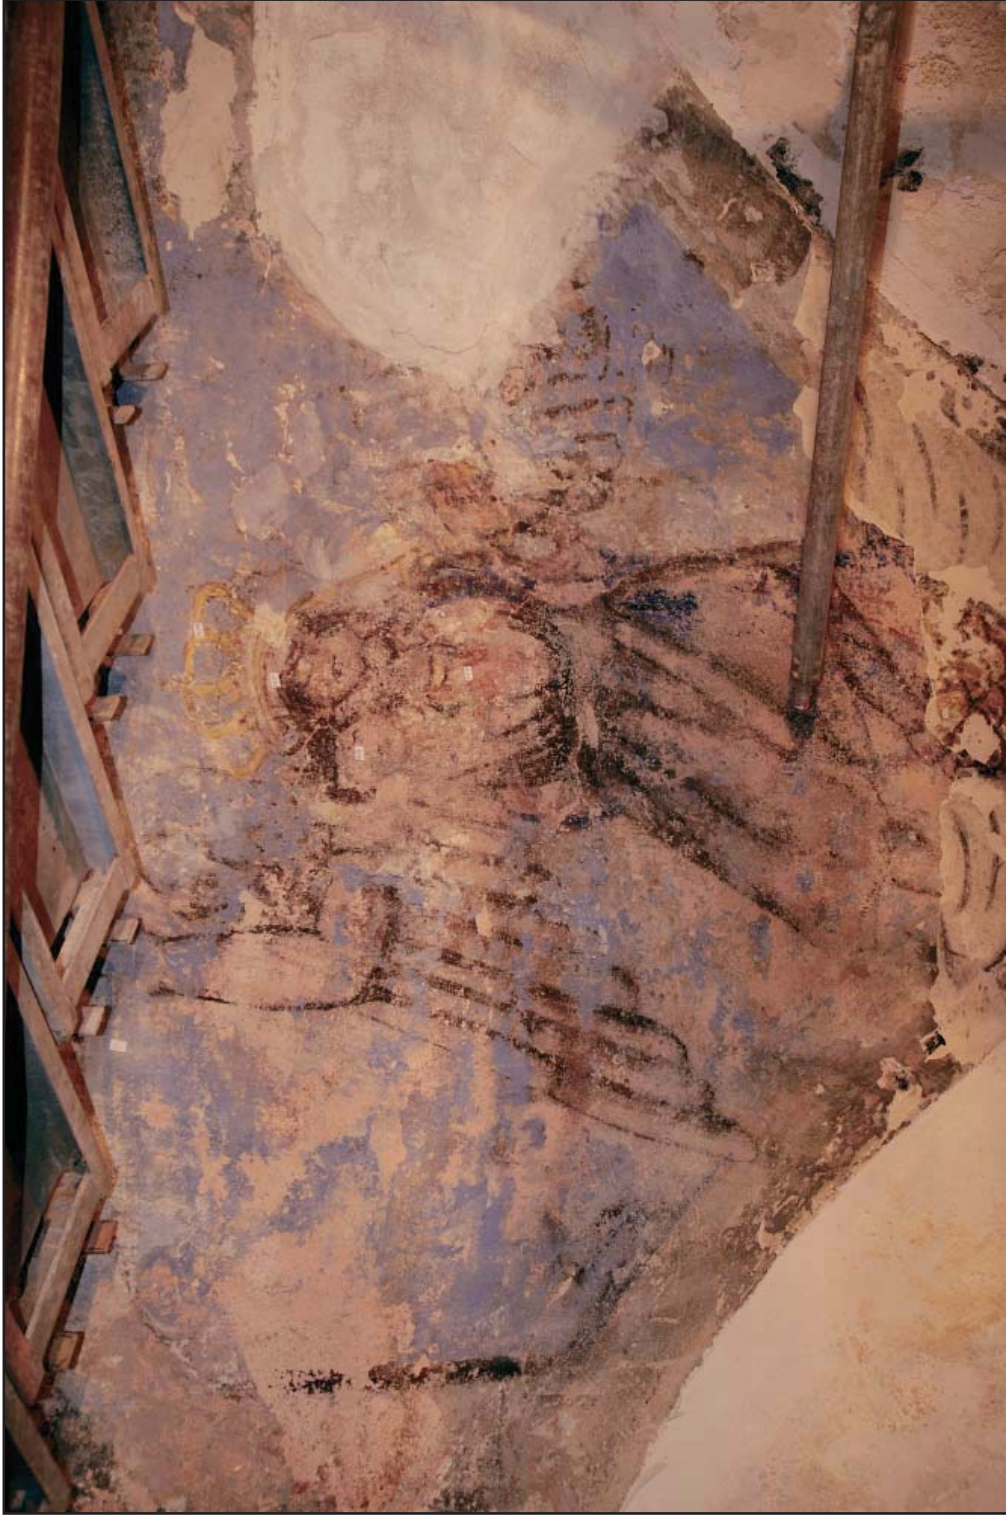
Figure 56: Detail (A7-6) Center of Pendentive 2 with repair on upper right (Source: C. Silva, 2006)
Note overlapping figures from Campaign C and D.

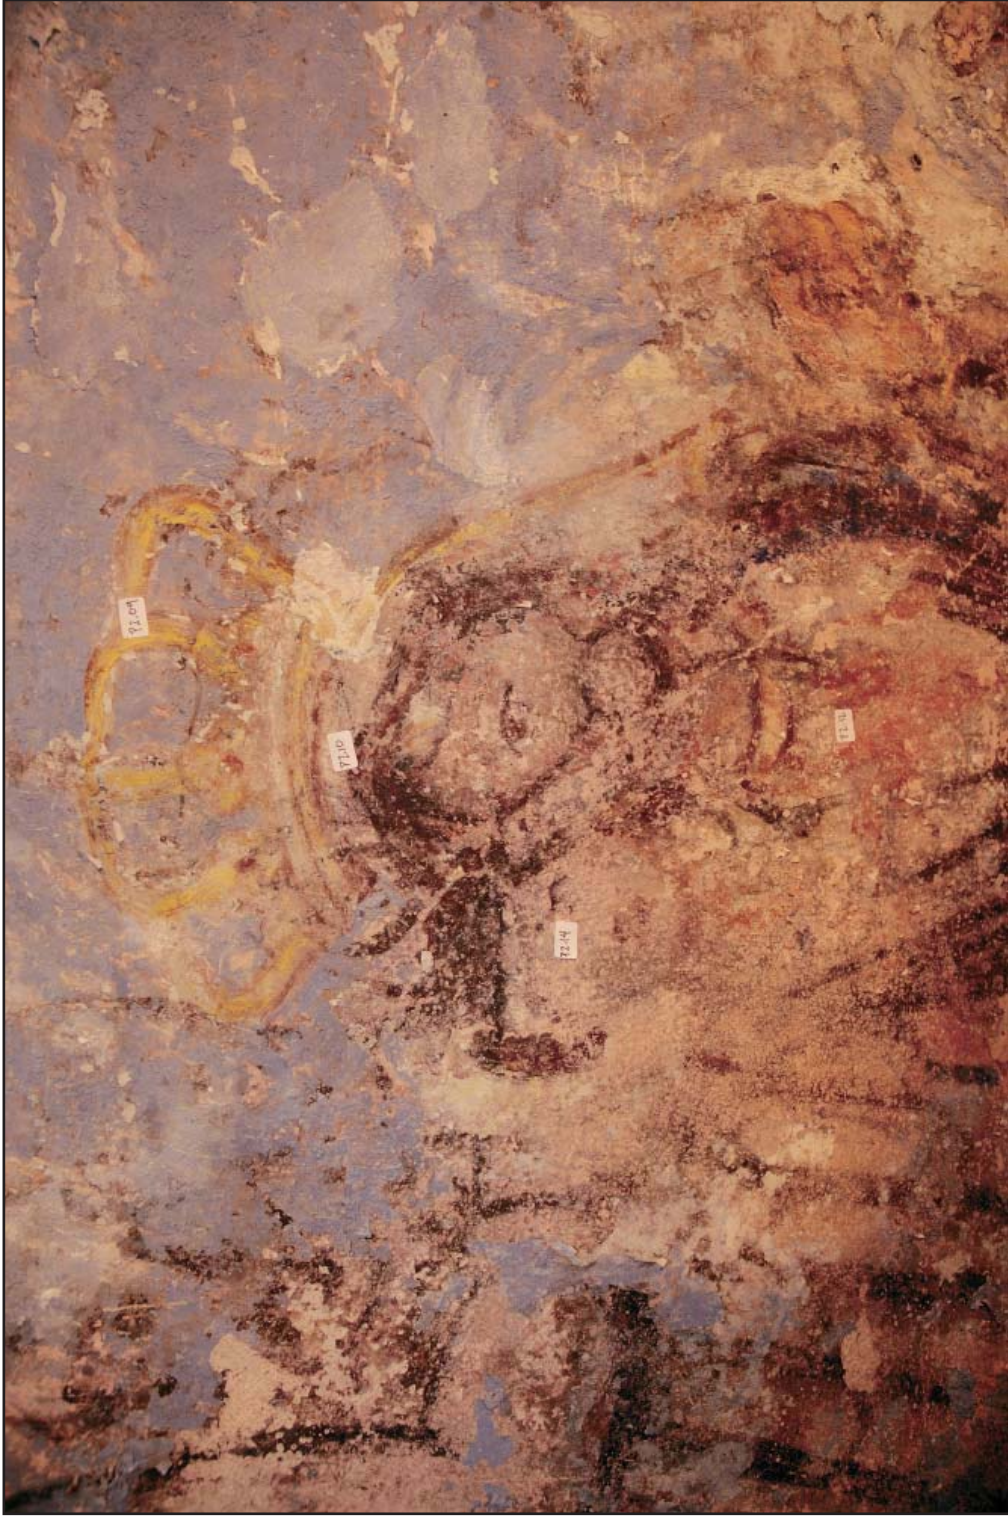
Figure 57: Detail (A7-7) Detail of Virgin and child, Campaign D (Source: C. Silva, 2006)

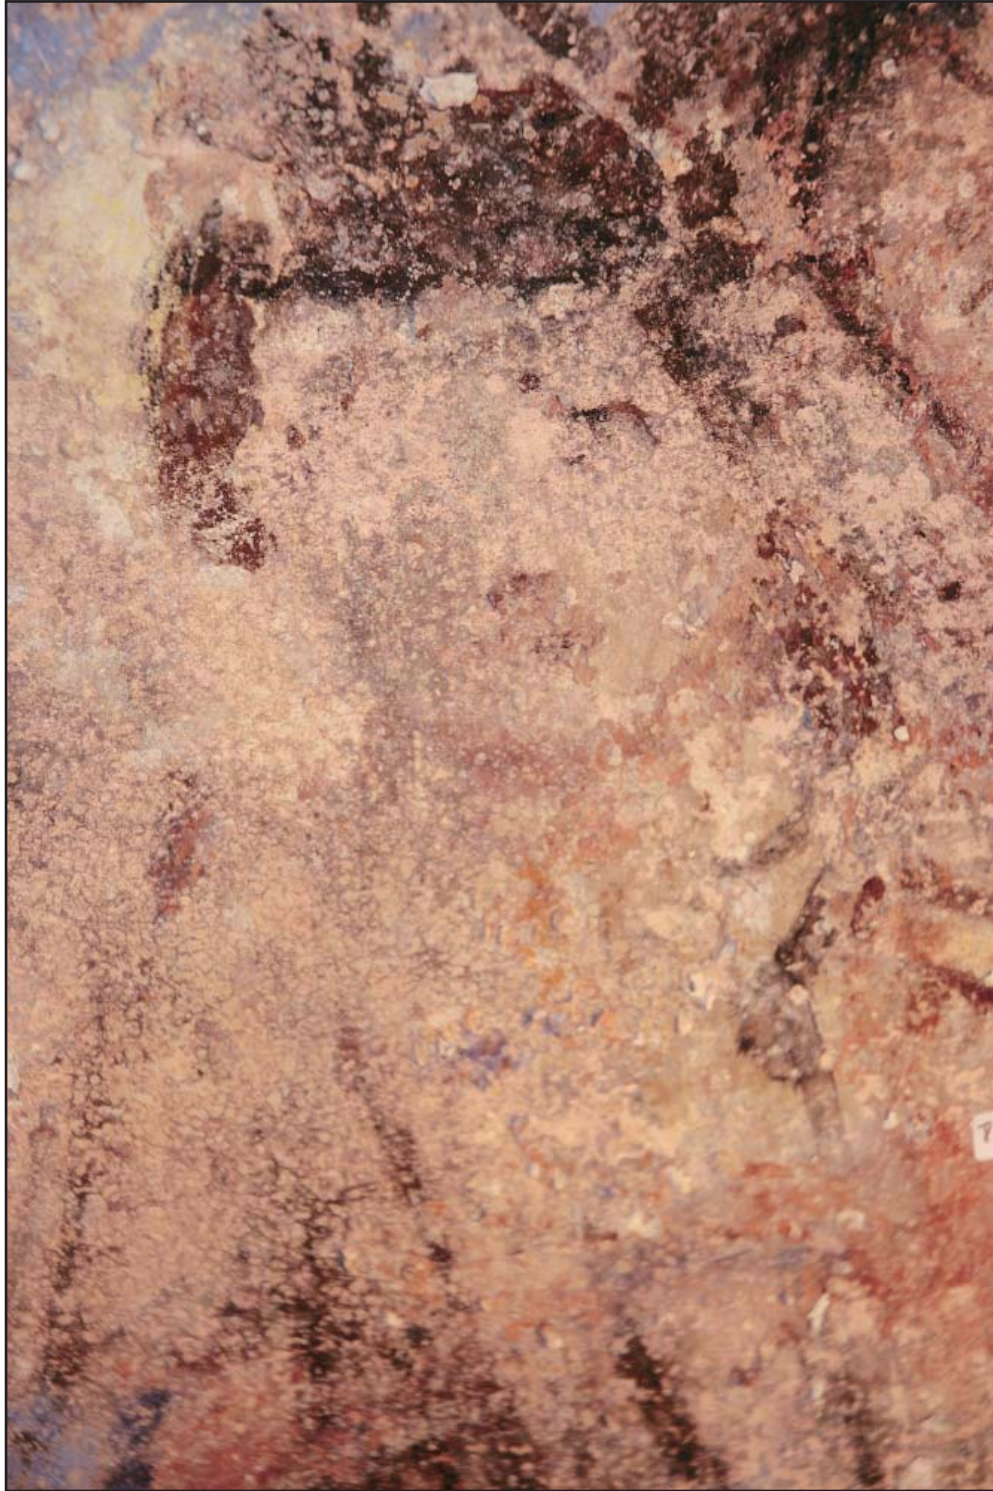
Figure 58: Detail (A-7-8) Detail of the child Jesus, Campaign D
(Source: C. Silva, 2006)

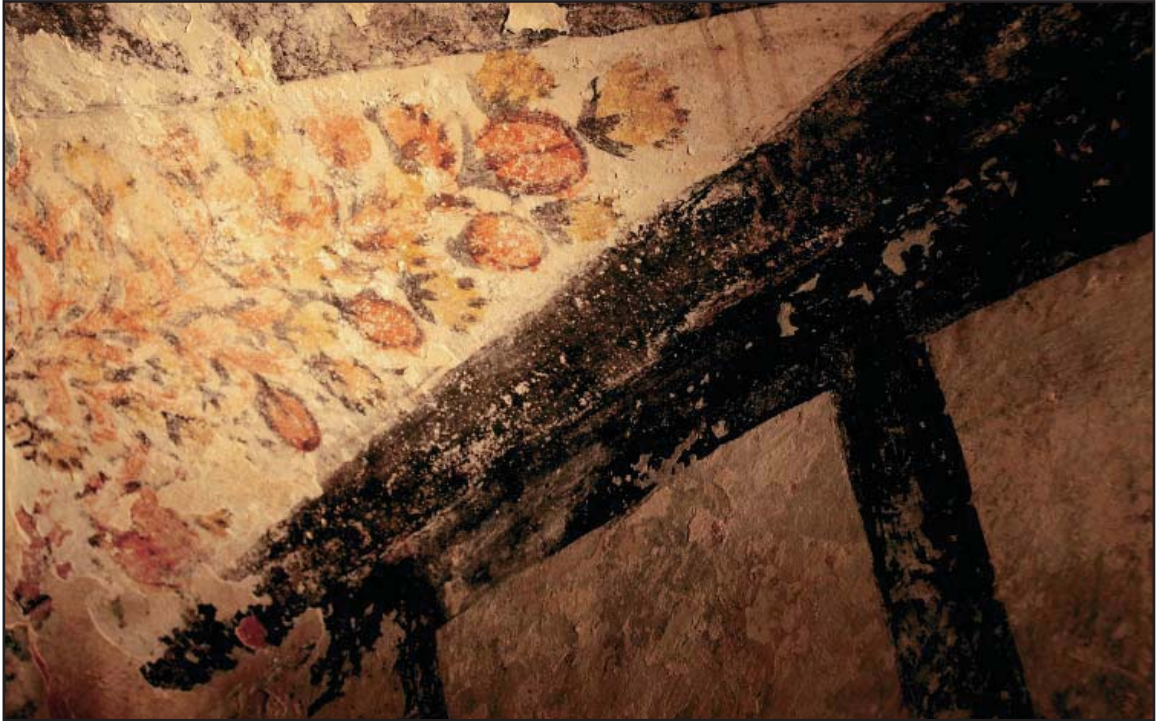
Figure 59: Detail (A8-1). Floral motif with faux voussoirs on the adjacent north arch, Campaign A (Source: C. Silva, 2006)

The faux ashlar motif is continued from the dome to the arches. Thick black lines, measuring 4" wide, trace the intrados and extrados of the arch form with 3" thick joint lines creating faux voussoirs (Figure: 59). The arch elements appear to have an additional gray limewash applied between the black lines used to distinguish the stone

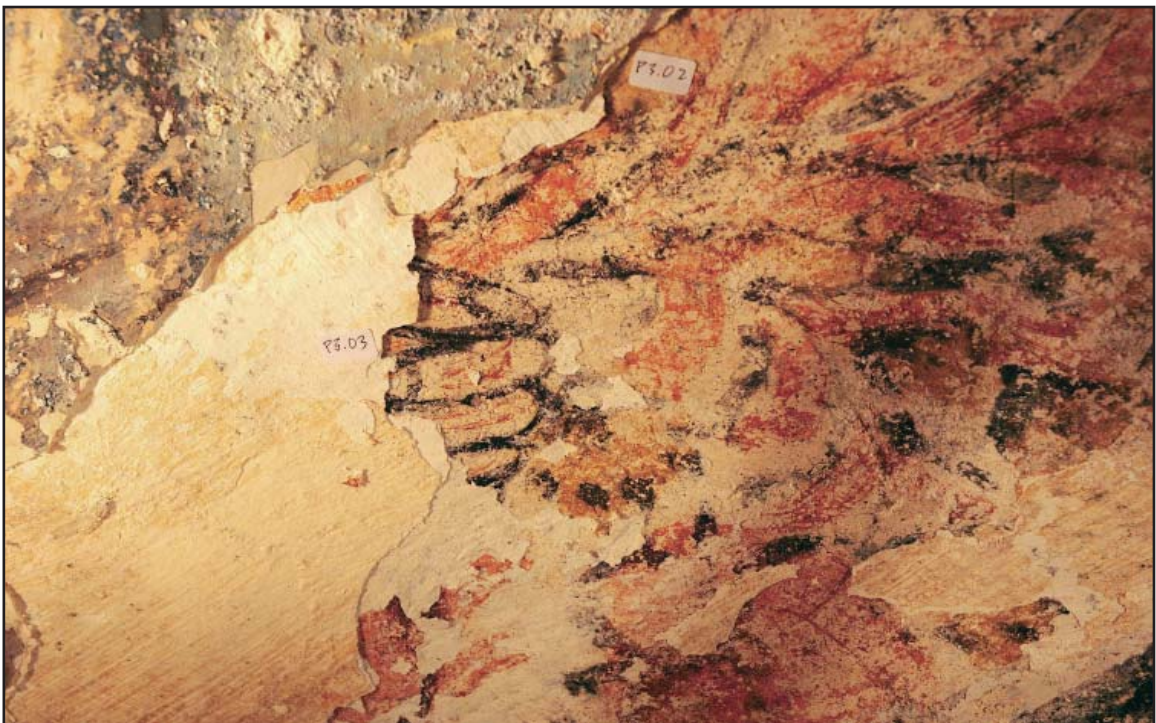
Figure 60: Detail (A8-2). Detail of a hand holding the floral bouquet, Campaign A (2006)

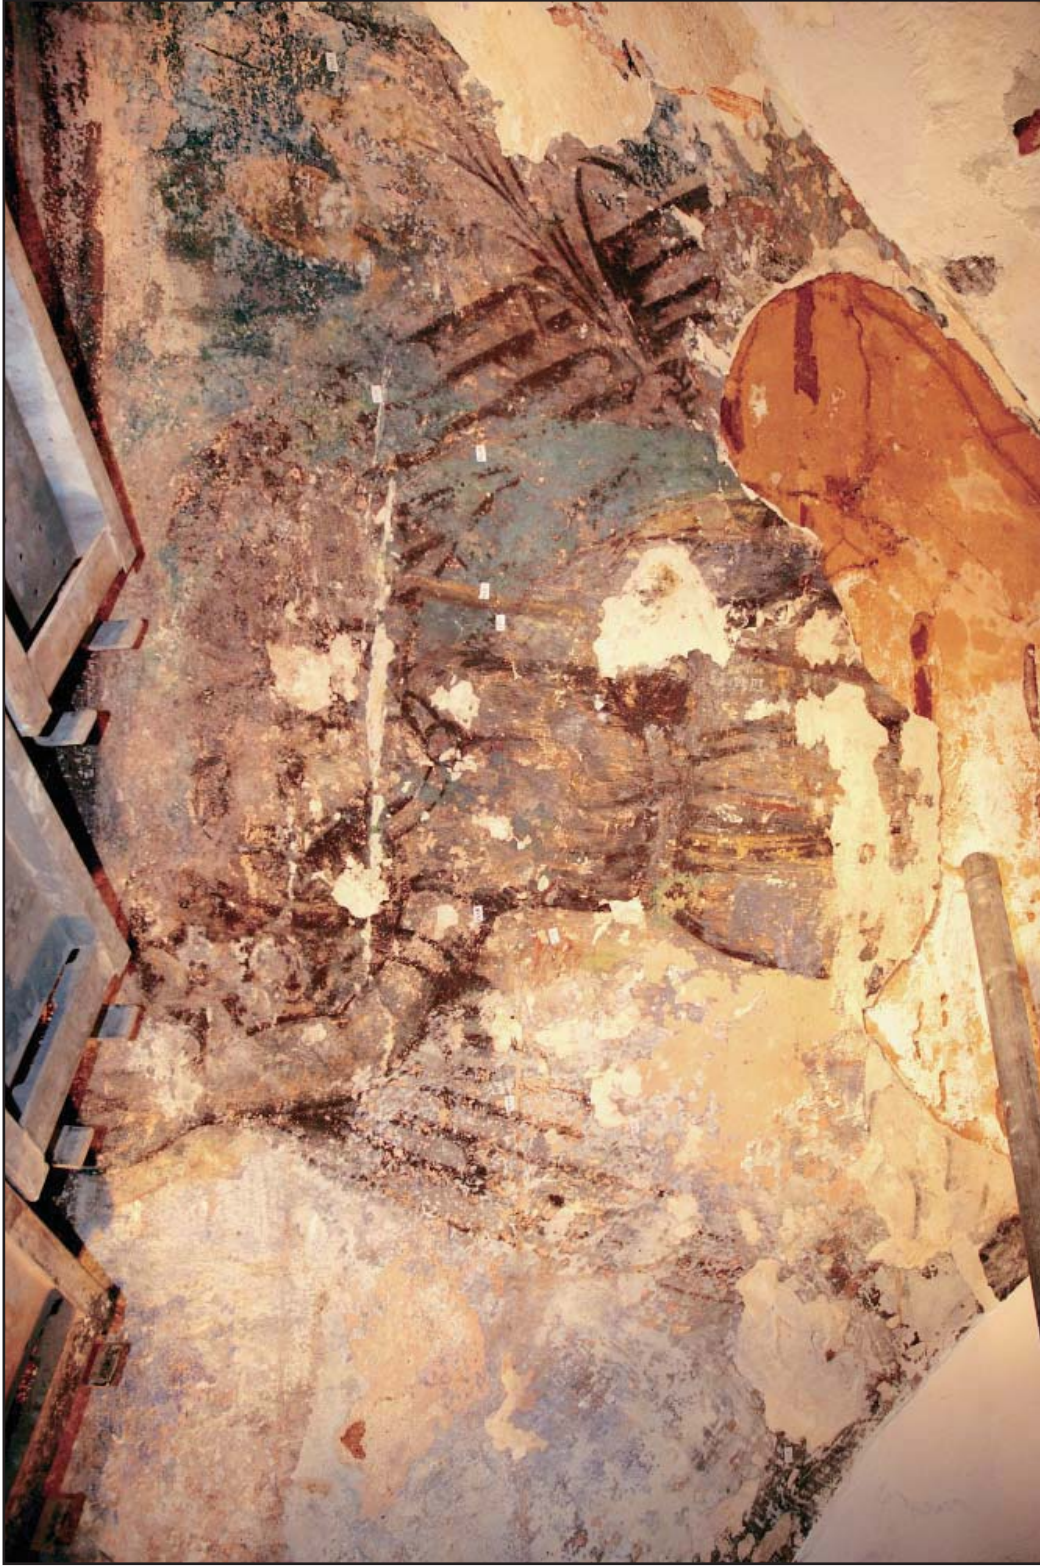
Figure 61: Detail (A8-3) Center of Pendentive 3, angel figure with loss on lower right, Campaign C
(Source: C. Silva, 2006)

The subject of this pendentive is a male figure holding a palm frond (Figure 63). He has short cropped hair with head turned in a ¾ view (Map 4 and Figures 61-62). The figure is wearing a simple short sleeved tunic, belted at the waist similar to Pendentive 2 (Figure 64). The collar of this garment has a circular button or fastener at the center of the neckline (Figure 62). A large three foot square area of Pendentive 3 is now lost down to the brick and enfoscado, and the upper right corner has lost all layers except for the first Campaign A (Map 4 and Figure 65).
