A Technical Study of the Mural Paintings of the Interior Dome of the Capilla de la Virgen del Rosario, Iglesia San José, San Juan, Puerto Rico

Presented to the Faculties of the University of Pennsylvania in Partial Fulfillment of the Requirements for the Degree of Master of Science in Historic Preservation 2006.

**A TECHNICAL STUDY OF THE MURAL PAINTINGS ON THE INTERIOR
DOME OF THE CAPILLA DE LA VIRGEN DEL ROSARIO,
IGLESIA SAN JOSÉ, SAN JUAN, PUERTO RICO**

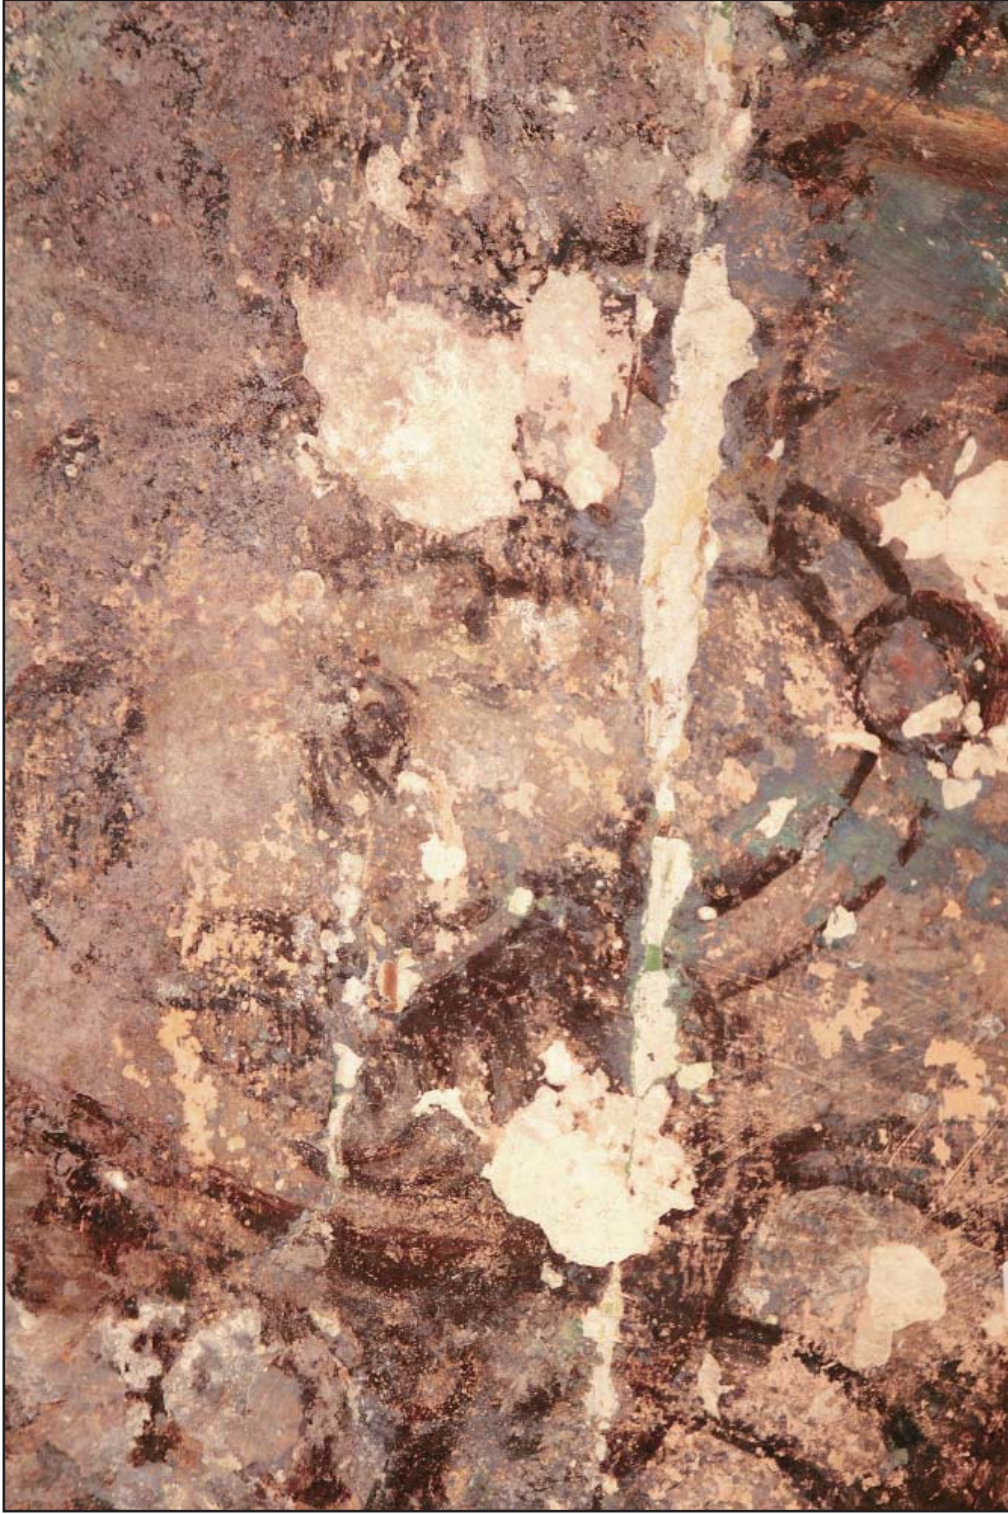
Figure 62: Detail of angel figure's face, Campaign C (Source: C. Silva, 2006)

The subject of this pendentive is a male figure holding a palm frond (Figure 63). He has short cropped hair with head turned in a ¾ view (Map 4 and Figures 61-62). The figure is wearing a simple short sleeved tunic, belted at the waist similar to Pendentive 2 (Figure 64). The collar of this garment has a circular button or fastener at the center of the neckline (Figure 62). A large three foot square area of Pendentive 3 is now lost down to the brick and enfoscado, and the upper right corner has lost all layers except for the first Campaign A (Map 4 and Figure 65).

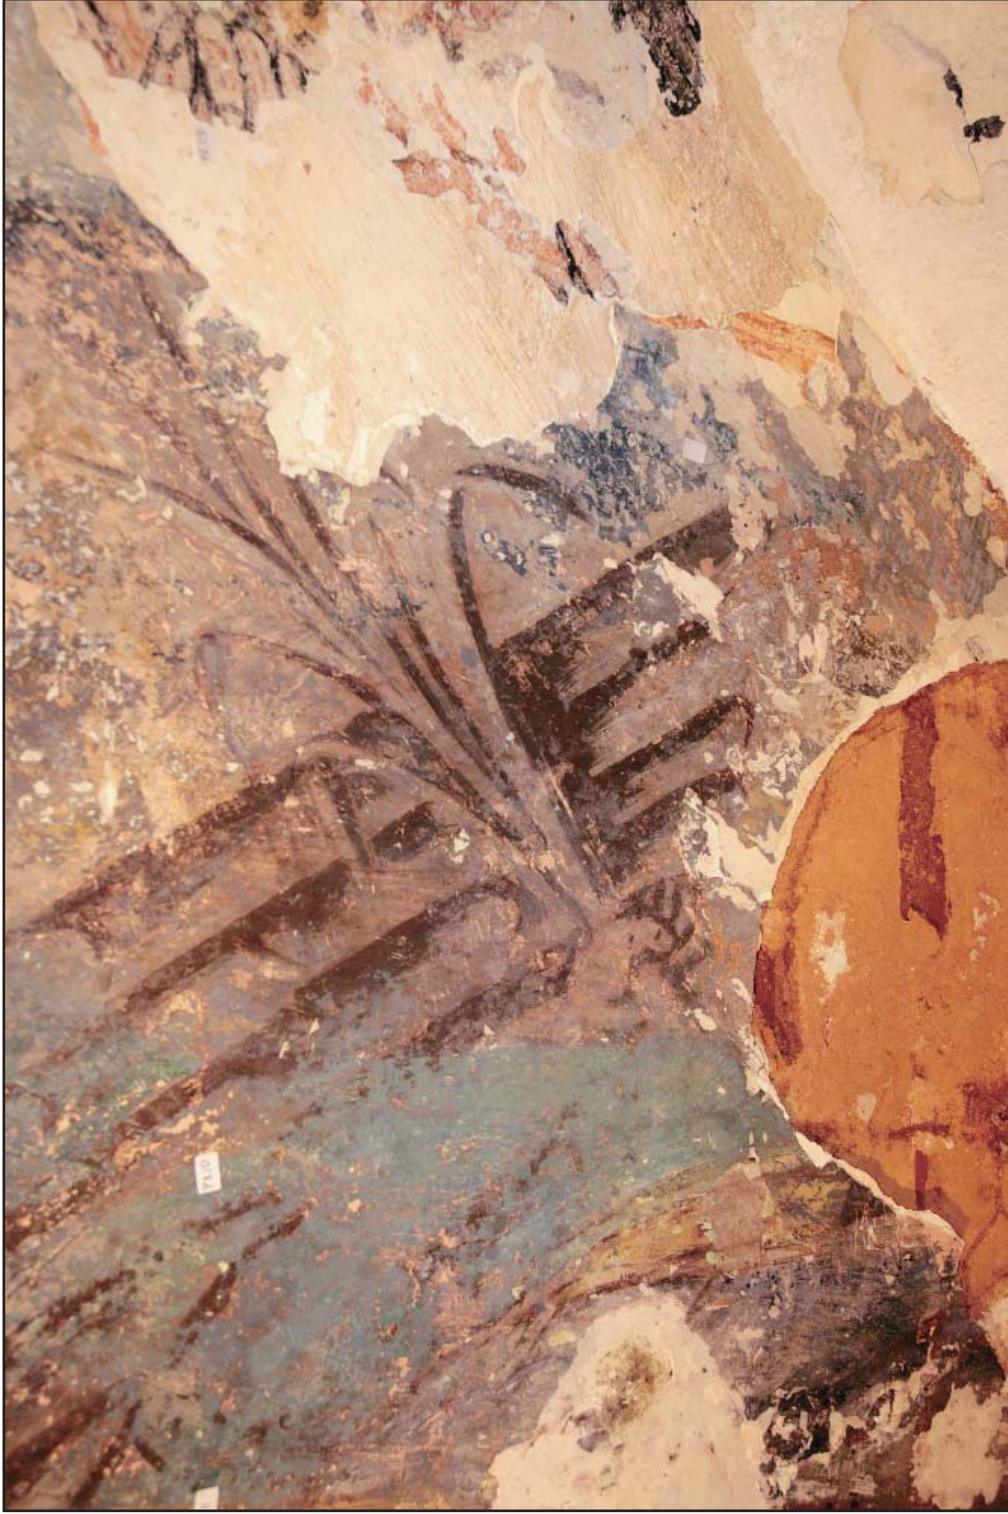
Figure 63: Detail (A8-5) Hand, palm frond, and lower right wing, Campaign C (Source: C. Silva, 2006)
Note the blue-green over-paint from Campaign D.

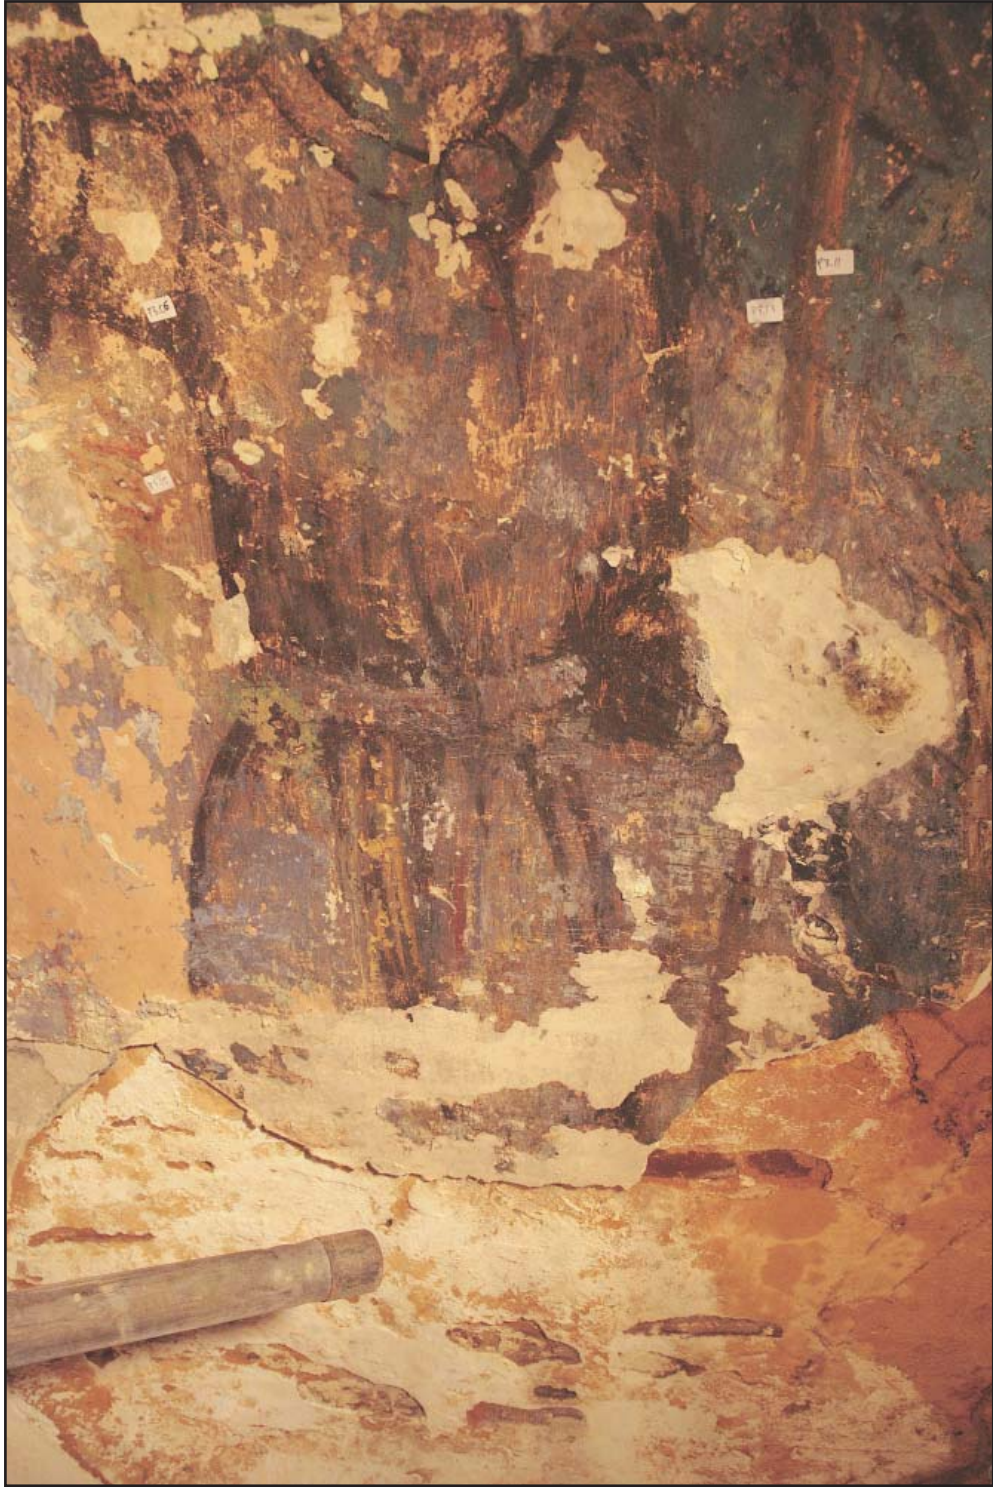
Figure 64: Detail (A8-6) Detail of garment, Campaign C
(Source: C. Silva, 2006)

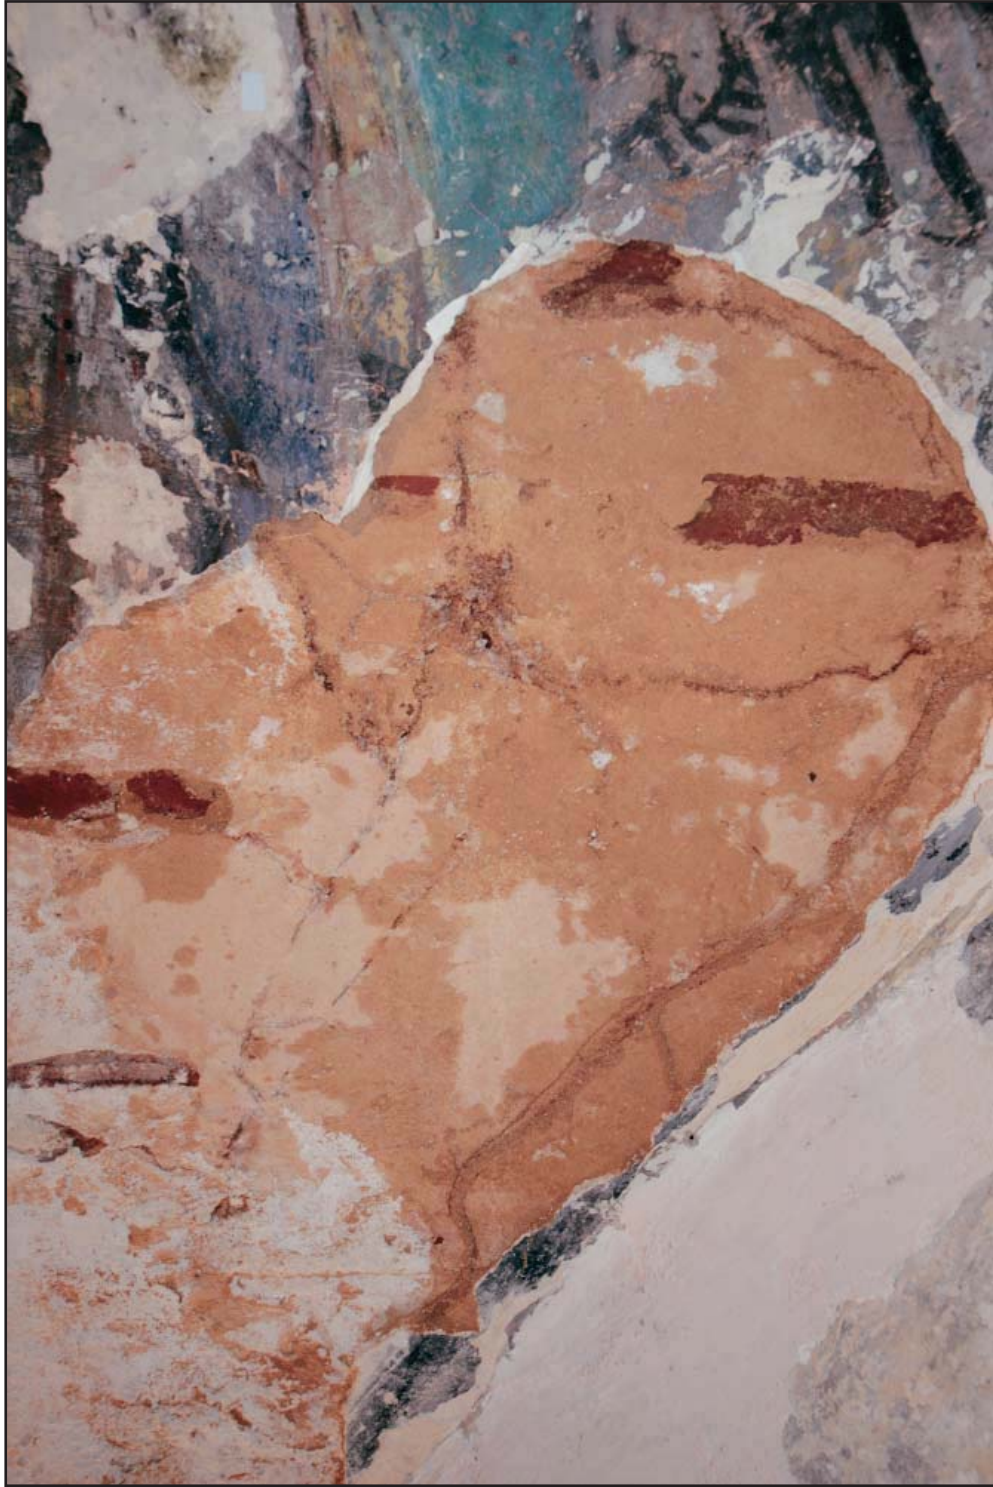
Figure 65: Detail (A8-7) Area of loss with termite tunnels
(Source: C. Silva, 2006)

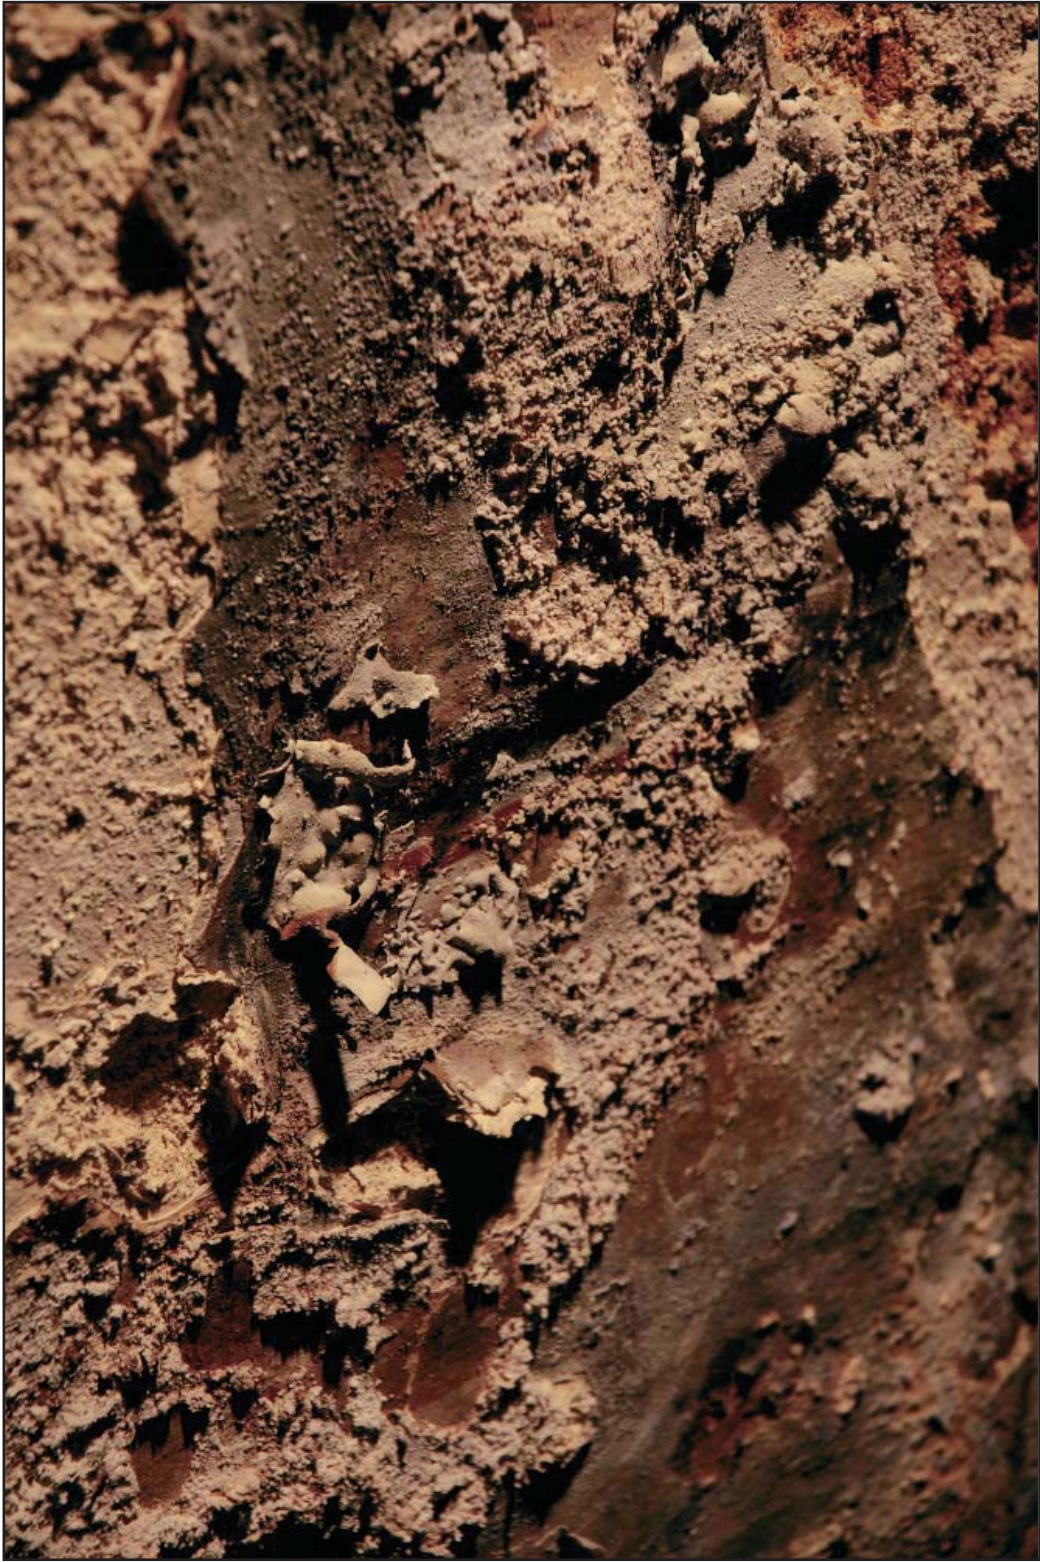
Figure 66: Detail (A8-8) Image of surface conditions: blistering, flaking, and salts (Source: C. Silva, 2006)

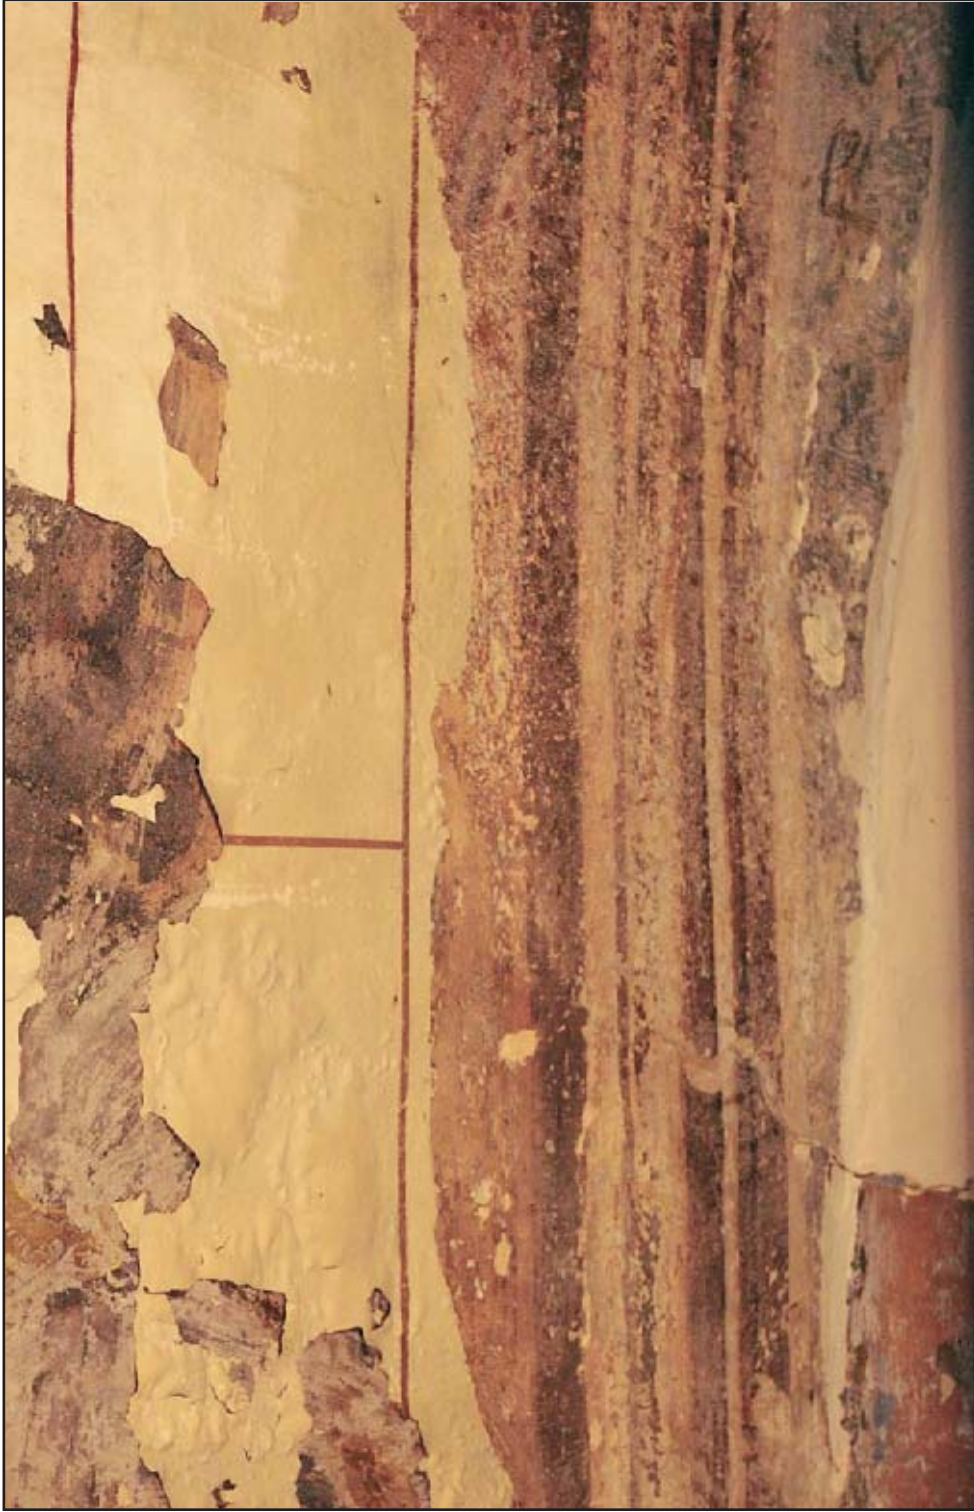
Figure 67: Detail (A8-9) Faux cornice, Campaign C (Source: C. Silva, 2006)

In Campaign C each of the pendentives are framed by thick light olive green border with a smaller rose colored banding. This outline traces the junctions of the arches which form the valley point of each pendentive. The border measures 7" in width with the rose banding measuring $\frac{3}{4}$ " (Figure 55). The bottom edge of the dome (framing the top of the pendentives), is defined by a faux cornice painted in a monochromatic brown palette ranging in value from dark umber to very pale beige using a series of nine smaller bands with widths between $\frac{3}{4}$ inch and two inches (Figure 67).

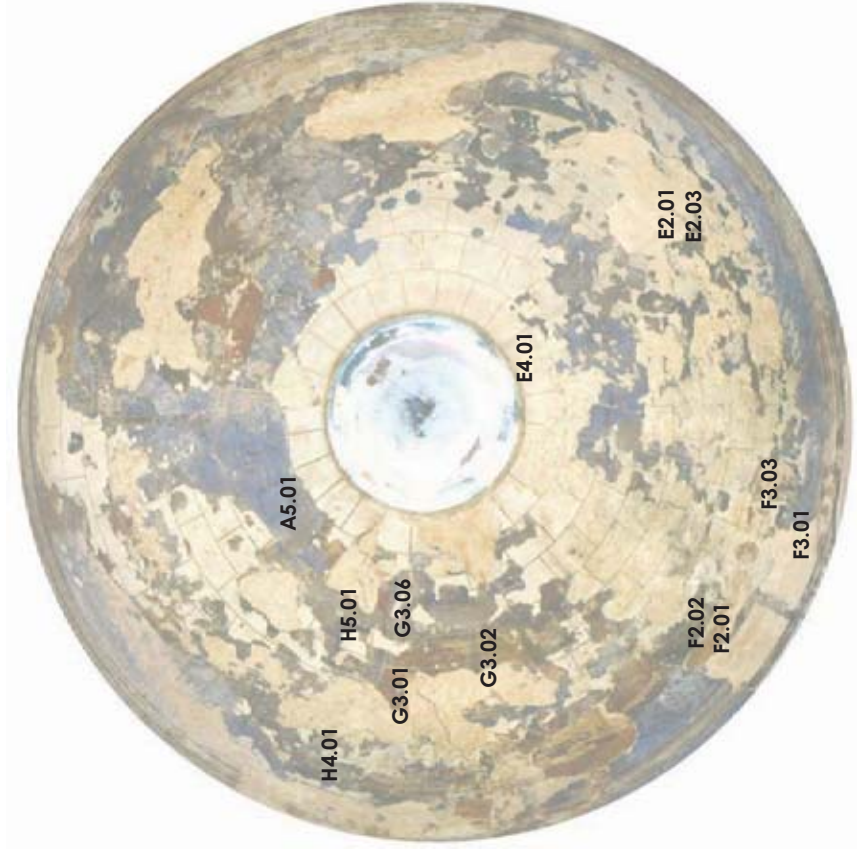
B-1, Map 9: Sample Locations, Dome

IGLESIA SAN JOSÉ, SAN JUAN PUERTO RICO
ROSARIO CHAPEL DOME
Sample Locations

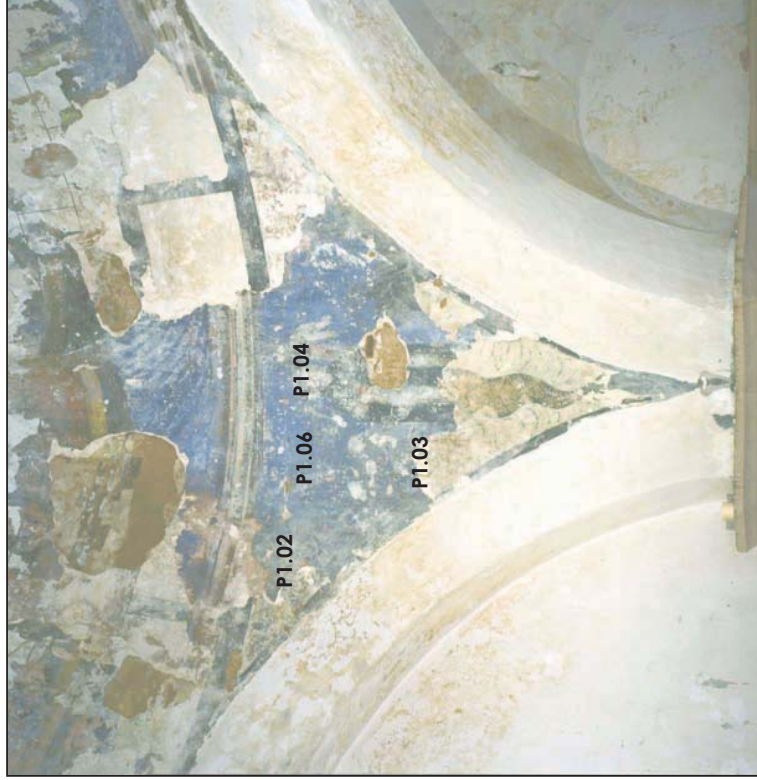
Pendentive 1 (Source: Joseph Elliott, 2004)

IGLESIA SAN JOSÉ, SAN JUAN PUERTO RICO
ROSARIO CHAPEL PENDENTIVES
Sample Locations

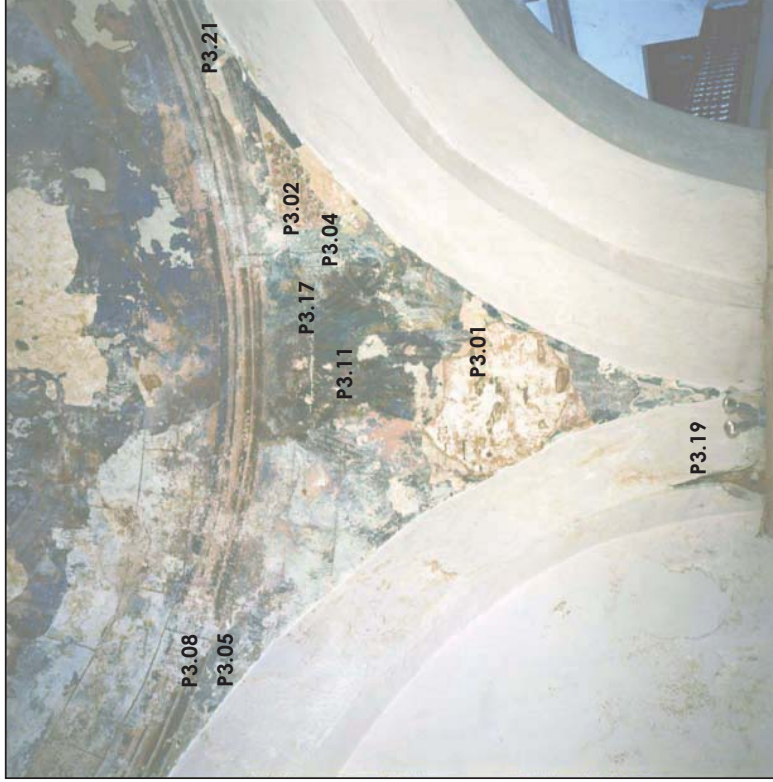
Pendentive 3 (Source: Joseph Elliott, 2004)

IGLESIA SAN JOSÉ, SAN JUAN PUERTO RICO
ROSARIO CHAPEL PENDENTIVES
Sample Locations

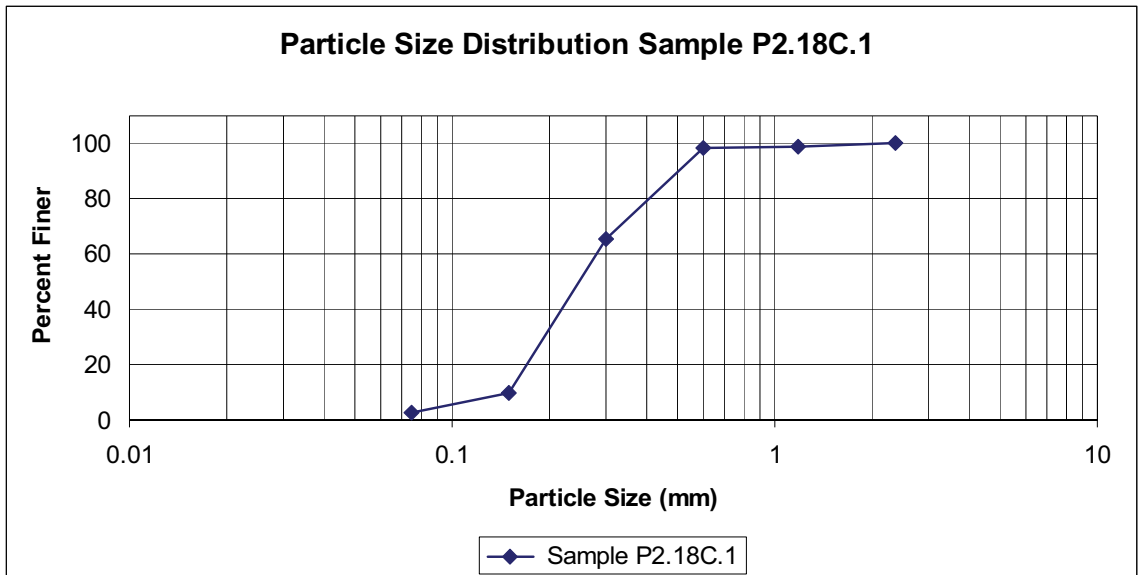
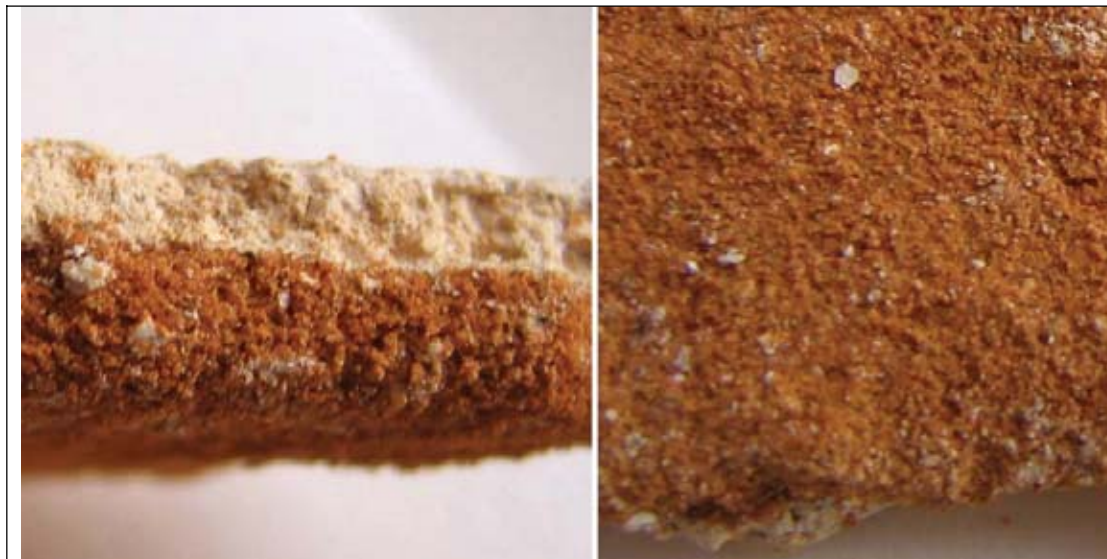
Chart 1: Particle Size Distribution, Sample P2.18C.1

Figure 68: Sample 2.18C.1, *enfoscado* plaster, Appendix C-1

$$\% \text{Mass Loss, } M_L \% = \frac{M_S - \sum M_r}{M_S} \times 100\% = 0.19\%$$

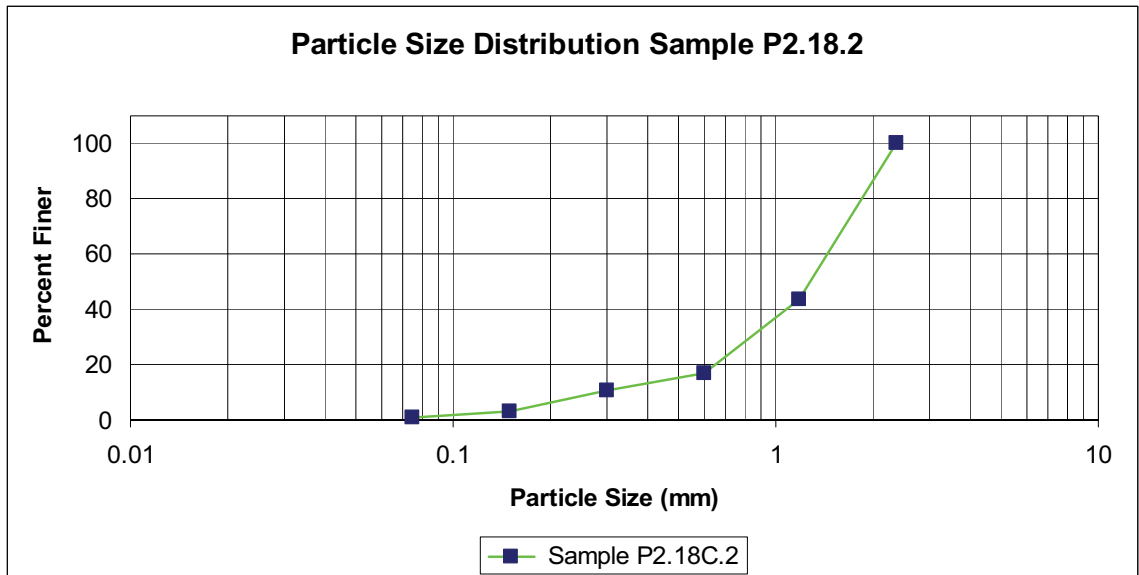
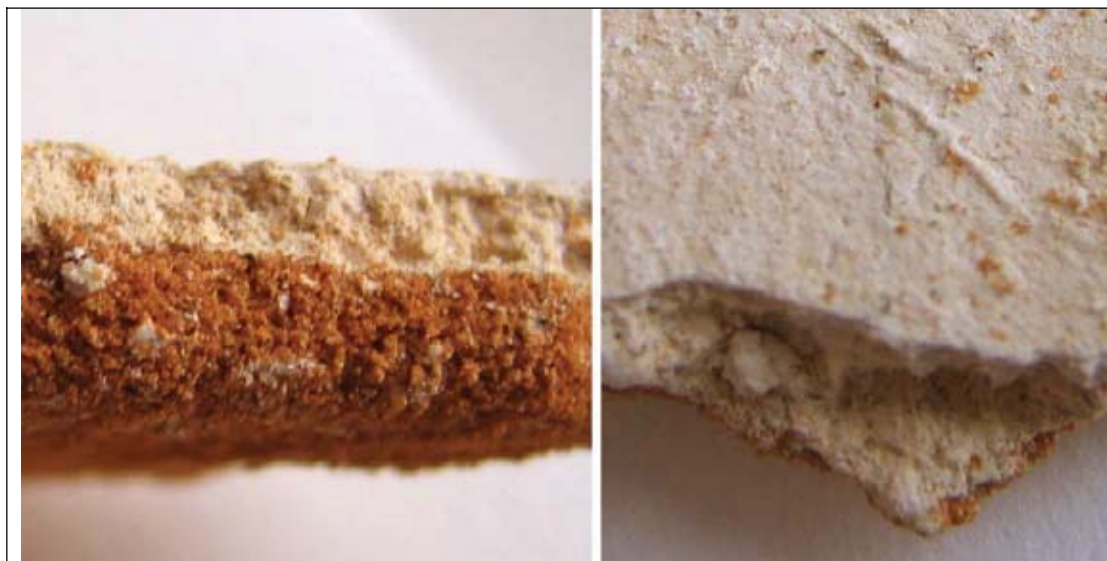
Chart 2: Particle Size Distribution, Sample P2.18C.2

Figure 69: Sample 2.18C.2, *enlucido* plaster

$$\% \text{Mass Loss, } M_L \% = \frac{M_S - \sum M_r}{M_S} \times 100\% = 0.43\%$$

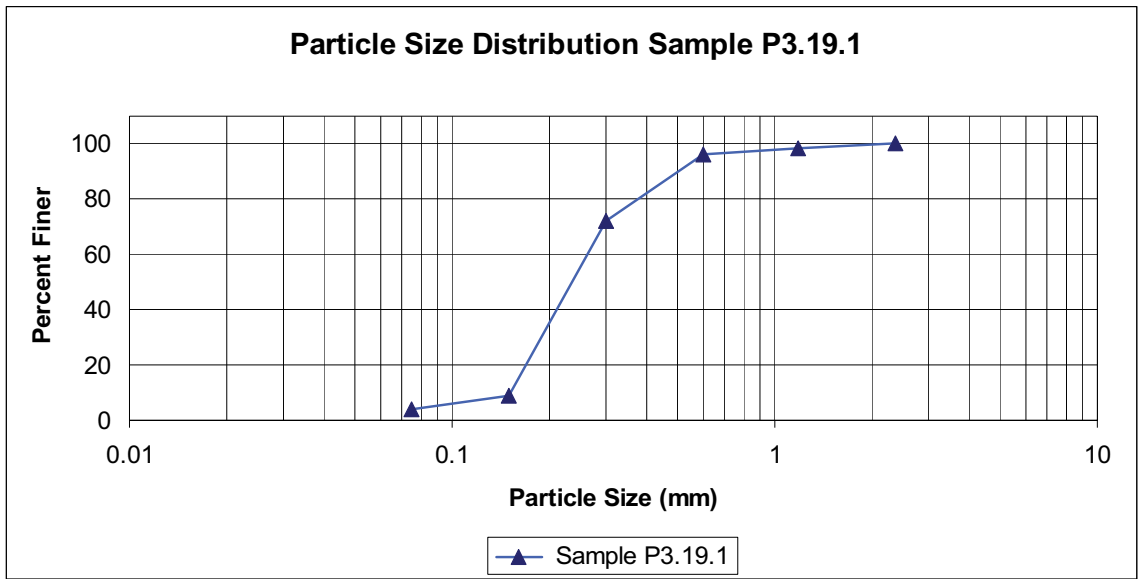
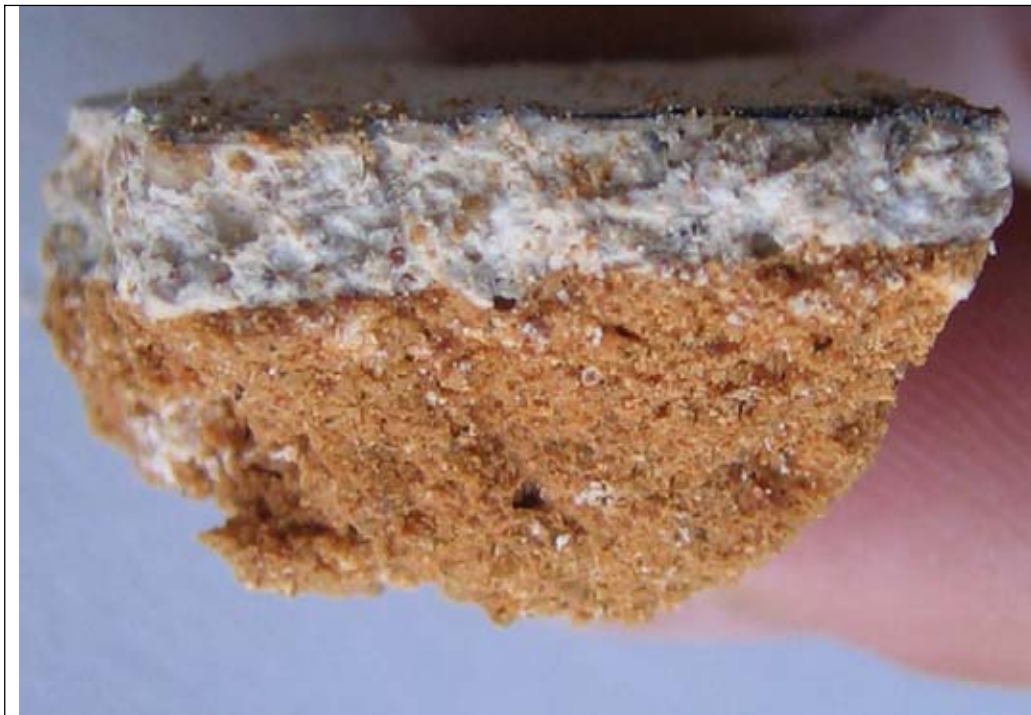
Chart 3: Particle Size Distribution, Sample P3.19.1

Figure 70: Sample 3.19, red *enfoscado* on the bottom of sample

$$\% \text{Mass Loss, } \mathbf{M_L} \% = \frac{M_S - \sum M_r}{M_S} \times 100\% = 0.17\%$$

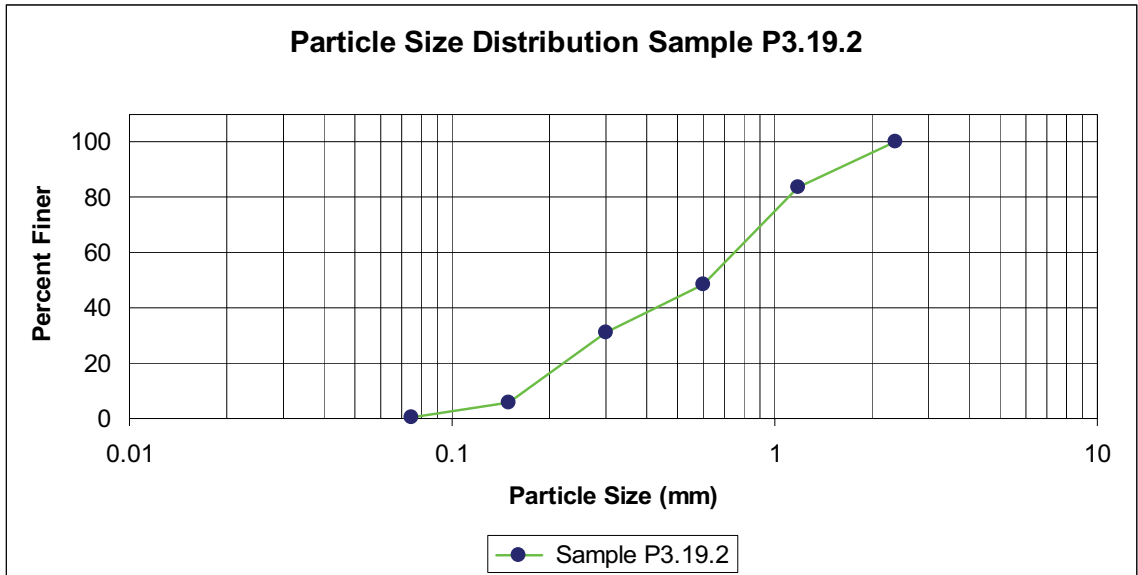
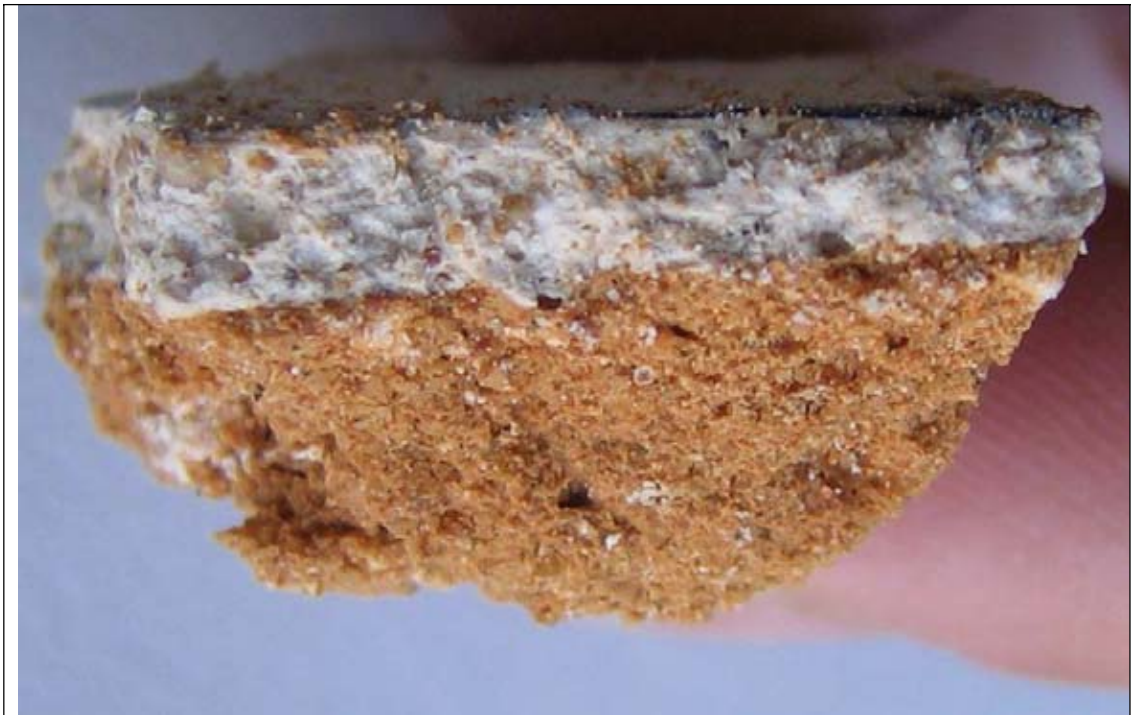
Chart 4: Particle Size Distribution, Sample P3.19.2

Figure 71: Sample 3.19, white *enlucido* on the top of sample

$$\% \text{Mass Loss, } M_L \% = \frac{M_S - \sum M_r}{M_S} \times 100\% = 0.27\%$$

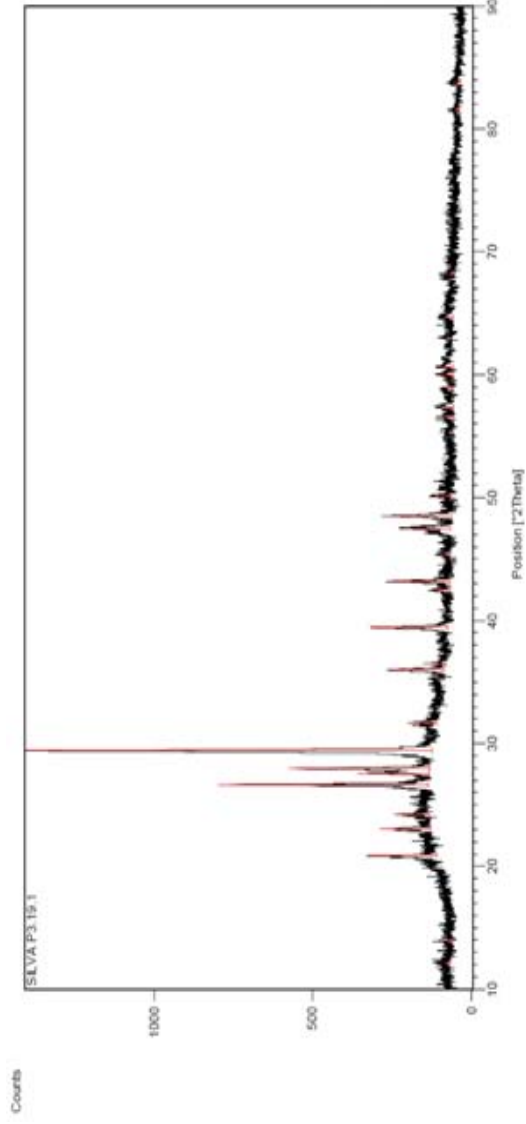
APPENDIX C-5

Chemical Formula
 Ca C O3
 Si O2
 Na Al Si3 O8
 (Na3 , K)3 Mg4 (Al , Mg)6 (Si , Al)24 O60
 Na Cl

Scale Factor Semi-Quant Composition
 0.943 52.2%
 0.529 29.3%
 0.182 10.1%
 0.08 4.4%
 0.072 4.0%
 1.806

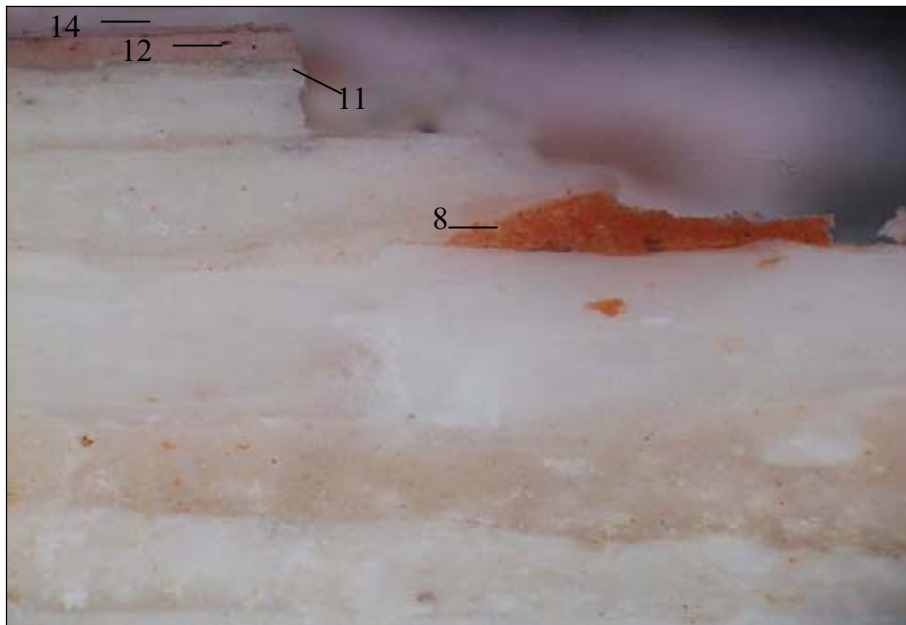
Photomicrograph of top of sample layers 6-14

STRATIGRAPHY (STARTING FROM SUBSTRATE)

1. Black (A)
2. Creamy White
3. Gray
4. Creamy White
5. Creamy White
6. Creamy White
7. Cool White
8. Red-Orange (B)
9. Creamy White
10. Creamy White
11. Gray
12. Peachy-Pink (C)
13. Slightly Darker Pink (C)
14. Gray(D)

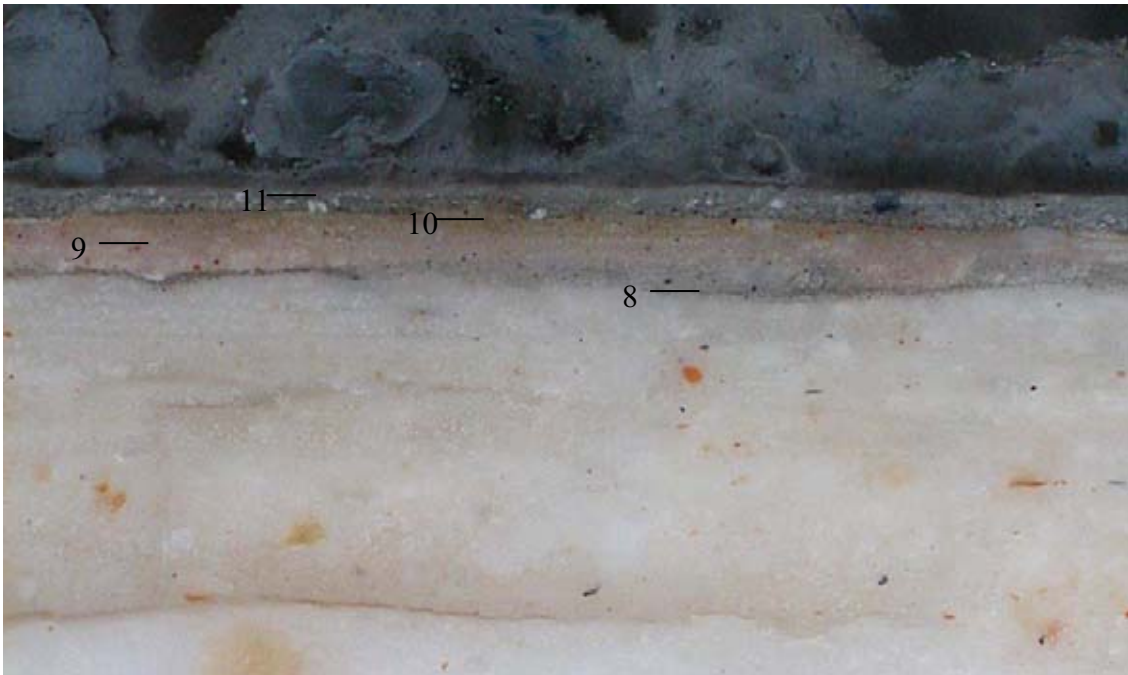
Top of sample layers 3-11

STRATIGRAPHY (STARING FROM SUBSTRATE)

1. Red and Black - not in image (A)
2. Creamy White- not in image
3. Cool White
4. Creamy White
5. Creamy White
6. Creamy White
7. Creamy White
8. Gray (C)
9. Peachy-pink (C)
10. Darker peach (C)
11. Gray-green (C)

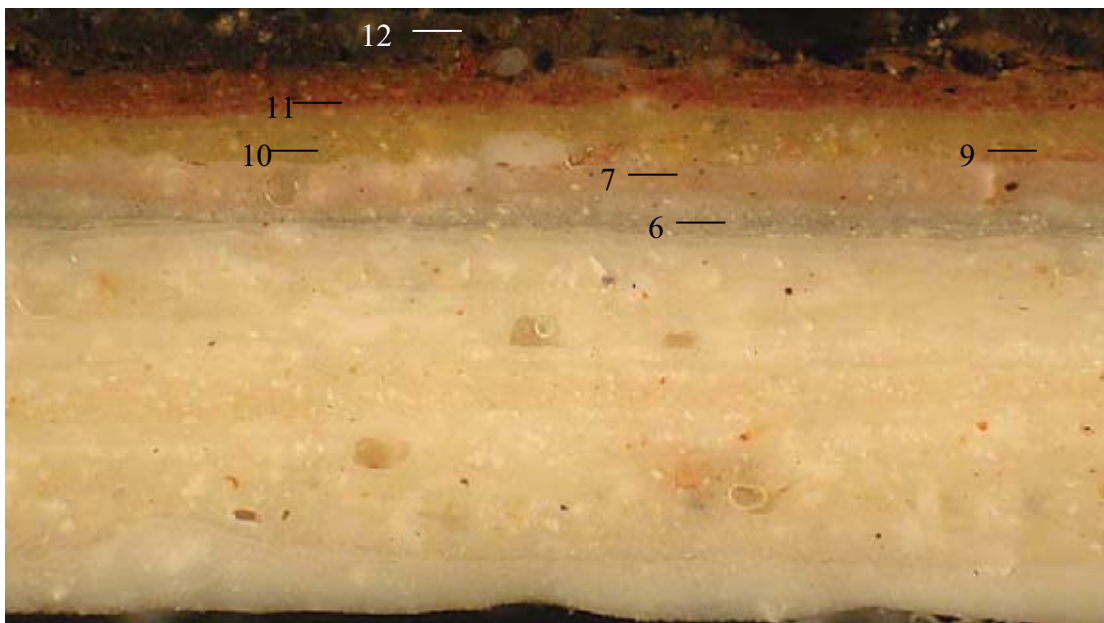
STRATIGRAPHY (STARING FROM SUBSTRATE)

1. Cool White
2. Creamy White
3. Creamy White
4. Creamy White
5. Creamy White
6. Light Gray (C)
7. Peachy-pink (C)
8. Black -not in image (C)
9. Pinkish-Rose (C)
10. Yellow (C)
11. Rust (C)
12. Gray (C)

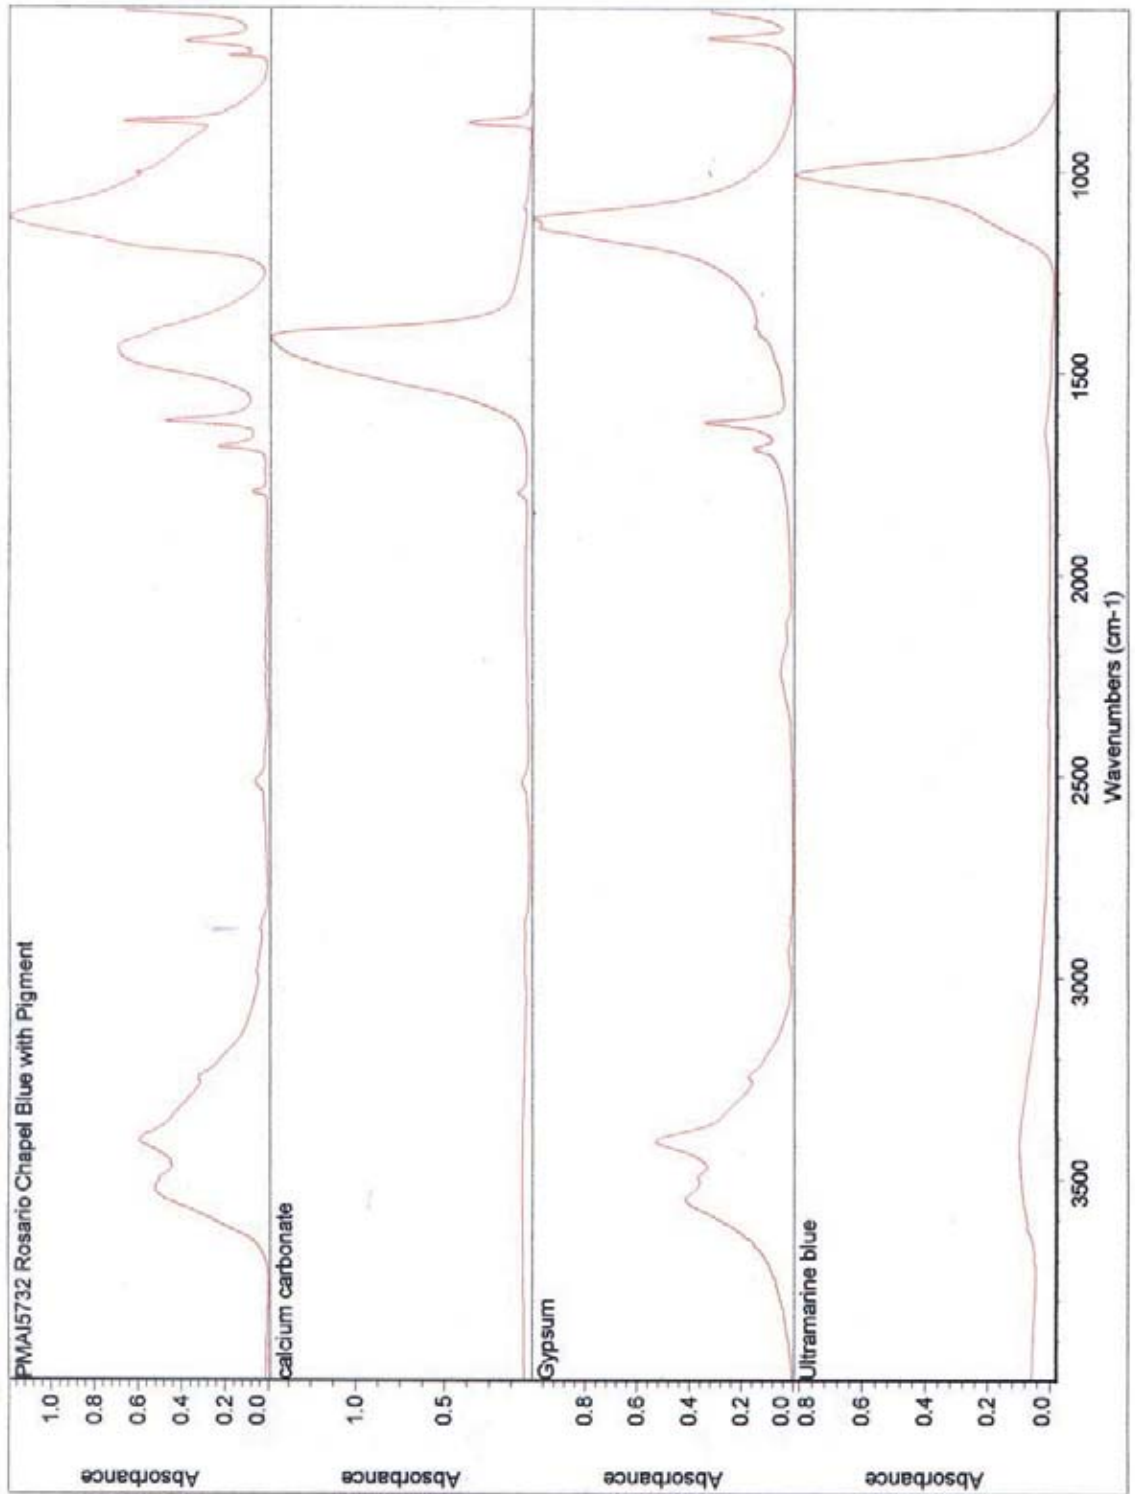
Chart 7: FTIR spectra, sample P1.06, Campaign D blue pigment and binder analysis
