A Technical Study of the Mural Paintings of the Interior Dome of the Capilla de la Virgen del Rosario, Iglesia San José, San Juan, Puerto Rico

Presented to the Faculties of the University of Pennsylvania in Partial Fulfillment of the Requirements for the Degree of Master of Science in Historic Preservation 2006.

**A TECHNICAL STUDY OF THE MURAL PAINTINGS ON THE INTERIOR
DOME OF THE CAPILLA DE LA VIRGEN DEL ROSARIO,
IGLESIA SAN JOSÉ, SAN JUAN, PUERTO RICO**

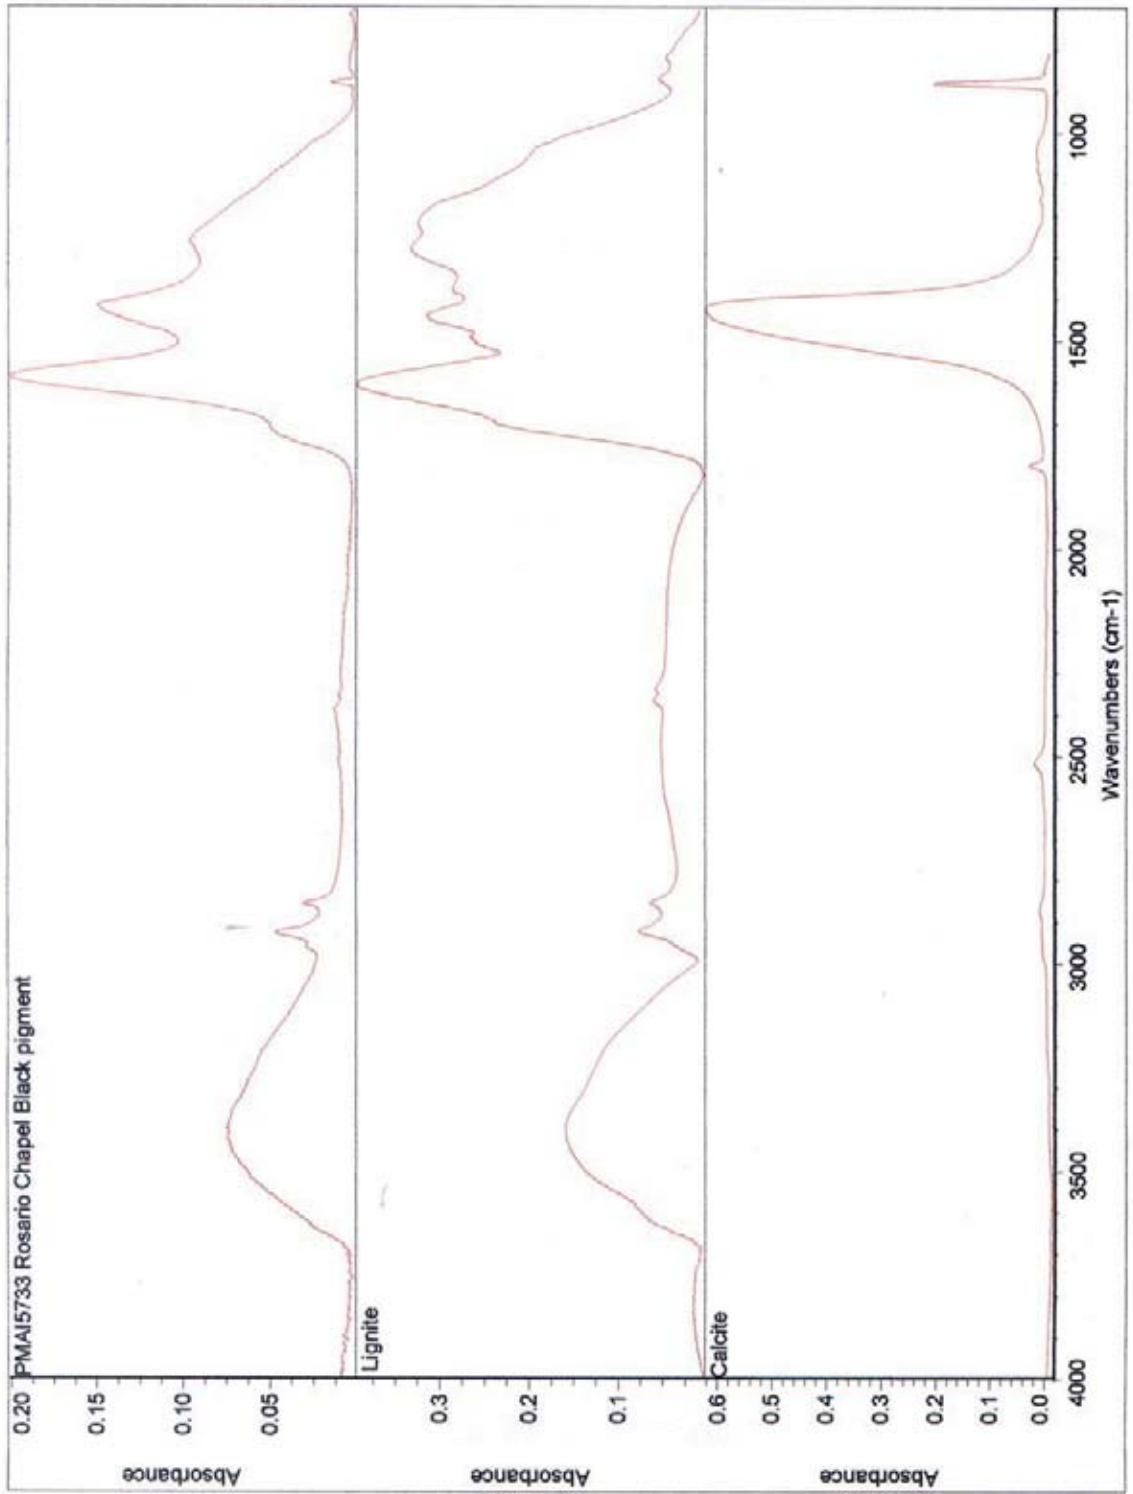
Chart 8: FTIR Spectra, Sample P2.18, Campaign A black pigment and binder analysis

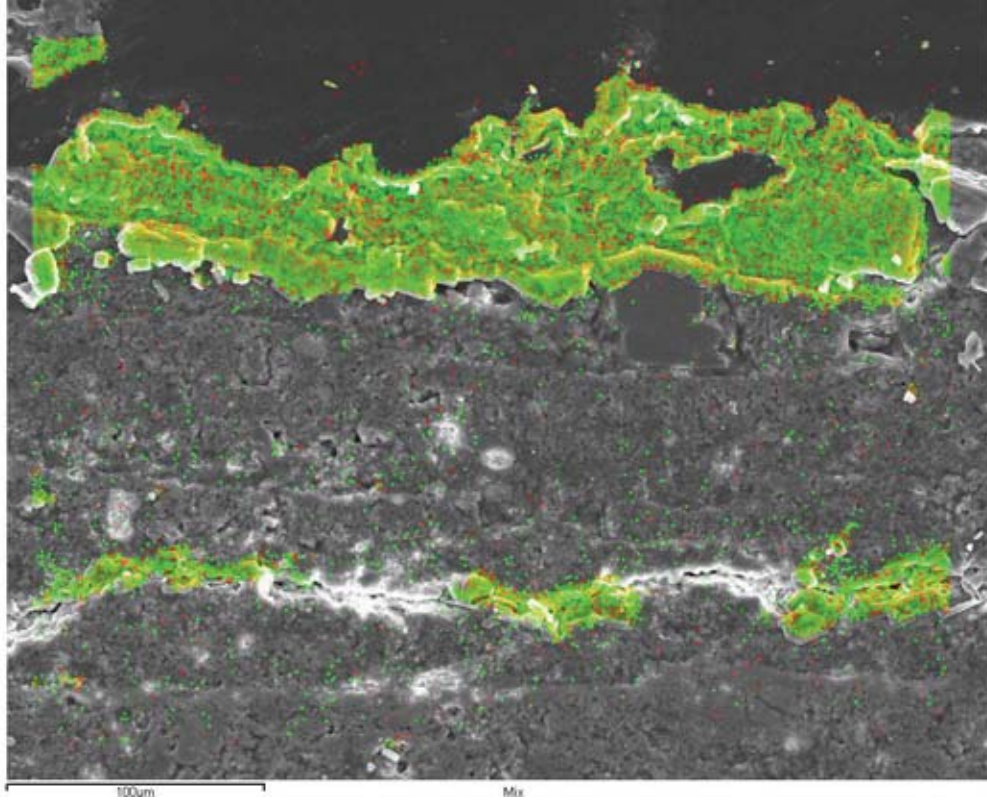
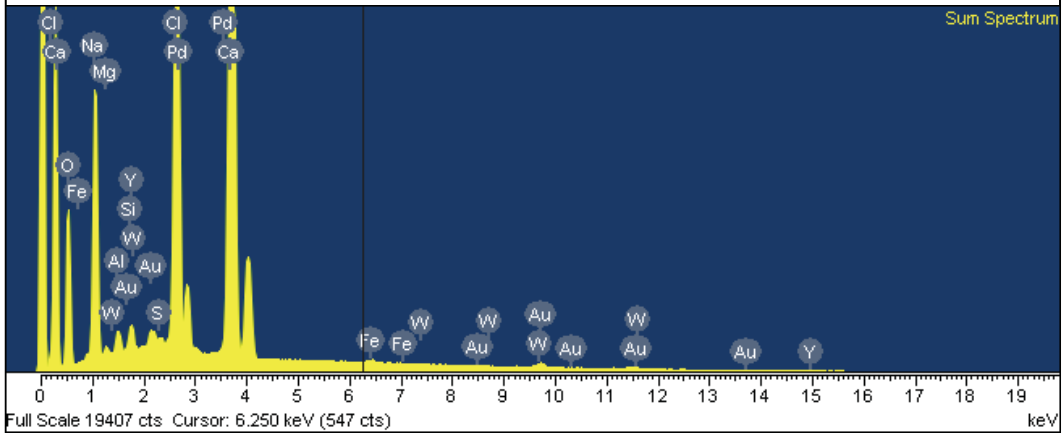
Sample ID: CU1
Magnification: 300x

Sample Description: Cross-section from cupola
Working Distance: 17mm

Comments: Electron mapping of Cl (green) and Na (red) indicating the presence of halite (sodium chloride) at detached interfaces.

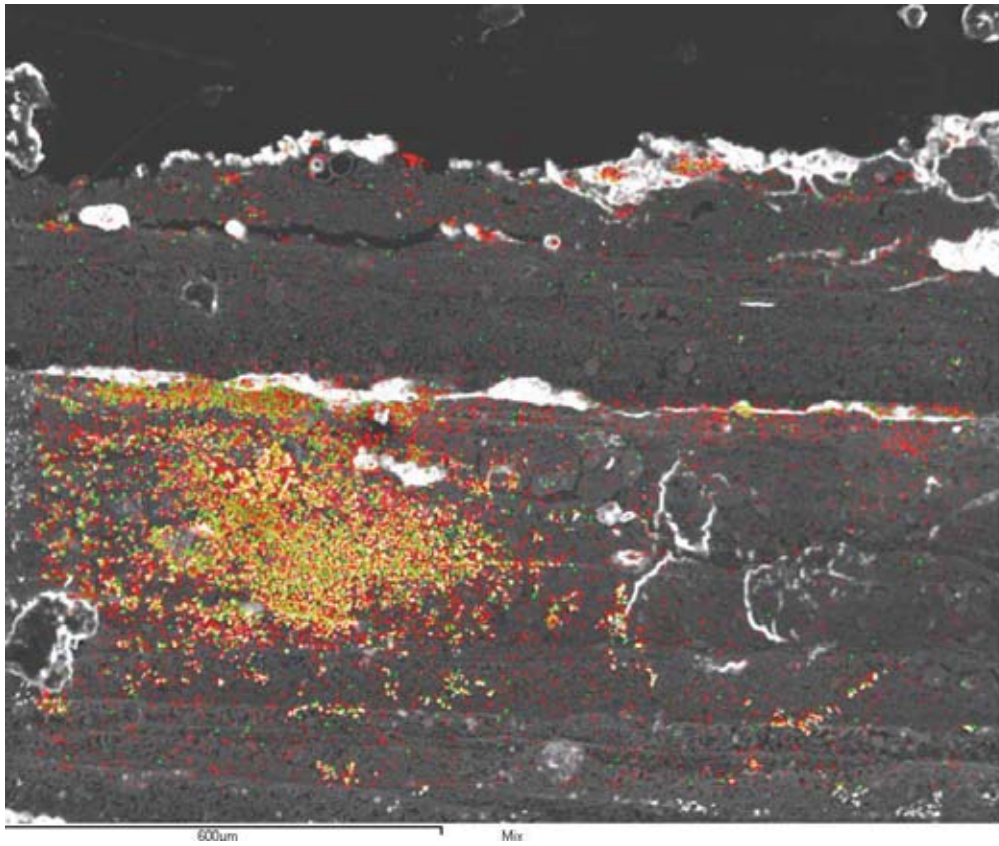
Sample Description: Cross-section from the North Arch
Working Distance: 17mm

Comments: Electron image of Na (green), Cl (yellow), and Fe (red).

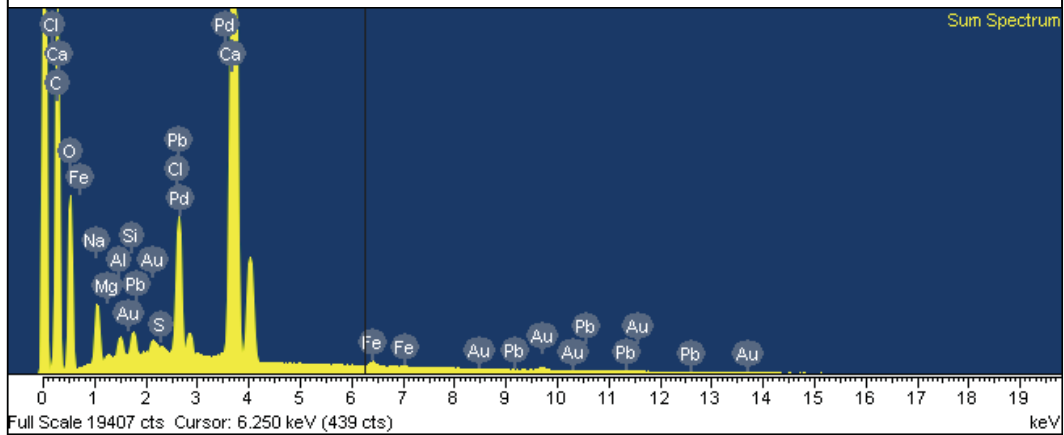
Chart 10: EDS Results, Sample NAR1

Sample ID: NAR1
Magnification: 85x

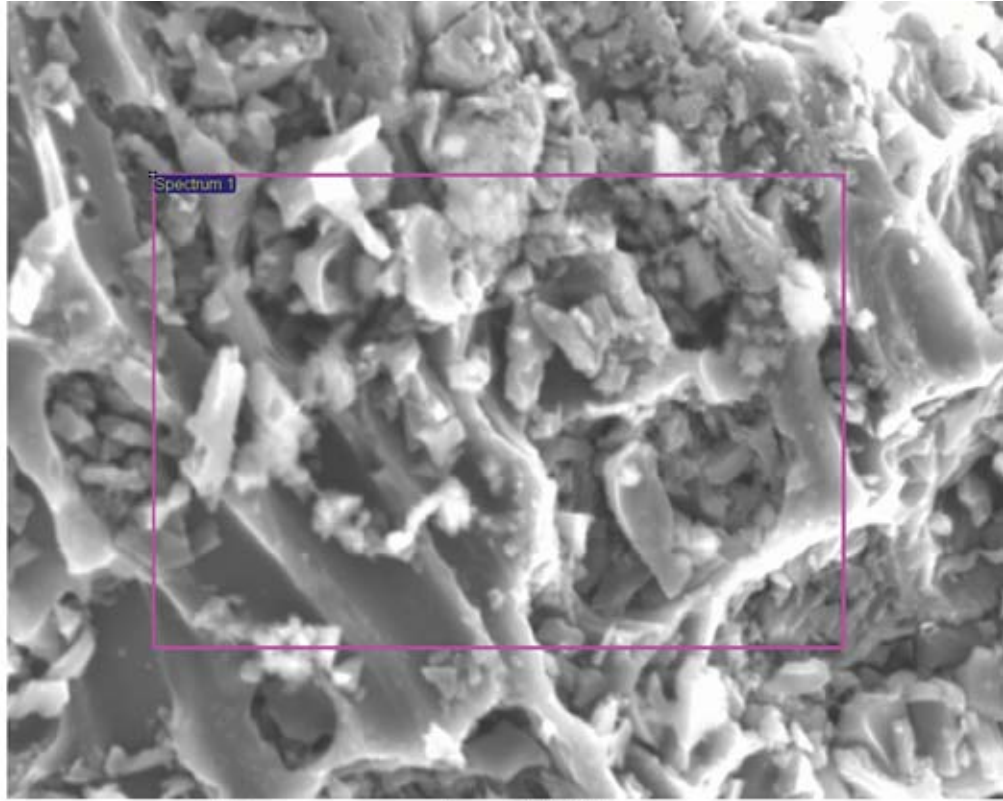
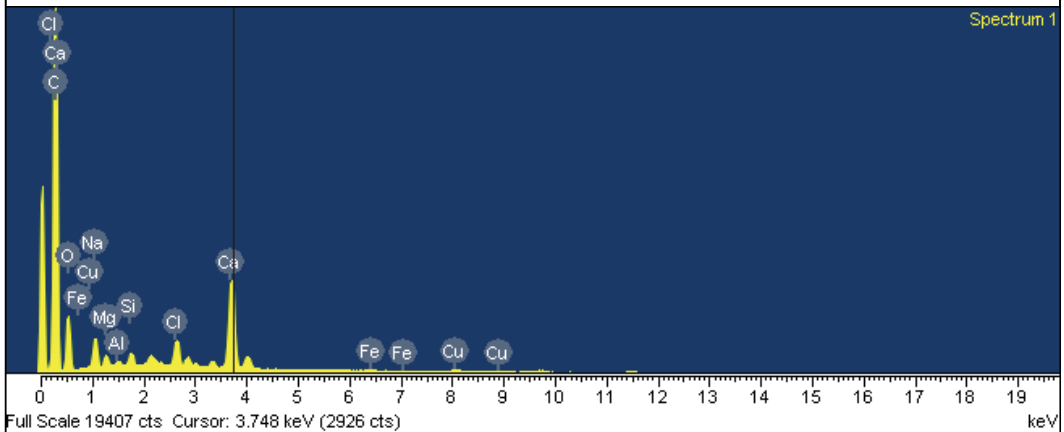
Chart 11: EDS Results, Sample P2.13.2

Sample Description: Black. Campaign (A)
Working Distance: 17mm

Comments: Carbon without phosphorous could be graphite or lamp black. Shiny metallic sheen observed in stereomicroscope suggests graphite.

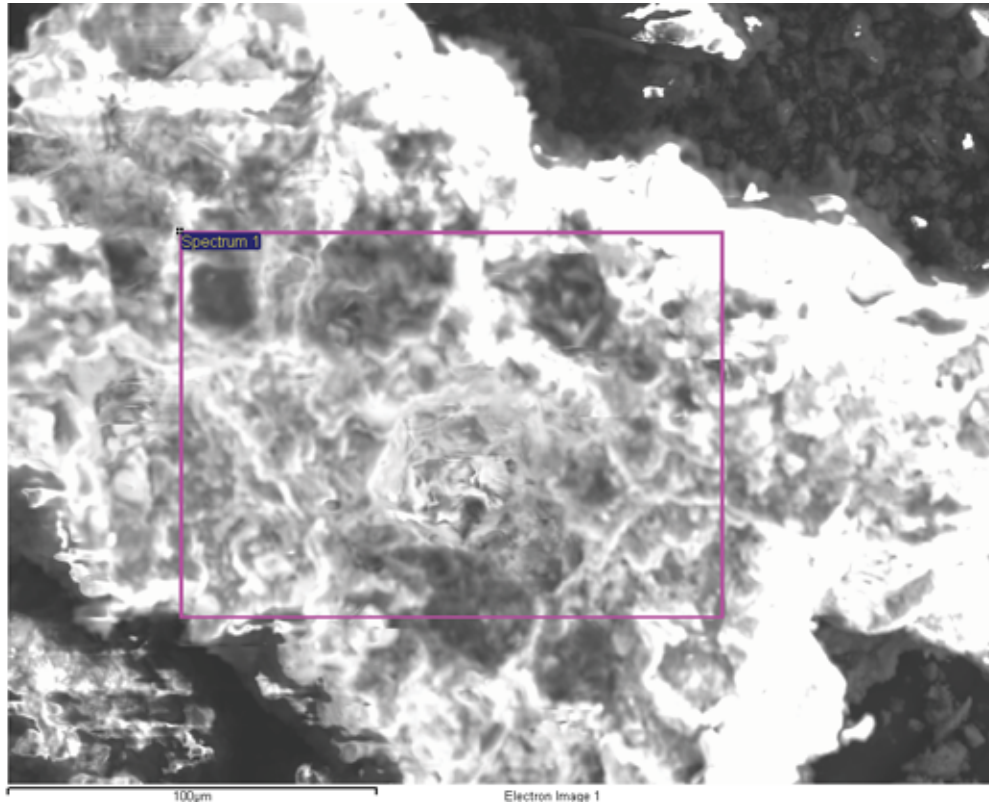
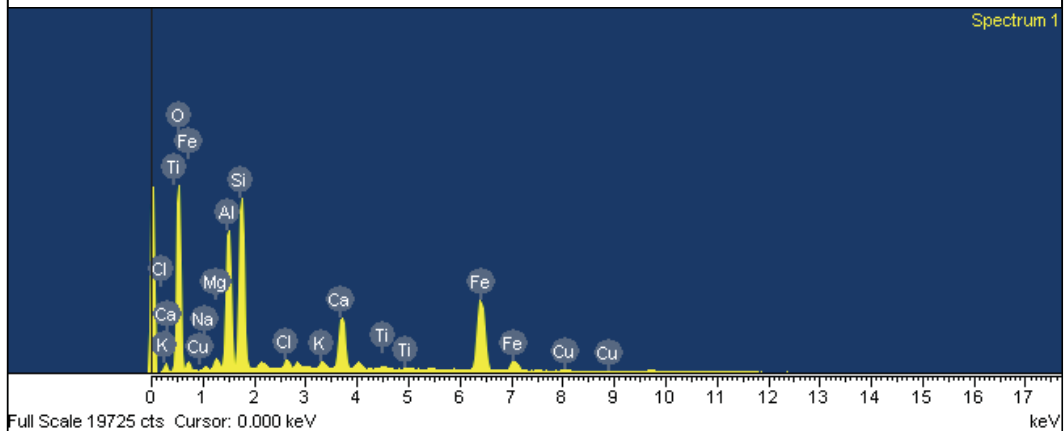
Sample ID: P2.13
Magnification: 430x

Description: Yellow, campaign (A)
Working Distance: 17mm

Comments: Presence of iron indicates possibility of ochre (iron oxide) pigment.

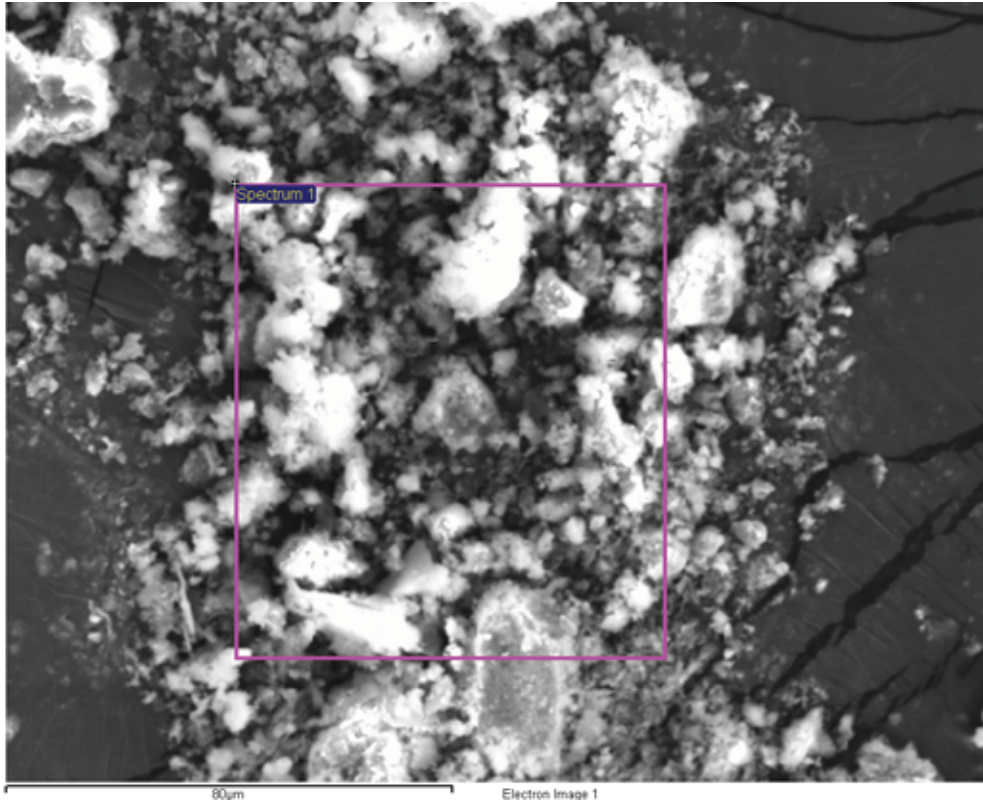
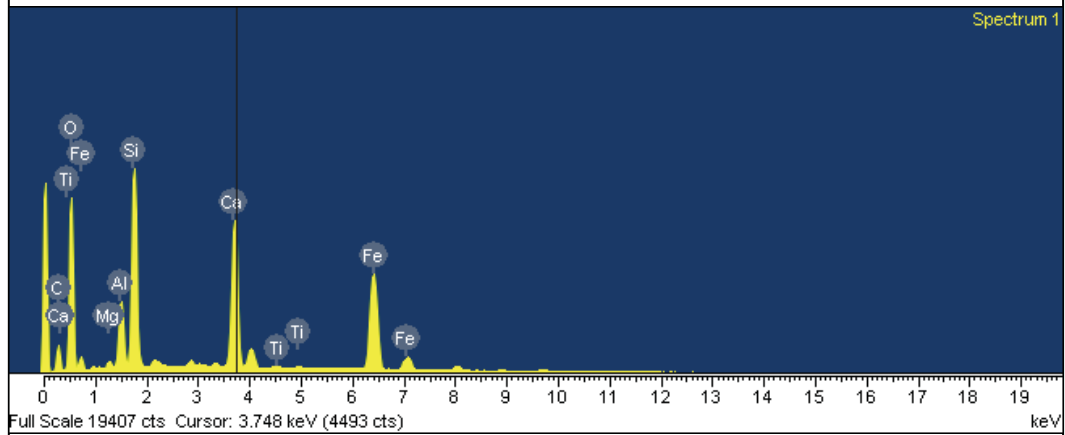
Sample ID: P1.02
Magnification: 650x

Sample Description: Red, Campaign (A)
Working Distance: 17mm

Comments: Presence of iron indicates possible red ochre, (iron oxide) pigment.

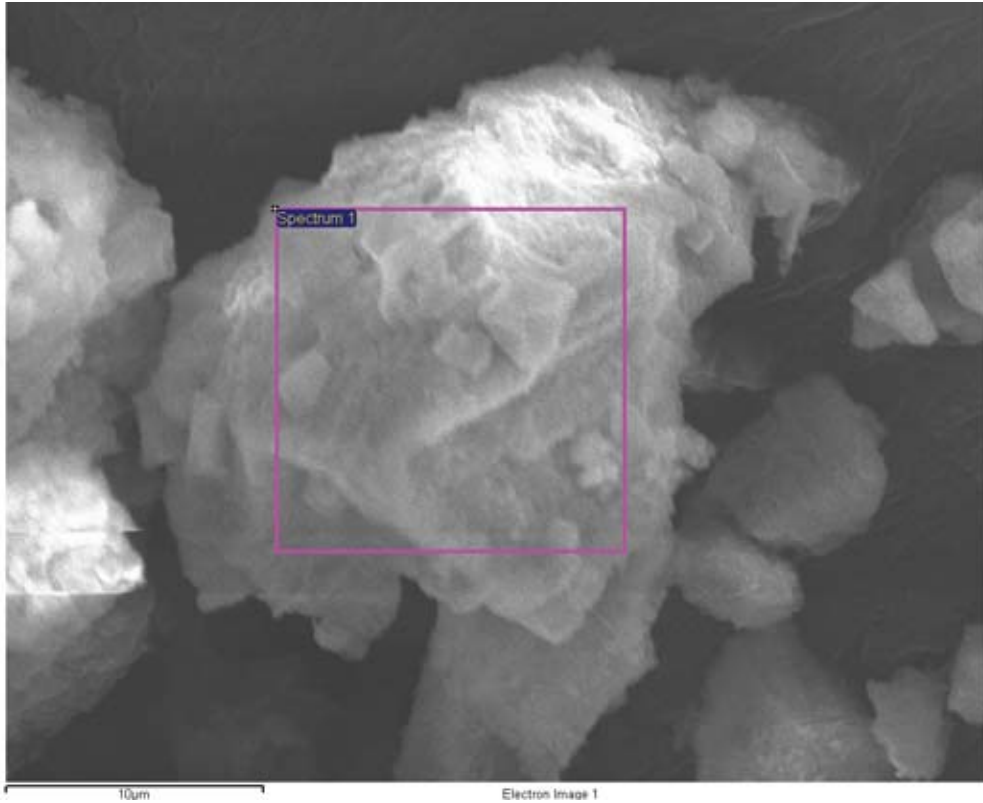
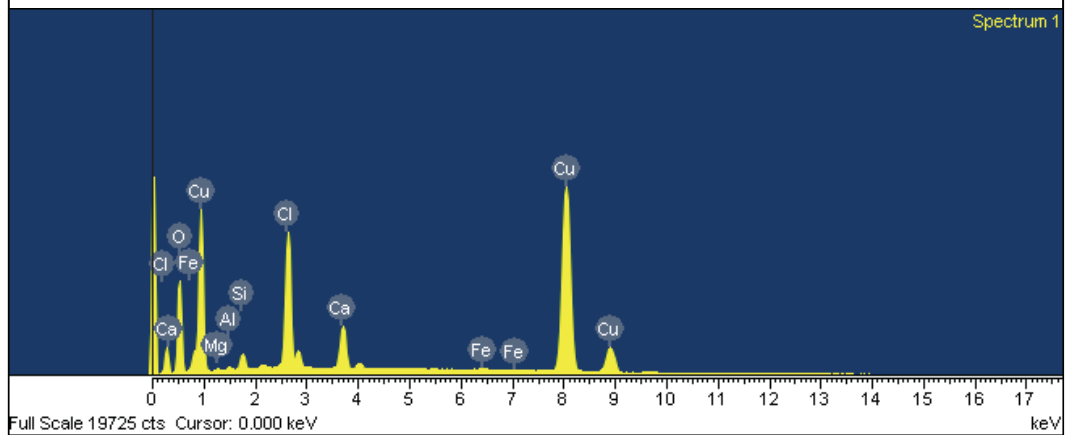
Sample ID: P2.15
Magnification: 3000x

Smple Description: Green, campaign (A)
Working Distance: 17mm

Comments: Copper without arsenic, or cobalt indicates possible verdigris.
Chloride salts present.

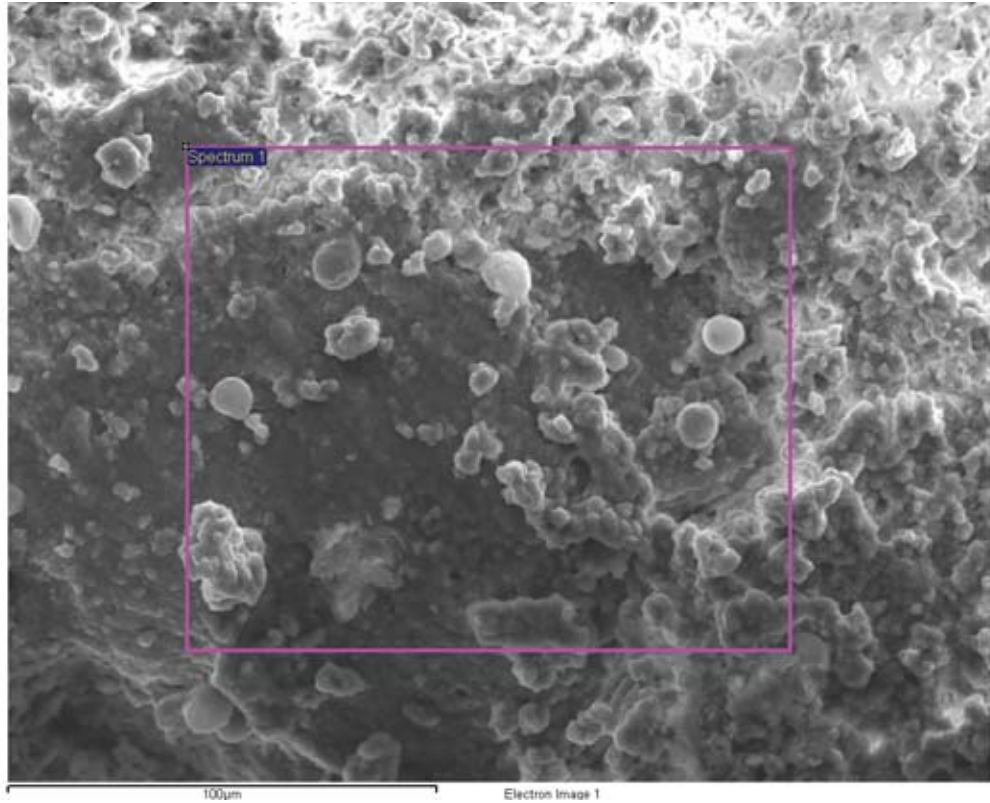
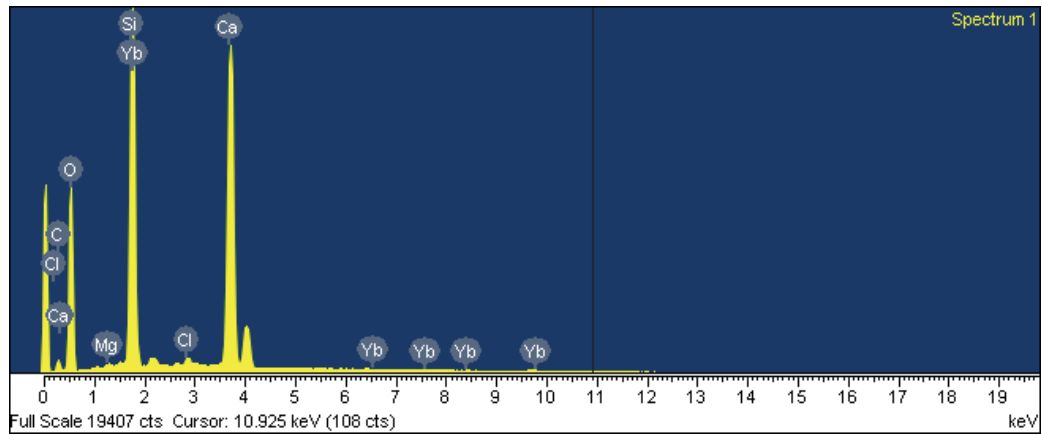
Sample ID: G3.08
Magnification: 500x

Sample Description: White, campaign (C)
Working Distance: 17mm

Comments: Possible Chalk, (calcium carbonate), Talc, (Mg, Si, O), or Diatomaceous Earth, (Si and O). Chloride salts.

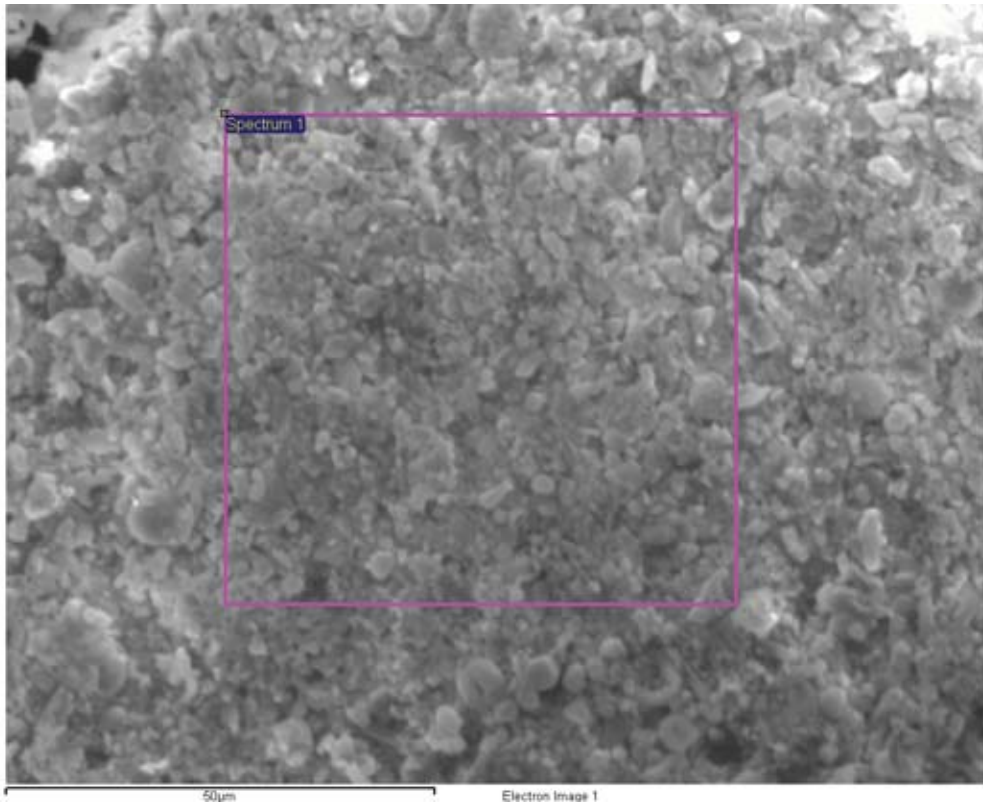
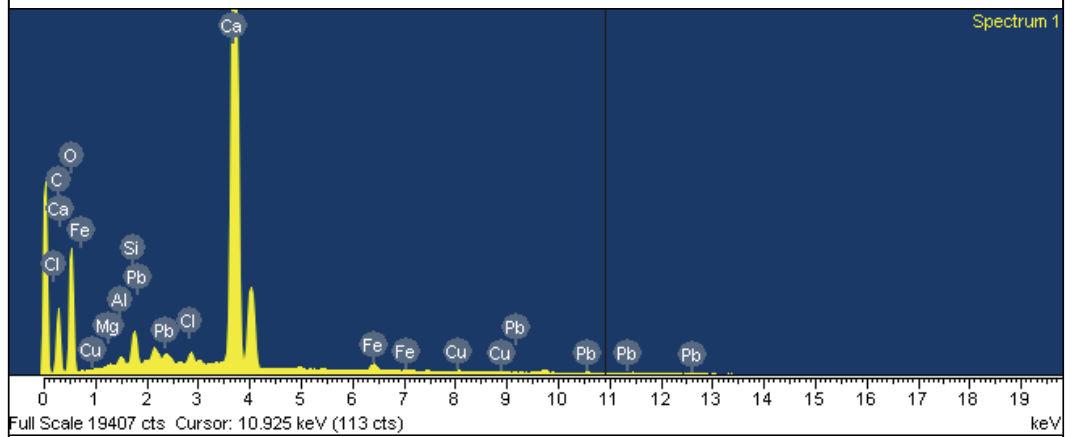
Sample ID: P3.11
Magnification: 1000x

Description: Yellow Ochre color, campaign (D)
Working Distance: 17mm

Comments: Iron indicating possible yellow ochre, (iron oxide) pigment.

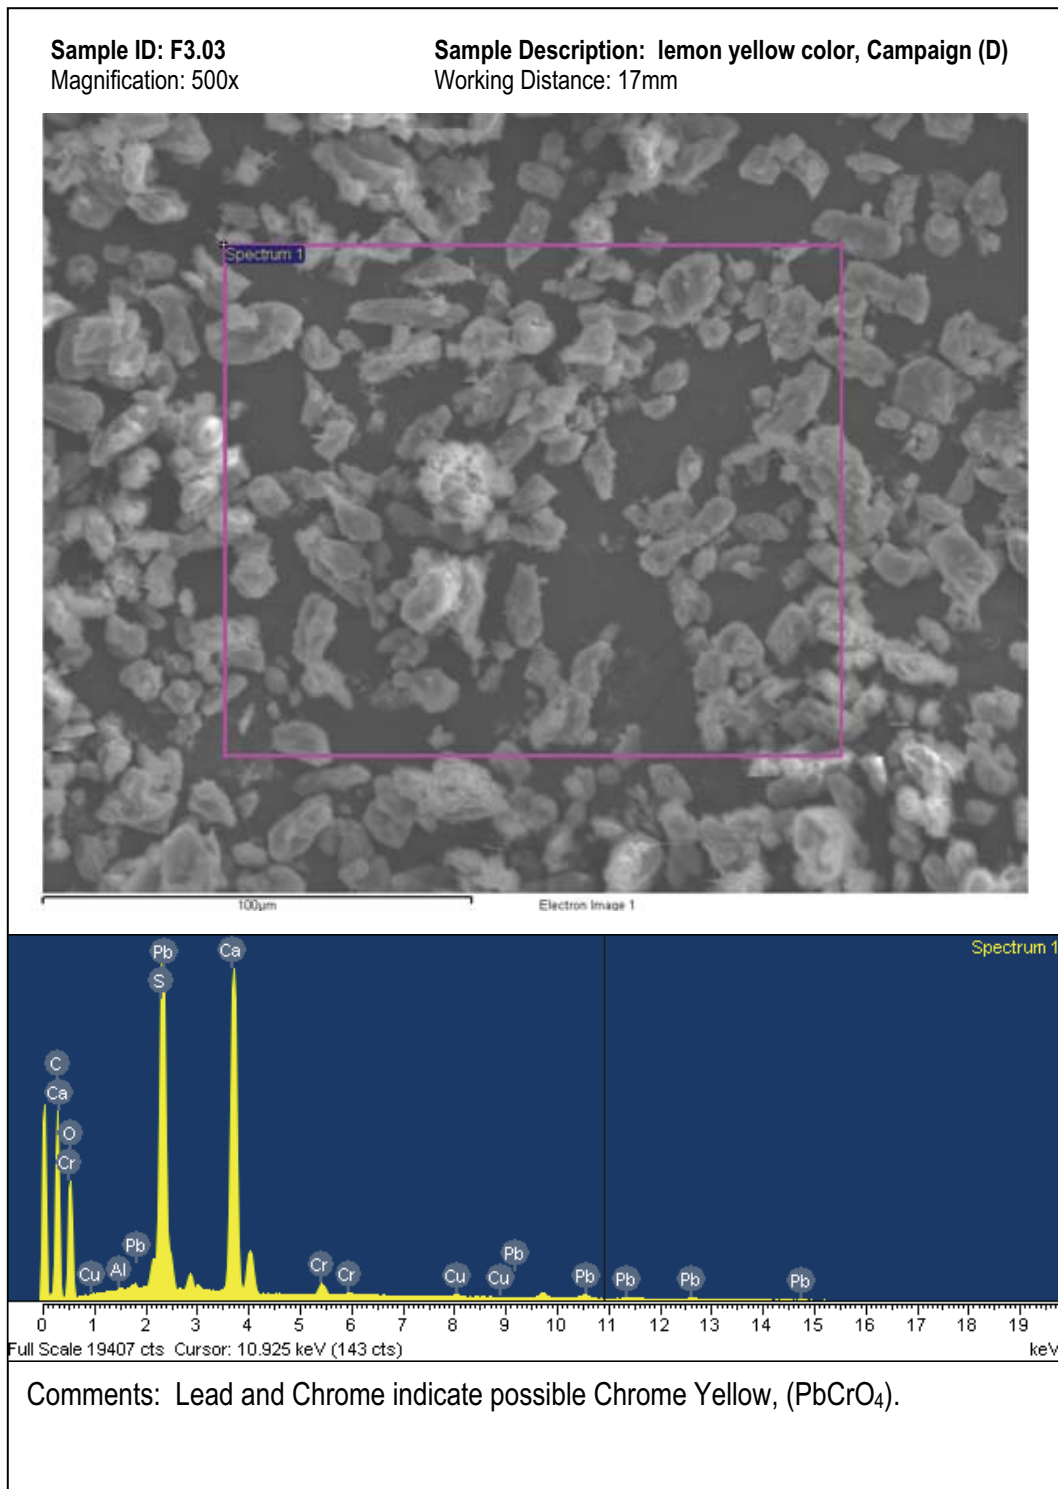
Chart 17: EDS Results, Sample F3.03

Sample ID: SAJO-ROSA F3.03

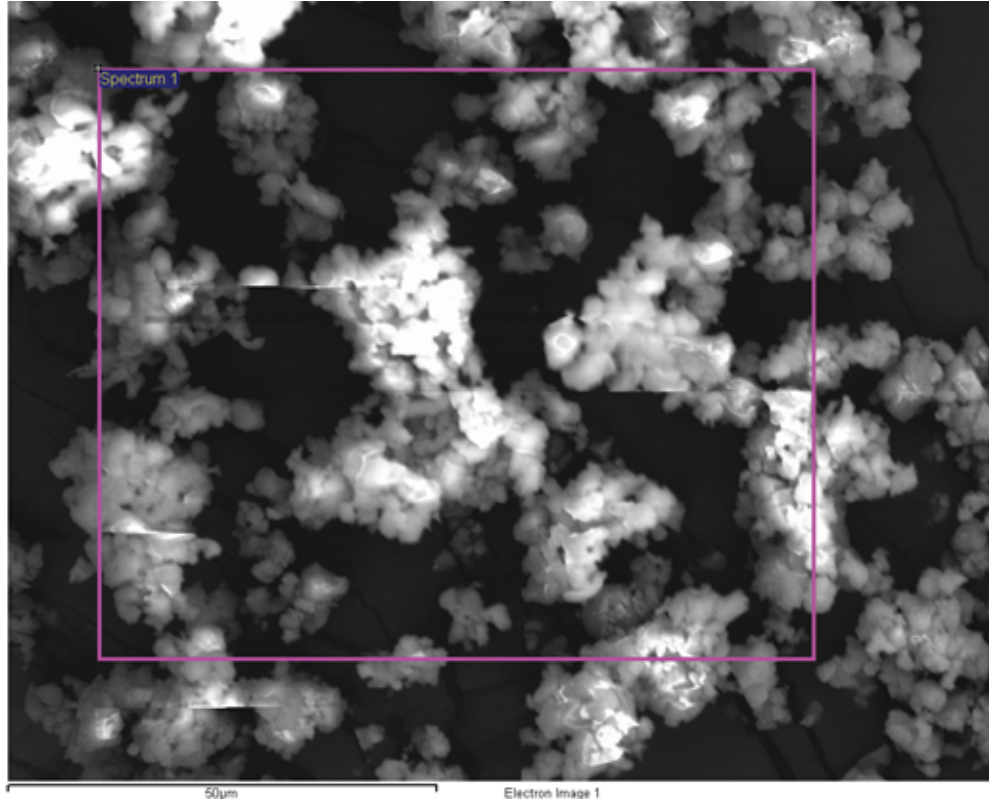
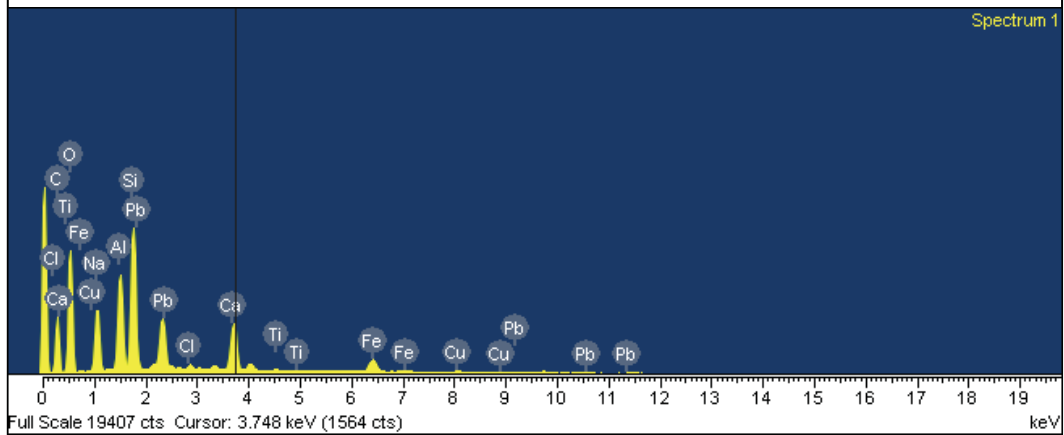
Sample ID: H4.01
Magnification: 1000x

Sample Description: Deep blue, Campaign (D)
Working Distance 17 mm

Comments: Potential pigments include **Ultramarine artificial**, ($\text{Na}_{6-10}\text{Al}_6\text{Si}_6\text{O}_{2-4}$).
Ultramarine natural, ($3\text{Na}_2 * 3\text{Al}_2\text{O}_3 * 6\text{SiO}_2 * 2\text{Na}_2$). Possible stray irradiation from adjacent sample picking up copper.

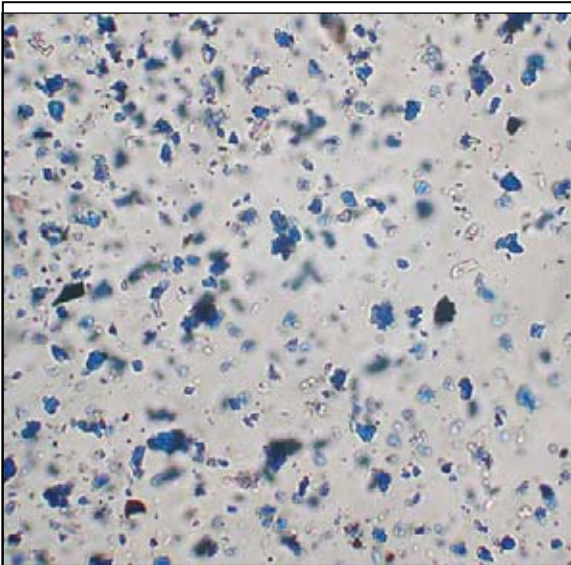
Figure 72: Pigment Dispersion, Sample H4.01.
Pigment identified as Ultramarine through EDS analysis
(plane polarized light, 600x)

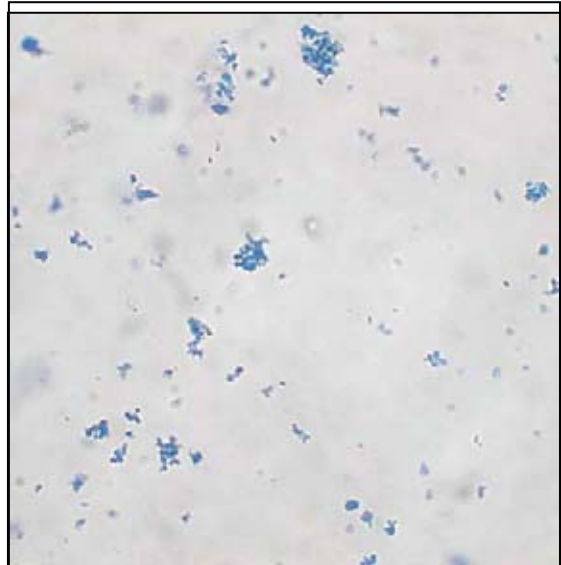
Figure 73: Pigment Dispersion, Synthetic
Ultramarine, McCrone Slide Collection.
(plane polarized light, 600x)

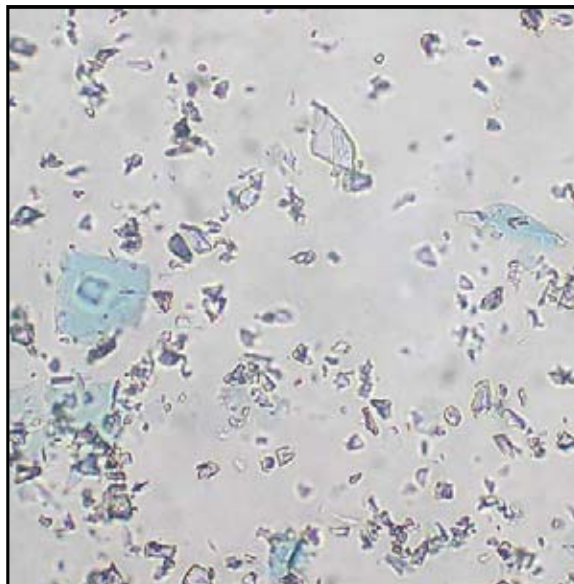
Figure 74: Pigment Dispersion, Lapis Lazuli, Forbes
Collection. (plane polarized light, 600x)

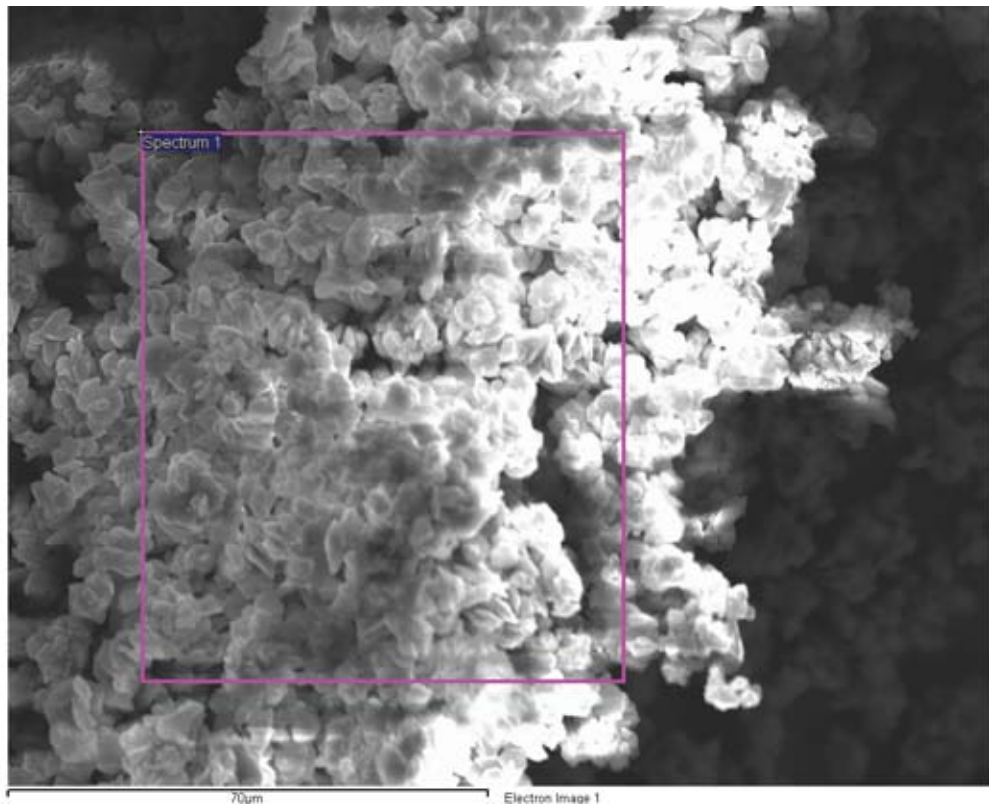
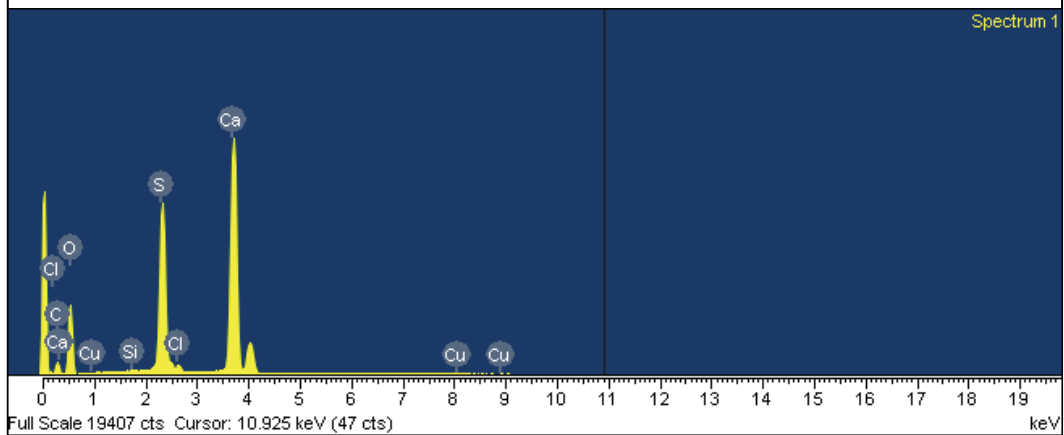
Chart 19: EDS Results, Sample G3.06

Sample ID: G3.06
Magnification: 800x

Description: White, campaign (D)
Working Distance: 17mm

Comments: Ca and S possible Gypsum as white. Chloride salts. Calcium Carbonate. part of binding media.
