Behind the Curtain: Mechanical Treatments for Bowed Marble Panels

Presented to the Faculties of the University of Pennsylvania in Partial Fulfillment of the Requirements for the Degree of Master of Science in Historic Preservation 2005.

BEHIND THE CURTAIN:
MECHANICAL TREATMENTS FOR BOWED MARBLE PANELS

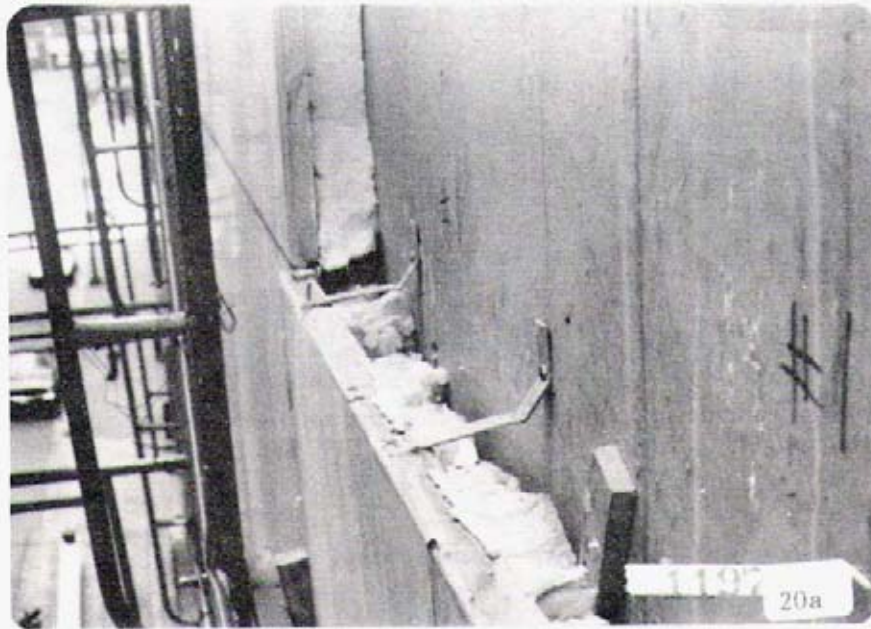
Figure 1.6 Bending anchor caused by lateral loading. (Photo from Bortz, et al., 27.)

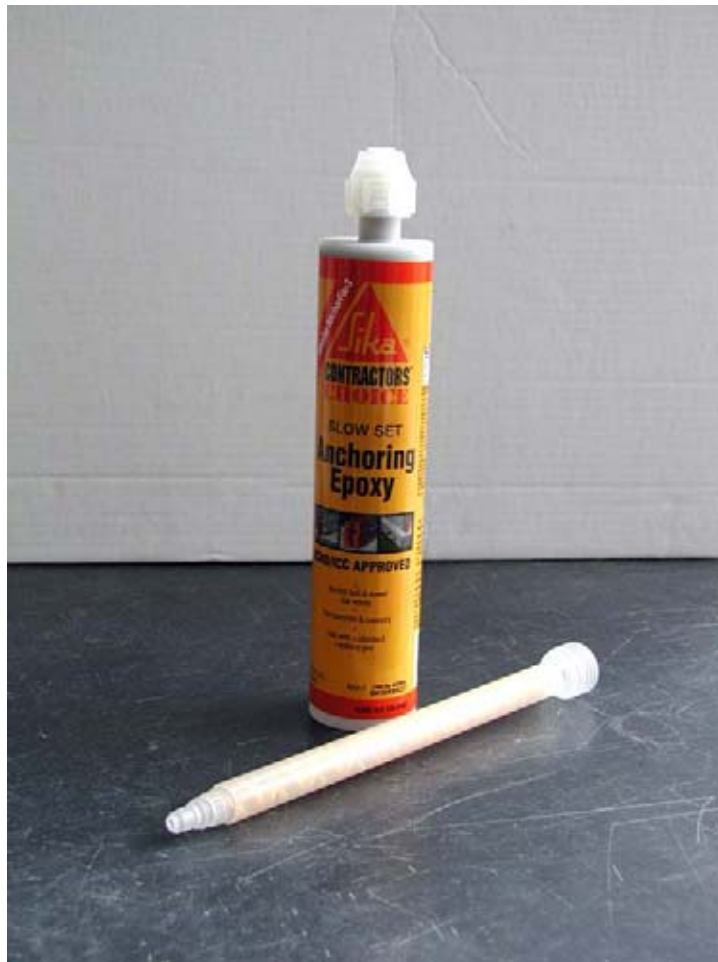
Figure 2.2 AnchorFix 3 epoxy gel used to adhere mechanical treatments to the marble panels.

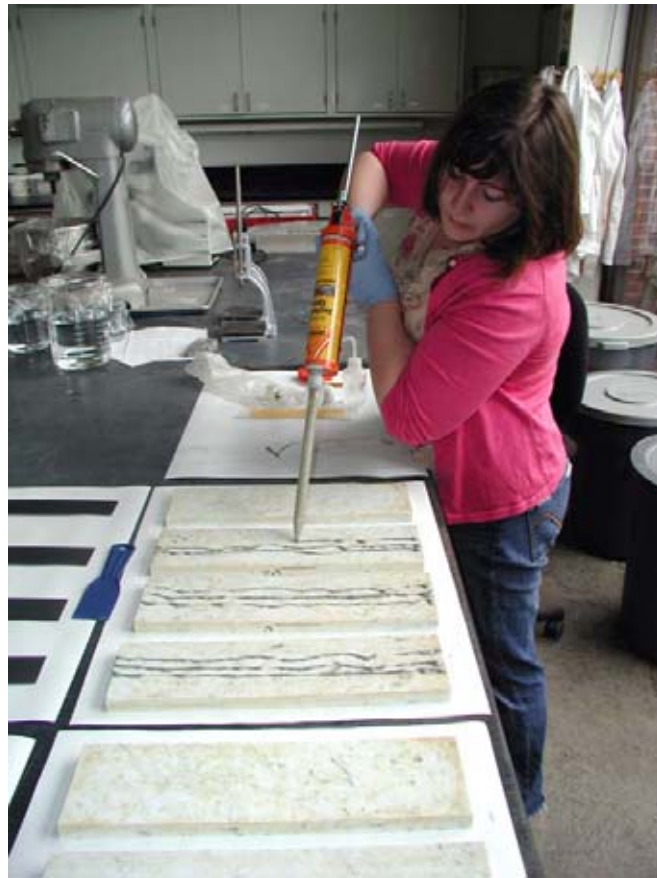
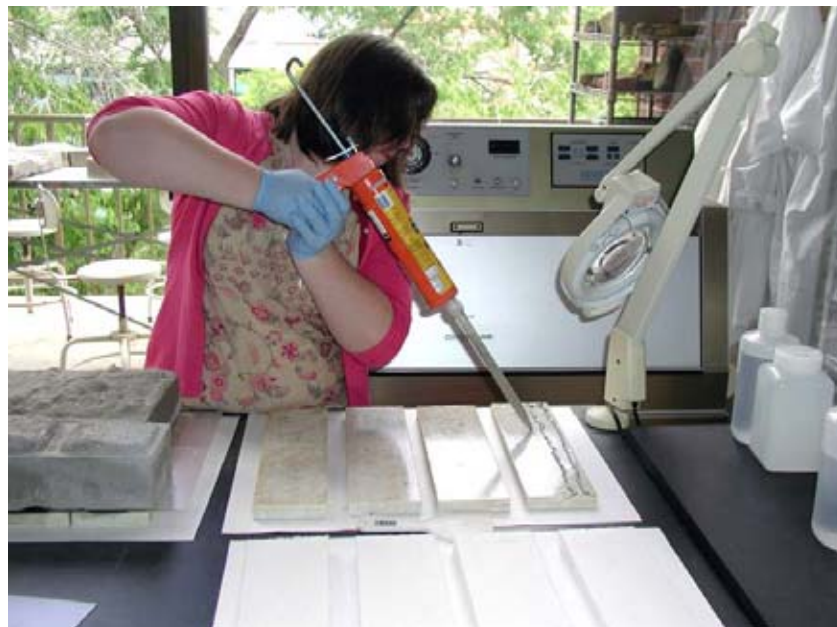
Figure 3.4 Step one: Apply epoxy to the marble panel.

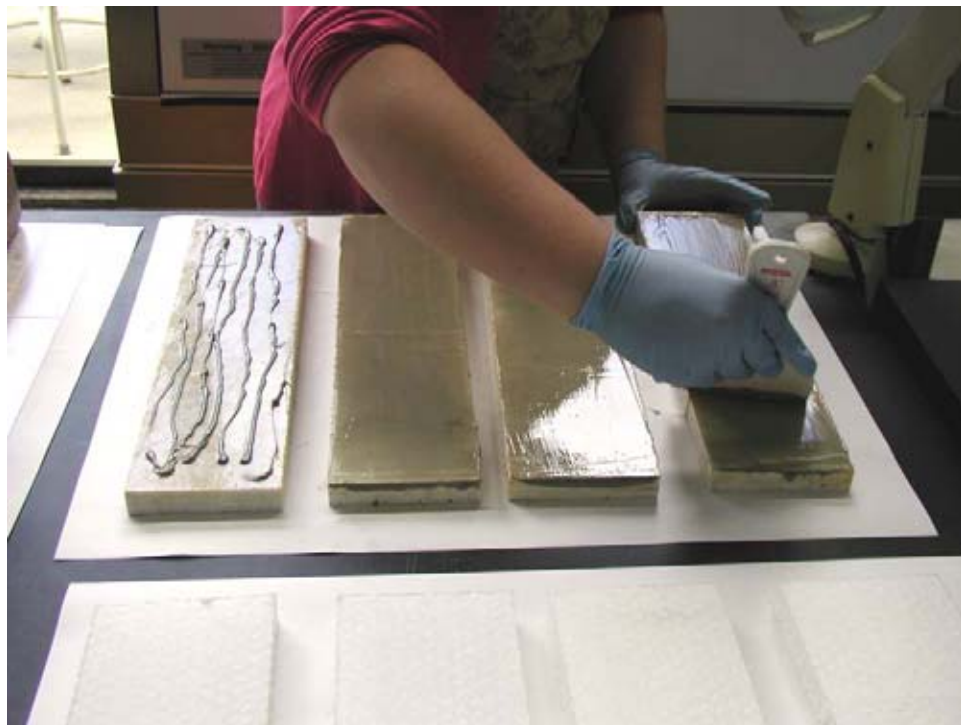
Figure 3.5 Step two: Spread the epoxy over the marble panel.

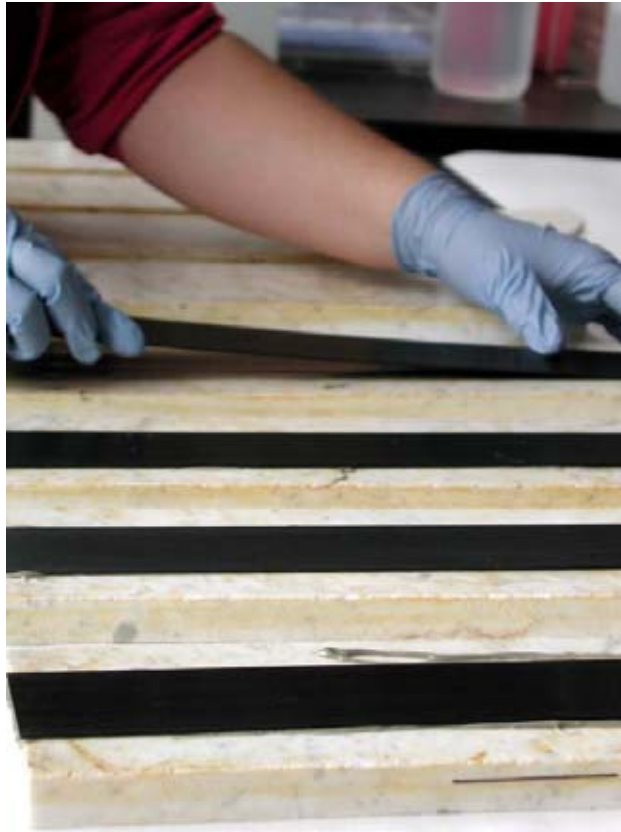
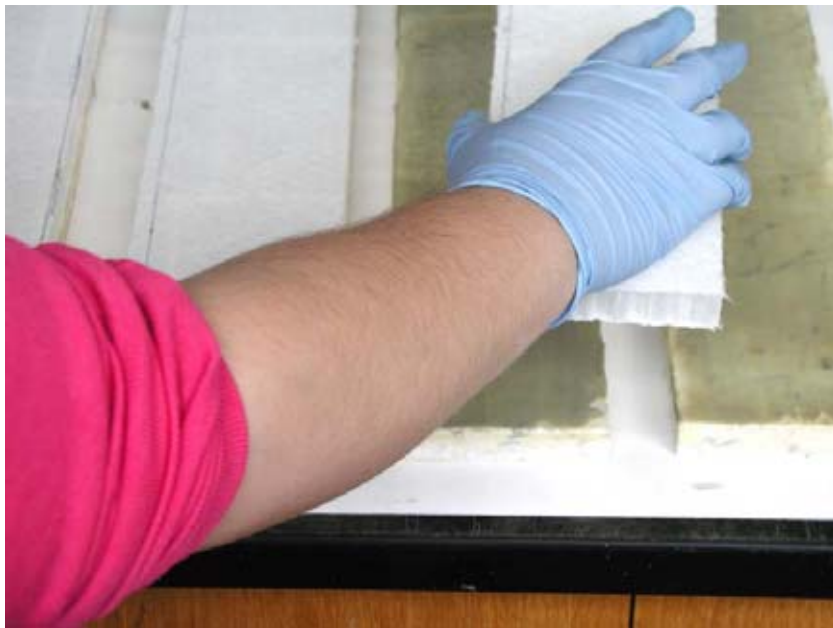
Figure 3.6 Step three: Apply treatments to the marble on top of the epoxy.

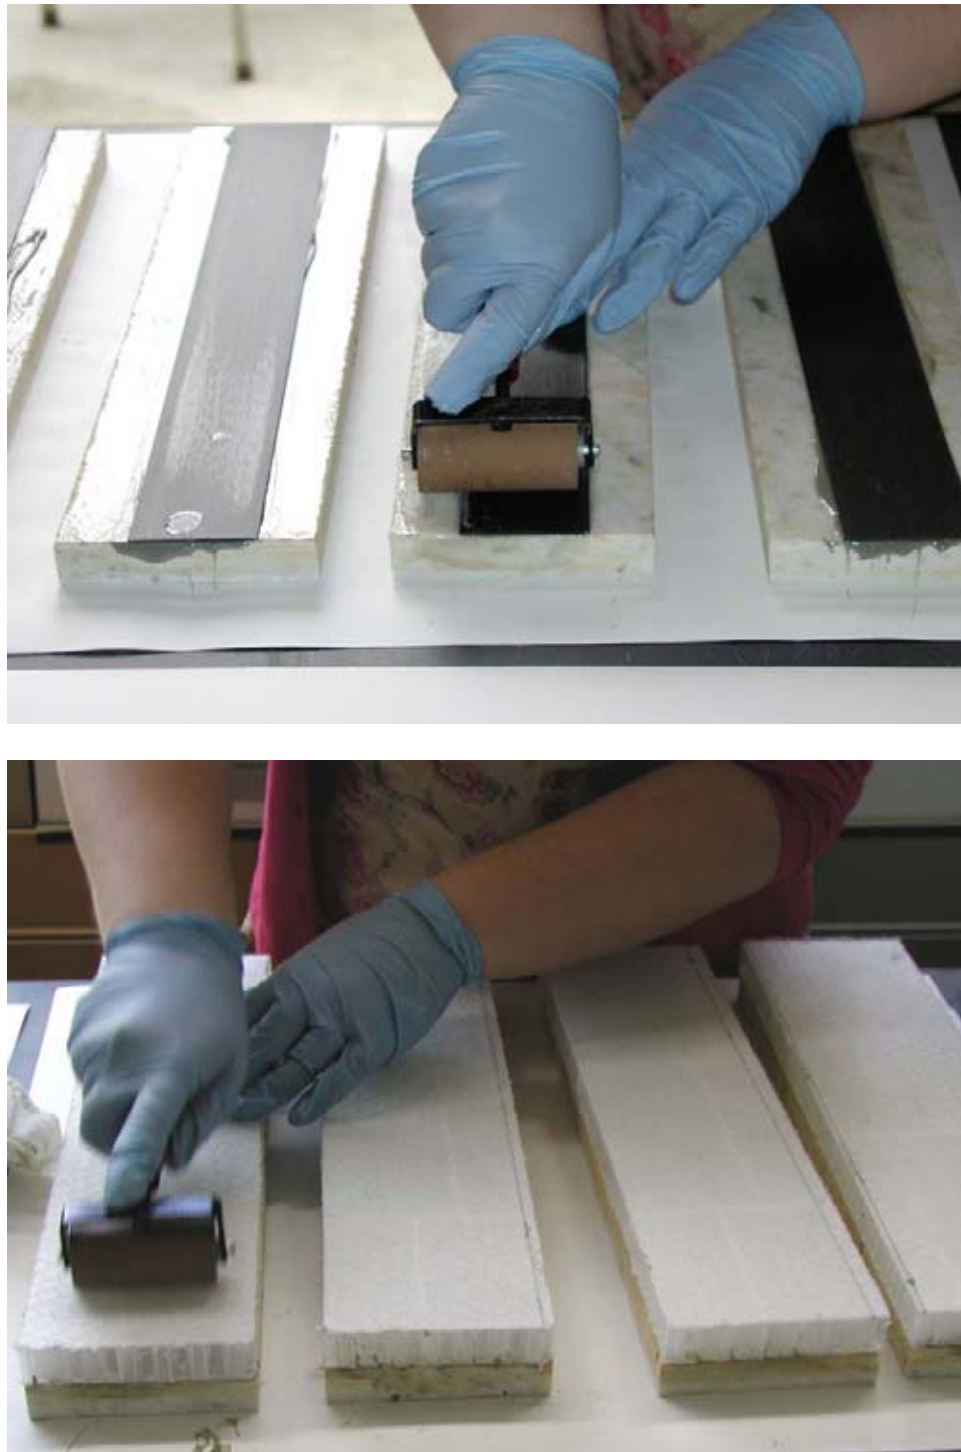
Figure 3.7 Step four: Roll the carbon fiber strap or the polypropylene honeycomb over the epoxy to ensure even contact.

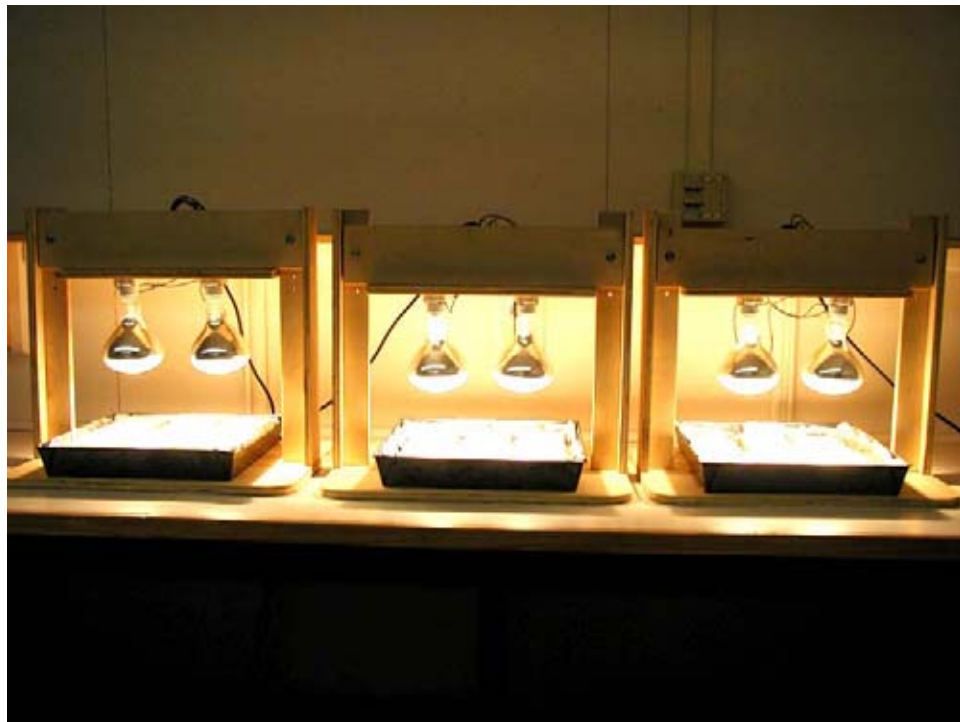
Figure 3.8 Constructed bowing potential assemblies.

there are two wired light sockets for the infrared heating lamps. Three pieces of marble were placed on top of $\frac{1}{2}$ " depth of glass marbles and sand in one steel pan (17" x 16" x 2 $\frac{1}{2}$ "). One of these set-ups was needed for the three samples that were cycled for twenty days, and three assemblies were needed for the nine samples that were cycled for forty days.

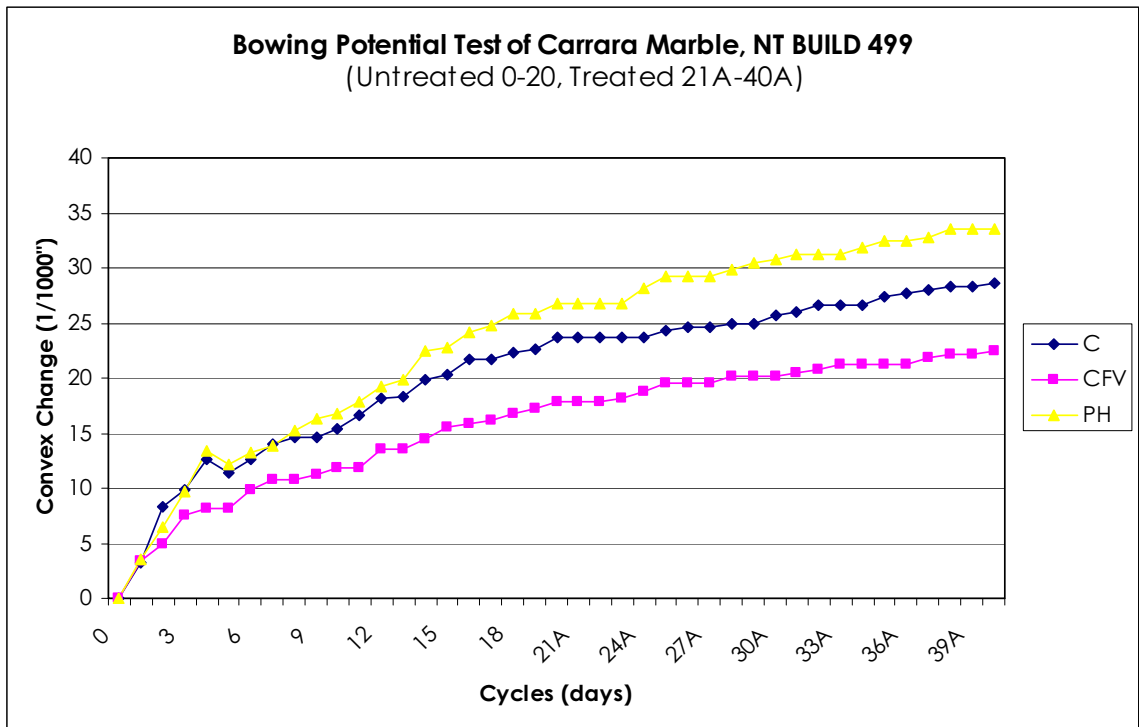
Figure 3.11 Bowing potential of treated and untreated Carrara marble.

trapped in the pores of the marble for longer than with the other marble samples. However, this is a topic that ought to be investigated further. After treatment, with all samples and both treatments, bowing continued with no bond failure. This indicates that the epoxy is a strong adherent and that the treatment materials were flexible enough to move with the marble as it changed.
