# Unveiling Ancestral Iconography: An Analysis of 13th C. AD Earthen Finishes Through Infrared Thermography at Fire Temple, Mesa Verde National Park

Daniel Stuart Castele  
*University of Pennsylvania*

Castele, Daniel Stuart (2013). *Unveiling Ancestral Iconography: An Analysis of 13th C. AD Earthen Finishes Through Infrared Thermography at Fire Temple, Mesa Verde National Park*. (Masters Thesis). University of Pennsylvania, Philadelphia, PA.

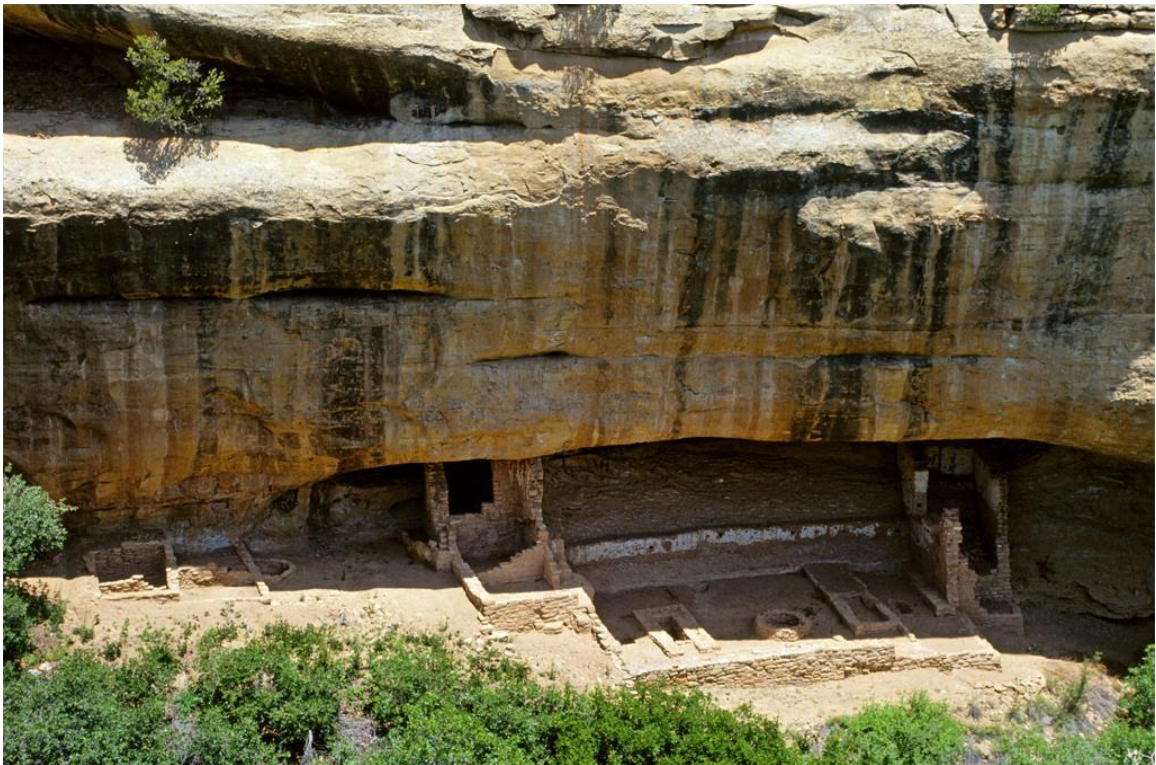
**Figure 3.1** Fire Temple, Mesa Verde National Park. Image and original data provided by Canyon lights World Art Slides and Image Bank. Photographer: Susan Silberberg-Peirce.

Constructed of the same stone and soil as the alcove, Fire Temple has two side chambers and a central grand room (figure 3.1). The central room, termed Kiva A, is the largest of the spaces with the most architectural features. Two large, rectangular foot-drums are in Kiva A, with a circular pit in between them. The easternmost part of the floor has another subterranean square pit.<sup>47</sup> Finally, a papu shaped hole along the North wall, and a bench running along the east wall complete the floor plan.

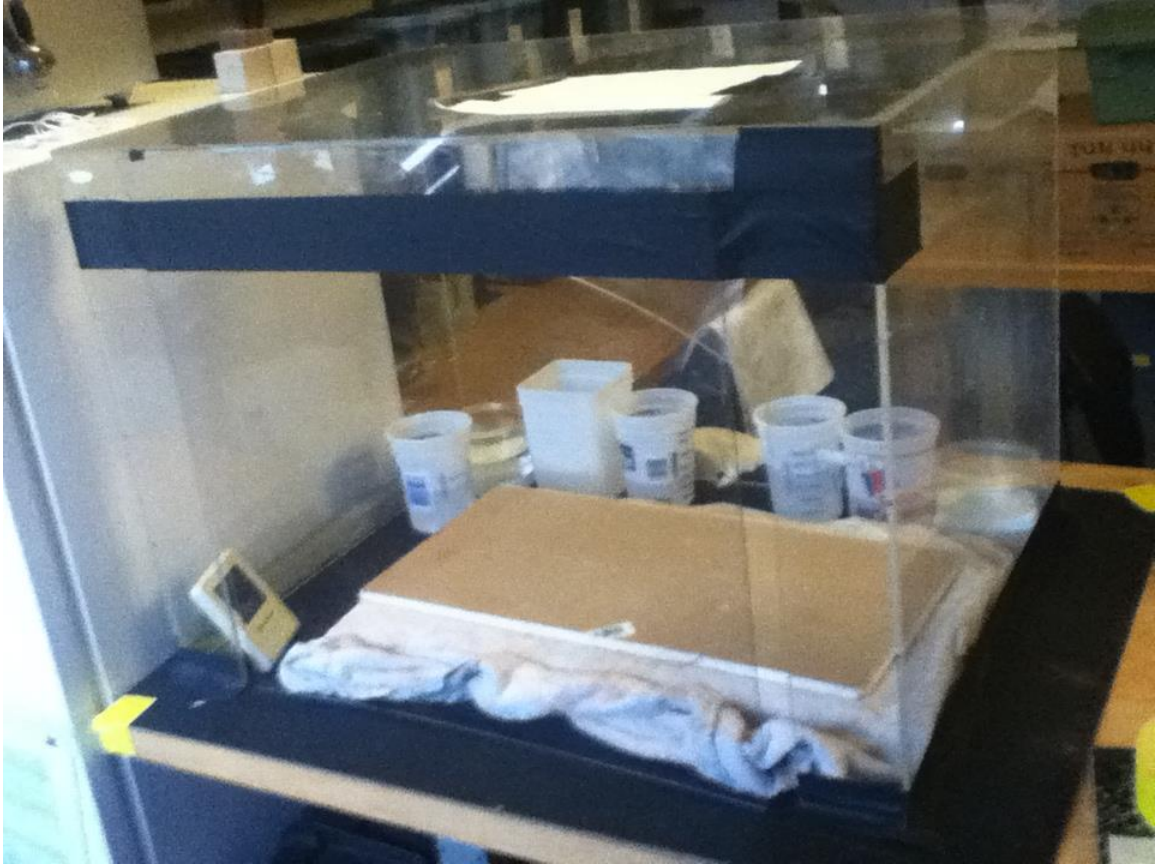
**Figure 5.1** Humidity chamber. Photo taken by author, 2013.

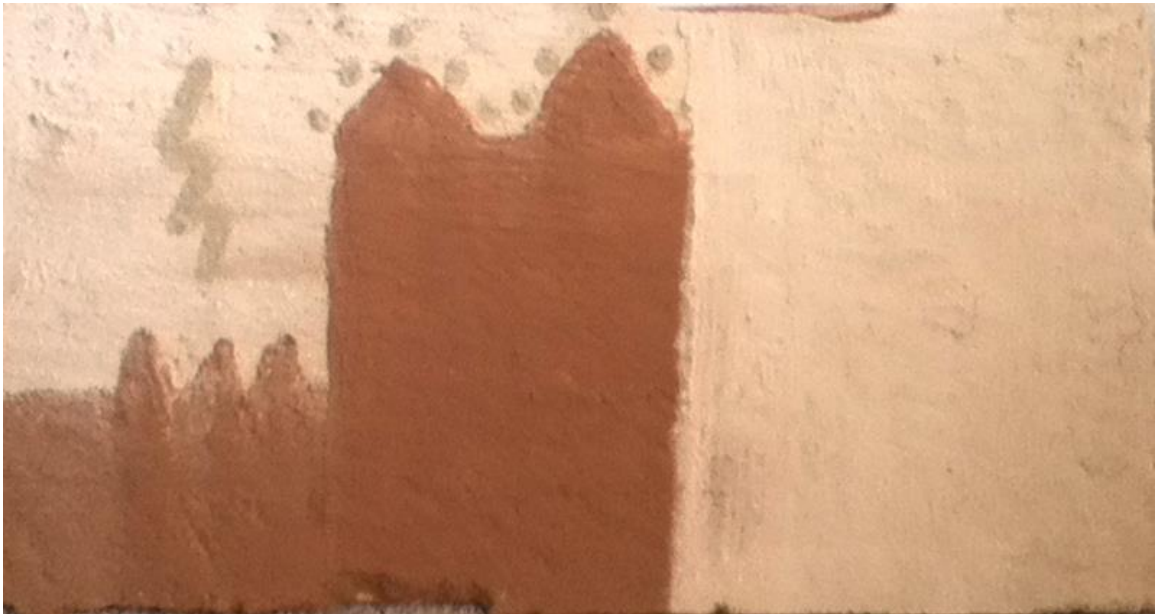
**Figure 6.1** Completed facsimile on which thermographic study underwent. Materials are sands native to the American Southwest. The most over-painted area is the right third (where the white architectural finish is all that is visible currently). 1'x 2". Facsimile made by author. Photo taken by author.

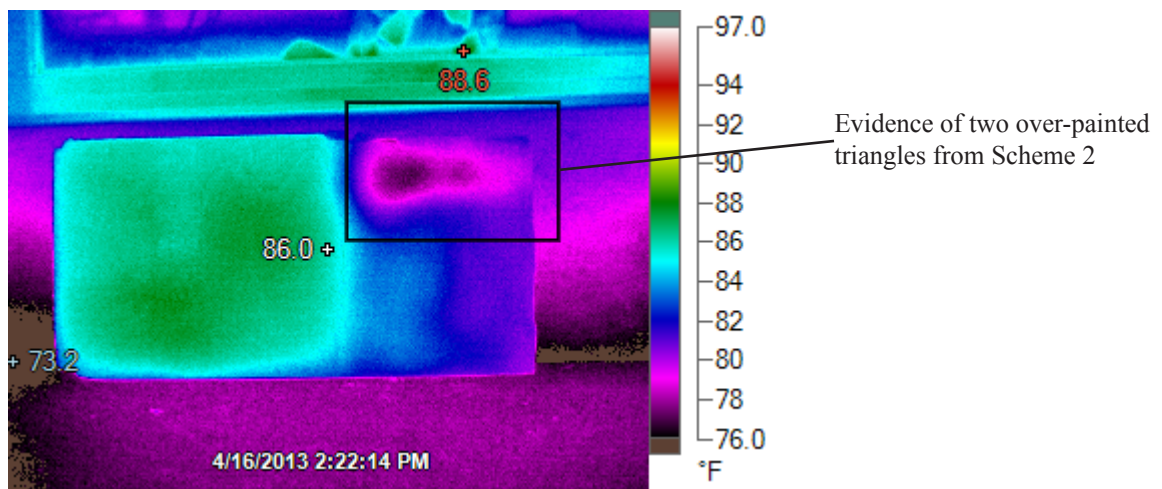
**Figure 6.4** Infrared thermogram taken by author. Acquired utilizing passive thermography. Notice the box which highlights two distinct triangles underneath a coat of white wash.

This thermogram (figure 6.4) arguably captures the 2 underlying triangles from scheme 2. The box highlights two areas that are colder than the rest of the area. The colder areas are spaced the same as the triangles and the cut off at the bottom does correlate to the dado height from scheme 2.
