# Repair of Damaged Glazed Terra Cotta Surfaces: A Comparative Study of Remedial Coatings for Their Effectiveness on Areas of Glaze Loss in Temperate Maritime Weathering Conditions

Jessica Amy Sloop  
*University of Pennsylvania*

A THESIS

Historic Preservation

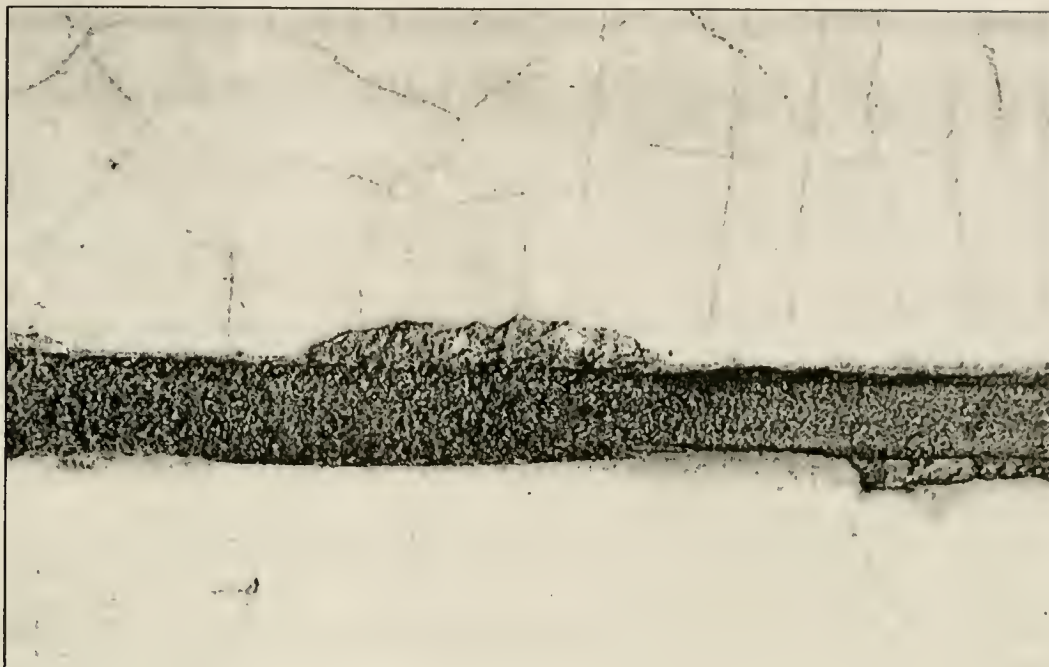
Figure 3.1 Glaze crazing, Berkeley Building, Boston, Massachusetts (Codman & Despradelle, 1905).

the greater the depth of the cracks, the greater the potential damage.

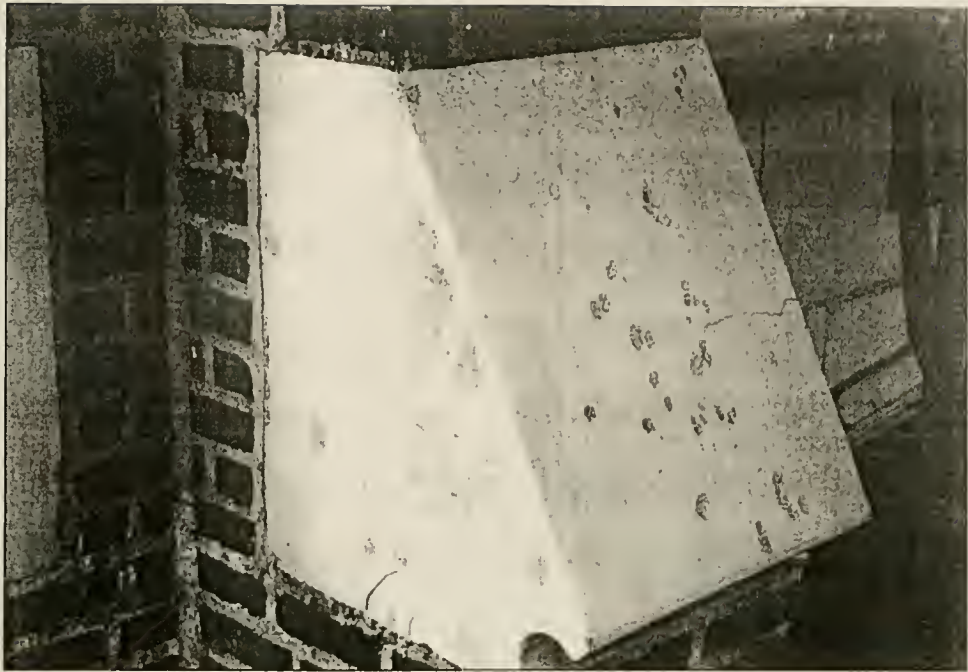
Figure 3.2 Glaze spalling, Ventnor City Hall, Ventnor, New Jersey (Vivian Smith, 1928-29).

Spalling is defined as a separation of the glaze with portions of the body attached<sup>67</sup> (fig. 3.2). In other words, the failure has occurred within the body of the piece, not at the glaze to body interface. This problem is probably the most frequently seen in buildings

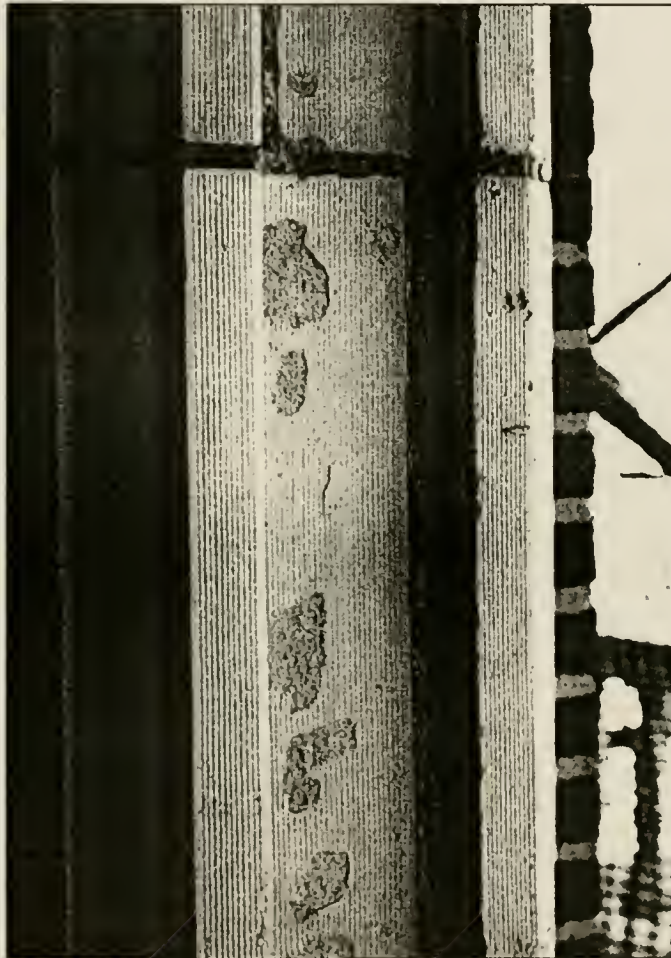
Figure 3.3 Glaze peeling, Ventnor City Hall, Ventnor, New Jersey (Vivian Smith, 1928-29).

and the glaze causing strains and eventual separation at this interface. Manufacturing faults may also cause peeling. For example, in the initial manufacturing process, soluble salts from the clay may have formed a coating on the surface of the substrate upon drying. These salts prevent underslip from adhering properly, but this condition may not materialize until the piece is in service for many years. In addition, proper adhesion of the glaze may also be hampered by the content of the glaze or underslip.<sup>71</sup>

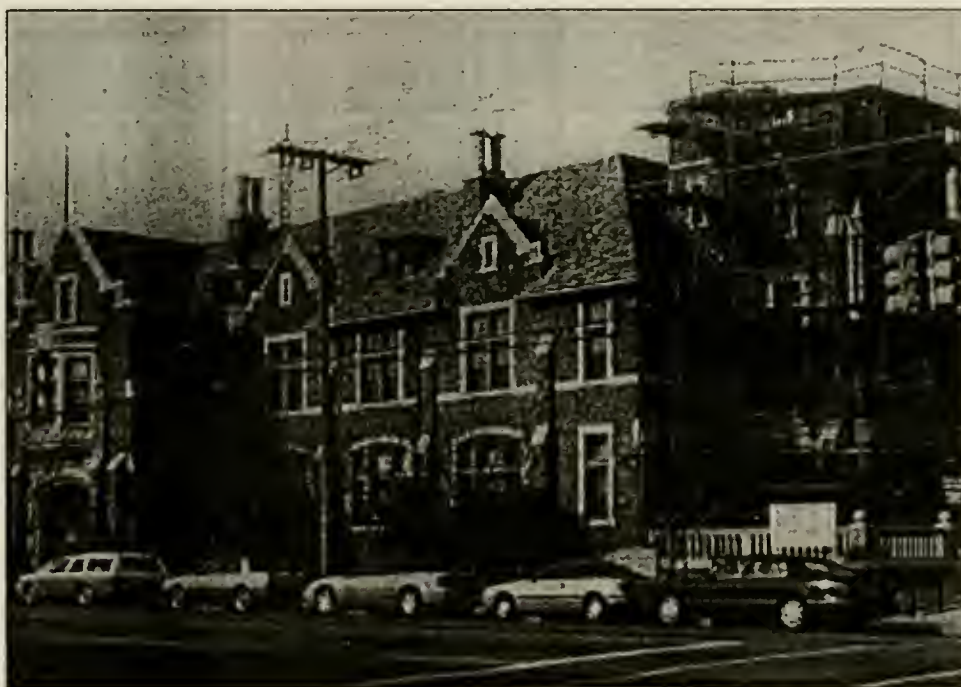
Figure 6.1 Ventnor City Hall

Samples were obtained from the Ventnor City Hall in Ventnor, New Jersey (1928-1929, Vivian Smith, Architect) located one block west of the Atlantic Ocean (fig. 6.1).

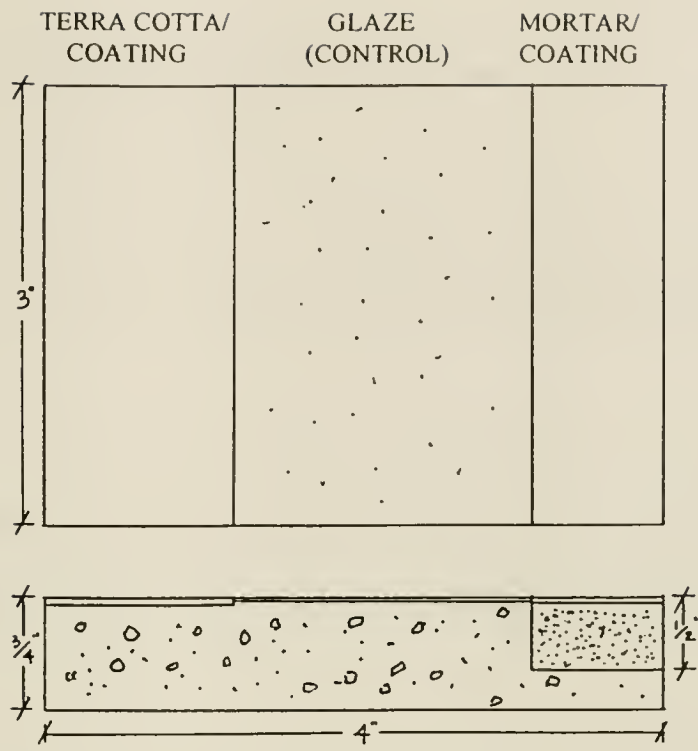
Figure 6.2 Specimen design for QUV Accelerated Weathering Tester (ASTM G 53-88)

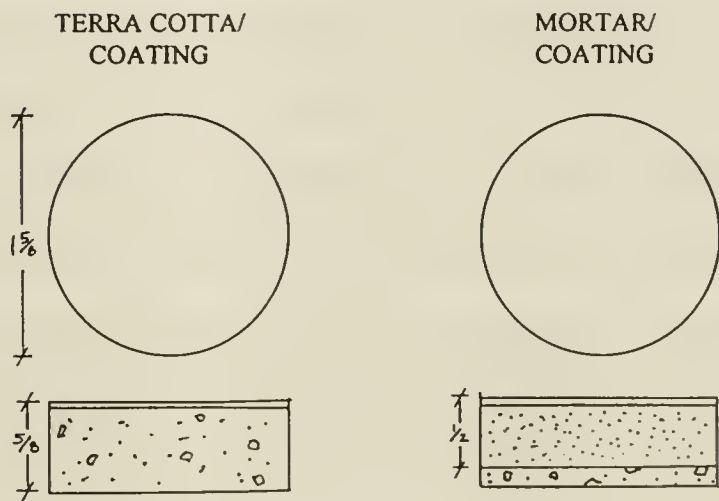
Figure 6.3 Specimen design for Water Vapor Transmission Test (ASTM E 96-80)

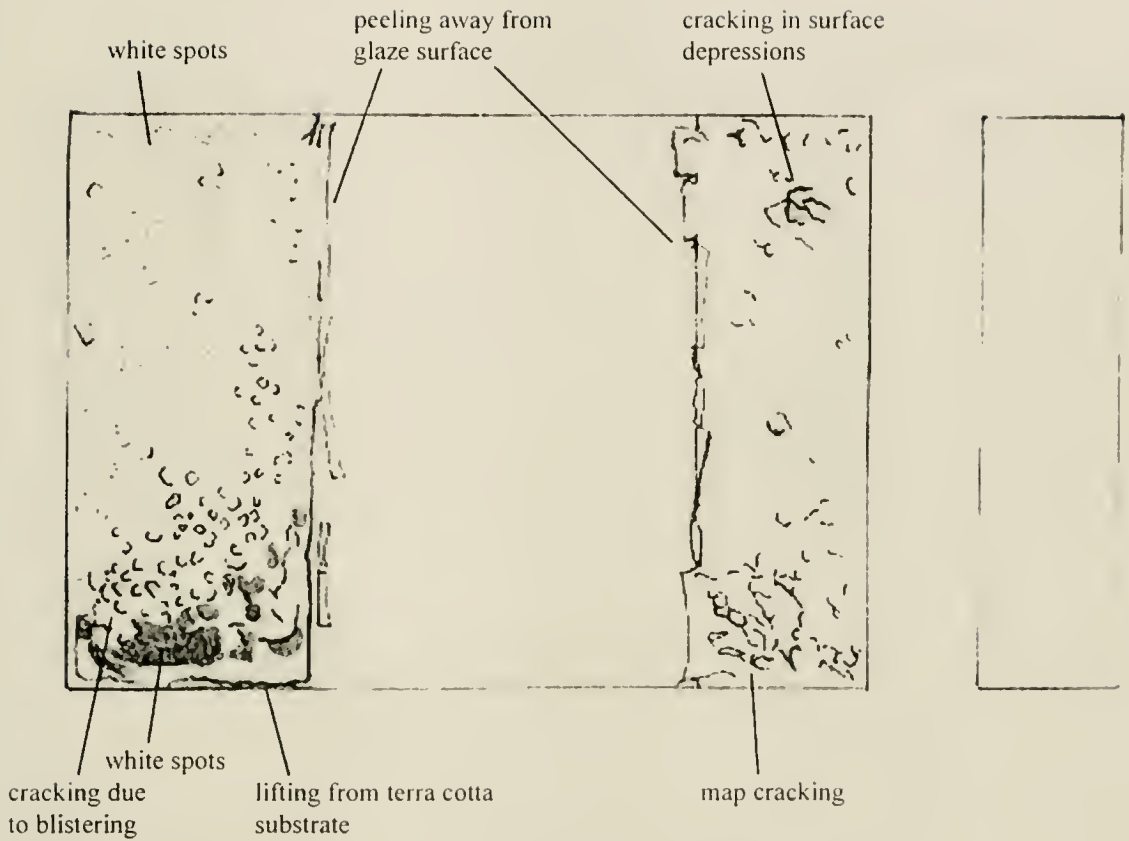
Figure 6.4 Edison Aquathane UA-210H specimen 1A after 52 cycles (624 hours)

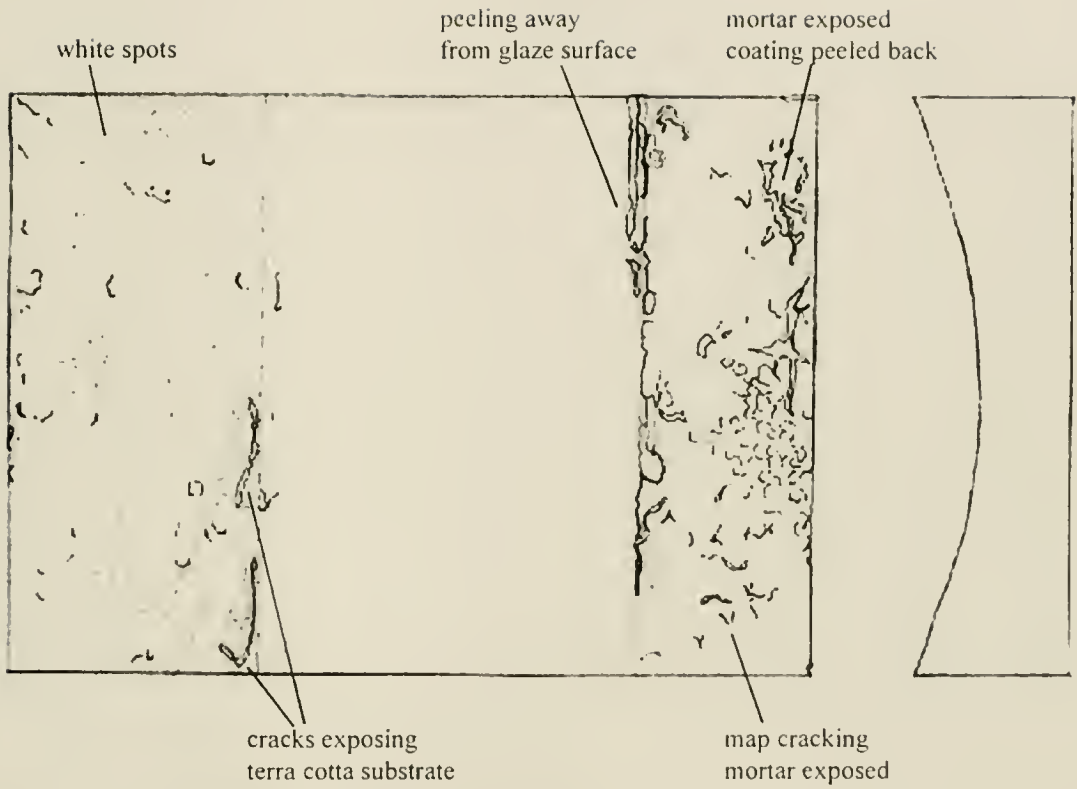
Figure 6.5 Edison Aquathane UA-210H specimen 1B after 52 cycles (624 hours)

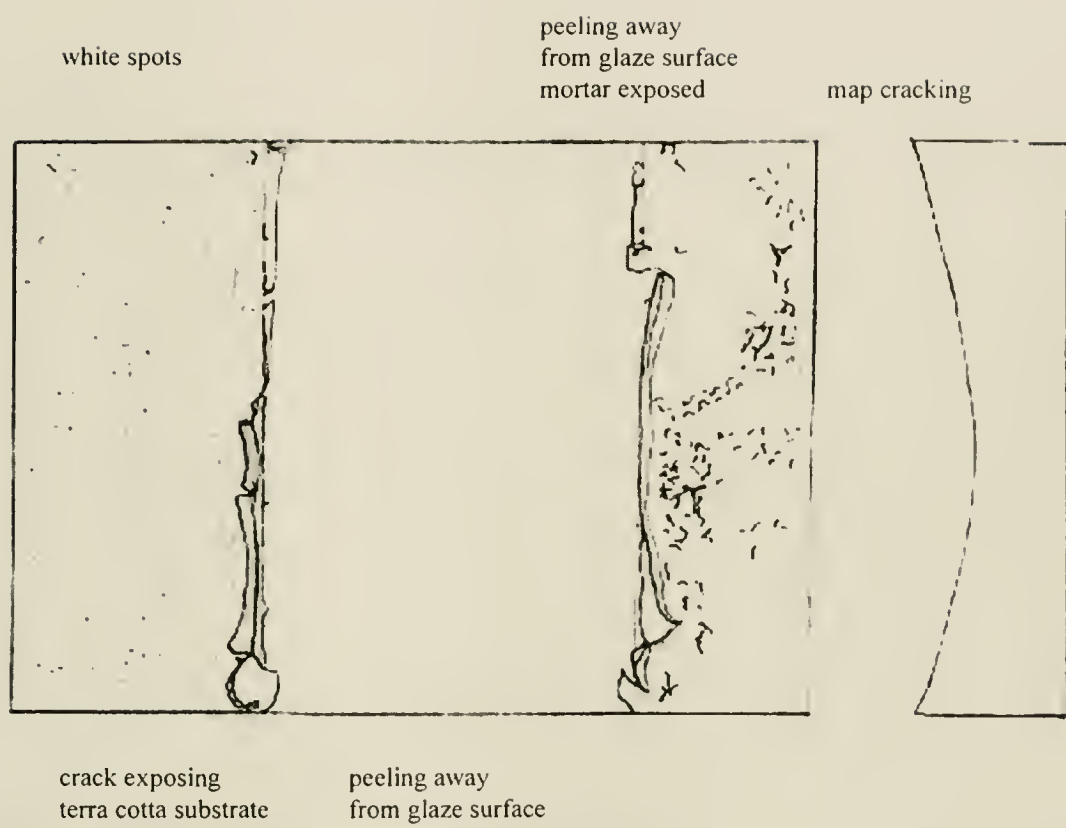
Figure 6.6 Edison Aquathane UA-210H specimen 1C after 52 cycles (624 hours)

map cracking

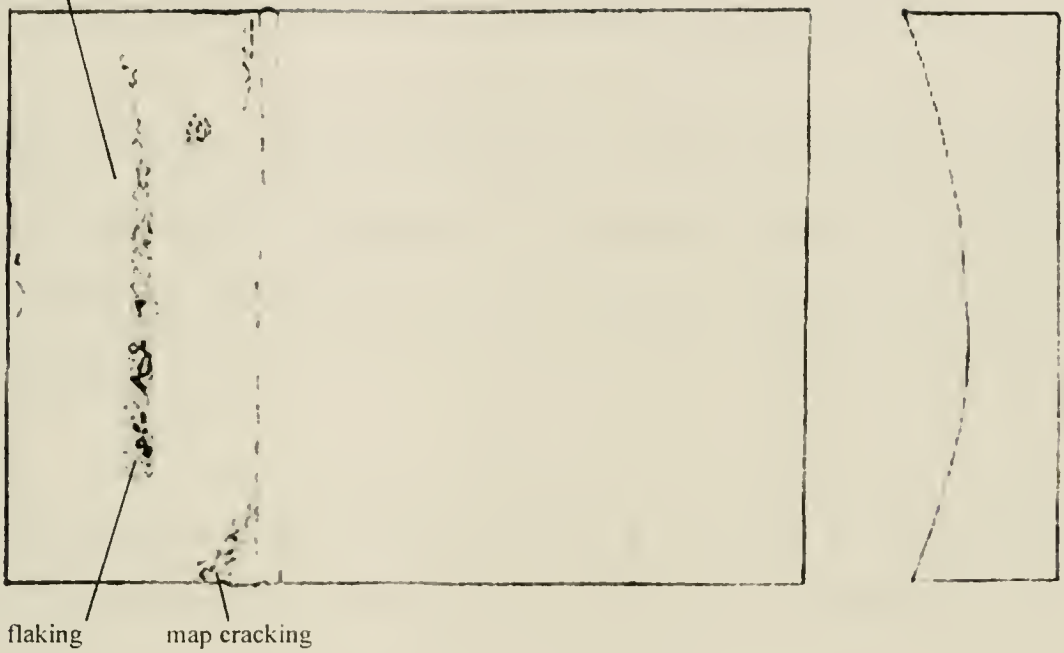
Figure 6.7 Conformal Stain specimen 4C after 12 cycles (144 hours)

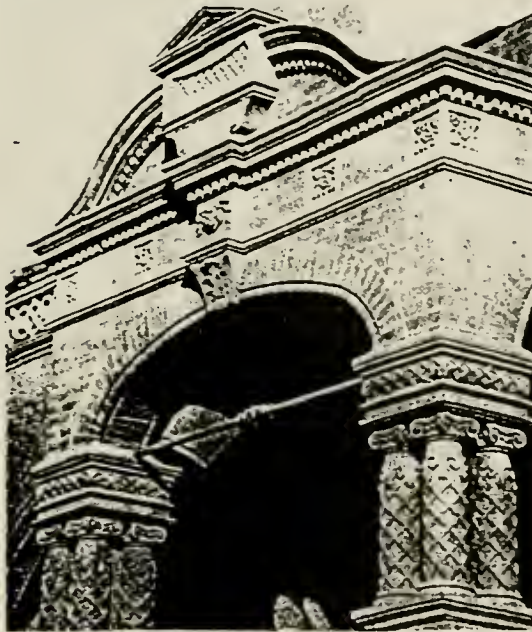
Textured Uimestone ELASTO WALL 351 provided a new stone-like finish without complete abrasive removal of existing paint from this church's cast stone elements.

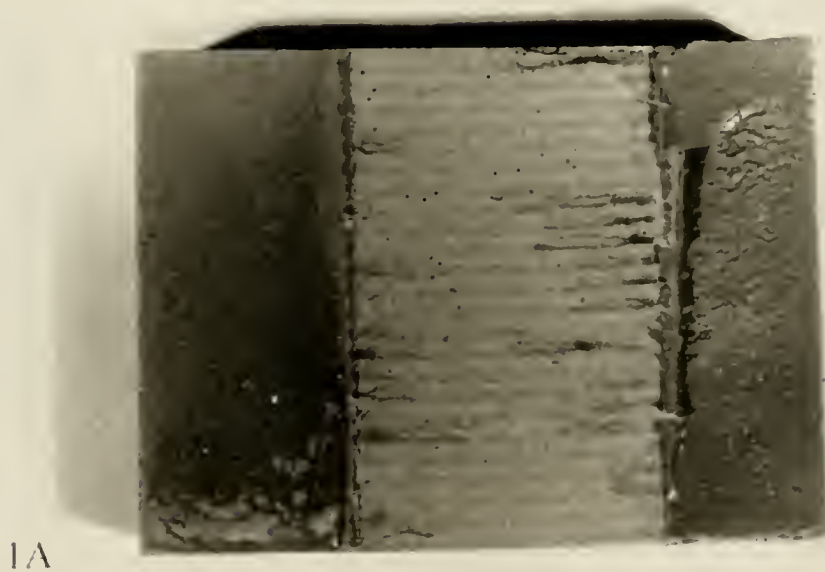
Figure B.7 Edison Aquathane UA-210-H specimen 1A after 6 cycles. Note peeling of coating from glaze surface, white spots on both coated surfaces, and minor cracking.

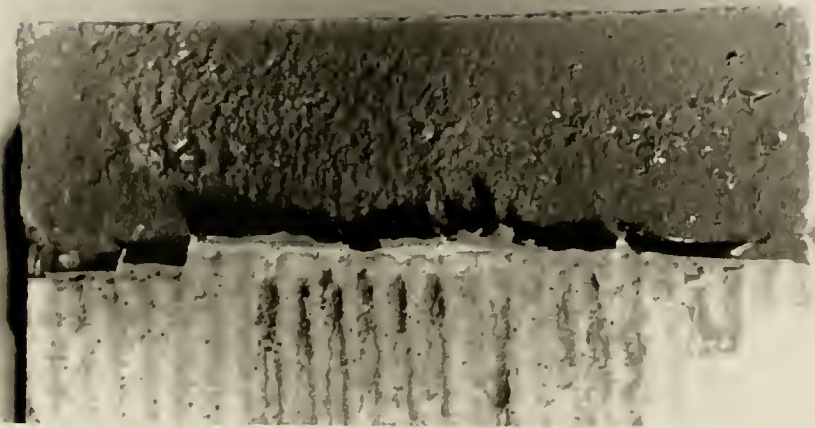
Figure B.8 Edison Aquathane UA-210-H specimen 1A mortar after 18 cycles. Note further peeling of coating from glaze surface, exposed mortar, and further cracking.

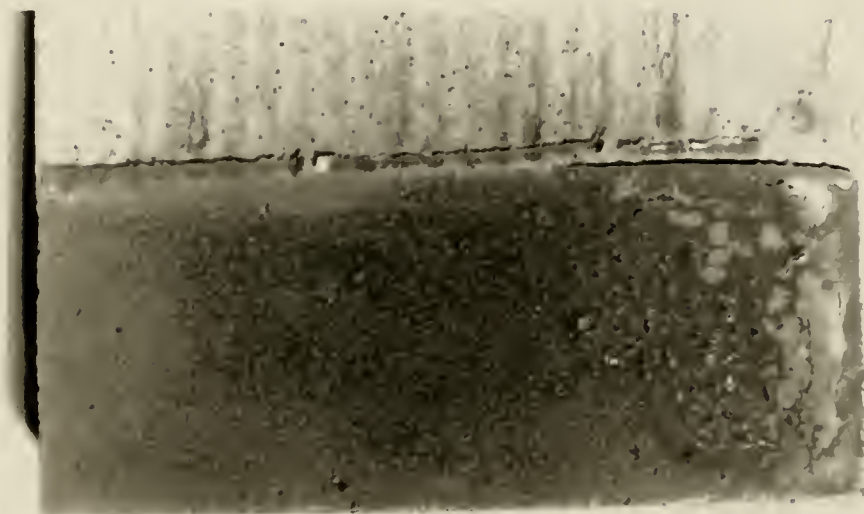
Figure B.9 Edison Aquathane UA-210-H specimen 1A terra cotta after 18 cycles. Note cracking, white staining, and coating lifted from glaze surface.

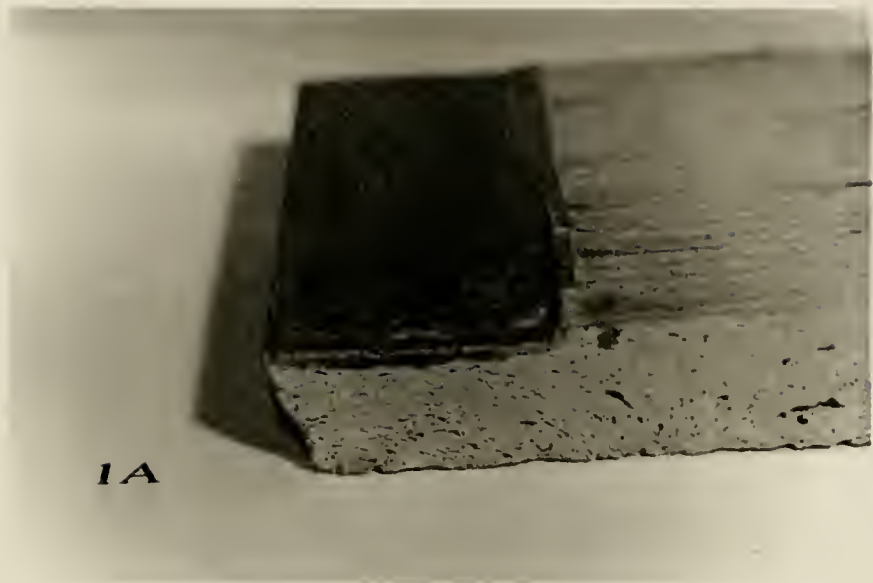
Figure B.10 Edison Aquathane UA-210-H specimen 1A terra cotta after 18 cycles. Note coating separated from edge of specimen.

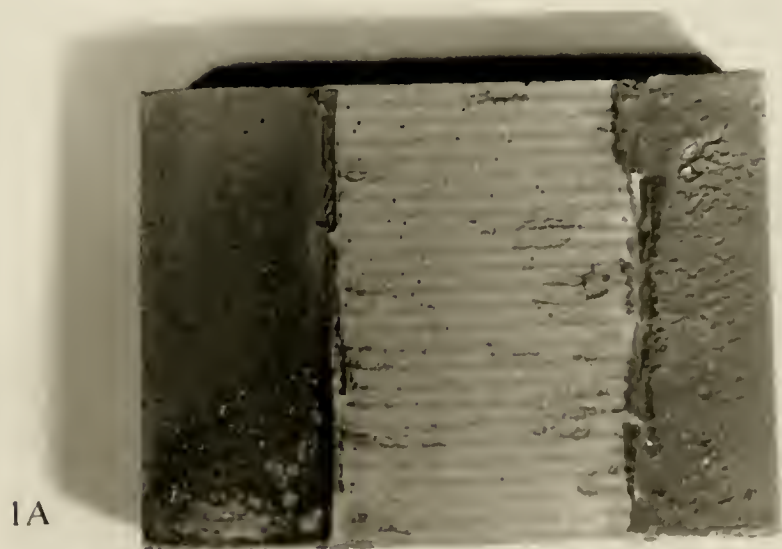
Figure B.11 Edison Aquathane UA-210-H specimen 1A after 52 cycles. Note continued weathering of all previous conditions.

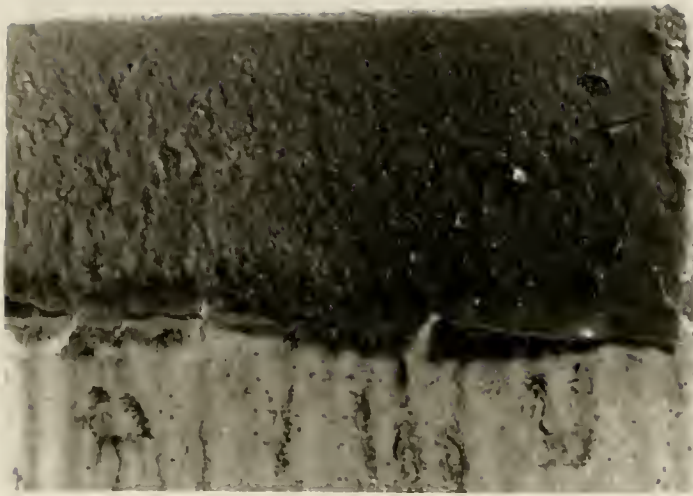
Figure B.12 Edison Aquathane UA-210-H specimen 1A mortar after 52 cycles. Note cracking and peeling of coating.

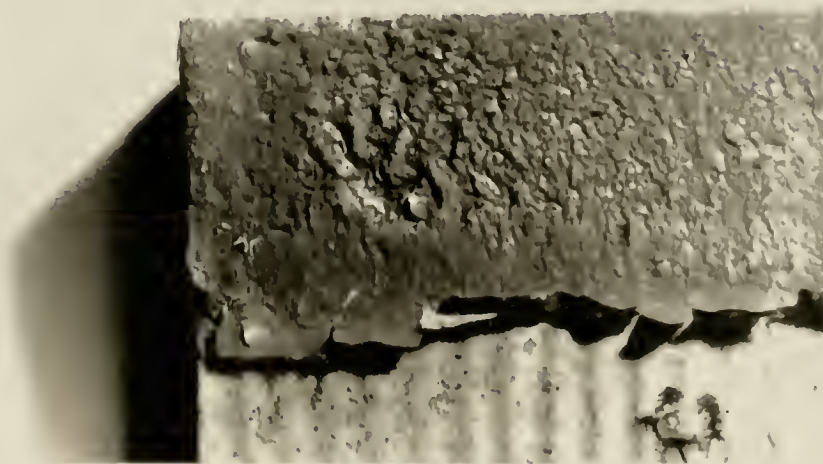
Figure B.13 Edison Aquathane UA-210-H specimen 1A mortar after 52 cycles. Note cracking and peeling of coating.

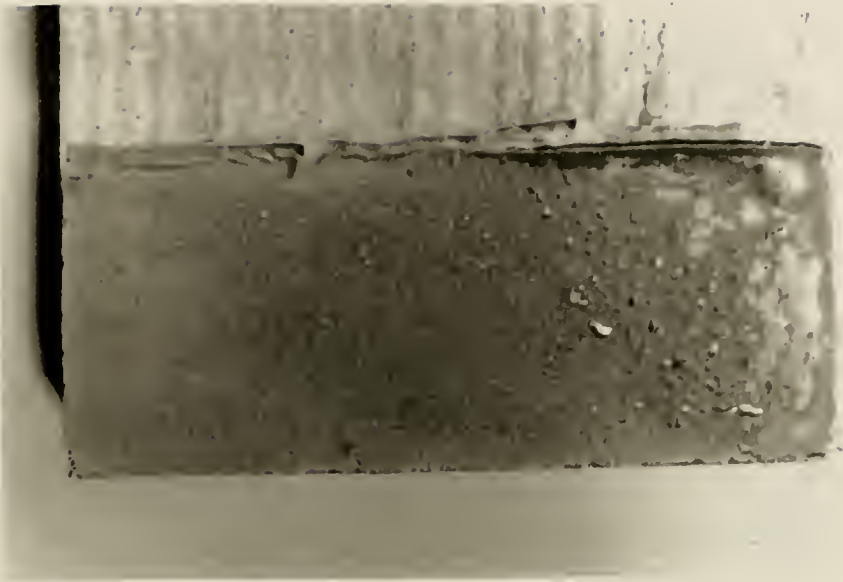
Figure B.14 Edison Aquathane UA-210-H specimen 1A terra cotta after 52 cycles. Note continued cracking, white staining, and coating separated from glaze surface.

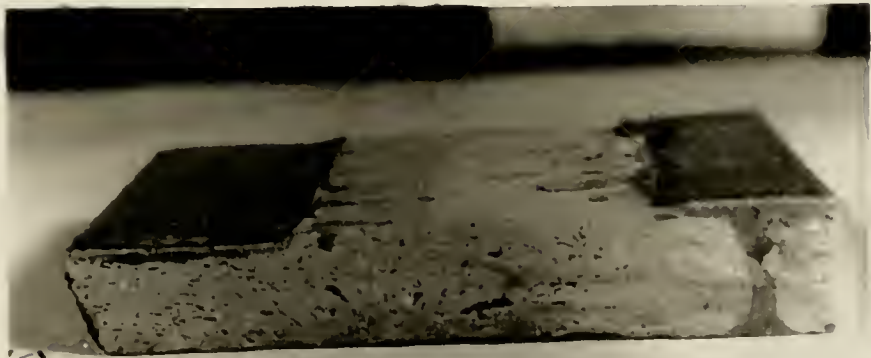
Figure B.15 Edison Aquathane UA-210-H specimen 1A after 52 cycles. Note coating further separated from edge of specimen.

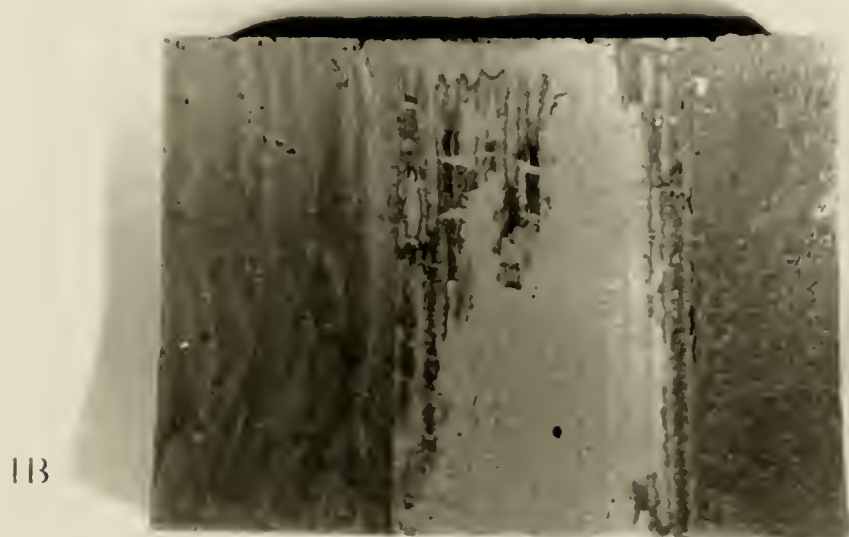
Figure B.17 Edison Aquathane UA-210-H specimen 1B after 6 cycles. Note minor cracking and lifting of coating from glaze surface on mortar side.

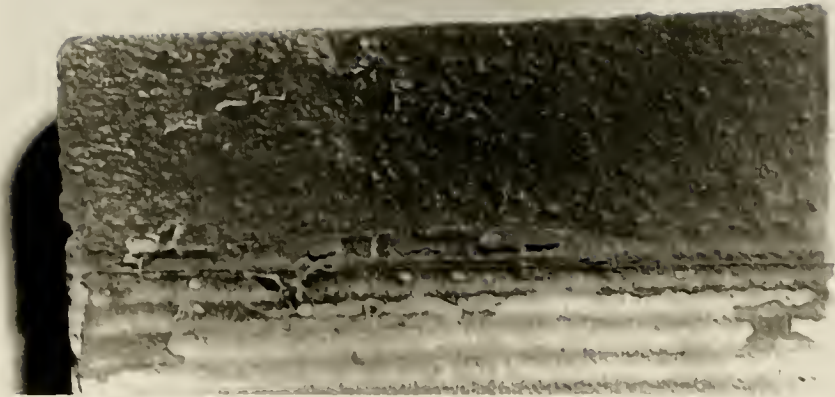
Figure B.18 Edison Aquathane UA-210-H specimen 1B mortar after 12 cycles. Note cracking and lifting from glaze surface.

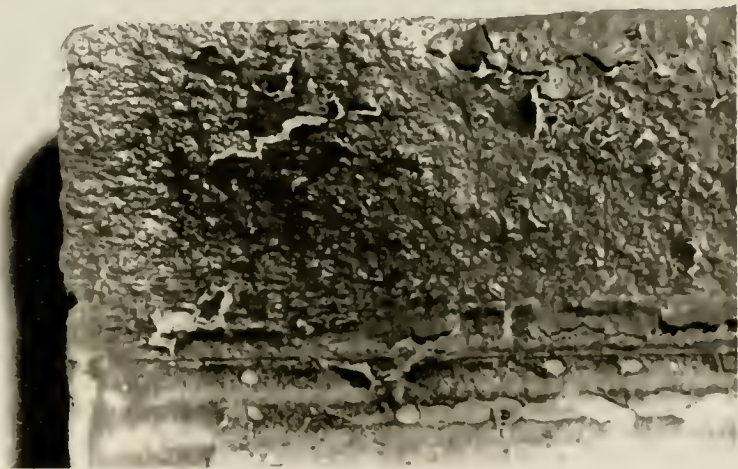
Figure B.19 Edison Aquathane UA-210-H specimen 1B mortar after 18 cycles. Note continued cracking and greater areas of mortar exposed.

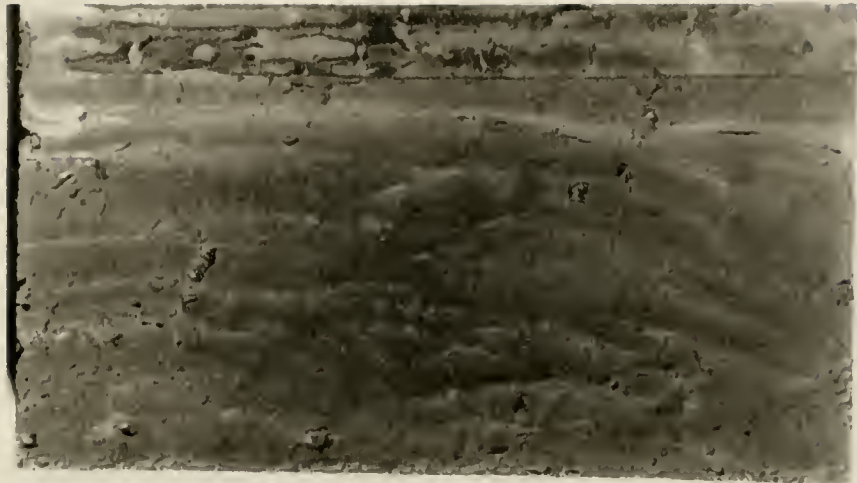
Figure B.20 Edison Aquathane UA-210-H specimen 1B terra cotta after 18 cycles. Note minor cracking at junction between glaze surface and terra cotta substrate surface.

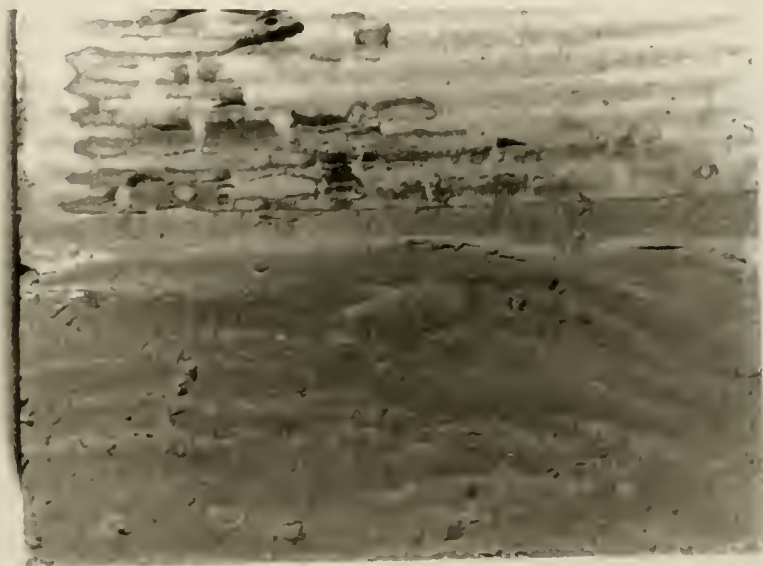
Figure B.21 Edison Aquathane UA-210-H specimen 1B terra cotta after 30 cycles. Note continued cracking in same areas as above.

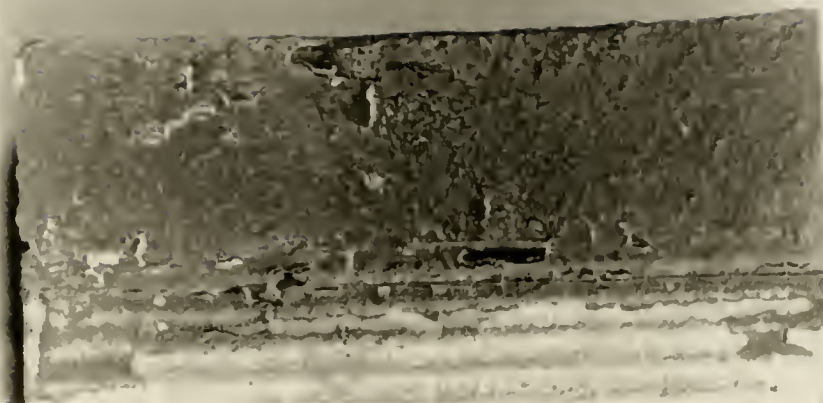
Figure B.22 Edison Aquathane UA-210-H specimen 1B mortar after 30 cycles. Note continued cracking and greater exposure of mortar.

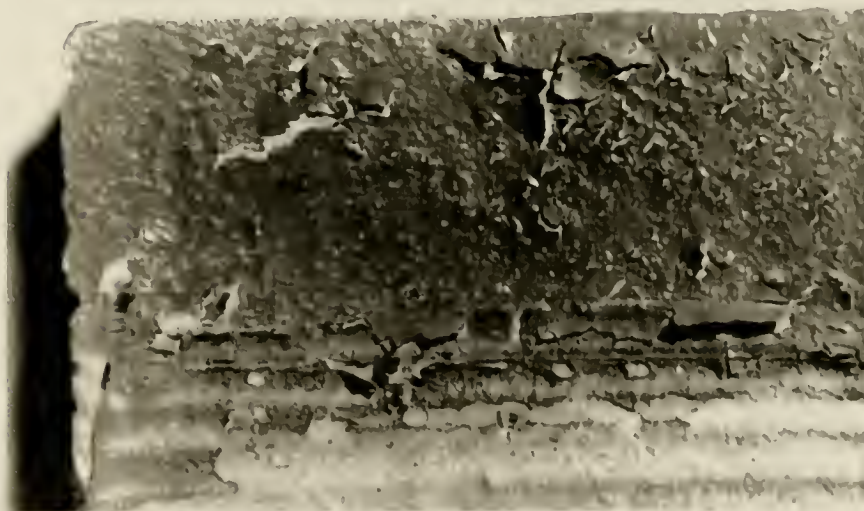
Figure B.23 Edison Aquathane UA-210-H specimen 1B mortar after 52 cycles. Note excessive map cracking, mortar exposure, and coating peeled from glaze surface.

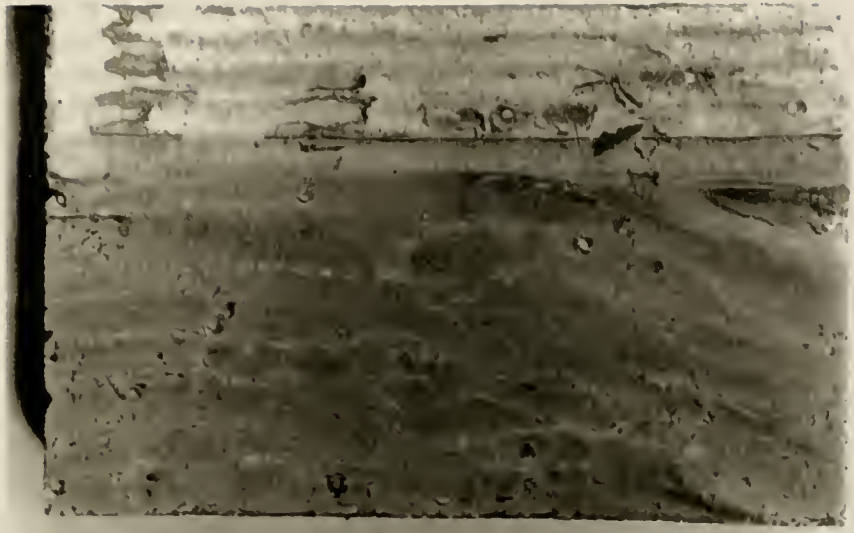
Figure B.24 Edison Aquathane UA-210-H specimen 1B terra cotta after 52 cycles. Note cracking.

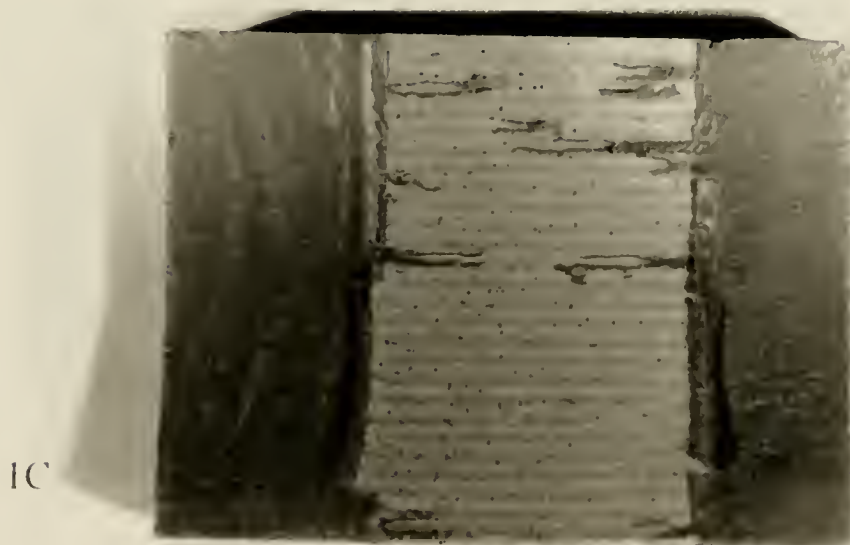
Figure B.27 Edison Aquathane UA-210-H specimen 1C after 6 cycles. Note coating peeled away from glaze surface.

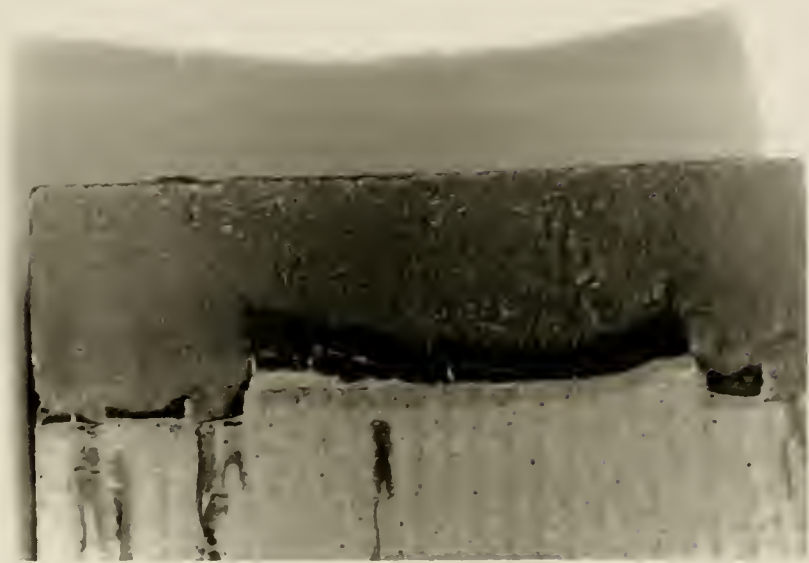
Figure B.28 Edison Aquathane UA-210-H specimen 1C mortar after 30 cycles. Note continued peeling of coating from glaze surface and map cracking.

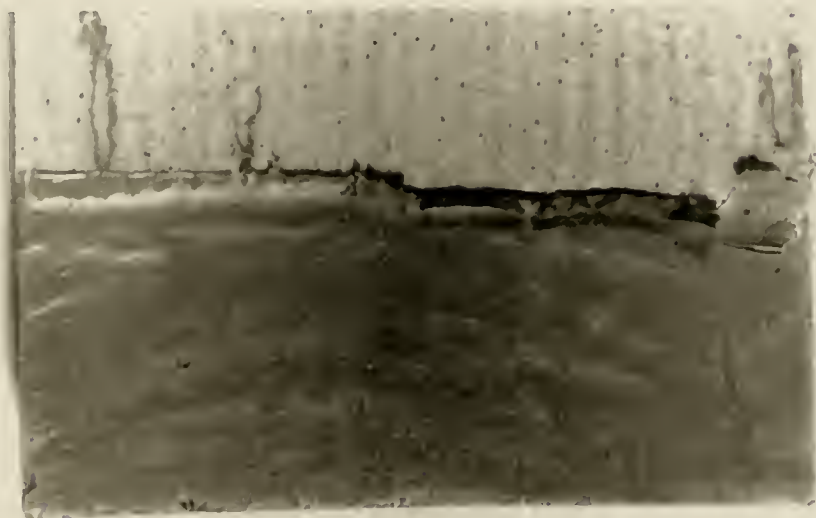
Figure B.29 Edison Aquathane UA-210-H specimen 1C terra cotta after 30 cycles. Note continued peeling of coating from glaze surface and small crack in coating at junction between glaze and terra cotta substrate.

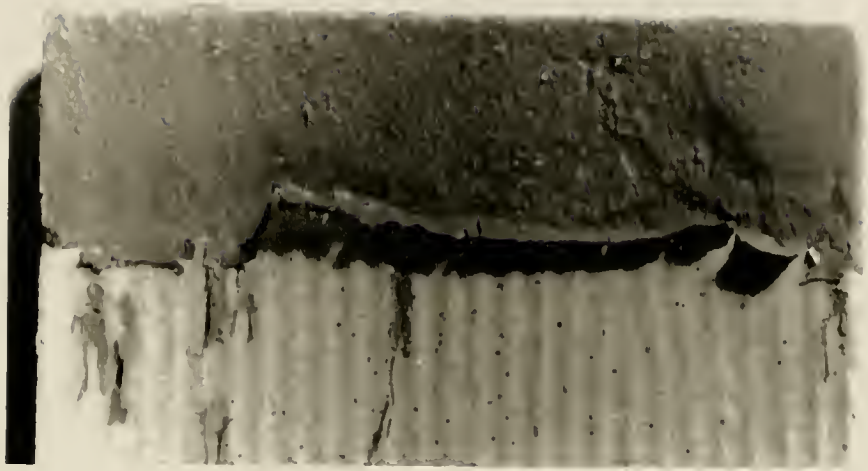
Figure B.30 Edison Aquathane UA-210-H specimen 1C mortar after 52 cycles. Note continued peeling of coating from glaze surface exposing mortar beneath.

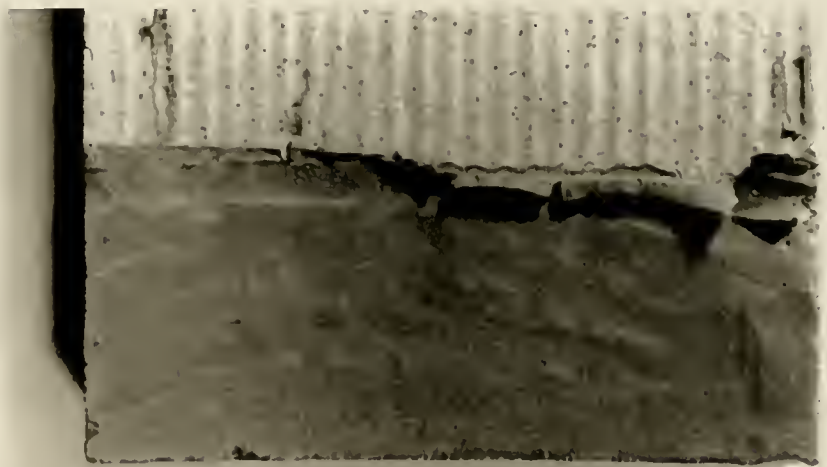
Figure B.31 Edison Aquathane UA-210-H specimen 1C terra cotta after 52 cycles. Note continued peeling of coating from glaze surface exposing terra cotta beneath.

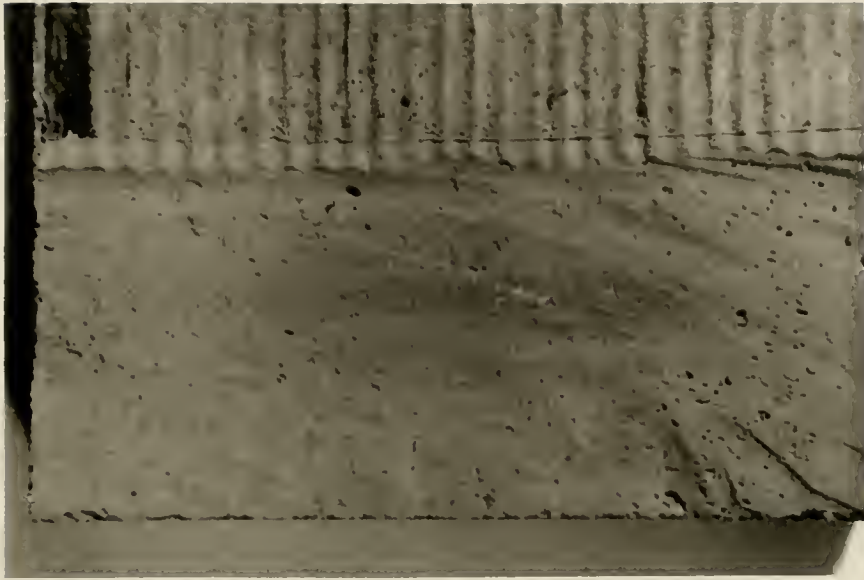
Figure B.34 Conformal Stain specimen 4C after 12 cycles. Note hairline cracking and flaking.
