Approaches to the Conservation of Salt Deteriorated Brick

James M. Hewat
University of Pennsylvania

Hewat, James M. (1996). *Approaches to the Conservation of Salt Deteriorated Brick*. (Masters Thesis). University of Pennsylvania, Philadelphia, PA.

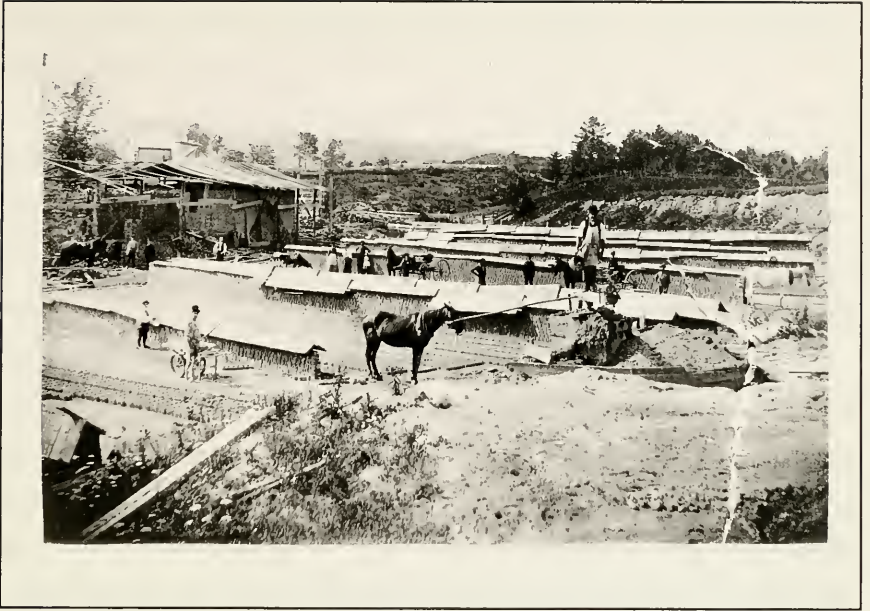
Figure 2. 1890 view of Fuller and Cony's Brickyard in Augusta, Maine. Note the horse powered pug mill and green brick s drying background.

The pug mill is credited by many historians to have facilitated the exponential explosion in brick production which occurred during the Industrial Revolution. Since the introduction of the pug mill, there have been a great many machines invented to aid the mixing of clay for brickmaking including roller mills used to crush and grind shale.

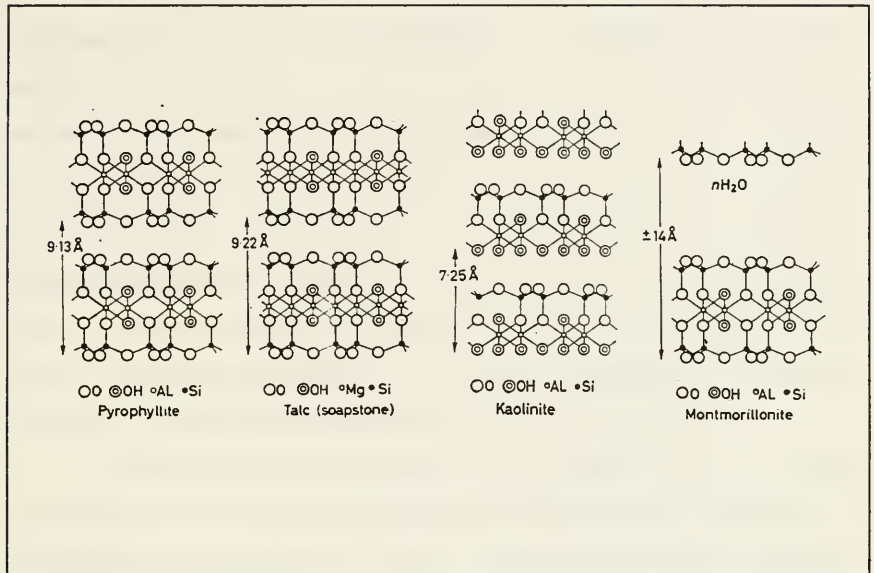
Figure 4. Layer-lattice structures of clay minerals.

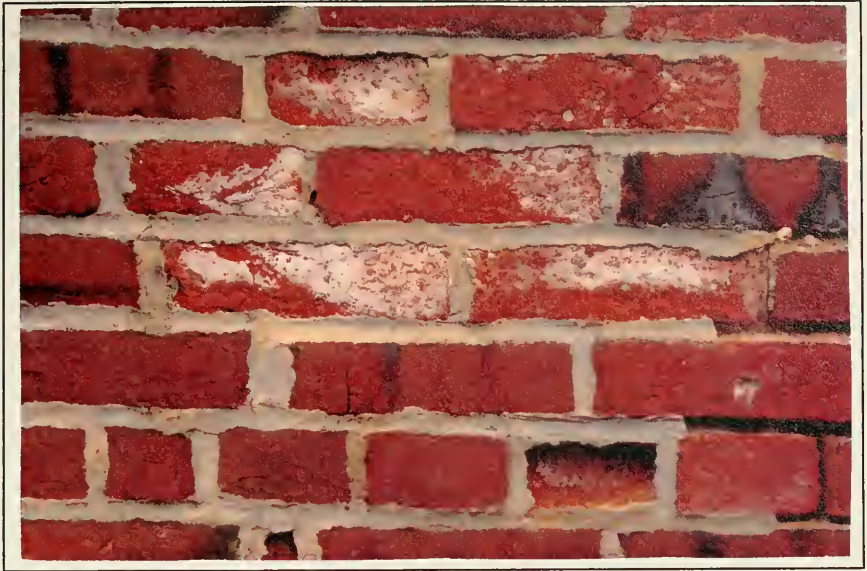
Figure 6 Efflorescence on nineteenth century hand moulded brick. Note the inappropriate repointing which can be a cause of extrinsic soluble salts.

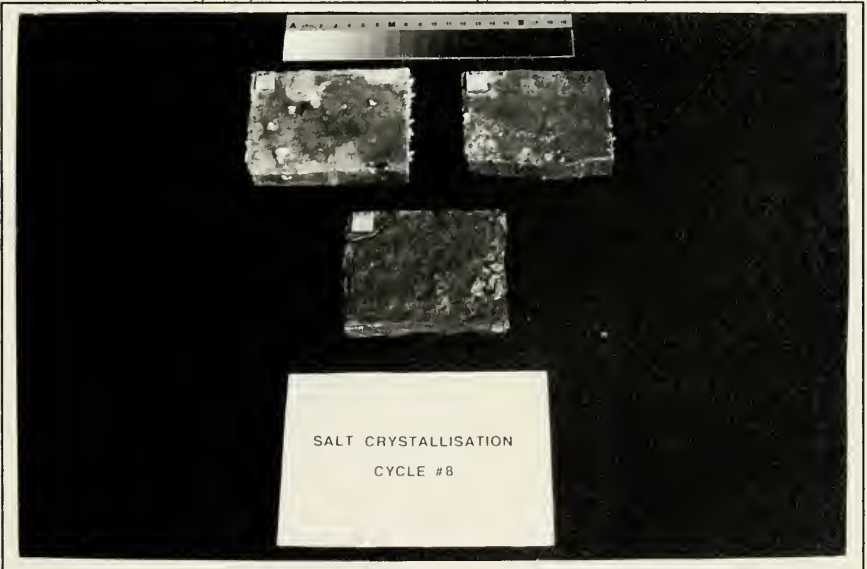
Figure 11 Brick Samples After Eight Cycles . Note the blistering, cracking, and decohesion of the bottom center (Type 1 sample). Both top (Type 2) samples exhibit salt crusting .

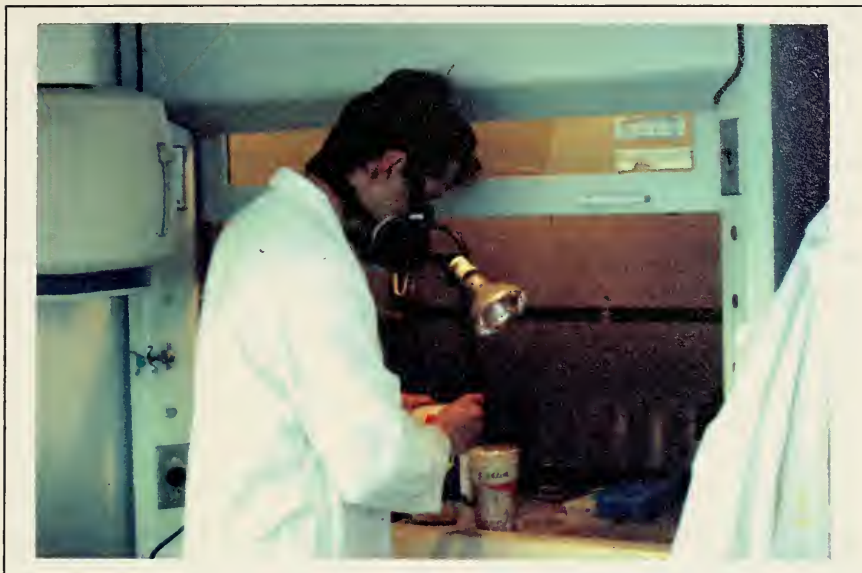
Figure 12. Mixing the Epoxy Resin /Silane Consolidant under a Fume Hood while wearing a respirator.

Because of the toxicity and flammability of the epoxy resin components and solvents used in this experiment a respirator, protective eye wear, gloves were used while carrying out the treatment process. All steps of the treatment were carried out under a fume hood.

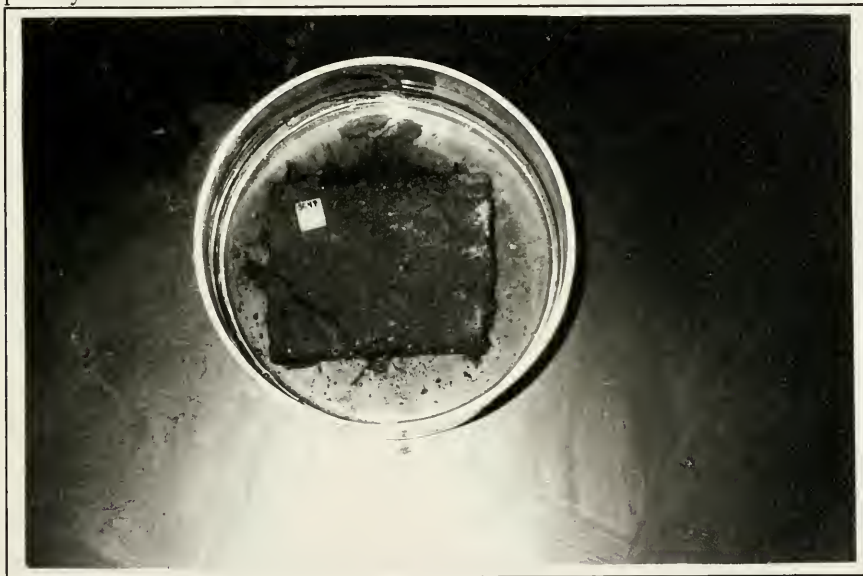
Figure 13. Salt Damaged Brick Sample Treated With B-67/Silane Consolidant After Two Hour Soak. This degree of damage was typical of Type 1 salt damaged samples treated with both the acrylic and epoxy resin consolidants.

The dramatic decohesion observed in the consolidated salt damaged samples indicates that neither the acrylic resin or epoxy consolidant was able to effectively penetrate the brick and encapsulate the sodium sulphate depositions as intended. It appears that the crystallised sodium sulphate was acting as the binding material in all of four of these brick samples. When the samples were soaked in water, rehydration of the salt crystals occurred resulting in the observed decohesion. The opaque film observed on both samples treated with the Eponex indicates that the consolidate was unable to penetrate the salt laden material and formed a layer on the brick surface. It seems clear that the failure of these consolidations appears to be attributable to the extent of sodium sulphate and related damage that occurred in the brick samples during the crystallisation cycles (see section 4.3).

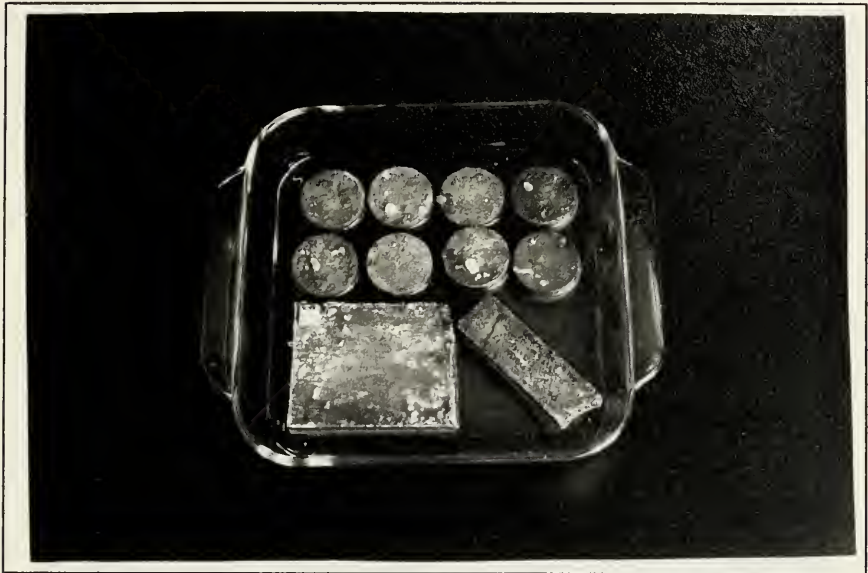
Figure 14. Samples Disks soaking in Epoxy Resin/Silane Consolidant in Preparation for Water Vapour Transmission Test.

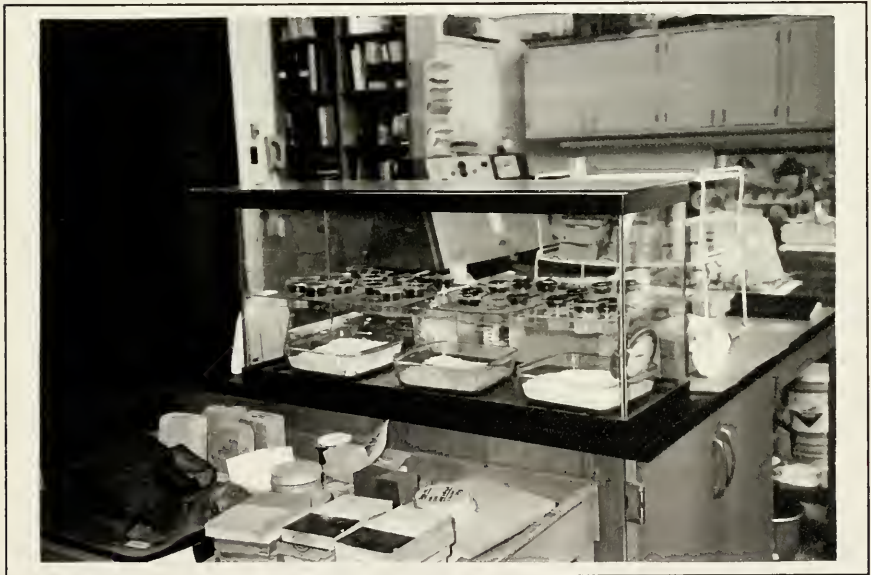
Figure 15. Water Vapour Transmission Tank During Testing of Brick Disks.

Five of the six salted samples began to spall after seven days in the desiccating chamber. An odor of toluene was discernible from the salted samples treated with the epoxy resin/silane consolidant. By the fourteenth day, significant decohesion was observed in the five of the salted samples.

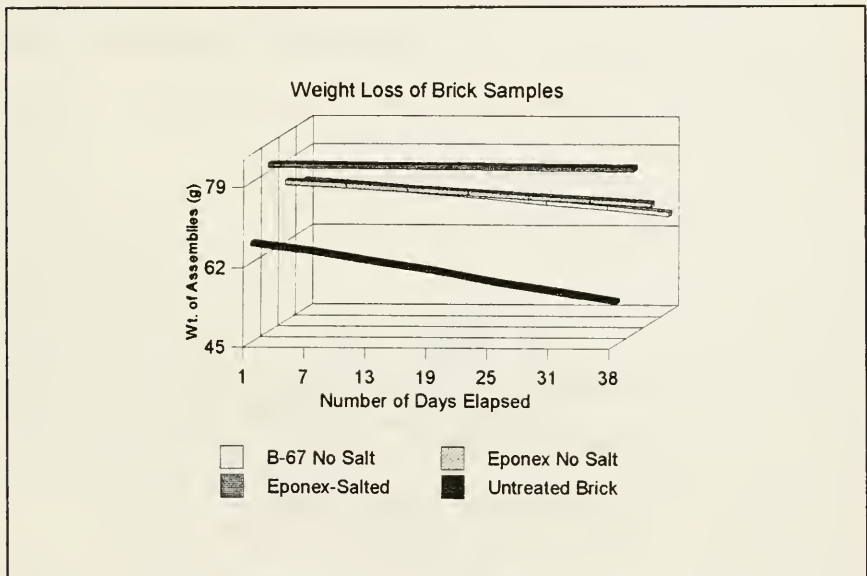
Table C. Graph Illustrating Weight Loss Averages of Each of the Sample Types during Thirty eight day water Vapour Transmission Test.

Except for the control, (sample 5.2) all of the sample types showed a marked loss of weight over the thirty eight day test period. The untreated,

unsalted sample showed the greatest weight loss with a decrease of 12.18 grams (18% of total assembly weight) while the salted, epoxy resin samples showed the smallest weight loss at 0.57 grams (less than 1% of total assembly weight). The non-salted samples treated with the B-67/silane mixture showed an average weight loss closest to that of the untreated sample with an average total weight loss over the thirty eight day period of 6.6 grams (9% of assembly weight). The non-salted samples treated with the epoxy/silane consolidants lost an average of 4.5 grams (6% of assembly weight). These figures indicate that the B-67/silane treatment resulted in a reduction of vapour transmission of roughly one-half, while the epoxy/silane consolidant decreased the rate by about two-thirds of untreated samples.

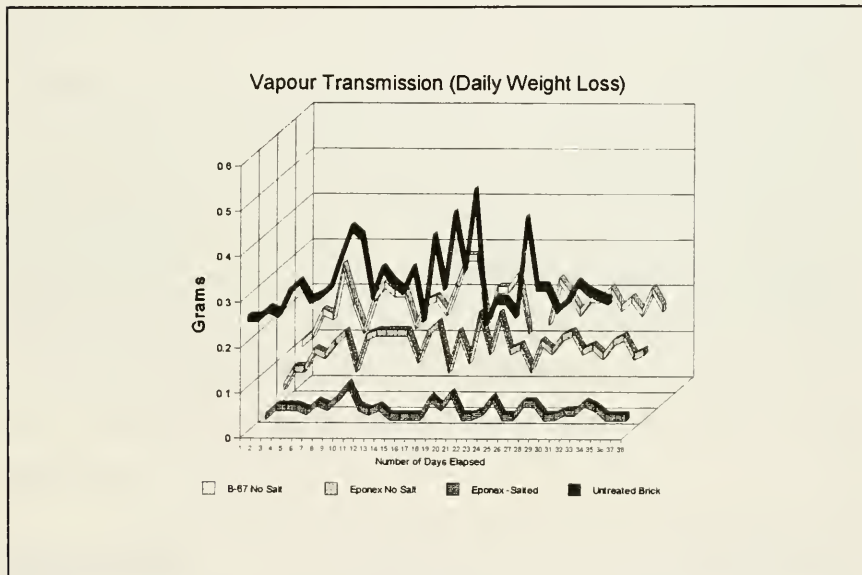
Table D. Graph Illustrating the Average Daily Fluctuations of each of the sample types during the Water Vapour Transmission Test.

Peak values for the average daily weight loss occurred on the twenty fifth day. The cumulative data chart graphically shows the average daily weight loss of each of the tested samples. The results indicate that the B-67/silane treated samples had a daily vapour transmission rate closest to that of the untreated brick. The low vapour transmission rate of the salt laden, epoxy resin consolidated sample may owe to the high concentration of sulphates deposited within the brick pore network and the resulting deposition of epoxy resin on the sample surface. The use of scanning electron microscopy would be useful to analyse the deposition of the sulphates and consolidants within the pore network of the brick samples. Because of time constraints, the water vapour transmission rate through a unit square meter of brick surface per hour was not calculated.
