# Preservation in Ridley Creek State Park: Documentation of the Historic Farmsteads

A Thesis  
in  
Historic Preservation

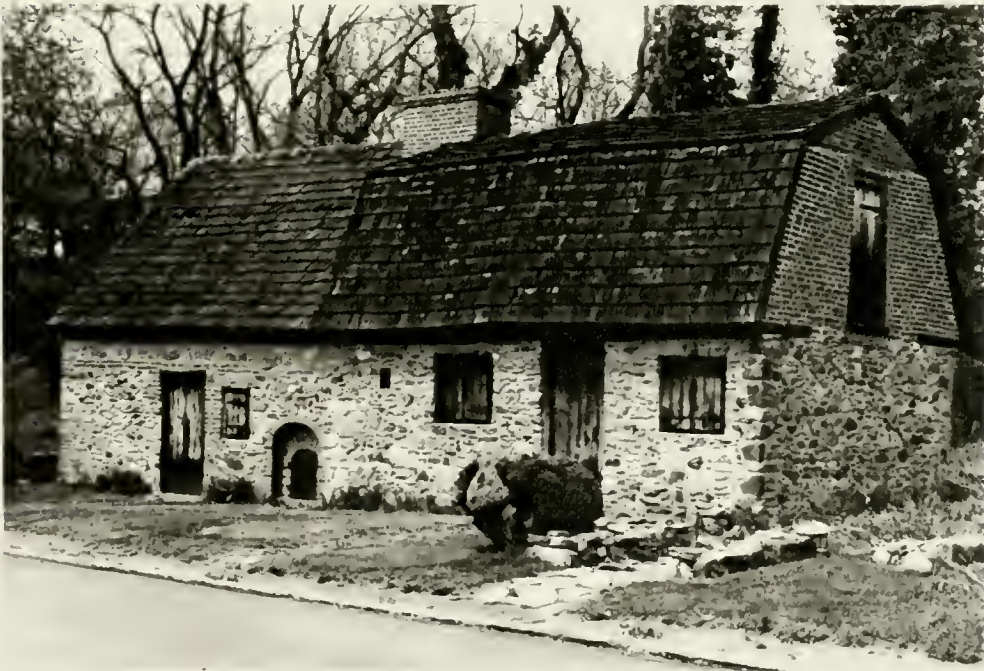
Fig. 2. The 1683 Caleb Pusey House. Chester, PA.

The construction of the Pusey house indicates that not all of the initial shelters in the region were built of log. The settlers were striving to establish permanent new homes for their families and appropriate building stone was abundant in the area. The granites, sandstones and schists suitable for construction were simply collected while clearing the fields or available from local outcrops. Lime mortar was produced by burning limestone or oyster shells in large open kilns. Rubble masonry construction was employed in all forms and types of structures, from the simple one room cottage to the local meetinghouse. Many of the early houses, mills, and farm buildings that survive today were built of the durable, rubble fieldstone masonry.

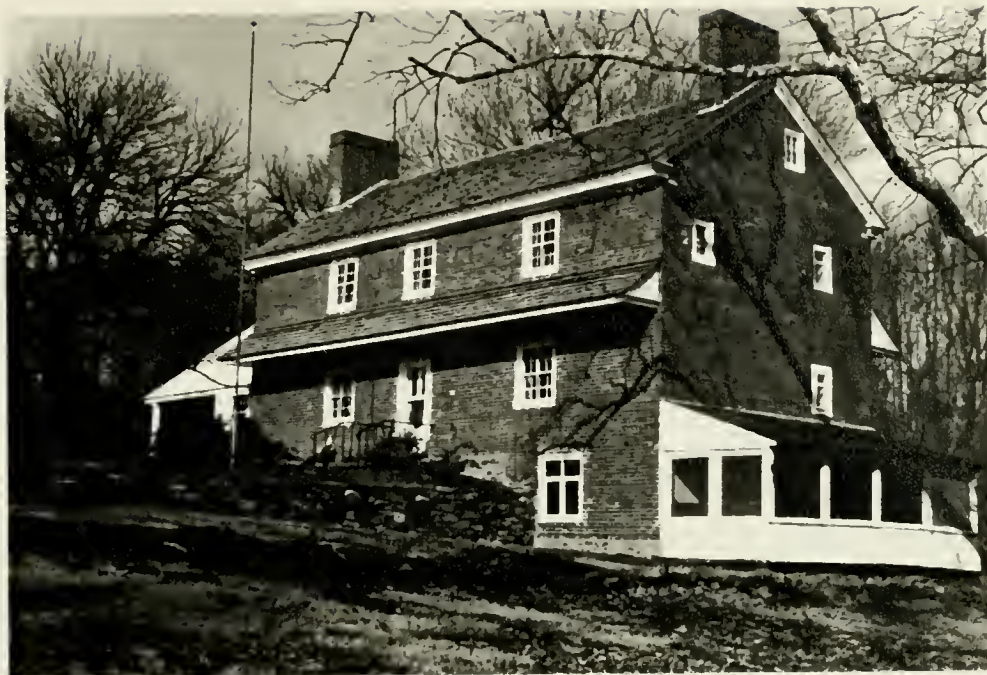
Fig. 3. The Samuel Levis House (late 17th c.). Springfield, PA.

There was also a tradition of brick masonry construction that evolved in certain areas throughout the mid-Atlantic region. (see Fig. 3) Early brick structures are typically identified by the irregular hand molded bricks and the

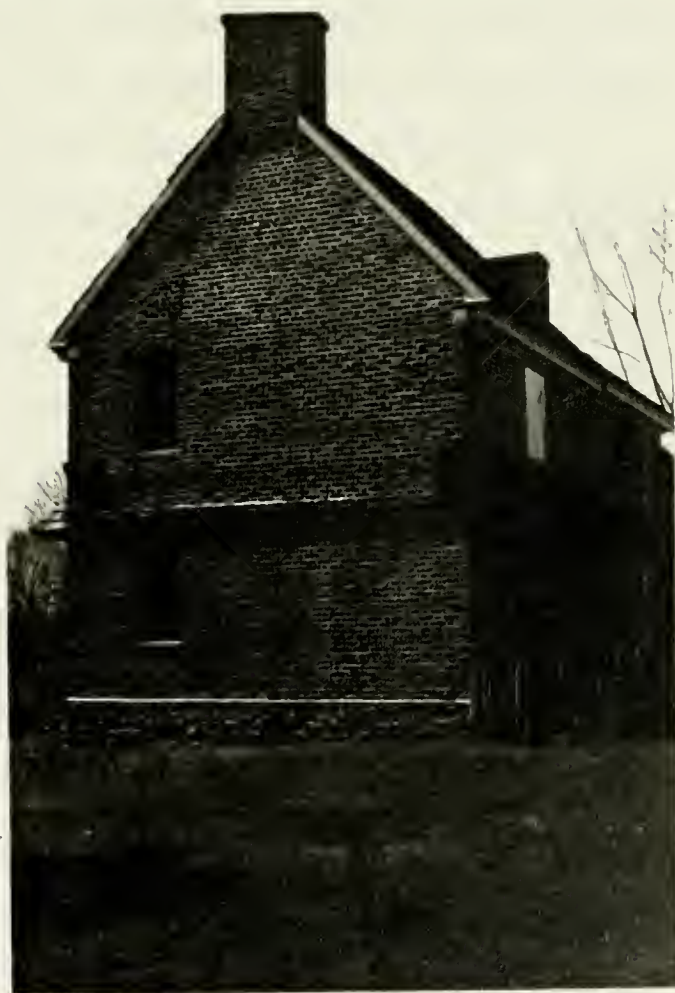
Fig. 4. The 1696 Thomas Massey House. Broomall, PA.

checkerboard pattern of the flemish bond construction. During the seventeenth and eighteenth-centuries, the walls were often laid up in an alternating header and stretcher pattern. The double thickness of the wall was bonded together by the header bricks which were laid perpendicular to the face of the wall. Often the headers were glazed, which created a checkerboard effect, or were utilized for more complex decorative patterns. (see Fig. 4)

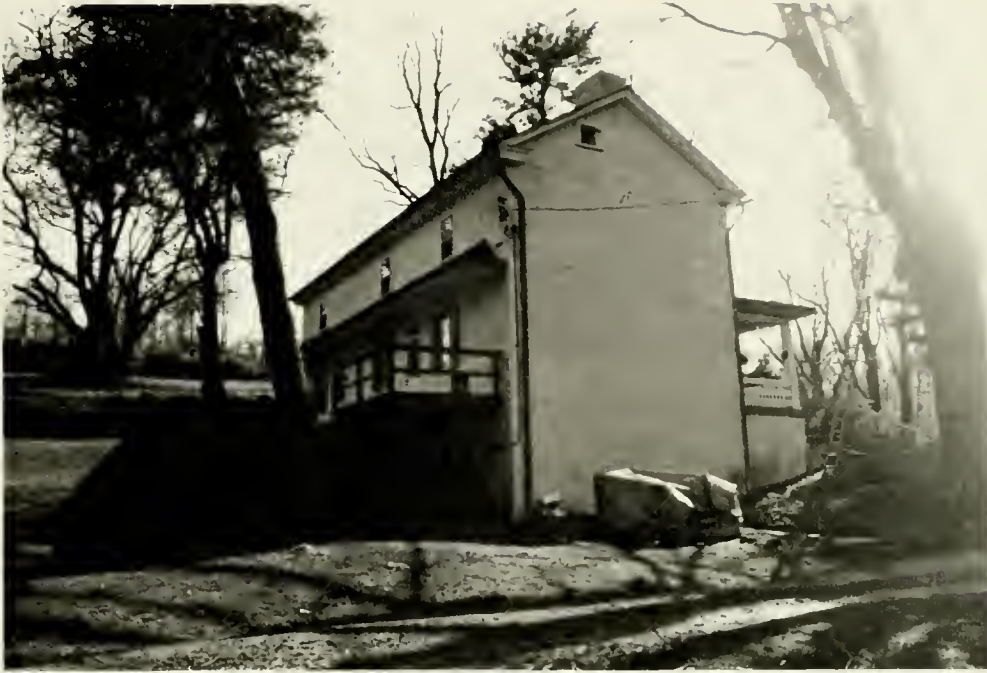
Fig. 7. The William Russell house. Typical I-house form. Ridley Creek State Park.

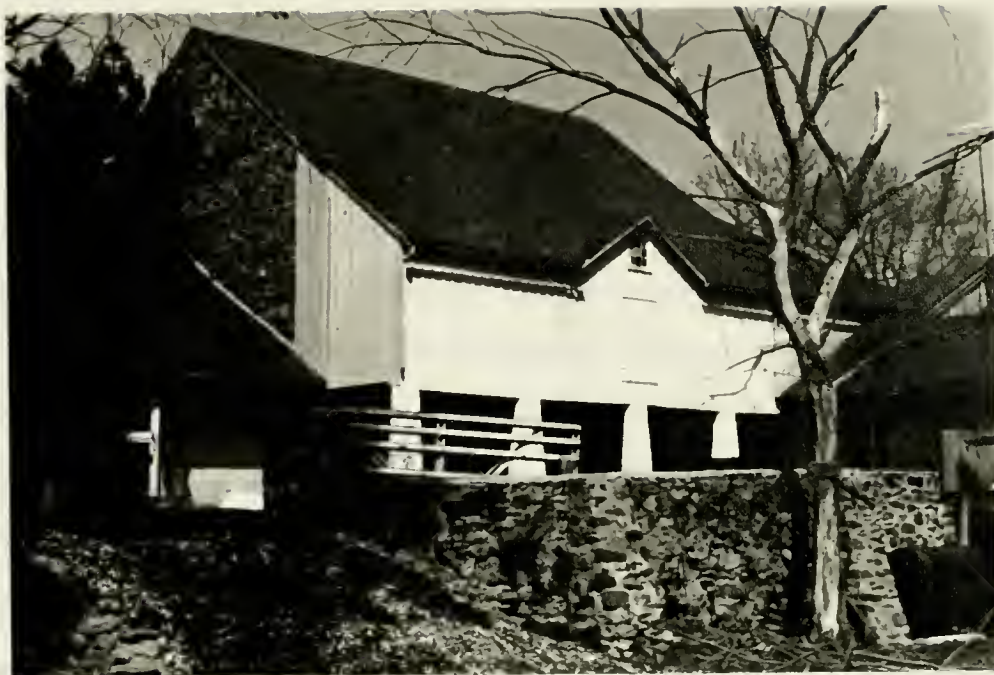
Fig. 9. Typical "Pennsylvania" Bank Barn. Ridley Creek Farm. Ridley Creek S. P.

The common "Pennsylvania" two level, bank barn was built of rubble stone with a cantilevered wood-framed fore bay. (see Figs. 9, 10) This form evolved over time and its two primary ancestors were the Germanic bank barn and the English, three bay, wood framed barn. The "Pennsylvania" barn maintained the three bay plan with a central threshing floor and flanking haymows. The banked construction of the barn, just as in bankhouses, allowed multi level access. Animals were housed on the lower level with access to and from a barnyard beneath the forebay. The main threshing floor was accessed by an earthen ramp or wooden bridge on the high side of the structure opposite the forebay.

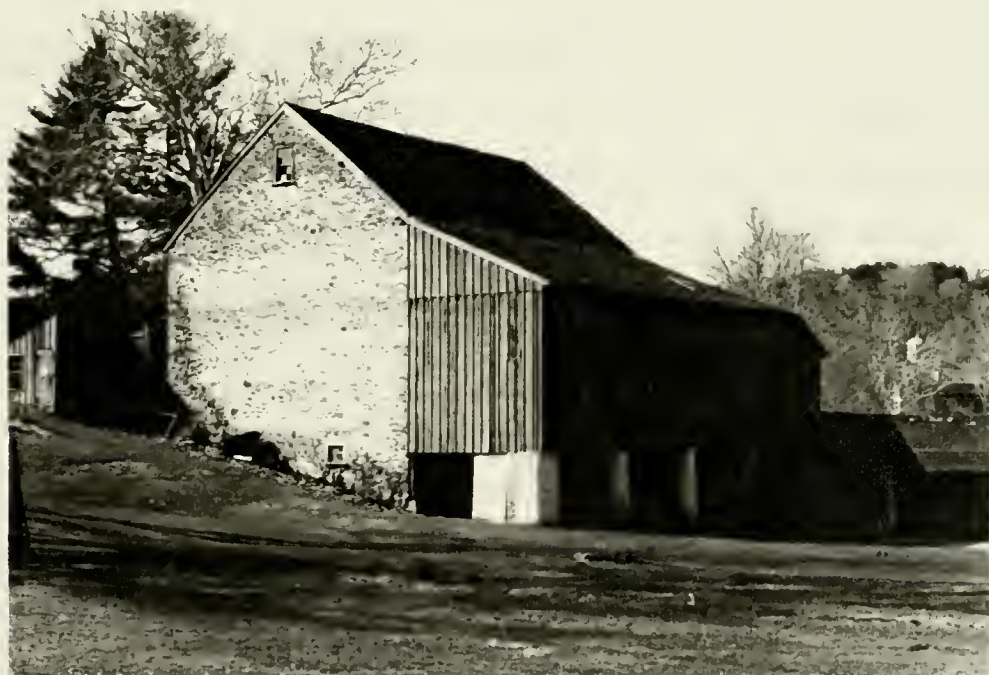
Fig. 10. Open Forebay. (Goldwater /Link) Bank Barn. Ridley Creek State Park.

The forebay is the characteristic feature of the classic "Pennsylvania" barn form.<sup>21</sup> It was an extension of the upper floor level and typically cantilevered over the lower level entrances. This provided weather protection for both the farmer and the livestock and allowed convenient transfer of feed and grain from above. The forebay usually contained granery bins and either access doors opening into the barn yard, or trap doors in the floor. A forebay that extends off of the barn and creates an asymmetrical gable end elevation is referred to as an open forebay. (see Fig.10) Closed forebays, on the other hand, have a recessed lower level. (see Fig. 1.5.) The closed forebay is contained within the body or

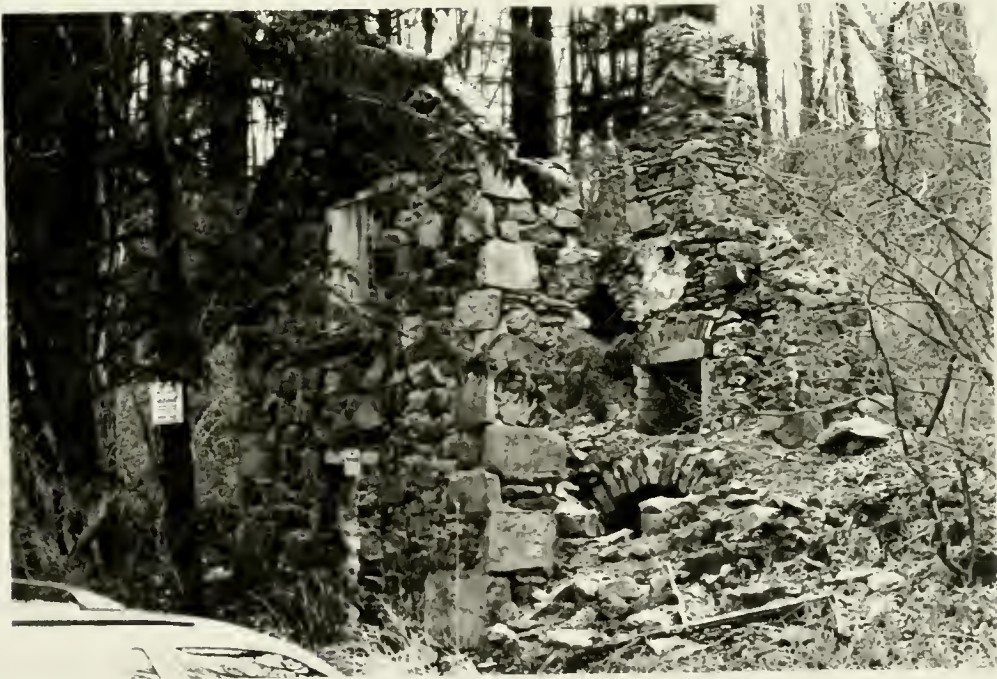
Fig. 14. Sycamore Mills Bakehouse. Ridley Creek State Park.

of a fireplace and a very large, well constructed bakeoven on its lower level. (see Fig. 14)

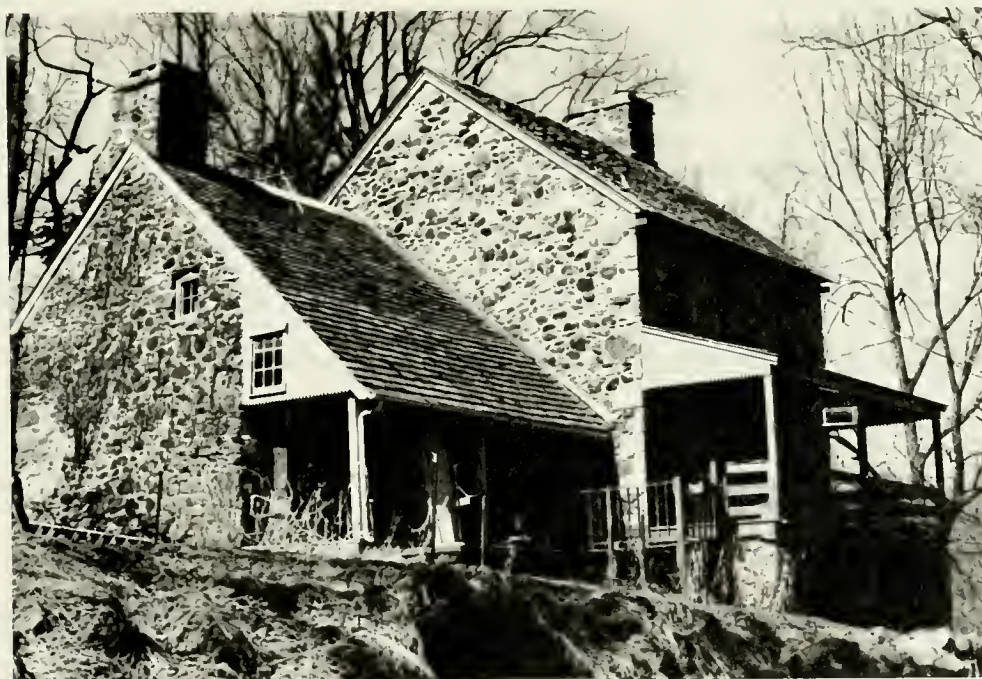
Fig. 16. The 1754 Abel Green House. Ridley Creek State Park.

contains much original detail and character. (see Fig. 16) The original 1754 western portion is a one and one half story single room plan. The larger portion was apparently added in the late eighteenth-century and is a full two story, Penn plan, bankhouse with cellar and attic. The house was apparently used and maintained by the Jeffords family as a "playhouse".<sup>36</sup> The impressive stone bank barn dating from the early nineteenth-century is an interesting early variation of the classic "Pennsylvania" form. Rather than a cantilevered forebay, a pent roof protects access on the lower level. (see Fig. 17) On the opposite side, a wood framed bridge/ramp accesses the upper level, which is a typical feature for Chester County barns.<sup>37</sup> The relatively good condition of the barn, the concrete silo, as well as a modern photograph of cattle on the property indicates an agricultural use until very recently.

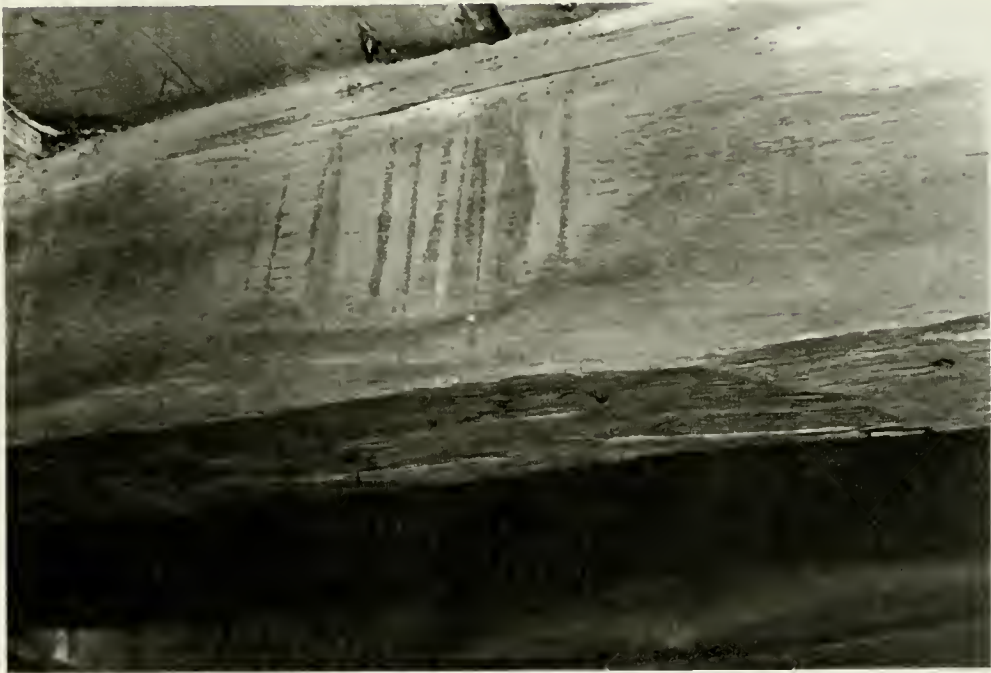
Fig. 1.8. John Worrall House. Detail of original pit sawn floor joists.

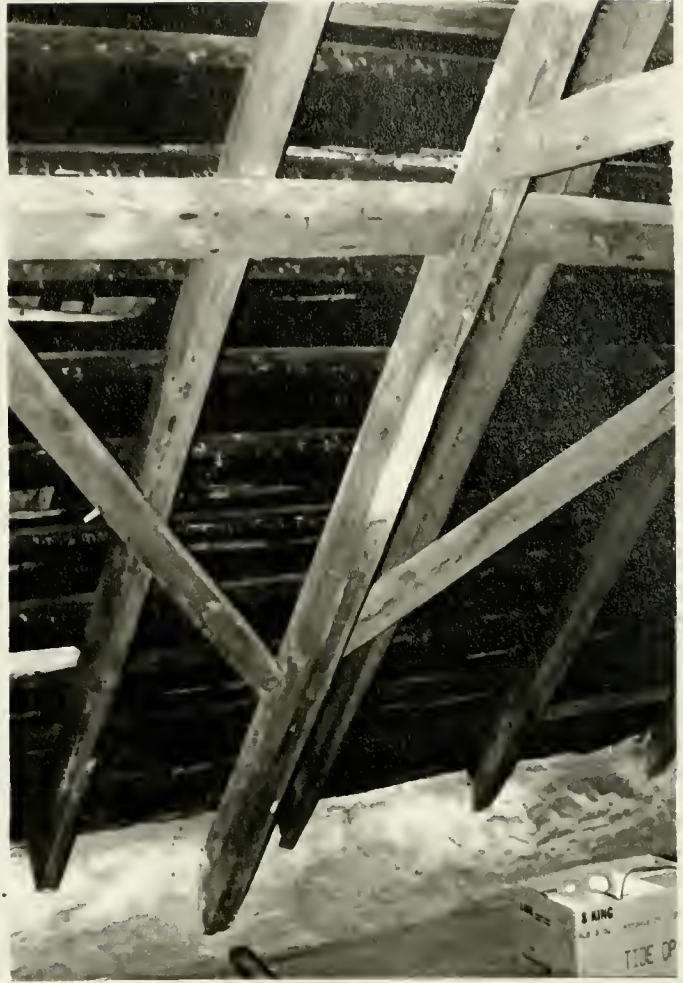
Fig. 1.11. John Worrall House.  
Detail of roof framing.

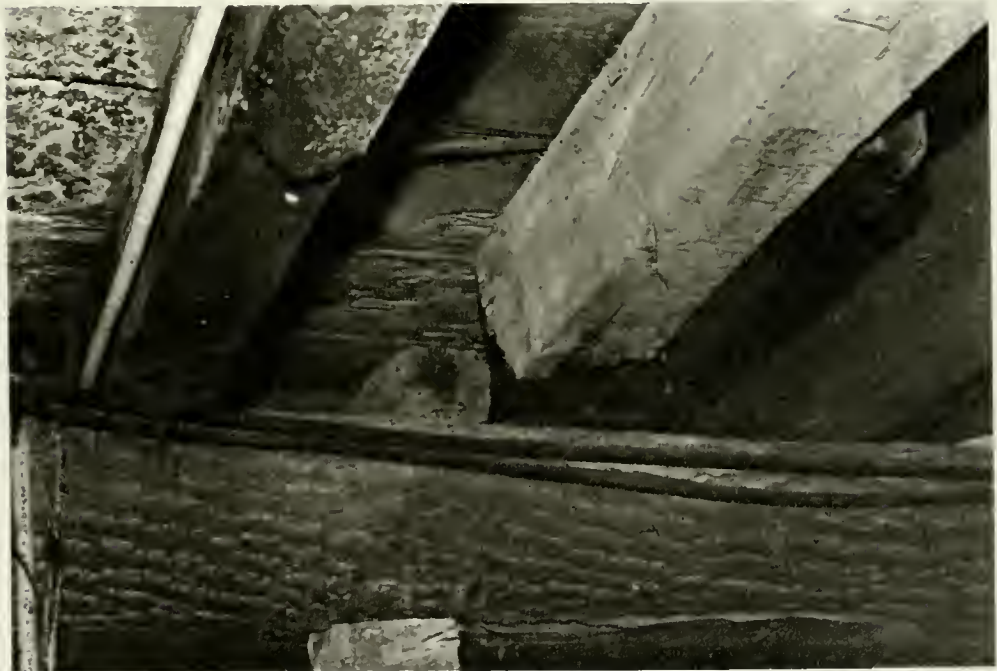
Fig. 1. 12. John Worrall House. Detail of original joists in 1703 section.

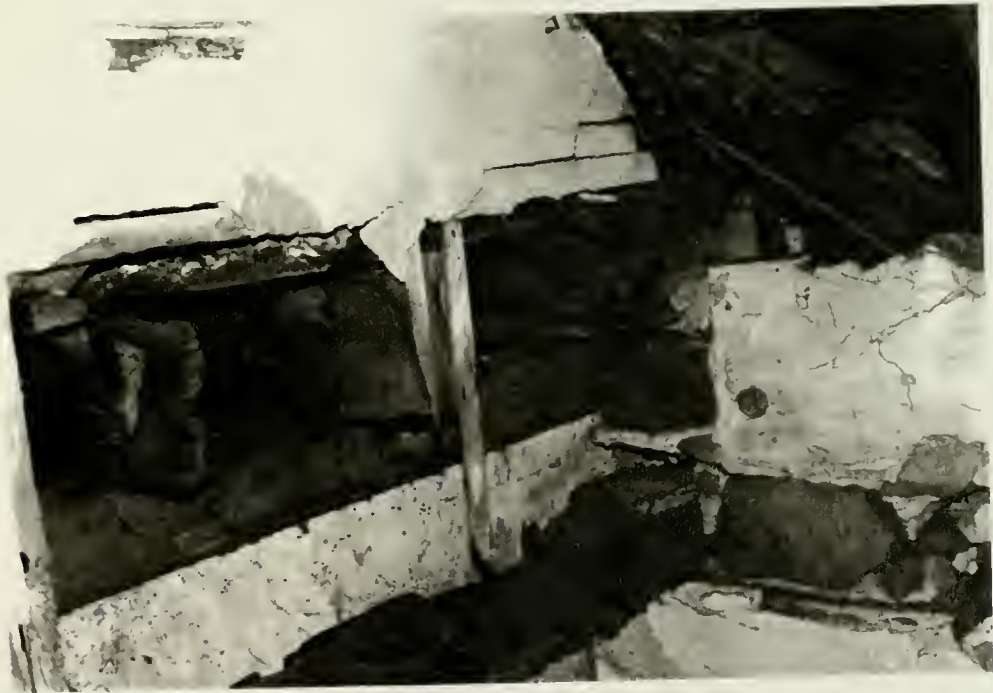
Fig. 2.12. Jacob Minshall House. Outlooker framing for original soffit on north facade.

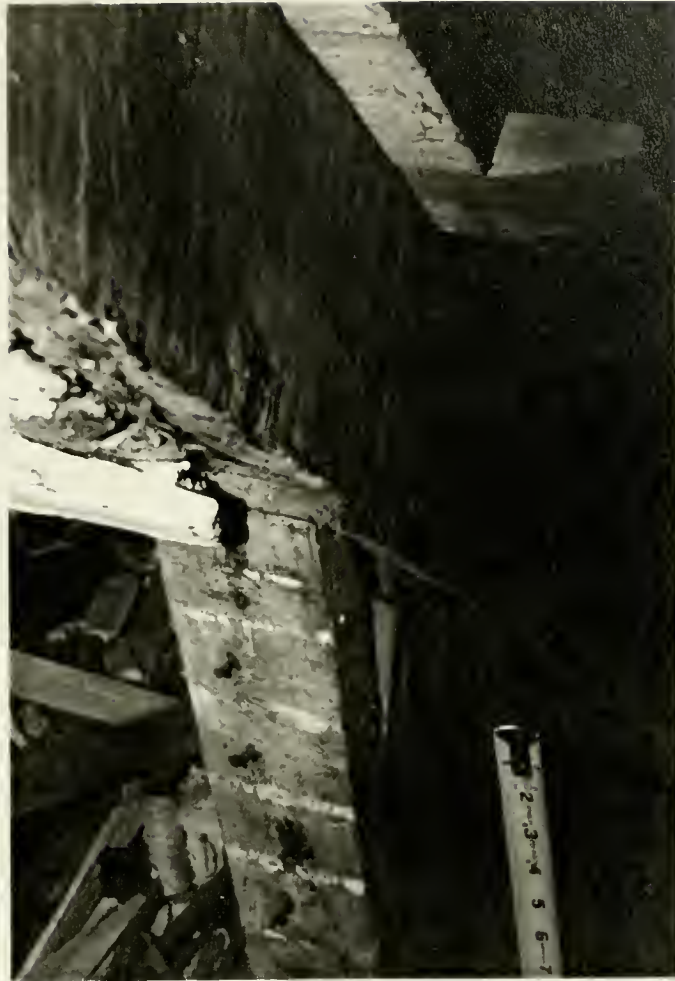
Fig. 2.15. Jacob Minshall House.  
Detail of pit sawn rafters.

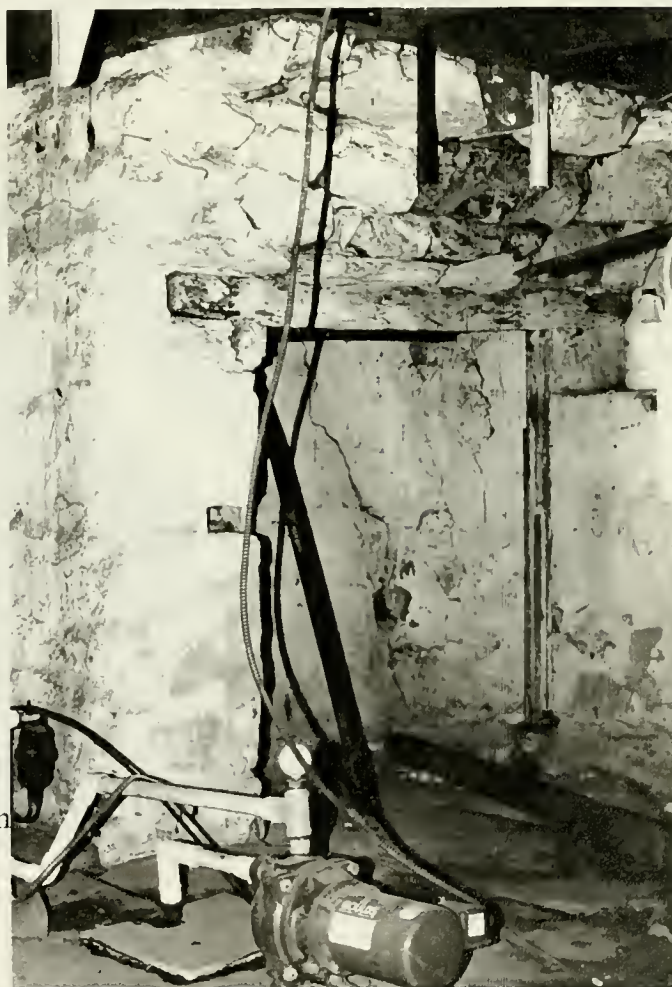
Fig. 3.10. Regester - Black House.  
Detail of fireplace foundation  
in kitchen ell.

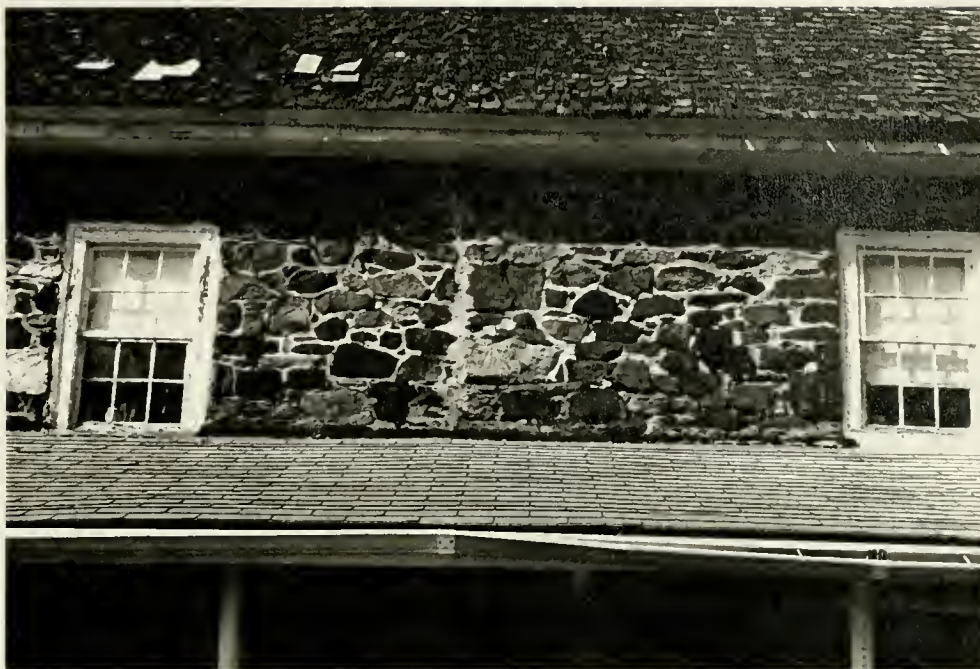
Fig. 3.11. Regester -Black House. Detail of vertical and horizontal seams.  
South facade.
