# Intervention in the Continuum: An Adaptive Use Plan for the PSFS Building on Washington Square

Lynette Ann Stuhlmacher  
*University of Pennsylvania*

Stuhlmacher, Lynette Ann (2001). *Intervention in the Continuum: An Adaptive Use Plan for the PSFS Building on Washington Square*. (Masters Thesis). University of Pennsylvania, Philadelphia, PA.

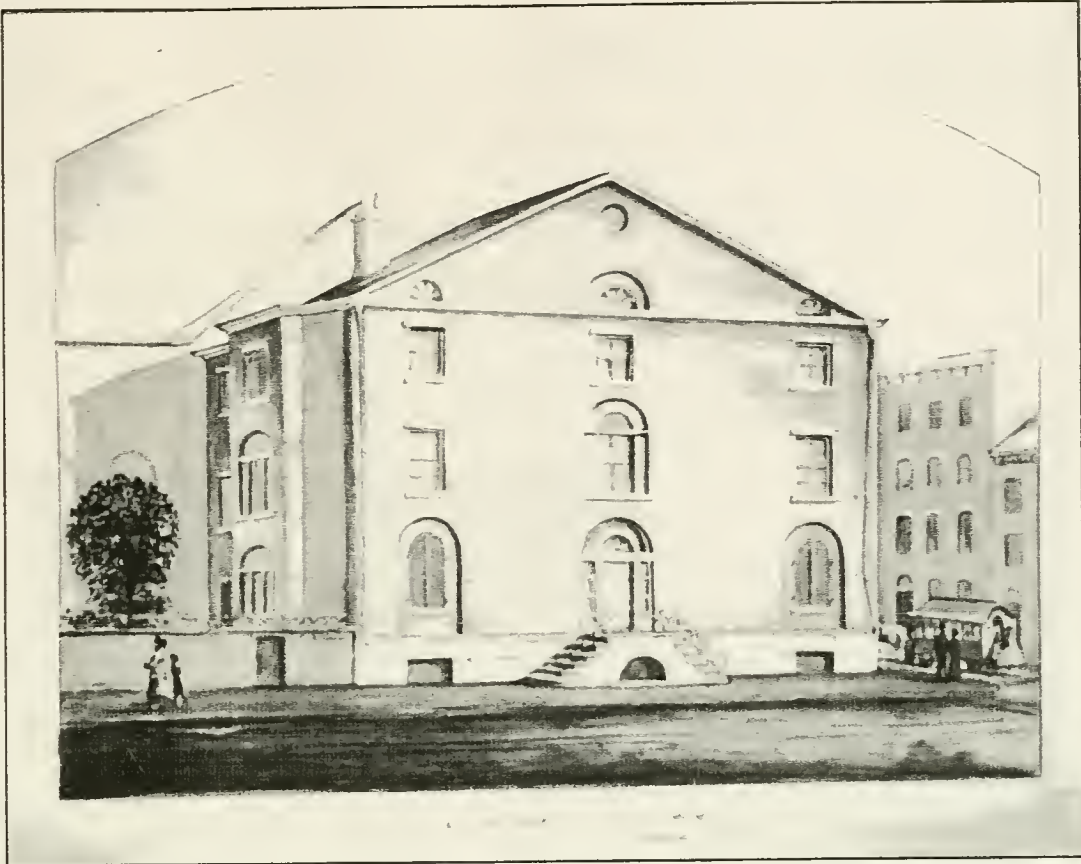
Figure 33. E.H. Klemroth, "SW corner Washington Square and Walnut Street, March 14, 1868" [nb: image was completed either just before or just after demolition of mansion, as the cornerstone was laid 13 June 1868], watercolor.

An E.H. Klemroth watercolor (see Figure 33) in the Castner Collection at the Free Library of Philadelphia<sup>110</sup> appears to match the Mills drawing, especially the back bay not found in any other views of the property. The fenestration and courses are all strikingly similar. With this information, it seems clear to assume that Robert Mills designed the Randall Mansion.

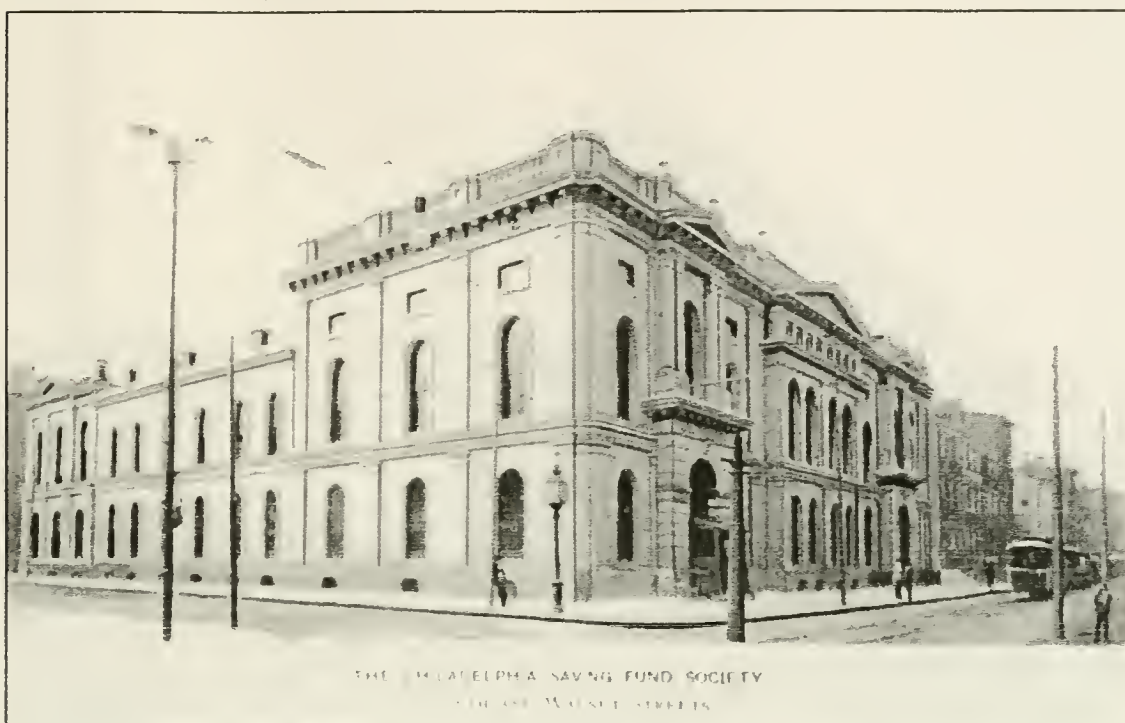
Figure 45. "Philadelphia Saving Fund Society, Seventh and Walnut Streets, 1898," photo.

708 and 710 Walnut Street were purchased in 1894; the addition extending the PSFS building to its final configuration was completed by November 1898 (see Figure 45); the vault was installed in early 1900.<sup>102</sup>

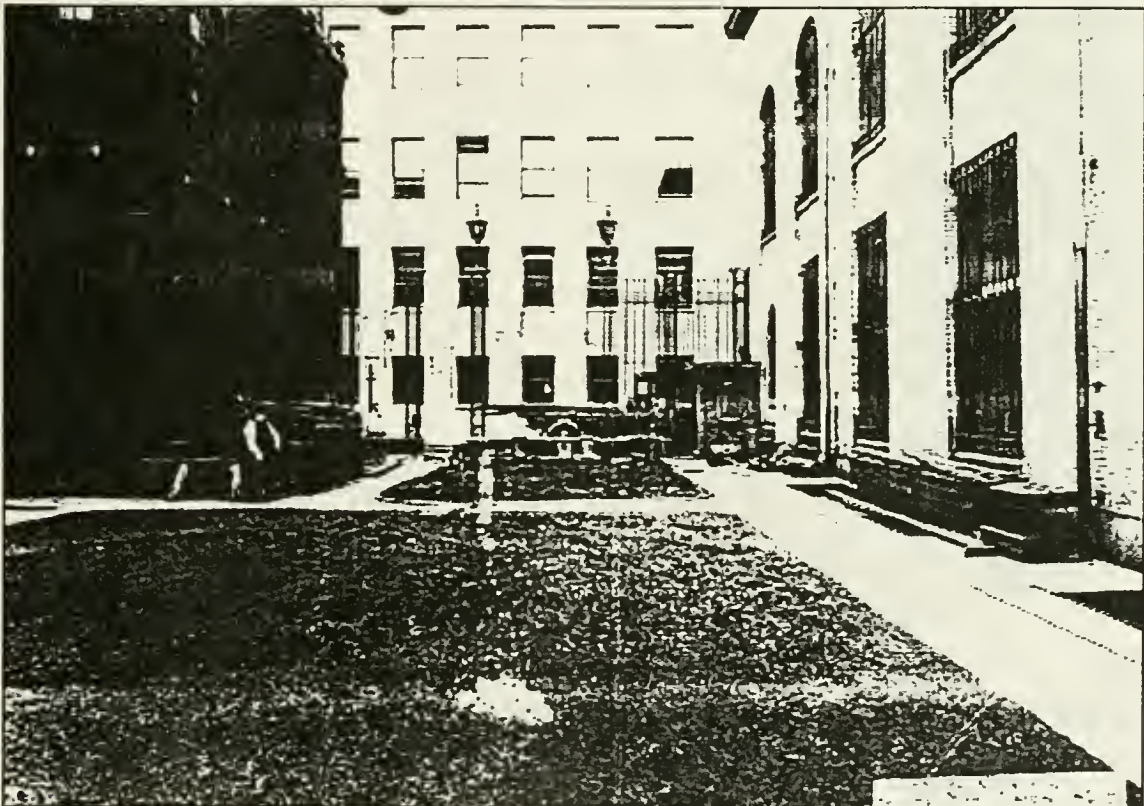
Figure 80. Excavation of courtyard for vault room construction, 17 June 1930 photograph.

- Figure 80 Excavation of courtyard for vault room construction, 17 June 1930 photograph, Pictorial Collections, Hagley Museum and Library.
- Figure 81 North view of courtyard, foundation walls of building phases visible, 2 July 1930 photograph, Pictorial Collections, Hagley Museum and Library.

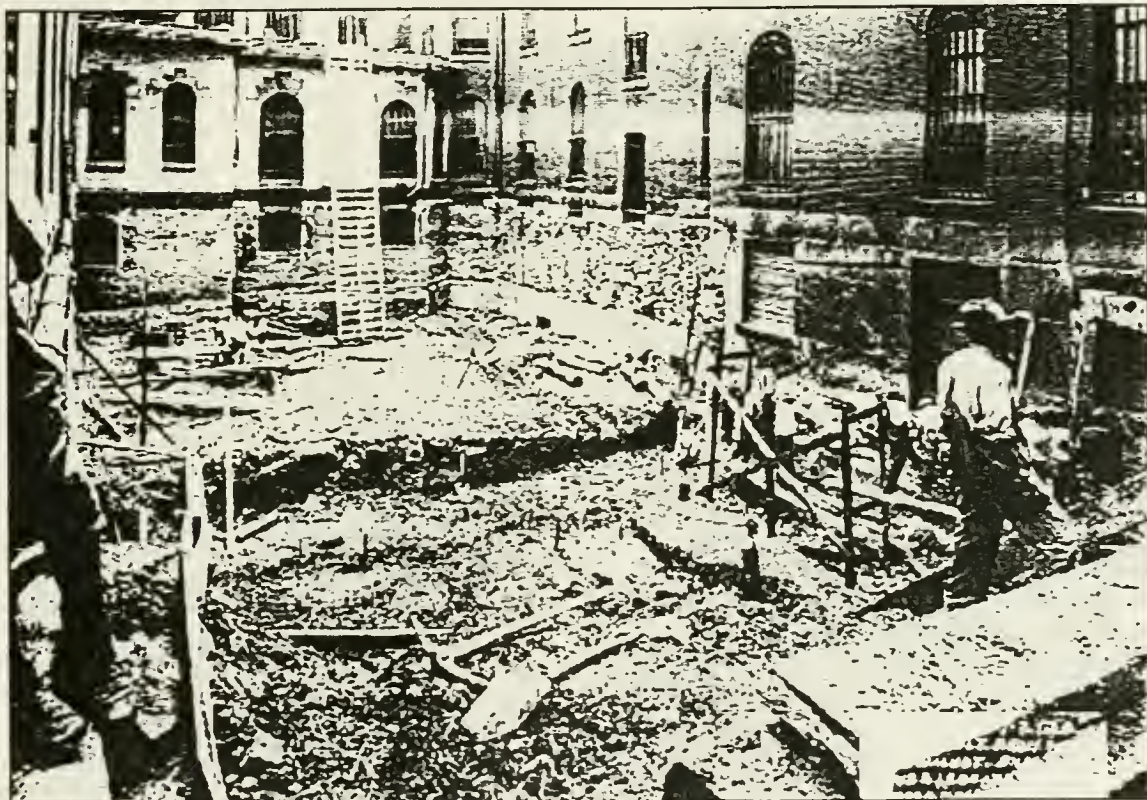
Figure 81. North view of courtyard, foundation walls of building phases visible, 8 July 1930 photograph.

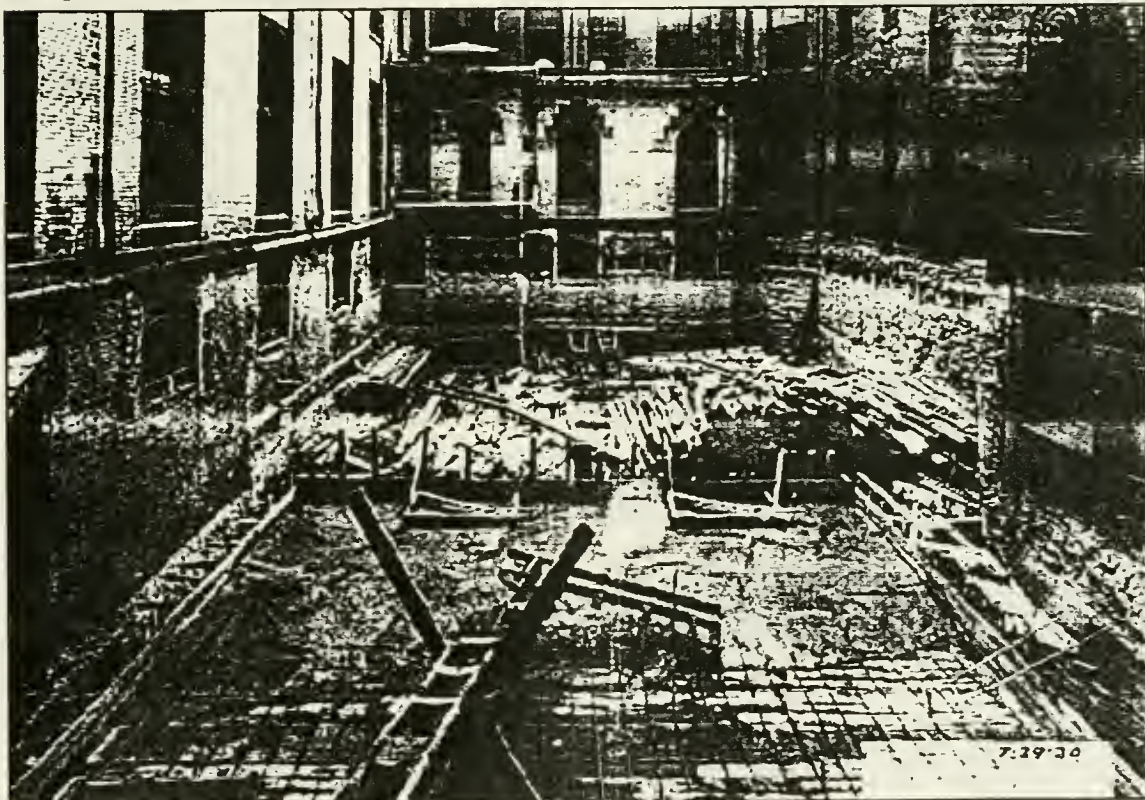
Figure 83. Vault room floor installation, 29 July 1930 photograph.

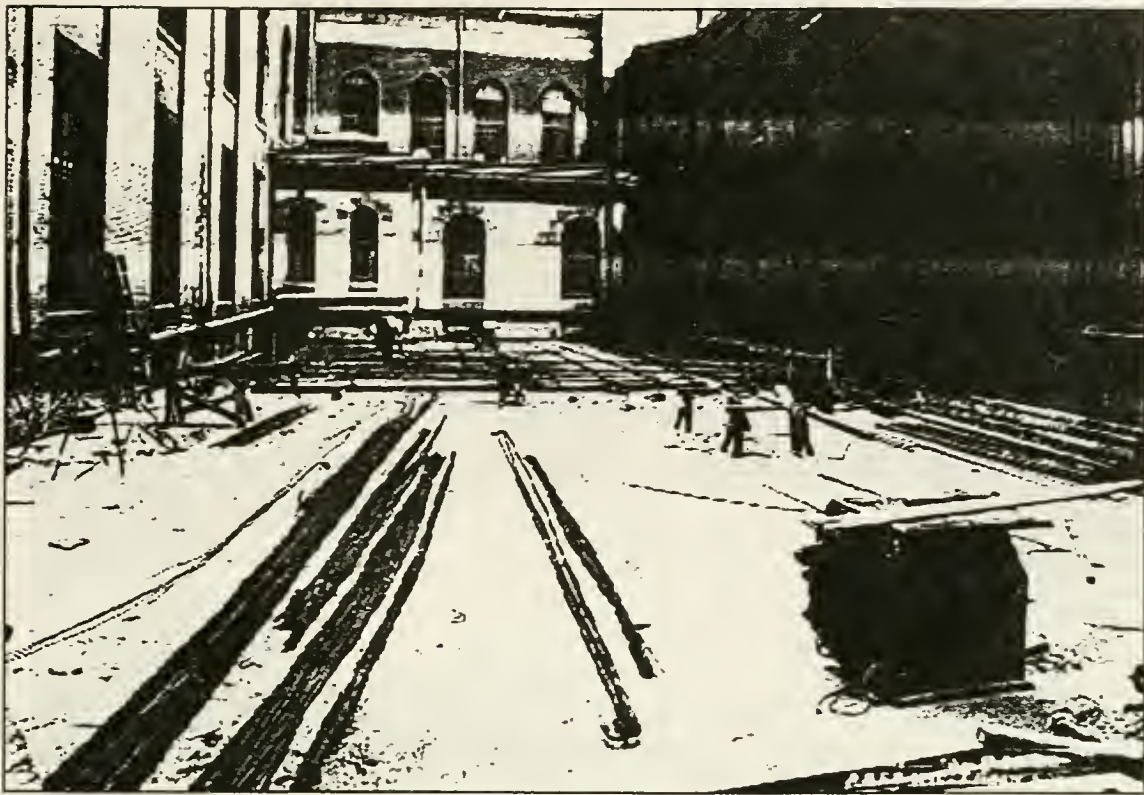
Figure 84. Vault room ceiling installation, 29 August 1930 photograph.

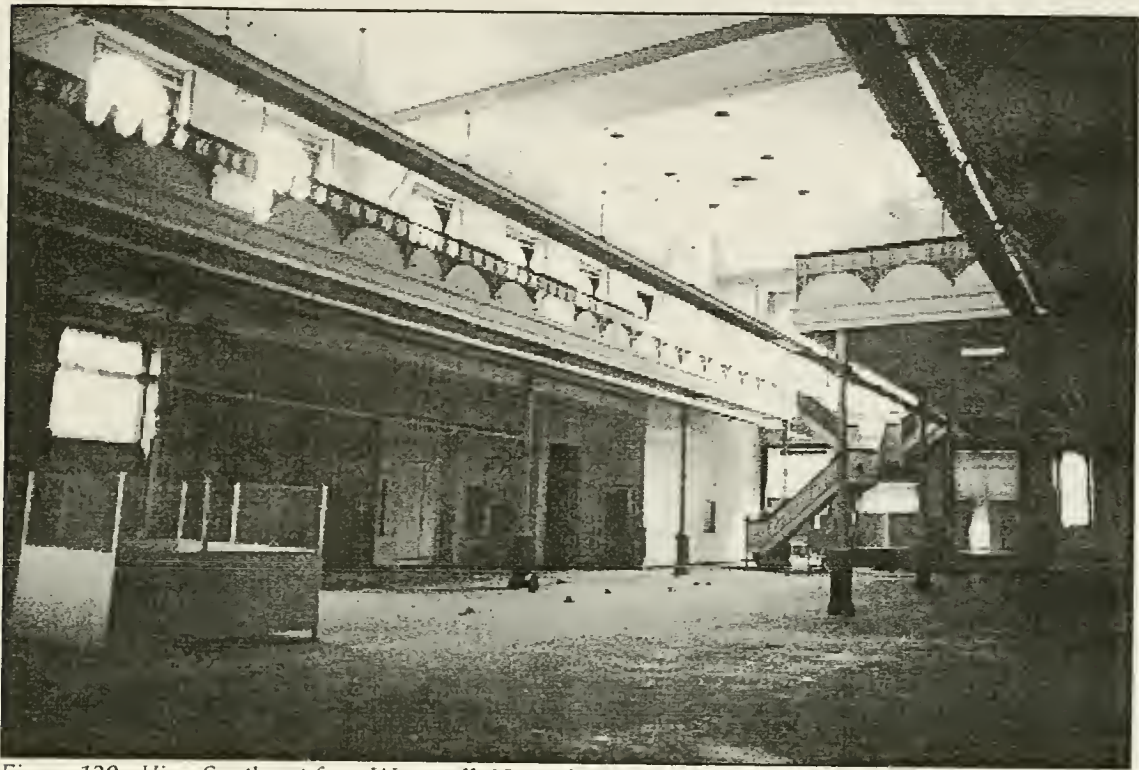
*Figure 120. View Southeast from West wall, November 2000 photograph.*

Subsequent alterations to the building were coordinated by the Architecture Unit of the Real Estate Department on the third floor at the new location. The mezzanine extension occurred in 1940. (see Figures 120 and 122) The 1940-1942 accounting room

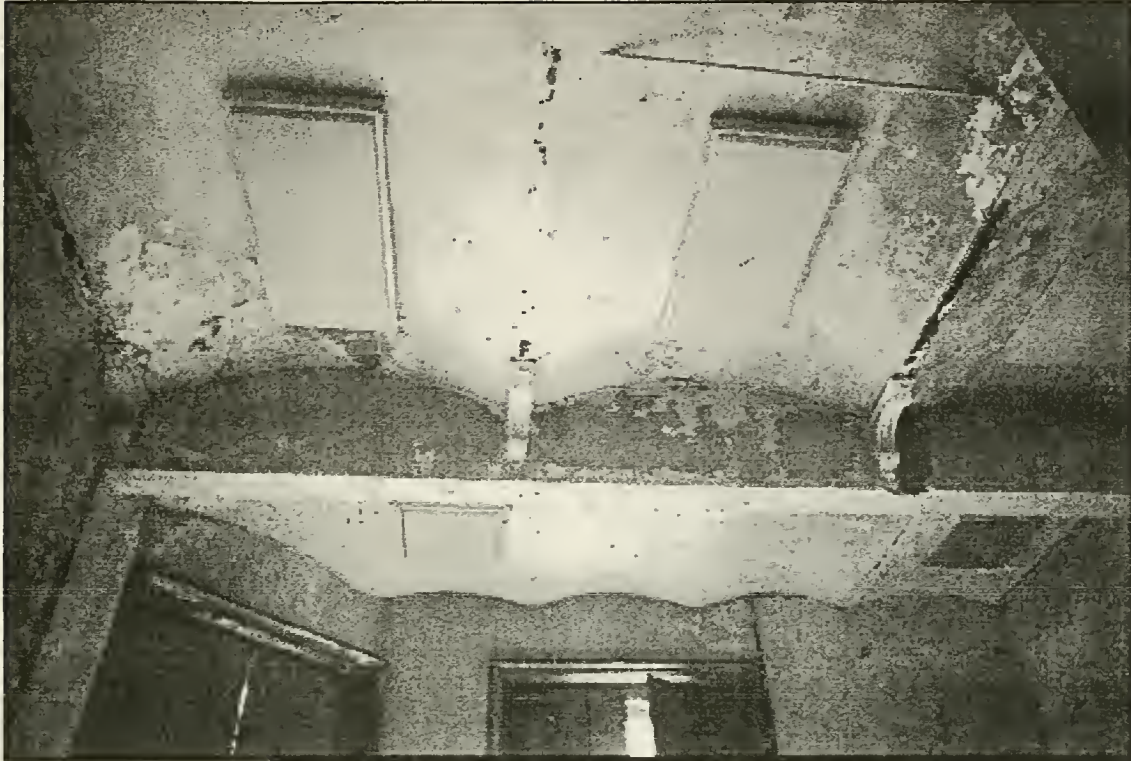
Figure 124. Arch ceiling construction in East wing, November 2000 photograph.

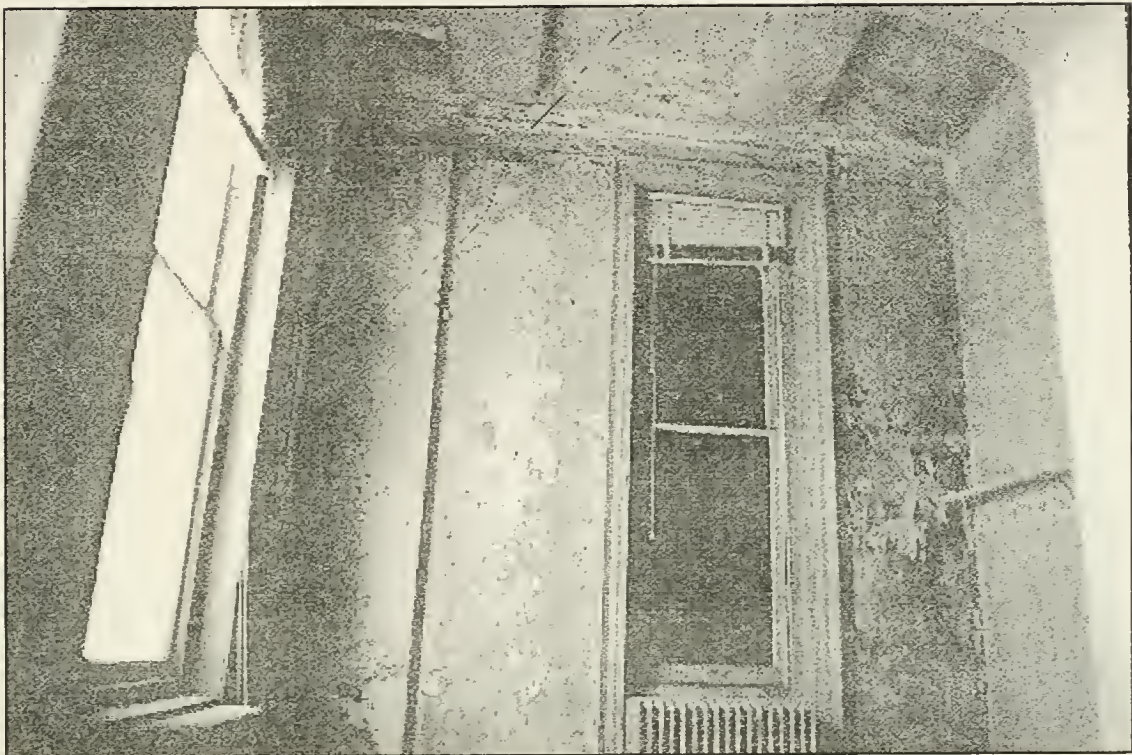
*Figure 132. Moisture infiltration deterioration in East wing, November 2000 photograph.*

- Figure 132 Moisture infiltration deterioration in East wing, November 2000 photograph.

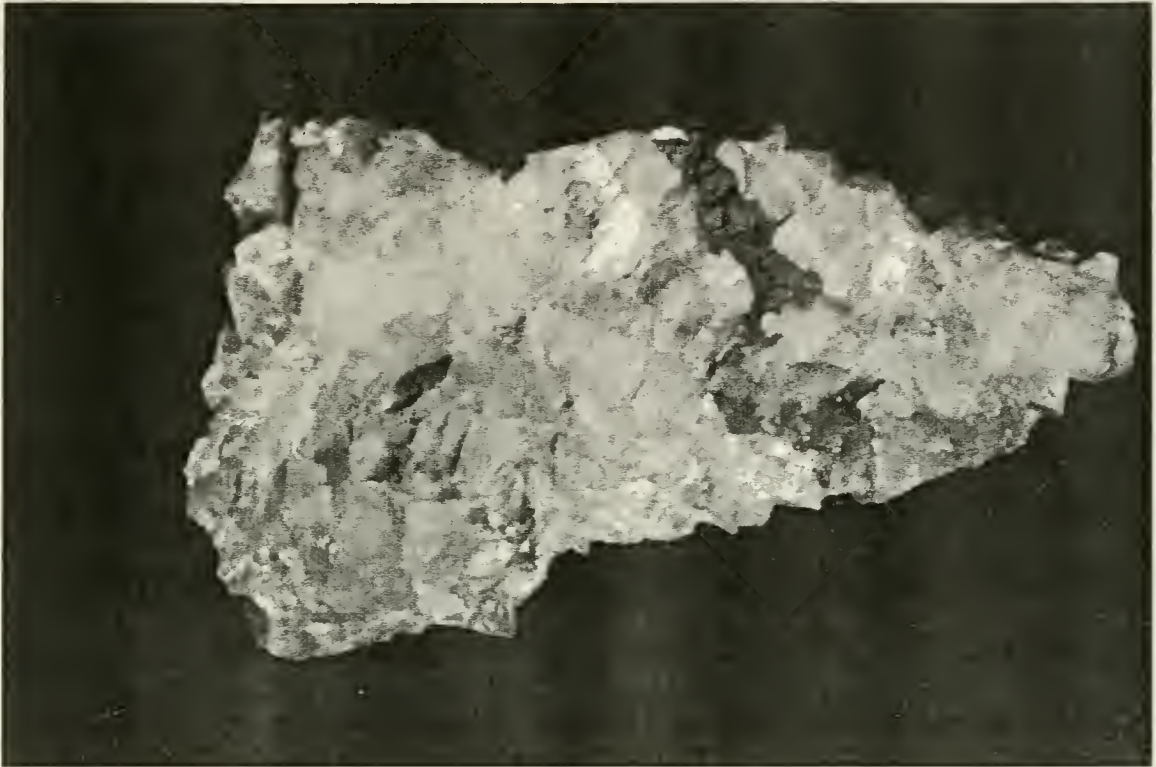
Figure 1. Sample 1, reflected light, 2.5x magnification.  
Note clear quartz, milky white feldspar, and dark mineral.

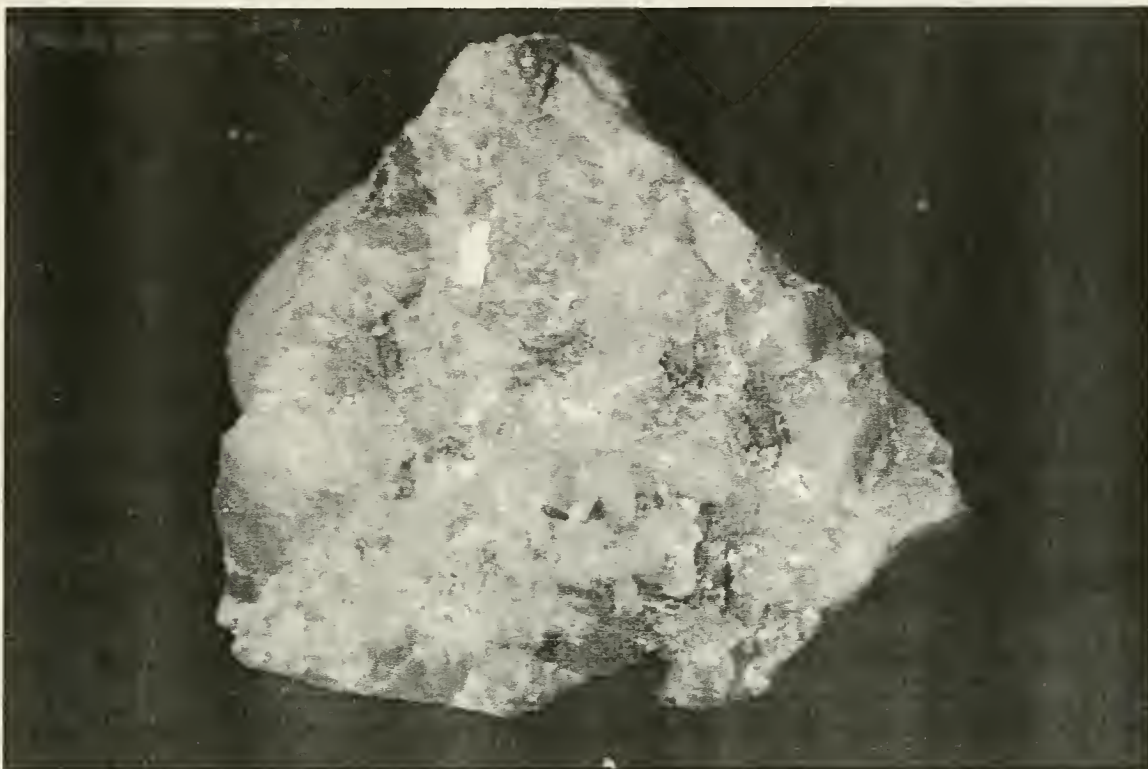
*Figure 5. Sample 2, reflected light, 2.5x magnification.  
Note milky white to gray feldspar and possibility of muscovite (silvery) and staining.*

- Figure 142 (*Appendix VII, figure 5*) Granite sample 2, reflected light, 2.5x magnification. Note milky white to gray feldspar and possibility of muscovite (silvery) and staining.

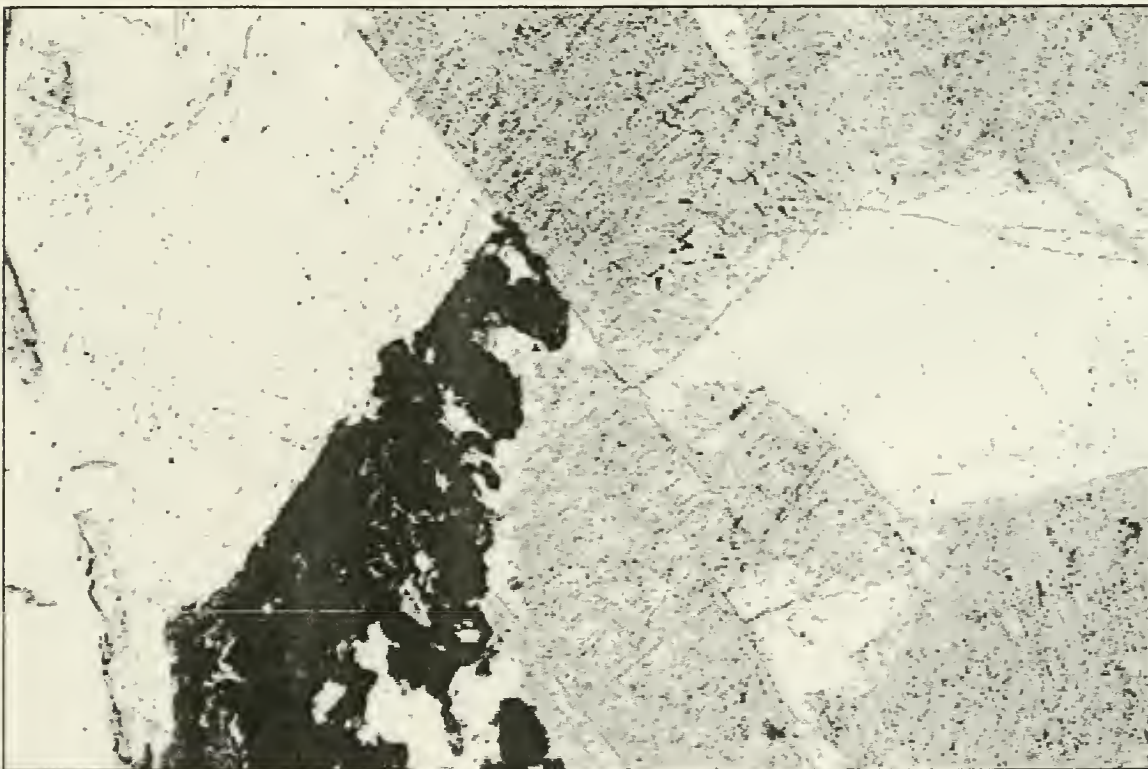
*Figure 6. Sample 2, transmitted light, 12.5x magnification.  
Note opacity within dark minerals, which might indicate inclusions of metallic content.*

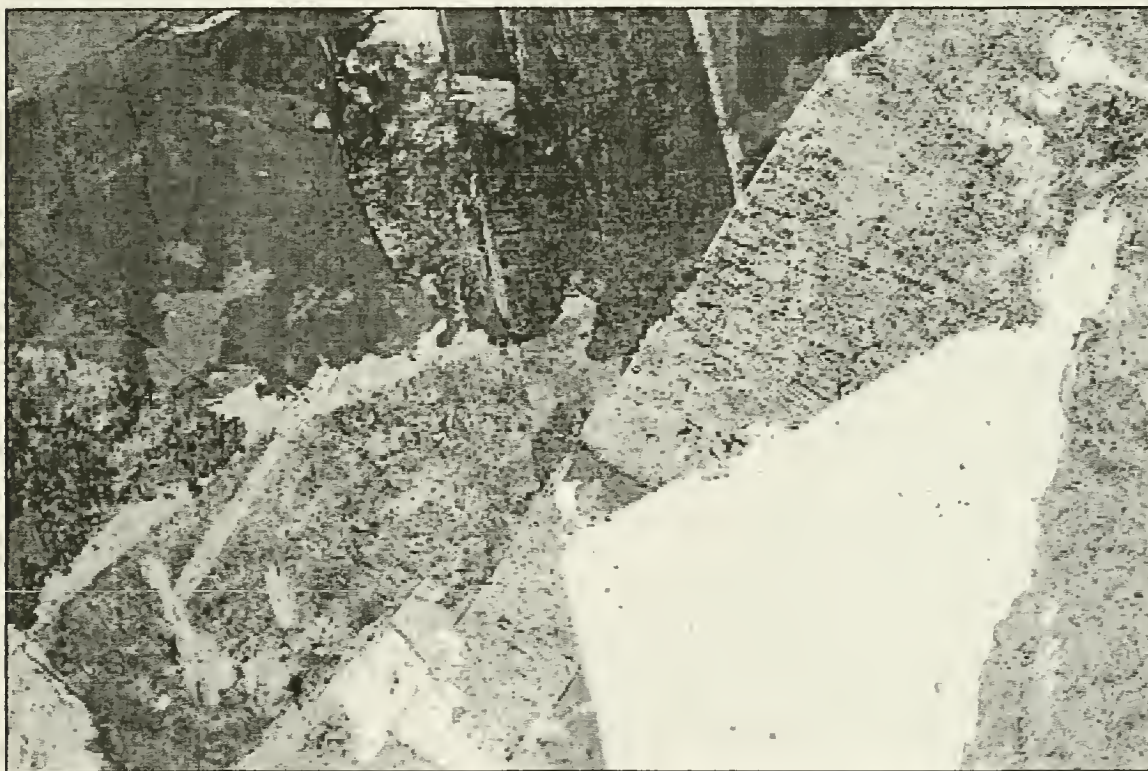
Figure 7. Sample 2, cross-polarized light, 12.5x magnification.  
Note opacity within dark minerals, pleochroism of hornblende, and inclusions within feldspar.

- Figure 144 (*Appendix VII, figure 7*) Granite sample 2, cross-polarized light, 12.5x magnification. Note opacity within dark minerals, pleochroism of hornblende, and inclusions within feldspar.

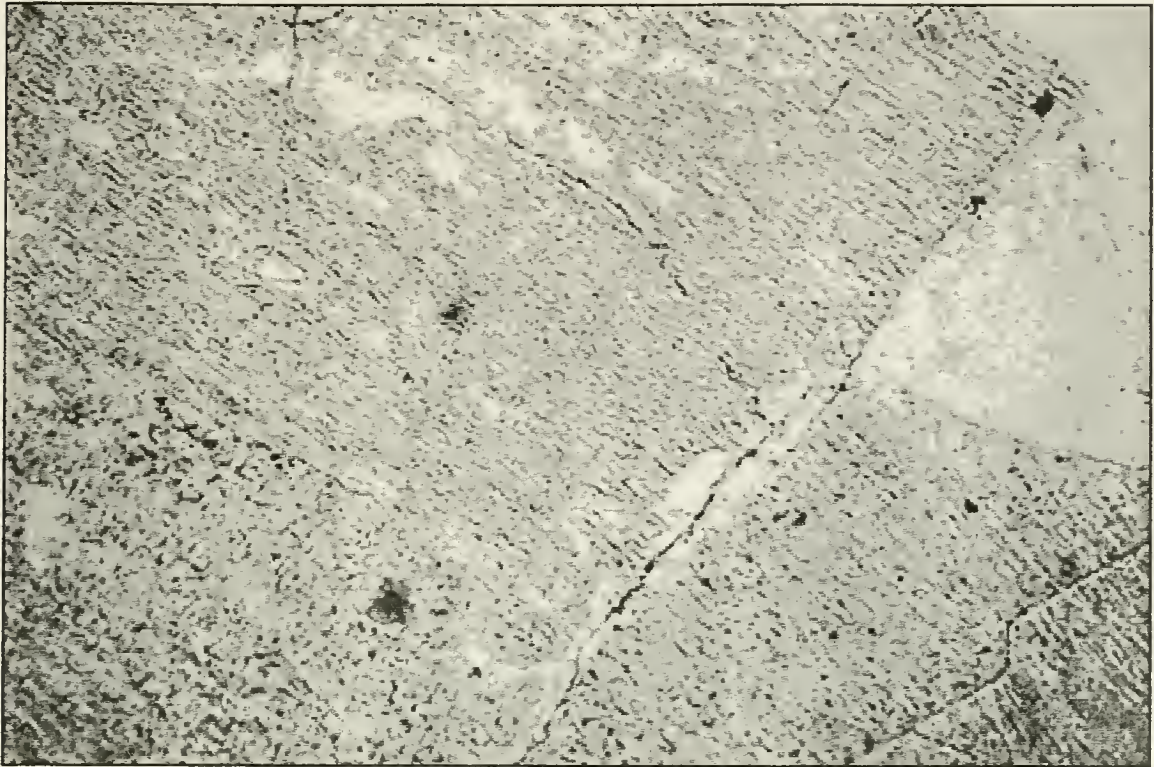
Figure 9. Sample 2, plane-polarized light, 12.5x magnification.  
"Rust" along boundaries affiliated with discoloration in hand sample.

- Figure 145 (*Appendix VII, figure 8*) Granite sample 2, cross-polarized light, rotated 45°, 12.5x magnification.
- Figure 146 (*Appendix VII, figure 9*) Granite sample 2, plane-polarized light, 12.5x magnification. "Rust" along boundaries affiliated with discoloration in hand sample.

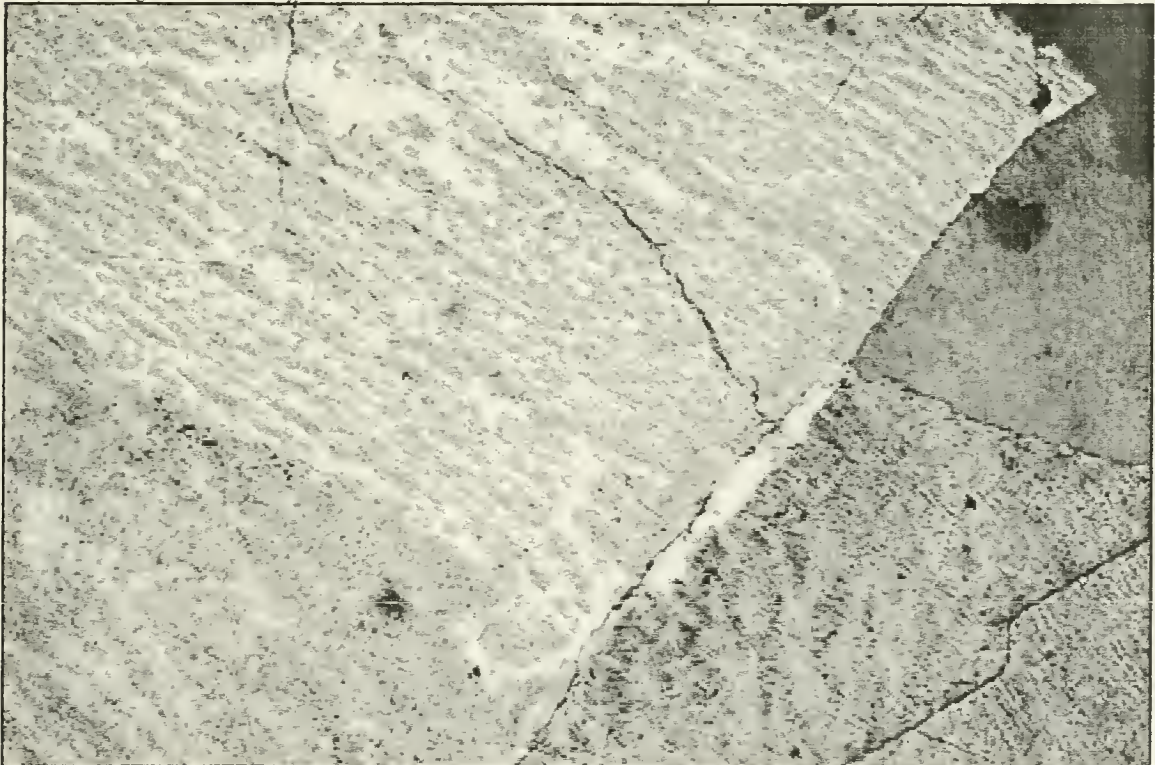
Figure 10. Sample 2, cross-polarized light, 12.5x magnification.  
"Rust" along boundaries affiliated with discoloration in hand sample.

- Figure 147 (*Appendix VII, figure 10*) Granite sample 2, cross-polarized light, 12.5x magnification. "Rust" along boundaries affiliated with discoloration in hand sample.

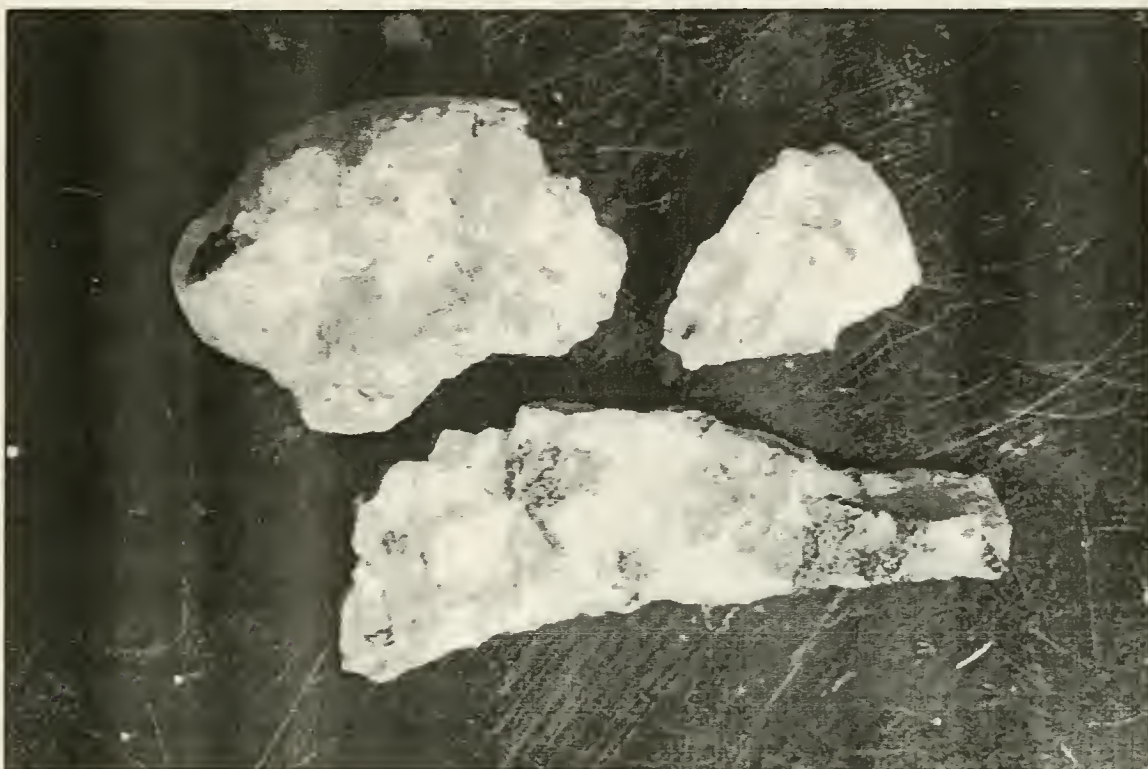
Figure 11. Sample 3, reflected light, 2.5x magnification.  
Note less even-grained texture, greater quartz content, and milky white to light gray feldspar.

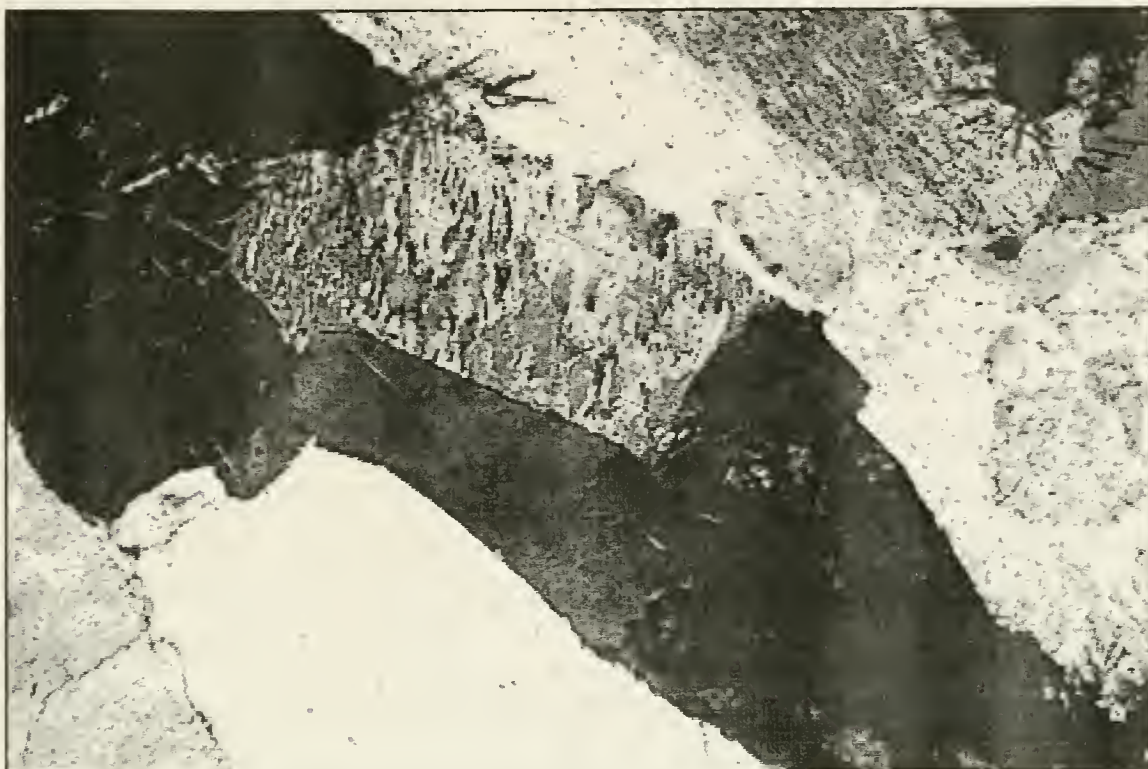
Figure 13. Sample 3, cross-polarized light, rotated 45°, 12.5x magnification.  
Quartz, orthoclase feldspar, spikey riebeckitic amphibole (appears blue in pleochroic transition).

- Figure 150 (*Appendix VII, figure 13*) Granite sample 3, cross-polarized light, rotated 45°, 12.5x magnification. Quartz, orthoclase feldspar, spikey riebeckitic amphibole (appears blue in pleochroic transition).

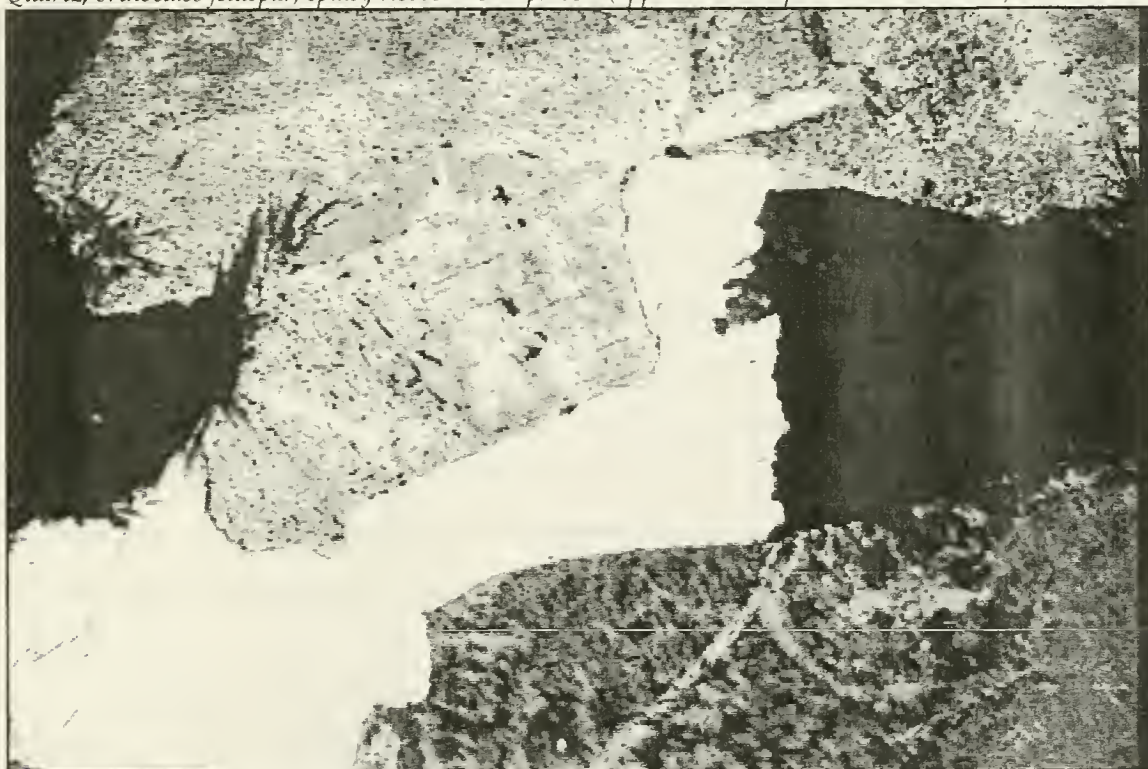
Figure 14. Sample 3, cross-polarized light, 12.5x magnification.  
Quartz, orthoclase feldspar, spikey riebeckitic amphibole (appears blue in pleochroic transition above).

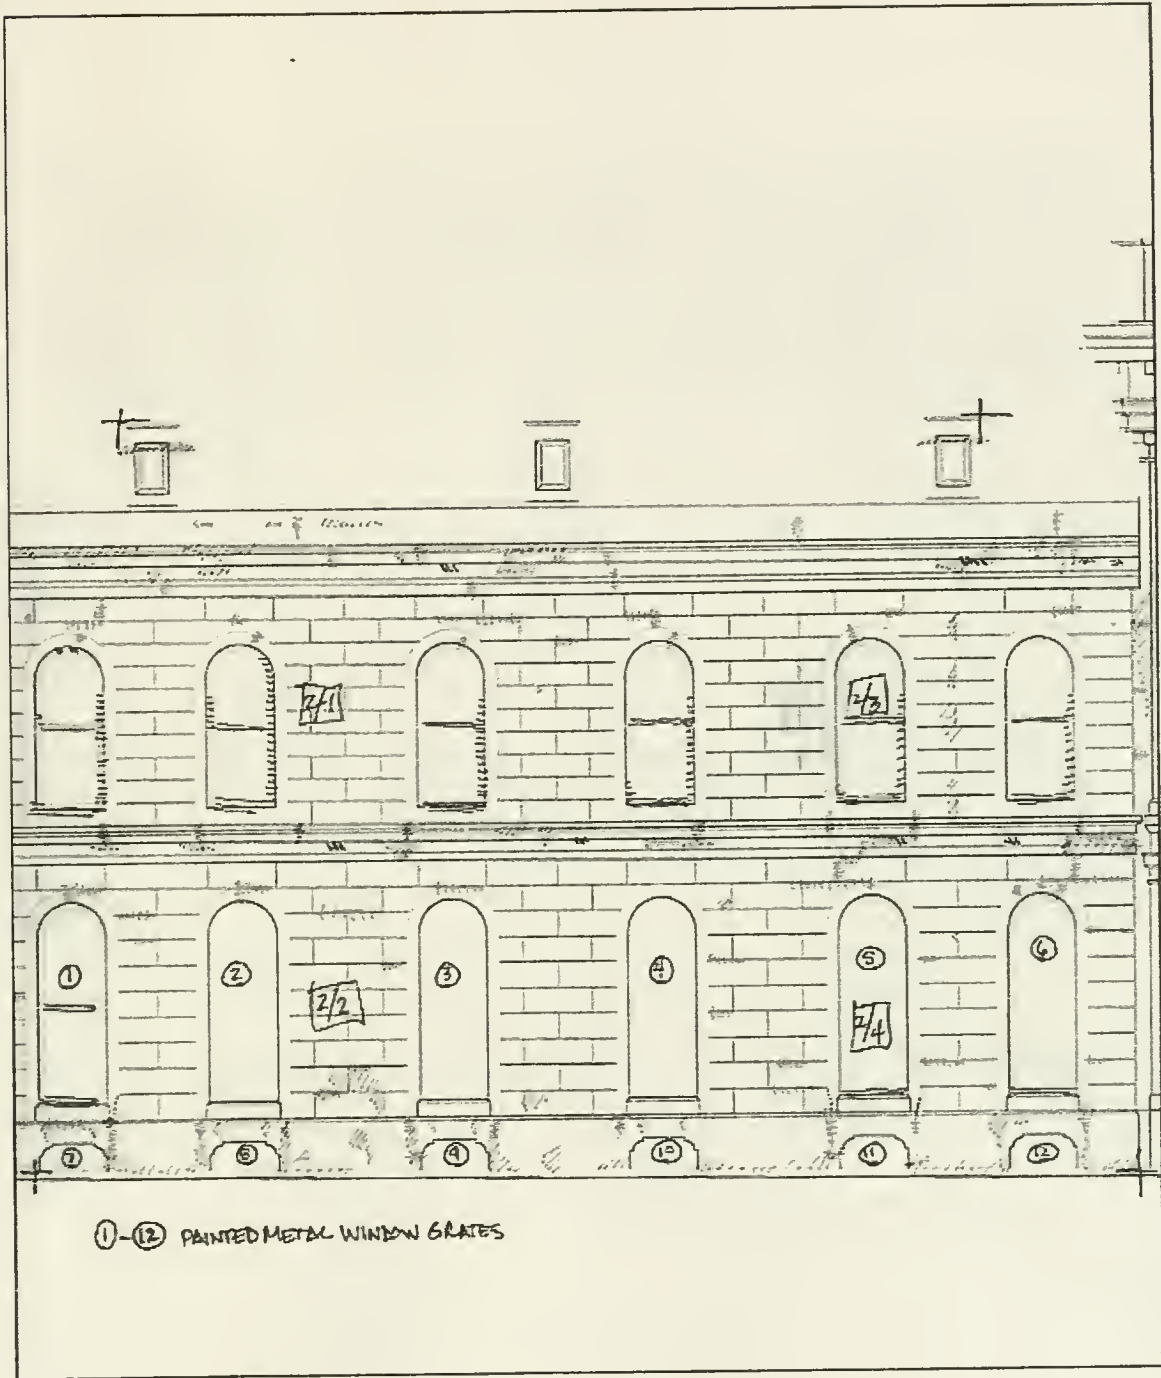
Figure 2. Condition Assessment: East façade, middle section.

- Figure 152 (*Appendix VIII, figure 1*) Condition Assessment: East façade, south section and conditions key.
- Figure 153 (*Appendix VIII, figure 2*) Condition Assessment: East façade, middle section.

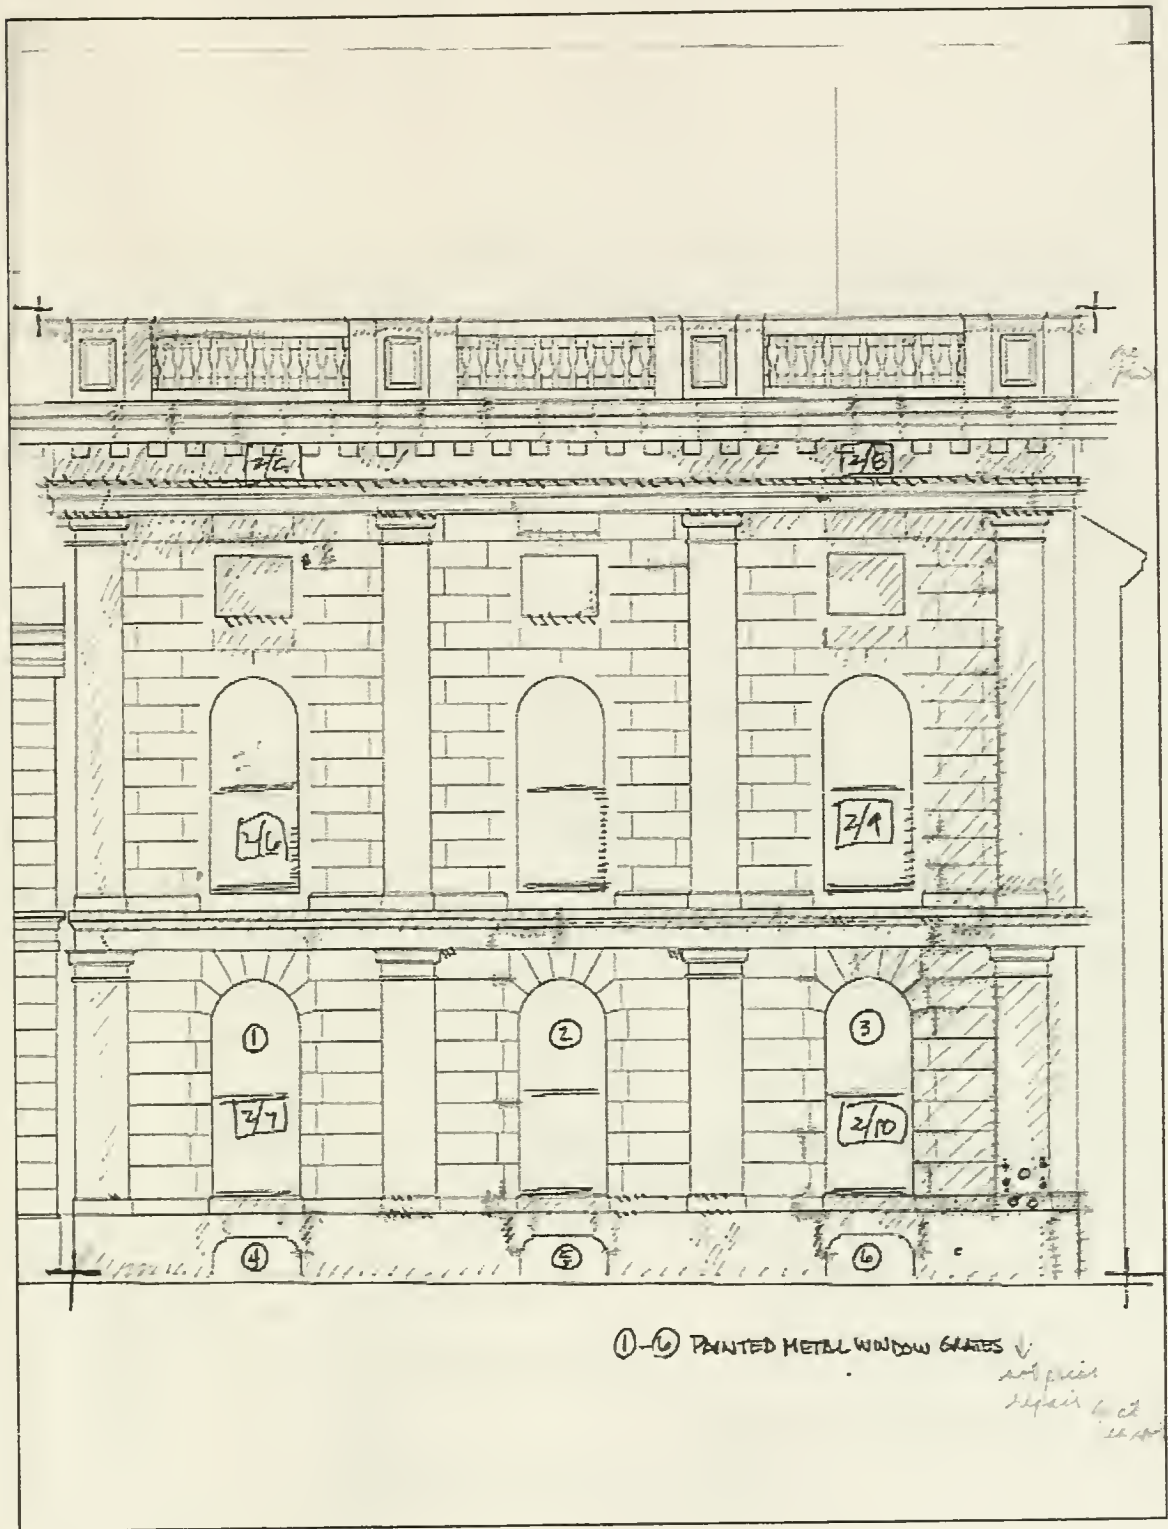
FIGURE 3. CONDITION ASSESSMENT: EAST FAÇADE, NORTH SECTION.

- Figure 154 (*Appendix VIII, figure 3*) Condition Assessment: East façade, north section.
- Figure 155 (*Appendix VIII, figure 4*) Condition Assessment: North façade, east section.

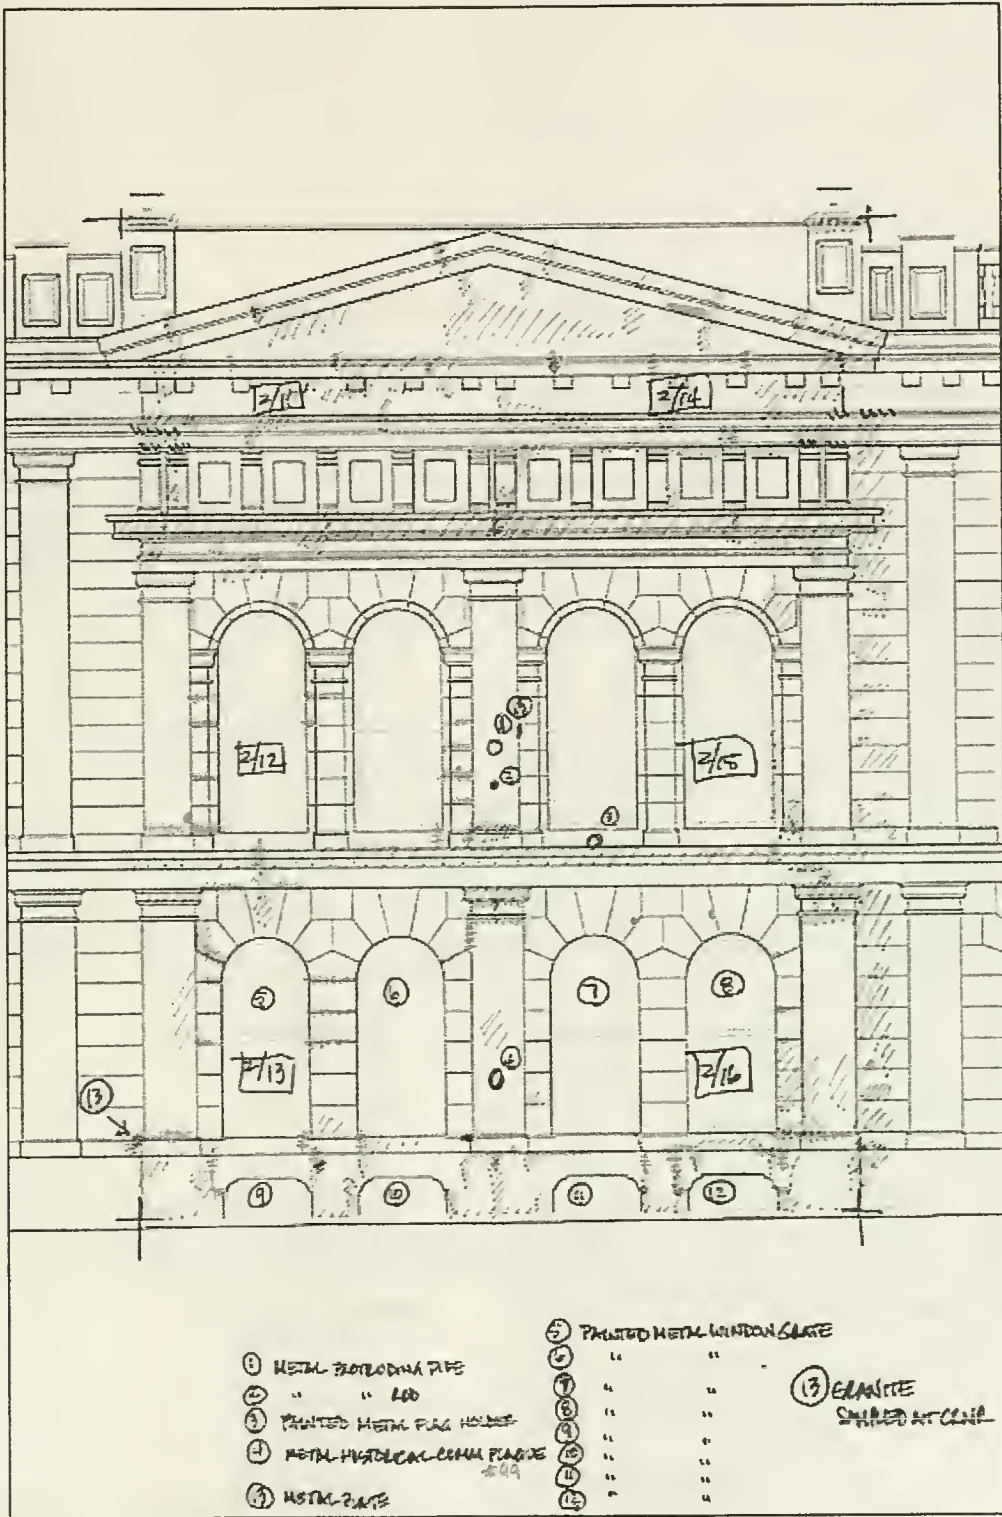
Figure 5. Condition Assessment: North façade, middle section.

- Figure 156 (*Appendix VIII, figure 5*) Condition Assessment: North façade, middle section.
- Figure 157 (*Appendix VIII, figure 6*) Condition Assessment: North façade, west section.
