# Intervention in the Continuum: An Adaptive Use Plan for the PSFS Building on Washington Square

Lynette Ann Stuhlmacher  
*University of Pennsylvania*

Stuhlmacher, Lynette Ann (2001). *Intervention in the Continuum: An Adaptive Use Plan for the PSFS Building on Washington Square*. (Masters Thesis). University of Pennsylvania, Philadelphia, PA.

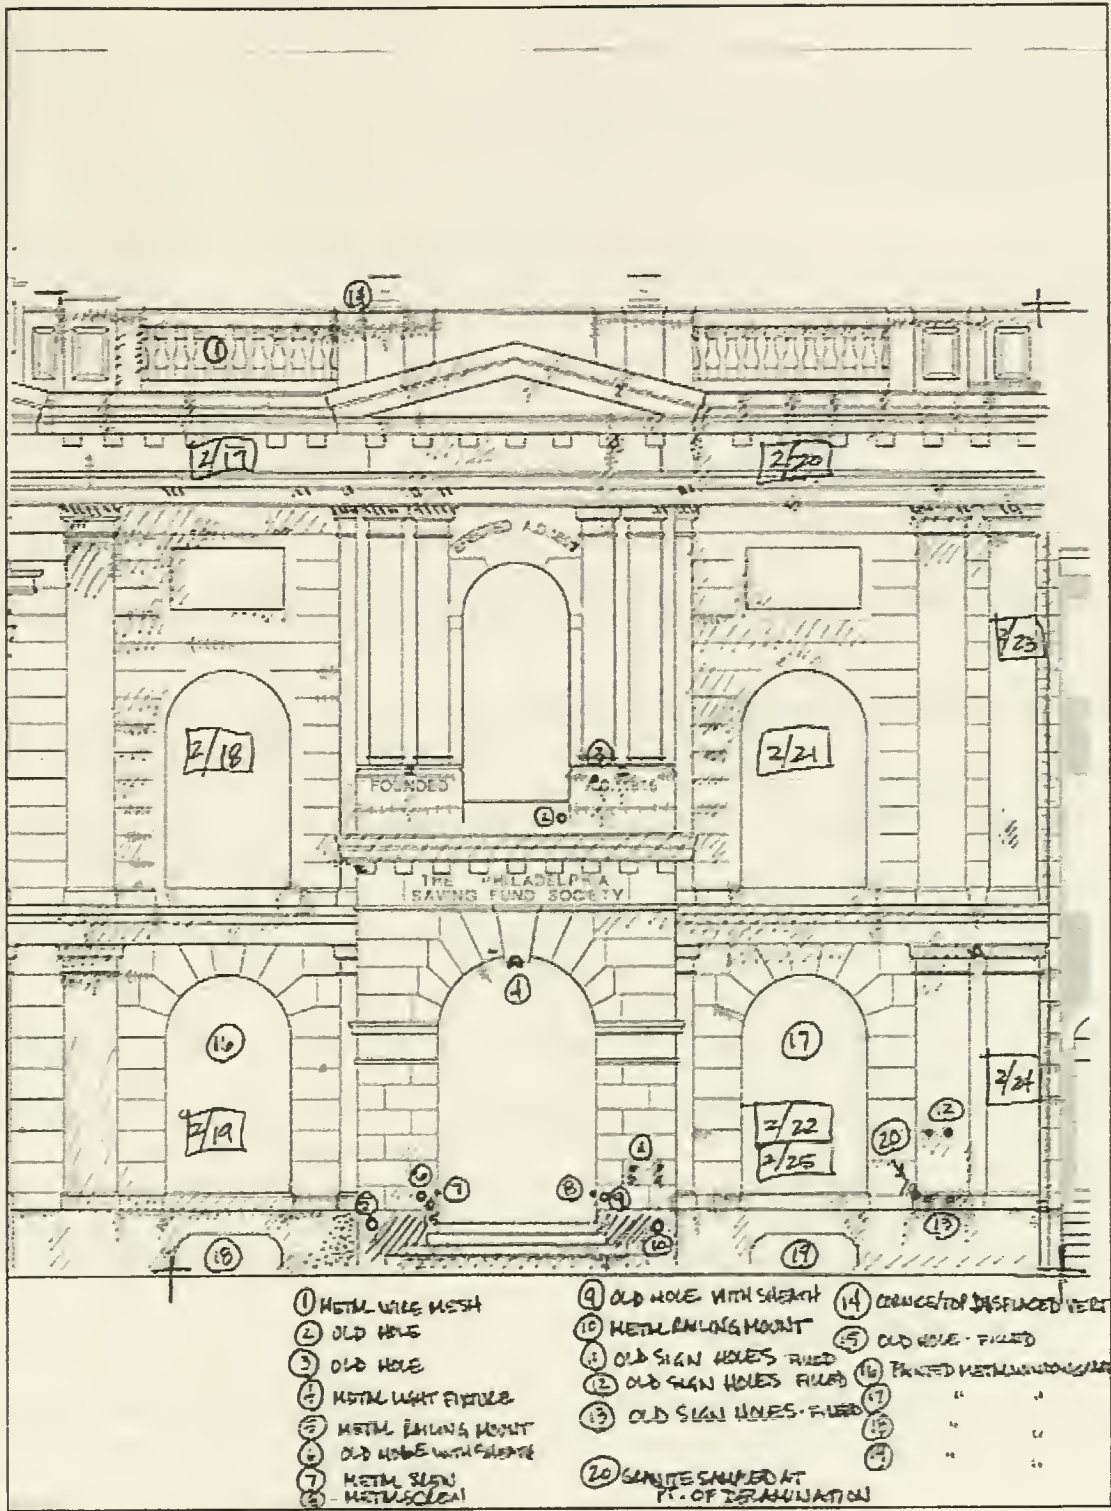
Figure 6. Condition Assessment: North façade, west section.

- Figure 156 (*Appendix VIII, figure 5*) Condition Assessment: North façade, middle section.
- Figure 157 (*Appendix VIII, figure 6*) Condition Assessment: North façade, west section.
