Untangling the History of the Pawling/Wetherill House at Walnut Hill Estate, Pawling Road, Lower Providence Township, Montgomery County, Pennsylvania

A THESIS
in
The Graduate Program in Historic Preservation

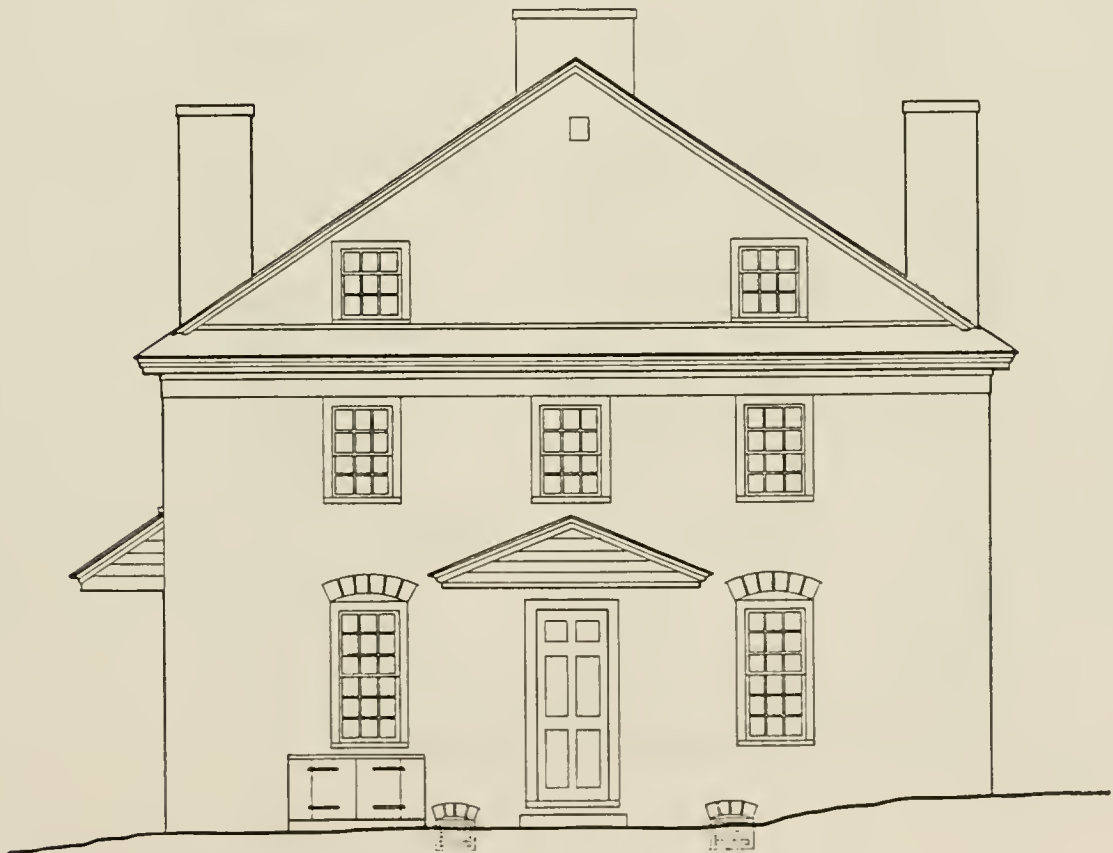
Fig. 11: Conjectural elevations of the Pawling House, circa 1760. Drawn by author, 1992.

The north elevation, in its original form, combined many features commonly found on the principal entry facade with the added height and monumentality of the gable end. (Plate 12) The resulting composition is both unique and pleasing and stands in sharp contrast to the almost universal practice, for this time and location, of building houses with the front door on a non-gabled facade.

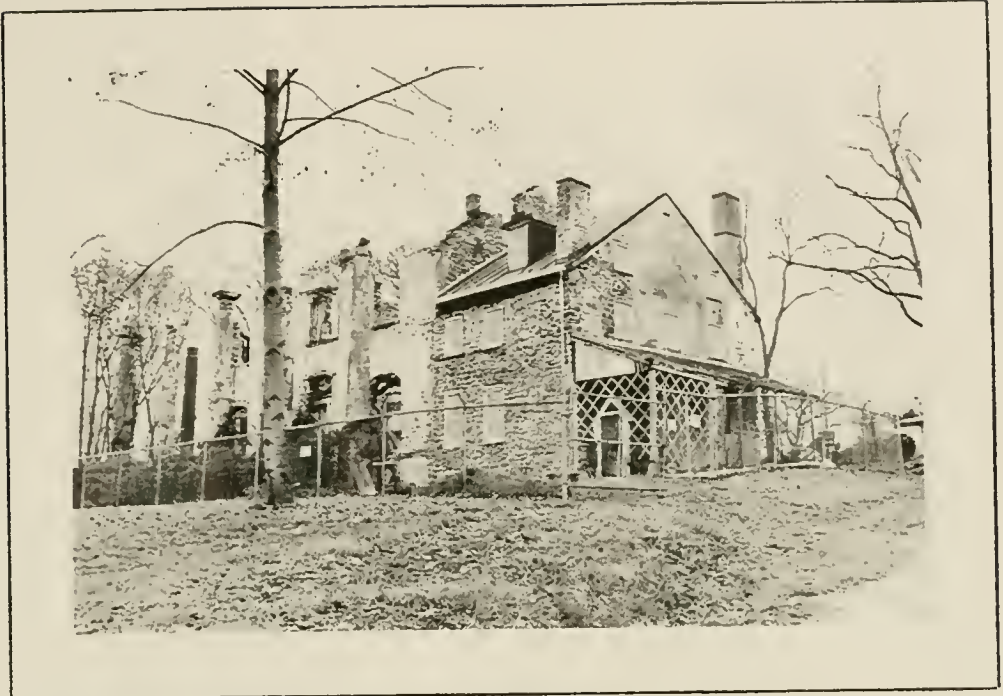
Plate 12: View from northeast, 1991.

Attached to the northern end of this enormous house is a diminutive stone wing built in an altogether different scale. (Plate 6) Local historians have long held that this end of the house was built by the Pawling family during the 18th century. When a disastrous fire destroyed the roof and upper floor of the 19th century wing in 1967, this section of the house was protected by a thick stone wall and only suffered minor damage to its roof. (Plate 11) Rainwater and decades of neglect have since destroyed most of the remaining fabric of the 19th century wing and severely damaged the 18th century wing. (Plate 12)

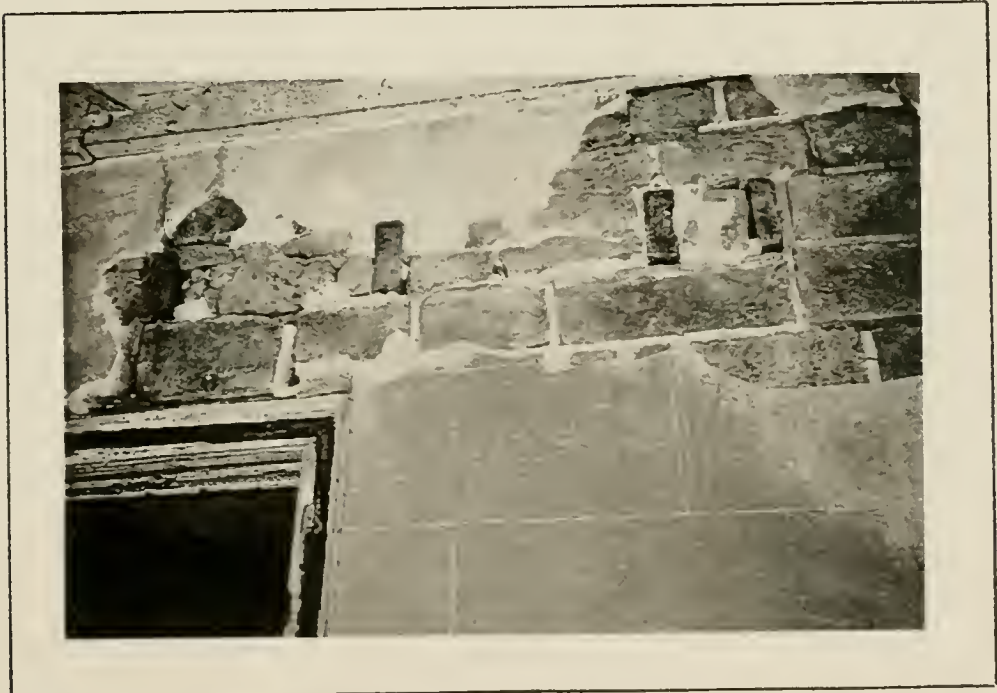
Plate 17: Detail of supports for cantilevered door hood on north facade, 1991.

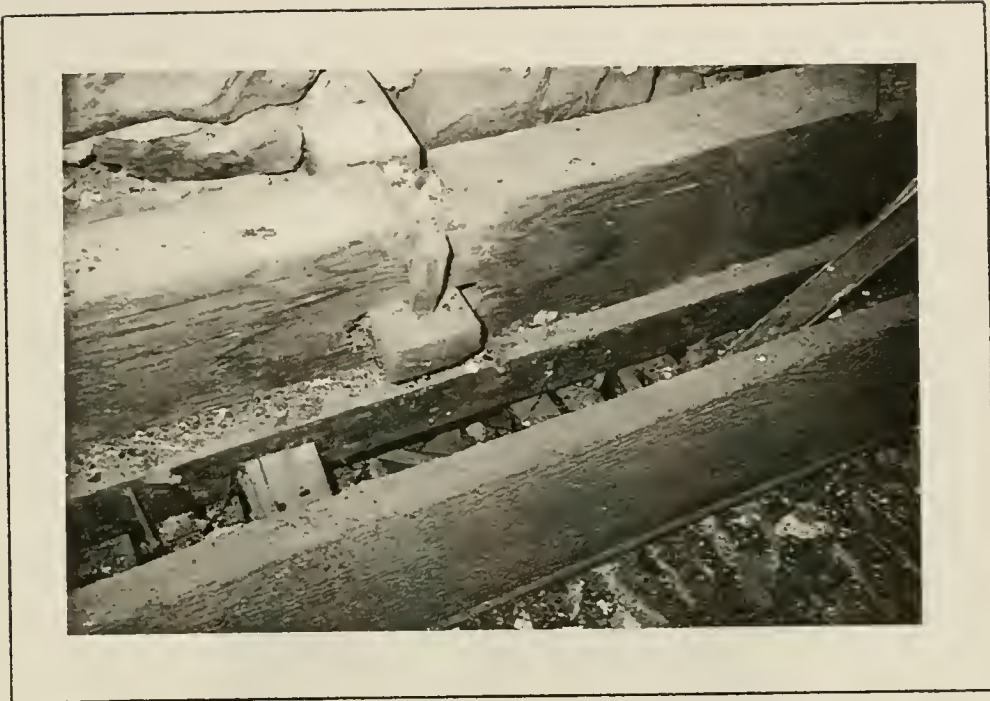
Plate 18: Detail of interior mortised connection of door hood supports, 1991.

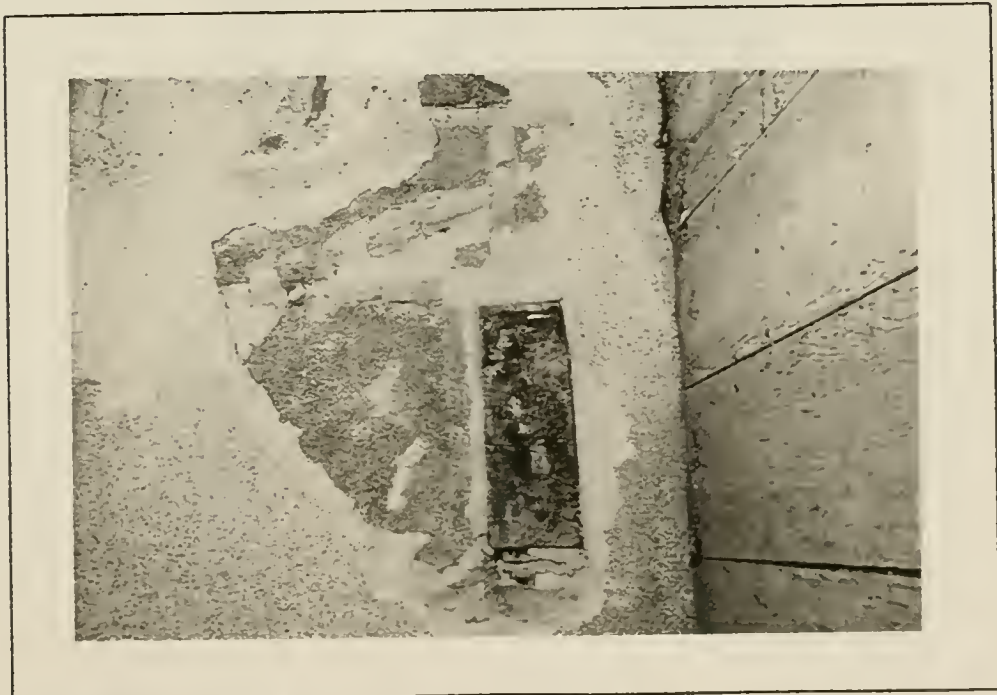
Plate 19: Detail of surviving mortar flashing of door hood above north entry door, 1991.

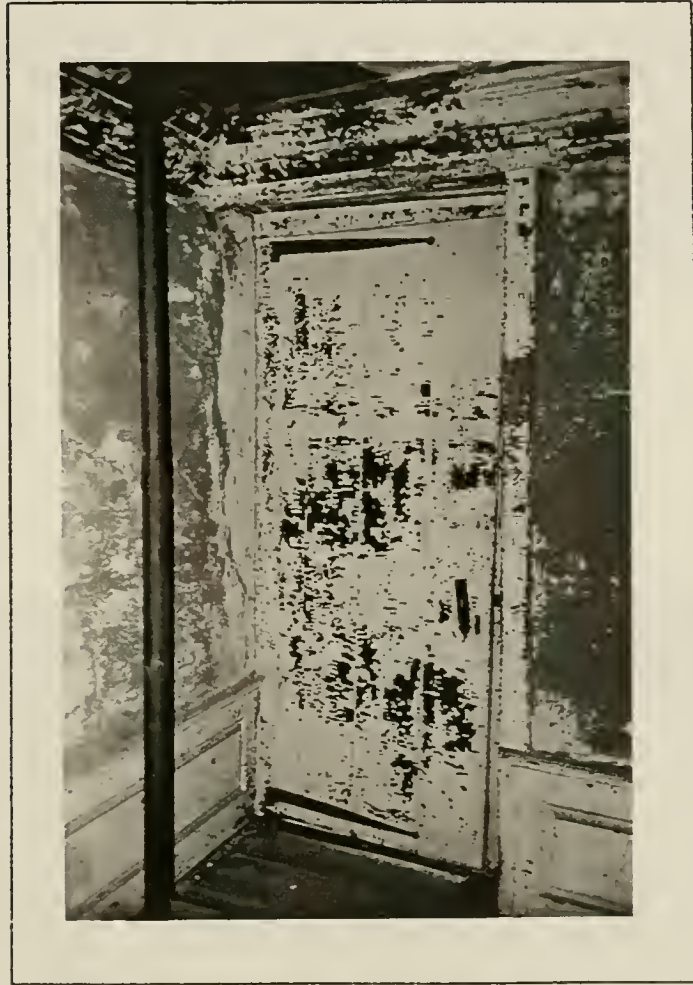
Plate 22: Interior elevation of 18th century door and frame, 1991.

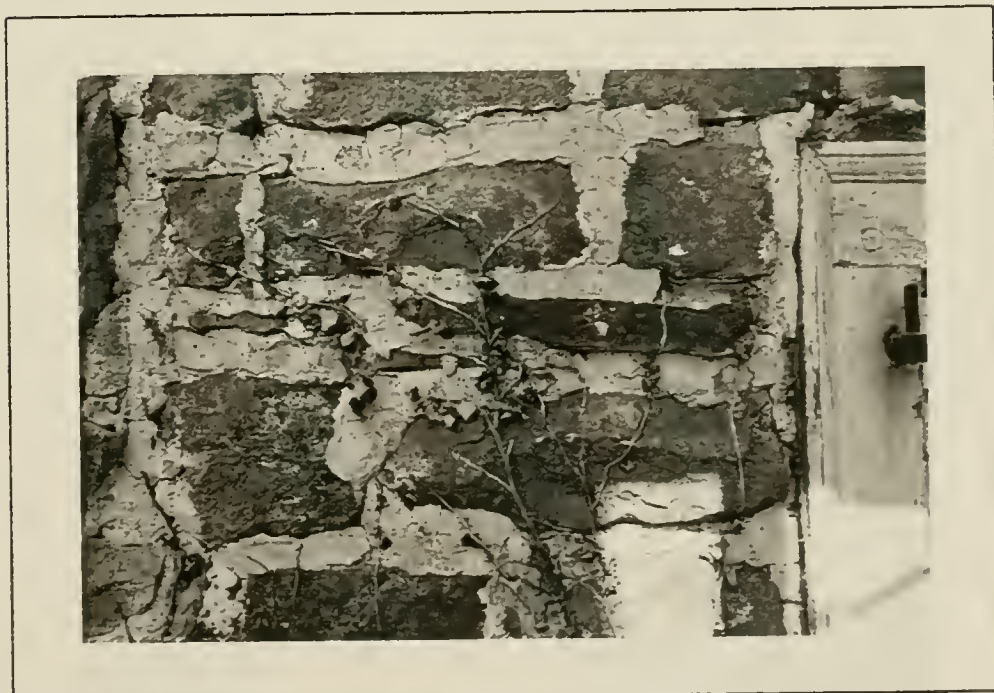
Plate 24: Detail of surviving smear pointing at first floor level of east facade, 1991.

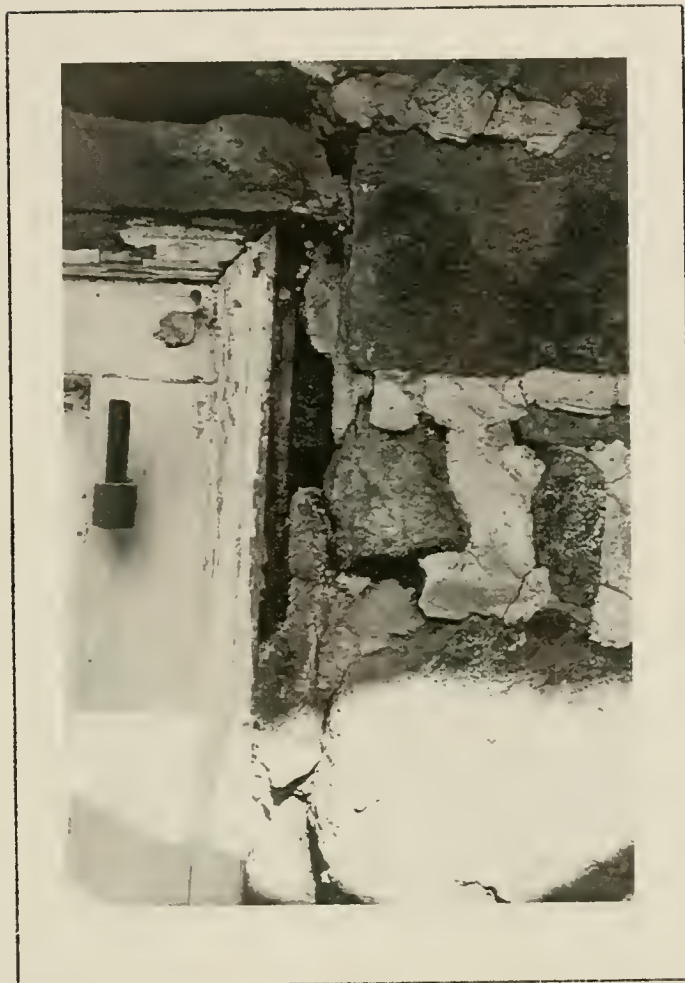
Plate 25: Detail of replacement window frame, first floor west.

century construction, however the wooden window frames are replacements of a slightly narrower dimension than the originals. (Plate 25) These frames appear to have been replaced at the same time as the application of the scored stucco surface. The existing frames are of heavy dimension softwood, assembled with mortise and tenon construction, and having applied moldings around the edges. The original frames would have probably more closely resembled the oak frame of the north doorway with its integral moldings and larger cross section.

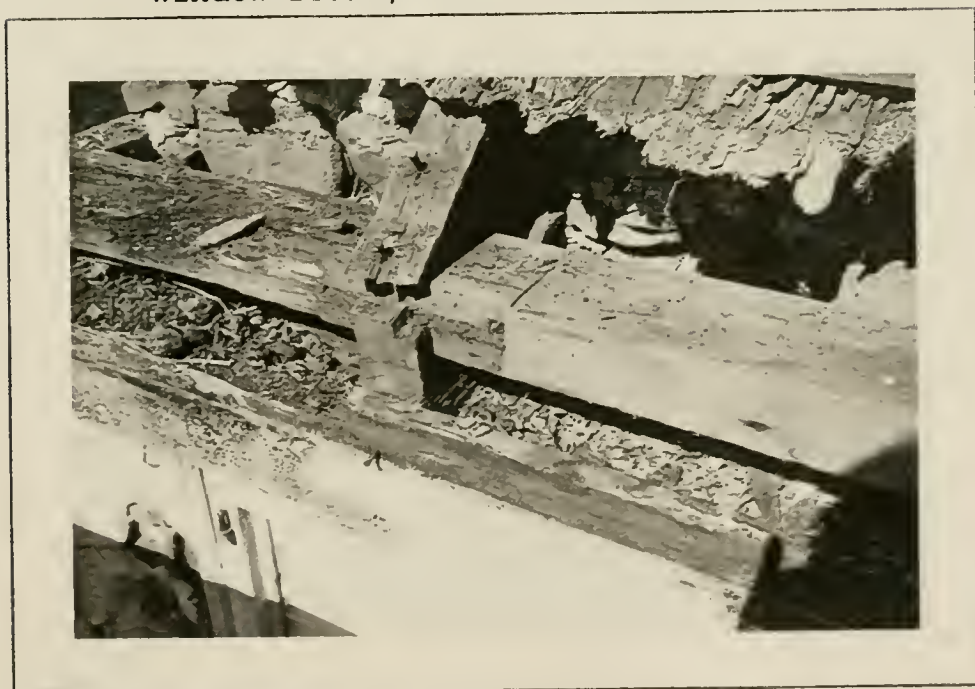
Plate 26: Detail of cornice framing, east side, 1991. Note rafter tips, plate and floor joists.

The cornice survives only in fragmentary form. The heavy oak framing is badly deteriorated, with most of the rafter and joist ends rotted, and only small pieces of the molding, soffit and fascia remain. (Plate 26) The construction details of this cornice are illustrated. The oak joists of the attic floor extend through the masonry for approximately 10". The oak rafters bear on a thick oak sill which is cut into the tops of the joists. An oak tenon locks the rafter to the sill. The top of the stone masonry was originally at the level of the top of the attic floor joists. At some later date, more masonry was added to extend the wall up to the bottom of the roofing. This must have helped to keep out the winter wind and rain. The stones used in this infill are smooth river stones, not the quarried brown sandstone which was used in the original construction and in the major 19th century renovations.

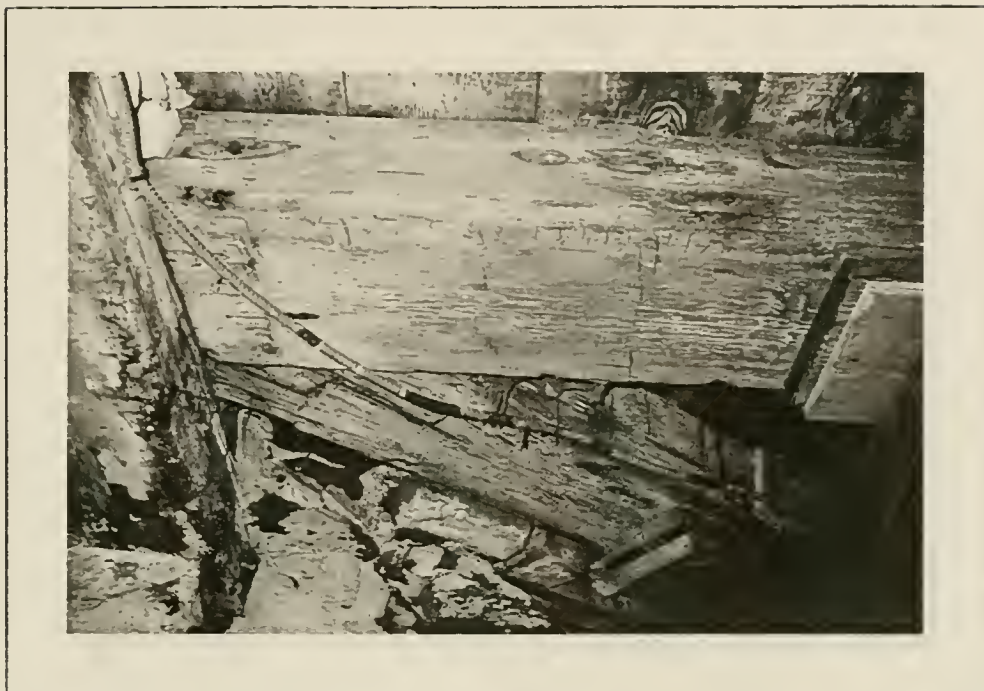
Plate 33: Detail of first floor joists bearing on lintel of basement stair opening, 1991. Note diagonal header below corner fireplace above.

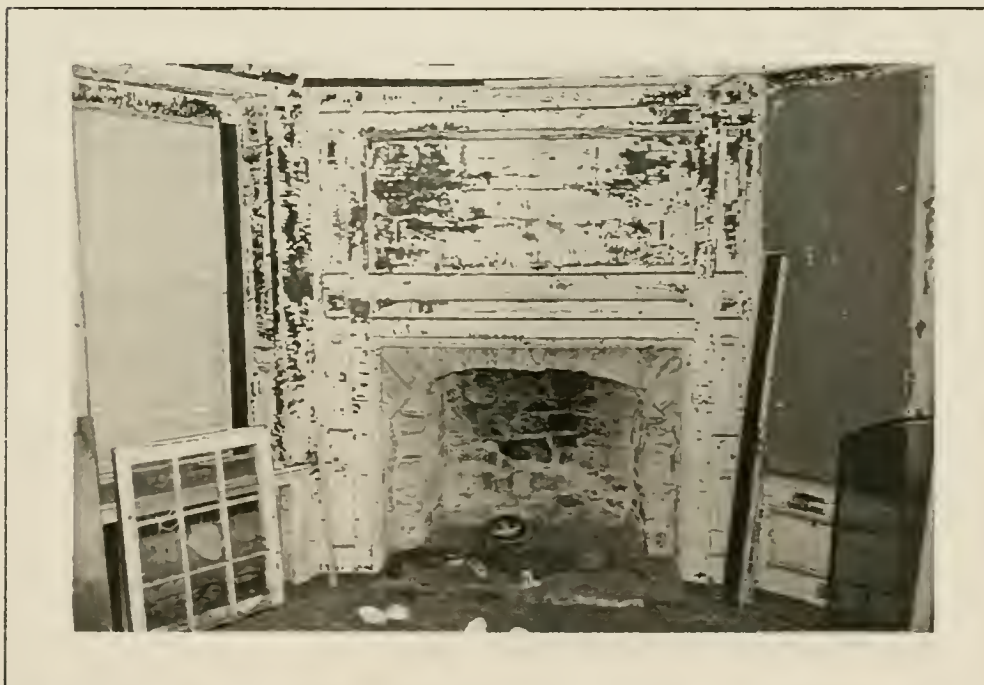
Plate 34: Detail of corner fireplace in Rm. 101, 1991.

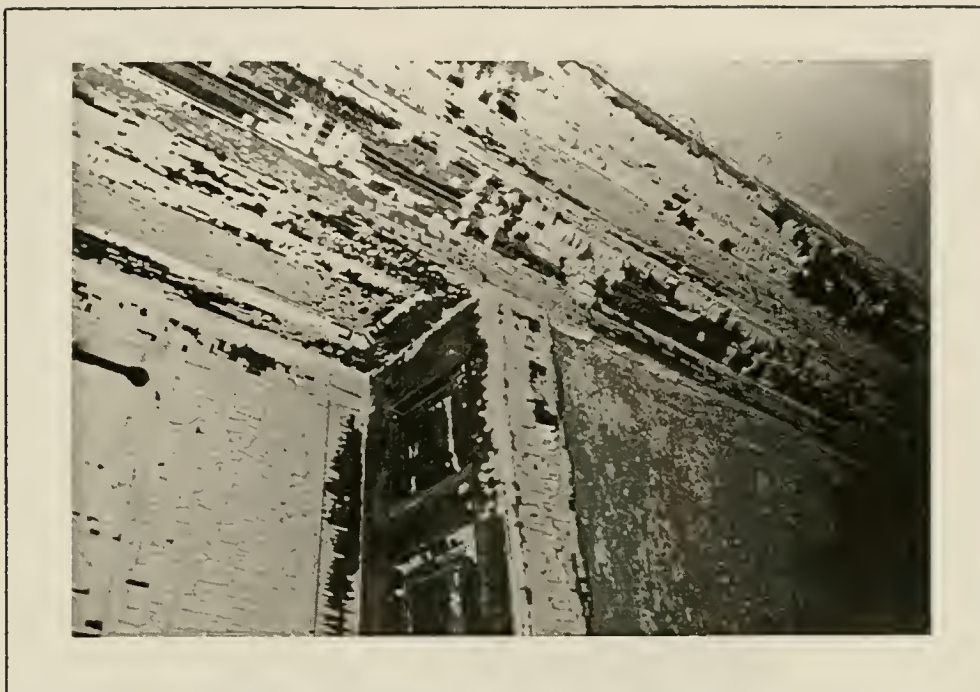
Plate 35: Detail of wood cornice and panelled door jamb at entry door to Rm.101, 1991.

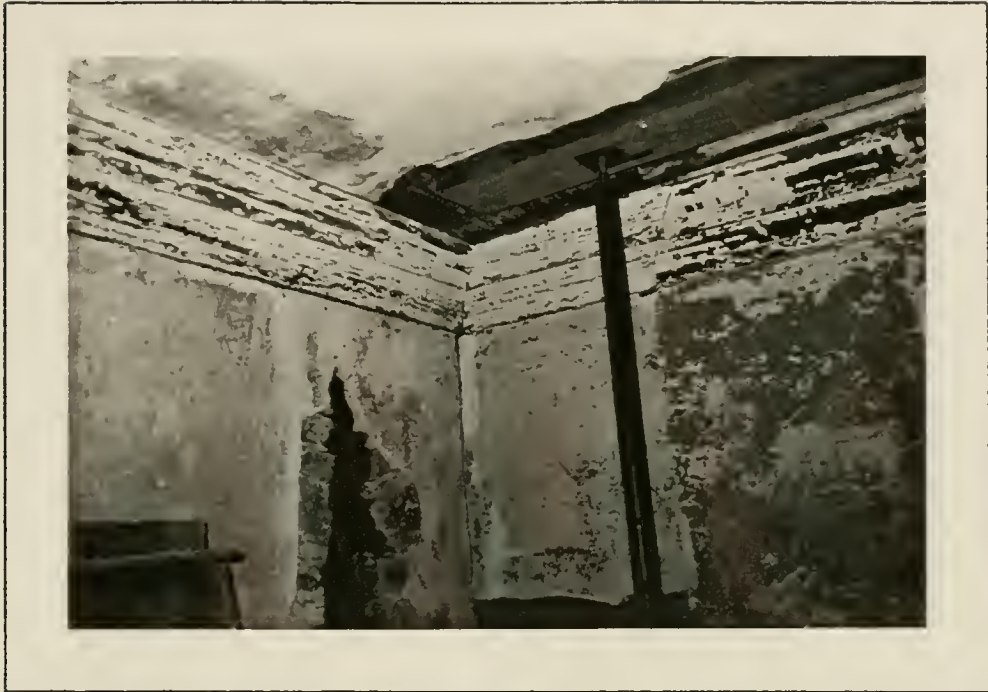
Plate 38: General view of location of corner cupboard in Rm.101, 1991.

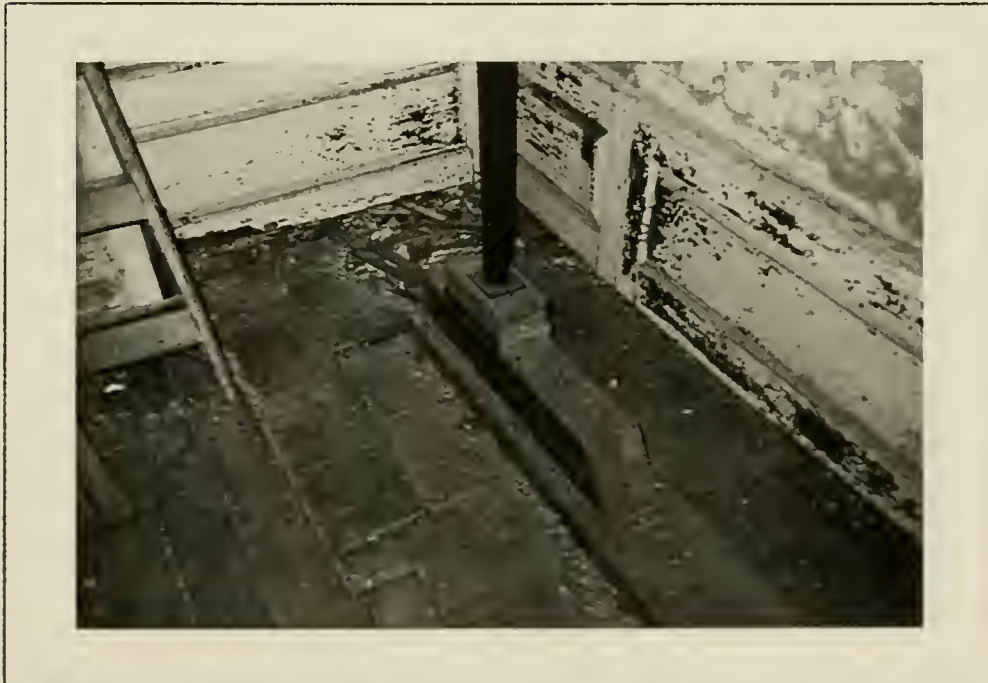
Plate 39: Detail of panelling at location of corner cupboard in Rm.101, 1991. Original dado panelling at right, 19th century infill at left.

The dado panelling is detailed with simple heavy moldings and is topped with a molded chair rail.(Plate 39) The panelling is interrupted on the west partition at the location of the corner cupboard. When the cupboard was removed during the 19th century, new panelling was installed, closely matching the original. On the south wall, all of the panelling dates to the late 19th century renovation. The panelling is topped by a molded chair of identical profile to the chair rails found elsewhere in the house.

Ample evidence remains to document the location and dimensions of the corner cupboard. The panelling, cornice and plaster finish of the west wall clearly show the presence of the side of the cupboard. (Plate 39) On the floor, a faint line traces the footprint of the diagonal cupboard. In the plaster of the 19th century south wall can be seen the location of the wood shelves inside the cupboard. (Plate 38) The original oak flooring remains below the existing finished wood floor. Buried in the masonry of the south wall behind this corner cupboard is a wooden post. Its severely deteriorated condition has denied any useful investigation, but its location below the summer beam suggests that it was installed as a temporary support during the 1836 reconstruction. (This post is only 3 or 4 inches thick and 6 inches wide, unlike the massive post directly above on the second floor.)

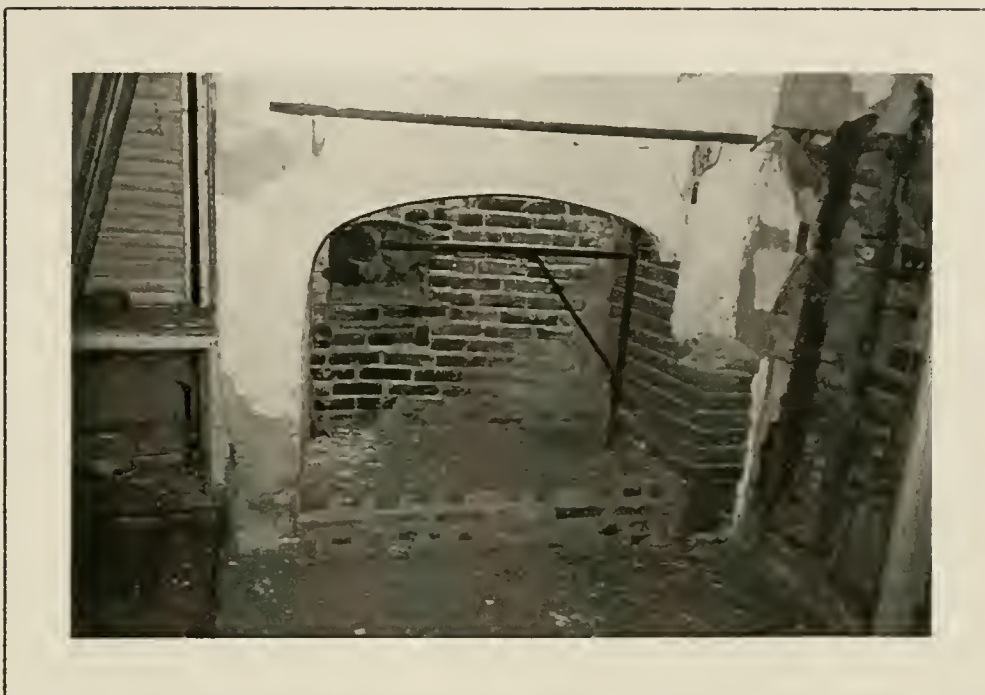
Plate 40: Detail of 19th century cooking hearth in Rm.102, 1991. Note location of oven door.

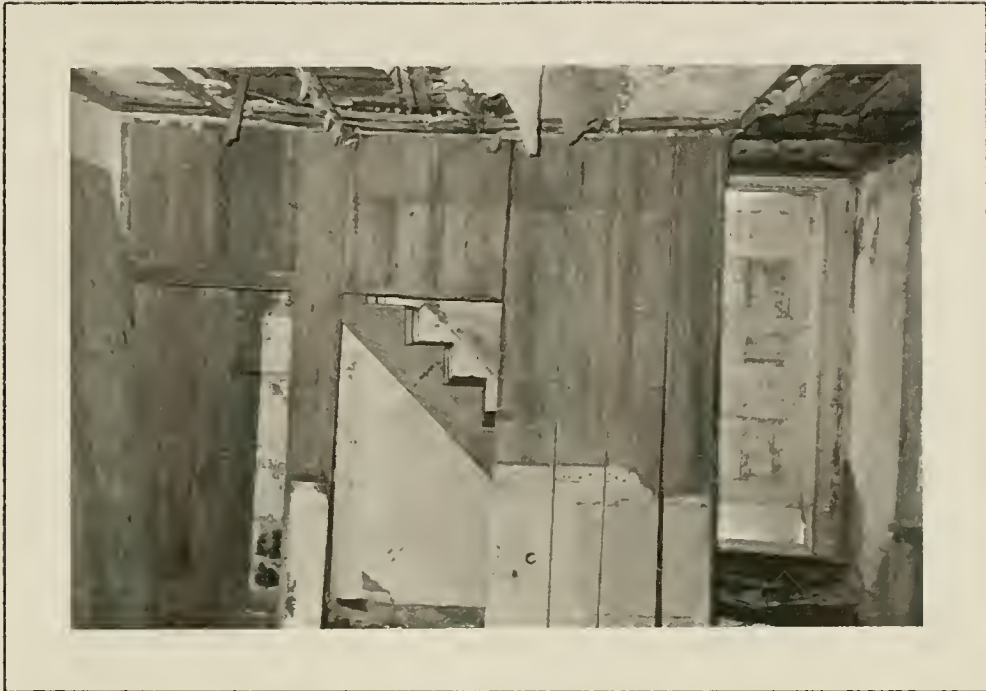
Plate 42: View of beaded-board wall at stair in Rm.102, 1991. Door at right cut through masonry in 1950s, center door in board wall circa 1880, door at left to cellar stair circa 1836..

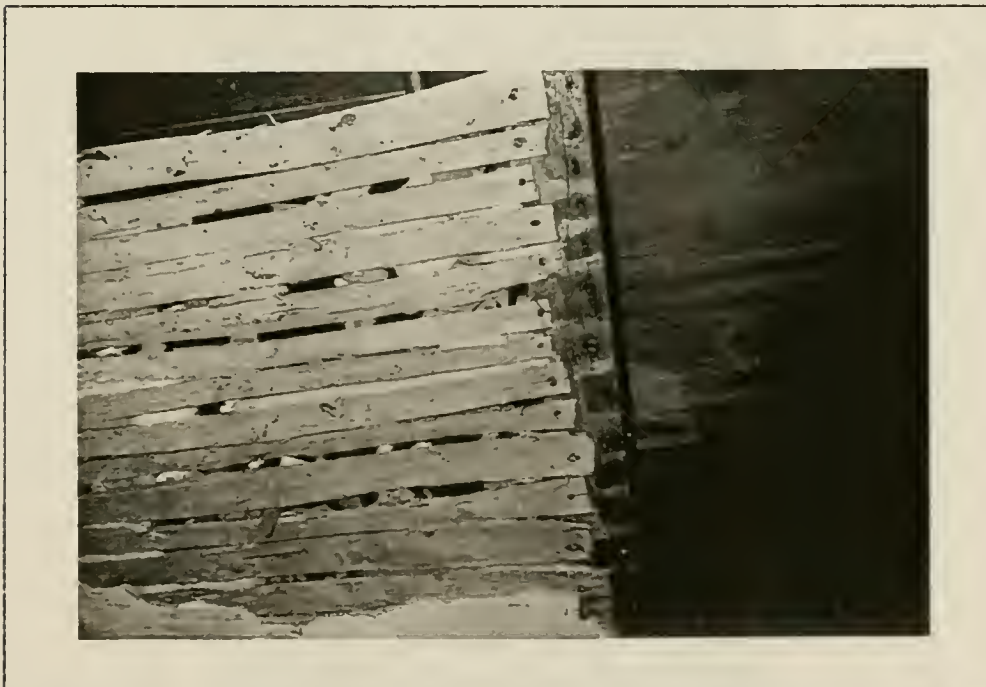
Plate 43: Detail of ceiling of Rm.102, 1991. Note handsplit oak lath with wrought nails, renailed with cut nails, covered with 19th century plaster.

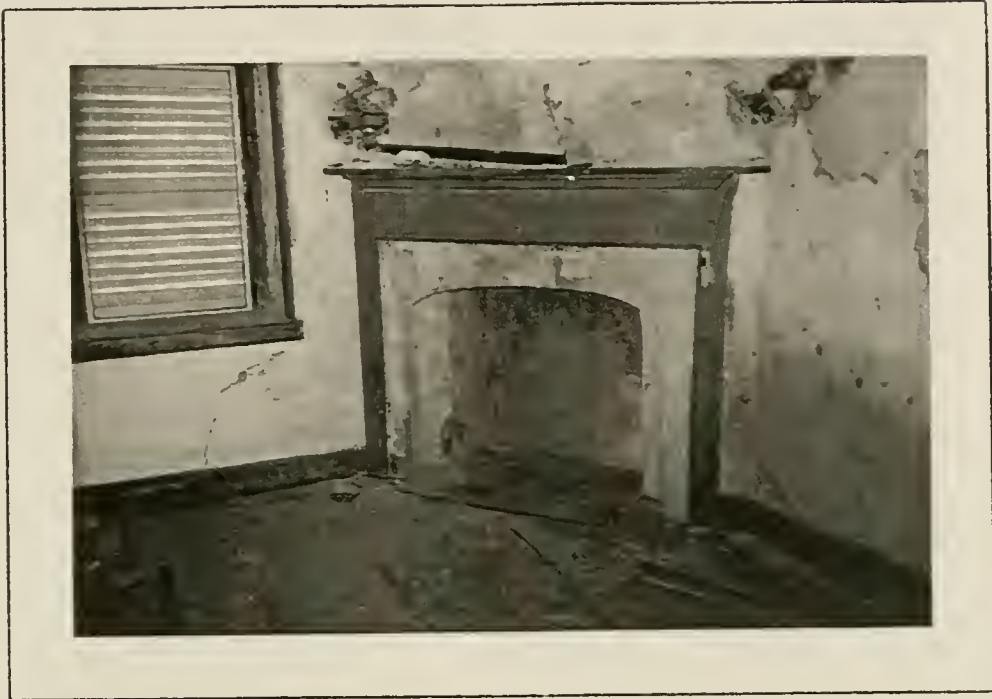
Plate 49: Detail of corner fireplace in Rm.201, 1991. Mantel is 19th century addition.

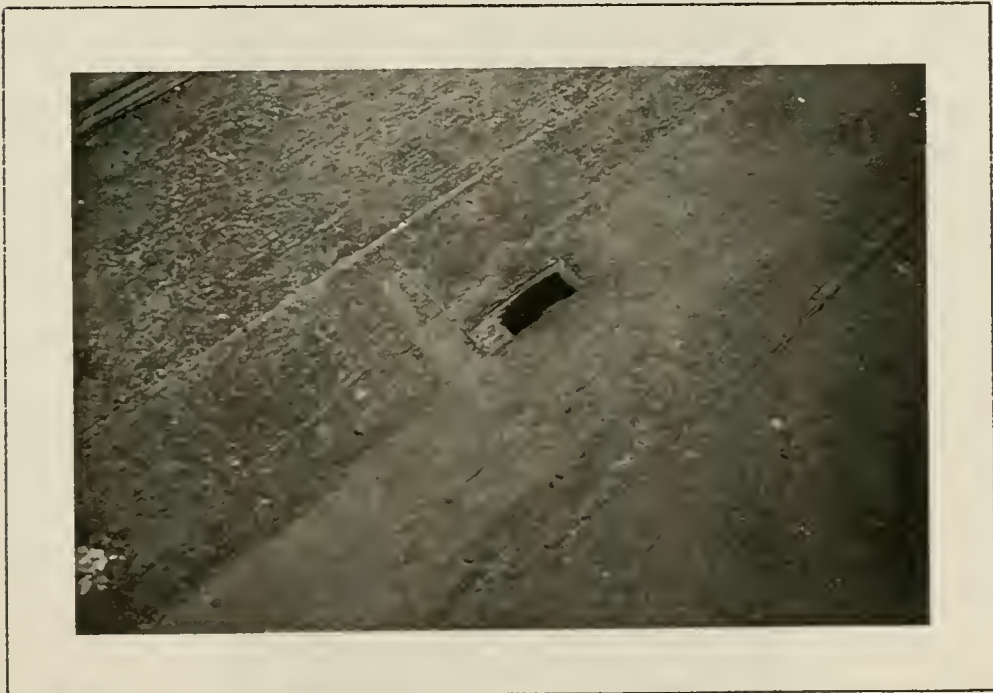
Plate 50: Detail of imprint on floor of 18th century partition and door jamb at top of stair on second floor, 1991.

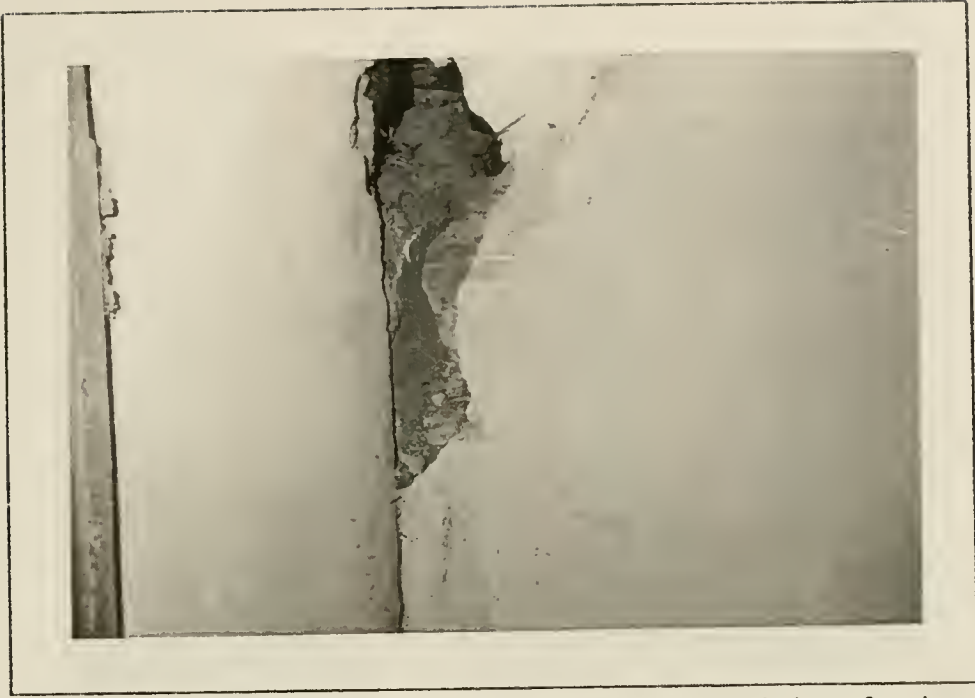
Plate 51: Detail of 18th century finish plaster continuing behind 19th century masonry, Rm.201.

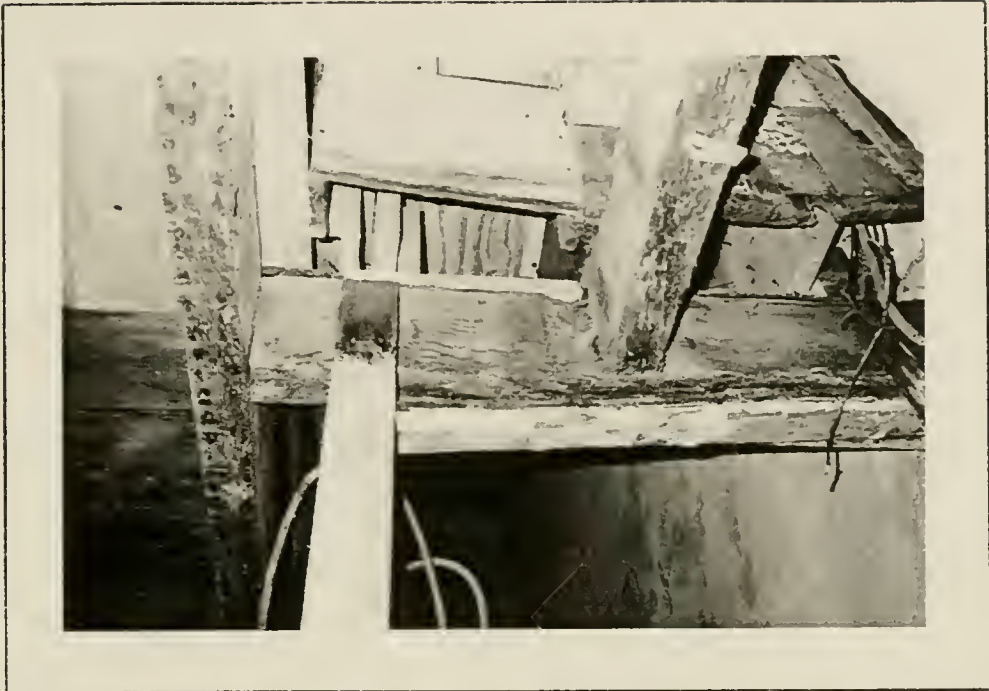
Plate 55: Detail from below of second floor framing around stair opening, 1991. All 3x8 joists and headers appear original and in original locations.

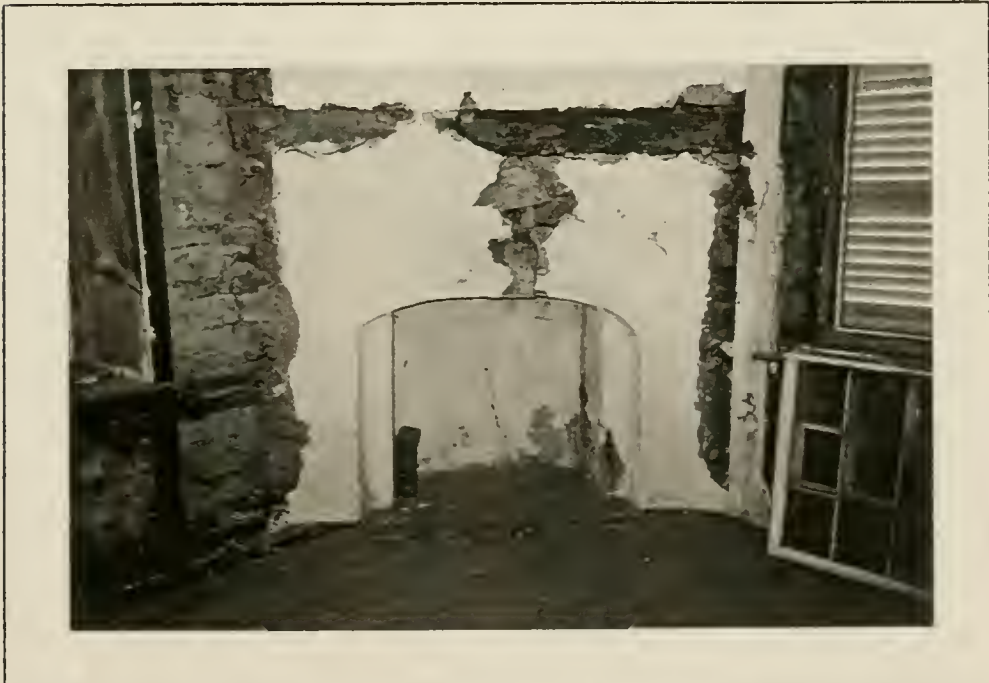
Plate 56: Detail of corner fireplace in Rm.202, 1991. Note evidence of baseboard and chair rail.

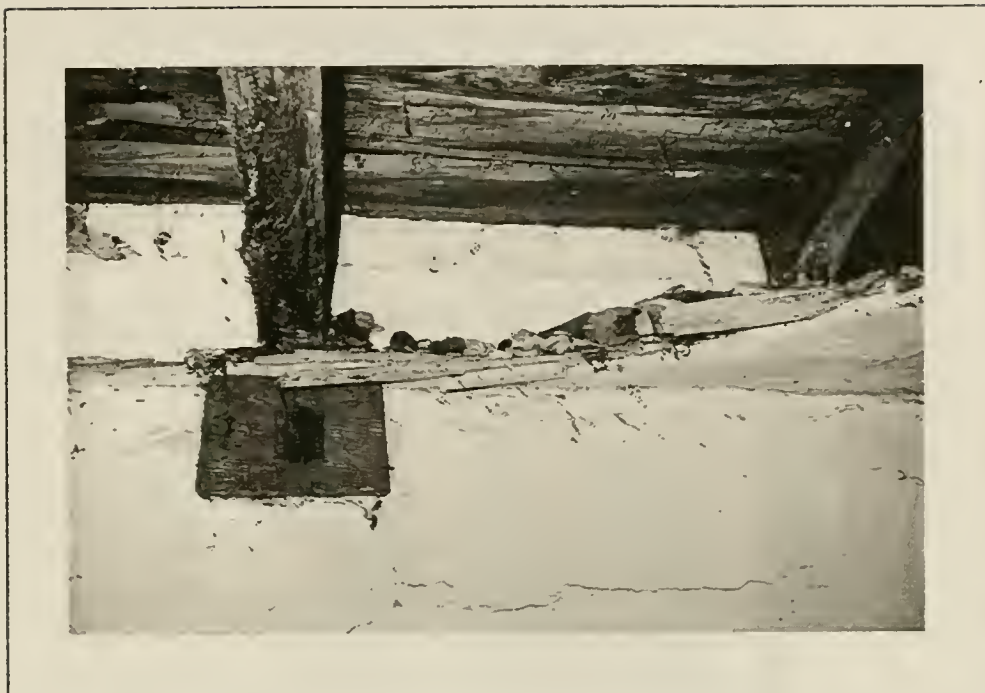
Plate 57: Detail of 18th century wall plaster in place above 19th century ceiling on west wall of Rm.202, 1991. Joists were originally exposed.

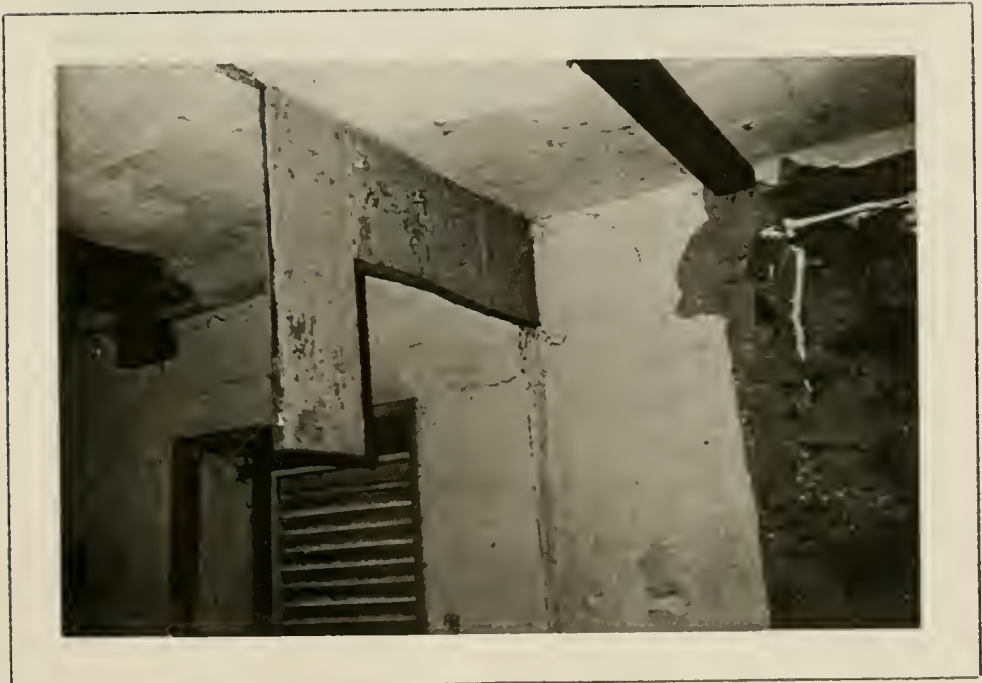
Plate 60: Detail of 19th century beaded-board partition at west wall of Rm.202, 1991.

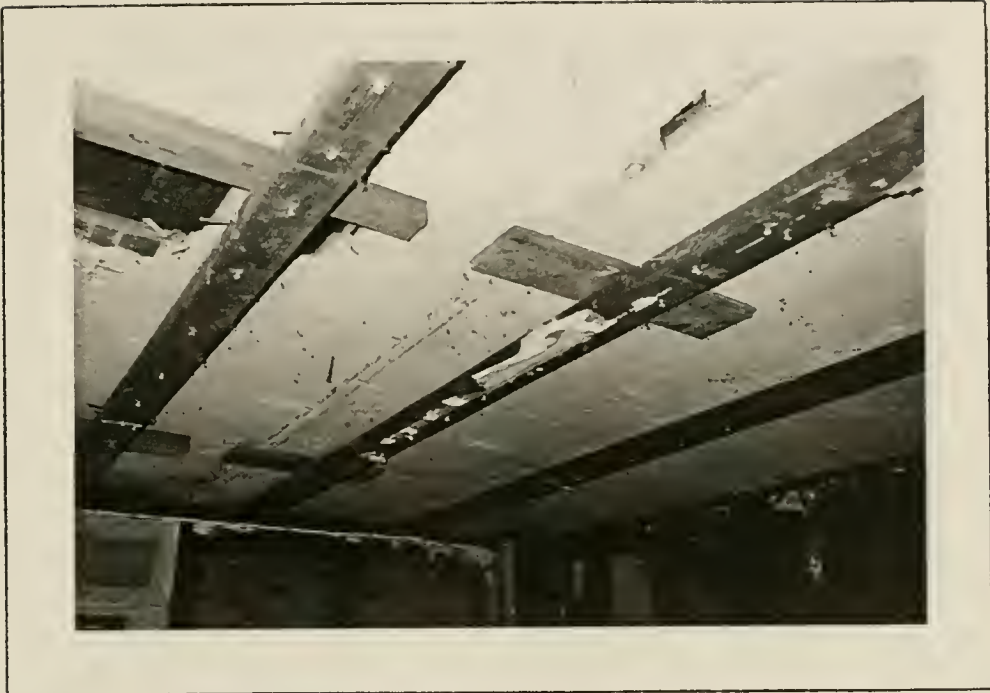
Plate 61: Detail of 19th century ceiling in Rm. 202, 1991. Note presence of beaded-board partition, installed with plaster ceiling and later removed.

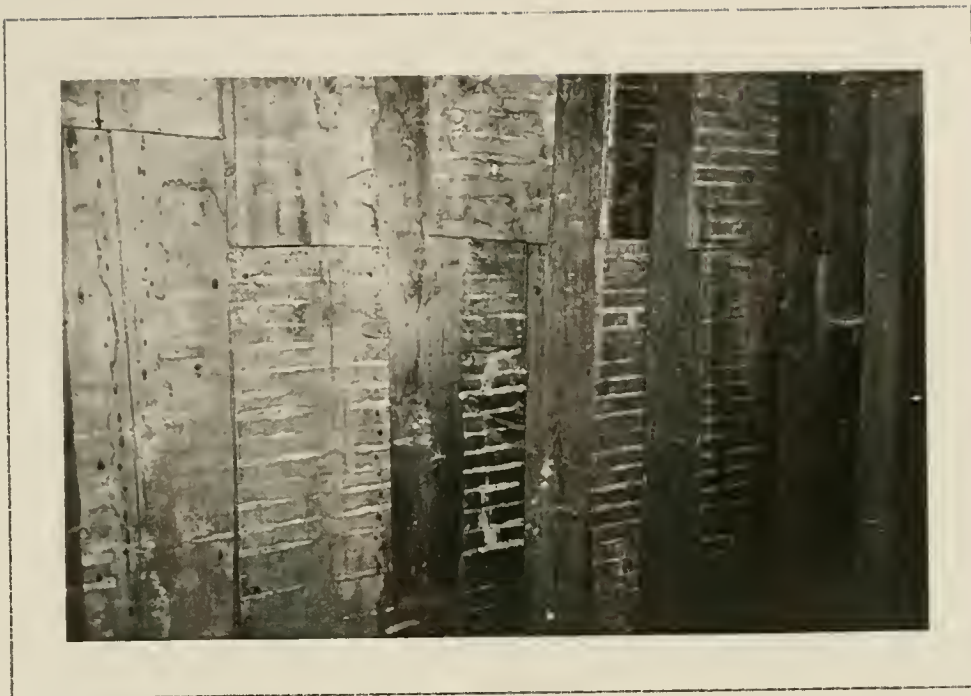
Plate 63: Detail of partition at attic floor level with plaster and lath removed.

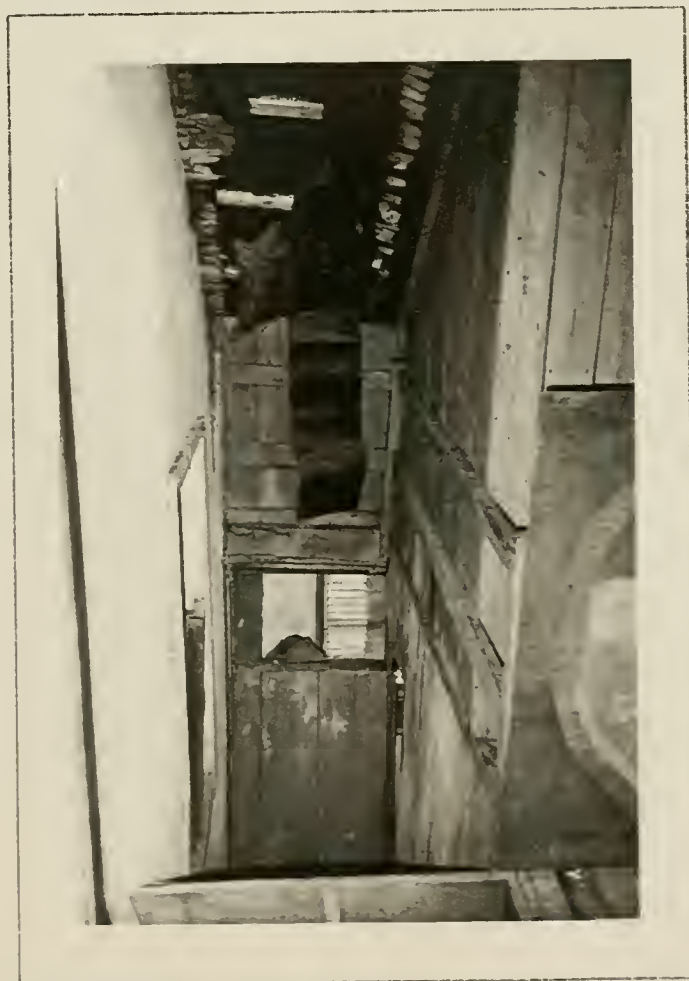
Plate 64: View down stairway from attic, 1991. Note 1836 railing.

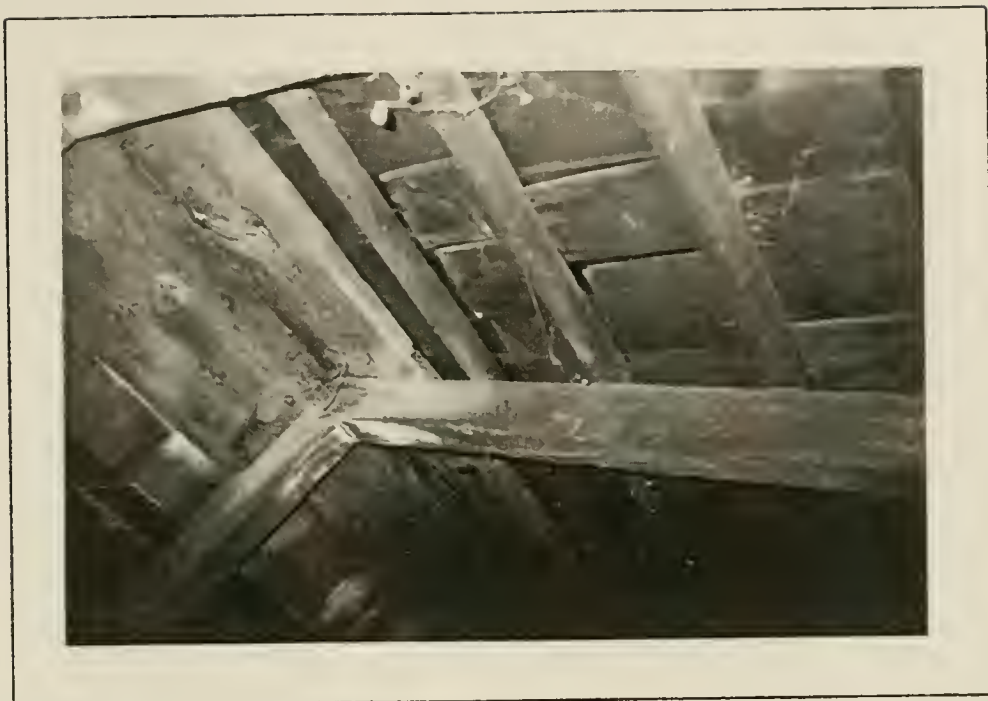
Plate 67: View into roof space above attic, 1991. Note wood shingle roofing in place below current standing seam metal roof.

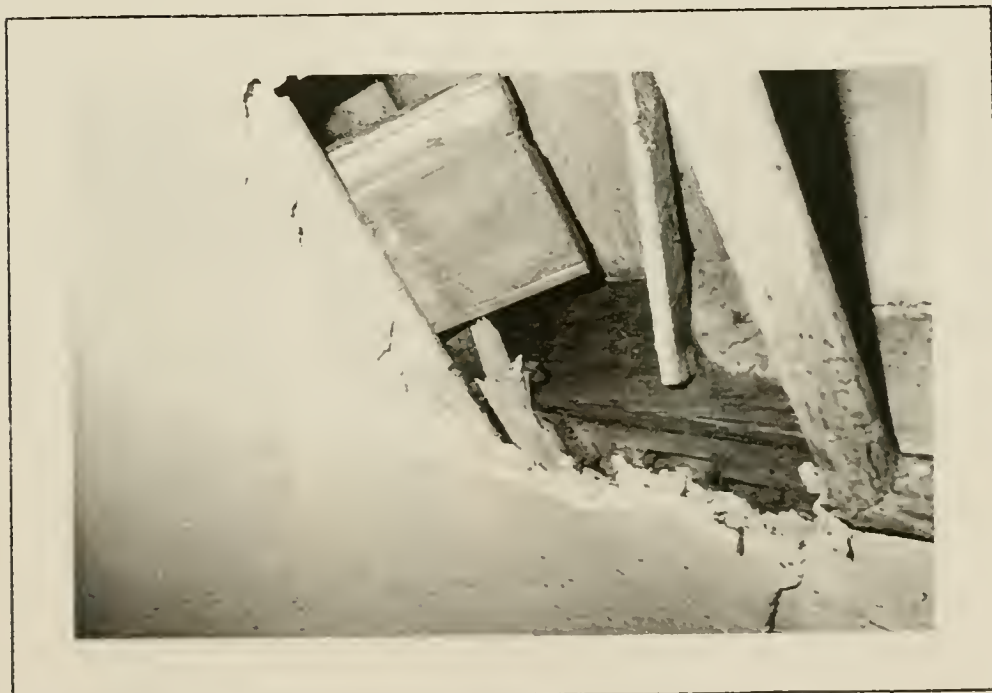
Plate 68: Detail of late 18th century jamb molding found in attic reused as nailer behind 19th century ceiling, 1991.

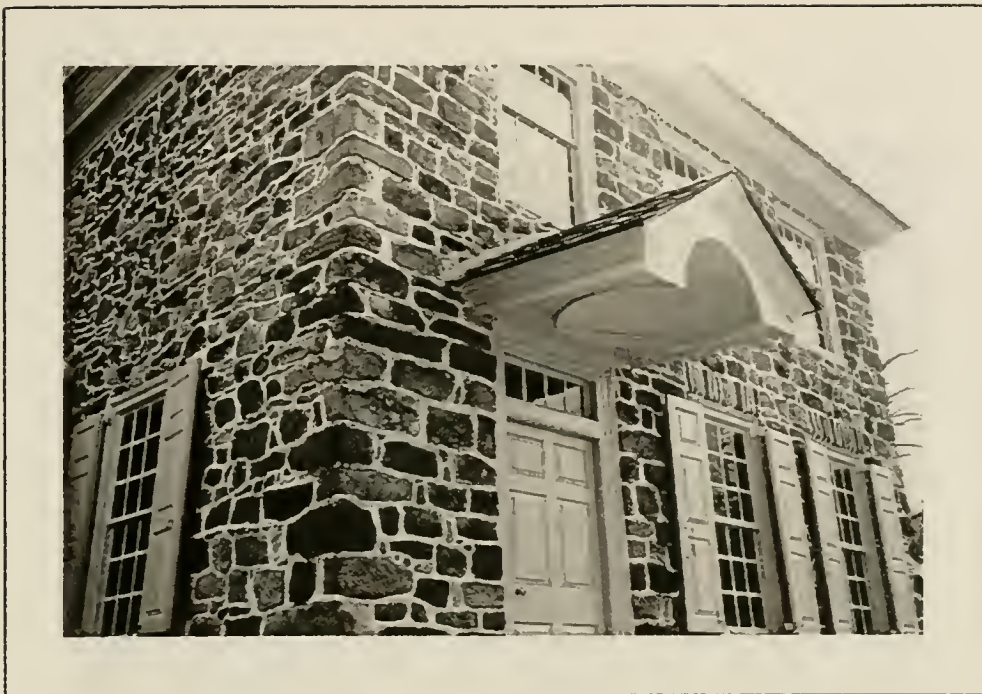
Plate 77: View of southwest corner of Isaac Potts House, 1991. Note differences in masonry.
