Untangling the History of the Pawling/Wetherill House at Walnut Hill Estate, Pawling Road, Lower Providence Township, Montgomery County, Pennsylvania

A THESIS
in
The Graduate Program in Historic Preservation

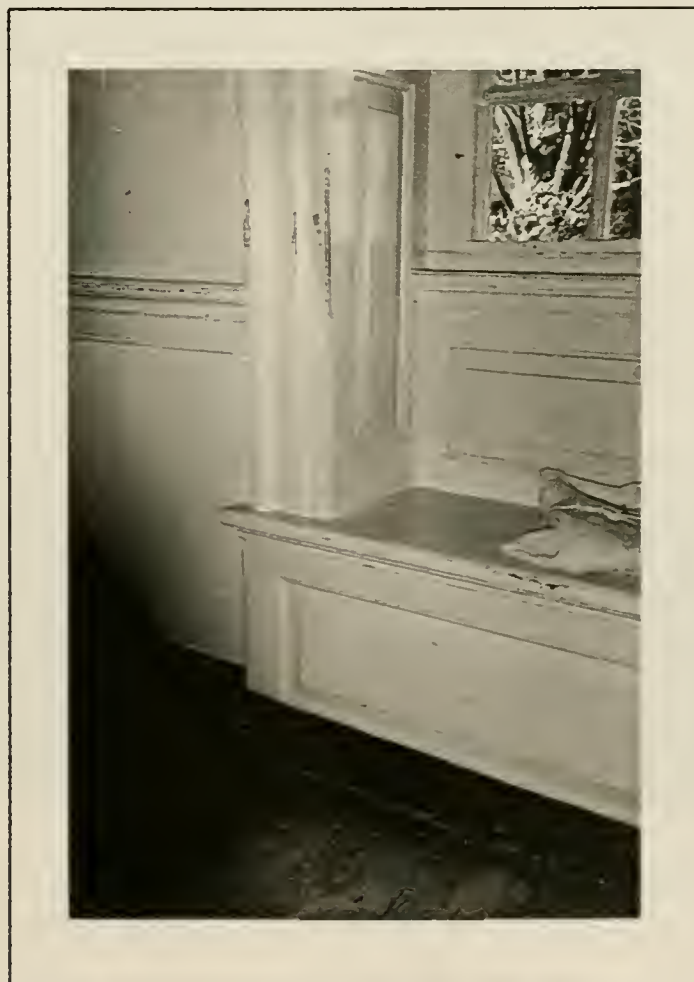
Plate 78: Detail of entry hall trim at Isaac Potts House, 1992.
