# Characterization and Analysis of Prehistoric Earthen Plasters, Mortars, and Paints from Mug House, Mesa Verde National Park Colorado

A THESIS

Historic Preservation

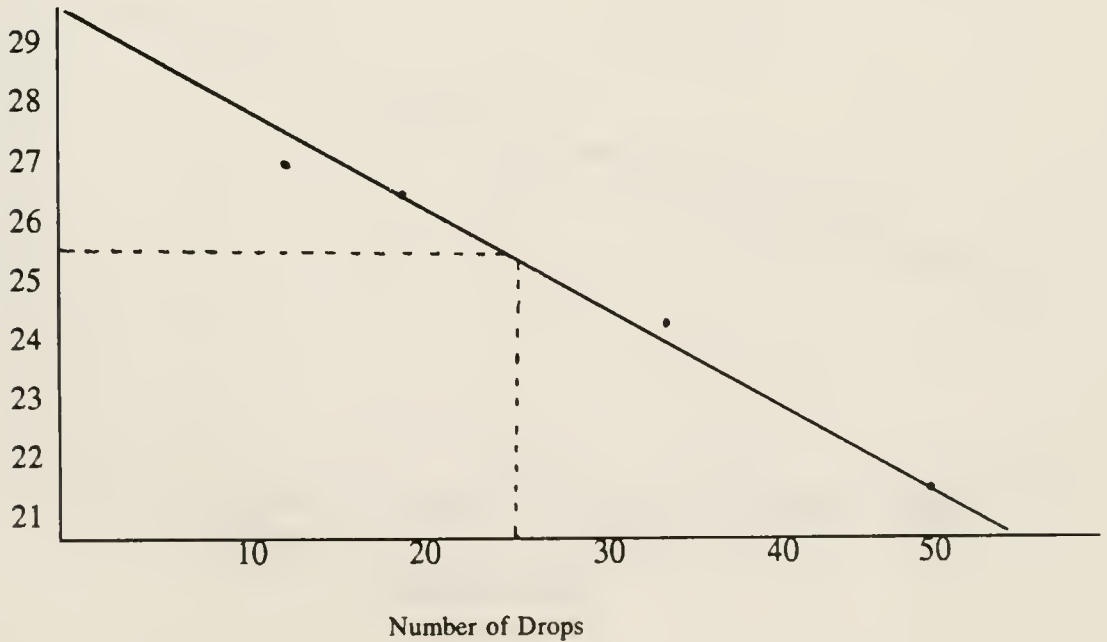
### FLOW CURVE

ROOM 28 MORTAR					
Container	A	B	C	D	E
Number of Drops	50	32	24	19	11
Wt. Wet Soil + Cont. ( $M_2$ )	15.53g	12.73	13.17	15.72	33.46
Wt. Dry Soil + Cont. ( $M_3$ )	13.24	10.55	10.77	12.77	31.02
Water Loss ( $M_2 - M_3$ )	2.29	2.18	2.4	2.95	2.44
Wt. Container ( $M_1$ )	2.65	1.63	1.61	1.64	21.97
Wt. Dry Soil ( $M_3 - M_1$ )	10.59	8.92	9.16	11.13	9.05
Moisture Content % $\frac{(M_2 - M_3)}{(M_3 - M_1)} \times 100$	21.6	24.4	26.2	26.5	27
Mean Moisture Content = 26%

Kiva C plaster and Room 28 mortar have similar liquid limits of 21% and 26% respectively. The Adobe Cave soil, in contrast, has a much higher liquid limit of 48%. As with the plastic limit, the vast difference in the liquid limit between the plaster and mortar on the one hand and the Adobe Cave soil on the other suggests that Adobe Cave soil was not the soil source for the building materials, at least not in its unmodified form. The Adobe Cave soil requires a significantly larger quantity of water to transform it from the semi-solid to the liquid state than do either of the other two soils. The high clay and silt content of the Adobe Cave soil and lack of sand allows it to hold more water than the other two soils before being transformed from one state to another. The Room 28 soil holds more water than the Kiva C soil because it has 10% less sand than the Kiva C soil.

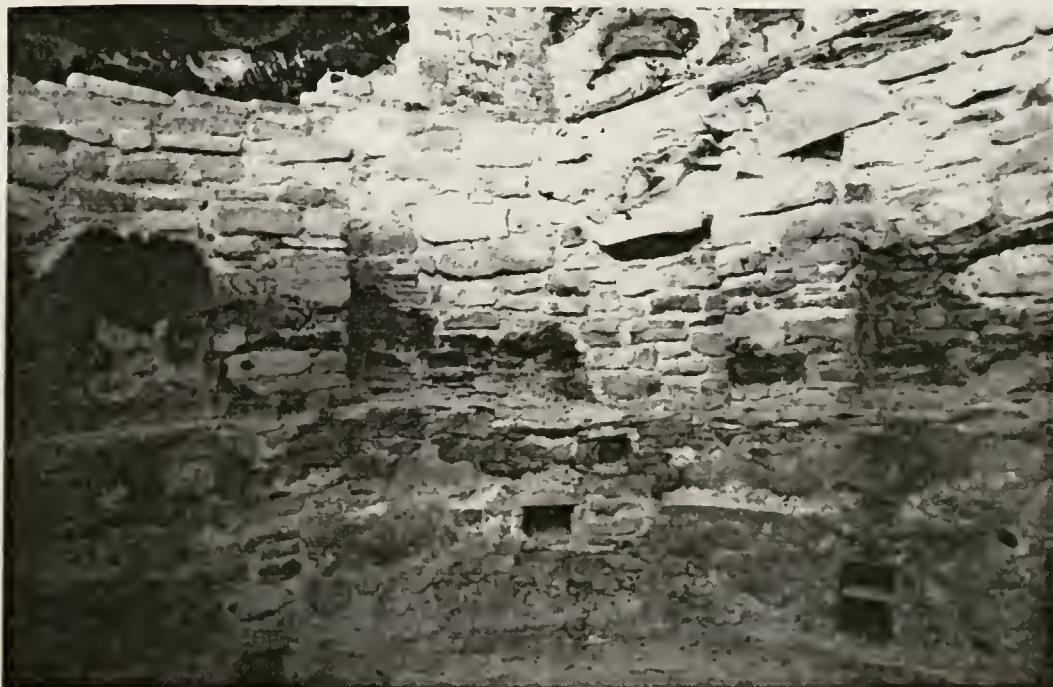
*Fig. 18 Elevation of Kiva C Interior Wall*

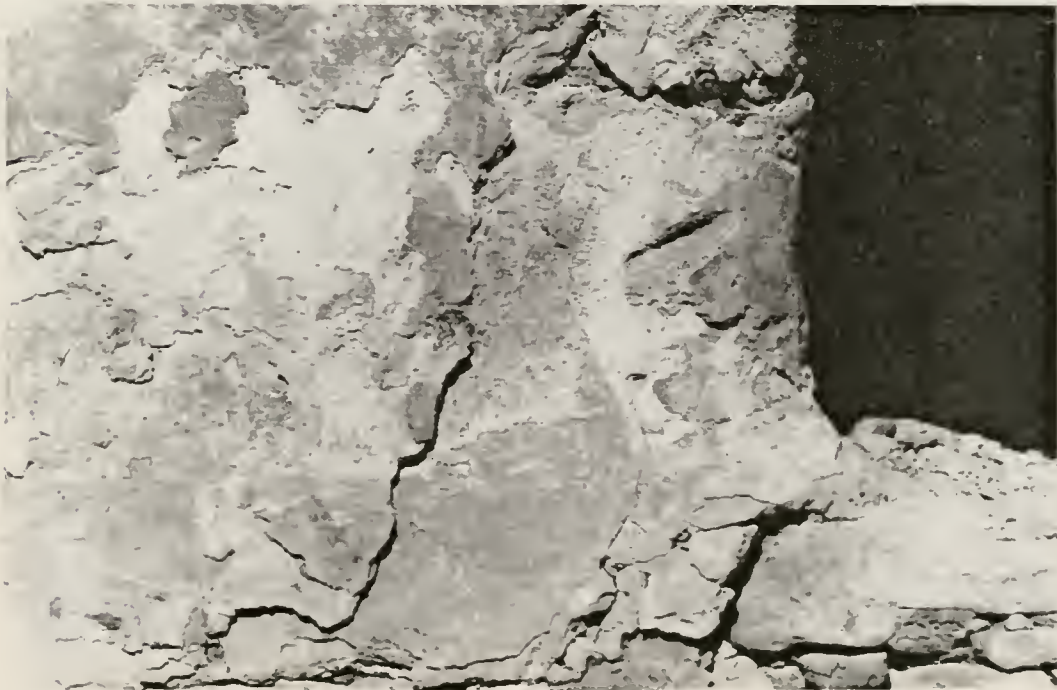
*Fig. 20 Detail of Kiva C Plaster — Note Triangle Design in Center of Photograph*

Subsequently, a bichrome scheme was introduced in Kiva C, usually found around layer six or seven, and features an orange lower dado with triangles and dots projecting into a white upper field. This effect was achieved by covering the kiva interior with

fresh tan plaster and painting it white; then the triangle design was etched into the plaster and the dark orange finish applied with a brush. The triangle peaks, which vary in height, rise on average 17 ½" above the kiva floor. Inconsistencies in stratigraphies below 16" fail to establish whether this orange field was merely a band of color encircling the central portion of the wall, or whether the entire lower dado was orange.

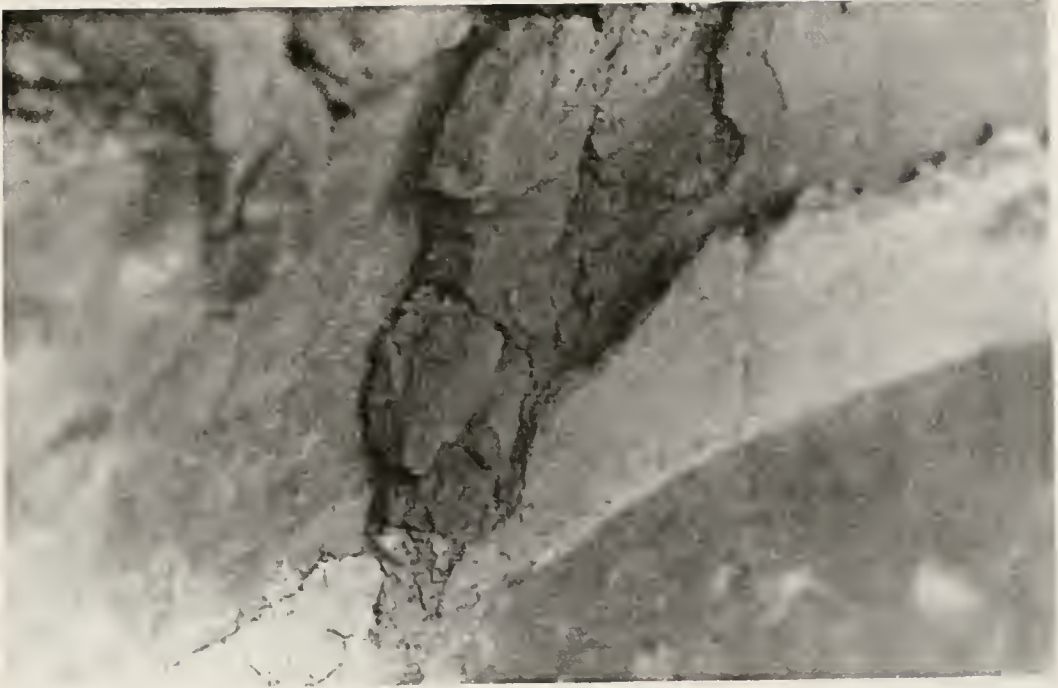
*Fig. 21 Detail of Base Coat Plaster in Kiva C*

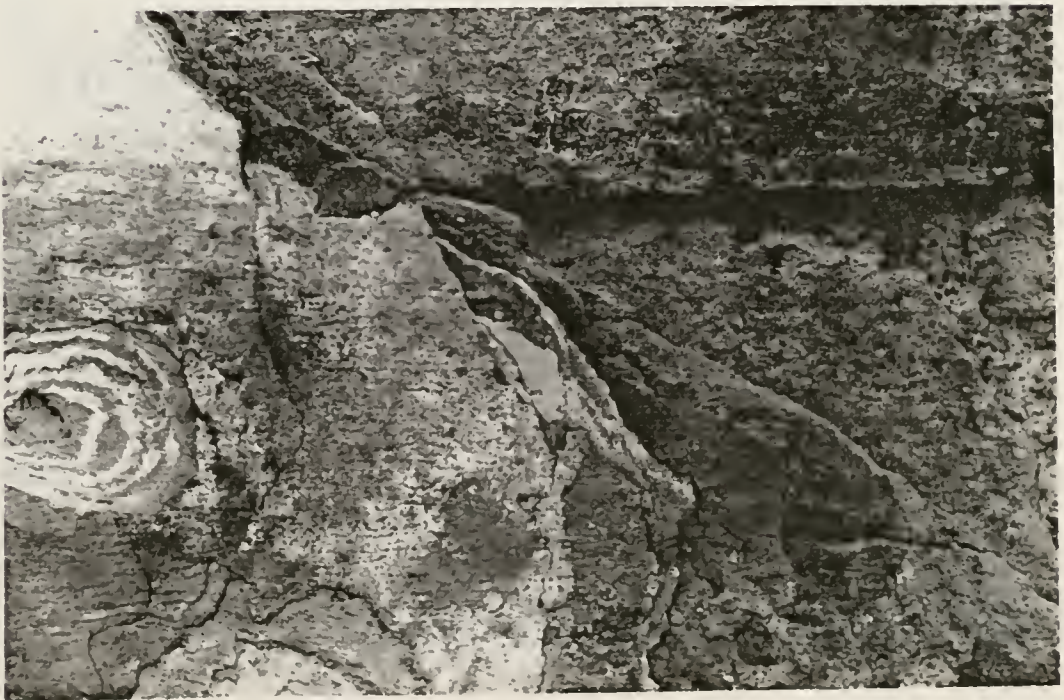
*Fig. 22 Detail of Exposed Plaster Layers in Kiva C*

The sequence of finishes in both Kiva C and Room 28 were documented through a visual survey. Surface deterioration in both rooms revealed the sequence of plaster and paint layers in many locations. Plaster surfaces were carefully examined with the unaided eye. By counting layers and noting features, 32 stratigraphies were observed by non-destructive means. (See Appendix A.)

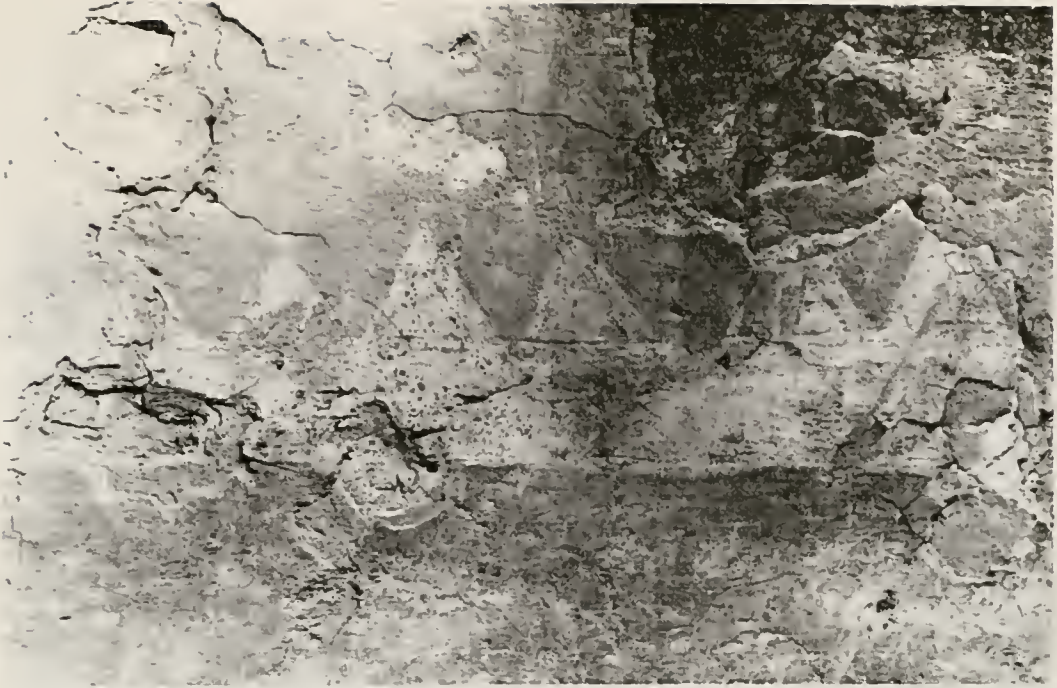
*Fig. 23 White Band and Triangle Design in Kiva C*

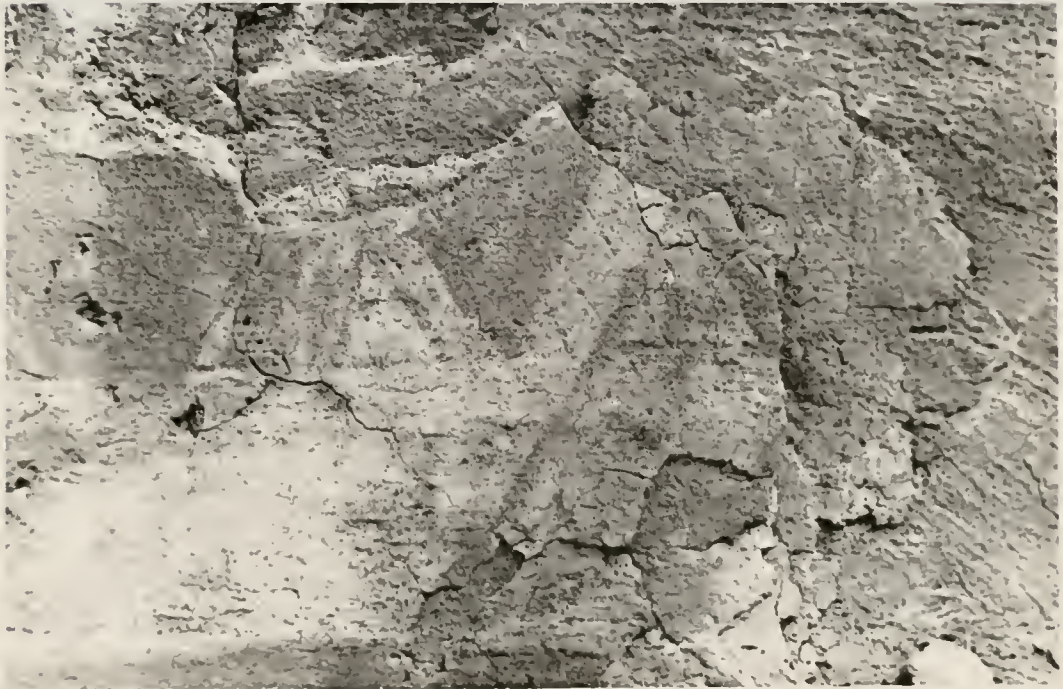
*Fig. 24 Detail of Triangles — Note Incision Marks*

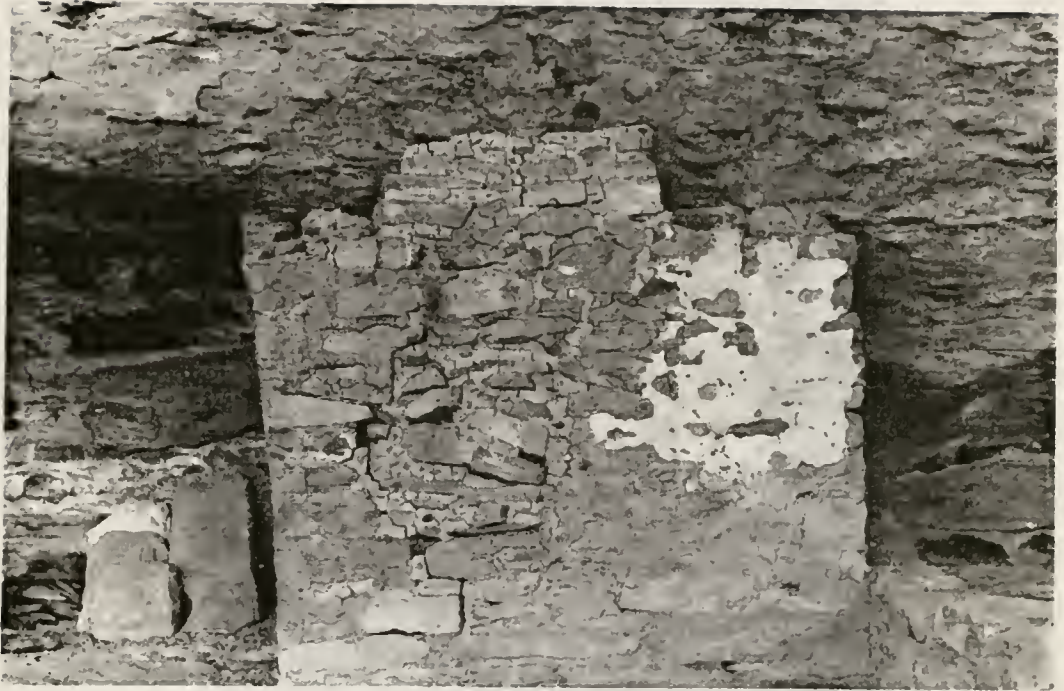
*Fig. 25 Elevation of Room 28*

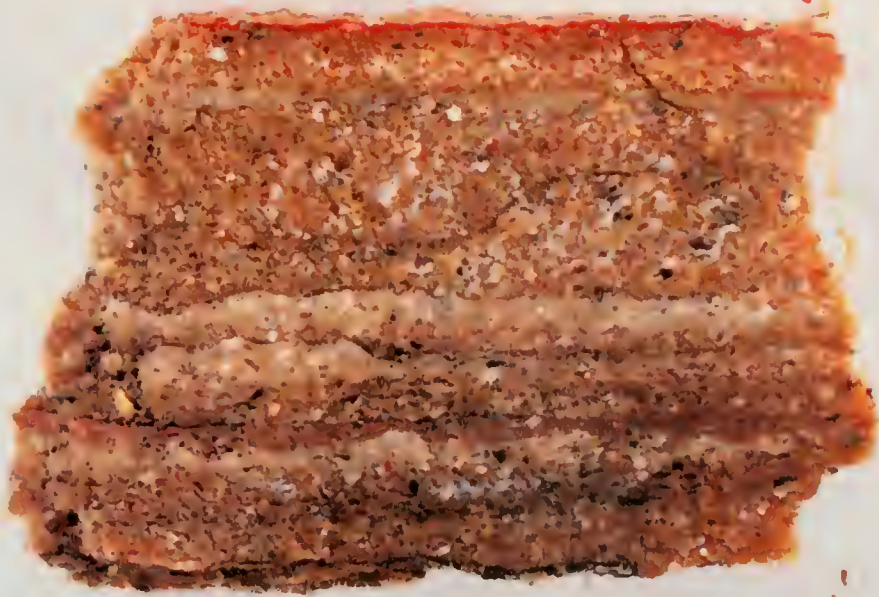
*Fig. 27 Cross Section of Kiva C Plaster from the Red Dado*

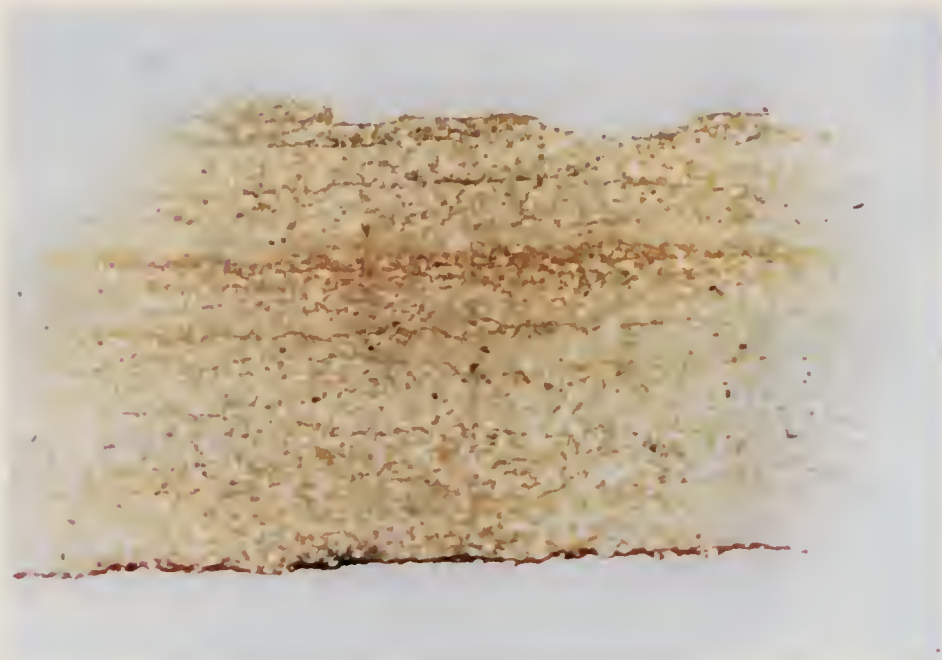
*Fig. 28 Thin Section of Plaster from Kiva C from the Red Dado*

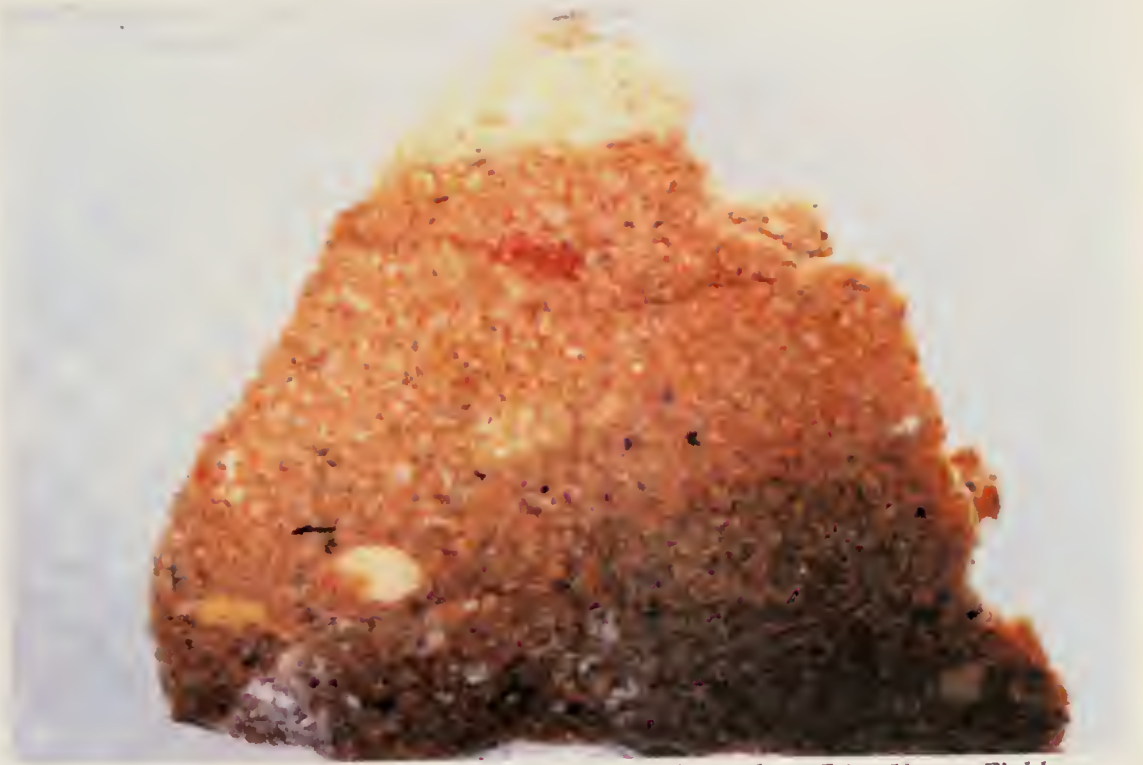
*Fig. 29 Cross Section of Room 28 Plaster from the White Upper Field*

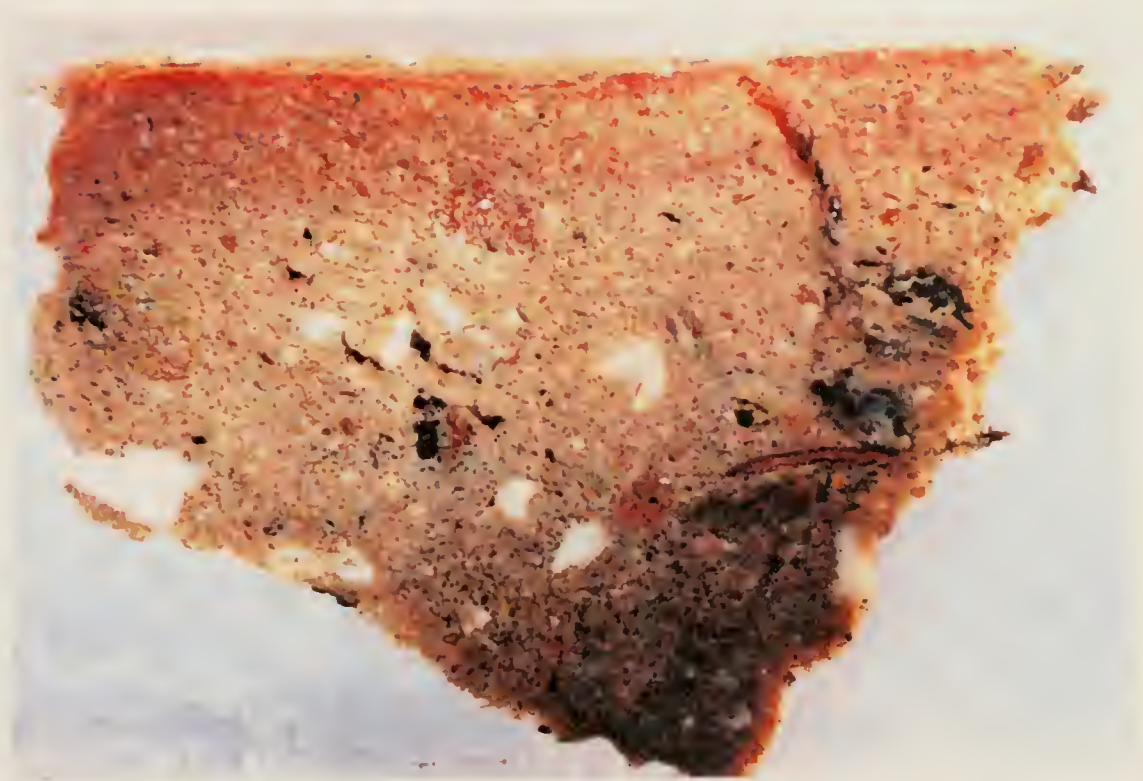
*Fig. 30 Thin Section of Room 28 Plaster from Red Lower Dado*

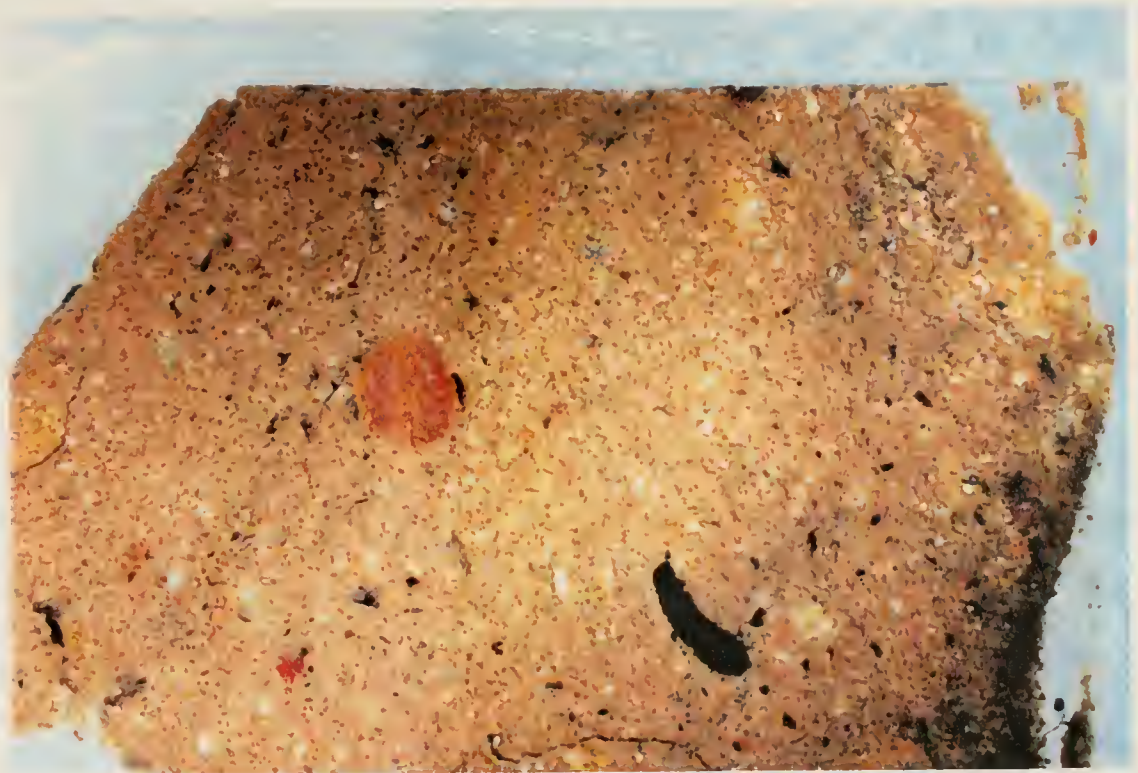
*Fig. 31 Cross Section of Mortar from Kiva C*

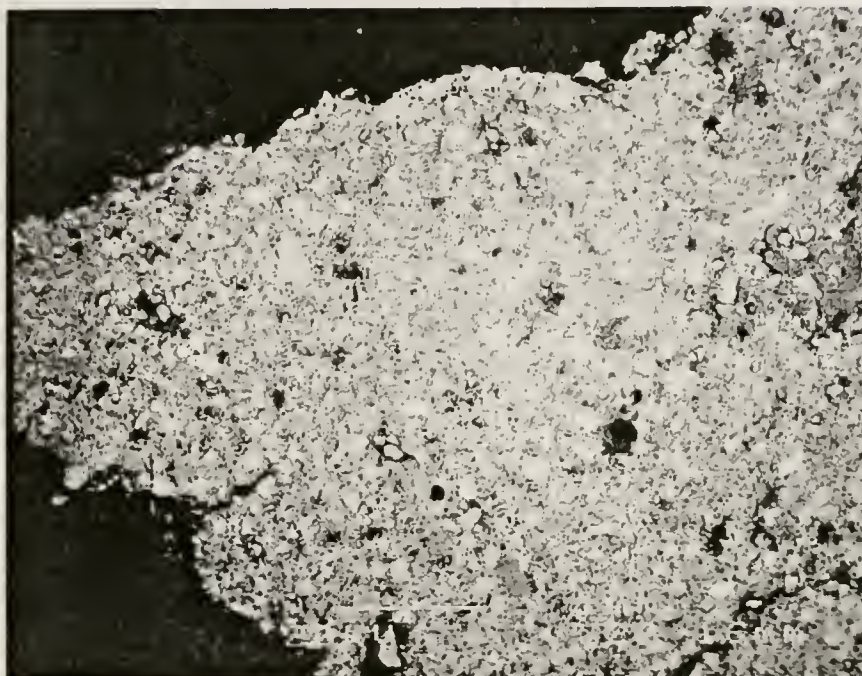
SAMPLE 03: BEDDING MORTAR FROM KIVA C

Sample 03: Electron Dot Map

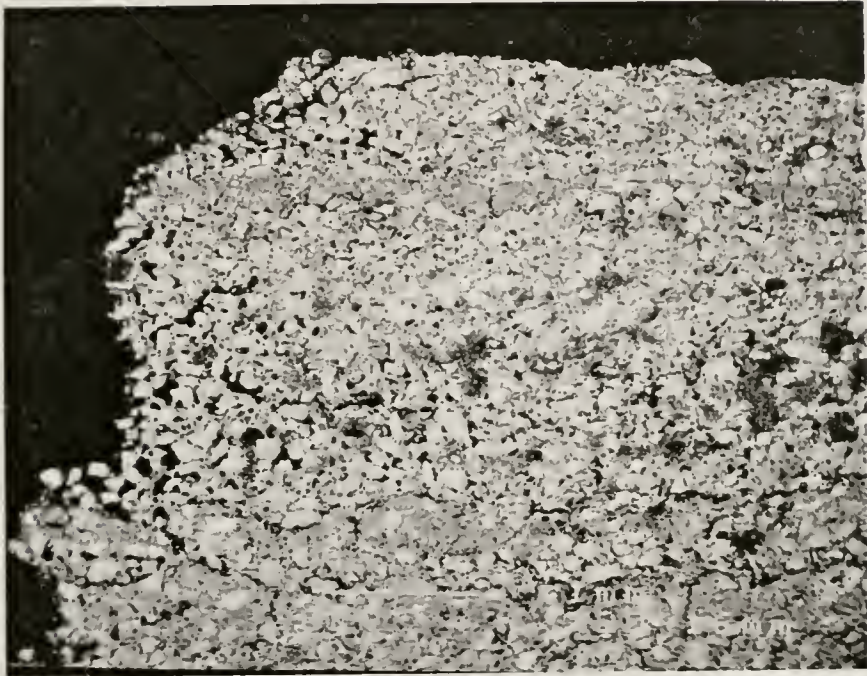
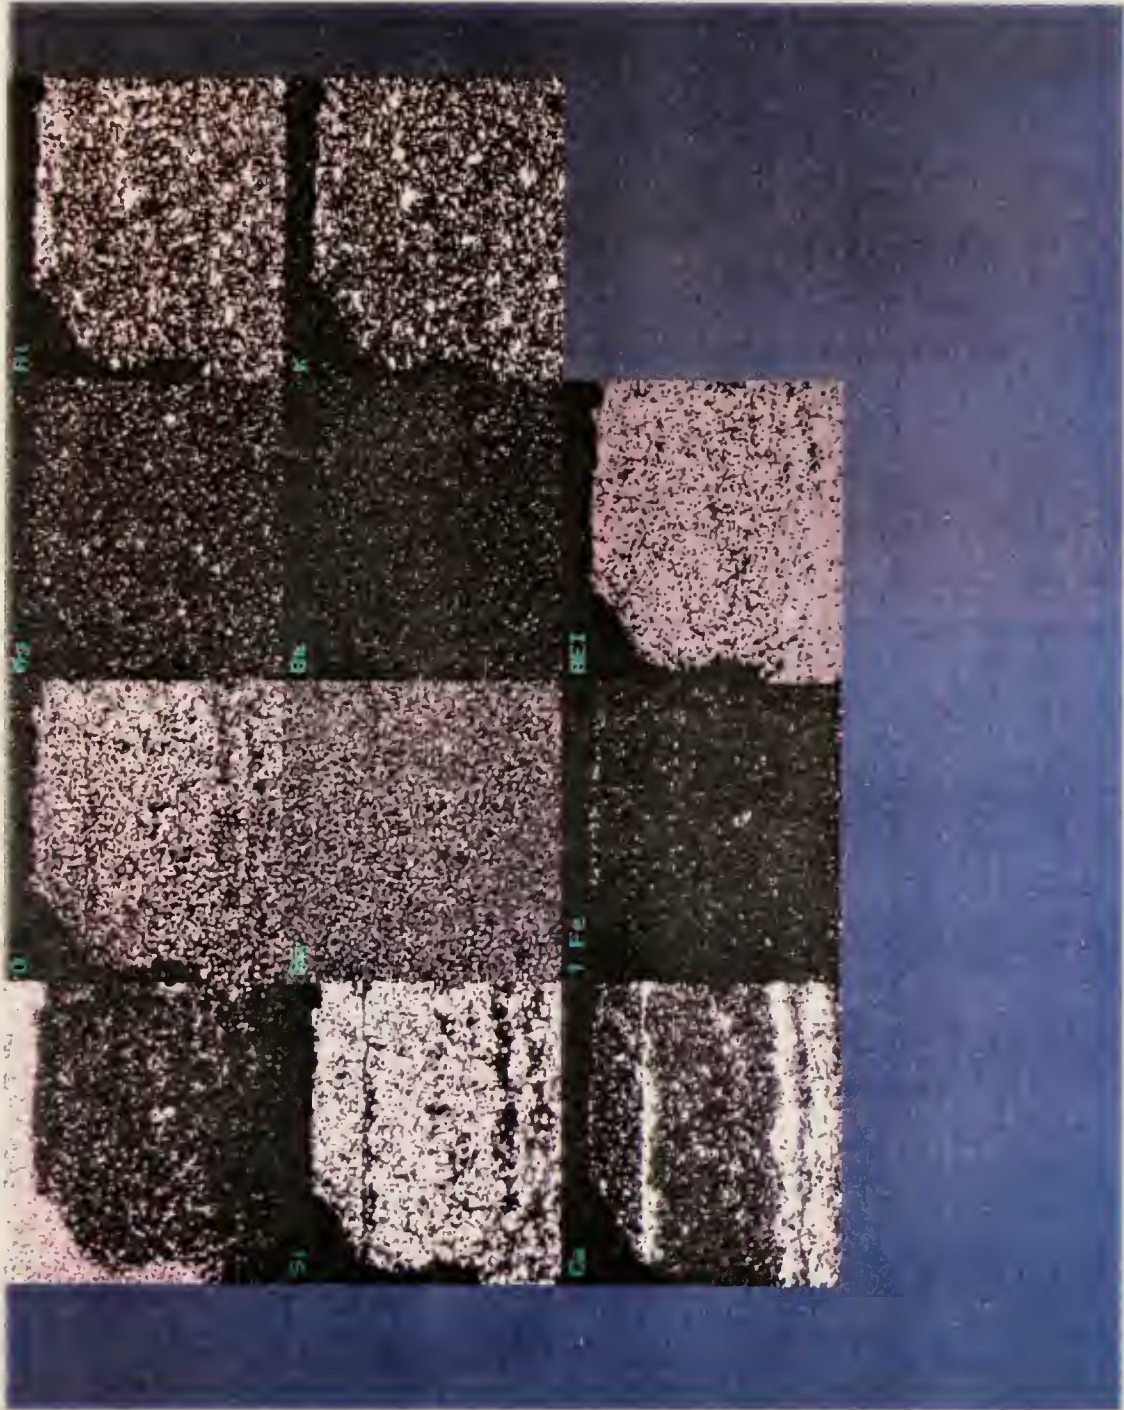
SAMPLE 06: PLASTER FROM KIVA C

Sample 06: Electron Dot Map

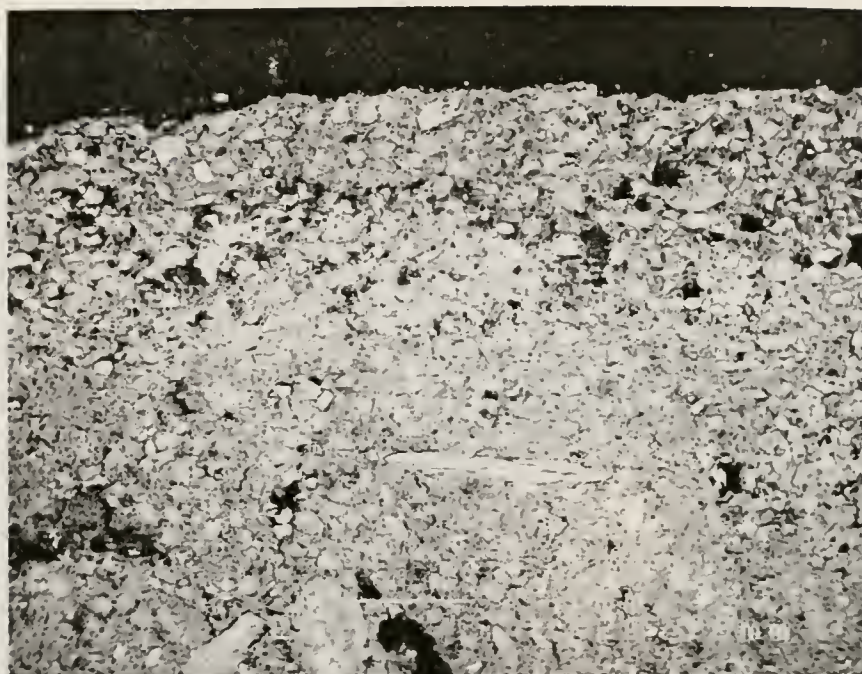
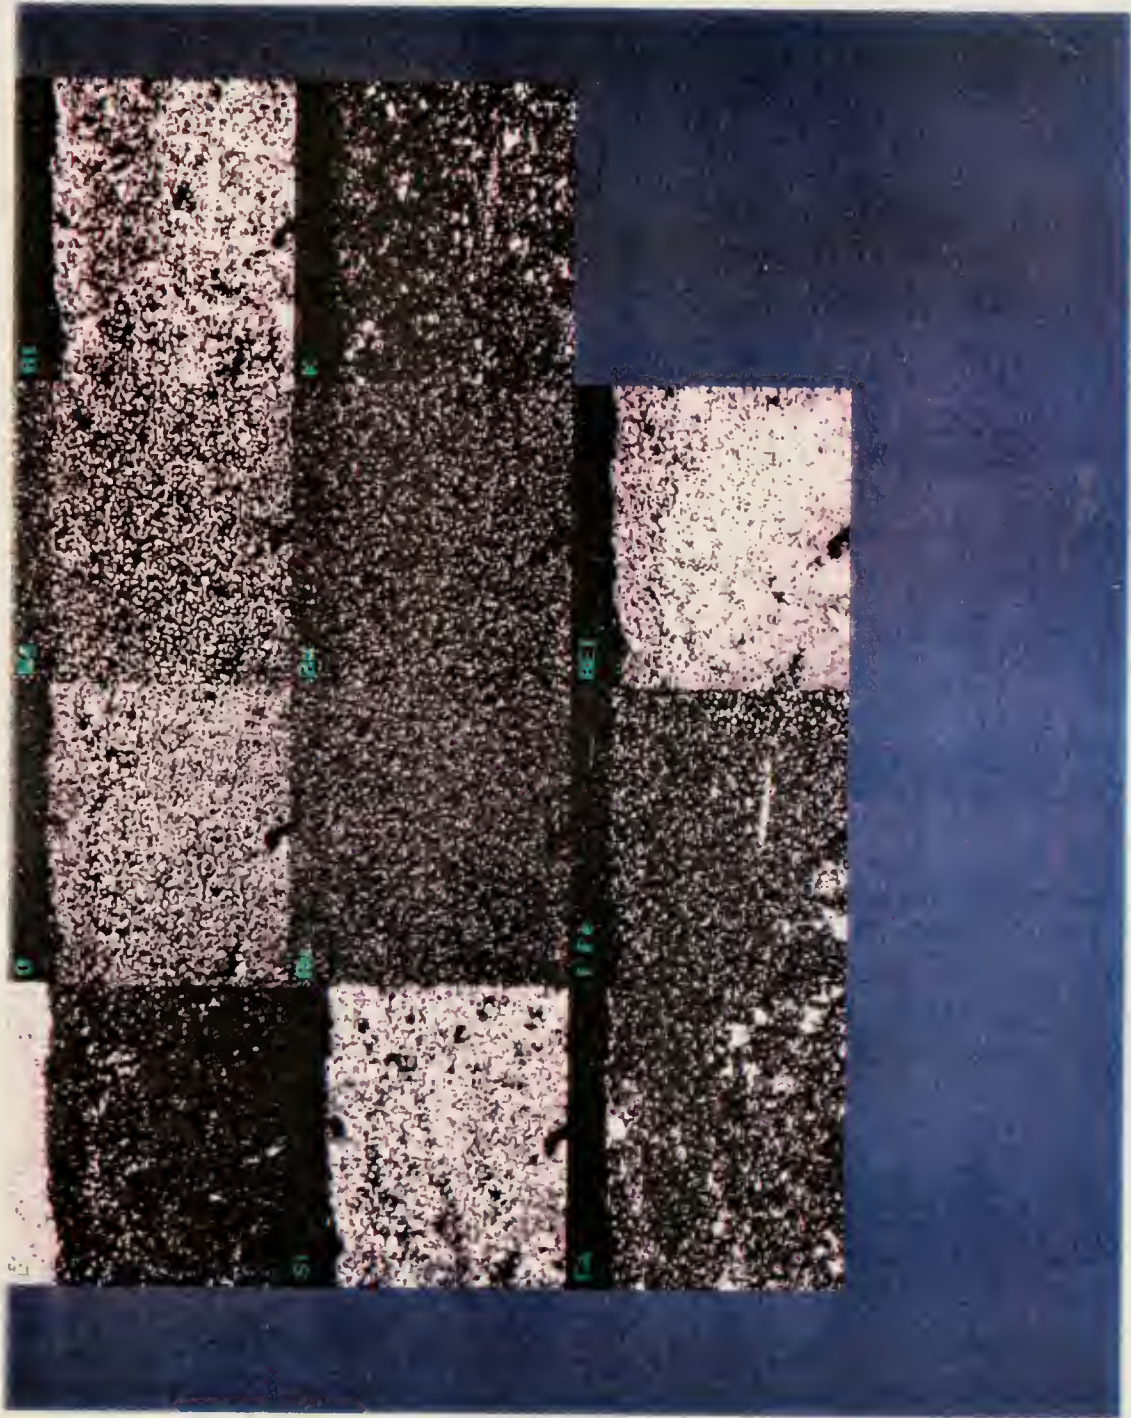
SAMPLE 14: PLASTER FROM ROOM 28

Sample 14: Electron Dot Map
