Exterior Stuccoes as an Interpretive and Conservation Asset: The Aiken-Rhett House, Charleston, SC

EXTERIOR STUCCOES AS
AN INTERPRETIVE AND CONSERVATION ASSET:
THE AIKEN-RHETT HOUSE, CHARLESTON, SC

The document which follows is an historical, analytical and technical analysis of the historic stuccoes which beautify and protect the Aiken-Rhett House, Charleston, SC, property of Historic Charleston Foundation, submitted to the faculty of the Graduate Program in Historic Preservation as a component requirement for the degree of Master of Science from the University of Pennsylvania, 1997.

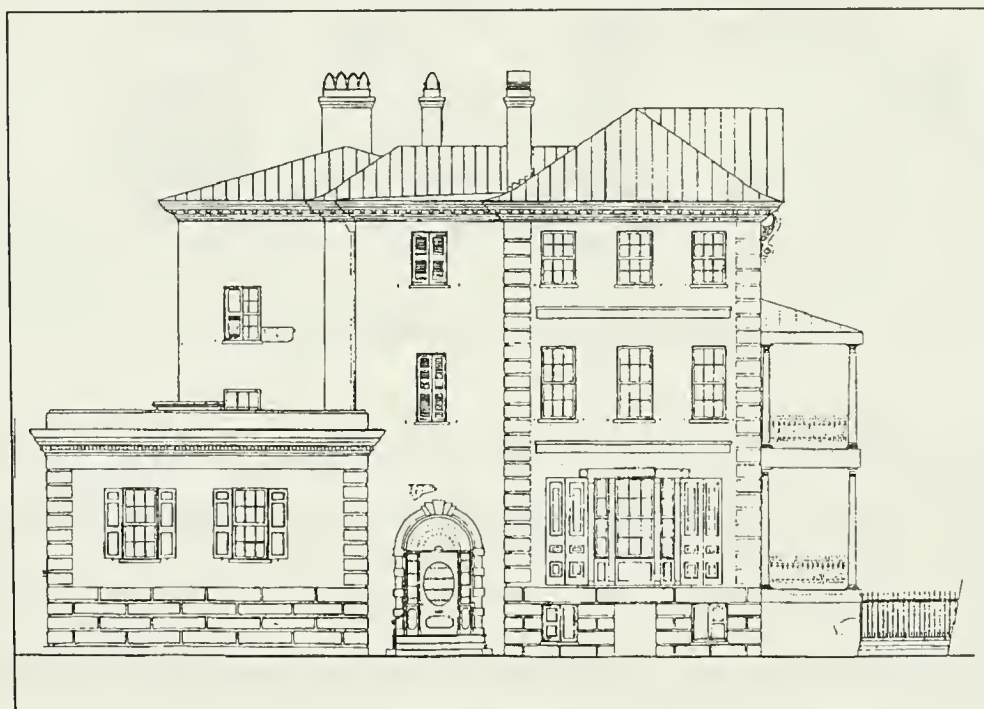
The west elevation (Figure 2.3) now provides entry to the building from an arched doorway with decorative iron grill work at street level. The main residence is essentially four bays wide, with a double-wide window similar to those on the south facade at first floor level, and four 6-over-6 windows on both the second and third story levels. A stuccoed brick art gallery addition with a rusticated base and quoins is an 1850s addition to the main residence.

Figure 2.3. West Elevation, HABS Drawings, 1985.

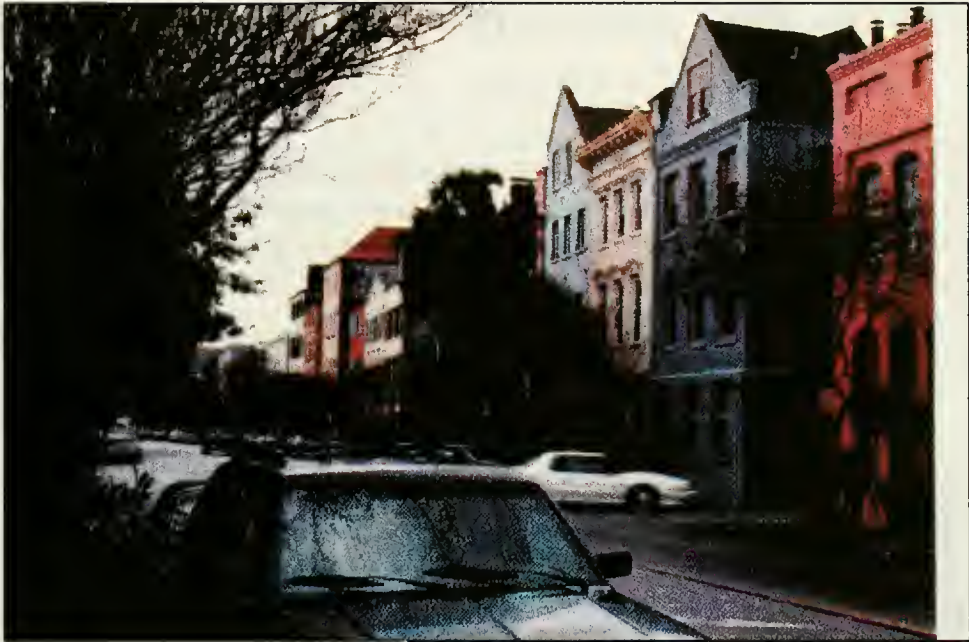
Figure 3.1. Colorful, painted stuccoed facades of “Rainbow Row” enunciate the vibrant tradition of adding flare to what is often considered a sacrificial, ephemeral material.

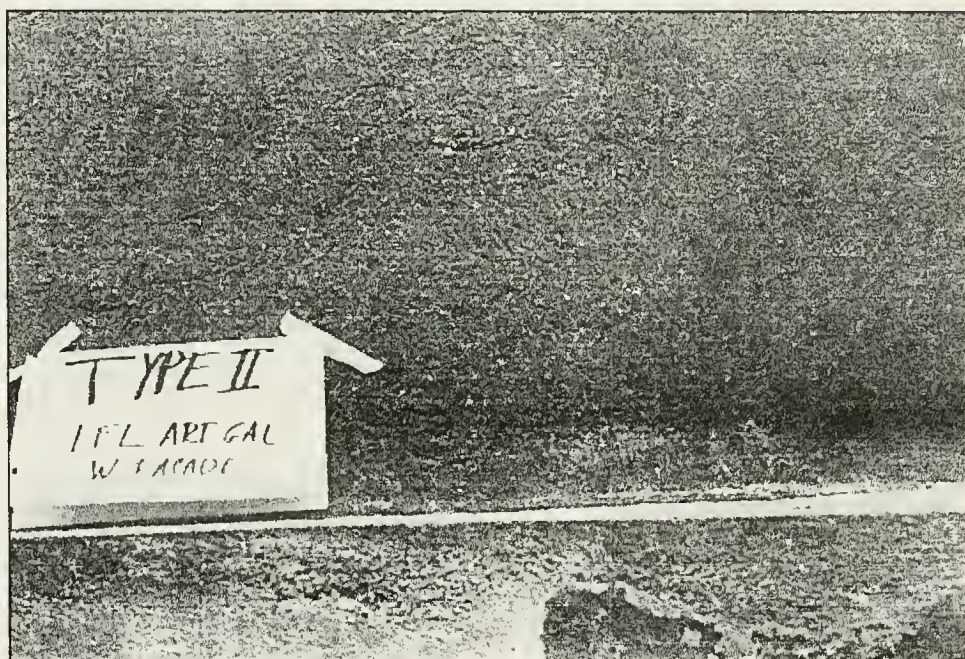
Figure 3.8. Example of stucco type 2, applied to exterior surface of 1858 art gallery. Visually and presumably compositionally different from type 1, it is characterized by floating tool marks applied in a circular pattern. West facade, first floor of art gallery.

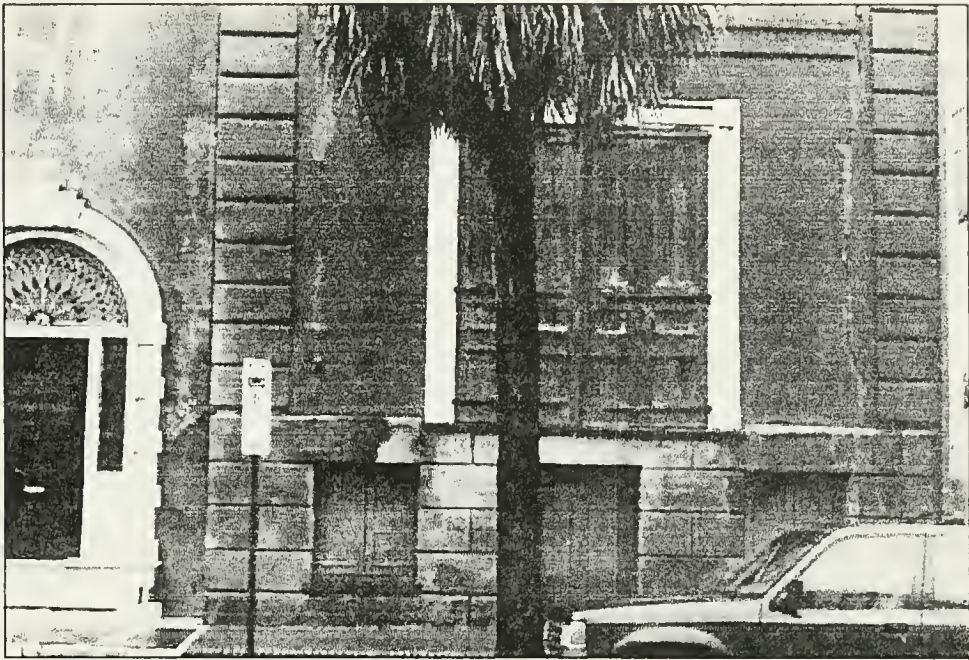
Figure 4.4. Cementitious composites used to patch original stucco may provide a temporary cure for unsightly cracks which result from structural inefficiency, but may also damage existing historic fabric. West facade.

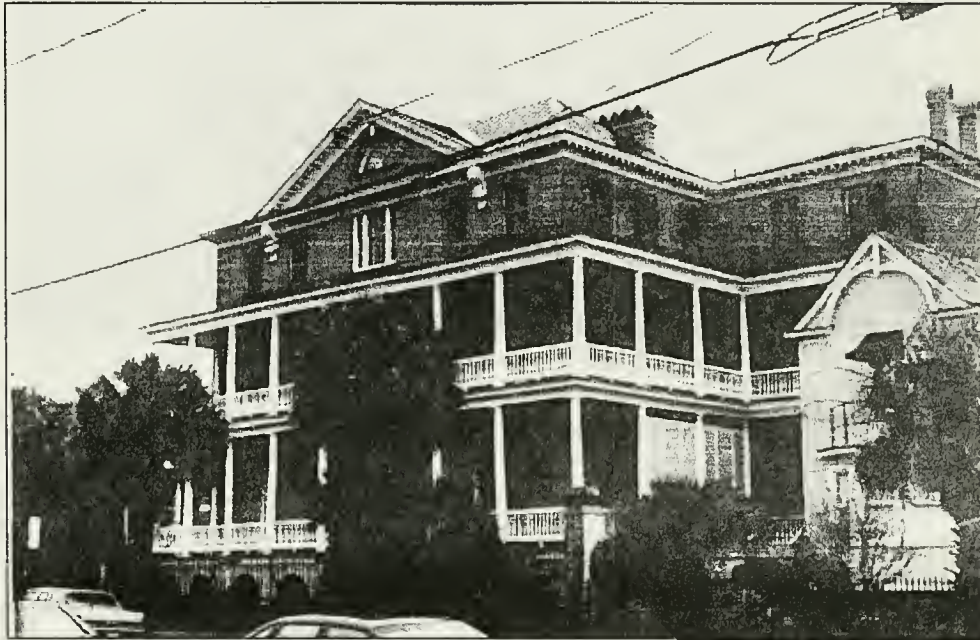
Figure 4.5. Stucco applied to the building in the 1830s was, in part, represents an aesthetic intention of providing unified, updated appearance to parts of the building which had been altered. View from southeast.

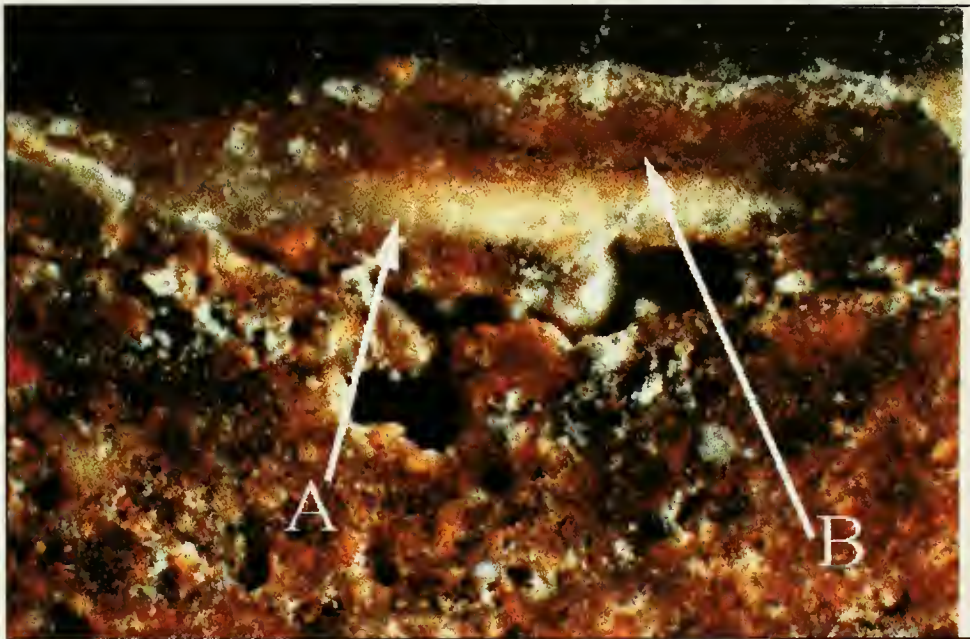
Figure 6.4 Aiken-Rhett Sample 101.2, first floor piazza, south facade. Following application of a single coat of stucco, the building was adorned with a layer of white lime wash (A) and a subsequent layer of light yellowish brown pigmented lime wash (B) Munsell 0.2Y 6.80/3.03. Cross-section in reflected light @ 40x magnification.

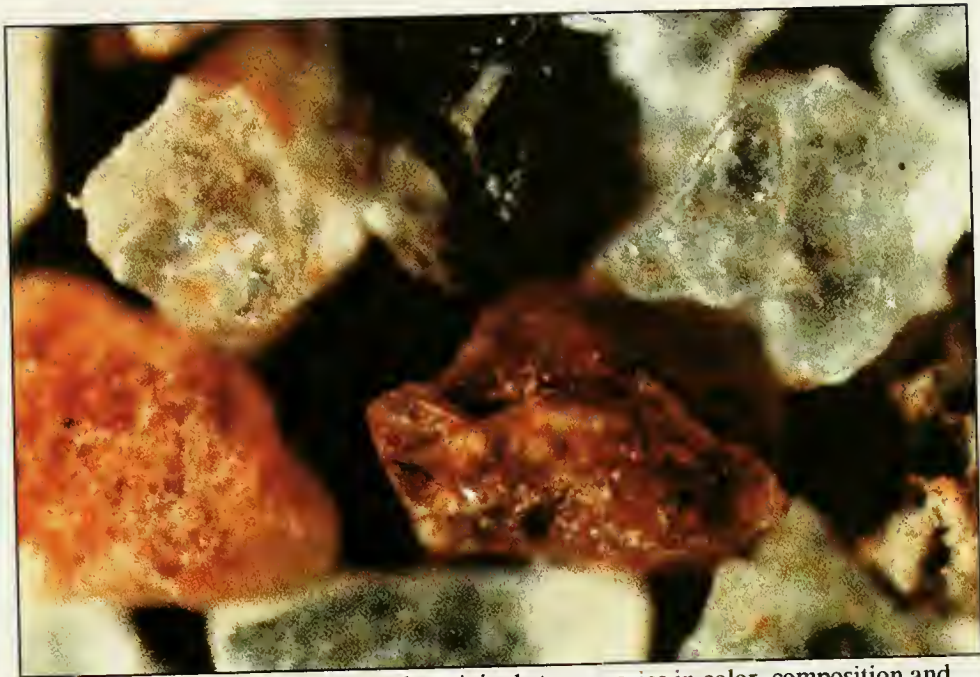
Figure 6.6. Aggregate used for the original stucco varies in color, composition and particulate shape. As shown, aggregate removed from matrix by digestion with hydrochloric acid. Reflected light @ 40x magnification.

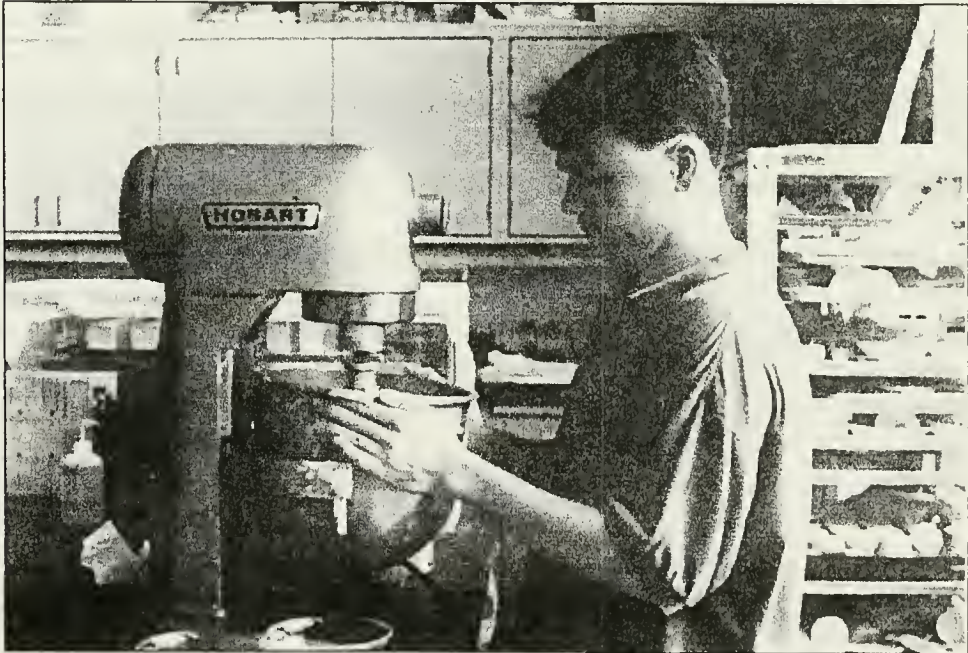
Figure 7.2. Mechanical mixing performed.

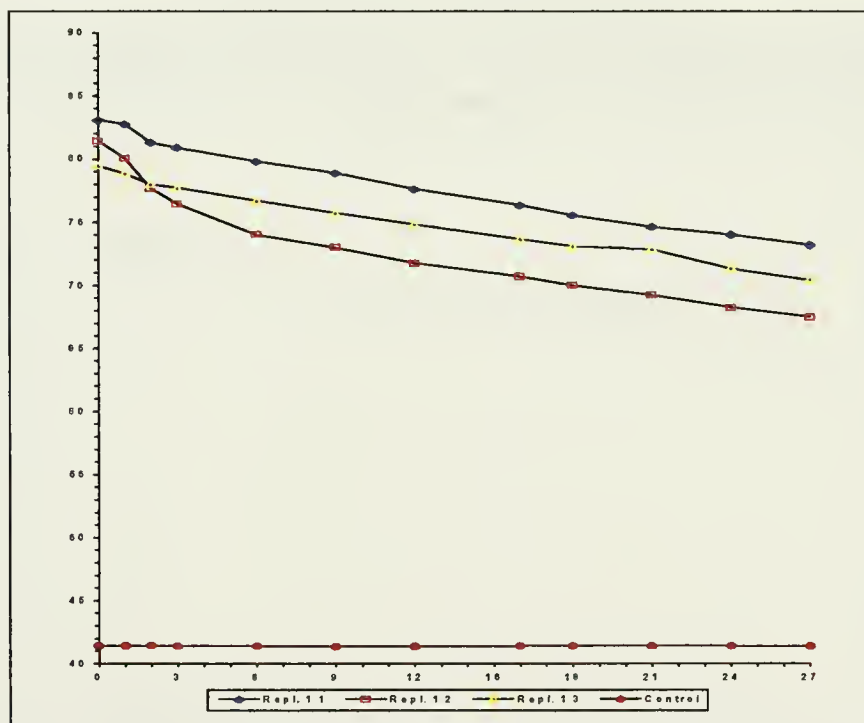
Chart 2. Comparative water vapor transmission rates (WVTRs) for Replication Stucco 1, Riverton HHL, expressed as a function of amount of water vapor passed through 42 mm-diameter specimens over a 27-day period. Y-axis values represent assembly mass (g) and X-axis values represent time (days).
