Cultural Landscape Study of Fort Davis National Historic Site, Texas

CULTURAL LANDSCAPE STUDY OF FORT DAVIS NATIONAL
HISTORIC SITE, TEXAS

A THESIS

Historic Preservation

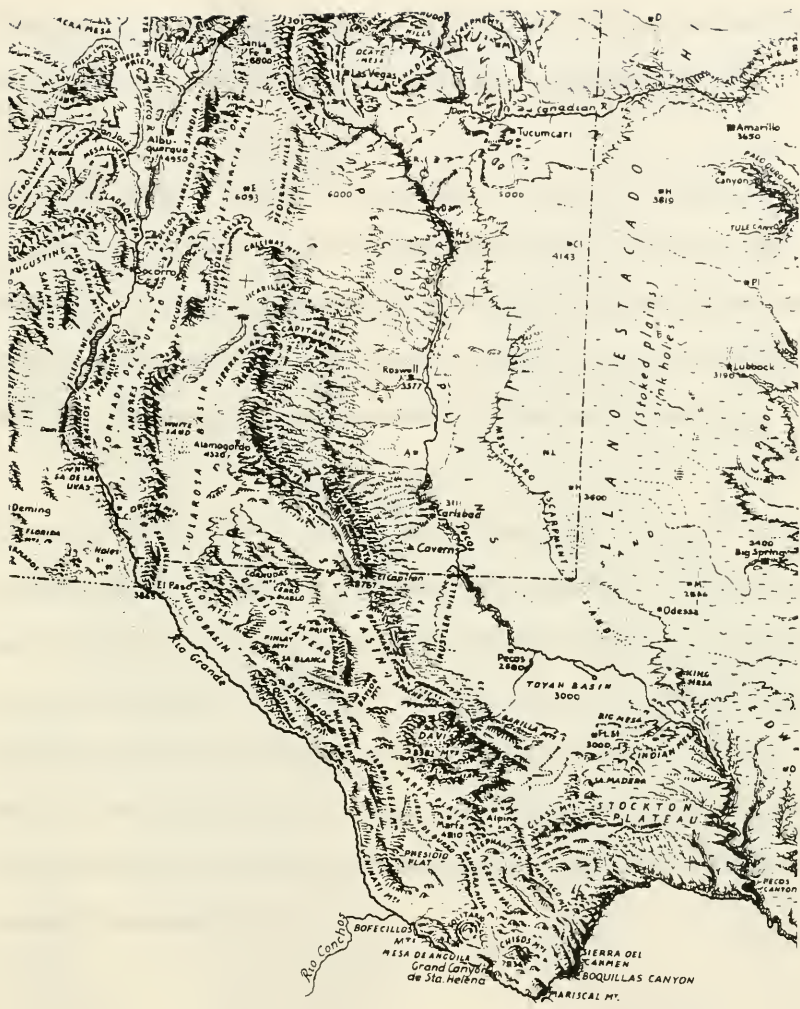
Figure 2. Map, Physiography of Trans-Pecos region (Source: Erwin Raisz, *Landforms of the United States*, 6th revised edition (Melrose, Mass.: Raisz Landform Maps, 1957), map.

Fort Davis National Historic Site is located at the eastern edge of the Davis Mountain region of western Texas that is located within the North American Basin and Range physiographic province. The numerous basins and ranges of the province were produced by faulting that started in the Tertiary geologic period, which has been accompanied periodically into the present by volcanic activity and regional uplift. The Davis Mountains in particular were formed during volcanic eruptions approximately thirty-five million years ago that centered around two main points – the Buckhorn Caldera, northwest of Fort Davis, and the Paisano Volcano, located west of Alpine in Brewster County. These rugged mountains, comprised of horizontal strata of igneous rock, are surrounded by a relatively flat plain. Large parts of this plain, which are elevated around 4,000 feet above sea level, are basins filled with eroded debris from the surrounding mountains. Much of the main mass of mountains lies higher than 5,000 feet, making it Texas's second highest range, including Mount Livermore, the state's fifth highest peak at 8,378 feet. The region spans an area of approximately forty-five miles in length from north to south and about thirty-five miles wide from east to west.

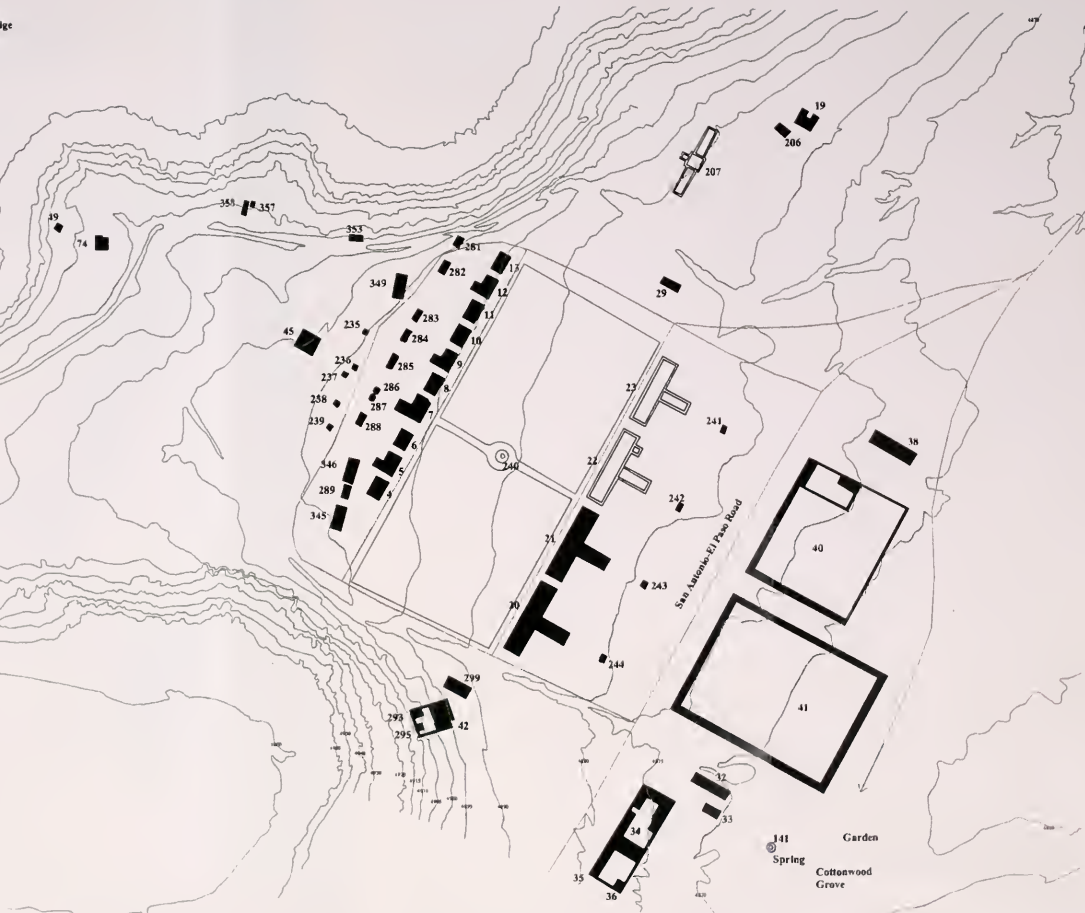
Figure 11. Plan of second Fort Davis, 1867-1873 (Source: author's adaptation of historic base map accompanying Greene)

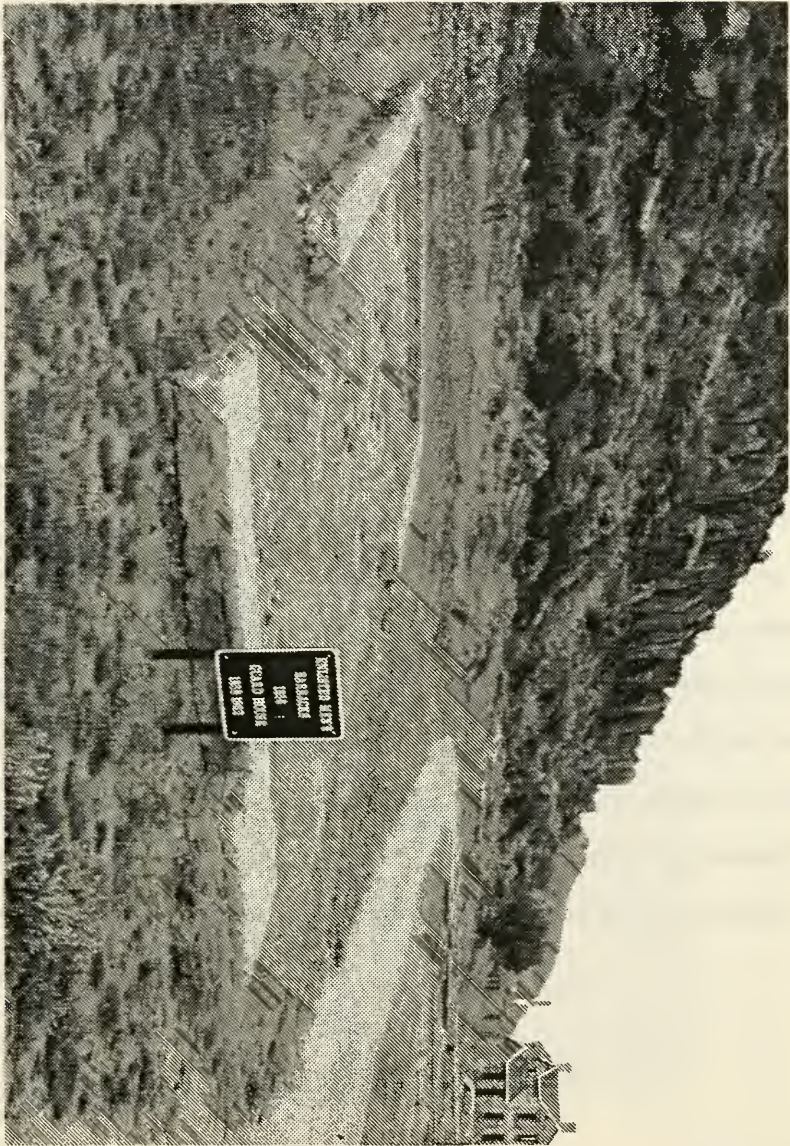
Figure 18. Photograph, First fort foundation footprint, 1999 (Source: author)

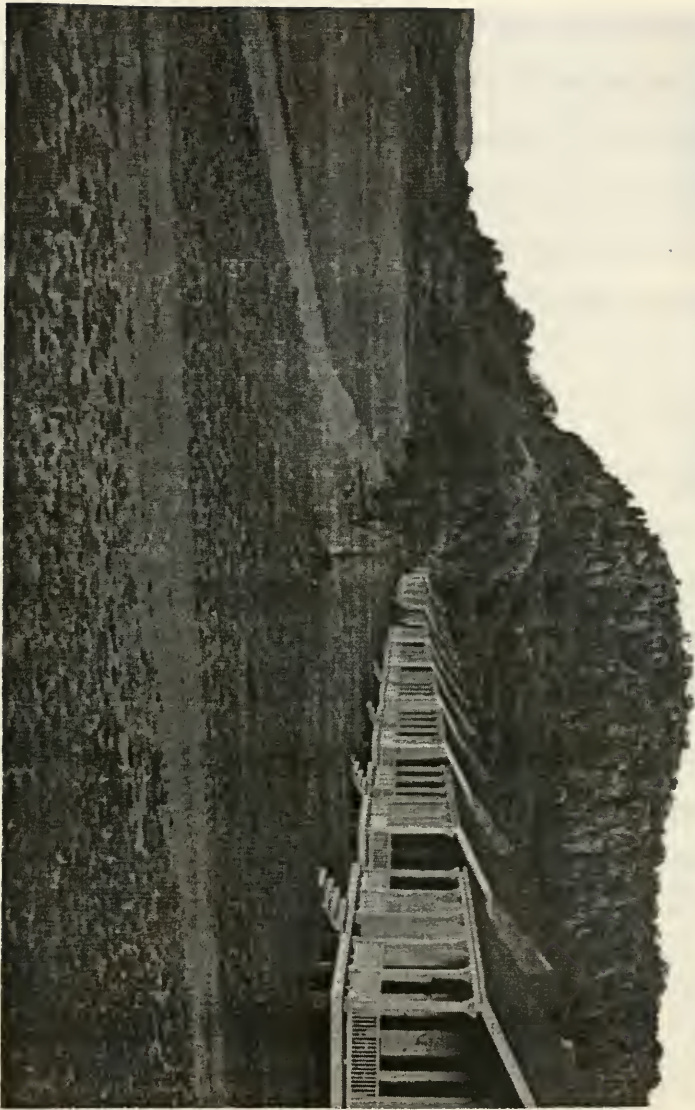
Figure 19. Photograph, Second Fort Davis officers' row, 1999 (Source: Author)

On the east side of the parade ground, the exteriors of barracks HB-20 and HB-21 have been restored, including walls, roofs, and porches. HB-20 houses the park's offices, museum, and visitor's center. Only the foundations remain of the other barracks, except that HB-26 has ruins of part of the sergeant's room at one end and of the bathhouse at the other. During the mid-1960s, the Park Service also demolished the private museum situated on the foundation of barrack HB-23 that had been operated by the Fort Davis Historical Society.¹⁶⁷

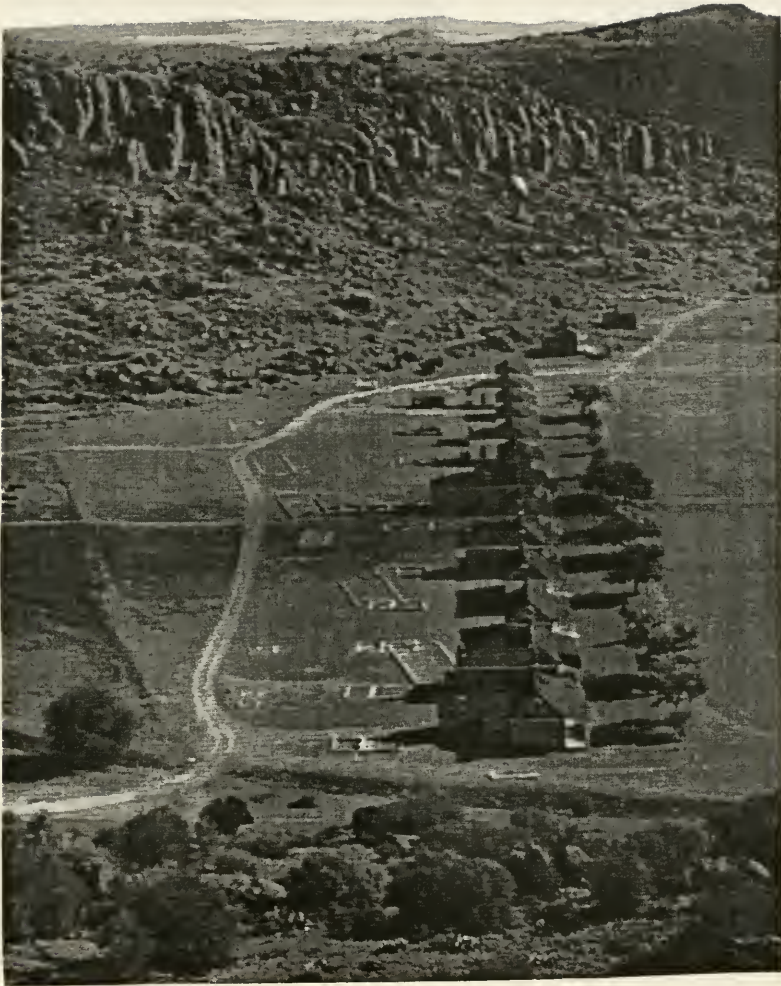
is a line of foundations of the barracks of the first fort that were uncovered through archaeological excavations.

Figure 22. Photograph, First and second fort alignments, 1999 (Source: Author)

Traces of the San Antonio-El Paso road, which was built during the period immediately preceding the erection of the first fort, run between the remaining foundations of barracks HB-26 and HB-27 and the partially restored new commissary storehouse (HB-37) to the west and the foundations of the quartermaster and cavalry corrals and stables and quartermaster storehouse (HB-38), as well as the partially restored forage house (HB-39), to the east. The remains of two other historic roads traveling within the post traverse east-to-west to the north and south of the parade ground.

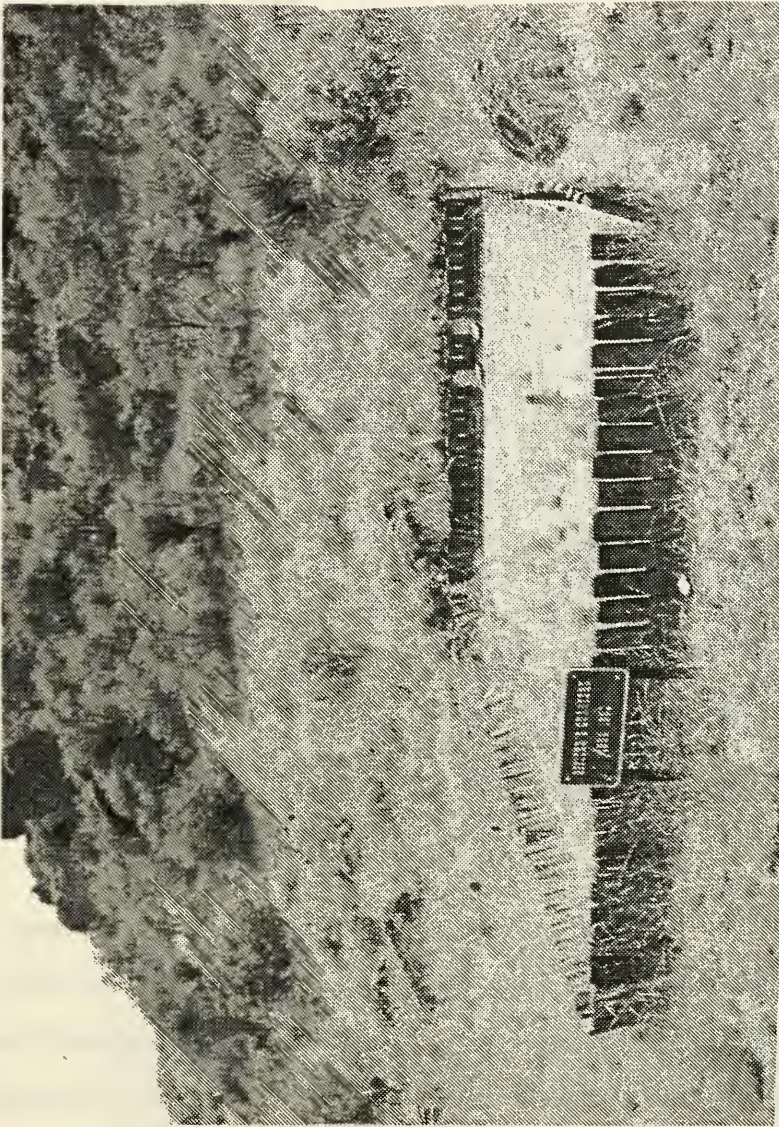
either soil cement adobes or vertical wooden stakes. These footprints are found in two clusters along the foothill of the North Ridge, one being to the west and northwest of the second fort's hospital complex and the second situated to the north and somewhat east of that complex.

Figure 23 Photograph, Representation of first Fort Davis wooden picket footprint, 1999 (Source: Author)

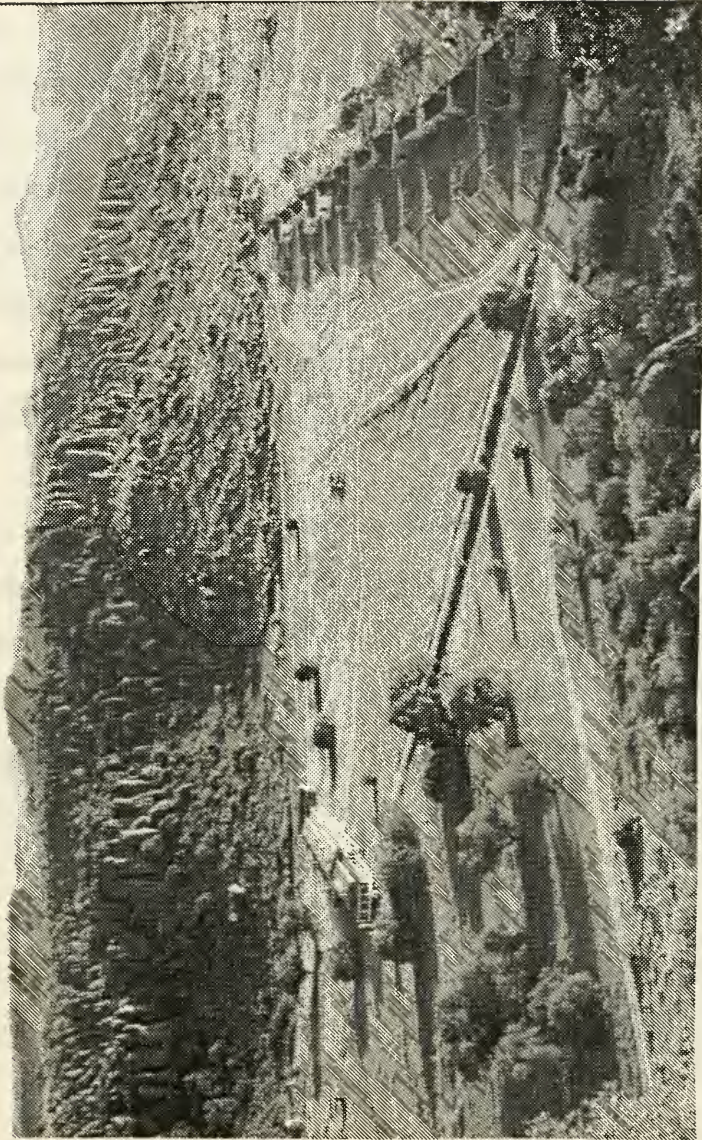
Each of the drainage ditches built at the time of the second fort, which are described in the "Topography" section affiliated with that period, remains today, although they apparently have been filled somewhat with sediment. The earthen embankment built to the rear of officers' row during the same period also remains.

Figure 24. Photograph, Remnants of Hospital Canyon drainage system, 1999 (Source: Author)

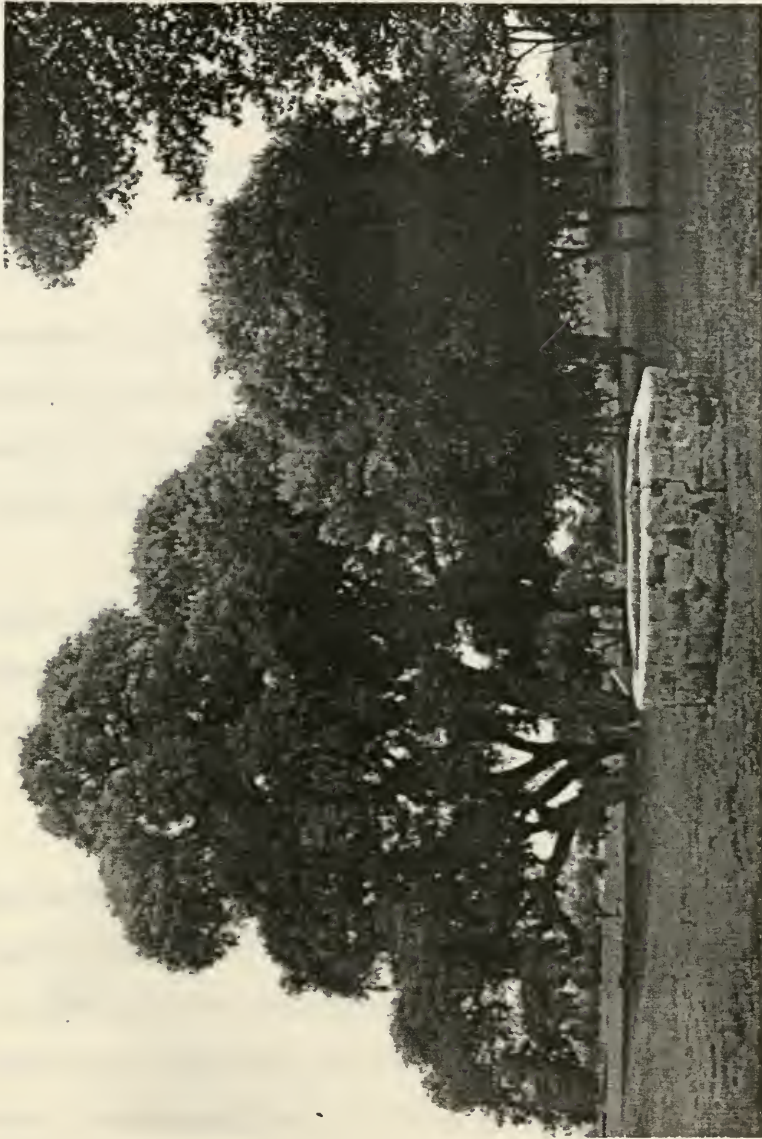
Figure 25. Photograph. Cottonwood grove and spring enclosure, 1999 (Source: Author)

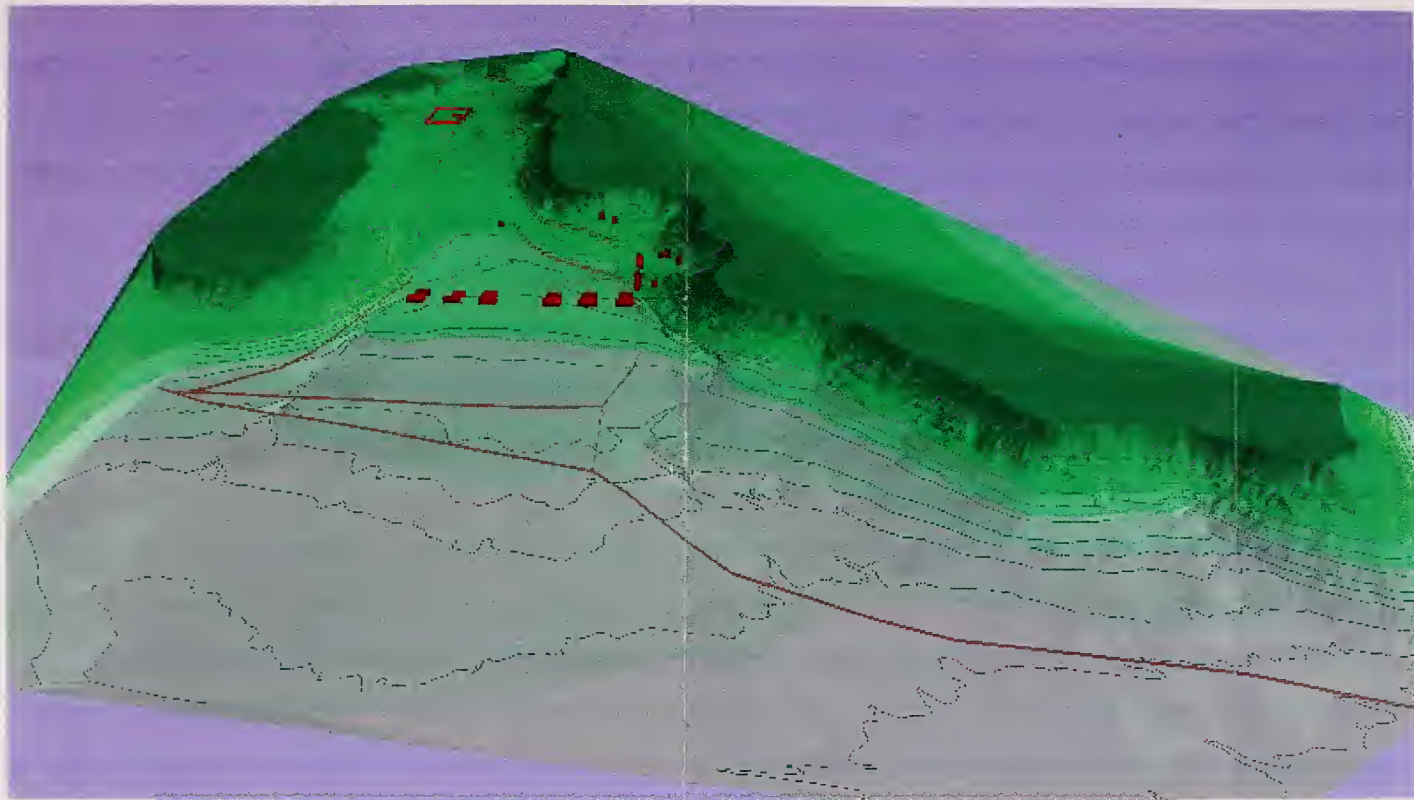
Figure 27. GIS 3-D model of first Fort Davis, 1854-1861 (Source: Author based on historic base map accompanying Greene)

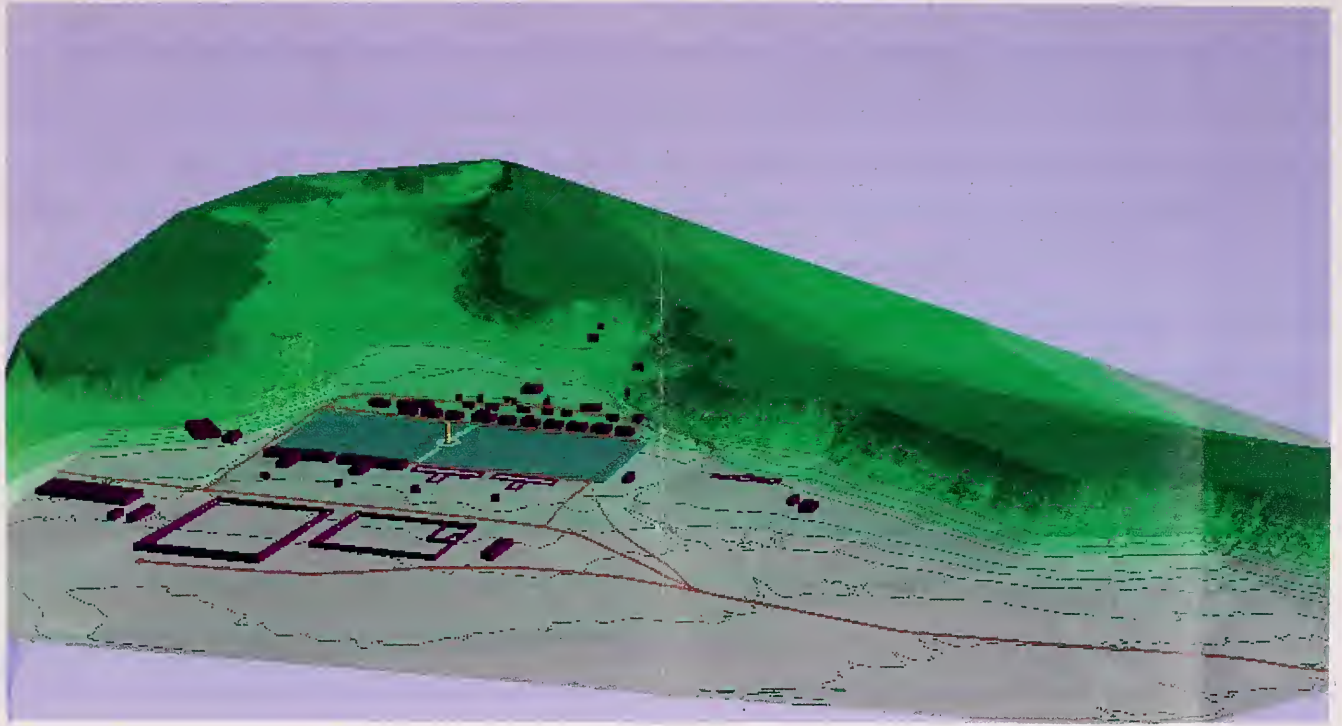
Figure 28. GIS 3-D model of second Fort Davis, 1867-1873 (Source: Author based on historic base map accompanying Greene)

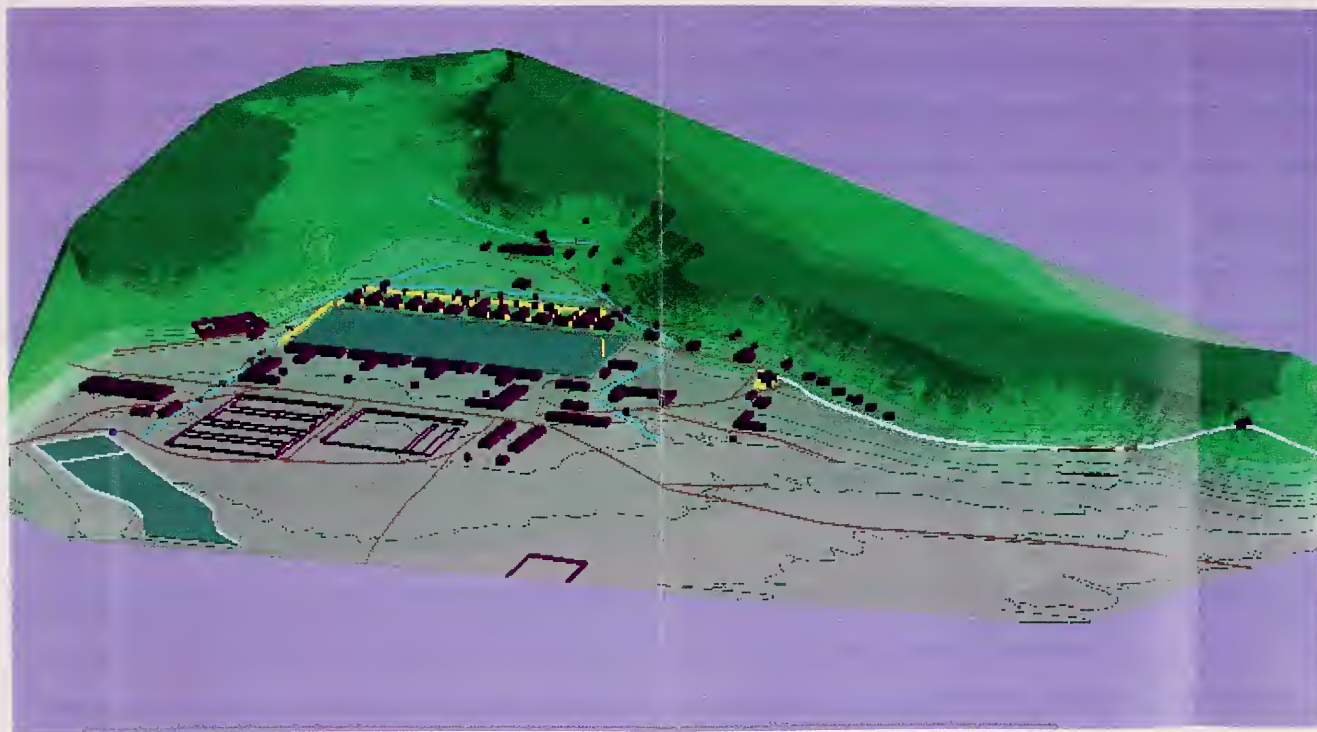
Figure 29. GIS 3-D model of second Fort Davis, 1874-1891 (Source: Author based on historic base map accompanying Greene)

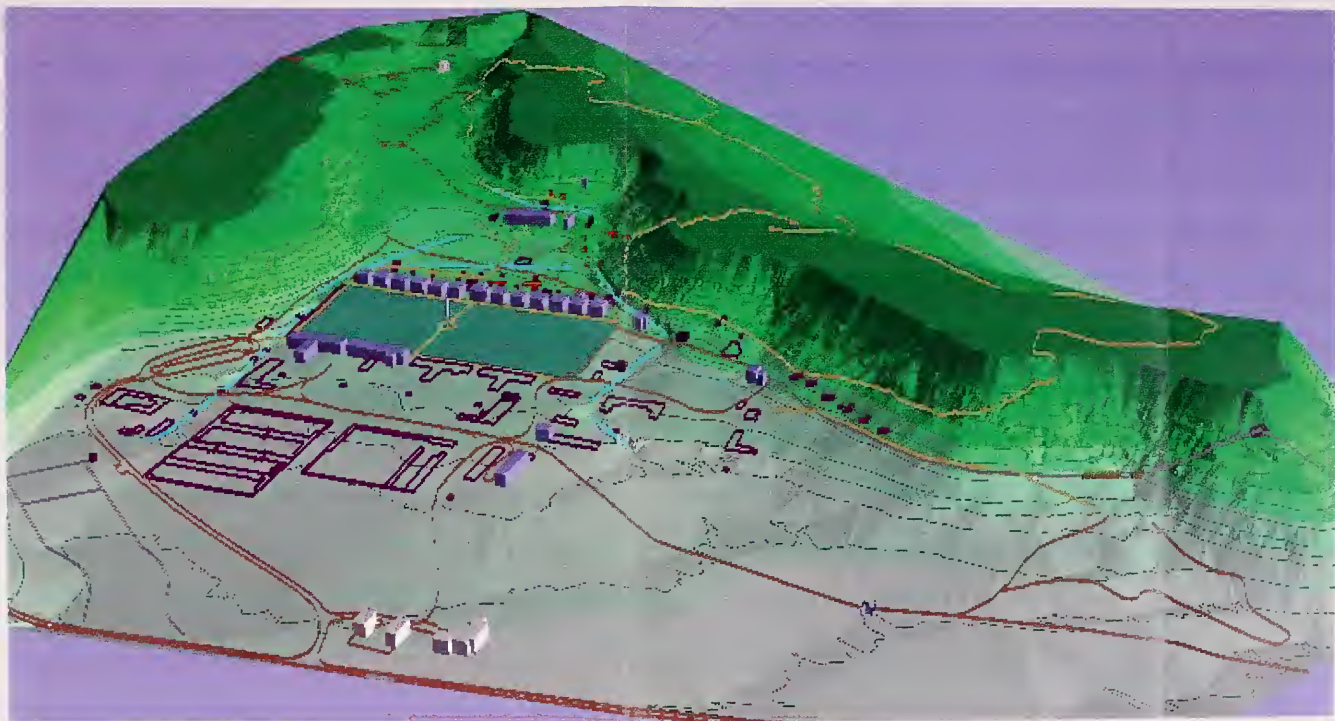
Figure 30. GIS 3-D model of Fort Davis NHS, Present conditions (Source: Author based on historic base maps accompanying Greene)
