Deterioration of Gneiss Due to Limewash at Eastern State Penitentiary

DETERIORATION OF GNEISS DUE TO LIMEWASH
AT EASTERN STATE PENITENTIARY

Elizabeth Lael Anthony Johansen

A THESIS

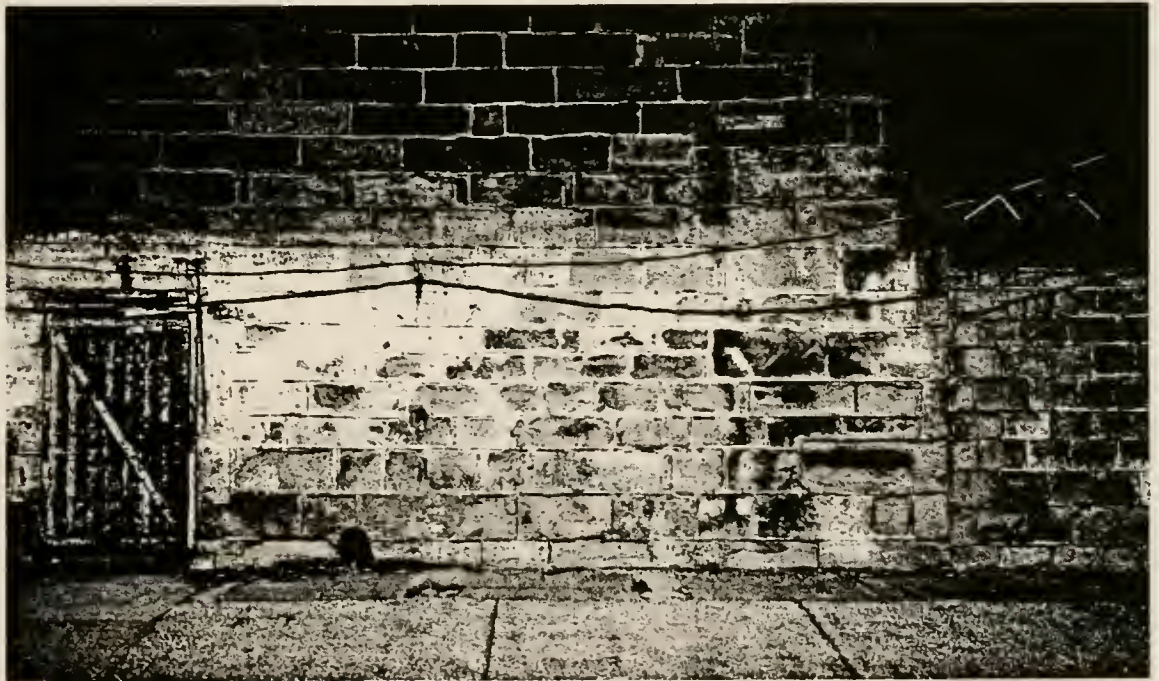
Figure 4: Differential Deterioration

Note the relative soundness of the upper material and the deterioration of the lower area.

satisfactorily explain the application of limewash on cell block elevations. Although the exact reason for treating the Cell Block Seven facade in this manner is not known, it is clear that the treatment has resulted in accelerated deterioration of the otherwise relatively durable stone.

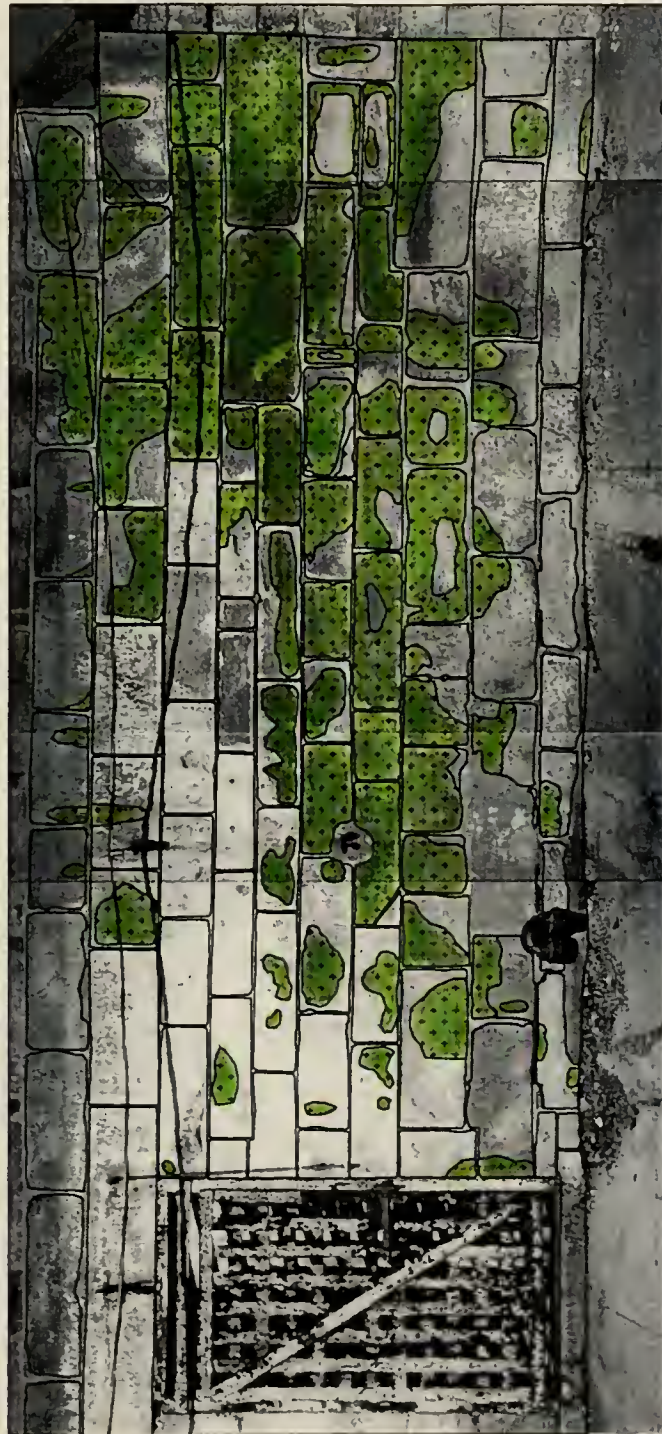
Figure 9: Salt Efflorescence

Efflorescence

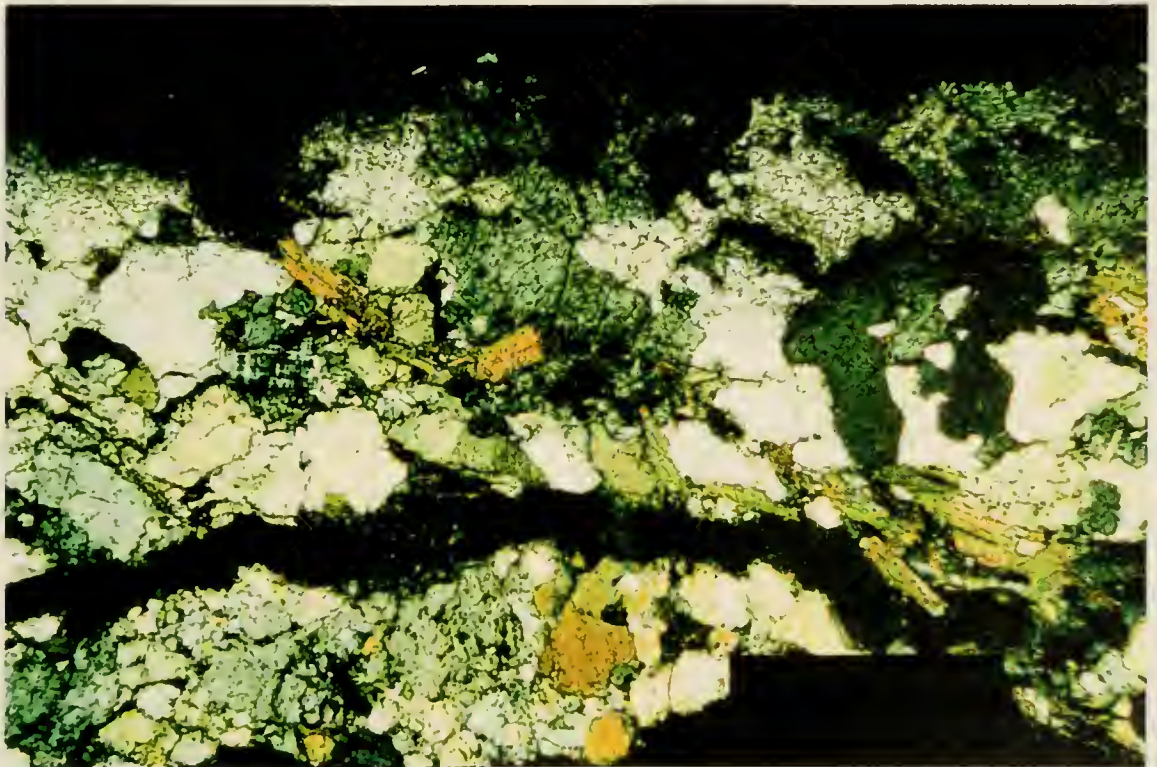
Deteriorated Crust, No Limewash

Polarized light photomicrograph under crossed nicols at 25x magnification
Photo: G.I. Omar

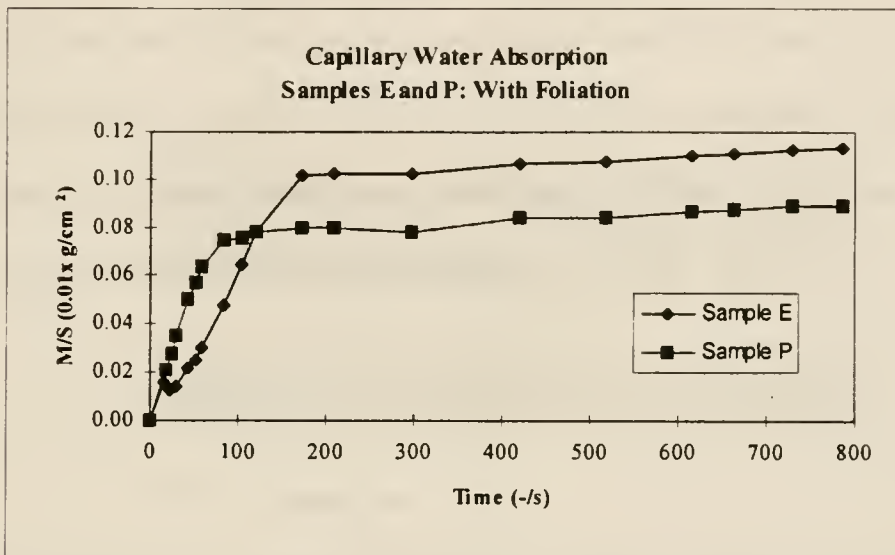
Although both Sample E and Sample P were tested with the foliation plane in the direction of capillary rise, the data from this test do not indicate a significant difference in results as a function of foliation plane orientation. The results for Sample K, which was tested with the foliation plane against the direction of capillary rise, fall within the range set by E and P.

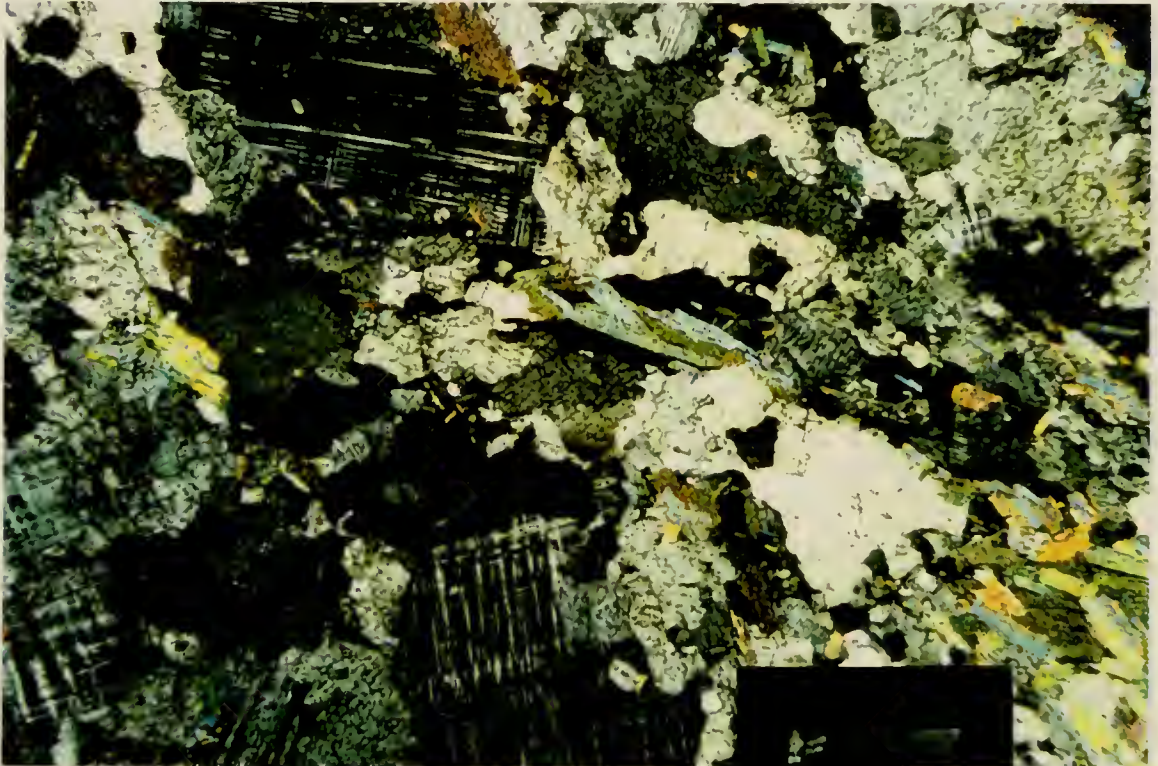
Figure 21: Sample Q, Untreated

Polarized light photomicrograph under crossed nicols at 25x magnification
Photo: G.I. Omar
