Modeling of Tomb Decay at St. Louis Cemetery No. 1: The Role of Material Properties and the Environment

Judith Alleyne Peters
University of Pennsylvania

A THESIS

Historic Preservation

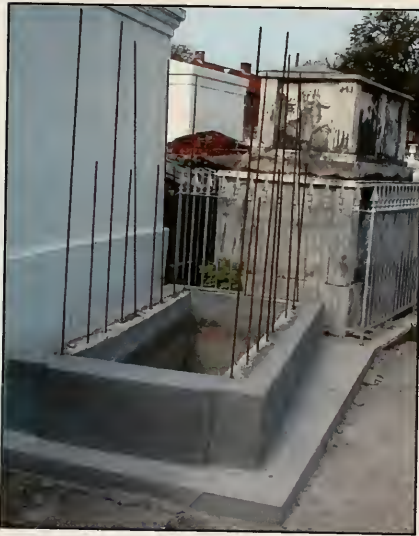
Fig. 2.8 Tomb #475, A Perpetual Care tomb being rebuilt, replacing the original historic materials.

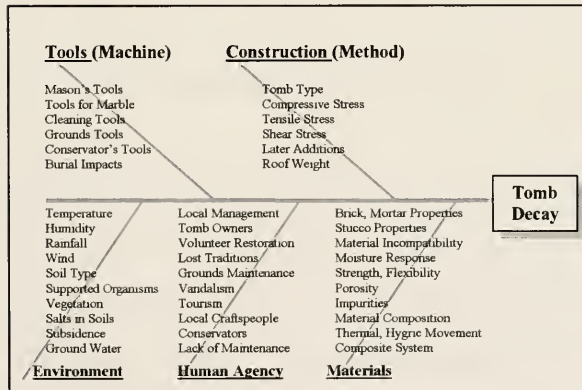
Fig. 3.1 Cause-and-effect diagram for tomb decay.

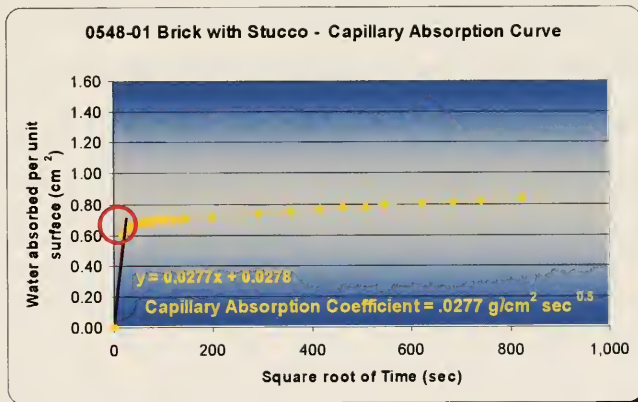
Fig 3.11 Capillary Absorption Curve for 548-01 Brick with Stucco.

When graphed as amount absorbed per unit surface (m) vs. the square root of time, as in Figure 3.11, this section of the absorption curve flattens out. The relationship of water absorption follows the law $m = A \sqrt{t}$, where m is the amount of water absorbed per unit surface and A is the slope of the first part of the absorption curve, or the Capillary Absorption Coefficient. An analogous formula to describe the penetration depth into a material (X) is $X = B \sqrt{t}$ and X is proportional to the square root of time (t). In this formula, B is called the water penetration coefficient and is also the slope of the first part of the curve. These coefficients establish the property of the hygroscopic behavior of a material. A comparison of the coefficients of each material in a composite structure highlights incompatibilities in how free water progresses, or is inhibited, within the total system.¹⁰³

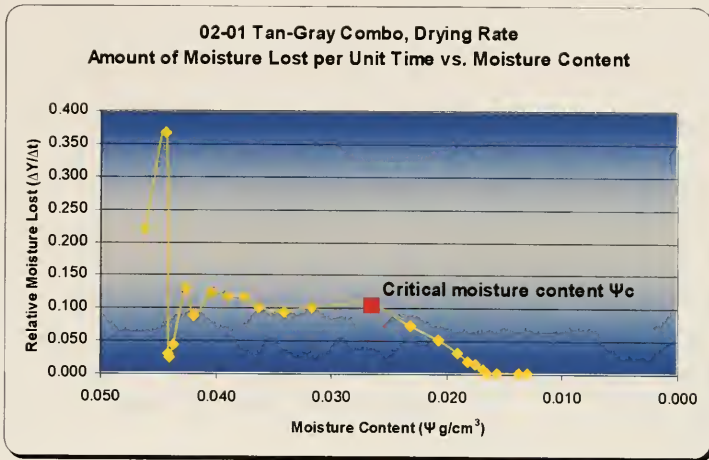
Fig. 3.13 Drying rate curve shows critical moisture content point.

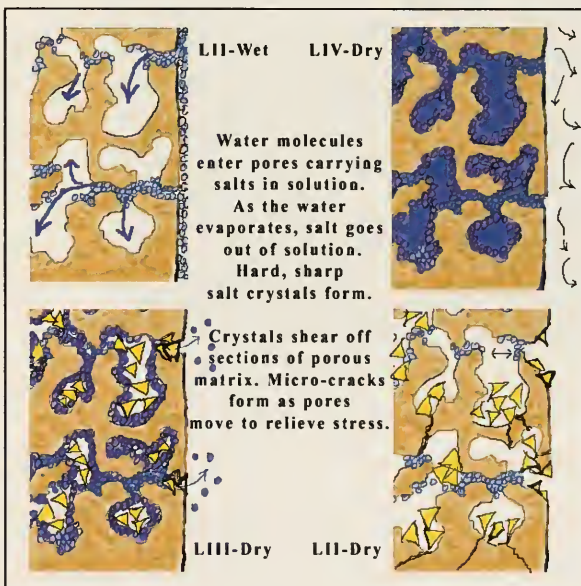
Fig. 3.14 The salt decay mechanism is a progressive mechanism, causing greater decay the more cycles the material experiences.

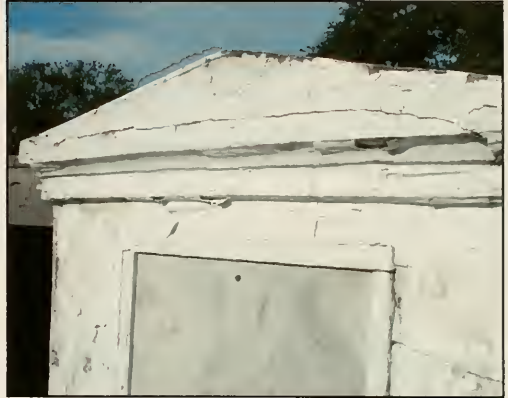
Fig. 4.3 An example of cracked and peeling modern finish..

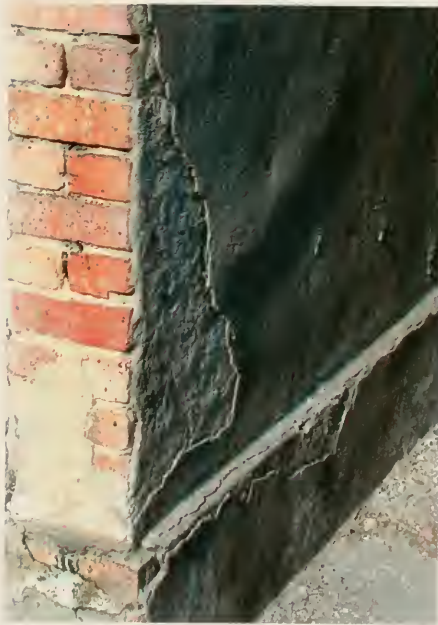
Fig. 4.4 Delamination and deformation of Stucco

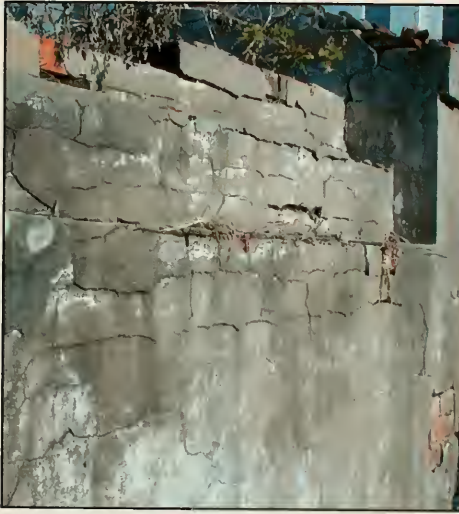
Fig. 4.5 Telescoping brick wall.

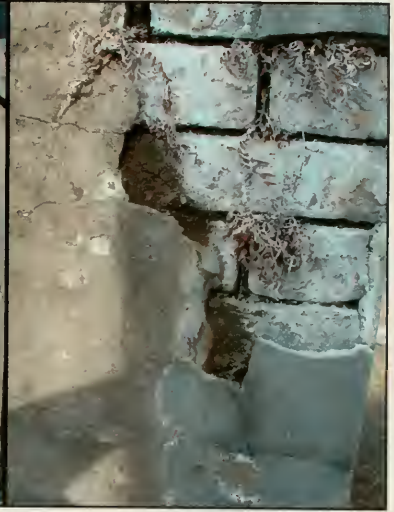
Fig. 4.6 Open mortar joints and evidence of wetness

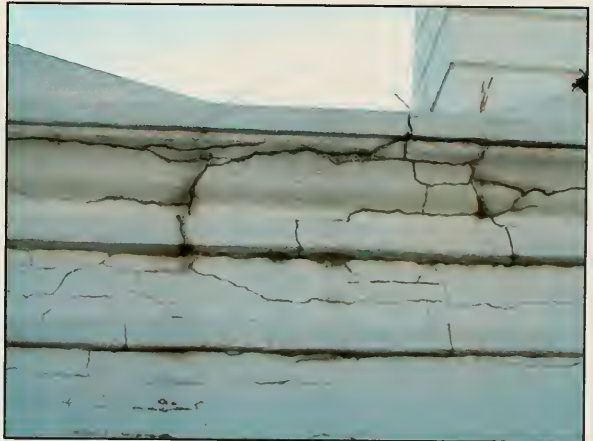
A more serious crack situation was seen in many of the original material tombs that were later encased in cement. In these tombs, the high strength of the outer cement stucco held the new casing together in

Fig. 4.7 Tomb #518 Sodiedad Cervantes de B.M. Restored in new cement.

compression for a certain time period as the soft permeable inner materials continued to shift according to moisture and temperature driven decay mechanisms. When the pressure became too great, the cement casing fractured, and caused large structural cracks in the structure, as the cement on each side of the crack held on tightly to the soft inner materials and tore them apart as the crack developed. These cracks could happen suddenly. The damage was traumatic to the tomb and could not be easily repaired.

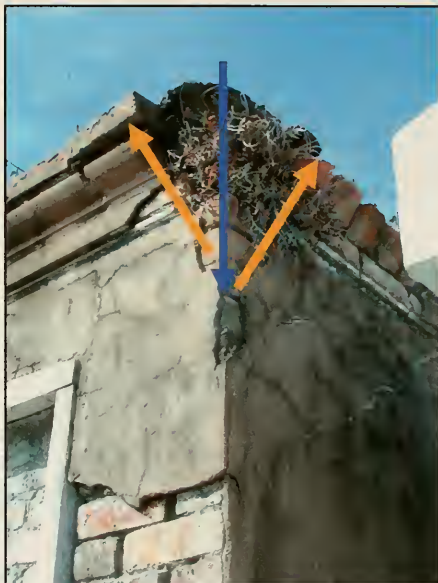
Fig. 4.11 Cornice failure.

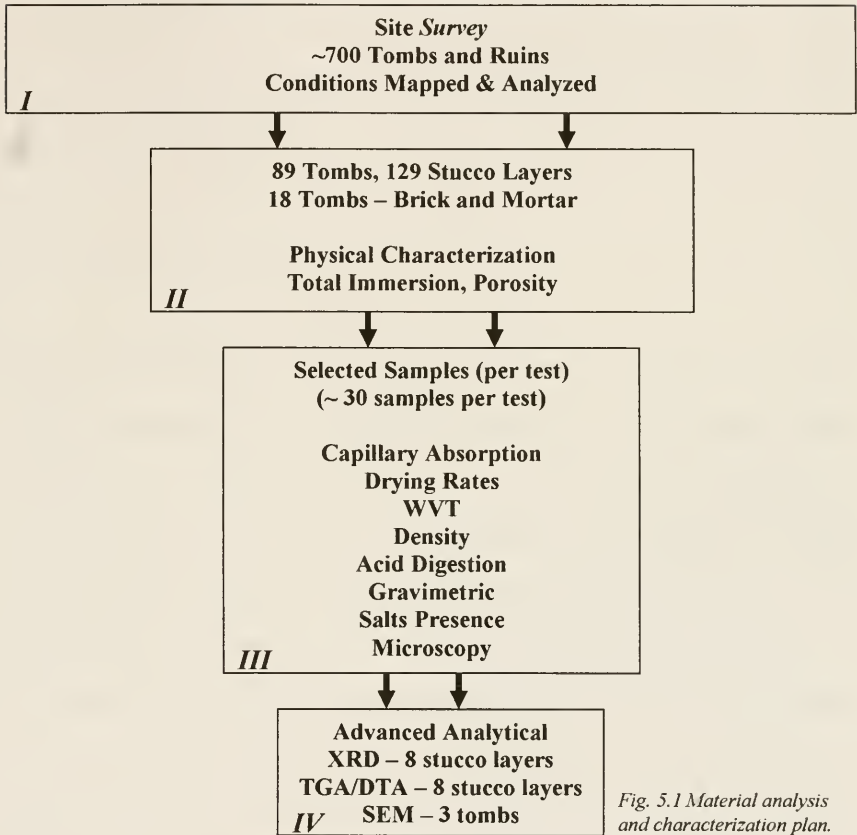
Fig. 5.1 Material analysis and characterization plan.

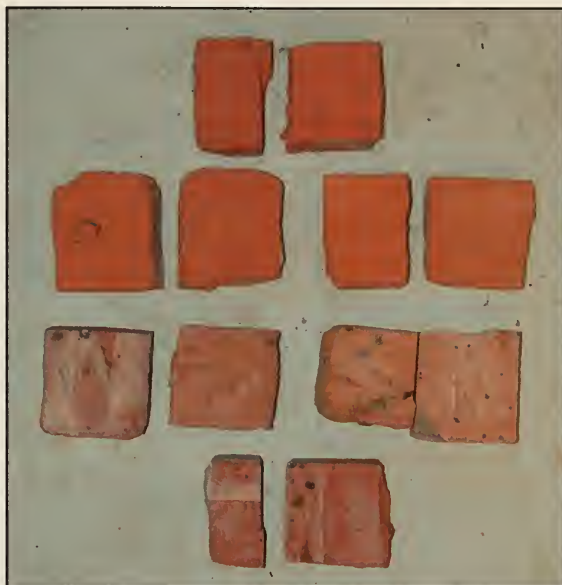
Fig. 5.5 Examples of brick samples. The top six samples are River brick which tend to be red to reddish orange. The bottom six samples are Lake brick, which are tan to pink and usually have spots of burnt impurities.

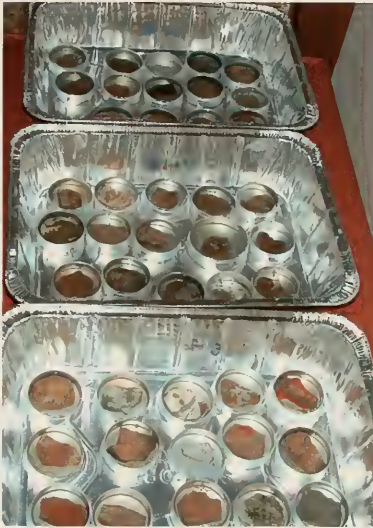
Fig. 5.6 Samples of stucco during total immersion test.

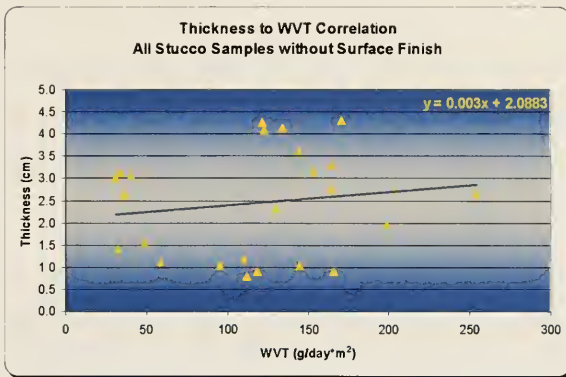
Fig. 5.13 Thickness to WVT correlation.

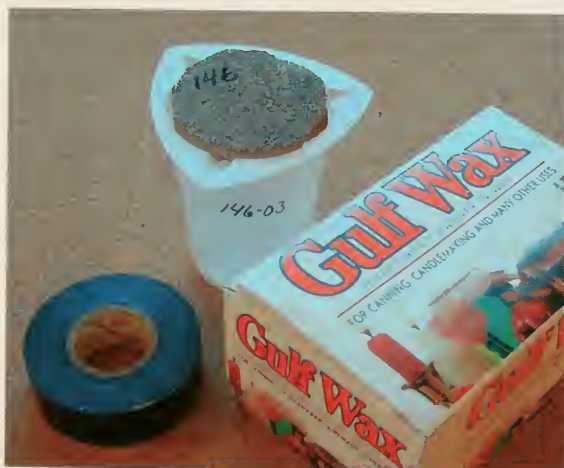
Fig. 5.14 Stucco sample preparation for WVT test.

Polyethylene beakers (100ml) with a 5.5 cm top opening and a 2 cm ledge were chosen for the test containers. Stucco discs were cut to 5.1-5.4 cm diameter. The discs were dried at 83°C for 12 hours, then cooled in a desiccator and weighed. During this time, the 10 gallon fish tank to be used as the desiccator was outfitted with wire shelves, and trays of anhydrous calcium sulfate (DRIERITE®). The tank was sealed with wide impermeable transparent tape to bring the interior to dry conditions before the start of the test. A combination thermometer and hygrometer was placed in the tank for temperature and humidity readings. The dried samples were wrapped tightly with electrical tape. The beakers were labeled and filled with 60 ml of distilled water, which brought the water level to within $\frac{3}{4} \pm \frac{1}{4}$ in of the bottom of the sample.

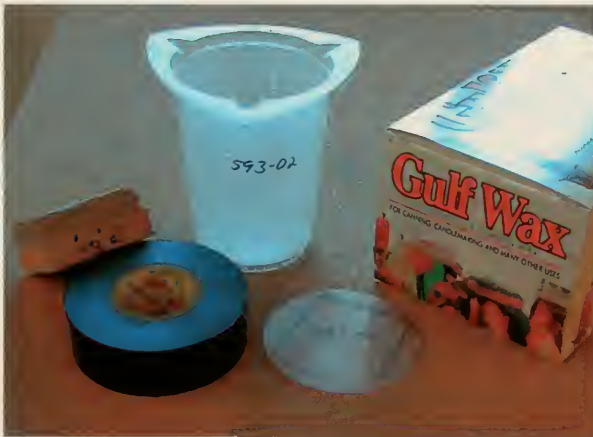
Fig. 5.15 Brick cubes for WVT test.

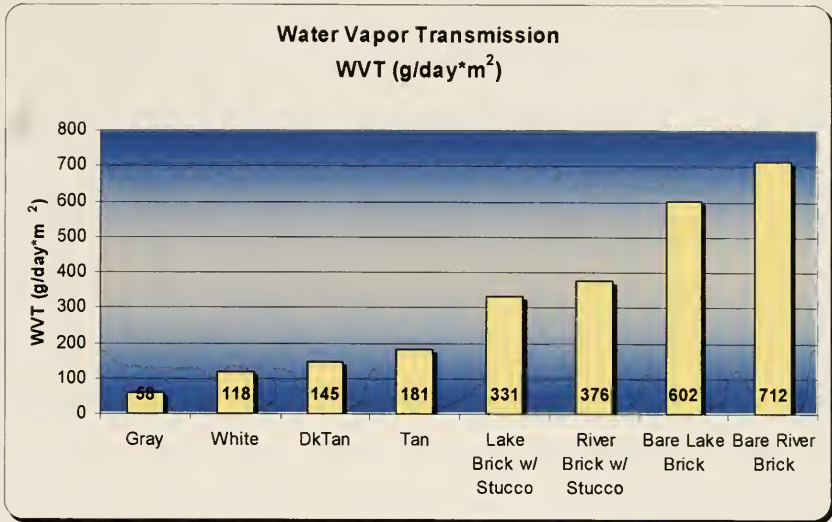
Fig. 5.18 Water vapor transmission results for brick samples.

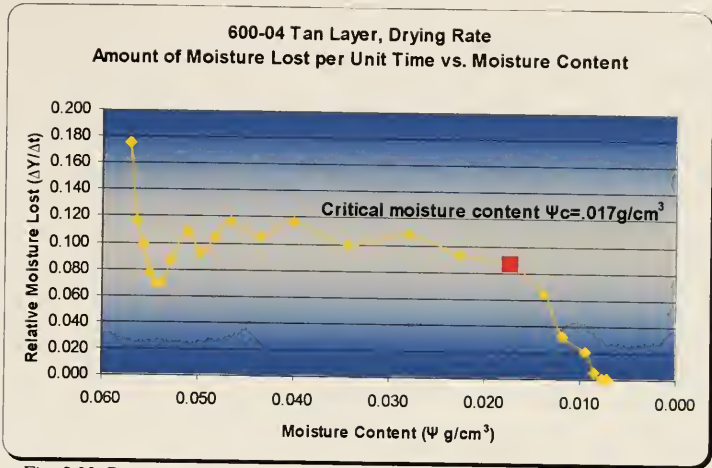
Fig. 5.22 Drying rate curve identifies the critical moisture content point.

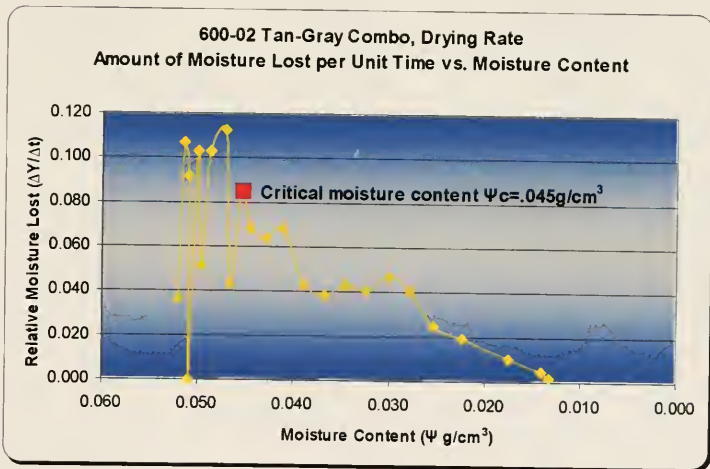
5.23 Drying rate curve for a combination sample.

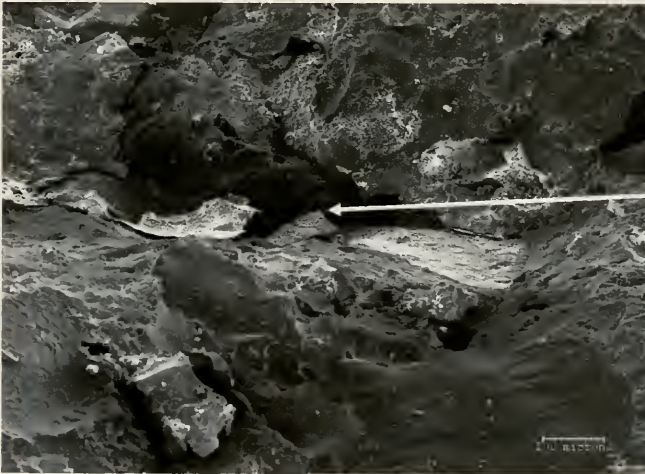
Fig. 5.48 Tomb #200, Interface between Dark Tan (top) and Gray (bottom) Stucco Layers, 100x. Note cracks and air spaces at the interface.

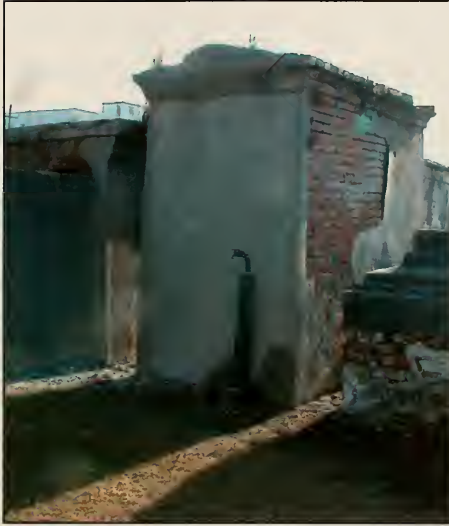
Fig. 6.8 The back of Tomb #600 covered in cement stucco. The front of the tomb is patched. Note the loss of the cornice with the new cement.

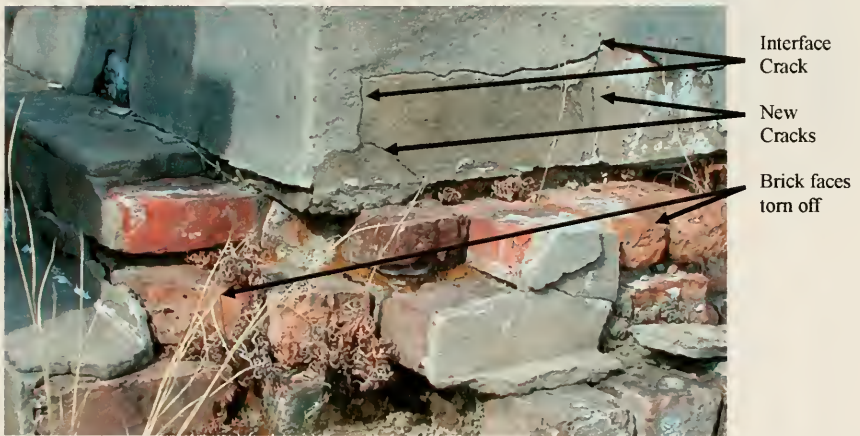
Fig. 6.10 Tomb #558 was originally covered in Tan stucco and has been patched with Gray (cement). When the Gray layer failed, it cracked at the interface with the original stucco, forcing new cracks into that layer, and tore off the brick faces wherever it was directly adhered. In some cases the released stress caused the pulling out of the entire brick. The missing bricks in the image above were found on the ground about the tomb with the cement stucco still firmly attached.

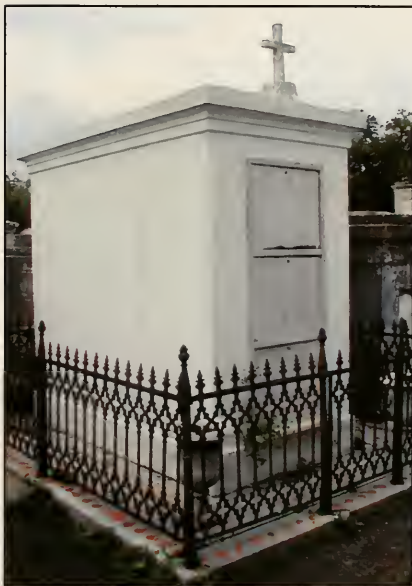
Fig. 6.12 The stucco skin on Tomb #230 has been well maintained. A modern finish coats the tomb, but has been applied over a well-prepared surface and shows no peeling or flaking. Some biological growth and higher vegetation is beginning to take hold and should be removed before problems start. A high integrity tomb on a marble precinct, surrounded by a path of grass. Studio photograph, March 2001.

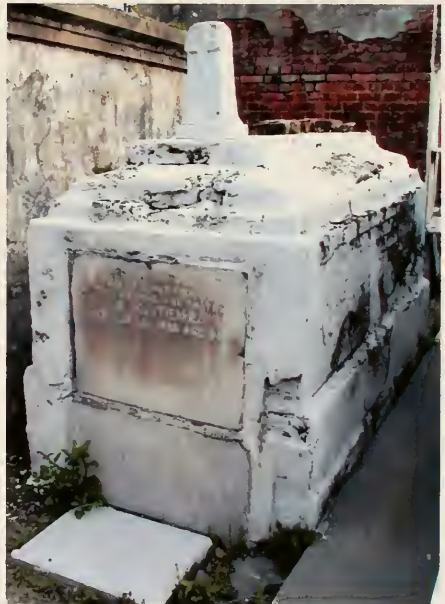
Fig. 6.21 Thick layers of peeling modern surface finishes, incomplete coverage and excessive biological growth in all the cracks and openings. Studio photograph, March 2001.

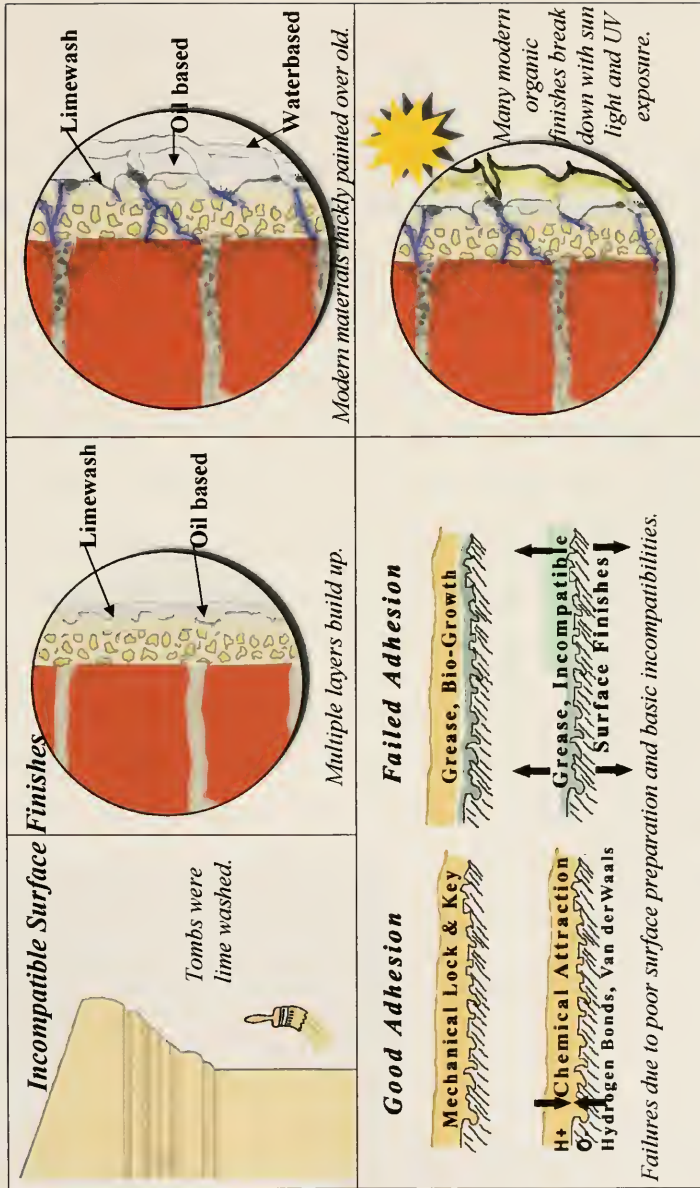
Fig. 6.22 Scenario: Incompatible surface finishes.
