A Cultural Resource Management Plan for Ephrata Cloister Historic Site

Jharna Joshi
University of Pennsylvania

A THESIS
in
HISTORIC PRESERVATION

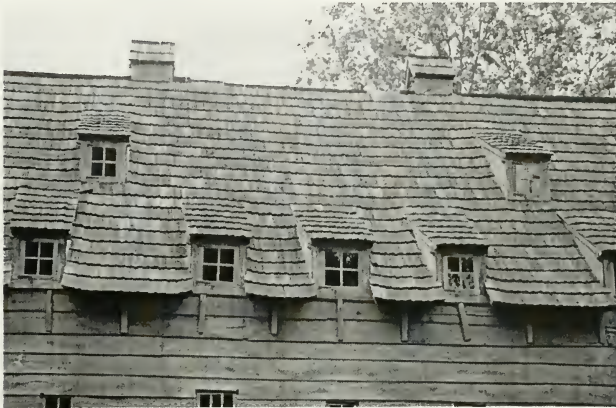
Figure 3: Multiple Rows of Shed Dormers

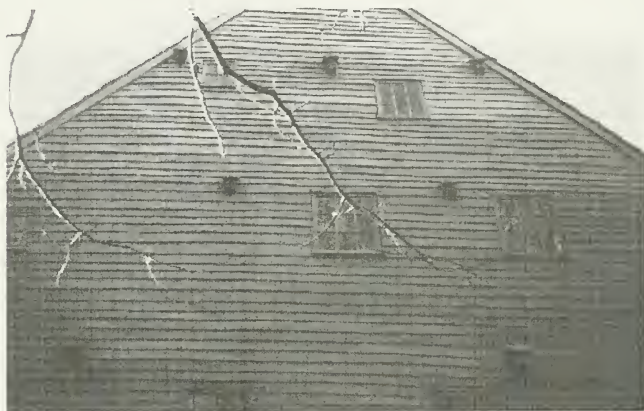
Figure 4: Exposed Beam-ends with Protective Shingle Covers

The two earliest extant buildings Saal and Saron are the main structures that contribute to the architectural significance of the site as a National Historic Landmark (See Figure 2). These buildings are excellent early examples of Germanic and medieval architecture found in North America.²⁴ Saal and Saron, built in 1741 and 1743 respectively, are unusually large for their period. Saal is a four and half-story half-timbered building with fillings of stones and clay protected on the outside by split and shaved clapboards. Saron is a three-story timber building laid out at right angles to Saal. The small casement windows, steep gable roof, and the multiple rows of shed dormers give these buildings a medieval appearance (See Figure 3). The exposed beam-ends with protective shingle covers are also a distinctive feature of these two buildings (See Figure 4).

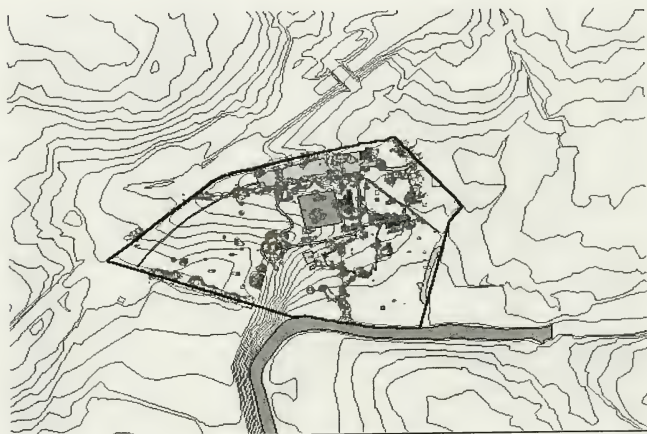
Figure 18: Major Magnetic Anomaly Locations

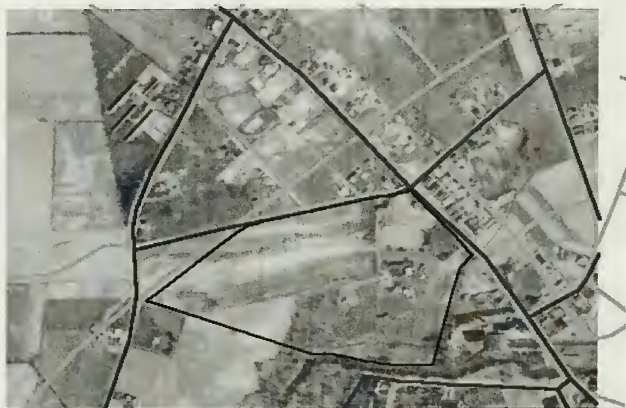
Figure 24: Comparison Between Highways and 1940 Landscape

picture of trees erroneously planted as part of the restoration projects (See Figure 24). The map and database for vegetation also includes the species of tree found today (See Figure 20). This information can assist in selecting alternative tree species and locations to replace those detrimental to the historic buildings and character of the site. Historic documents indicate that there was an orchard during the 18th century that was cut down perhaps as early as 1745.⁵² However, further research is required to locate the exact location of this orchard. The current orchard is a representation of one of the Cloister community's various activities. The concrete walkways are also intrusive and do not present historic appearance. Alternative material that is compatible in appearance to the natural walkways should be considered for replacement to provide a more accurate visitor experience.

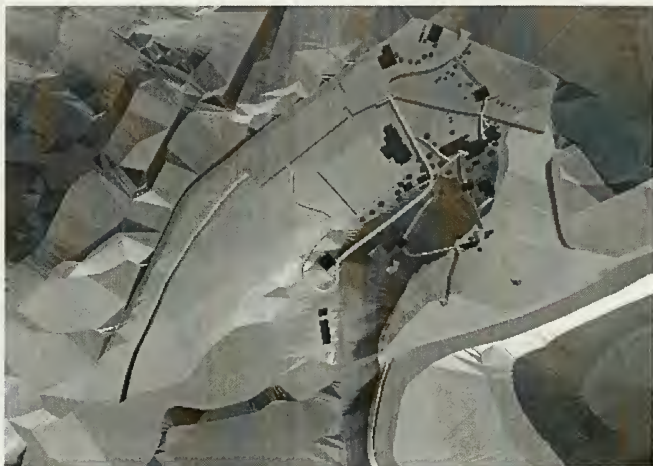
Figure 25: Three Dimensional View of Ephrata Cloister 1999

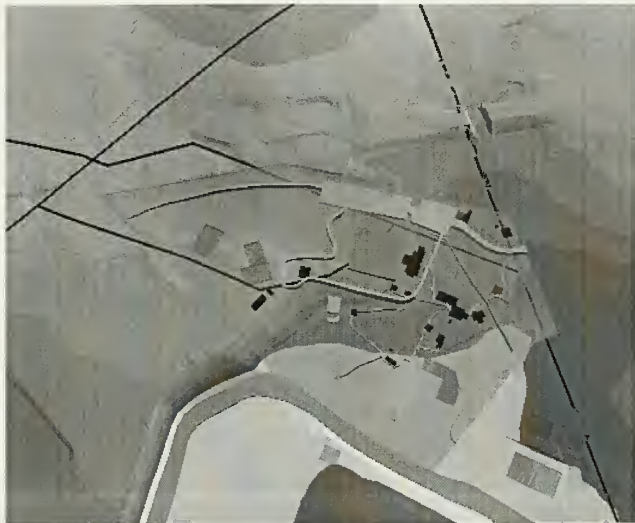
Figure 27: Three Dimensional Presentation of Ephrata Cloister today with the buildings existing in 1815 shown as transparent
