GIS as a Tool to Assess Heritage Risk: A Case Study in Frijoles Canyon, Bandelier National Monument

**GIS AS A TOOL TO ASSESS HERITAGE RISK:
A CASE STUDY IN FRIJOLES CANYON, BANDELIER NATIONAL MONUMENT**

A THESIS

Historic Preservation

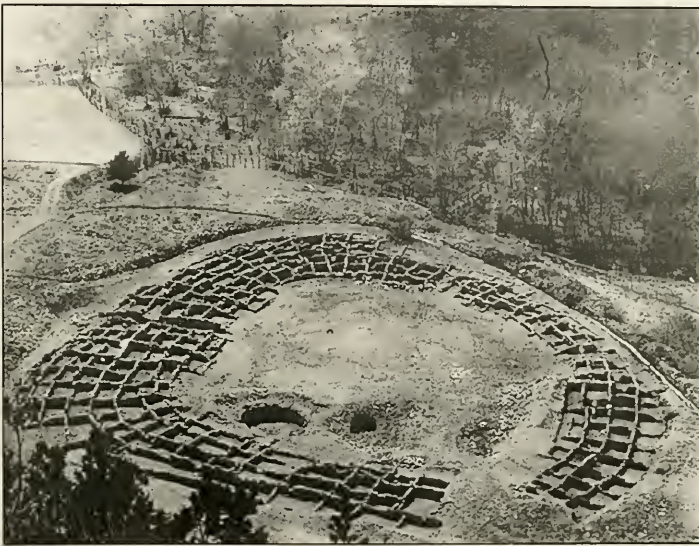
Figure 4.2 *Tyuoni Pueblo: a circular, communal pueblo in Frijoles Canyon.*

Within Frijoles Canyon there are two primary categories of ruins: pueblo ruins and cliff-dwellings. Hewett defines pueblo ruins as "communal houses of the Pueblo Indians that

are situated on mesas, in valleys, or on plains, independent of support from natural rock walls; they are both ancient and

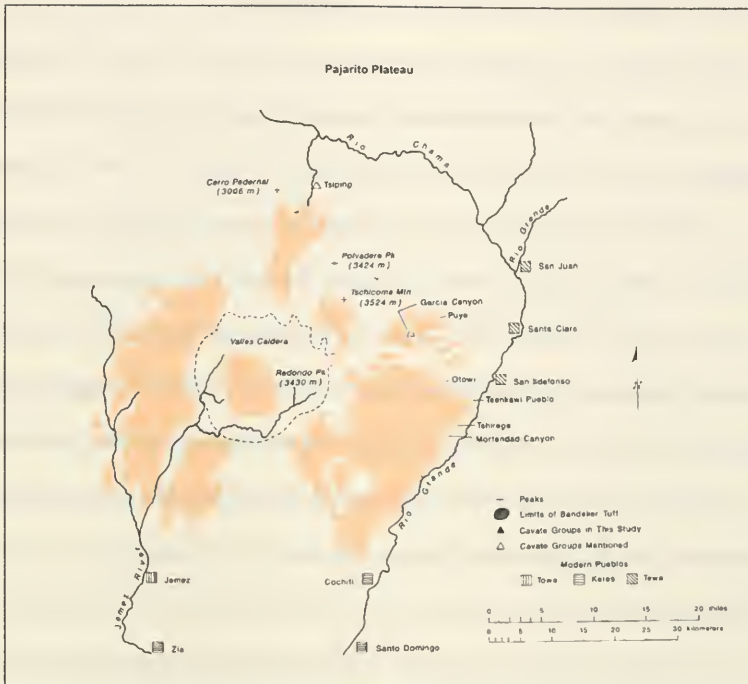
Figure 4.3 Areas in pink show the distribution of Bandelier Tuff on the Pajarito Plateau, based on image by H. Wolcott Toll, page 4.

The stratigraphy of the Pajarito Plateau consists of a cover of volcanic ash that has hardened over layers of pumice and basalt. Two categories of Bandelier Tuff – Tschirege Member, or Upper Bandelier Tuff, and Otowi Member, or Lower Bandelier Tuff – cover the Pajarito Plateau; each results from the volcanic activity of the region, and each is primarily a welded rhyolitic formation. In the report of the 1999 study *Tsankawi Unit Cavate Conditions Assessment and Treatment Recommendations* conducted by the Architectural Conservation Laboratory of University of Pennsylvania and the National

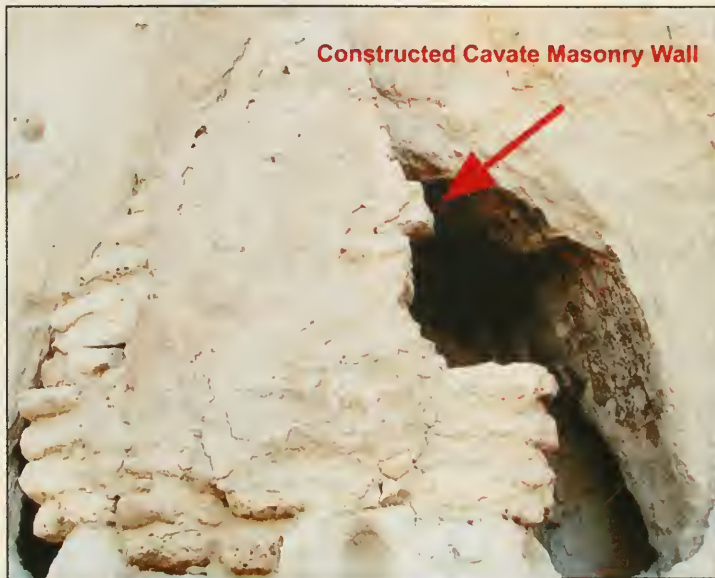
Figure 5.1 *Cavate MJ092, considered "protected," with a masonry wall.*

In the *unit summary* section, the exposure of each cavate is listed as either “open,” or “protected.” “Open” cavates refer to cavates that have lost the walls that surround constructed entrances, and are now more than fifty percent exposed. “Protected” cavates retain at least fifty percent of the masonry walls of the entrance segment. The “orientation” of each cavate was recorded with a standard compass, using true north and decimal degrees, standing in a

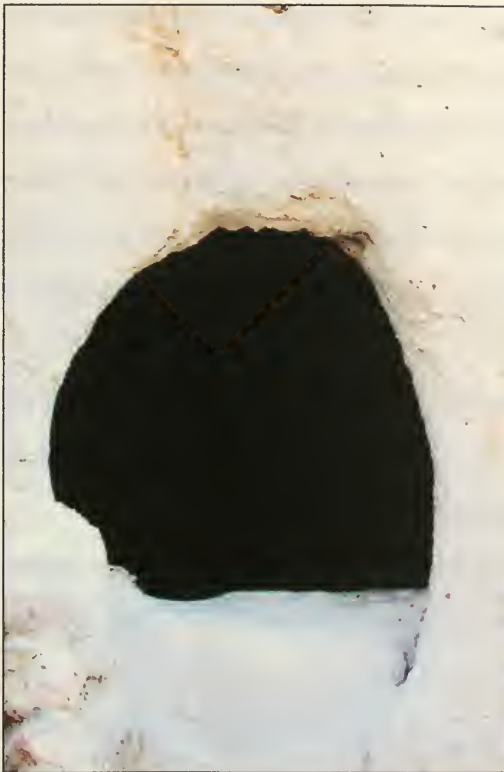
Figure 5.2 *Cavate MJ100: Isolated and open.*

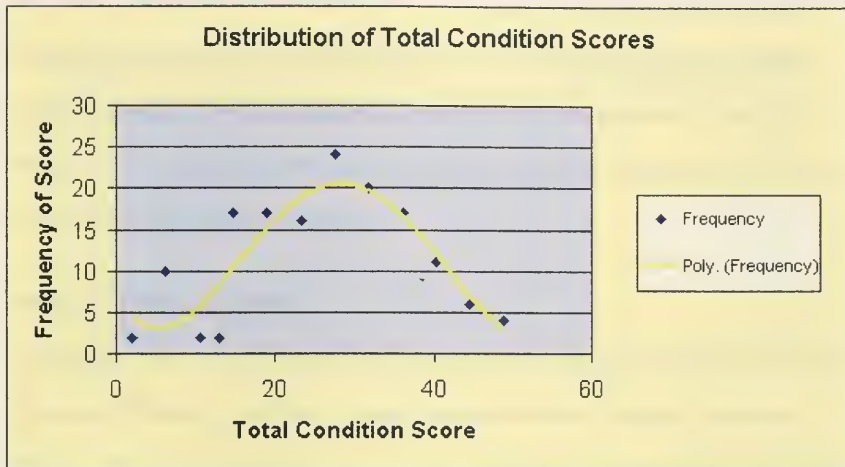
Figure 5.3 *A histogram displays the distribution of total condition scores.*

The format of the field survey allows for the arbitrary creation of three categories of condition score, grouped as “high,” “medium,” and “low.” Total condition scores range from two to fifty-three, where two represents cavates in the best condition and fifty-three is the cavate in the most deteriorated state. A histogram displays the numeric distribution of condition scores by plotting the frequency of total scores against total condition values. The graph indicates that most of the scores, 111 of 148 surveyed cavates, are concentrated in the range of 14.75 to 36.

Based on the distribution of total condition scores, the three groups of condition break down into the following three categories: high condition value, including those cavates with a total condition score of greater than 36; medium condition value, which includes those cavates with a total condition value in the range of 14.75 to 36; low condition value, made up of cavates with a total condition score of less than 14.75. An initial map query shows the spatial distribution of condition categories. (See Appendix C, Layout 4)

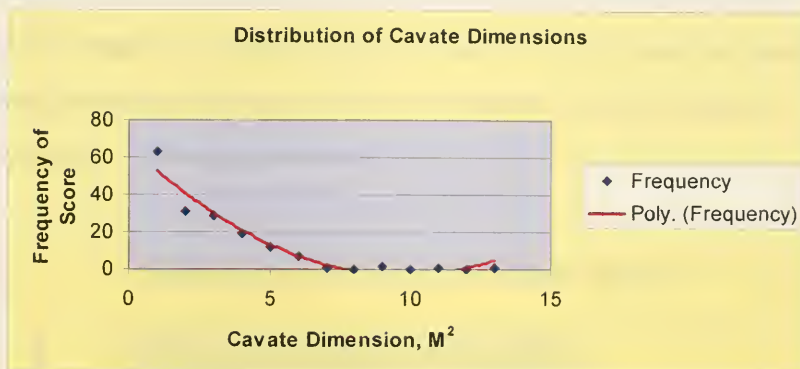
Figure 5.4 The histogram shows the distribution of cavate opening dimensions.

Dimensions recorded in Cavate Group M range from 0.1 square meters to 18.27 square meters. As the histogram below illustrates, most of the cavate openings (55 percent) range in size from 1.5 to six square meters.

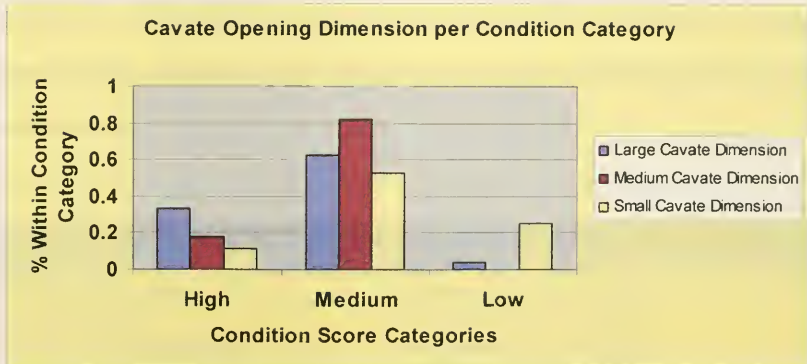
Figure 5.5 The bar graph displays the cavate opening dimension size per condition category.

Large opening dimensions correlate with high and medium condition scores. Of the 24 cavates with large opening dimensions, eight cavates (33 percent) have high total condition scores, 15 (63 percent) have medium total condition scores, and one cavate (four percent) has a low condition score. By contrast, 31 of the 123 cavates with small opening dimensions (25 percent) also have a low condition score. (See Appendix C, Layout 12)

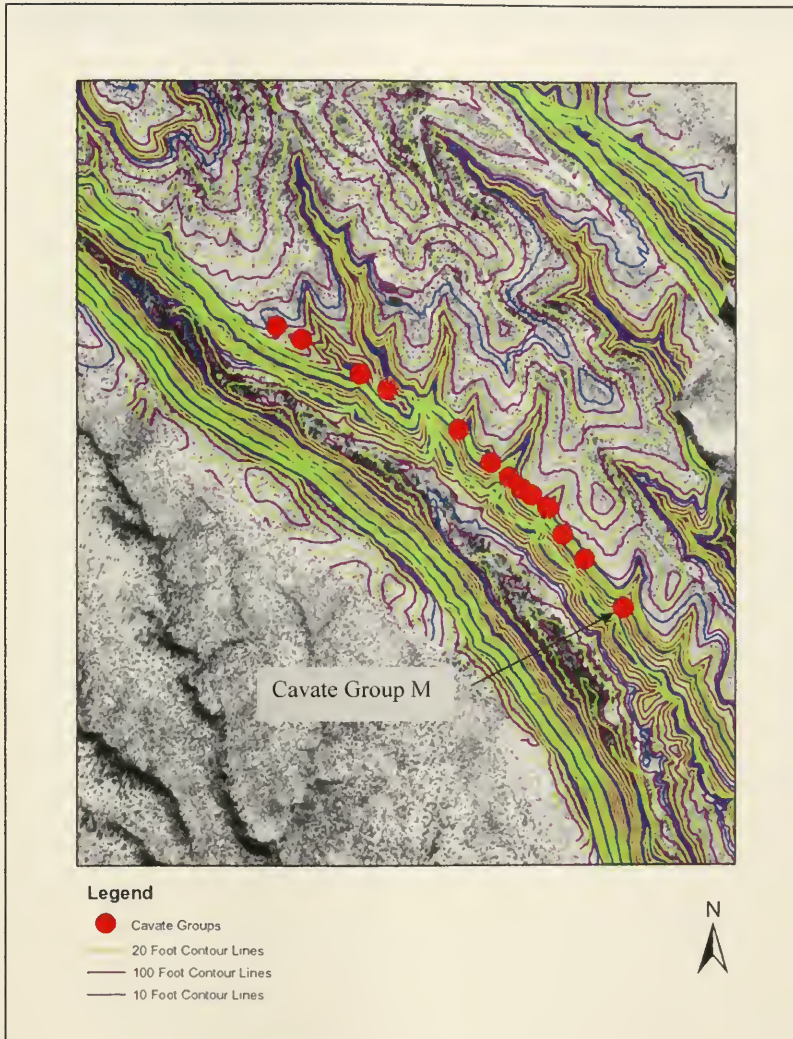
Figure A.2 *Aerial Photograph of Frijoles Canyon, Overlaid with Contour Lines. Cavate Groups A-M are marked in Red.*

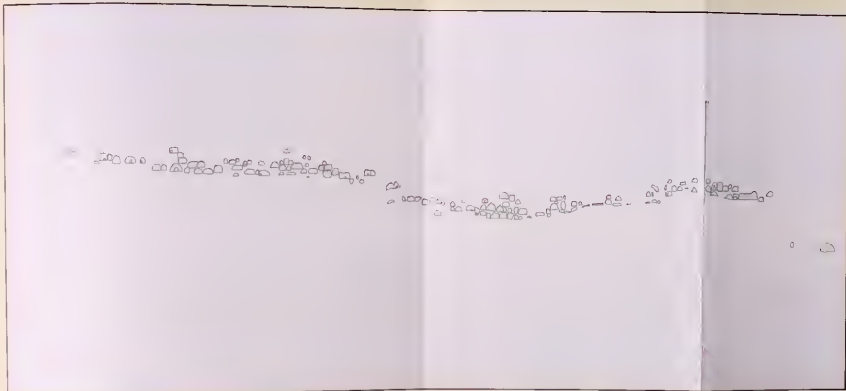
APPENDIX C, Layout 2

Cavate Elevation Image Imported into the GIS

The Cavate Elevation drawings were imported into the GIS as individual polygons, and assigned the appropriate Cavate Identification number

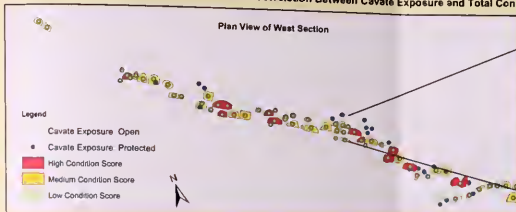
Panel E Cavates
Protected due to niche in cliff face

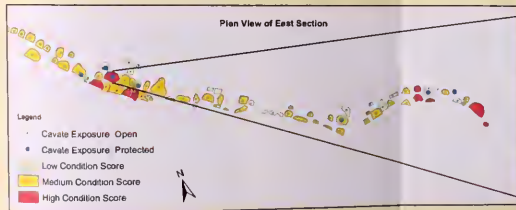
Panel J Cavates
Cavates considered "protected"
due to constructed masonry walls

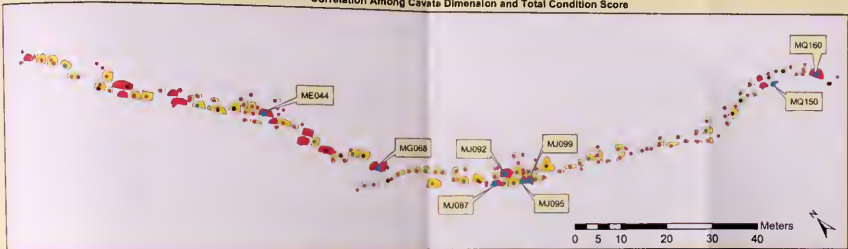
APPENDIX C, Layout 12

Correlation Among Cavate Dimension and Total Condition Score

Most of the cavates in the High Condition group have large opening dimensions. Many cavates with small opening dimensions fall within the low condition category.

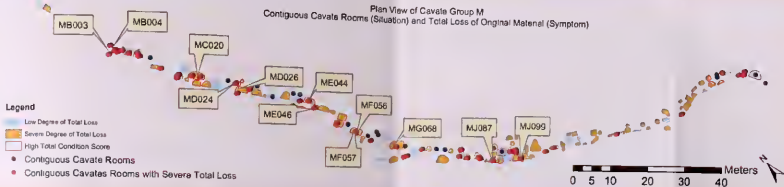
Plan View of Cavate Group M
 Contiguous Cavate Rooms (Situation) and Total Loss of Original Material (Symptom)

There are twelve cavate rooms with a severe score recorded for total loss of original fabric, and fall into the high condition score category

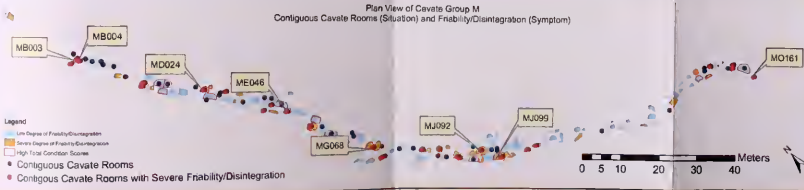
Plan View of Cavate Group M
 Contiguous Cavate Rooms (Situation) and Friability/Disintegration (Symptom)

There are eight contiguous cavates with severe friability/disintegration scores, and fall into the high condition score category.

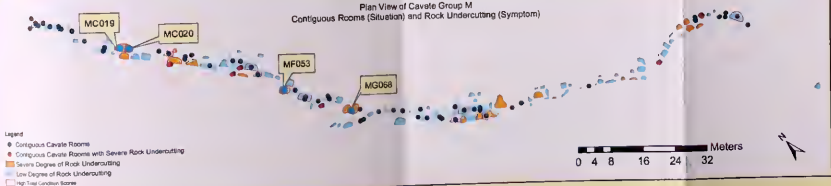
Plan View of Cavate Group M
Contiguous Rooms (Situation) and Rock Undercutting (Symptom)

Four cavates are contiguous, with a severe score for rock undercutting, and fall into the high condition score category.

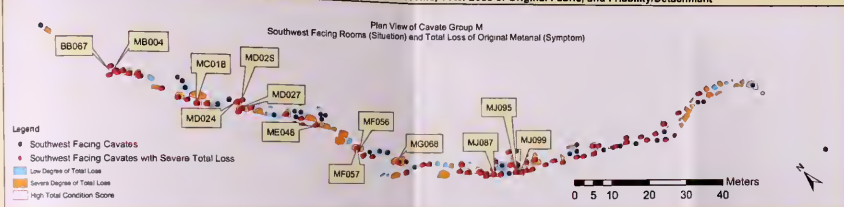
APPENDIX C, Layout 15
Correlation Between Southwest Facing Cavate Rooms, Total Loss of Original Fabric, and Friability/Detachment

Thirteen cavates face southwest with a severe score recorded for total loss of original fabric, and fall into the high condition score category.

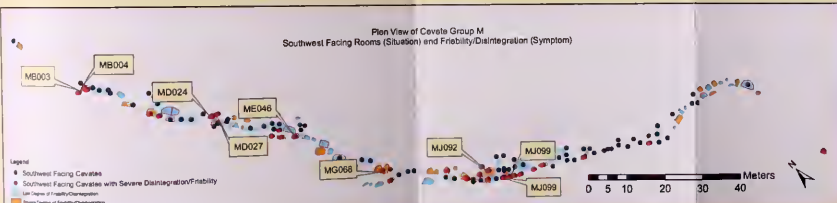
Nine cavates face southwest, with severe friability/diintegration scores, and fall into the high condition score category.

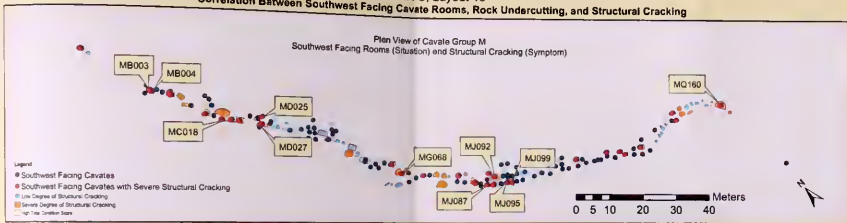
APPENDIX C, Layout 16
Correlation Between Southwest Facing Cavate Rooms, Rock Undercutting, and Structural Cracking

Eleven cavates face southwest with a severe score recorded for structural cracking, and fall into the high condition score category

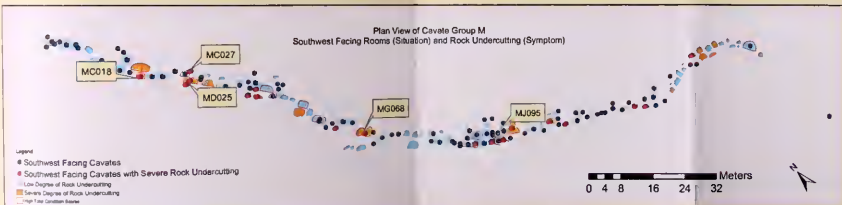
Five cavates face southwest, with a severe score for rock undercutting, and fall into the high condition score category.

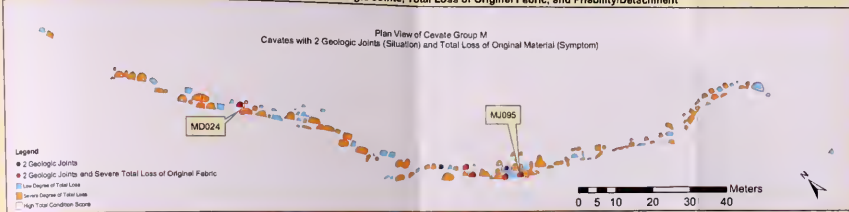
APPENDIX C, Layout 17
Correlation Between 2 Geologic Joints, Total Loss of Original Fabric, and Friability/Detachment

Two cavates have two geologic joints with a severe score recorded for total loss of original fabric, and fall into the high condition score category

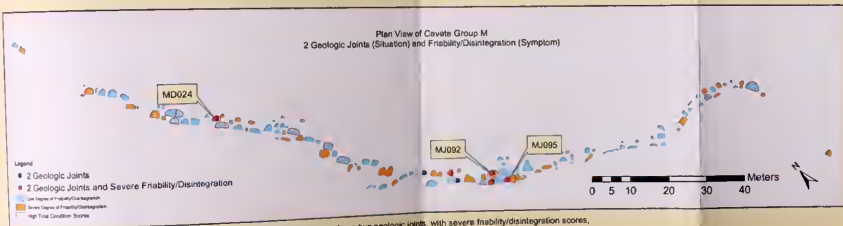
Three cavates have two geologic joints, with severe friability/disintegration scores, and fall into the high condition score category.

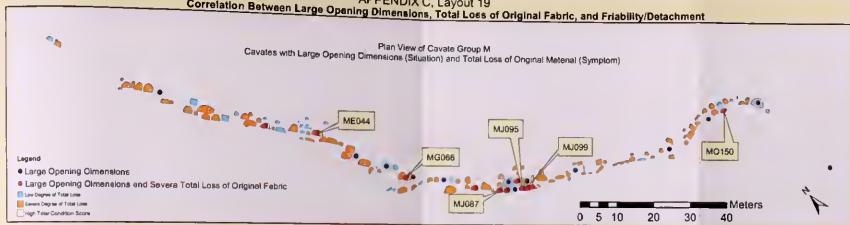
APPENDIX C, Layout 19
Correlation Between Large Opening Dimensions, Total Loss of Original Fabric, and Friability/Detachment

Six cavates have large opening dimensions with a severe score recorded for total loss of original fabric, and fall into the high condition score category

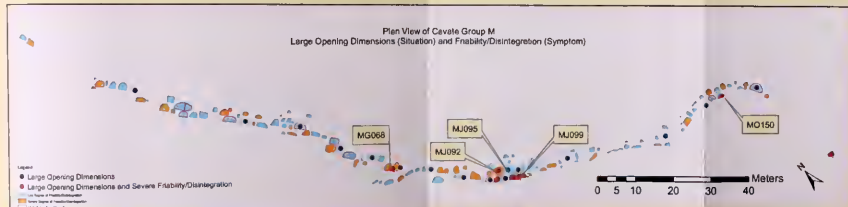
Five cavates have large opening dimensions with severe friability/disintegration scores, and also fall into the high condition score category.

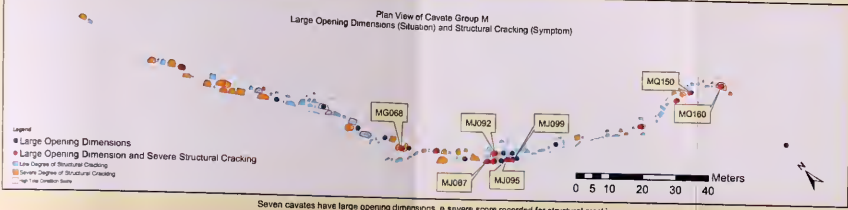
APPENDIX C, Layout 20
Correlation Between Large Opening Dimensions, Rock Undercutting, and Structural Cracking

Seven cavates have large opening dimensions, a severe score recorded for structural cracking, and fall into the high condition score category

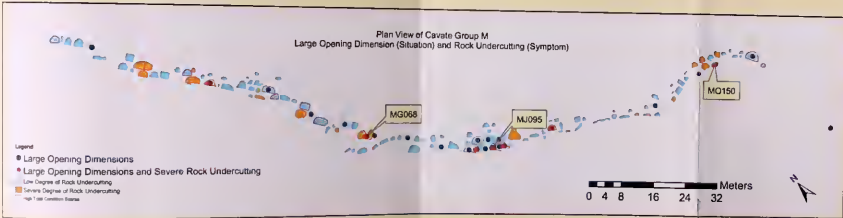
Three cavates have large opening dimensions, with a severe score for rock undercutting, and a high total condition score.
