Evaluation of Cementitious Injection Grouts for the Stabilization of Holly Tower Support Rock, Hovenweep National Monument

Naima A. Sweeting
University of Pennsylvania

This thesis addresses the testing and evaluation of the use of a cementitious injection grout for the reattachment of detached slabbing on the sandstone support rock of Holly Tower at Hovenweep National Monument. This research follows on a previous condition assessment and diagnosis of the deterioration of the sandstone support rock and the effects of consolidation on the rock as the first step in a multi-phase conservation program.

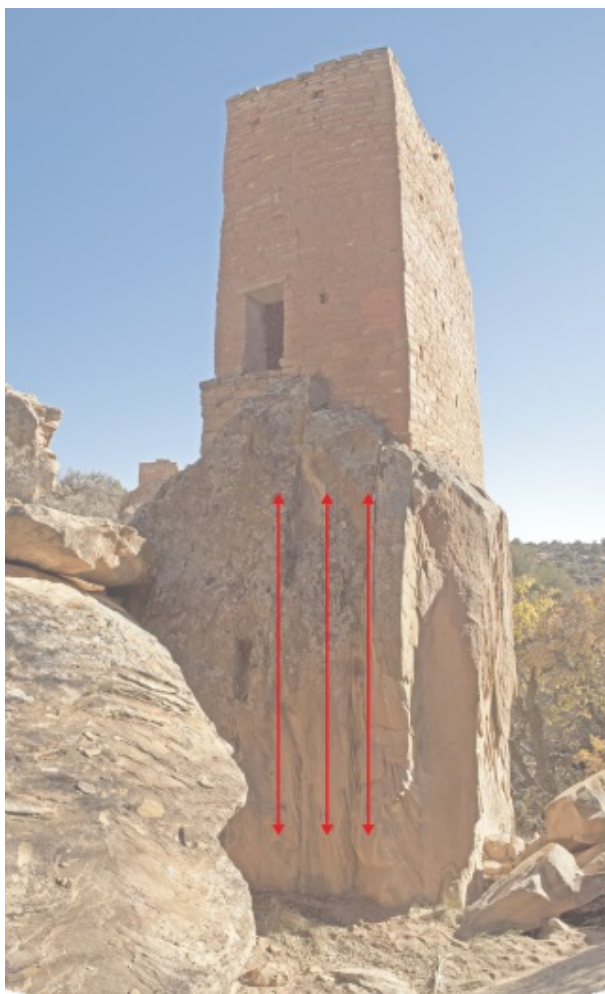
Figure 5. Vertical bedding orientation of the Holly Tower support rock.
Source: Architectural Conservation Laboratory, University of Pennsylvania, 2012.

Prior to the construction of Holly Tower, the support rock detached from the canyon rim and rotated roughly ninety degrees from its original orientation. As a result, the bedding planes are oriented vertically, allowing rain and snow to infiltrate between the layers of stone and accelerate deterioration. Petrographic analysis has revealed that the fine-grained heterogeneous cement binding the coarser mineral grains together is highly weathered and porous. As water leaches through the stone, the cement migrates to the surface and is re-deposited, resulting in a densified, less porous or “case-hardened” surface coupled with a mineral-depleted core beneath. Micrite, or microcrystalline calcite, accounts for a large percentage of the cement. Calcite exhibits anisotropic behavior when exposed to heat. The crystals do not expand equally in all directions when heated, causing dislocations along the interface between the crystals. This dislocation prevents the crystals from returning to their original positions when they cool, and the result

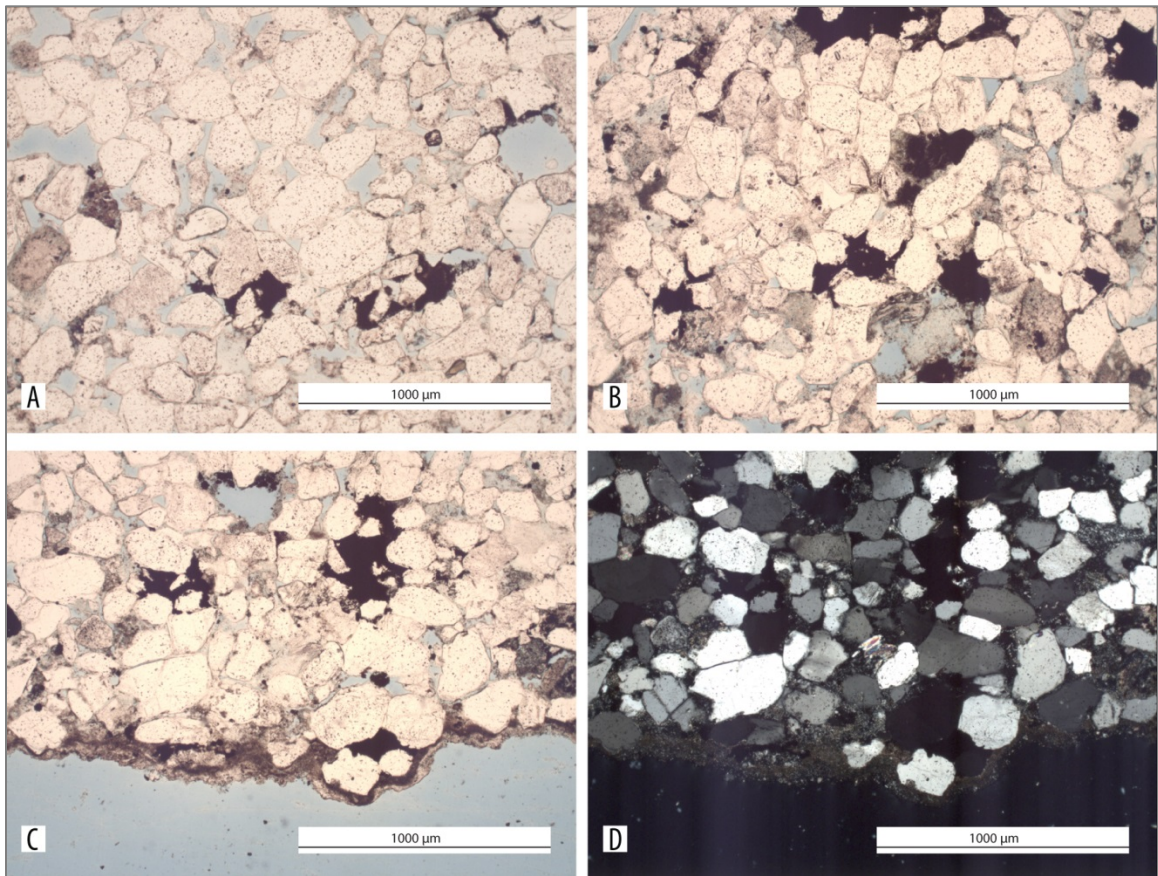
Figure 8. Comparison of porosity between sample HT.N1 (A) and sample HT.E1 (B) in PPL, magnification 50x; migration of cement to surface of stone in sample HT.E1 as shown in PPL (C) and XPL (D), magnification 50x; images by author.

The cement is patchy and heterogeneous. Drusy calcite mosaic (micrite) is a major component (Figure 9, image B), often precipitating in fractures and cleavages in the grains and causing them to split. Due to the high porosity of the cement, it may be assumed that the calcite precipitated into the stone after the quartz overgrowths formed.¹⁶ While present in both samples, sericite is more abundant and the crystals were larger in sample E1, which was collected from the east face of the support rock. In addition to being a major component of the cement, sericite is also present as inclusions in many of the coarse grains. Micron-size hematite was observed as both thin rims around many of the coarse grains, and as dark concentrated clusters in the cement. Altered chert was also very abundant in the cement. Viewed as a whole, the cement reflects a series of dynamic processes which have occurred over the life of the stone. Flow patterns were visible in many parts of the cement, which is consistent with the migration of the cement to the surface of stone and the mineral depletion of the core (Figure 8, images C and D).

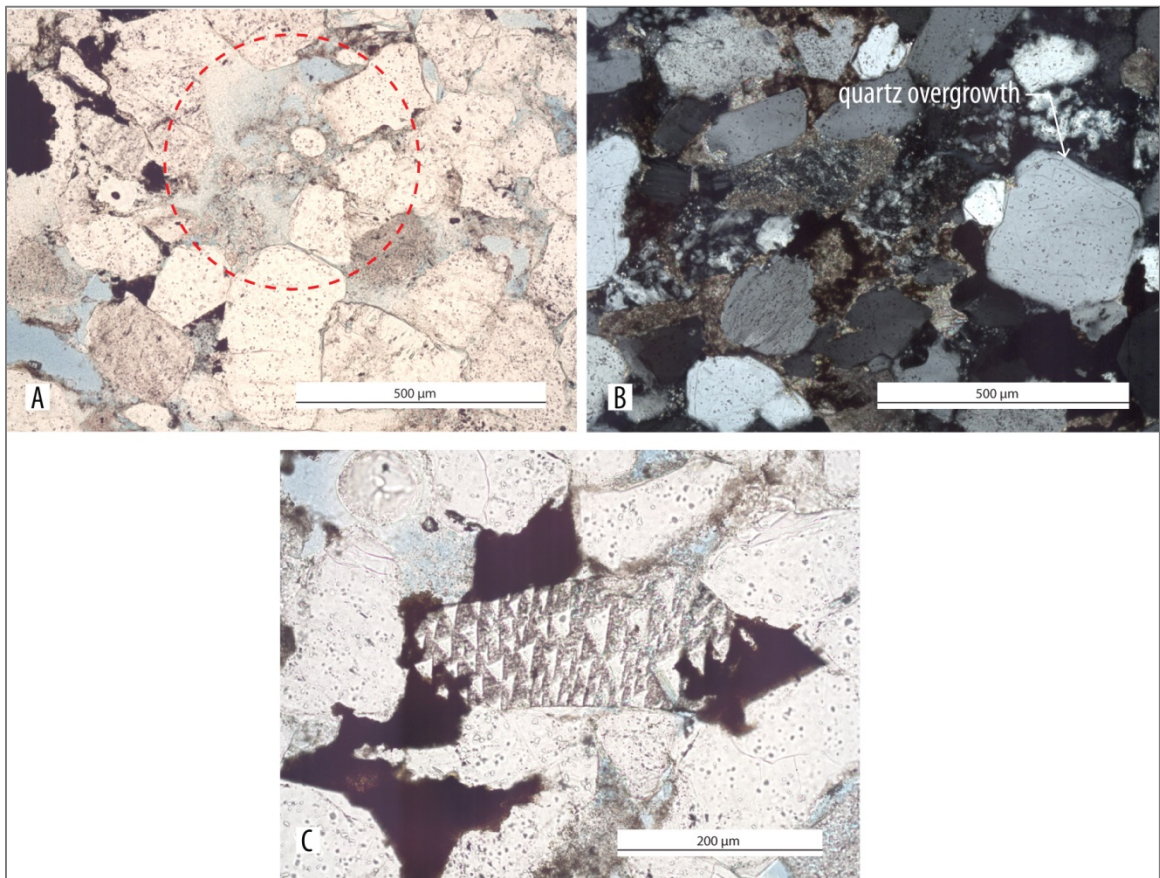
Figure 9. Alteration of grains in sample HT.N1 as shown in PPL (A), magnification 100x; overgrowth of quartz grains and heterogeneous cement in sample HT.E1 as shown in XPL (B), magnification 100x; graphic intergrowth of quartz and K-feldspar surrounded by hematite in sample HT.E1 as shown in PPL (C), magnification 200x; images by author.

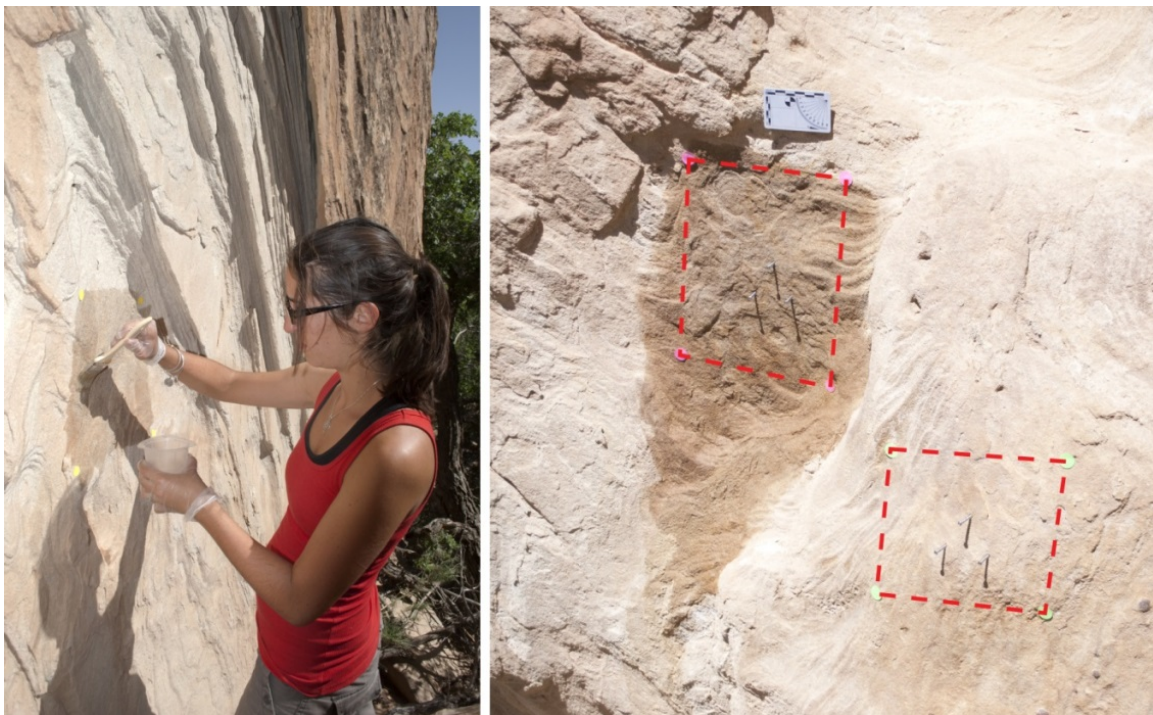
Figure 10. Demarcation of friable and non-friable areas and application of consolidant. Photographs by author, 2013.

Remmers was applied 24 hours after the Funcosil instead of allowing for a seven day cure time between treatments as recommended by the manufacturer. Stable or non-friable areas adjacent to the treated areas were also demarcated, and RILEM water absorption tests which conformed to RILEM Test No. 11.6 were also performed in these areas. During these tests, the ambient temperature and relative humidity were recorded using a Fluke 971 temperature humidity meter. Following this, a cordless drill was used to drill 3 holes in both the treated and untreated demarcated areas. The holes were positioned in a triangular configuration which was measured so that each hole was the same distance from the other two holes. Each hole was drilled to the same depth and loose particulate matter was removed using a compressed air canister. Stainless steel pins (bone screws) were inserted into each hole to the same depth using an allen wrench and the depth of each pin was measured with digital calipers. The pins were left in place to monitor surface erosion.

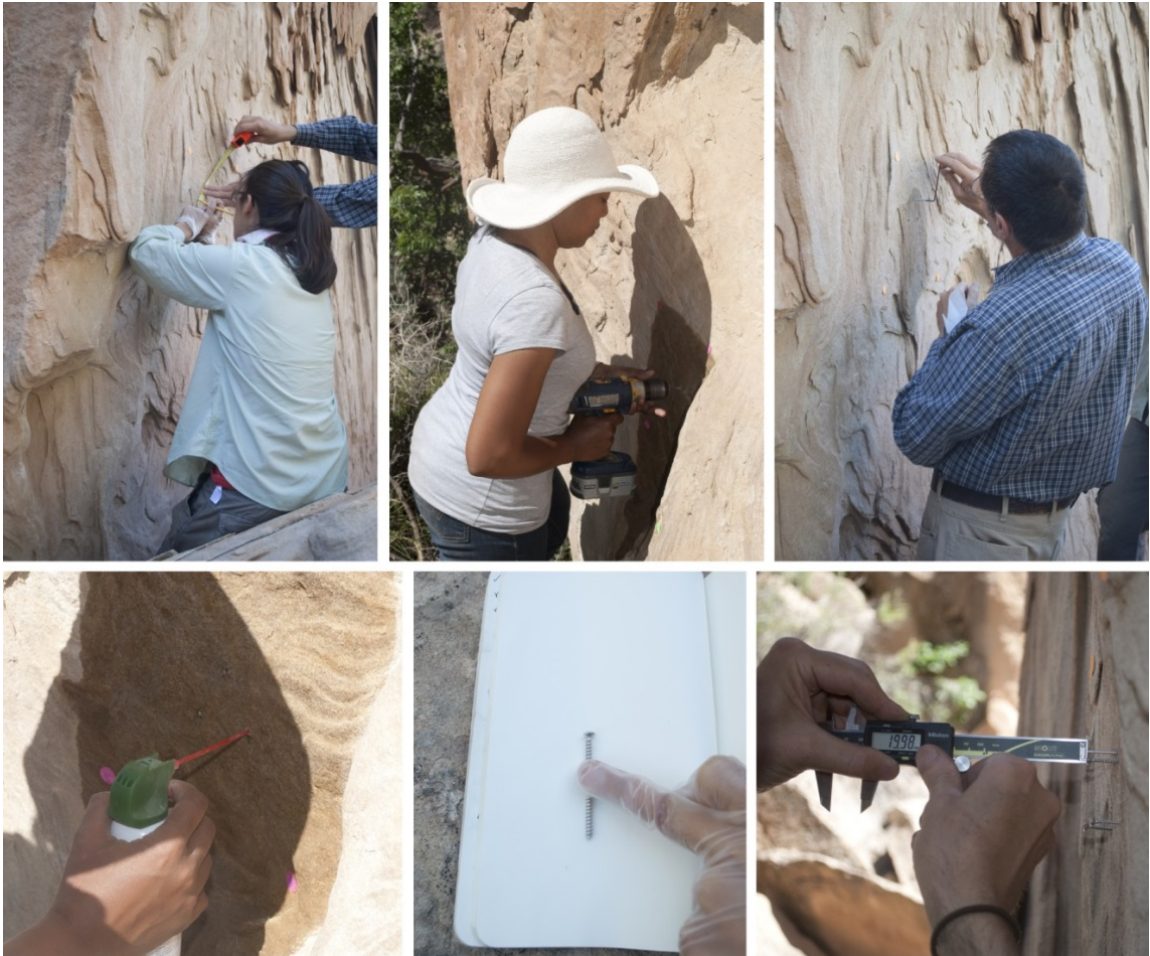
Figure 12. Installation of stainless steel pins to monitor surface erosion. Sources: Laura Lacombe, Milot Berisha and author, 2013.

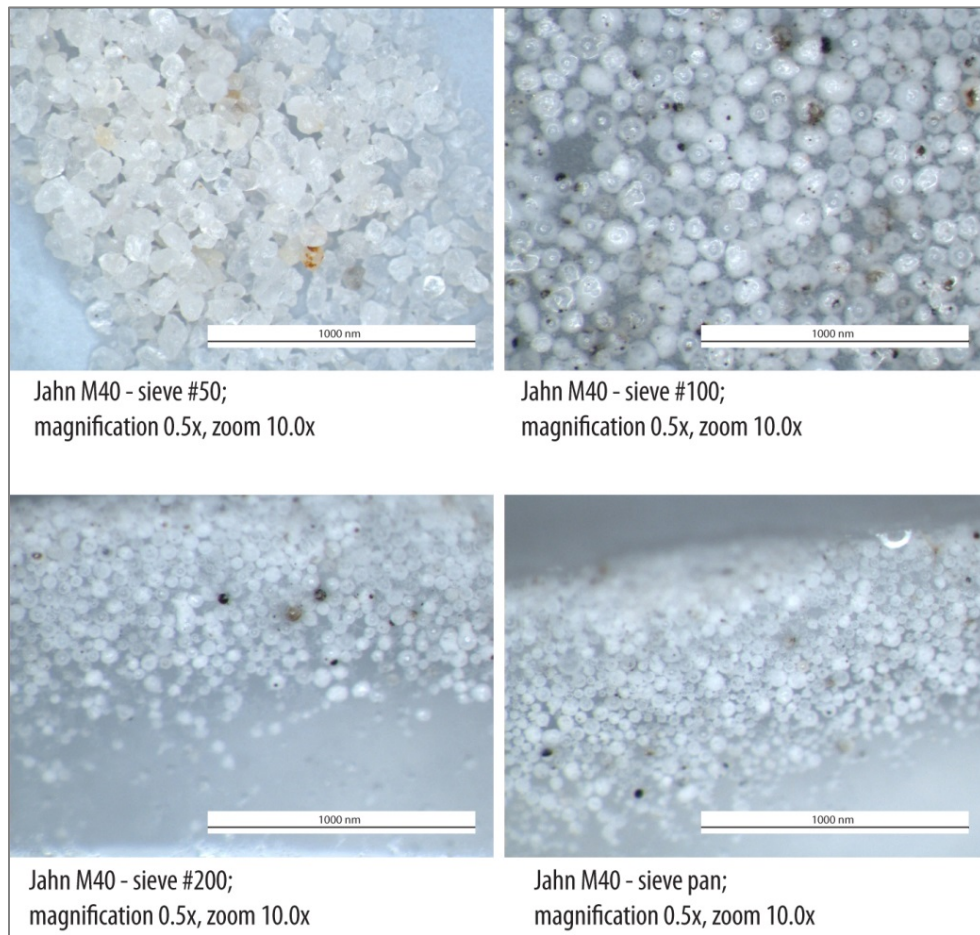
Figure 13. Jahn M40 sand and microspheres clearly visible after water was added to the weighing boats.

After an initial attempt to dry sieve the Jahn M40, excessive electrostatic attraction between the particles, specifically the clay-sized particles, caused them to cling to the sand and microspheres and thereby distorted the dry sieving results. After the contents of each sieve screen were placed in small weighing boats, several drops of water were added to each weighing boat to separate the sand and microspheres from the clinging particles of clay and the contents were observed under the Leica MZ16 stereo binocular microscope. The microspheres in each weighing boat floated to the surface and it was then clear that a range of microsphere sizes were used in the M40 formulation.

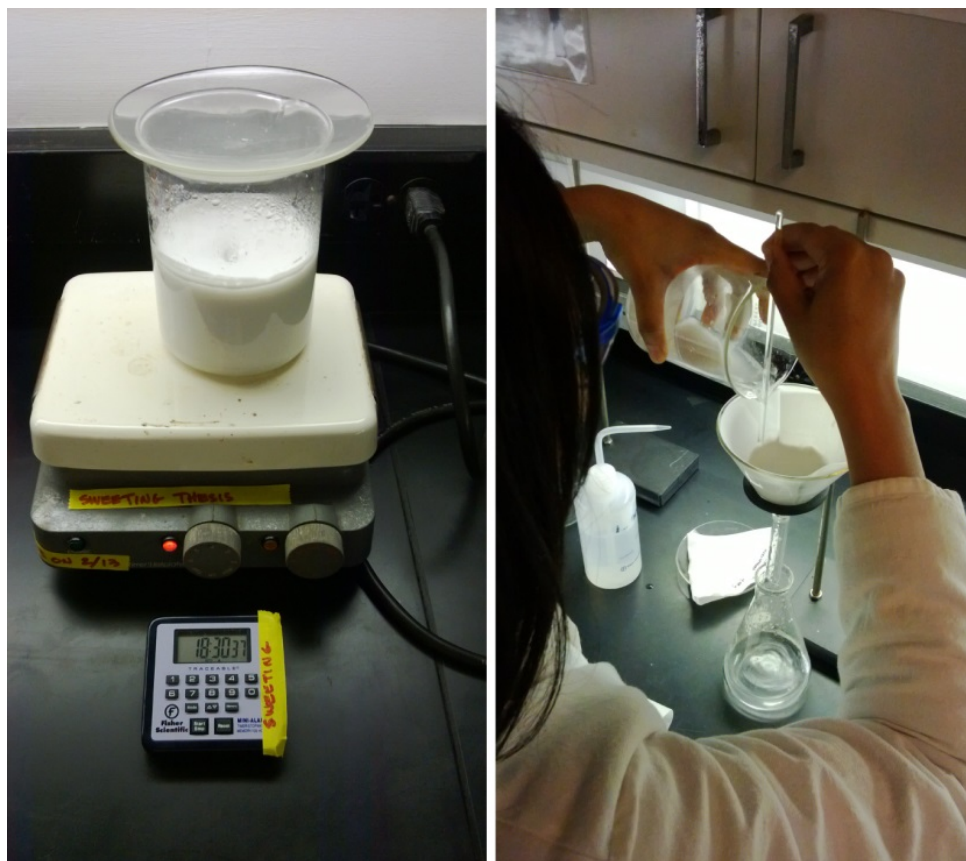
Figure 14. Sample preparation and levigation of microspheres and fines.

Using a glass stirring rod to direct the flow of water, the microspheres, which floated to the top, were first poured off into the first funnel with filter paper (Figure 14). This step was repeated in 15 minute intervals to prevent the binder from mixing with the microspheres. When the microspheres were removed, the glass stirring rod was used to agitate the grout mixture to levigate the lighter clay-sized particles, separating them from the heavier sand particles. Immediately after agitation, the fine particles were poured off into the next filter paper which was pre-wet just before use. This process was repeated until only the sand remained at the bottom of the beaker. Finally, the beaker was held at an angle over the third filter paper and deionized water was squirted into the beaker until all of the sand was removed. The filter papers were then placed on watch glasses and placed in the oven at $60^{\circ}\text{C} \pm 5^{\circ}$ for 24 hours to dry.

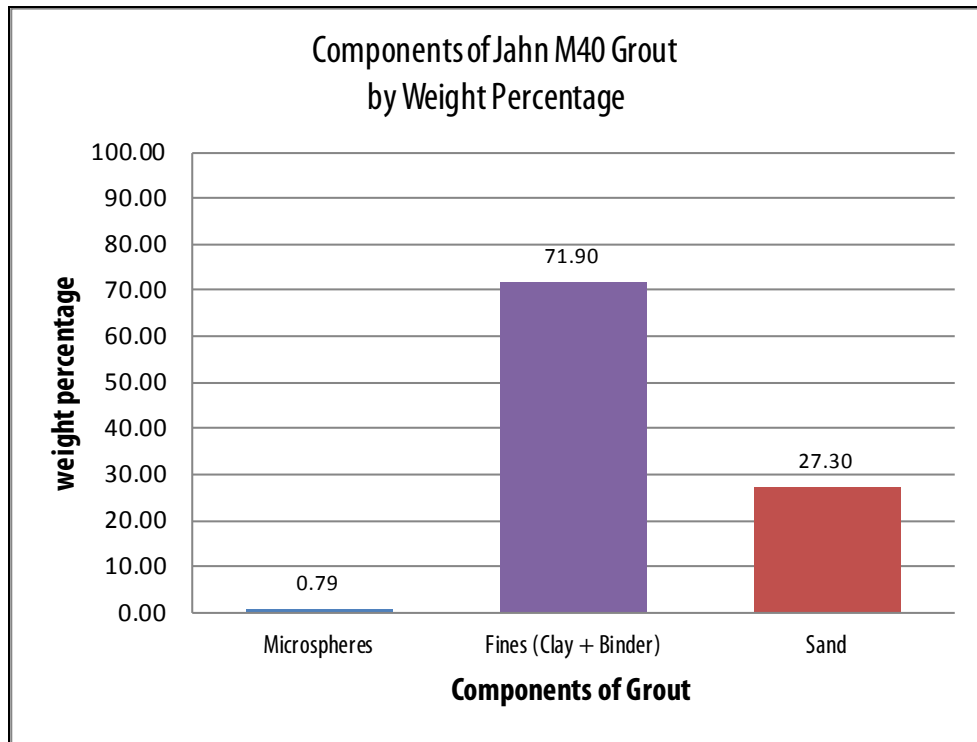
Graph 1. Weight percentage of the components of Jahn M40.

Based on the results of the gravimetric analysis, it was determined that Jahn M40 is composed of approximately 72% fines, 27% sand and 1% microspheres by weight (Graph 1).

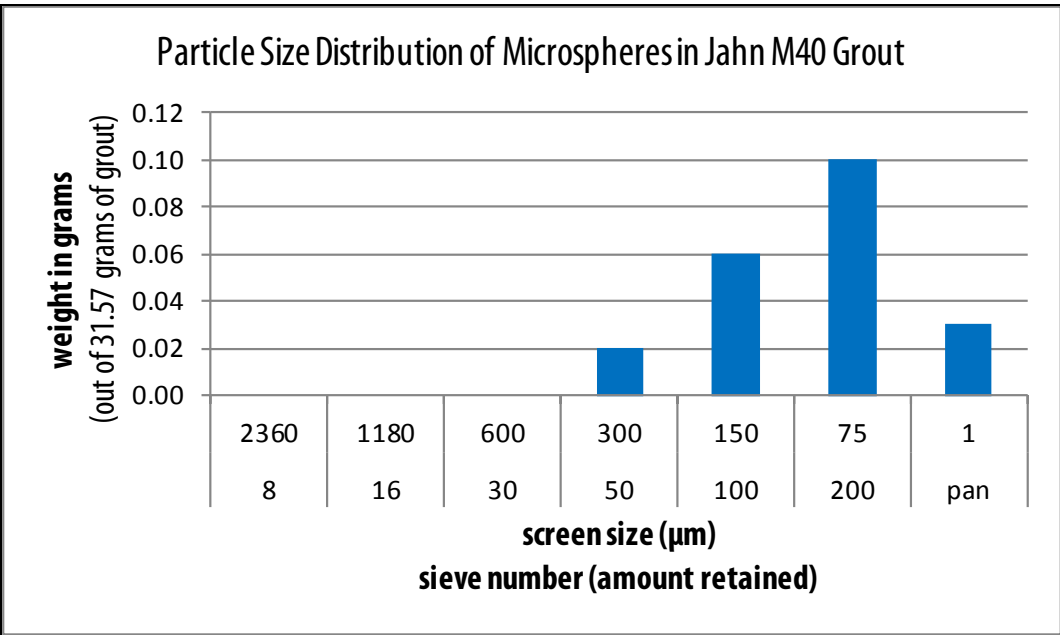
Graph 2. Particle size distribution of microspheres in Jahn M40.

Based on the results of the dry sieving procedure, the sand and the microspheres were retained in sieve #50, 100, 200 and pan suggesting a particle size range of $<75\mu\text{m}$ to $300\mu\text{m}$ and the shape of the sand can be characterized as ranging from sub-rounded to sub-angular.

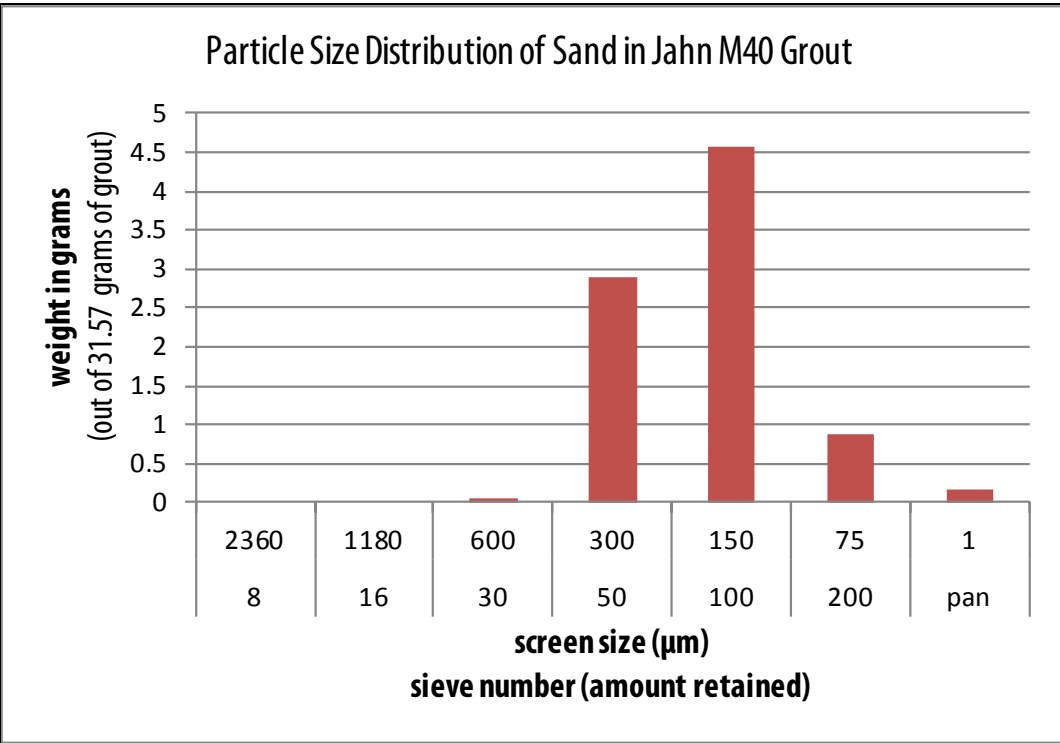
Graph 3. Particle size distribution of sand in Jahn M40.

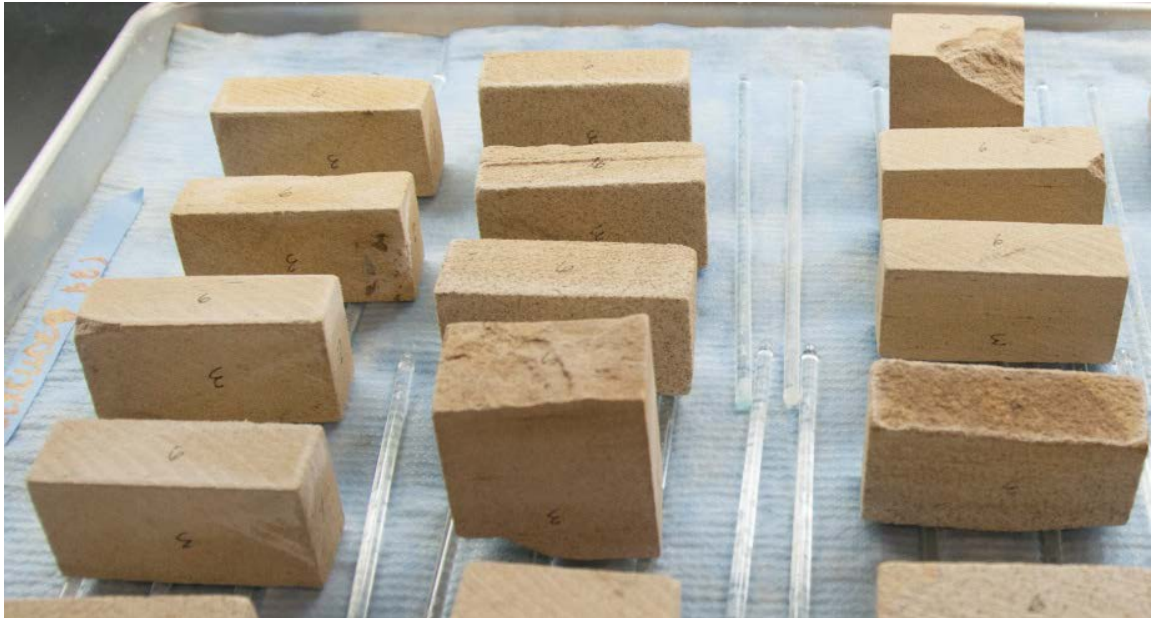
Figure 15. Formation of white residue after pre-treatment with Fungosil Antihygro.

The temperature in the lab was 23.1°C and the relative humidity was 27%. One cycle of treatment was applied to the same face of all of the samples at the same time. Following this, they were blotted and rotated after waiting at least two minutes to inspect the samples for pooling on the surface. The stone samples which were treated on all six sides required between 3 and 4 cycles before pooling was observed. The samples which were only treated on one side required 15 cycles. When the samples were inspected 7 days after pre-treatment, a thin white residue was observed on the majority of the stones, resulting in a slightly lighter color (Figure 15).

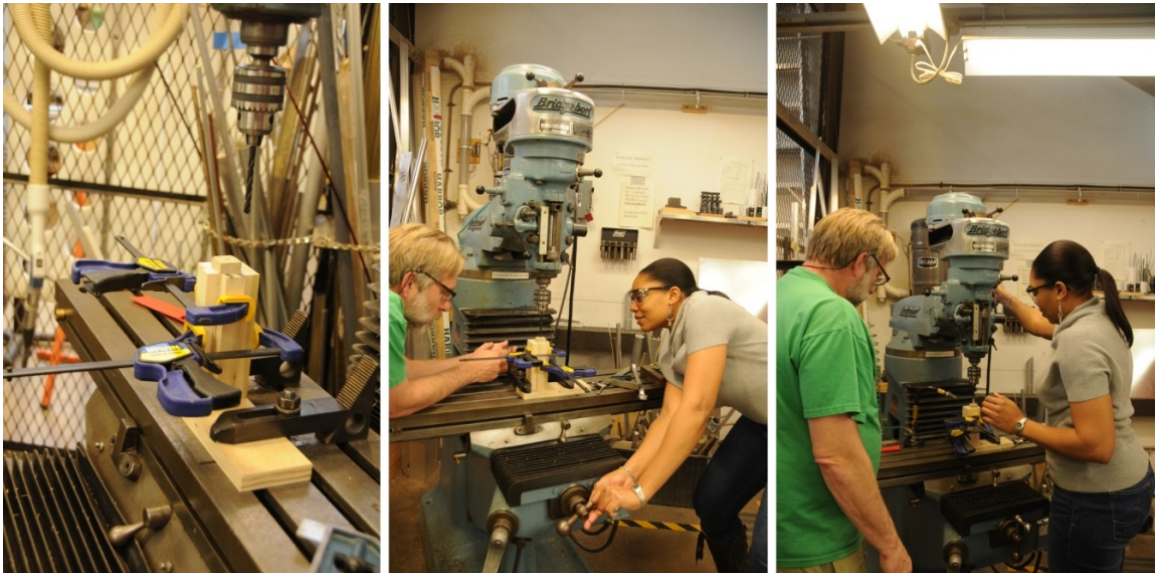
Figure 19. Peck drilling the stone on the vertical mill.

than the gauge stud diameter to allow room to insert the epoxy around the entire stud. The center of each end of the prism was determined by drawing two diagonal lines at opposing corners. In order to protect the stone and minimize vibrations during the drilling process, a vertical jig designed by Dennis Pierattini in the fabrication laboratory was clamped to the bed of a Bridgeport Vertical Mill. A 9/32" diameter round shank masonry drill bit from McMaster Carr was inserted into the mill, which was run with a spindle speed of 660 RPM. The mill was set to drill to a depth of 5/8" plus the depth of the v-shaped tip of the drill bit to ensure that the gauge stud was inserted to the correct depth. A technique referred to as peck drilling was used during the drilling process in which the drill bit was repeatedly retracted while compressed air was directed at the tip to continuously remove loose material and prevent the drill bit from overheating.

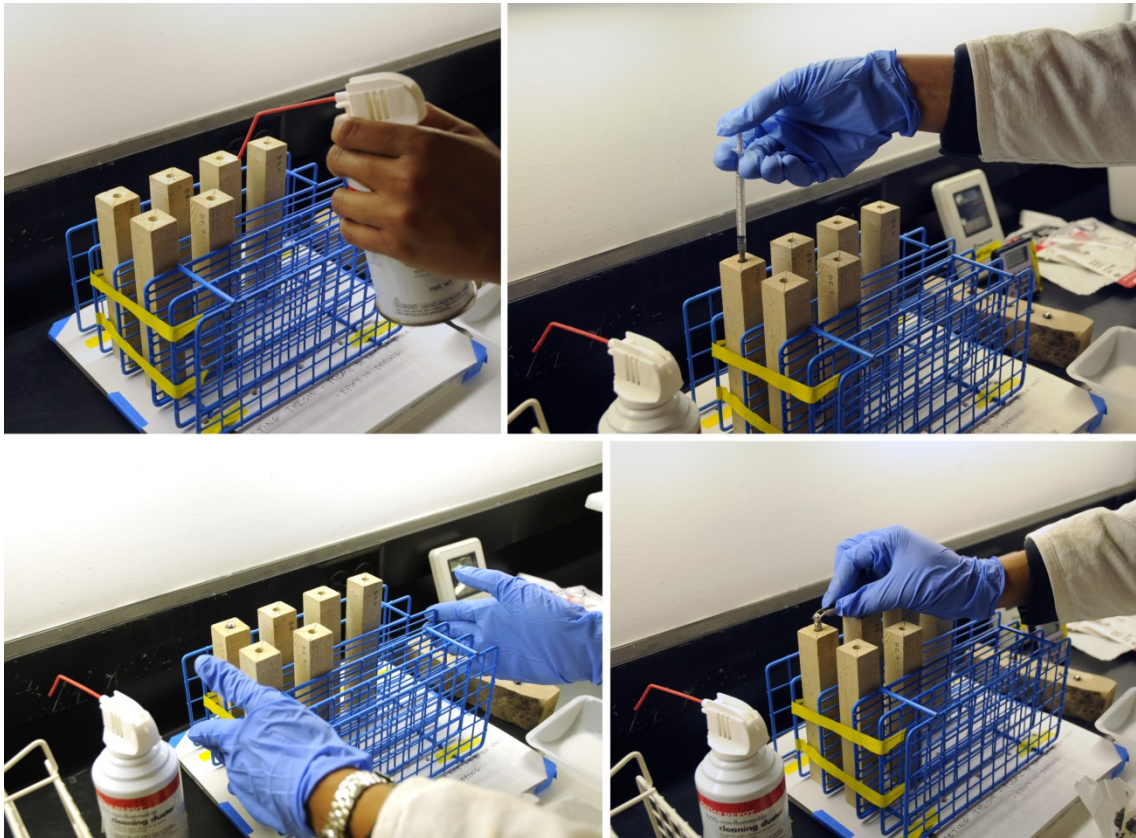
Figure 21. Aspirating holes in the stone; injecting epoxy into holes; inserting and rotating the gauge stud.

taped to prevent them from shifting or falling. The prisms were then placed over the perforations and the entire process of inserting the epoxy and gauge studs was repeated. After the epoxy set, the prisms were then ready to be treated with consolidant.

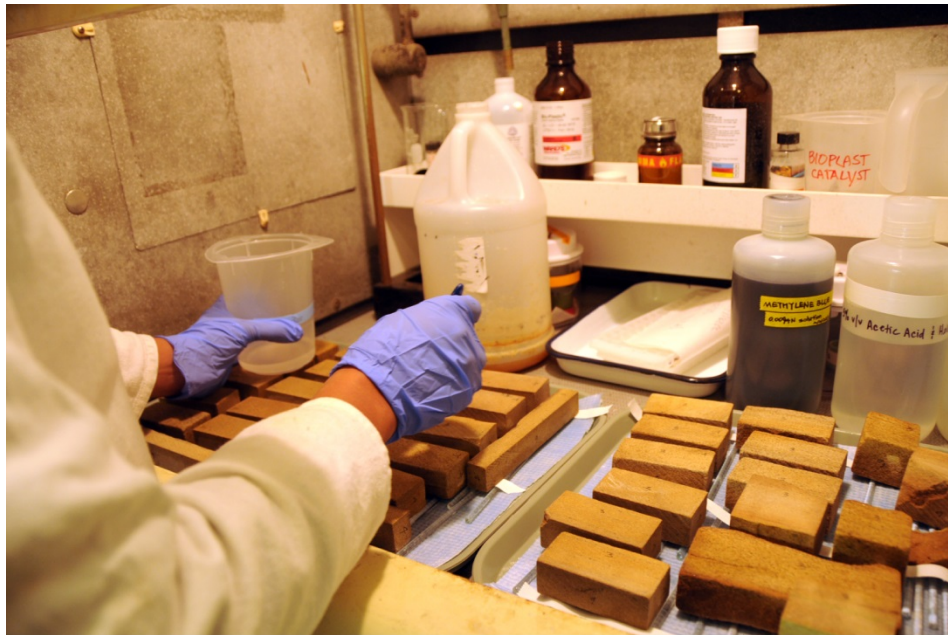
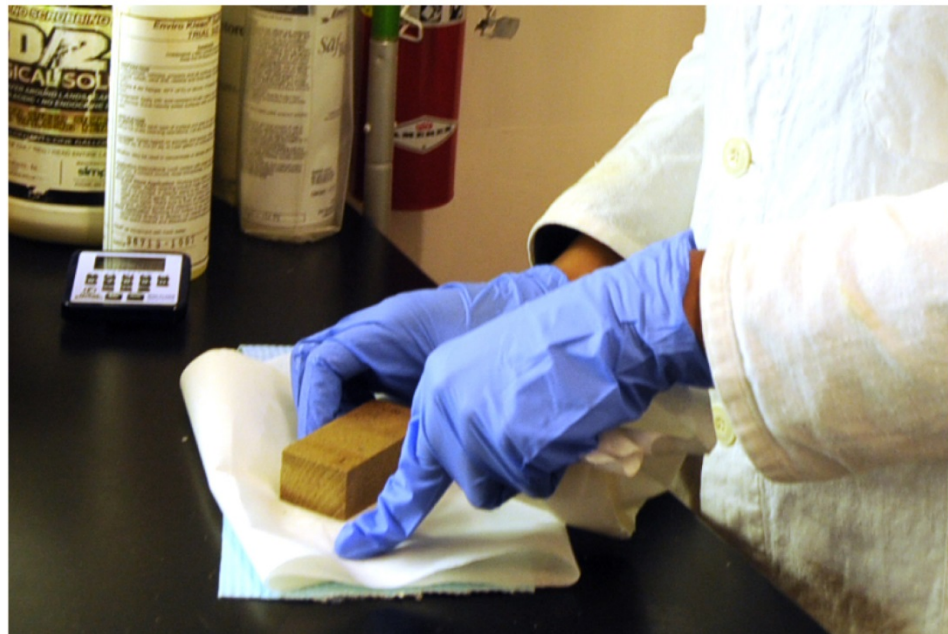
Figure 22. Applying Remmers KSE 300 E and blotting samples between cycles.

Immediately after treatment, all of the samples were blotted and brushed with methyl ethyl ketone to remove excess consolidant from the surface. Due to the toxicity of the Remmers KSE 300 E and the methyl ethyl ketone, the samples were left under the fume hood for 24 hours.

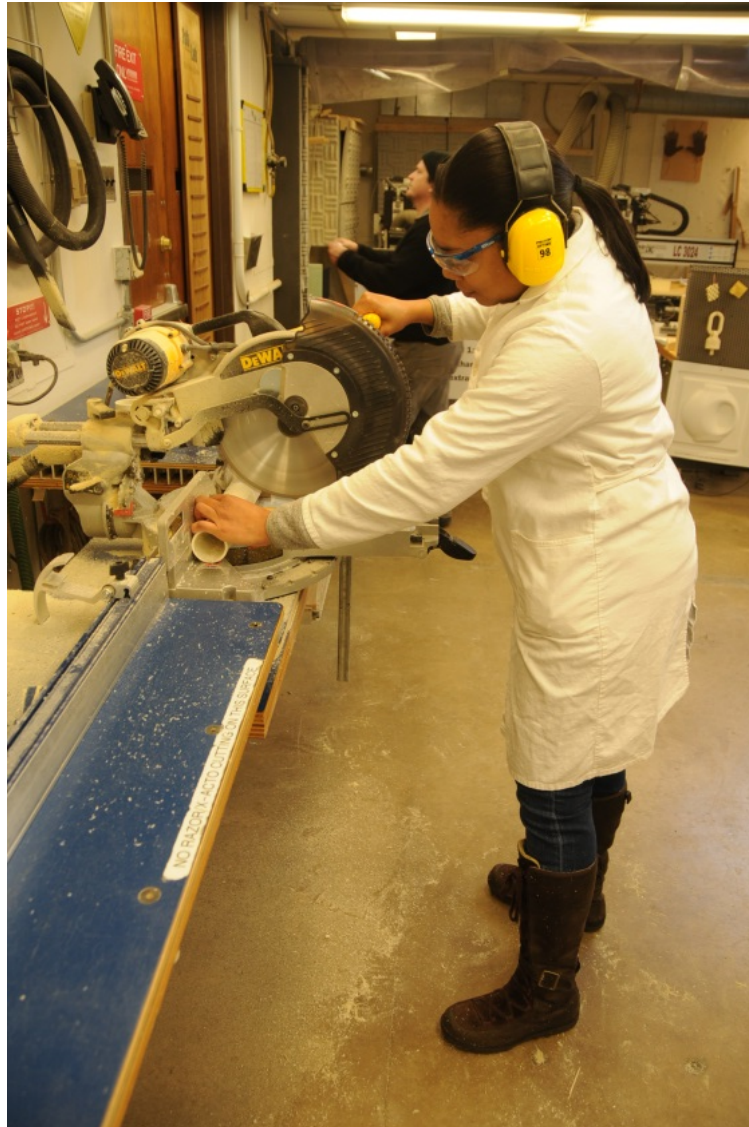
Figure 23. Cutting PVC pipe for splitting tensile strength molds with chop saw

Molds for the splitting tensile strength test were based on sample dimensions specified in ASTM C 496/496M-11 and were created using PVC pipe with an inside diameter of 2 inches. The molds were cut to 4 inch lengths using a chop saw and cut once along the length of the pipe with the band saw to allow the molds to pried open slightly during the de-molding process. Additional $\frac{3}{4}$ inch lengths of PVC pipe with the same diameter with vertical slits were attached to the top of each mold with electrical tape to allow the molds to be over-poured and trimmed just before final set.

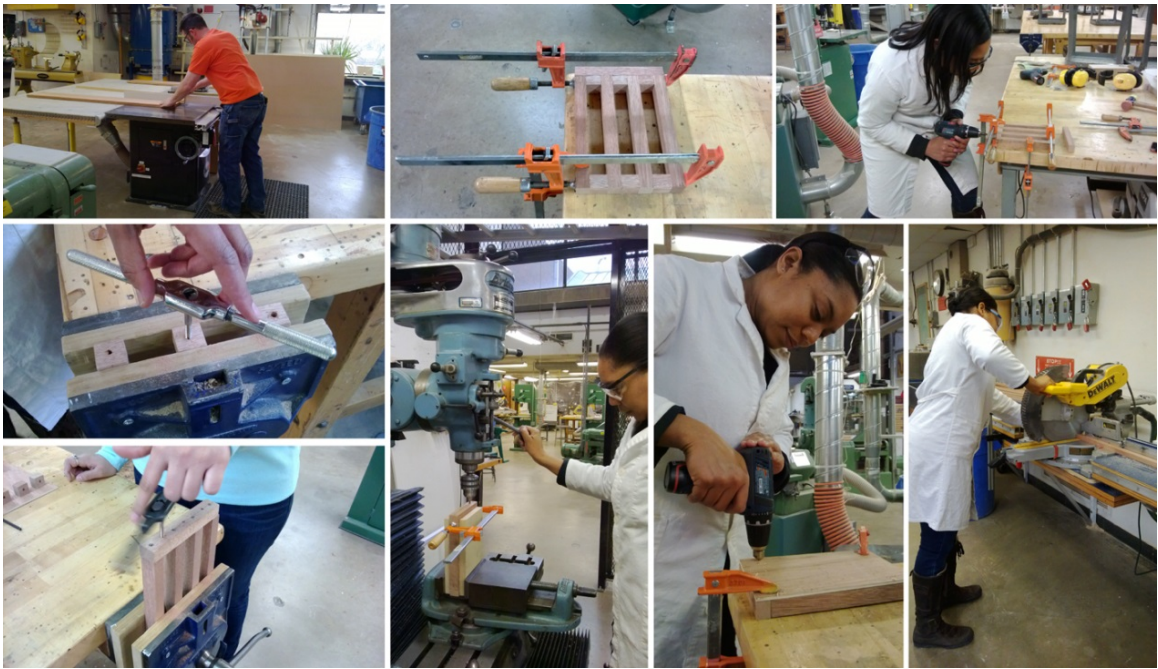
Figure 24. Preparation of molds for thermal expansion test.

base, 316 stainless steel #6 flat head Phillips screws from McMaster Carr were used to assemble the molds. Pre-drilled holes with a slightly smaller diameter than the Humboldt gauge studs and the 316 stainless steel 1/4"-20 socket head screw caps were created. A 1/4 - 20 tap was then twisted into the holes to cut spiral grooves into the holes to allow the gauge studs to be twisted into place.

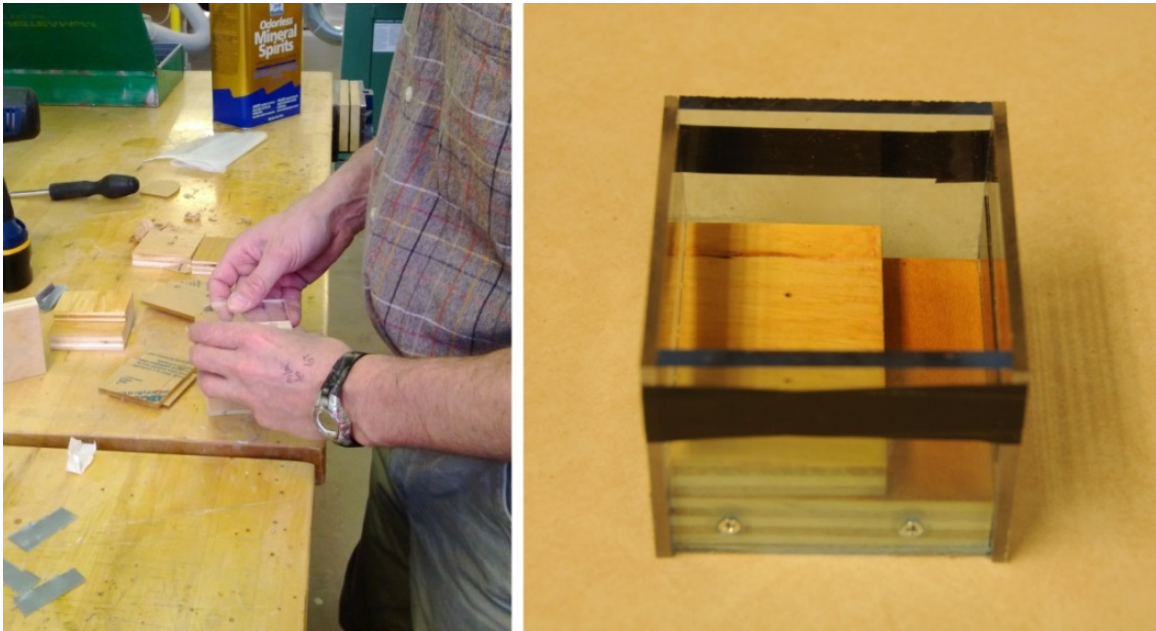
Figure 25. Construction of the shear bond strength molds

allow the samples to be easily de-molded. The acrylic sides were held in place with electrical tape (Figure 25). The frost resistance molds were constructed in the same manner with exception that the plywood base was flat. The molds were designed and built by John Hinchman at the Architectural Conservation Laboratory (ACL).

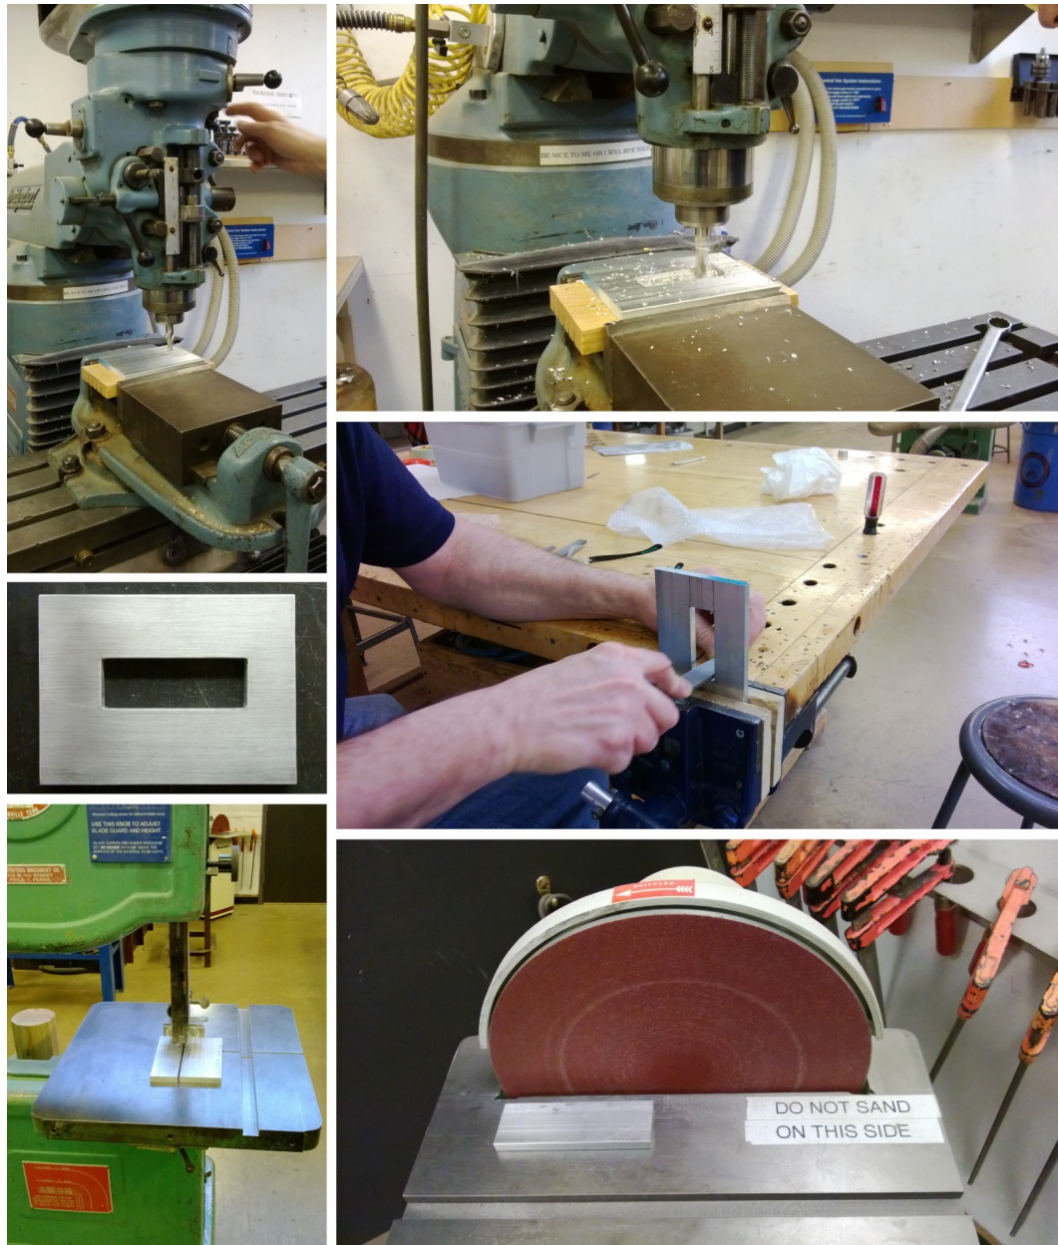
Figure 26. Fabrication of the aluminum plates for the shear bond strength test.

To maintain the vertical orientation of the shear bond strength samples during the test, a 4" x 5 1/4" x 3/8" thick aluminum plate with a 1 1/32" x 3 1/32" central slot was designed by LRSM supervisor, Dr. Alex Radin. Using a Bridgeport steel end mill with a speed of 1750 RPM, a drill bit was lowered incrementally to remove material until a central slot was created. A second drill bit with a smaller diameter was used in a similar manner to remove additional material from the corners. Following this, a metal file and sandpaper were used to smooth the interior edges of the slot.

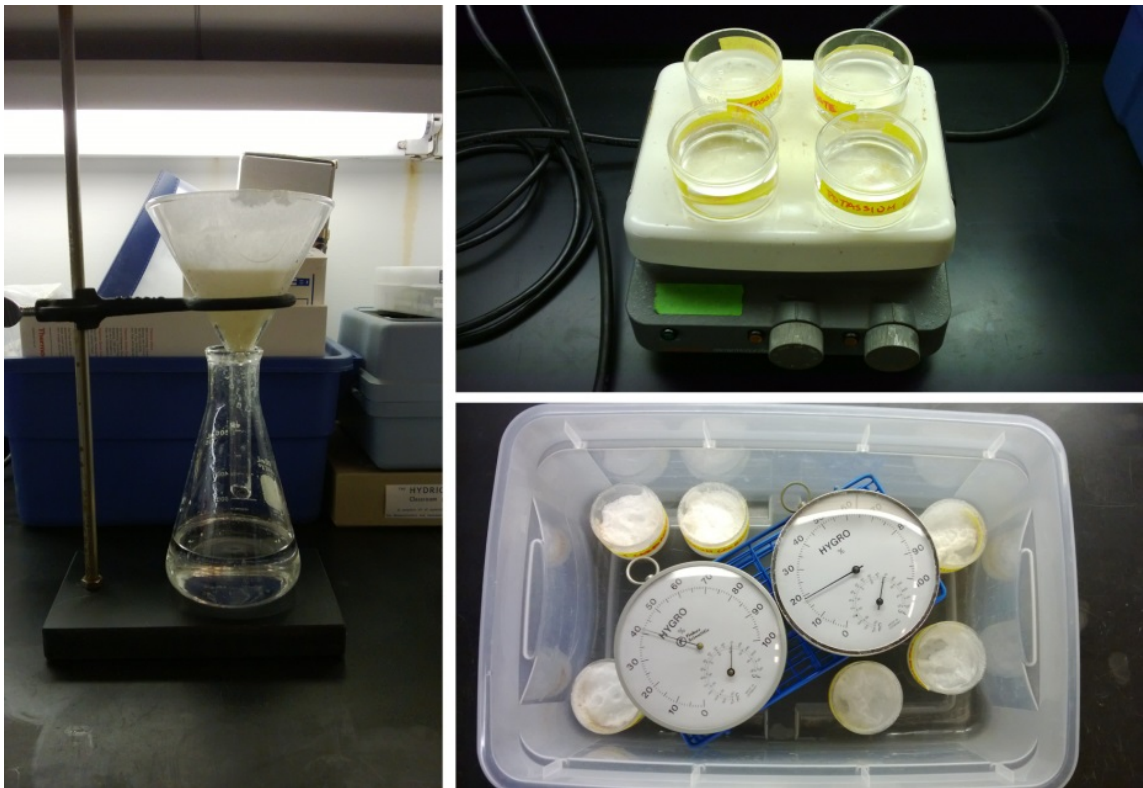
Figure 27. Test chamber with potassium carbonate

In an effort to replicate the testing methods of the manufacturer, a chamber was prepared to maintain a relative humidity between 30 and 40%. Potassium carbonate solution was filtered through 24 cm diameter #4 grade filter paper and evaporated on a hot plate. The dried salt was slightly moistened with deionized water and placed in a plastic bin where the relative humidity level was monitored (Figure 27).

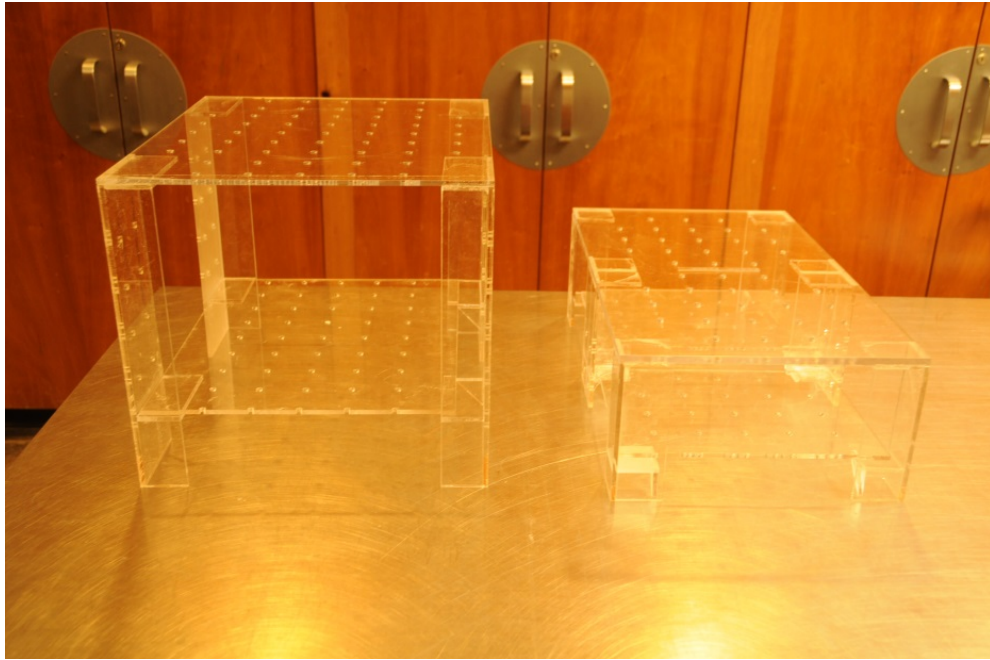
Figure 28. Acrylic shelves for curing chambers

laboratory (Figure 28). One version of the shelves was designed to fit into an existing stationary acrylic curing chamber. The second version was design to fit into Rubbermaid Clever Store Basic Latch 95 Quart plastic bins which would be used as portable curing chambers to store the molds just after they were filled with grout, and for various tests, such as the visual shrinkage and vicat tests.

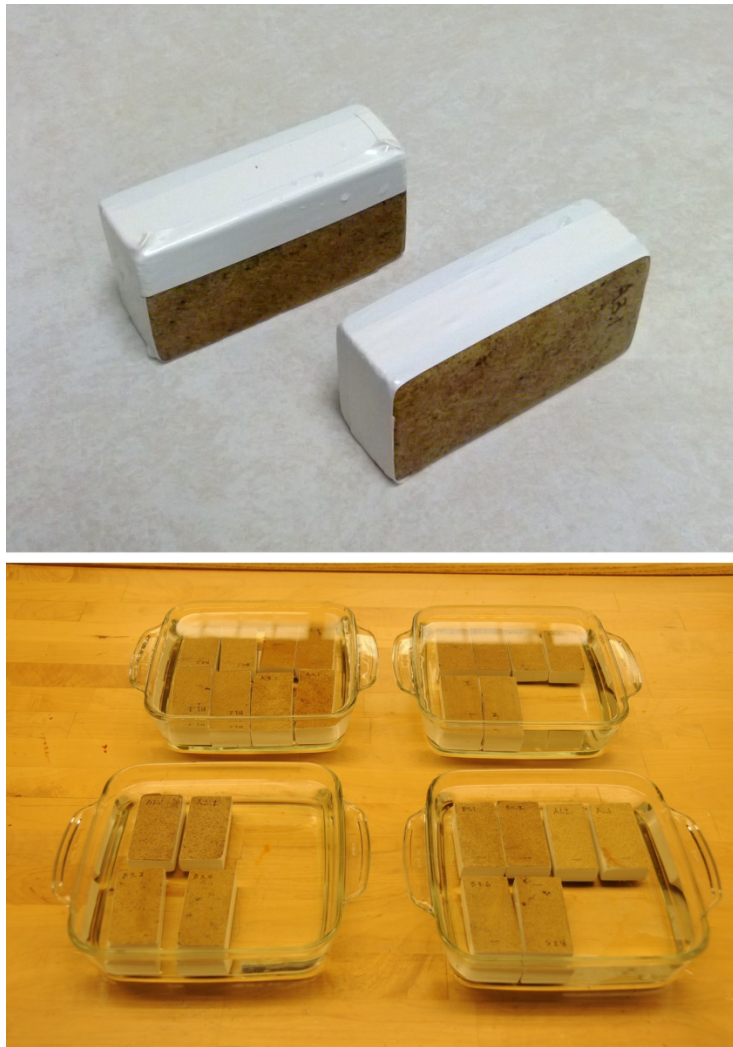
Figure 29. Wrapping and soaking stone prior to pouring

The plywood base on the shear bond strength molds was lightly coated with mineral oil twice before pouring and then blotted. During a previous iteration of the molds in which the wood was heavily saturated with mineral oil, the oil began to seep into the stone. This should be taken into account in the final results of the shear bond strength test. The stone samples that were used for this test were wrapped with electrical tape on the perimeter to prevent the grout from sticking to the stone after pouring. The stone was then soaked in deionized water for 27 hours prior to pouring. Additional preparations will be discussed later when the flow test procedure is described.

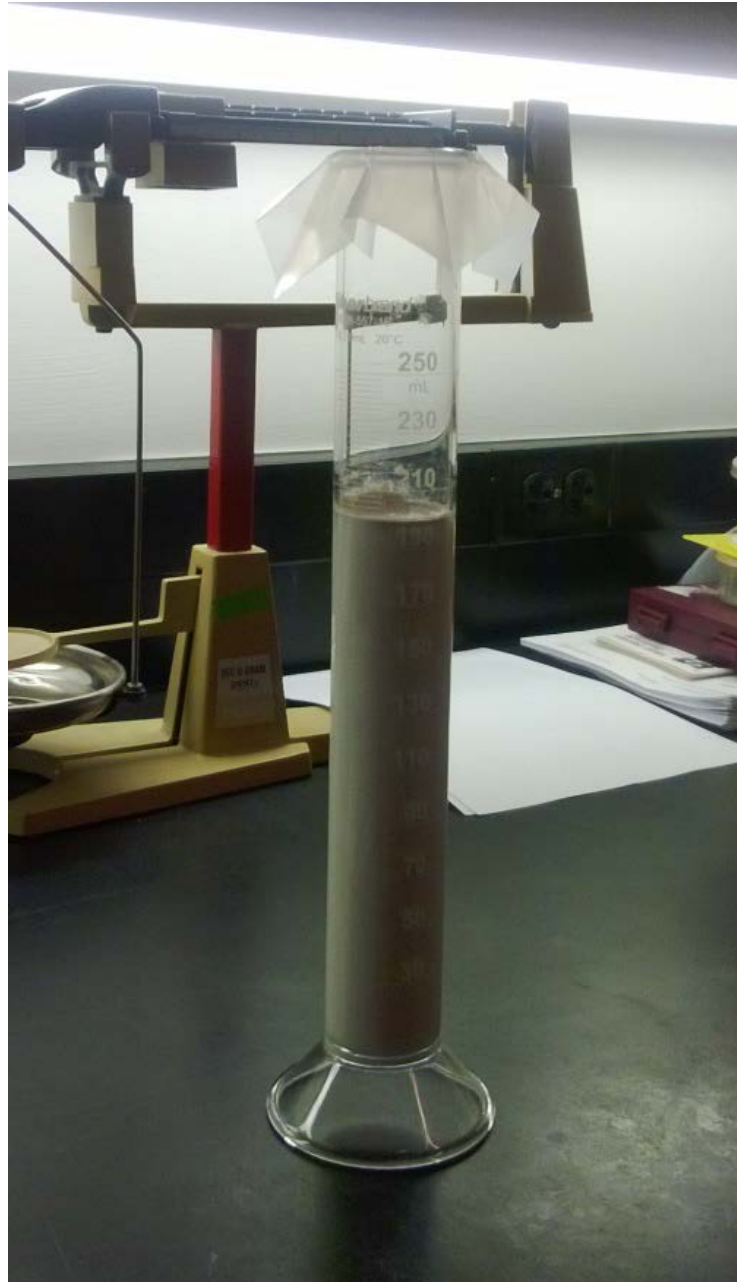
Figure 31. Expansion and bleeding test in progress
