Evaluation of Cementitious Injection Grouts for the Stabilization of Holly Tower Support Rock, Hovenweep National Monument

Naima A. Sweeting
University of Pennsylvania

This thesis addresses the testing and evaluation of the use of a cementitious injection grout for the reattachment of detached slabbing on the sandstone support rock of Holly Tower at Hovenweep National Monument. This research follows on a previous condition assessment and diagnosis of the deterioration of the sandstone support rock and the effects of consolidation on the rock as the first step in a multi-phase conservation program.

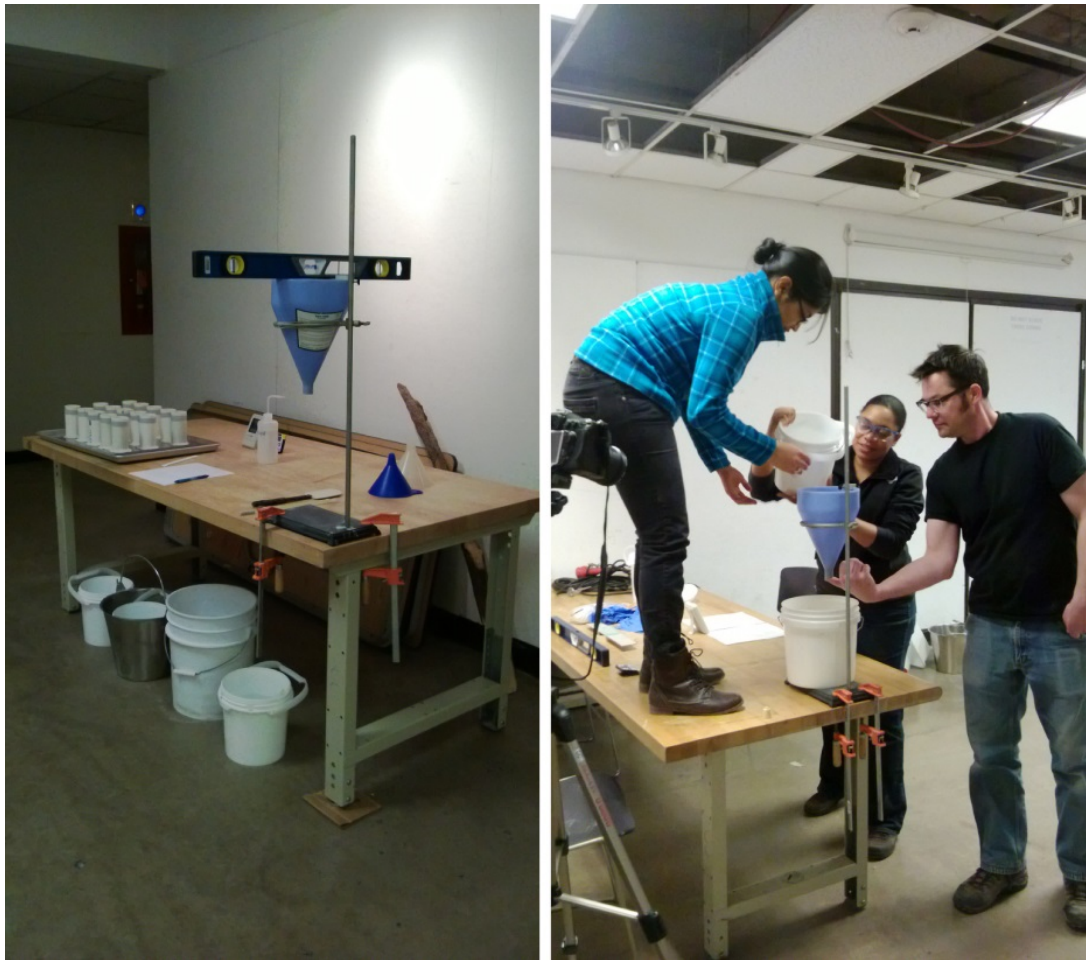
Figure 32. Leveling flow cone and performing flow test.

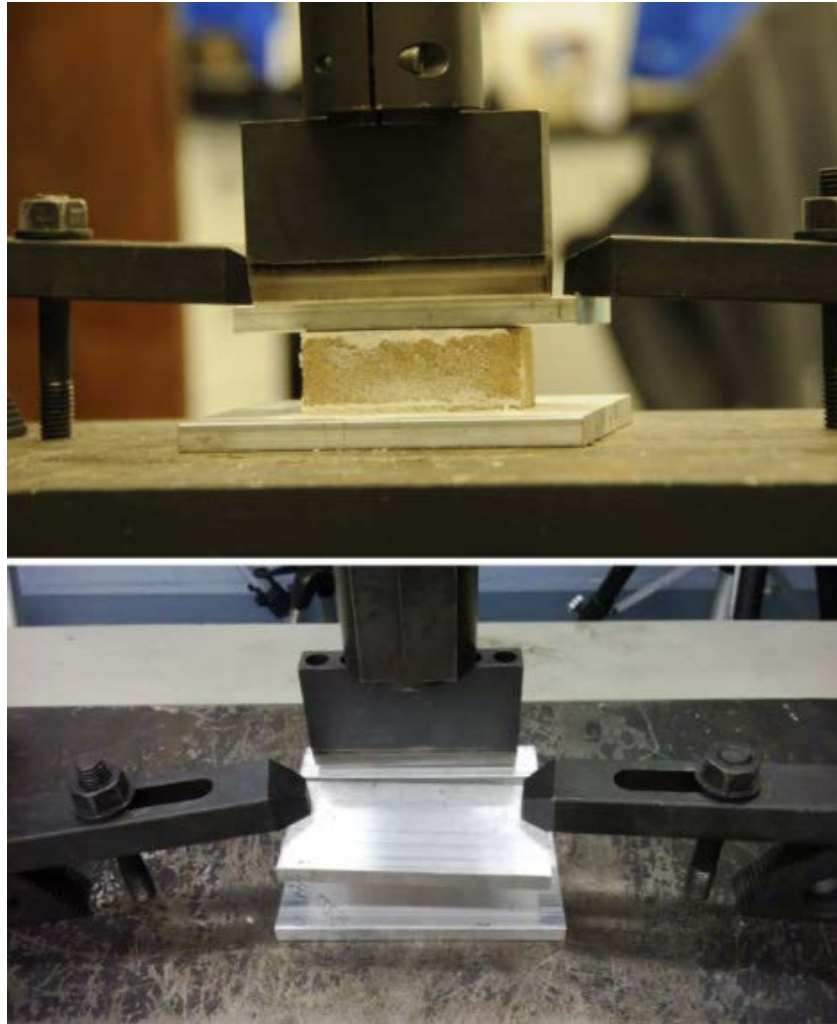
Figure 33. Aluminum plates used to distribute the load during shear bond strength test.

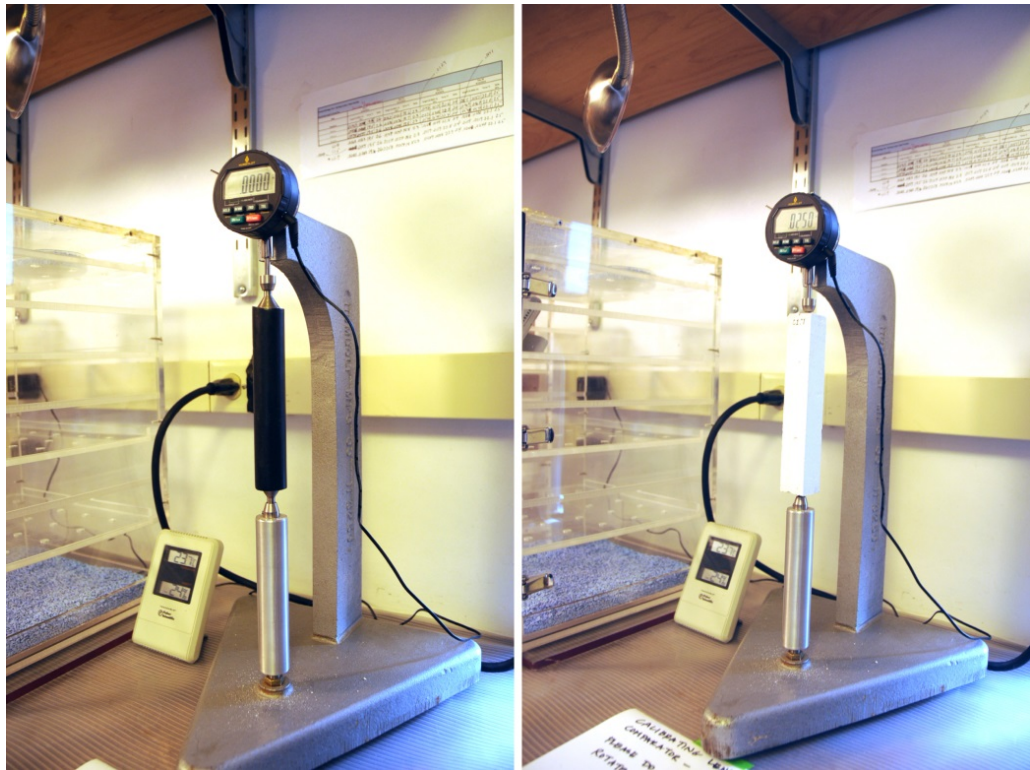
Figure 35. Reference bar and grout sample inserted into length comparator.

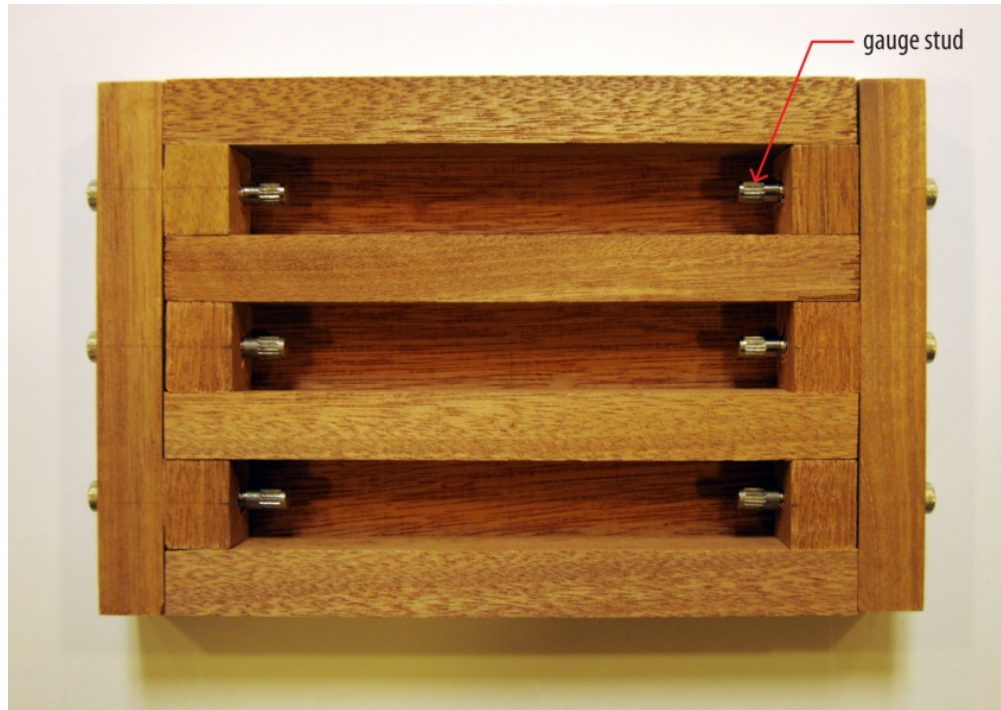
Figure 36. Mold for thermal expansion and drying shrinkage tests.

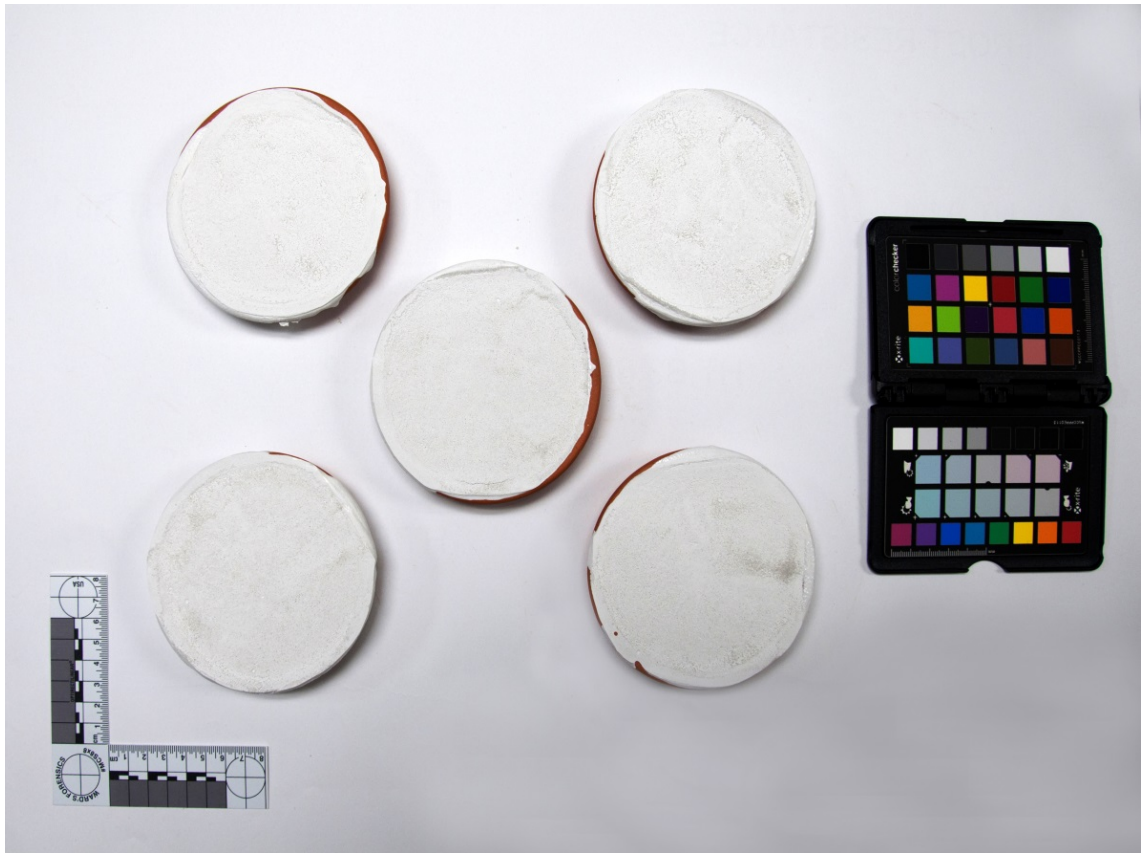
Figure 37. Photograph of visual shrinkage test samples after 28 days of curing.

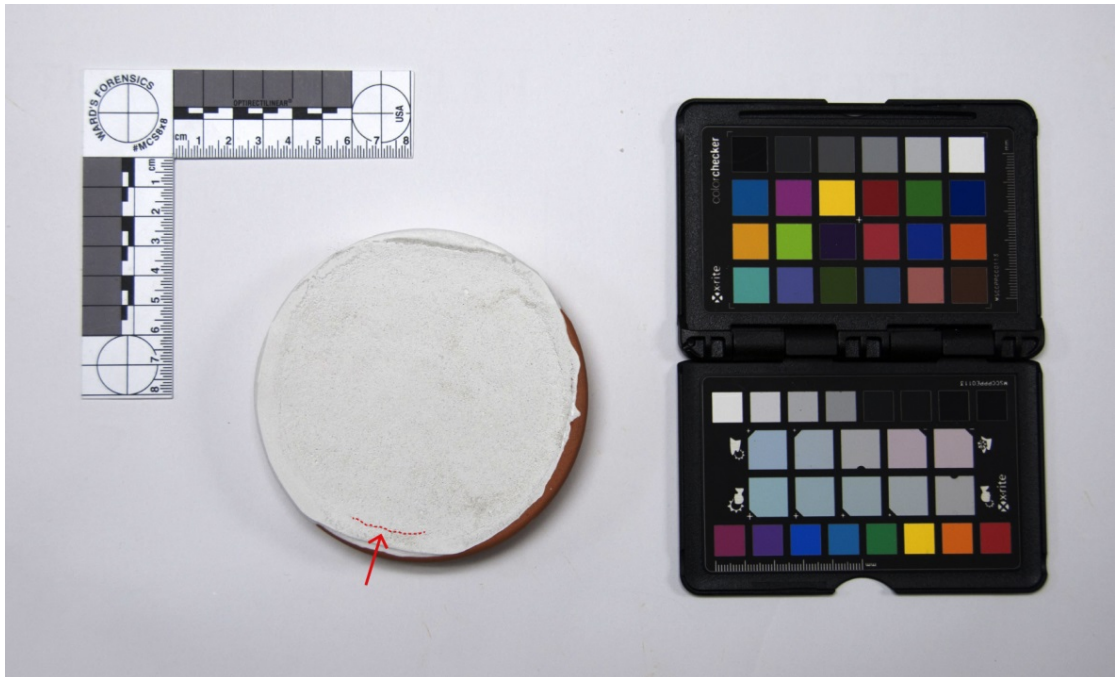
Figure 38. Detail photograph of cracking along the perimeter of the sample.

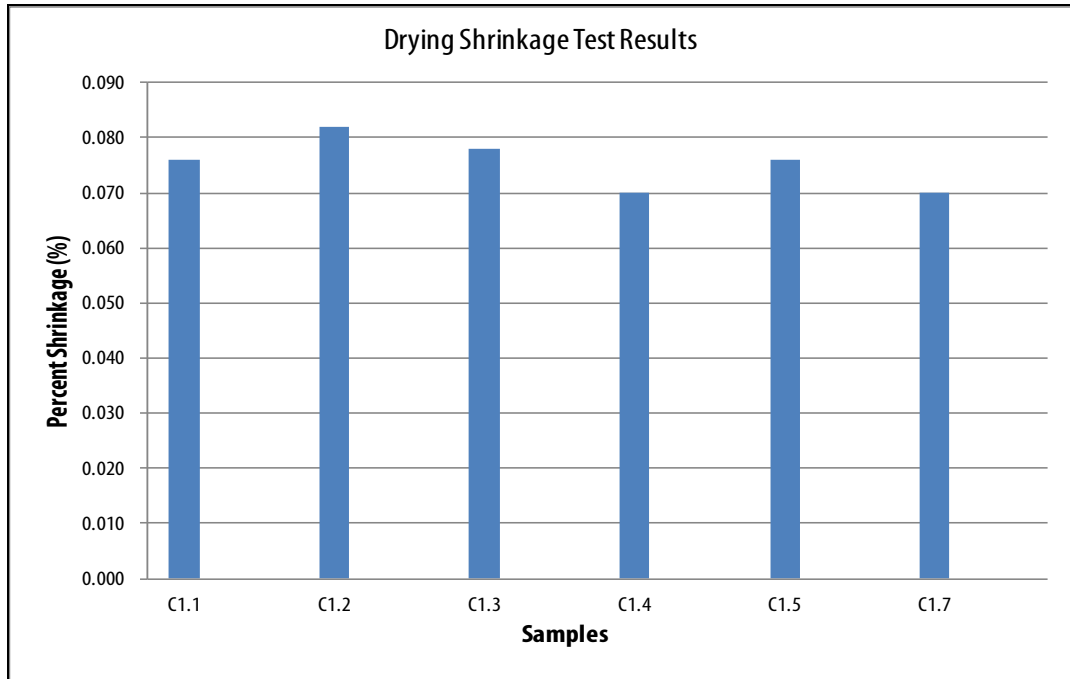
Graph 4. Results for drying shrinkage test.

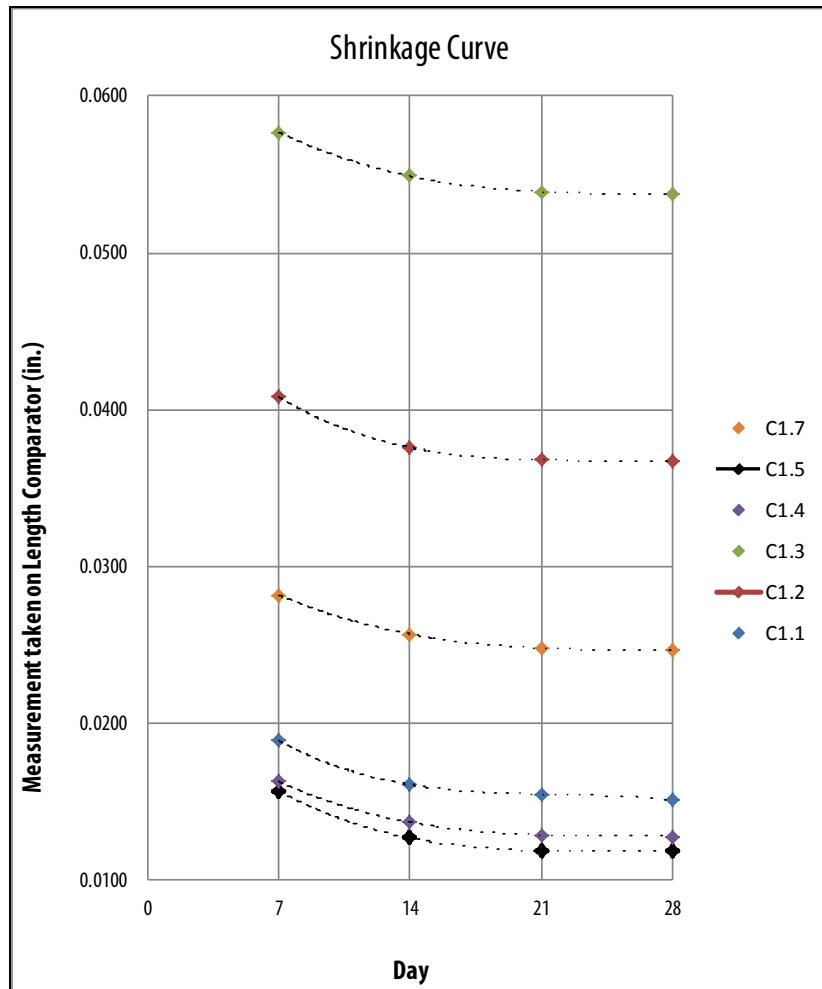
Graph 5. Shrinkage curve for grout samples recorded over 28 days.

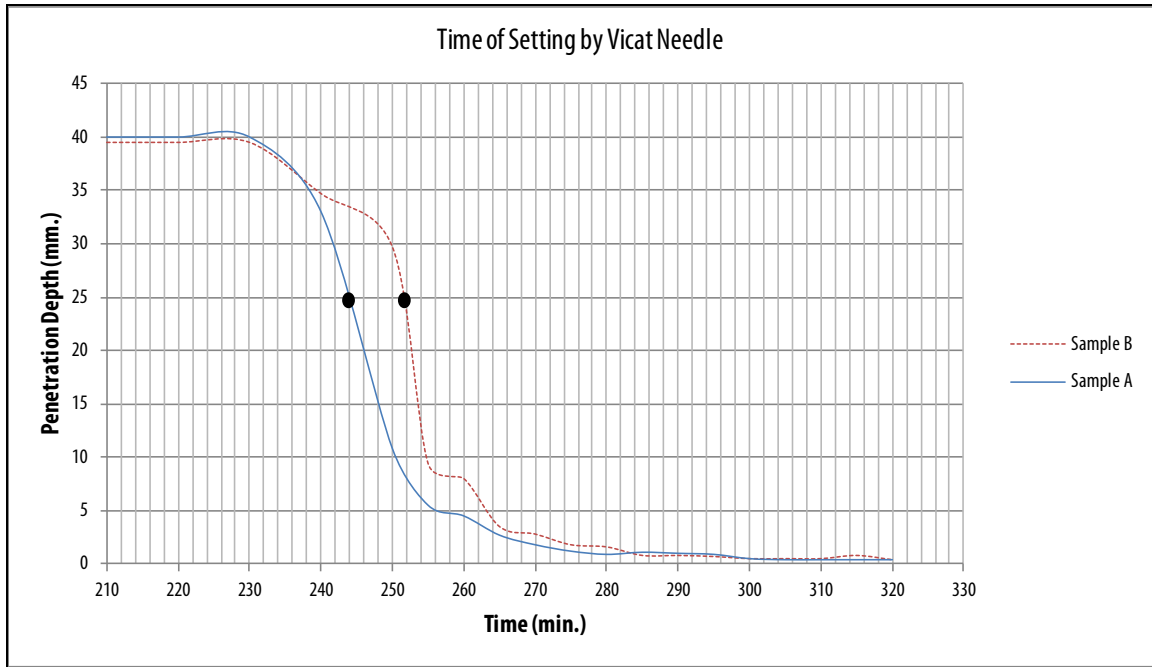
Graph 6. Results of vicat test (initial set indicated with black dots).

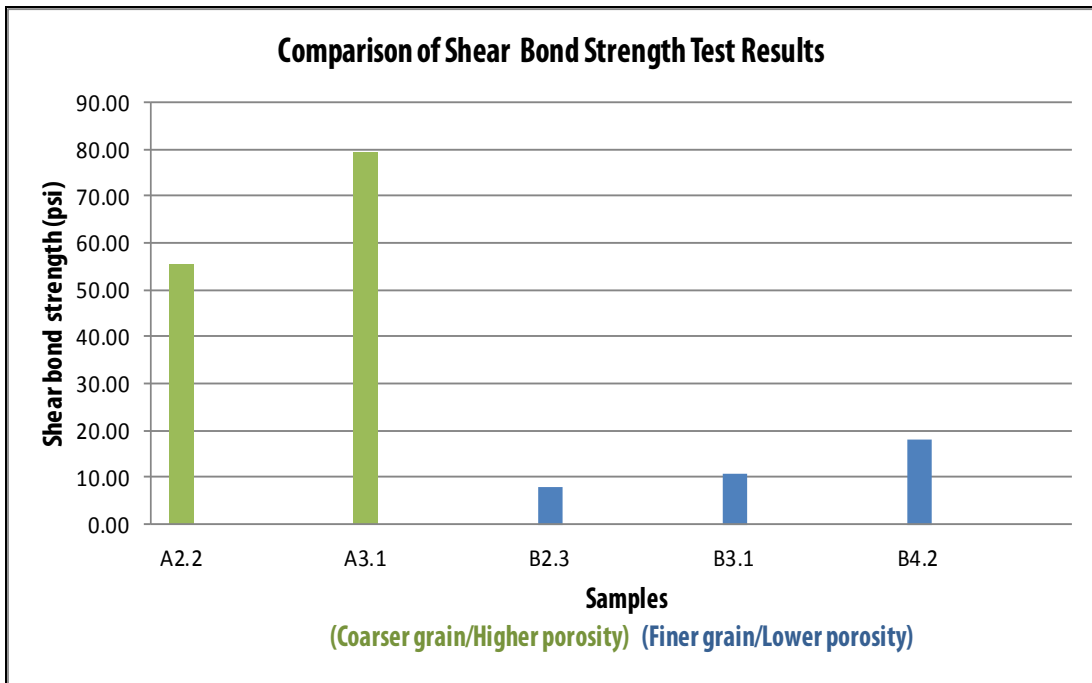
Graph 7. Comparison of shear bond strength test results.

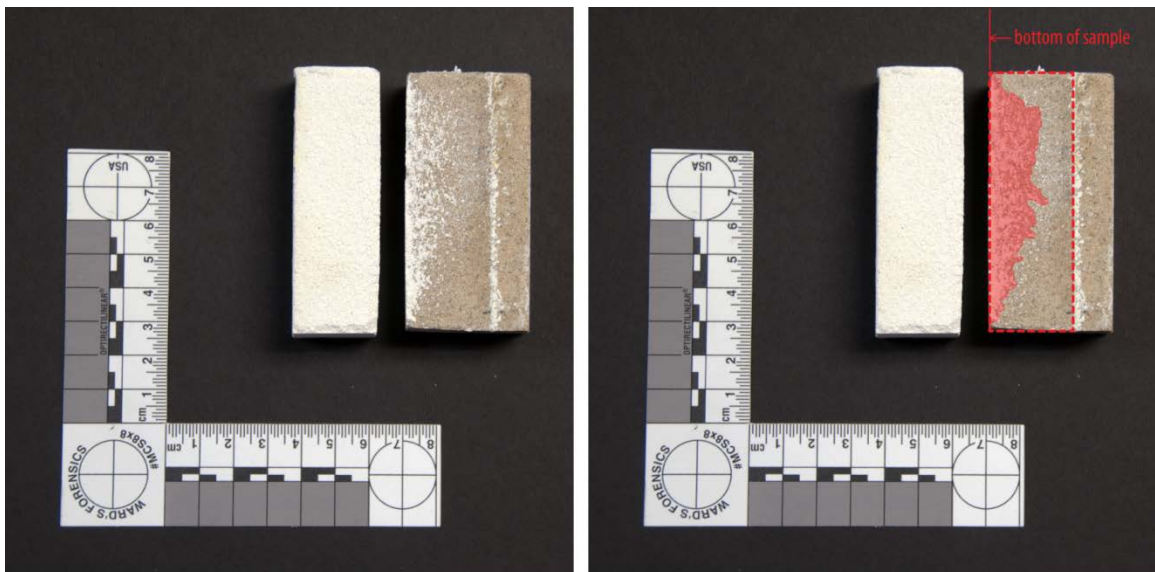
Figure 40. Sample A2.2 – Original grouted area: 2.850 sq. in. / Bond line area: 1.156 sq. in.

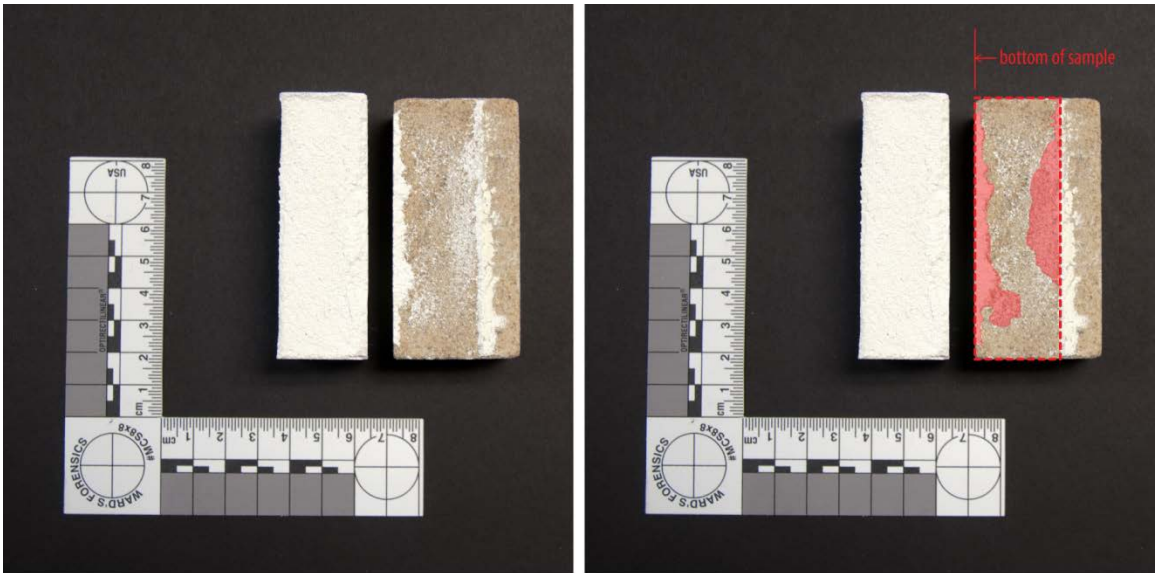
Figure 41. Sample A3.1 – Original grouted area: 2.935 sq. in. / Bond line area: 1.022 sq. in.

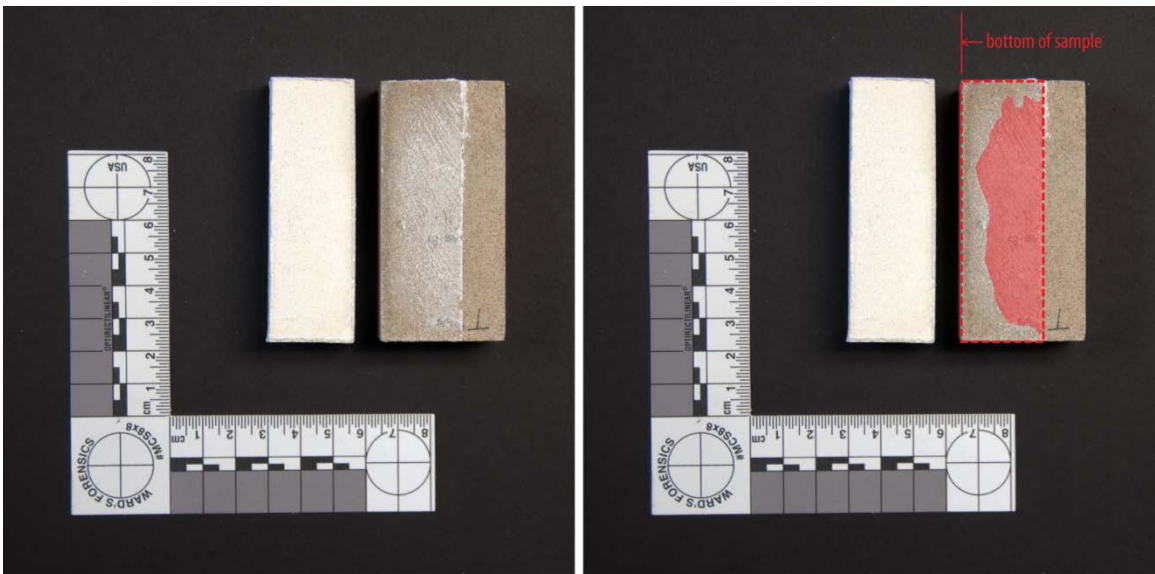
Figure 42. Sample B2.3 – Original grouted area: 3.039 sq. in. / Bond line area: 1.623 sq. in.

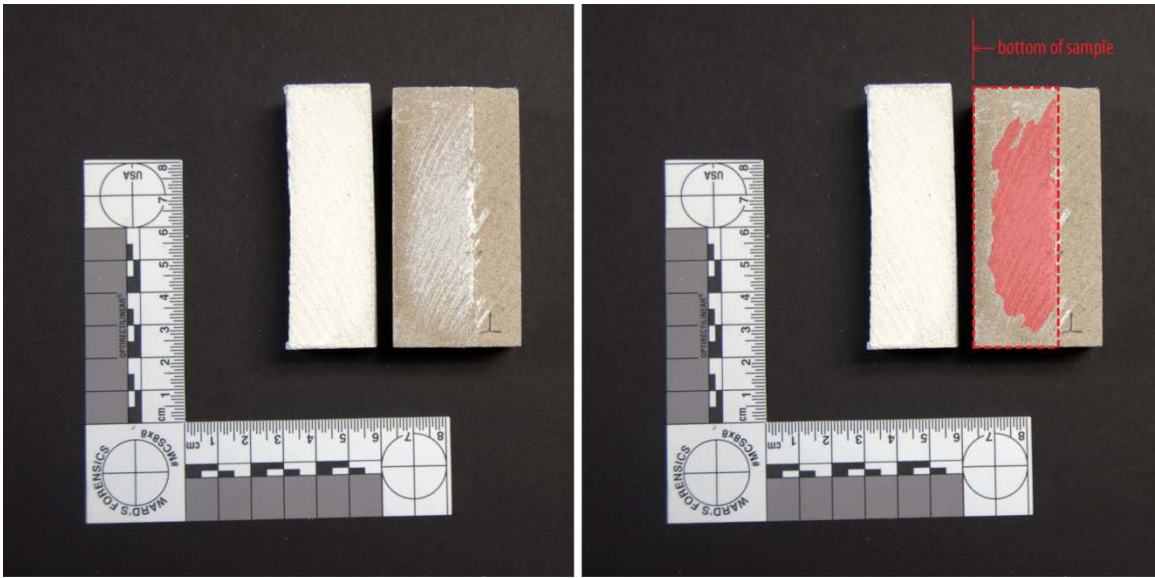
Figure 43. Sample B3.1 – Original grouted area: 2.859 sq. in. / Bond line area: 1.534 sq. in.

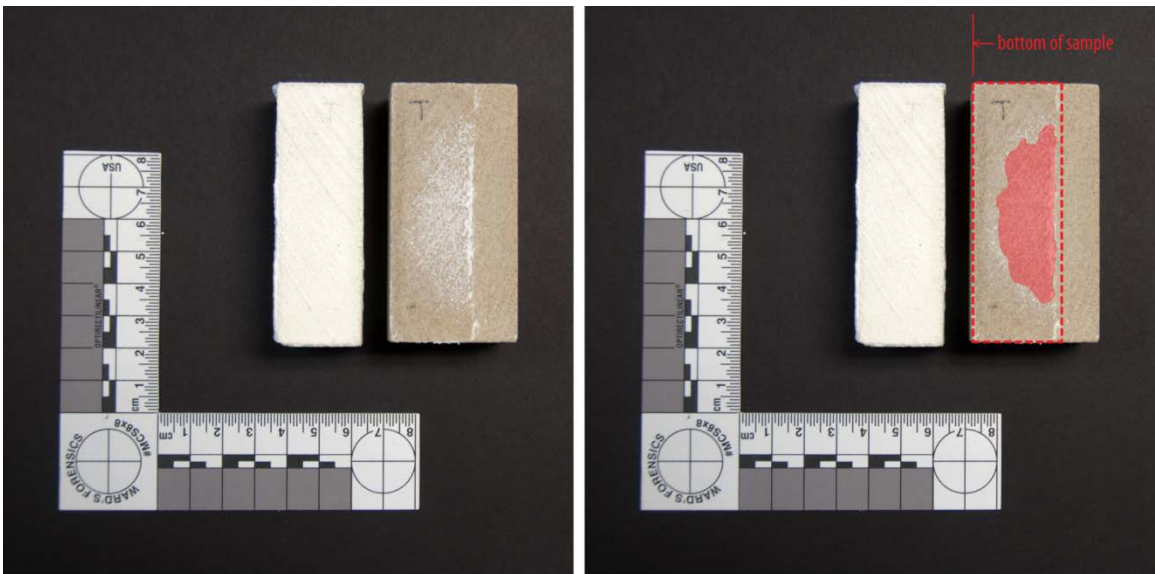
Figure 44. Sample B4.2 – Original grouted area: 3.021 sq. in. / Bond line area: 1.021 sq. in.

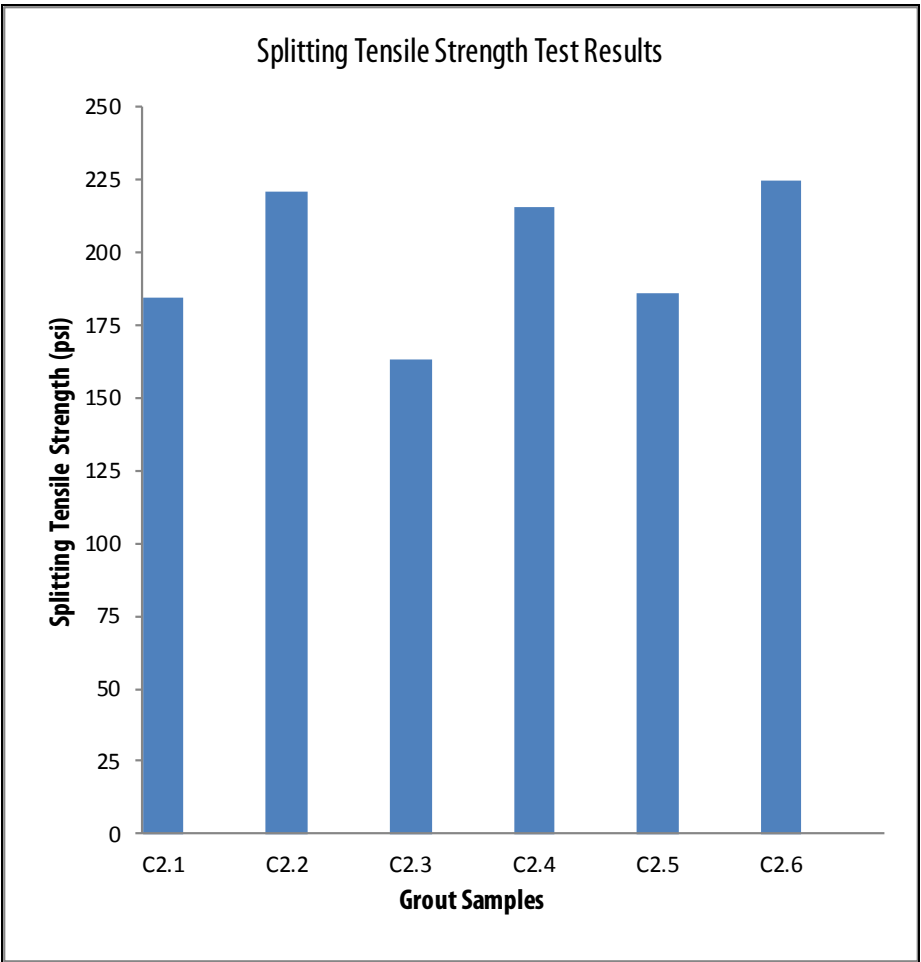
Graph 8. Comparison of test results.

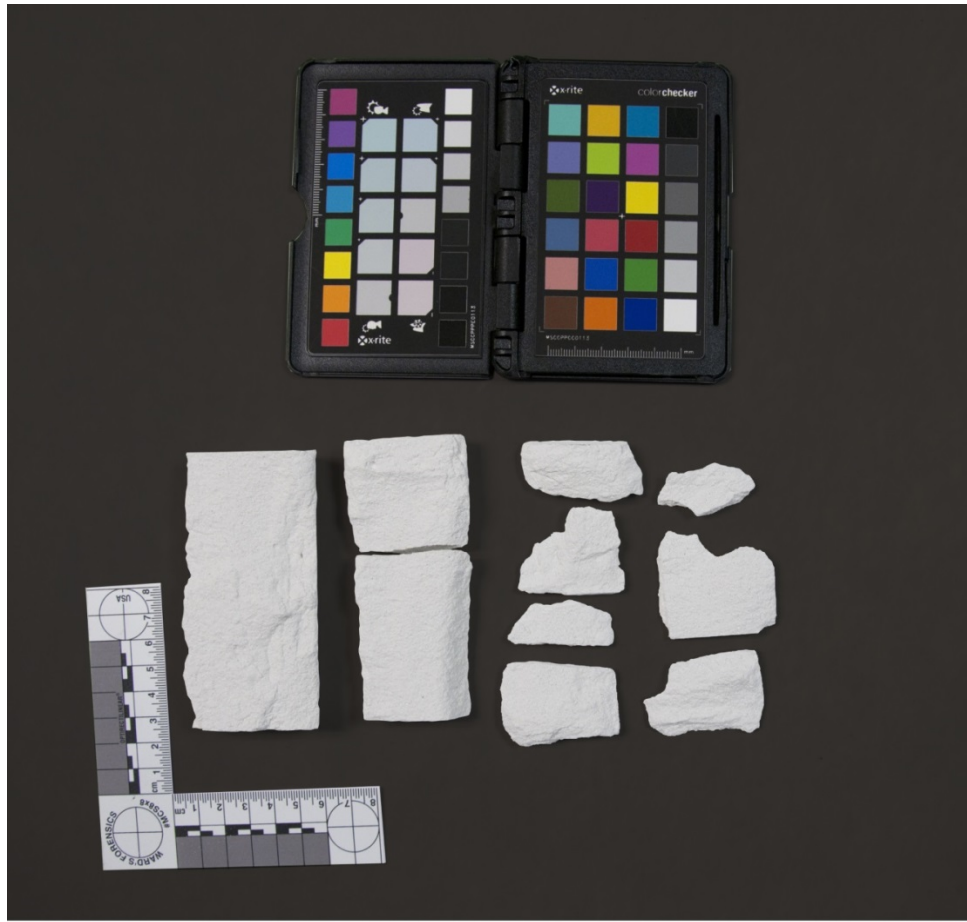
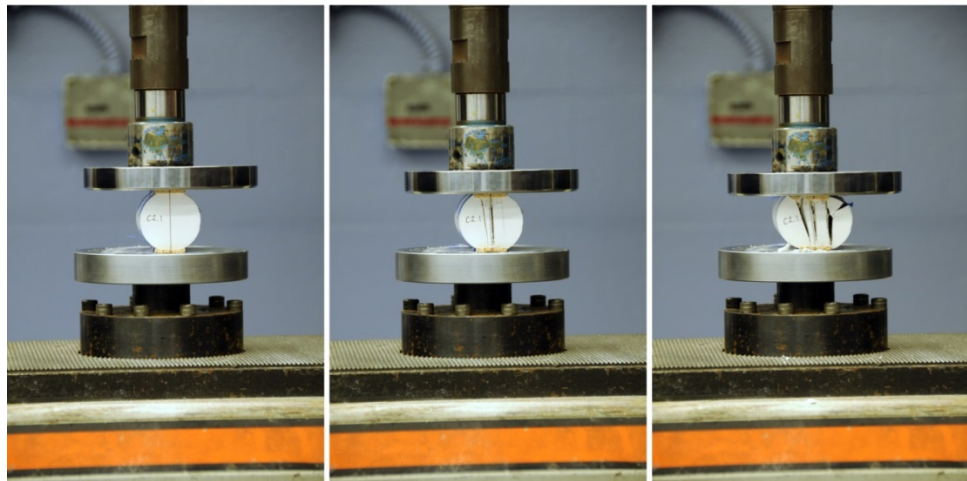
Figure 46. Splitting tensile strength procedure and fracture pattern for sample C2.1.

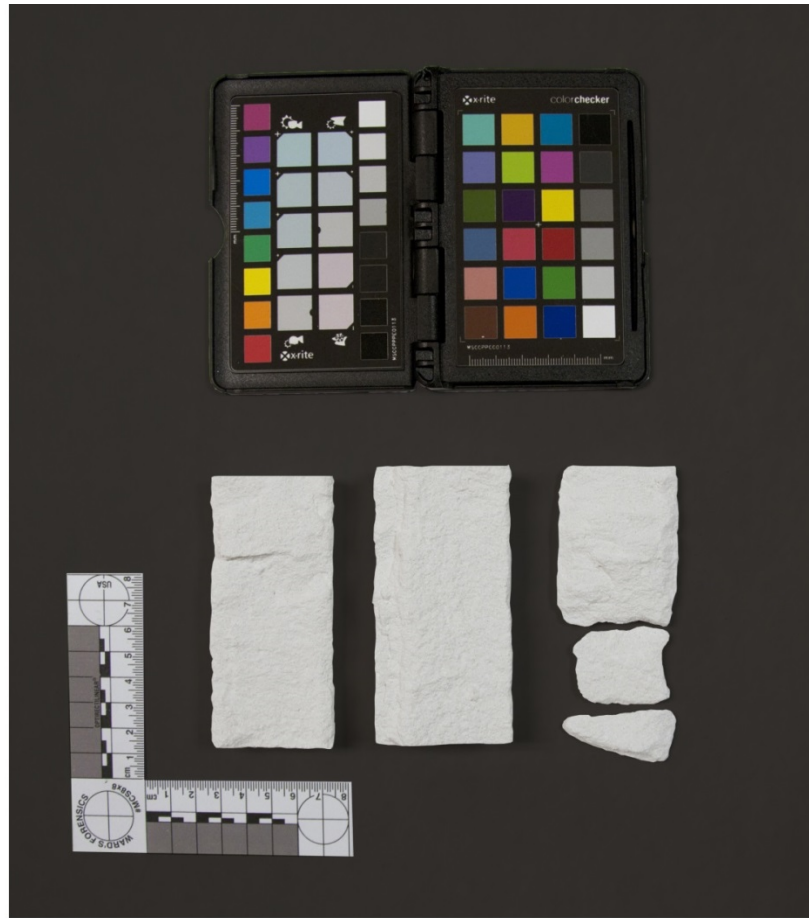
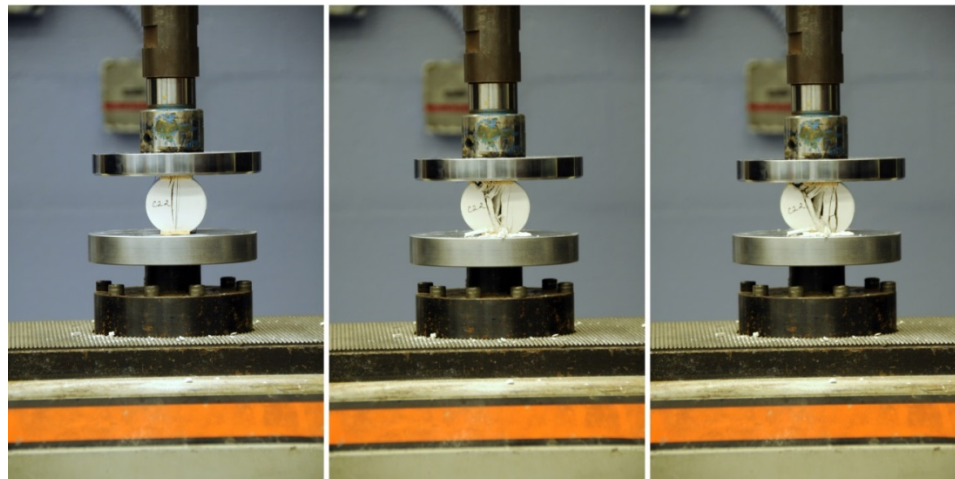
Figure 47. Splitting tensile strength procedure and fracture pattern for sample C2.2.

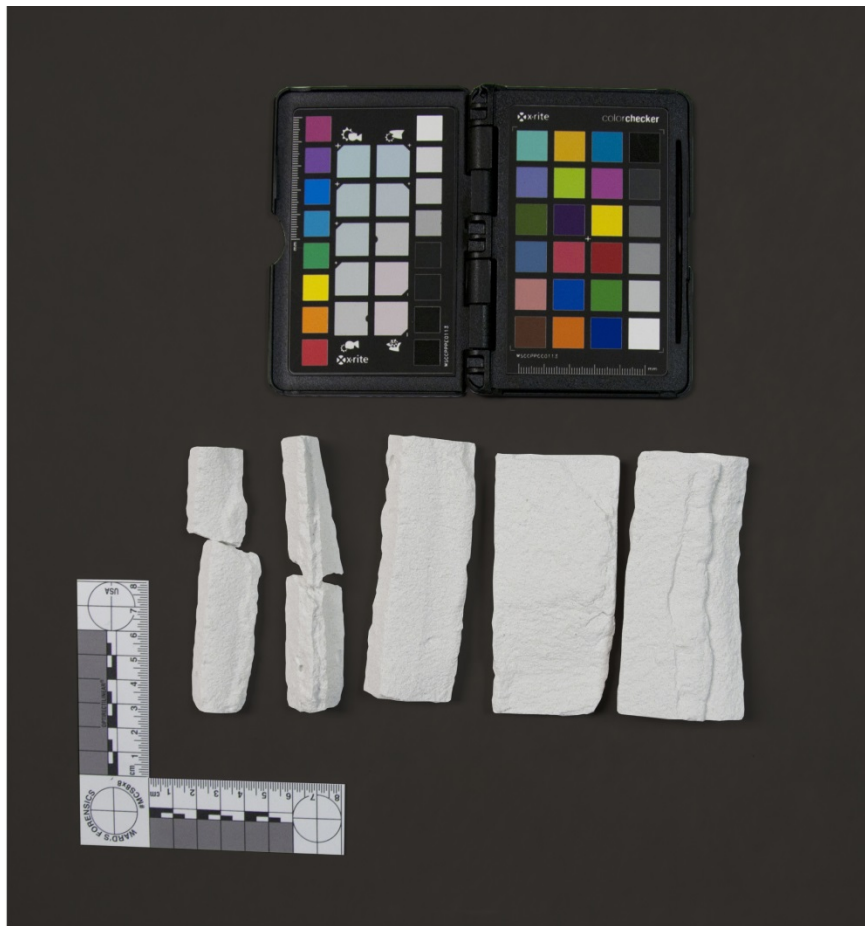
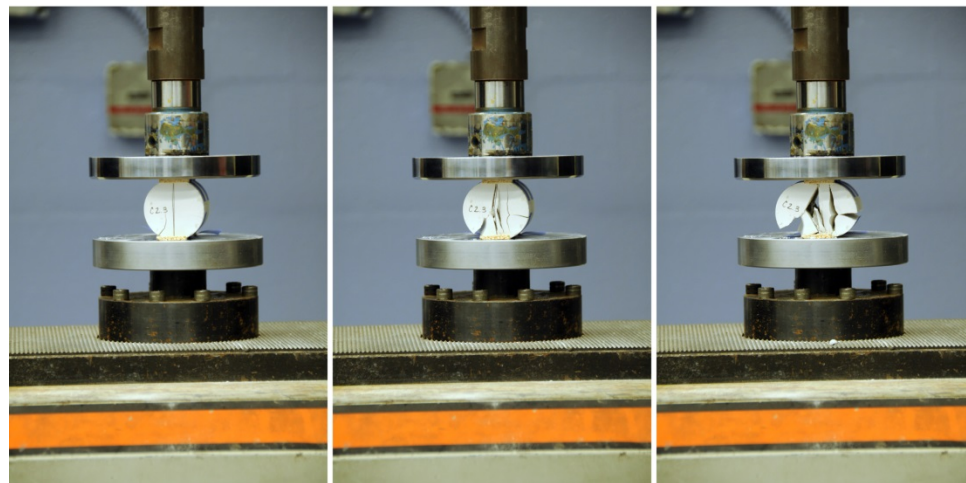
Figure 48. Splitting tensile strength procedure and fracture pattern for sample C2.3.

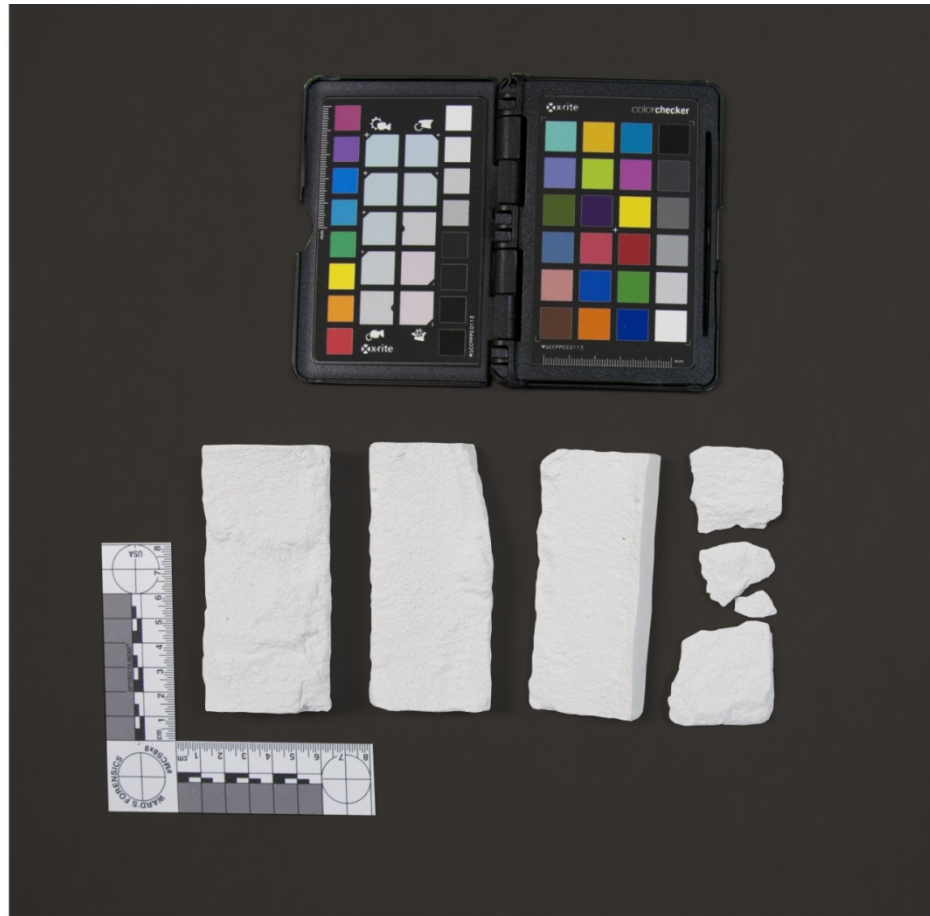
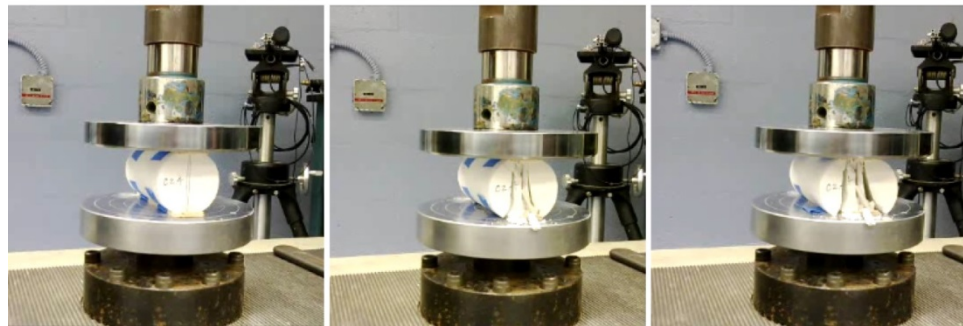
Figure 49. Splitting tensile strength procedure and fracture pattern for sample C2.4.

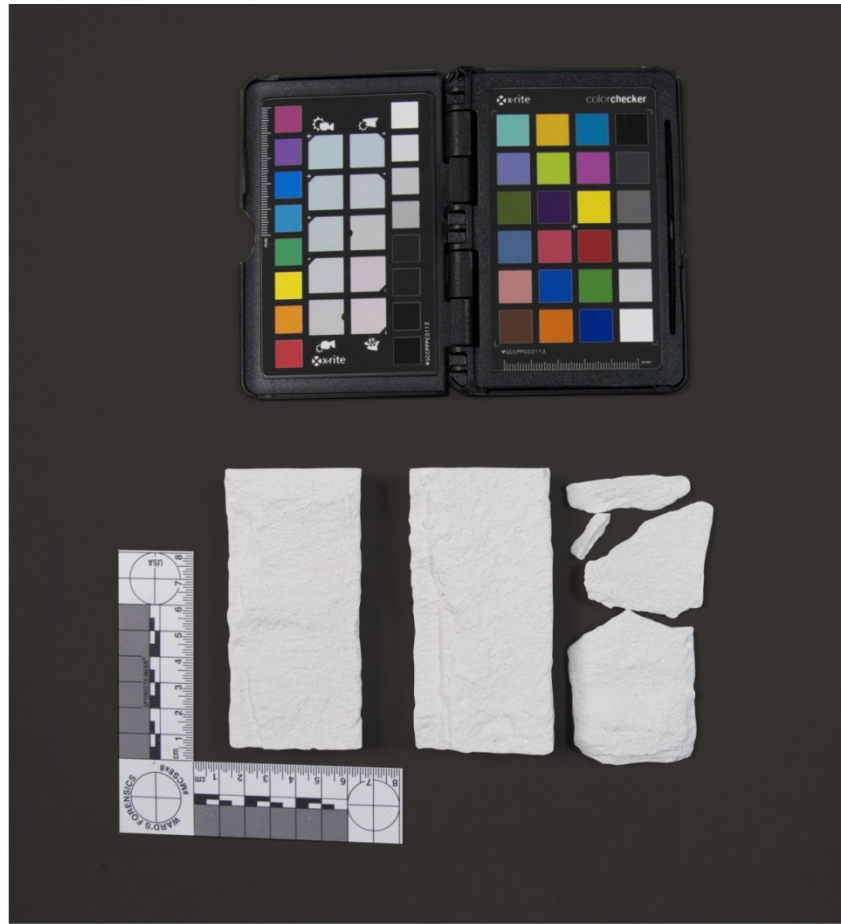
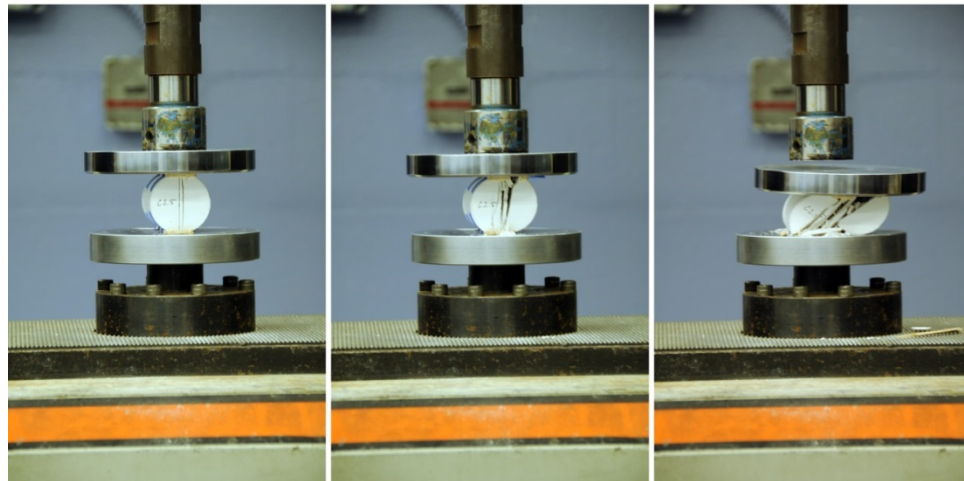
Figure 50. Splitting tensile strength procedure and fracture pattern for sample C2.5.

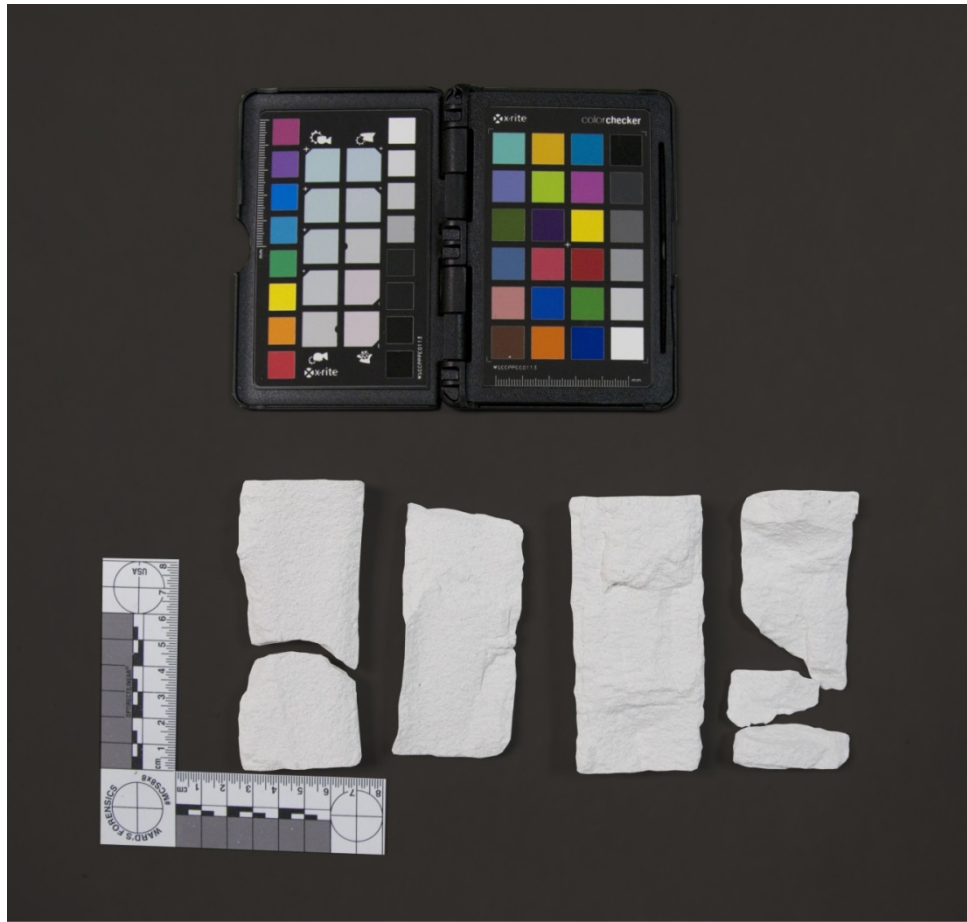
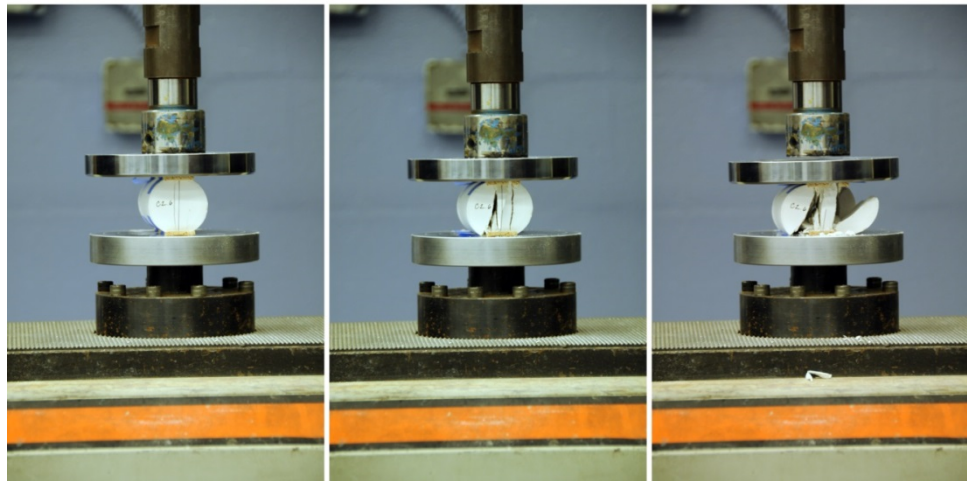
Figure 51. Splitting tensile strength procedure and fracture pattern for sample C2.6.

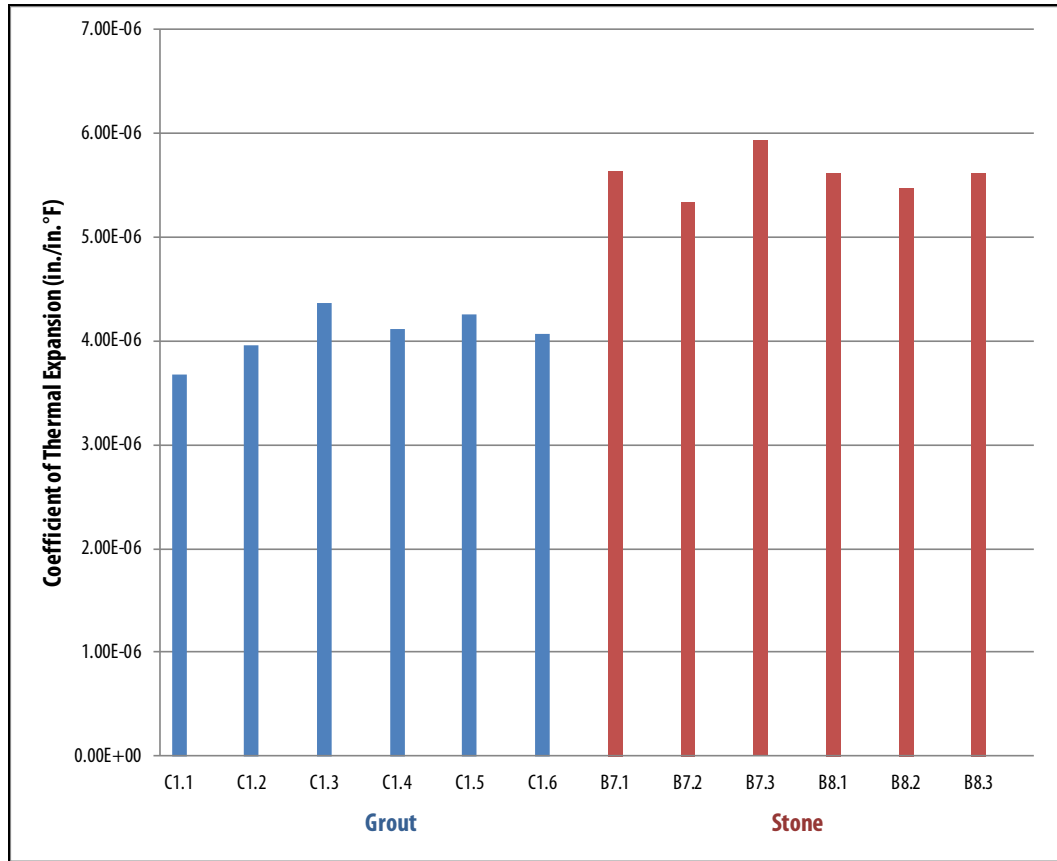
Graph 9. Comparison of thermal expansion in the grout and stone samples.

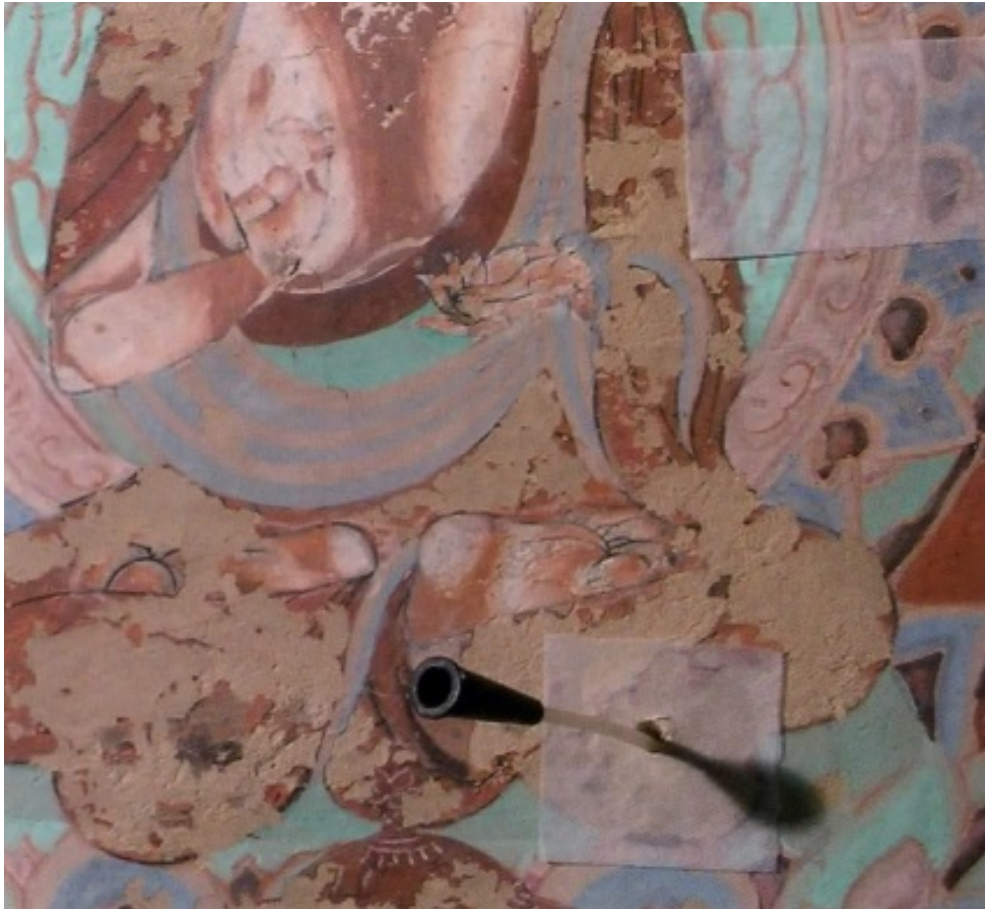
Figure 53. Mural painting in cave 85 of the Mogao grottoes stabilized with temporary facing prior to grouting. Source: Stephen Rickerby et al. Los Angeles: The Getty Conservation Institute, 2010.
