Evaluation of Cementitious Injection Grouts for the Stabilization of Holly Tower Support Rock, Hovenweep National Monument

Naima A. Sweeting
University of Pennsylvania

This thesis addresses the testing and evaluation of the use of a cementitious injection grout for the reattachment of detached slabbing on the sandstone support rock of Holly Tower at Hovenweep National Monument. This research follows on a previous condition assessment and diagnosis of the deterioration of the sandstone support rock and the effects of consolidation on the rock as the first step in a multi-phase conservation program.

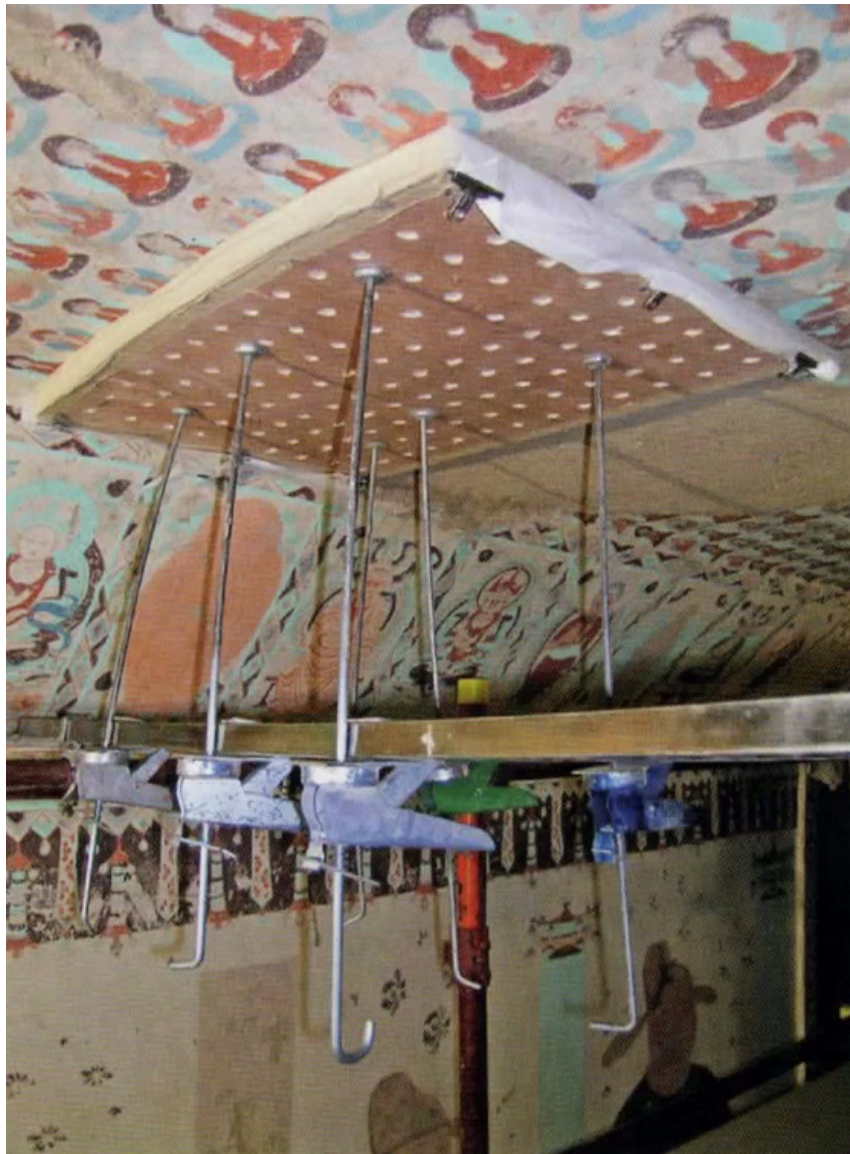
Figure 54. Custom press in cave 85 of the Mogao grottoes.
Source: Stephen Rickerby et. Al. Los Angeles: The Getty
Conservation Institute, 2010.
