Analysis and Interpretation of the Interior Painted Finishes of the Mathews-Lockwood Mansion

**ANALYSIS AND INTERPRETATION OF THE INTERIOR
PAINTED FINISHES OF THE MATHEWS-LOCKWOOD MANSION**

A THESIS

Historic Preservation

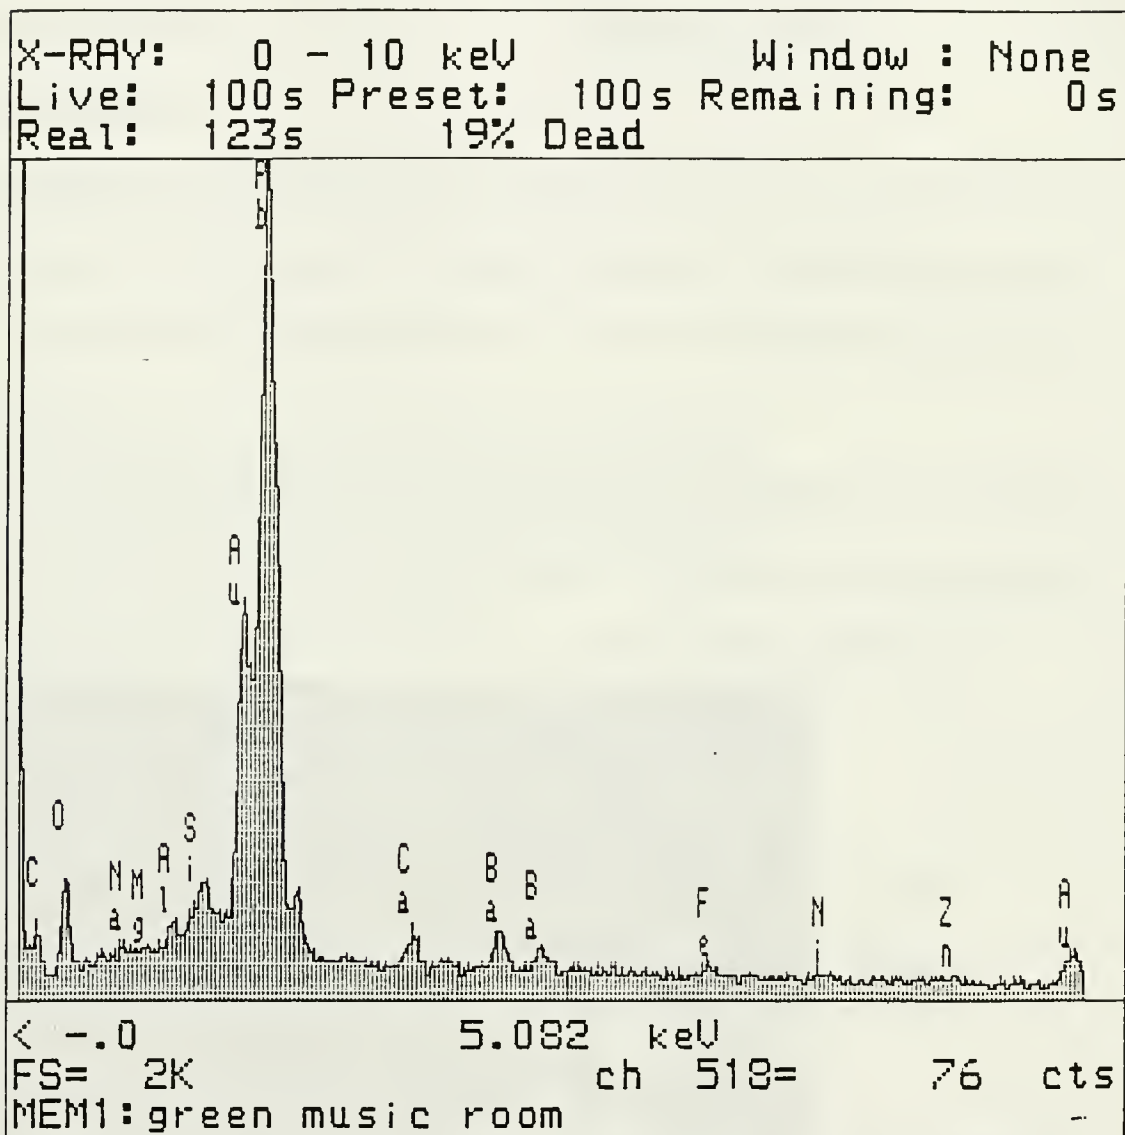
This gold coated sample revealed that the green was made with green earth and ultramarine. The rest of the chemical compounds are lithopone.

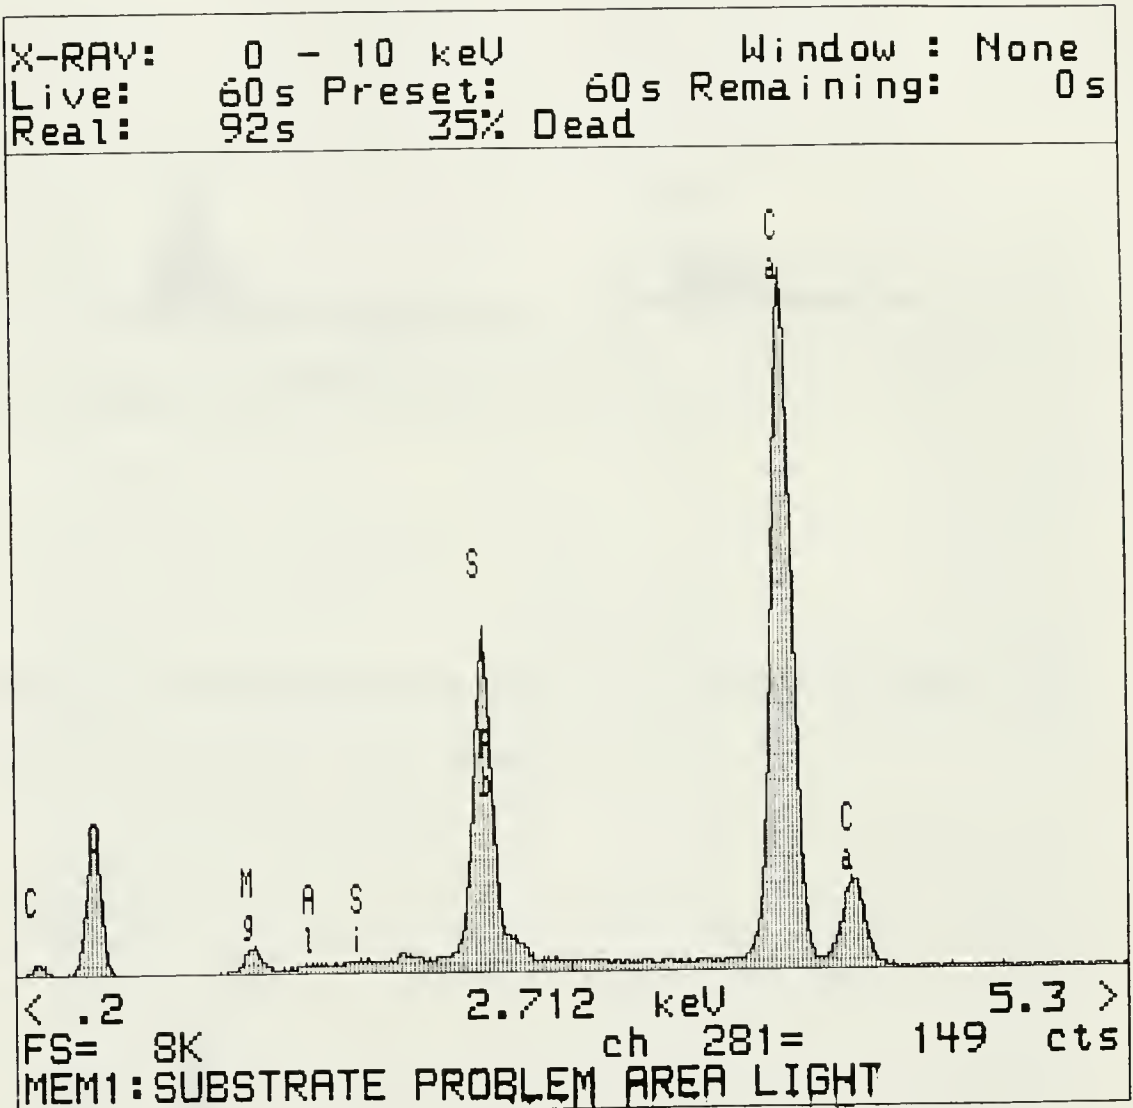
Figure 61: X-Ray Energy Dispersive Analysis of Sample 59: Music Room

The light area has lead and sulphur. The higher presence of sulphur indicates that the gypsum recrystallizes.
