The Washington Memorial Chapel: Historic Structure Report and Condition Assessment

Shelley A. Perdue
University of Pennsylvania

Presented to the Faculties of the University of Pennsylvania in Partial Fulfillment of the Requirements for the Degree of Master of Science Degree in Historic Preservation 2005.

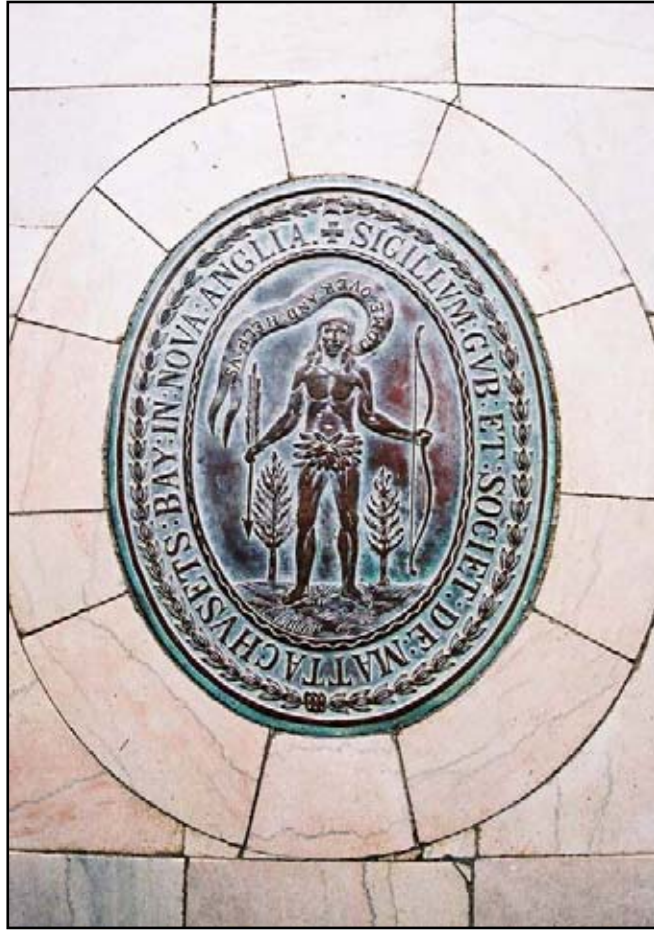
Figure 13. Knoxville marble stone flooring located in the Cloister of the Colonies. Each bay contains an inset bronze medallion depicting its state.

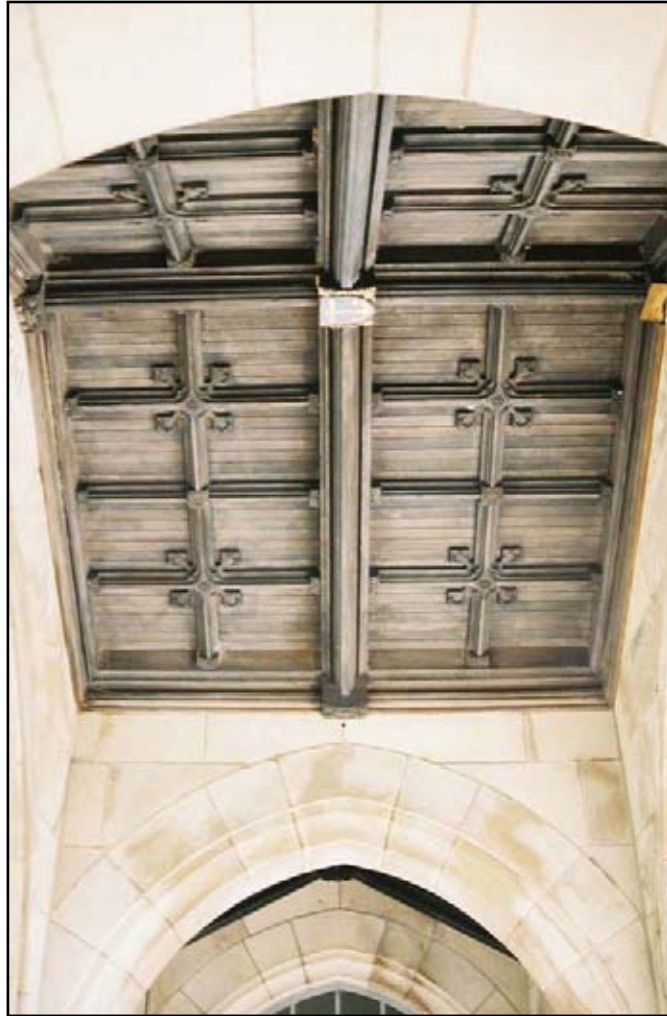
Figure 14. The cloister roof is constructed of Indiana white oak in a tongue and groove pattern and supported by bevel edged trusses.

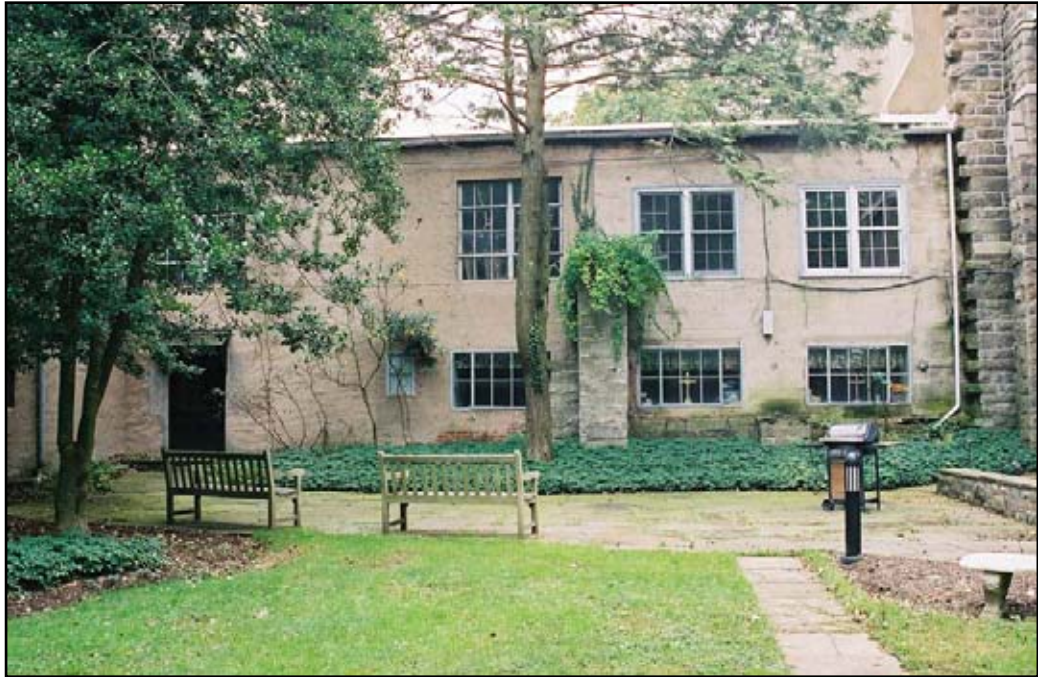
Figure 26. North façade of Patriot's Hall with stucco finish over brick, containing basement entrance.

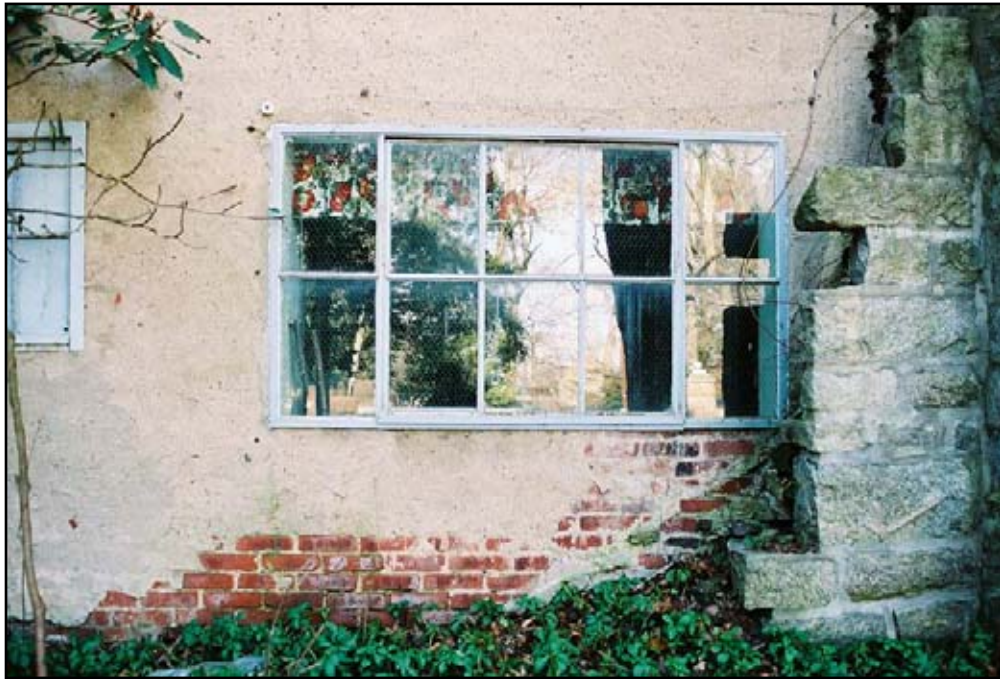
Figure 27. Toothed granite masonry intended to be extended upon the completion of Patriot's Hall.

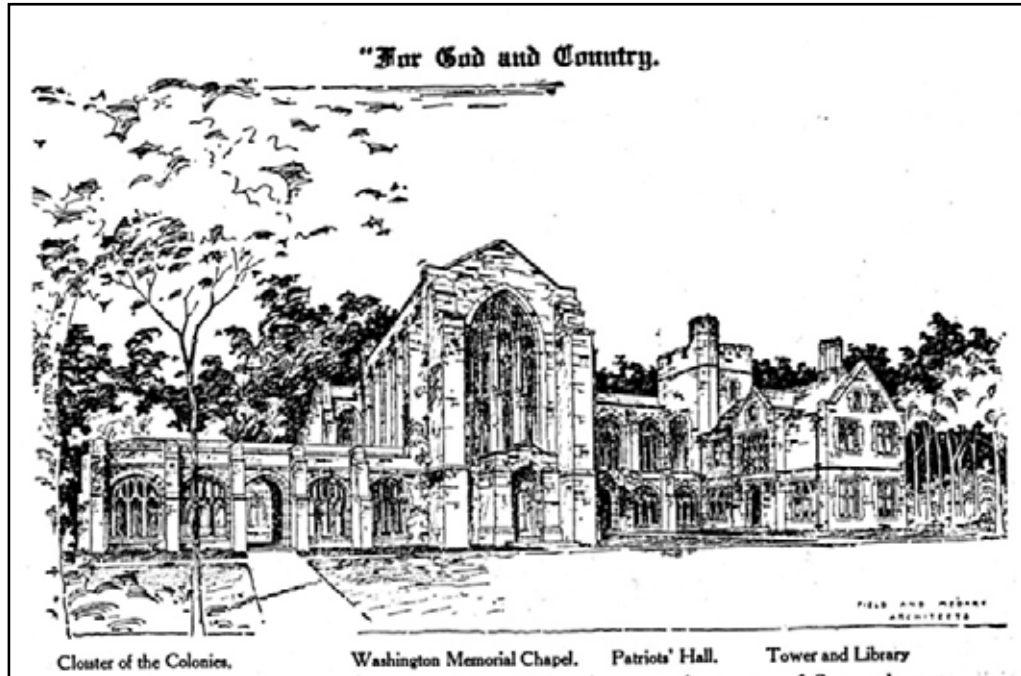
Figure 36. An early image of the Washington Memorial Chapel proposal which appeared on the cover of the *Chronical* in 1912.

Churches of America.²⁸ The school sponsored a design competition in order to choose the building which would best articulate Burk's ideal. During this process the idea for a simple chapel expanded into plans for a large complex to include a museum of American history, a library and a bell tower [Figure 36]. Architect Milton B. Medary Jr. won the contract on April 13, 1915, and his design was described by Professor Laird in these words:²⁹

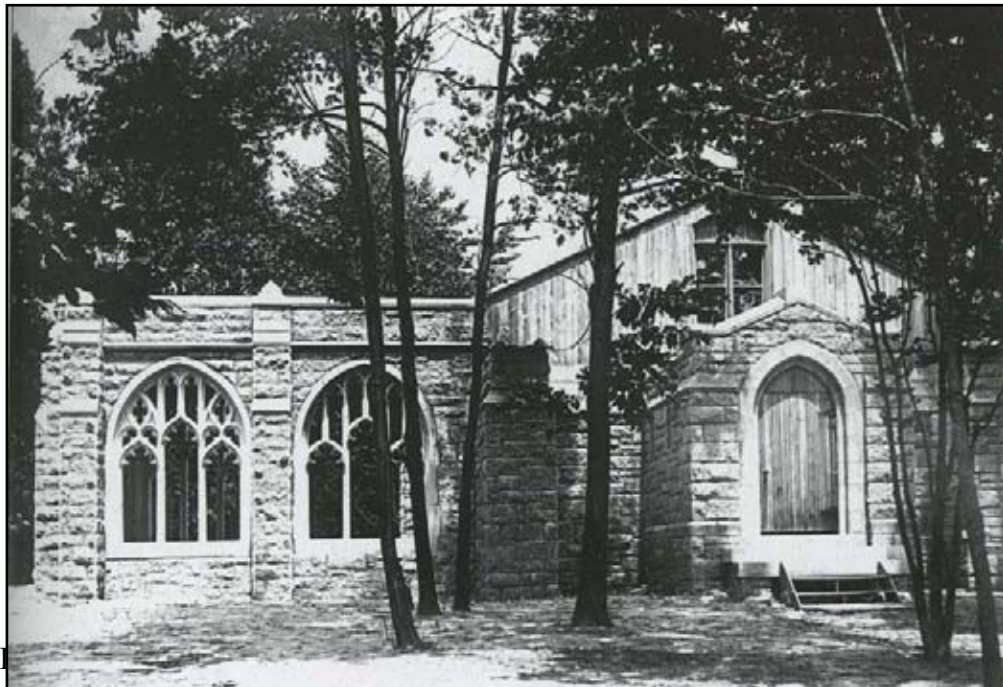
Figure 37. An early image of the chapel with only two completed bays of the Cloister and a temporary wooden roof (Swiggart, 67).

The first sermon delivered within the walls of the new chapel took place on Washington's Birthday in 1904 underneath a temporary roof. The walls were only ten feet high at this time, raised to the level of the window sills [Figure 37]. This drawn out building process was made necessary by the lack of funds available to the Episcopal Church. The Washington Memorial Guild was created specifically to act as a fundraising committee for the building campaign as well as the church's many other missions. Money for the building project was raised through private donations and through some advertising fees collected from the publishing of the annual Washington Memorial Chapel Year Book and various souvenir books. Additionally, parishioners were expected to fill out weekly pledge cards and make regular contributions to the campaign. The church also organized

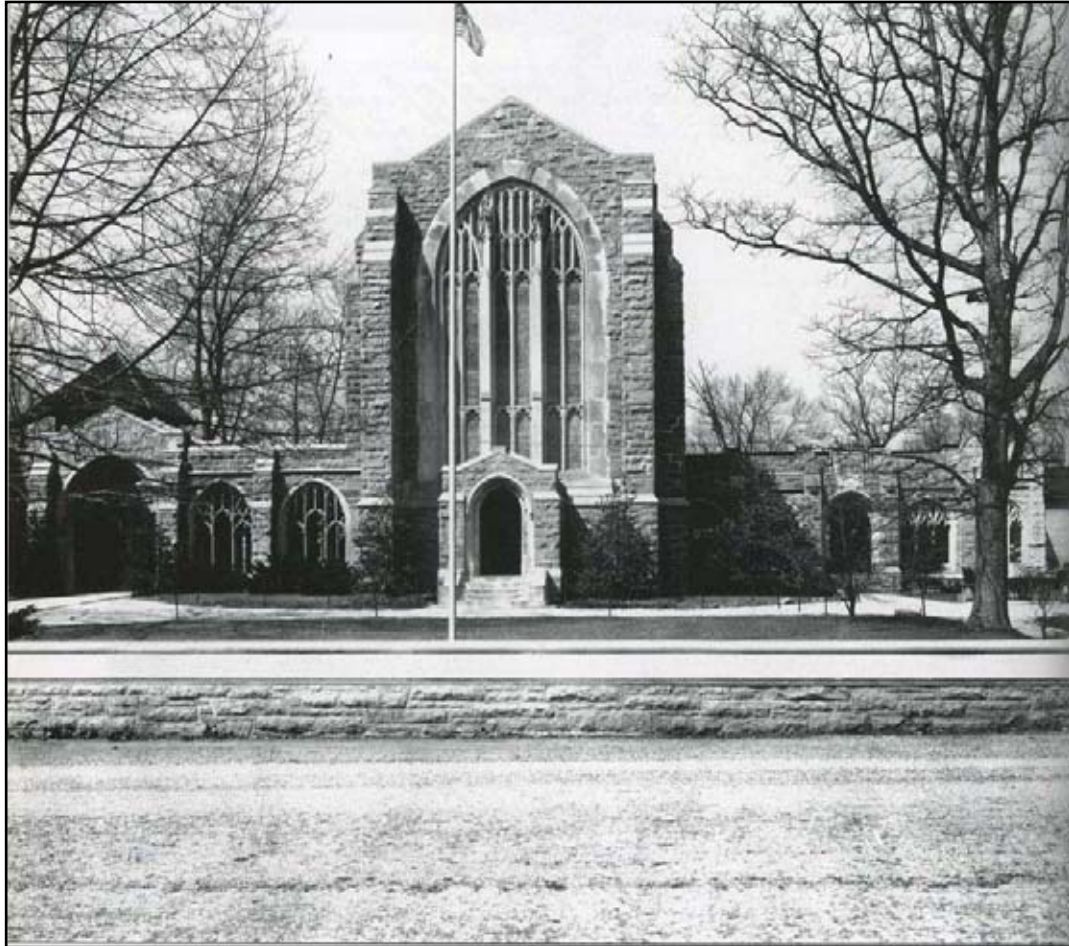
Figure 40. This undated photograph shows the building complex at about the period of Hart's arrival with the Porch of the Allies completed but the carillon yet to be built (Swiggart, 110).

Reverend Burk's vision for the memorial also included a museum of American history to house relics from the Revolutionary War. This section of the building would also be dedicated to the meetings of patriotic and historical societies. Construction began on Patriot's Hall in 1908. The addition was attached to the eastern wall of the chapel to be accessed through the Porch of the Allies. The new building was a steel and concrete structure approximately 28 by 24 feet designed specifically to hold the museum cases [Figures 43-47]. The museum was officially dedicated in 1909 but, like the chapel, was only partially completed at the time. For a time the museum was covered by a wooden frame roof and shingles rather than the current slate roofing [Figure 40].

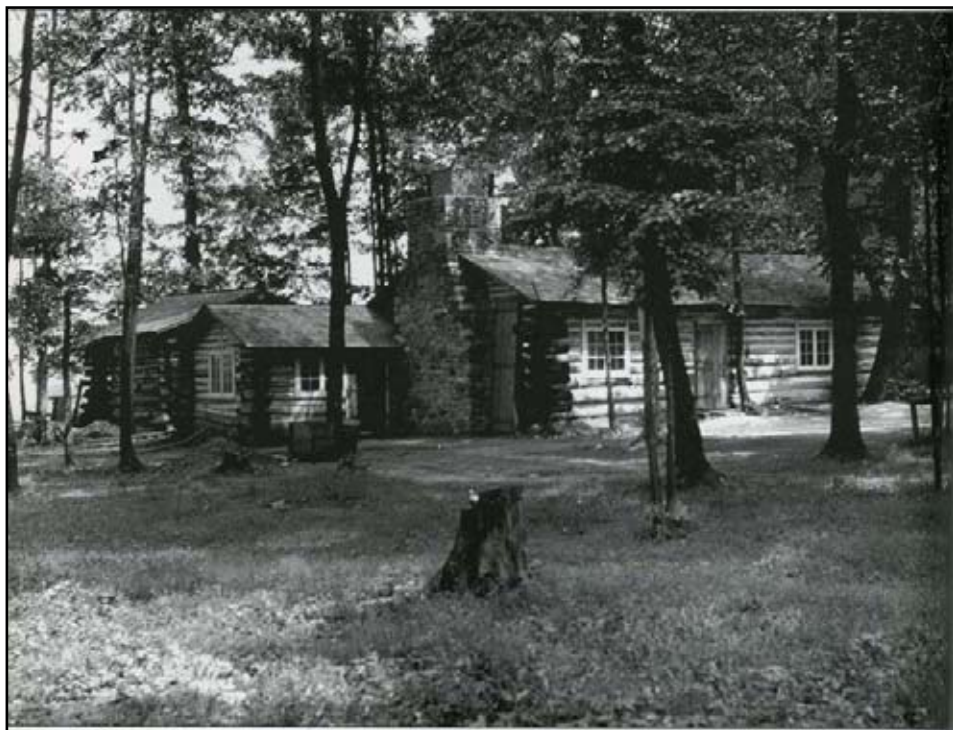
Figure 48. Log cabin constructed to house the Sunday School (Swiggart, 86).

church functions [Figure 48].⁵² Meanwhile, Burk had made progress on his plans for the Valley Forge Historical Society, which was created in 1918, and focus shifted to completing the plans for Patriots' Hall [Figure 49]. In 1924, three additional rooms were planned for Patriot's Hall. At about the same time, the sexton moved out of his living quarters below the museum floor, opening up more space for the expanding collection.⁵³

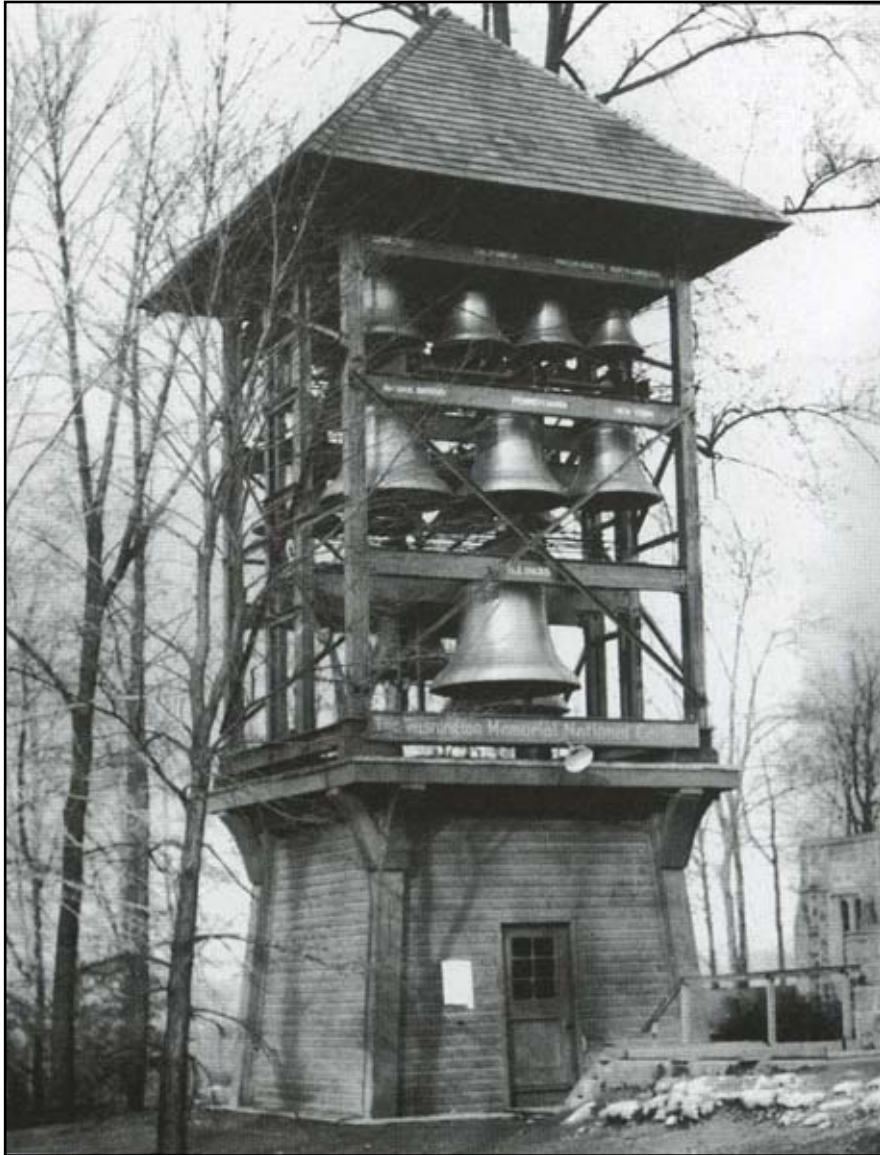
Figure 50. The temporary bell tower located to the west of the chapel (Swiggart, 84).

By 1926, plans for a carillon had begun with an order of the first set of bells.⁵⁴ A temporary wooden and steel structure was constructed at this time to the west of the chapel to hold thirteen bells [Figure 50]. Construction of the permanent bell tower began in 1941; however, construction was halted during the war and would not begin again until 1949. The temporary structure was dismantled in 1958 when the bells were transferred to the permanent carillon.

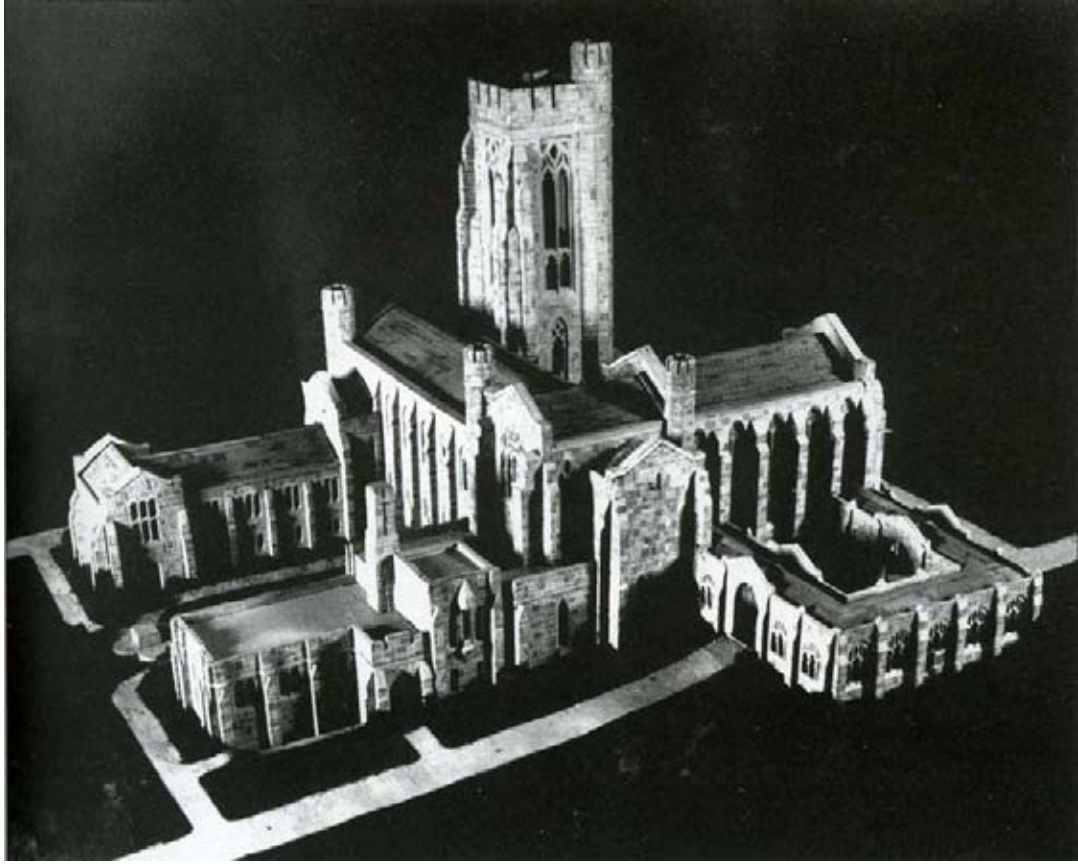
Figure 51. Model from the 1950's completion study (Swiggart, 57).

by Borie and Smith show. Just the year prior in 1955, the plans for the completion of Patriot's Hall and an auditorium wing had begun again [Figure 51]. The drawings from this planning period show the last addition which leads north from the half-completed carillon.

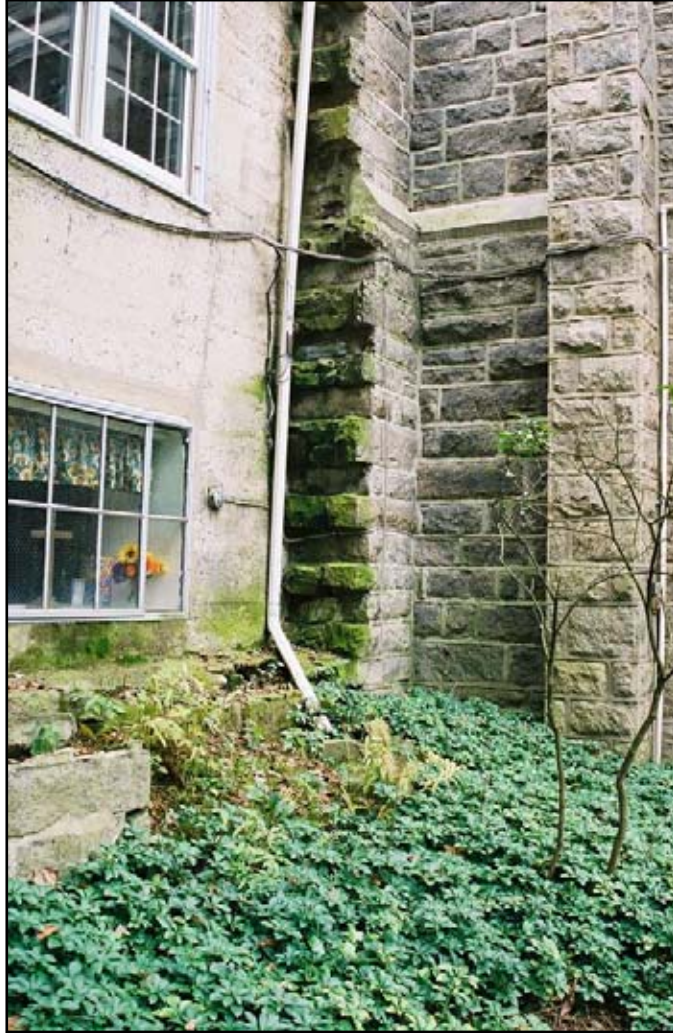
The condition of the granite at Washington Memorial Chapel is generally good. It shows minimal biogrowth. Algae are found mostly in areas of shade, such as under the trees on the east wall of the chapel, or near deep cracks or seams in the stone where water is more likely to collect. The most severely affected area is the open keyed wall leading into the rear wall of the museum. The shade and damp here has allowed for moss and ivy to cover nearly a third of the surface area of the stone [Figure 53].

Figure 53. Biogrowth attacking the damp stone and stucco on the north wall of Patriot's Hall.

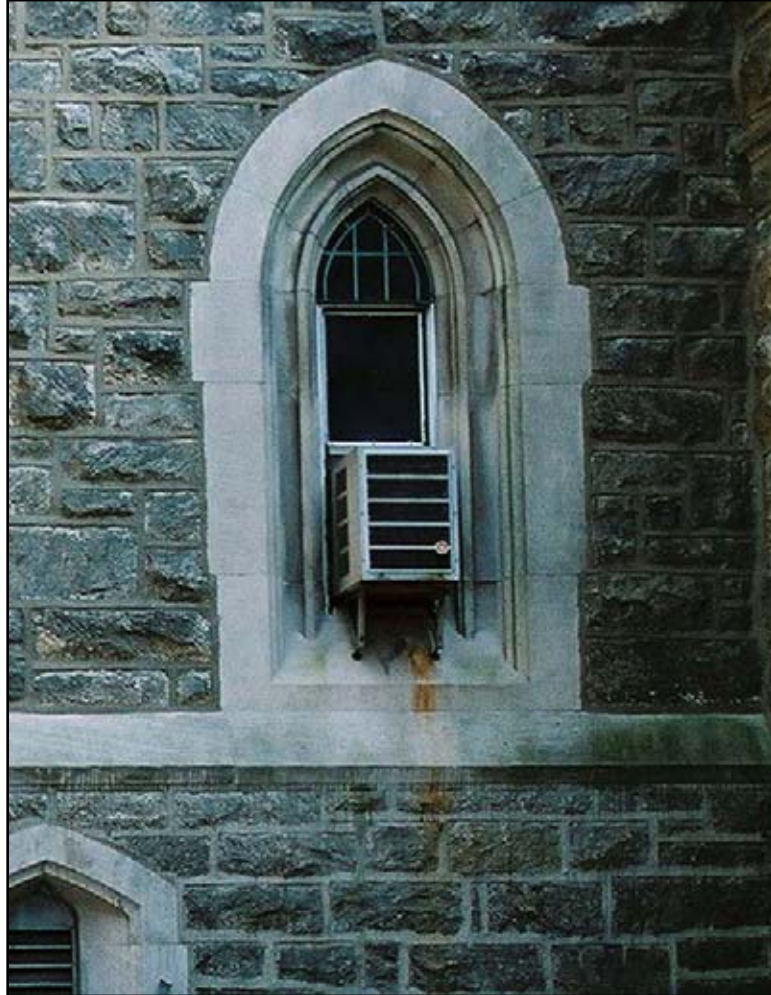
The stone is also minimally affected by soiling and staining. Soiling is found mostly in protected areas that are not washed by rain. Staining has occurred mainly where the copper gutters and downspouts have failed and begun to leak rainwater, spreading a greenish copper stain. Overall, however, the granite appears to resist the copper staining more effectively than the Indiana limestone. There is also superficial rust staining beneath the air conditioning unit on the west wall of the library [Figure 54]

Figure 54. Rust staining resulting from leaking air conditioning unit.

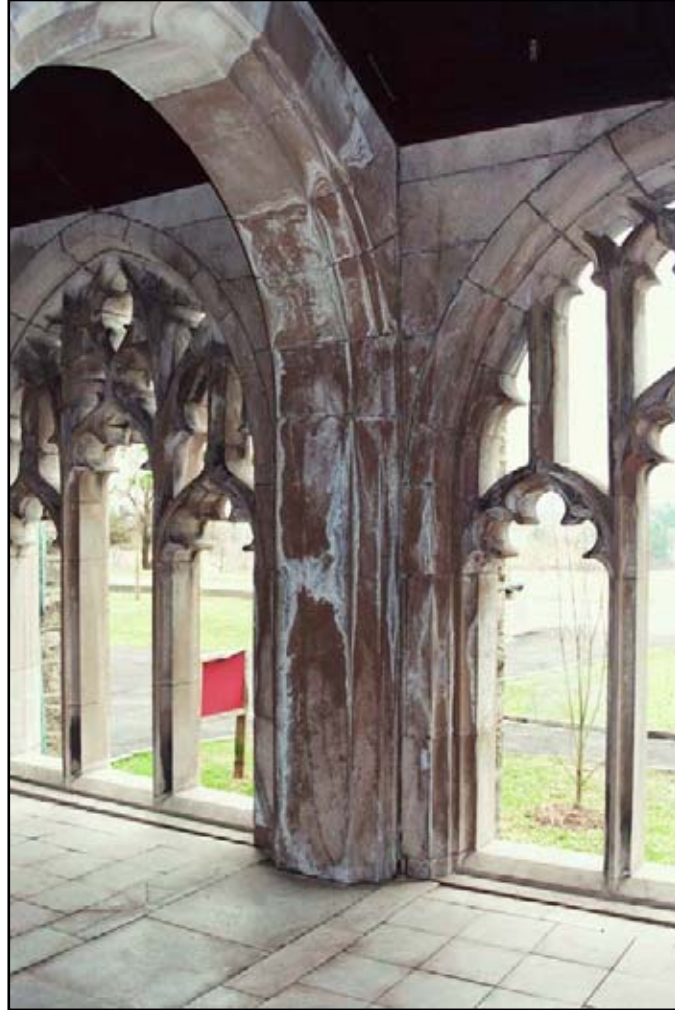
The limestone tracery at the chapel is in overall poor condition, especially within the Cloister where it has previously been repaired with an apparently incompatible mortar mixture.⁶⁴ The efflorescence now visible on the surface of the stone indicates that salts are present in the stone [Figure 55]. The cycle of salt dissolution and recrystallization will continue to cause delamination of the stone surface if not treated. Delamination occurs when layers of stone are forced apart, often through the action of salt or water crystallization. The same process of crystallization is causing cracking in some areas [Figure 56].

Figure 55. Salt efflorescence in the Cloister of the Colonies.

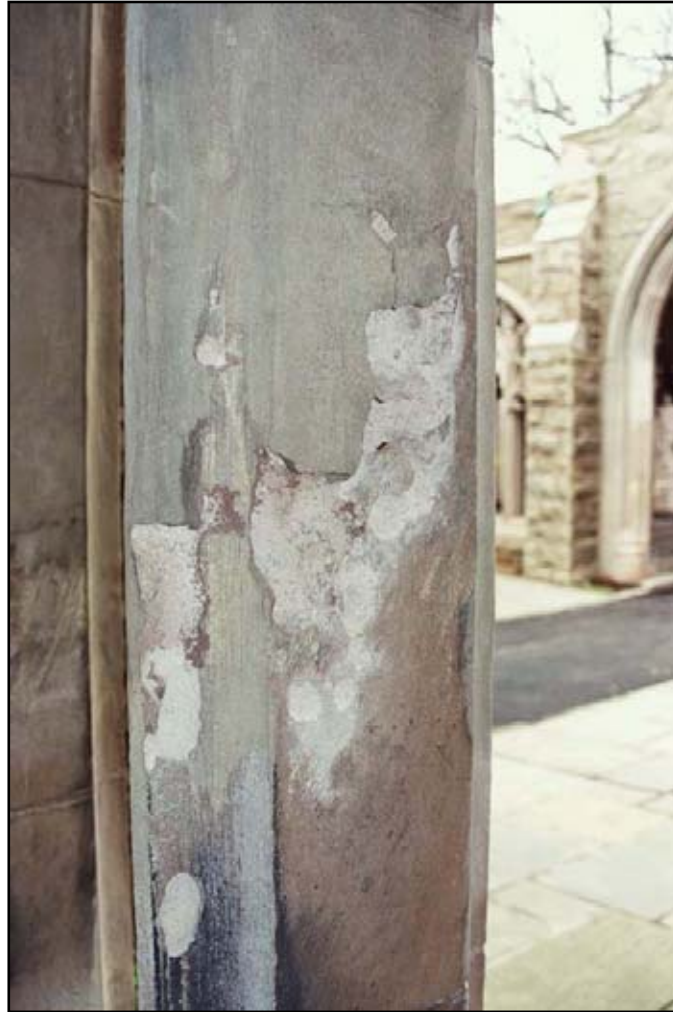
Figure 56. Delamination of the stone presumably caused by salt crystallization.

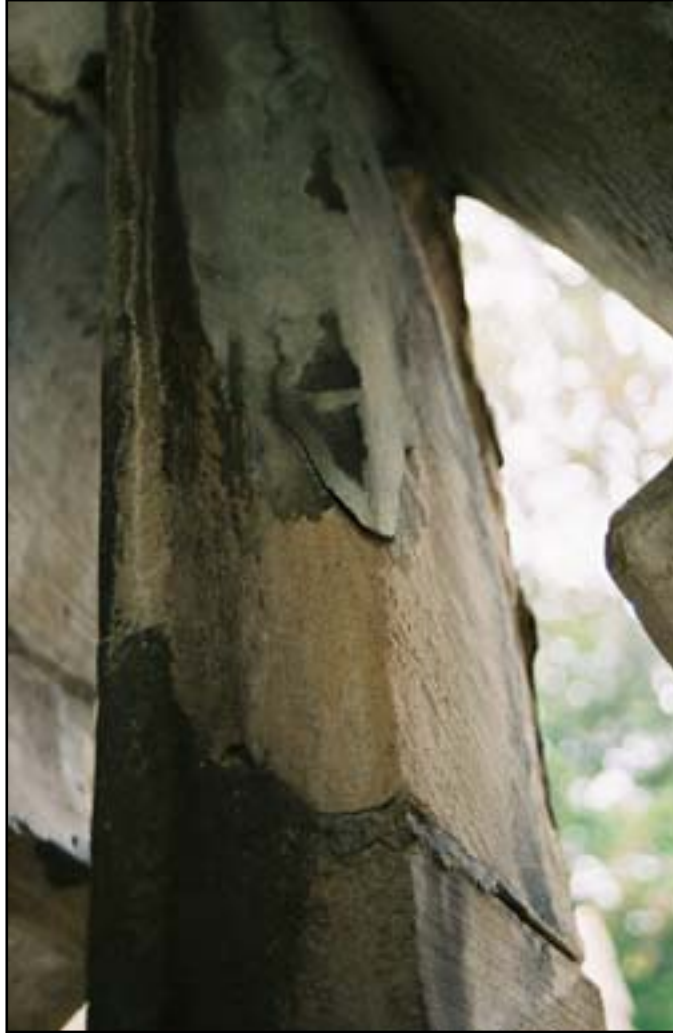
Where the cement patches are separating from the stone, original fabric is also being lost as the surface layer of limestone remains adhered to the cement patch and pulls away from the body of the stone [Figure 57]. This behavior of the patch implies that the mortar mixture chosen for this repair was too strong and dense as it is sacrificing the original material during failure rather than the replacement material.

Figure 57. Cement patching separating from the limestone body.

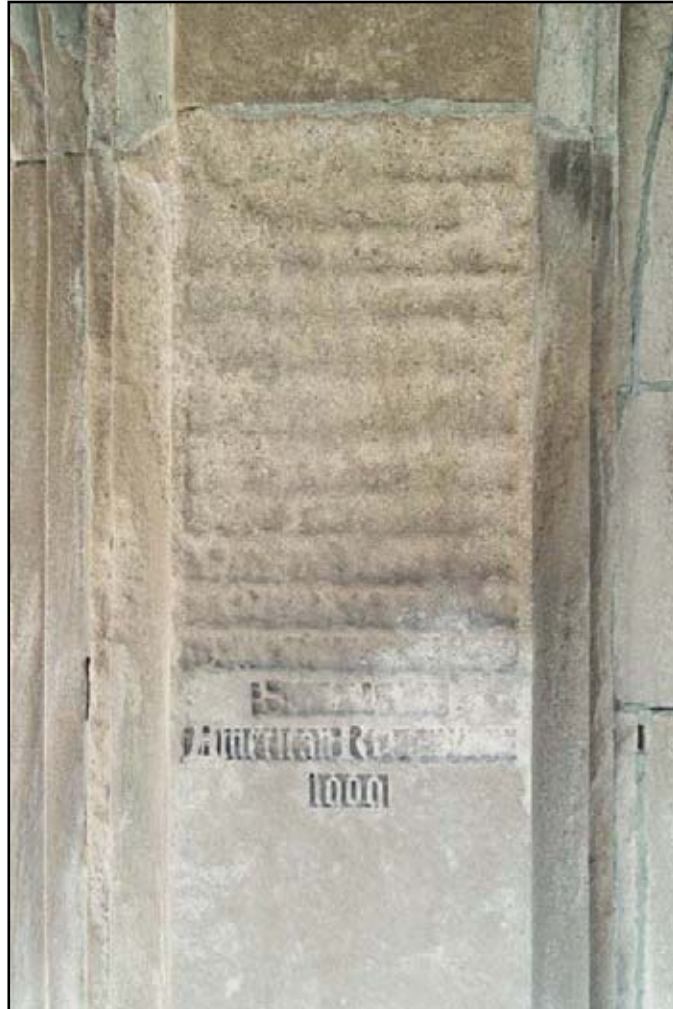
The limestone surface is also exhibiting sugaring of the surface layer. This may be caused by the dissolution of the stone's calcium binder due to interaction with acid rain.

This condition exists mostly in areas which are continuously exposed to flowing rainwater that enters through the failing roof [Figure 58].

Figure 58. Area below a leak in the Cloister roof, which is allowing rainwater to erode the stone's surface.

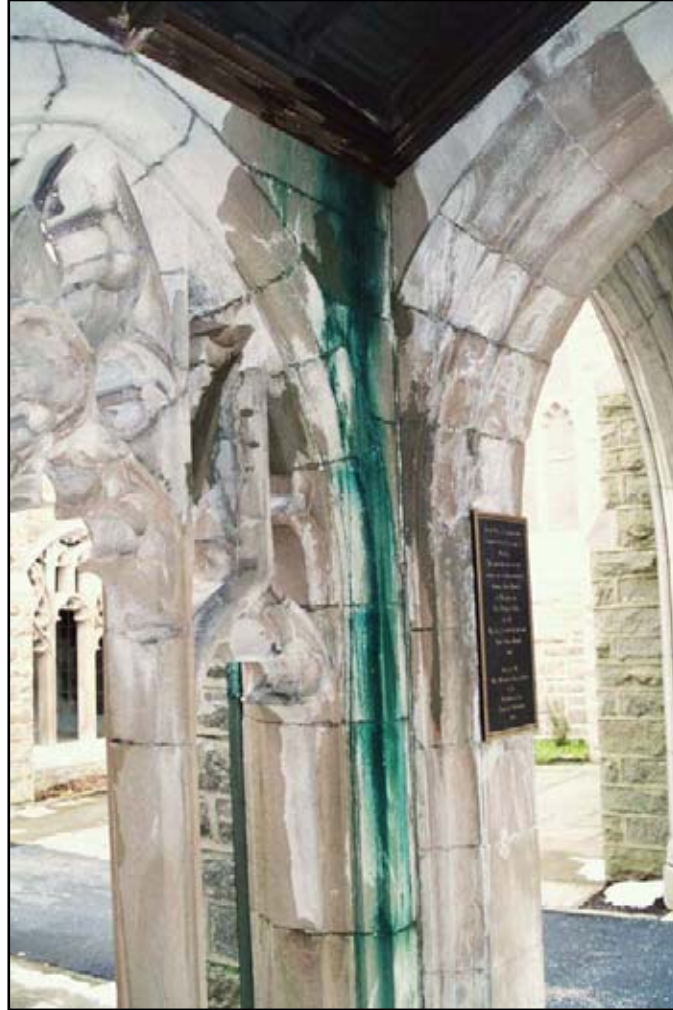
The stone is also affected in several areas by staining. It is susceptible to green copper staining from the gutters and downspouts [Figure 59]. It also exhibits some blackening in areas which are not washed by the rain [Figure 60]. These particular areas should be monitored for the development of gypsum crusts which can develop through the interaction of the stone with sulfites in the sooty film.

Figure 59. Copper staining from the Cloister gutters is spreading below a leak in the roof.

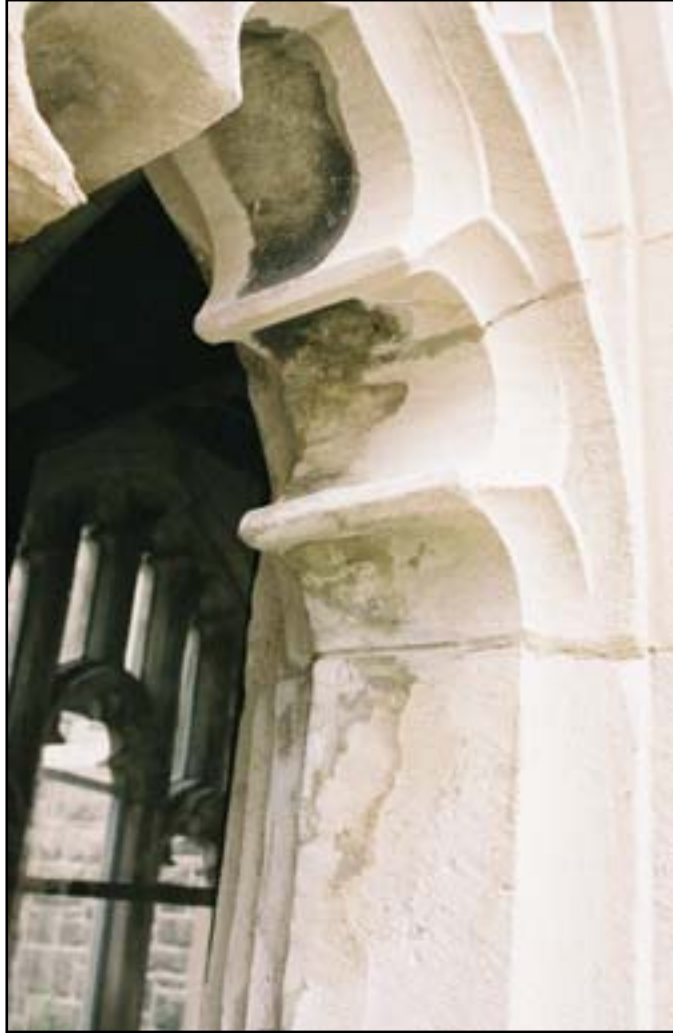
Figure 60. Black staining is found in areas that are not washed by rainwater.

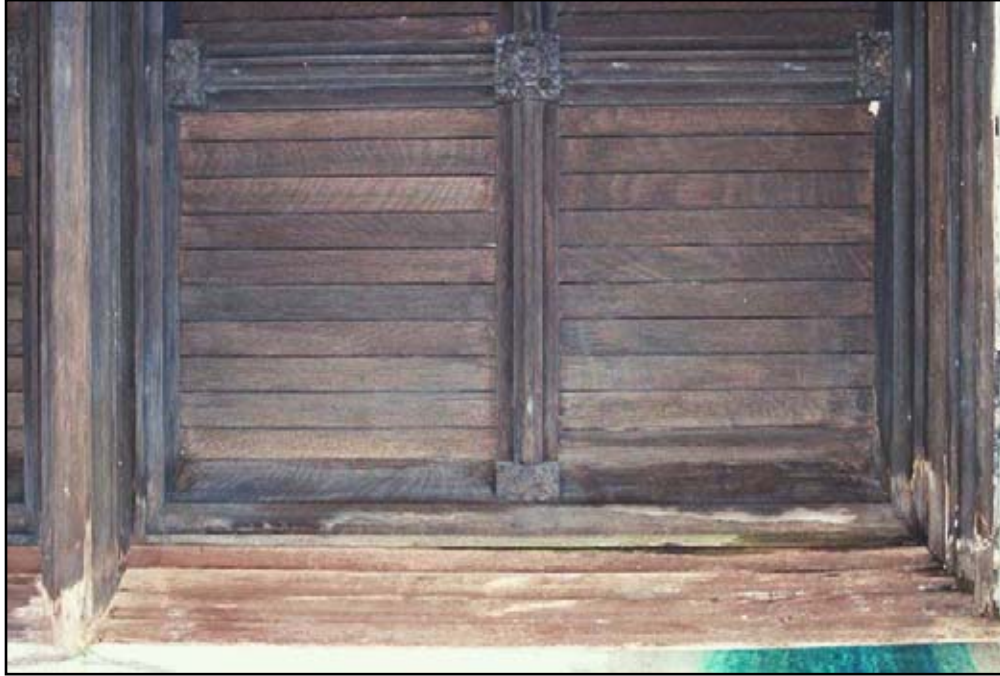
The oak ceilings in the cloister are overall in good condition. The areas of damage are limited to the areas where water has seeped through the roofing material, specifically in the southern corridor of the cloisters. In these areas the wood appears swelled and darkened, suggesting that wood may be becoming rotten. In these areas there is also a

whitening of the surface [Figure 61]. Although not closely inspected, this discoloring may be due either to salt efflorescence or the deterioration of the finish layer.

Figure 61. The oak ceiling is exhibiting water damage in small areas due to the leaking roof.

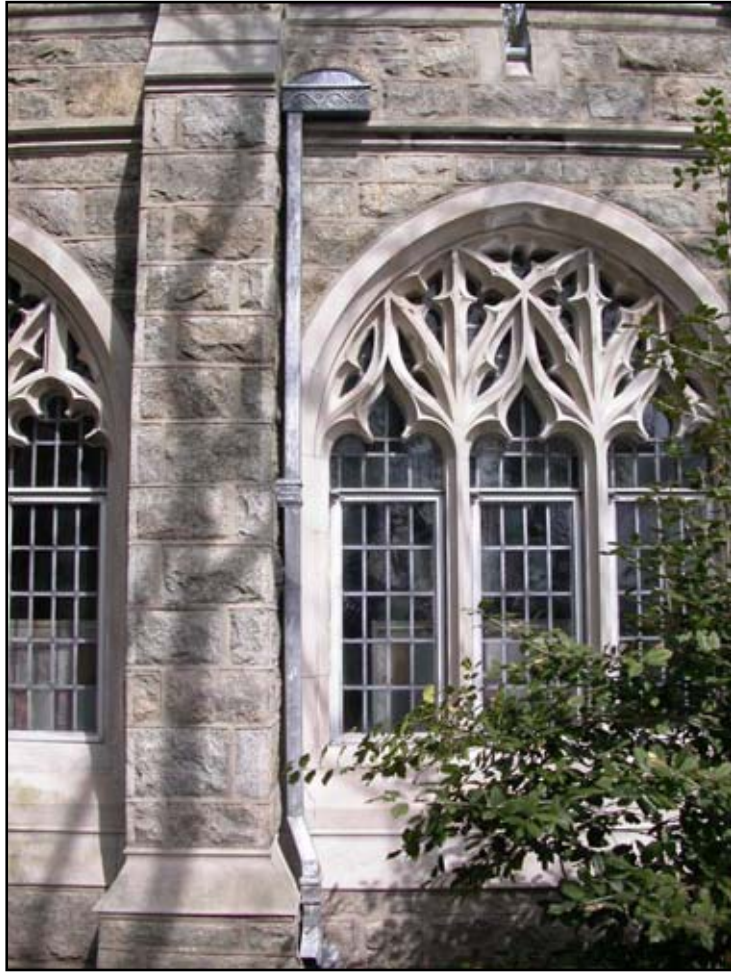
Figure 62. Example of the lead downspouts found within the Cloister.

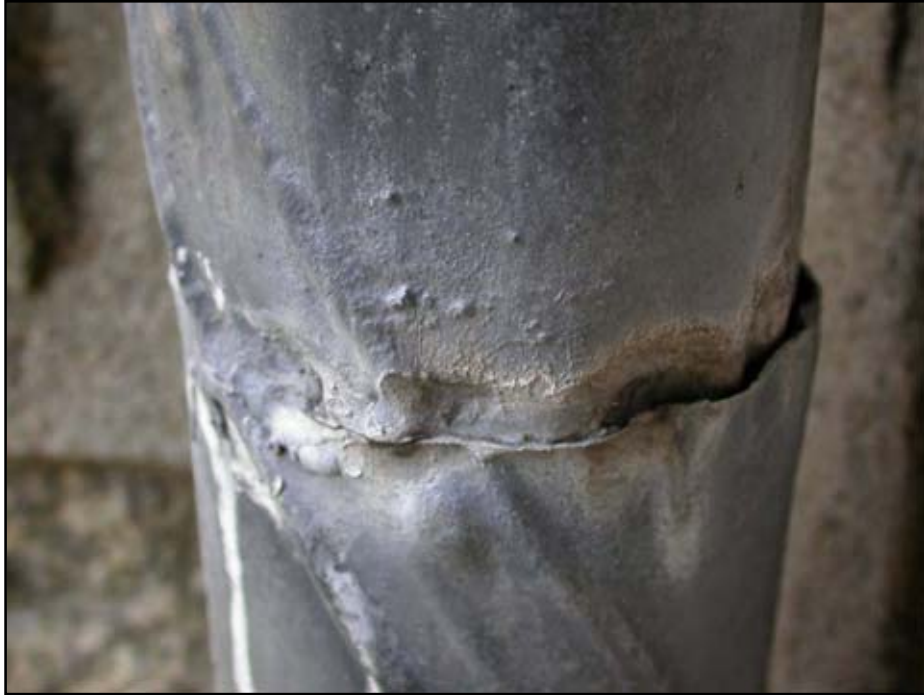
Overall, the downspouts are in good condition. The joints toward the base of each downspout are consistently an area of weakness. The damage appears to have been caused by poor joinery during re-fitting for the installation of the iron underground storm water drains. The new joints are separating and exhibiting heavy corrosion [Figure 63]. The upper portion of the downspout at the south end of the west façade has been replaced with a different metal. From the ground, the exact type of metal used could not be determined. The remaining portion of the lead downspout does not appear to have any structural damage.

Figure 63. Joint repair & corrosion on downspout located on west façade, south end.

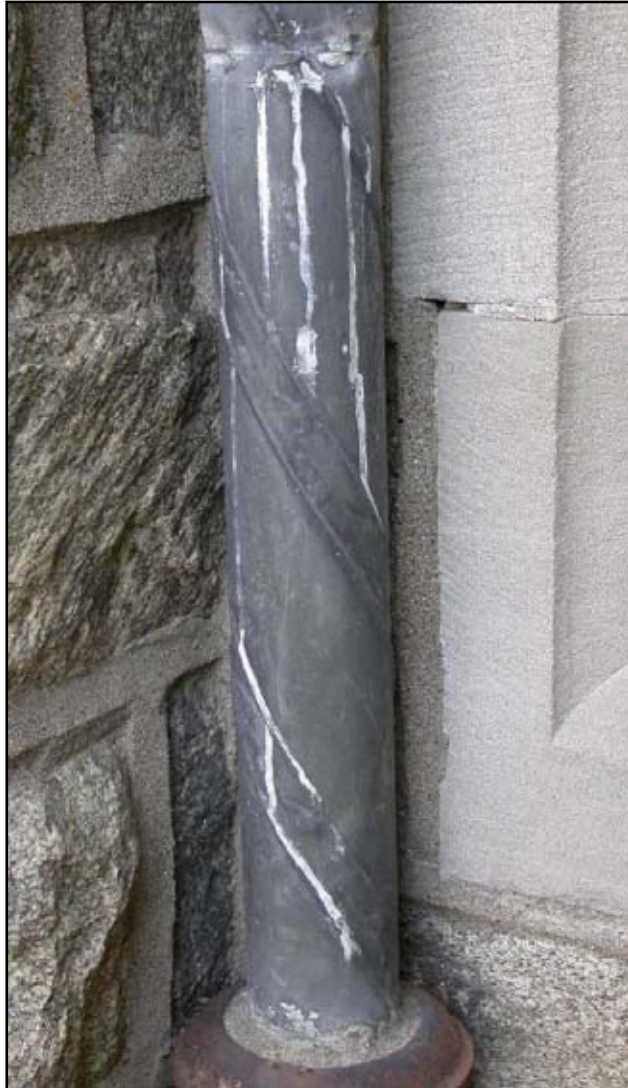
Most corrosion is present at the joints and attachment plates. White corrosion drips appear to have been caused by the repair materials used on the lower joint of the

downspout at the south end of the west façade [Figure 64]. The two downspouts on the north façade have an overall higher level of corrosion than the downspouts on the east and west facades.

Figure 64. White corrosion drips on downspout on west façade of the Cloister, southern end.
