An Investigation of the Painted Finishes of Mission San José de Tumacácori's Façade: At the Interface of Materials Analysis, Conservation, and Cultural Confluence

Jocelyn Chan
University of Pennsylvania

Chan, Jocelyn (2015). *An Investigation of the Painted Finishes of Mission San José de Tumacácori's Façade: At the Interface of Materials Analysis, Conservation, and Cultural Confluence*. (Masters Thesis). University of Pennsylvania, Philadelphia, PA.

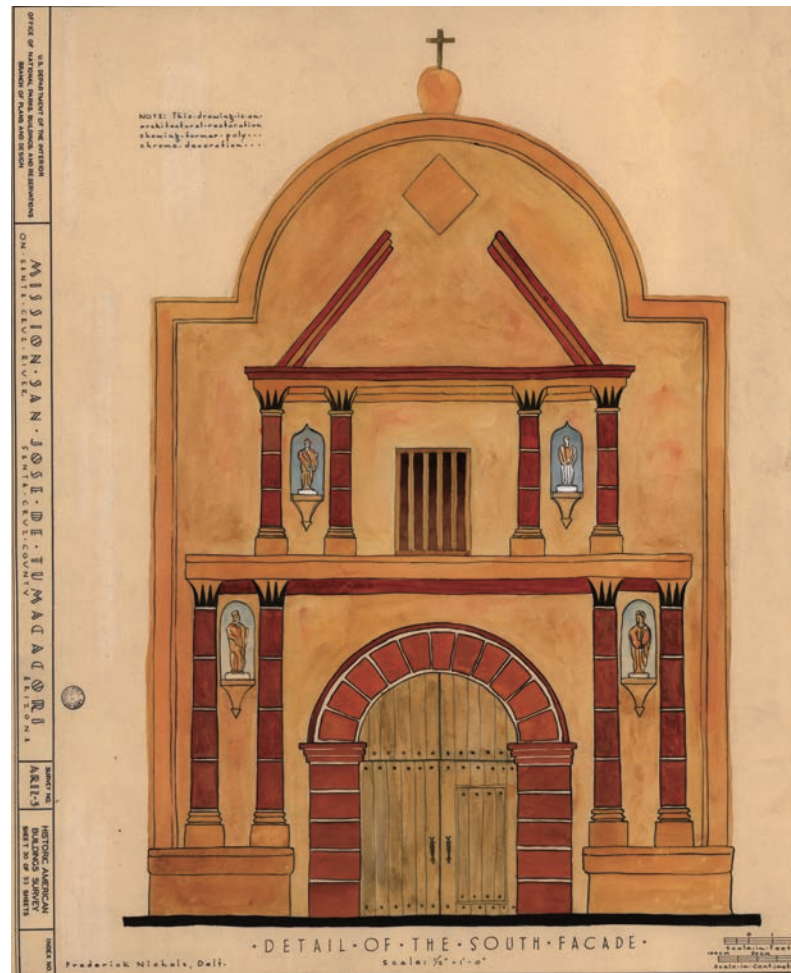
Figure 1.3: 1934 HABS watercolor rendering of original polychromy scheme based upon observations by former Superintendent Frank Pinkley¹⁰

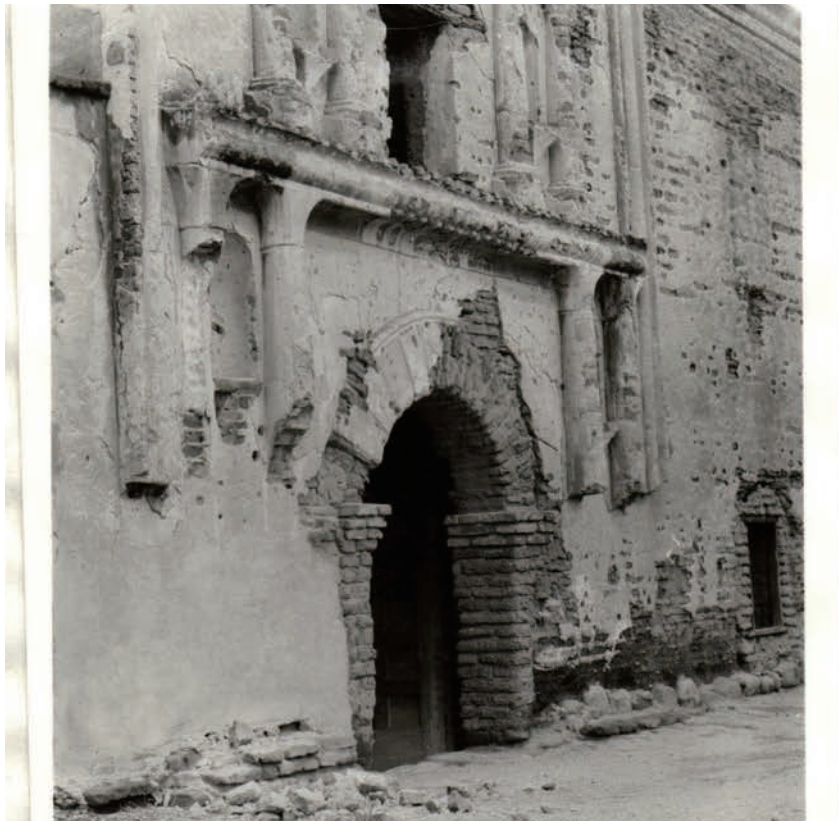
Figure 5.1: Photograph indicating damage from 1944 storms²²

Damage to the original plaster at Tumacácori continued steadily. Heavy rainfall in 1944 destabilized the lower pilaster on the mission façade, causing it to collapse as reported in August 1944 by acting custodian Ted C. Sowers – while it was noted that “all material was picked up by Ranger Brewer so that it can be restored in the immediate future,” not much more was expounded upon this small project in later documentation.²¹

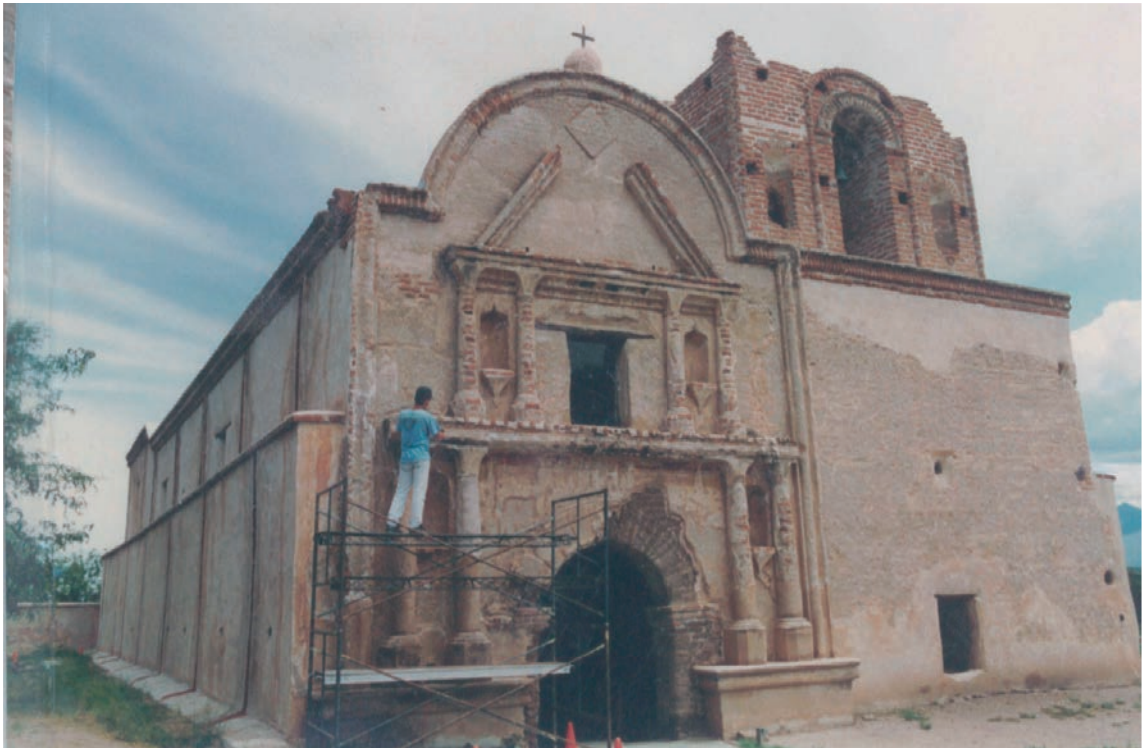
Figure 5.2: 1992 treatment to facade

Bernard Fontana, members of the Tohono O’odham team agreed to perform conservation work on the interior dome at Tumacácori. Objectives included the repair of delaminated plaster, repair edges, and filling of holes with materials as specified in the 1982 conservation work – the only notable difference was the suggestion of Rhoplex E330 instead of PVA.⁶² Treatments to the façade continued through the 1990s as shown below.⁶³

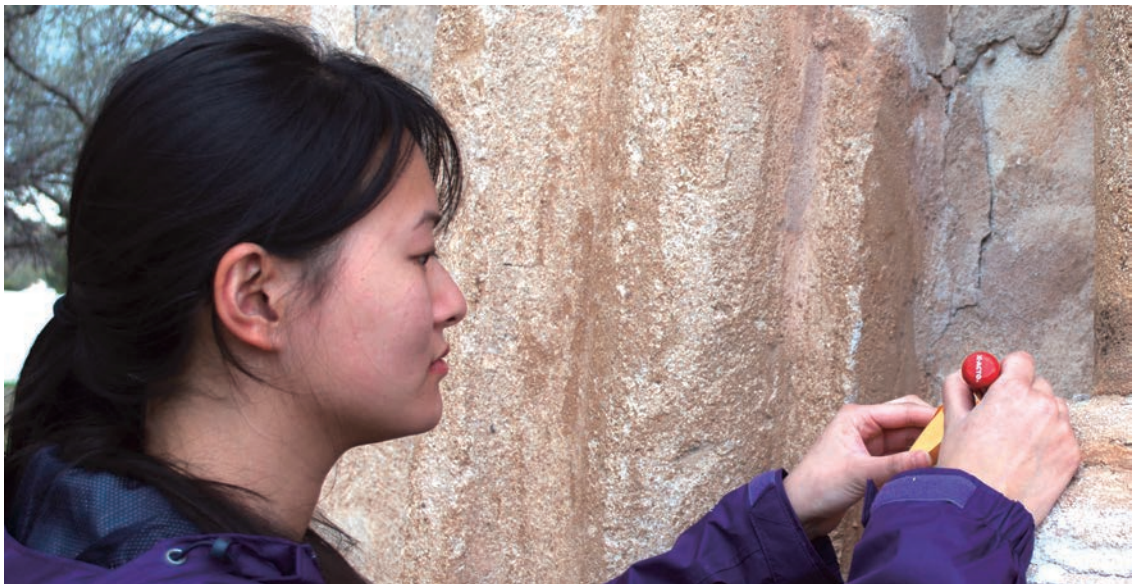
Figure 7.2: Taking samples of a repair campaign January 2015

While on site, NPS Exhibition Specialist Alex Lim noted that the current NPS mason tends to prefer coarse coats of plaster for repairs visible on faces and that storms tend to travel east to west on site. Following preliminary documentation, original surface finishes and subsequent repair campaigns were examined in-situ and small samples from protected areas were taken for further laboratory analysis.

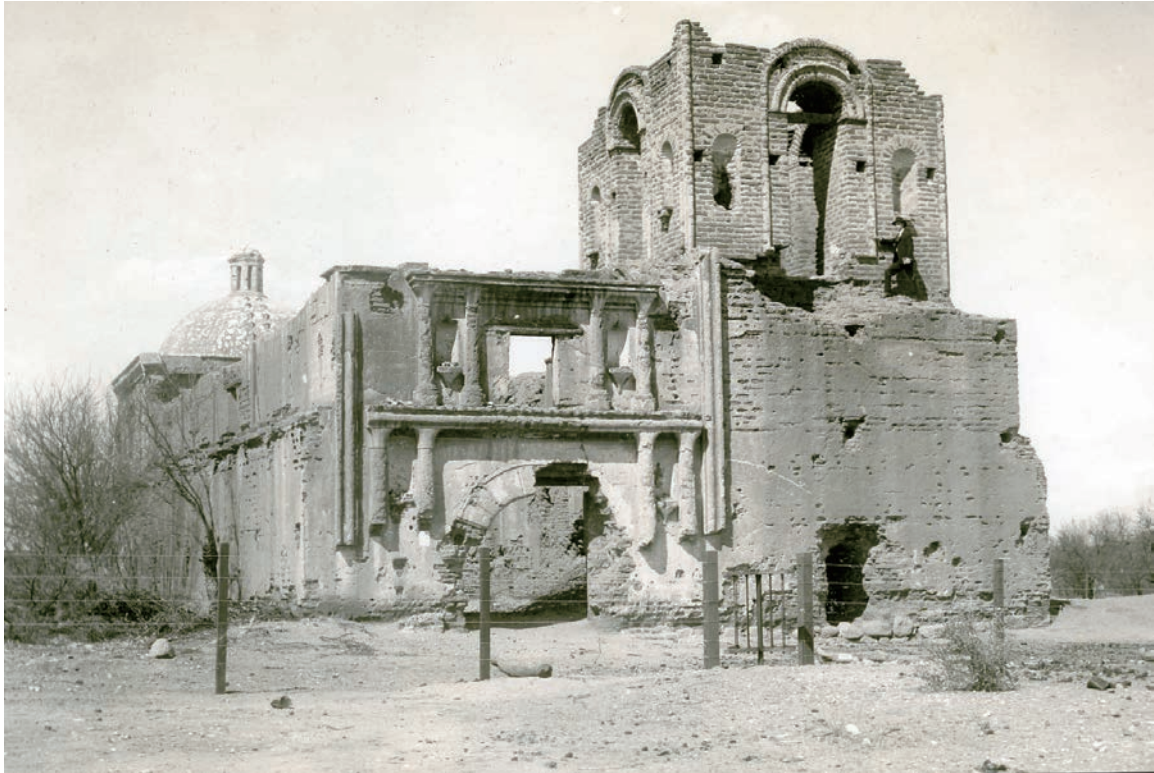
1912 Tumacácori

Title	Tumacácori 1912
	Credit	Unknown
	Date	1912
	Description	In the aftermath of an earthquake in 1890, the large rounded pediment came down from the top of the façade. Observe, too, the first bit of preservation efforts after Tumacácori's establishment as a national monument in 1908. A fence has been erected in front of the ruins (and a man is standing on the wall of the bell tower)
	Source	NPS website "Changing Face of Tumacácori"
