From Philadelphia Country House to City Recreation Center: Uncovering the Architectural History of the Building Known Successively as Blockley Retreat, Kirkbride Mansion, and Lee Cultural Center Through Building Archaeology

Joseph C. Mester
University of Pennsylvania

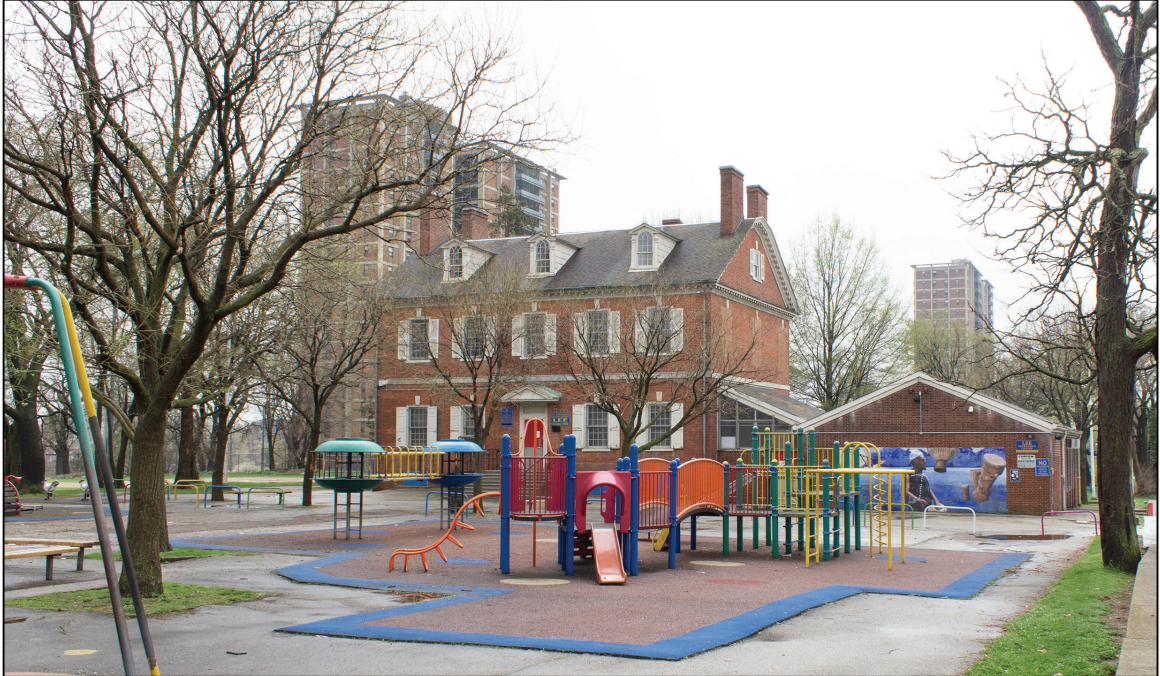
Figure 1.1. A perspective of the John A. Lee Cultural Center from the northwest. Photograph by Grace Meloy, 2015.

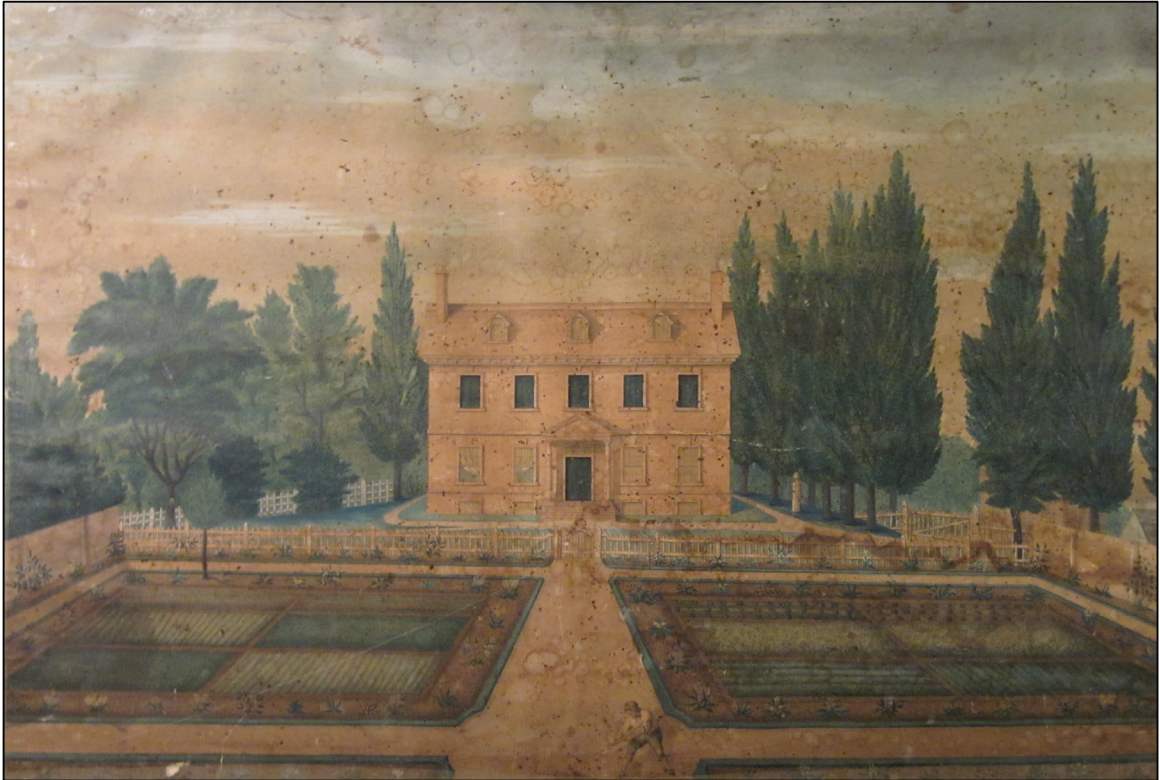
Figure 3.3. North elevation of the McConnell-Busti Country House. Watercolor by an unknown artist, c. 1800. Courtesy of the Historical Society of Pennsylvania, Philadelphia.

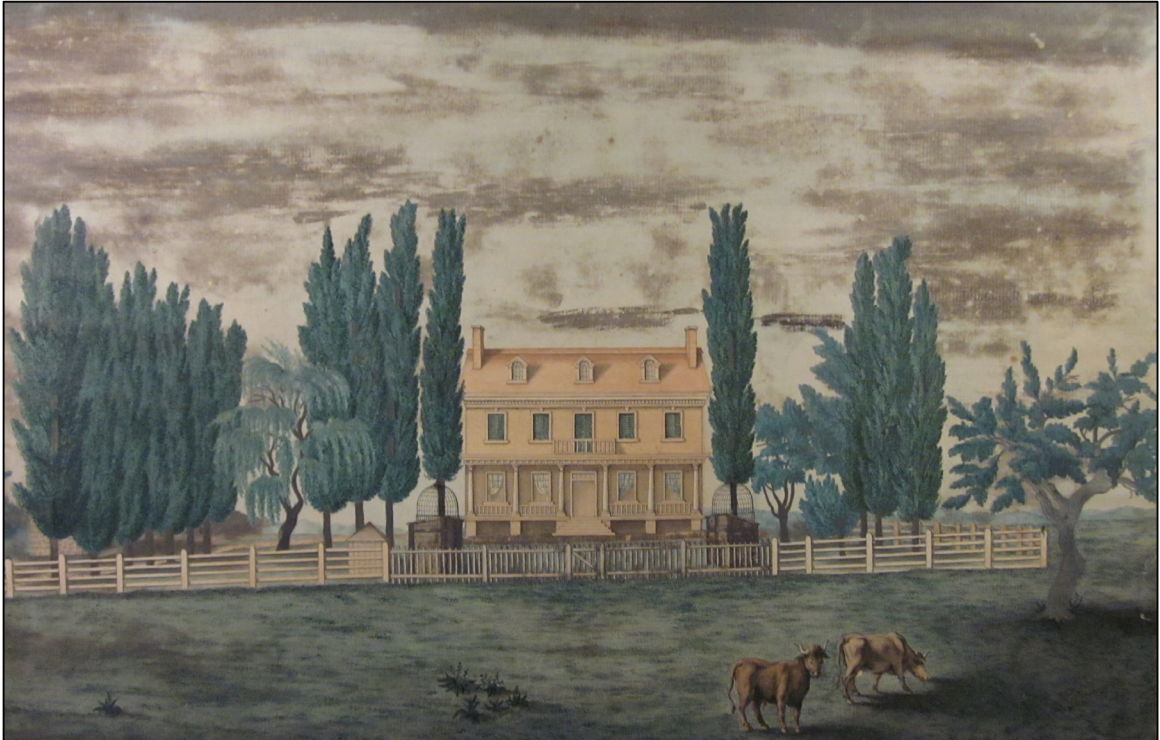
Figure 3.4. South elevation of the McConnell-Busti Country House. Watercolor by an unknown artist, c. 1800. Courtesy of the Historical Society of Pennsylvania, Philadelphia.

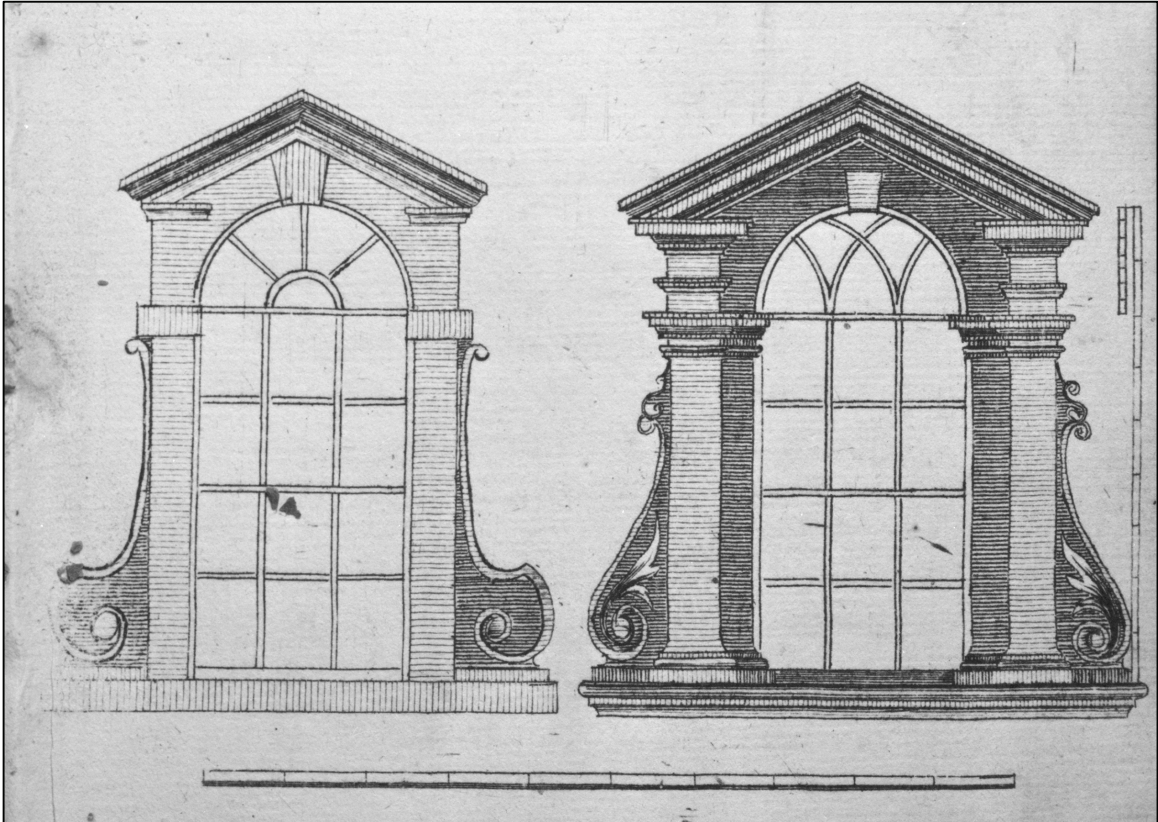
Figure 3.5. Detail of plate 8 from *Articles of the Carpenters Company of Philadelphia and Their Rules for Measuring and Valuing House-Carpenters Work* (Philadelphia: Hall and Sellers, 1786). The original dormer sash configuration was as delineated on the left with the pilasters and pediment as printed on the right. Courtesy of the Library of Congress, Historic American Building Survey.

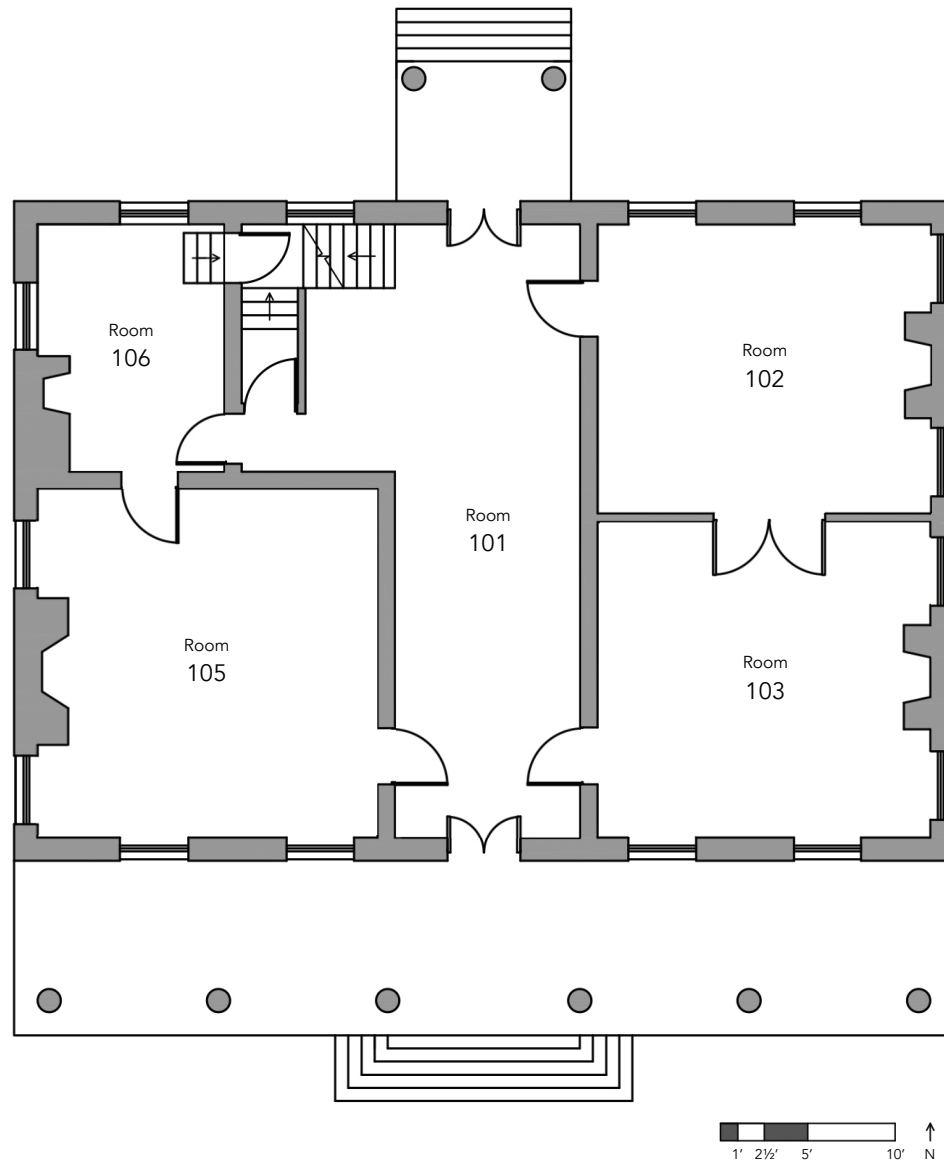
Figure 3.6. First Floor Plan of the McConnell-Busti Country House. Drawn by author, 2016.

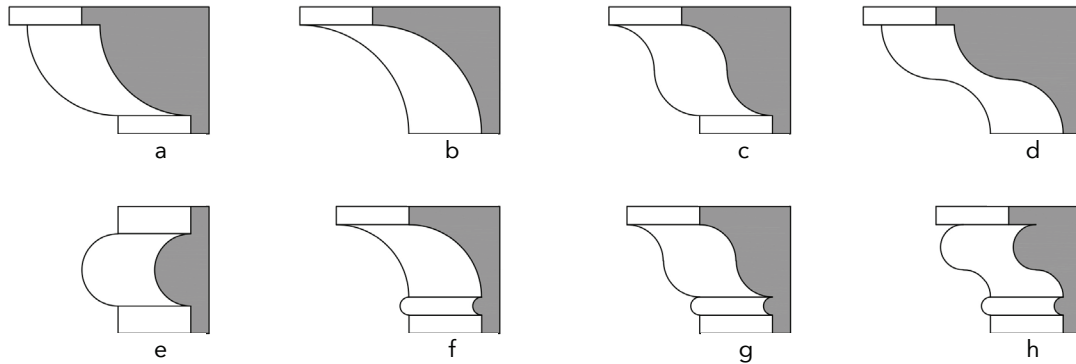
Figure 3.7. Lexicon of moldings as seen at the Lee Cultural Center: a, ovolo; b, cavetto; c, cyma recta; d, cyma reversa; e, torus; f, cavetto-and-astragal; g, cyma recta-and-astragal; h, quirked-ogee-and-astragal. Drawn by author, 2016.

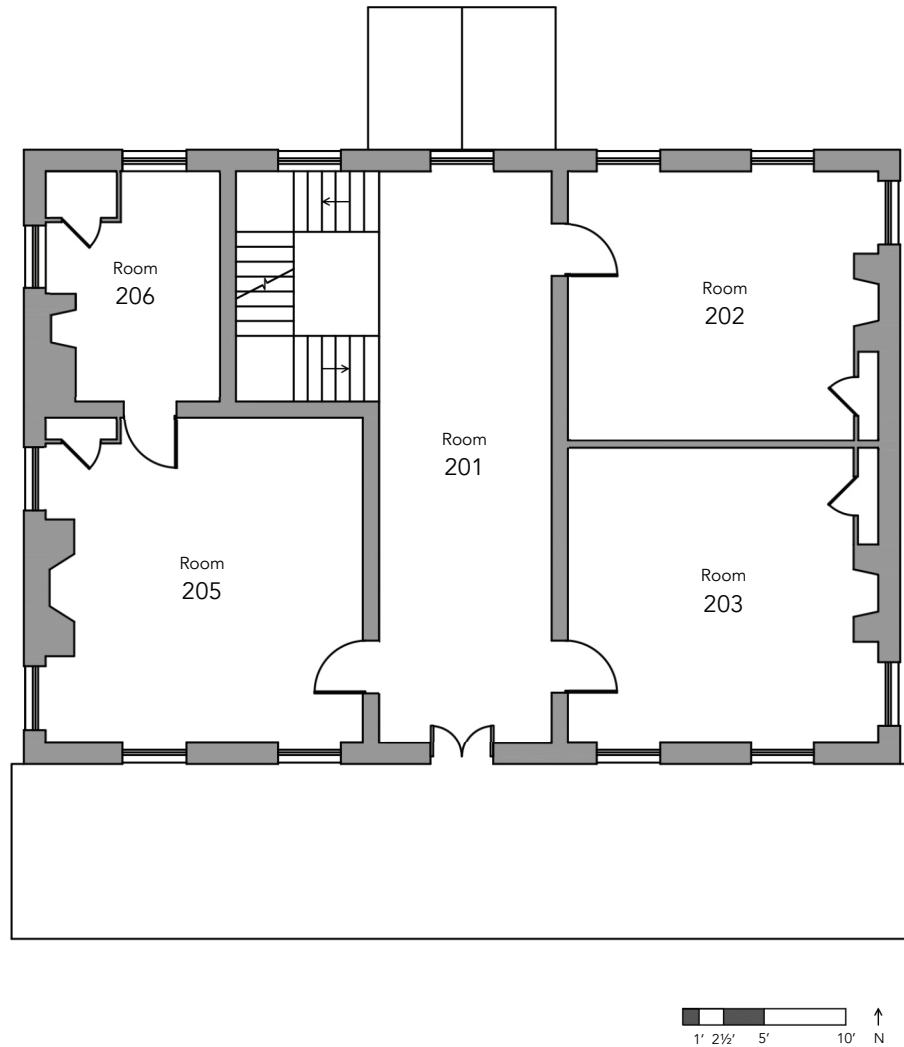
Figure 3.8. Second Floor Plan of the McConnell-Busti Country House. Drawn by author, 2016.

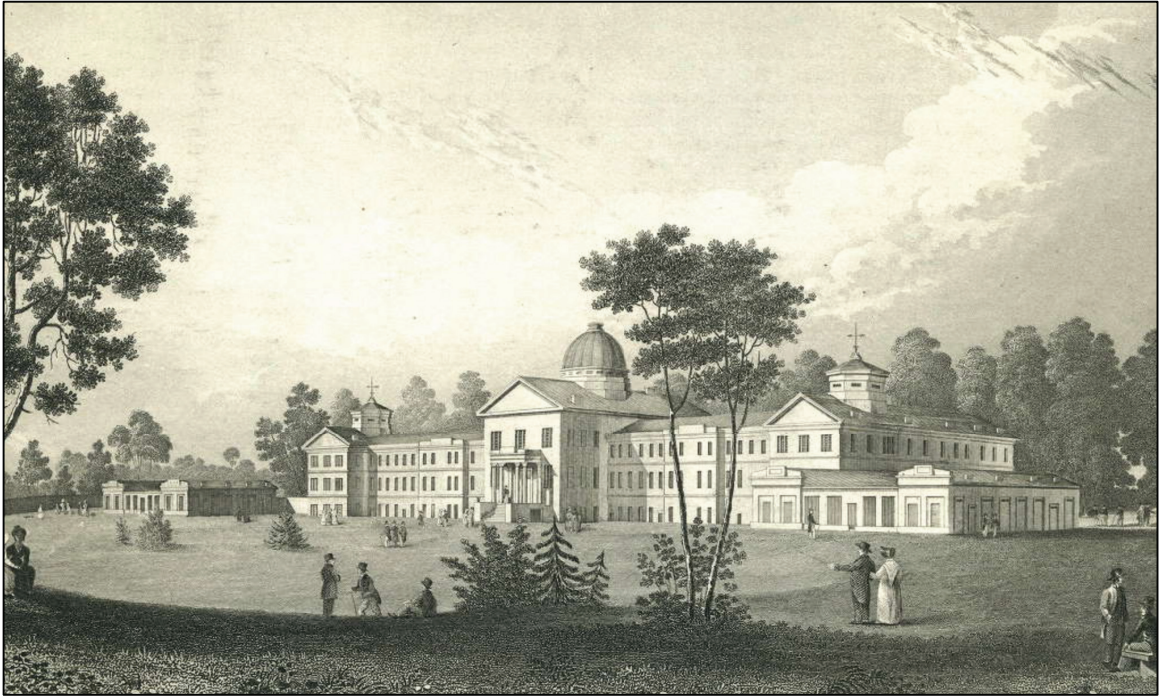
Figure 4.1. Pennsylvania Hospital for the Insane at 44th and Market Streets. It was designed by Isaac Holden, complete in 1841, and demolished in 1959. Lithograph by W. Mason, artist, and W.E. Tucker, engraver, c. 1845. Courtesy of the Free Library of Philadelphia.

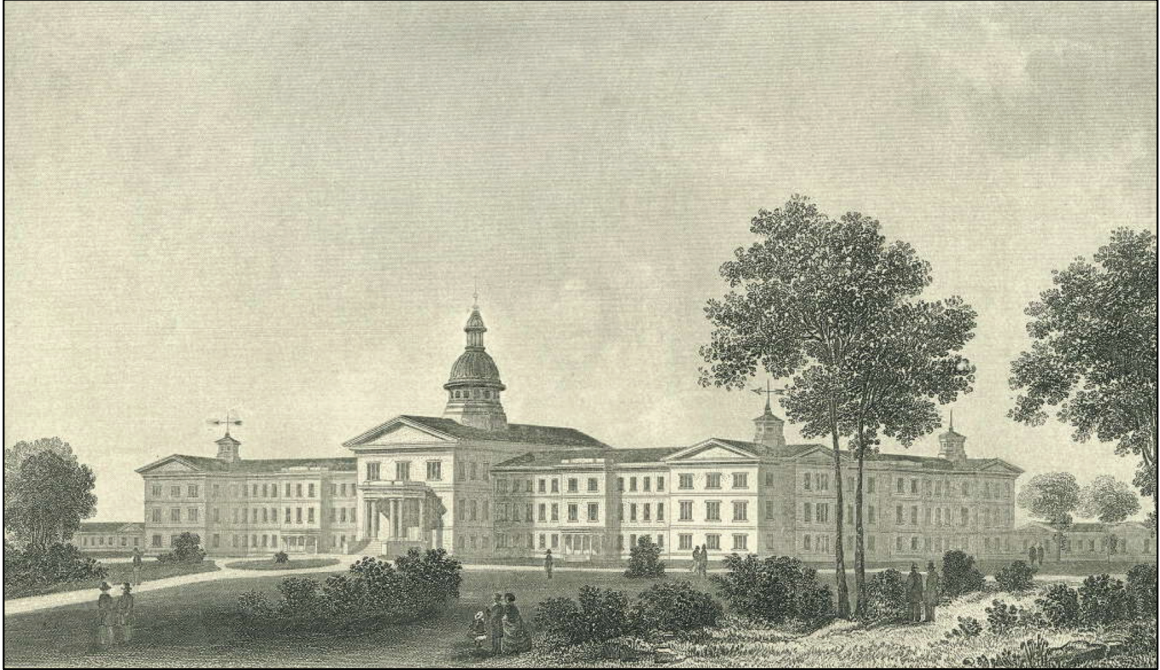
Figure 4.3. Pennsylvania Hospital for the Insane Department for Males at 49th and Market Street. It was design by Samuel Sloan and Thomas S. Kirkbride and completed in 1859. Lithograph by Samuel Sloan, artist, and J.M. Butler, engraver, c. 1860. Courtesy of the Free Library of Philadelphia.

the cutting edge hospital building to house male patients. The brick and stone edifice, west of Mill Creek, was begun in 1856.¹³⁴

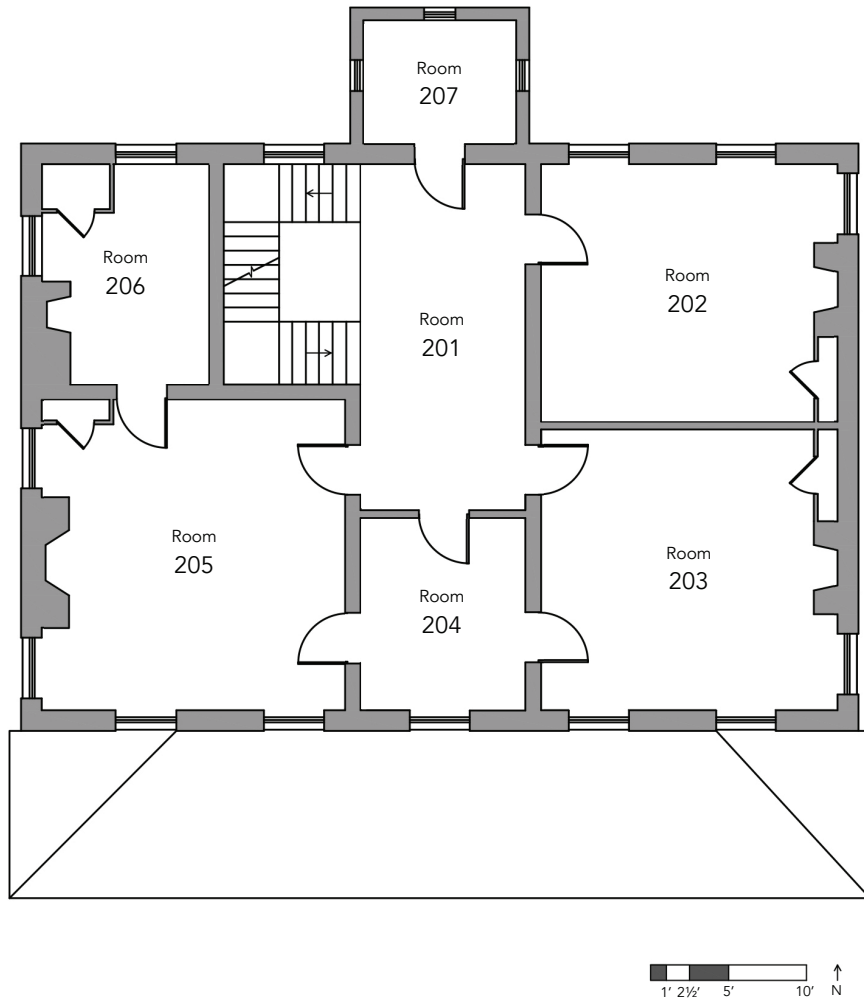
Figure 4.5. Second Floor Plan of the Kirkbride Mansion, c. 1877. Drawn by author, 2016.

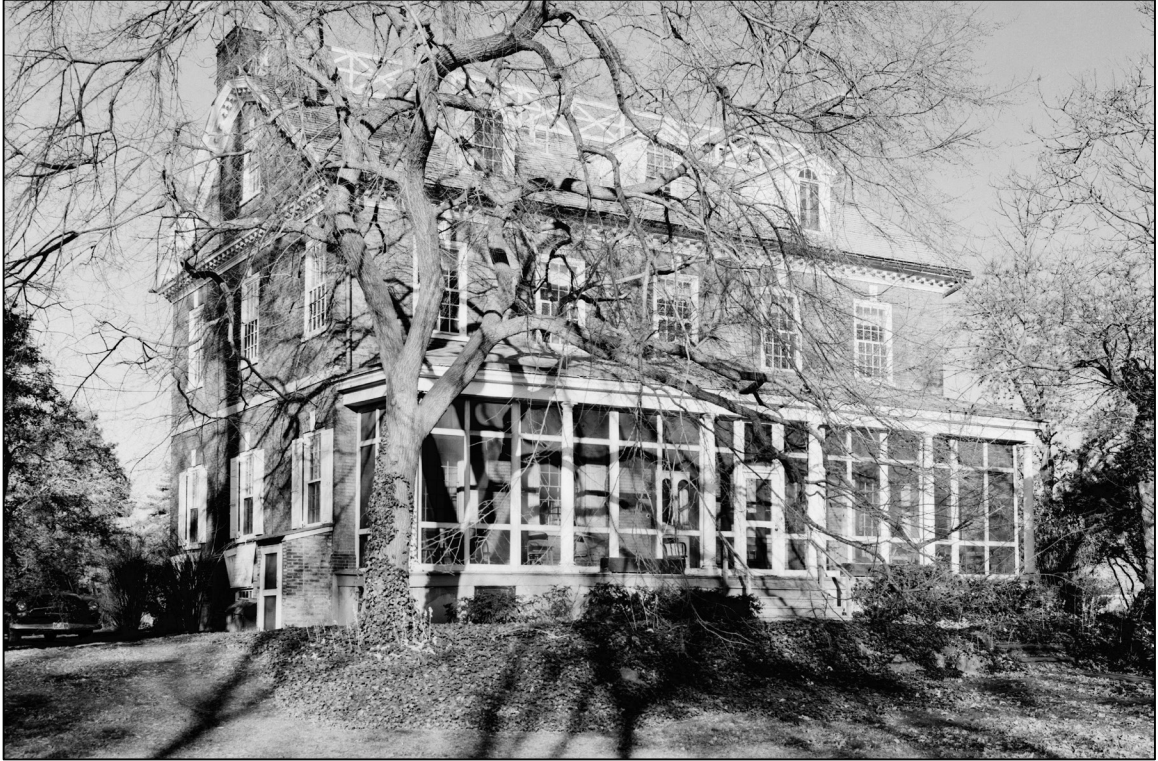
Figure 5.2. PA-1628-1 Front (South) Side. Photograph by Theodore F. Dillon, 1958. Courtesy of Library of Congress, Historic American Building Survey.

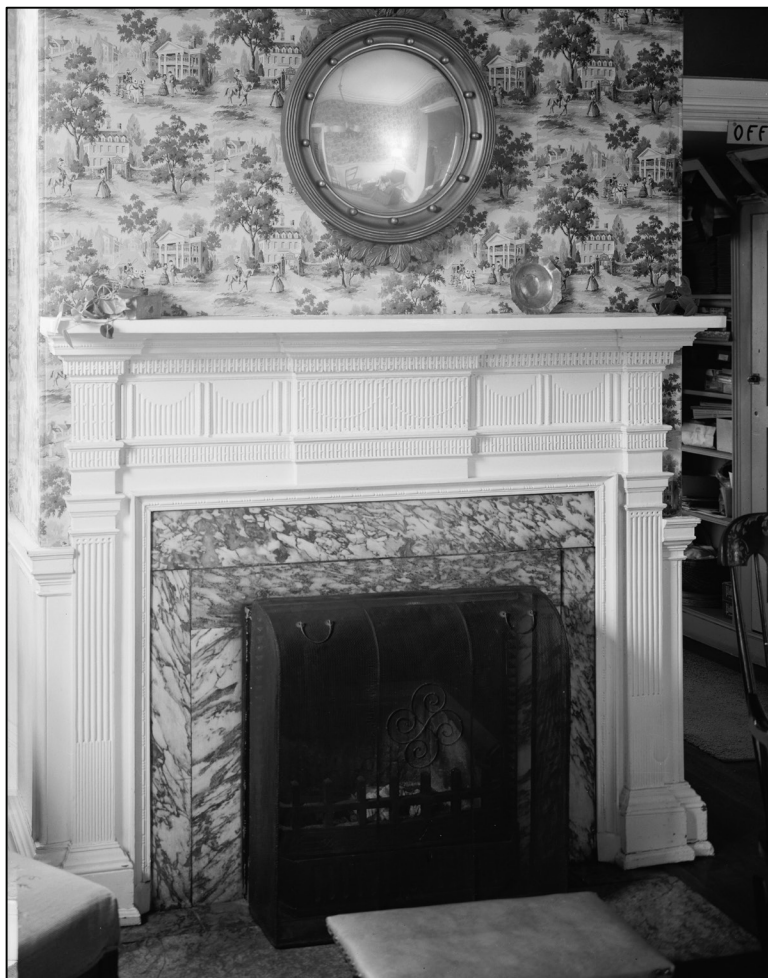
Figure 5.3. The bookshelves of the office addition can be seen through the doorway to the right of the fireplace in Room 102. *PA-1628-4 Fireplace, First Floor*. Photograph by Theodore F. Dillon, 1958. Courtesy of the Library of Congress, Historic American Building Survey.

The mantels in both rooms, Room 102 and 103, were identical with significant punch-and-gouge work and pilasters corresponding to those supporting the window architraves (Refer to Figure 5.3).¹⁰⁹ The exuberant use of the punch and gouge, or carpenter's fancy, across Philadelphia, like that seen in the McConnell-Busti Country House, led Benjamin Latrobe to share his disdain. He commented that these types of pilasters were "all spindle shanked, gouty legged, jeweled, dropsical, crysypaglastic, hydrocephalic columns."¹¹⁰

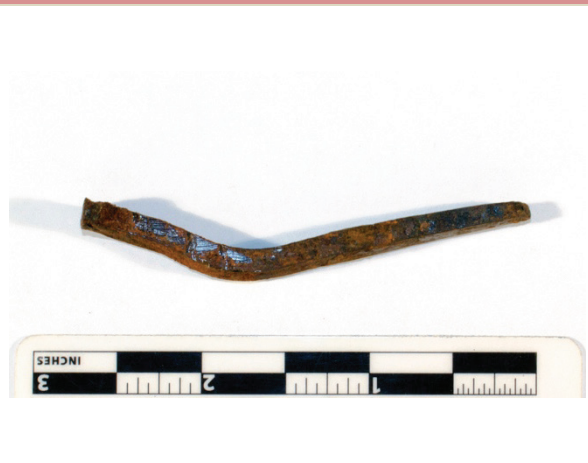
Site	Lee Cultural Center		
Artifact ID	N.000.001		
Extracted by	Joseph C. Mester		
Extracted on	February 11, 2016		
Analyzed by	Joseph C. Mester		
Analyzed on	March 23, 2016		
Location (in structure)	Taken from area of removed step on stringer between Rooms 000 and 106. This stairway has been enclosed with remnants accessible through the doorway at the landing of the basement stair.		
Features			
1. Metal	Iron	6. Burr	N/A
2. Mfg. Method	Hand	7. Pinch	N/A
3. Grain Direction	Cross	8. Shaft Taper	Two-side
4. Point	Chisel	9. Shaft Section	Rectangular
5. Head Mfg.	Hand		
Nail Type	Hand-forged brad, pre-1850 (floor nail)

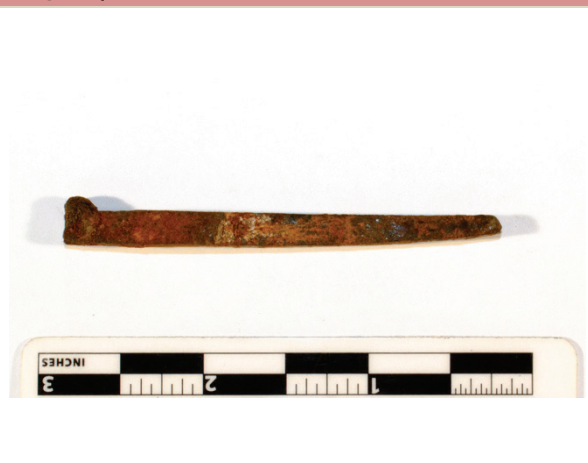
Site	Lee Cultural Center		
Artifact ID	N.000.002		
Extracted by	Joseph C. Mester		
Extracted on	February 11, 2016		
Analyzed by	Joseph C. Mester		
Analyzed on	March 23, 2016		
Location (in structure)	Taken from area of removed step on stringer between Rooms 000 and 106. This stairway has been enclosed with remnants accessible through the doorway at the landing of the basement stair.		
Features			
1. Metal	Iron	6. Burr	N/A
2. Mfg. Method	Hand	7. Pinch	N/A
3. Grain Direction	Cross	8. Shaft Taper	Two-side
4. Point	Chisel	9. Shaft Section	Rectangular
5. Head Mfg.	Hand		
Nail Type	Hand-forged brad, pre-1850 (floor nail)

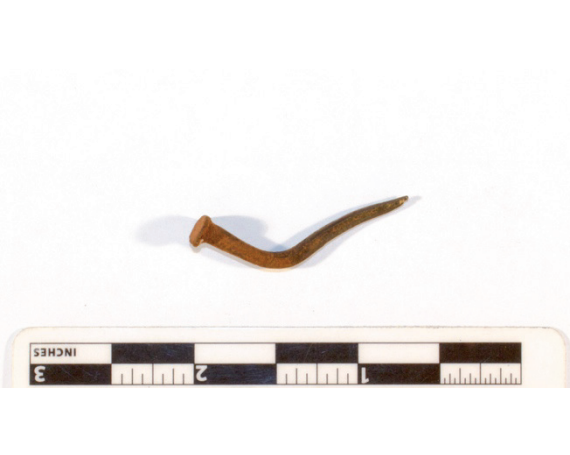
Features			
1. Metal	Iron	6. Burr	Same face
2. Mfg. Method	Cut	7. Pinch	Side
3. Grain Direction	Cross	8. Shaft Taper	Two-side
4. Point	Sharp	9. Shaft Section	Rectangular
5. Head Mfg.	Hand		
Nail Type	Machine-cut lathe nail with hand-forged head, c. 1790 - c. 1810

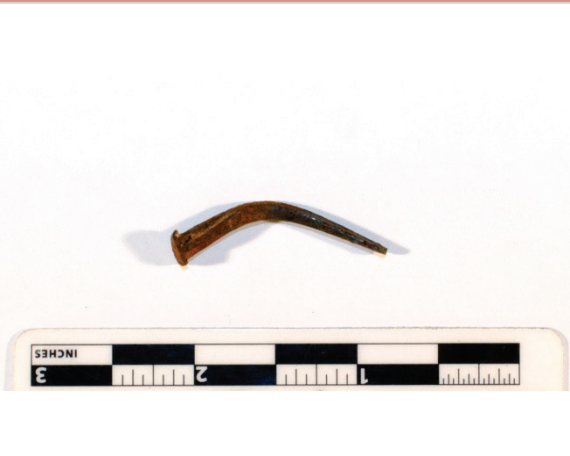
Features			
1. Metal	Iron	6. Burr	Same face
2. Mfg. Method	Cut	7. Pinch	Side
3. Grain Direction	Cross	8. Shaft Taper	Two-side
4. Point	Sharp	9. Shaft Section	Rectangular
5. Head Mfg.	Hand		
Nail Type	Machine-cut lathe nail with hand-forged head, c. 1790 - c. 1810

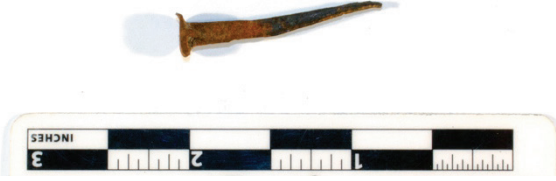
Site	Lee Cultural Center		
Artifact ID	N.000.005		
Extracted by	Joseph C. Mester		
Extracted on	February 11, 2016		
Analyzed by	Joseph C. Mester		
Analyzed on	March 23, 2016		
Location (in structure)	Taken from south wall of stairway between Rooms 000 and 106. This stairway has been enclosed with remnants accessible through the doorway at the landing of the basement stair.

Features			
1. Metal	Iron	6. Burr	Same face
2. Mfg. Method	Cut	7. Pinch	Side
3. Grain Direction	Cross	8. Shaft Taper	Two-side
4. Point	Sharp	9. Shaft Section	Rectangular
5. Head Mfg.	Hand		
Nail Type	Machine-cut lathe nail with hand-forged head, c. 1790 - c. 1810

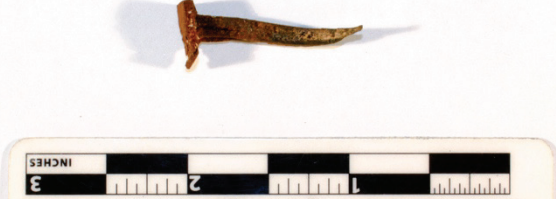
Site	Lee Cultural Center		
Artifact ID	N.000.006		
Extracted by	Joseph C. Mester		
Extracted on	February 11, 2016		
Analyzed by	Joseph C. Mester		
Analyzed on	March 23, 2016		
Location (in structure)	Taken from south wall of stairway between Rooms 000 and 106. This stairway has been enclosed with remnants accessible through the doorway at the landing of the basement stair.

Features			
1. Metal	Iron	6. Burr	Same face
2. Mfg. Method	Cut	7. Pinch	Side
3. Grain Direction	Cross	8. Shaft Taper	Two-side
4. Point	Sharp	9. Shaft Section	Rectangular
5. Head Mfg.	Hand		
Nail Type	Machine-cut lathe nail with hand-forged head, c. 1790 - c. 1810

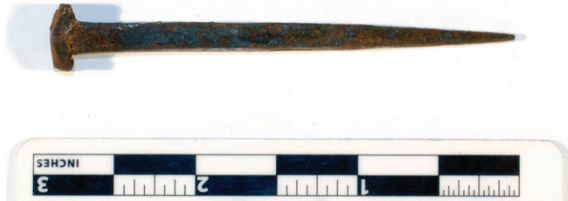
Site	<i>Lee Cultural Center</i>		
Artifact ID	<i>N.000.007</i>		
Extracted by	<i>Joseph C. Mester</i>		
Extracted on	<i>February 11, 2016</i>		
Analyzed by	<i>Joseph C. Mester</i>		
Analyzed on	<i>March 23, 2016</i>		
Location (in structure)	<i>Taken from header of doorway to stairway connecting Rooms 000 and 106. This stairway has been enclosed with remnants accessible through the doorway at the landing of the basement stair.</i>		
Features			
1. Metal	<i>Iron</i>	6. Burr	<i>N/A</i>
2. Mfg. Method	<i>Hand</i>	7. Pinch	<i>N/A</i>
3. Grain Direction	<i>In-line</i>	8. Shaft Taper	<i>Four-side</i>
4. Point	<i>Sharp</i>	9. Shaft Section	<i>Square</i>
5. Head Mfg.	<i>Hand (T-head)</i>		
Nail Type	<i>Hand-forged T-head nail, pre-1850</i>

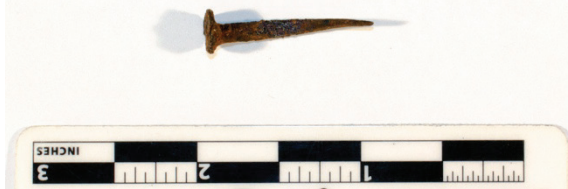
Site	<i>Lee Cultural Center</i>		
Artifact ID	<i>N.003.001</i>		
Extracted by	<i>Joseph C. Mester</i>		
Extracted on	<i>February 11, 2016</i>		
Analyzed by	<i>Joseph C. Mester</i>		
Analyzed on	<i>March 17, 2016</i>		
Location (in structure)	<i>Taken from lathe attached to bottom face of floor boards between joists. Accessible via ladder in Room 003.</i>		
Features			
1. Metal	<i>Iron</i>	6. Burr	<i>Same face</i>
2. Mfg. Method	<i>Cut</i>	7. Pinch	<i>Side</i>
3. Grain Direction	<i>Cross</i>	8. Shaft Taper	<i>Two-side</i>
4. Point	<i>Sharp</i>	9. Shaft Section	<i>Rectangular</i>
5. Head Mfg.	<i>Hand</i>		
Nail Type	<i>Machine-cut lathe nail with hand-forged head, c. 1790 - c. 1810</i>

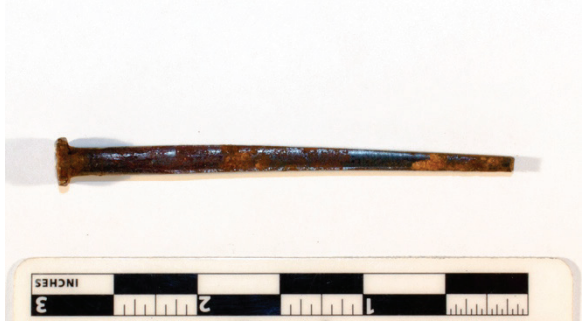
Features			
1. Metal	Iron	6. Burr	Same face
2. Mfg. Method	Cut	7. Pinch	Side
3. Grain Direction	Cross	8. Shaft Taper	Two-side
4. Point	Round	9. Shaft Section	Rectangular
5. Head Mfg.	Machine		
Nail Type	Machine-cut nail with machine-made head, 1810 – 1840.

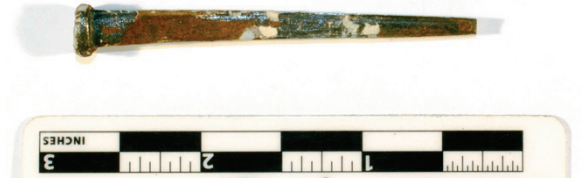
Site	Lee Cultural Center		
Artifact ID	N.005.001		
Extracted by	Joseph C. Mester		
Extracted on	February 11, 2016		
Analyzed by	Joseph C. Mester		
Analyzed on	March 17, 2016		
Location (in structure)	Taken from inside built-in cabinet beneath drawers. The cabinet is located in the northeast corner of Room 005.

Features			
1. Metal	Iron	6. Burr	Same face
2. Mfg. Method	Cut	7. Pinch	Face
3. Grain Direction	Cross	8. Shaft Taper	Two-side
4. Point	Flat	9. Shaft Section	Rectangular
5. Head Mfg.	Machine		
Nail Type	Machine-cut nail with machine-made head, 1820 - 1890

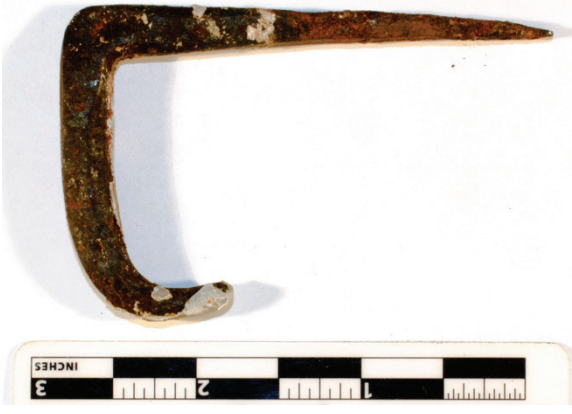
Site	Lee Cultural Center		
Artifact ID	N.005.003		
Extracted by	Joseph C. Mester		
Extracted on	February 11, 2016		
Analyzed by	Joseph C. Mester		
Analyzed on	March 24, 2016		
Location (in structure)	Taken from west wall of ceiling well for Window 007 (window in southwest corner) in Room 005.

Features			
1. Metal	Iron	6. Burr	N/A
2. Mfg. Method	Hand	7. Pinch	N/A
3. Grain Direction	In-line	8. Shaft Taper	Four-side
4. Point	N/A	9. Shaft Section	Square, Rectangular, Round
5. Head Mfg.	N/A

Nail Type	Hand-forged hook, c. 1800
------------------	---------------------------

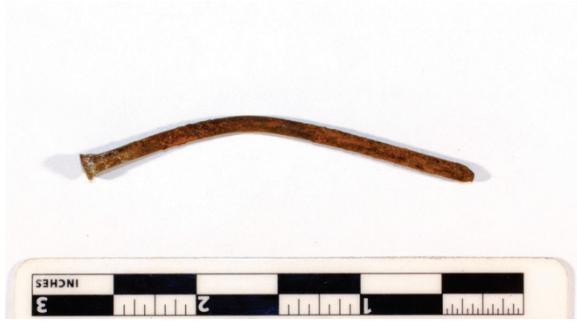
Features			
1. Metal	Steel	6. Burr	N/A
2. Mfg. Method	Drawn	7. Pinch	N/A
3. Grain Direction	N/A	8. Shaft Taper	None
4. Point	Pyramidal	9. Shaft Section	Round
5. Head Mfg.	Machine		
Nail Type	Wire finish nail, 1870 - present

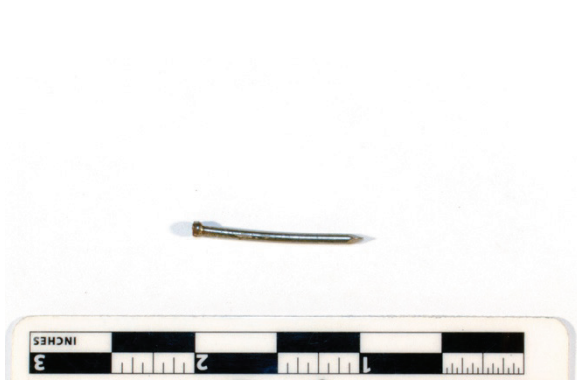
Features			
1. Metal	Steel	6. Burr	N/A
2. Mfg. Method	Drawn	7. Pinch	N/A
3. Grain Direction	N/A	8. Shaft Taper	None
4. Point	Pyramidal	9. Shaft Section	Round
5. Head Mfg.	Machine		
Nail Type	Wire brad, 1870 - present

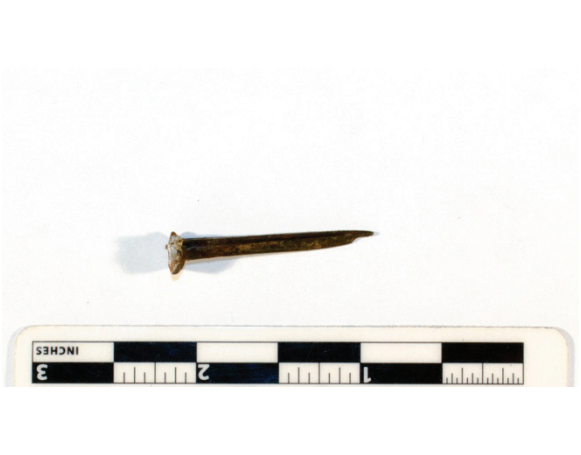
Site	Lee Cultural Center		
Artifact ID	N.202.001		
Extracted by	Joseph C. Mester		
Extracted on	February 24, 2016		
Analyzed by	Joseph C. Mester		
Analyzed on	March 23, 2016		
Location (in structure)	Taken from lathe of vertical plank wall above closet door in Room 202. This nail was made accessible with the installation of pipe for a heating system.

Features			
1. Metal	Iron	6. Burr	Same face
2. Mfg. Method	Cut	7. Pinch	Side
3. Grain Direction	Cross	8. Shaft Taper	Two-side
4. Point	Sharp	9. Shaft Section	Rectangular
5. Head Mfg.	Hand		
Nail Type	Machine-cut lathe nail with hand-forged head, c. 1790 - c. 1810

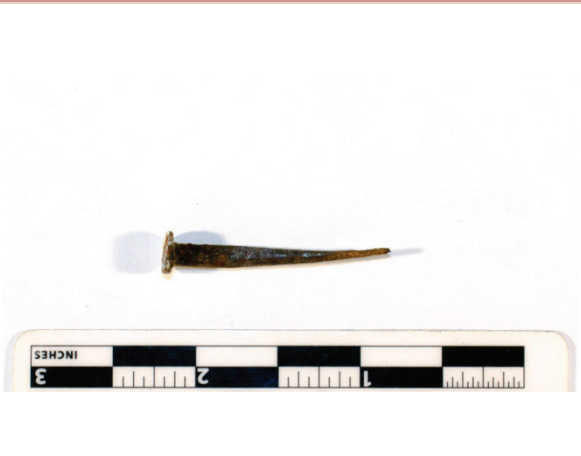
Site	Lee Cultural Center		
Artifact ID	N.202.002		
Extracted by	Joseph C. Mester		
Extracted on	February 24, 2016		
Analyzed by	Joseph C. Mester		
Analyzed on	March 23, 2016		
Location (in structure)	Taken from lathe of vertical plank wall above closet door in Room 202. This nail was made accessible in Room 202 with the installation of pipe for a heating system.

Features			
1. Metal	Iron	6. Burr	Same face
2. Mfg. Method	Cut	7. Pinch	Side
3. Grain Direction	Cross	8. Shaft Taper	Two-side
4. Point	Sharp	9. Shaft Section	Rectangular
5. Head Mfg.	Hand		
Nail Type	Machine-cut lathe nail with hand-forged head, c. 1790 - c. 1810

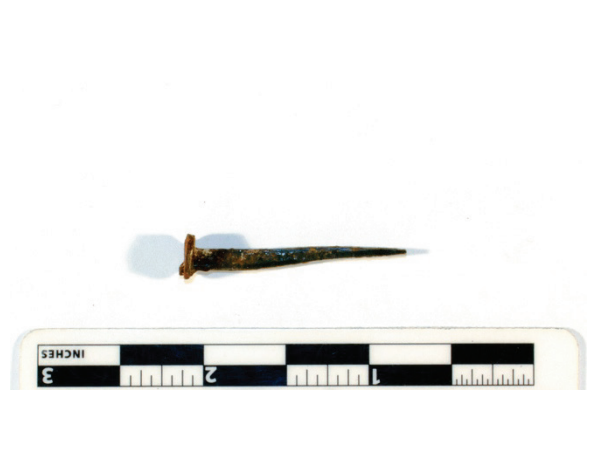
Site	Lee Cultural Center		
Artifact ID	N.203.001		
Extracted by	Joseph C. Mester		
Extracted on	February 24, 2016		
Analyzed by	Joseph C. Mester		
Analyzed on	March 23, 2016		
Location (in structure)	Taken from lathe of vertical plank wall separating Rooms 202 and 203. This nail was made accessible in Room 203 with the installation of pipe for a heating system.

Features			
1. Metal	Iron	6. Burr	Same face
2. Mfg. Method	Cut	7. Pinch	Side
3. Grain Direction	Cross	8. Shaft Taper	Two-side
4. Point	Sharp	9. Shaft Section	Rectangular
5. Head Mfg.	Hand		
Nail Type	Machine-cut lathe nail with hand-forged head, c. 1790 - c. 1810

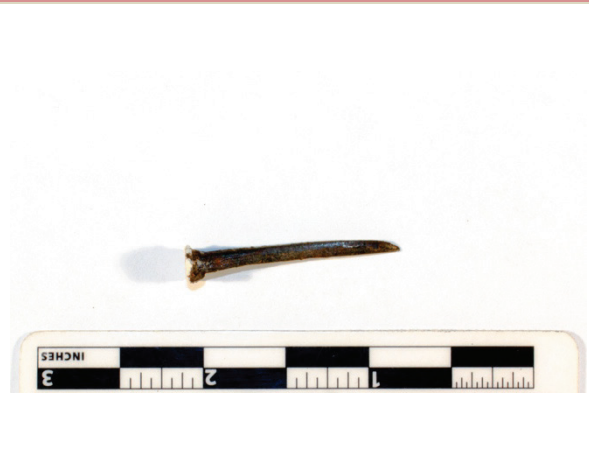
Site	Lee Cultural Center		
Artifact ID	N.203.002		
Extracted by	Joseph C. Mester		
Extracted on	February 24, 2016		
Analyzed by	Joseph C. Mester		
Analyzed on	March 23, 2016		
Location (in structure)	Taken from lathe of vertical plank wall separating Rooms 202 and 203. This nail was made accessible in Room 203 with the installation of pipe for a heating system.

Features			
1. Metal	Iron	6. Burr	Same face
2. Mfg. Method	Cut	7. Pinch	Side
3. Grain Direction	Cross	8. Shaft Taper	Two-side
4. Point	Sharp	9. Shaft Section	Rectangular
5. Head Mfg.	Hand		
Nail Type	Machine-cut lathe nail with hand-forged head, c. 1790 - c. 1810

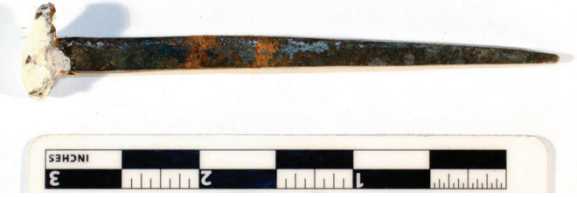
Features			
1. Metal	Iron	6. Burr	N/A
2. Mfg. Method	Hand	7. Pinch	N/A
3. Grain Direction	In-line	8. Shaft Taper	Four-side
4. Point	Sharp	9. Shaft Section	Square
5. Head Mfg.	Hand (T-head)		
Nail Type	Hand-forged T-head nail, pre-1850

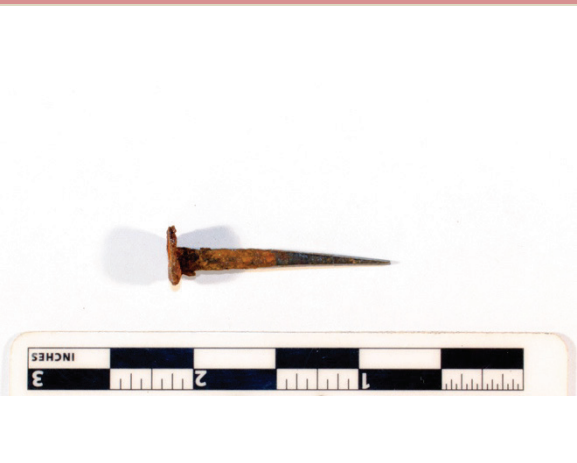
Site	Lee Cultural Center		
Artifact ID	N.206.001		
Extracted by	Joseph C. Mester		
Extracted on	February 24, 2016		
Analyzed by	Joseph C. Mester		
Analyzed on	March 23, 2016		
Location (in structure)	Taken from lathe of the ceiling in Room 206. The nail was accessible via a failed area of plaster caused by water infiltration.

Features			
1. Metal	Iron	6. Burr	Same face
2. Mfg. Method	Cut	7. Pinch	unidentifiable due to corrosion
3. Grain Direction	Cross	8. Shaft Taper	Two-side
4. Point	Sharp	9. Shaft Section	Rectangular
5. Head Mfg.	Hand		
Nail Type	Machine-cut lathe nail with hand-forged head, c. 1790 - c. 1810

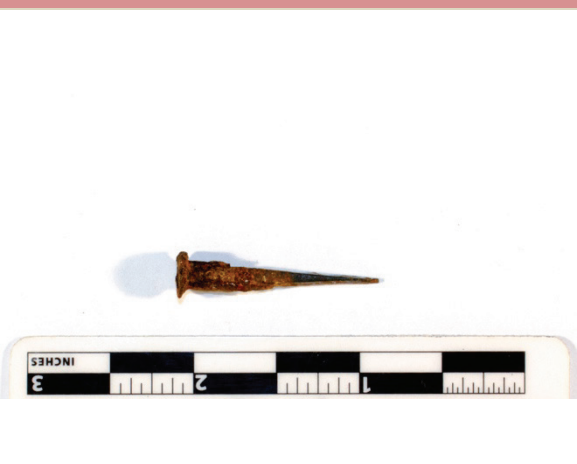
Site	Lee Cultural Center		
Artifact ID	N.206.002		
Extracted by	Joseph C. Mester		
Extracted on	February 24, 2016		
Analyzed by	Joseph C. Mester		
Analyzed on	March 23, 2016		
Location (in structure)	Taken from lathe of the ceiling in Room 206. The nail was accessible via a failed area of plaster caused by water infiltration.

Features			
1. Metal	Iron	6. Burr	Same face
2. Mfg. Method	Cut	7. Pinch	unidentifiable due to corrosion
3. Grain Direction	Cross	8. Shaft Taper	Two-side
4. Point	Sharp	9. Shaft Section	Rectangular
5. Head Mfg.	Hand		
Nail Type	Machine-cut lathe nail with hand-forged head, c. 1790 - c. 1810

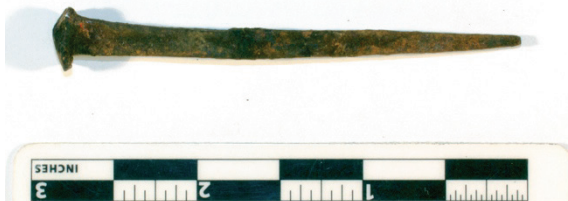
Site	Lee Cultural Center		
Artifact ID	N.400.001		
Extracted by	Joseph C. Mester		
Extracted on	February 17, 2016		
Analyzed by	Joseph C. Mester		
Analyzed on	March 24, 2016		
Location (in structure)	Taken from frame of the trap door aperture.		
Features			
1. Metal	Iron	6. Burr	N/A
2. Mfg. Method	Hand	7. Pinch	N/A
3. Grain Direction	In-line	8. Shaft Taper	Four-side
4. Point	Sharp	9. Shaft Section	Square
5. Head Mfg.	Hand		
Nail Type	Hand-forged rose head nail, pre-1850

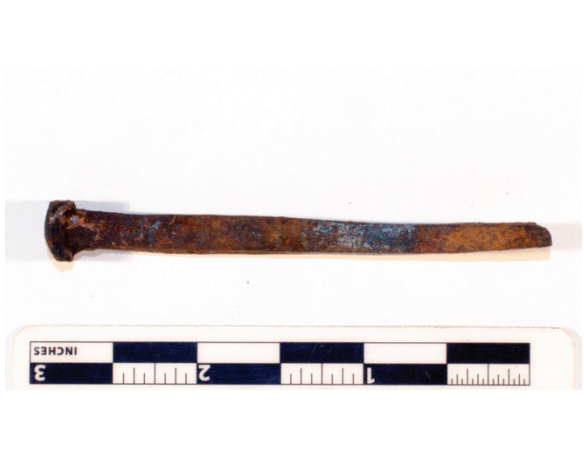
Features			
1. Metal	Iron	6. Burr	N/A
2. Mfg. Method	Hand	7. Pinch	N/A
3. Grain Direction	In-line	8. Shaft Taper	Two-side
4. Point	unidentifiable	9. Shaft Section	Square
5. Head Mfg.	Hand		
Nail Type	Hand-forged rose head nail, pre-1850

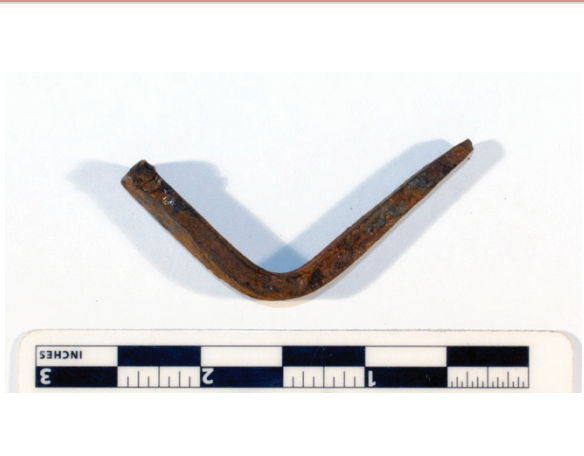
Features			
1. Metal	Iron	6. Burr	N/A
2. Mfg. Method	Hand	7. Pinch	N/A
3. Grain Direction	In-line	8. Shaft Taper	Two-side
4. Point	Chisel	9. Shaft Section	Square
5. Head Mfg.	Hand		
Nail Type	Hand-forged brad, pre-1850

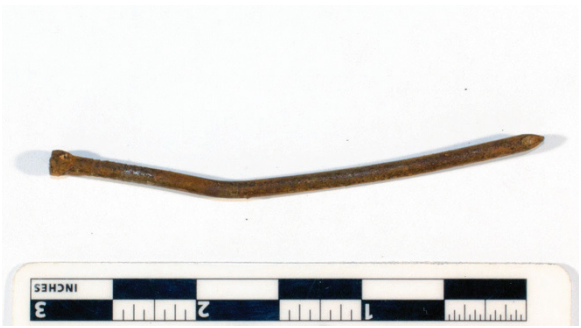
Artifact ID	<i>N.400.004</i>	
Extracted by	<i>Joseph C. Mester</i>	
Extracted on	<i>February 17, 2016</i>	
Analyzed by	<i>Joseph C. Mester</i>	
Analyzed on	<i>March 24, 2016</i>	
Location (in structure)	<i>Taken from frame of the trap door aperture.</i>

The originality of the aperture for the trap door was corroborated through fastener analysis. A hand-wrought brad and two rose-head nails were extracted from the woodwork surrounding the the trap door (Refer to Appendix C to see data sheets on N.400.001 – N.400.003). These nails shared identical characteristics with other nails removed from more tightly dated contexts. The presence of these nails confirmed that this feature was part of the original construction, as first recorded in an 1806 Mutual Assurance Company fire insurance survey (Refer to Appendix B).

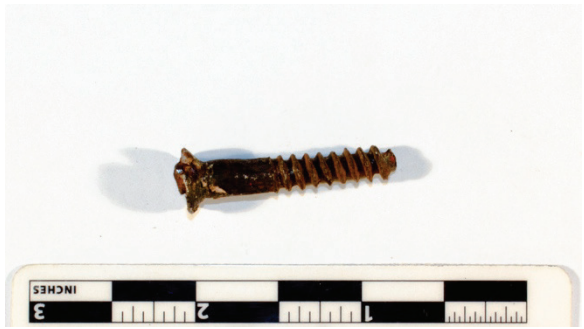
Features			
1. Metal	<i>Ferrous</i>	5. Head Mfg.	<i>Hand</i>
2. Shank Mfg.	<i>Hand</i>	6. Slot	<i>Off-center</i>
3. Thread Mfg.	<i>Lathe</i>	7. Shank Taper	<i>No</i>
4. Trough Shape	<i>Square</i>	8. Point	<i>Blunt</i>
Screw Type <i>Early machine made screw, c. 1795</i>

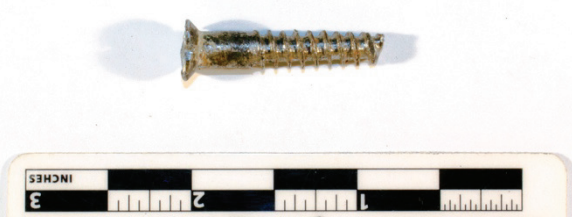
Site	Lee Cultural Center		
Artifact ID	S.205.001		
Extracted by	Joseph C. Mester		
Extracted on	February 18, 2016		
Analyzed by	Joseph C. Mester		
Analyzed on	March 25, 2016		
Location (within structure)	Taken from top hinge of Door 212. Door 212 is the closet door for the closet in Room 205.

Features			
1. Metal	<i>Ferrous</i>	5. Head Mfg.	<i>Hand</i>
2. Shank Mfg.	<i>Hand</i>	6. Slot	<i>Off-center</i>
3. Thread Mfg.	<i>Lathe</i>	7. Shank Taper	<i>No</i>
4. Trough Shape	<i>Square</i>	8. Point	<i>Blunt</i>
Screw Type <i>Early machine made screw, c. 1795</i>

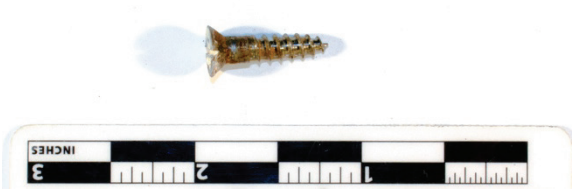
Site	<i>Lee Cultural Center</i>		
Artifact ID	<i>S.205.006</i>		
Extracted by	<i>Joseph C. Mester</i>		
Extracted on	<i>February 18, 2016</i>		
Analyzed by	<i>Joseph C. Mester</i>		
Analyzed on	<i>March 25, 2016</i>		
Location (within structure)	<i>Taken from broken hook hardware (two screws) mounted to the plank lining of the closet in Room 205.</i>

Features			
1. Metal	<i>Ferrous</i>	5. Head Mfg.	<i>Lathe</i>
2. Shank Mfg.	<i>Machine</i>	6. Slot	<i>Center</i>
3. Thread Mfg.	<i>Lathe</i>	7. Shank Taper	<i>Yes</i>
4. Trough Shape	<i>Square</i>	8. Point	<i>Gimlet</i>
Screw Type		<i>Modern screw, c. 1840 – present</i>

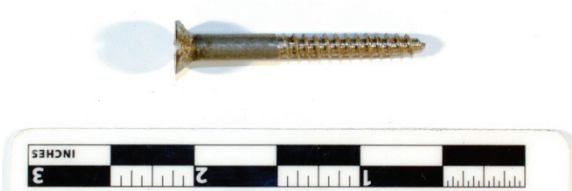
Site	<i>Lee Cultural Center</i>		
Artifact ID	<i>S.205.007</i>		
Extracted by	<i>Joseph C. Mester</i>		
Extracted on	<i>February 18, 2016</i>		
Analyzed by	<i>Joseph C. Mester</i>		
Analyzed on	<i>March 25, 2016</i>		
Location (within structure)	<i>Taken from jamb edge of Door 210 in Room 205. The screw was used to secure the mortis lock in the door.</i>

Features			
1. Metal	<i>Ferrous</i>	5. Head Mfg.	<i>Lathe</i>
2. Shank Mfg.	<i>Drawn</i>	6. Slot	<i>Center</i>
3. Thread Mfg.	<i>Lathe</i>	7. Shank Taper	<i>Yes</i>
4. Trough Shape	<i>Square</i>	8. Point	<i>Gimlet</i>
Screw Type		<i>Modern screw, c. 1840 – present</i>

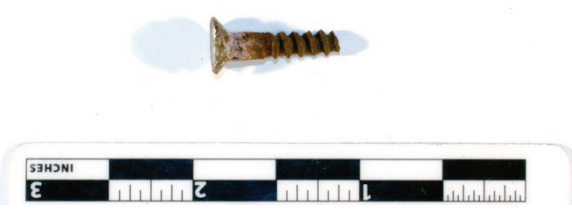
Site	Lee Cultural Center		
Artifact ID	S.306.001		
Extracted by	Joseph C. Mester		
Extracted on	February 24, 2016		
Analyzed by	Joseph C. Mester		
Analyzed on	March 25, 2016		
Location (within structure)	Taken from sash pulley of Window 301 in Room 306.

Features			
1. Metal	<i>Ferrous</i>	5. Head Mfg.	<i>Hand</i>
2. Shank Mfg.	<i>Hand</i>	6. Slot	<i>Off-center</i>
3. Thread Mfg.	<i>Lathe</i>	7. Shank Taper	<i>No</i>
4. Trough Shape	<i>Square</i>	8. Point	<i>Blunt</i>
Screw Type		<i>Early machine made screw, c. 1795</i>

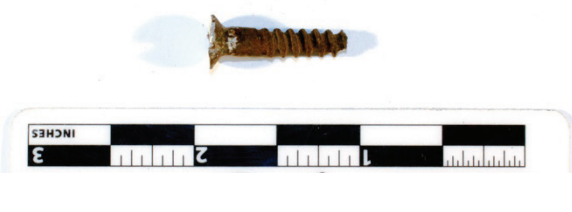
Site	Lee Cultural Center		
Artifact ID	S.306.002		
Extracted by	Joseph C. Mester		
Extracted on	February 24, 2016		
Analyzed by	Joseph C. Mester		
Analyzed on	March 25, 2016		
Location (within structure)	Taken from sash pulley of Window 301 in Room 306.

Features			
1. Metal	<i>Ferrous</i>	5. Head Mfg.	<i>Hand</i>
2. Shank Mfg.	<i>Hand</i>	6. Slot	<i>Off-center</i>
3. Thread Mfg.	<i>Lathe</i>	7. Shank Taper	<i>No</i>
4. Trough Shape	<i>Square</i>	8. Point	<i>Blunt</i>
Screw Type		<i>Early machine made screw, c. 1795</i>

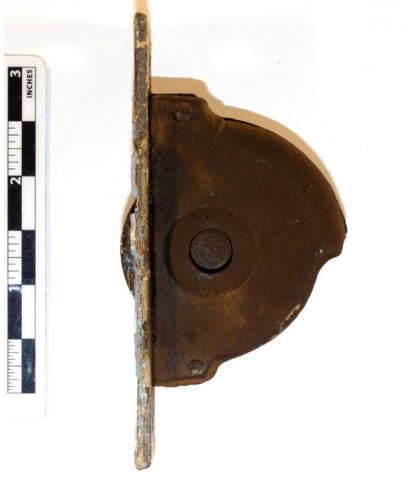
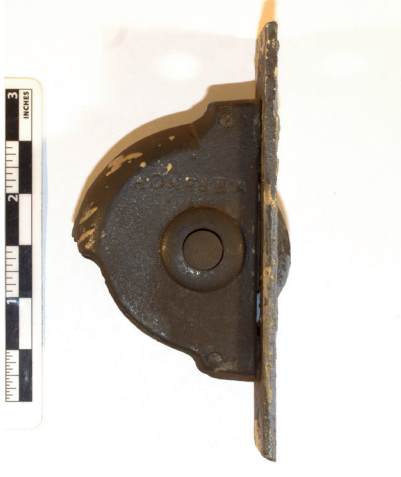
Artifact ID	H.206.001	
Artifact Type	Framed Axle Sash Pulley	
Analyzed by	Joseph C. Mester	
Analyzed on	May 9, 2016	
Location (within structure)	The sash pulley was located in the eastern most box jamb of Window 201 (northeastern window) in Room 206.	
Metal	Cast iron

Manufacture	Machine made	
Assembly	Two rivets joined the face plate to side plates. The side plates carried the axle of the pulley wheel.	
Fasteners	Two screws secured the axle pulley to the box frame (Refer to S.206.001 and S.206.002).	
Approximate Date	c. 1840 – c.1900	
Notes:	<p>"W. French" was stamped on a side plate. This may be a manufacturer or seller stamp.</p> <p>A similar axle pulley was pictured in: Price List and Illustrated Catalogue of Hardware Manufacture and For Sale by Sargent & Co (New York, 1871), 148; Wyvill James Christy, A Universal Dictionary for Architects, Civil Engineers, Surveyors, and Builders (London: Griffith & Farran, 1879), 72.</p>

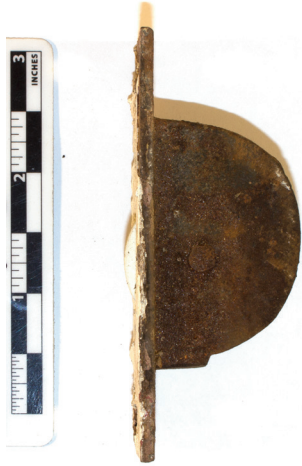
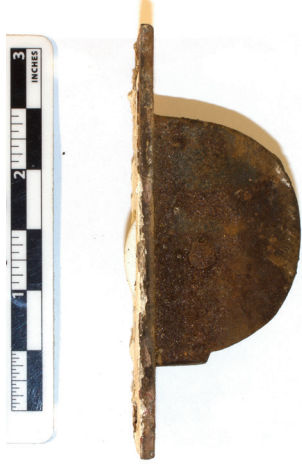
Artifact ID	H.306.001	
Artifact Type	Framed Sash Pulley	
Analyzed by	Joseph C. Mester	
Analyzed on	May 9, 2016	
Location (within structure)	The sash pulley was located in the eastern most box jamb of Window 301 (dormer window) in Room 306.	
Metal	Cast iron

Manufacture	Early machine made with hand finishing	
Assembly	Face plate and sides was cast as one piece. The rivet-like axle carried the sash wheel.	
Fasteners	Two screws secured the axle pulley to the box frame (Refer to S.306.001 and S.306.002).	
Approximate Date	Late-eighteenth century, c. 1795	
Notes:	The screw holes in the face plate were not in-line with the sash wheel.

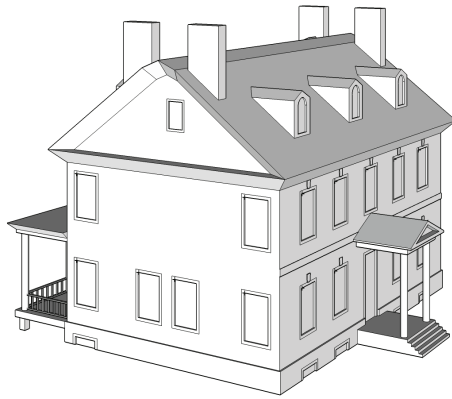
Figure E.1. Southwest perspective of the McConnell-Busti Country House, 1794 - 1824. Drawn by author, 2016.

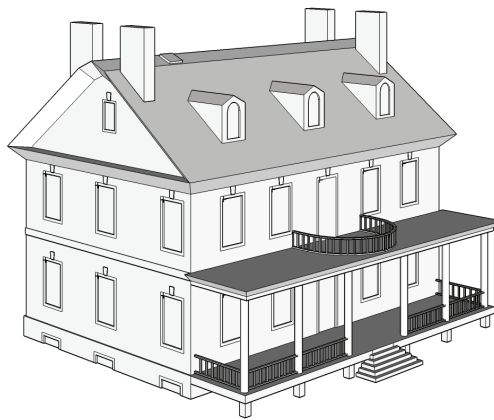
Figure E.2. Northeast perspective of the McConnell-Busti Country House, 1794 - 1824. Drawn by author, 2016.
