From Philadelphia Country House to City Recreation Center: Uncovering the Architectural History of the Building Known Successively as Blockley Retreat, Kirkbride Mansion, and Lee Cultural Center Through Building Archaeology

Joseph C. Mester
University of Pennsylvania

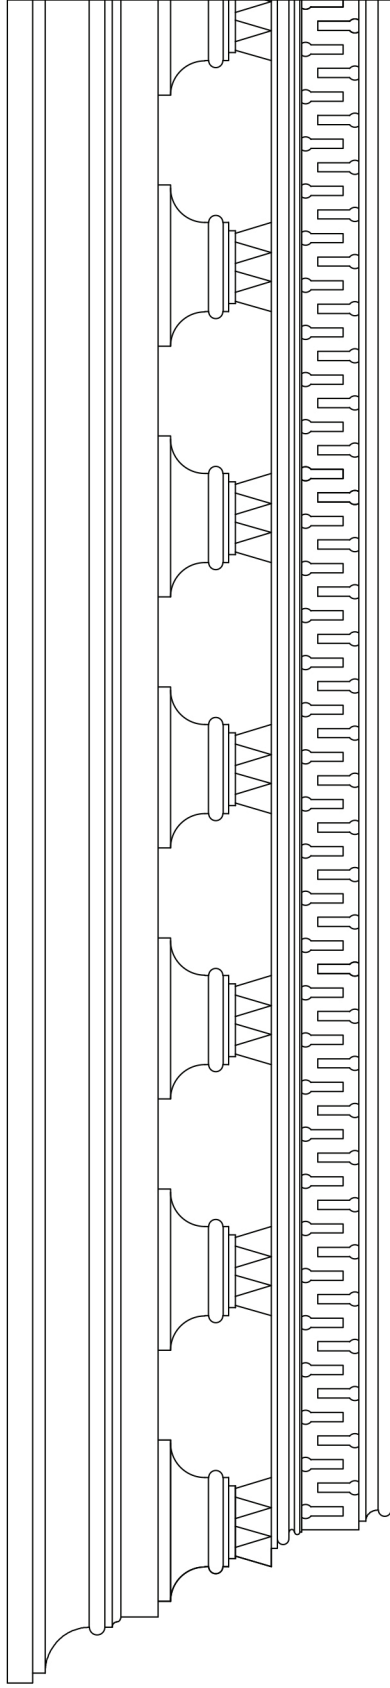
Figure E.13. Cornice of the central hall, Room 101. Drawn by author, 2015; edited 2016. Scale: 2½" = 1'.

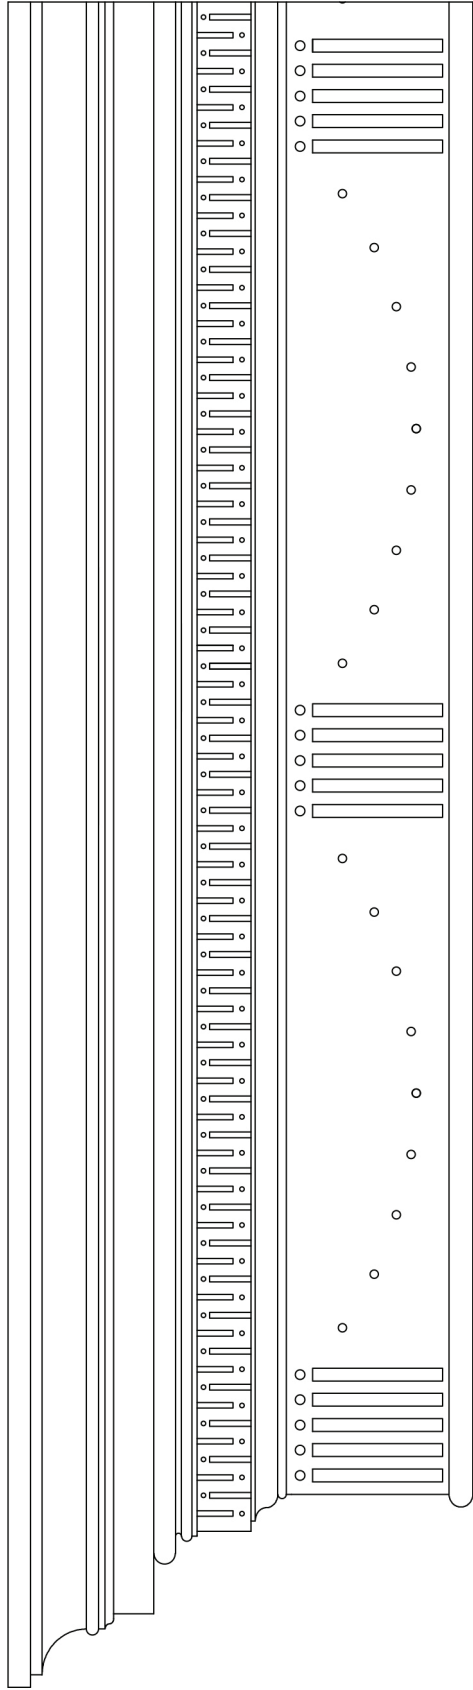
Figure E.14. Cornice of double parlor, Rooms 102 and 103. Drawn by author, 2015; edited 2016. Scale: 2 1/2" = 1'.

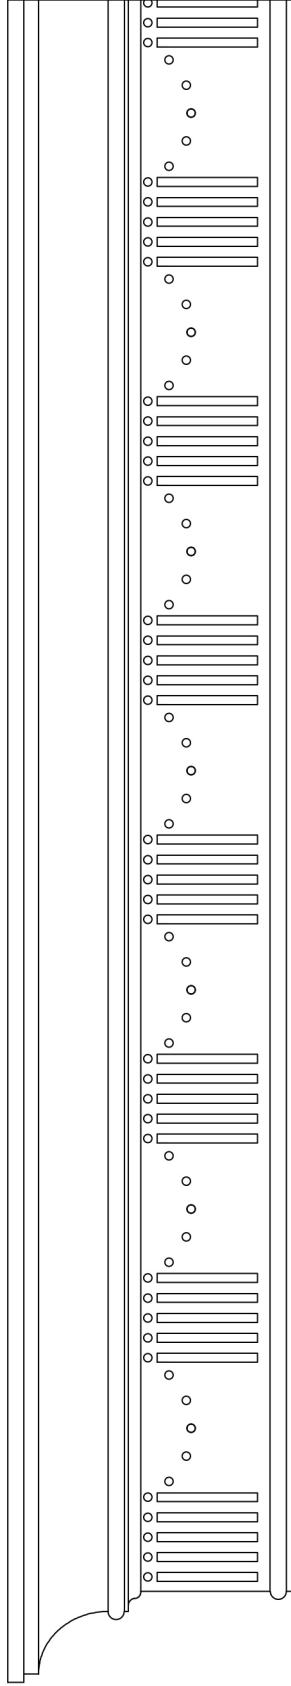
Figure E.15. Cornice of dining room, Room 105. Drawn by author, 2016. Scale: 2½" = 1'.
