Final Report
for
Iowa Highway Research Board
Research Project HR-266

THE RELATIONSHIP OF
FERROAN DOLOMITE AGGREGATE
TO
RAPID CONCRETE DETERIORATION

January 1987

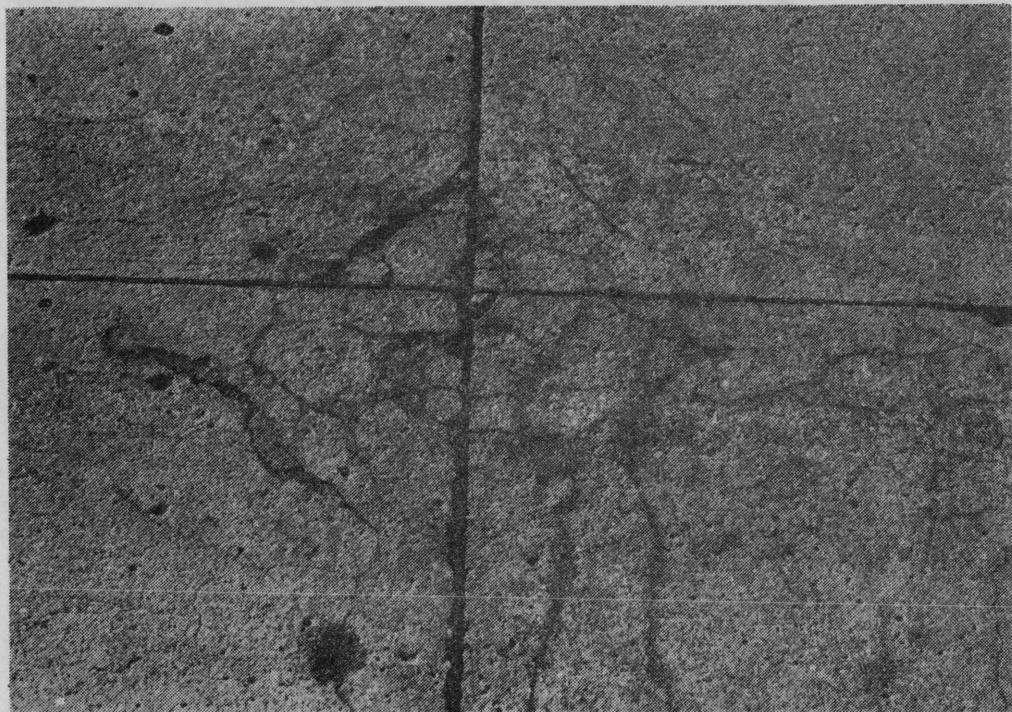
Figure 1 A close-up of D-cracking at the intersection of the transverse and longitudinal joints

In general, Iowa has had good performance from pcc pavement. One of the major problems in Iowa with some pcc pavements has been a rapid deterioration usually beginning at the joints and referred to as D-cracking (1). D-cracking (Figure 1) has severely reduced the life of these pcc pavements in Iowa, necessitating extensive full depth patching. Research in the 1960's identified the major factor in D-cracking as nondurable coarse aggregate. This research further revealed that the mechanism causing the cracking was freezing and thawing of water within the concrete. Iowa began using an ASTM C666, Method B (freezing in air, thawing in water) test in 1962 to further identify nondurable coarse aggregates. A 90-day moist-cure preparation prior to the ASTM C666, Method B testing produced results that correlated relatively well with the performance history of pcc pavements in Iowa. Research beginning in 1978 revealed a relationship between the freeze/thaw failure of carbonate aggregates and their pore systems (2, 3). The Iowa Pore Index was adopted and again was relatively reliable in identifying nondurable carbonate coarse aggregate.

1. A close-up of D-cracking at the intersection of the transverse and longitudinal joints.
2. SEM photomicrograph of a polished Garrison dolomite surface after boiling in distilled water.

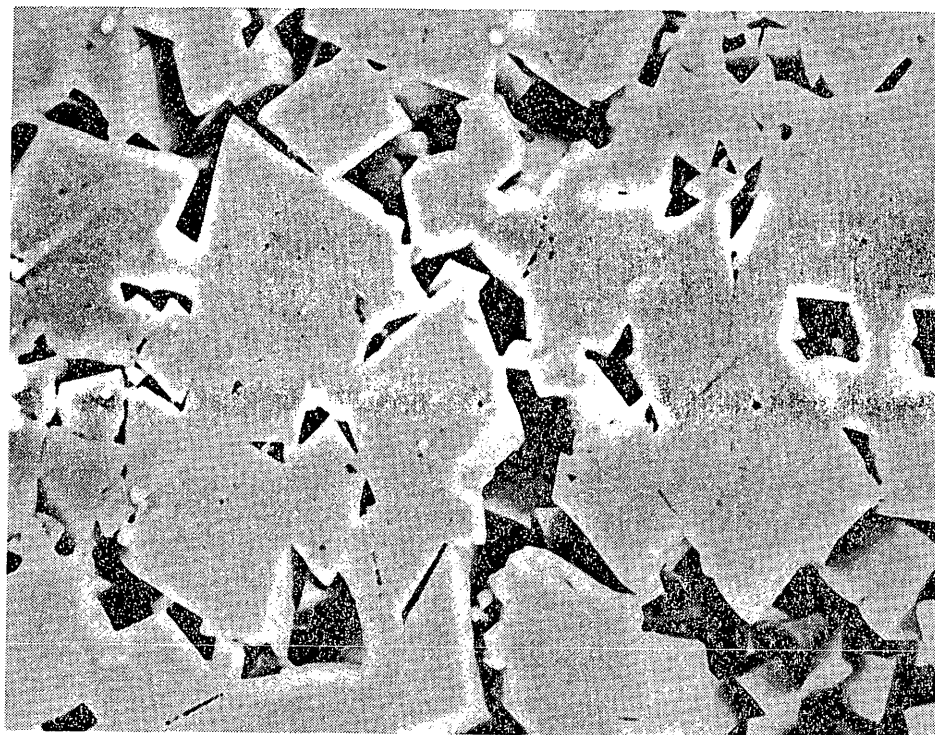
Figure 2 SEM photomicrograph of a polished Garrison dolomite surface after boiling in distilled water

Another relatively simple test was used in an effort to determine the chemical reaction that was taking place with the carbonate aggregates. A slice of rock was sawed from a piece of Garrison ferroan dolomite. One side of this slice was polished. The polished slice was broken into three pieces which were boiled in three different liquids for two hours. One liquid was distilled water, the second was a calcium chloride solution and the third was a sodium chloride solution. Scanning electron microscope photomicrographs were taken of each sample (Figures 2, 3 & 4). The piece boiled in distilled water showed no appreciable change. The section boiled in calcium chloride solution exhibited only minor etching and discoloration. The section that was boiled in sodium chloride showed substantial etching and discoloration (an apparent disruption of the crystal surface). X-ray diffraction analysis of material boiled in the calcium chloride solution showed changes that were not visually evident (Figure 5). Prior to the boiling of the material in the

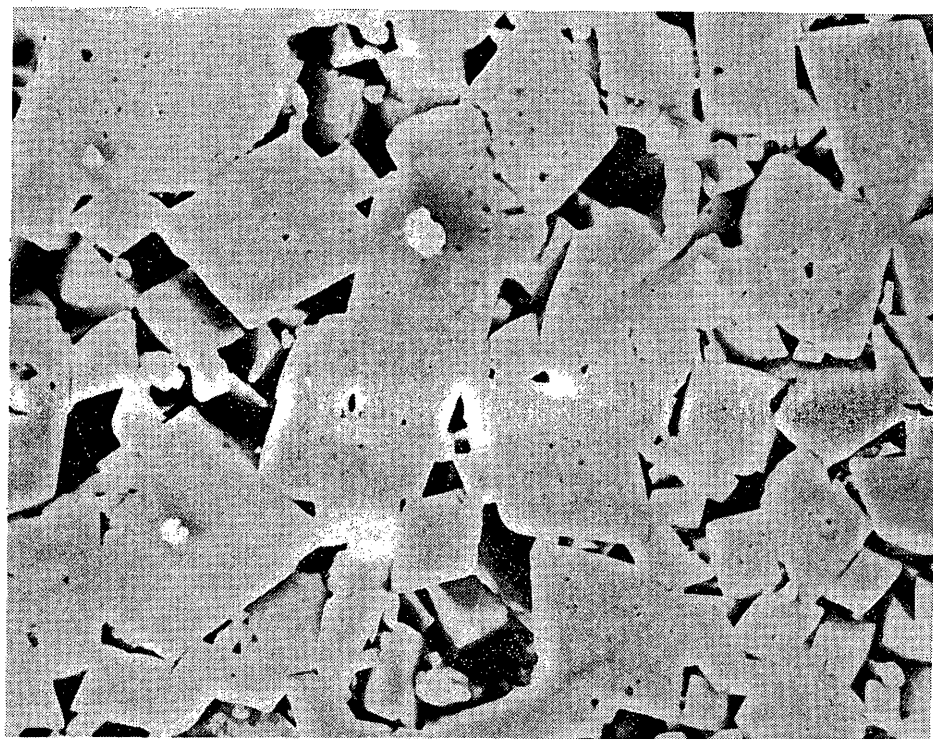
Figure 3 SEM photomicrograph of a polished Garrison dolomite surface after boiling in a calcium chloride solution

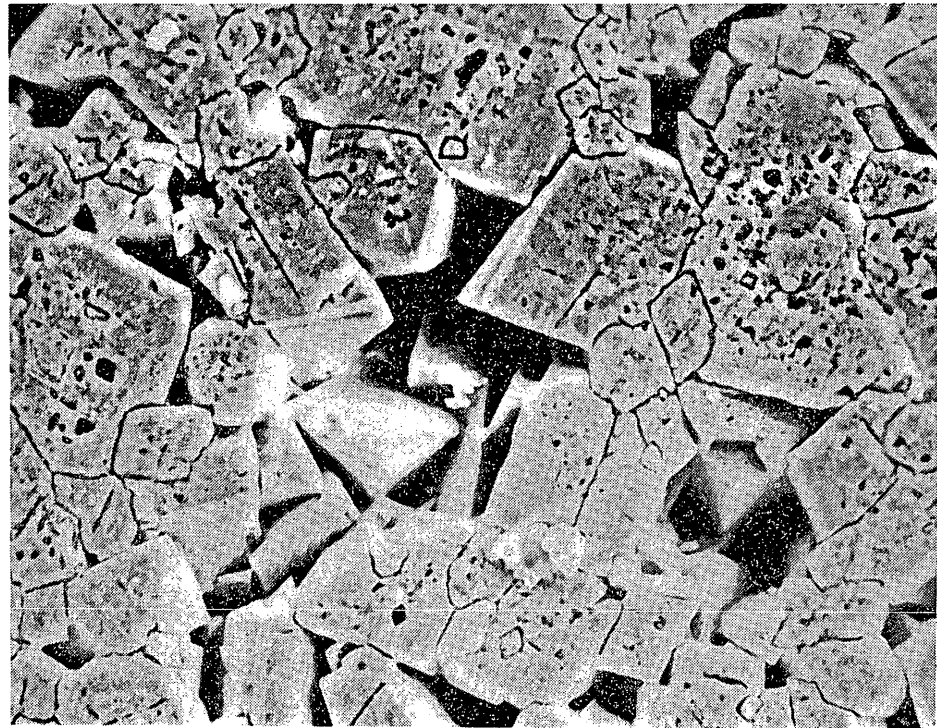
Figure 4 SEM photomicrograph of a polished Garrison dolomite surface after boiling in a sodium chloride solution

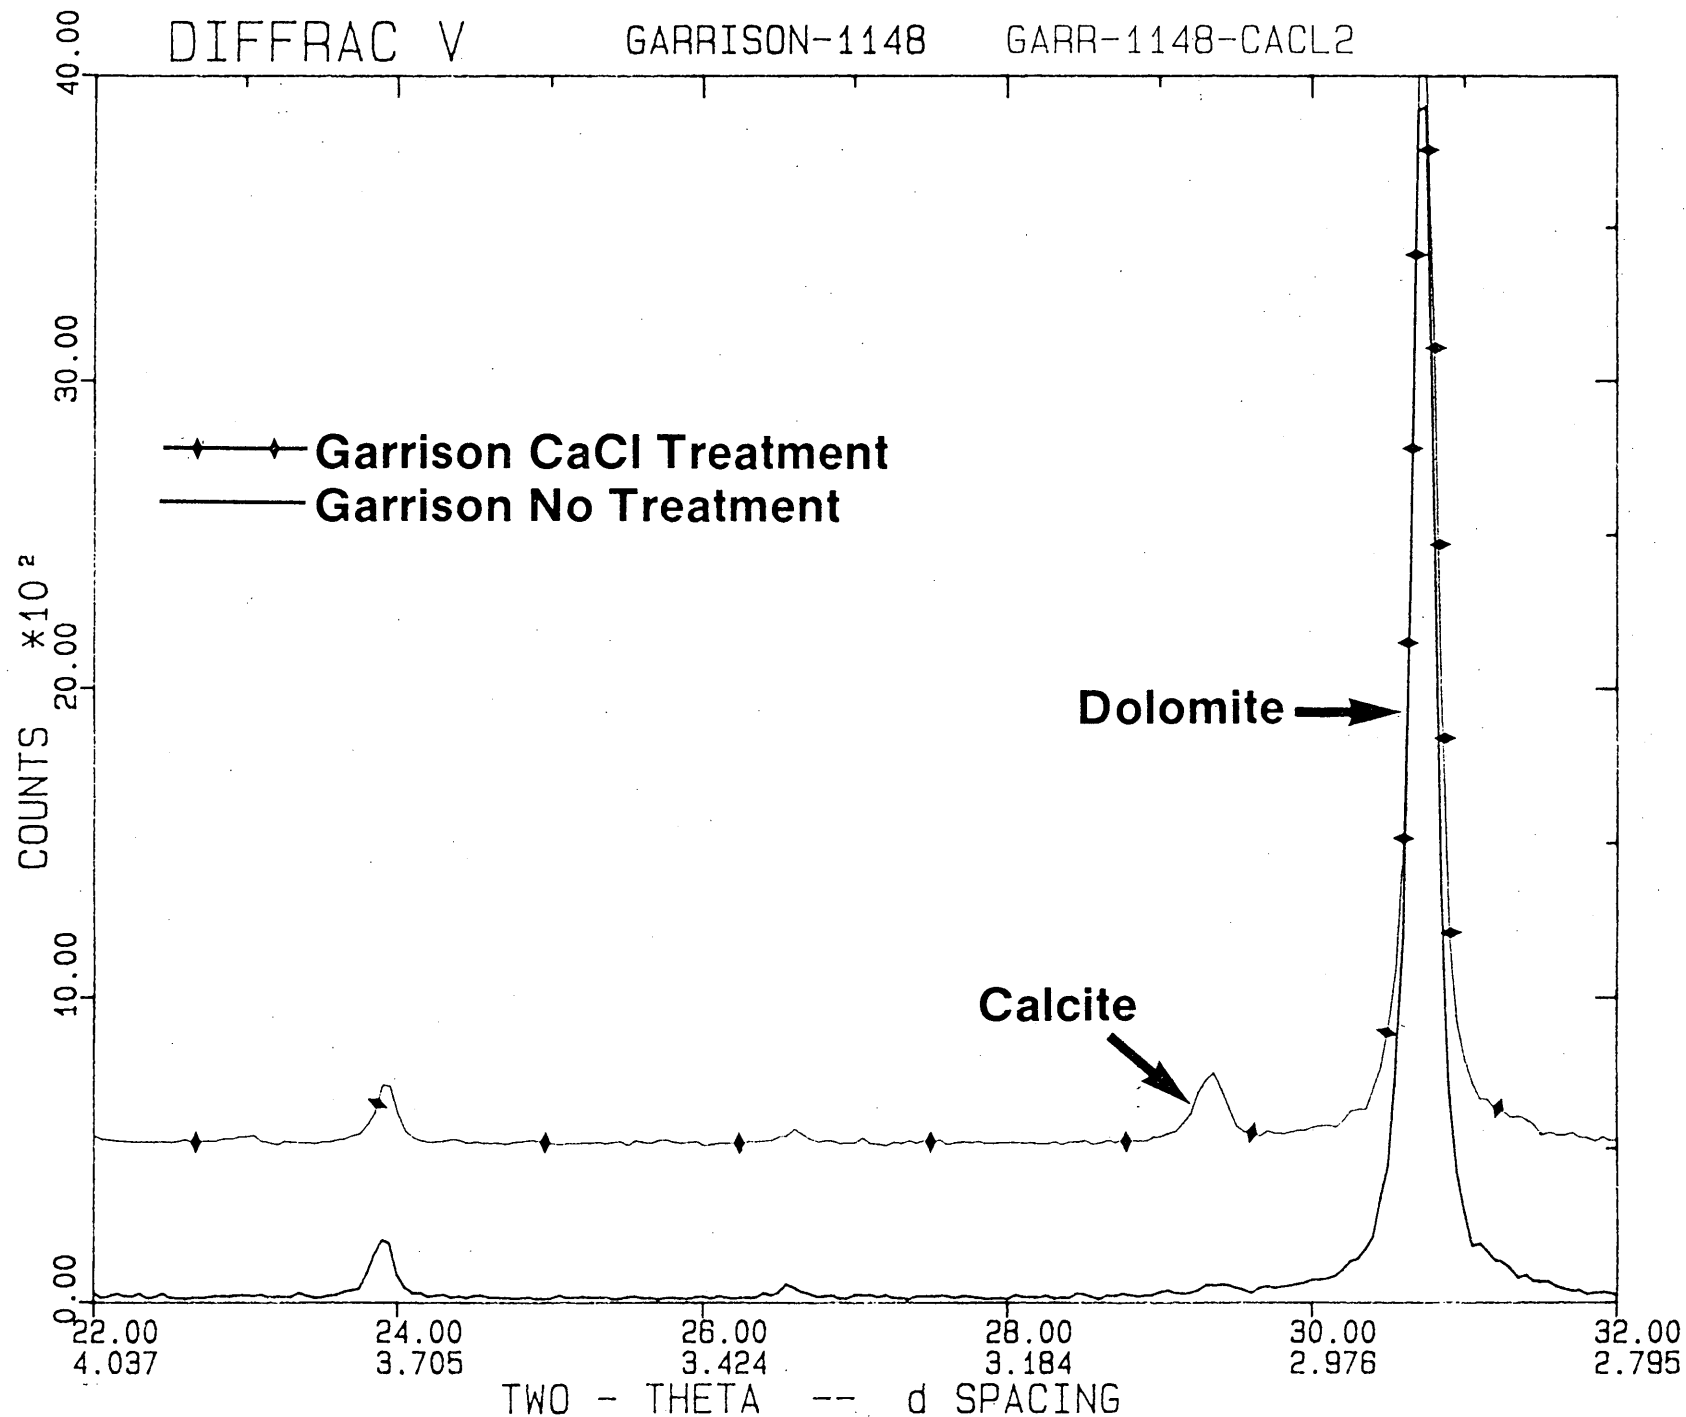
FIGURE 5 GARRISON X-RAY DIFFRACTOGRAM. - NO TREATMENT AND BOILING IN CALCIUM CHLORIDE SOLUTION

calcium chloride solution, there was no maximum-intensity calcite peak. There was a strong dolomite maximum-intensity peak at 2.904 angstroms. After boiling in calcium chloride there was still a strong maximum-intensity dolomite peak at 2.904 angstroms but there was also a maximum-intensity calcite peak at a d-spacing of 3.039 angstroms. This would indicate that some of the iron and/or magnesium was replaced by calcium, but this apparently did not change the appearance of the polished surface to any extensive degree. The diffraction plots of the Garrison dolomite after boiling in water, sodium chloride or magnesium chloride showed no significant change (Figures 6, 7 & 8). Boiling of a Maryville non-ferroan dolomite in calcium chloride also produced a calcite peak (Figure 9). While this study does not prove the aggregate is weakened by deicing salts, it does suggest that deicing salts produce chemical and crystallographic changes within the aggregate that may lead to deterioration.

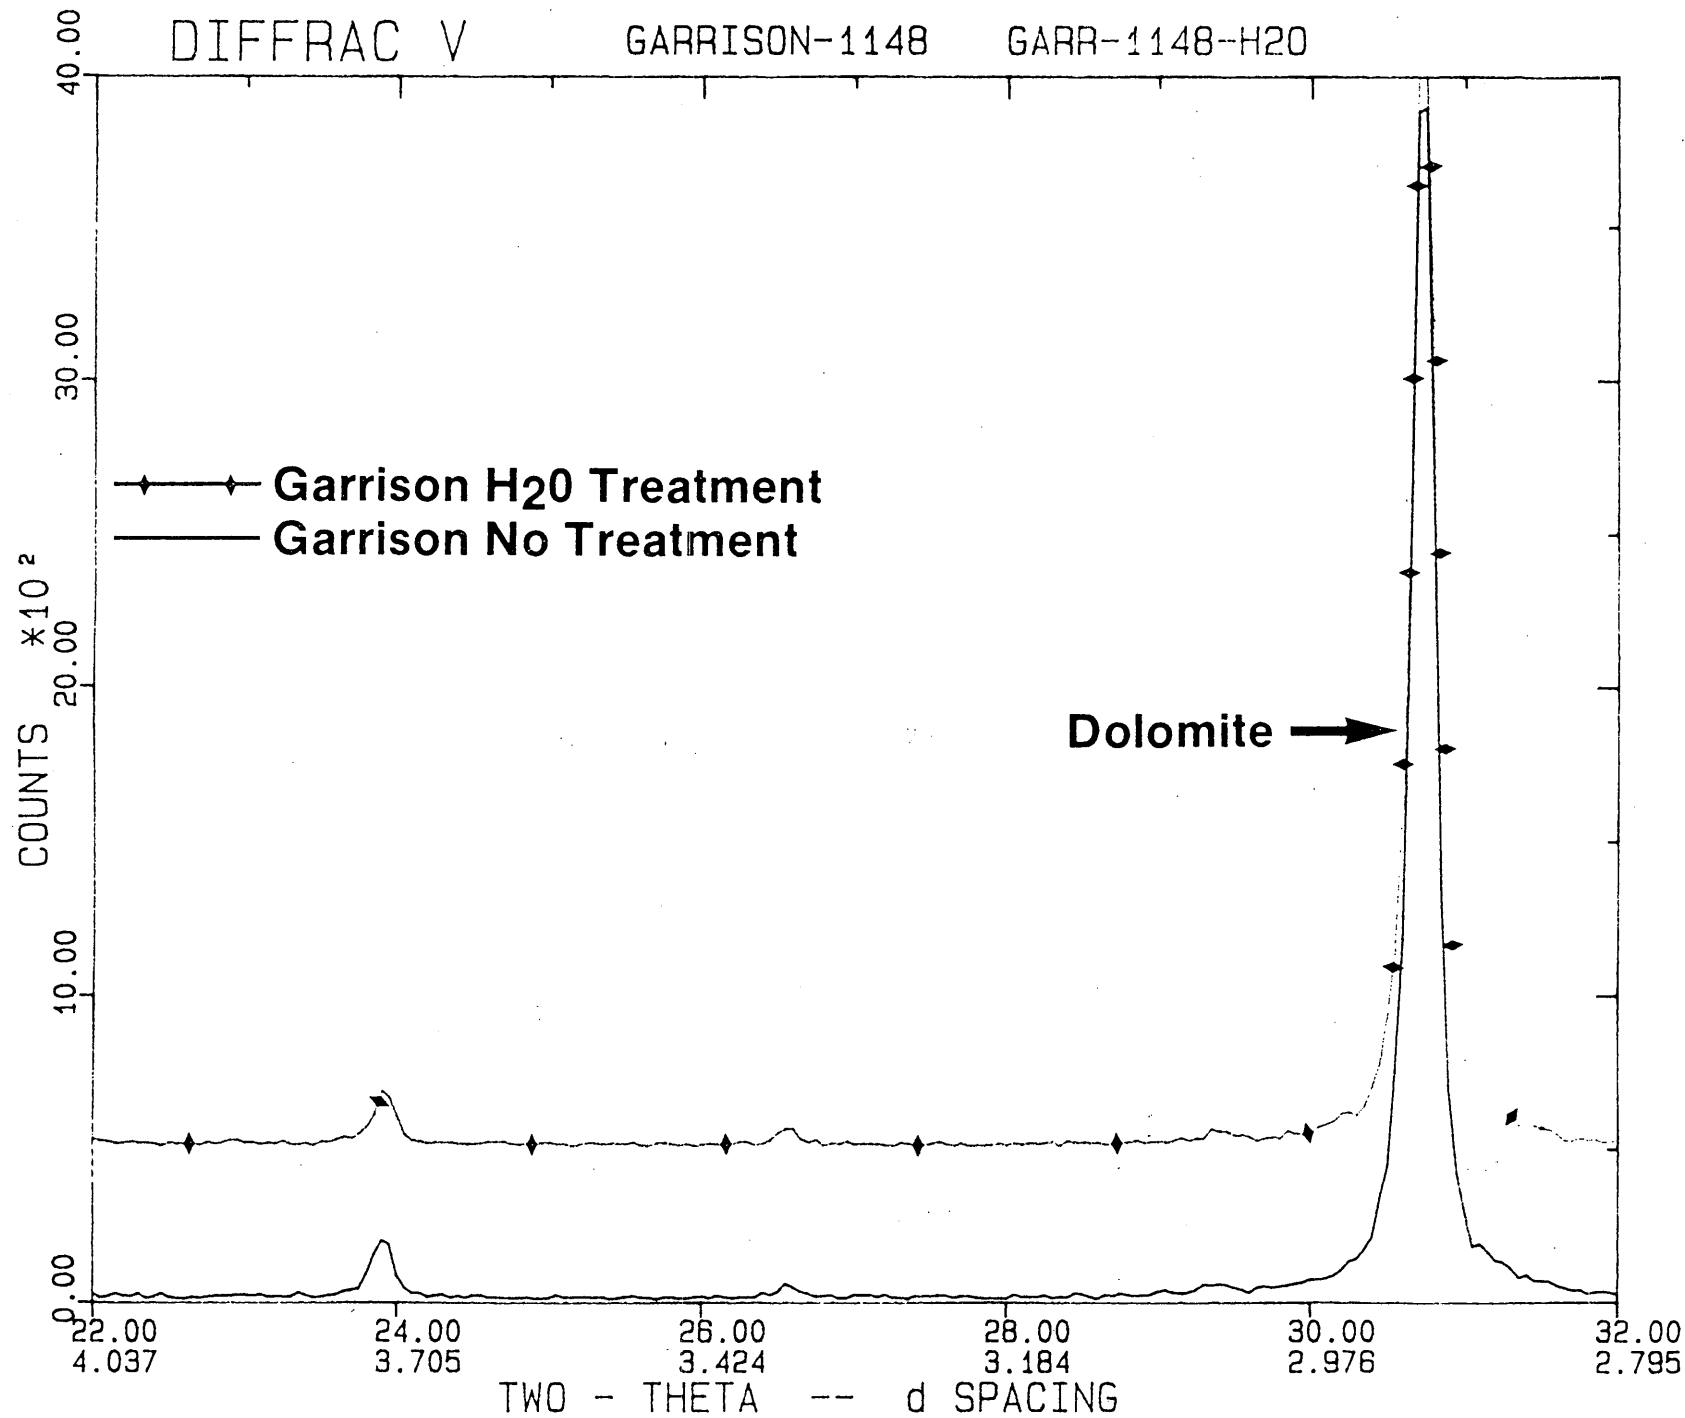
FIGURE 6 GARRISON X-RAY DIFFRACTOGRAM - NO TREATMENT AND BOILING IN DISTILLED WATER

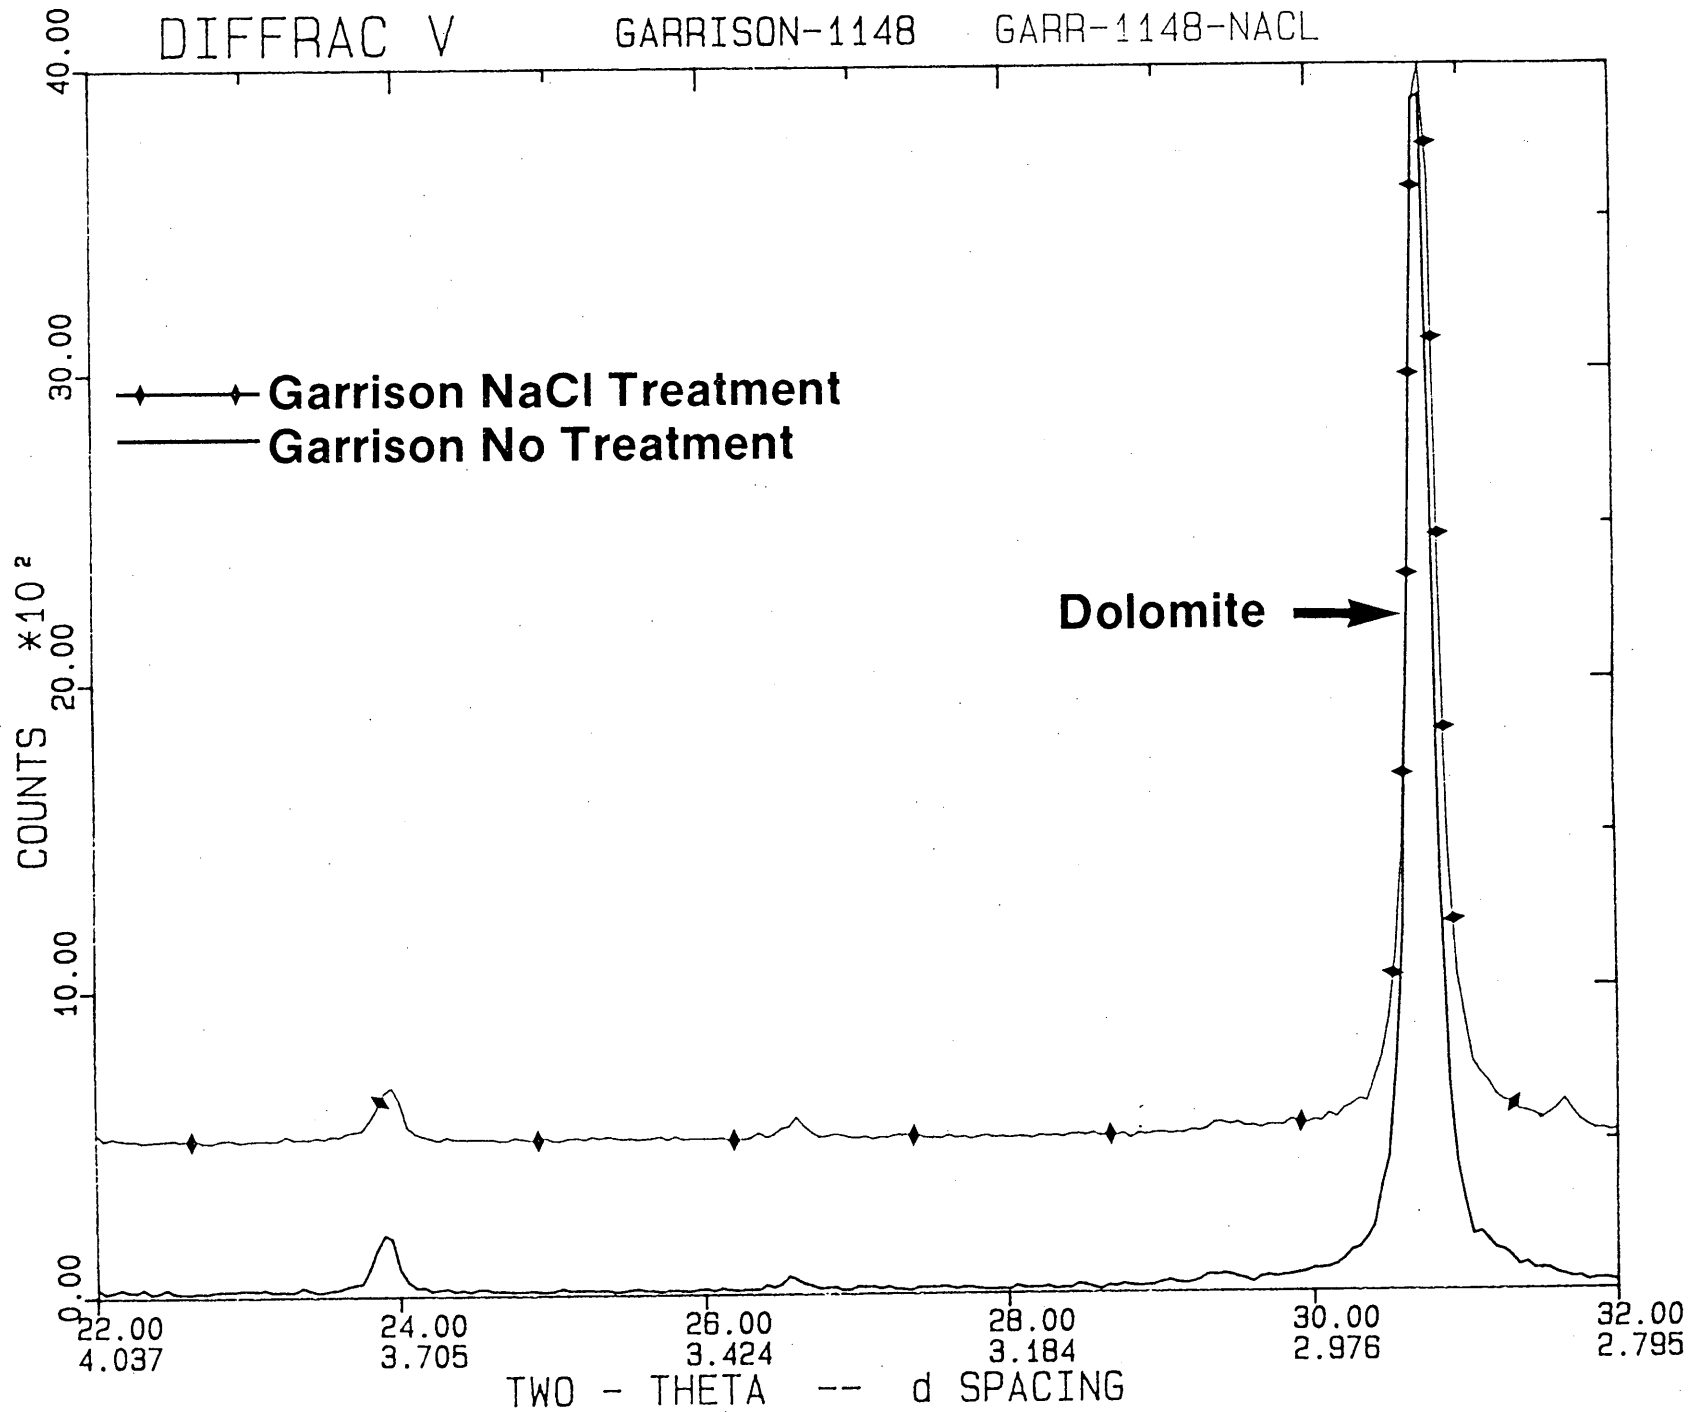
FIGURE 7 GARRISON X-RAY DIFFRACTOGRAM - NO TREATMENT AND BOILING IN A SODIUM CHLORIDE SOLUTION

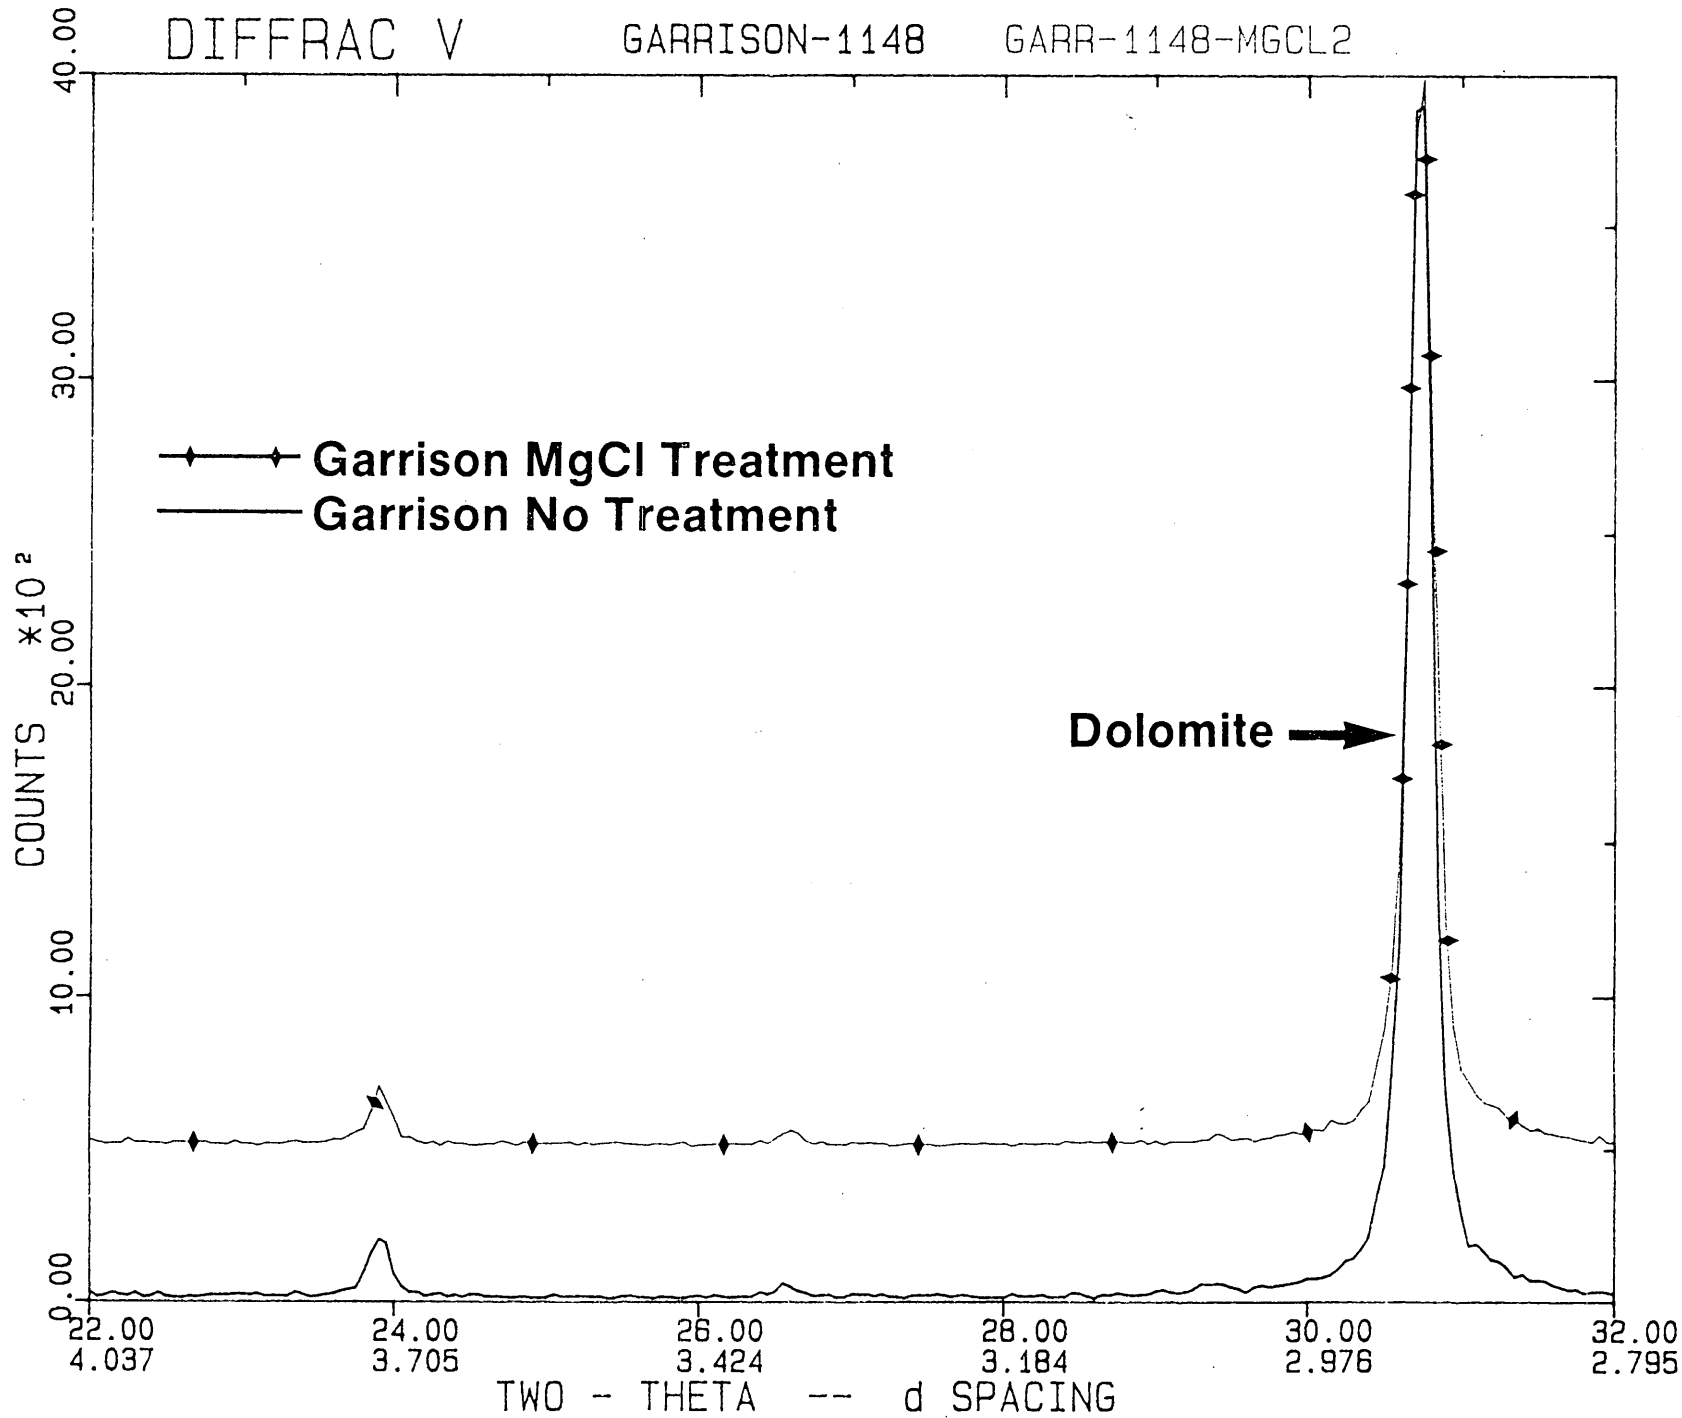
FIGURE 8 GARRISON X-RAY DIFFRACTOGRAM - NO TREATMENT AND BOILING IN A MAGNESIUM CHLORIDE SOLUTION

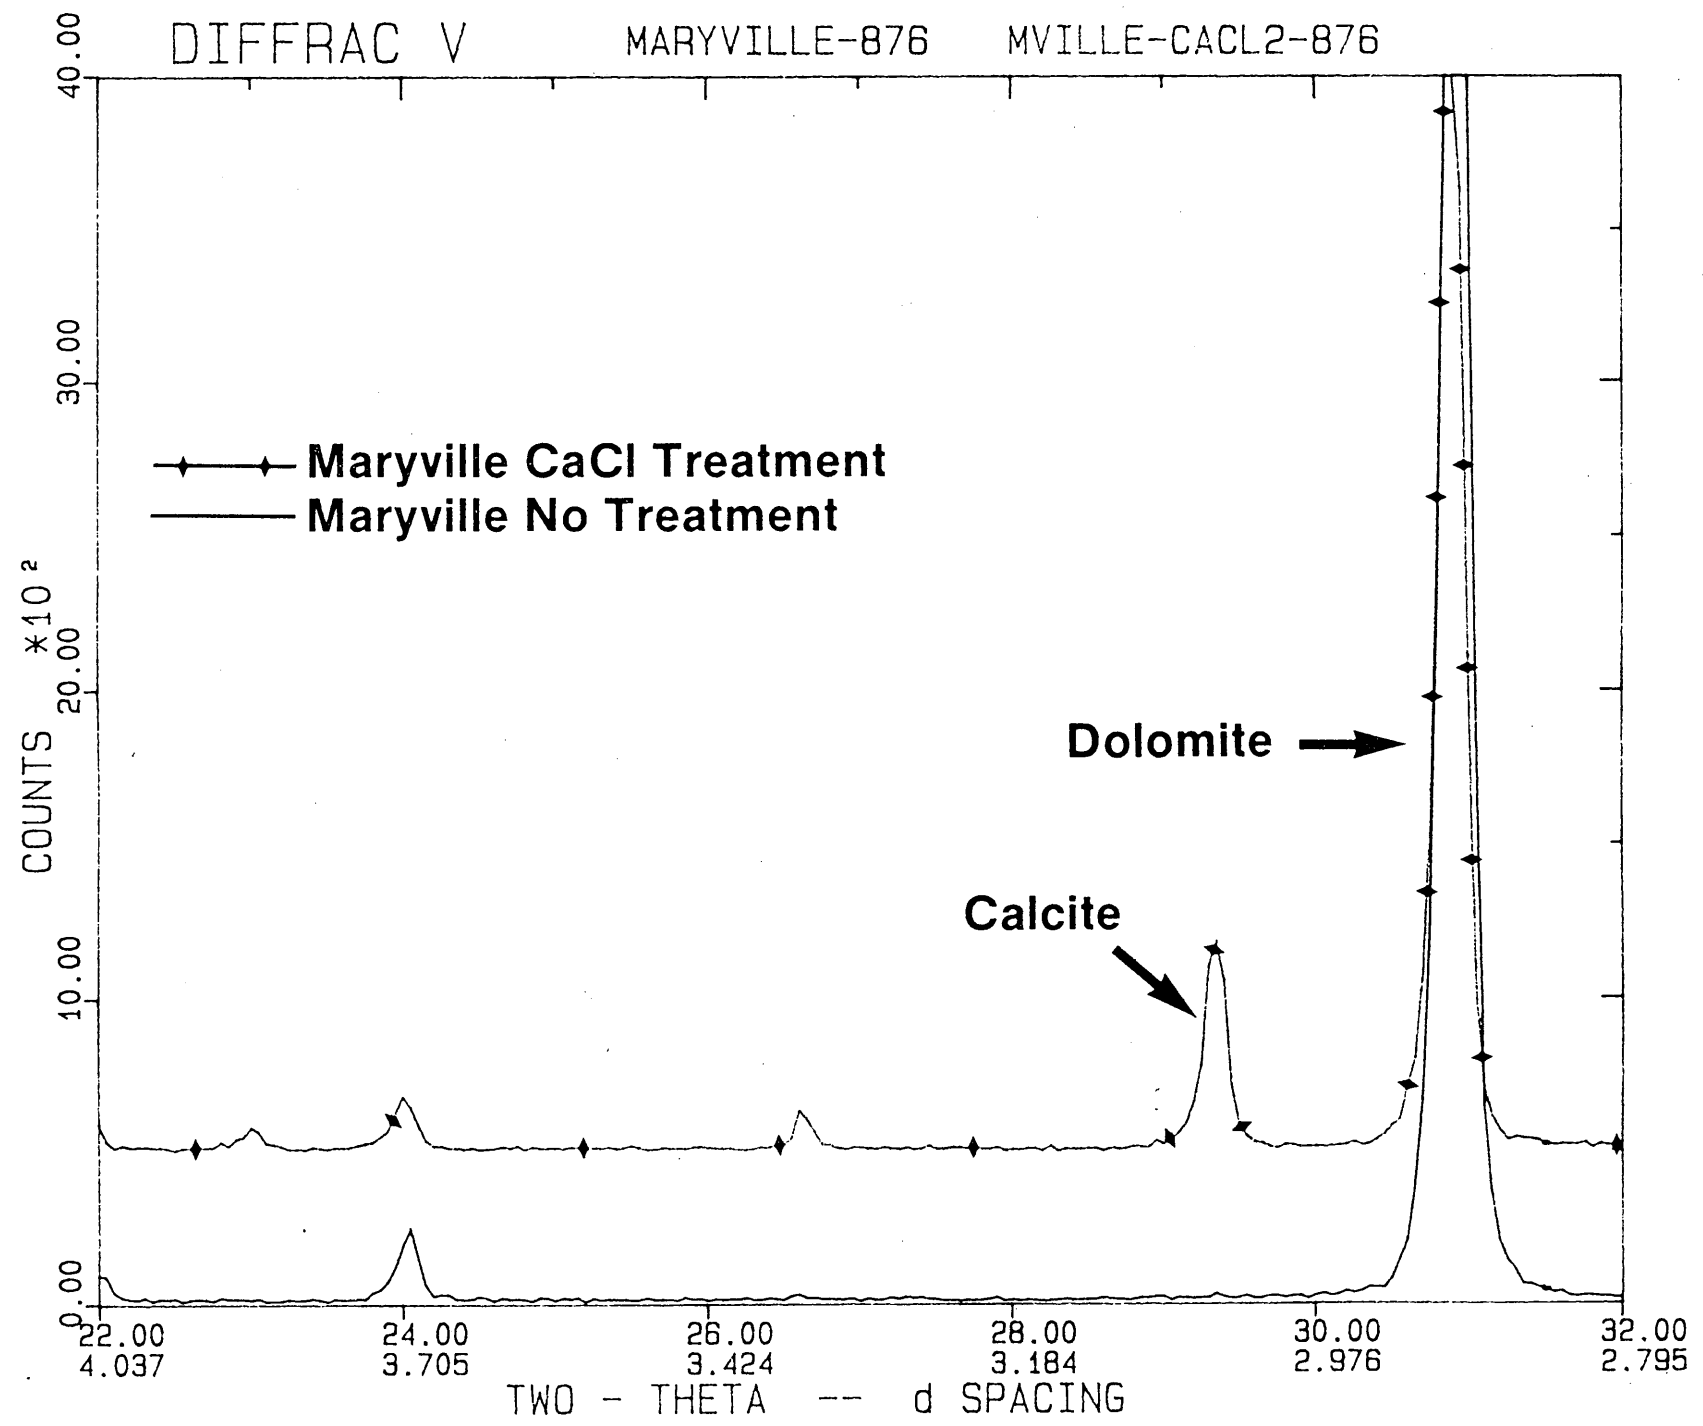
FIGURE 9 MARYVILLE DOLOMITE X-RAY DIFFRACTOGRAM - NO TREATMENT AND BOILING IN A CALCIUM CHLORIDE SOLUTION

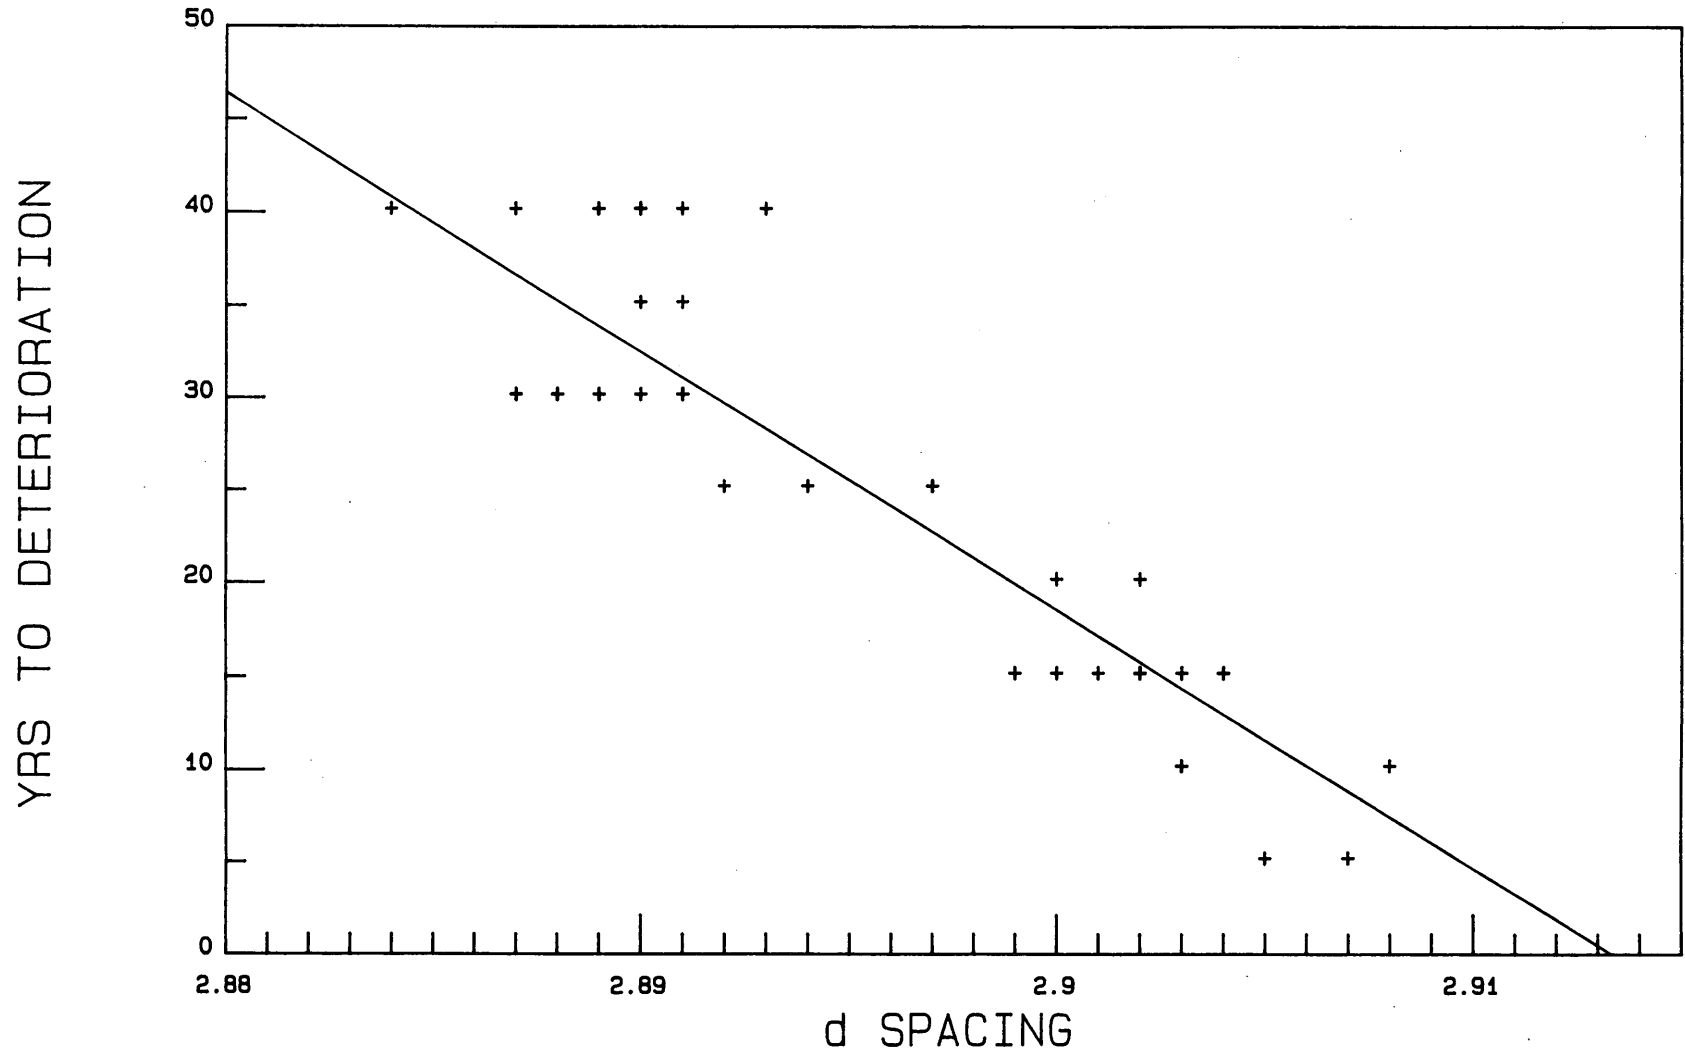
FIGURE 11 GRAPH OF d-SPACING OF MAXIMUM-INTENSITY DOLOMITE PEAK VS YEARS TO VISIBLE DETERIORATION OF THE CONCRETE

d SPACING OF MAXIMUM INTENSITY DOLOMITE PEAK
VS
YEARS TO VISIBLE DETERIORATION OF THE CONCRETE

SAVECODE: PEAKSFT2
IOWA DOT AMES, IOWA 1-515-239-1339 NOV 86
AGGREGATES WITH INFERIOR PORE SYSTEMS EXCLUDED

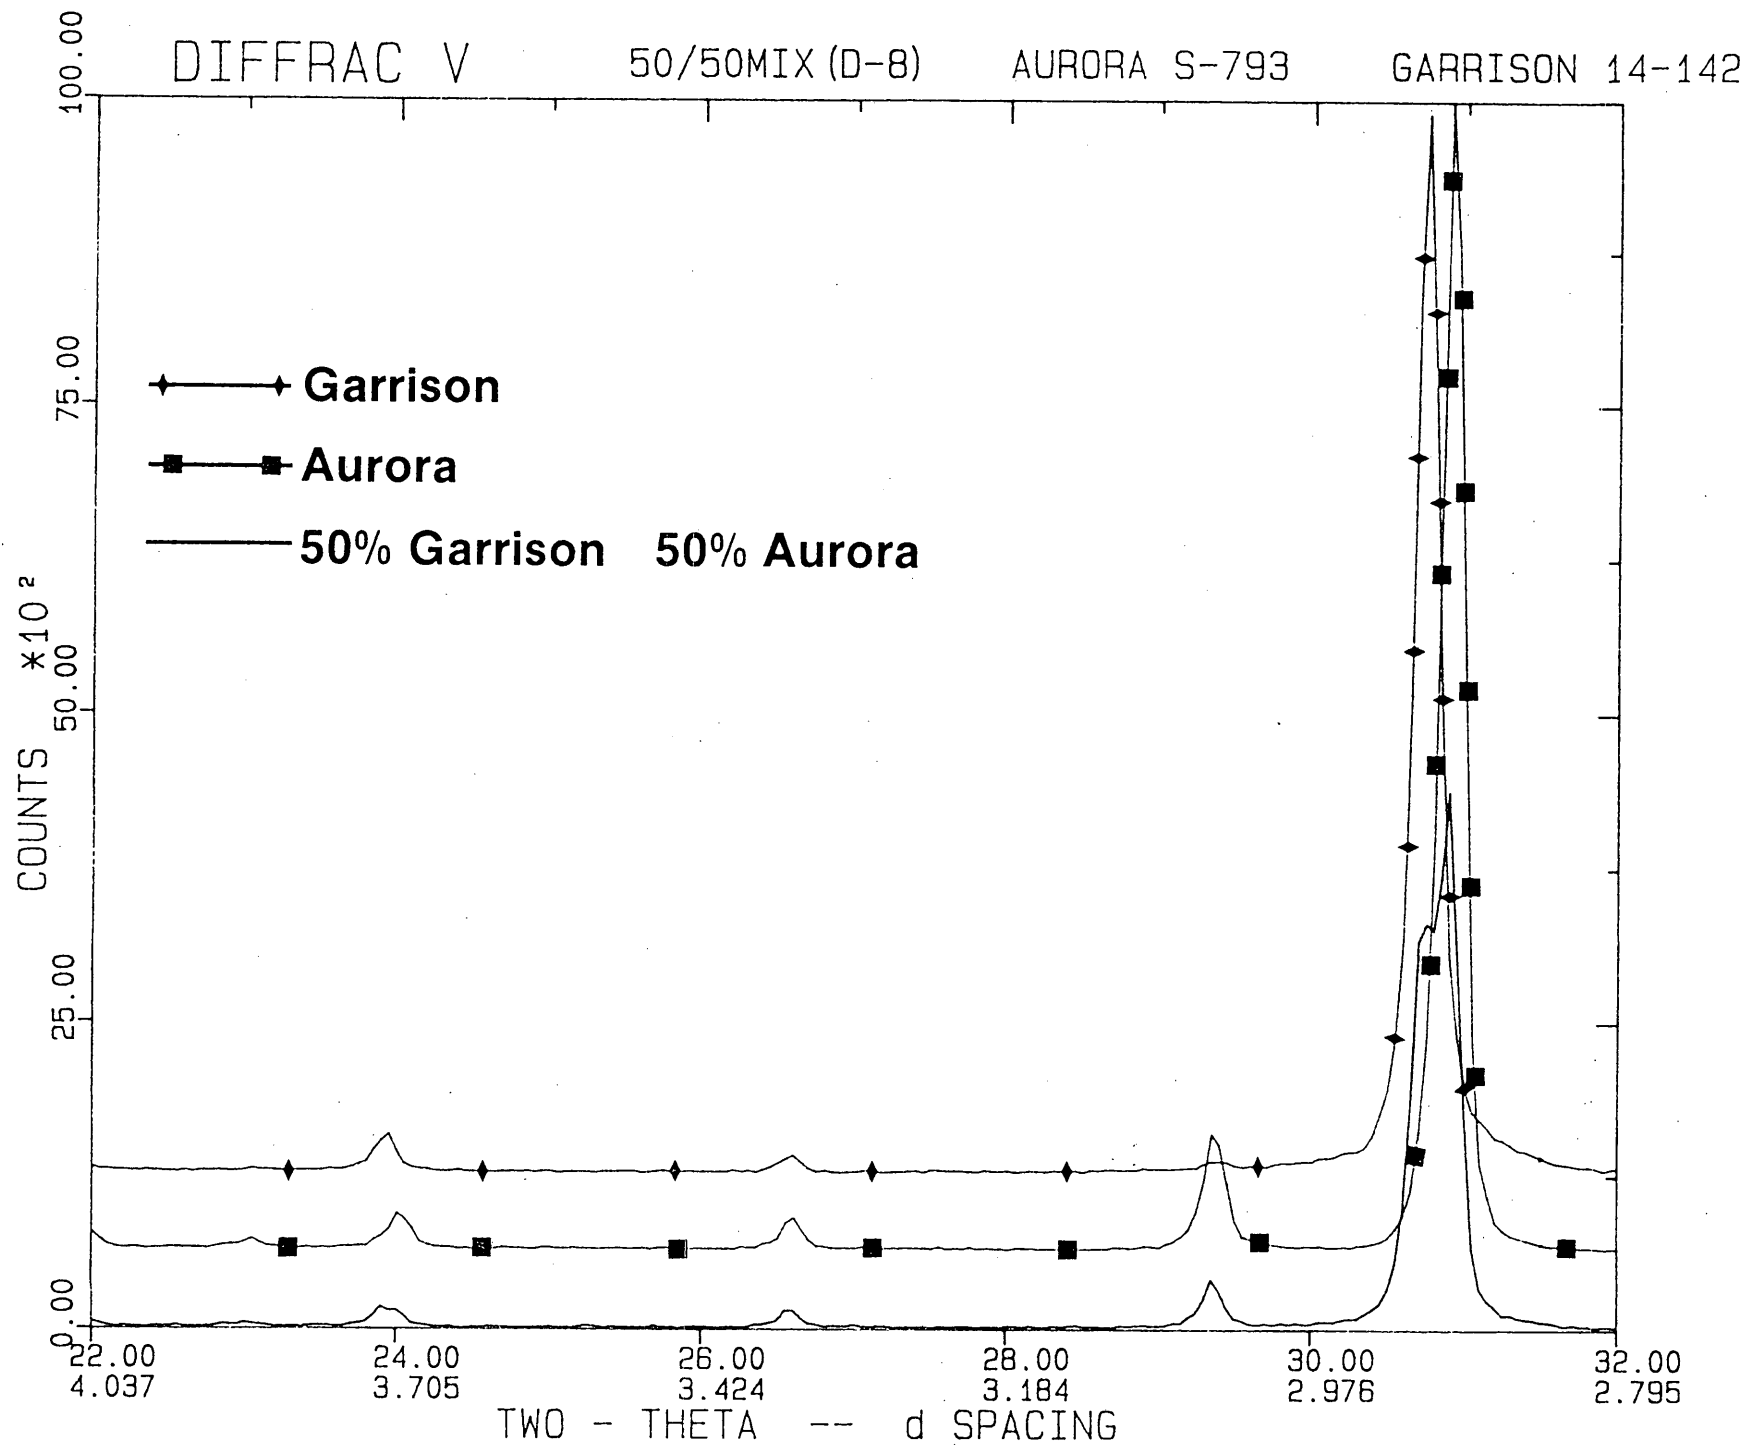
FIGURE 12 X-RAY DIFFRACTION PLOTS OF GARRISON AND AURORA DOLOMITE AND A 50% GARRISON - 50% AURORA MIXTURE

An X-ray diffraction analysis was conducted on a sample made by combining 50% of the Garrison ferroan dolomite with 50% of an Aurora (Silurian age very similar to Maryville) non-ferroan dolomite (Figure 12). It did not result in

one maximum-intensity dolomite peak but yielded two peaks of approximately one half the intensity of the individual samples.
