IN-PAVEMENT PEDESTRIAN FLASHER EVALUATION: CEDAR RAPIDS, IOWA

CTRE Project 03-145

Final Report • April 2004

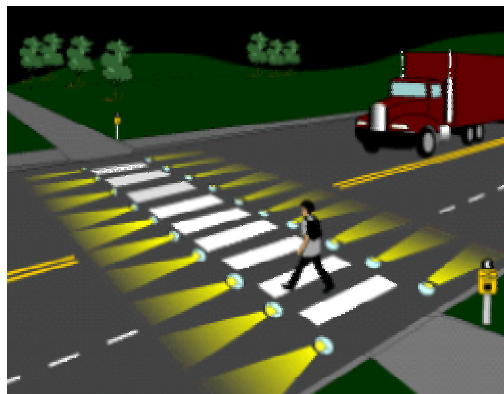
Figure 1. In-pavement flashing warning lights (walkinginfo.org)

Prior to MUTCD approval in 2000, several experimental applications of in-pavement flasher systems (see Figure 1) were completed and evaluated in other states, including Florida, New Jersey, Washington, and Hawaii. The use of in-pavement flashing lights has, to-date, been restricted to uncontrolled intersections and to mid-block locations to avoid becoming commonplace and to ensure that drivers are made aware of the special condition that exists at the specially-marked crossing. The in-pavement flashing units direct two or more flashing lights to the drivers when a pedestrian, or cyclist enters the cross walk. The lighting system is activated by a push-button or by a passive system that detects the breaking of a beam of energy by a cross walk user. Important design and operational details for the system include the method of activation, the number and placement of lights, the duration of the flashing period, and more. The following literature review will highlight portions of those issues, but the common feature in all of the systems is that the flashing units are placed to help drivers recognize the presence of crosswalk users and are the equivalent of a stop sign or a red traffic signal.

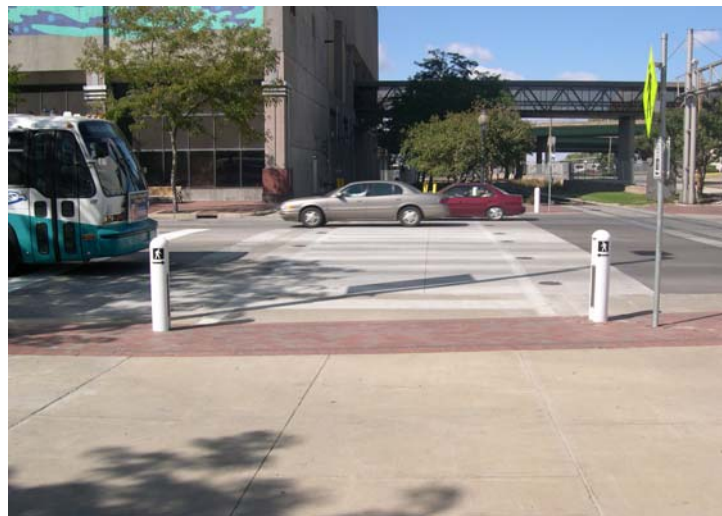
Figure 4. Crosswalk at ground level, looking northbound

The location has many complexities that cause pedestrian crossings to become more difficult to execute safely. The Union Pacific Railroad, which services nearby industry, has a spur line that runs parallel to 4th Street NE; a bicycle/pedestrian trail runs adjacent to the rail line and crosses 1st Avenue NE at this crosswalk location. A 15-foot-wide service drive from the Crowne Plaza Hotel is located on the east side of the hotel and falls partially within the crosswalk where it meets the north curb line. Figure 4 is a northbound view showing the site after the in-pavement system was in place. In addition, the total distance to be crossed is rather large—approximately 80 feet from curb to curb across five lanes of traffic and two parking lanes. Traffic volumes on 1st Avenue NE are approaching 25,000 vehicles per day, with heavy peaking characteristics centered around the A.M. and P.M. peak periods. The posted speed limit through the corridor is 25 mph, but the 85th percentile speeds approach 30 mph. All of these issues make the crosswalk at this location difficult for pedestrians, bicyclists, and motorists to navigate while avoiding conflicts with each other and with the different physical features of the project location.

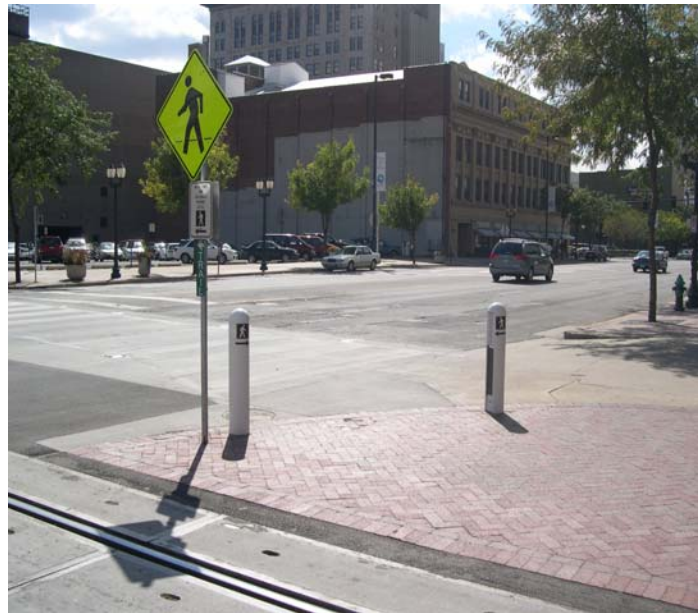
Figure 5. Crosswalk at ground level, looking southbound

The access drive posed a special design challenge to the contractors and the city. The city selected a passive detection system whereby the pedestrians were detected by passing between pairs of bollards located with one on each side of the crosswalk, as seen in Figure 4. Because the access entrance occurred in the crosswalk area on the far side of the street, vehicles entering the access drive would have activated the system if the detecting bollards on the north side were placed as widely as the bollards seen in Figure 4 on the south side of the street. As a result, pedestrians and cyclists approaching from the north had a smaller detection zone, as seen in Figure 5. Crosswalk users approaching from the right (west) had to make a greater effort to activate the flashers before they crossed.

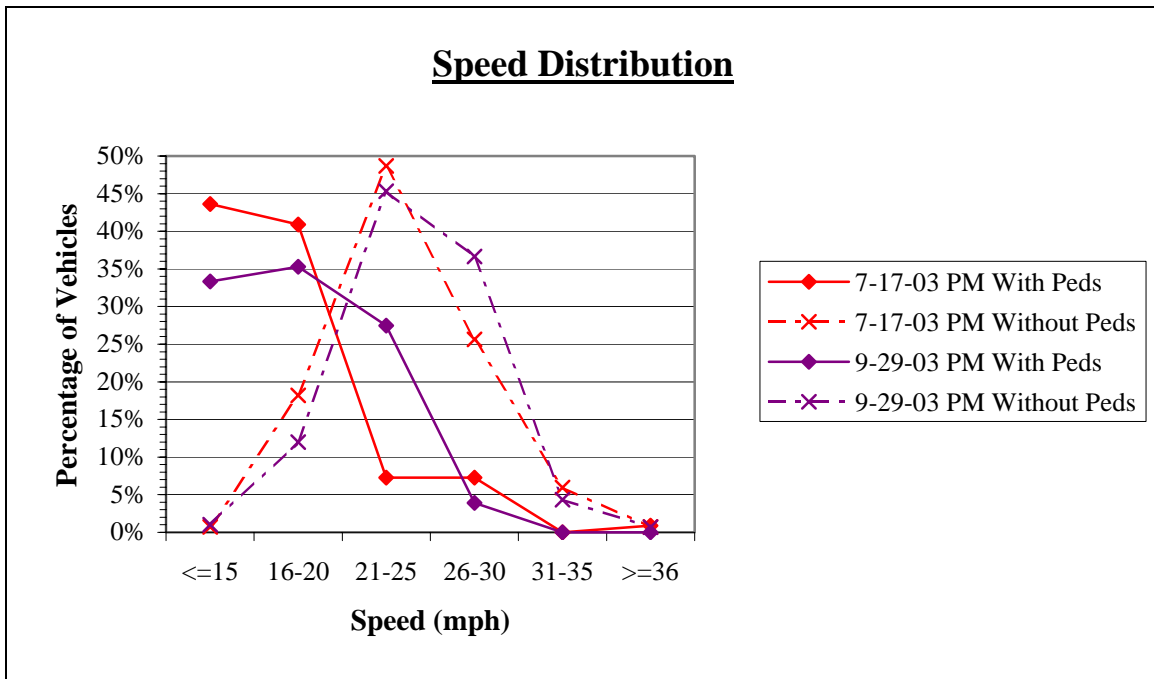
Figure 6. Spot speed distribution before and after project implementation

Figure 6 shows a slight shift to the right from before the improvement to after, indicating a slight increase in the average speed of vehicles through the project location. Additional analysis of the data, as shown in Table 1, indicates the changes in mean, 85 percentile, median, and speed range.
