# Remote Continuous Evaluation of a Bridge Constructed Using High- Performance Steel

**Final Report**  
**May 2006**

**Sponsored by**  
the Iowa Department of Transportation (CTRE Project 02-123)

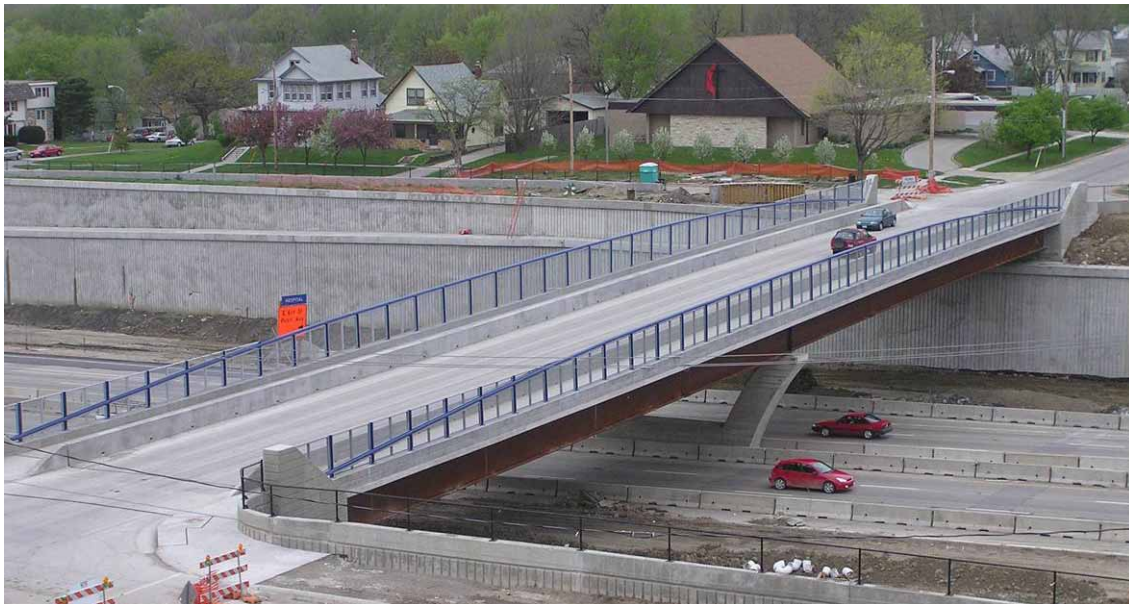
**Figure 1.1. East 12th Street Bridge over I-235 in Des Moines, Iowa**

The E. 12th St. Bridge (Figure 1.1), constructed using HPS girders, replaced a deteriorated concrete box girder bridge. The replacement is part of a renovation of the I-235 corridor through Des Moines and the surrounding metro area. The two-span bridge runs nearly north and south, providing one lane of traffic in each direction. The bridge connects the state capital area on the south to a residential area, including East High School, on the north.

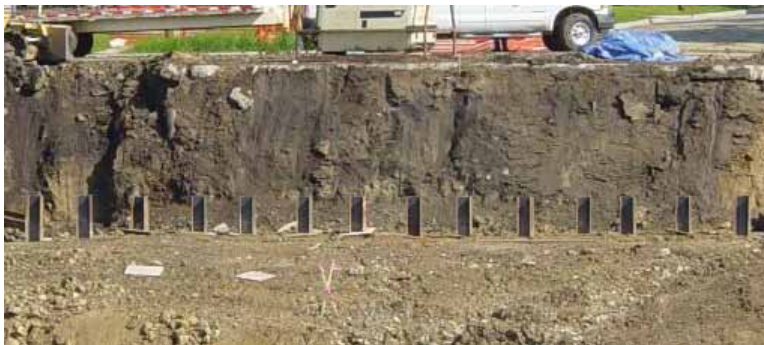
**Figure 3.9. Piles at south abutment before abutment concrete was placed**

After the box-girder bridge had been removed, work began by constructing new bridge abutments. Because the replacement bridge has integral abutments, work started by driving H-piles. The north abutment consists of a row of 15 HP 10x42 piles, with a single HP 10x42 pile behind each outer pile in the row, for a total of 17 piles. The south abutment was constructed with a row of 14 HP 10x42 piles, with a single HP10x42 pile behind the outer pile on the west side of the abutment and 2 HP10x42 piles behind the outer pile on the east side of the abutment, for a total of 17 piles. The piles were driven to a depth at which they reached the design bearing value (73 Kips). Exposed piles following installation can be seen in Figure 3.9. After the piles were driven, the top of the piles were encased in concrete to form the complete abutment. Figure 3.10 shows an abutment under construction.

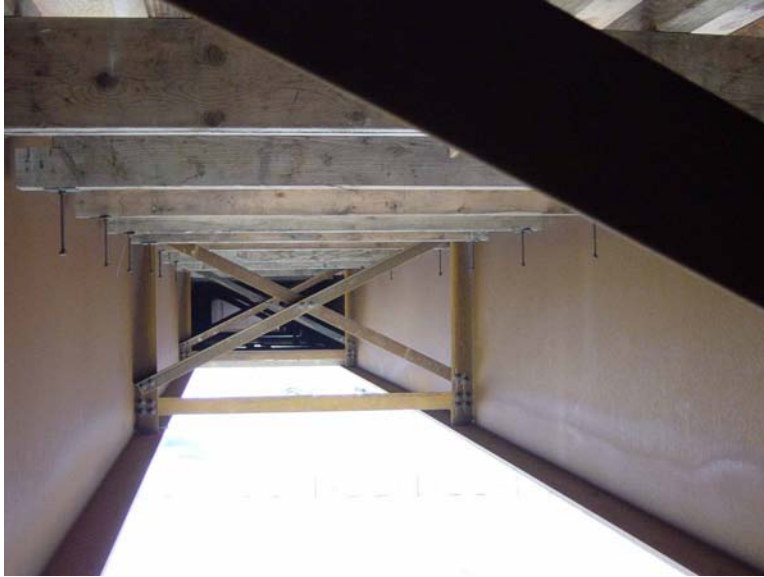
**Figure 3.24. Intermediate cross-frames and deck formwork stringers**

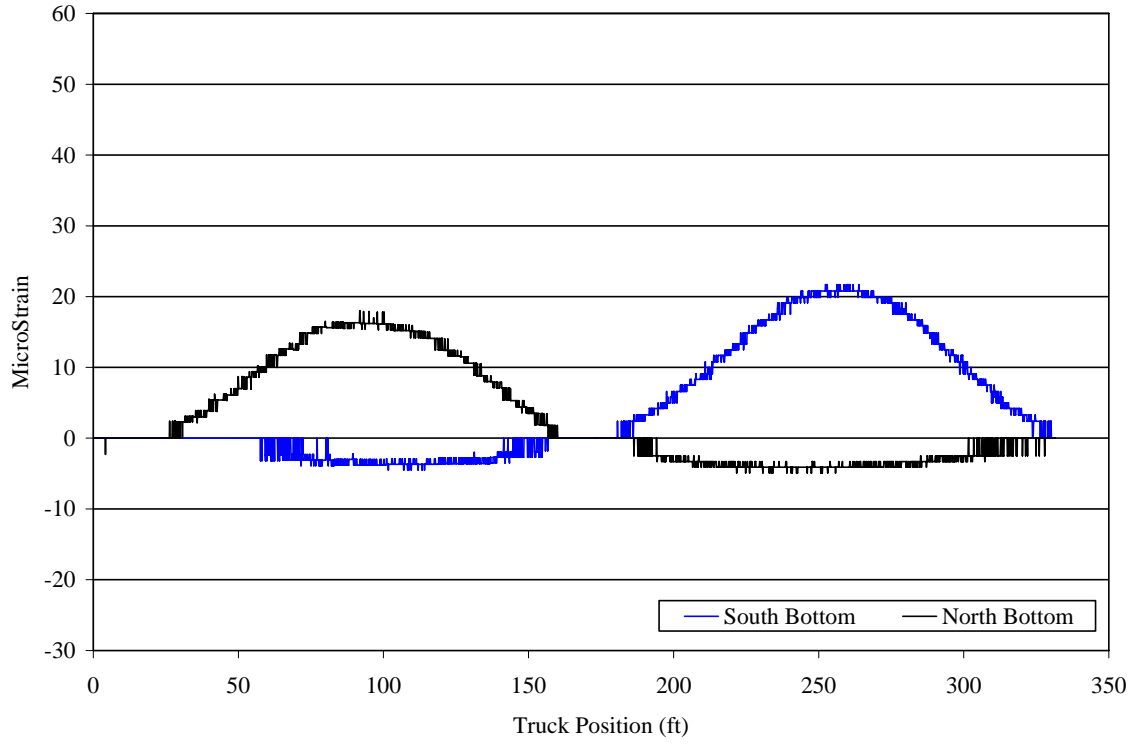
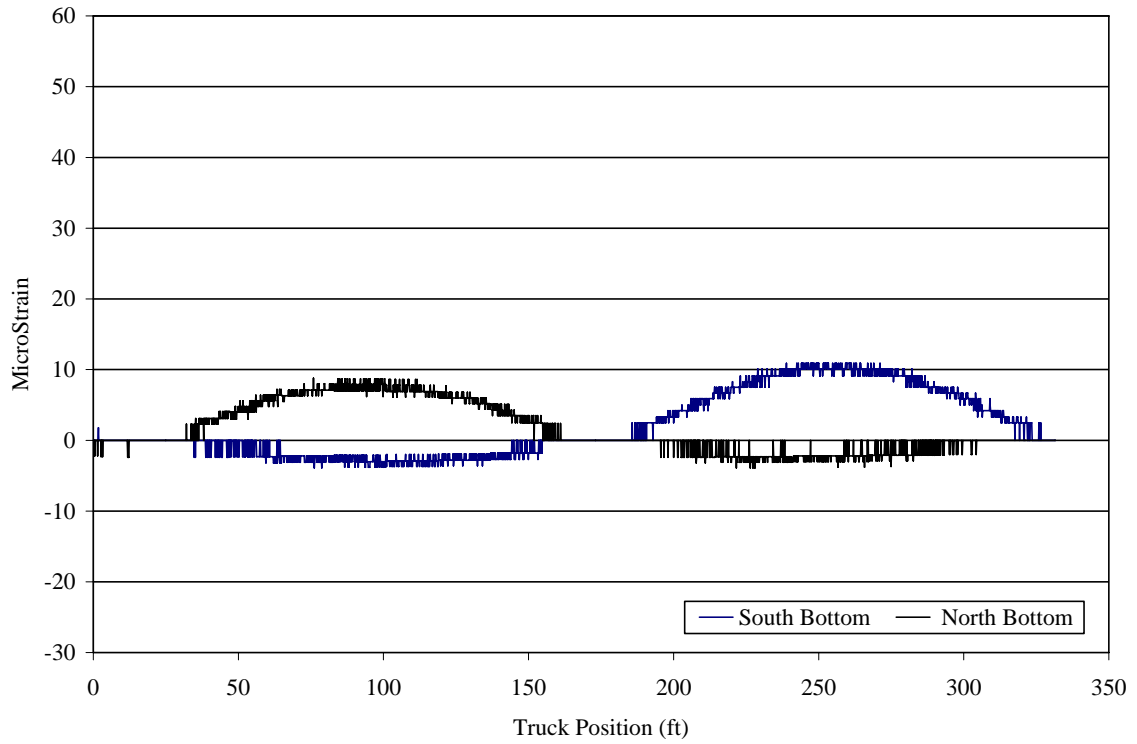
**Figure 5.15. Strain plot from run 2 of the controlled load test**

The bridge's live load performance is presented in the following subsection using data from runs 2, 4, and 6. Not all of the data from the load tests are presented, but the data shown are representative of all of the data collected.
