Clear Lake Watershed Storm Water Improvement Project

Final Report (Revised)

Watershed Name: Clear Lake Watershed

Grant Agreement Number: 5035-012

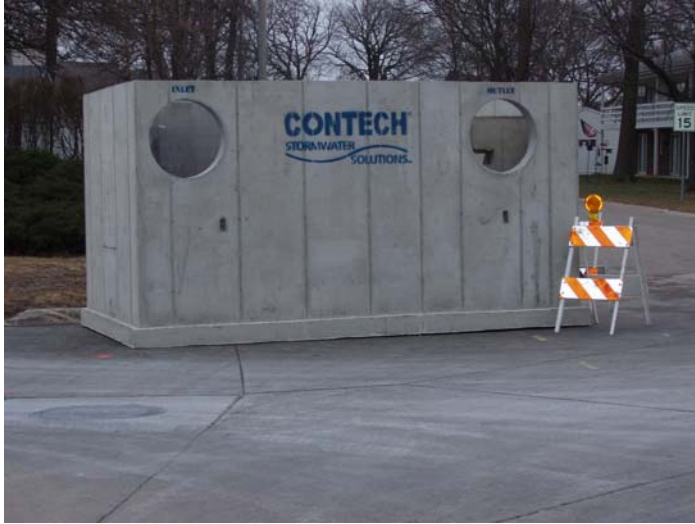
Grit Collection Chamber (Site G4)

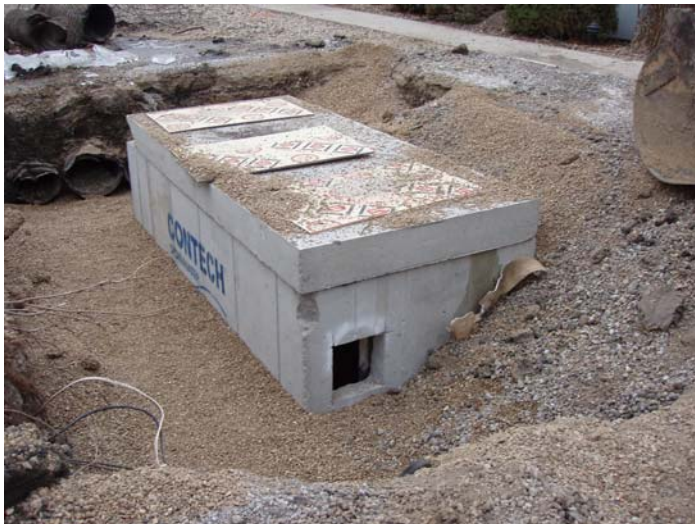
Grit Collection Chamber (Site H8)

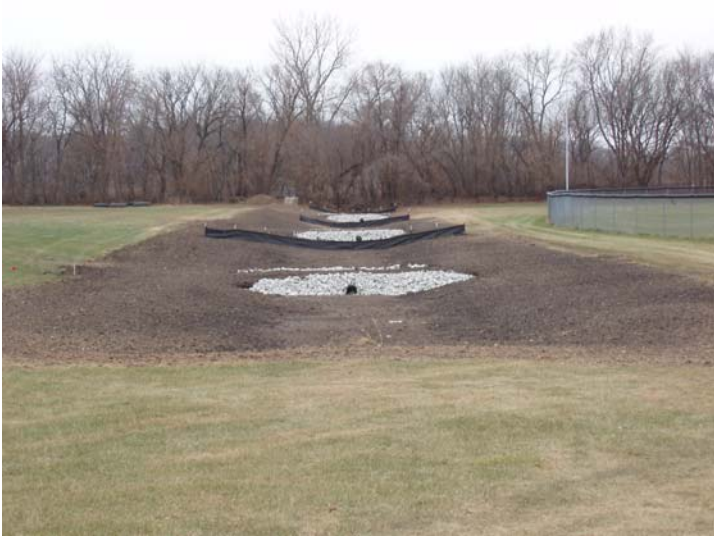
Vegetated Swale (Site M1)

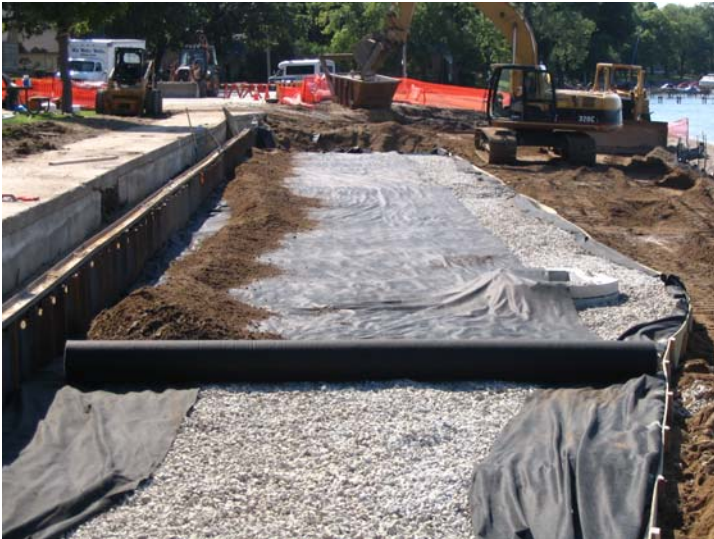
Infiltration Trench (Previous Project)

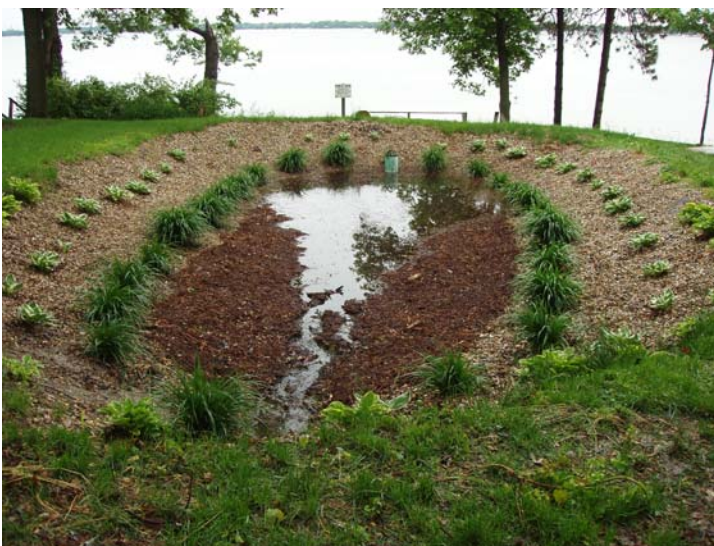
Rain Garden (Site F5)
