Russell, J.M. and Owen, J.S. and Hajirasouliha, I.
(2015) Experimental investigation on the dynamic
response of RC flat slabs after a sudden column loss.
Engineering Structures, 99 . pp. 28-41. ISSN 0141-0296

Experimental investigation on the dynamic response of RC flat slabs after a sudden column loss

J.M. Russell^{a,*}, J.S Owen^a, I. Hajirasouliha^b

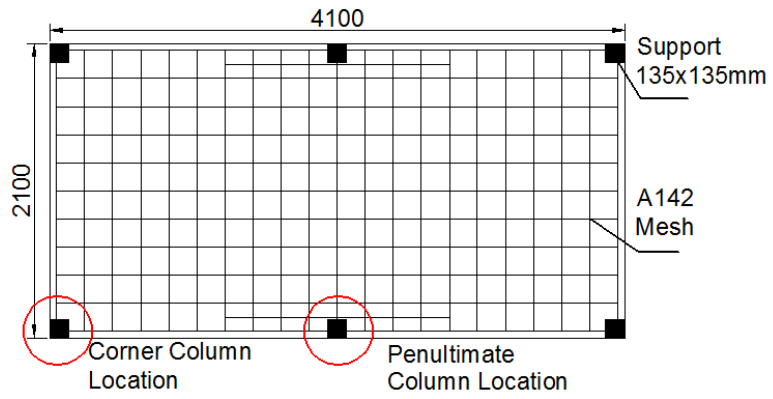
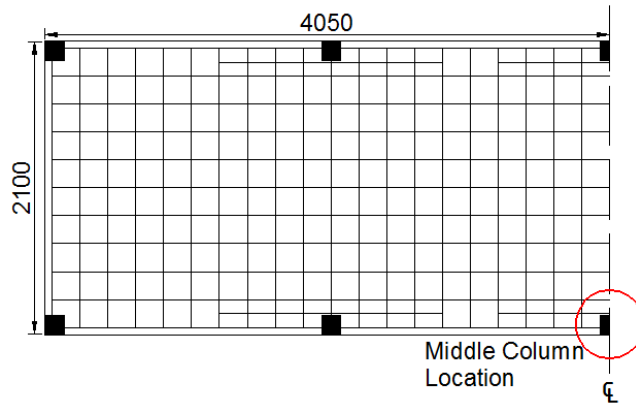
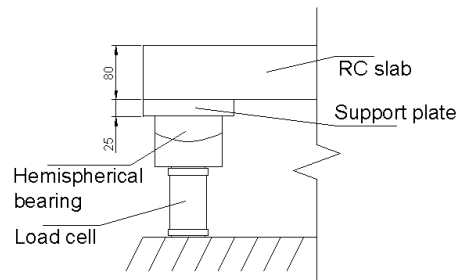
Figure 1: Details of specimens

(a) Corner and penultimate removal conditions

(b) Middle removal condition

(c) Support details

168 Each support included a load cell to measure the vertical reactions, see Figure
169 1(c). The calibration was checked before each test, with a typical uncertainty of

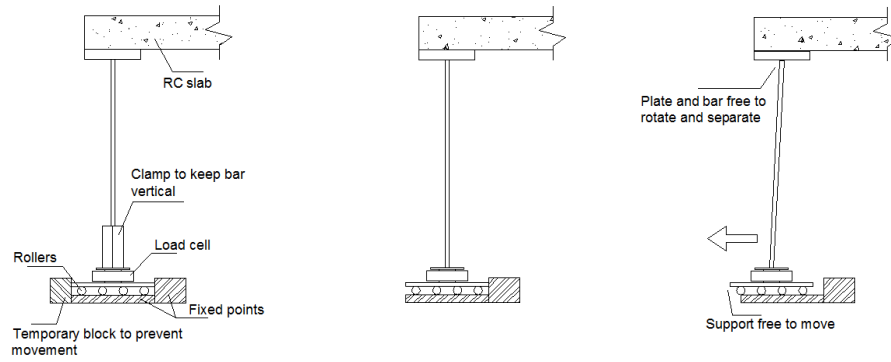
(a) Fully supported (b) Unstable condition (c) Support being removed

Figure 2: Diagram showing the process of removing the temporary support for dynamic tests

160 unstable condition (Figure 2(b)). Finally, a rope attached to the bar was pulled
161 sharply, causing the support base to move and the bar to disengage with the slab,
162 as in Figure 2(c). This system did not cause a true instantaneous removal, how-
163 ever, as the purpose of these tests is to provide information to validate a numerical
164 model, this limitation will be addressed in later work.

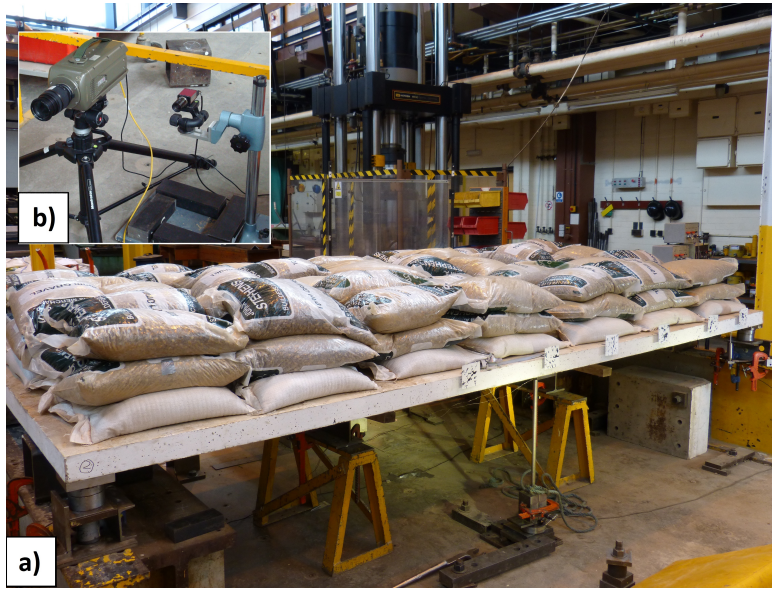
Figure 3: a) Photograph of slab PC-D before dynamic testing; b) Cameras for visual monitoring

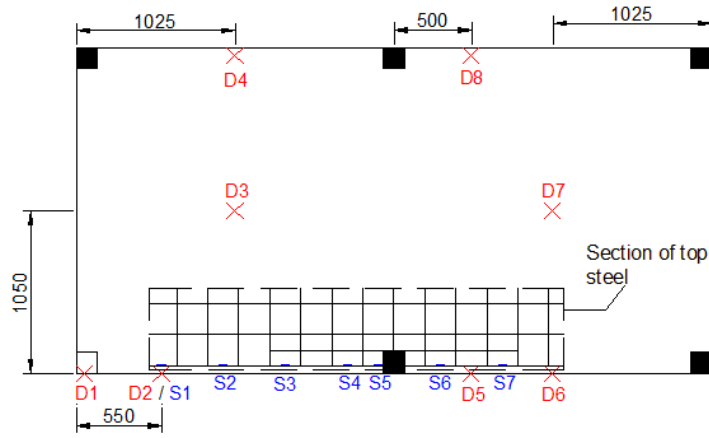
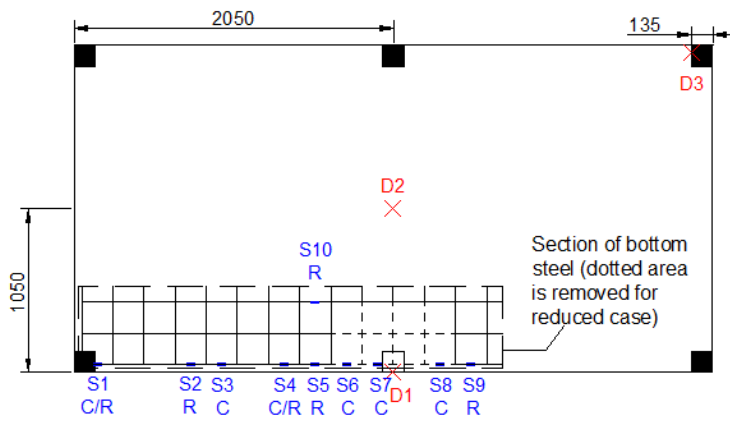
(a) Corner condition

(b) Penultimate removal conditions - Continuous (C) and Reduced (R)

Figure 4: Locations of LVDTs and visual targets (D) and strain gauges (S)

241 sponse observed in the middle (point D7, Figure 4(a)) due to the flexural sagging
242 cracks in that area. The high deflections in the damaged area also led to a relative

367 Figure 16 shows the strain profiles of the bottom reinforcement bars for tests
 368 PC-S and PR-S. The location of the strain gauges are shown in Figure 4(b)). For
 369 the continuous reinforcement case (Figure 16(a)), the middle area ($\pm 500\text{mm}$ from
 370 the removed column) had the highest strain for loading less than 4.5kN/m^2 . How-
 371 ever, once cracking started there was a significant change in the stress distribution
 372 and yielding occurred across much of the length of the monitored bar. The drops
 373 in values can be explained by local variation in stress due to the effect of concrete
 374 de-bonding around the steel. Removing the central bottom flexural steel from the

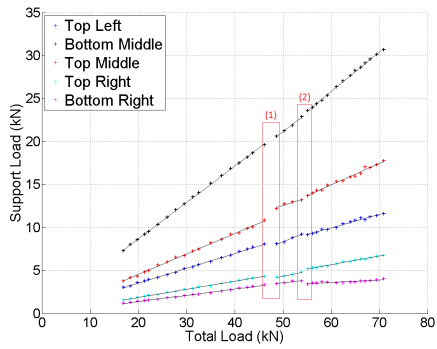
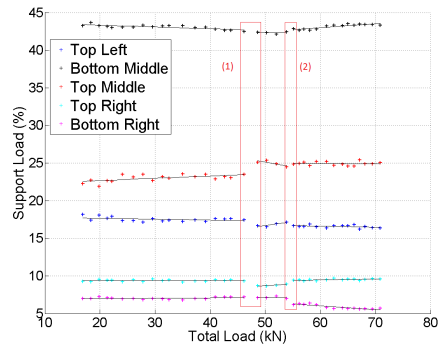
(a) Vertical reaction to each support

(b) Percent of total load to each support

Figure 5: Distribution of forces to supports - Test C-S

206 Figure 5(a) shows the vertical reactions at the supports during the corner static
 207 test (C-S) (see Table 1). As it was expected, the reaction forces increased linearly
 208 by increasing the total load in the elastic range. However, beyond 46.2kN total
 209 load (5.4kN/m²) there was a change in distribution (label 1) until approximately
 210 55kN (6.4kN/m²), coinciding with the formation of cracking across the element.
 211 Past this phase (label 2) there is a linear increase of reactions again, though with
 212 a larger deviation from the trend line. The relative distribution of forces to each
 213 support given in Figure 5(b), suggests that the relative demand stayed constant in
 214 the elastic and final ranges. Between labels 1 and 2 there was again a noticeable
 215 change as redistribution of forces occurred due to extensive crack formation. Con-
 216 sidering, however, the entire range, suggests that a linear model could be used to

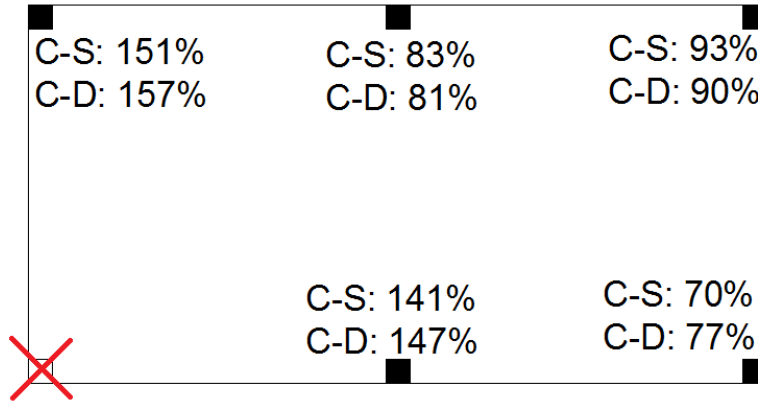
Figure 6: Mean change in distribution of forces to each support after corner column loss - Tests C-S and C-D

218 Comparison between the averaged reaction forces for fully supported and
219 damaged conditions (see Figure 6) indicates that the two orthogonally adjacent
220 supports experienced a 41-57% increase in their vertical reaction while all other
221 supports had a decrease in demand. It should be noted that C-S and C-D showed
222 similar ratios, indicating dynamic removal did not change the final distribution of
223 reaction forces.

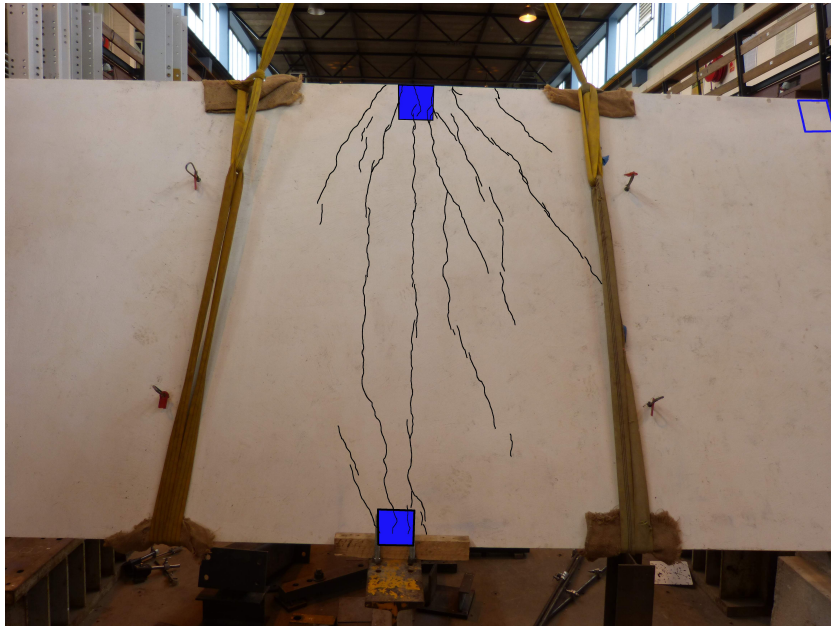
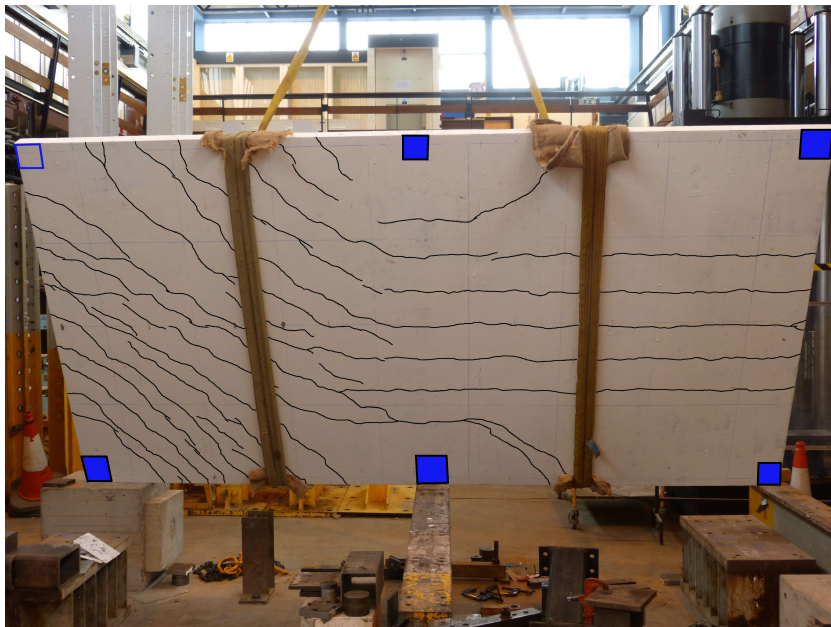
(a) Top surface

(b) Bottom surface

Figure 7: Annotated flexural cracks after corner column loss

224 At higher levels of loading, significant flexural cracks formed due to the large
225 increase in hogging moments in both tests, initially on the top surface over the ad-
226 jacent support (Figure 7(a)). Sagging flexural cracks also formed on the underside
227 as the slab now spanned diagonally between the two supports nearest the removal
228 location (Figure 7(b)). The location of permanent supports (solid boxes) and the
229 removed support (outline) are annotated in this figure.

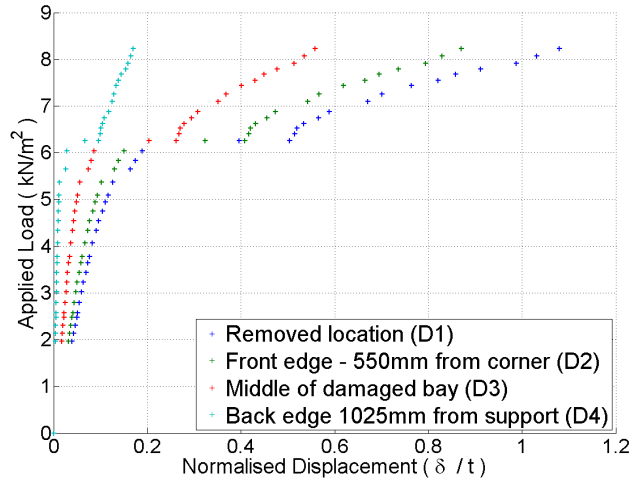
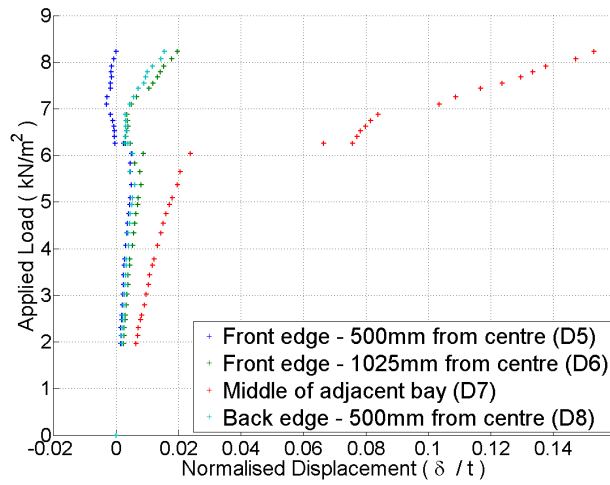
(a) Displacements in the damaged bay

(b) Displacements in the adjacent bay

Figure 8: Load against normalised displacements - Test C-S

230 The plot of normalised displacements, deflection (δ) / slab thickness (t), against
231 load in the damaged bay area (Figure 8(a)) shows an initial linear response. How-
232 ever, after a load of 4.6kN/m² flexural cracks start to form resulting in a decrease in
233 stiffness to around 57% of the initial value. At 6.0kN/m², when the peak displace-
234 ment equals 0.19 times the slab depth, there is a discontinuity due to significant
235 cracking over the adjacent support along with yielding of the reinforcement. This
236 led to an increase in displacements across the entire sample, with the maximum
237 exceeding half the slab depth. After this, there was a brief stiffening phase be-
238 fore a final softening with a relative stiffness of 6% of the elastic range. The slab
239 continued to carry additional load until the test was aborted at 8.2kN/m². In the
240 adjacent bay, shown in Figure 8(b), once damage occurred there was a jump in re-

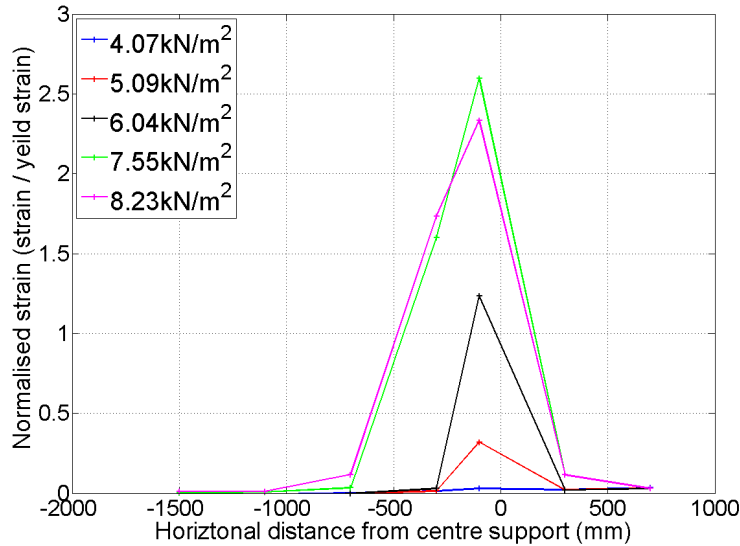
Figure 9: Normalised strain against position for top reinforcement bars - Test C-S

246 The strain data in Figure 9 provides a further understanding of the damage
247 profile. Strain readings have been corrected against the fully loaded condition
248 under the slab's own self weight, i.e. the results demonstrate the change from
249 the starting condition, and then normalised against the yield strain. Below a load
250 of 4.1kN/m^2 , strains on the steel over the central column were relatively low.
251 However, after the formation of flexural cracking there was a peak in strain on the
252 damaged side of the support at 6.04kN/m^2 , corresponding to the large increase in
253 displacements seen in Figure 8(a). As loading increased there was local yielding
254 of the reinforcement in this area, while other areas remain well below the yield
255 strain.

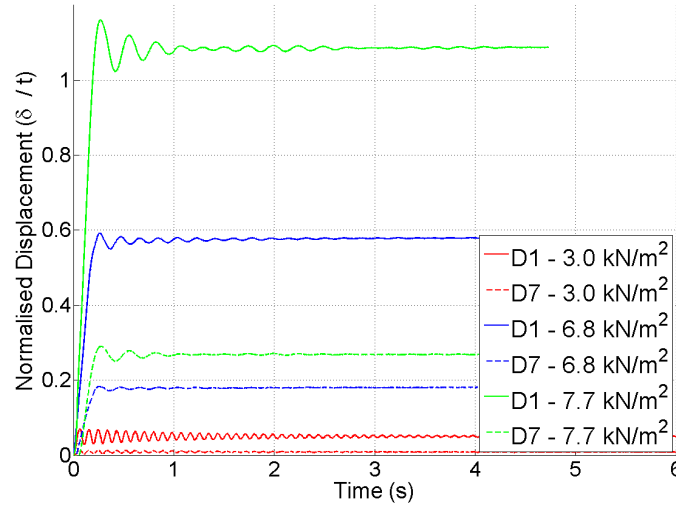
Figure 10: Normalised displacement against time after column removal at different positions and loading - Test C-D

257 The normalised displacements (displacement/ slab thickness) for dynamic re-
258 moval at three different levels of loading are plotted in Figure 10 for the removal
259 location and the middle of the adjacent bay (Points D1 and D7 in Figure 4(a)).
260 Peak displacements, damped natural frequency and damping ratio results for these
261 tests are compared in Table 3.

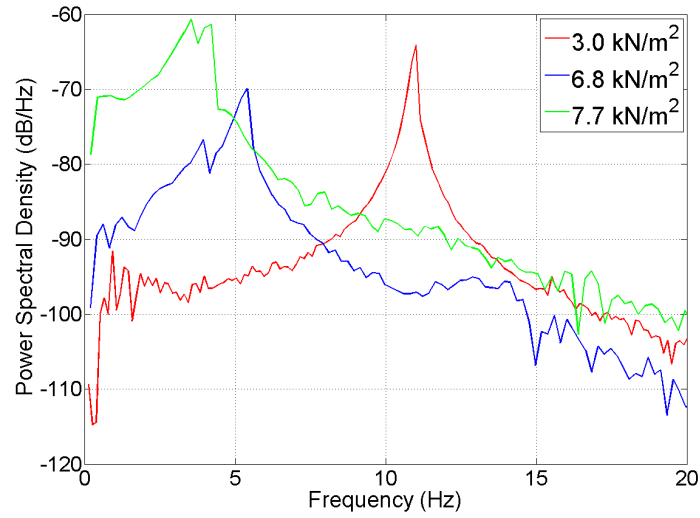
Figure 11: Power spectral density of displacement following corner column loss at different load levels - Test C-D

274 For the final case the load was increased to 7.7kN/m^2 and the test repeated.
 275 Figure 11 shows the power density spectrum from a Fourier transform of dis-
 276 placement readings following a corner column loss at different load levels. The
 277 results indicate that for the slab in the plastic region (i.e. 7.7kN/m^2), the large de-
 278 flections and resulting damage created a different response to the single dominant
 279 frequency peaks seen before. As cracks had already formed during the 6.8kN/m^2

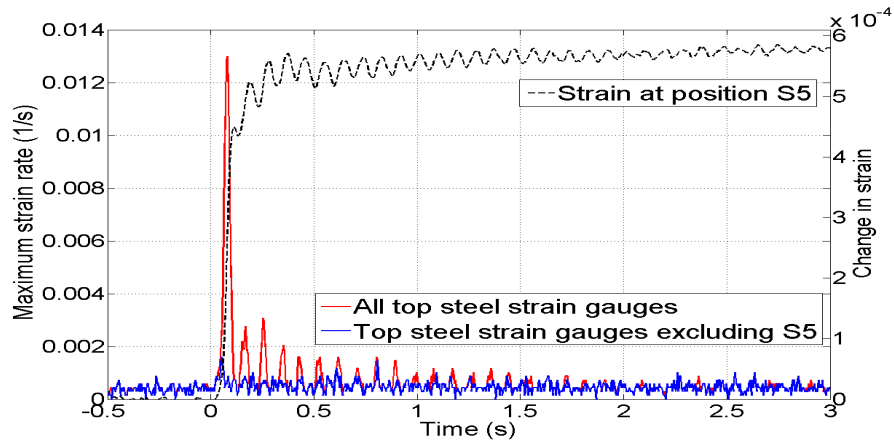
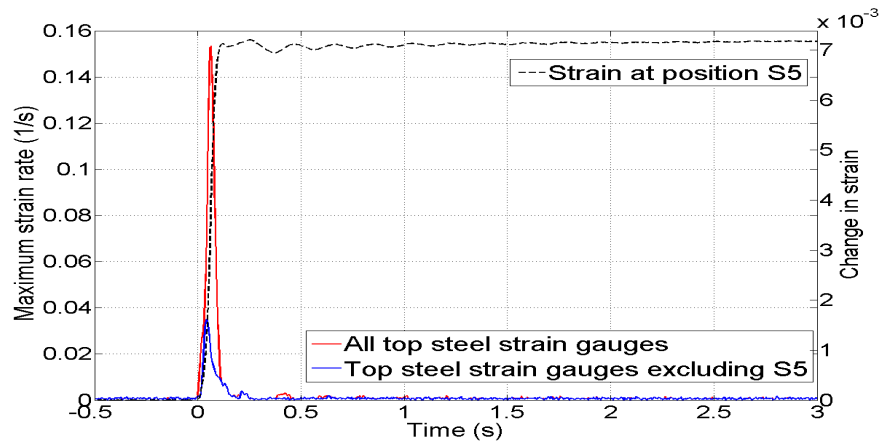
(a) 3.0 kN/m² loading

(b) 6.8 kN/m² loading

(c) 7.7 kN/m² loading

Figure 12: Maximum steel strain rates against time. Also showing changes in strain against time.

293 Strain gauge S5, positioned next to the central support, see Figure 4(a), ex-
294 perience a much higher strain rate for each loading level. Since the graph only
295 presents the maximum value, the response of the other gauges is hidden. There-
296 fore, a second line is plotted excluding this sensor. Additionally, the key strain
297 data with time, adjusted against the strain readings at the fully support condition,
298 is also plotted on the second vertical axis to allow further comparisons.

299 In Figure 12(a), the elastic case, most the sensors on the top steel show very
300 low levels of strain rates, with only sensor S5 showing a strong peak. However, it
301 is clear that the peak strain occurs a period of time after the peak strain rate. This
302 is significant in considering the influence of strain rate effects in increasing the
303 material tensile capacity during sudden column losses. At 6.8kN/m^2 of loading,
304 shown in Figure 12(b), a similar pattern is seen, however there is still a reasonable
305 peak at other locations. Overall, high strain rates are observed here with a max-
306 imum rate of 0.153s^{-1} occurring just before the maximum strain. The change in
307 maximum strain from the fully supported case suggests that the steel has yielded
308 in this area; this may explain the localised high strain rate and also affect the final
309 results.

310 The final loading case presented in Figure 12(c) shows a different response.
311 The largest strain rate does again comes from sensor S5 (next to the central sup-
312 port), the rates and change in strains are smaller than the previous case. This is
313 most likely due to the plastic deformations that occurred. Of further interest is
314 sensor S3, see Figure 4(a) for its location. As this position was previously closer
315 to the middle of the span, it was under a compressive condition and then changed
316 to a tensile state due to the column loss. This change demonstrated itself by a

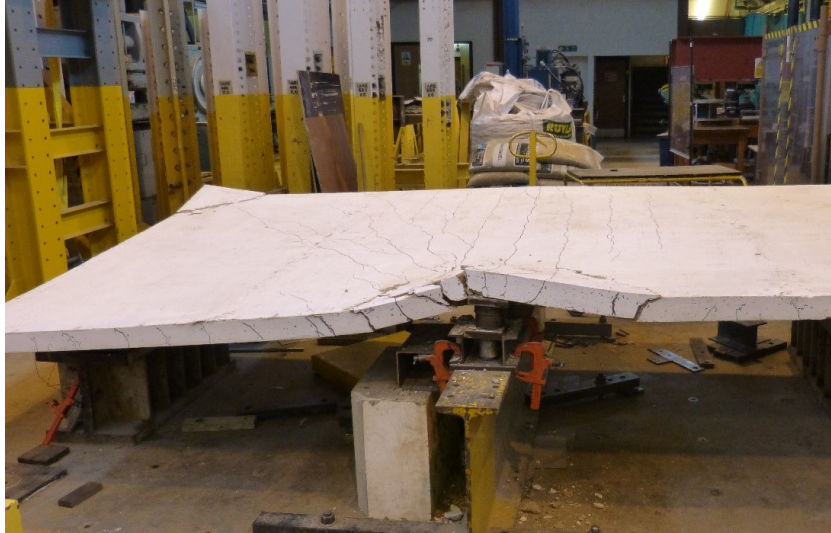
Figure 13: Final state of corner removal case after shear failure - Test C-D

319 Finally the sample was loaded to failure, which occurred due to punching shear
320 at the two adjacent supports as shown in Figure 13. Table 4 gives the shear failure
321 details of all the slabs tested.

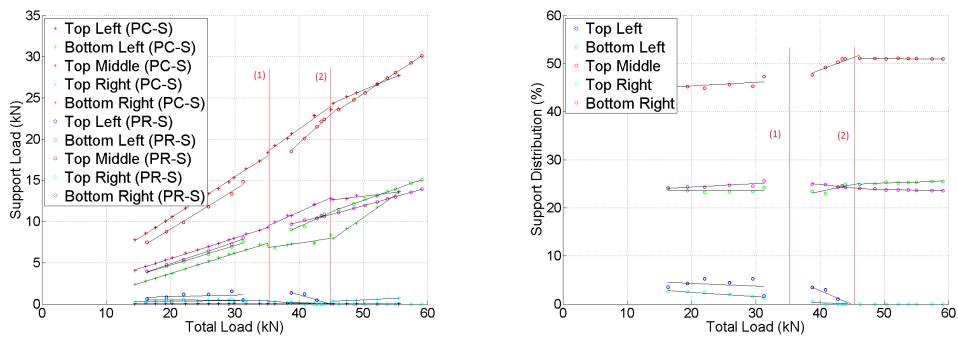
(a) Vertical reaction to each support - Tests PC-S and PR-S (b) Percent of total load to each support - Test PR-S

Figure 14: Distribution of forces to supports - Tests PC-S and PR-S

324 The load increase to each support for two Penultimate removal cases with
325 static loading are shown in Figure 14(a). Similar responses are observed for the
326 two conditions with nearly all points showing a simple linear relationship at low
327 loading at equivalent rates. The back middle support takes the highest proportion
328 of loading, followed by the front corners.

329 Flexural cracking occurred at 35kN and 30kN of total load, for PC-S and PR-S
330 respectively, which was followed by a period of redistribution of reaction forces
331 across the samples until approximately 45kN, between labels (1) and (2). After
332 this stage the distribution remains reasonably constant until failure.

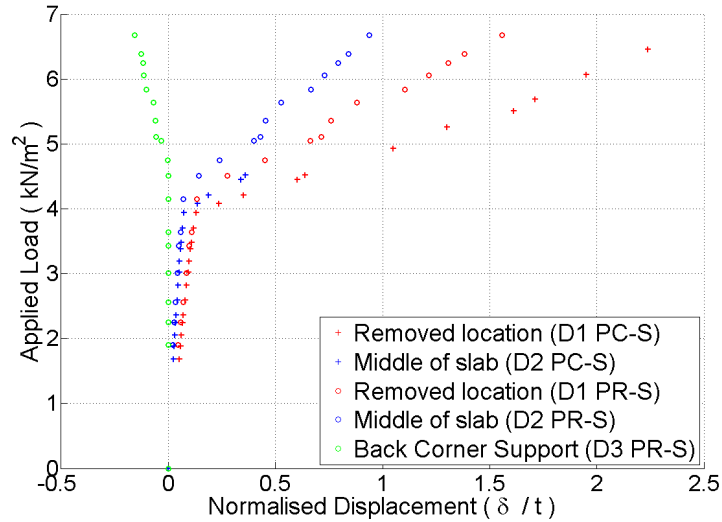
Figure 15: Load against normalised displacement for PC-S and PR-S

341 Deflections of PC-S and PR-S are given in Figure 15 for the positions identi-
342 fied in Figure 4(b). It is shown that there is a clear linear response across all parts
343 of the slab before cracking occurs. Additionally, the initial stiffness of the two re-
344 inforcement cases was identical. Both cases started to crack at similar points, with
345 a slight reduction in stiffness observed after 3.4kN/m². This corresponds to a peak
346 normalised displacements of 0.1. However, after peak displacement of 0.13 times

347 the depth there is a significant reduction in stiffness due to more extensive flexural
 348 cracking. After this point there was a linear trend for the remaining data, though
 349 the new stiffnesses were less than 5% of the initial values. In the corner removal
 350 case there was a large increase in displacements as cracking formed, which does
 351 not occur here. The geometry of these tests meant that sagging cracks were the
 352 most significant form of damage and these were spread out across the midspans
 353 and so did not cause the sudden drop in stiffness observed from the very localised
 354 hogging cracks in the previous test. The results also demonstrate the uplift ef-
 355 fect experienced at the back support (point D3 in Figure 4(b)), as shown by the
 356 negative displacement.

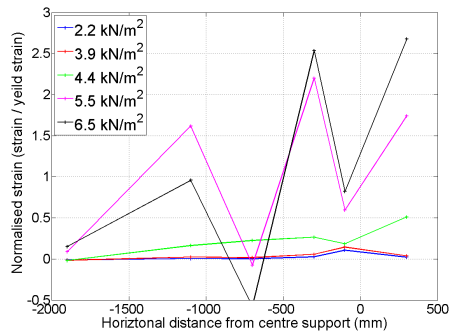
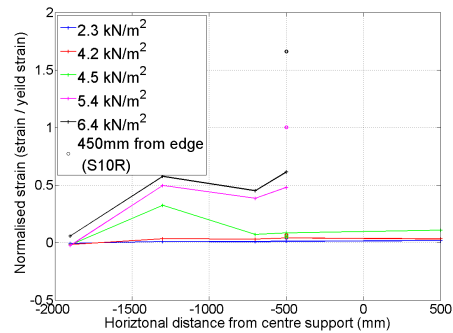
(a) Continuous reinforcement - Test PC-S

(b) Reduced reinforcement - Test PR-S

Figure 16: Normalised strain against position for bottom reinforcement bars

375 column location ($\pm 400\text{mm}$ from the centre) resulted in a different response (see
376 Figure 16(b)). Note that for loading greater than 4.5kN/m^2 the strain gauge at
377 500mm (gauge S9R) failed and its values have been removed. Due to the non-
378 continuous state of the reinforcement, smaller strain was observed at equivalent
379 loading and positions compared to PC-S, and none of the steel bars yielded. How-
380 ever, an extra gauge (S10R) at -500mm horizontal distance and 450mm away from
381 the edge, is included (marked with o's). This sensor was on the first bar that is
382 continuous along the length and did yield. Strain gauges on the top surface of the
383 concrete, along with visual inspections, revealed that the concrete never under-
384 went crushing.

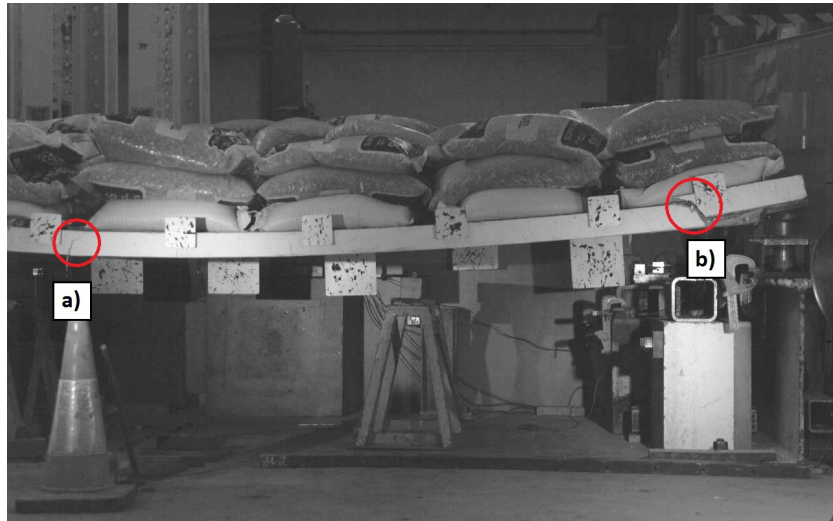
Figure 17: Failure of slab PR-D captured from high speed camera - a) Flexural cracking; b) Shear crack

386 The failure of the reduced reinforcement condition under dynamic removal
 387 with 5.7kN/m² of loading is shown in Figure 17, captured by the high speed camera.
 388 A wide flexural crack initially occurred due to the lack of tensile reinforcement,
 389 before a final shear crack formed leading to complete shear failure, see
 390 Figure 17(a) and (b) respectively.

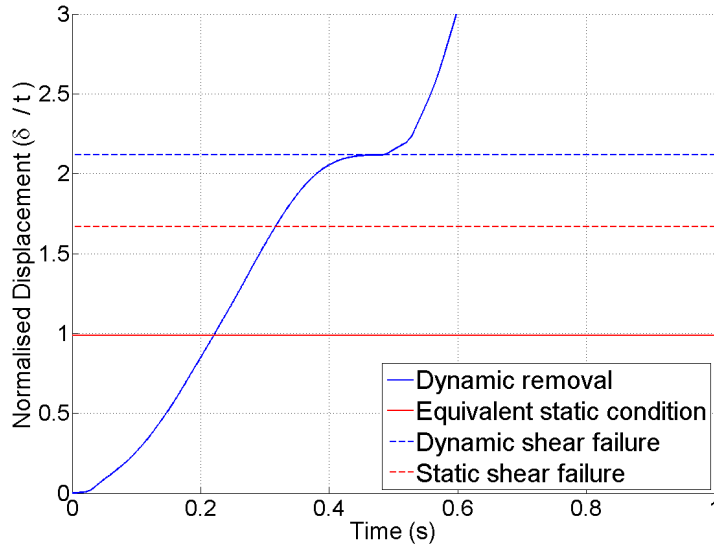
Figure 18: Displacement against time for PR-D at 5.7kN/m²

391 The normalised deflections against slab thickness for this test are plotted in
 392 Figure 18, along with the static case at equivalent loading to demonstrate the in-
 393 crease in deflections experienced due to the dynamic effects. In the dynamic case
 394 there was a peak displacement of 2.12 times the slab depth, before the shear crack
 395 formed at 0.47 seconds. Comparing the results to the static test gives a dynamic
 396 displacement amplification ratio of 2.14. However, due to the nonlinear relation-

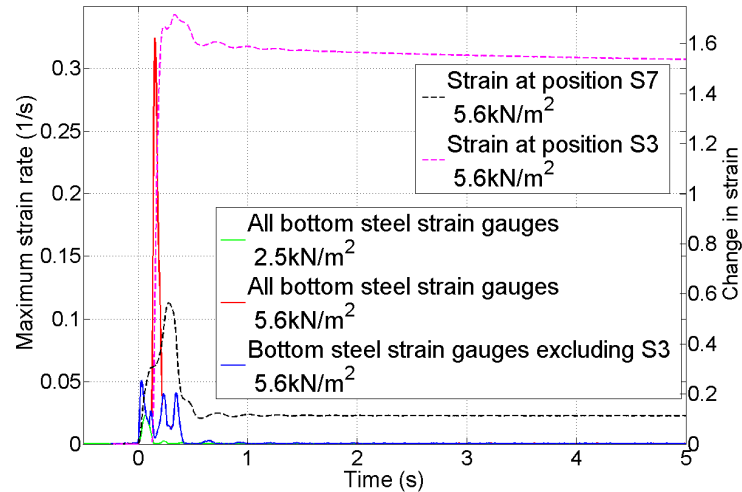
Figure 19: Maximum steel strain rates against time. Also showing changes in strain against time.
 - Test PC-D

416 is strain gauge S7, which was positioned at the support that was removed. This
417 location quickly switched from a compressive, hogging state, to a sagging, tensile
418 condition, which explains its high strain rate immediately after removal. However,
419 this area became less critical due to further damage occurring across the slab.

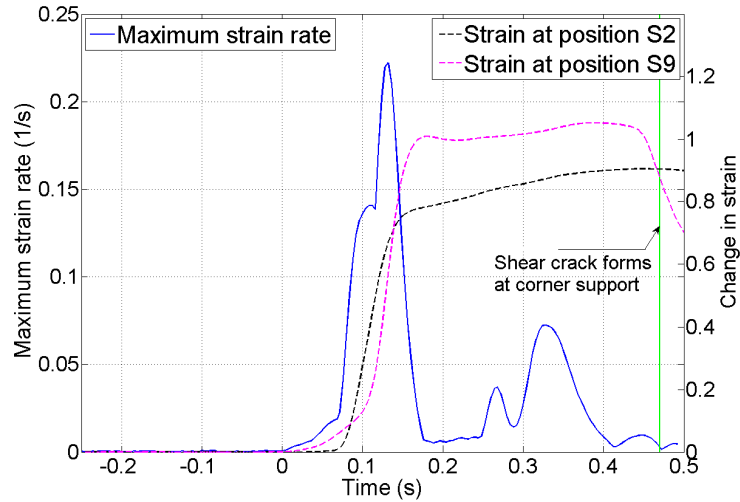
Figure 20: Maximum strain rates against time at 5.7kN/m^2 . Also showing changes in strain against time - Test PR-D

420 Figure 20, showing strain rate data from test PR-D, gives a comparison be-
421 tween maximum strain rates and maximum strain. Additionally, the vertical line

422 indicates the time at which the shear crack formed. Considering strain positions
 423 S3 and S7, it can be seen that the sample had reached its maximum deflection and
 424 strain and was about to continue its oscillation when the slab failed due to shear.
 425 At this time the strain rates were very low at all points across the slab.

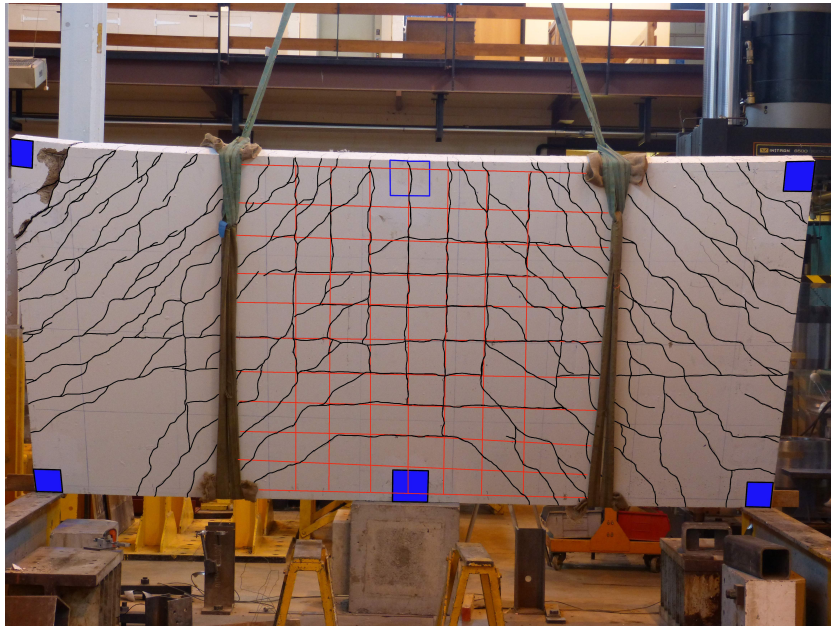
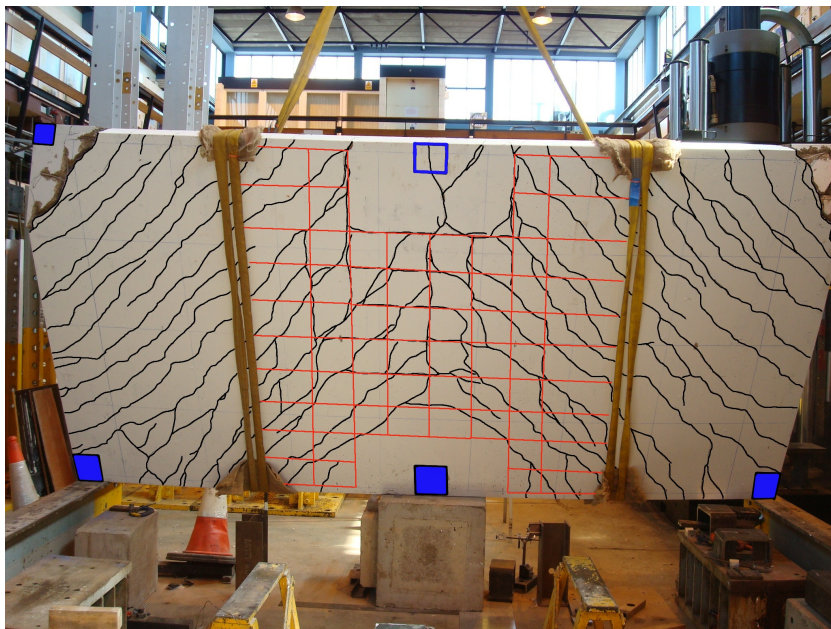
(a) Continuous reinforcement - Test PC-D

(b) Reduced reinforcement - Test PR-D

Figure 21: Annotated bottom surface flexural cracks and reinforcement after penultimate column loss

426 The flexural cracks on the underside of the test specimens are shown in Fig-
 427 ure 21, Permanent supports (solid boxes) and the removed support (outline) are
 428 shown. In both cases there were primary cracks spreading perpendicular to the
 429 new support arrangement. The position of the bottom reinforcement mesh is also
 430 indicated to show that the orthogonal cracks in the middle area follow the steel po-
 431 sitions. This is especially pronounced in PC-D, where the diagonal cracks reach
 432 right to the centre line. Whereas for the reduced case (PR-D) it is shown in Figure
 433 21(b) that the cracks were non-continuous at the column loss location and prop-

434 agated around the edge of column area, following the reinforcement lines, rather
 435 than exploiting the lack of tensile reinforcement in the central area (c.f. Figure
 436 21(a)). However, these cracks were wider and deeper than at other locations and
 437 in other tests. For all penultimate removal tests, there was only minimal hogging
 438 cracking on the top side running down the centre line, which was followed by
 439 shear failures on one or both of the front corner supports (see Table 4).

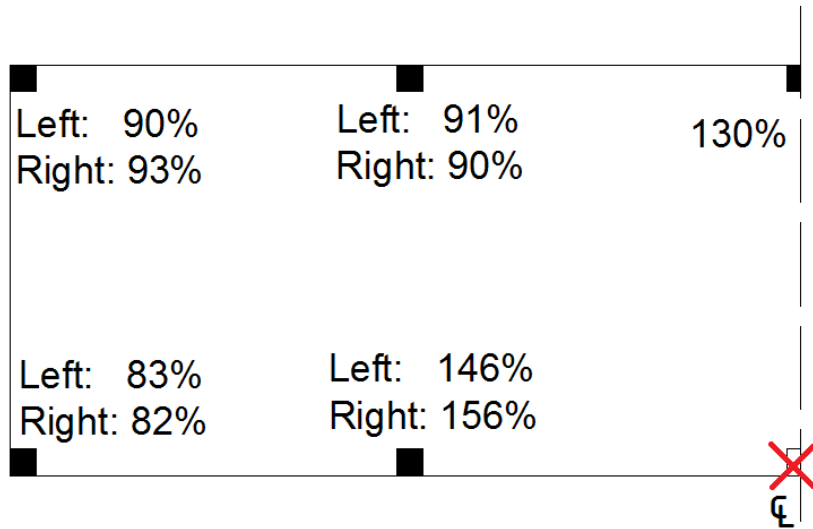
Figure 22: Mean change in distribution of forces to each support after corner column loss - Test M-D

441 Test M-D was a 4x1 bay continuous slab with a middle column dynamically
 442 removed. The change in support reactions from fully supported to the damaged
 443 case are shown in Figure 22. Similar to the previous tests, the largest increase
 444 in reaction occurred at the supports immediately adjacent to the removal point,
 445 whereas the supports further away have a relative reduction in vertical reaction

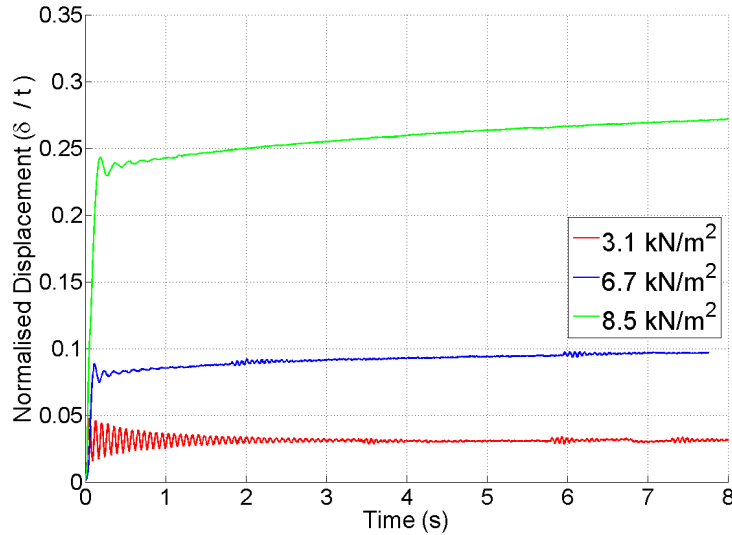
Figure 23: Displacements against time at the removal location for different loadings - Test M-D

447 Dynamic removal tests were conducted at different loadings and normalised
 448 deflections were calculated using images captured from the high speed camera.
 449 Figure 23 compares displacement at the removal location in test M-D for different
 450 load levels. Although this arrangement in general shows the same behaviour as
 451 the previous tests, there was a significant reduction in the normalised displace-
 452 ments. Comparing the key results given in Table 5 with the equivalent loading for
 453 the corner removal case (Table 3), gives a reduction of 55% for the peak displace-
 454 ment in elastic cases. Additionally, at the next loading level (6.8/6.9kN/m²), the
 455 continuous slab peak displacement was only 0.09 times the slab depth, compared
 456 to 0.59 in test C-D. As this set up caused a stiffer structure compared to the corner
 457 removal tests, displacements are expected to be smaller. Furthermore this also

466 Cracking of both the top and bottom surfaces of the concrete led to large plastic
 467 deformations and the drift observed in Figures 23 and 24. However, collapse due
 468 to total flexural failure did not seem likely and shear cracks did not form within
 469 the levels of loads tested (see Table 4).

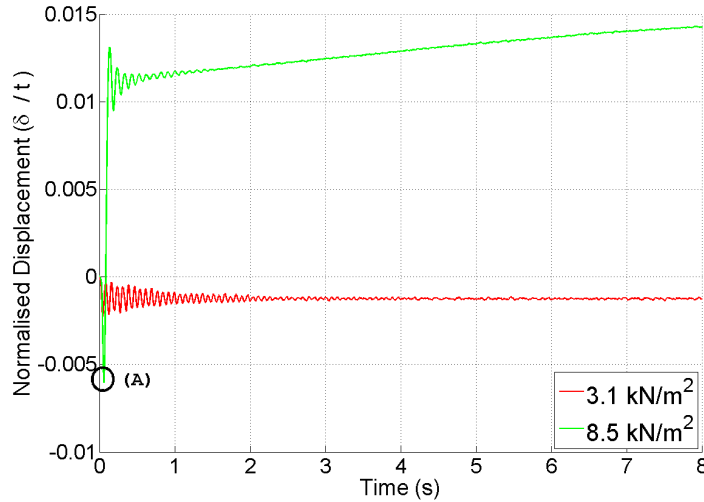
Figure 24: Displacements against time at the center of the adjacent bay for different loadings Test M-D

460 At lower levels of load, the bays adjacent to the damaged area experienced
 461 a slight uplift, as shown by the negative displacements in Figure 24, due to the
 462 slab rotating inwards towards the removed support. Initially, after the column
 463 was removed in the 8.5kN/m² test, there was a brief uplift (label (A) in Figure
 464 24), however, the damage sustained across the slab resulted in a final downward
 465 motion.

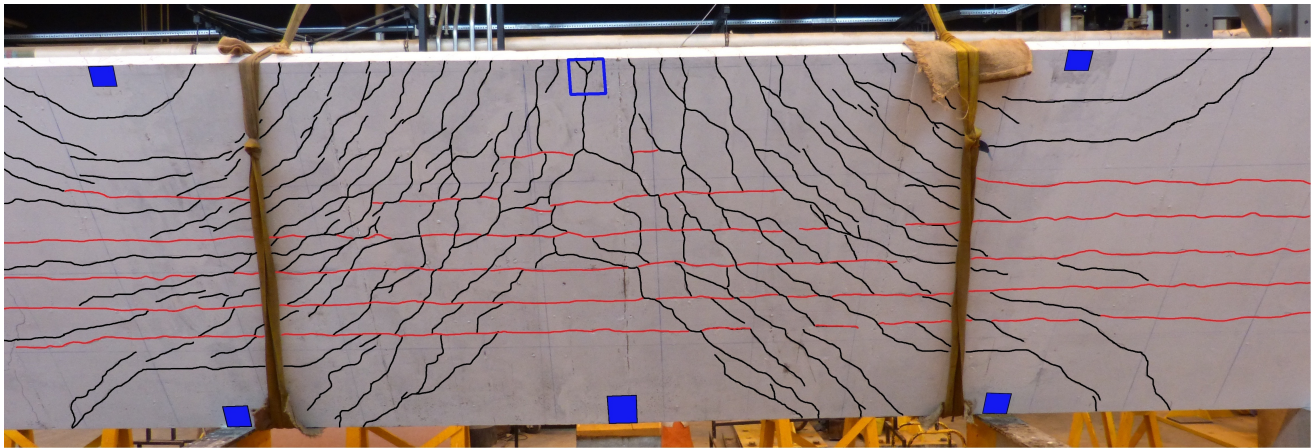
Figure 25: Annotated underside cracking pattern for continuous slab Test M-D

484 Figure 25 shows a photograph of the underside of slab M-D after the test was
 485 completed with the cracks annotated. The primary cracking pattern is shown in
 486 black. In this specimen the two-way spanning nature of a slab structure after a
 487 column loss is clear by the diagonal cracks. The red lines are secondary flexural
 488 cracks that follow the reinforcement lines. As the slab was not continuous in both
 489 directions these cracks were more extensive than would be expected in a typical
 490 structure. The top cracking due to the increased hogging moments over the adja-
 491 cent supports was almost identical to the corner removal case shown previously
 492 in Figure 7. These cracks followed the same pattern as seen in Figure 21, though
 493 were less extensive due to the smaller deflections and the influence of adjacent
 494 bays.
