Change Detection and Assessment of Fire-Damaged Concrete Using Terrestrial Laser Scanning

**Wallace MUKUPA, Gethin Wyn ROBERTS, Craig Matthew HANCOCK,
Khalil AL-MANASIR, China.**

FIG Working Week 2016
Recovery from Disaster
Christchurch, New Zealand, May 2–6, 2016

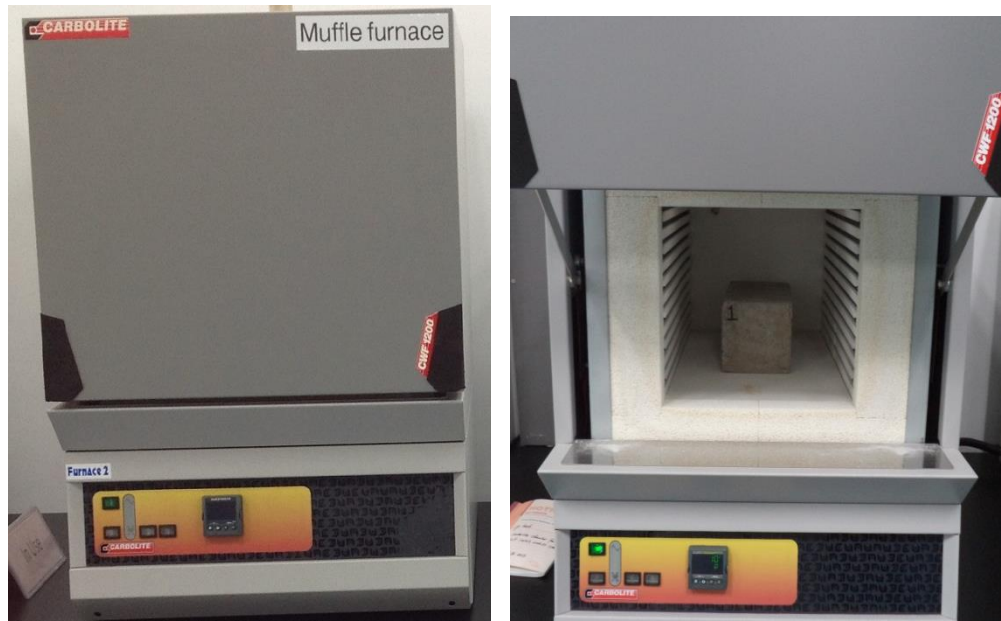
After scanning the unheated concrete specimens with the laser scanner, the specimens had to be heated. A Carbolite CWF 12/23 electric furnace (Fig. 2) was used for the thermal treatment of the specimens. It is worth mentioning that the furnace used in this study is not a typical high end furnace used in civil engineering. The specimens were placed in the furnace chamber and thereafter heated at designated temperatures of 250, 400, 700, and 1000°C with a ramping rate of 10°C/min. The peak temperatures were maintained for 1 hour (fire exposure time) and after that time, the furnace was switch off with the specimen inside and left to cool down to room temperature in order to avoid thermal shock. For comparison purpose with the other heated specimens, one specimen was left unheated.

Fig. 2: Carbolite Furnace, shown is the outside and the chamber with a concrete block inside

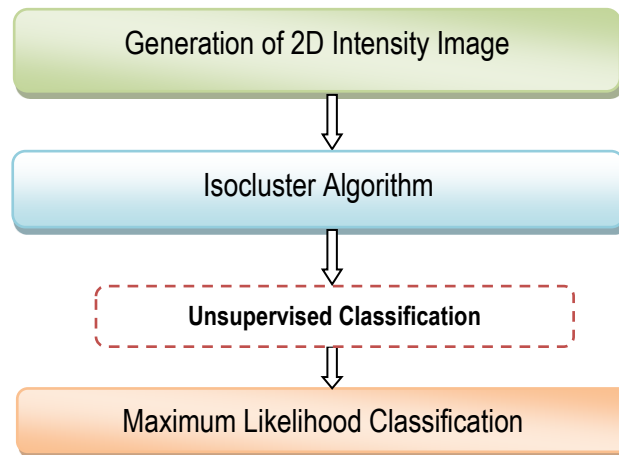
The image classification procedure (Fig. 3) employed involved first creating a 2D intensity image, secondly generation of signature files and thirdly running the unsupervised classification using the maximum likelihood classifier. These procedural steps are explained in detail in the subsequent sections below.

Fig. 3: Image Classification Procedure

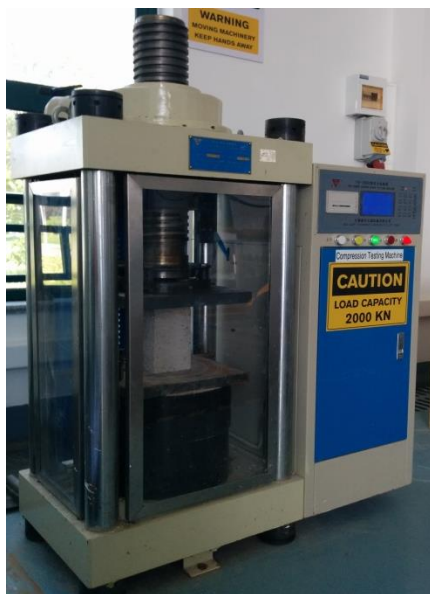
Compressive testing of the heated concrete blocks was conducted as shown in Fig. 6a and the relative compressive strength values of the concrete specimens after temperature exposure are presented in Fig. 6b. The relative strength was calculated as the percent retained strength of concrete with respect to the strength of the unheated concrete specimen. The relative strength of concrete significantly decreased after heating the blocks to the various temperatures. Between a temperature range of 250°C to 1000°C, the concrete strength degraded from 49 to 4% of original strength of unheated concrete.

Fig. 6a: Compressive Strength Testing

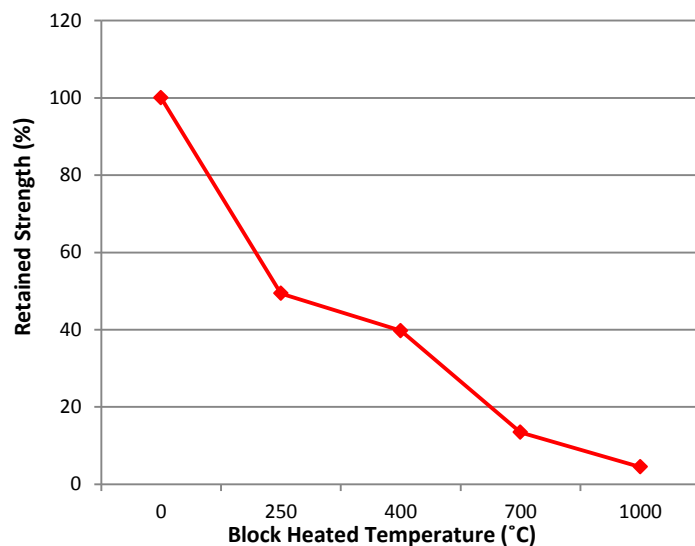
Fig. 6b: Retained Strength vs Block Heated Temperature

- ii. The relative strength of concrete reduced with an increase in exposure temperature whereas the intensity increased with a decrease in the strength of concrete. High intensity therefore implies a reduction in compressive strength of concrete.

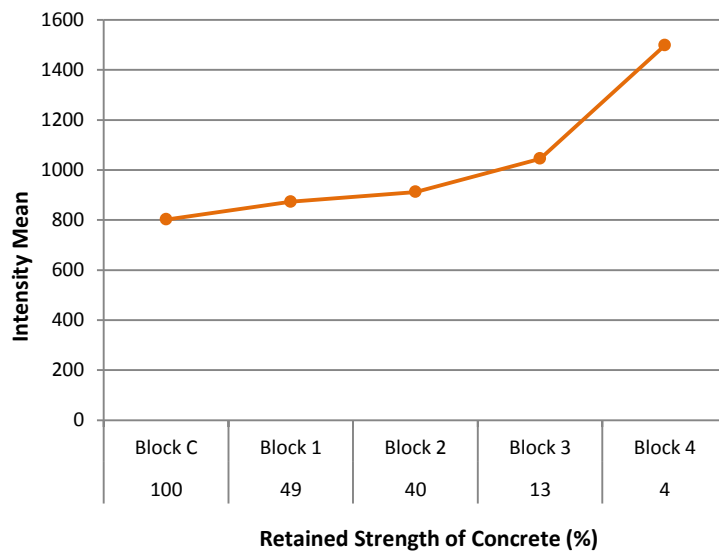
The relationship between intensity and the retained strength of concrete is presented in Fig. 7 and it can be seen that the intensity increases with a decrease in the retained strength of the blocks which occurs when concrete is heated to elevated temperatures. Block C which acted as a control block has its strength intact as it was not heated. However, the intensity for this block is low compared to all other blocks (i.e block 1 to block 4) whose intensity increase with an increase in their exposure temperature which ranged from 250°C to 1000°C.

Fig. 7: Intensity vs retained Strength of heated concrete

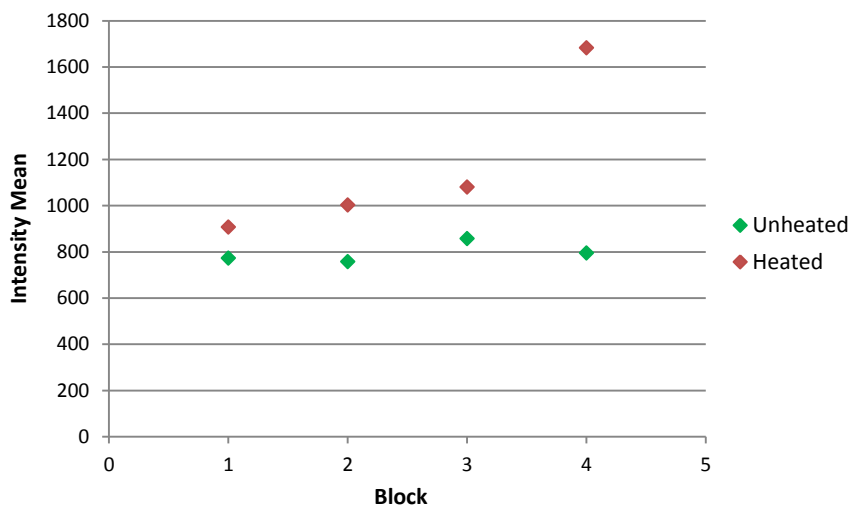
The intensities of the concrete blocks before and after heating were compared with the aim of assessing if there were any differences and trends that could be observed in relation to the exposure temperature that each block was heated to. The results of the comparative analysis are shown in Fig. 8 and it can be observed that the intensity values of the blocks increase after heating and with an increase in exposure temperature.

Fig. 8: Comparison of Unheated and Heated Concrete. The Blocks were heated as follows: Block 1 (250°C), Block 2 (400°C), Block 3 (700°C) and Block 4 (1000°C).

- iii. Heated concrete has higher intensity return compared to unheated concrete and this implies that laser intensity can be used to distinguish heated from unheated concrete.
