Seismic Retrofitting and Health Monitoring of School Buildings of Cyprus

C.Z. Chrysostomou^{1,*}, N. Kyriakides¹, A.J. Kappos^{2,3}, L. Kouris³, E. Georgiou⁴ and M. Millis⁵

Abstract: The vulnerability of existing buildings to seismic forces and their retrofitting is an international problem. The majority of structures in seismic-prone areas worldwide are structures that have been designed either without the consideration of seismic forces, or with previous codes of practice specifying lower levels of seismic forces. In Cyprus, after the three earthquakes that occurred in 1995, 1996, and 1999, the Cyprus State, acting in a pioneering way internationally, has decided the seismic retrofitting of all school buildings, taking into account the sensitivity of the society towards these structures, which house the future generation of the society. In this paper the overall assessment methodology is presented, along with details of the over 10 year ongoing retrofitting program of the school buildings of Cyprus, with emphasis on the description of the program and the development of a wireless monitoring system. In addition, mathematical models of selected school buildings are presented and

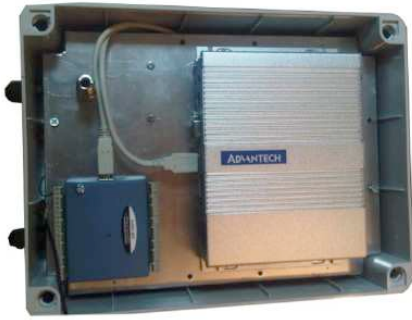
The innovation of this wireless system lies in the fact that it can be used for recording signals from ambient excitations. This requires a 16 bit resolution of the recorded data which is very demanding for a wireless system. The system consists of two independent subsystems (Fig. 13): the first one on the left of the figure is the personal computer on which the developed graphical unit interface (GUI) is running, and the second one is the wireless sensors system, which consists of the data-processing unit Advantech ARK 1360, the receiver unit MC-USB 1608FS and the selected sensors. The received data are stored in a database which is located in the data-processing unit. The communication between the two subsystems is achieved through Wi-Fi that provides adequate bandwidth for efficient data transfer. The complete wireless-node system developed by the partner of the project SignalGeneriX is shown in (Fig. 14).

Fig. (14). The complete wireless-node system.

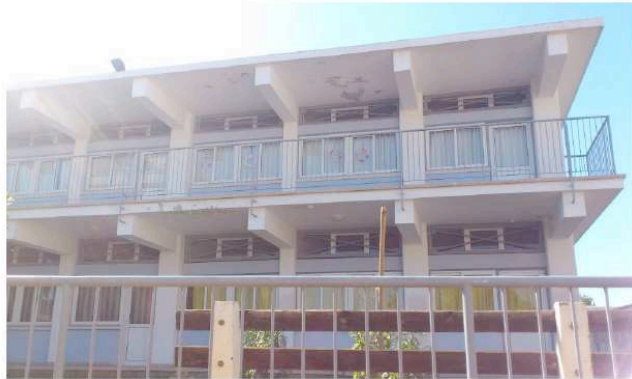
The R/C building was approximately 200m² in plan (20mx10m) with R/C frames at 3m spacing providing the resistance in the short direction. In the long direction 2 lines of columns are present connected only through the slab. A skylight extending to a height of approximately 500mm below the slab was left open to enhance the lighting of the building. During the retrofitting of the building steel truss members were introduced to strengthen the opening and provide frame action in the long direction as well. In the short direction the frame beams have dimensions 300mmX700mm and they were not strengthened. The back view of the selected R/C building is shown in (Fig. 15) and a plan view in (Fig. 16). As far as the columns are concerned, they are placed in two lines, one in each side of the building in the long direction. Their initial dimensions of all the columns were 300mmx300mm. More than half of them were increased in area (500mmx500mm) using R/C jackets for retrofitting purposes.

Fig. (15). Back view of the selected strengthened R/C building.

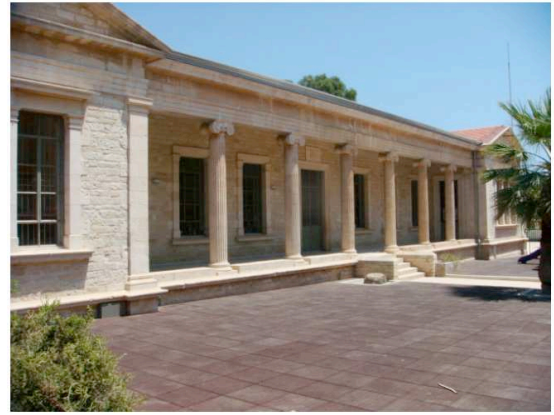
The front view of the masonry building is given in (Fig. 17) and a plan view is shown in (Fig. 18). It is of Π -shape in plan and consists of thick load bearing walls (approximately 600mm thick). The compressive capacity of the walls was approximated at about 4.27MPa based on the type of the stone and test results from similar buildings.

Fig. (17). Front view of the selected Masonry building.

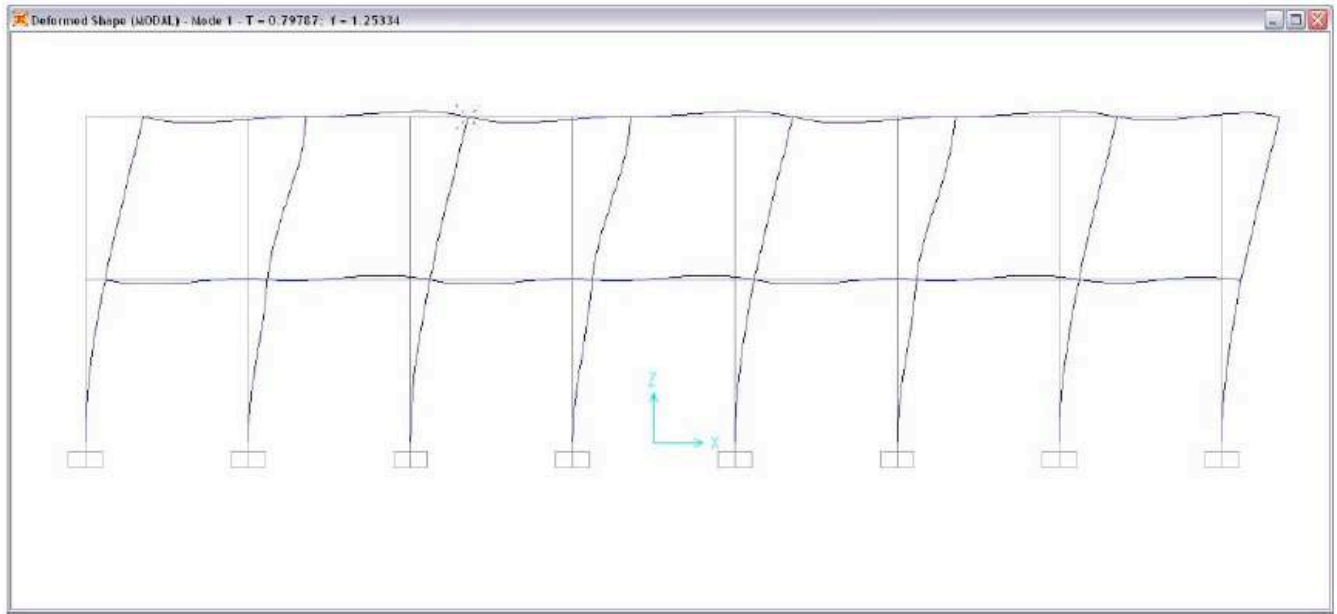
The results of the modal analysis for the 1st and 2nd modes of vibration are shown in (Figs. 21 and 22). The comparison of the corresponding results from both simulation frames clearly shows excellent correlation.

Fig. (21). View of the 1st mode of vibration of R/C building using SAP2000 (1.25Hz).

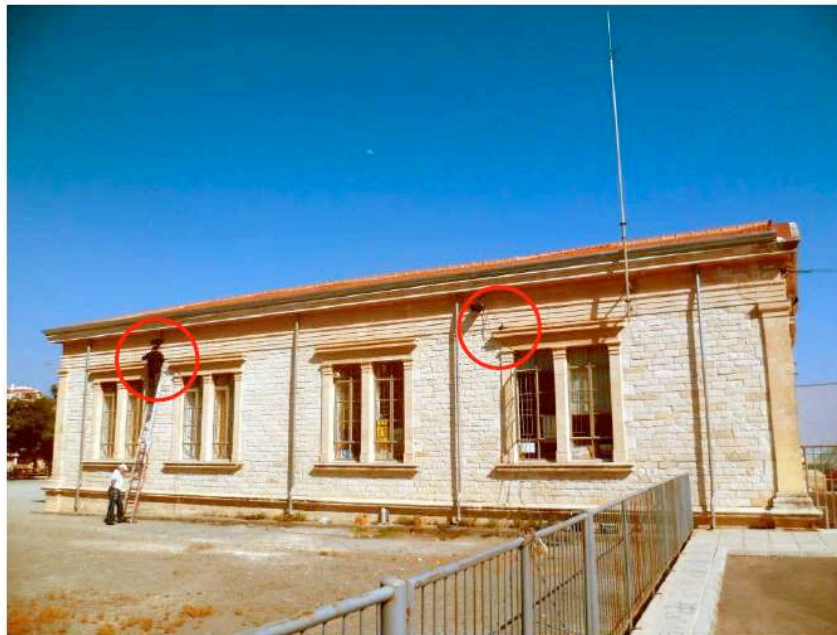
In the case of the masonry building, the accelerometers were placed on the lintel over the windows as shown in (Fig. 24), in order to monitor the vibration of the stone walls next to the selected windows. These walls were found in the analysis to vibrate at a higher extend compared to the rest of the walls at the side of the building. Ambient vibration recordings were conducted the results of which are shown in (Figs. 25 and 26). As can be seen in (Fig. 26), the recorded 1st and 2nd periods of vibration of the building are 0.26s and 0.23s, respectively.

Fig. (24). Position of the 2 accelerometers at one side of the building.

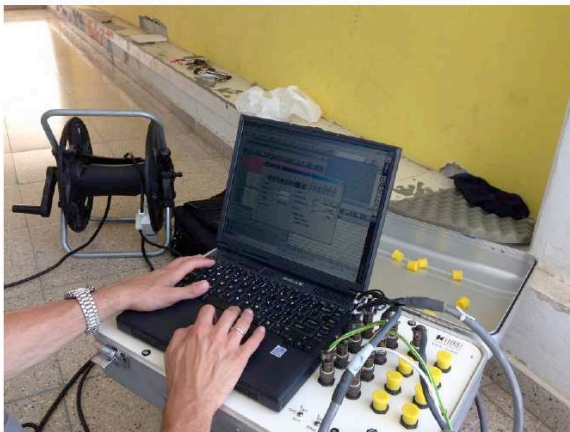
In the case of the R/C building, 3 accelerometers were used for the wired network (Fig. 27) and 1 for the wireless (Fig. 28). One of the wired accelerometers was placed near a column of the 1st floor whereas the remaining 2 were placed on the corner frame, one at each side of the building in the short direction (front and back).

Fig. (27). Wired network recording unit.

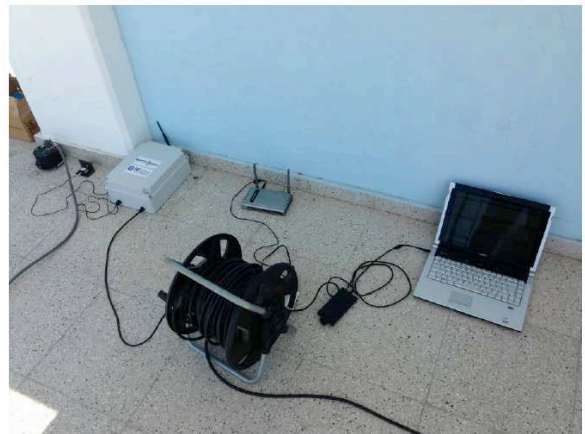
Fig. (28). Wireless network recording unit.
