OBSERVATION OF DEFECTS IN DEVICE SILICON

Thesis submitted for the Degree of  
Doctor of Philosophy of the  
University of London

Raymond Ogden  
Imperial College of Science and Technology.

January 1977

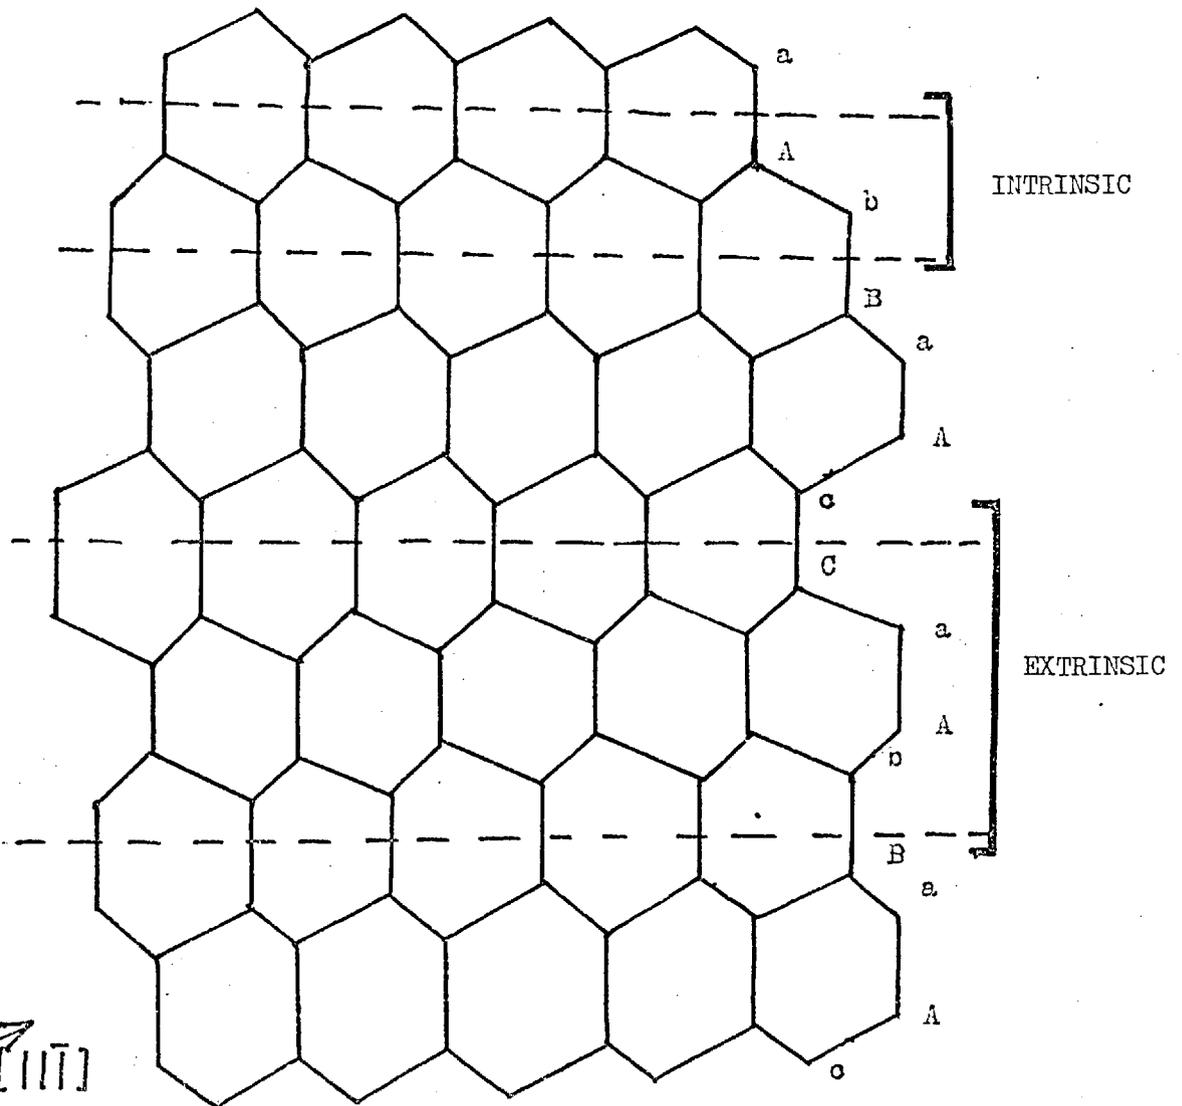
FIG. 1.3

STACKING FAULTS IN THE DIAMOND LATTICE OF INTRINSIC AND EXTRINSIC TYPE;  
THE BROKEN LINES DEMOTE TWIN PLANES, PROJECTED ON  $(1\bar{1}0)$  PLANES.

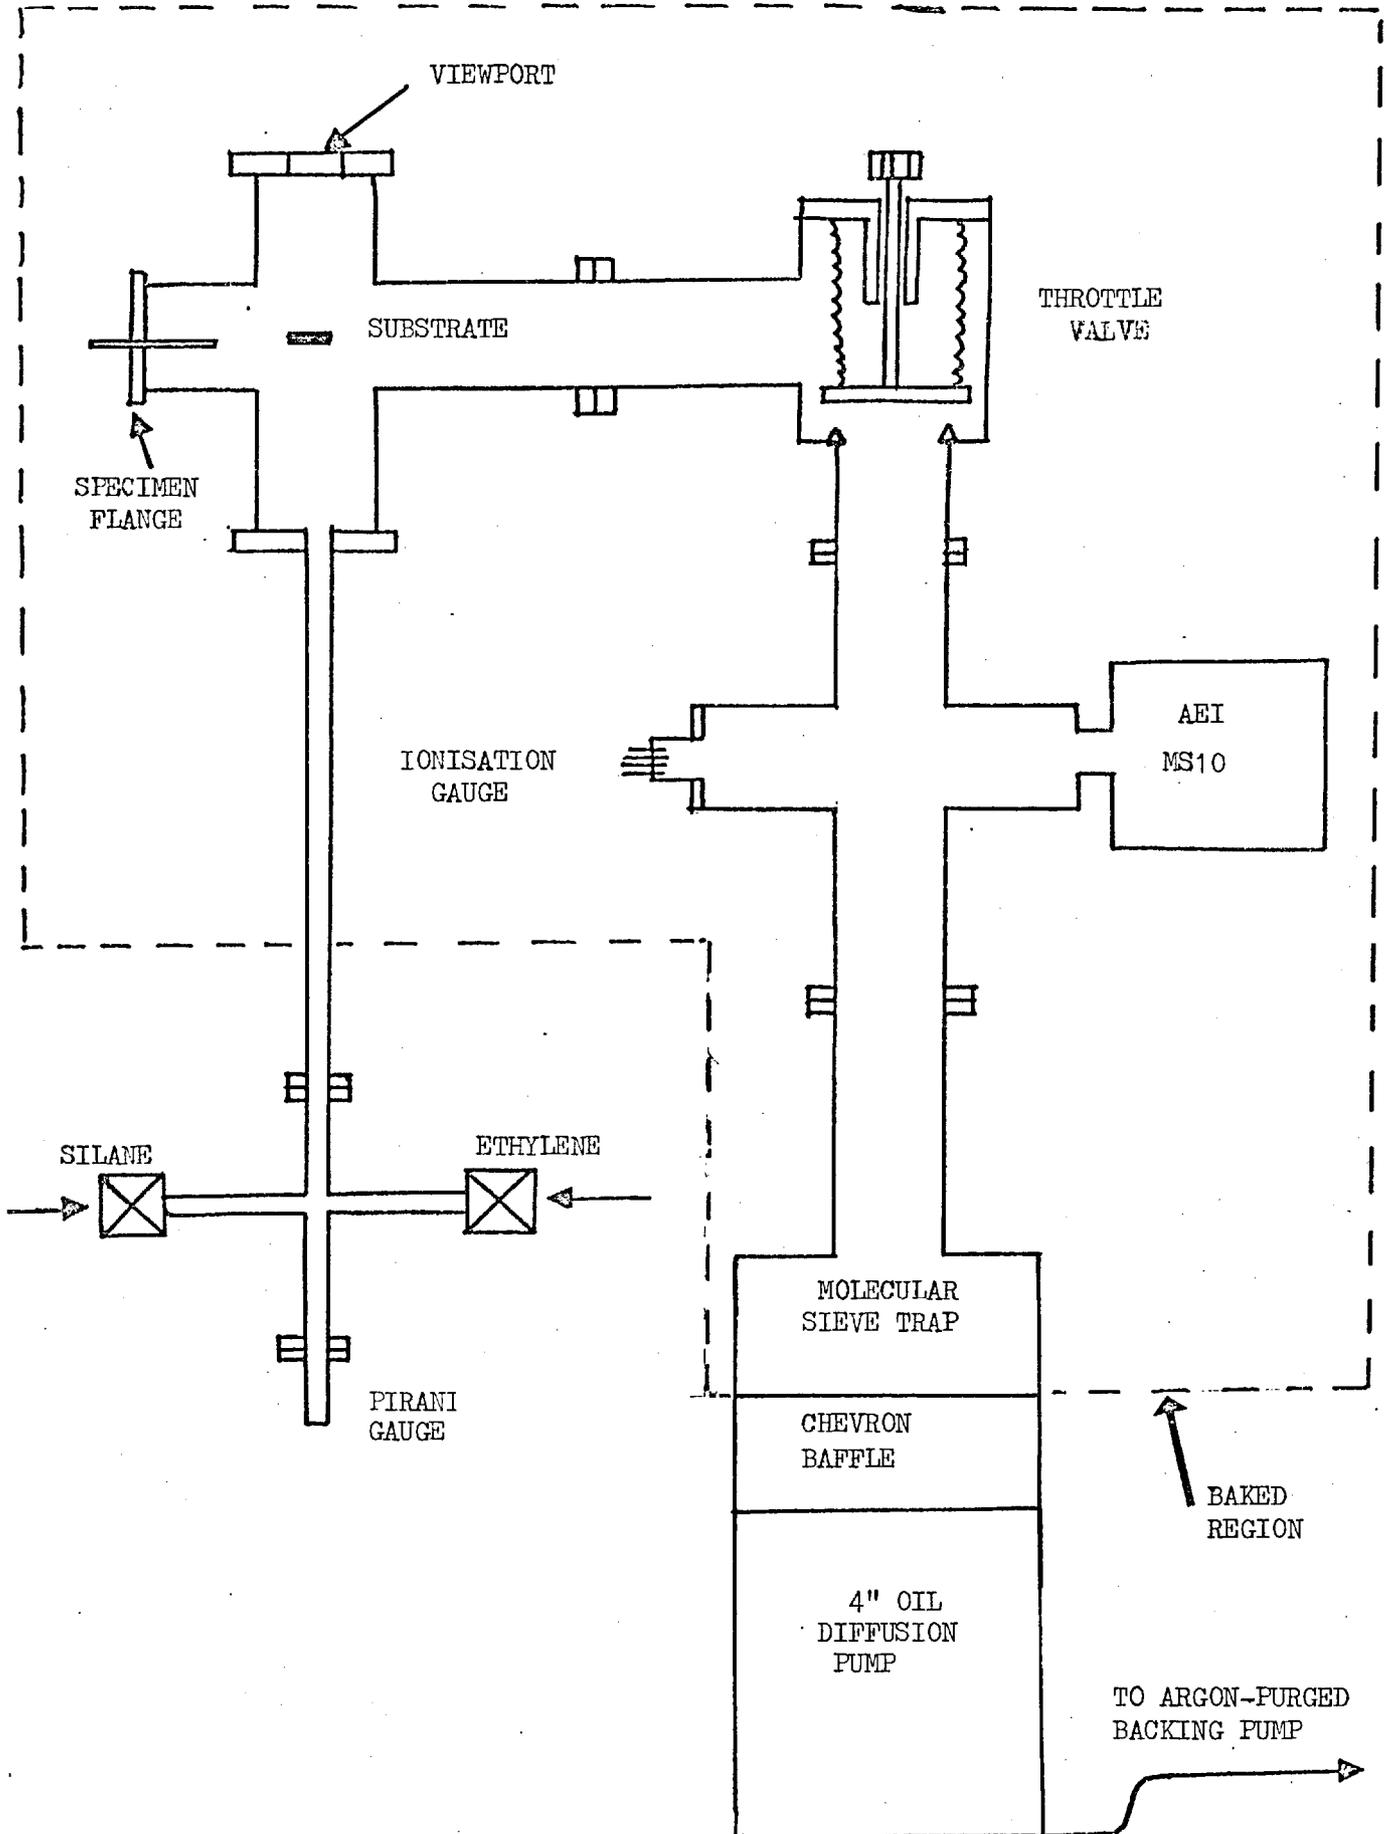
UHV SYSTEM FOR EPITAXIAL GROWTH OF SILICON FROM SILANE.

The gases chosen in this study: hydrocarbons, oxygen and water vapour can be present in a conventional flow system. Water vapour was obtained by fracturing a sealed ampule of high purity water in a special chamber attached by a gas line to the growth chamber. Silane (semiconductor grade) was then introduced into the growth chamber to give the desired silane:contaminant ratio. After stabilisation, the specimen temperature was quickly raised to  $1200^{\circ}\text{C}$  and the magnetically operated throttle valve closed to raise the growth chamber pressure to the growth pressure, typically 0.3 torr. The substrate temperature was then lowered to the growth temperature. This procedure was adopted when using ethylene contamination to minimise the formation of SiC on the substrate prior to growth. Throughout the run, the throttle valve was adjusted so that the maximum pressure in the mass spectrometer chamber did not exceed  $3 \times 10^{-4}$  torr. This way the spectrometer was always operative and excessive oil backstreaming into the growth chamber was avoided. Si growth rates of typically  $0.5 \mu\text{m}/\text{min}$ . were achieved and layers 4-6  $\mu\text{m}$  thick were deposited. The run was terminated by switching off the substrate heating current, closing the gas inlet and opening the throttle valve.

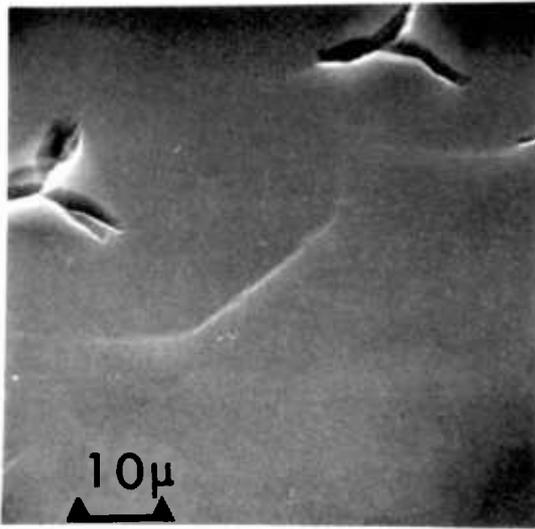
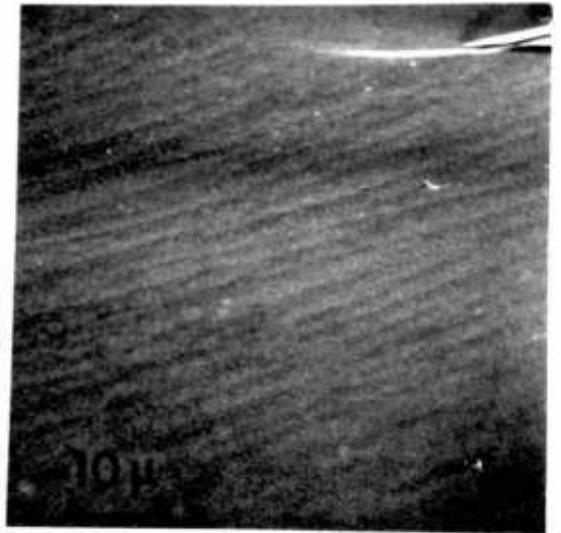
Micrographs of epitaxial Si layer showing defective growth

a) SEM, secondary electron emission mode, beam normal to surface

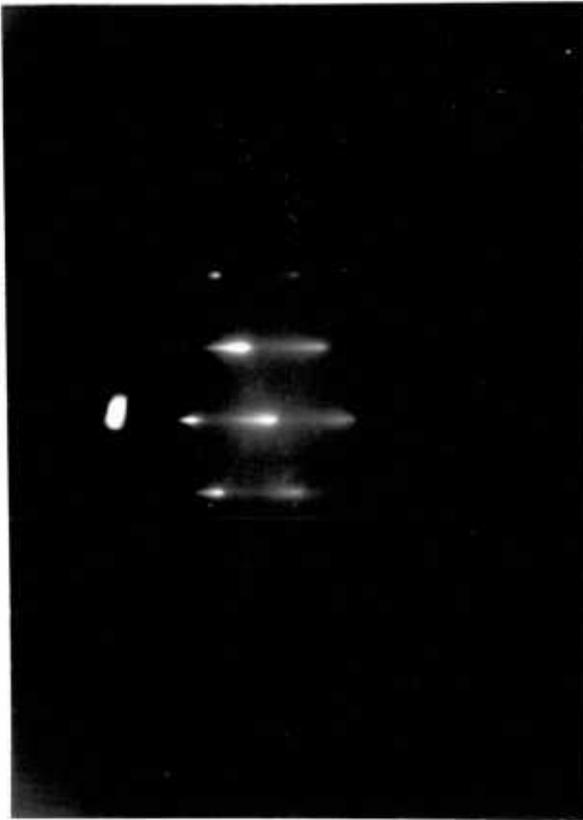
Surface studies & microstructure of very heavy ethylene contamination layer RB35A

a) GAED, showing streaked spots

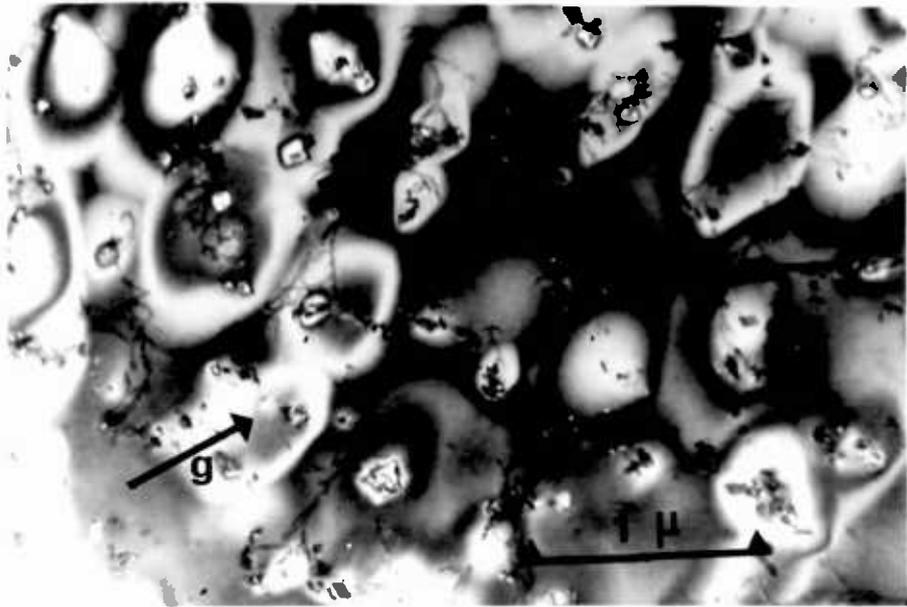
Resolution of stacking fault structure of  $\{110\}$  layer RB 7

a)  $\{111\}$  refln. near  $[110]$  zone

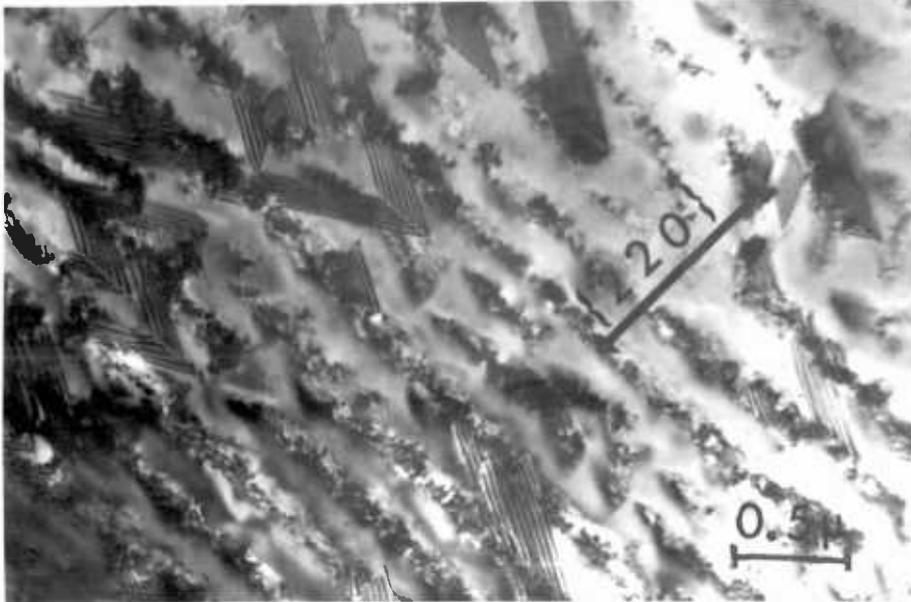
FIG. 5.3  
Stacking faults & precipitation in RB47B  
grown with water vapour contamination.

a) TEM showing stacking fault structures & precipitation bands

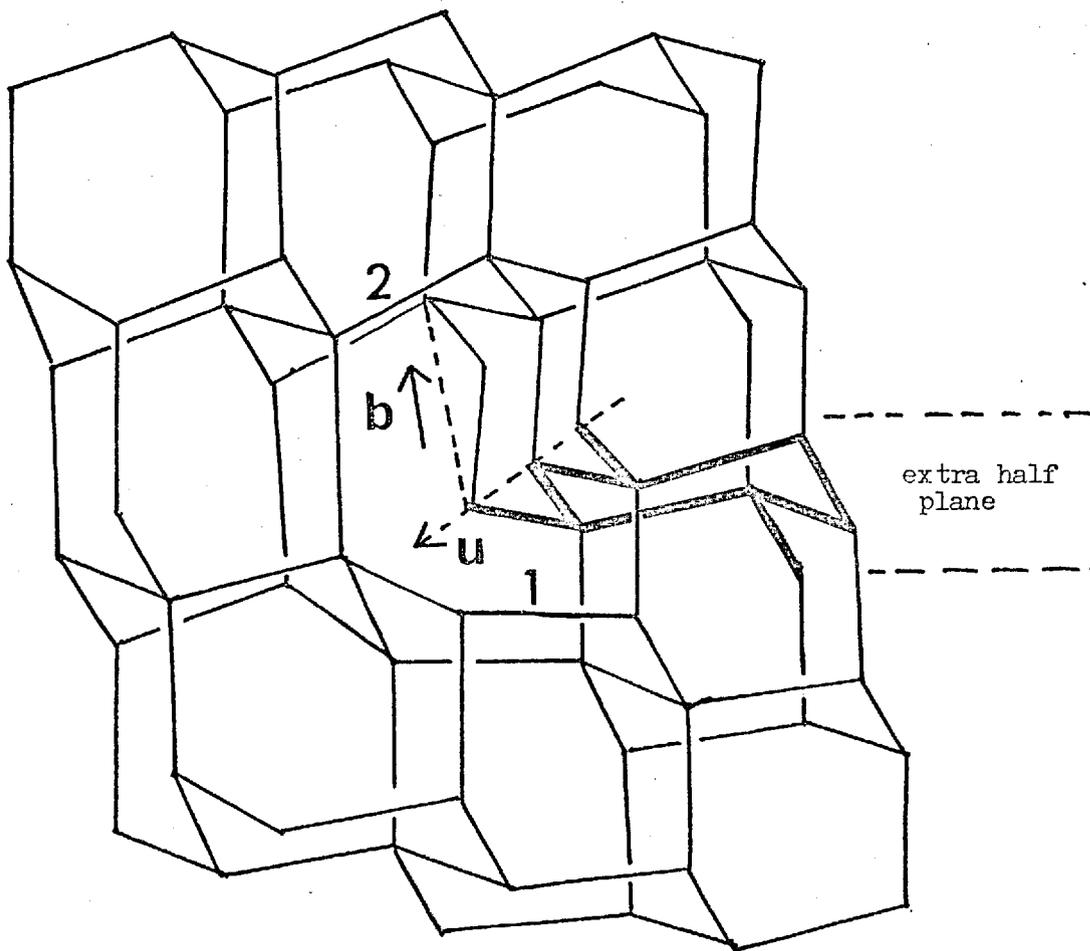
CONFIGURATION OF  $60^\circ$  DISLOCATION LYING IN  $[1\bar{1}0]$  orientation in  
(111) SUBSTRATE PLANE, HAVING BURGERS VECTOR OF  $\frac{1}{2}[011]$   
INCLINED TO SUBSTRATE PLANE

$$\underline{b} = \frac{1}{2} [011]$$

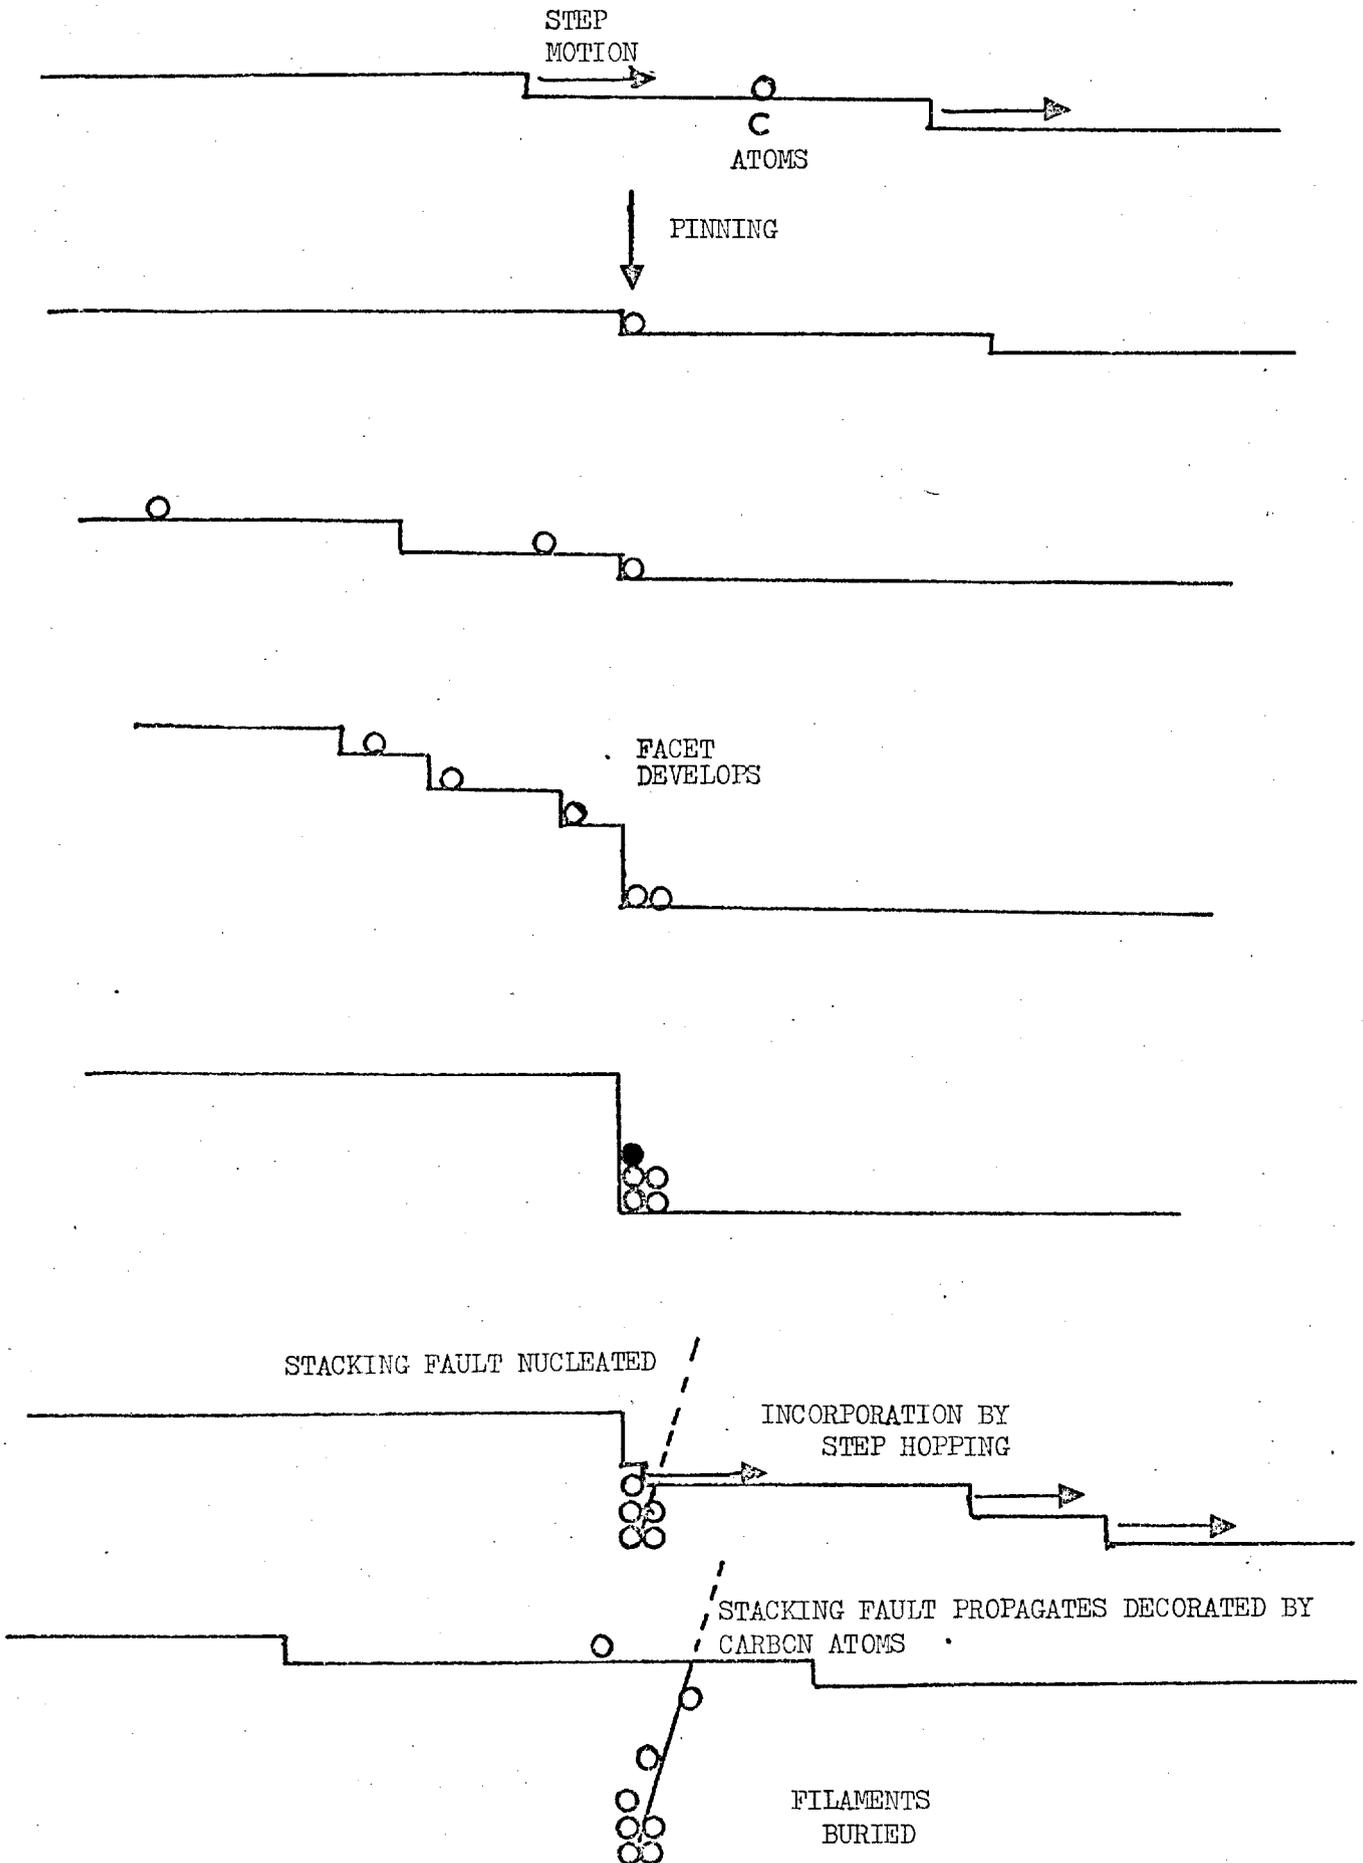
DIAGRAM REPRESENTING GROWTH STEP RETARDATION BY CARBON IMPURITY ATOMS AND THEIR SUBSEQUENT INCORPORATION IN EPITAXIAL LAYER.

then continues to absorb carbon during subsequent step motion. It is significant that the ribbons in Fig.3.4 are not wider than  $\sim 0.4 \mu\text{m}$  which is the maximum length of the straight portions of the surface steps in Figs. 3.6a) & b). The observation of wider faults at lower ethylene levels, Figs. 3.7a) b) is coupled with much less faceted surfaces, Figs. 3.7c) & d) and presumably carbon segregates on long portions of steps before being incorporated in the layer. Competition for carbon atoms from neighbouring faults or changes in surface topography could terminate the carbon supply to a particular fault. During subsequent epitaxial growth, the fault will not propagate but will terminate within the layer, forming a buried loop as the ringed example in Fig.3.5(a). This behaviour is quite different from the propagation of the more usual type of stacking fault structure shown in Figs. 3.13 and 3.14 which, once formed, grow with the epitaxial layer without needing stabilising impurity atoms because of the high stability of the bounding stair-rod dislocations.

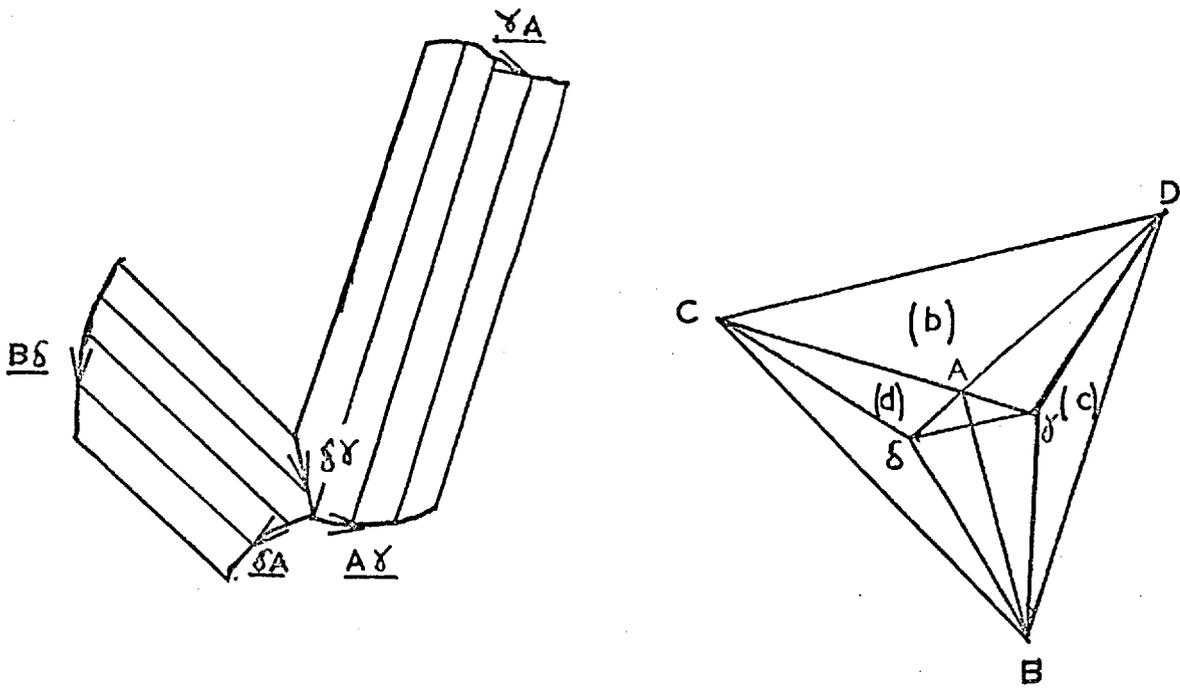
FIG. 6.5(b)

ANALYSIS OF RIBBON INTERSECTION SHOWN IN FIG. 3.12.

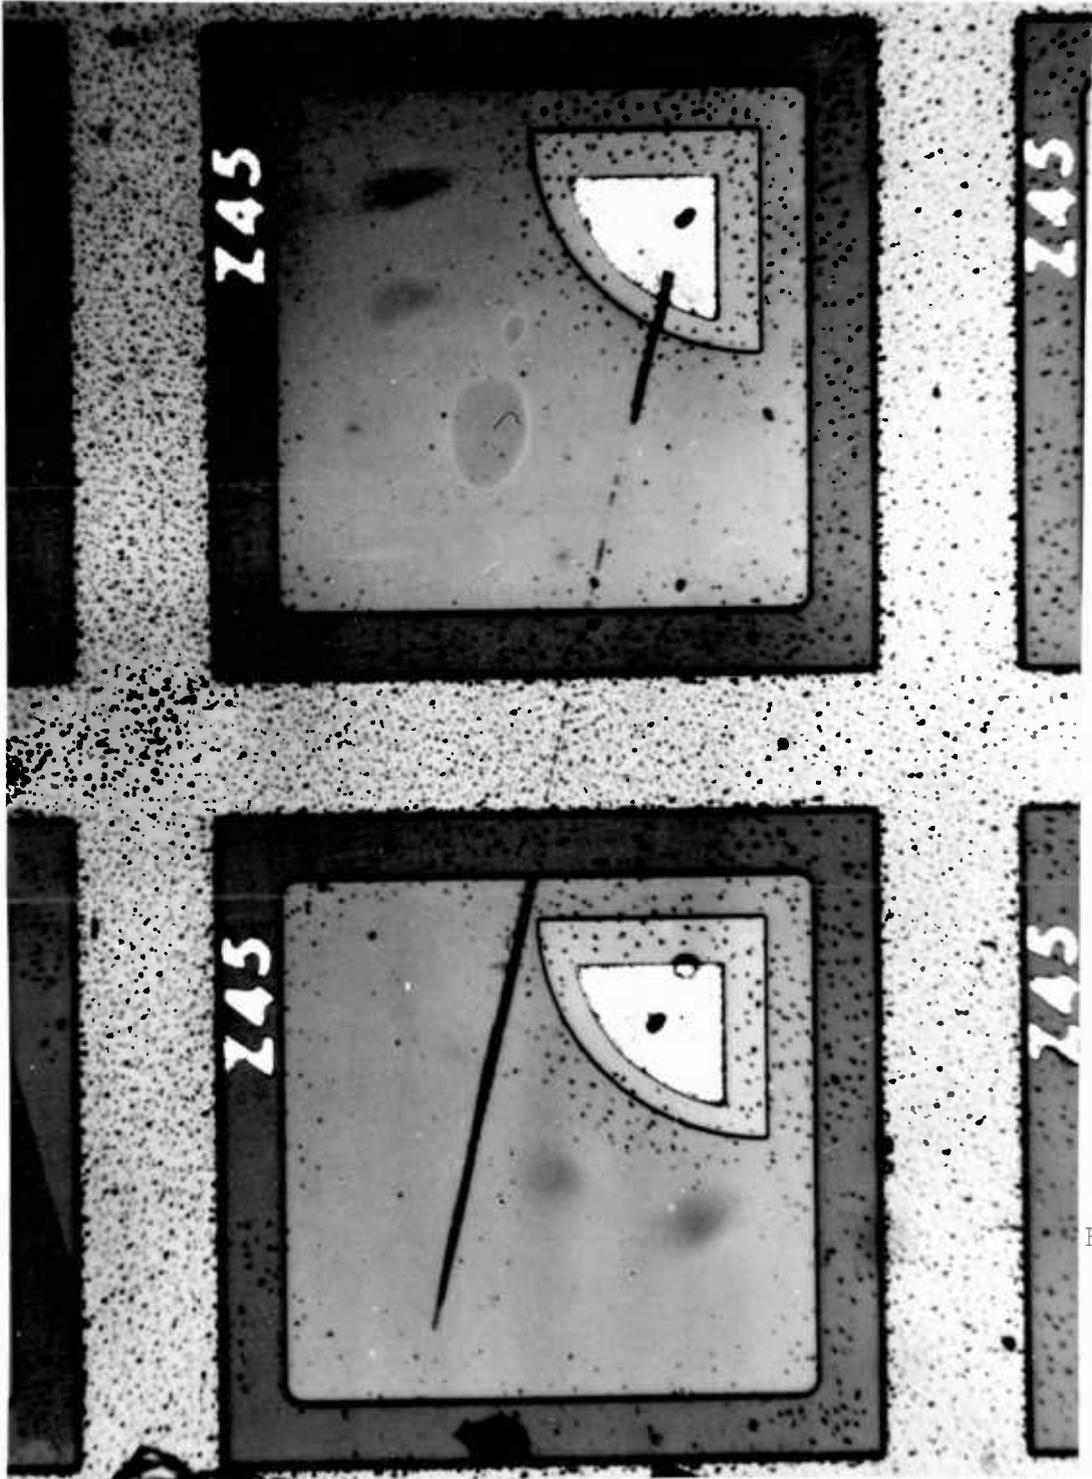
Optical Micrograph of "scratch" on probe-tested Dow Corning Z45 Slice

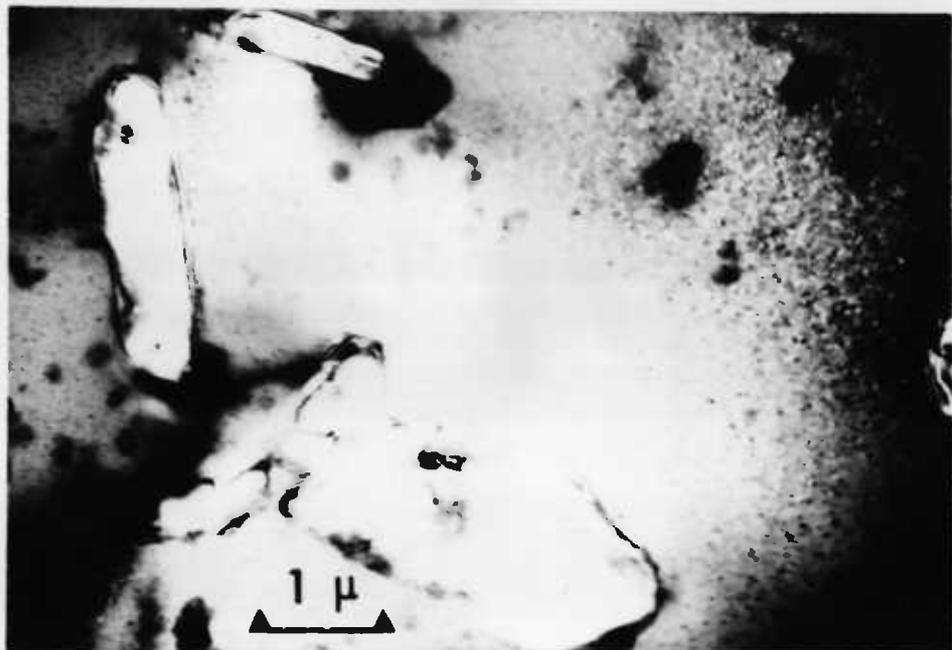
Fig.10.14 Pitting in end strip of T.I. slice

Fig.10.14 was taken from an end strip region showing heavy slip in XRT. This region had been subjected to a boron diffusion followed by a phosphorous diffusion. A band of dislocations about 10  $\mu\text{m}$  across was found in this specimen. The dislocations were lying largely in the (111) substrate plane and formed long chains of helices. Small dislocation loops and isolated segments were also present, Fig.10.15. Diffraction contrast analysis in the electron microscope, Figs. 10.16(a) to (f), Table 10.5, proves that the dislocation arrays are in fact helices with  $\frac{1}{2} [0\bar{1}1]$  Burgers vectors lying parallel to their axis. The dislocation loops, formed by pinched-off turns of the helices have the same  $\frac{1}{2} [0\bar{1}1]$  Burgers vectors. The significance of these results will be discussed later. The crystalline debris observed on the foil was not identified but is possibly a silicate.

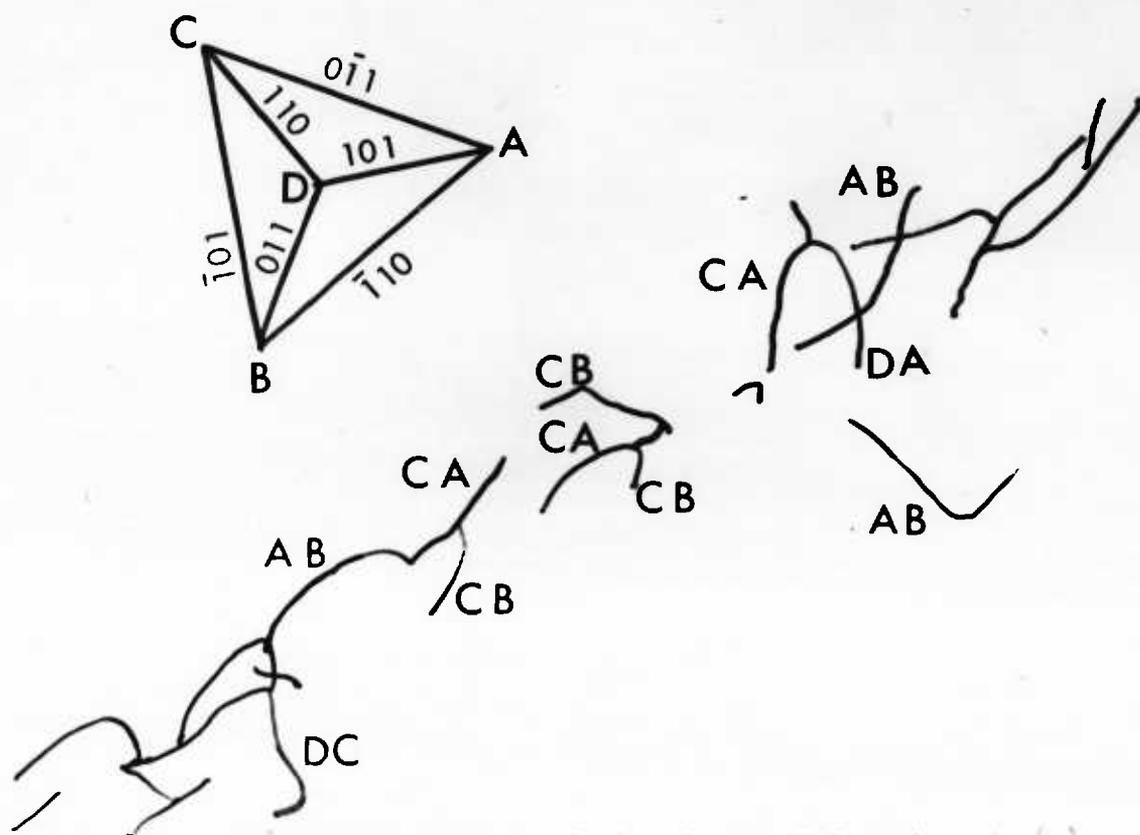
(a) TEM micrograph

(b) Burgers vector analysis of some dislocations in (a)

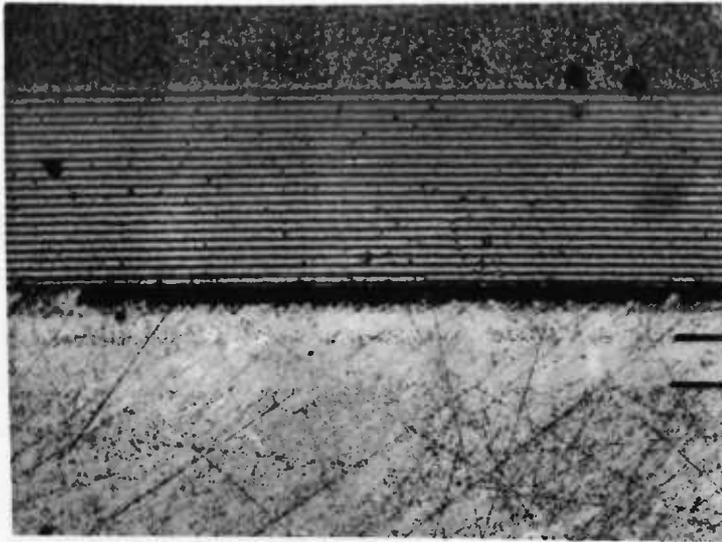
Sections of double-diffused regions obtained by the bevel & stain technique

1 oxide fringe =  $2068\text{\AA}$

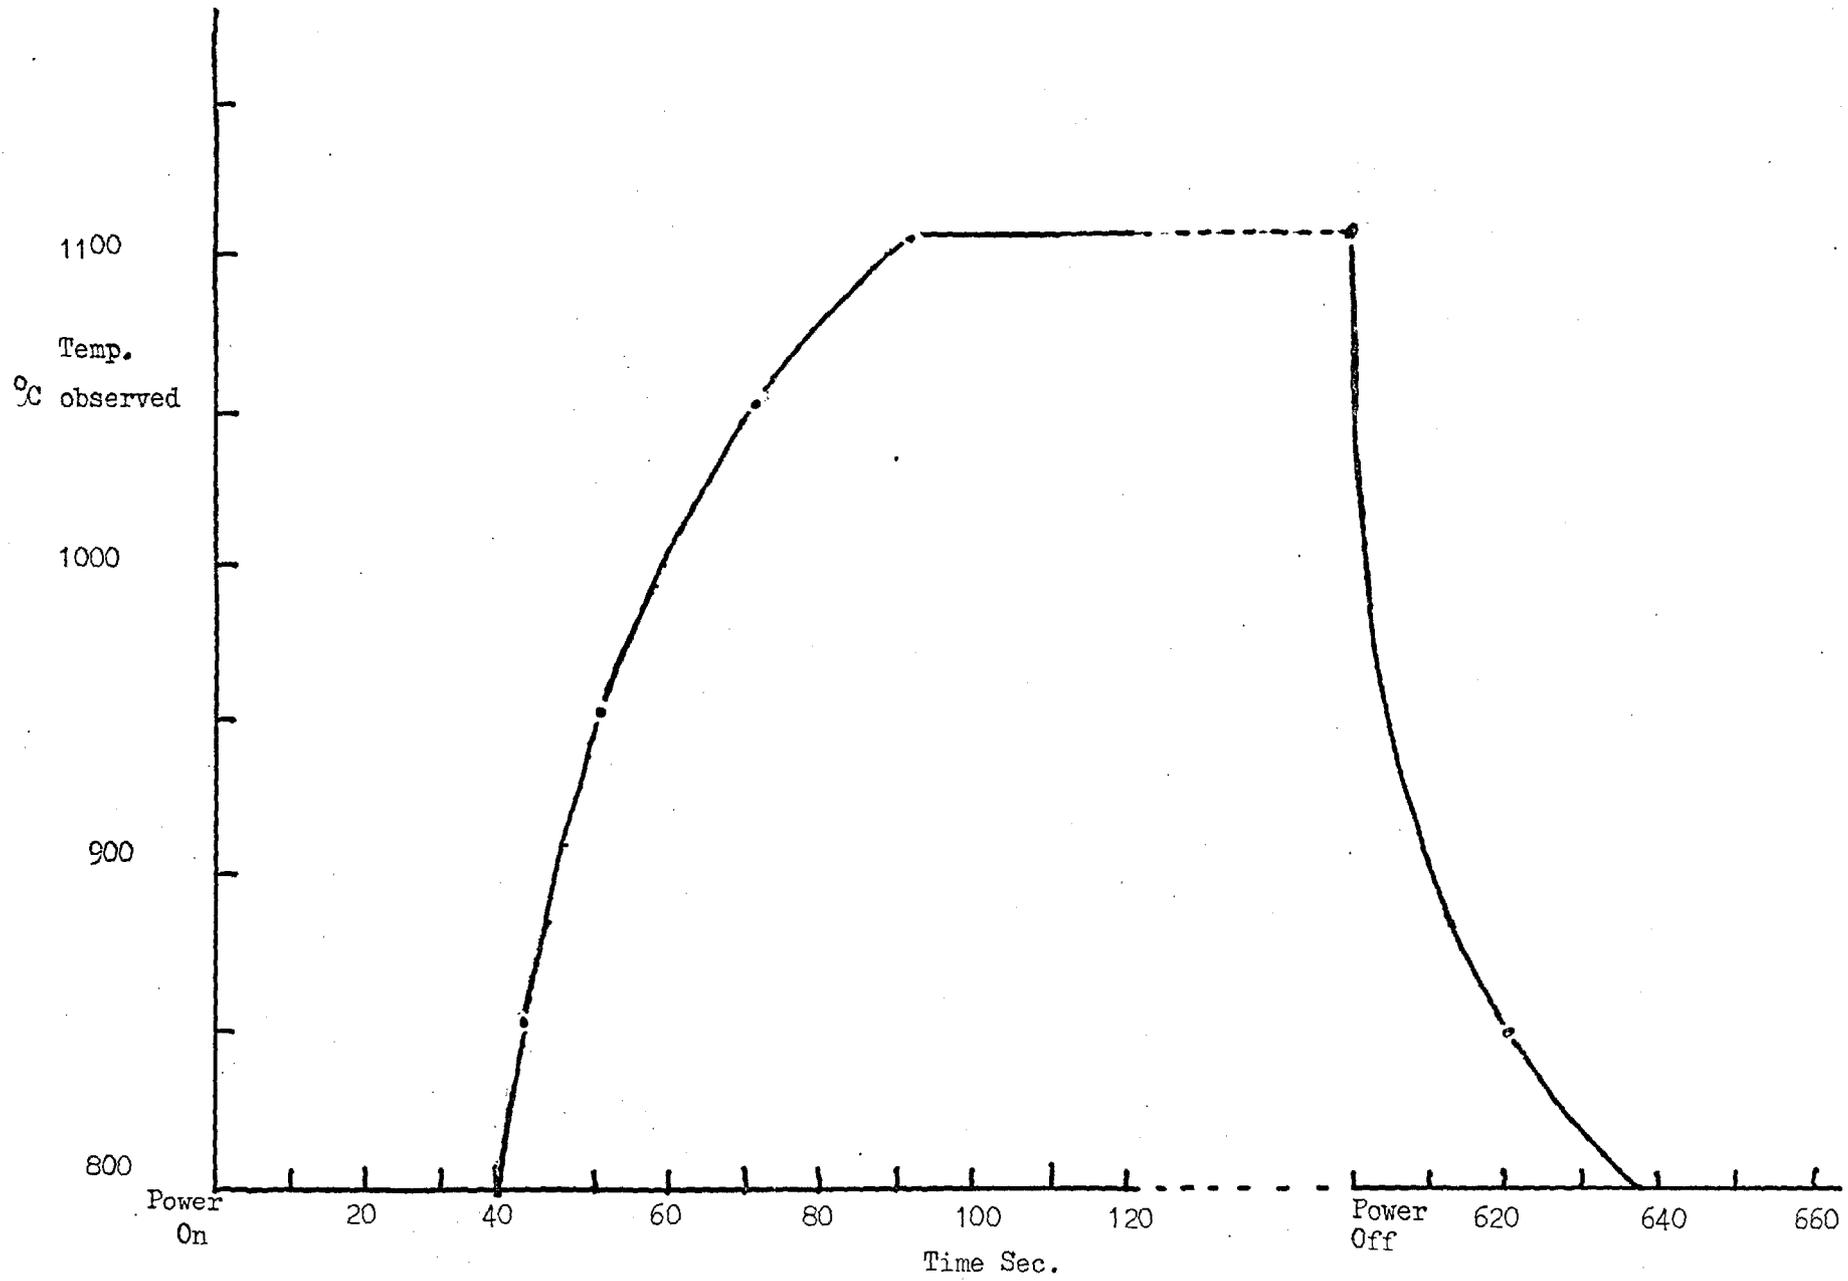
Typical observed temperature cycle of Si slice on IR heated susceptor during gas polishing.

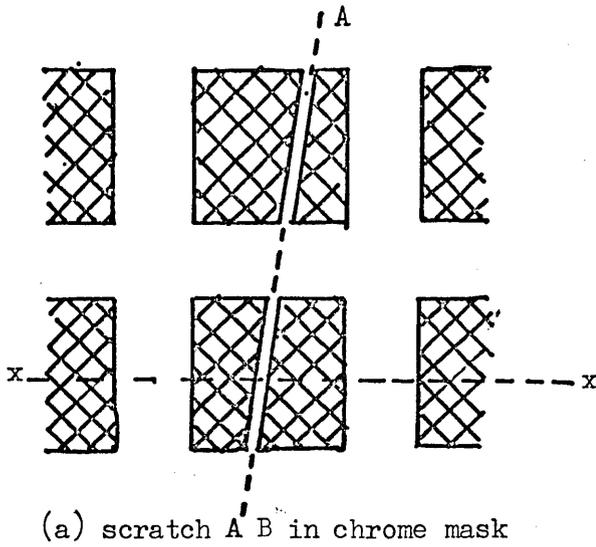
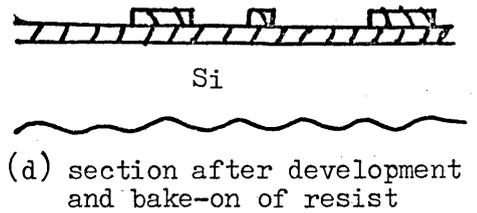
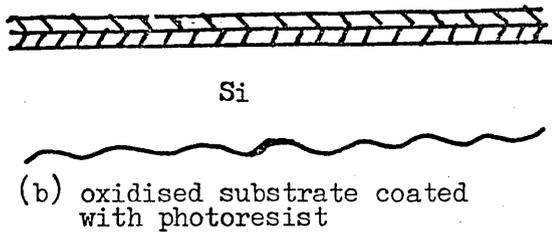
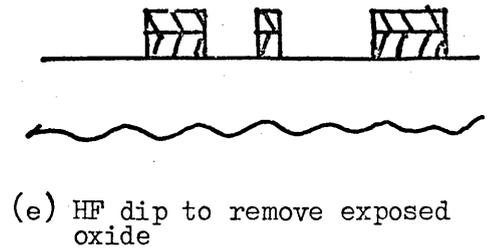
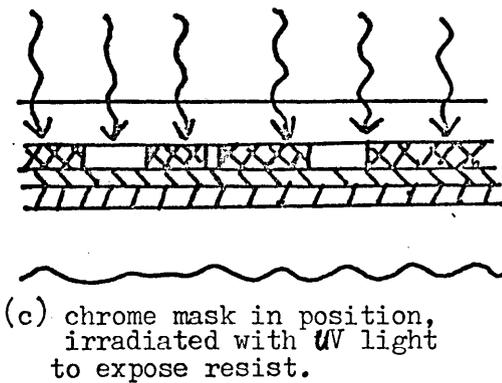
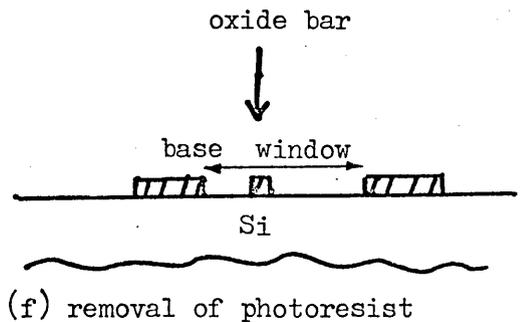
Formation of oxide bar photoengraving faults in base window

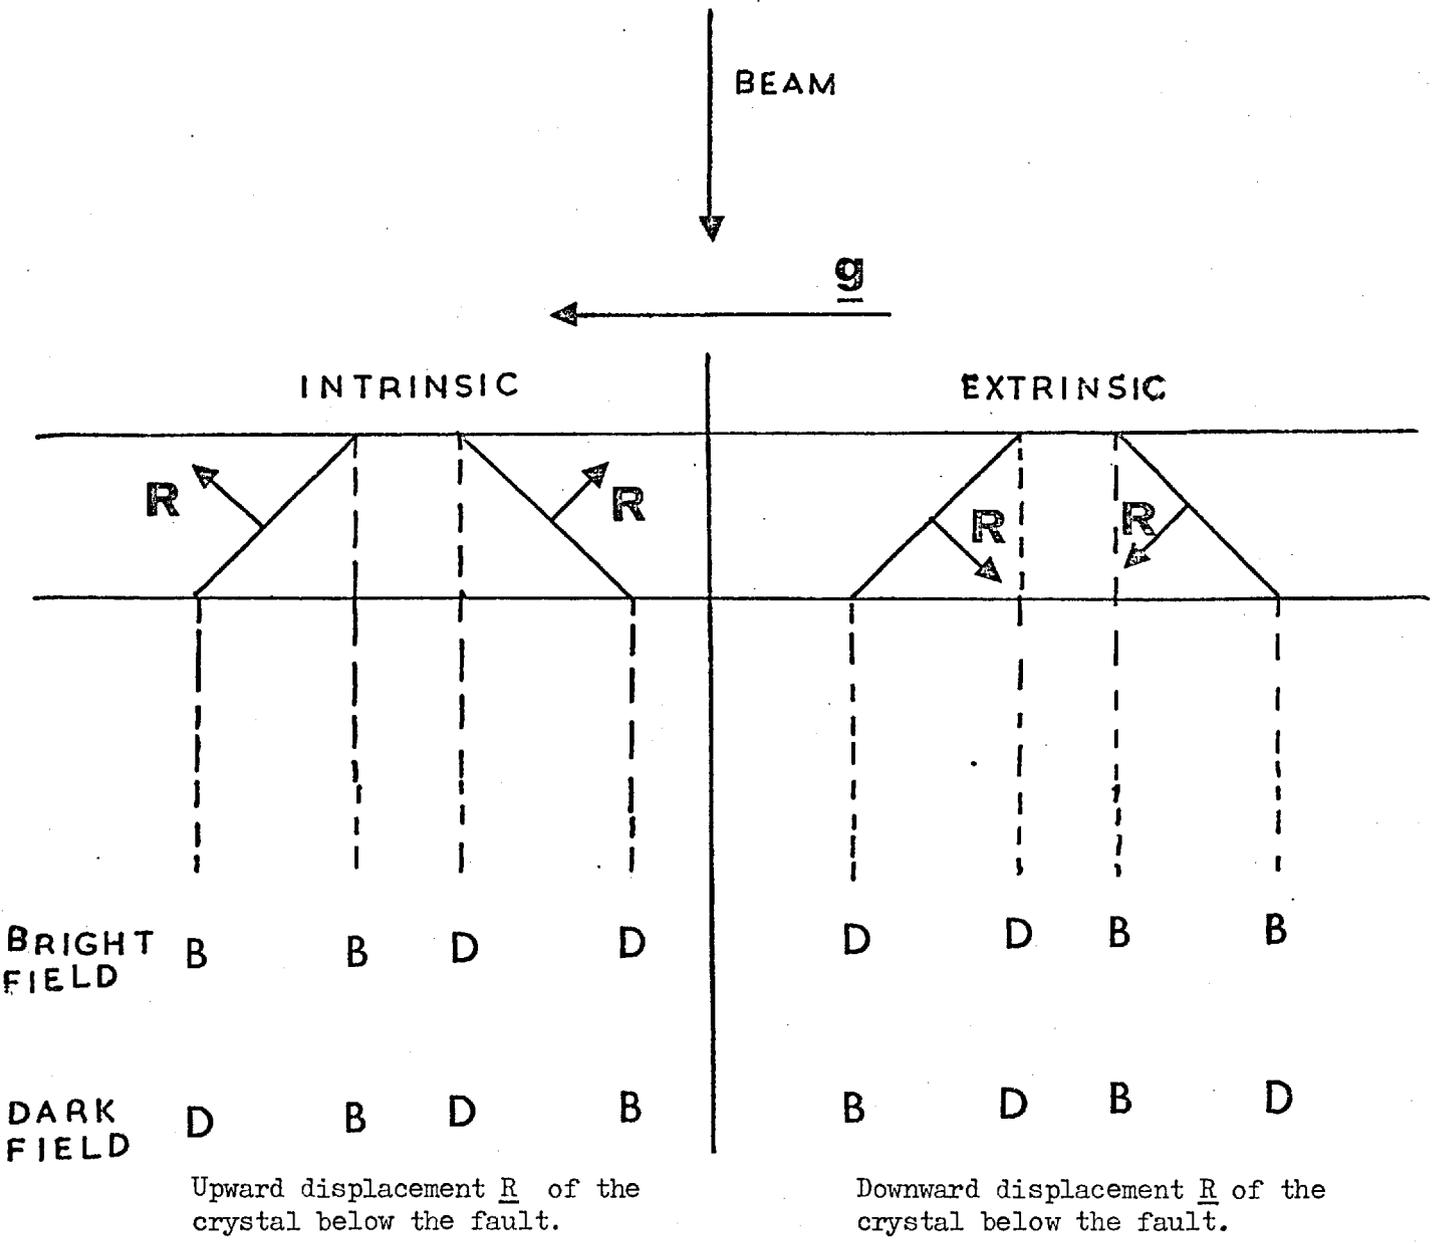
Outer fringe contrast of intrinsic and extrinsic stacking faults using  
2 beam,  $s = 0$  diffraction conditions

B = bright outer fringe  
 D = dark outer fringe

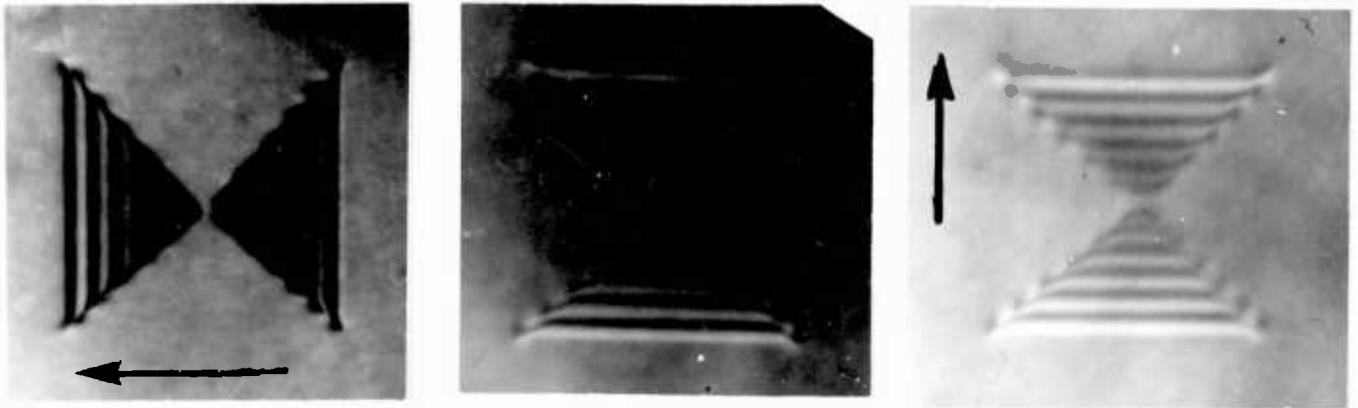
FIG.A9  
 Analysis of stacking fault pyramid in  $\{100\}$  epitaxial Si

a)  $\bar{2}\bar{2}0$  B.Fb)  $\bar{2}\bar{2}0$  B.Fc)  $\bar{2}\bar{2}0$  D.F

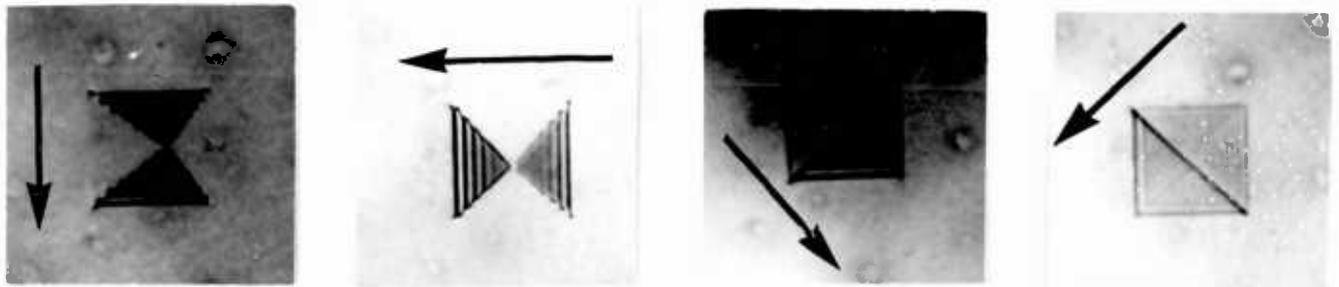
Analysis of stair-rod dislocations in stacking fault pyramid,  
 all micrographs bright field,  $s > 0$  condition.

a)  $\bar{2}\bar{2}0$ b)  $\bar{2}\bar{2}0$

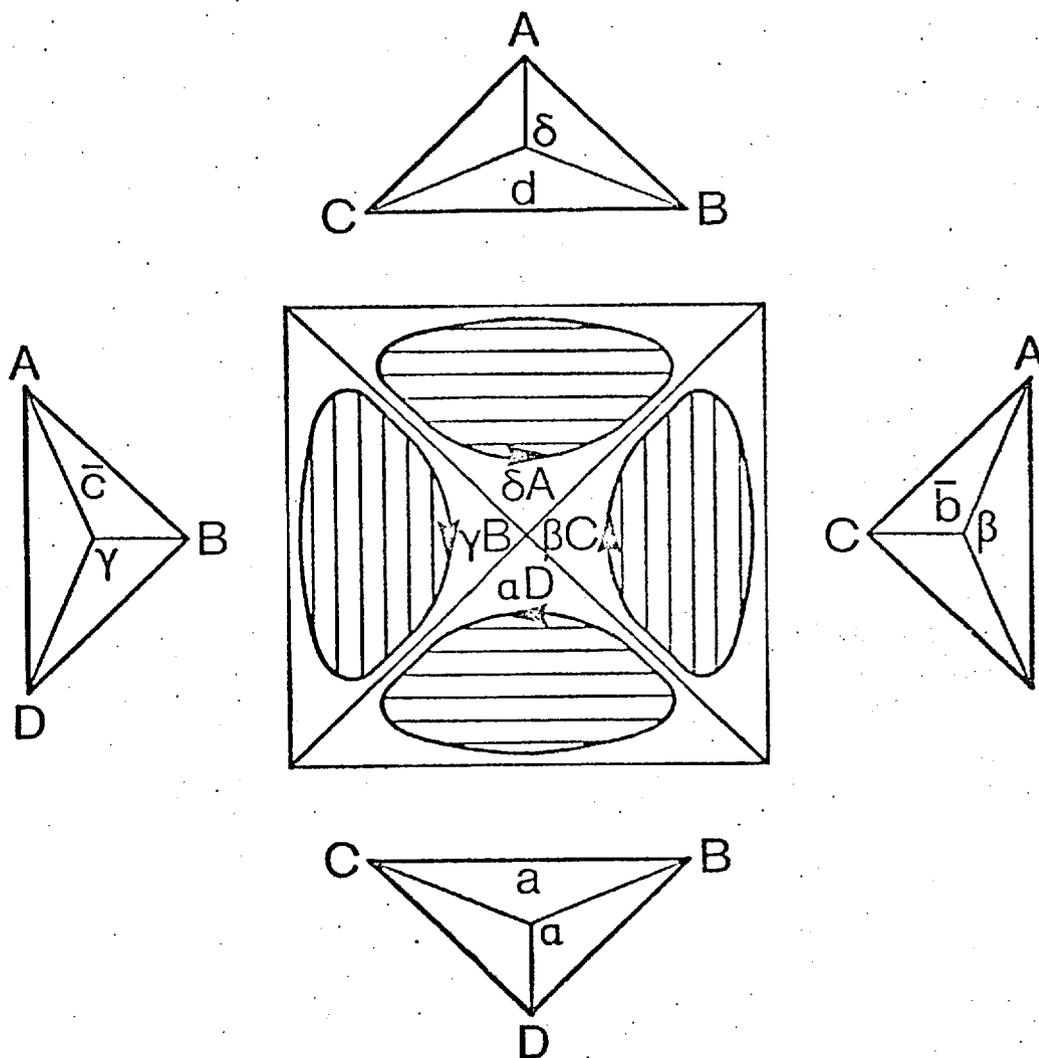
Intrinsic Shockley loops which could form observed stair-rods, apex of pyramid pointing up, also showing each projected face of Thompson tetrahedron against appropriate loop.

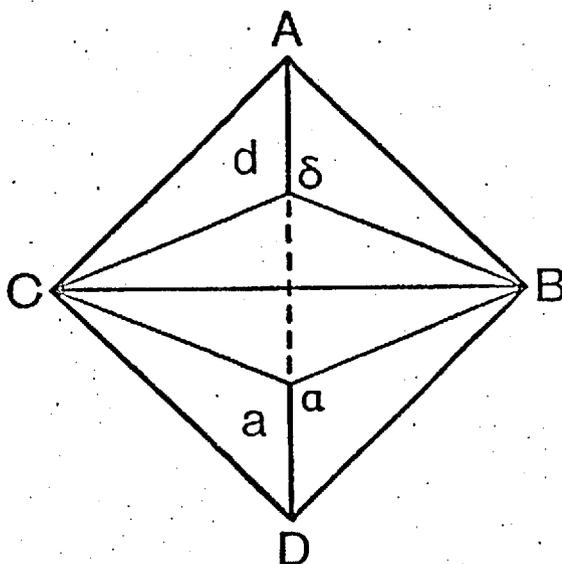
FIG. A12(b)

Completed Thompson tetrahedron viewed from above
