OBSERVATION OF DEFECTS IN DEVICE SILICON

Thesis submitted for the Degree of  
Doctor of Philosophy of the  
University of London

Raymond Ogden  
Imperial College of Science and Technology.

January 1977

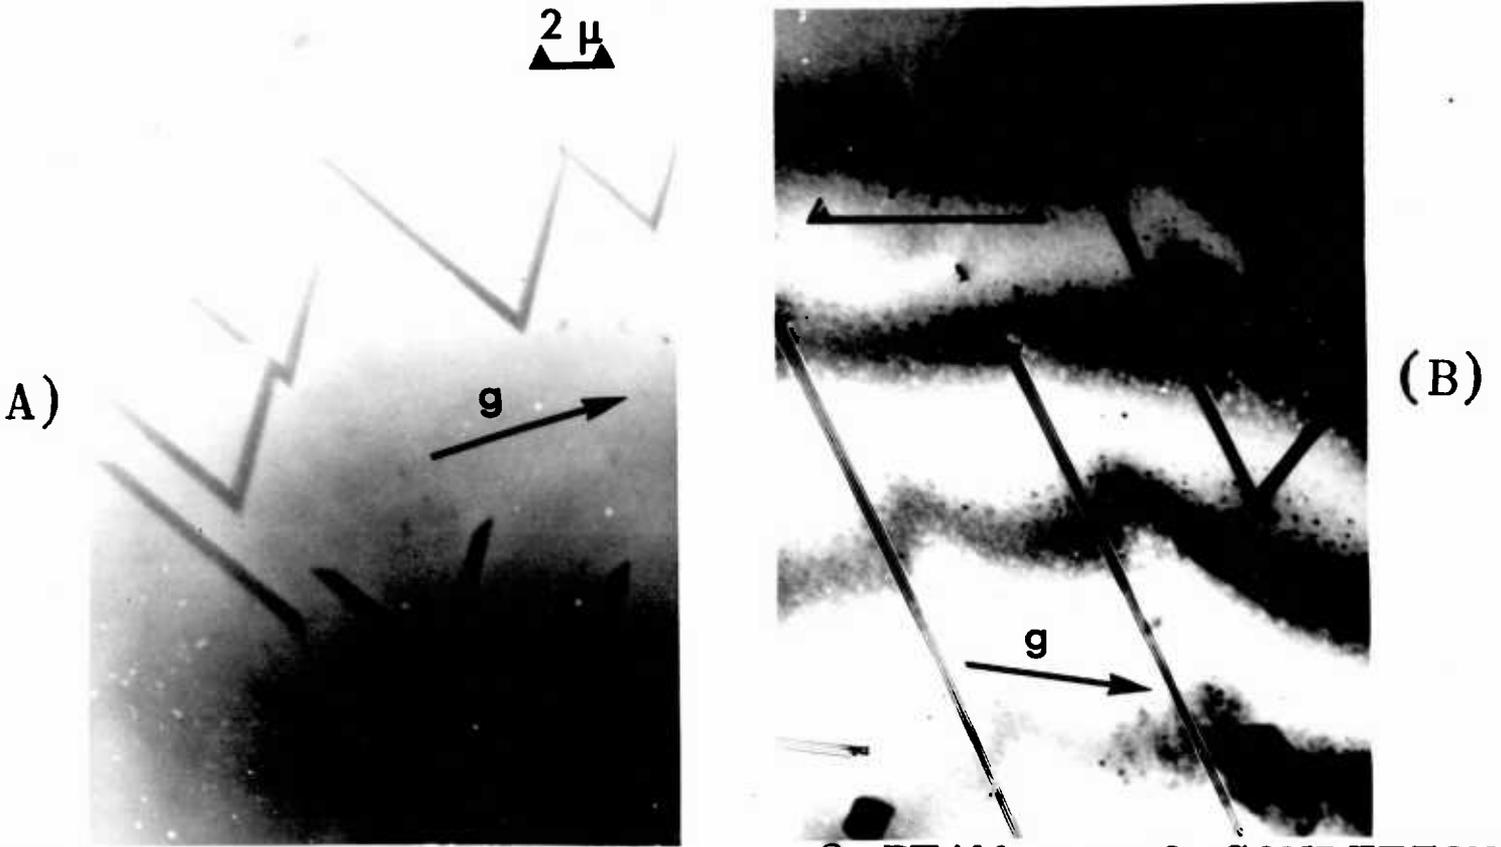
DEFECTS IN EPITAXIAL LAYER GROWN ABOVE ION-  
LANTED REGIONS ON SUBSTRATE WITH 1% O<sub>2</sub> DRIVE-IN

THICK FOIL REGION, LOW  
MAGNIFICATION SHOWING SF  
TETRAHEDRA OF VARYING SIZE

2 BEAM  $s = 0$  CONDITION  
SHOWING THICKNESS  
& SF FRINGES

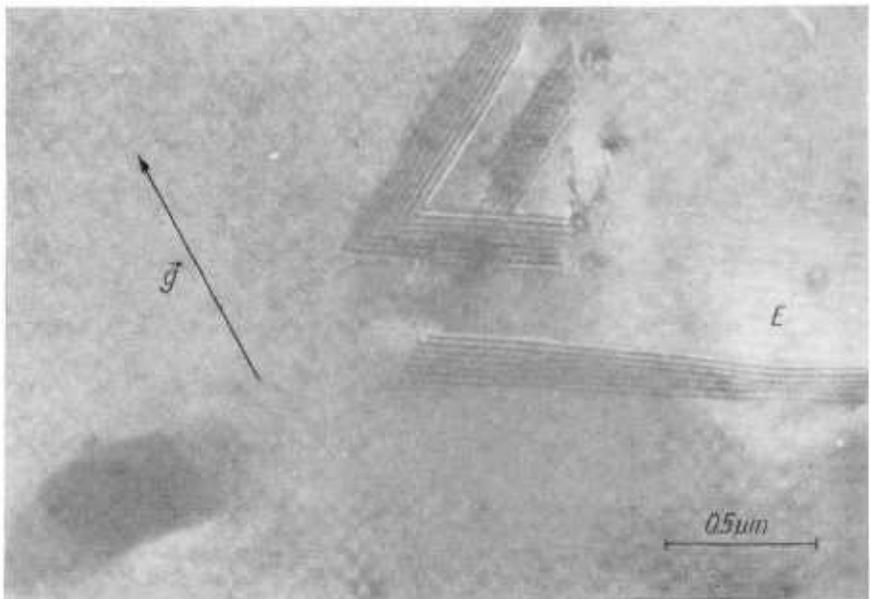
Fig. 2. Stacking fault structure formed at 850 °C, 4 ppm ethylene, dark-field T.E.M.

As the level of ethylene contamination was reduced, the stacking fault densities dropped and the ribbon faults tended to be wider. A long extrinsic fault in

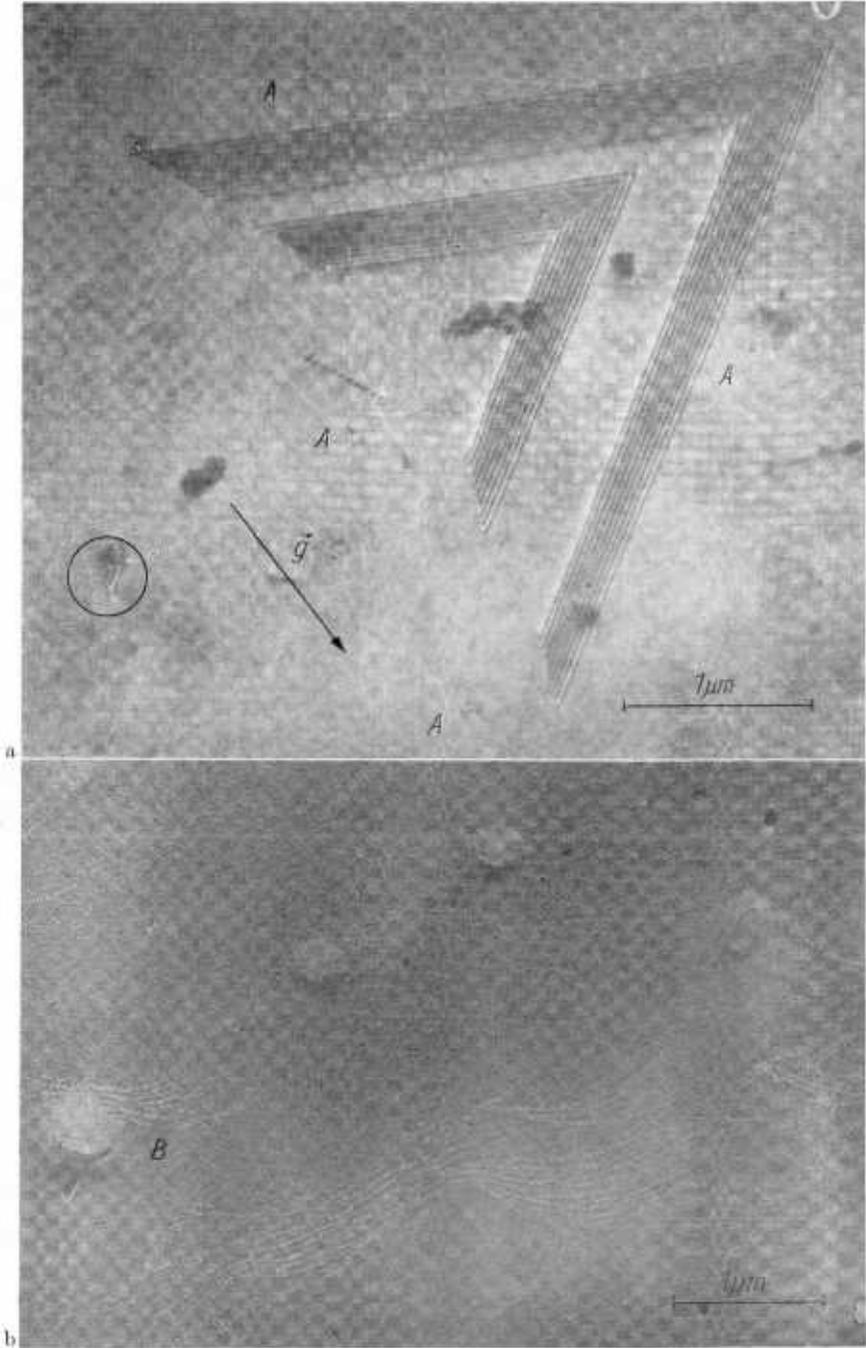
Fig. 3. a) Structure of Si layer grown with 50 ppm ethylene at 1065 °C, bright-field T.E.M. 220 type reflection. The closing stacking faults parallel to the diffraction vector are out of contrast. Note second phase particles (marked A), probably SiC; b) Pt/C replica of layer grown with 100 ppm ethylene at 1065 °C

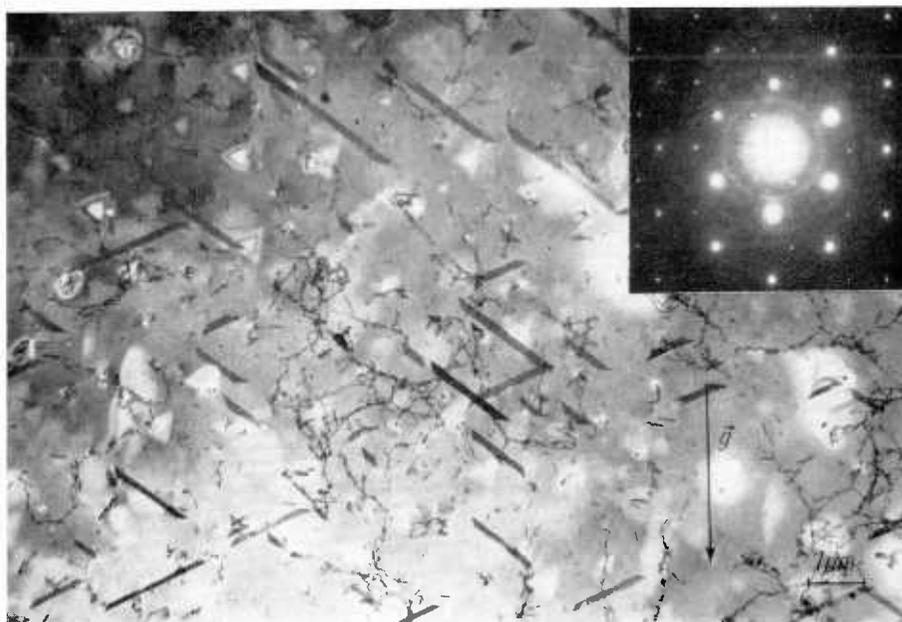
Fig. 4. Structure of Si layer grown at 960 °C with 100 ppm ethylene showing  $\beta$ -SiC debris on foil surface. Inset is electron diffraction pattern from thin area of foil showing [111] Si post pattern and  $\beta$ -SiC polycrystalline ring pattern

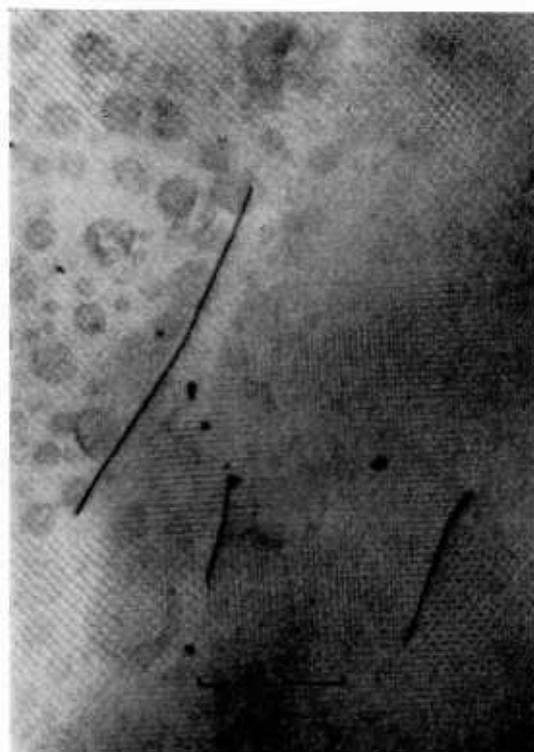
Figure 2 Transmission electron micrograph of dislocation loops.  $220$  type reflection, bright-field. Bar = 1  $\mu\text{m}$ .

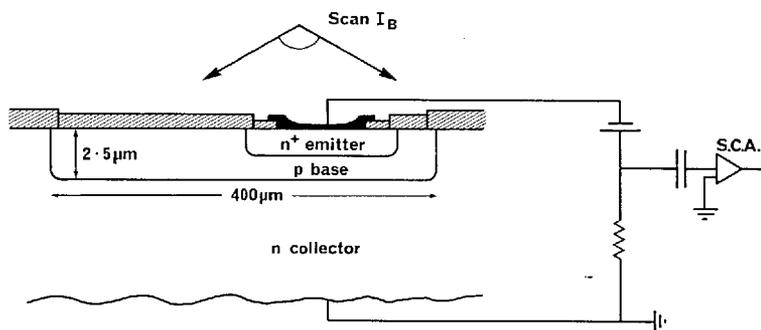
Fig. 1. Barrier electron voltaic effect detection circuit for the examination of planar devices scanned in plan view.

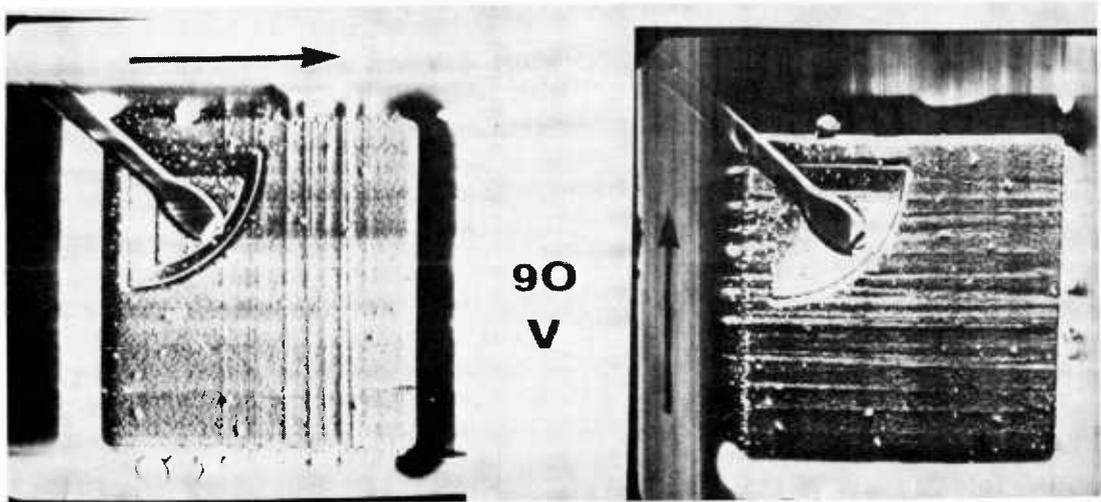
Fig. 4. Two barrier e.v.e. micrographs of the device shown in Fig. 2(b). The scan direction in (a) was horizontal, that in (b) was vertical. The lines of enhanced contrast which appear in each case are those orthogonal to the scan direction.
