**Green Maintenance for Historic Masonry Buildings:
A Life Cycle Assessment Approach**

Submitted for the degree of Doctor of Philosophy

Heriot-Watt University

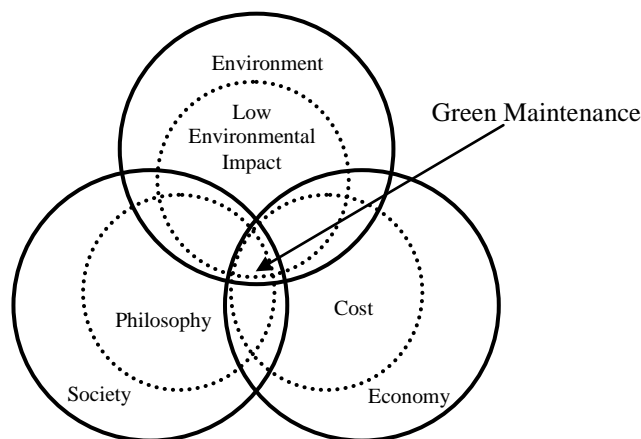
Figure 2.1: Parameters for evaluating maintenance interventions for buildings

own needs” (WCED, 1987: 24). Citing the same report, Banfill and Peacock (2007) suggested that sustainability is the duty on “*the present inhabitants of the world*” to “*pass it on to the next generation in a state which is no worse than now*” (Banfill & Peacock, 2007:426). However, complex prioritisation and parameters influence building maintenance and environmental sustainability. Bell (1997) highlighted influencing factors in building maintenance, such as least intervention, like for like material replacement and respect for traditional craft skills (Bell, 1997). The degree of success in maintenance of historic masonry buildings relies on conformity to these aforementioned factors. The most effective maintenance interventions in terms of environmental sustainability are those that most suitably accommodate all priorities, parameters and sustainable solutions. In addition to the complexity of prioritisation within the philosophical and economic contexts, a third and emerging factor in the evaluation of maintenance is environmental sustainability. This tripartite approach draws parallels with the generally accepted model of sustainable development (Brundtland, 1987) and offers a potentially useful framework for evaluation of ‘sustainable’ or ‘green’ maintenance interventions (Figure 2.1).

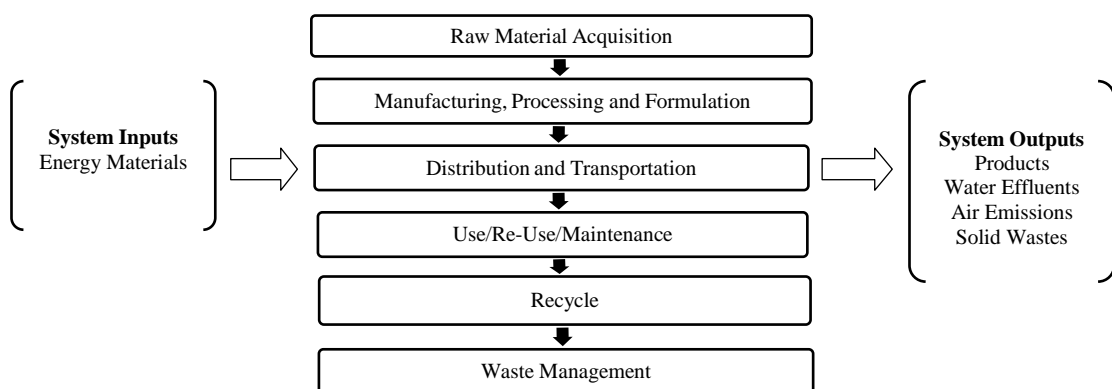
Figure 2.3: Diagrammatically representation of inputs/outputs of LCA

Suh and Hupples (2005) state that the common methods for LCA include process analysis (process flow diagrams and Life Cycle Inventory), input–output analysis, process-based matrix representation and hybrid analysis (Suh and Hupples, 2005). International Standards 14041 and various authors suggest two fundamental methods of LCA based on compilation: i.e. ‘*process analysis*’ and ‘*input-output analysis*’ (Consoli et al., 1993; Raynolds et al., 2000; Suh et al., 2004). Input-output analysis of LCA can be diagrammatically represented as shown in Figure 2.3. Under ‘*process analysis*’, comprehensive assessment has been undertaken using “process-flow diagrams” (Suh et al., 2004).

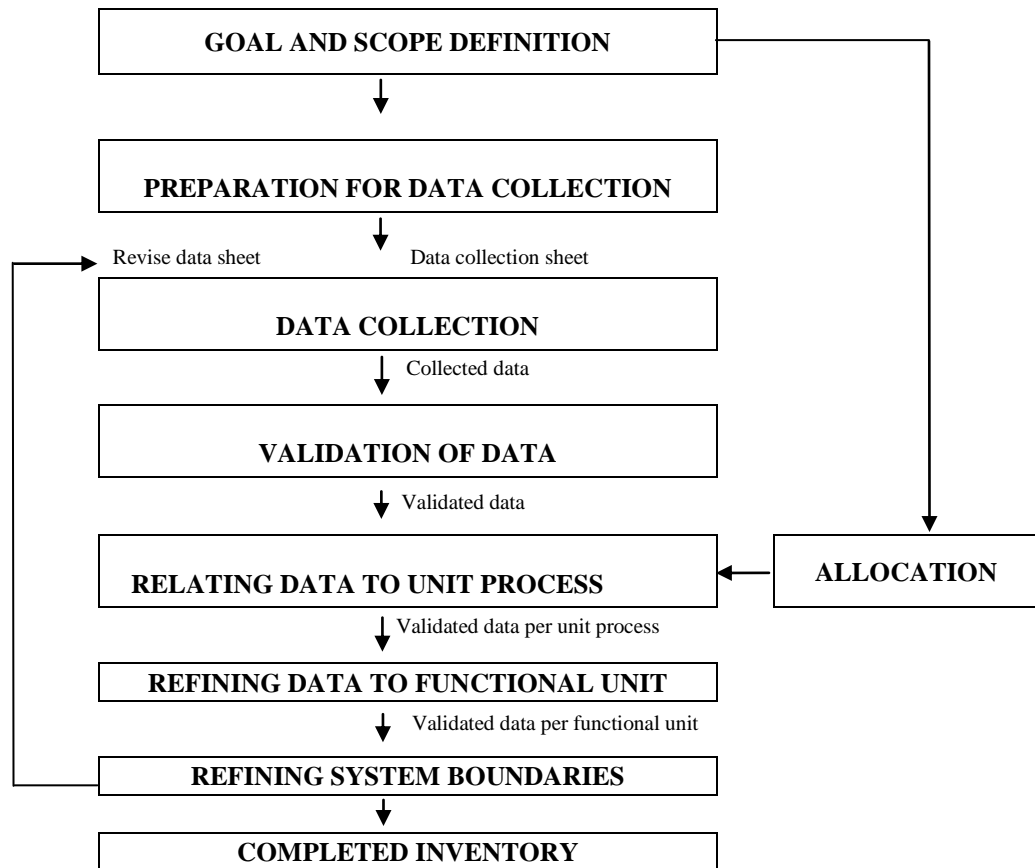
Figure 2.4: Simplified procedures for inventory analysis

Life Cycle Inventories (LCI) (Figure 2.4), are however prone to inaccuracy issues. Khasreen et al., (2009) suggest that “*It is essentially important that the diagram of the process should be as complete as possible to get a high level of accuracy*” (Khasreen et al., 2009: 685).

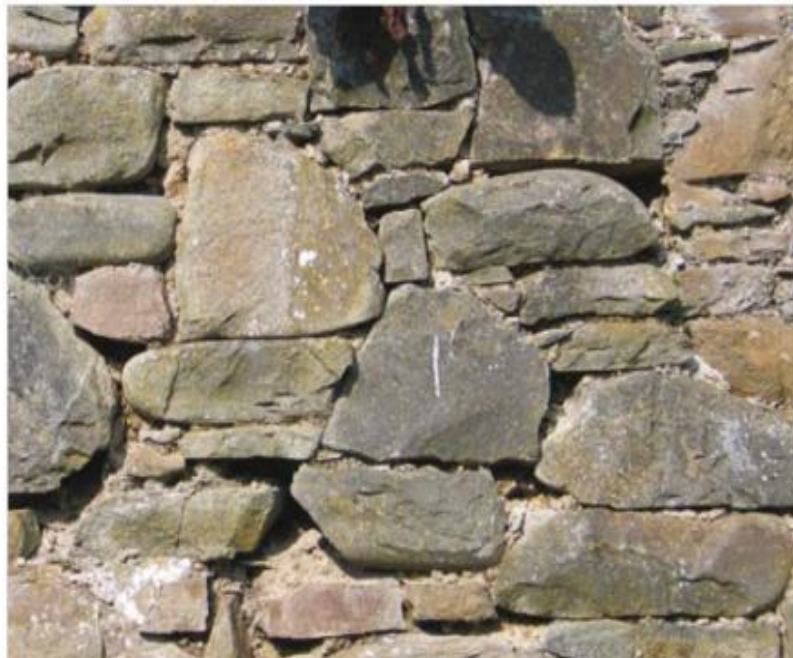
Figure 2.5: Typical example of rubble masonry with lime mortar joints
Source: Historic Scotland, 2007d.

The term “rubble” encompasses many forms of stonework that are commonly categorised as different types: “common” or uncoursed (Figure 2.5), coursed (levelled every 300-600 mm to increase stability or to meet the level of dressed quoins, sills and etc); “squared rubble” (coursed in alternating units – 100, 200 and 300 mm deep – of consistent deep and shallow stones or “shoddie”); “uncoursed squared rubble” or “snecked rubble” (a simple pattern of deep through-stone “risers” combined with long flat “levellers”, which even up the coursing and “snecks” that fill in the gaps); and “block-in Course” (a rare type of Victorian walling in which the blocks were consistent in height, 10 mm joints and >400 mm deep, completed in hammer-finished) (Glasgow West Conservation Trust, 1999: 21). Rubble masonry has traditionally been considered a cheap method of construction when compared with ashlar techniques. Expended carbon for these types of repair must be based on the volume of natural stone, lime mortar transportation and sourcing.

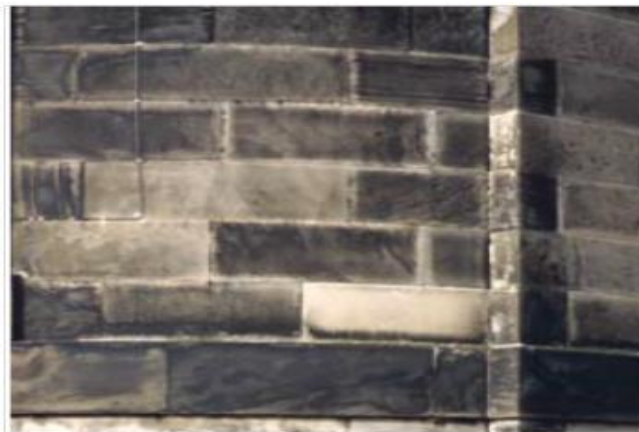
Figure 2.6: Typical example of ashlar masonry with ashlar mortar joints
Source: Historic Scotland, 2007a.

Commonly, ashlar walling was the finest type of stonework (Figure 2.6) requiring the highest workmanship to manufacture and set squared and polished stone blocks (Historic Scotland, 2007a). These were usually cut with a flat bed of the outer six inches (150 mm) from the face, and thus was the most expensive element for stone tenement terraces, terraces and villas. Ashlar blocks of this type of wall were generally seven or eight inches (175-200 mm) thick, bedded in soft lime mortar at a lime : sand ratio of 1:3-4 and often left with $\frac{3}{4}$ inch (20 mm) deep lime putty pointed to an open joint. Header stones were normally placed on every course, commonly between 1.5-3.6m with actual placement depended on the location of window and door openings with “inbands”. It must be emphasised that “pinned” or wedged beds of narrower dimension ashlar blocks have often resulted in chipping off due to uneven pressure (Glasgow West Conservation Trust, 1999: 18-19).

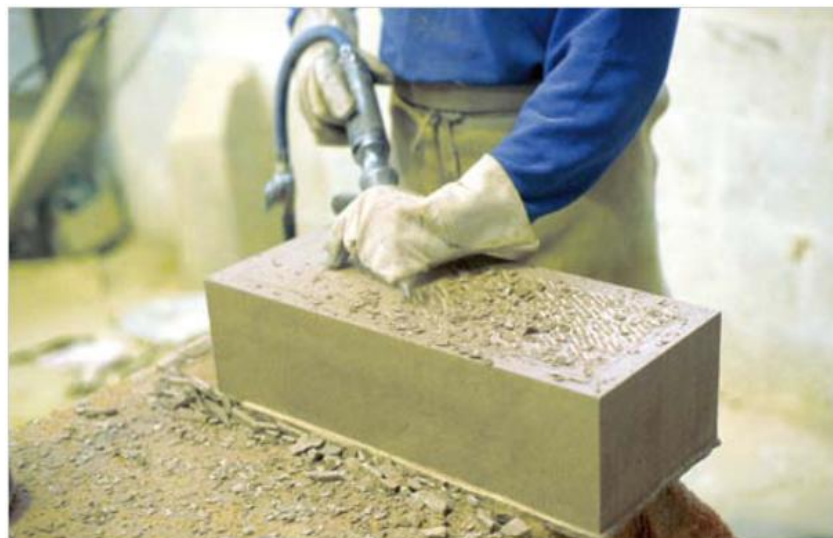
Figure 2.7: Tooling of ashlar masonry

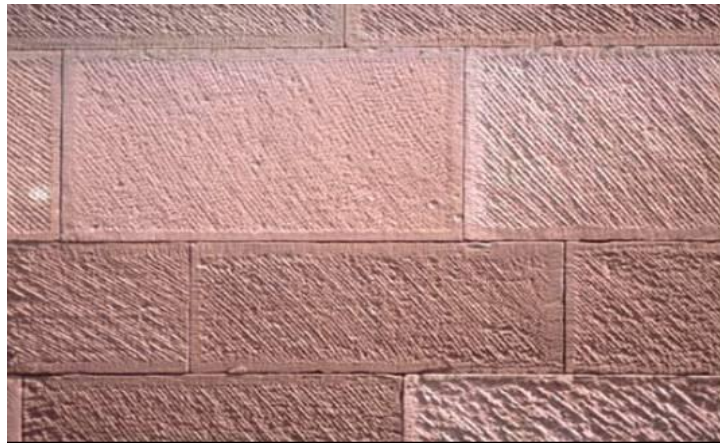
Figure 2.8: Typical example of stone tooling effects

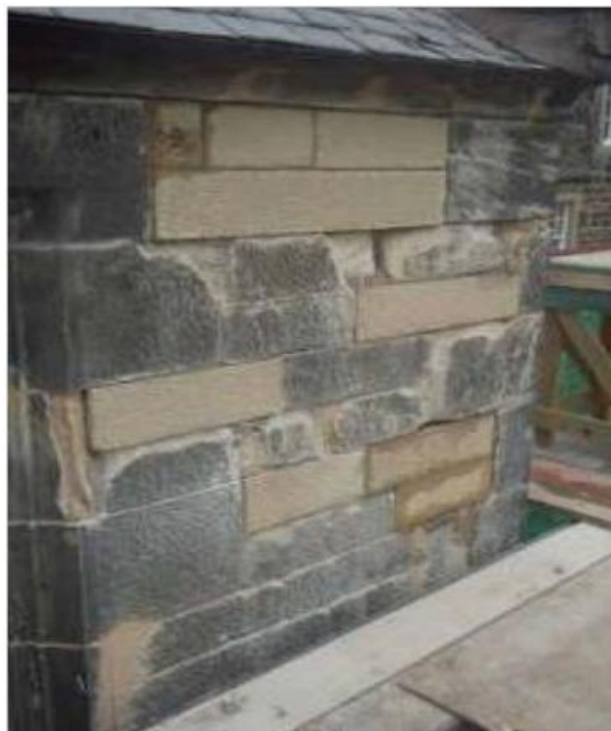
Figure 2.11: Replacing natural stone and built in without cramps
Source: Forster, 2010b.

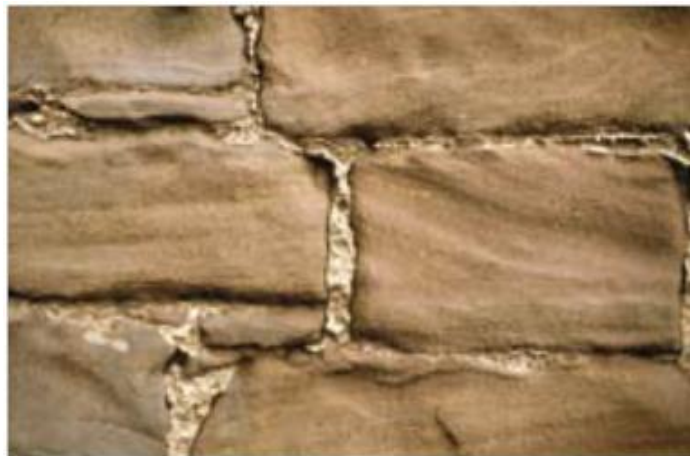
Figure 2.12: Loose joint of rubble stonework

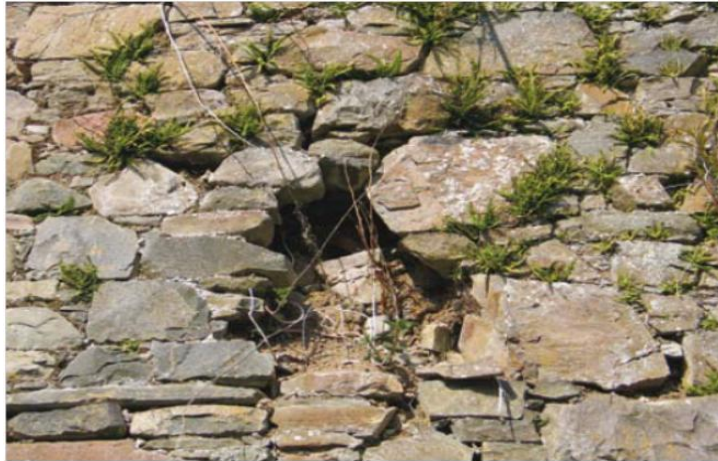
Figure 2.13: Deteriorated mortar that has ultimately led to the loosening and collapse of rubble masonry.

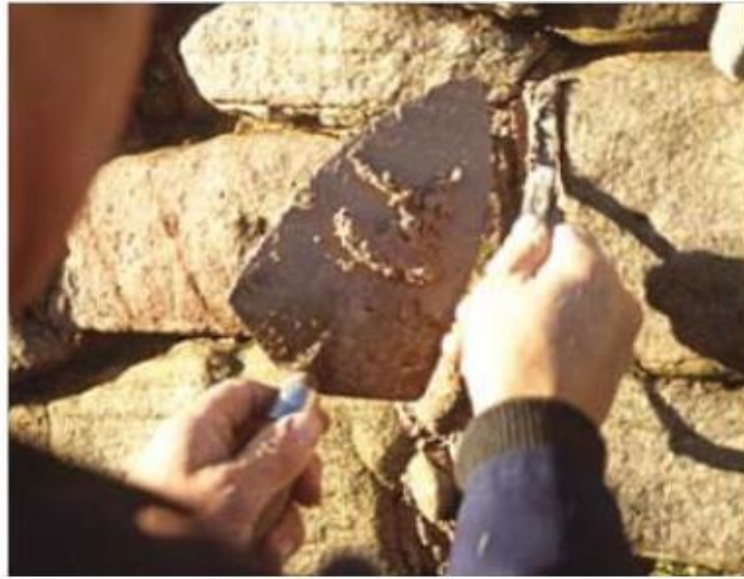
Figure 2.14: Repointing process rubble stonework

Deep joints should be filled with lime mortar tamped to a depth of 25mm from the arris and later pointed and flushed in a separate operation (Glasgow West Conservation Trust, 1999: 44; Historic Scotland, 2007d). This process starts with tamping (pushing new mortar back into the heart/core of the stone masonry wall), followed by pointing (pointing decayed mortar joints) (Figure 2.14), and may also include the pinning of loose stone (in the case of rubble stonework).

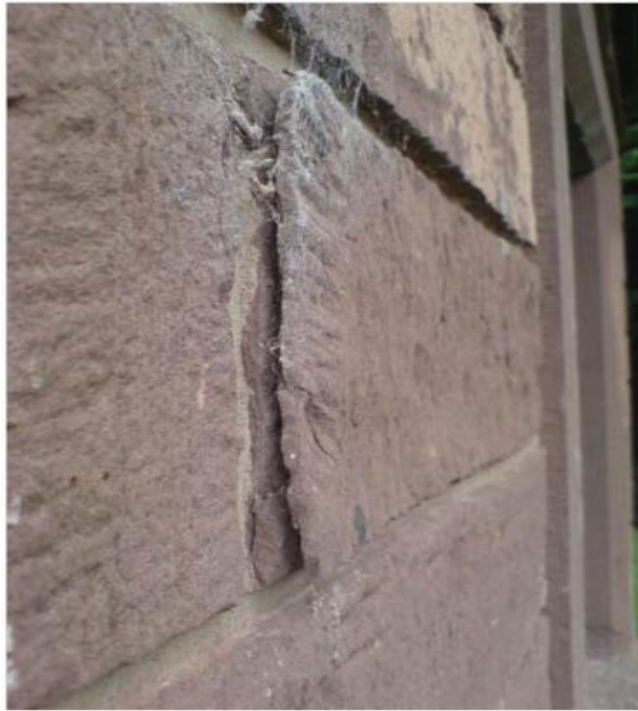
Figure 2.17: Delaminating argillaceous (clay rich) sandstone, Doune Castle
Source: Forster, 2010b.

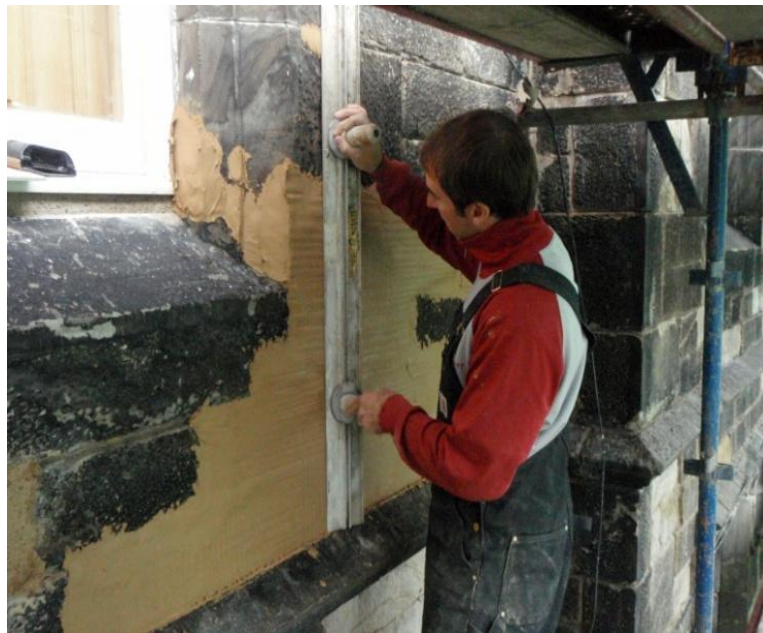
Figure 2.19: Execution of plastic repair to ashlar façade, Edinburgh.

Commonly, plastic repairs are an alternative option for stone masonry walls and are characterised as a surface repair to deteriorated masonry faces (Figure 2.19). It must be emphasised that the term ‘plastic’ relates to the plasticity of the materials in application, rather than implying that they contain polymers (Ashurst and Ashurst, 1988). Using this technique, deteriorated and friable stone is ‘cut-back’ (minimum 15 mm) until a sound surface is achieved, upon which lime mortars are used to resurface the stone.

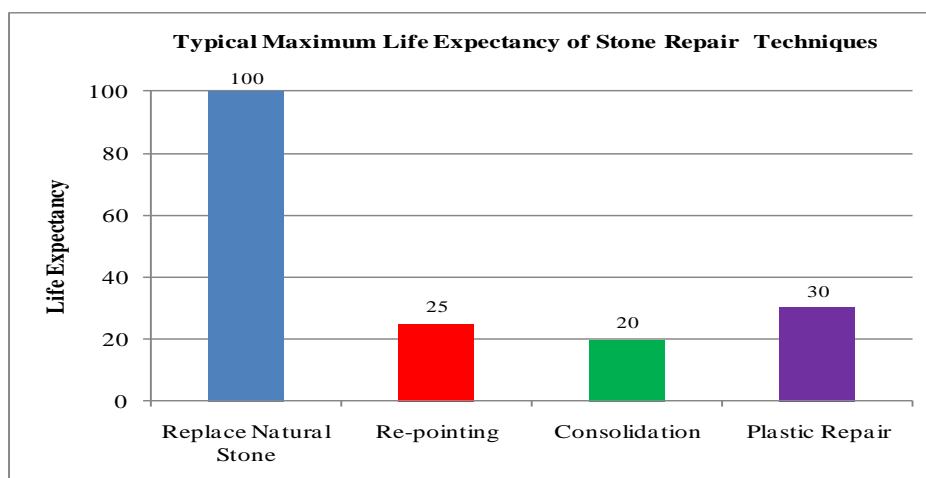
Figure 3.1: Typical approximate maximum life expectancy of different stone masonry wall repair techniques

Figure 3.1 illustrates the typical approximate maximum life expectancy (longevity of repair) of different repair techniques for stone masonry walls. It reveals that different stone masonry wall repair techniques have different life expectancies and, therefore, contribute to different embodied carbon expenditure.

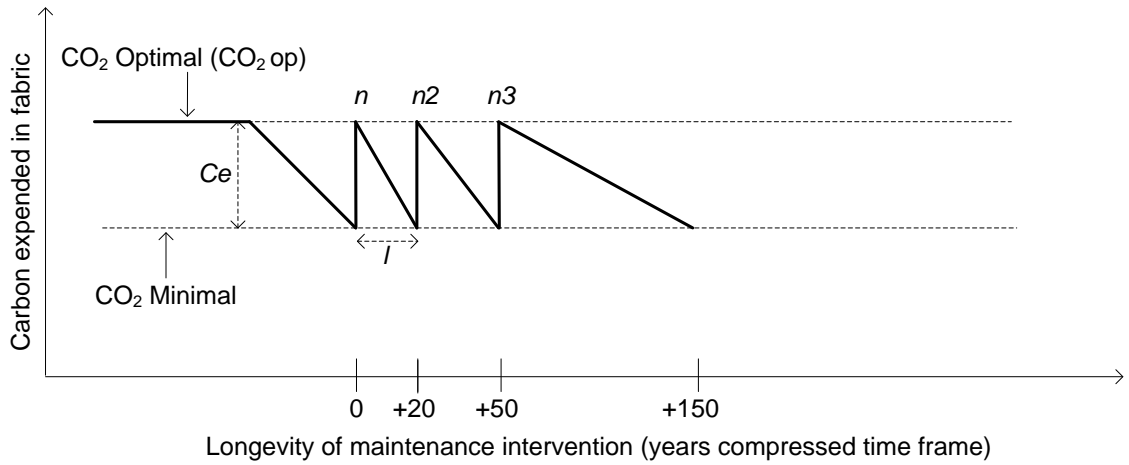
Figure 3.4: Determination of theoretical ‘Environmental Maintenance Impact’ (EMI) of maintenance interventions

repair (l). The total embodied carbon expended by maintenance interventions through repair is illustrated by Equation No. (1).

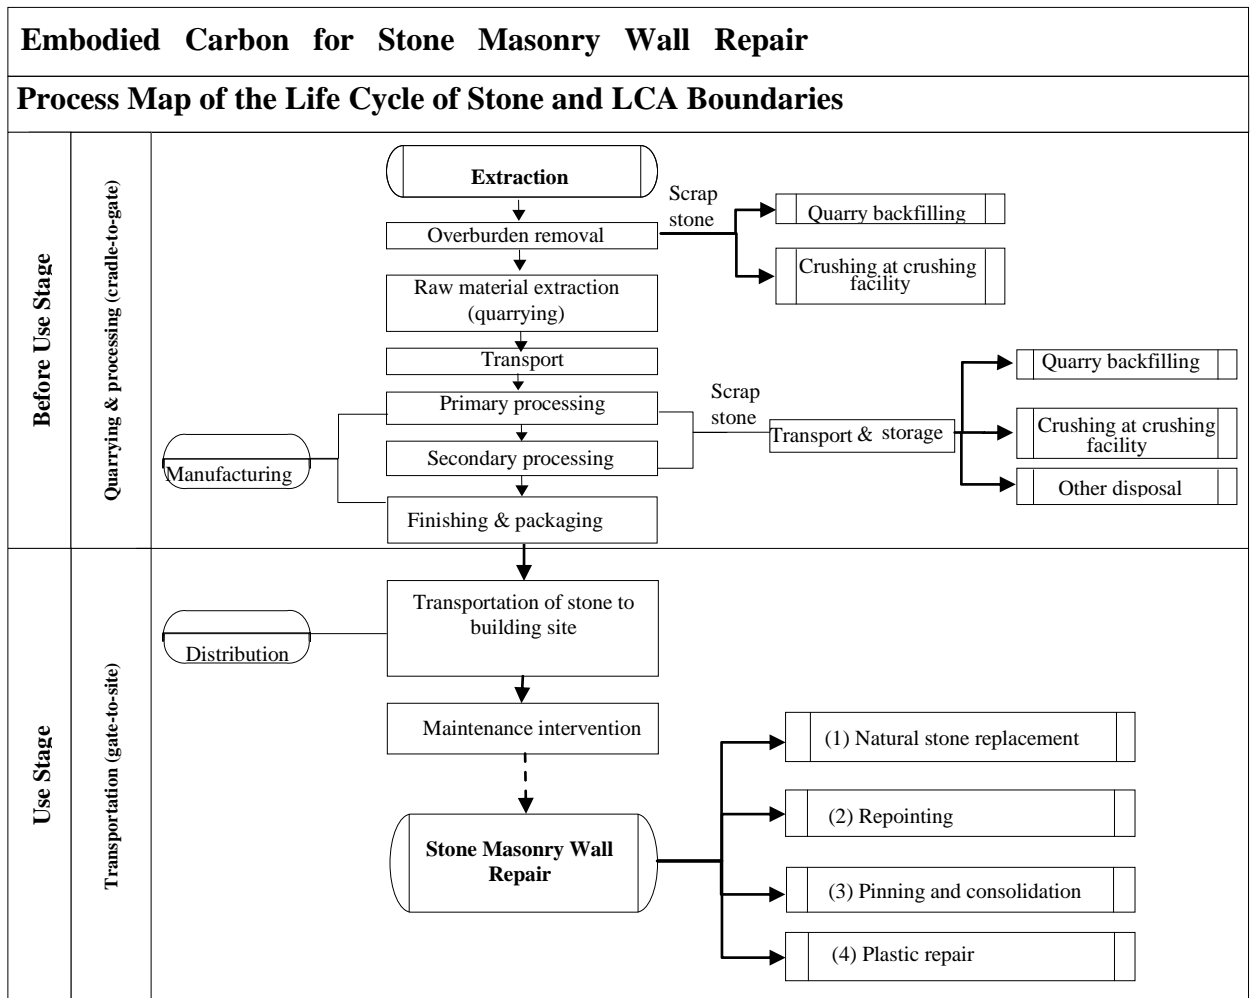
Figure 4.2: Process map of the life cycle of stone for historic buildings

The first step of the 'Green Maintenance' model methodological framework attempted to investigate the stone masonry wall repair association with embodied carbon expenditure. In this first step, the life cycle of stone masonry walls for historic masonry buildings was represented in a repair process map (Figure 4.2). The repair processes of stone masonry walls were illustrated in a flow diagram of their life cycle, starting from their resourcing to eventual repair. Prior to mapping out the process, it must be noted that repair processes of stone masonry walls were verified by selected collaborative partners for this research. Wherever applicable, justifications were clearly stated throughout this research for any selected relevant criteria, assumptions and decisions, and inclusions or exclusions of life cycle stages of stone masonry wall repair materials for embodied carbon expenditure calculations (see Optis and Wild, 2010: 647).

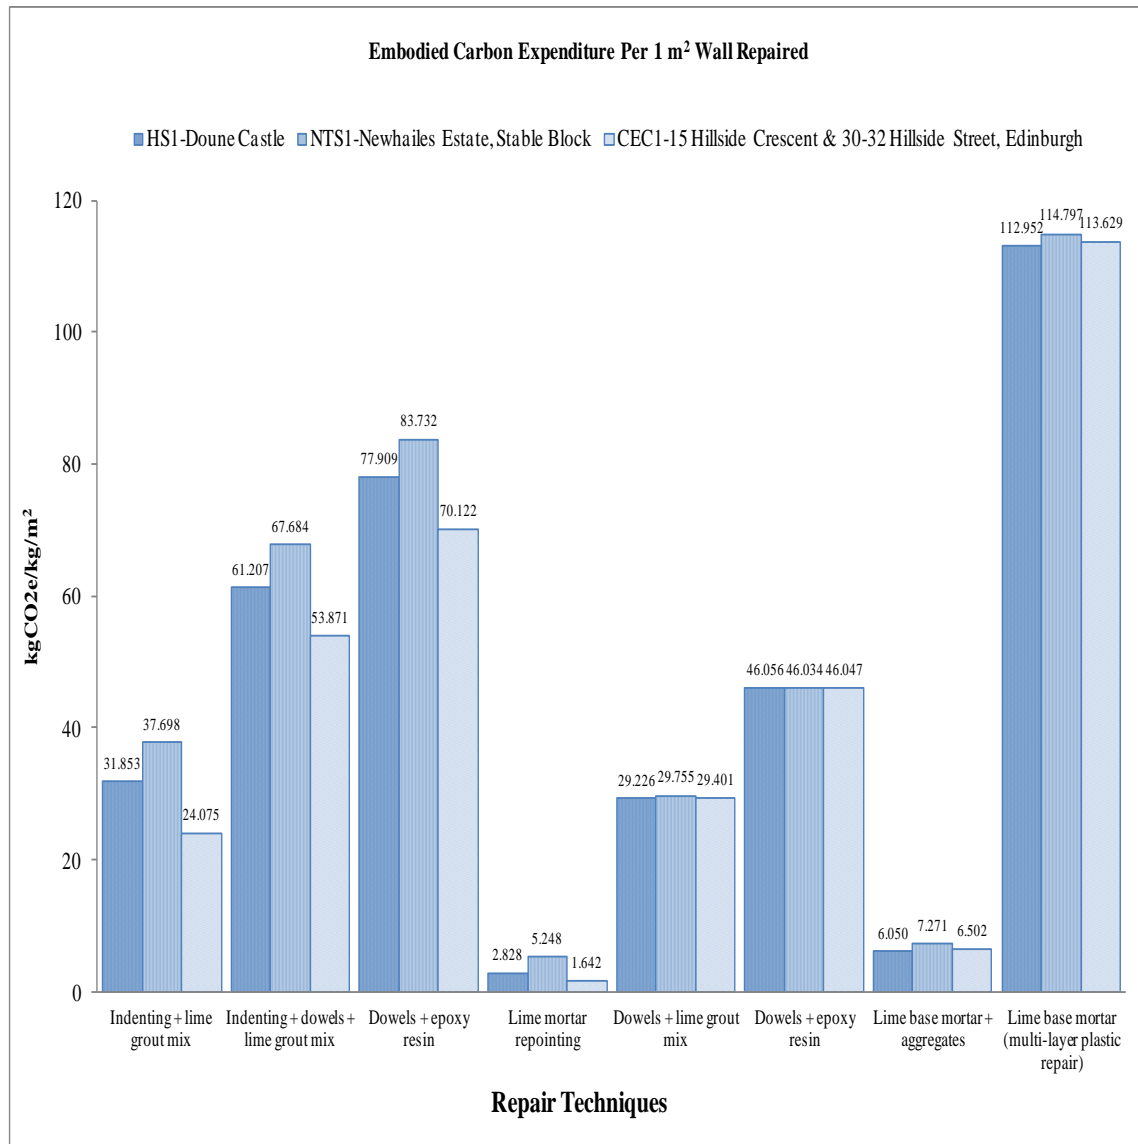
Figure 5.1: Total embodied carbon expenditure per 1m² repaired wall (kgCO₂e/kg/m²) for typical selected sample properties

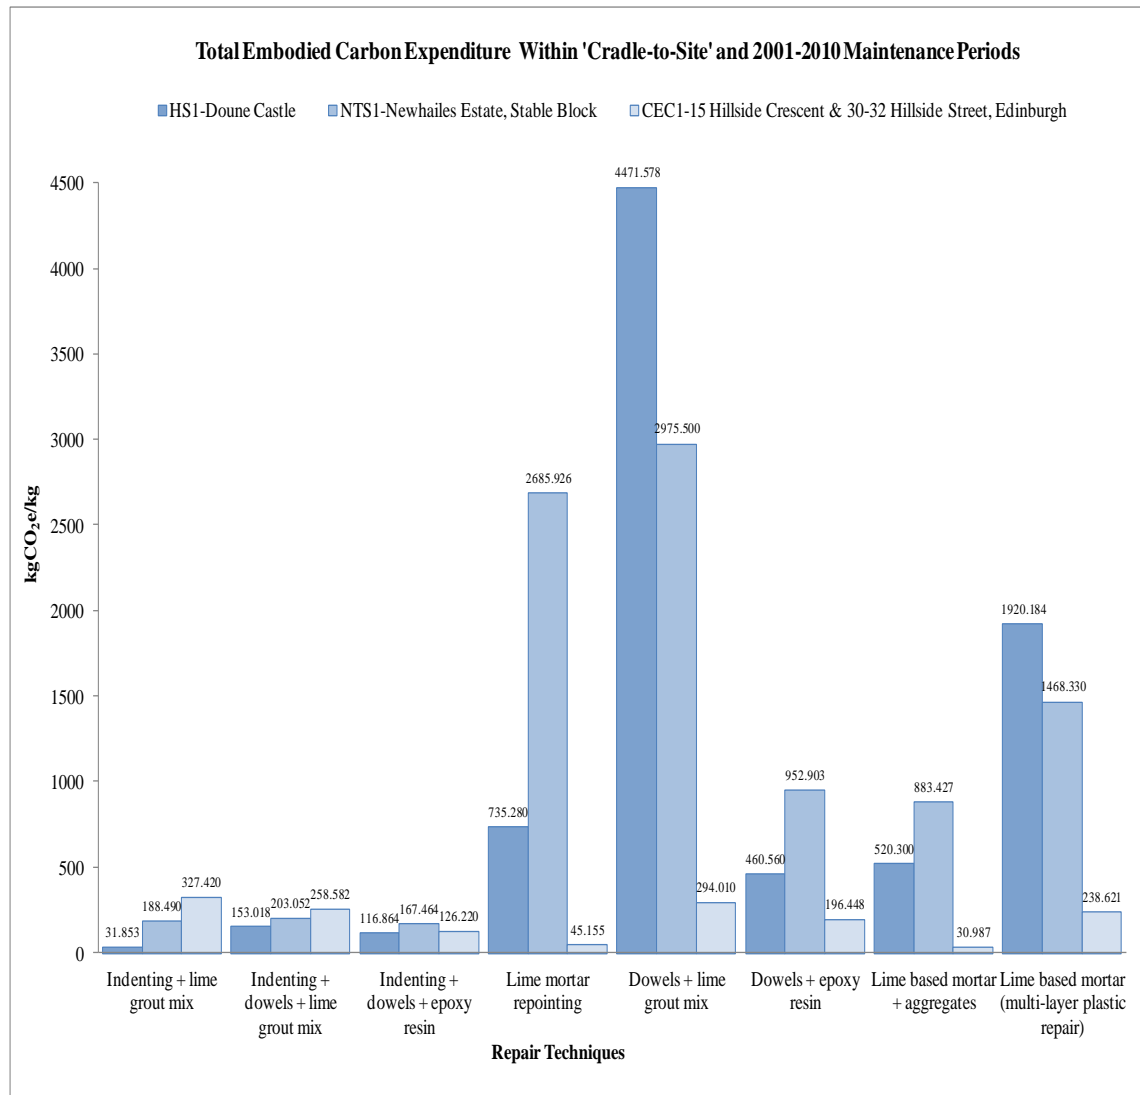
Figure 5.2: Total embodied carbon expenditure for typical selected sample properties

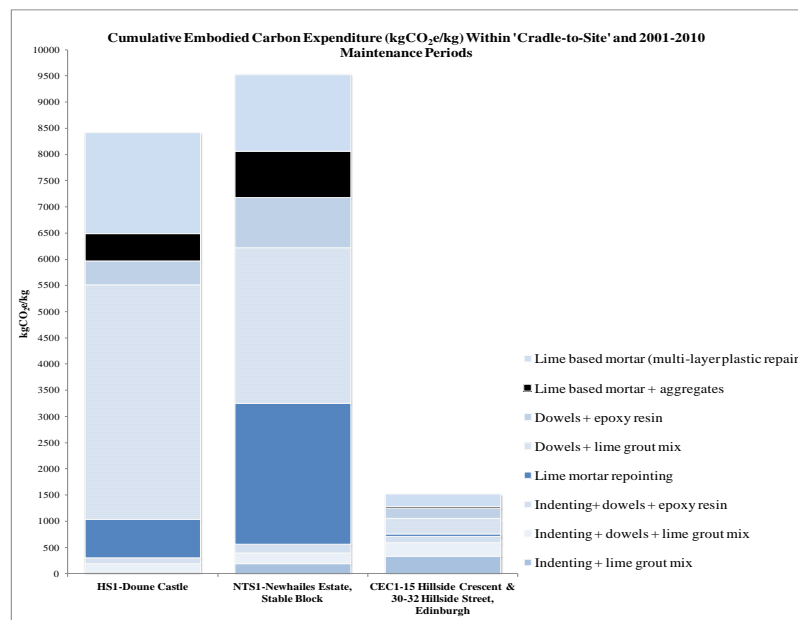
Figure 5.3: Cumulative embodied carbon expenditure for typical selected sample properties

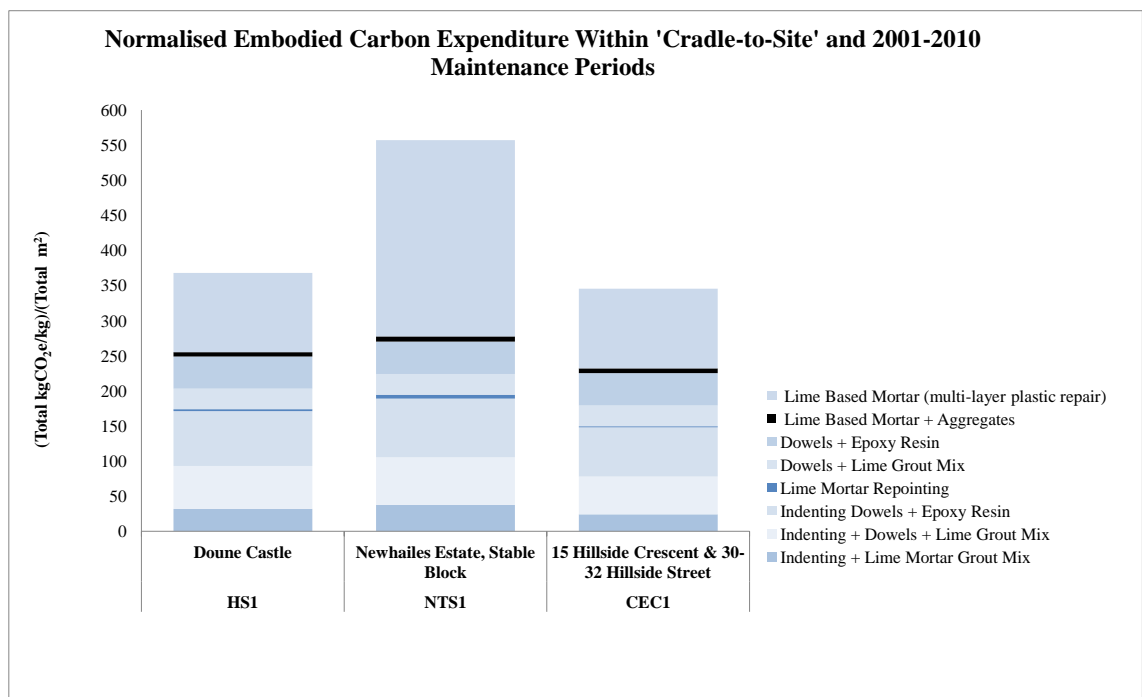
Figure 5.4: Normalised embodied carbon expenditure [(Total kgCO₂e/kg)/(Total m²)]

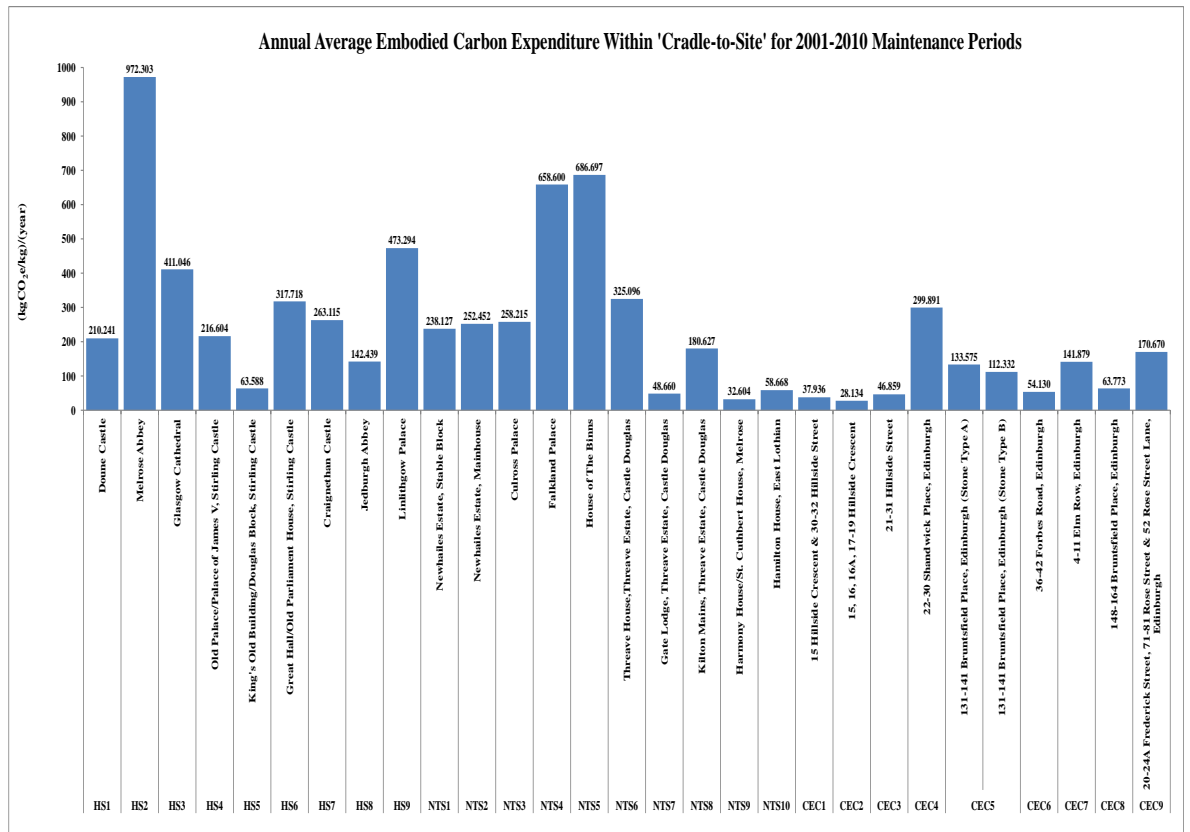
Figure 5.6: Annual average embodied carbon expenditure for selected sample properties.

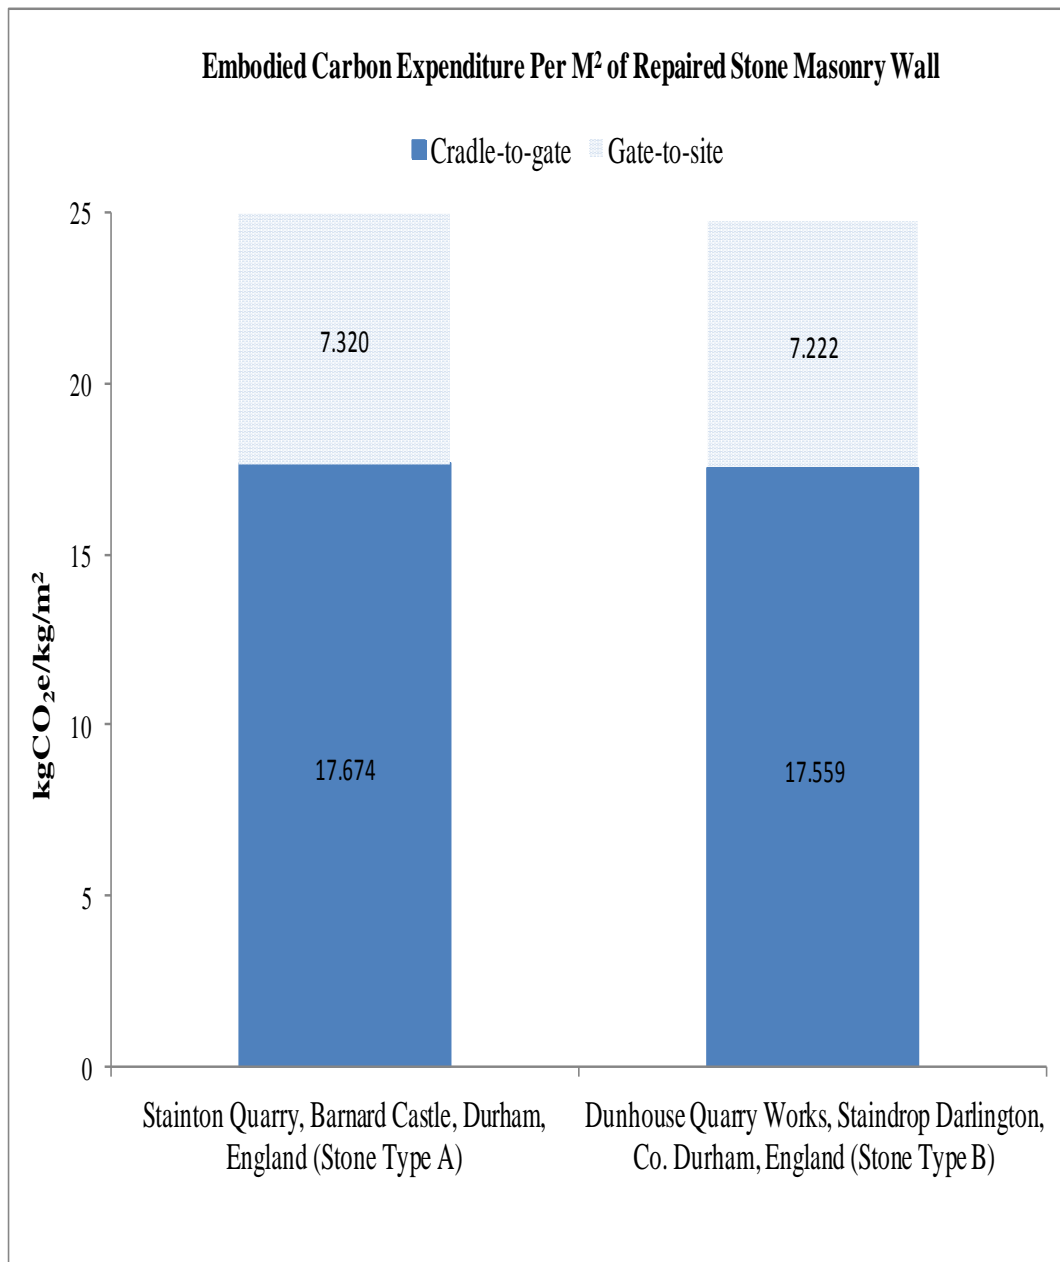
Figure 5.7: Embodied carbon expenditure per m² of repaired stone masonry wall (kgCO₂e/kg)
